PLANNING & ZONING COMMISSION FEBRUARY 7, 2023

LEE RESIDENCE
507 97 CIRCLE-2206
COLOR/MATERIAL BOARD
12.09.22

TO: Michelle Eddy, CMC/CPM - Town Manager/Clerk
FROM: Kyle Parag, Plan Reviewer/Building Official - CAA
DATE: December 19, 2022
RE: Planning/Zoning/Architectural Guidelines review – 0507 97 CIR

LEE RESIDENCE
507 97 CIRCLE BLUE RIVER, COLORADO

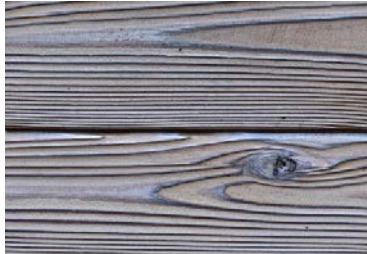
HORIZONTAL SIDING

SHIP LAP-NAKAMOTO FORESTRY-PIKA PIKA-'SOLAR SHIELD WHITE'

5 HORIZONTAL SIDING
SHIP LAP-NAKAMOTO FORESTRY-PIKA PIKA-'SOLAR SHIELD WHITE'

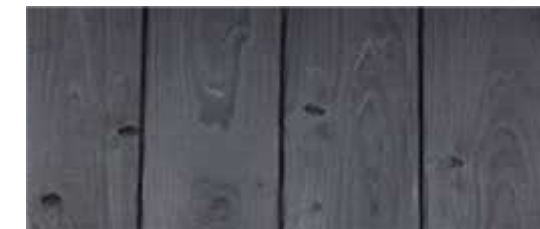
6 VERTICAL SIDING
SHIP LAP-NAKAMOTO FORESTRY-GENDAI-'ALKYD OIL BLACK'

VERTICAL SIDING

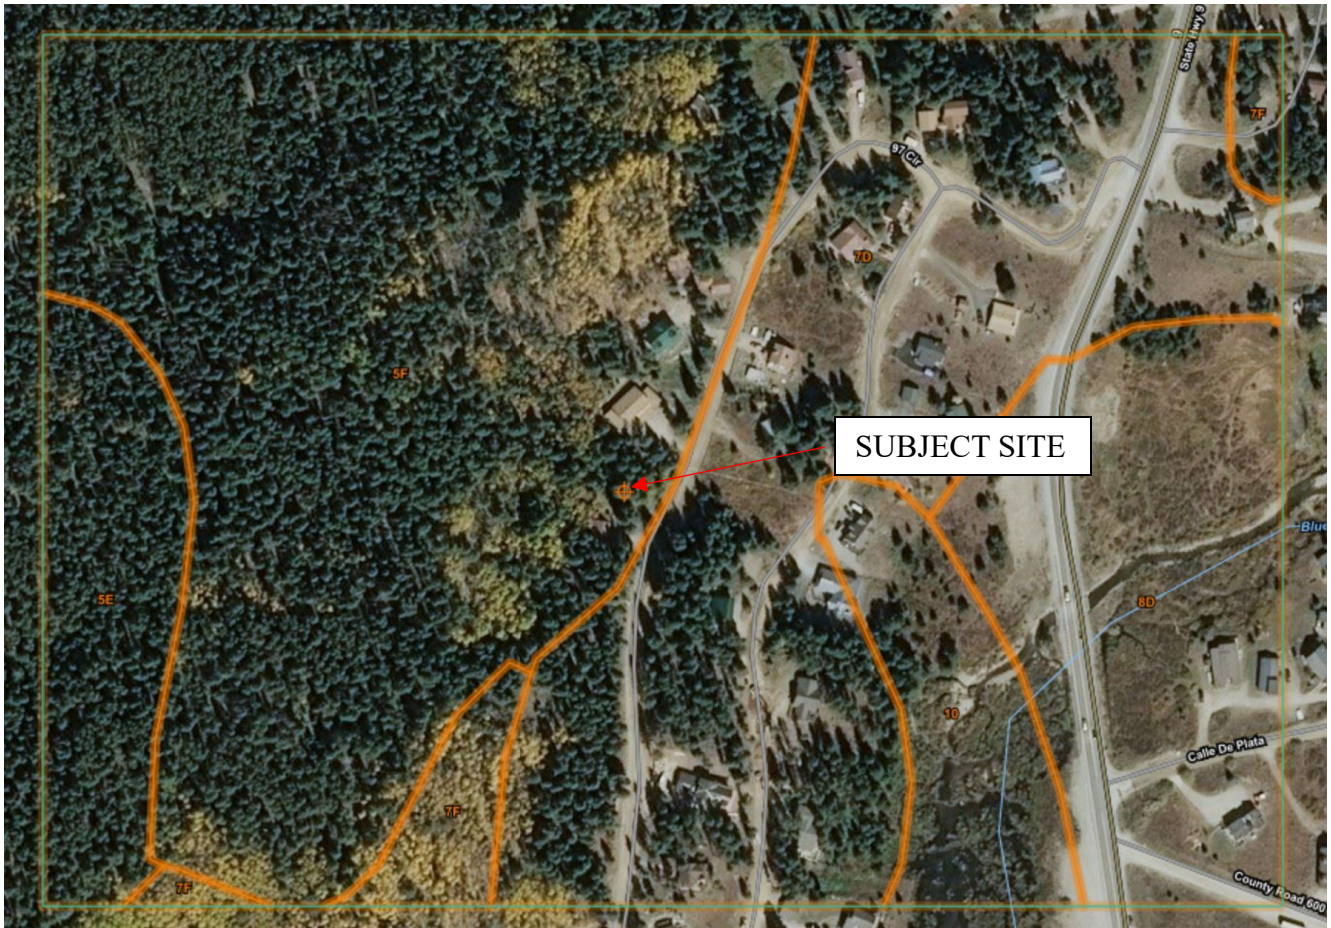
Hydric soils were encountered within the wetlands. The hydric soils generally consisted of saturated soils with low chroma and value and redoximorphic features. Sandy hydric soils were also encountered at the site. See attached data forms for more specific information regarding soil types. According to NRCS soils map data, the wetland areas of the project are located within the mapping unit 5F – Frisco-Peeler Complex with 25% – 65% slopes.

Figure 2 – USDA Web Soil Survey Mapping
