CITY of BRISBANE

Planning Commission Meeting Agenda

A RESOLUTION OF THE PLANNING COMMISSION OF BRISBANE
CONDITIONALLY APPROVING GRADING REVIEW 2024-EX-4, USE PERMIT 2024-UP-3 LOT
MERGER 2024-LLA-2, HABITAT CONSERVATION PLAN COMPLIANCE 2024-HCP-1
TO ALLOW AN APPROXIMATELY 5,000 SQUARE FOOT EXPANSION OF THE CURRENT
CONTRACTOR'S STORAGE YARD PREVIOUSLY PERMITTED UNDER UP-9-12
AT 3708 BAYSHORE BOULEVARD

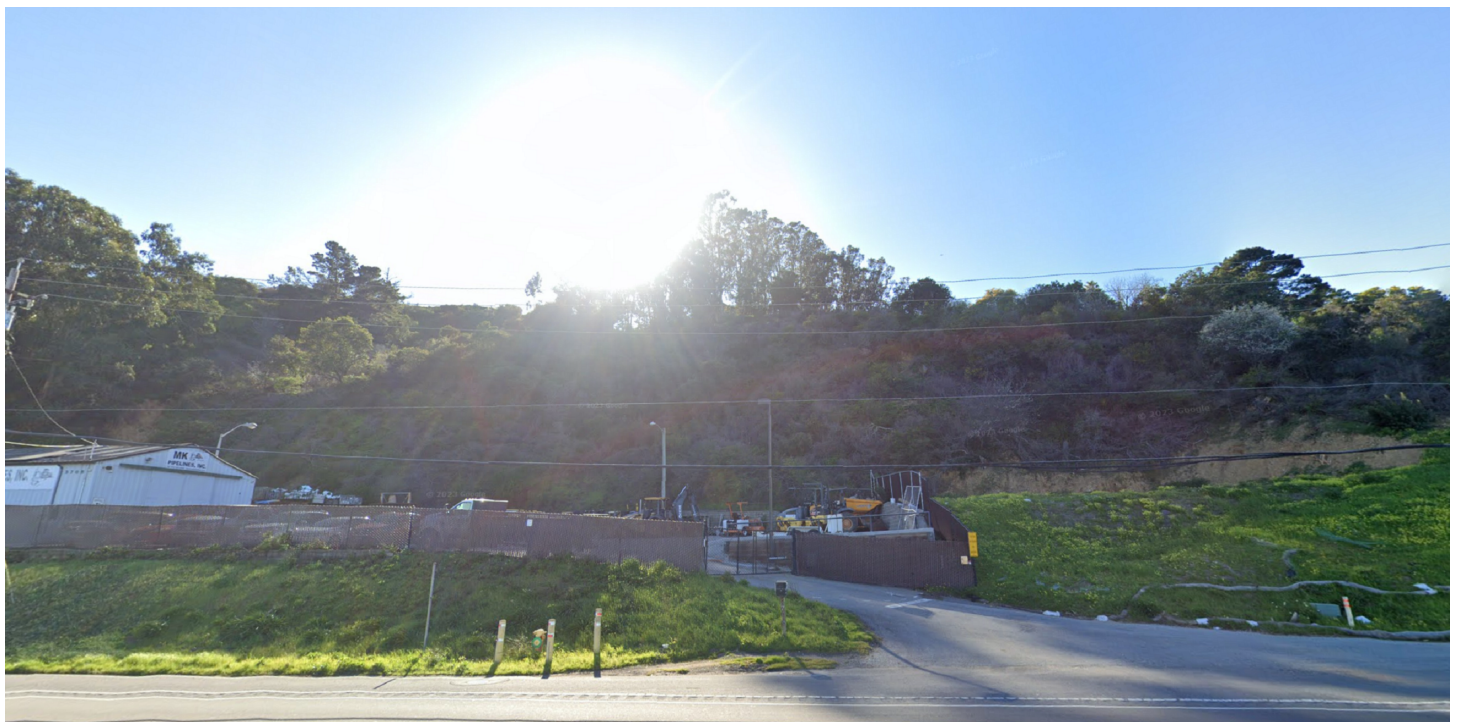
Existing facility above; proposed expansion lower right

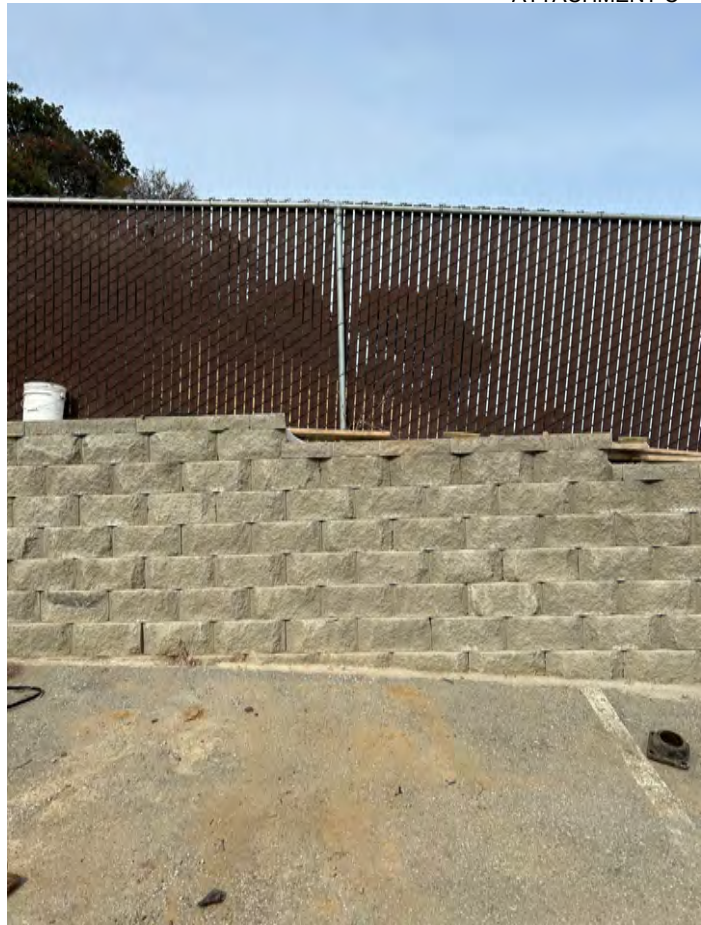
Existing brown-slatted fence and Allen-block retaining wall used throughout the site

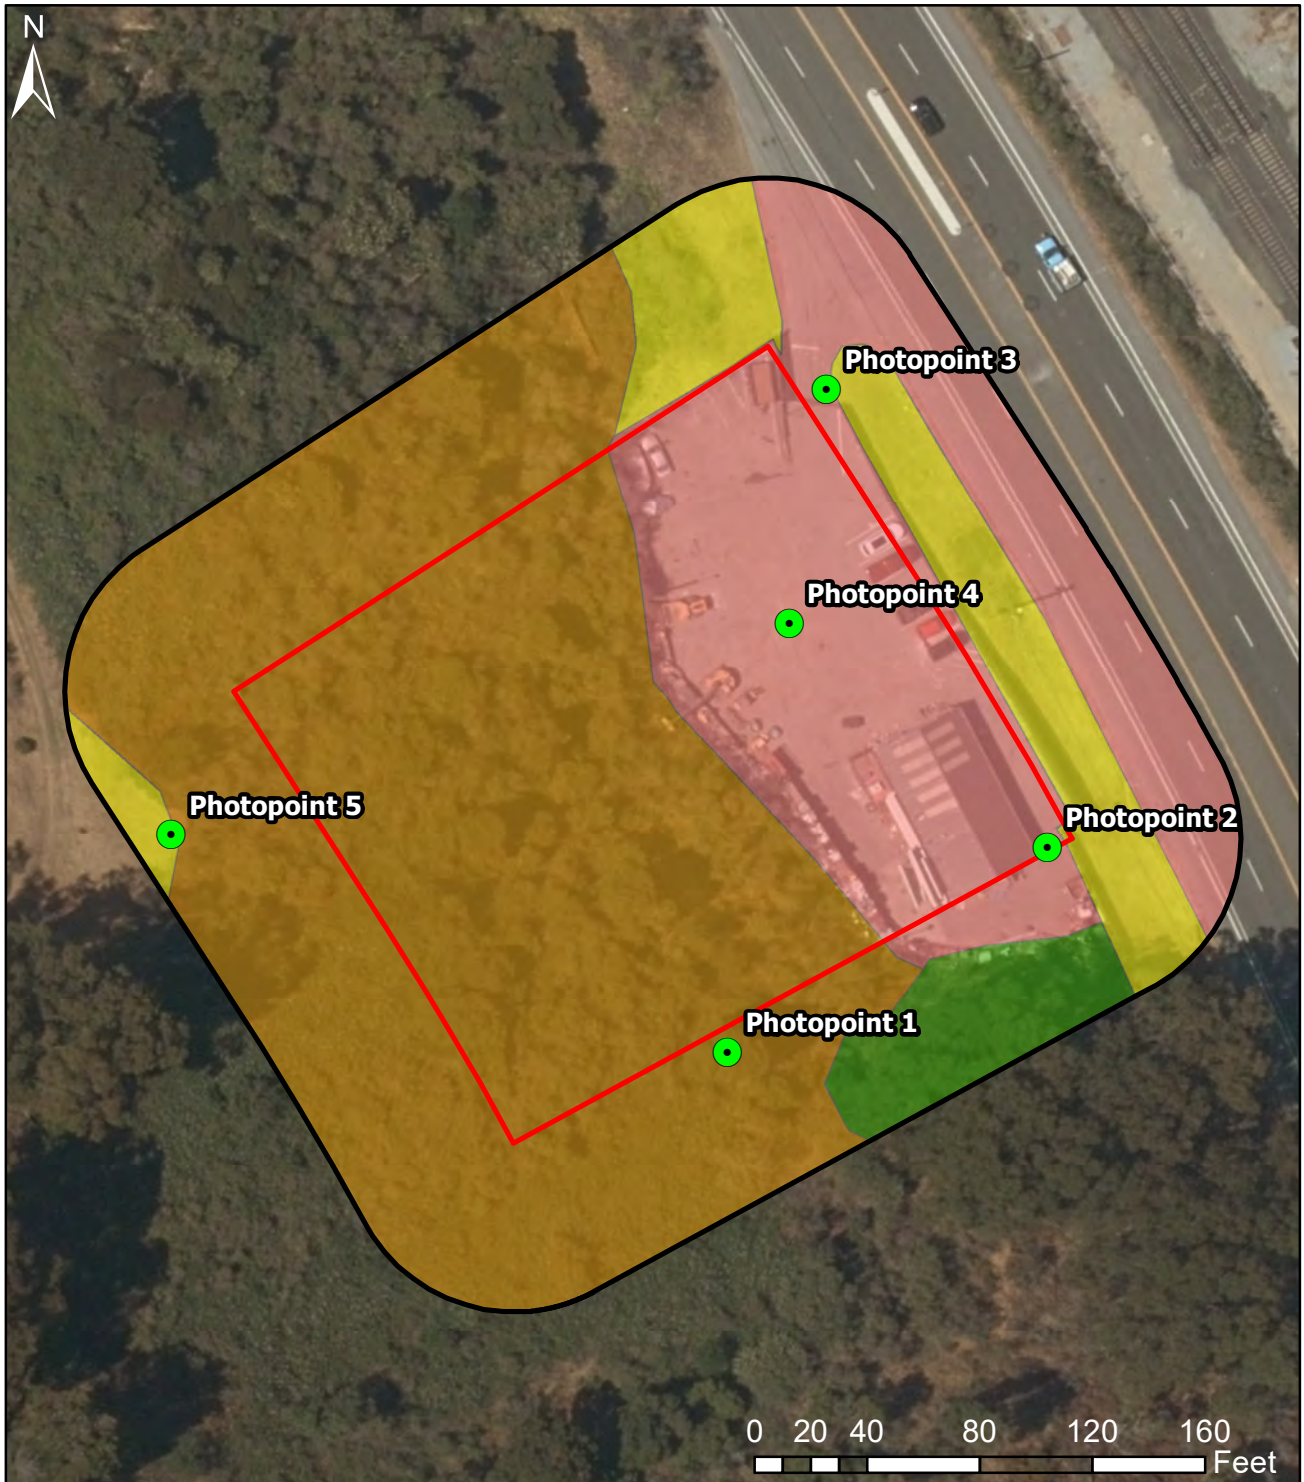
Figure 3: Plant Communities and Photopoints Map

A total of four vegetation communities are found within the study area: **French Broom Semi-Natural Shrubland Stands, Developed, Eucalyptus Semi-Natural Woodland Stand and Wild Oats Semi-Natural Herbaceous Stands** (CNPS, 2009). Only two of these vegetation communities are found within the project parcels; French Broom Semi-Natural Shrubland Stands and Developed. The location of the plant communities within the survey area are shown in Figure 3.

Map Key ¹	MCV Alliance	MCV Association	Misc.	Status	Condition	Acres Total	Acres Impacted	Comments
PC1	Semi-Natural Shrubland Stands	Broom patches	Toyon and coyote brush provide some native cover		Intact	1.42	0	Non-native dominant
PC2	Developed		Developed	None		0.69	0	Generally unvegetated, paved asphalt surface
PC3	Semi-Natural Herbaceous Stands	Wild oats grassland			Intact	0.25	0	Non-native dominant
PC4	Semi-Natural Woodland Stands	Eucalyptus groves		None	Intact	0.10	0	Non-native dominant.
					Totals		0

P-designation refers to Photopoint locations illustrated on Figure 3. Plant Communities Map.

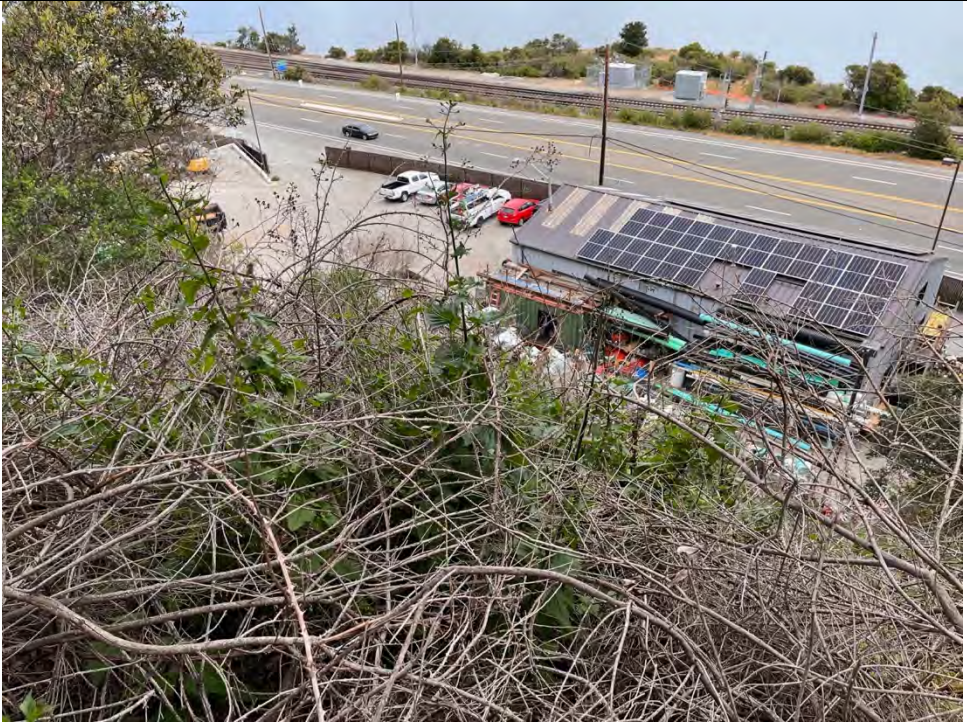
<p>3708 Bayshore Blvd</p>	
<p>Map Key</p>	
<p>P1</p>	
<p>View Direction</p>	
<p>Northeast and downslope.</p>	
<p>Description</p>	
<p>View of parcels from south edge. California figwort, Himalayan blackberry, French broom, and toyon are visible on the hillside. The construction yard and Bayshore Blvd. are in the mid-ground.</p>	
<p>Location</p>

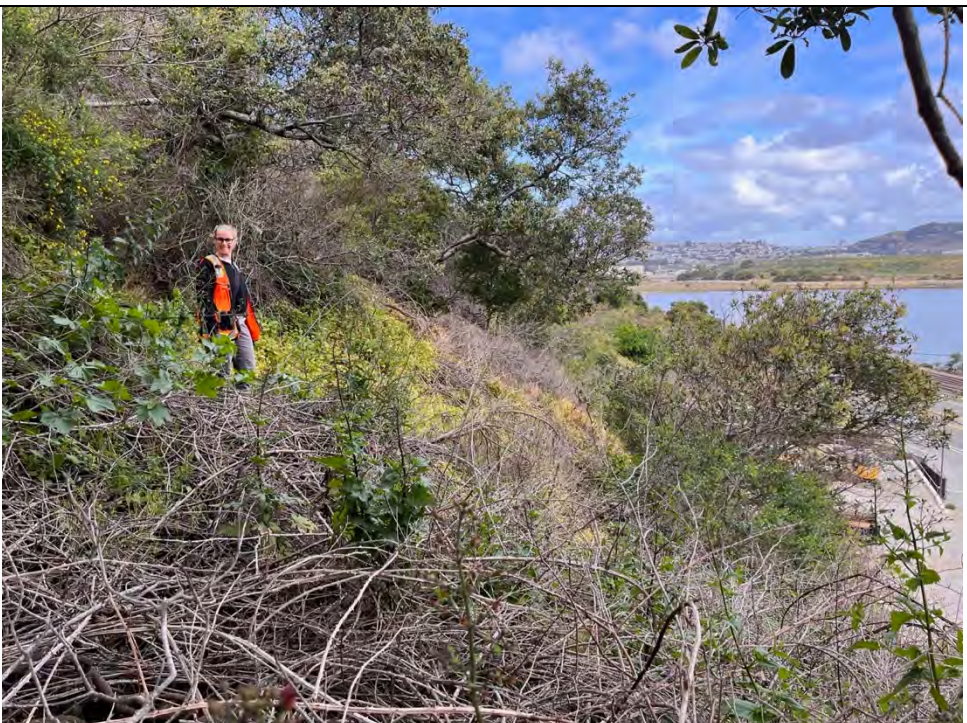
<p>3708 Bayshore Blvd</p>	
<p>Map Key</p>	
<p>P1</p>	
<p>View Direction</p>	
<p>Northwest</p>	
<p>Description</p>	
<p>View of vegetation on the steep western slopes of the parcel, including Himalayan blackberry, California figwort, French broom, and toyon.</p>

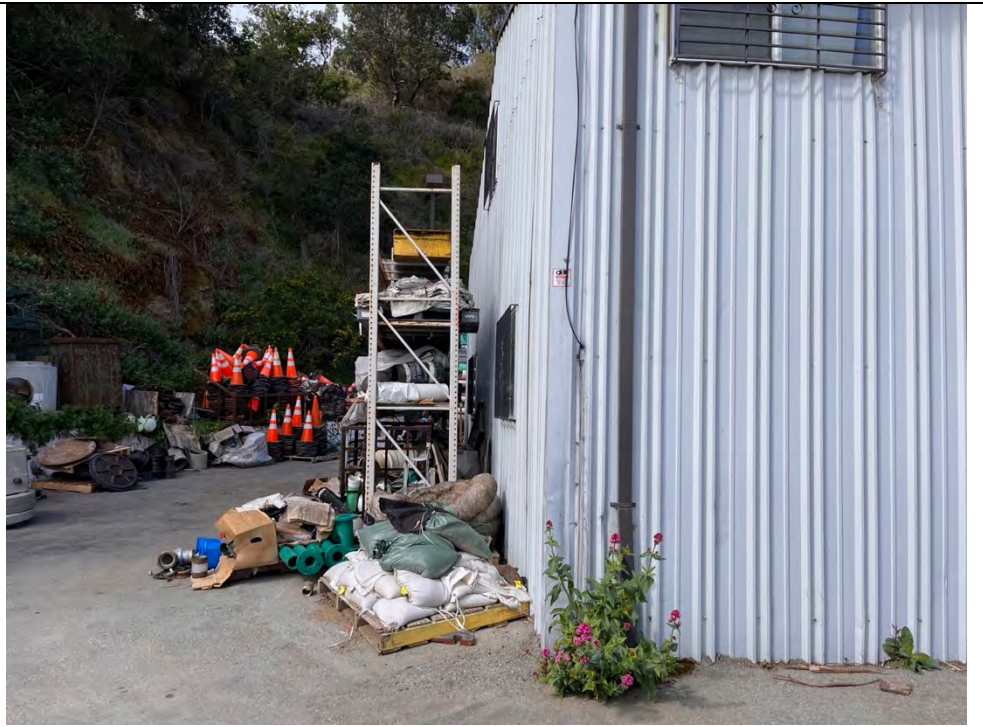
Location
3708 Bayshore Blvd
Map Key
P2
View Direction
West
Description
View of the office building and supplies on the construction lot, as well as the steep hillside in the background.

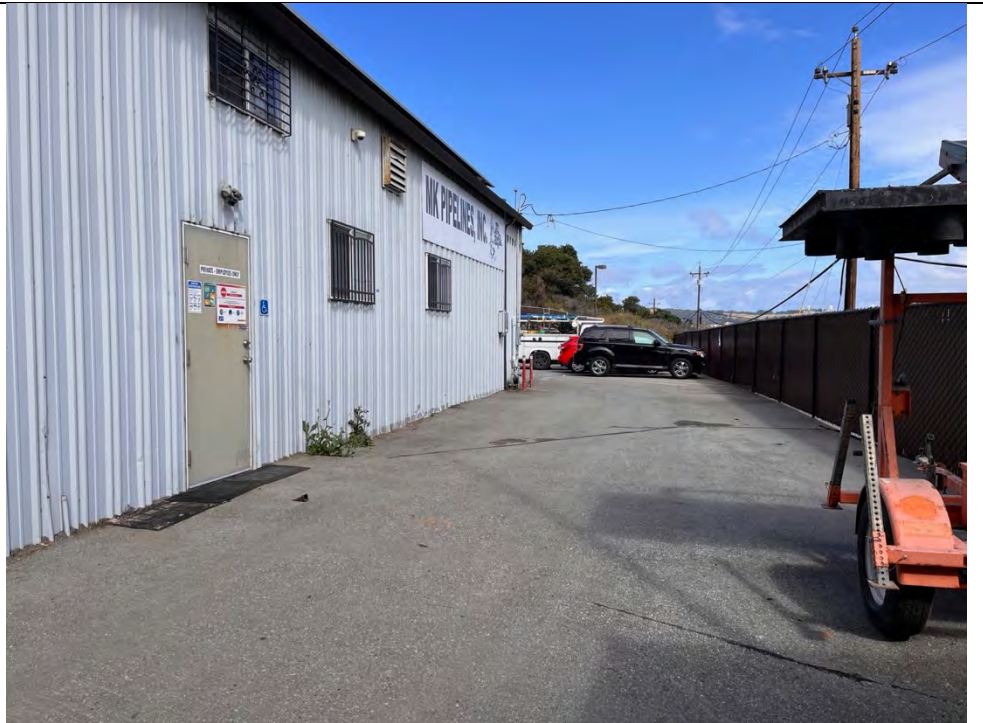
Location
3708 Bayshore Blvd
Map Key
P2
View Direction
North
Description
View of the office building on the construction lot, and the paved asphalt parking area.

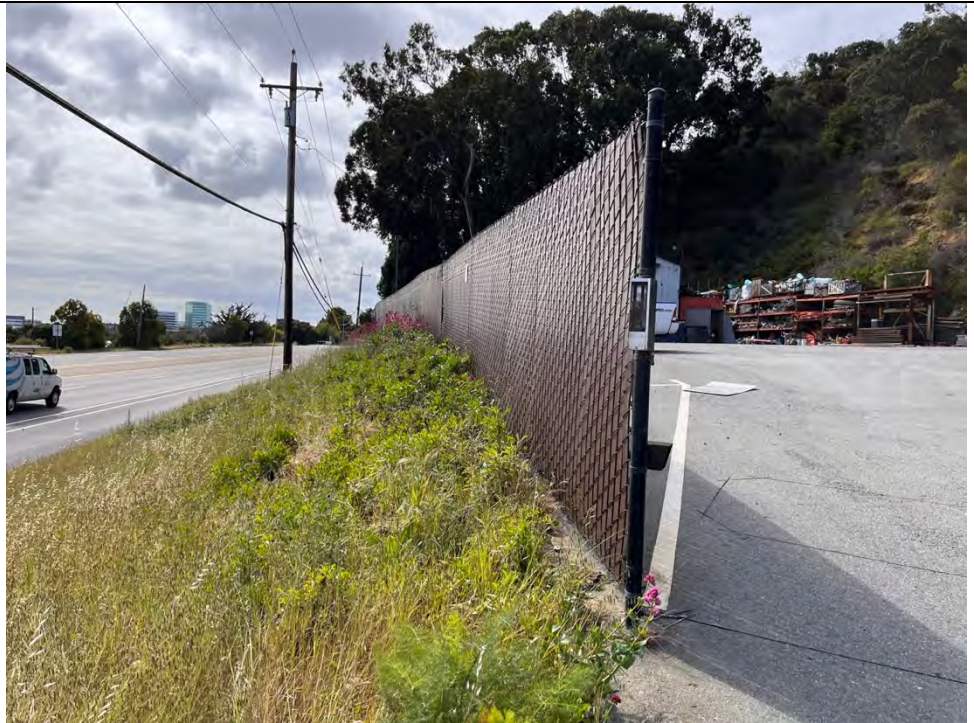
Location
3708 Bayshore Blvd
Map Key
P3
View Direction
South southeast
Description
View of the MK Pipelines, Inc construction lot on the right, and the non-native oat grassland and Bayshore Blvd on the left.

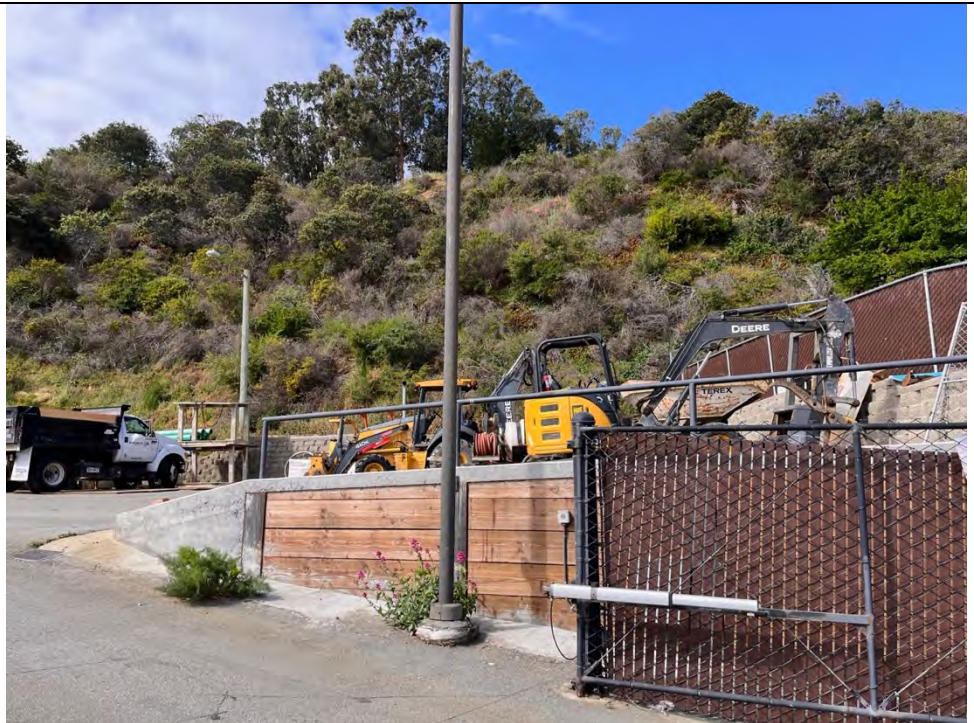
Location
3708 Bayshore Blvd
Map Key
P3
View Direction
Southwest
Description
View of the driveway to the parcels/ the MK Pipelines, Inc construction lot in the foreground, with the steep vegetated slope in the background.

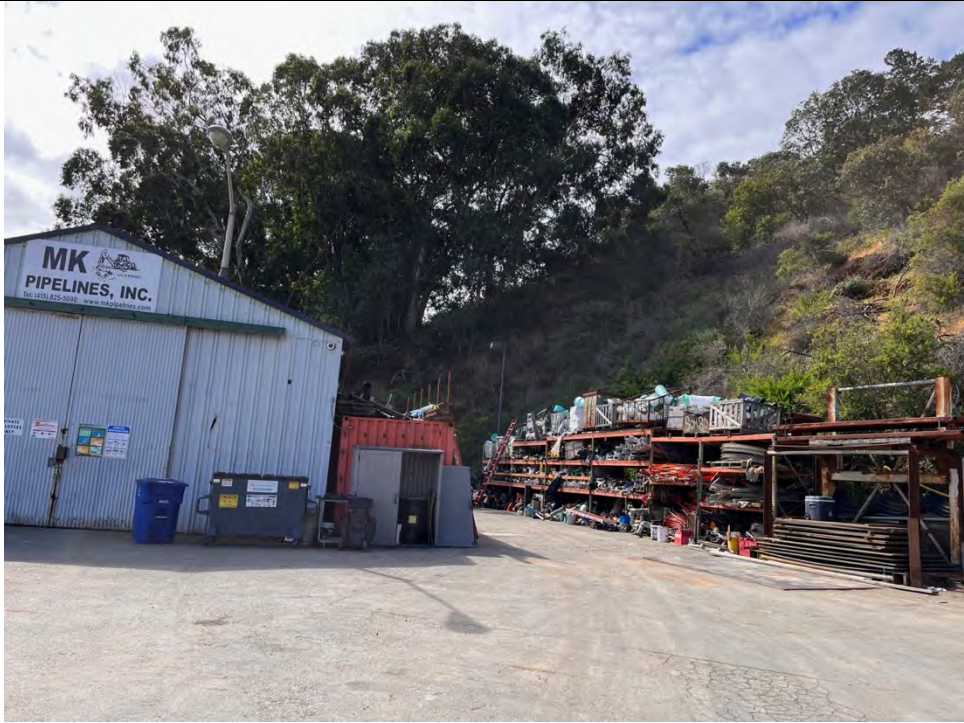
3708 Bayshore Blvd	
Map Key	
P4	
View Direction	
South southeast	
Description	
View of the MK Pipelines, Inc construction lot, and office building, with the vegetated slope in the background, including the eucalyptus grove located within the study area but outside the parcels.

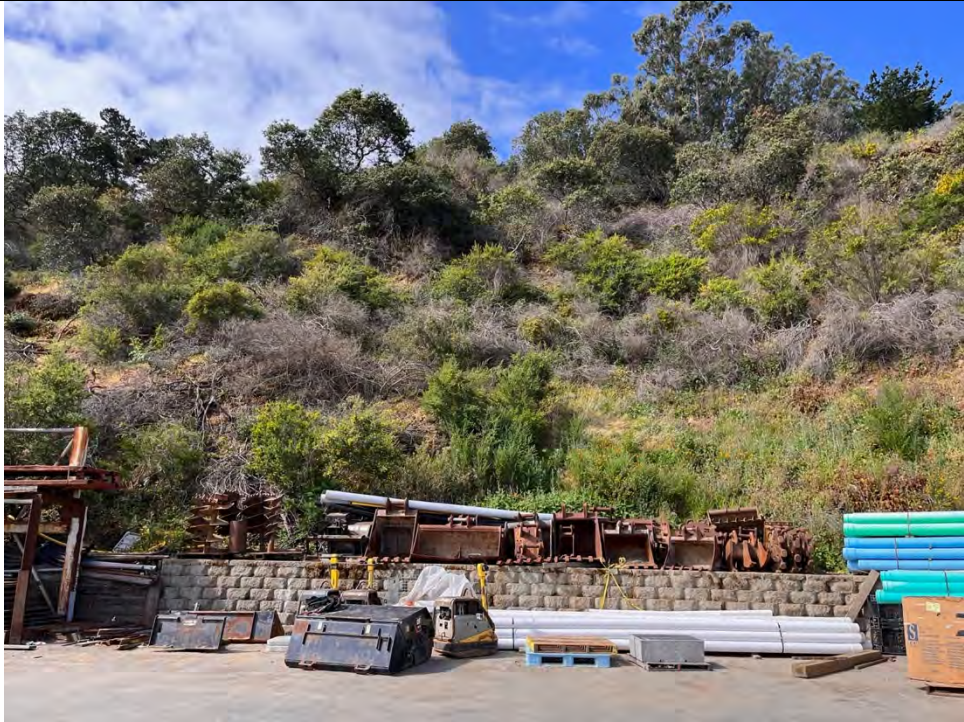
3708 Bayshore Blvd	
Map Key	
P4	
View Direction	
West southwest	
Description	
View of the construction lot, storage materials, and the vegetated slope on the western portion of the parcels. French broom is the dominant vegetation.

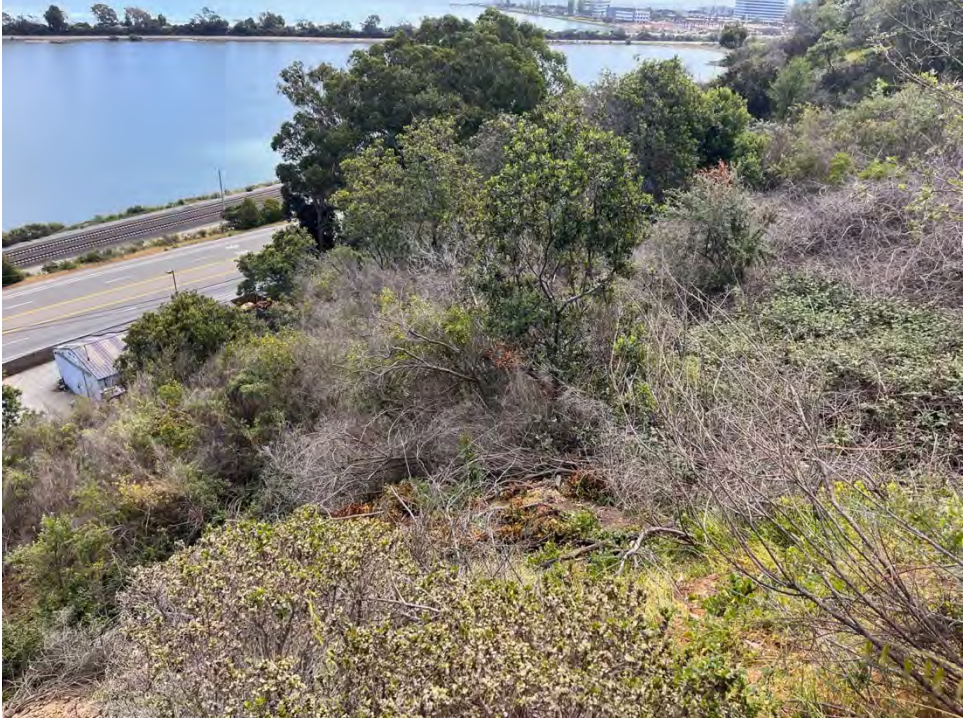
3708 Bayshore Blvd	
Map Key	
P5	
View Direction	
Southeast	
Description	
<p>View of the southwestern portion of the study area and site, taken from upslope of the parcels. The Brisbane lagoon and Bayshore Blvd are visible in the background of the photo. Visible vegetation include toyon, coyote brush and French broom.</p>
