HISTORIC DISTRICT COMMISSION MEETING

**Historic District Commission Meeting Agenda
Thursday, February 05, 2026 at 7:00 PM
Bristol Town Hall, 10 Court Street, Bristol, RI 02809**

HERRESHOFF MARINE MUSEUM
BURNSIDE BUILDING REHABILITATION - PHASE 3

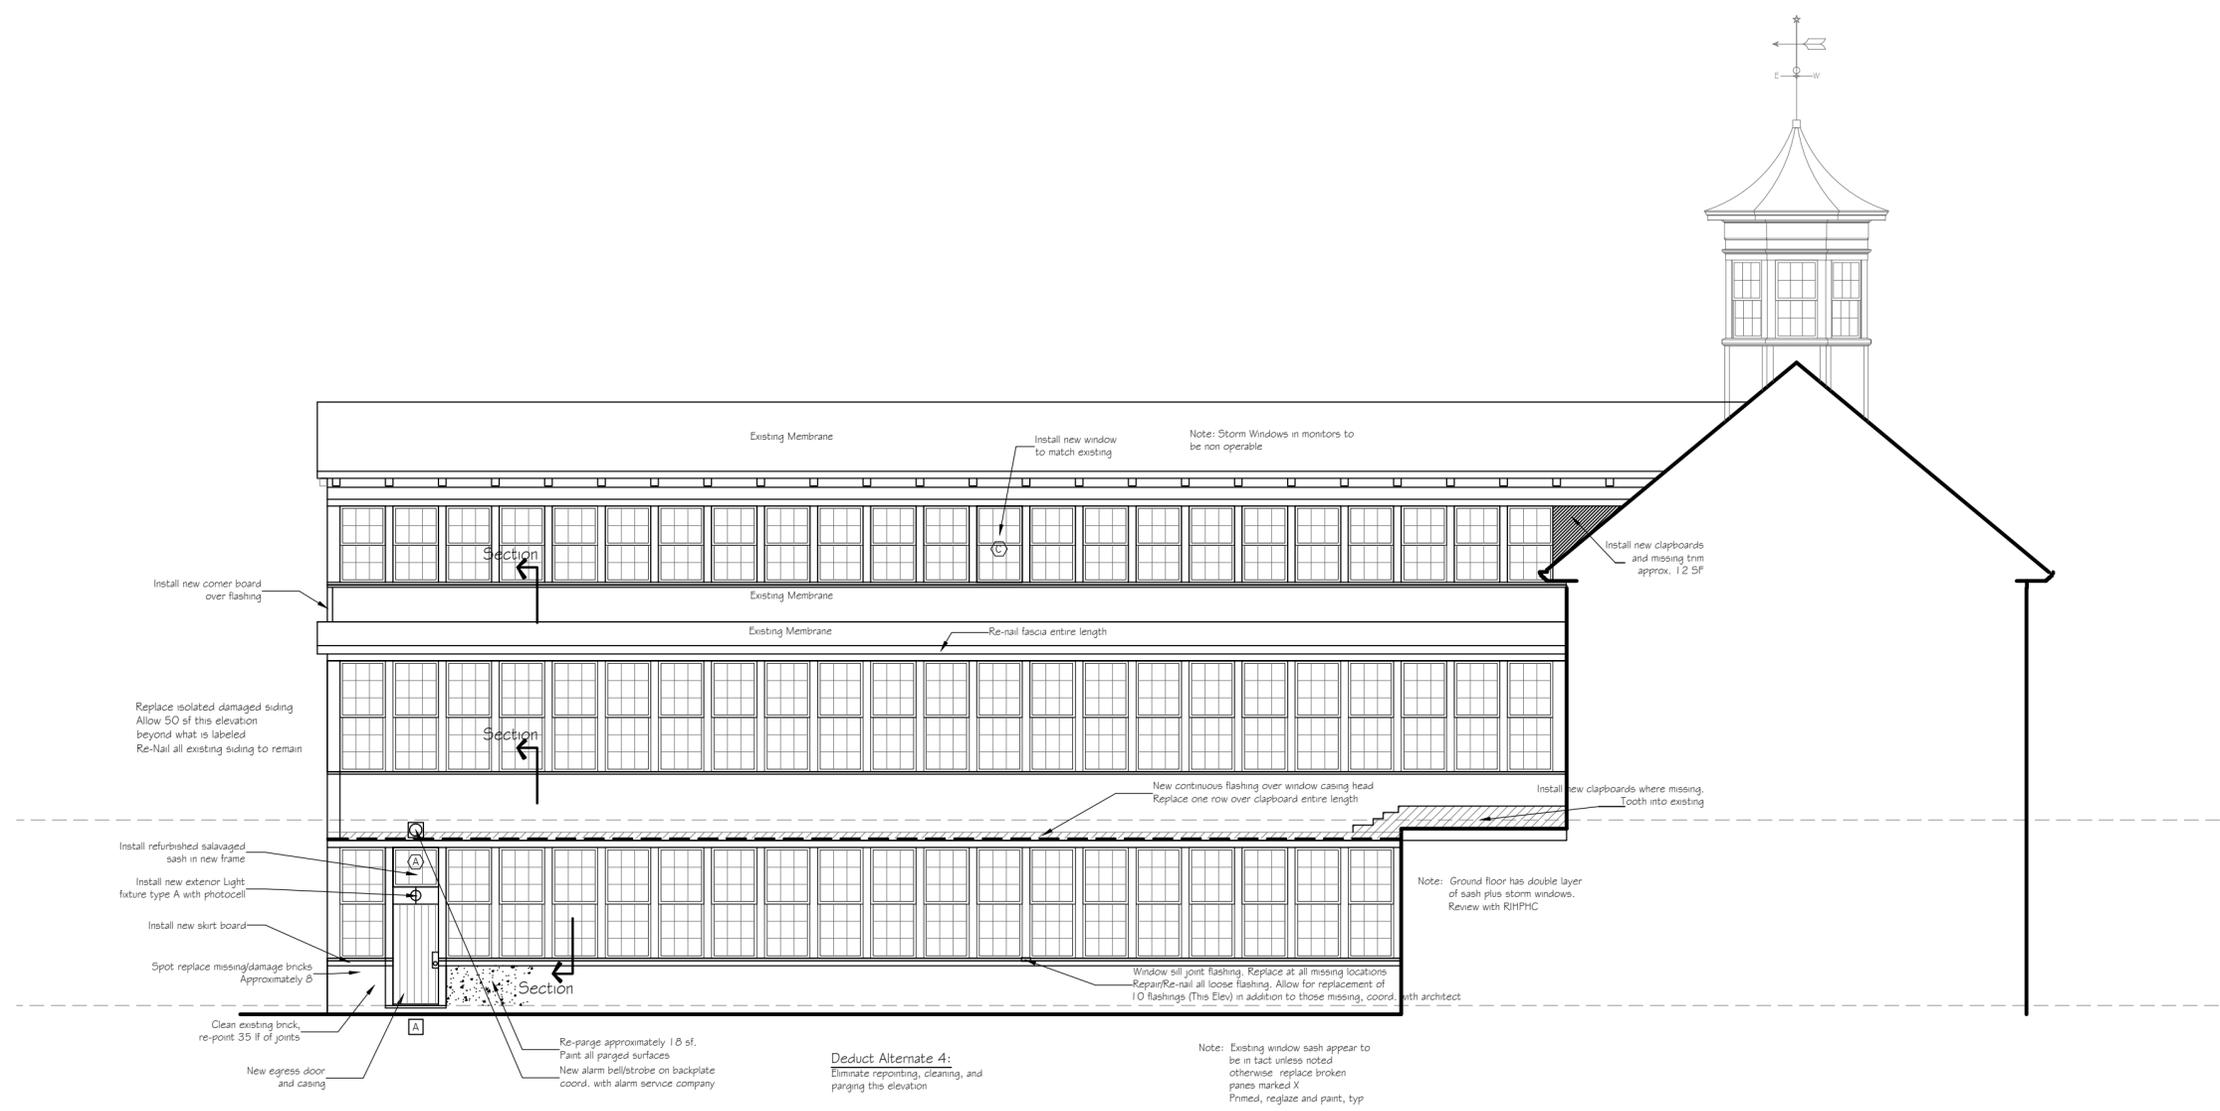
A-10

Deduct Alternate 4:
Eliminate repointing, cleaning, and
parging this elevation

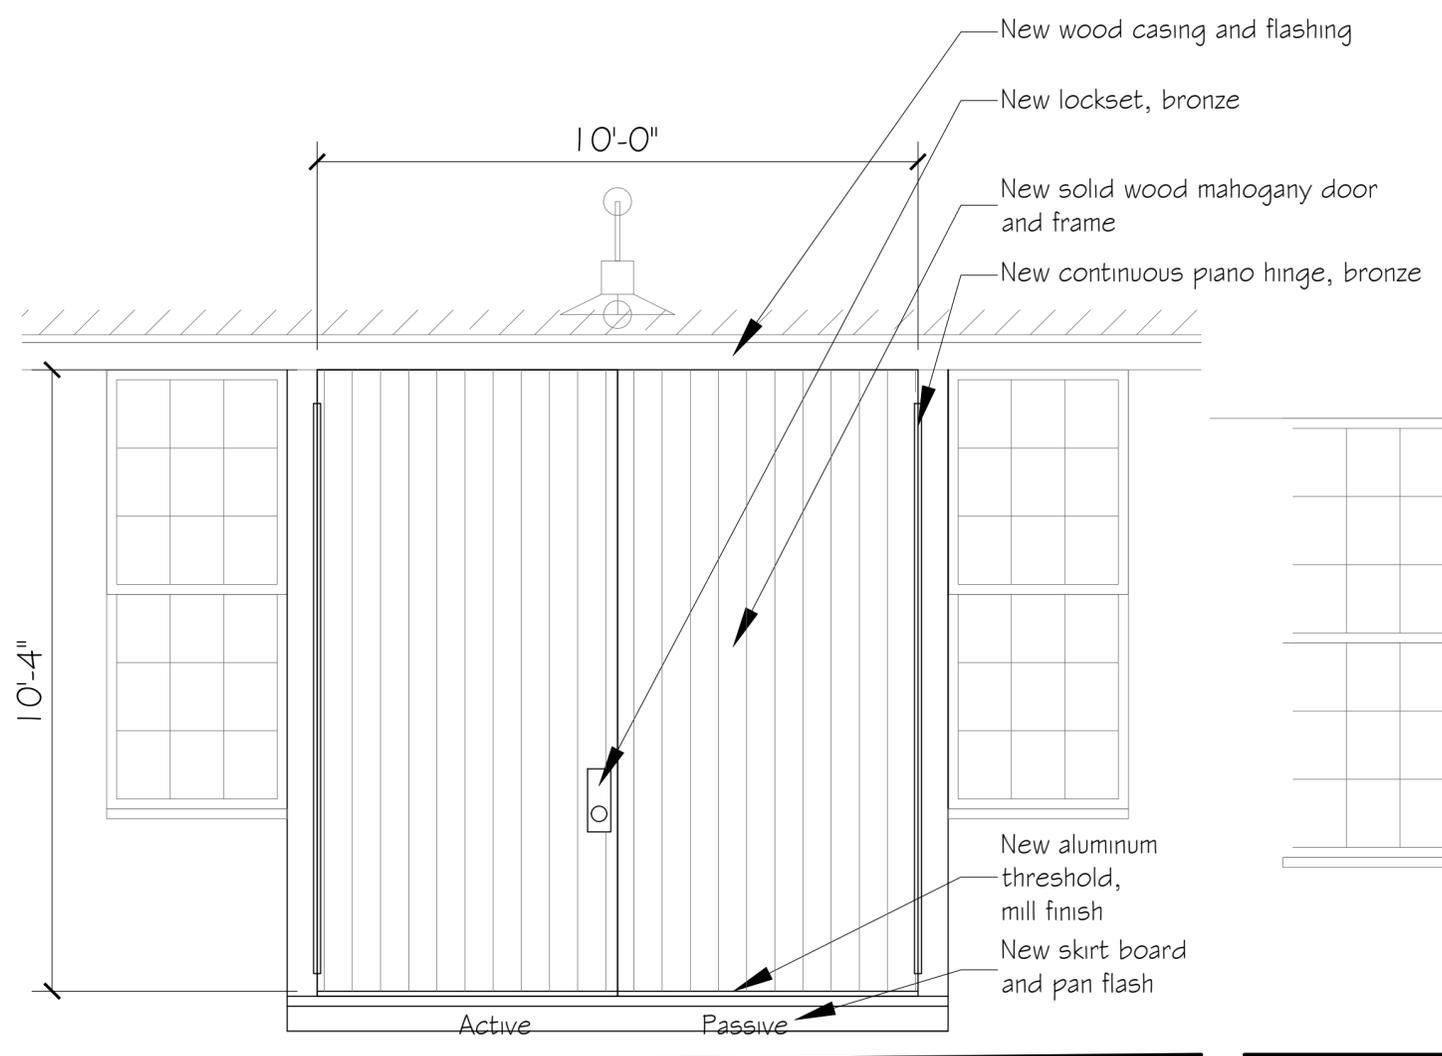
A-28

NEW DOOR TYPE B
Scale 1/2" = 1'-0"

Interior View

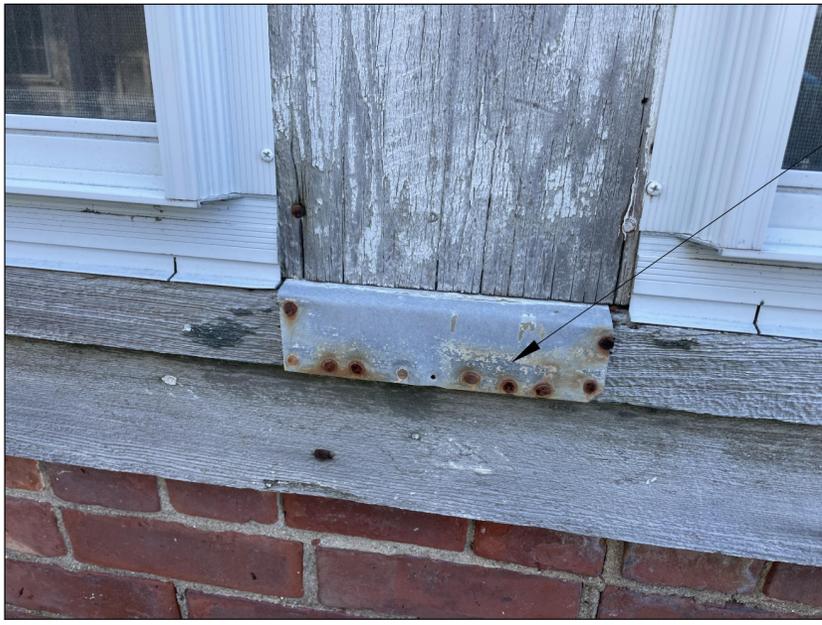
A-30

Re-nail loose flashing, Replace missing flashing.

Window sill joint flash photo with notes

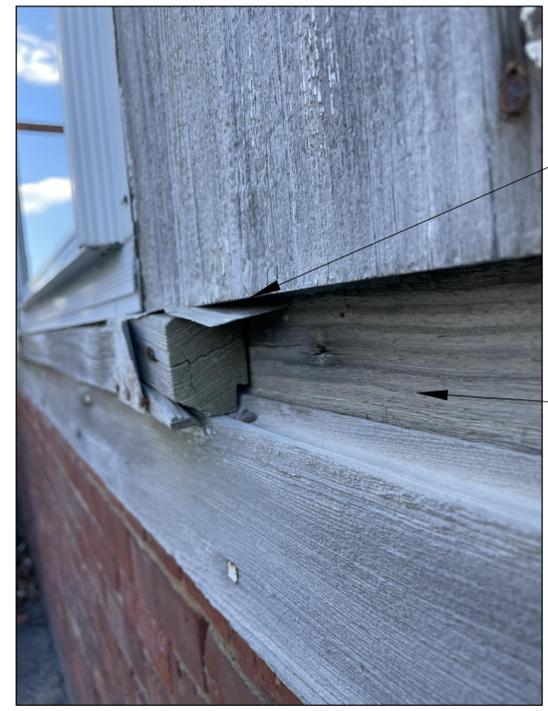
Insert new flash under casing.

Install new sill board over rabbeted trim.

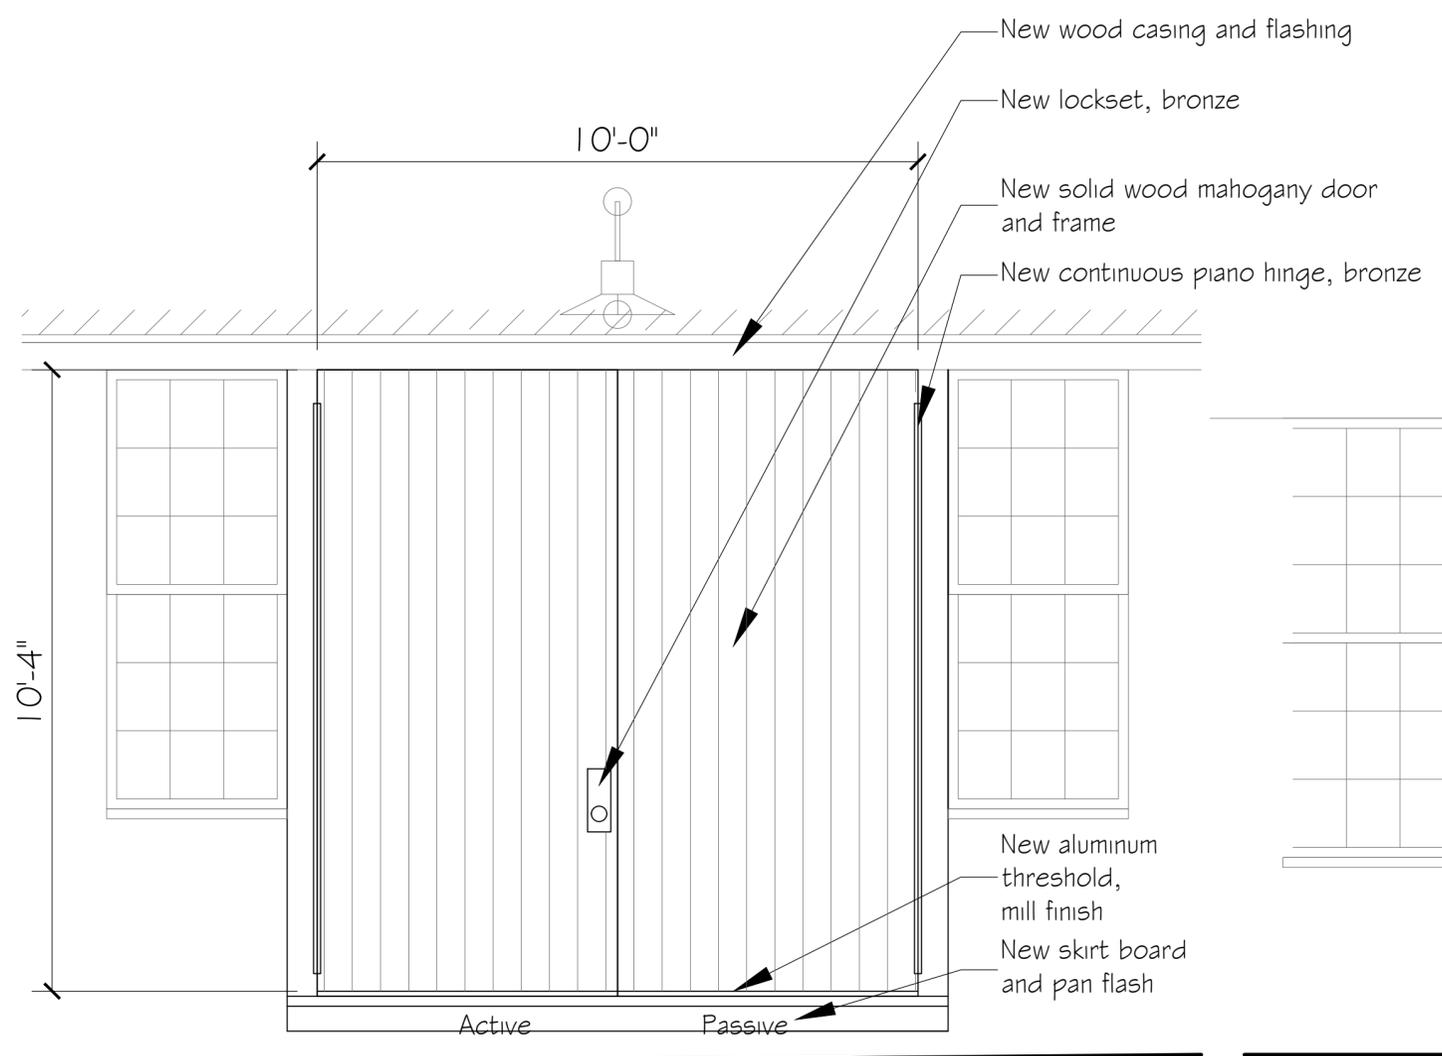
Verify all dimensions in field before fabrication
Exterior View

NEW DOOR TYPE B
Scale 1/2" = 1'-0"

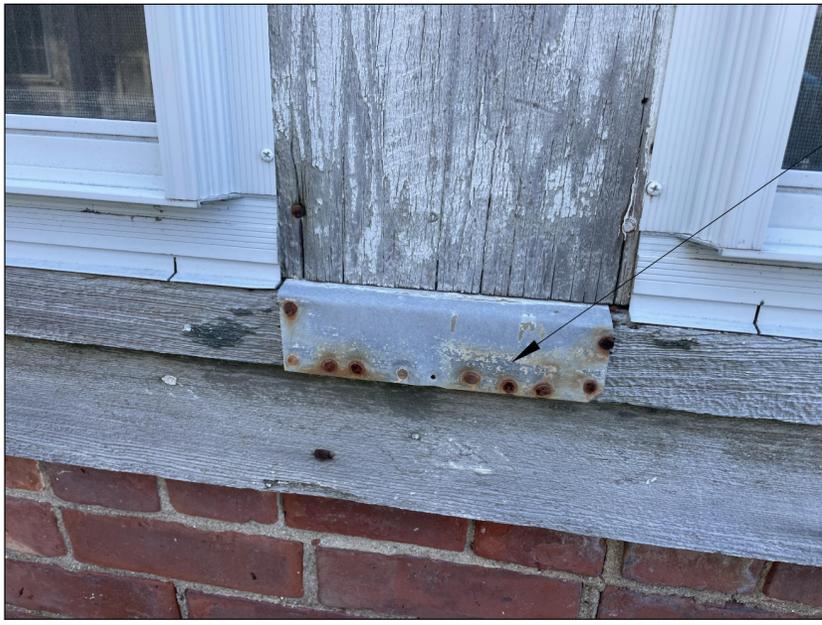
A-30

Re-nail loose flashing, Replace missing flashing.

Window sill joint flash photo with notes

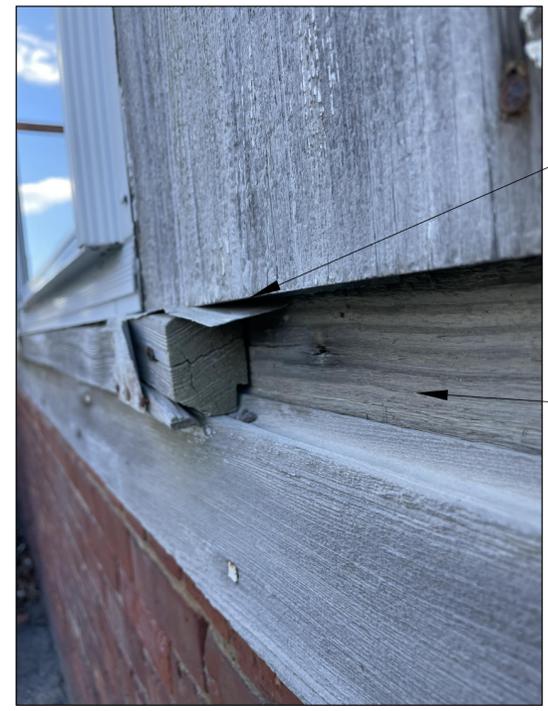
Insert new flash under casing.

Install new sill board over rabbeted trim.

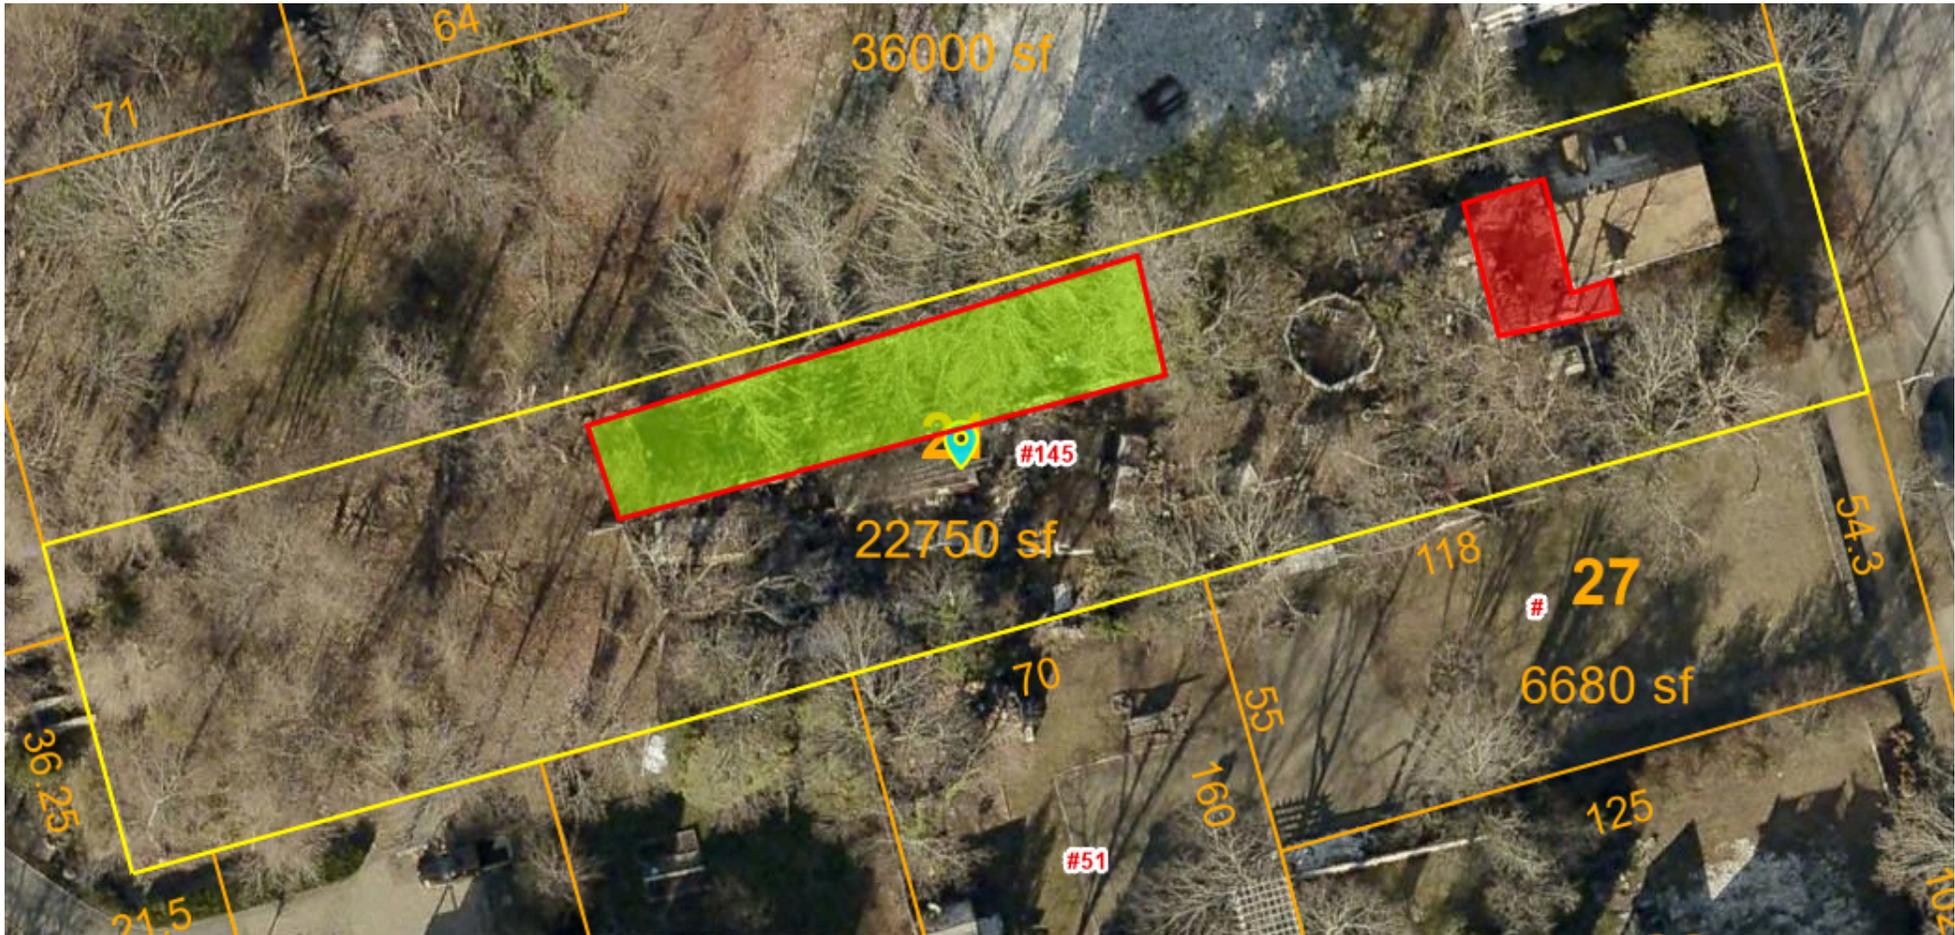
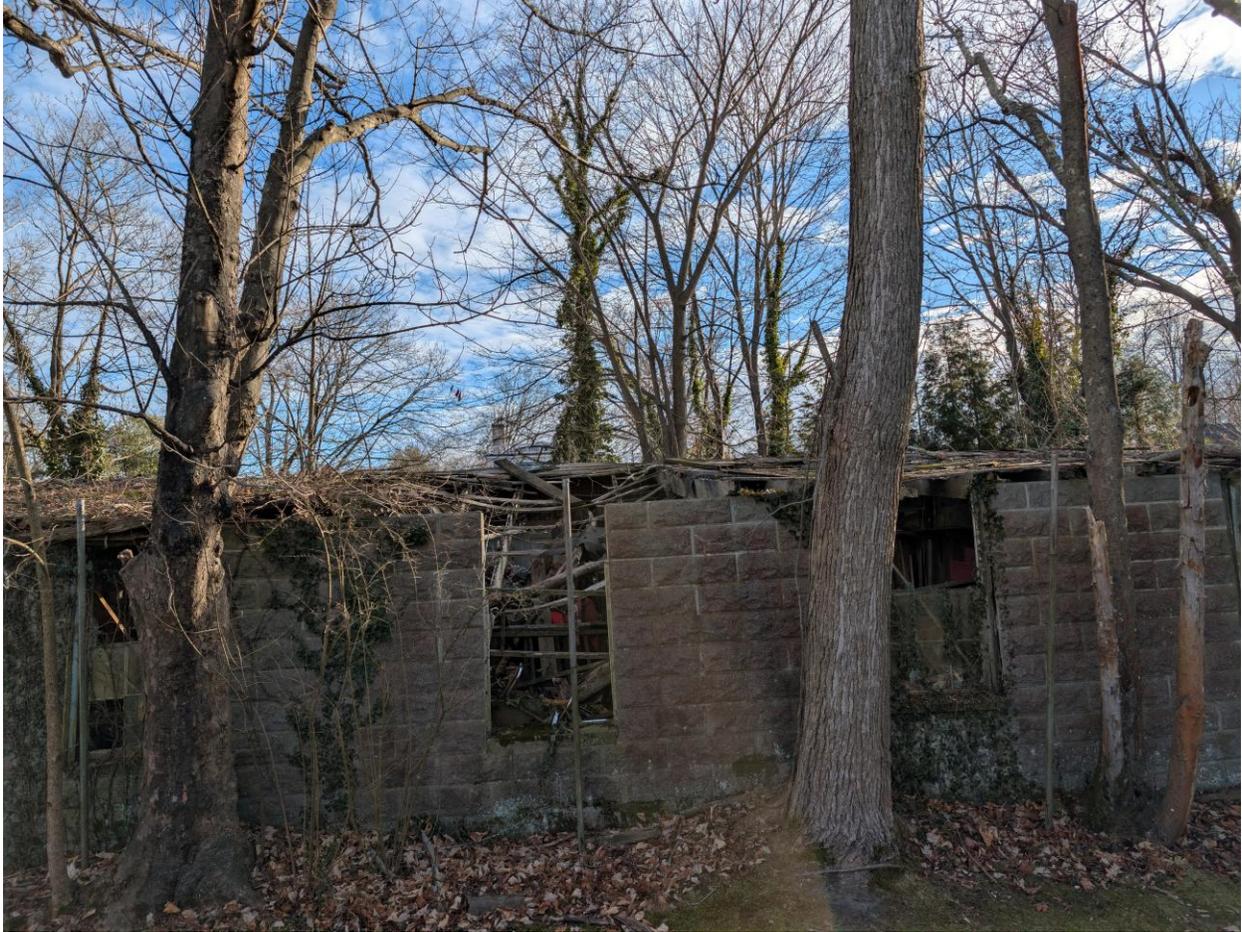
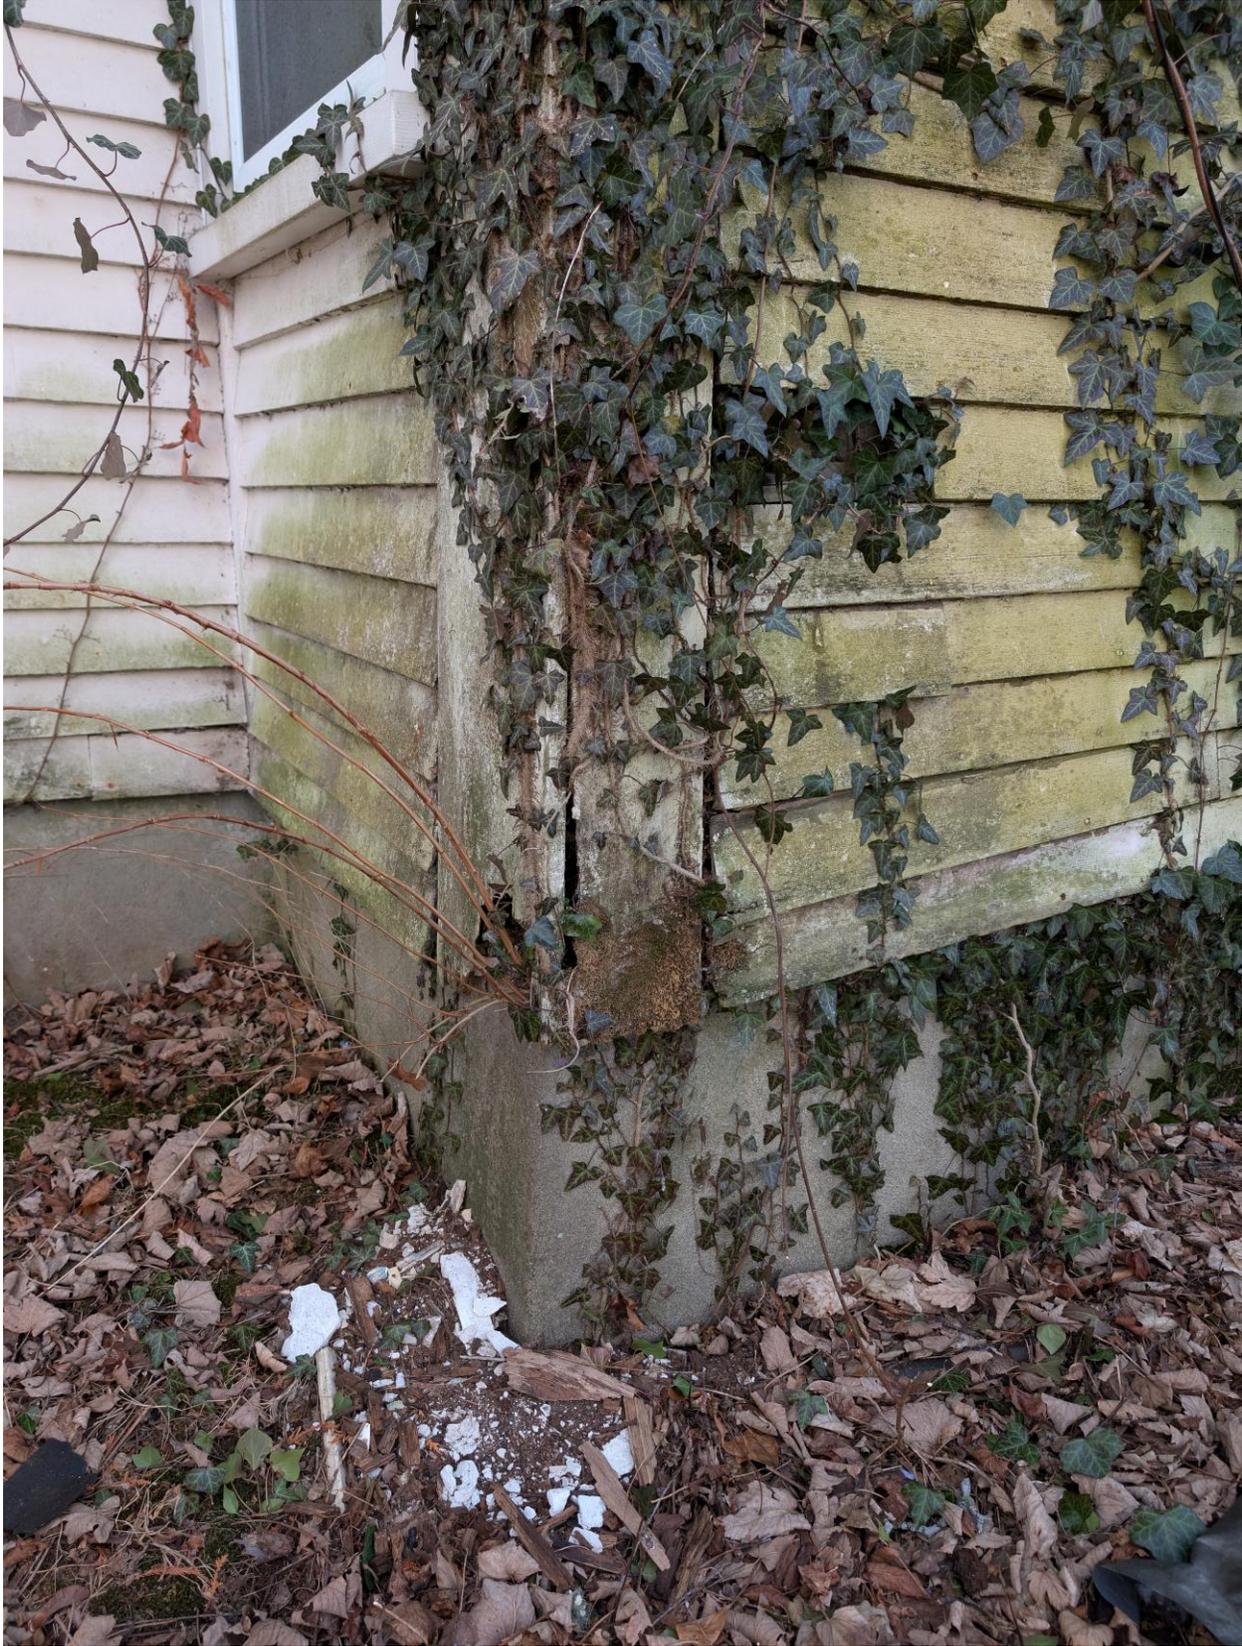
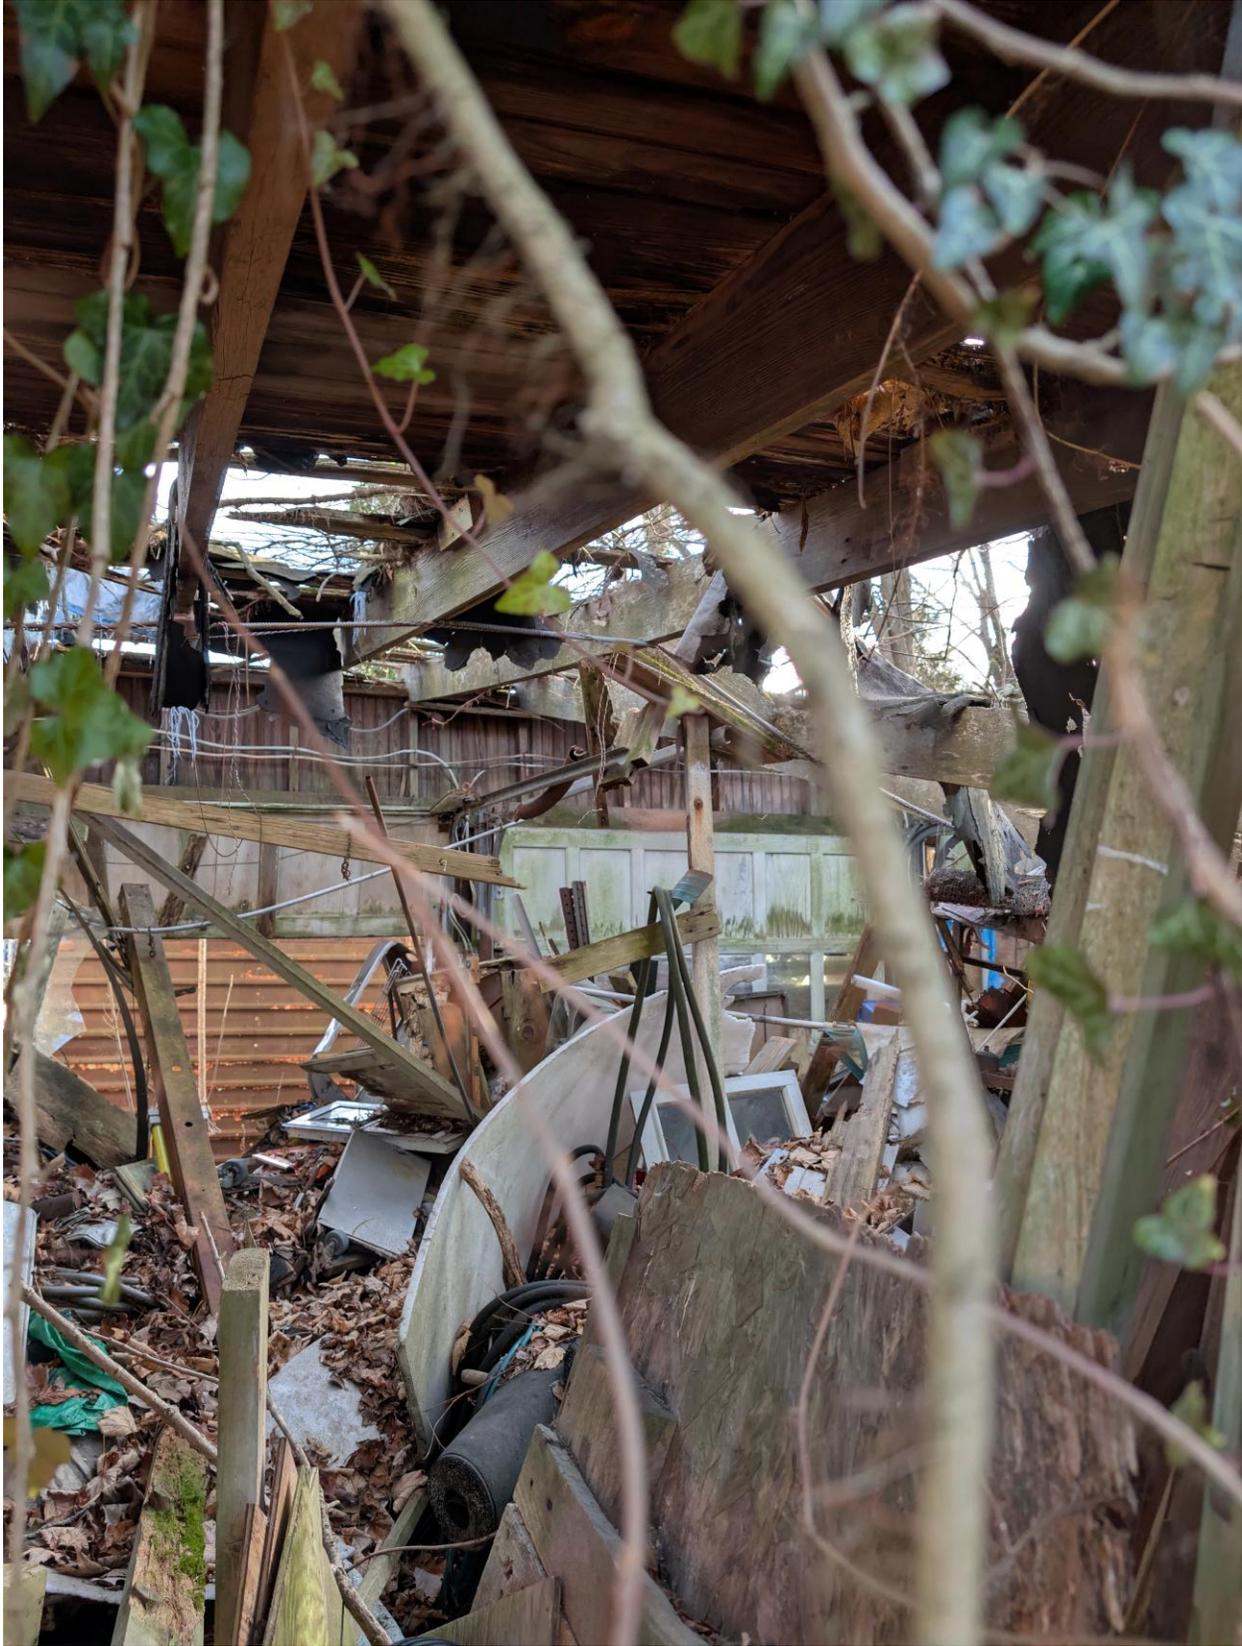
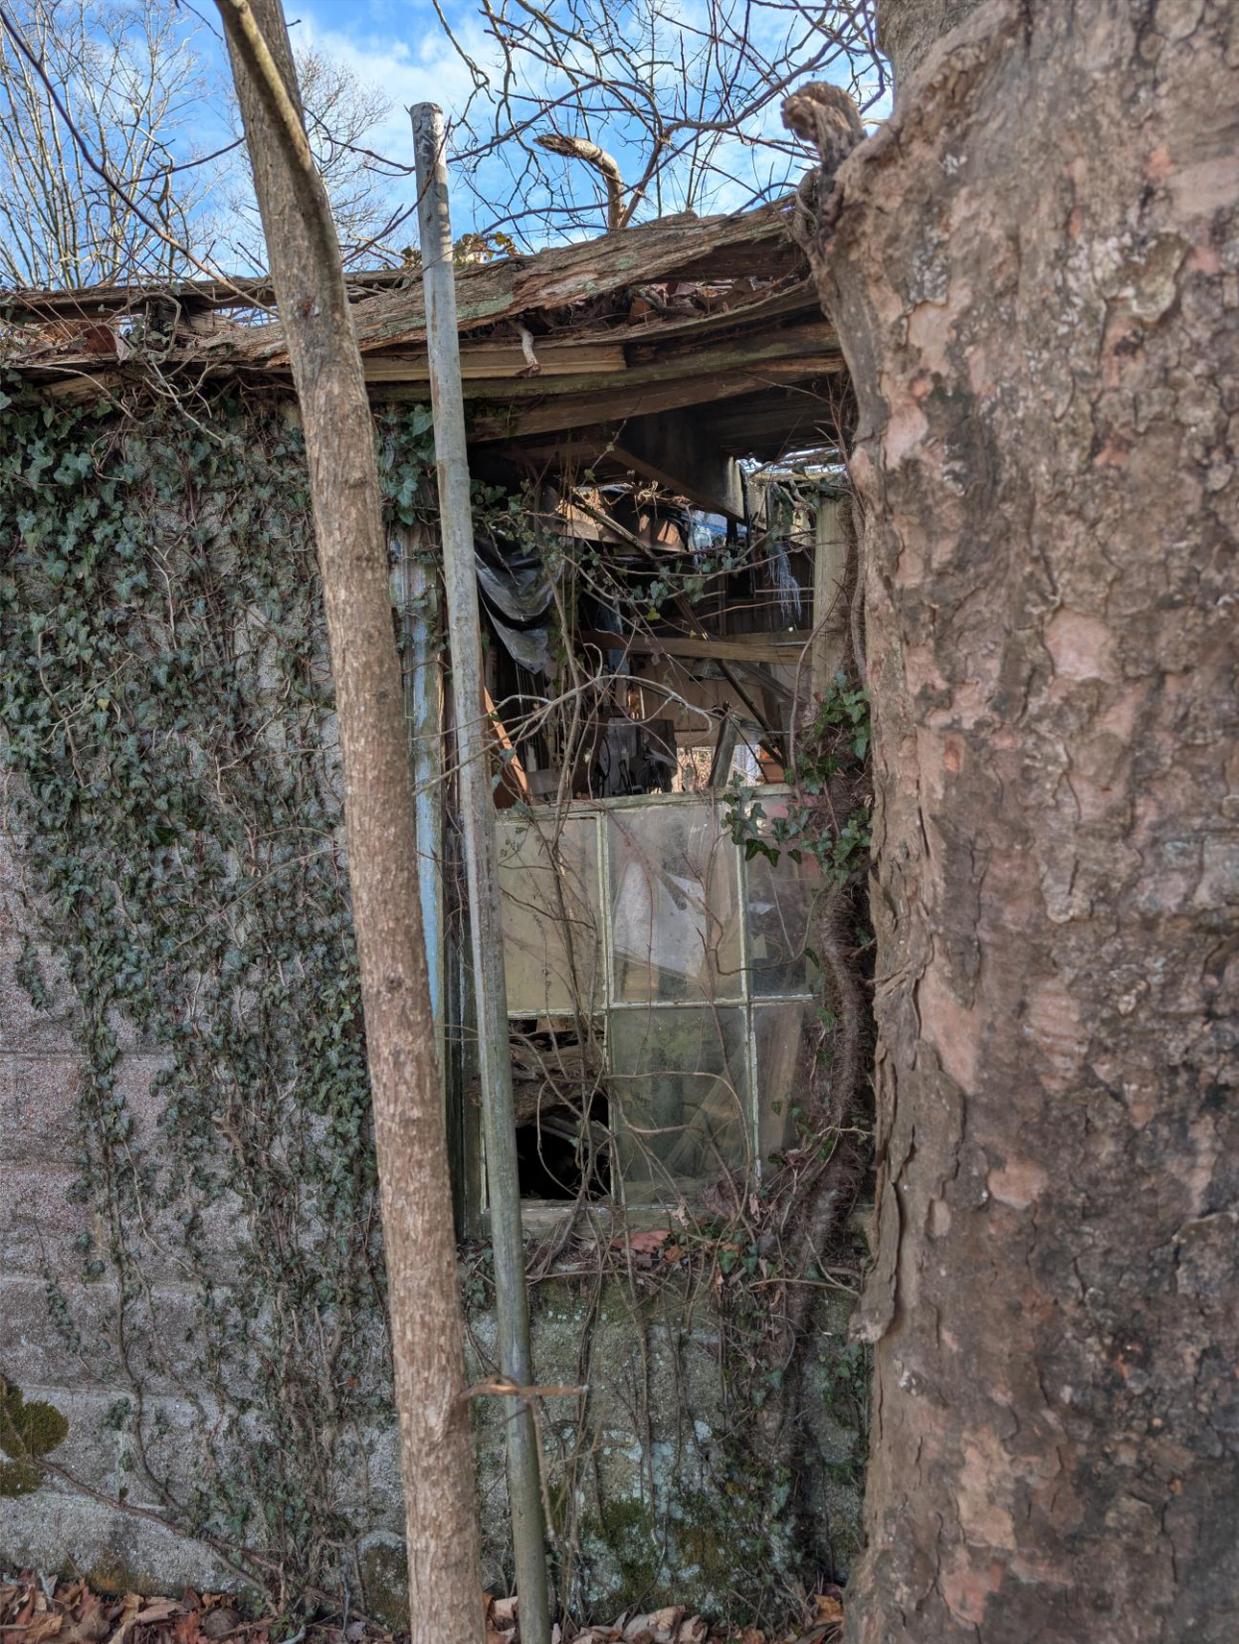
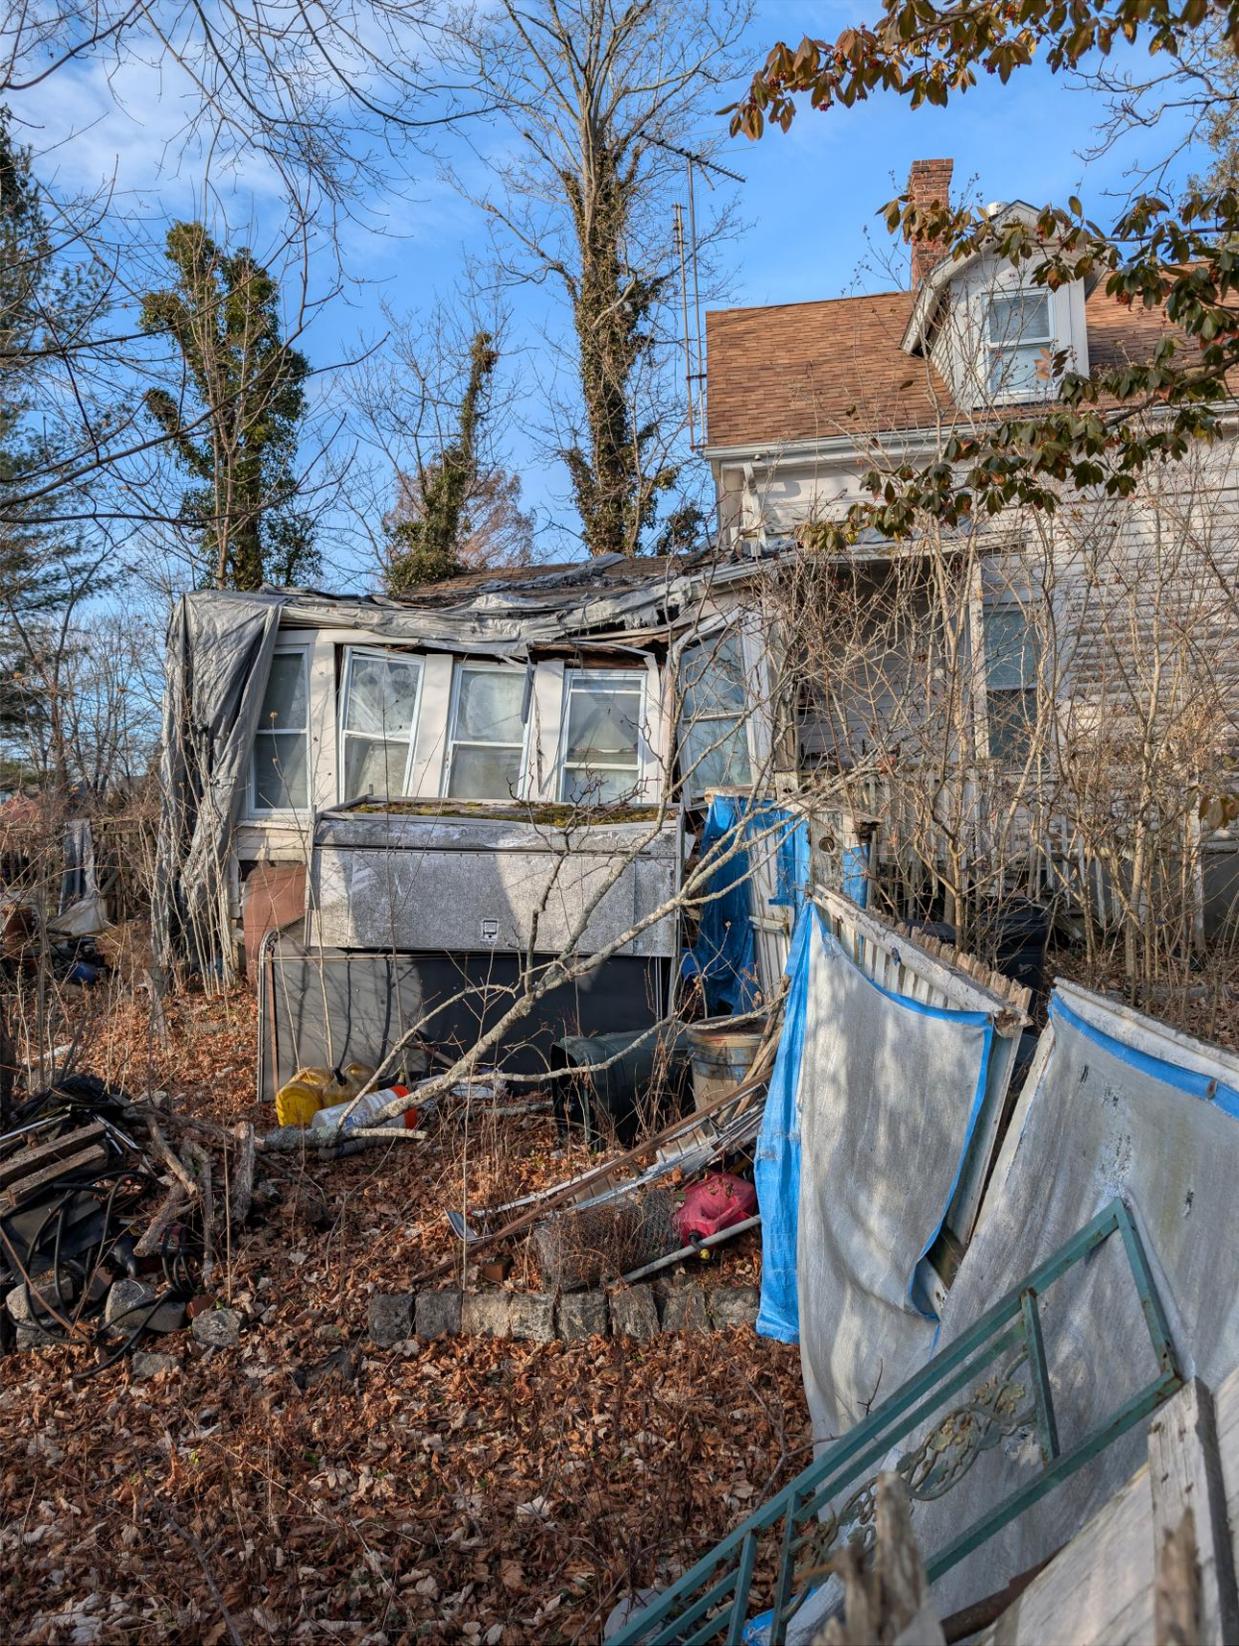
Demo regarding the existing 10-car garage, we will be removing the roof and fallen debris that has completely caved in. While our intent is to retain the exterior masonry walls, several have been compromised. We will evaluate their structural integrity once the roof and debris are cleared; any walls deemed unsafe will be removed and rebuilt during the reconstruction phase.

As for the main house, the rear portion has collapsed and is currently unsafe. We will proceed with the demolition of that section while maintaining the main portion of the house, which appears stable. Following the demolition, we will protect the remaining structure from further damage and secure the open foundation with fencing.

This property is extremely distressed, and upon a site visit with the applicant, staff observed that the roof of the garage has, speaking generously, partially collapsed, and the addition on the main structure has a caved in roof and collapsing wall. Staff observed the applicant take a piece of wood from the wall that is collapsing and crumble it by hand.

In discussions with the applicant, it has been recommended that they may begin clearing the property, including fully collapsed portions of the garage roof, to facilitate clean up of the debris and abandoned materials within.

Additional work to clear and secure the property will include removing a collapsing fence, excavation of area around the foundation of the garage to facilitate repairs and assess condition, demolishing a severely deteriorated deck, and general cleanup. Commissioners should however stress the importance of maintaining the original house, which the applicant wishes to retain and remodel into a multi-family.
