LAND USE DECISION

STAFF REPORT

CJ DENS SUBDIVISION (File No. SUB20-02)

CONSOLIDATED FILES: SHORELINE SUBSTANTIAL DEVELOPMENT PERMIT, SHORELINE CONDITIONAL USE PERMIT AND SHORELINE VARIANCE (SHOR20-01); CRITICAL AREAS REVIEW (CA20-08); ARCHAEOLOGICAL REVIEW (ARCH20-08); TEMPORARY USE PERMIT (TUP20-05); STATE ENVIRONMENTAL POLICY ACT (SEPA20-17)

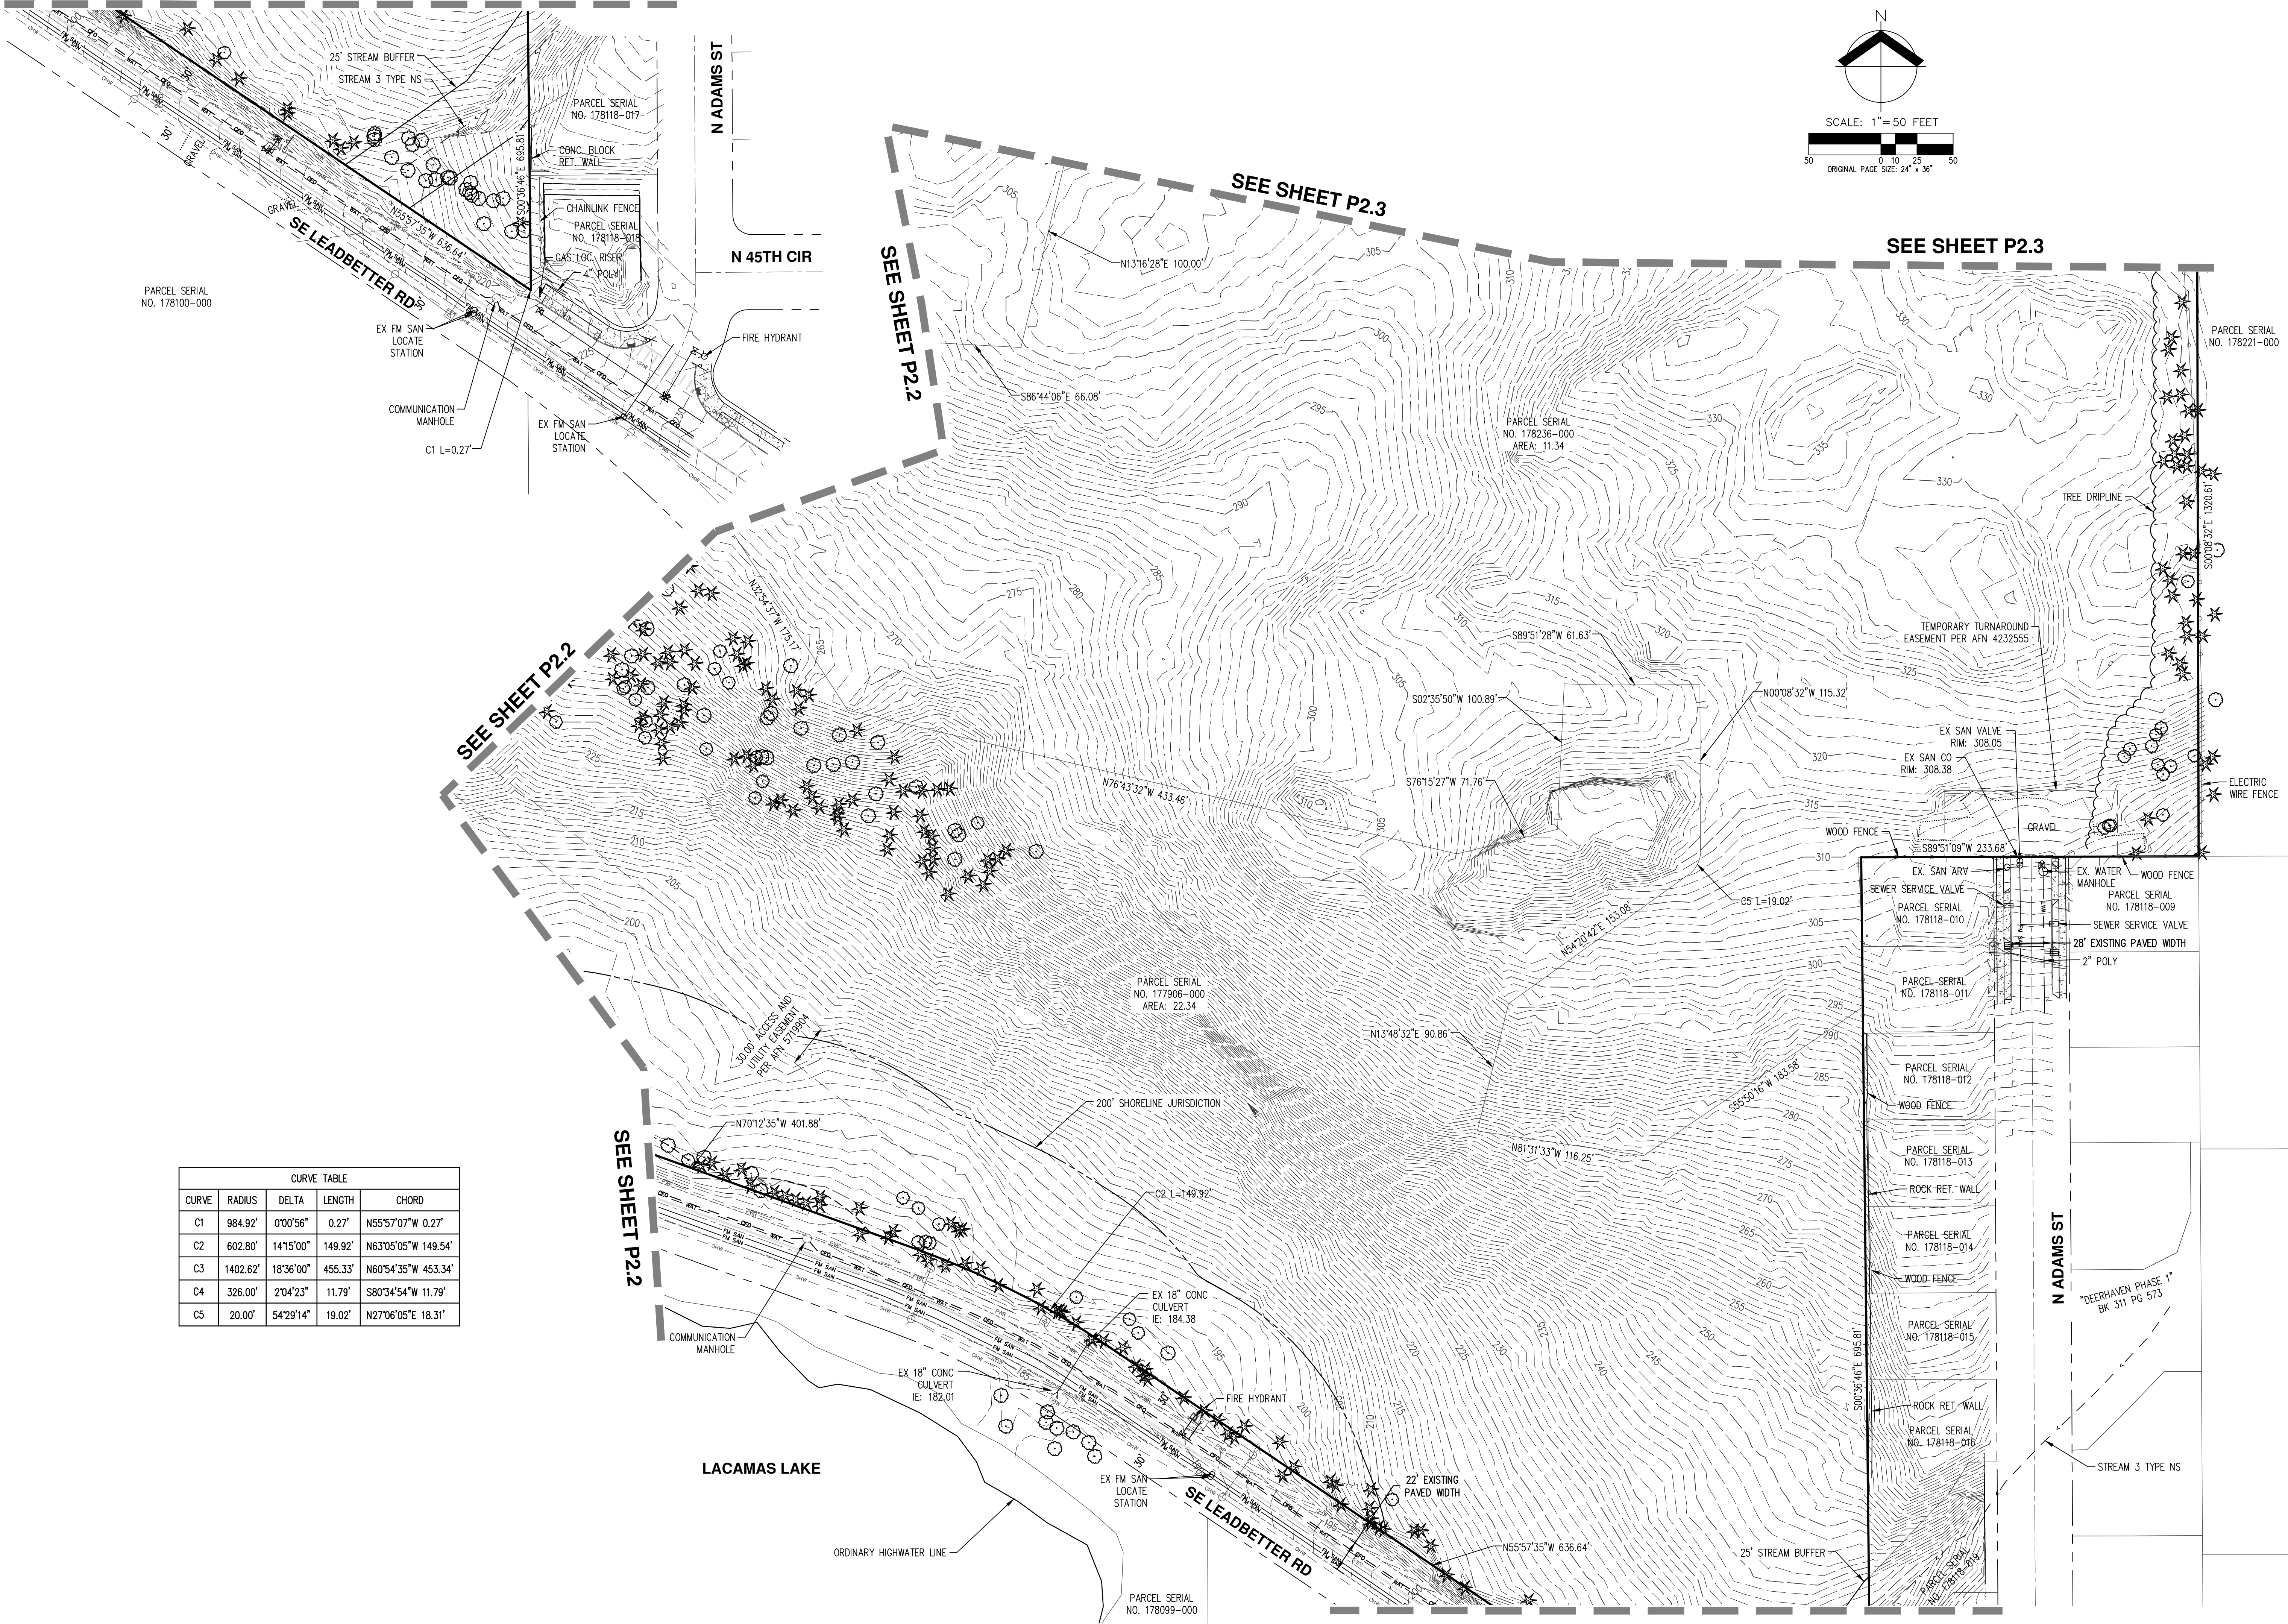
P2.1

EXISTING CONDITIONS (SOUTH)
CJ DENS SUBDIVISION
CJ DENS LACAMAS II LLC
CAMAS, WASHINGTON

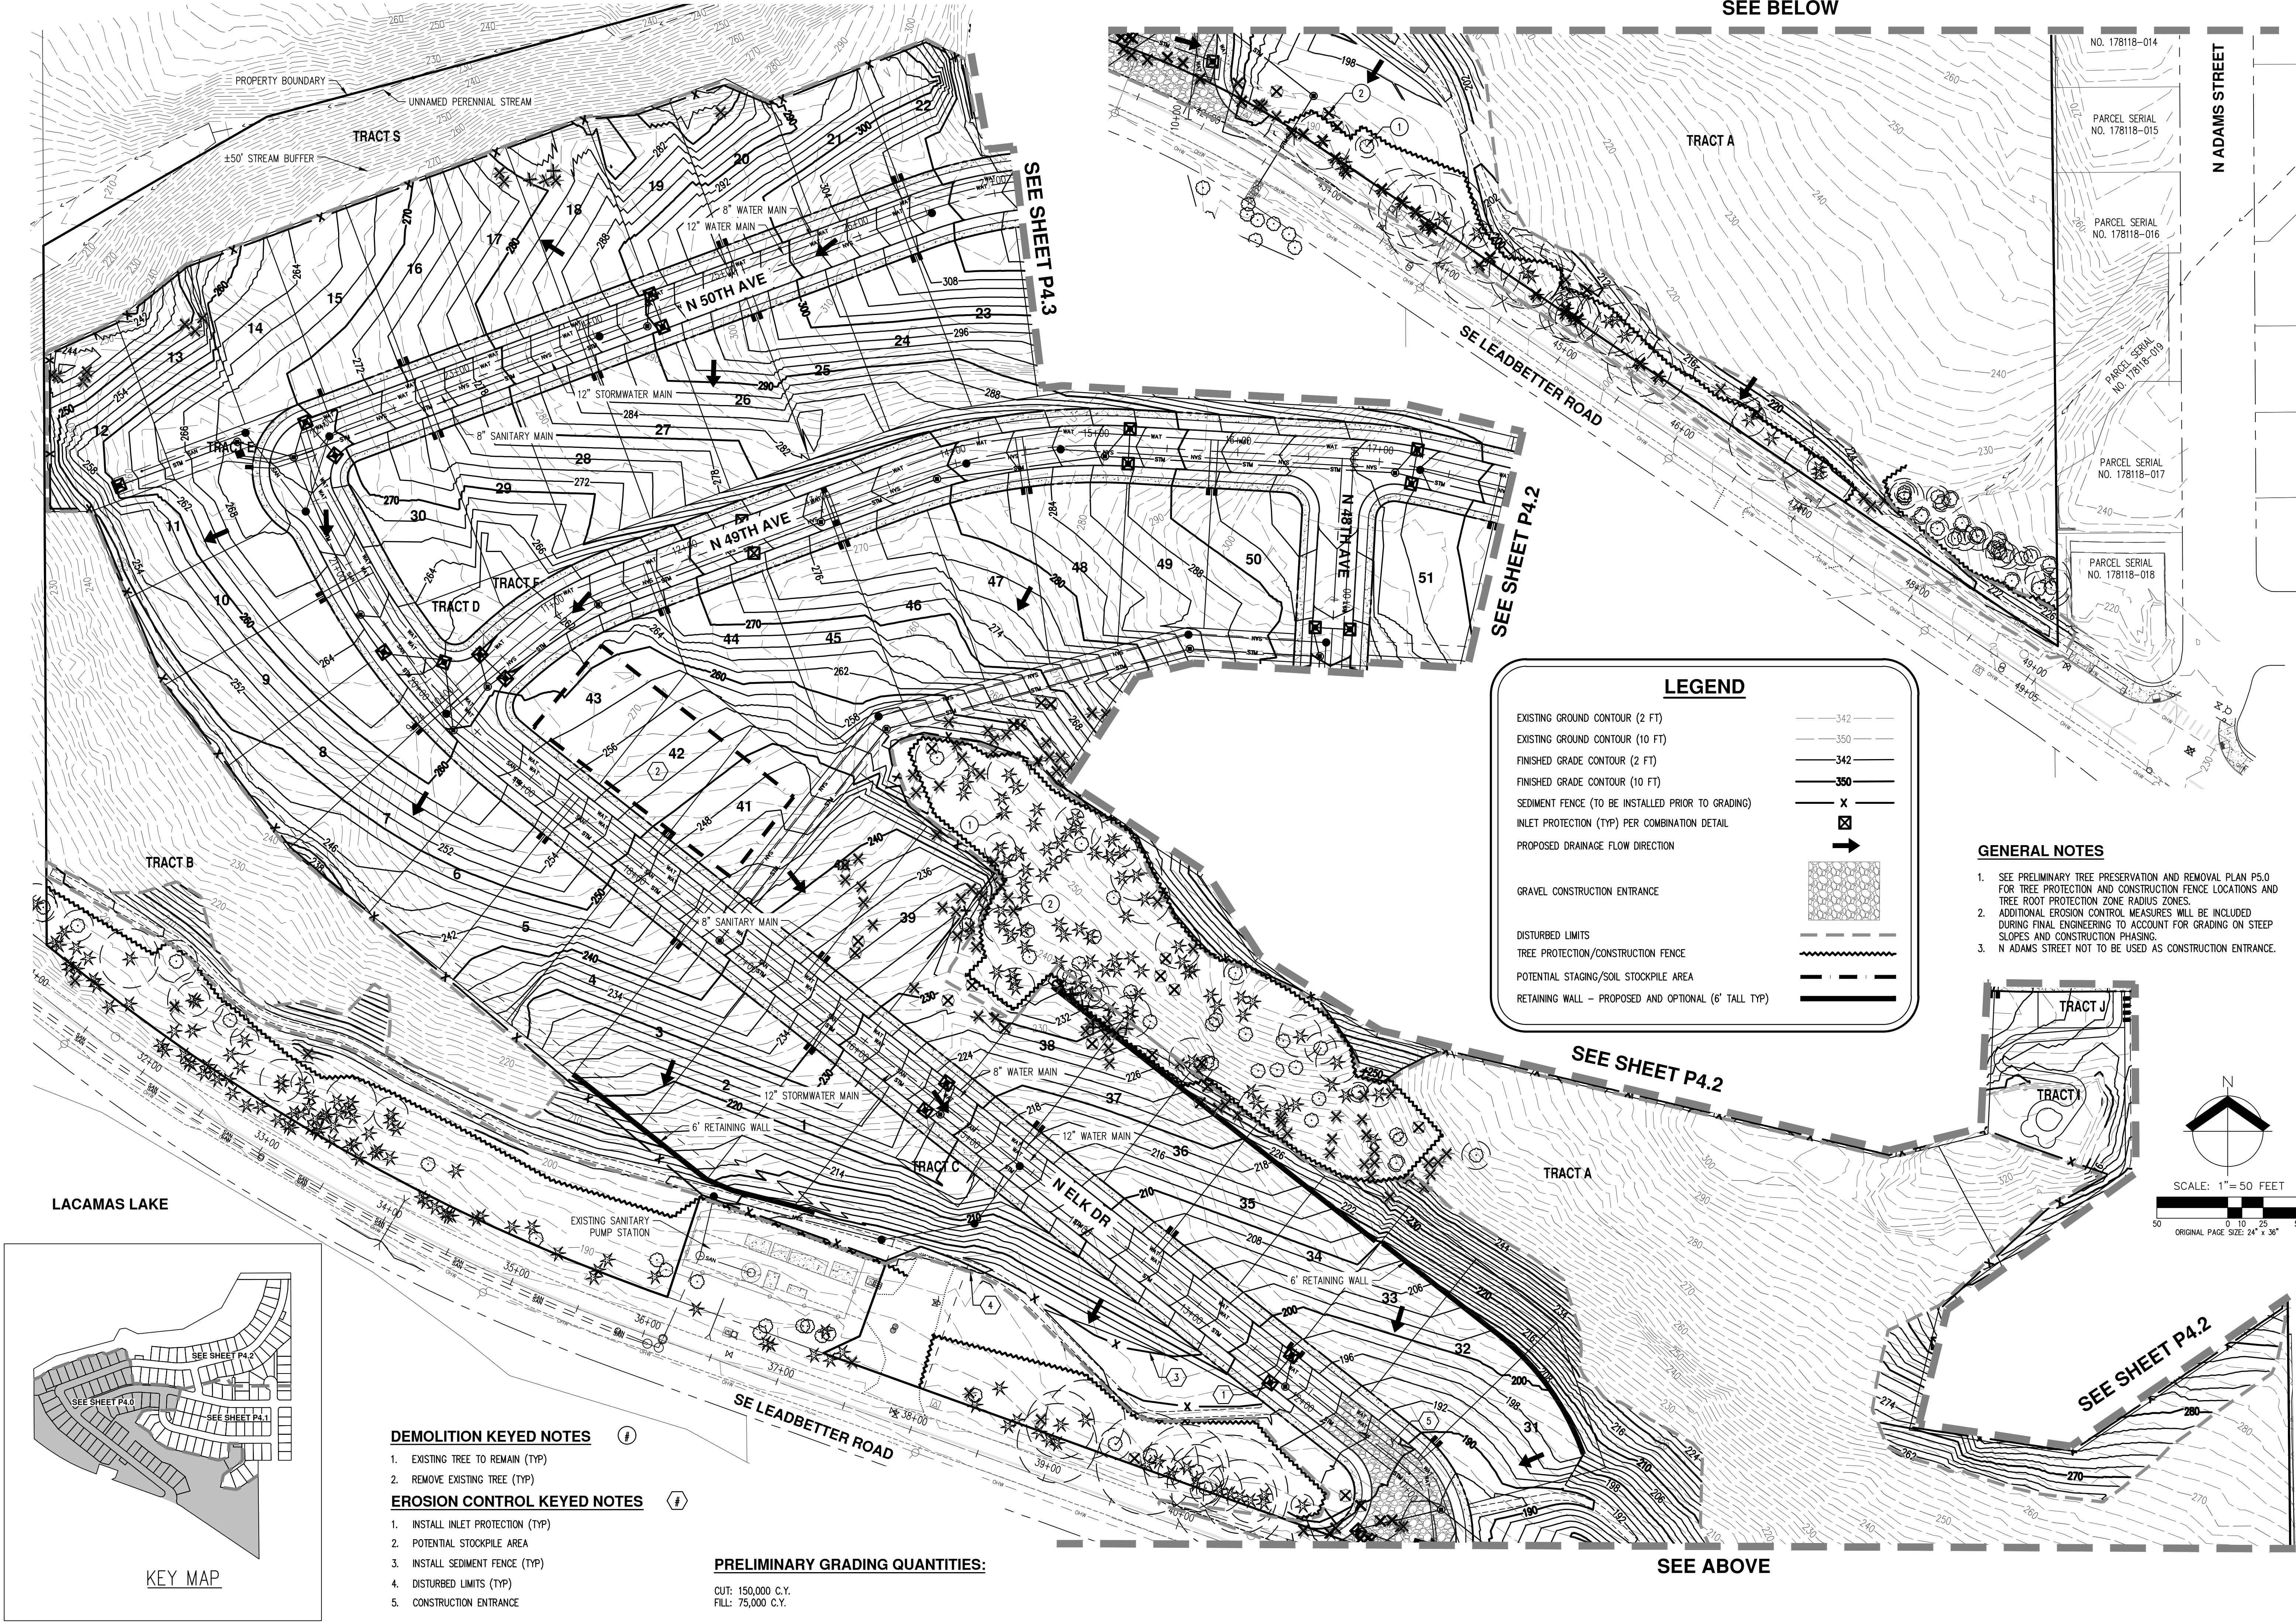
PRELIMINARY GRADING AND ESC PLAN - PHASE 1
CJ DENS SUBDIVISION
CJ DENS LACAMAS II LLC
CAMAS, WASHINGTON

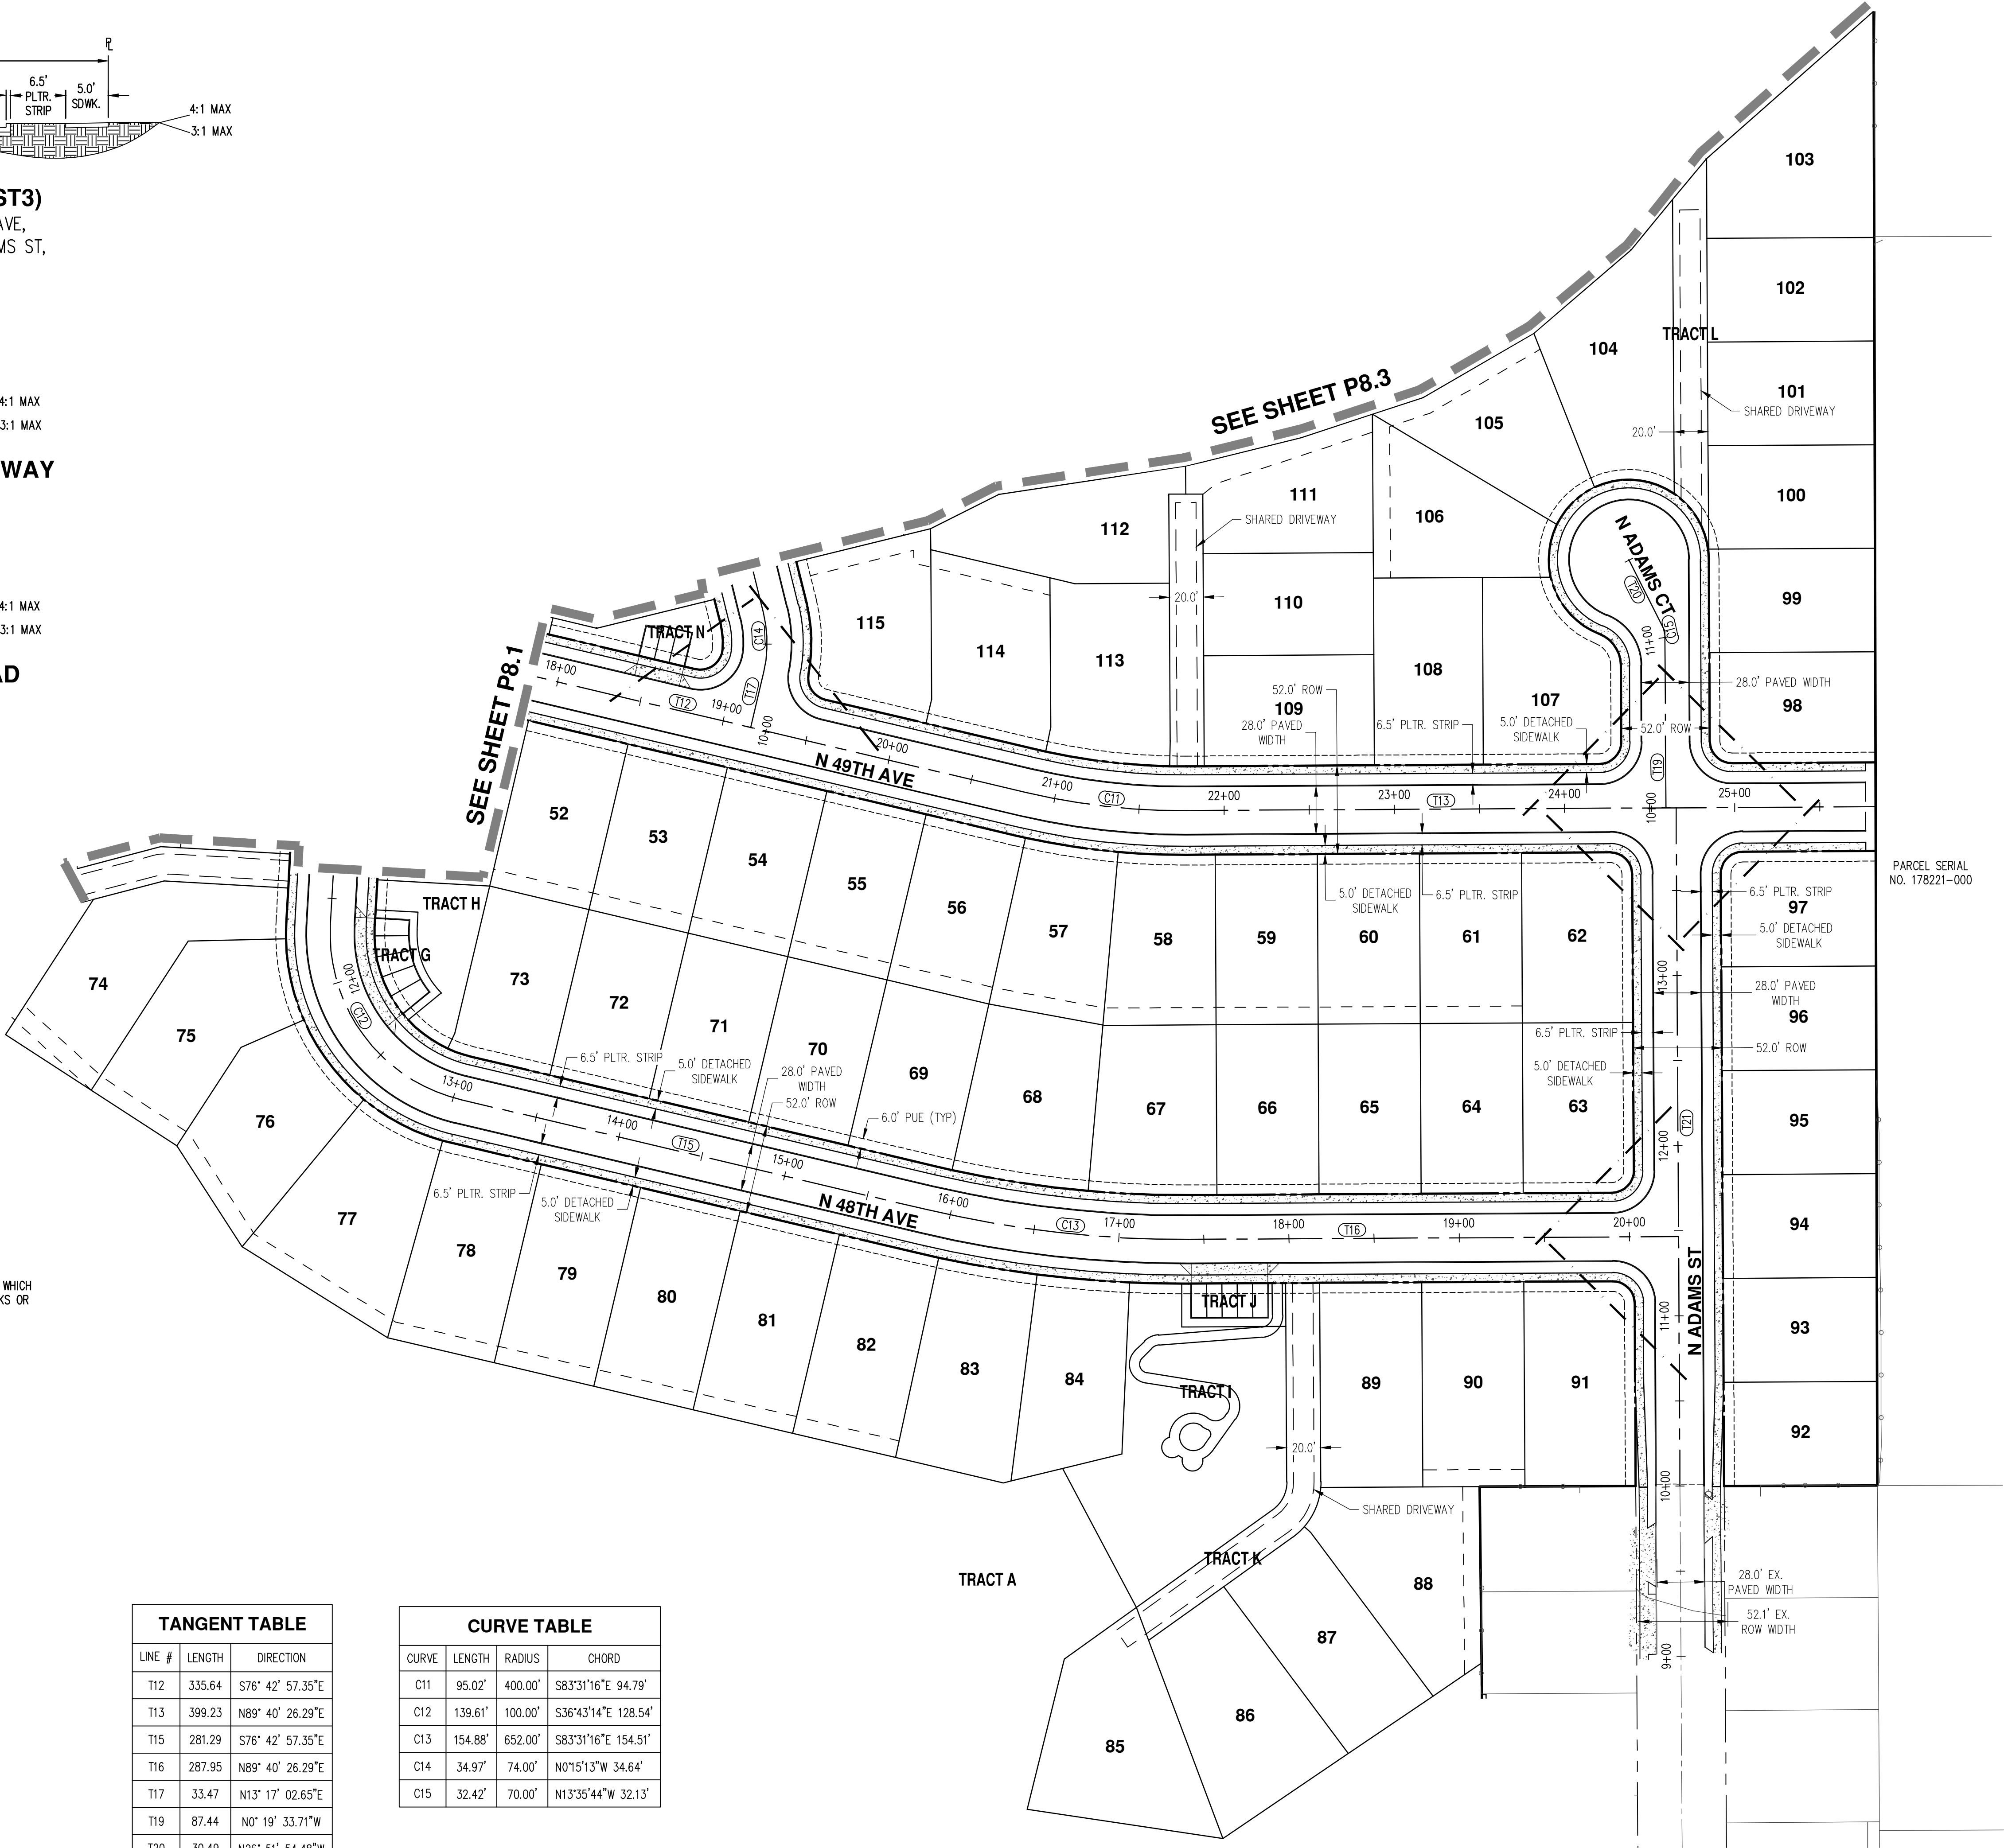
PRELIMINARY STREET PLAN - PHASE 2
CJ DENS SUBDIVISION
CJ DENS LACAMAS II LLC
CAMAS, WASHINGTON

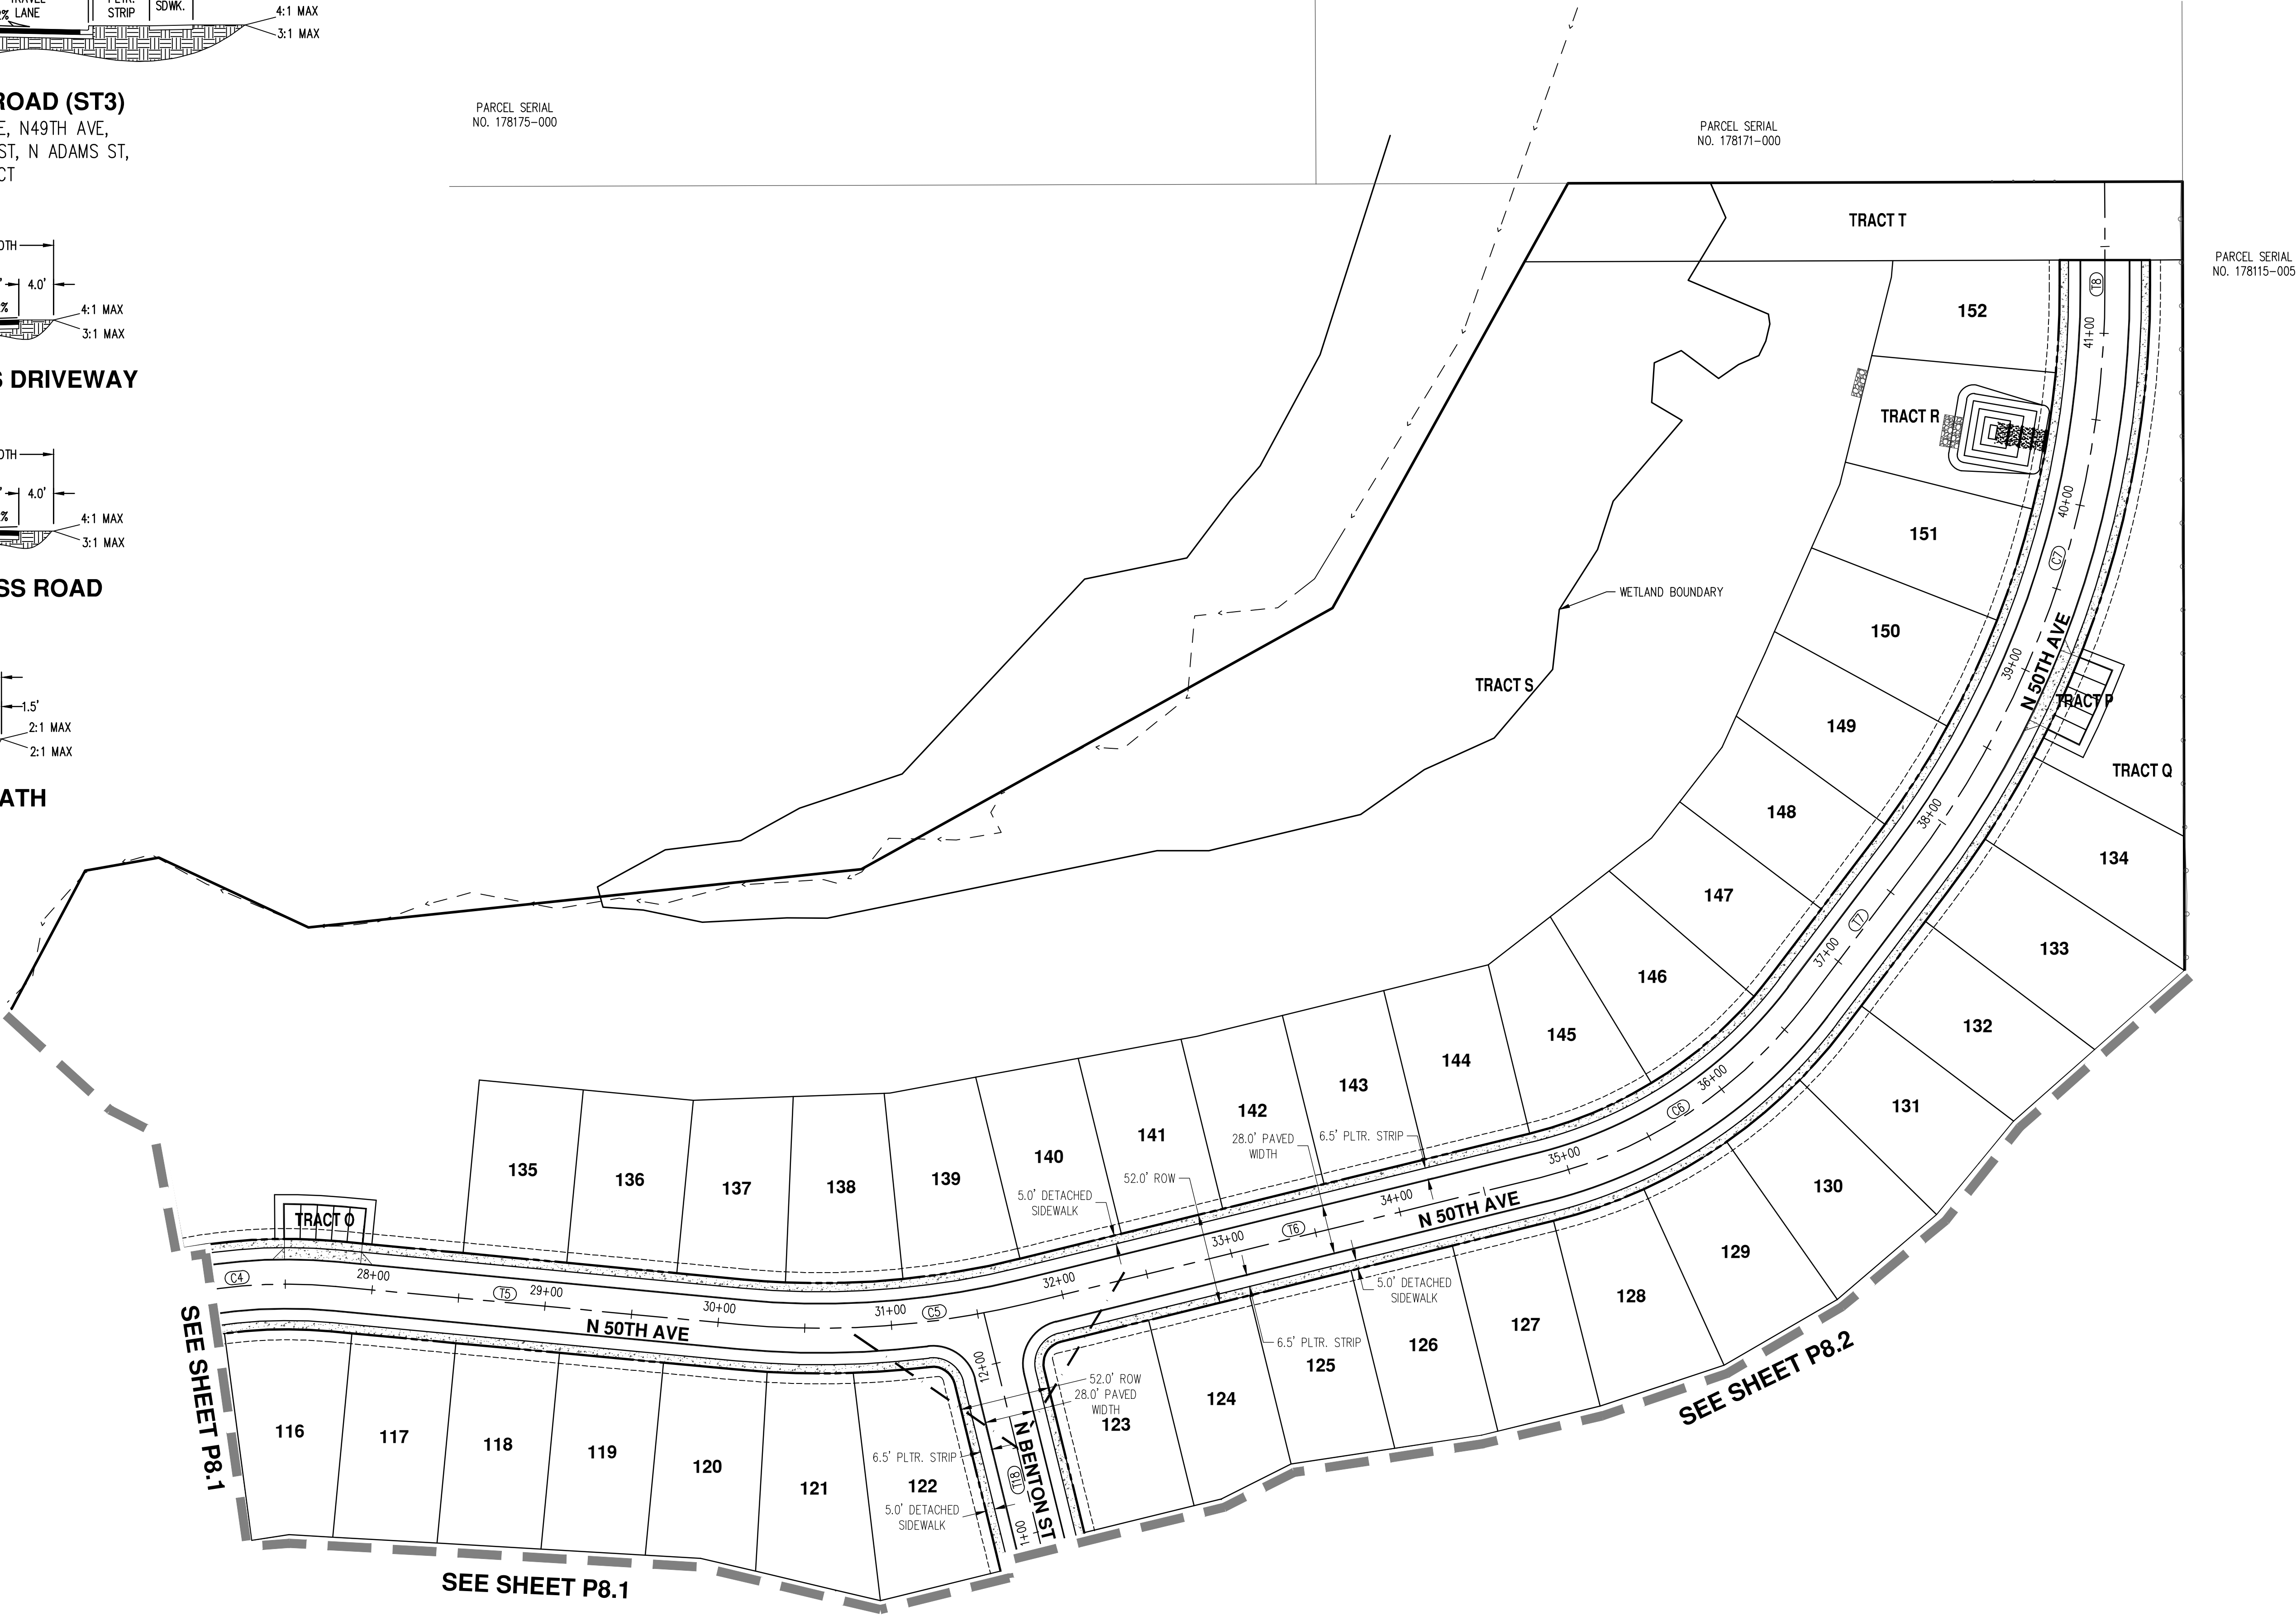
PRELIMINARY STREET PLAN - PHASE 3
CJ DENS SUBDIVISION
CJ DENS LACAMAS II LLC
CAMAS, WASHINGTON

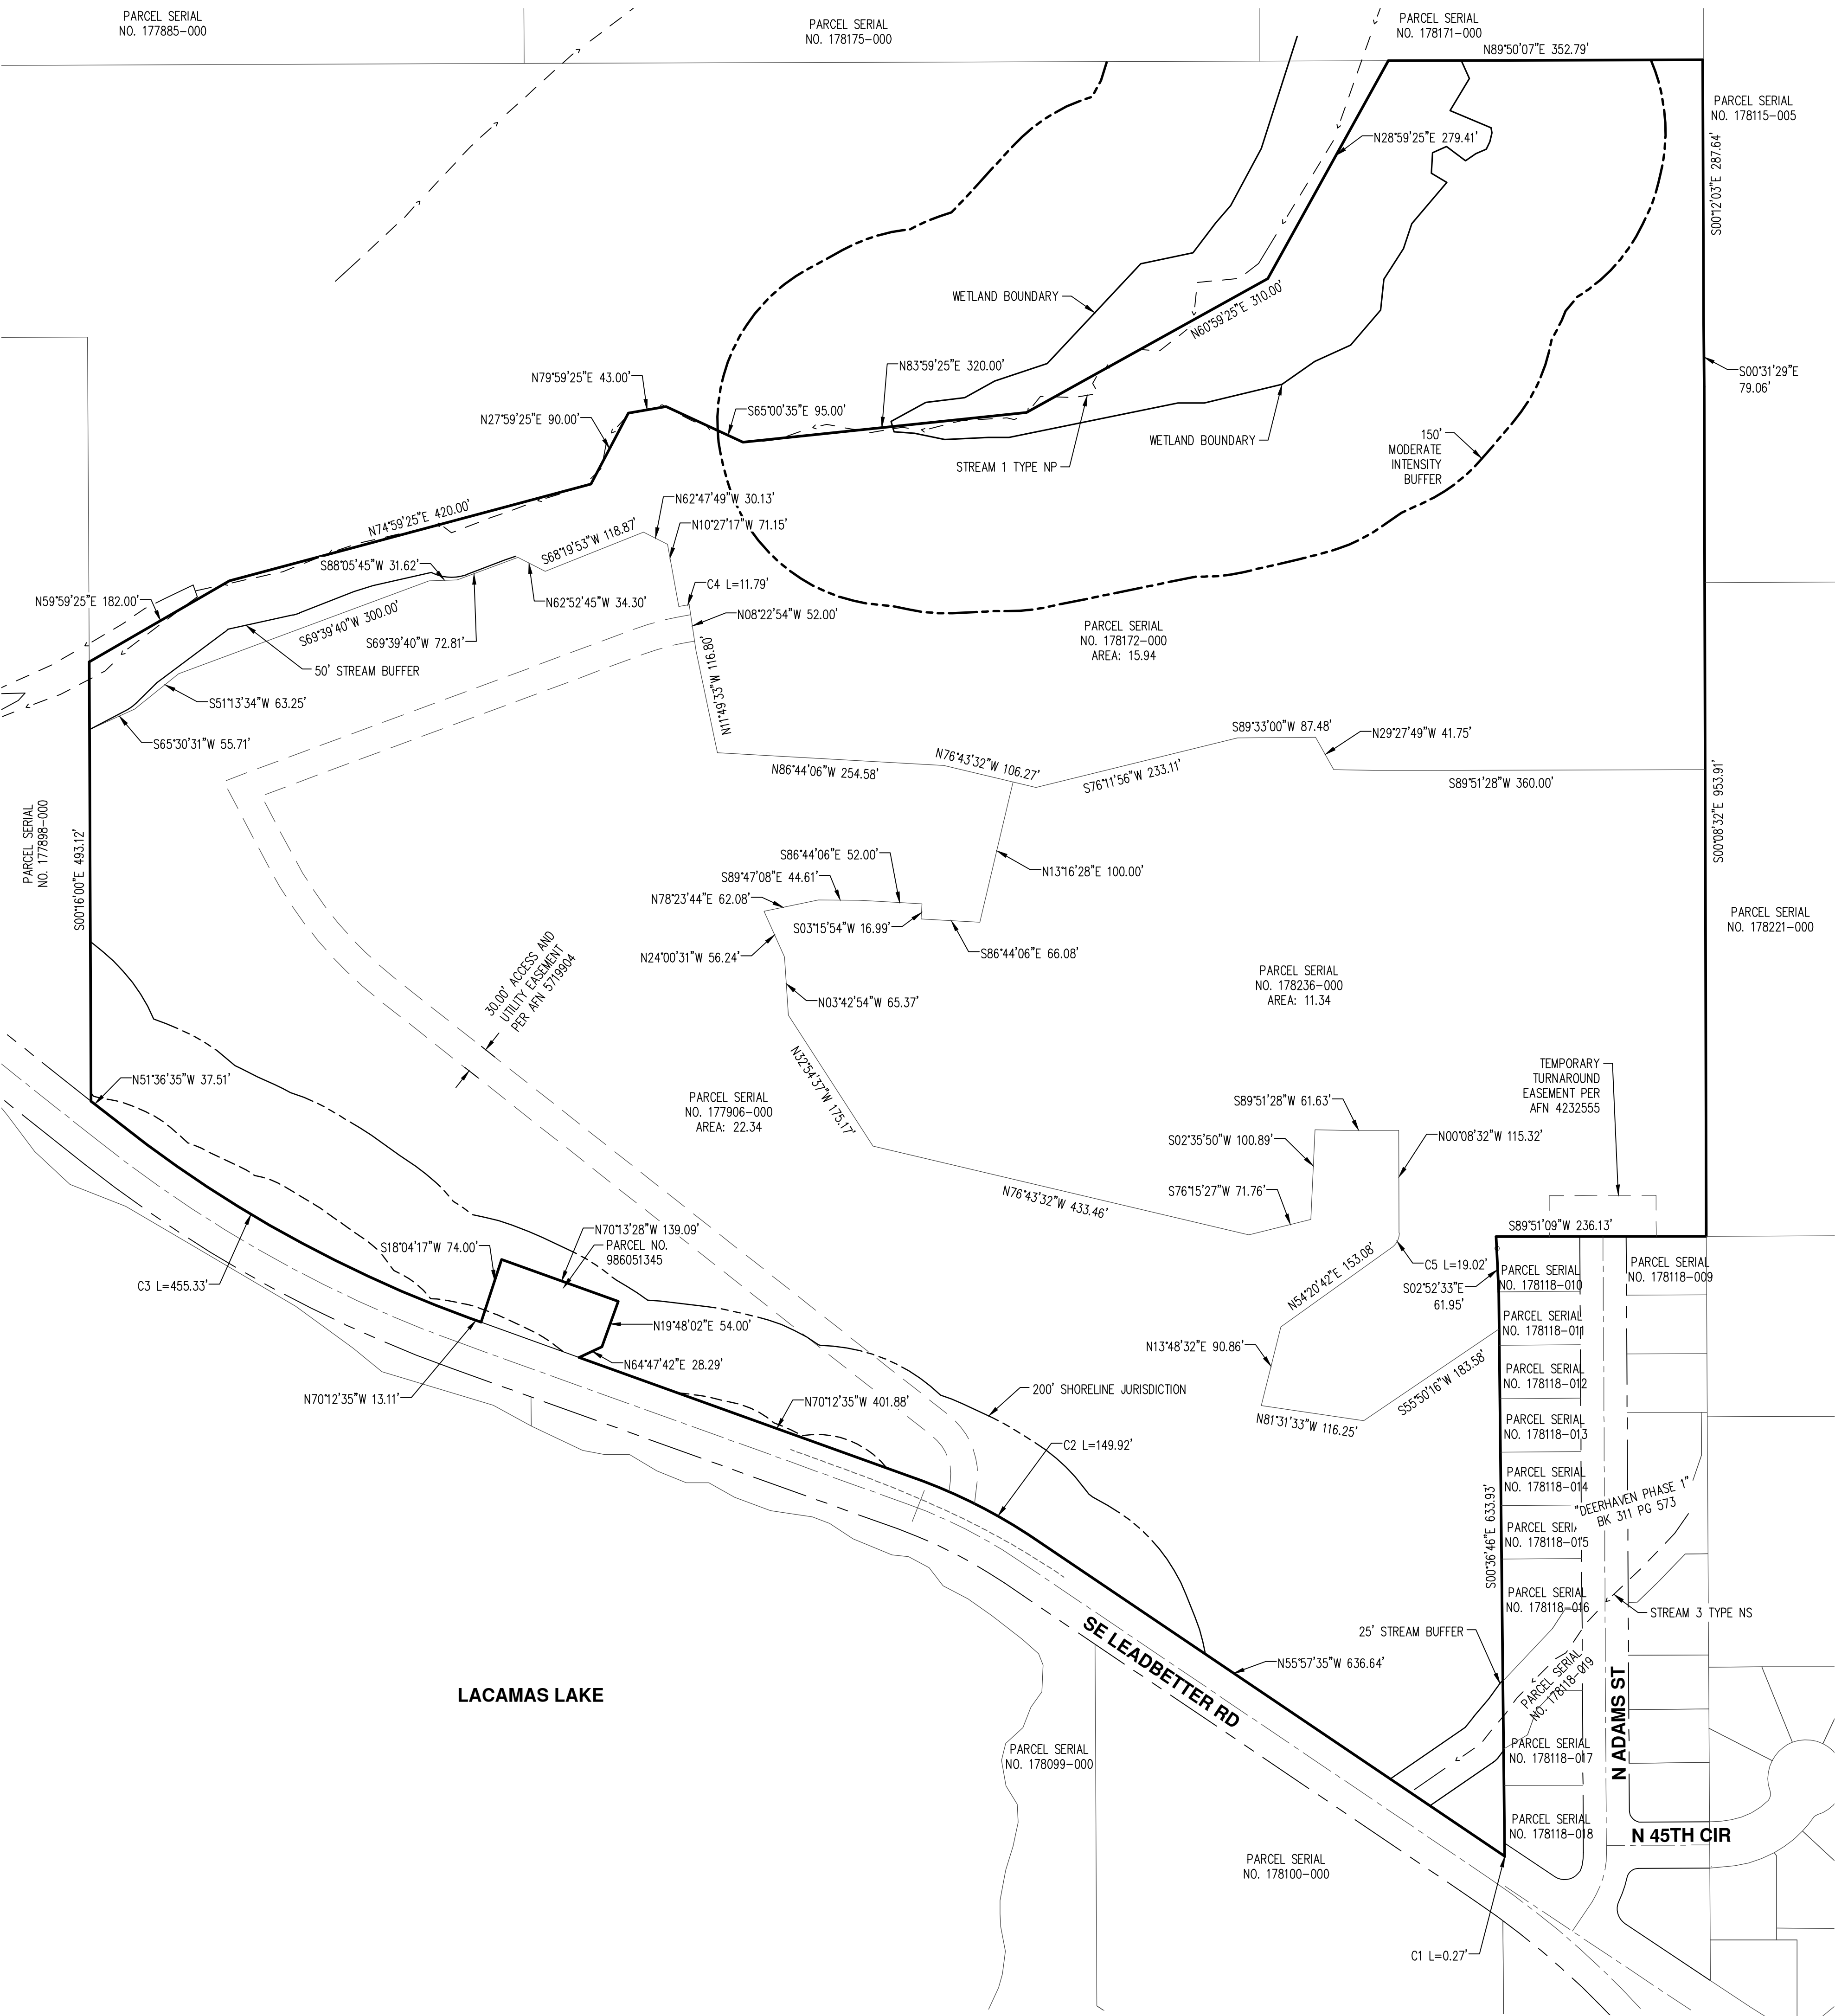
EXISTING CONDITIONS
CJ DENS SUBDIVISION
CJ DENS LACAMAS II LLC
CAMAS, WASHINGTON

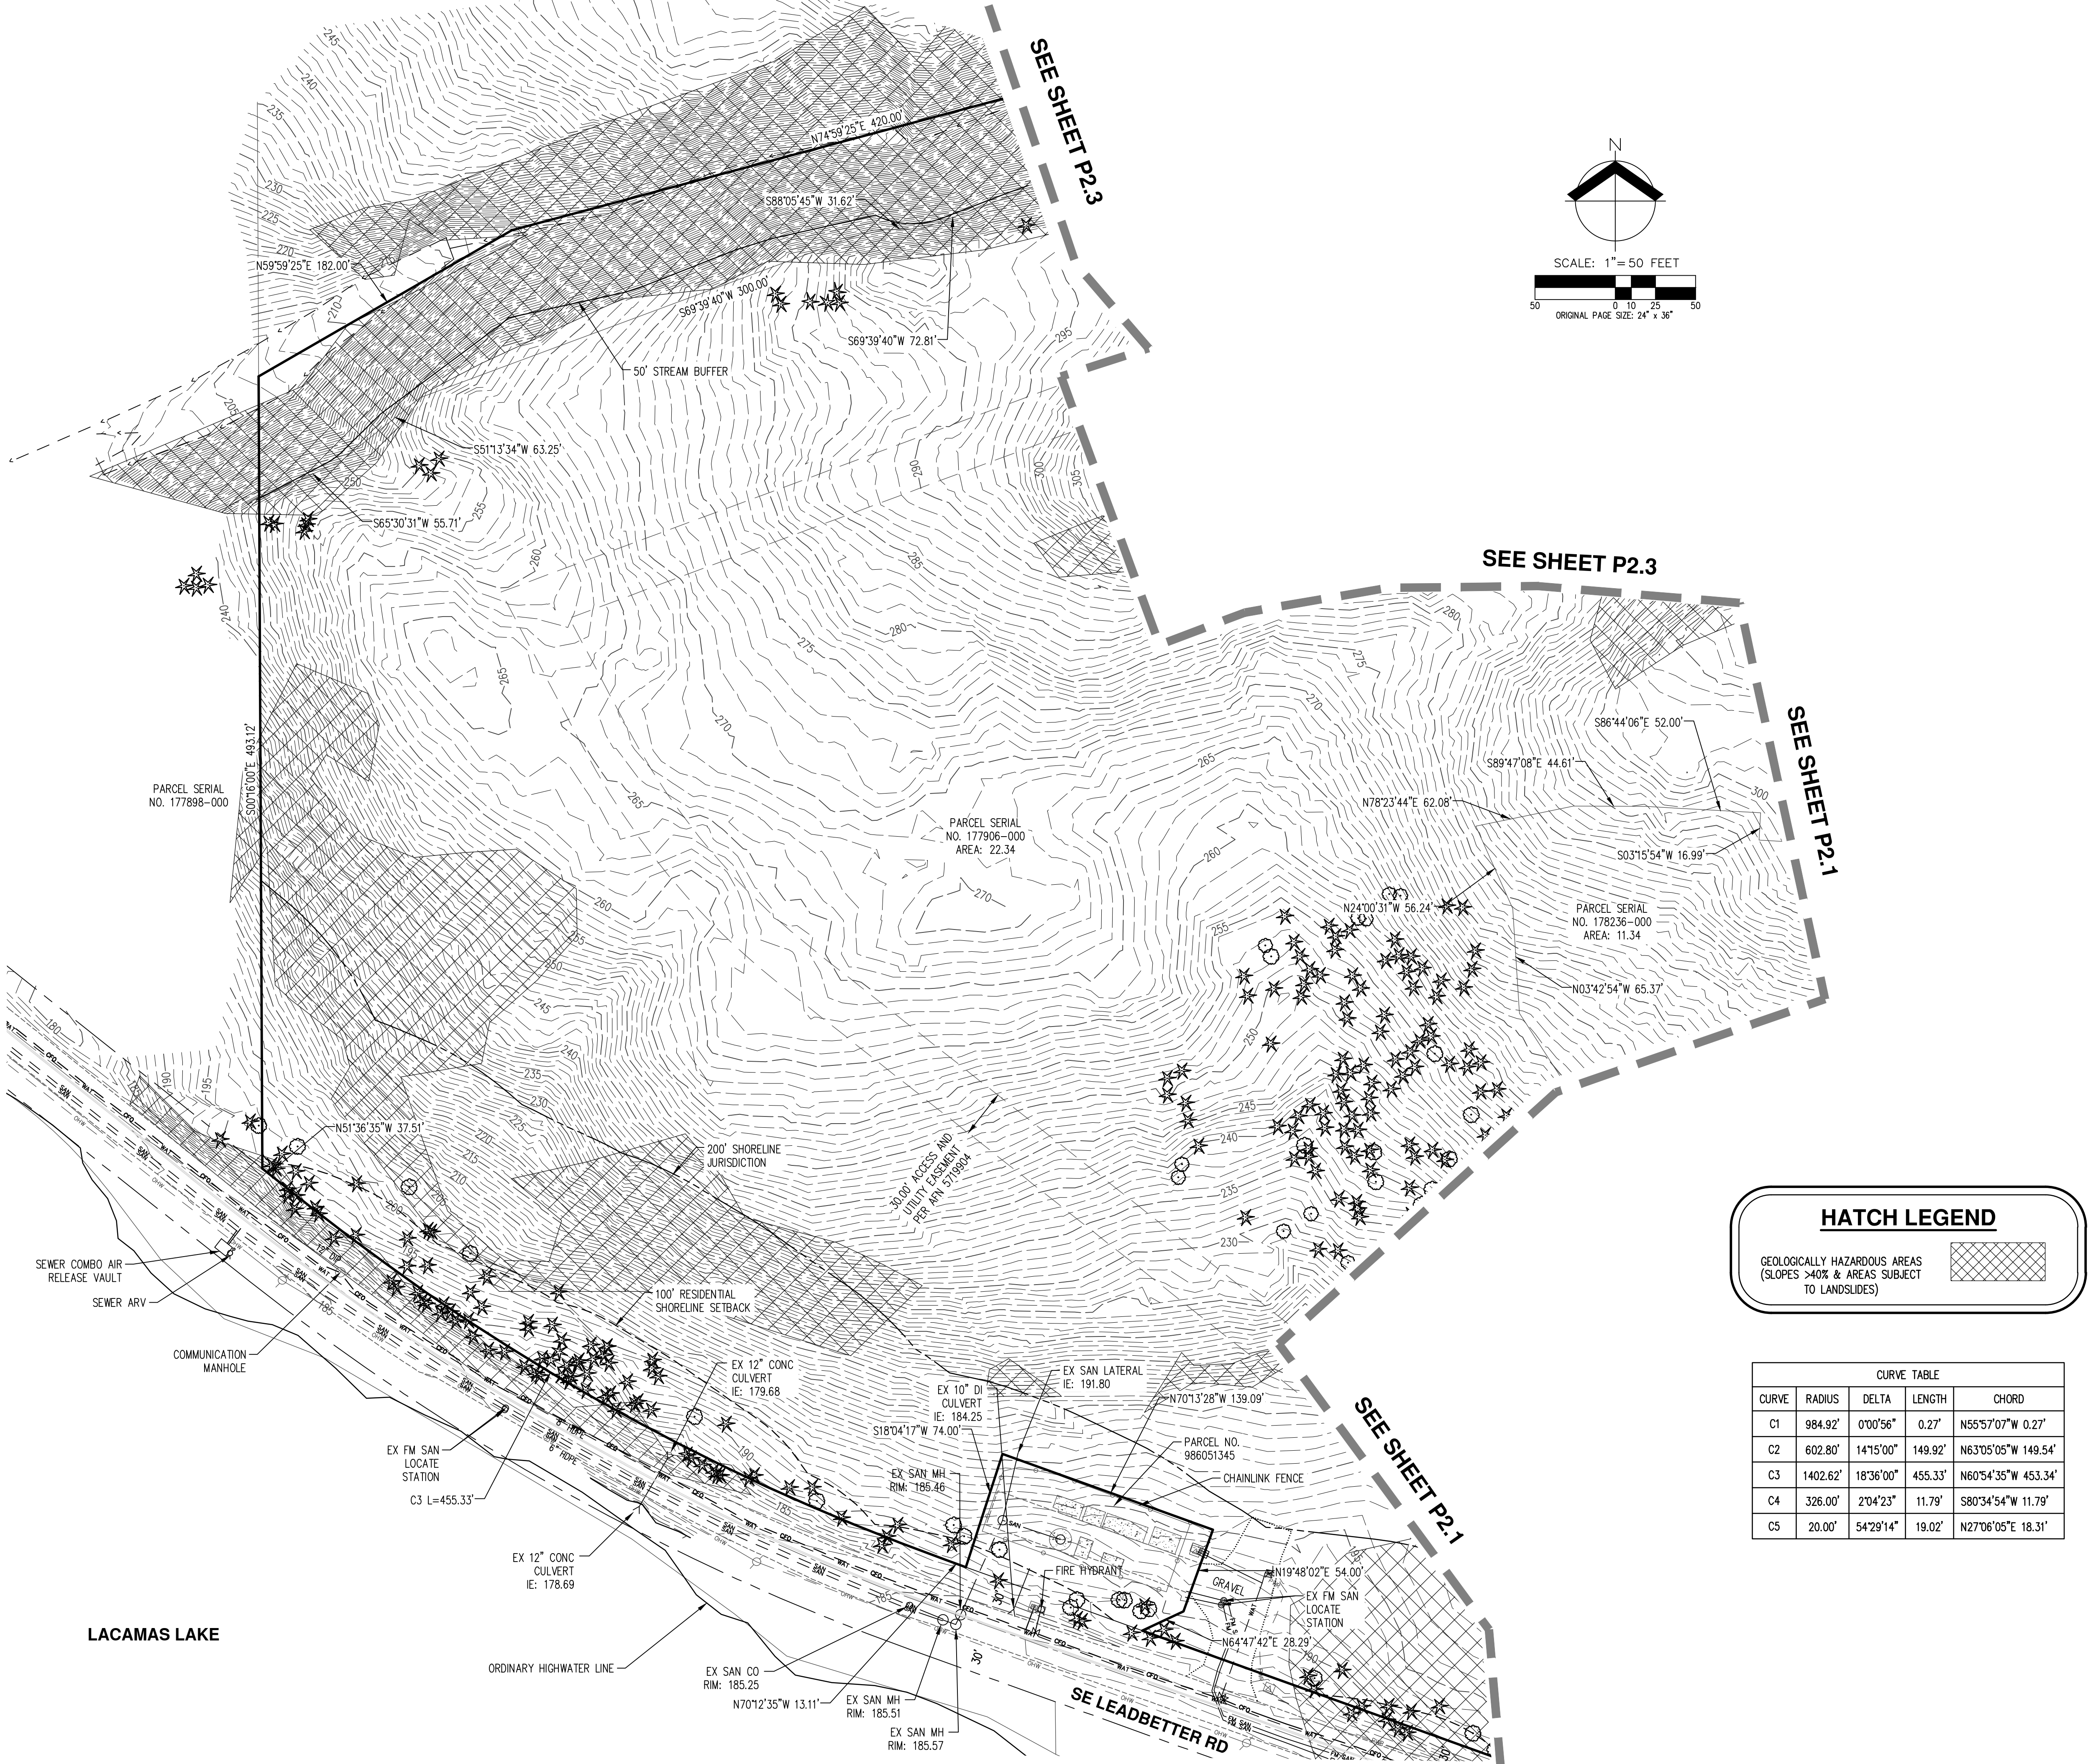
EXISTING CONDITIONS (WEST)
CJ DENS SUBDIVISION
CJ DENS LACAMAS II LLC
CAMAS, WASHINGTON
