LAND USE DECISION

STAFF REPORT

CJ DENS SUBDIVISION (File No. SUB20-02)

CONSOLIDATED FILES: SHORELINE SUBSTANTIAL DEVELOPMENT PERMIT, SHORELINE CONDITIONAL USE PERMIT AND SHORELINE VARIANCE (SHOR20-01); CRITICAL AREAS REVIEW (CA20-08); ARCHAEOLOGICAL REVIEW (ARCH20-08); TEMPORARY USE PERMIT (TUP20-05); STATE ENVIRONMENTAL POLICY ACT (SEPA20-17)

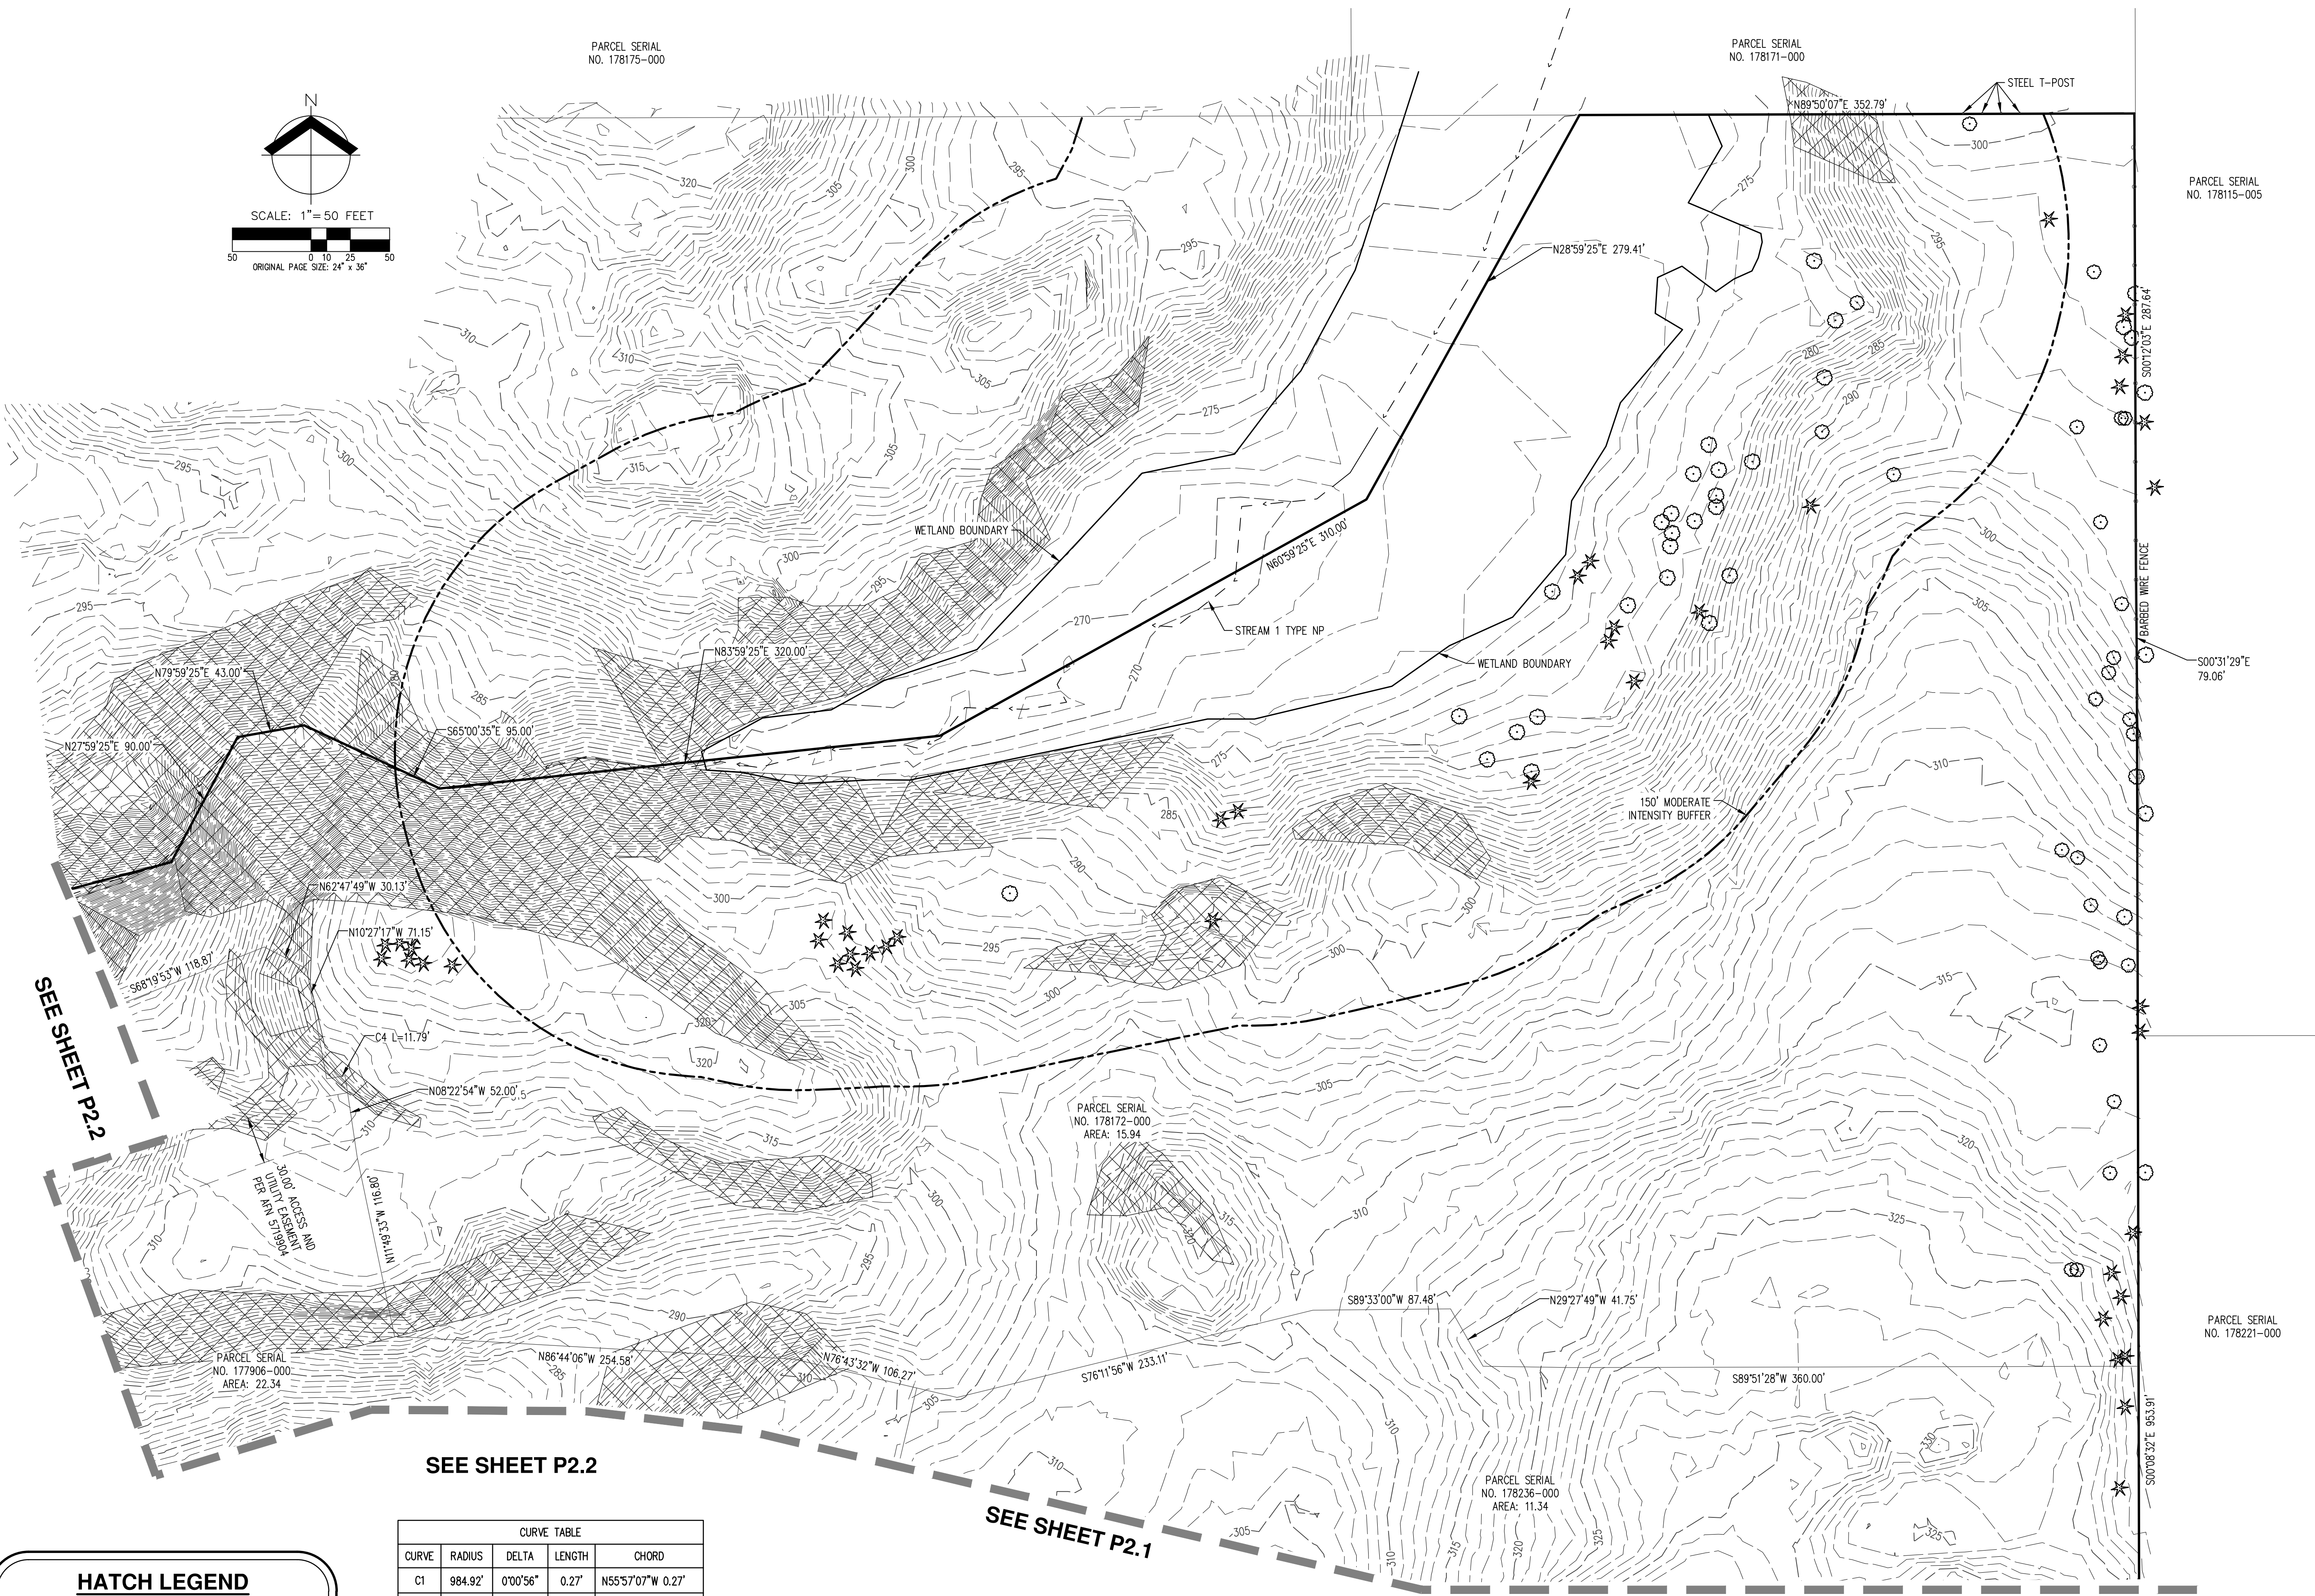
P2.3

EXISTING CONDITIONS (NORTH)
CJ DENS SUBDIVISION
CJ DENS LACAMAS II LLC
CAMAS, WASHINGTON

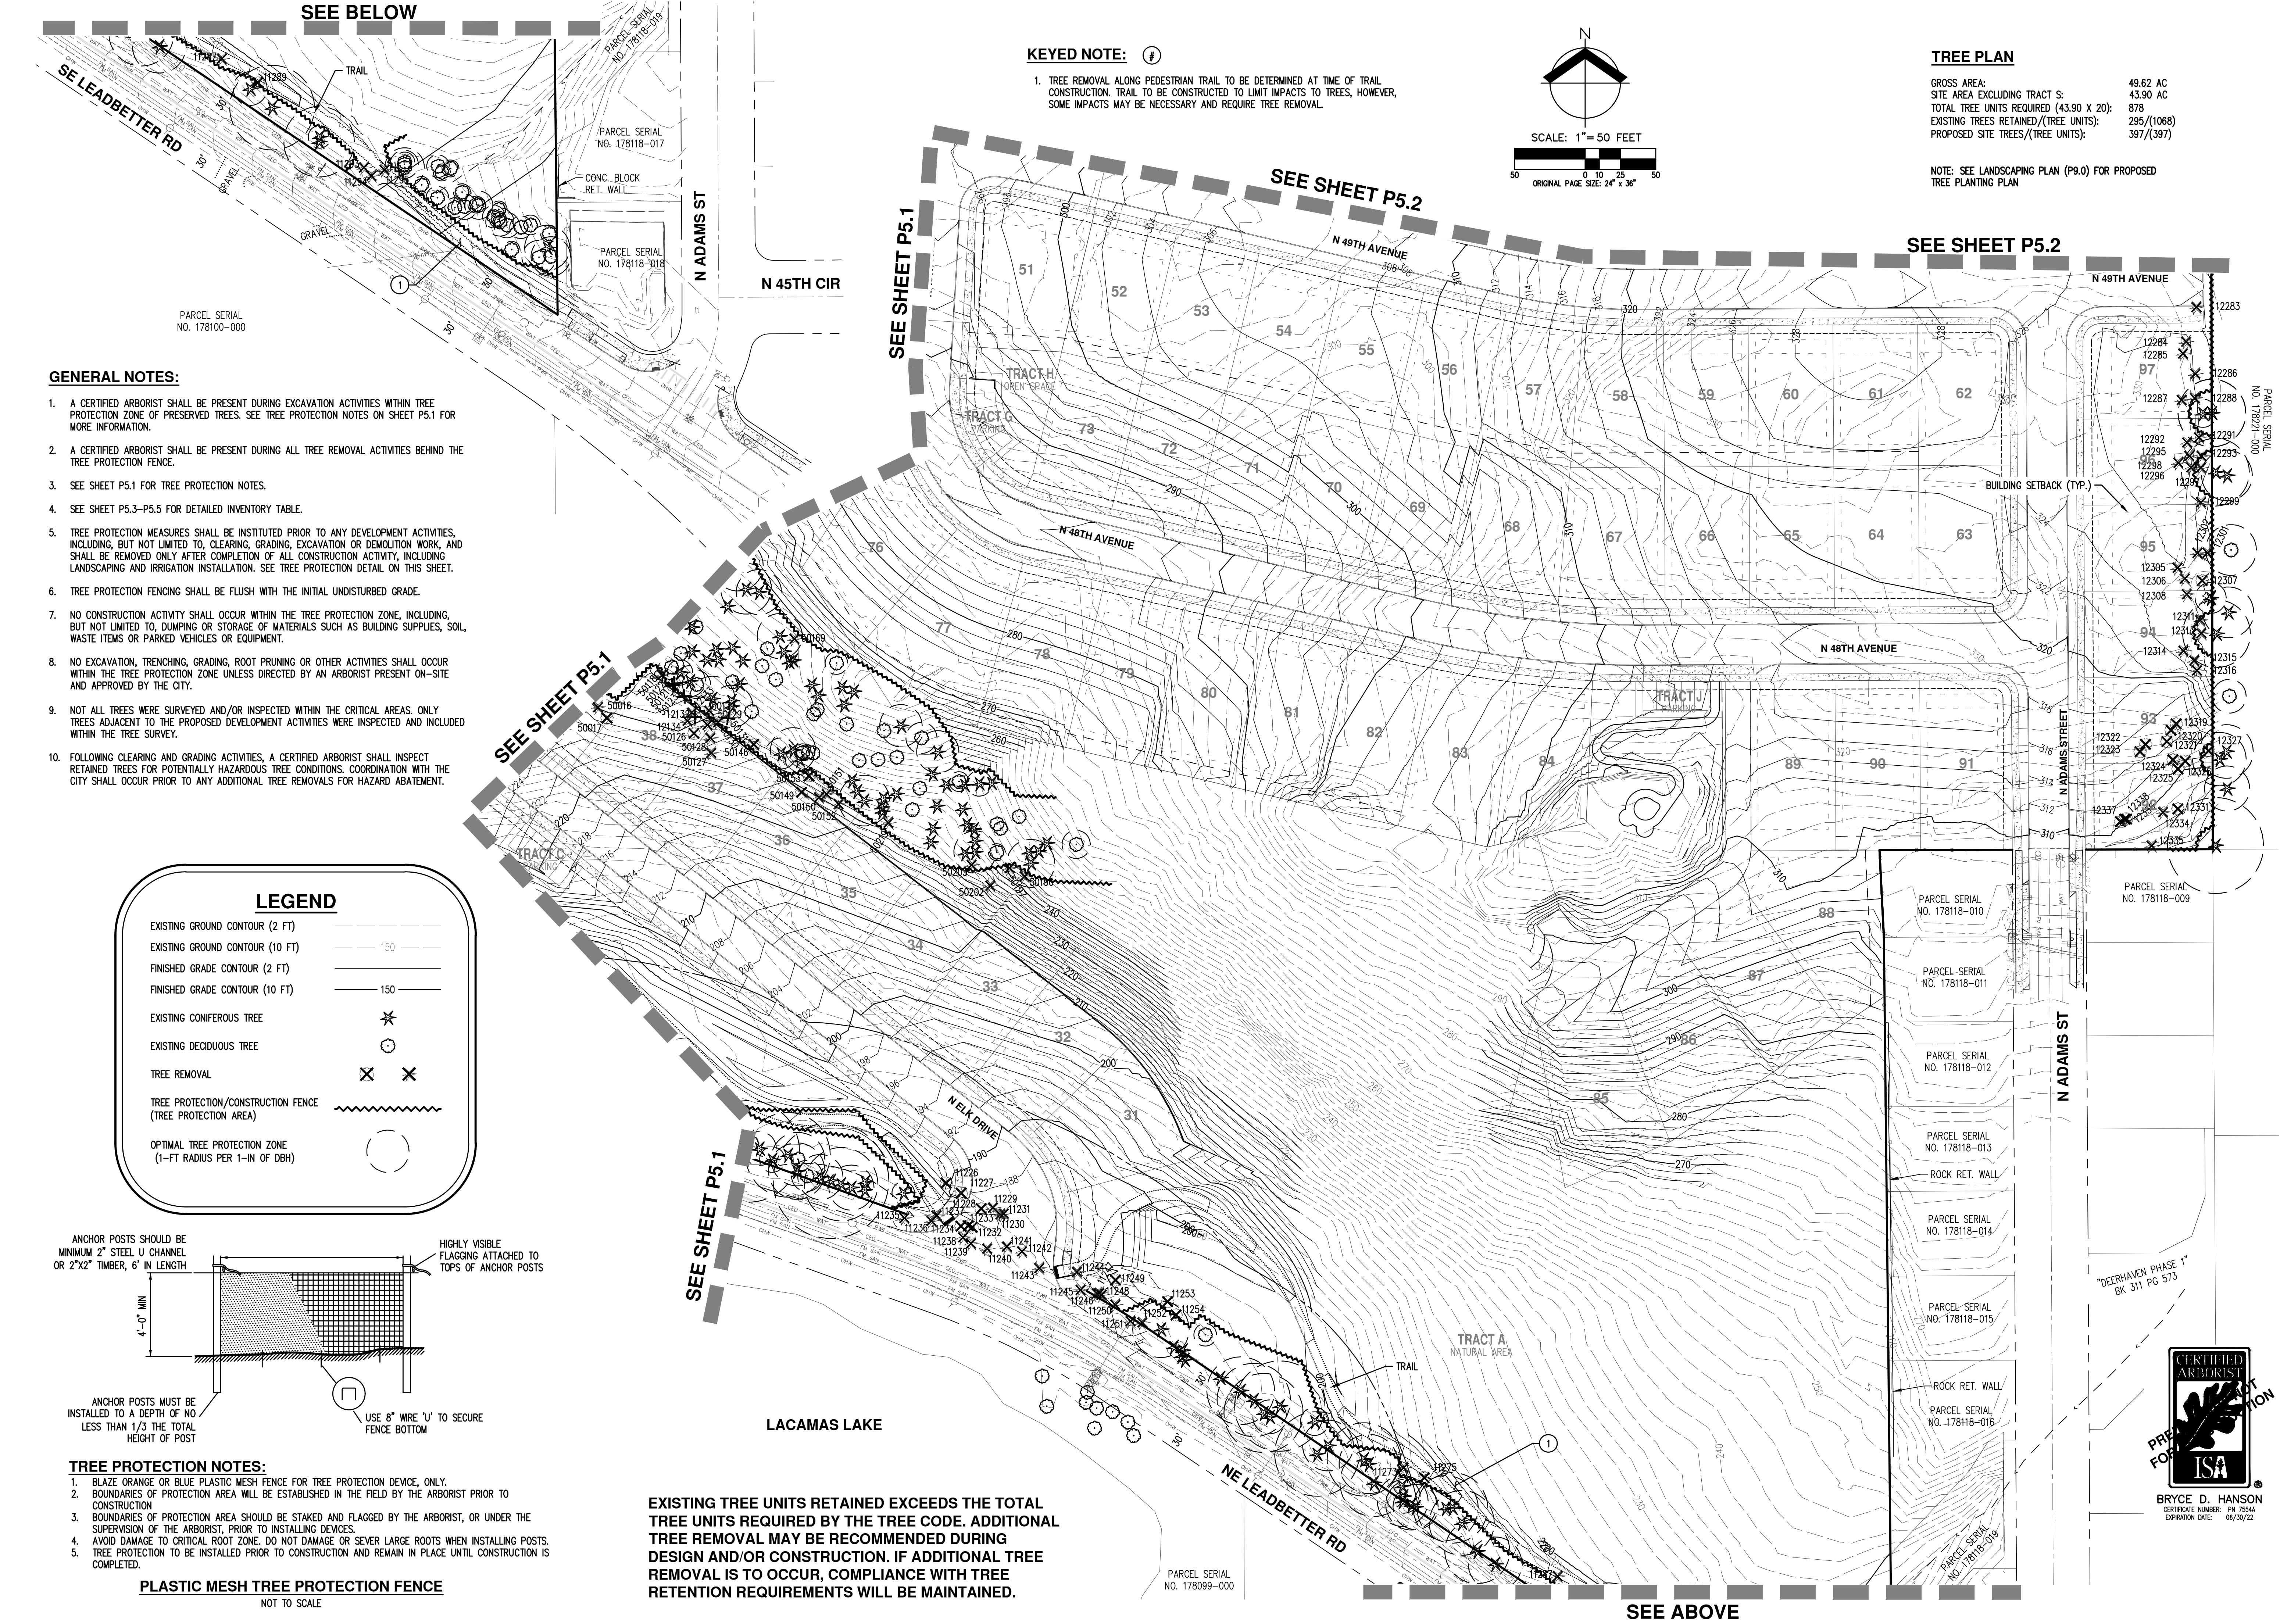
PRELIMINARY TREE PRESERVATION AND REMOVAL PLAN (SOUTH)

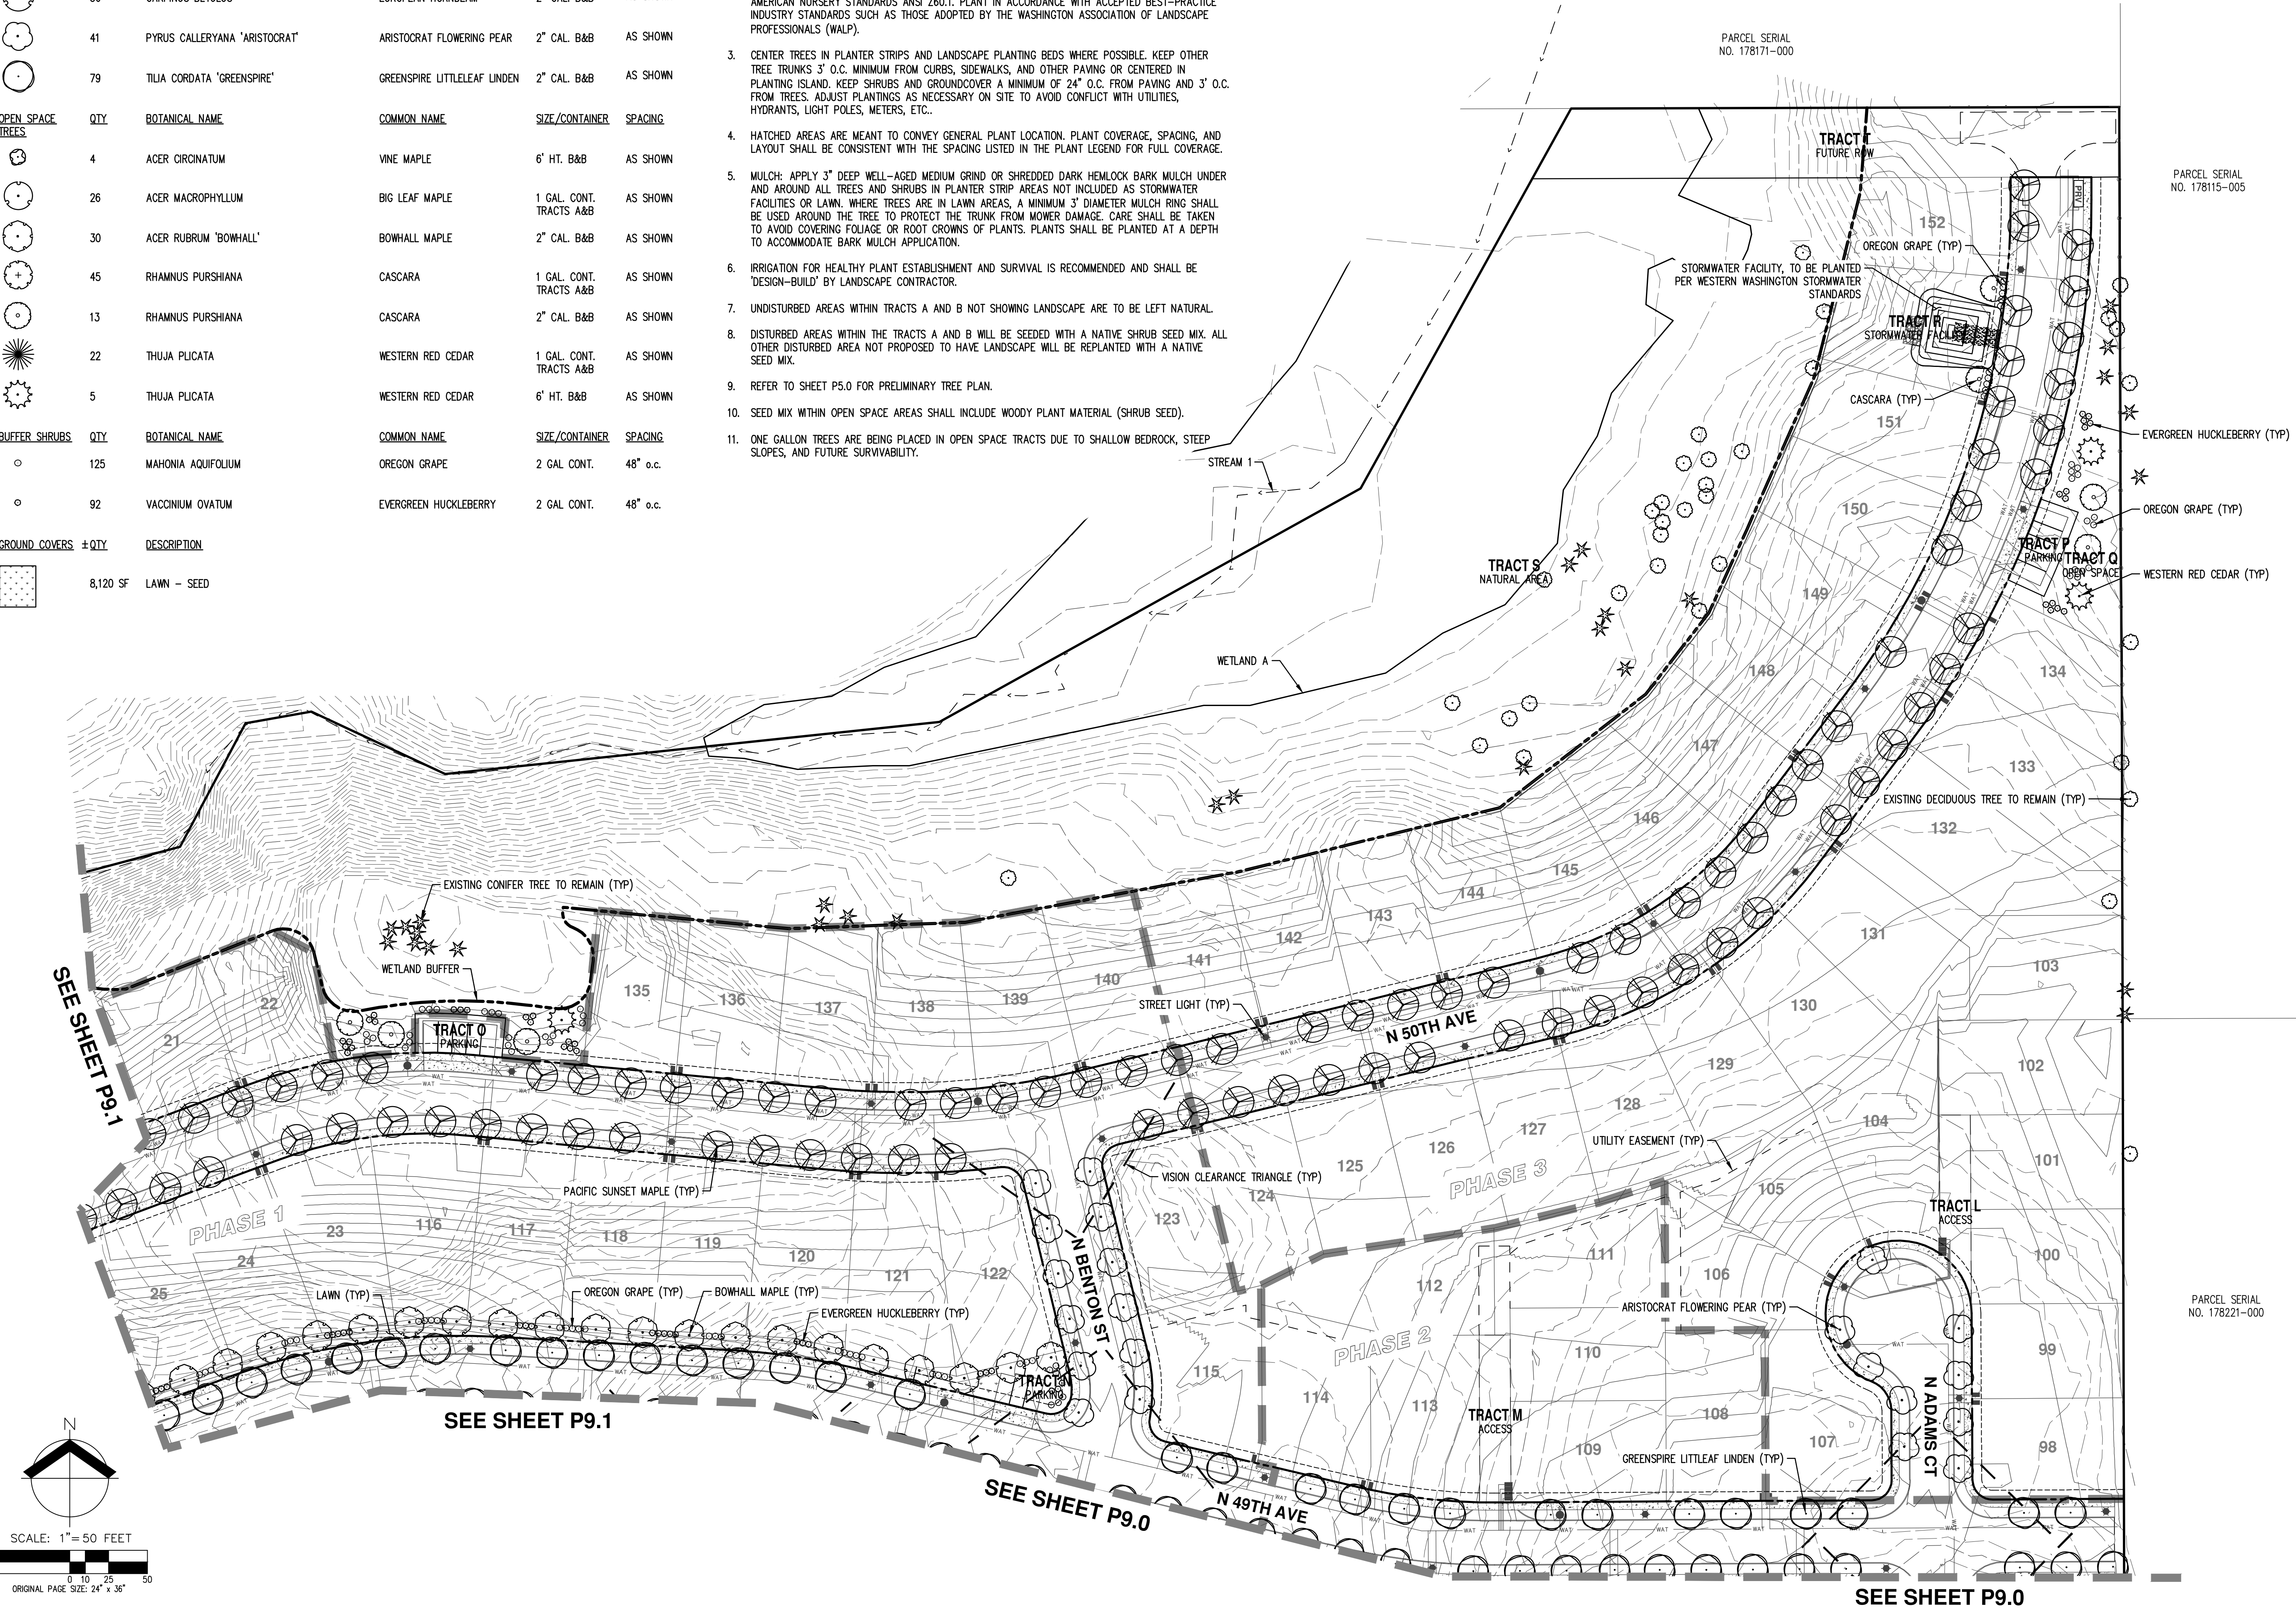
PRELIMINARY LANDSCAPE AND LIGHTING PLAN (NORTH)

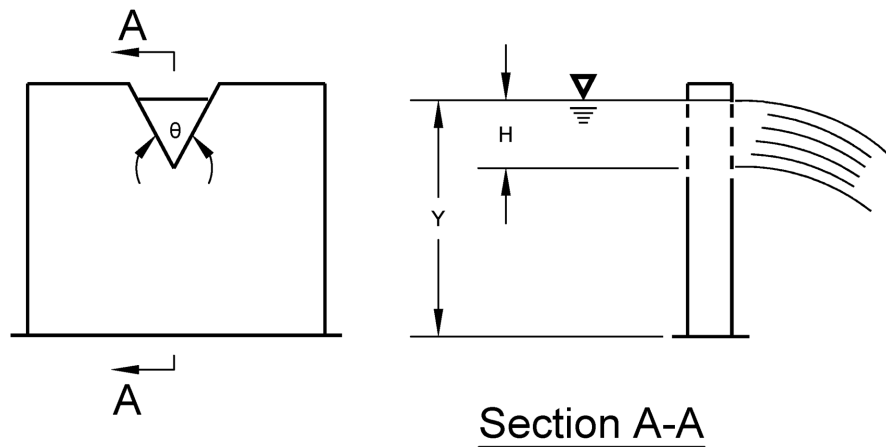
Figure V-12.6: V-Notch, Sharp-Crested Weir

$$Q = C_d \left(\tan \frac{\theta}{2} \right) H^{\frac{5}{2}} \text{ in cfs}$$

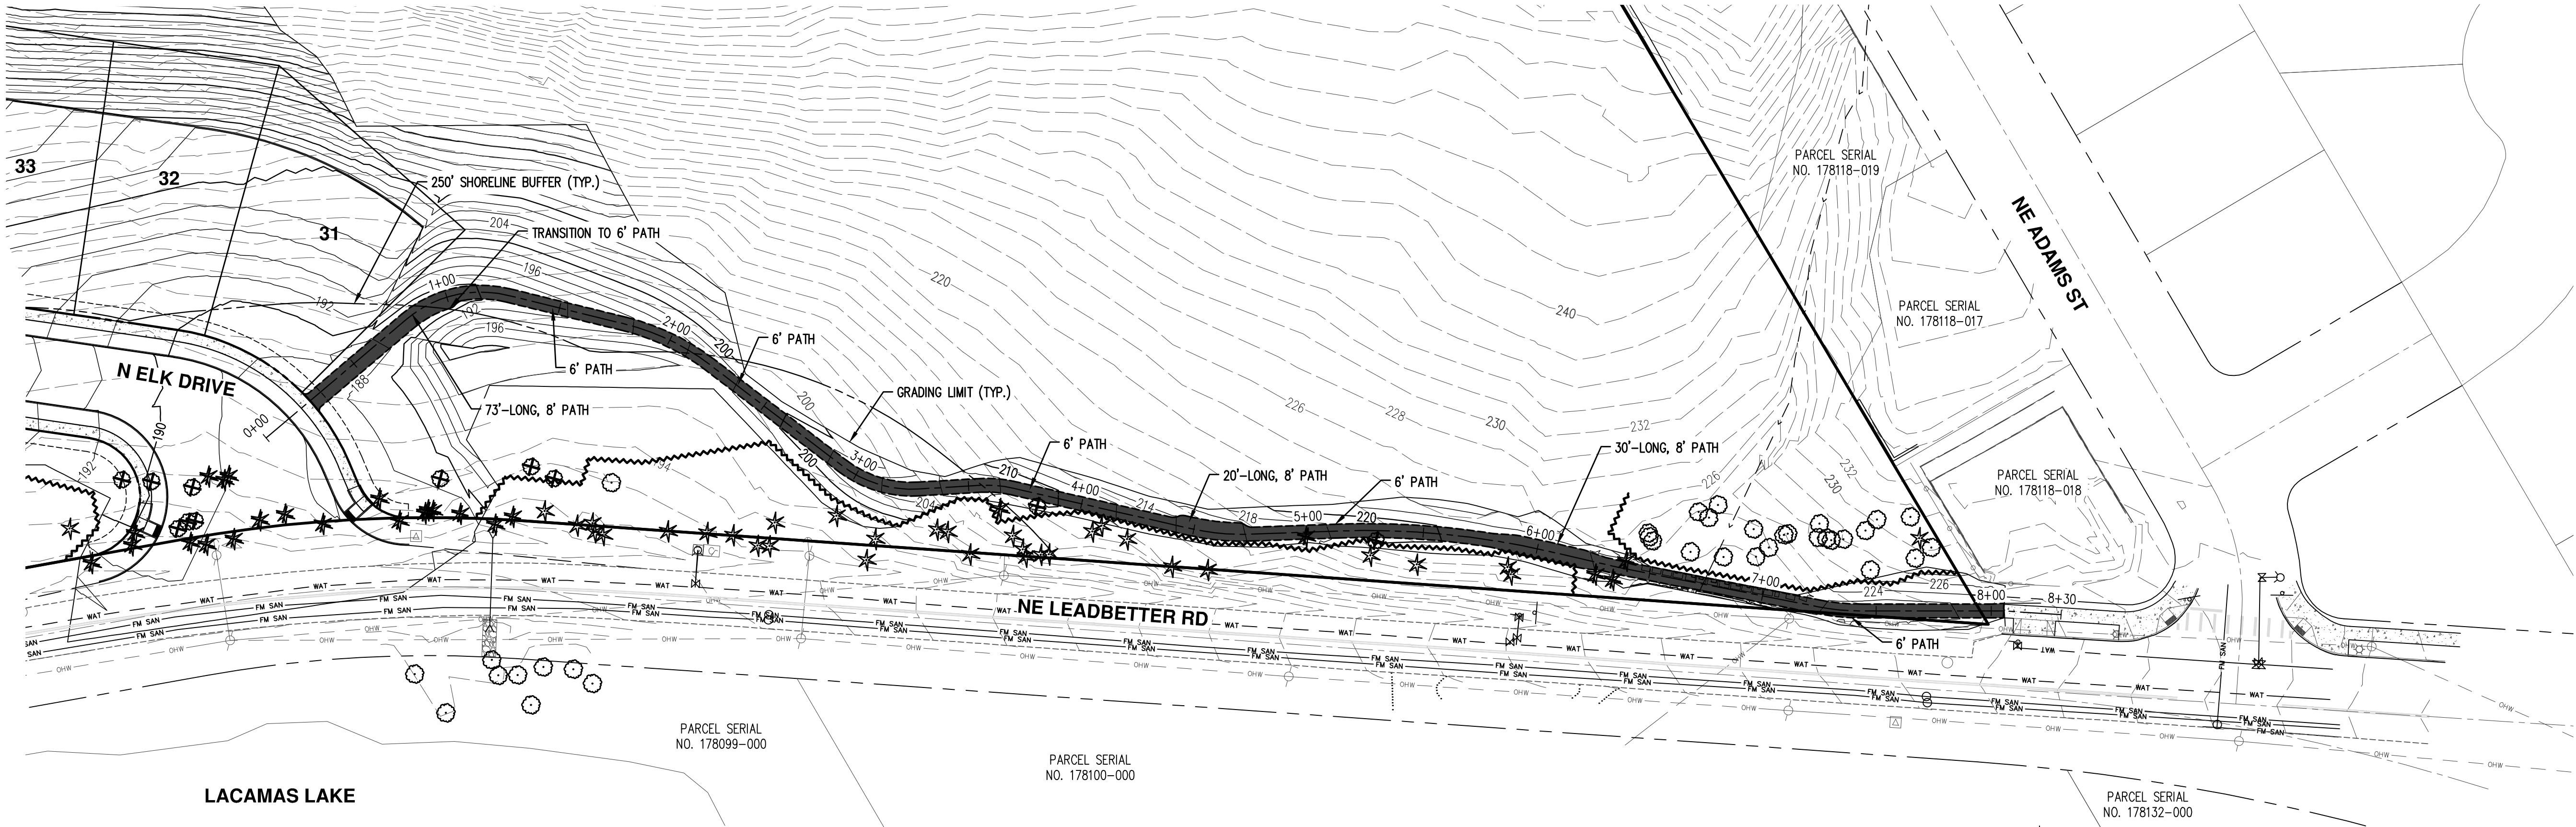
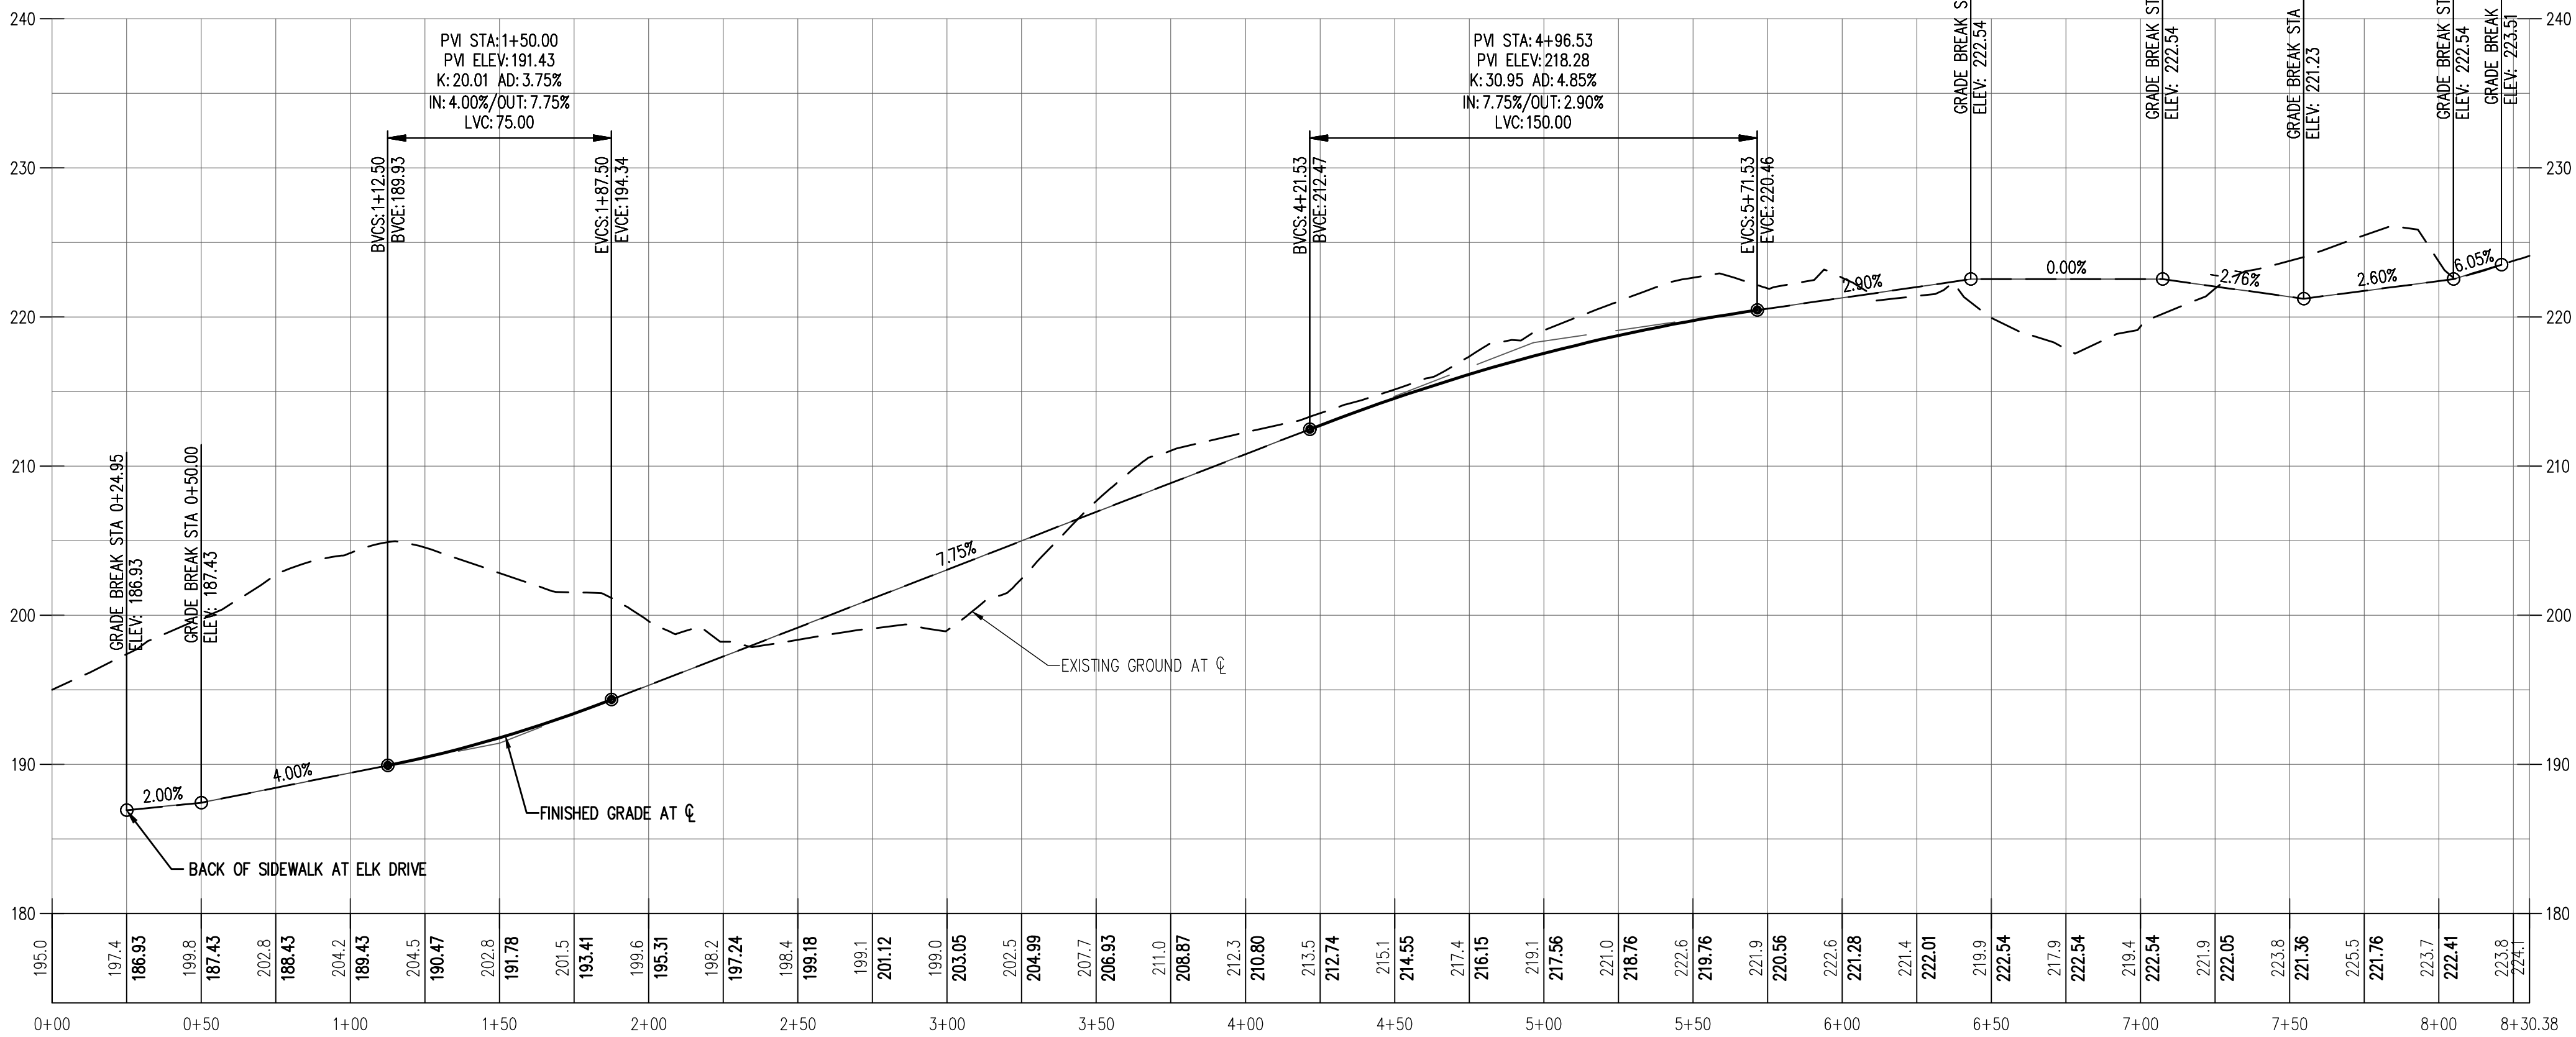
TRAIL 1.1
Hor. Scale: 1"= 40'
Vert. Scale: 1"= 8'
STATIONING IS BASED ON TRAIL
CENTERLINE UNLESS OTHERWISE NOTED

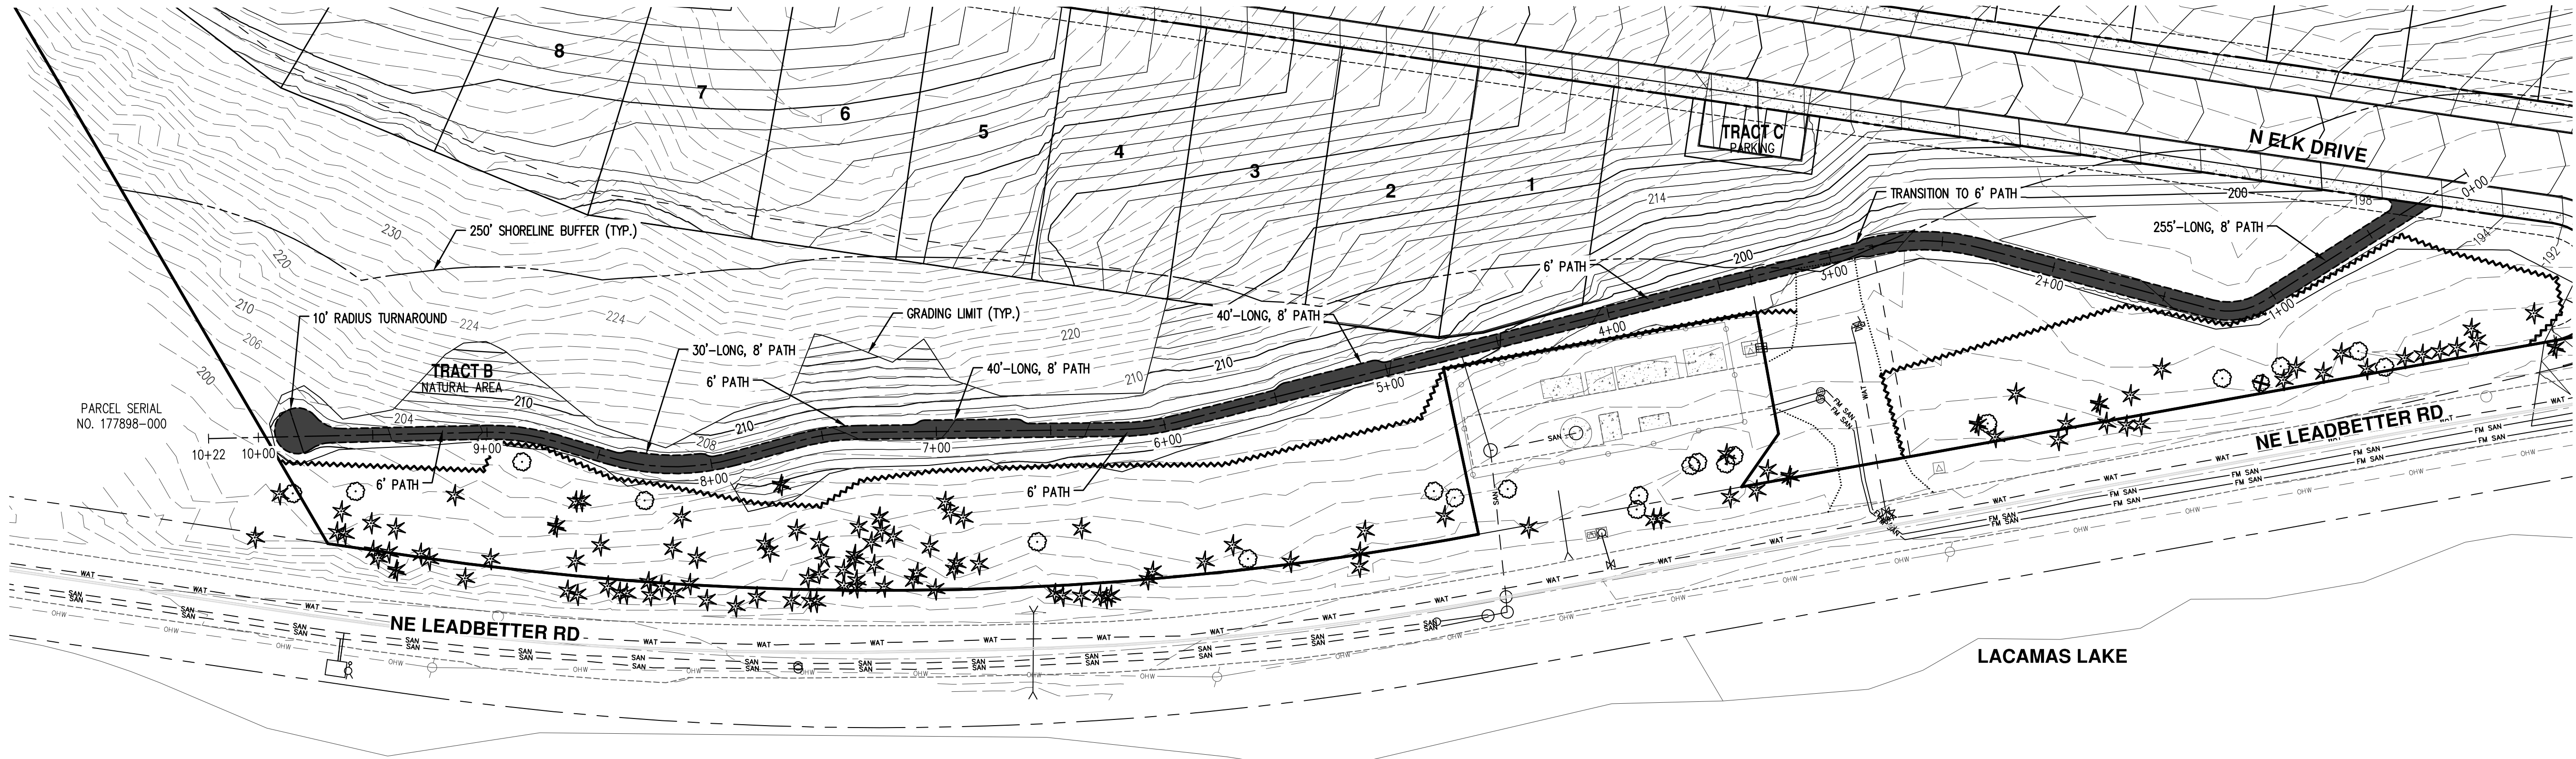
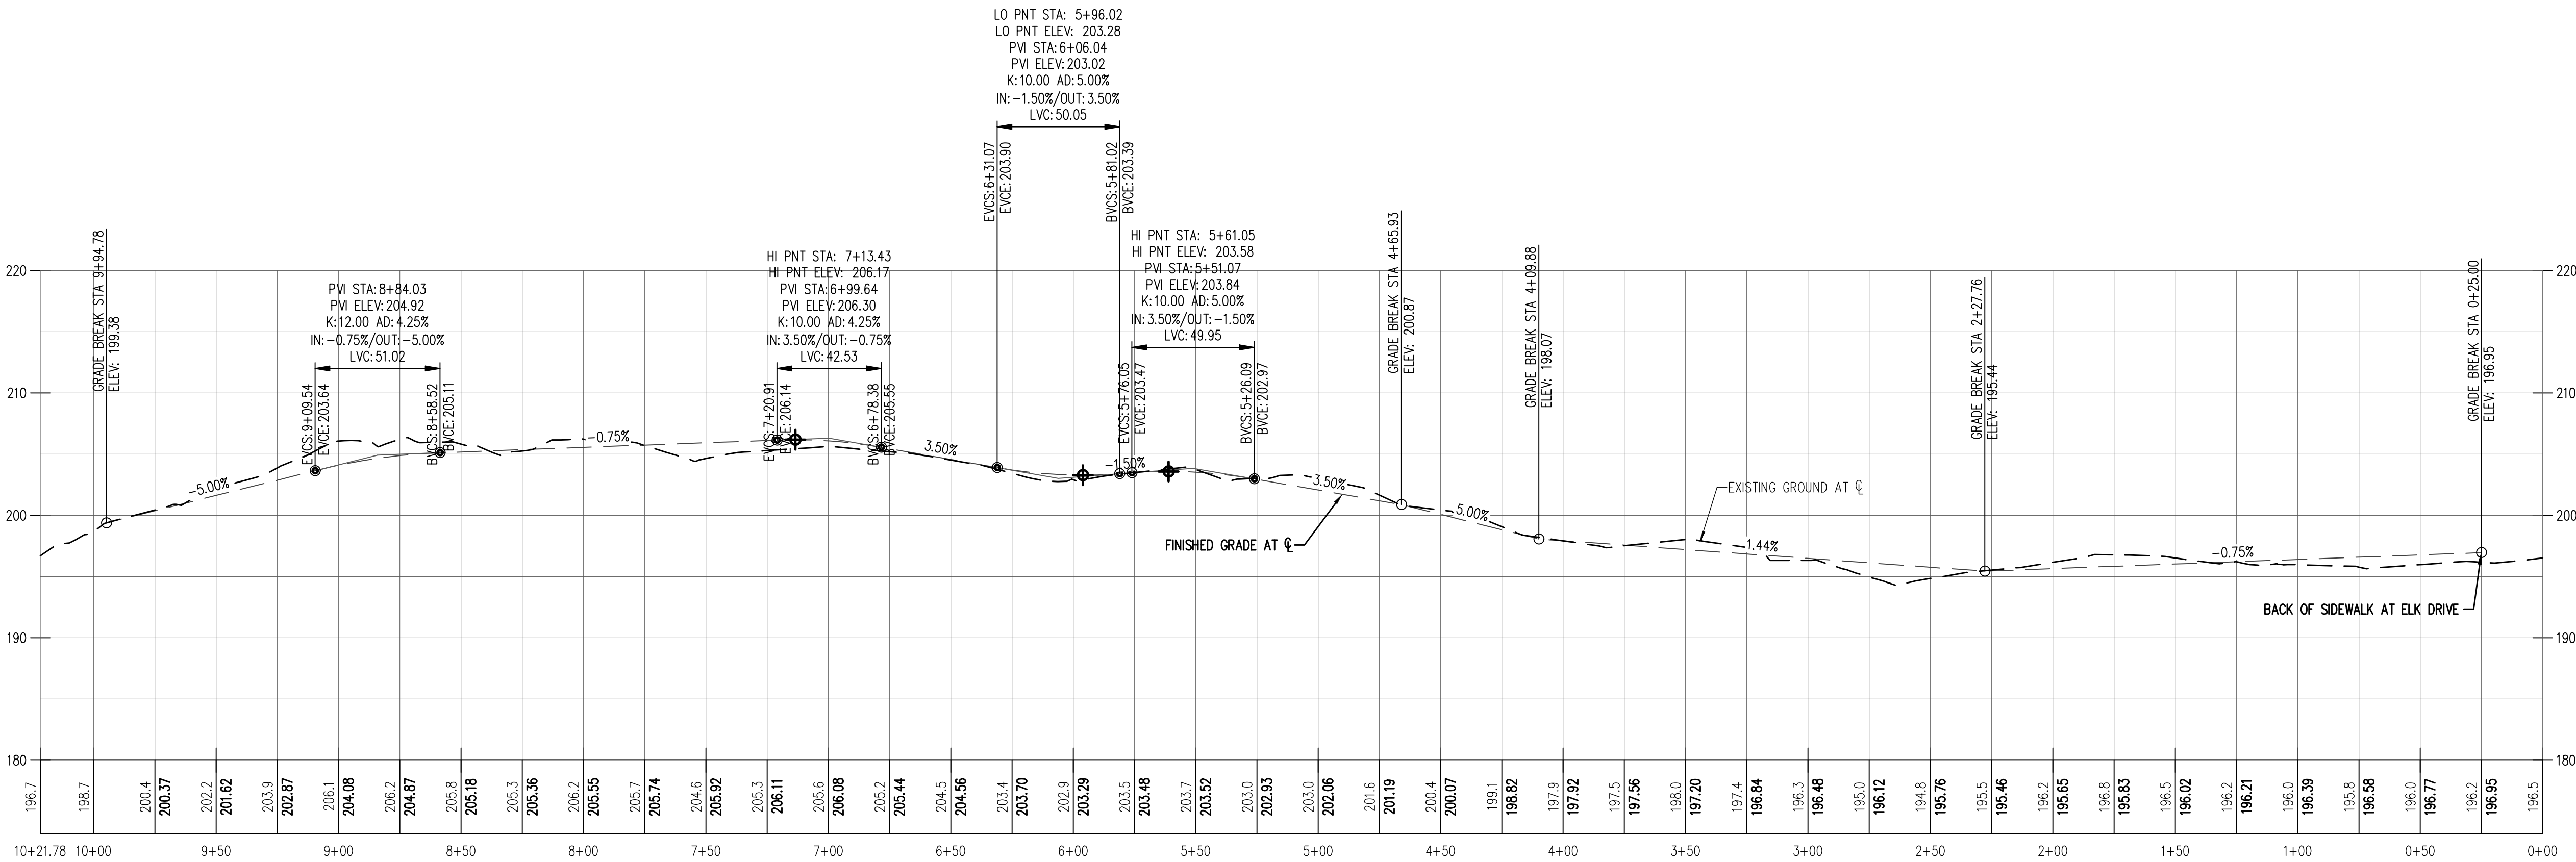
TRAIL 1.2
Hor. Scale: 1"= 40'
Vert. Scale: 1"= 8'
STATIONING IS BASED ON TRAIL
CENTERLINE UNLESS OTHERWISE NOTED
