LAND USE DECISION

STAFF REPORT

CJ DENS SUBDIVISION (File No. SUB20-02)

CONSOLIDATED FILES: SHORELINE SUBSTANTIAL DEVELOPMENT PERMIT, SHORELINE CONDITIONAL USE PERMIT AND SHORELINE VARIANCE (SHOR20-01); CRITICAL AREAS REVIEW (CA20-08); ARCHAEOLOGICAL REVIEW (ARCH20-08); TEMPORARY USE PERMIT (TUP20-05); STATE ENVIRONMENTAL POLICY ACT (SEPA20-17)

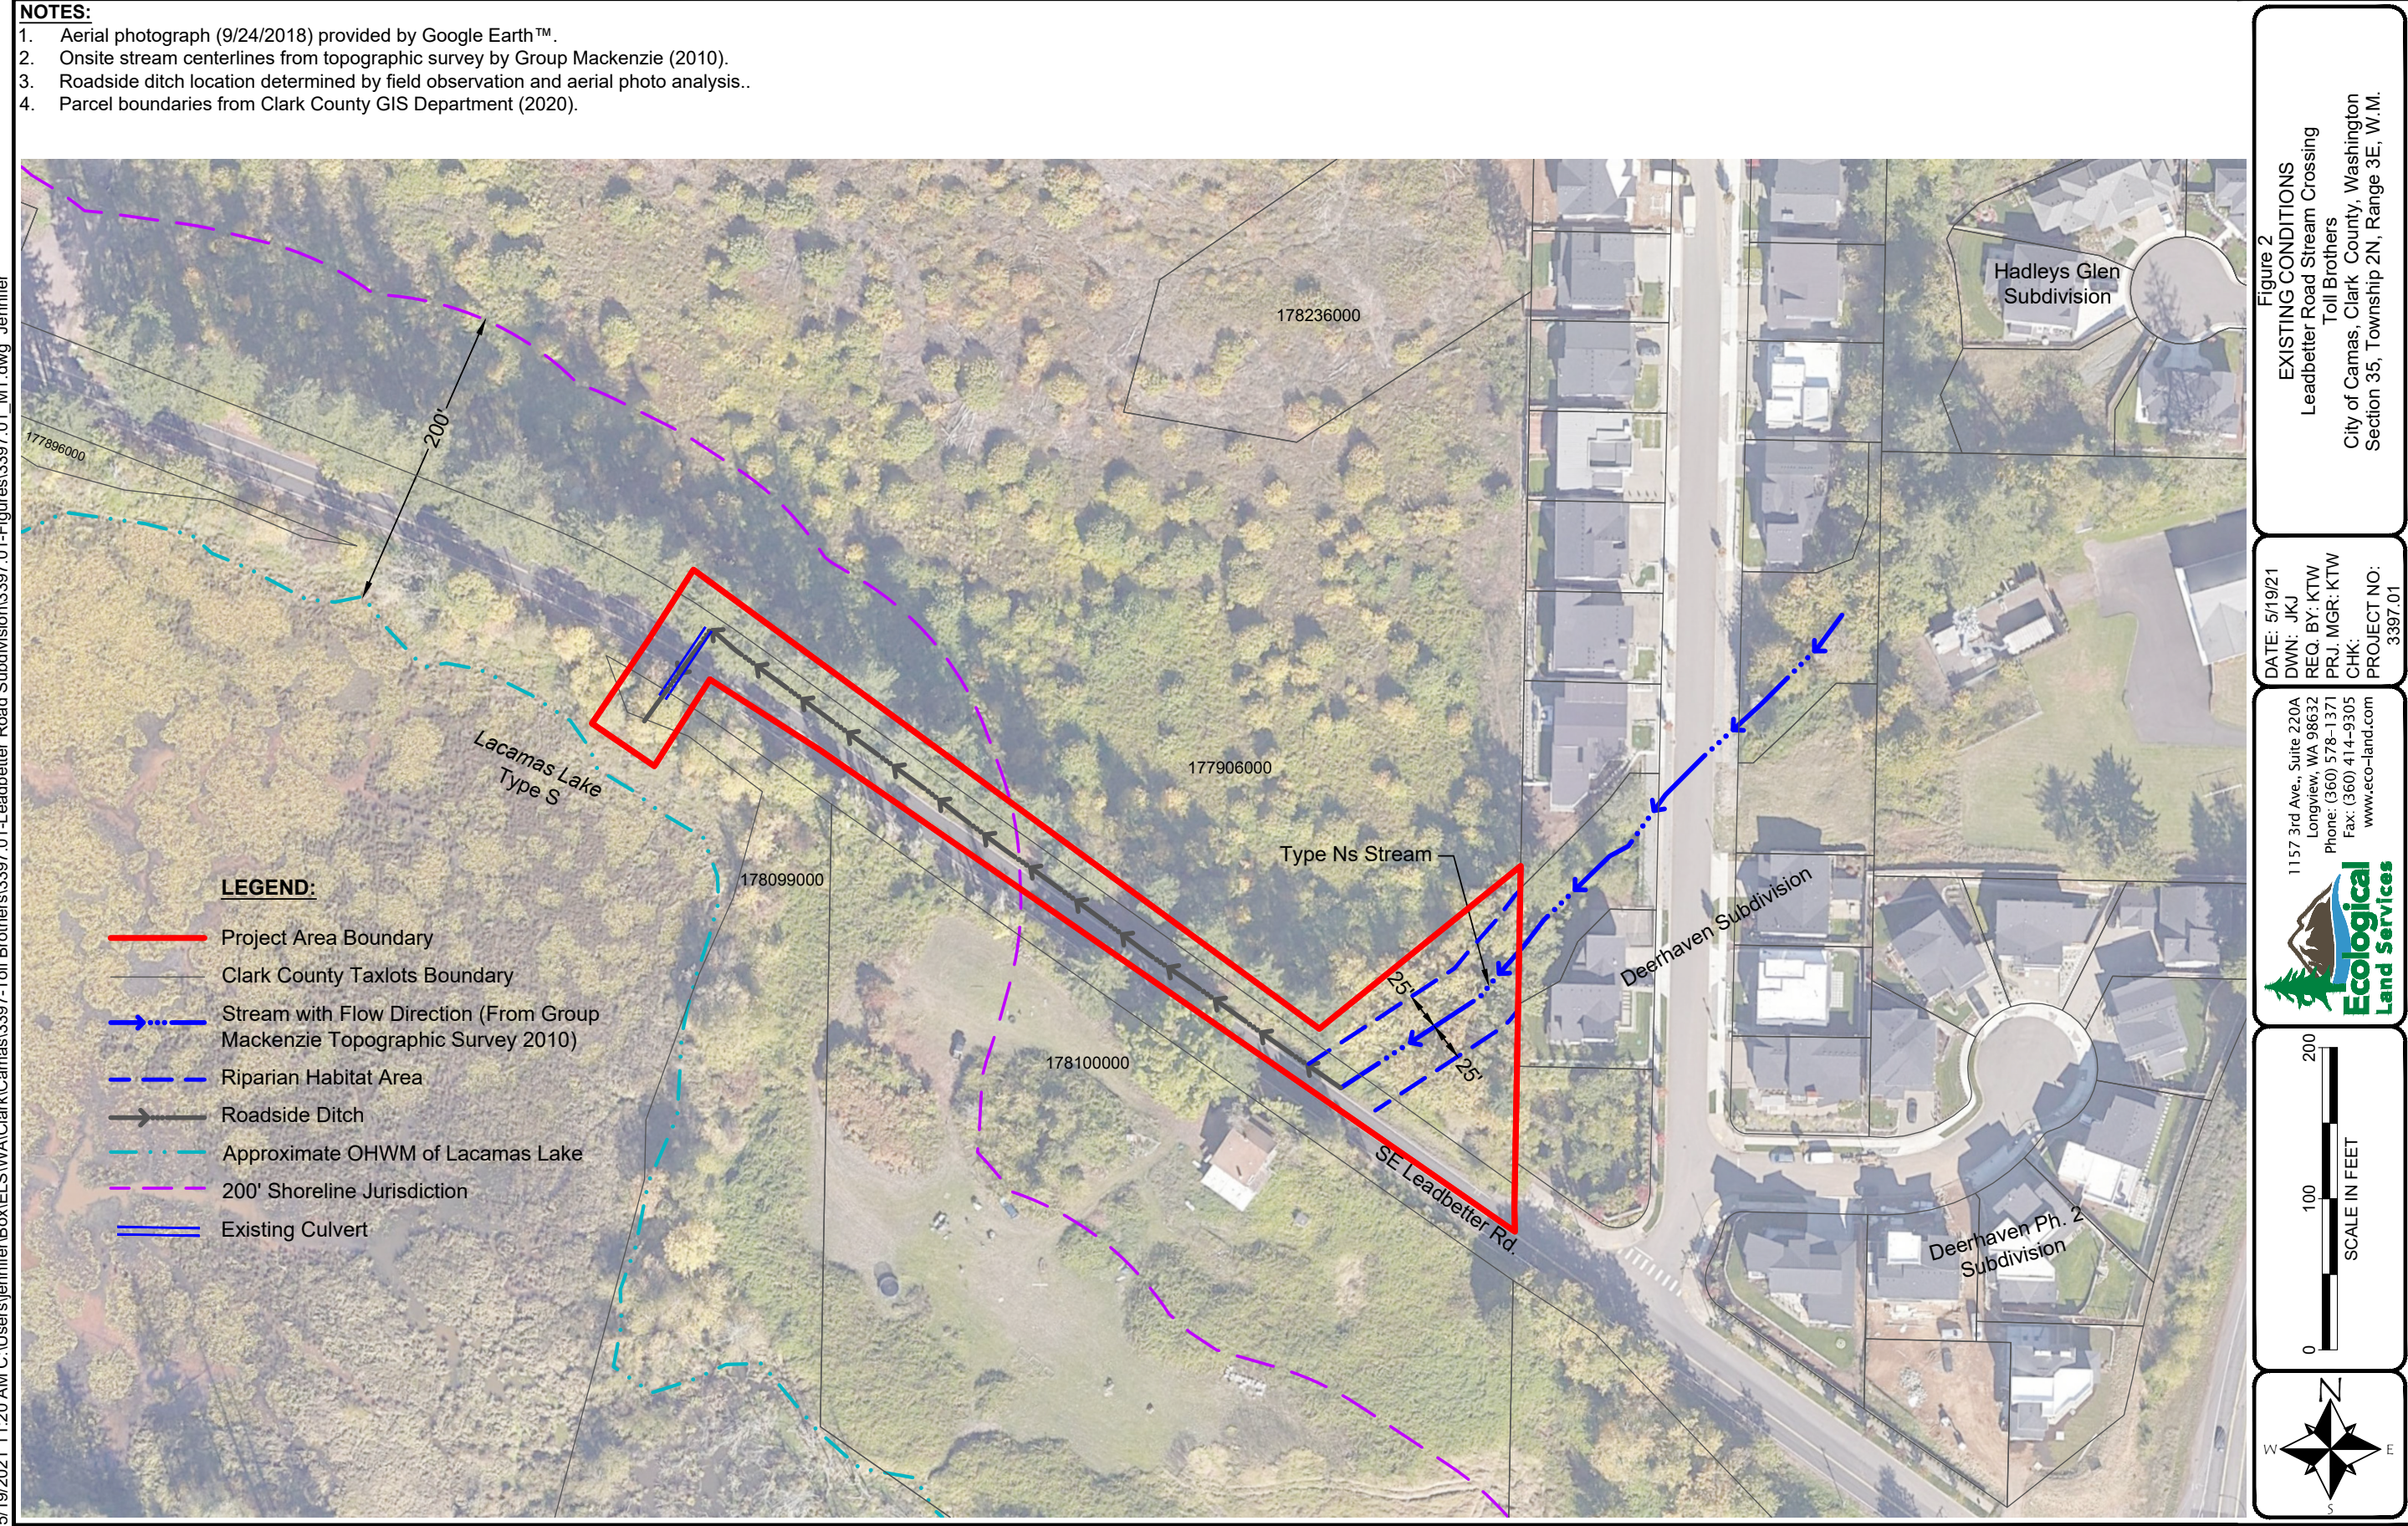
Figure 2
EXISTING CONDITIONS
Leadbetter Road Stream Crossing
Toll Brothers
City of Camas, Clark County, Washington
Section 35, Township 2N, Range 3E, W.M.
