Hearings Examiner Meeting Agenda Wednesday, October 25, 2023, 5:00 PM Council Chambers, 616 NE 4th AVE

1. Georgia Pacific In-Water and Over-Water Structures Removal Project (SHOR23-01)
Presenter: Lauren Hollenbeck, Senior Planner

STAFF REPORT

GEORGIA PACIFIC IN-WATER OVER-WATER REMOVAL PROJECT Shoreline Substantial Development Permit and Shoreline Conditional Use (SHOR23-01)

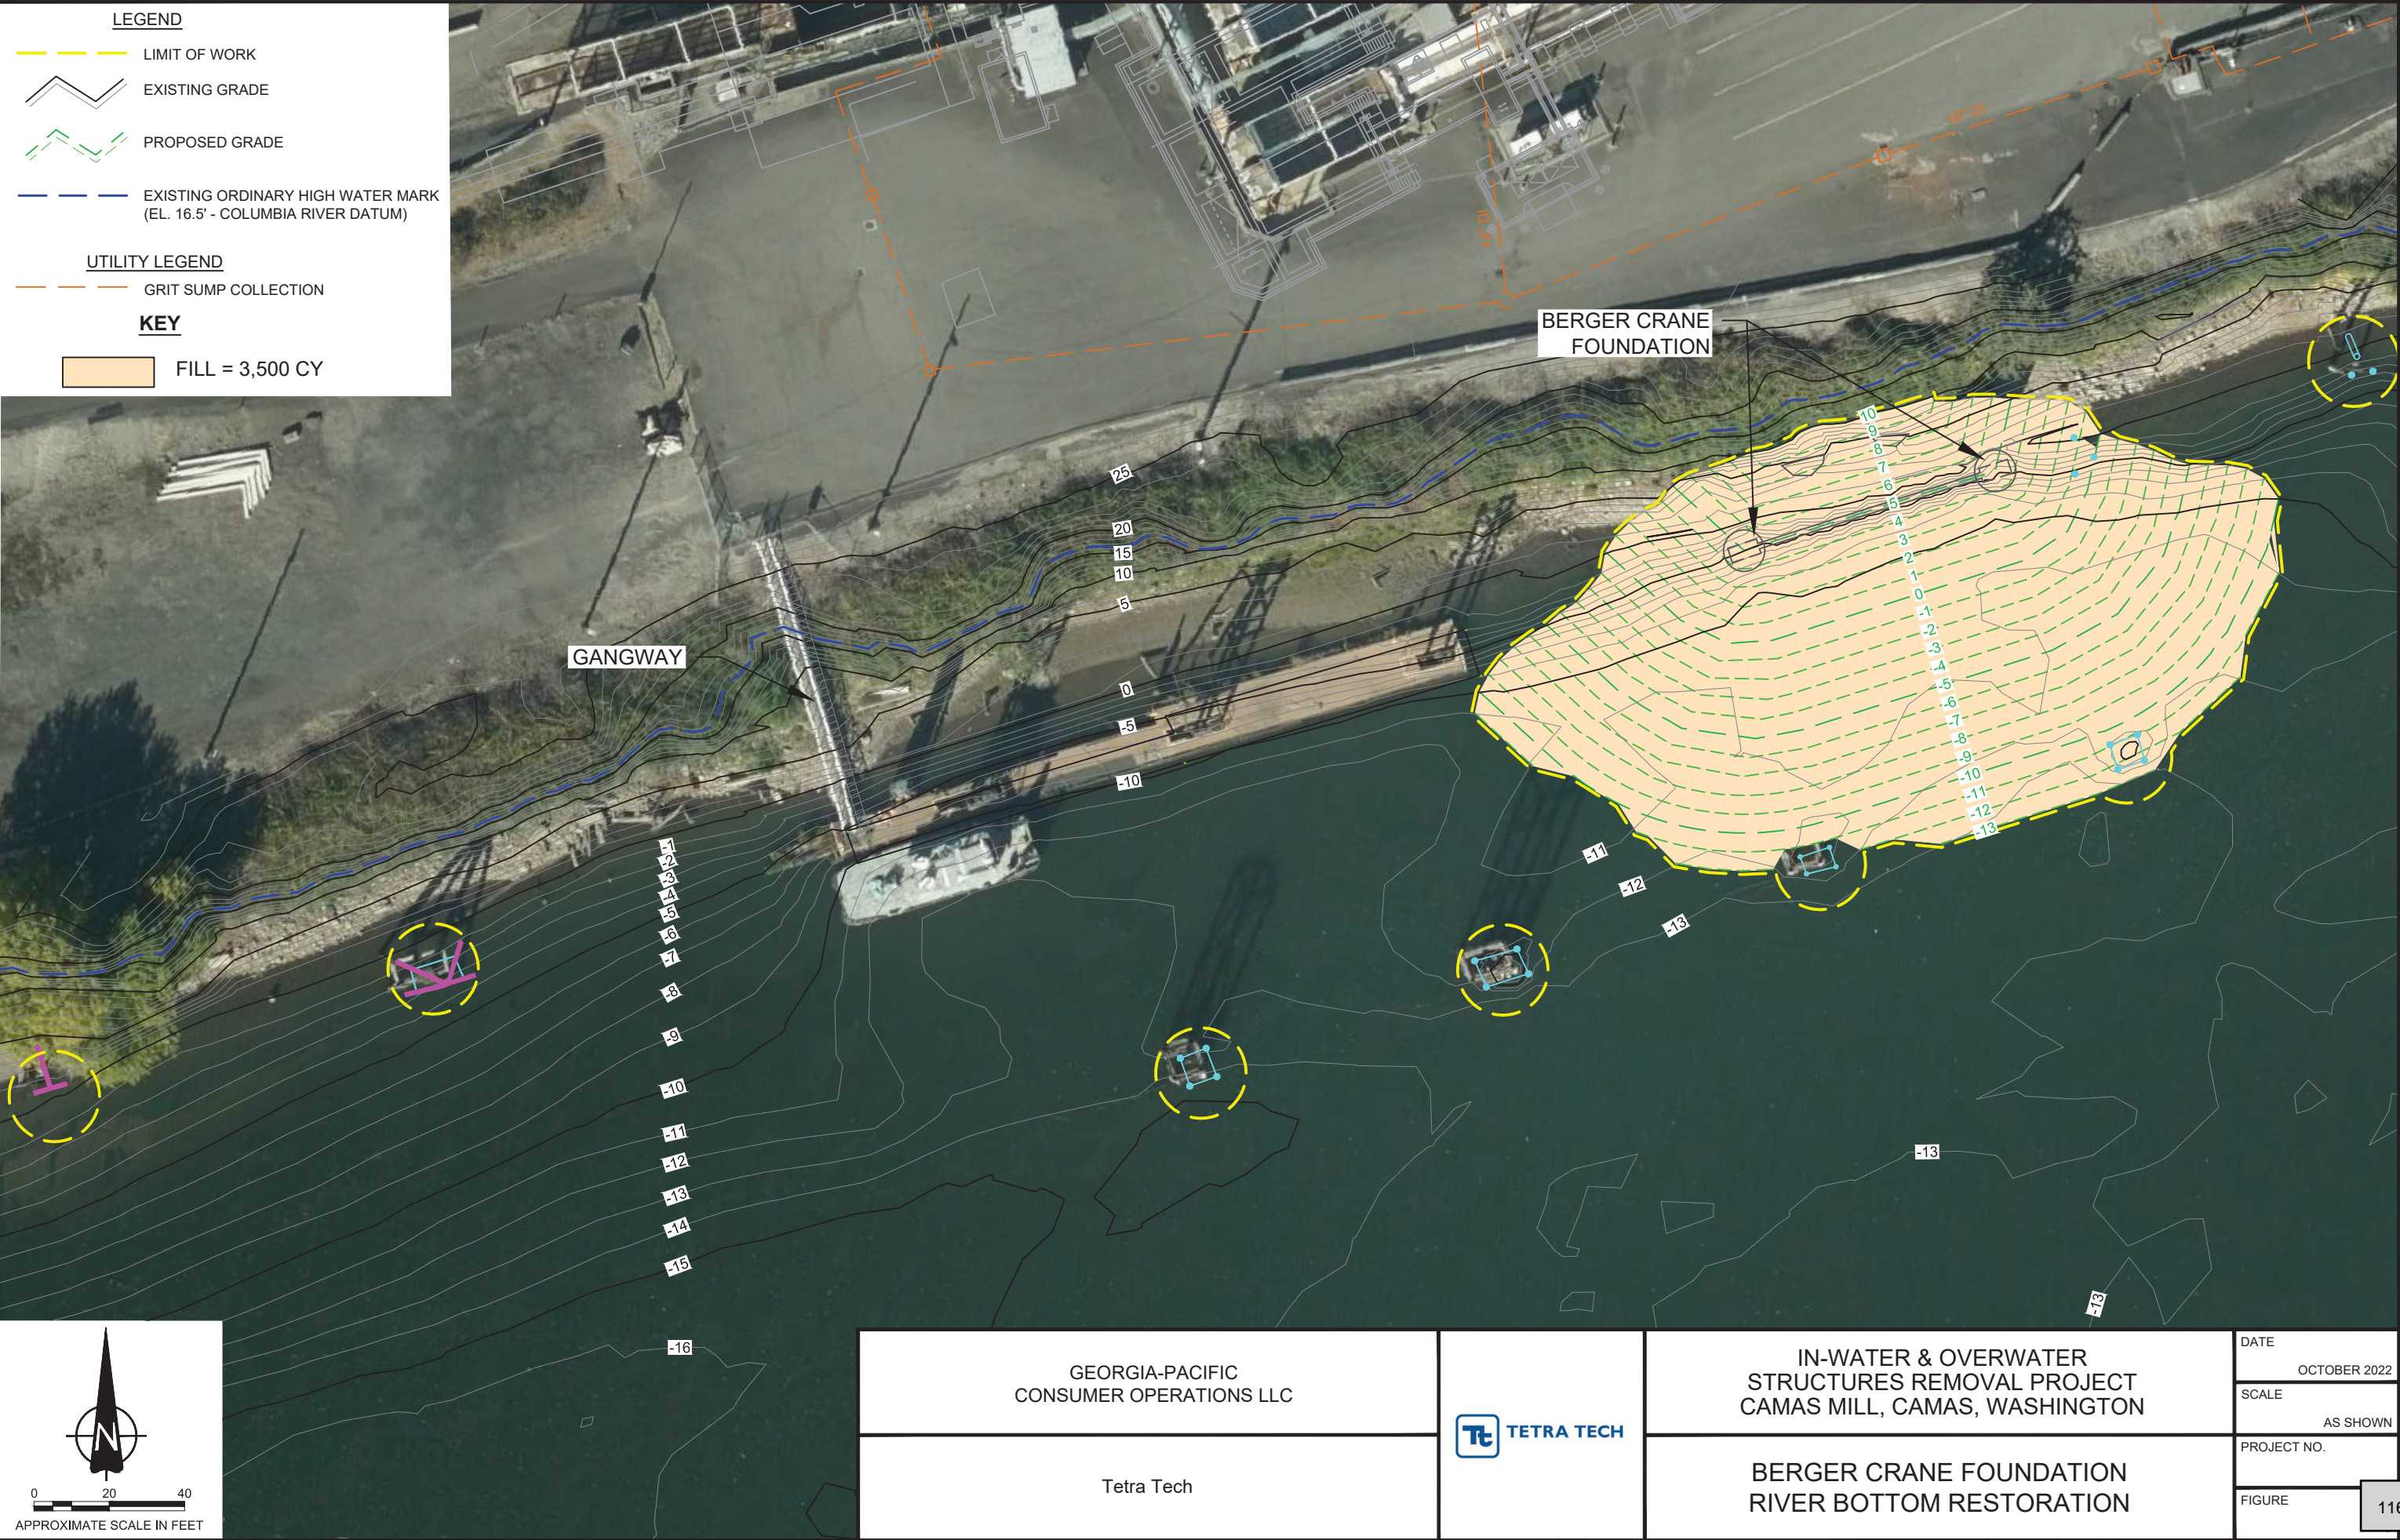
DATE	OCTOBER 2022
SCALE	AS SHOWN
PROJECT NO.	
FIGURE	115

3,500 c³ FILL

GRADING PLAN
BERGER CRANE FOUNDATION

Per the *Project Narrative*, the in-water structures proposed for removal include dolphins and pilings, the dock warehouse piers, and the Berger crane foundation. Riverbed dredging is required for demolition barge access to the dock warehouse piers. Fill would be used to cover the retained lower columns of the Berger crane foundation, creating bottom contours that match the adjacent natural riverbed.

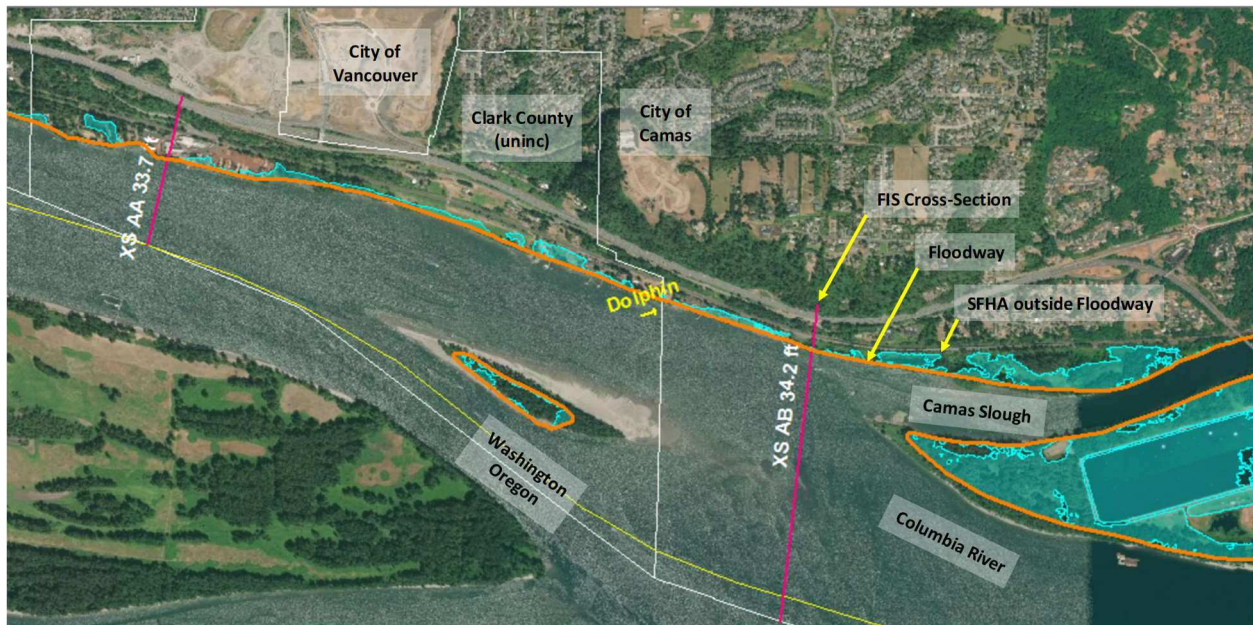
Figure 1. Vicinity of Dolphin Proposed for Demolition. Notes: Location is highlighted with yellow arrow labeled “Dolphin” and is between FEMA Cross-Sections AA and AB on the Columbia River about 65 feet west of the boundary between the City of Camas and unincorporated Clark County. Elevations are in feet relative to the North American Vertical Datum of 1988 (NAVD88). Flood hazard information is shown for the Washington side.

The proposed demolition of the dolphin does not constitute development in the floodplain because no construction or renovation of a structure will occur, nor will any fill be placed in the floodplain or floodway, and no change in grade will result following demolition and removal. The activity is solely to demolish and remove an existing multi-pile dolphin structure that currently encroaches flow in the floodway. The encroachment is small relative to the full cross-section of the Columbia River, and is further lessened because the dolphin is hydraulically “sheltered” by the “L”-shaped dock just upstream. That dock is not part of the project and will remain. Following removal of the dolphin, the bathymetry and bank elevations will be the same as before. As a result of this removal, hydraulic conveyance in this vicinity will either be unchanged or slightly improved, and the removal cannot result in an increase in base flood elevations both at this site and further away, either upstream or downstream.

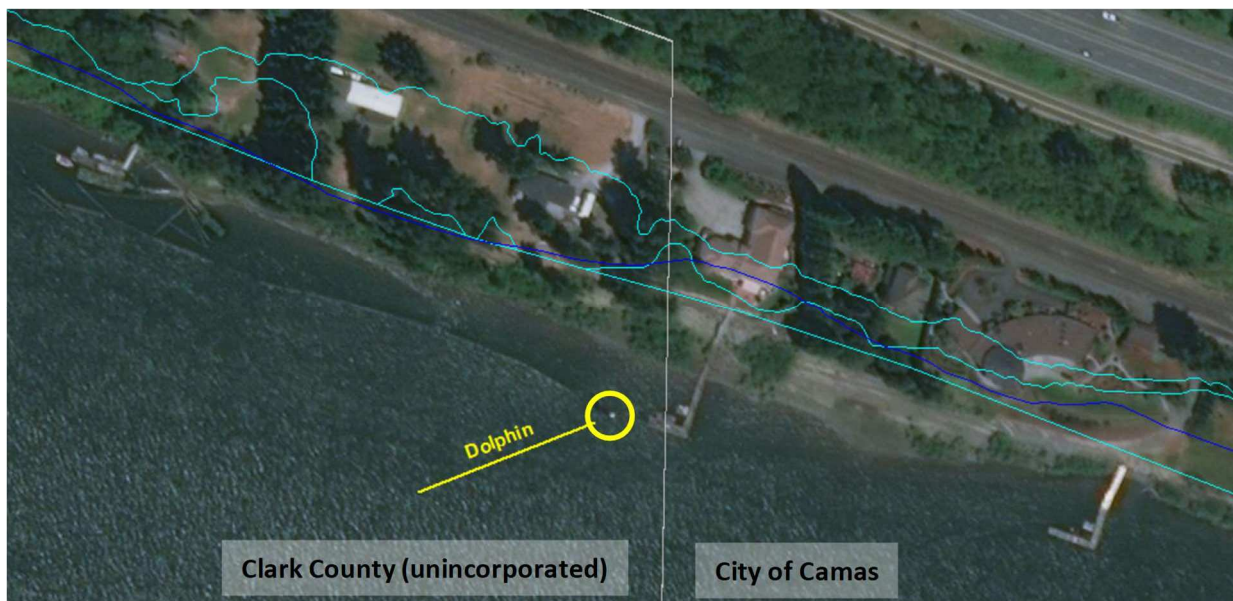
Figure 2. Location of Dolphin Proposed for Demolition. Note: Dolphin is about 65 feet west of the boundary between the City of Camas and unincorporated Clark County. The “L”-shaped dock upstream is not part of the project.

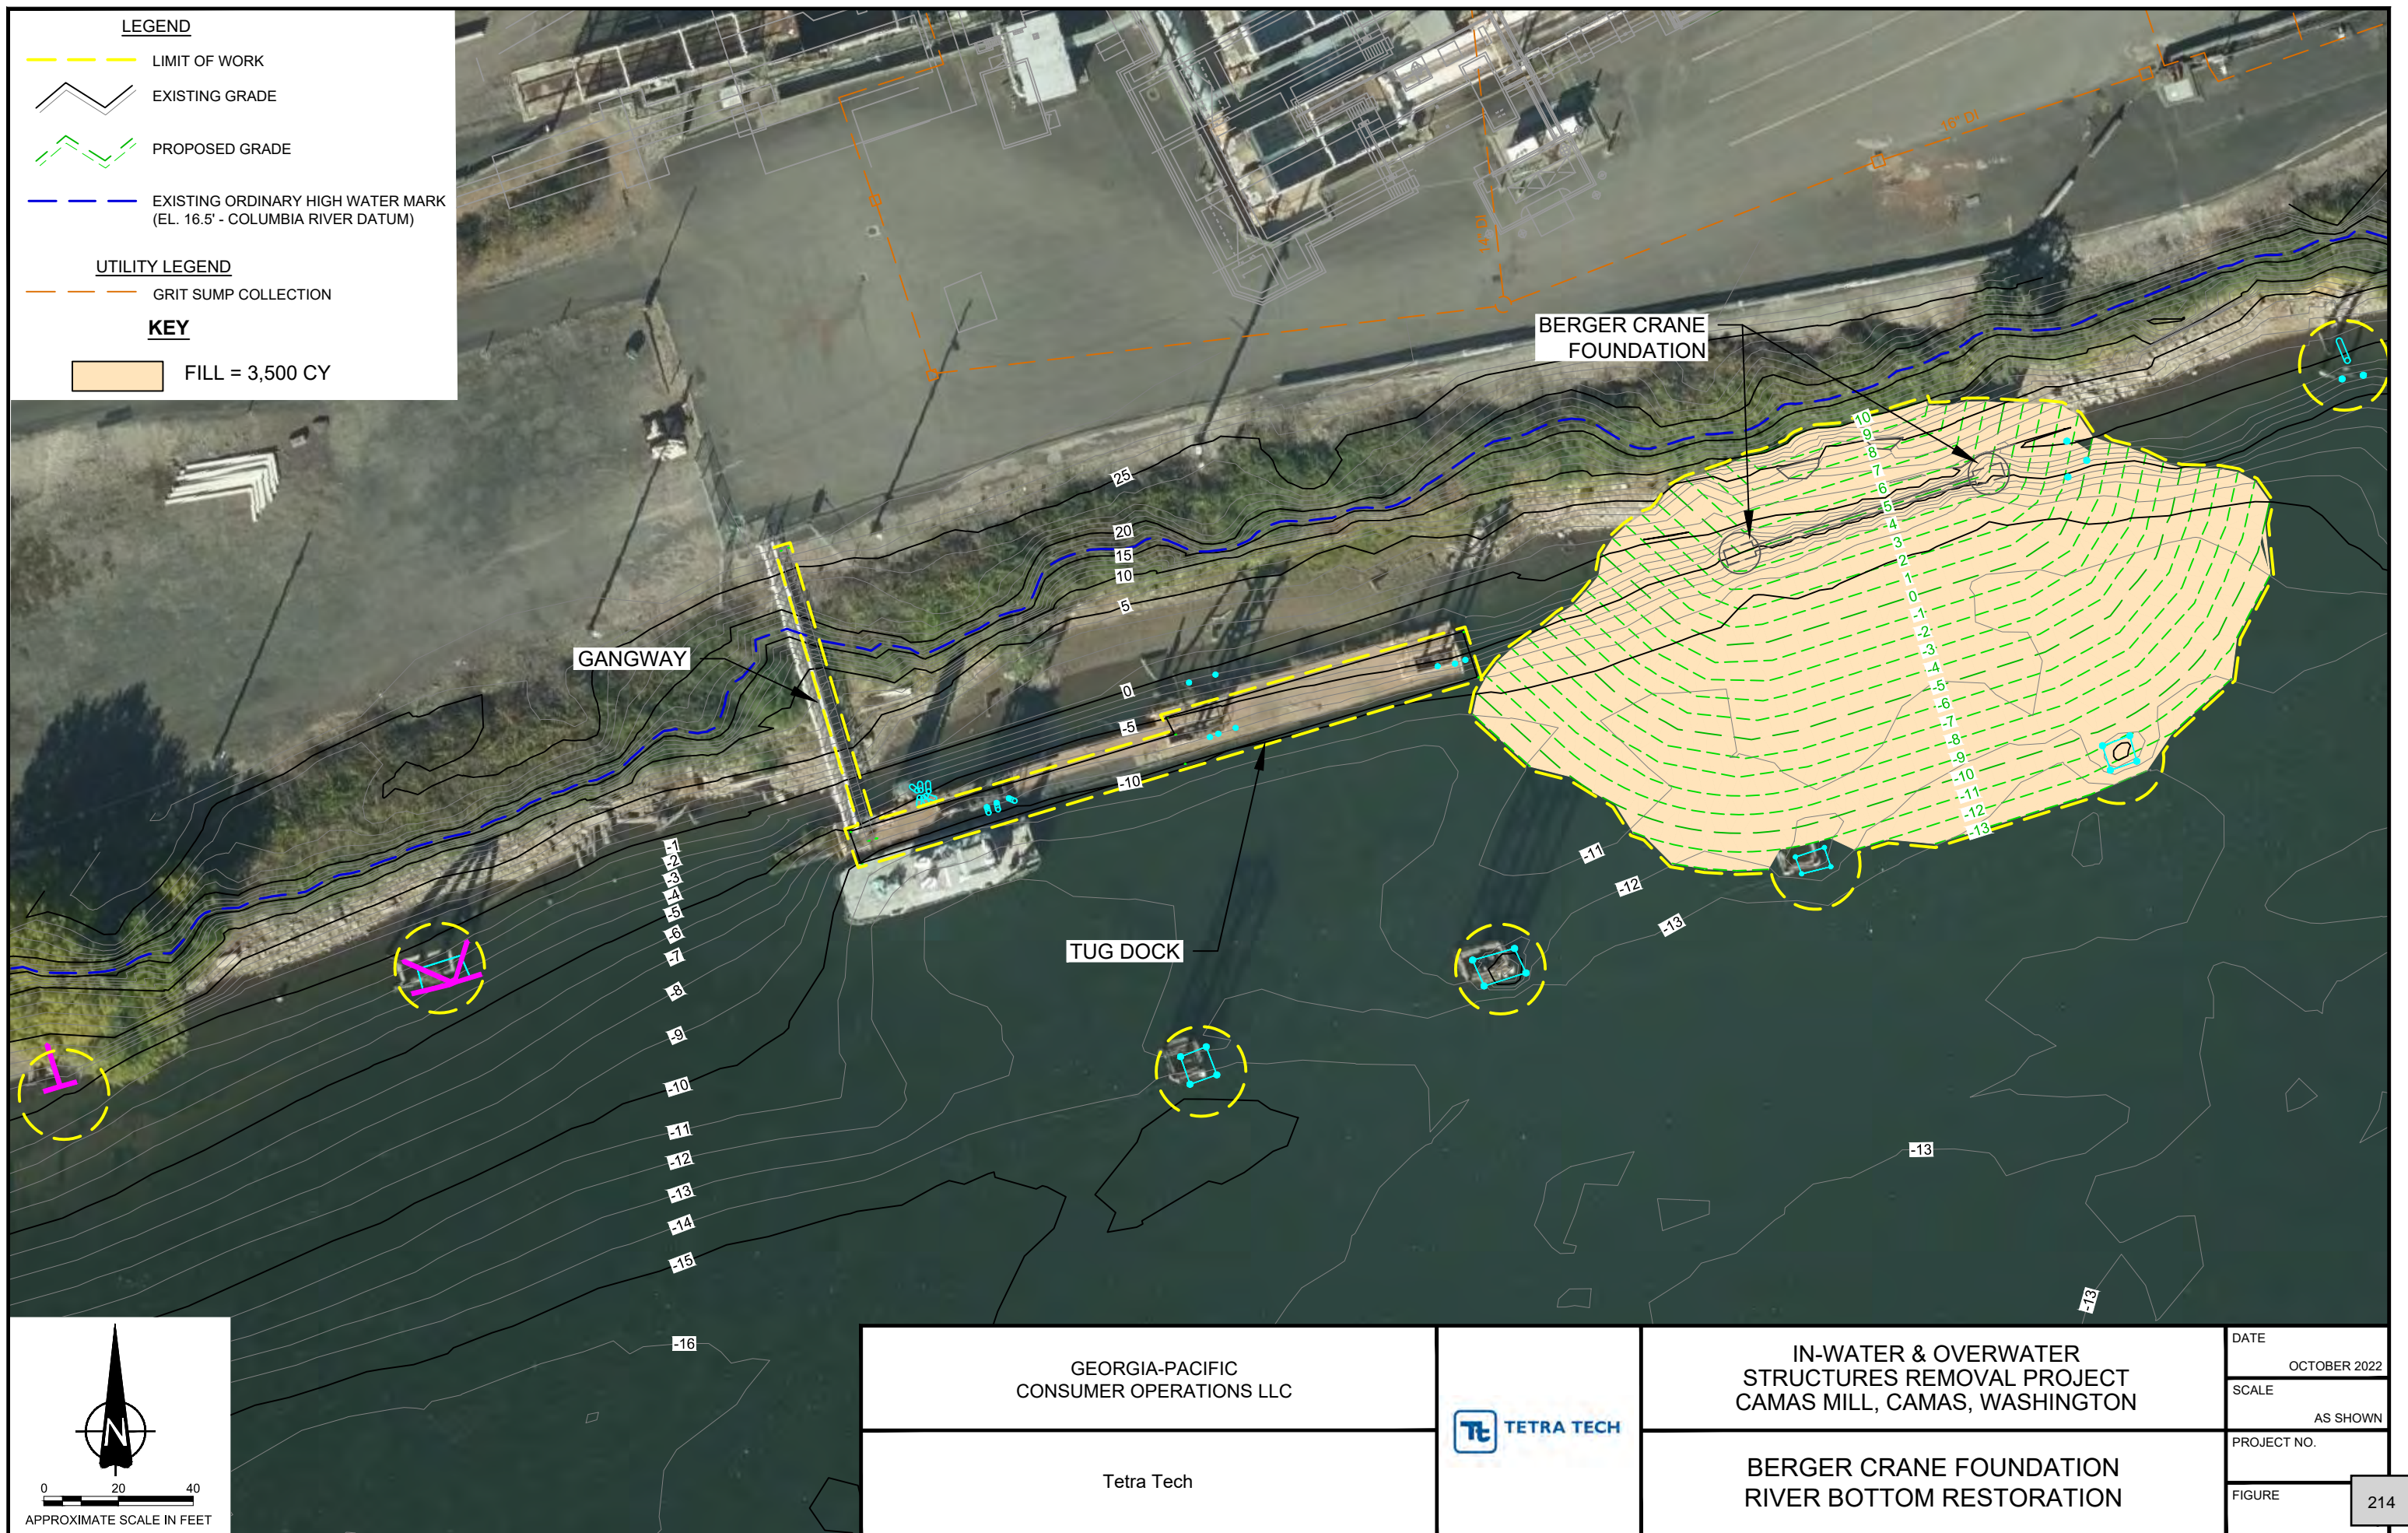
DATE	OCTOBER 2022
SCALE	AS SHOWN
PROJECT NO.	
FIGURE	213

3,500 cy FILL

GRADING PLAN
BERGER CRANE FOUNDATION

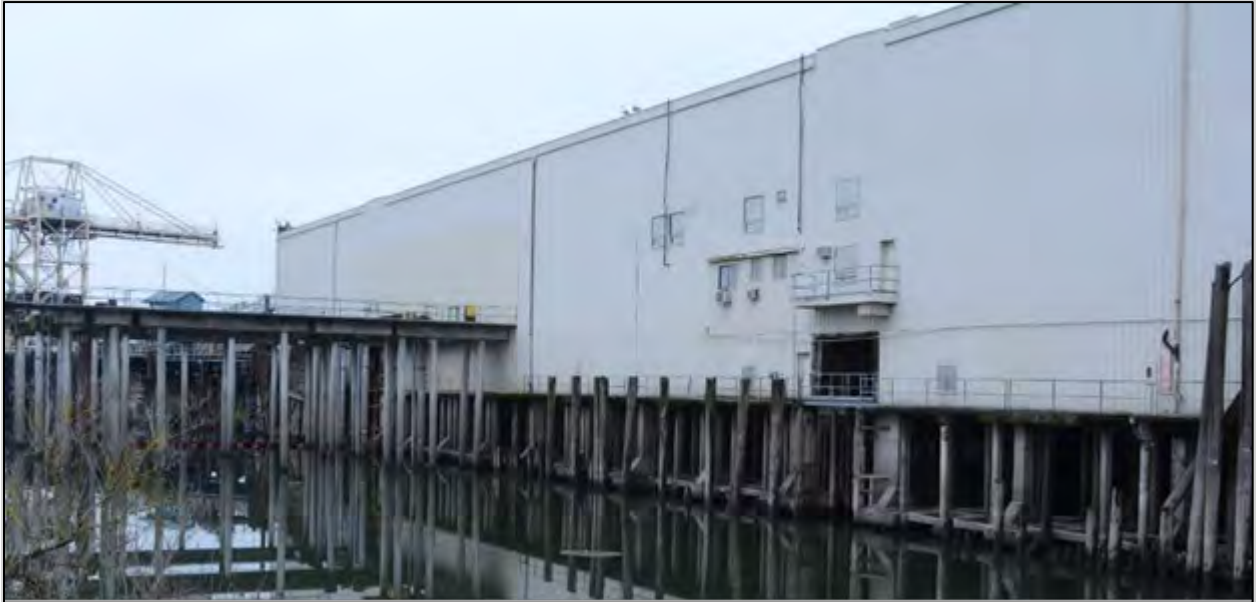
Photograph 3. Dock Warehouse situated between the Truck Dock and PECO Dock and supported by approximately 800 piles, with foundations on the riverbank side.

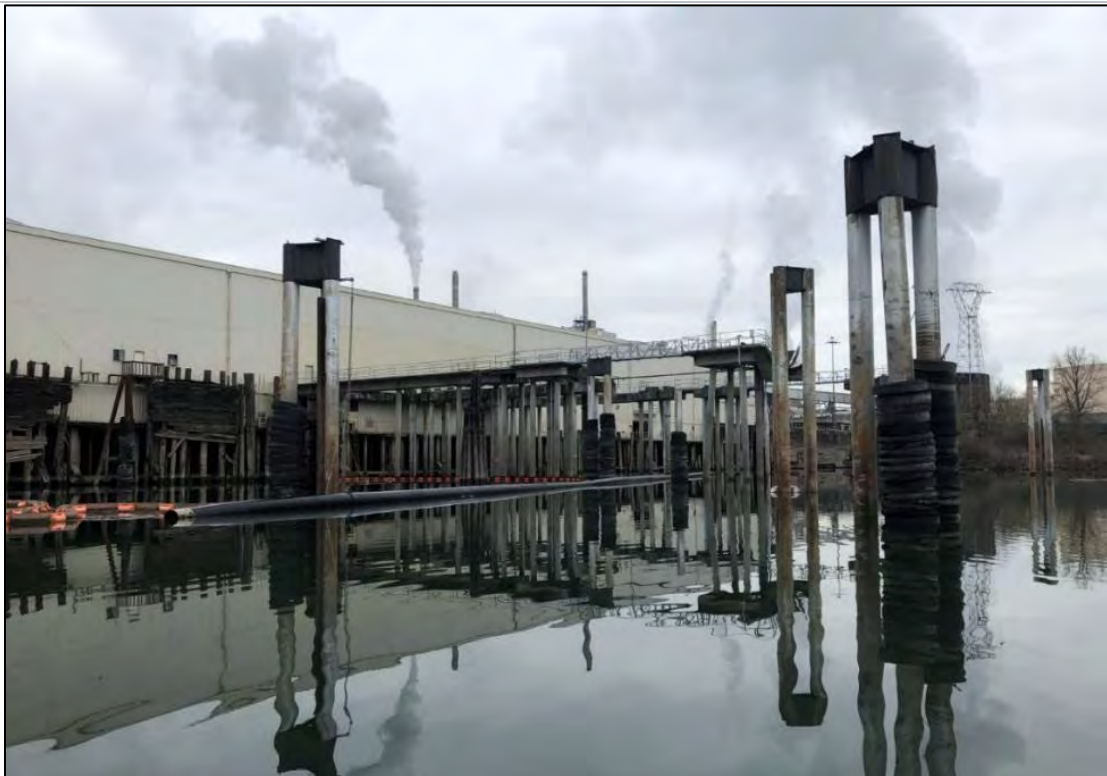
Photograph 4. Three piers extend from the Dock Warehouse that are supported by 54 concrete piles along with 21 carbon steel pipe piles. Three guidance dolphins are arranged at the end of the piers.

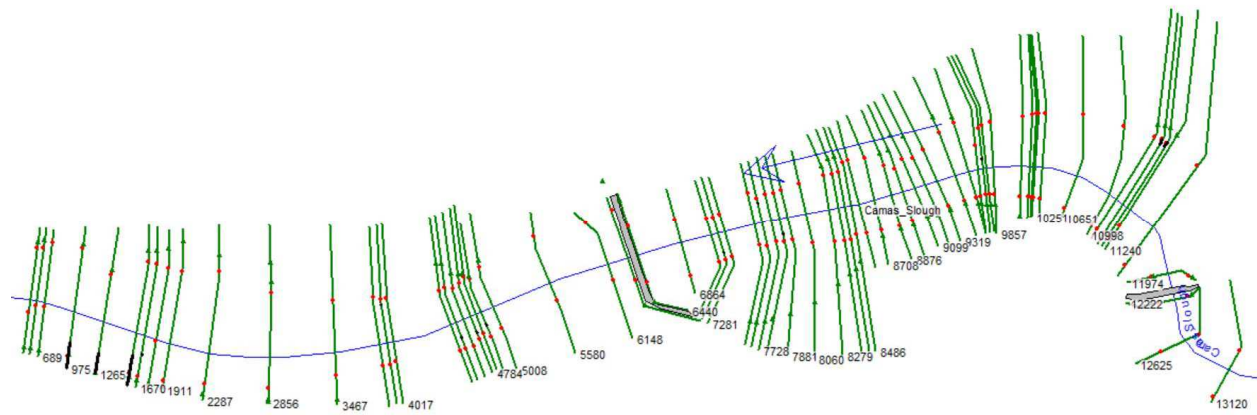
Schematic of Camas Slough Model Cross-Section Locations

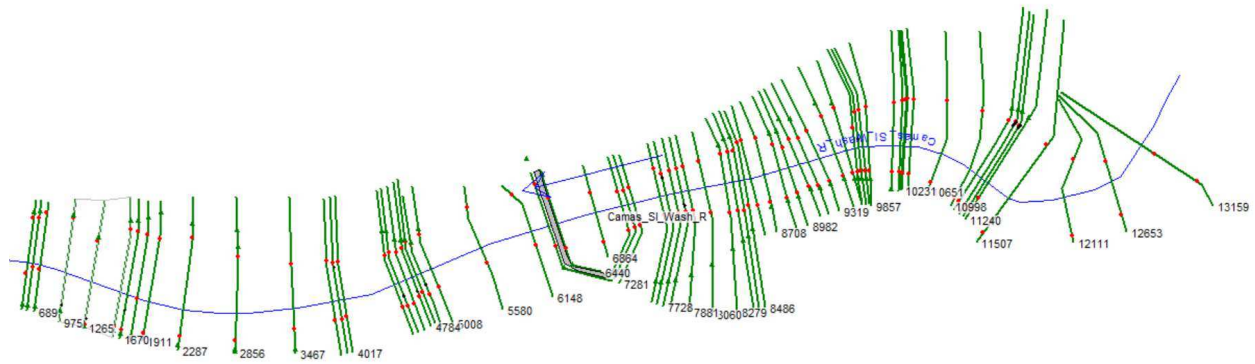
Schematic of Washougal River/ Camas Slough Model Cross-Section Locations

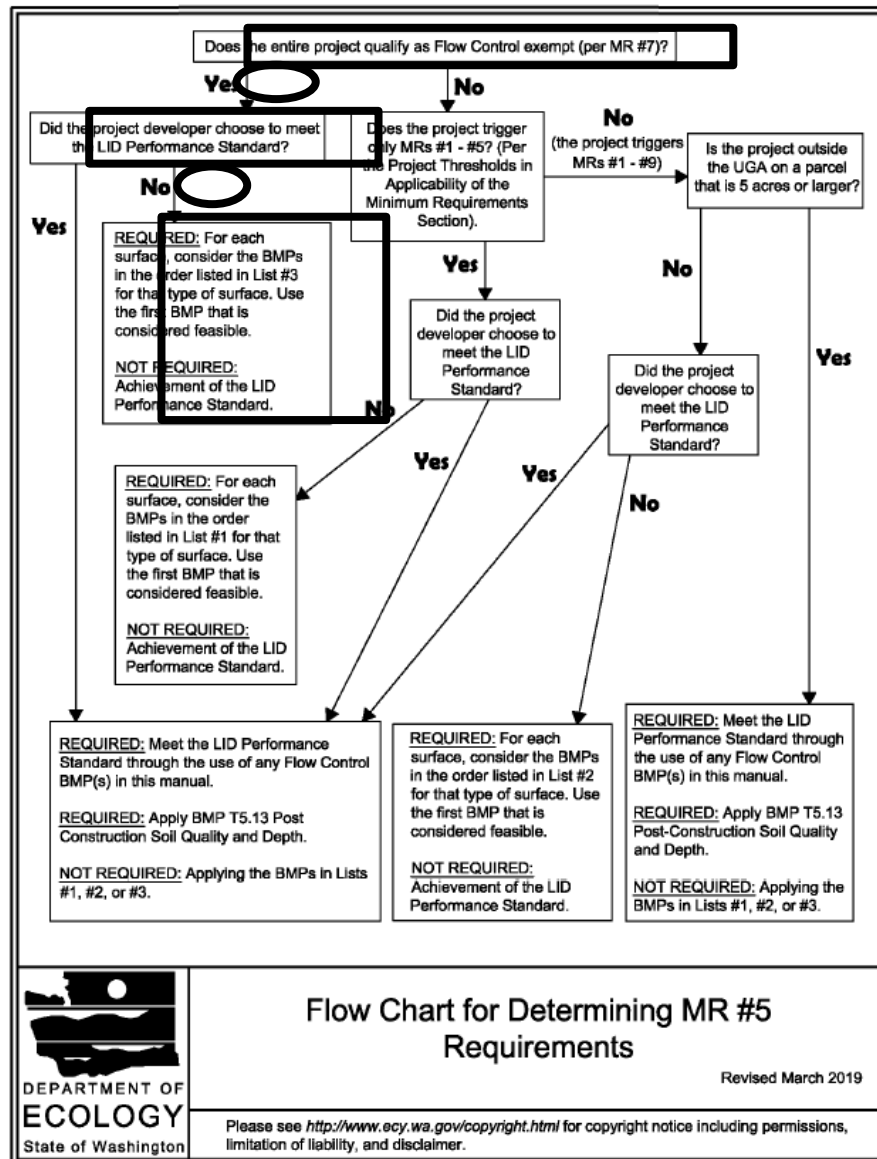
requirements. Figure 2 below shows a flow chart to determine the requirements of MR5 for this project.

Figure 2. Flow Chart for Determining MR5 Requirements

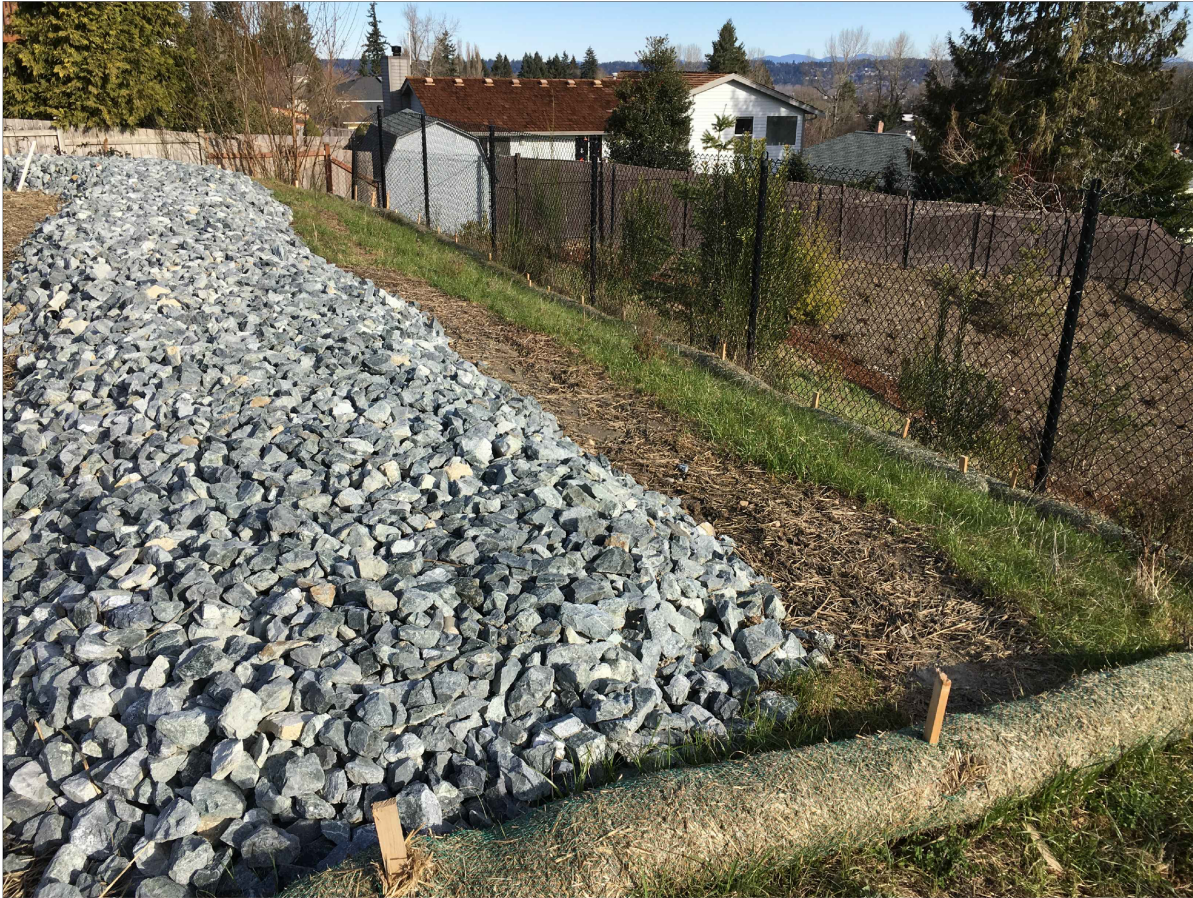
Figure II-3.21: Gravel Filter Berm

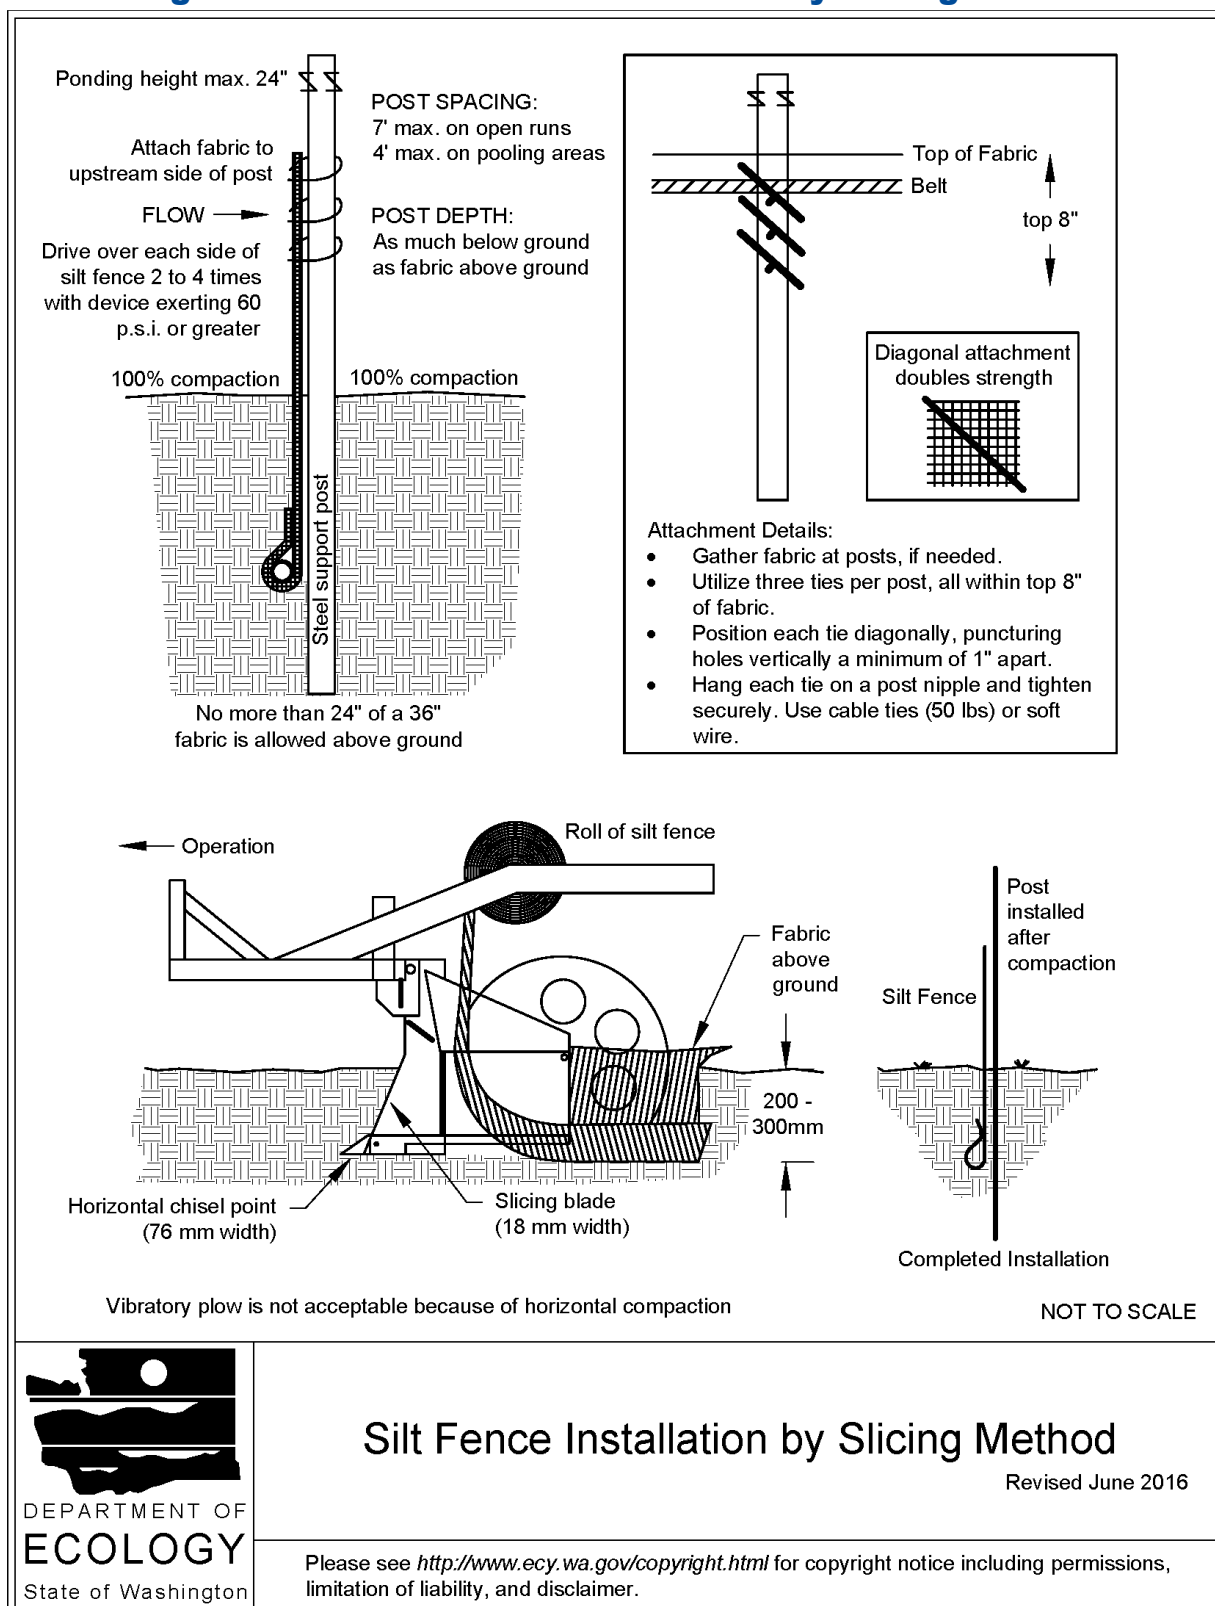
Figure II-3.23: Silt Fence Installation by Slicing Method

- Repair any damage immediately.
- Intercept and convey all evident concentrated flows uphill of the silt fence to a sediment trapping BMP.
- Check the uphill side of the silt fence for signs of the fence clogging and acting as a barrier to flow and then causing channelization of flows parallel to the fence. If this occurs, replace the fence and remove the trapped sediment.
- Remove sediment deposits when the deposit reaches approximately one-third the height of the silt fence, or install a second silt fence.
- Replace geotextile fabric that has deteriorated due to ultraviolet breakdown.

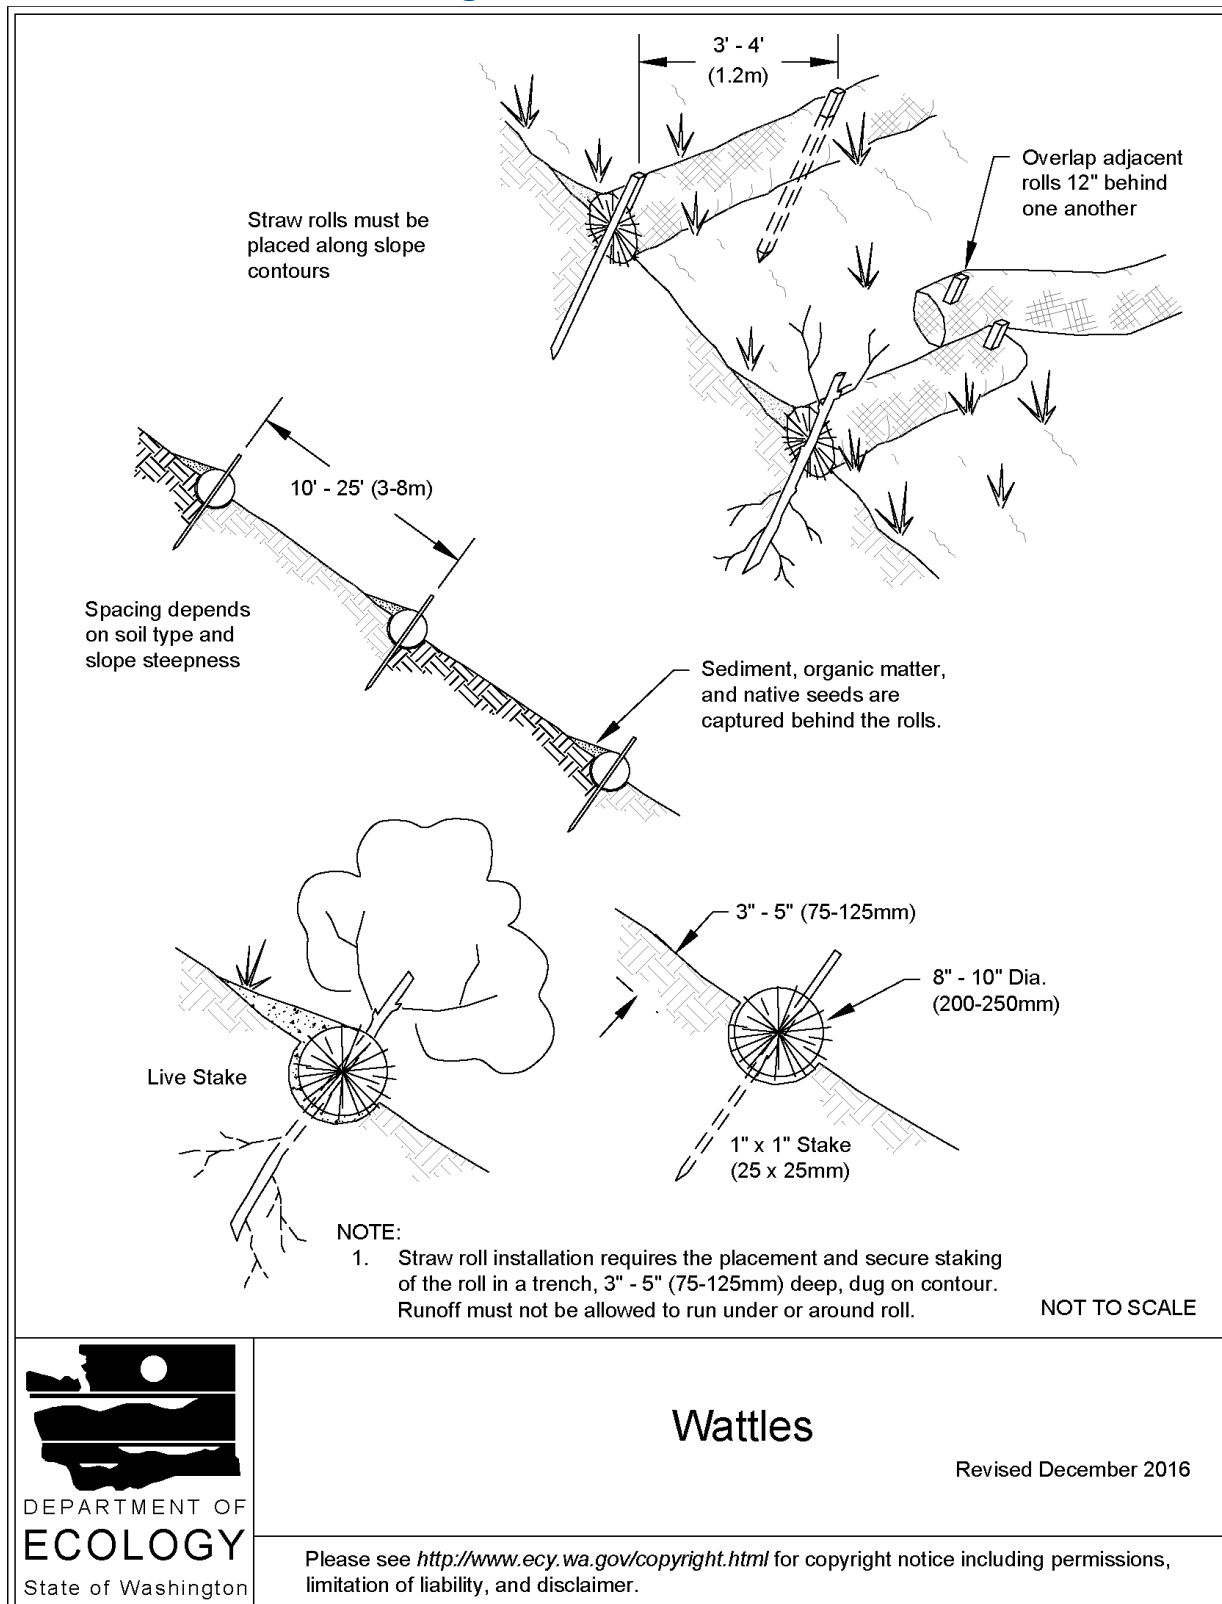
Figure II-3.24: Wattles

- Wattles may require maintenance to ensure they are in contact with soil and thoroughly entrenched, especially after significant rainfall on steep sandy soils.
- Inspect the slope after significant storms and repair any areas where wattles are not tightly abutted or water has scoured beneath the wattles.

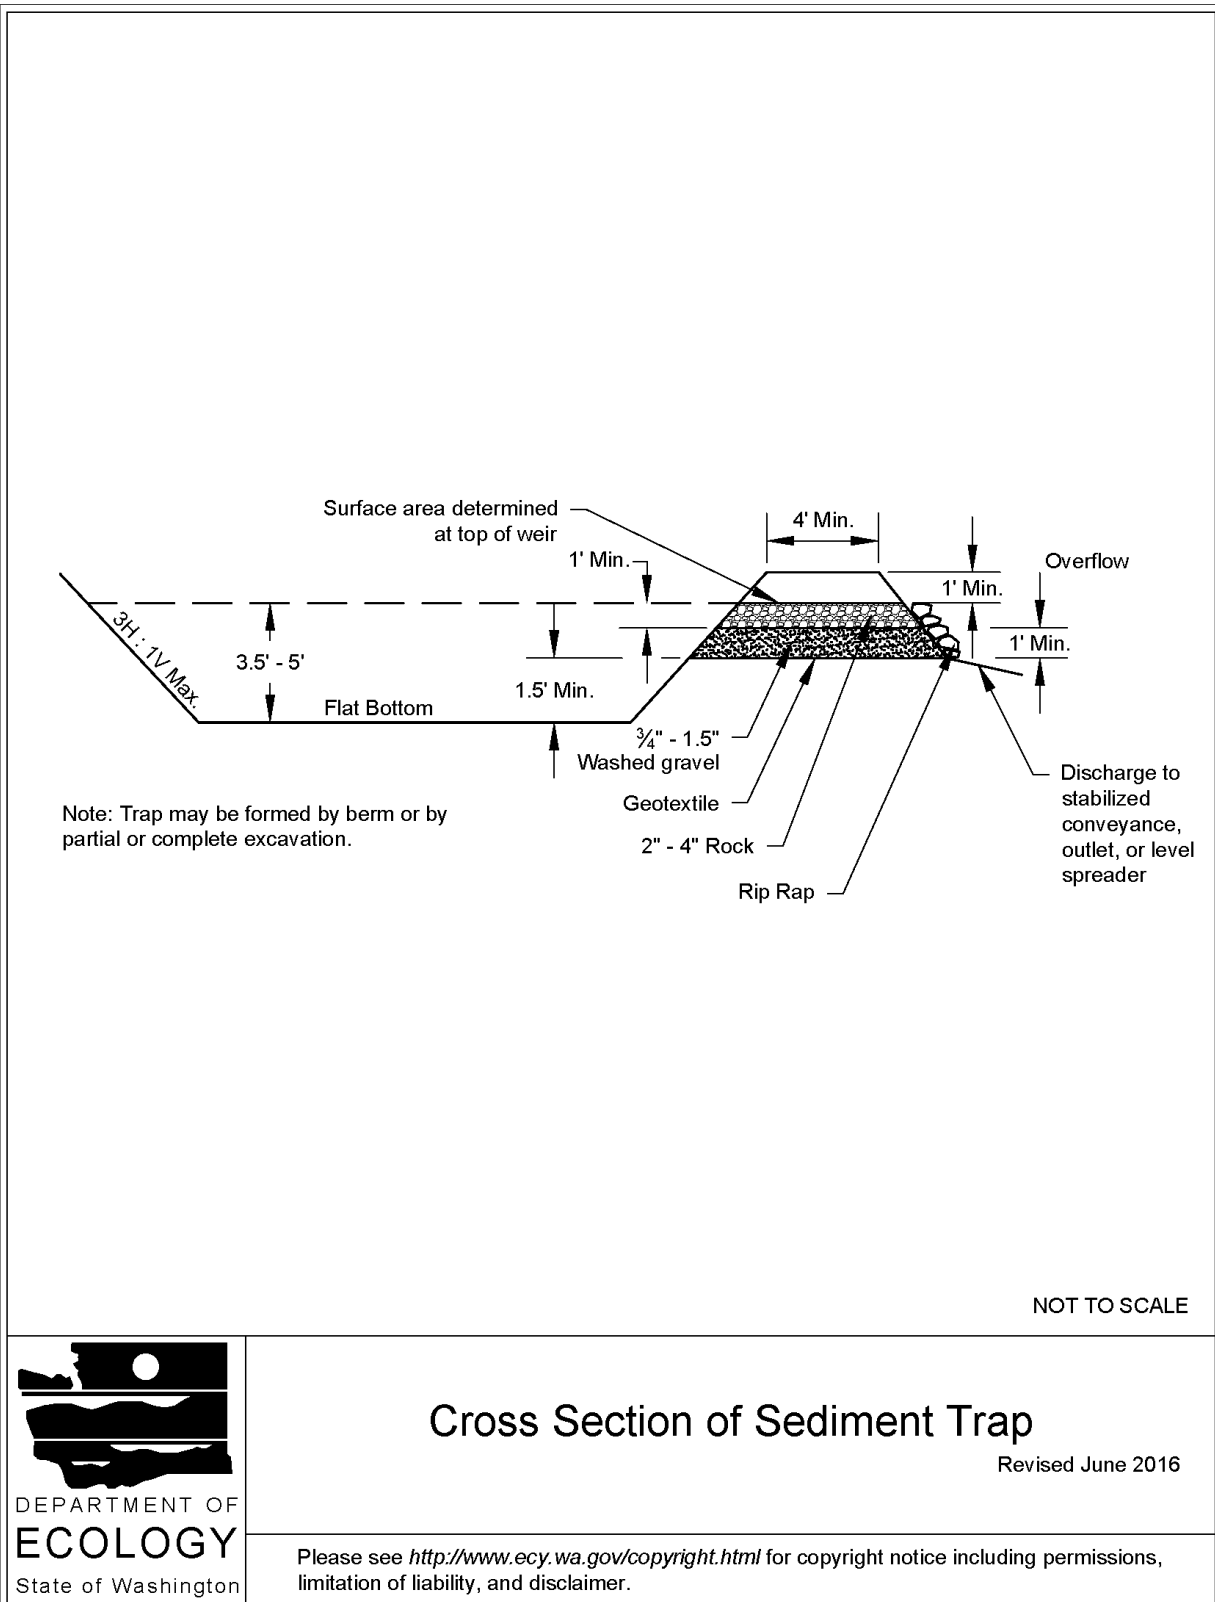
Figure II-3.26: Cross Section of Sediment Trap

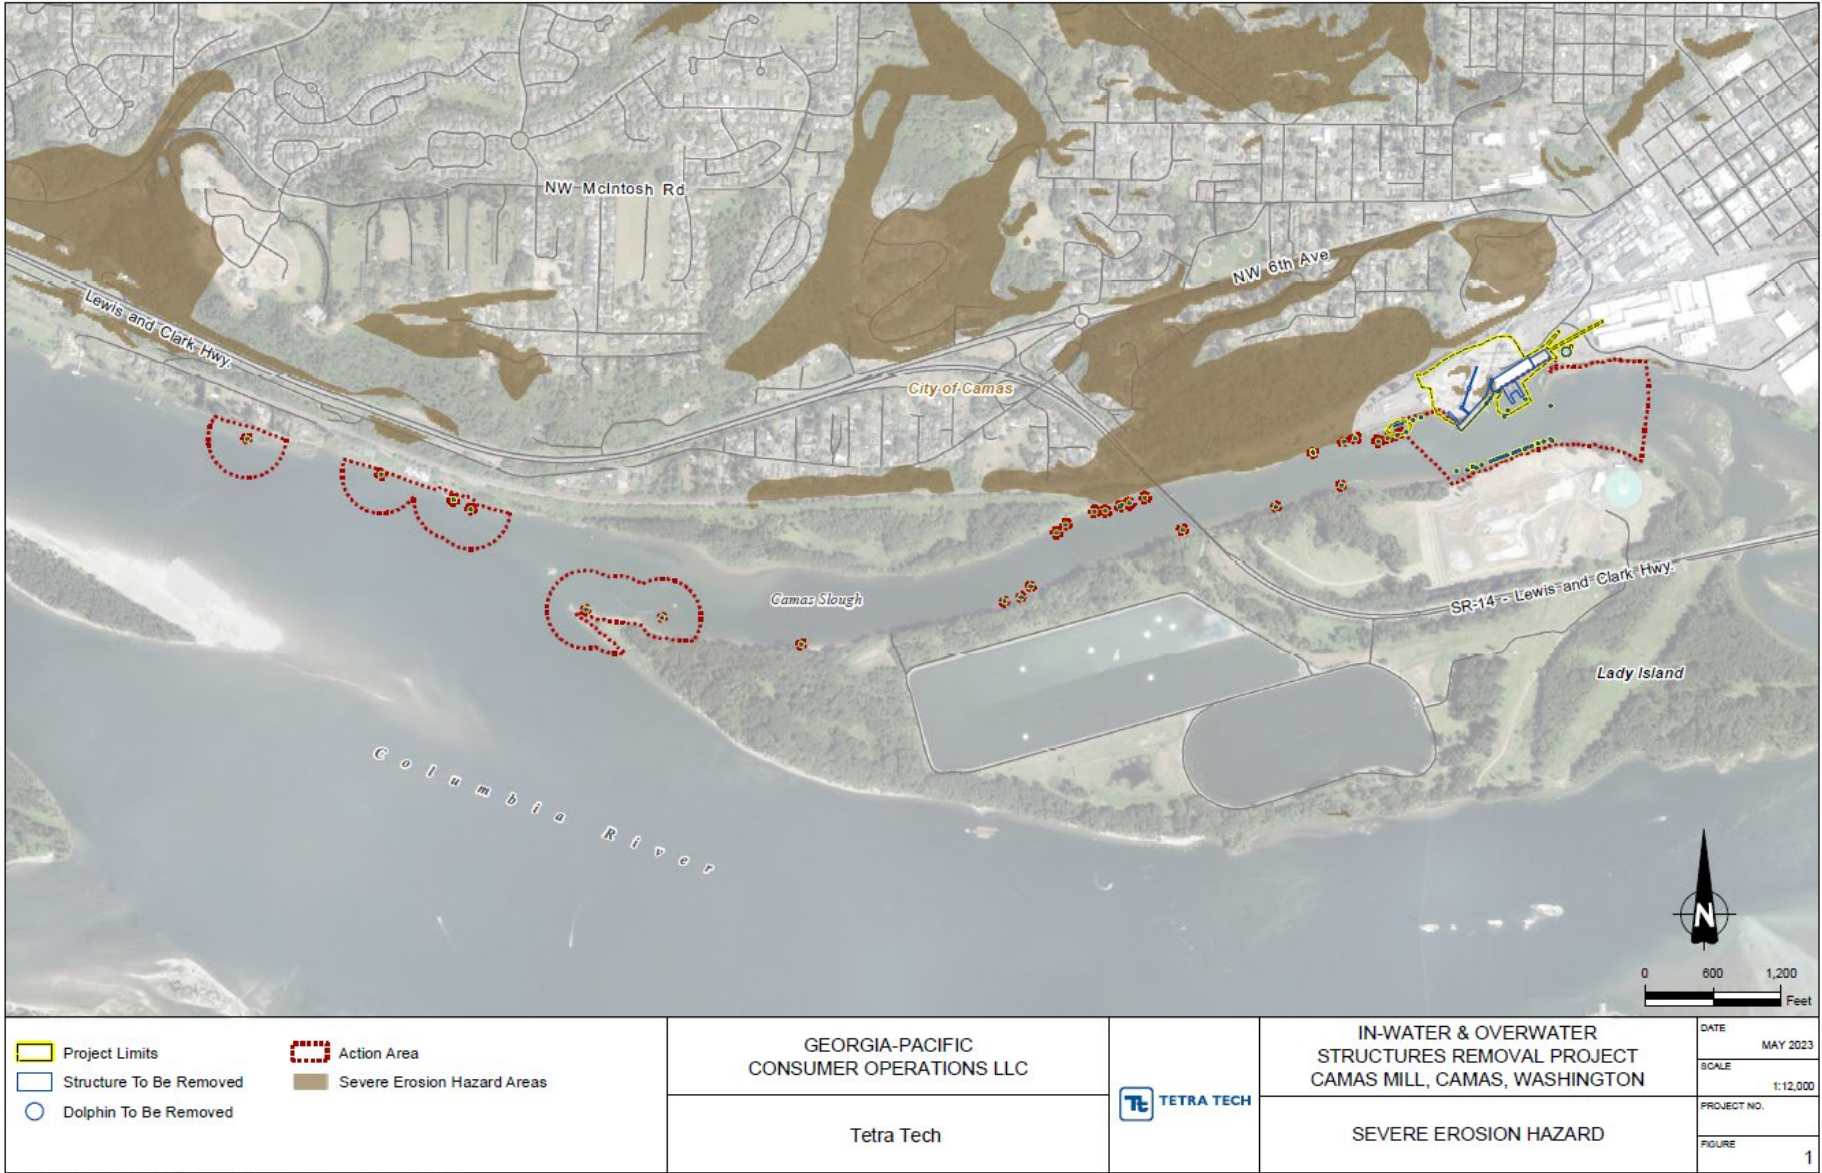
Figure 1. Severe Erosion Hazard Map
