Hearings Examiner Meeting Agenda Wednesday, October 25, 2023, 5:00 PM Council Chambers, 616 NE 4th AVE

1. Georgia Pacific In-Water and Over-Water Structures Removal Project (SHOR23-01)
Presenter: Lauren Hollenbeck, Senior Planner

STAFF REPORT

GEORGIA PACIFIC IN-WATER OVER-WATER REMOVAL PROJECT Shoreline Substantial Development Permit and Shoreline Conditional Use (SHOR23-01)

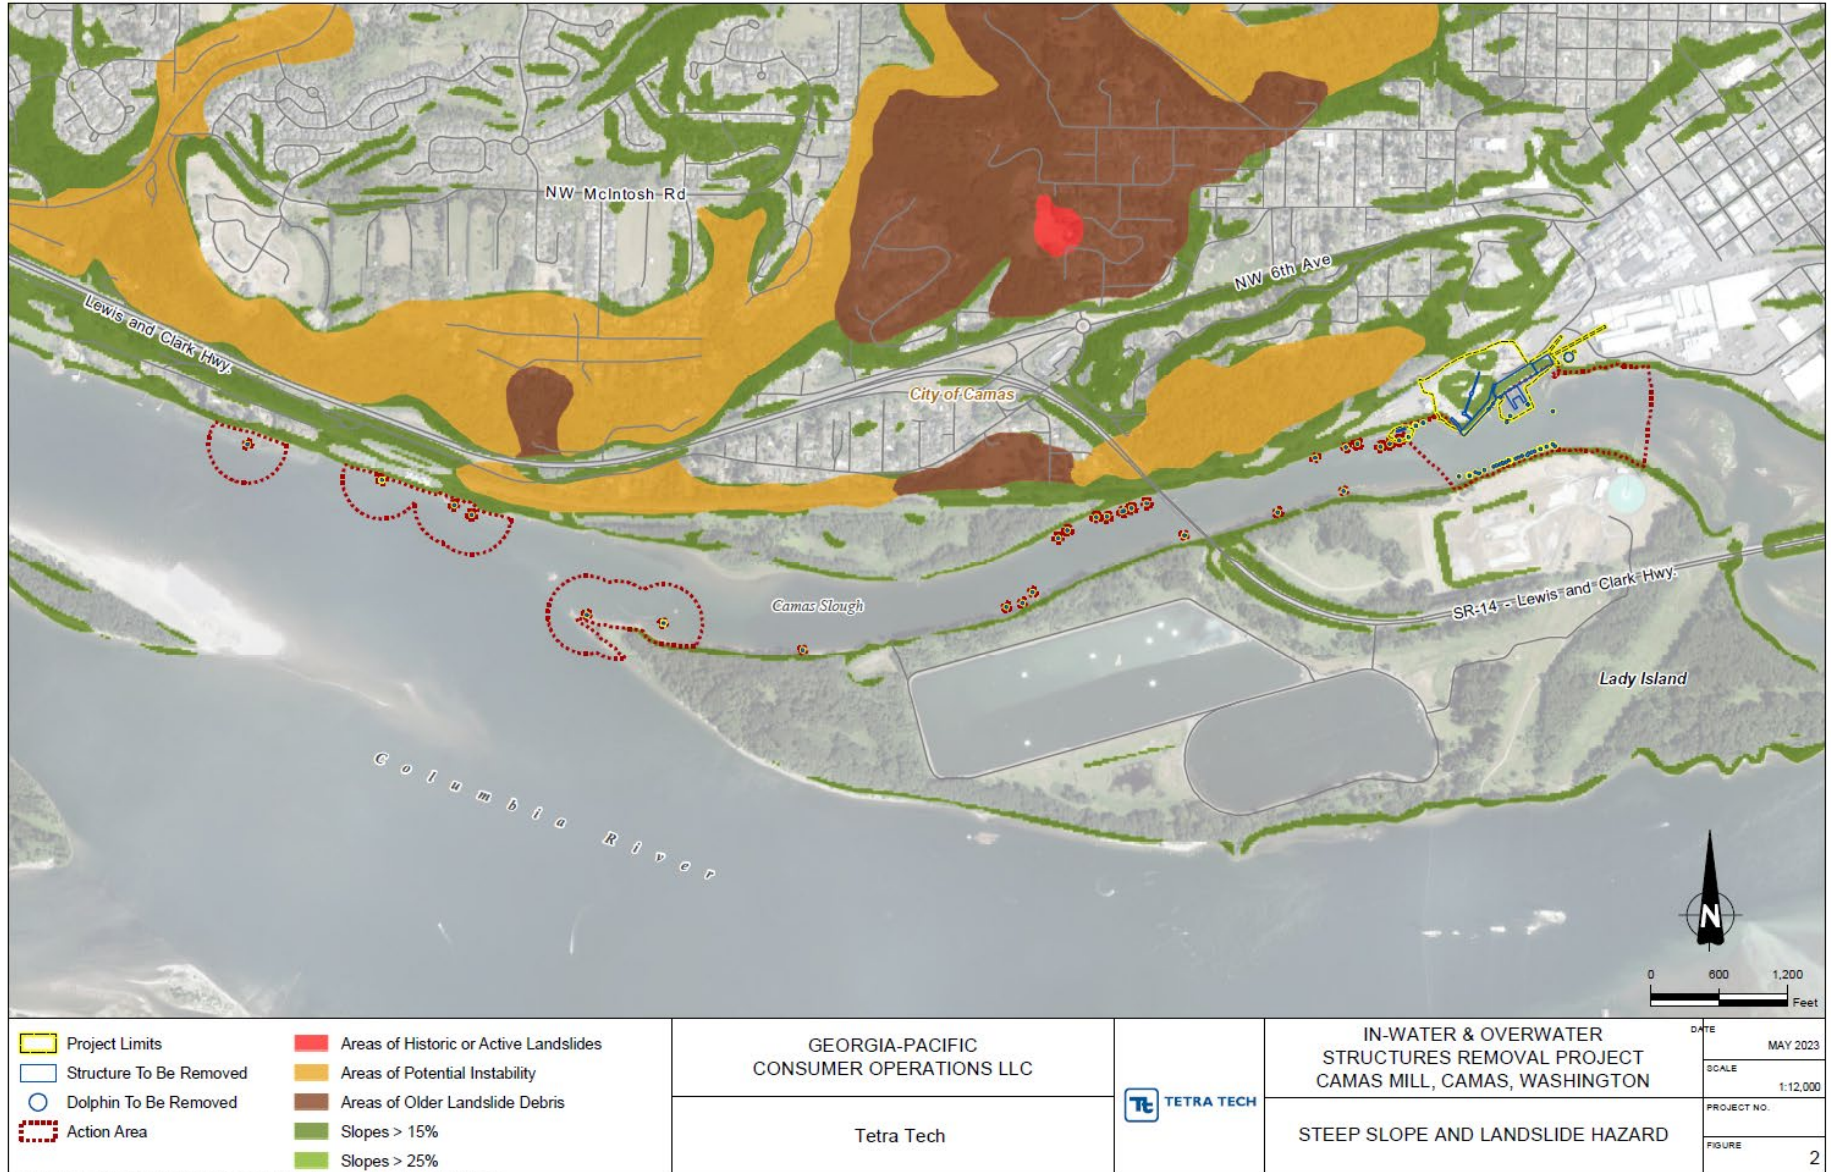
Figure 2. Steep Slope and Landslide Hazard Map

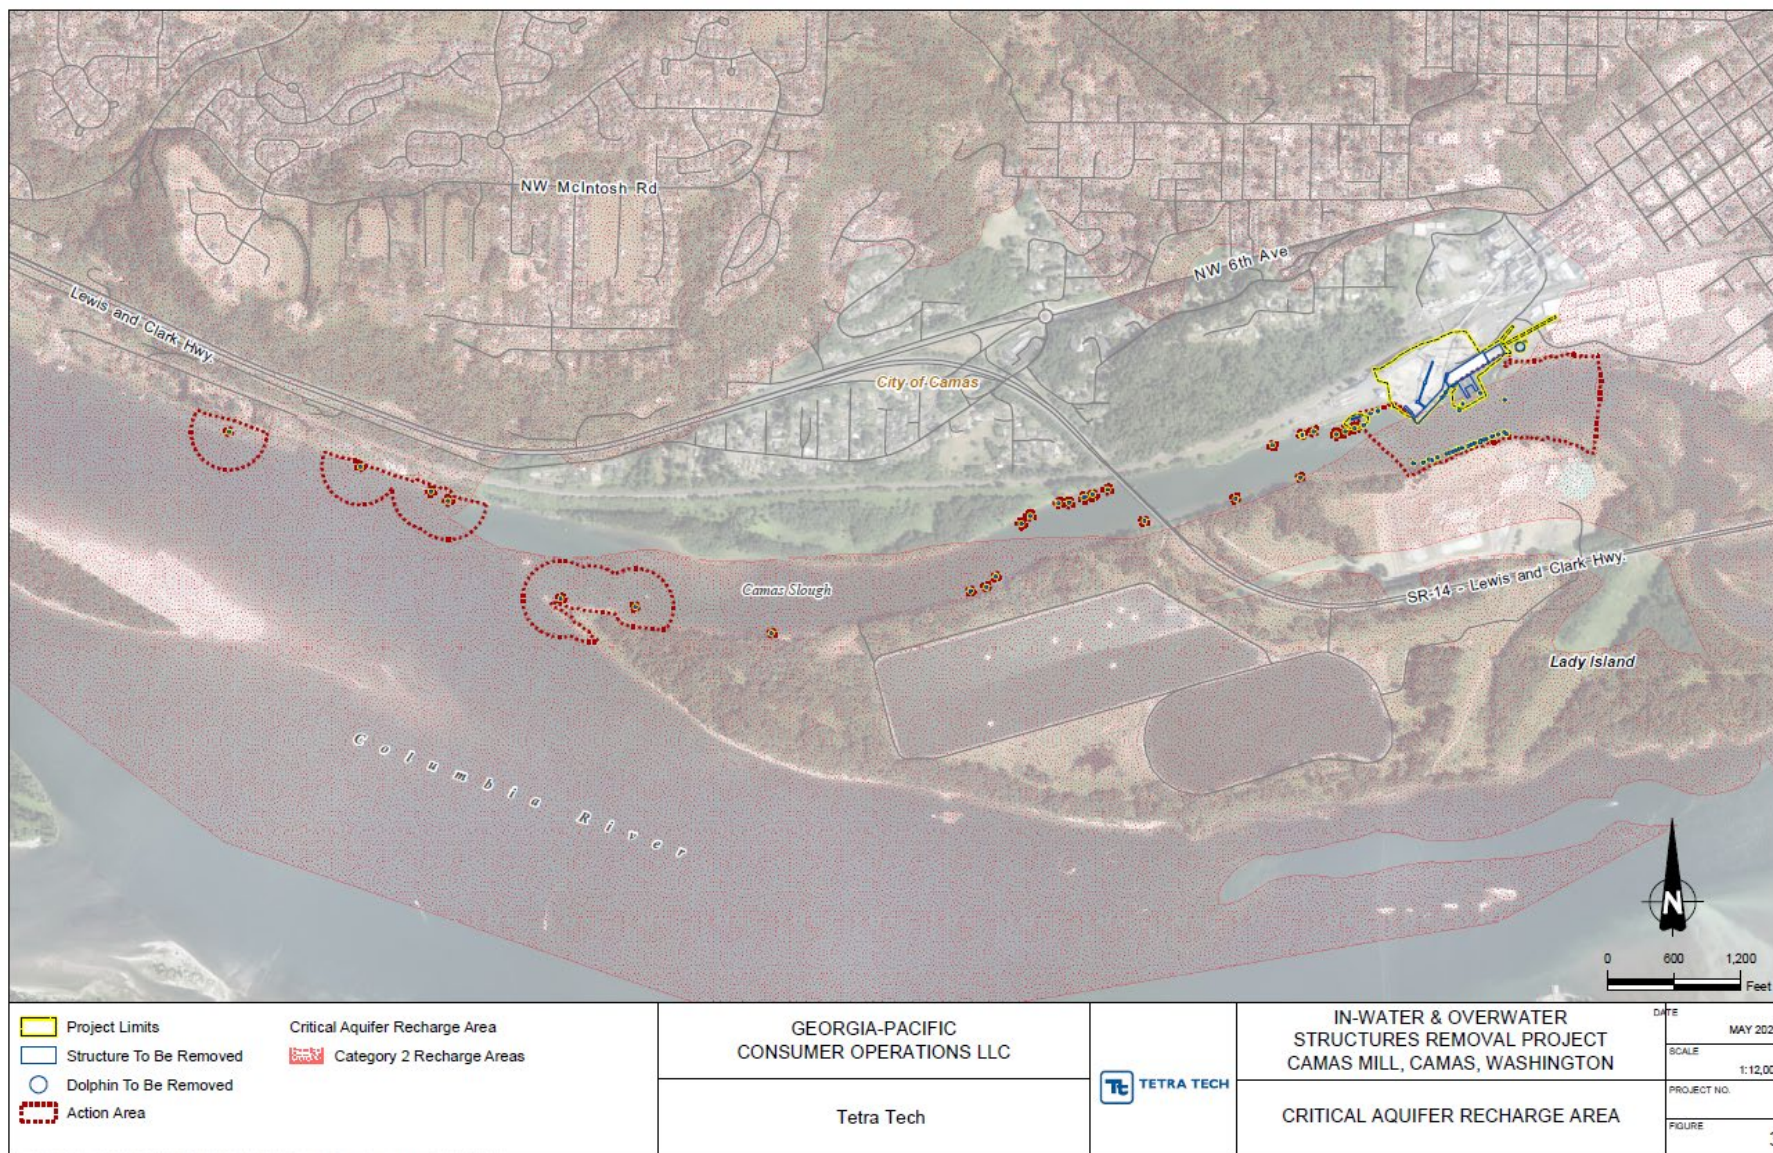
Figure 3. Critical Aquifer Recharge Area Map

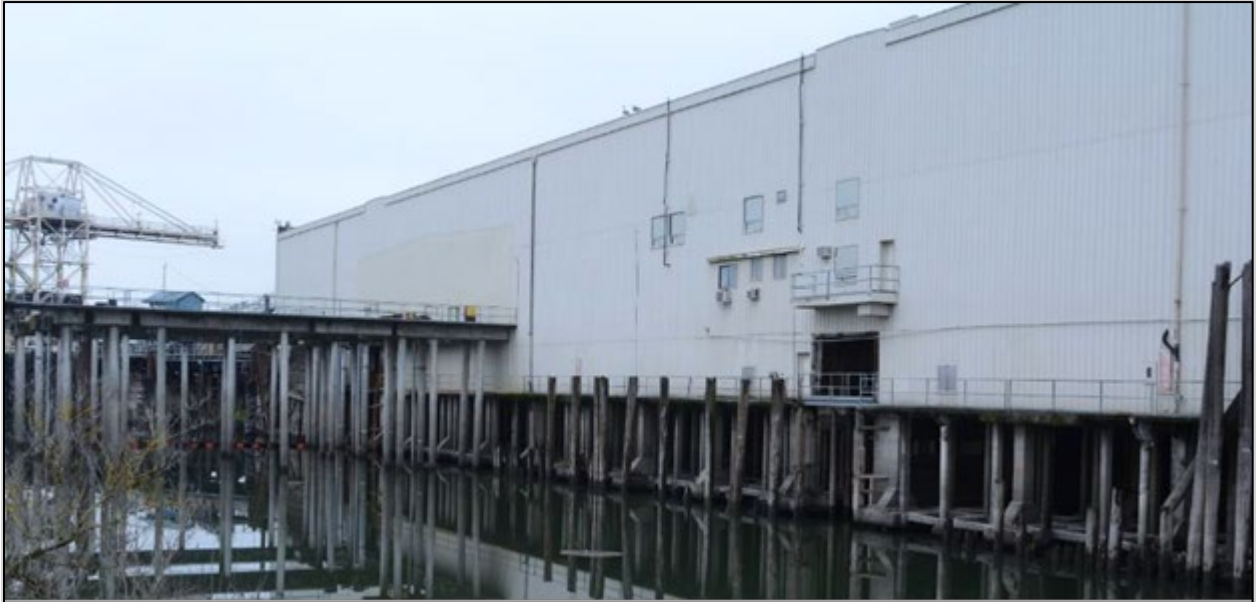
Photograph 3. Dock Warehouse situated between the Truck Dock and PECO Dock and supported by approximately 800 piles, with foundations on the riverbank side.

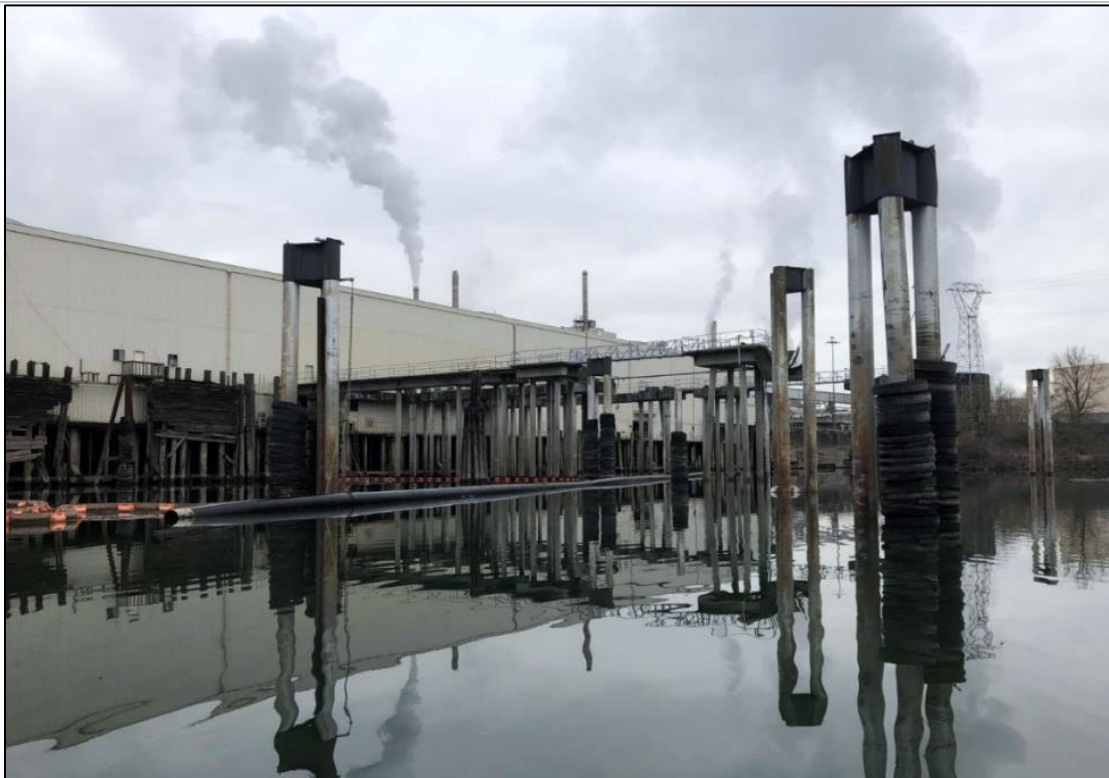
Photograph 4. Three piers extend from the Dock Warehouse that are supported by 54 concrete piles along with 21 carbon steel pipe piles. Three guidance dolphins are arranged at the end of the piers.
