## City Council Workshop Agenda Monday, August 07, 2023, 4:30 PM Council Chambers, 616 NE 4th AVE

## Staff Report

Downtown Tree Succession Plan

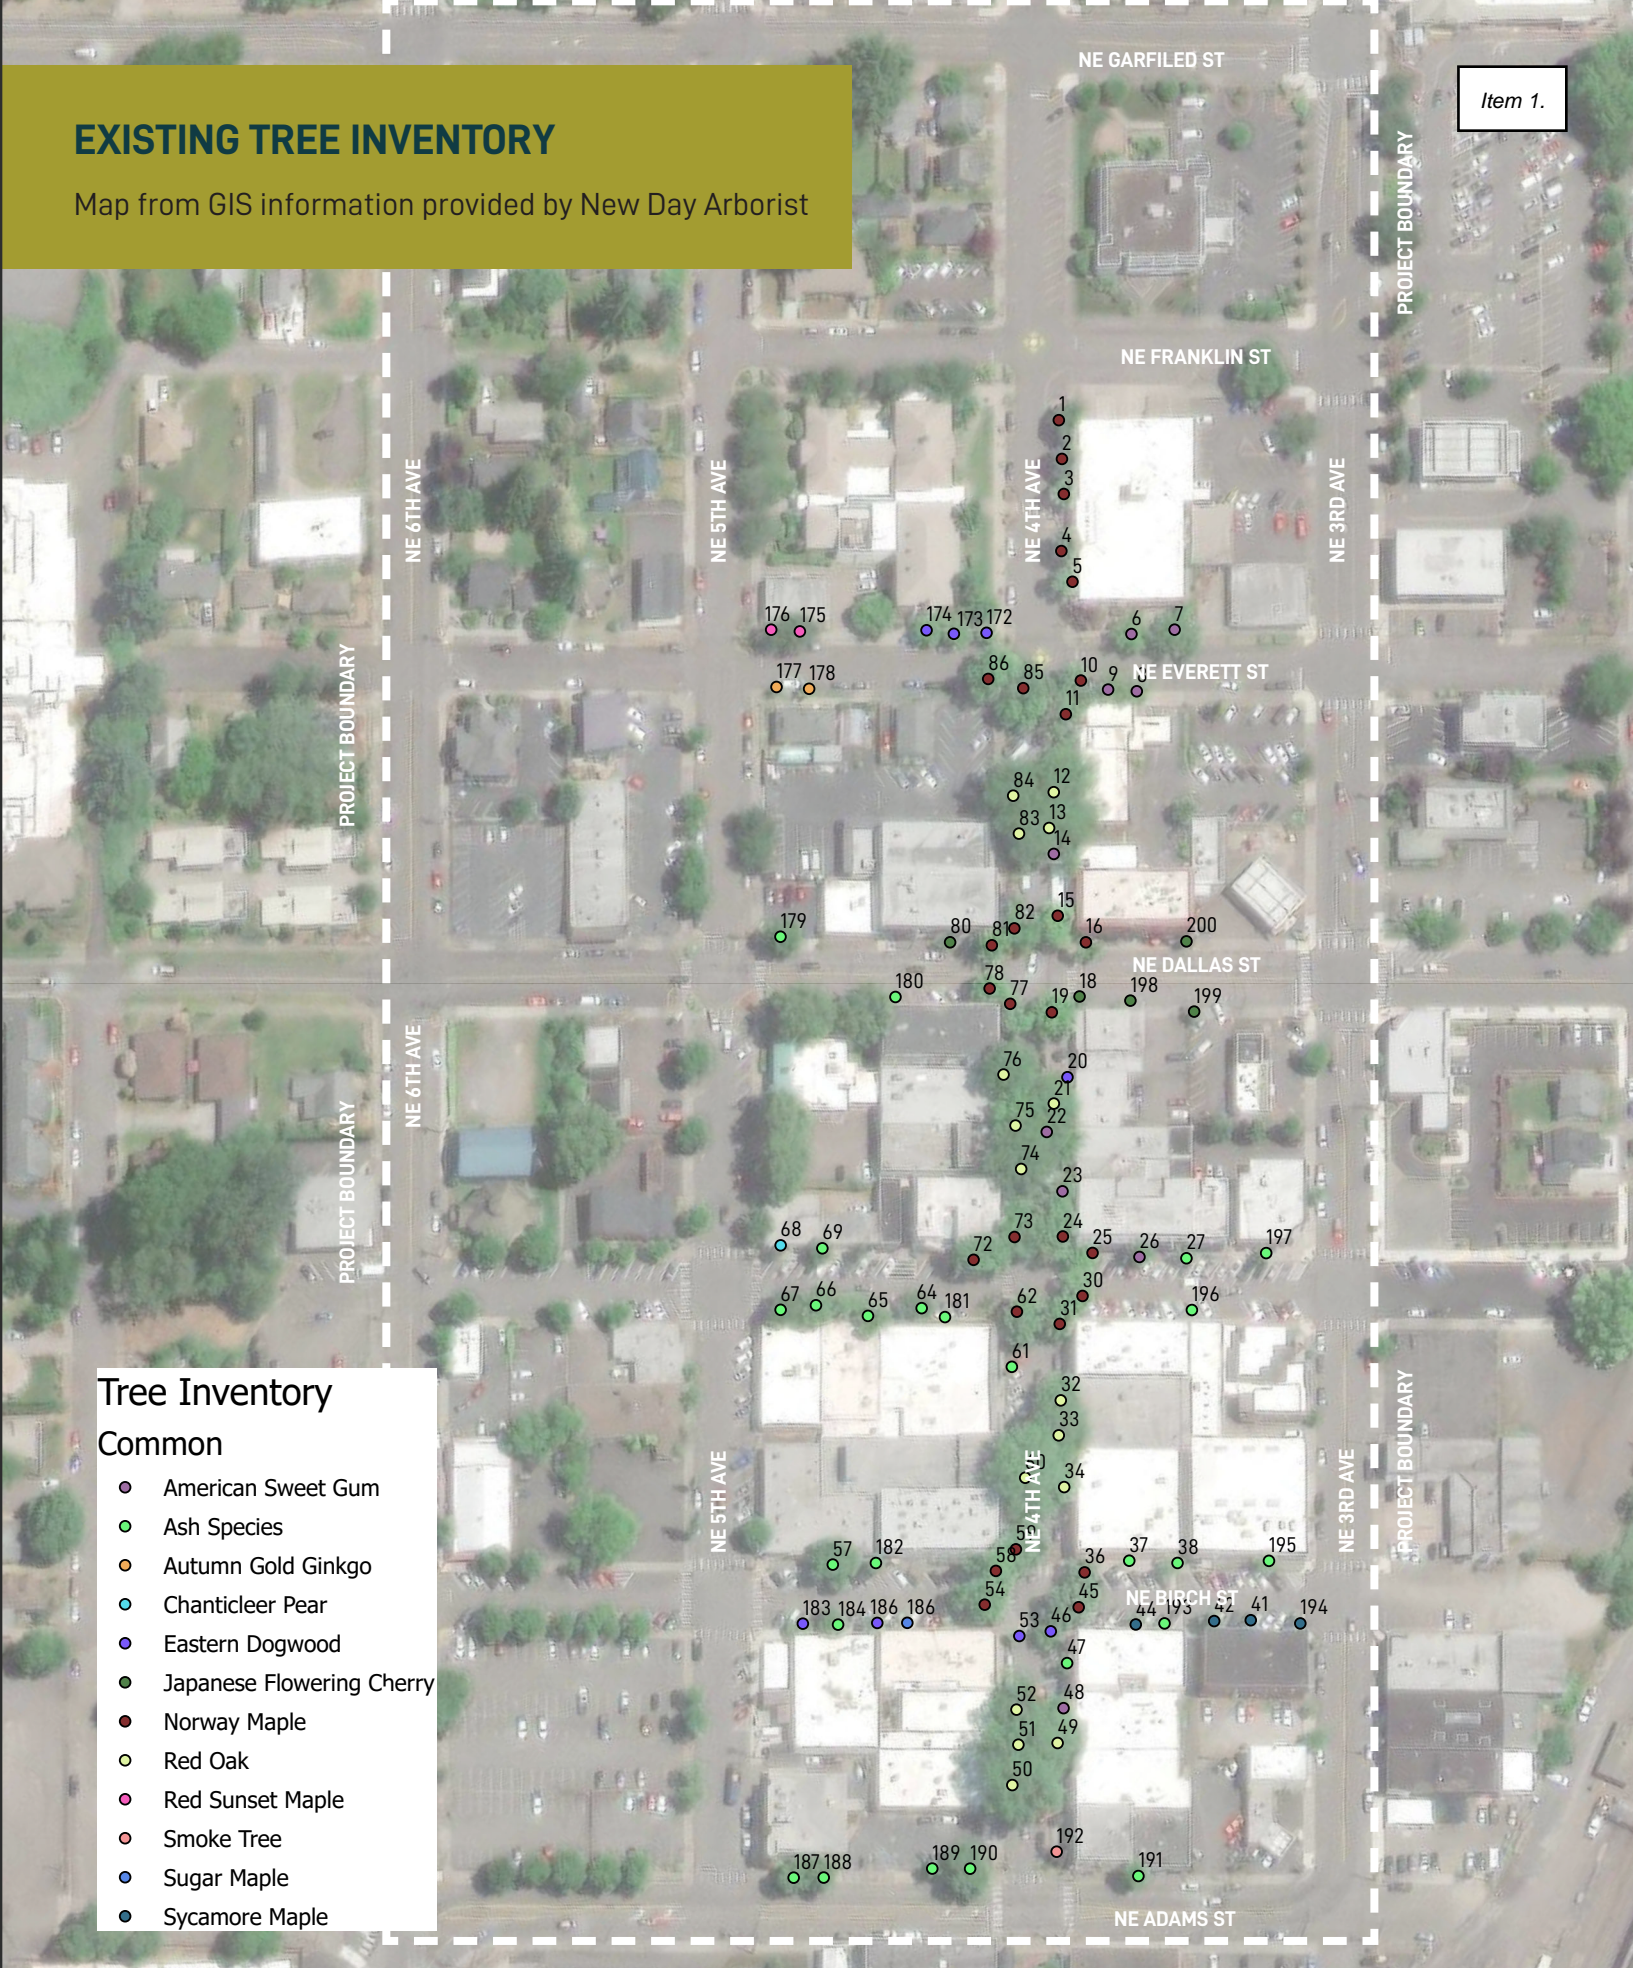
EXISTING TREE INVENTORY

The tree inventory noted a number of critical issues that helped inform this succession plan:

- Most species within the project area are Red Oaks (*Quercus rubra*) and Norway Maples.
- Most of the Norway Maple trees in the area are over-mature and showing signs of decline. The inventory recommends that the majority should be budgeted for removal and replacement.

Map from GIS information provided by New Day Arborist

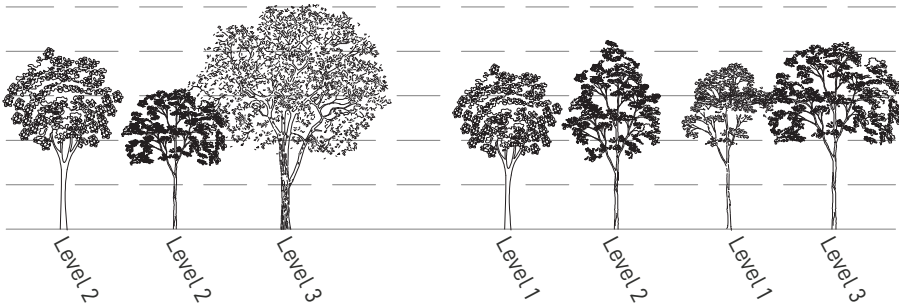
TREE SUCCESSION DIAGRAM

**Existing Conditions:**  
Some diversity in species and age but many trees in moderate or poor health.

See page 22 for descriptions of Level 1, Level 2, and Level 3 trees.

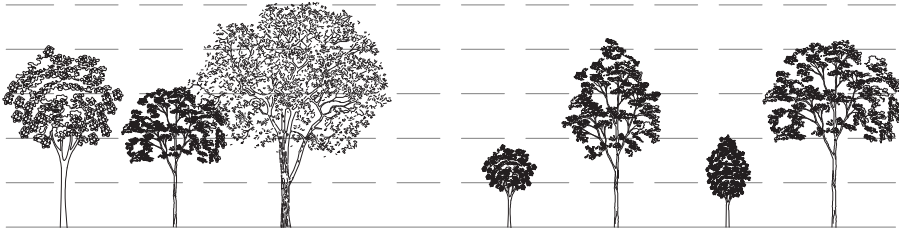
**0-5 Years**  
Dead, hazardous, and high risk trees removed and replaced.

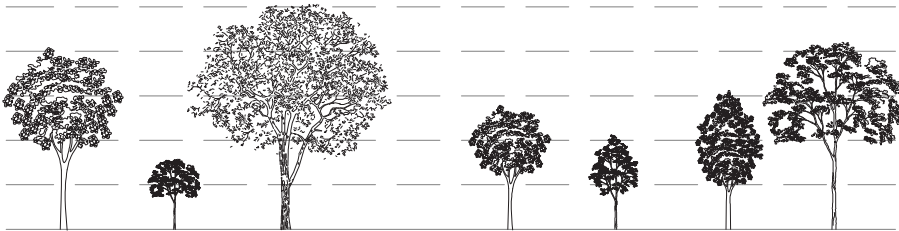
**5-10 Years:**  
Level 2 trees replaced. All trees monitored for changes in health.

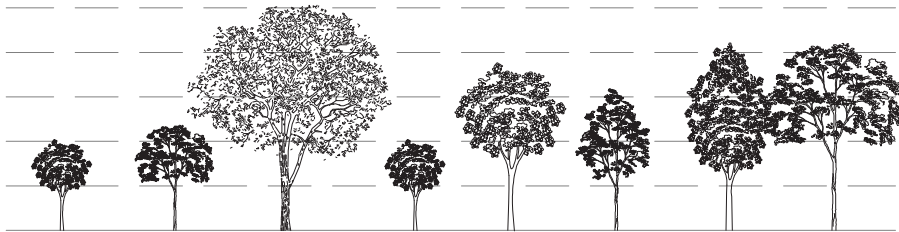
**10+ Years:**  
Level 3 trees begin to decline in health and will need to be replaced.

Plant trees in gaps in the tree canopy.

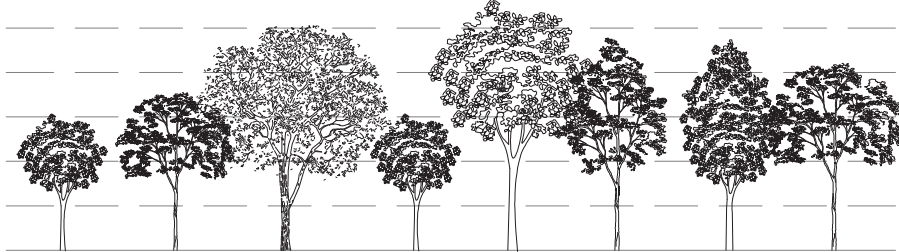
**Goal:**  
Healthy canopy with a diversity of tree species and ages.

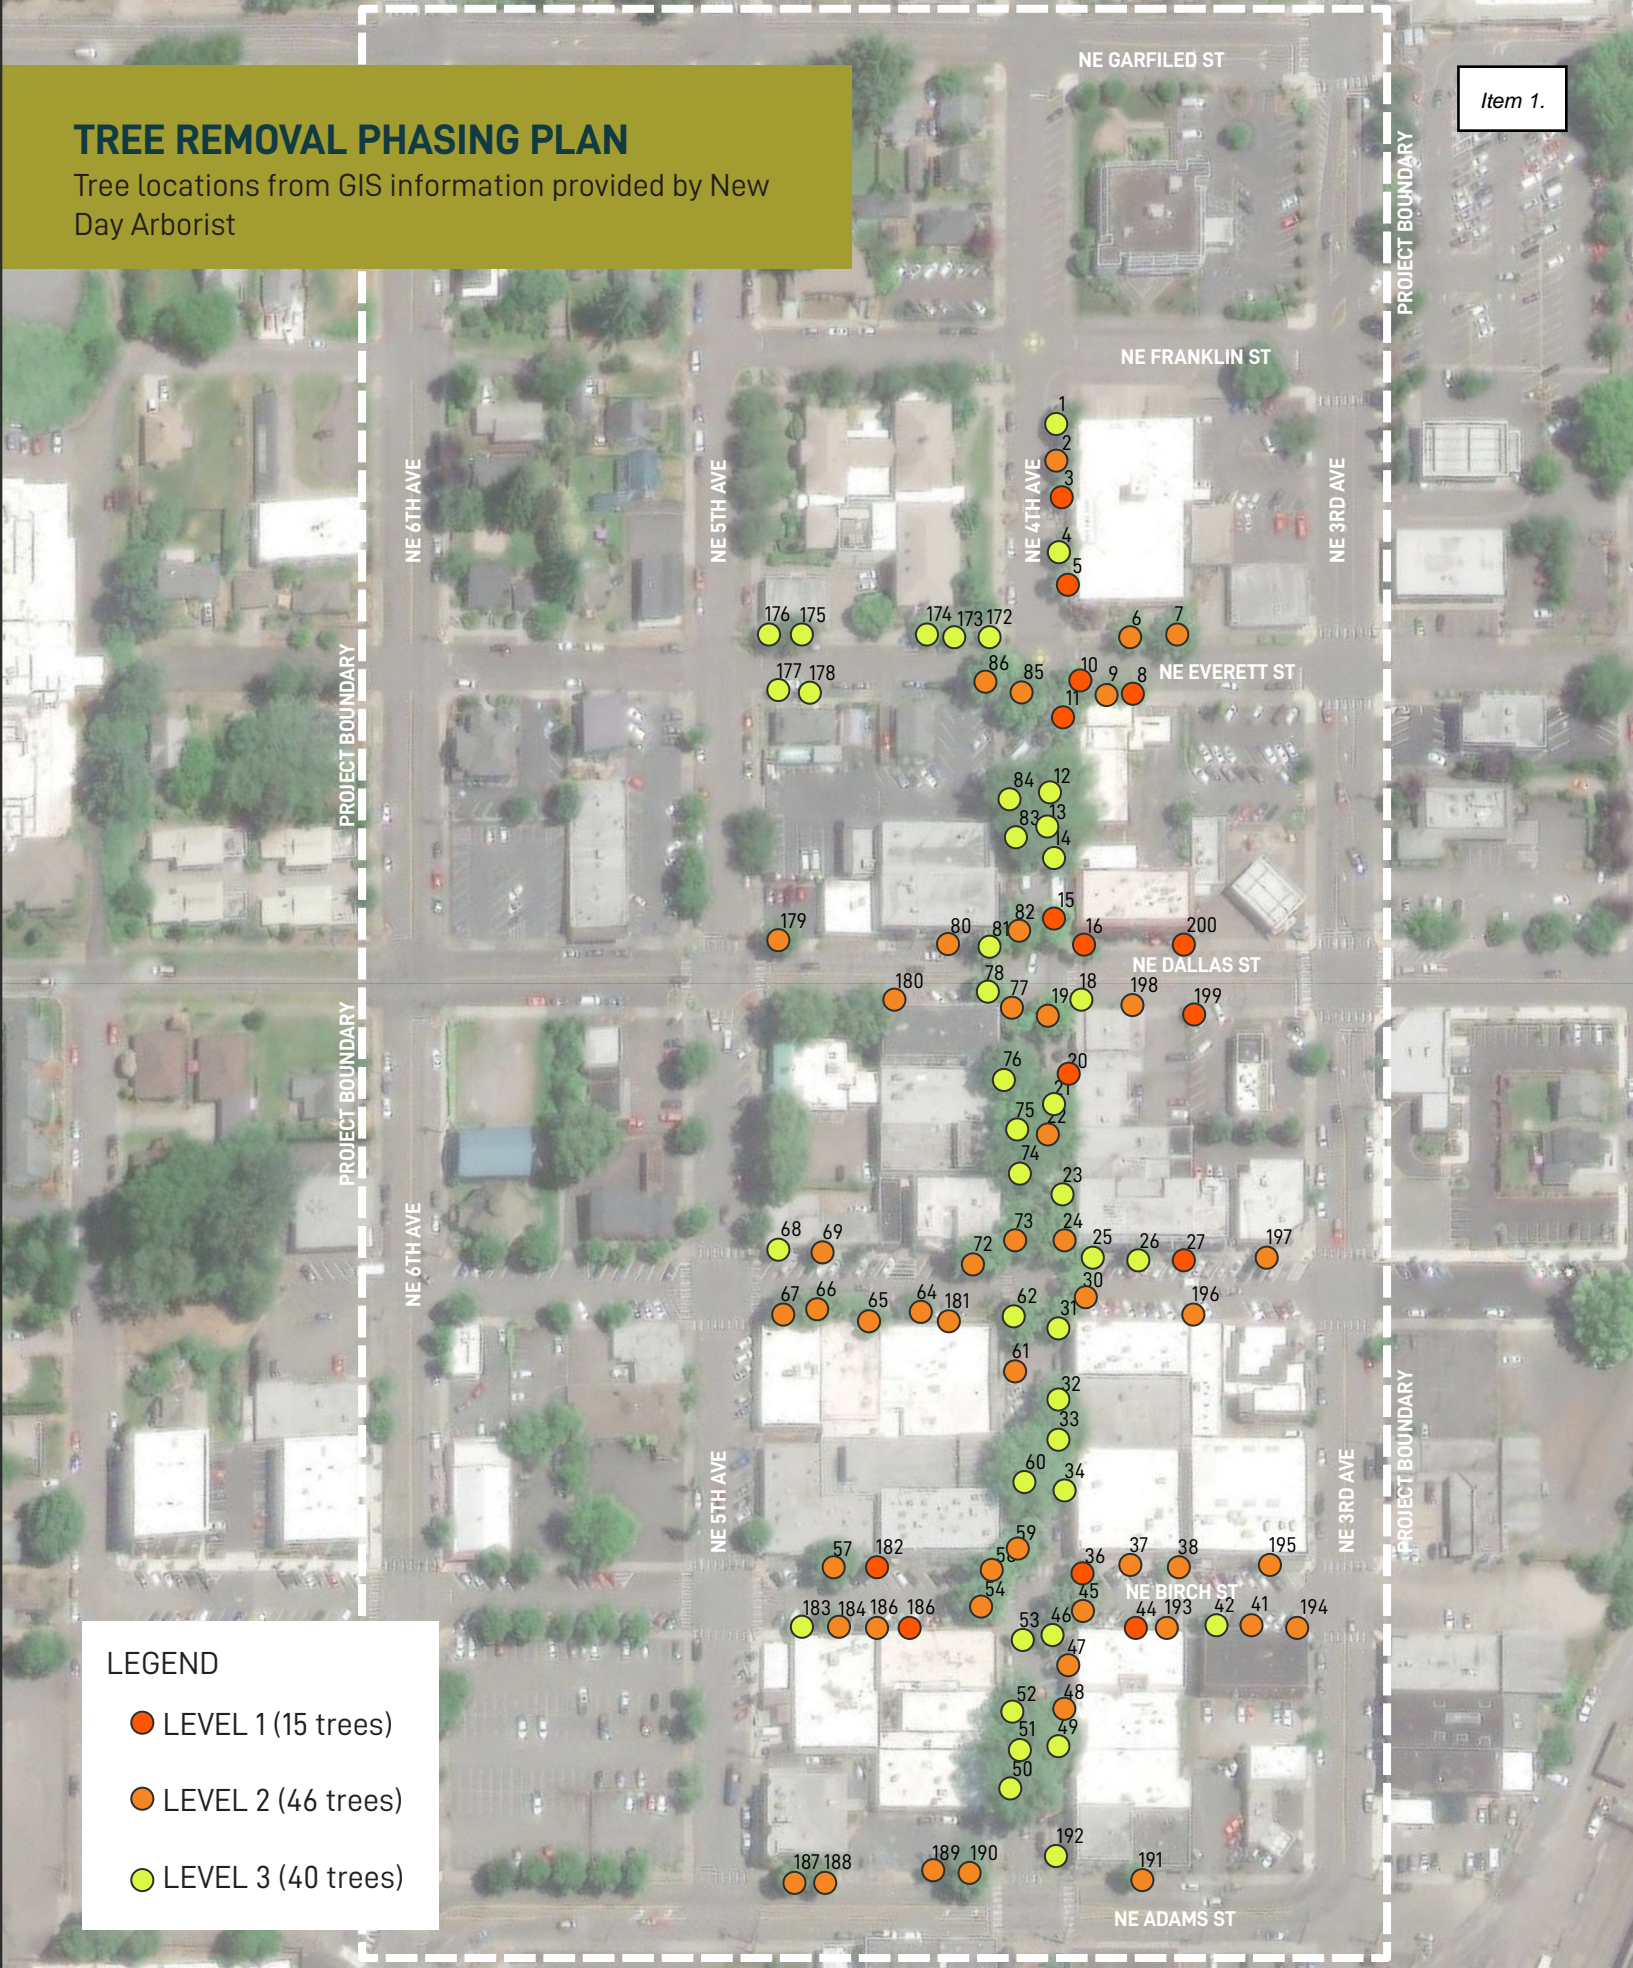
TREE REMOVAL PHASING PLAN

These categories formed the baseline for the recommended removal timeline. Trees are recommended for removal and replacement based on the following criteria:

- Level 1: Urgent/High Risk/Hazard Tree  
Timeframe: 0-5 years  
Remove any dead or dying trees or trees classified as 'high risk'. Remove dead wood in the canopy of all species.
- Level 2: Moderate  
Timeframe: 5-10 years  
Tree is in moderate or poor health but does not immediately pose a risk. Remove and replace on an ongoing basis as time and budget allows. This category generally includes
- Level 3: Good  
Timeframe: Monitor  
Tree currently in good health. Monitor every 10 years. If tree health declines, consider moving it to Level 1 or Level 2 as needed.

Tree locations from GIS information provided by New Day Arborist

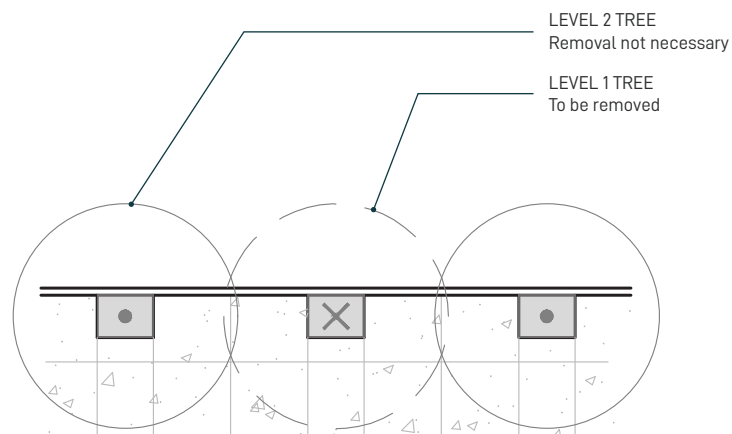
### Existing Conditions:

Sidewalk with street trees. Tree wells are undersized and soil volume is too small. One tree is listed as Level 1 and ready for removal.

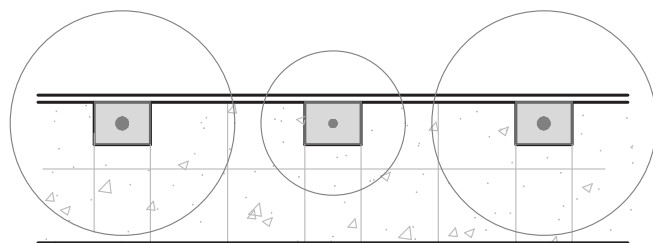
### Option 1:

Remove and replace single Level 1 tree. No supplemental infrastructure improvement. Lowest cost in the short term. Option not recommended as it does not improve tree health long-term.

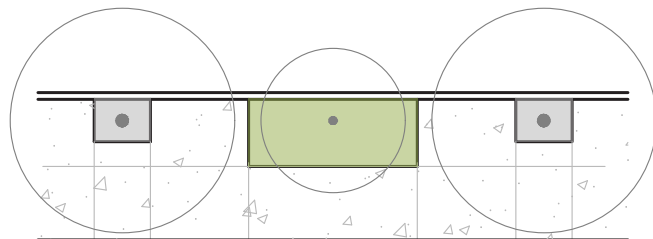
### Option 2:

Remove and replace single Level 1 tree with supplemental infrastructure improvement to increase soil volume. Moderate cost in the short term. Some improvement in individual tree health however infrastructure is piecemeal.

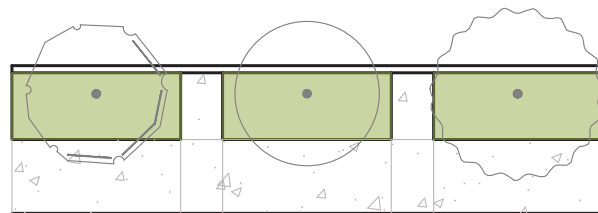
### Option 3:

Remove and replace Level 1 tree and adjacent Level 2 trees. Higher upfront cost but cost savings over time. Improved soil volume increases long-term tree health and reduces maintenance costs.

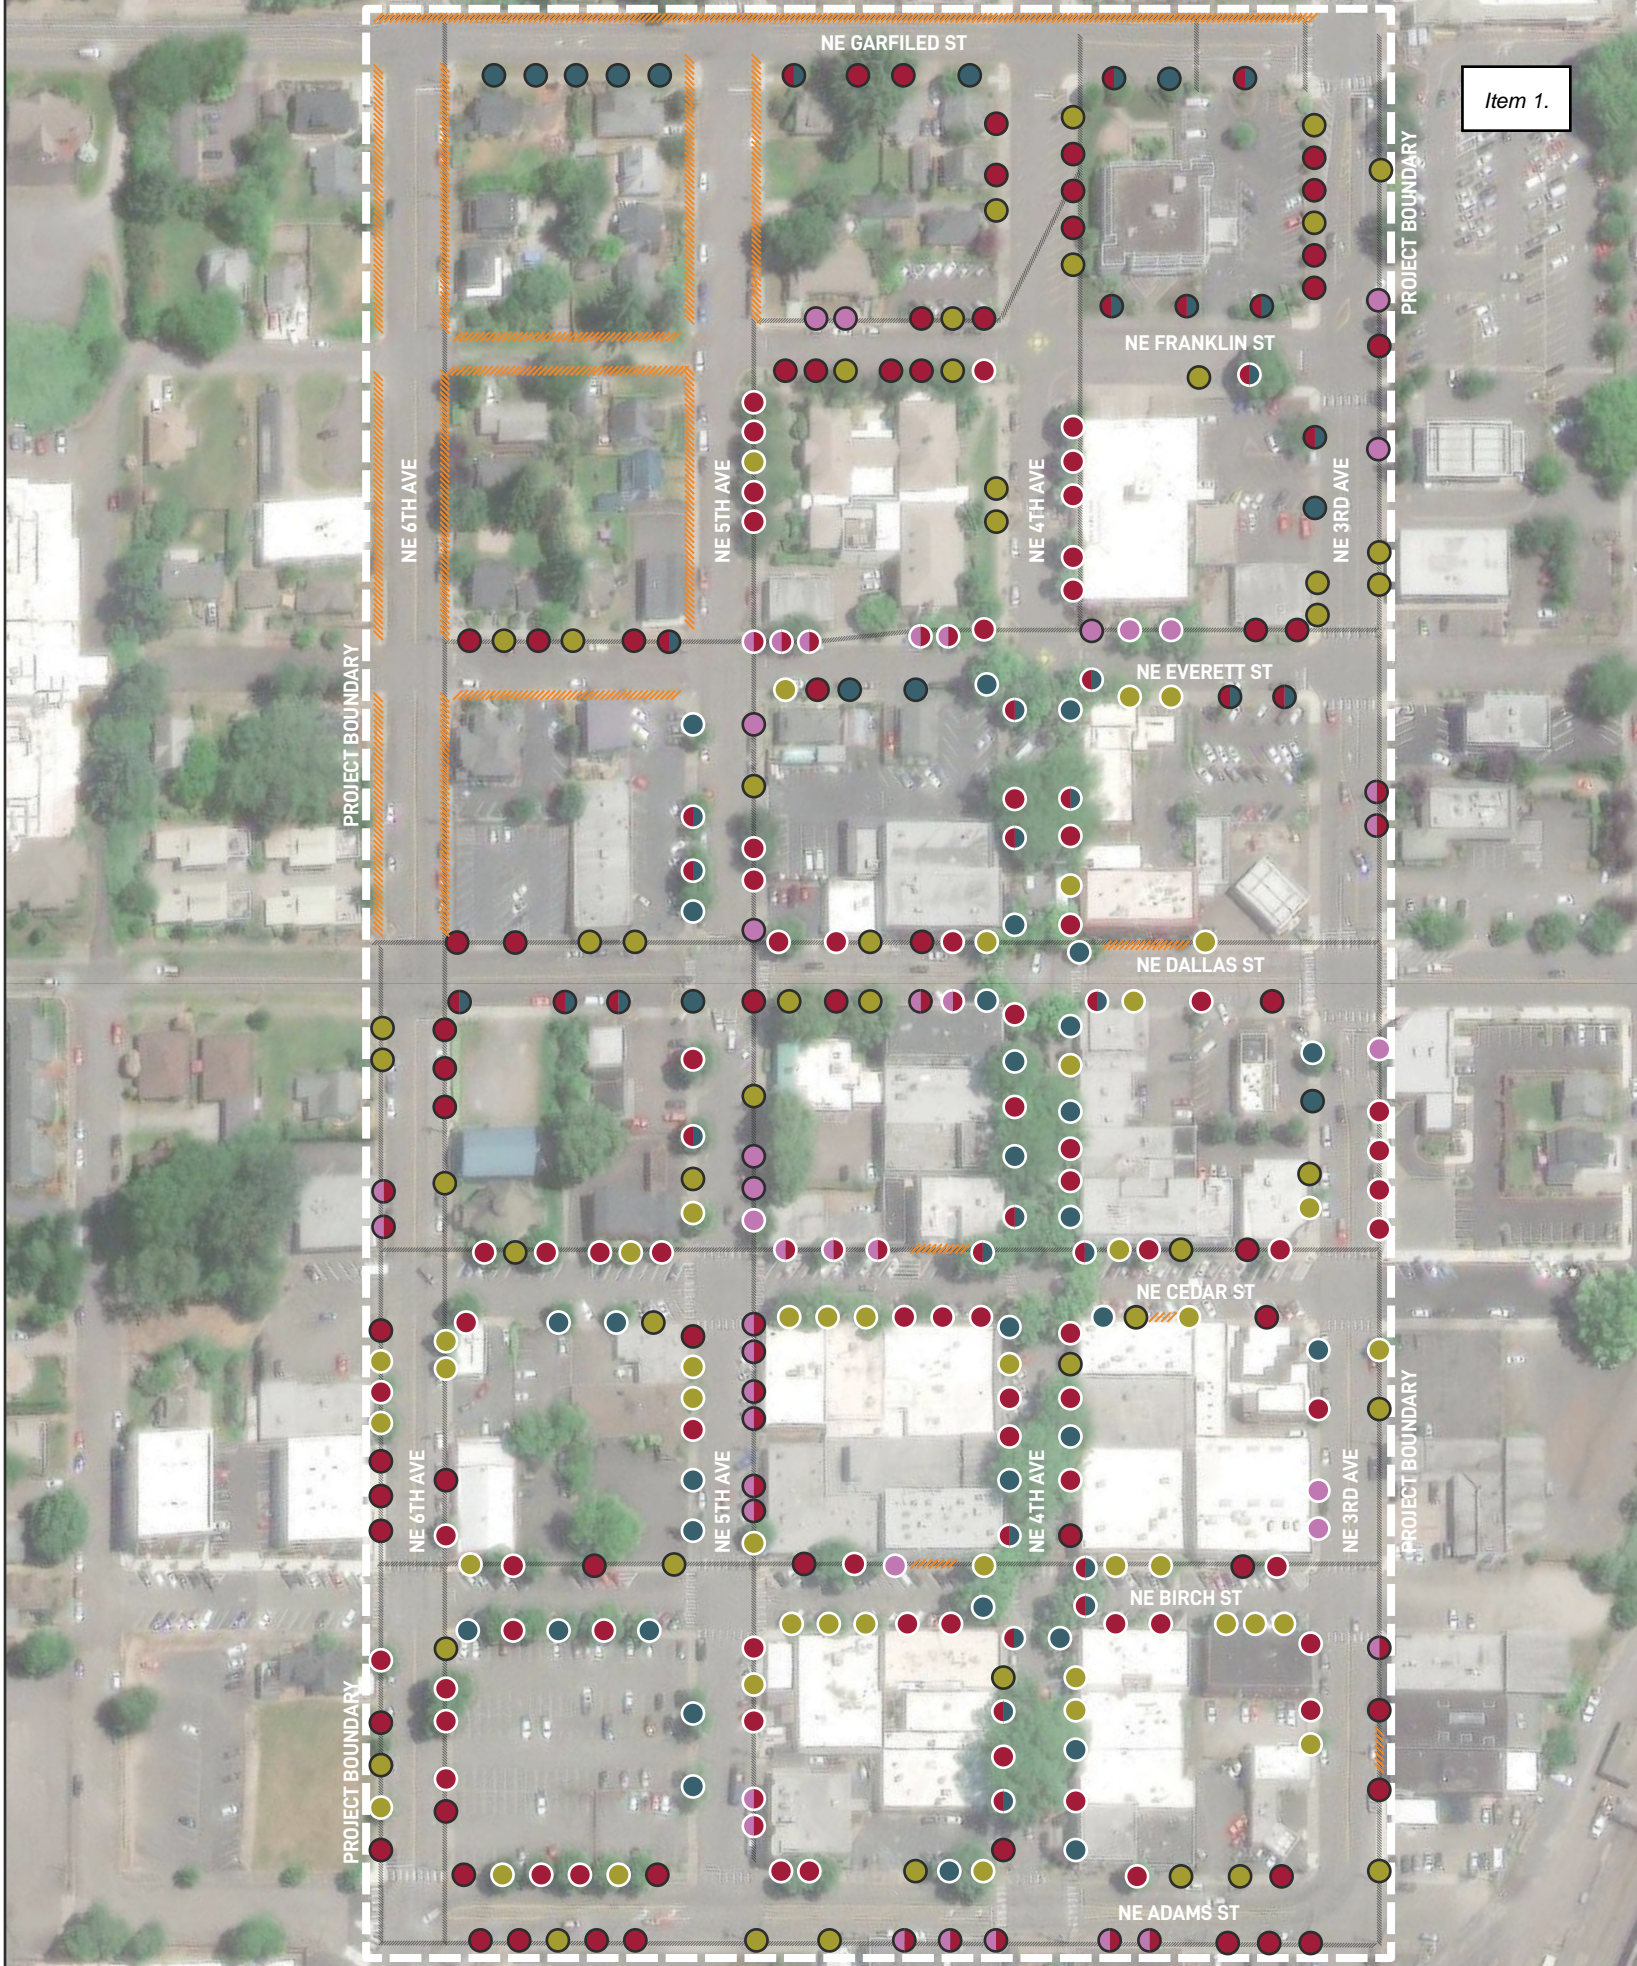
- Tree Replacement Guidelines
- New trees should be planted with a diverse range of species.
  - No species shall exceed 20% of total site area and no species should make up more than half the trees of each block face.
  - No large trees should be planted under overhead utilities.

- Recommendations were made based on the following spatial elements:
- 1) Existing sidewalk width
  - 2) Overhead Utilities
  - 3) Distance to Adjacent Buildings
  - 4) Adjacent Trees

Existing sidewalk too narrow to support street trees. Consider future improvements to widen sidewalk.

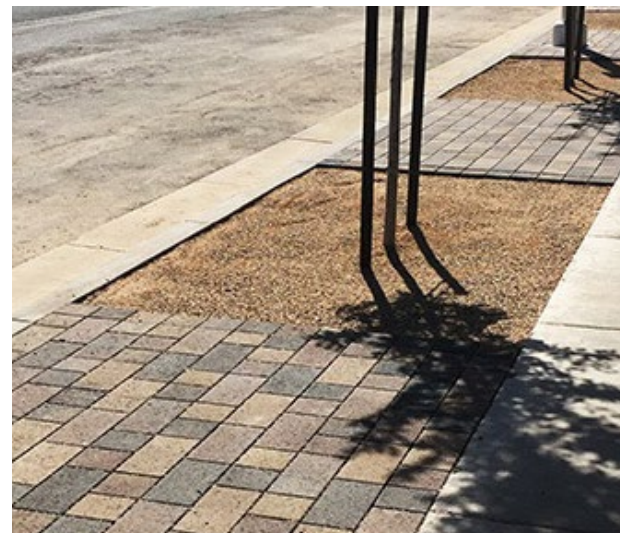
### Tree Grates

Tree grates can be a useful tool when space is limited. Tree grates help to preserve pedestrian space while also providing soil below for the tree. However, tree grates are not always the best option for the tree as they can outgrow the size of the grate, thus damaging the overall tree health.

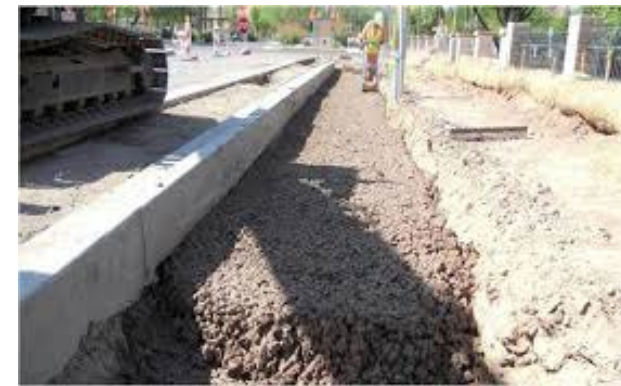
### Permeable Pavers

Permeable pavers allow water to infiltrate into the soil below instead of running off. This also puts less pressure on the stormwater system and reduces irrigation needs for trees.

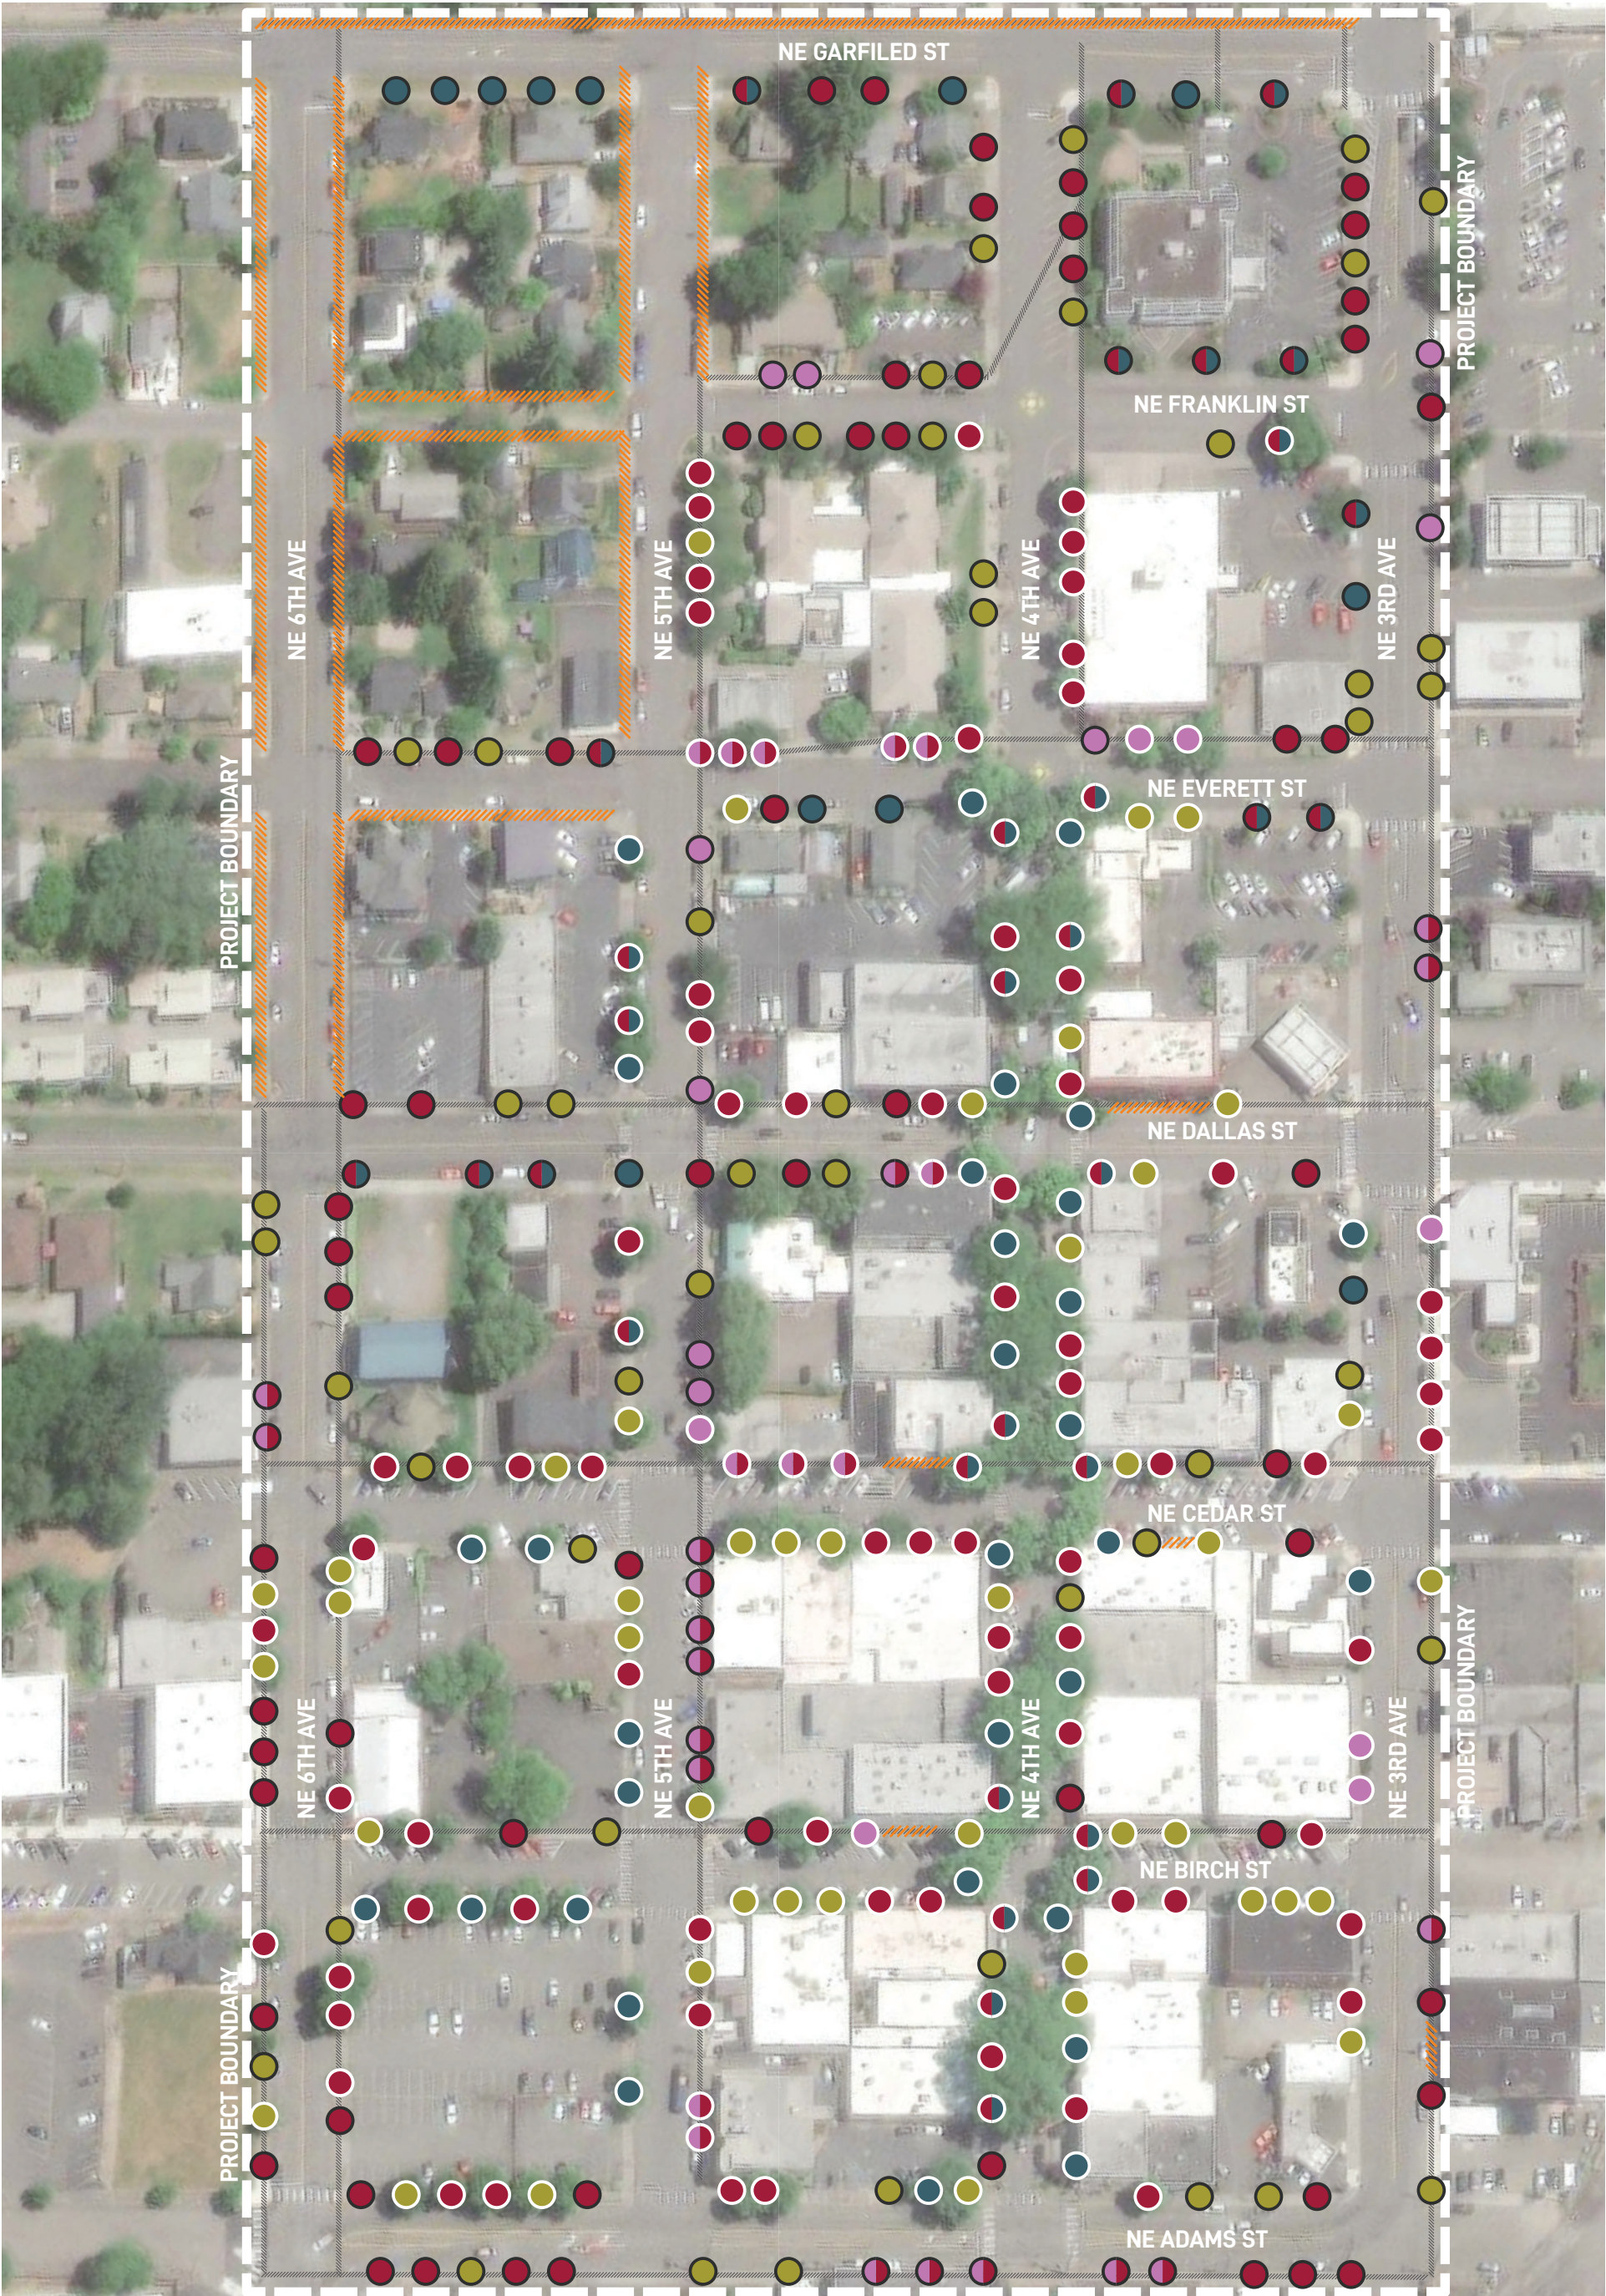
### TREE REPLACEMENT PLAN

| Small or Ornamental Tree | Small tree recommended, Medium possible with infrastructure improvements | Existing Tree Replacement | Overhead Utility |
| Broadleaf Evergreen Tree | Medium tree recommended, Large possible with infrastructure improvements | Gap or Infill Tree | Existing sidewalk too narrow to support street trees. Consider future improvements to widen sidewalk. |

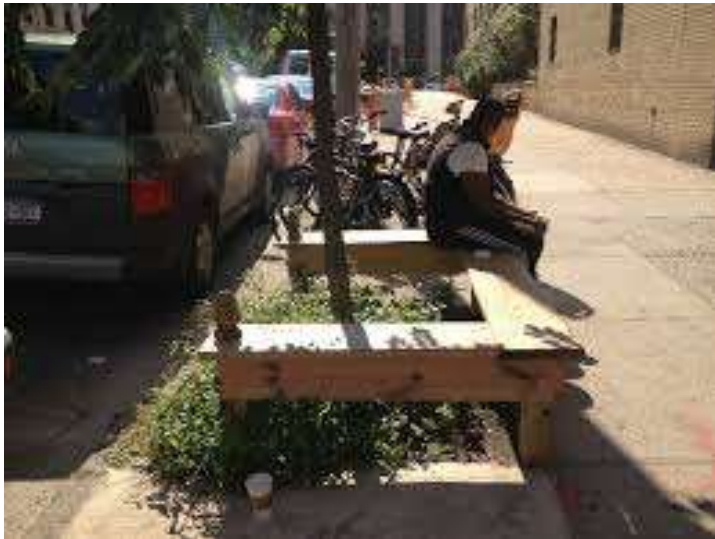
One idea for a more interesting planting space.

Creating larger openings for the trees, and adding a more “interactive” place for pedestrians.

This helps to reduce the amount of compacted soil around the tree. The planters should be as large as possible. Overall, my idea is fewer trees, but higher end species, quality, and more consideration to location through the downtown area.
