Historic Preservation Commission Regular Meeting

City of Dripping Springs Council Chambers 511 Mercer Street – Dripping Springs, Texas Thursday, May 02, 2024, at 4:00 PM

- 2. Public hearing, discussion, and consideration of approval of COA2024-0003: Application for a Certificate of Appropriateness for the installation of signage at Roxie's located at 299 Mercer Street in the Mercer Street Historic District. Applicant: Silver Garza, Roxie's LLC.
 - a. Presentationb. Staff Reportc. Public Hearingd. COA2024-0003
- **3.** Presentation, discussion, and consideration of acceptance of the Old Fitzhugh Road Local Historic District Resurvey Historic Resources Survey Report. Post Oak Preservation Solutions LLC
- **<u>4.</u>** Discuss and consider possible action regarding the Historic Preservation Commission Fiscal Year 2025 Budget Recommendation.

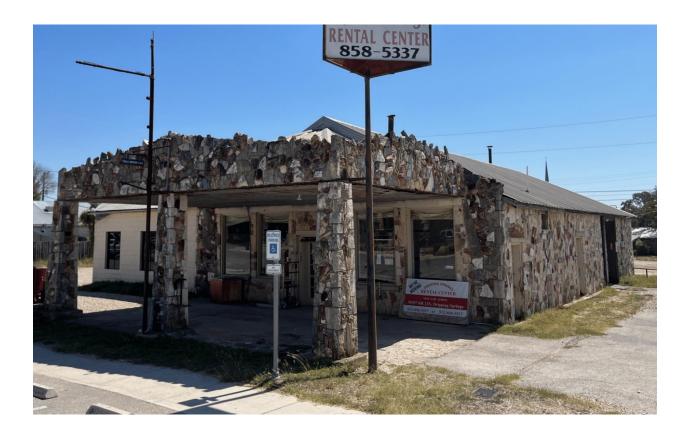
299 Mercer: "Current Condition". Images from Google Maps, 2023.

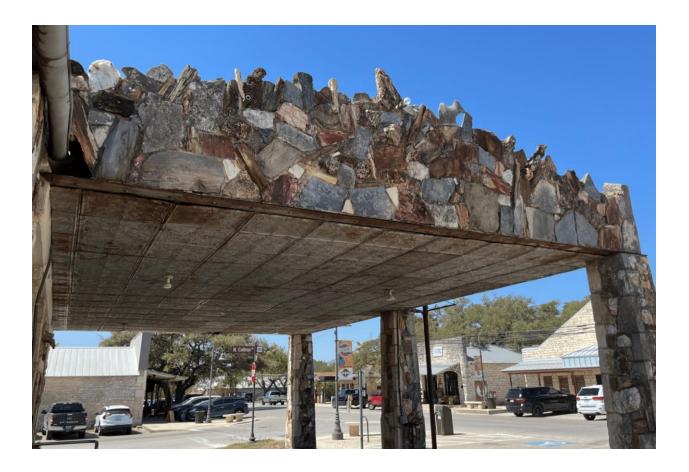
299 Mercer: More detailed imagery of the native stone and wood of the structure.

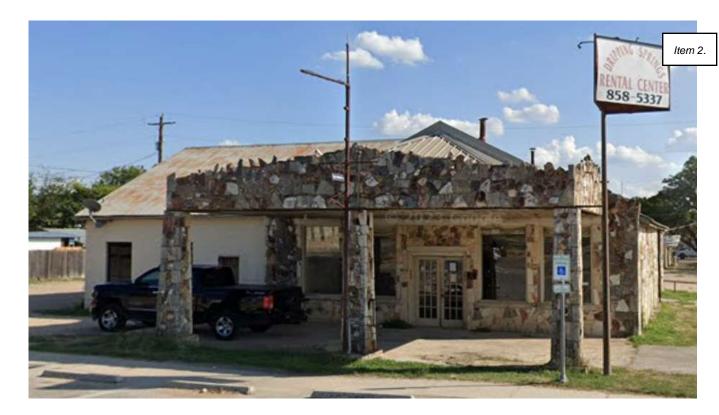
Existing Conditions

Retains rustic look with native stone and wood paneling. Possesses unique stone pillars. Sloped metal roofing and small signage at front of property.

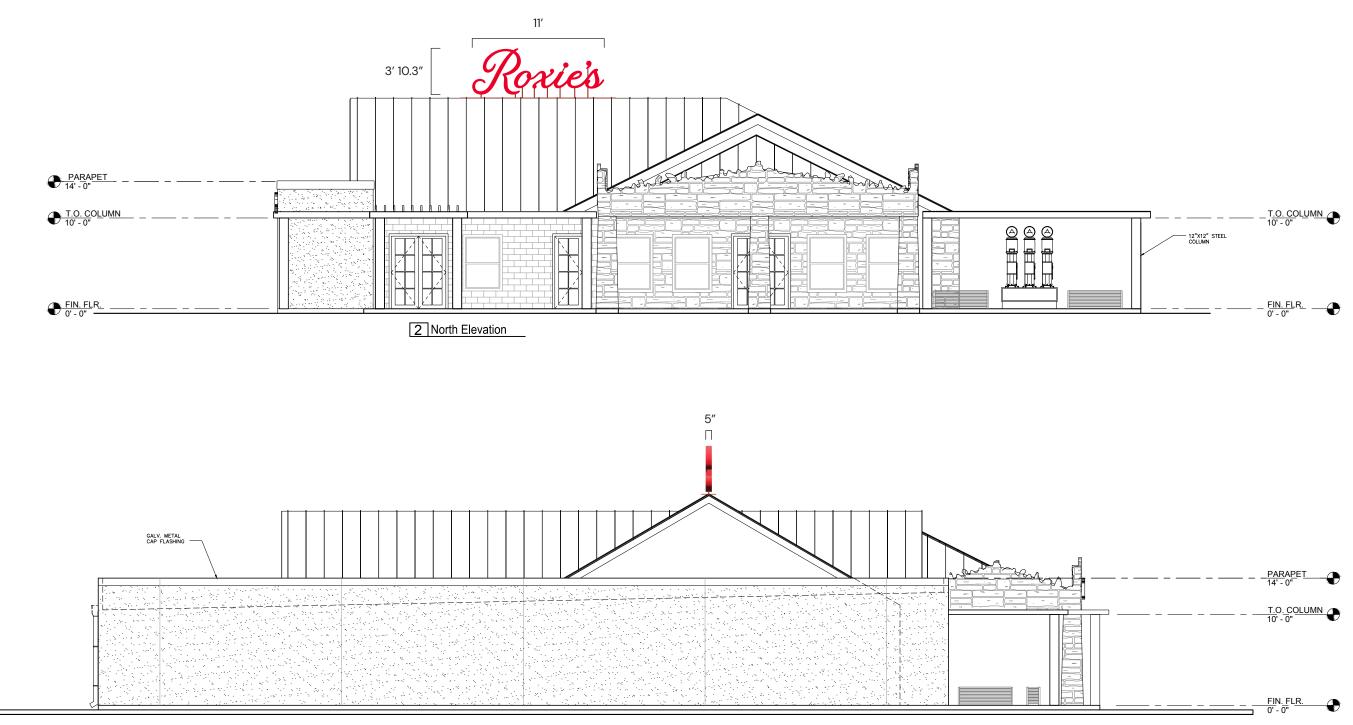
1 East Elevation

The submitted renderings and designs show two shades of red. The signage on the structure is a bright red, which stands out against the earth tones of the natural stone and materials of the structure. The second piece of signage is a rustic and muted red that will be placed on the edge of the property.

The applicant is seeking to include the addition of a sign above the apex of the building as well as a sign that sits atop the building. The sign itself is 3' 10'' x 11' in size and PMS 185 C in color. Additional signage on barrels 3'8'' x 3'8'' in size that sit on the corner of Wallace St and College St. The color is PMS 484 C (red). The applicant is also aiming to replace a sign at the front of the building with a Texas State Flag design.

Color Palette: "Muted, Rustic Earth Tone Hues" The signage for the building appears to be a bright red, which would go against the guidelines of the Mercer Street Historic District

"Muted, rustic Earth Tone Hues" The shades of red are rustic, but the brighter shade of red would need approval. The PMS 185 C is a bright red that stands out from the rest of the building.

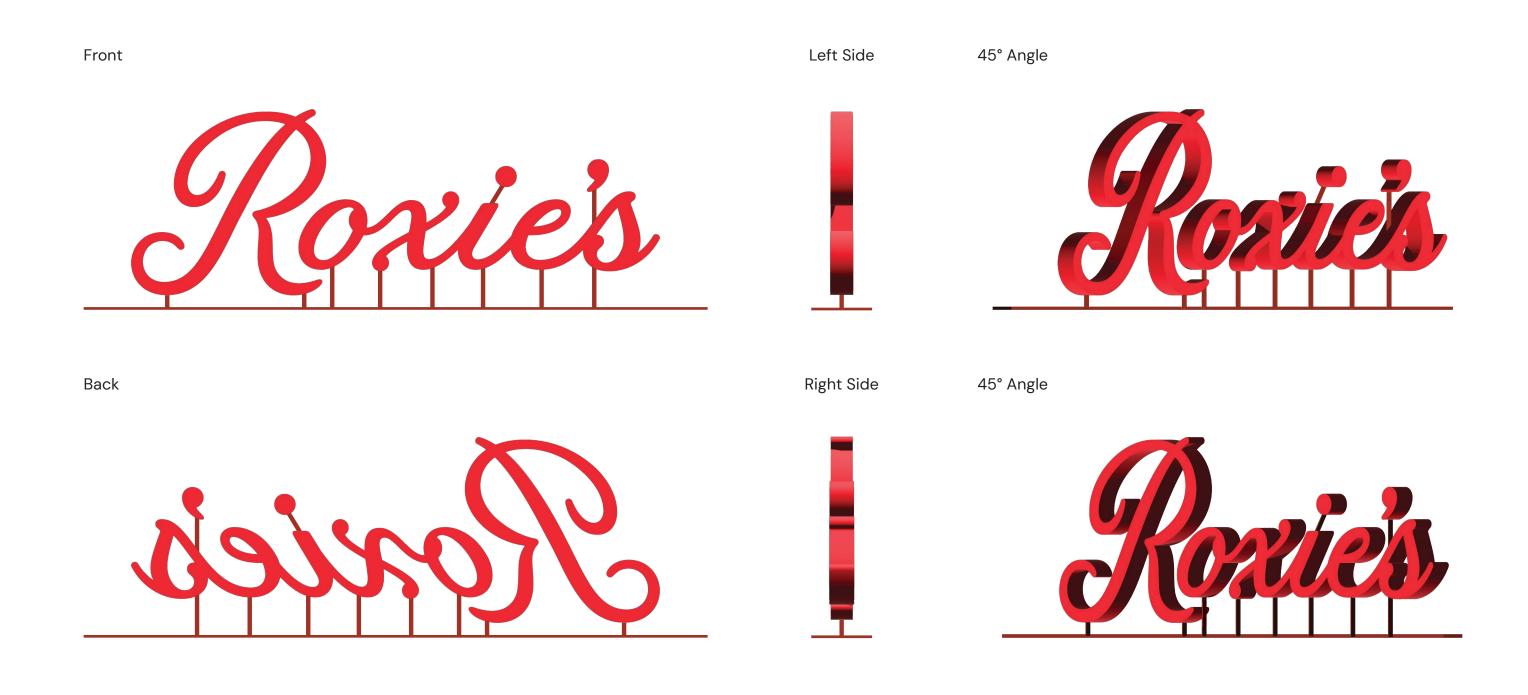
Rooftop Sign Production Details

- Unlit channel letters, bottom pin-mounted to a rail
- Pins be installed through center of letters to provide a clean back view
 Letters to be painted to match PMS 185 C

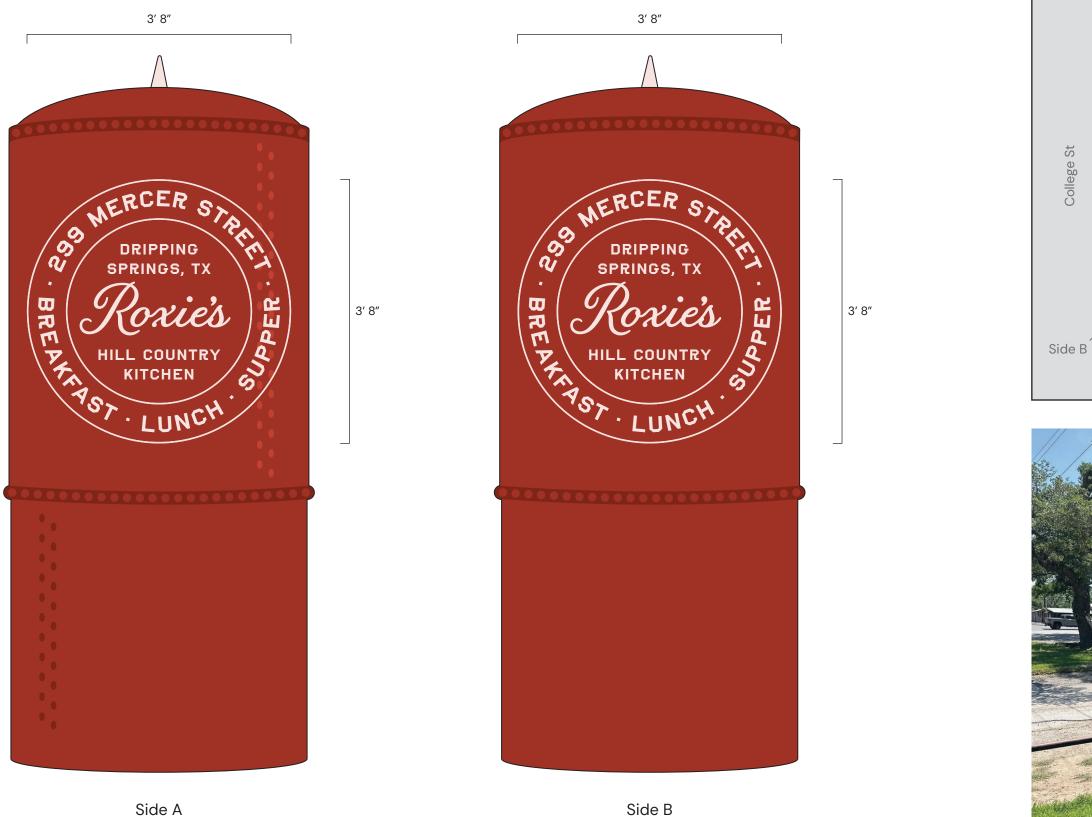
Hand-painted artwork on existing tank on premise

- 1 color badge painted on 2 sides, PMS 9240 C
- Tank to have a base color applied all over, PMS 484 C

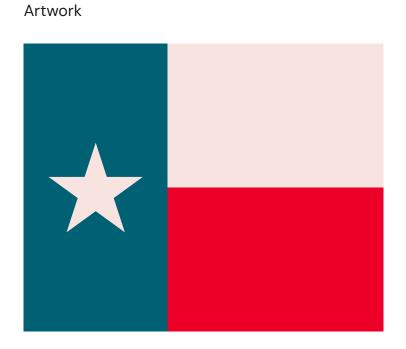
Roxie's Exterior Signage

Pole with triangular sign

Hand-painted artwork on the existing three panels of pole sign - 3-color artwork, on 3 sides, PMS 185 C, PMS 3155 C, and PMS 9240 C

Scale: 1'=1/8"

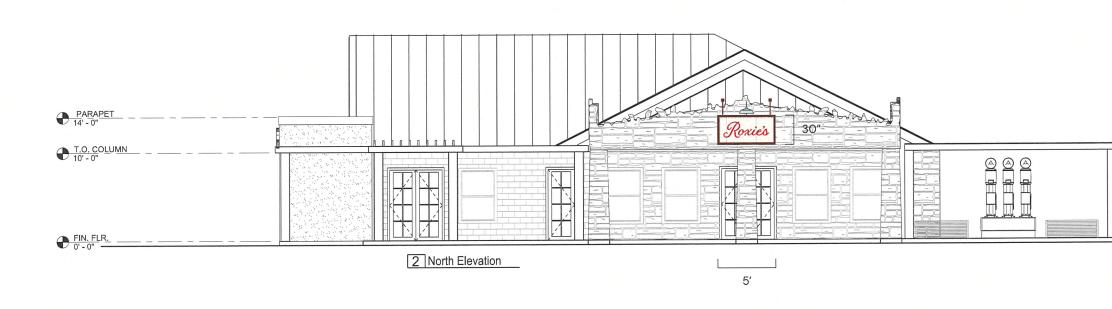
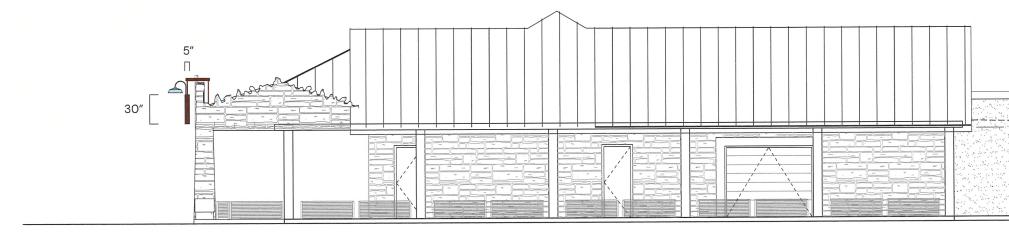
Roxie's Exterior Signage Building Sign Building Elevation View

4 West Elevation

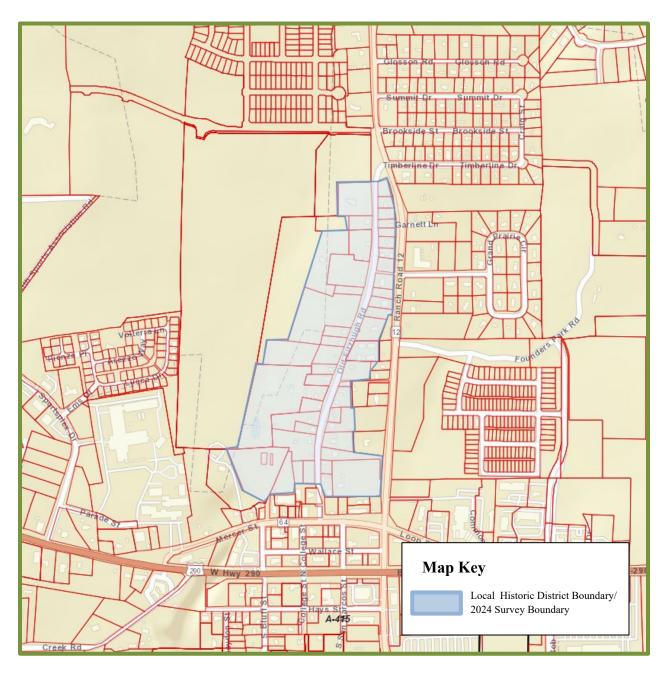
Map 1. Old Fitzhugh Road Local Historic District Survey Area.

The survey area is defined as the boundary of the determined by the City of Dripping Springs' local Old Fitzhugh Road Historic District. Image from Hays CAD, 2023.

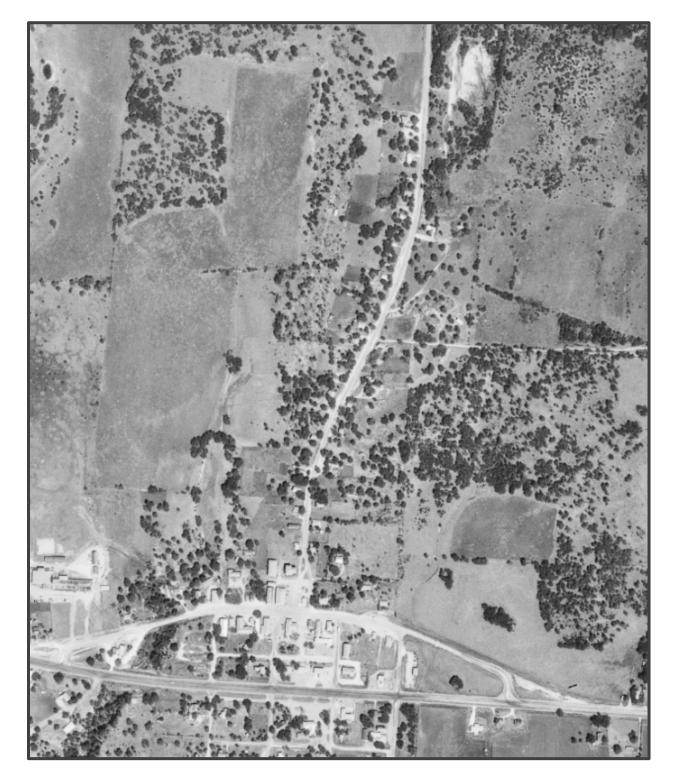
Map 4: 1962 Aerial photograph of Old Fitzhugh Road, courtesy of USGS Earth Explorer. Note realignment of US 290 south of Mercer Street.

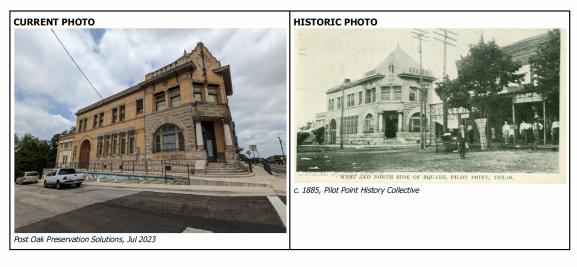
Resource 1

100 NORTH WASHINGTON Parcel #: 39436 Year Built: 1896 Style/Form: Eclectic, 2-part commercial block C/NC: Contributing

Historic function: Housed the Farmers and Merchants Bank until 1929 and never reopened as a bank. Current function: Residence on second story Current conditions: Largely unchanged since original construction. Unpainted stone exterior. Retains historic wood windows with leaded glass transoms and decorative first-story grills.

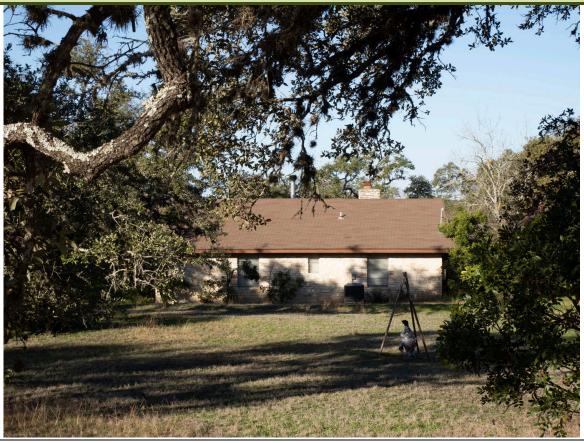
View W | East elevation, facing Old Fitzhugh Road

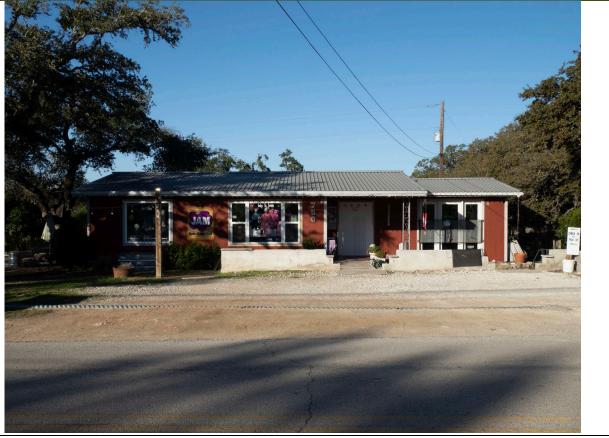
View W | East (primary) elevation and east parking lot

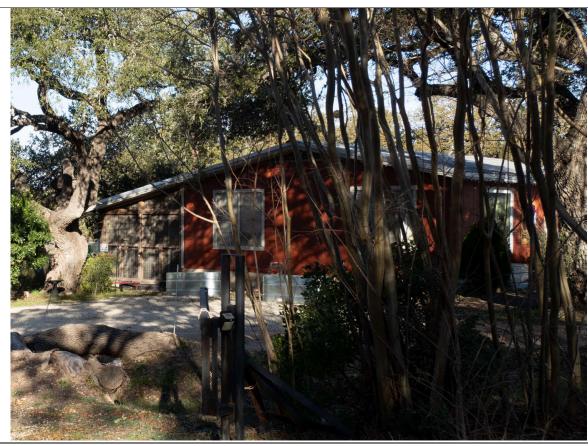
View NE | South elevation and south parking lot

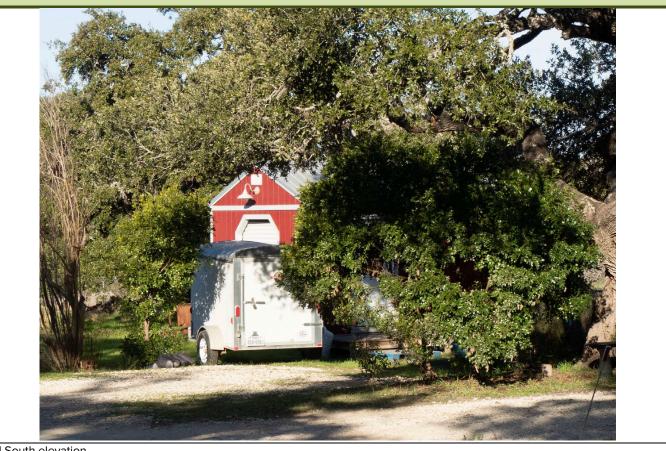
PRIORITY ASSESSMENT
PRIORITY High Medium Low
INTEGRITY Location Setting Design Materials Workmanship Feeling Association Not historic-age
ALTERATIONS Not historic-age; no alterations noted.
NOTES

View NE | South elevation

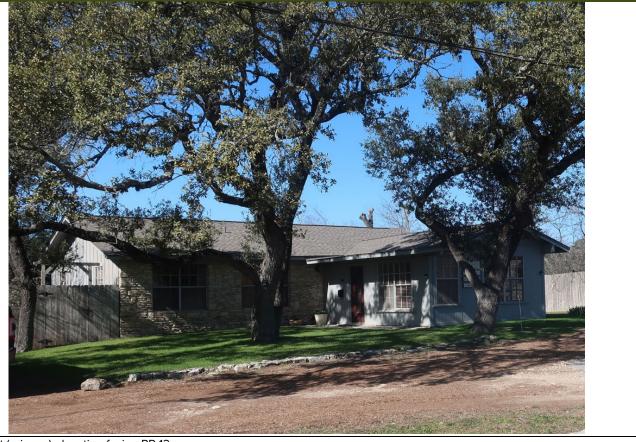
PRIORITY ASSESSMENT PRIORITY High Medium Low INTEGRITY Location Setting Design Materials Workmanship Feeling Association Not historic-age ALTERATIONS Non-historic windows; c. 2023 wooden pergola added to the west (rear) elevation. NOTES

View NW | West (primary) elevation facing RR 12

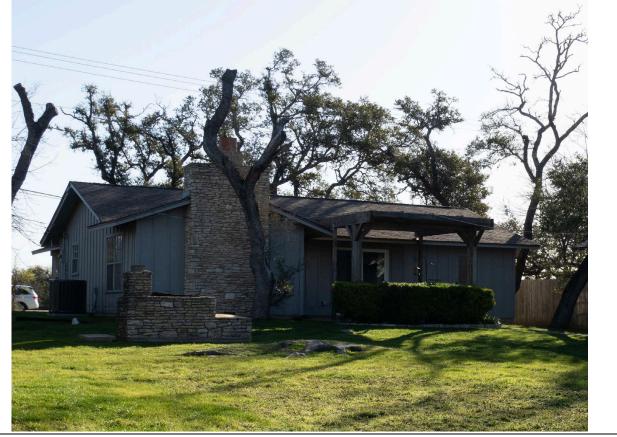
View SE | North and east (rear) elevations

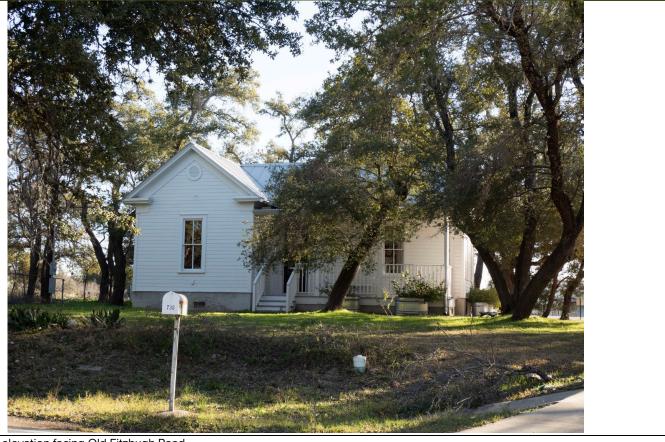
PRIORITY High Medium Low
INTEGRITY Location Setting Design Materials Workmanship Feeling Association Not historic-age
ALTERATIONS C. 2015, moved from original location on Rainey Street in Austin; c. 2016, concrete foundation and east/west elevation
porches added.
NOTES Moved outside the period of significance.

View NE | West elevation facing Old Fitzhugh Road

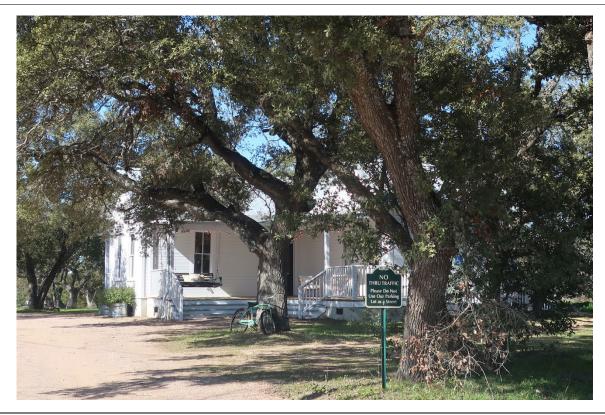
View NW | East (primary) and south elevations

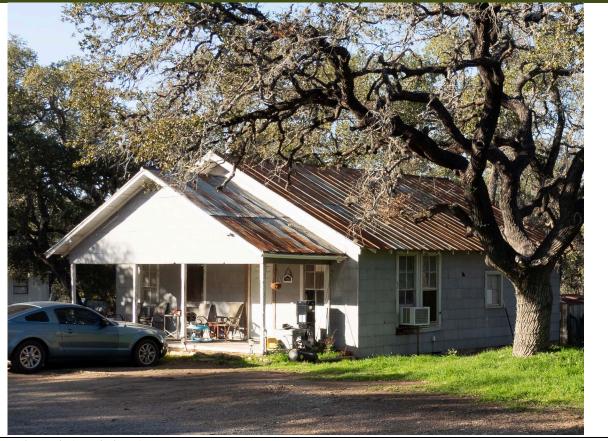
PRIORITY High Medium Low
INTEGRITY 🖾 Location 🖾 Setting 🖾 Design 🖾 Materials 🖾 Workmanship 🖾 Feeling 🖾 Association 🗌 Not historic-age
ALTERATIONS Non-original roof; non-original porch posts; c. 2019 entry doors.
NOTES

View SW | North and west (primary) elevations

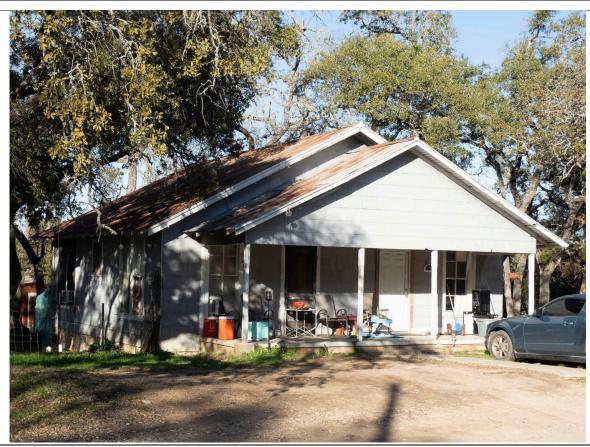
View NW | West (primary) and south elevations

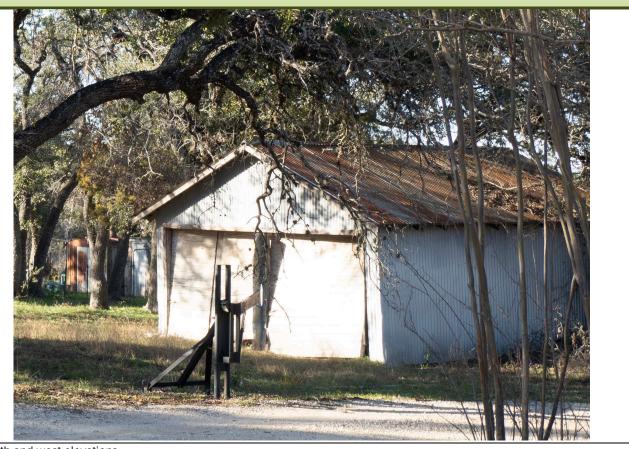
Roof material, cladding, and doors appear to be replacements. ie time as the main building.

PRIORITY High Medium Low
INTEGRITY
ALTERATIONS Non-original roof; non-original siding; non-original doors.
NOTES

View SW | North and west elevations

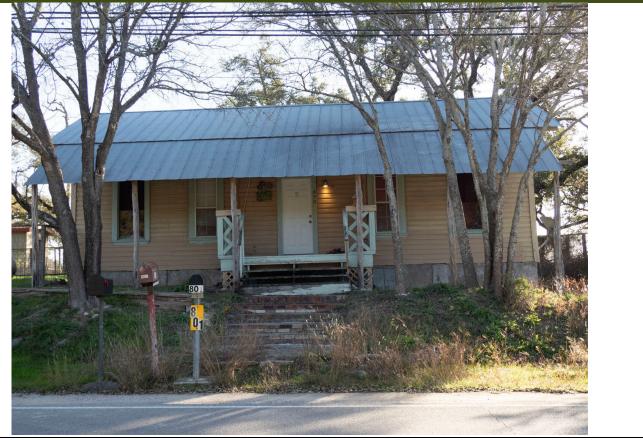
PRIORITY ASSESSMENT PRIORITY High Medium Low INTEGRITY XLocation XSetting Design Materials Workmanship XFeeling Association Not historic-age ALTERATIONS Some non-original windows; non-original entry door; porch has likely been altered. NOTES ENDANGERED No Yes

View E | West (primary) elevation

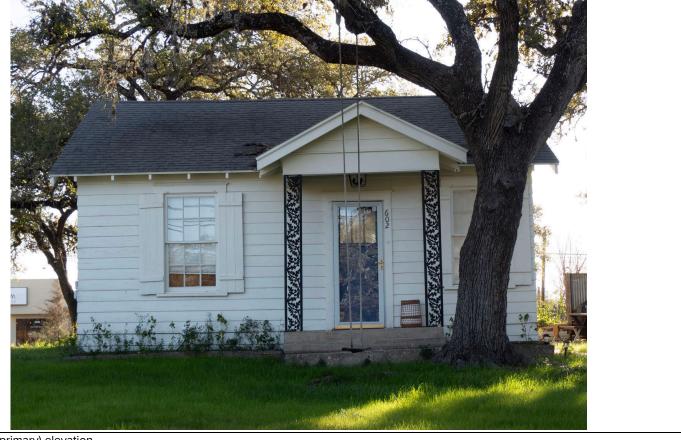
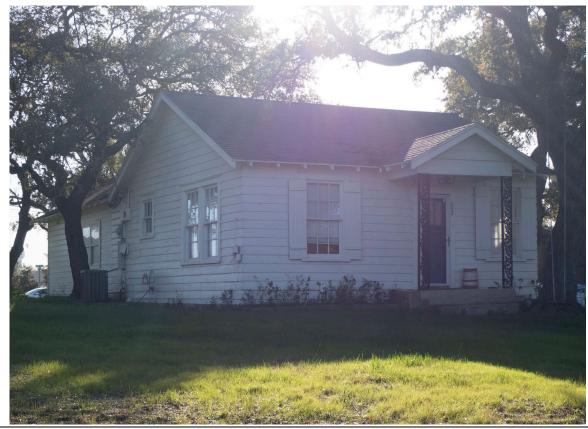
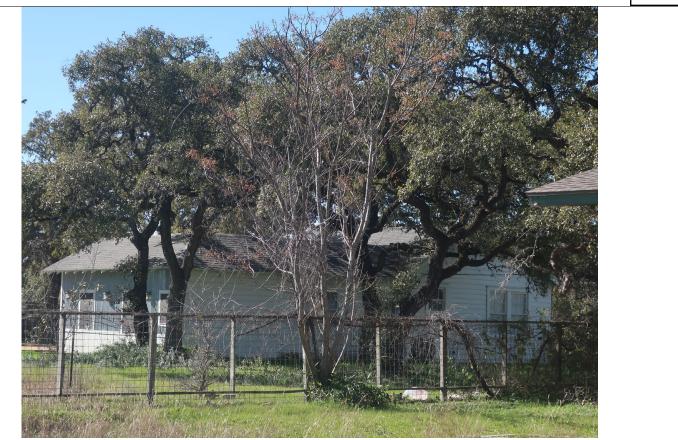
NOTES The east addition is significant in size, but it does not overly detract from the integrity of the house, especially given its position at the rear.

View E | West (primary) elevation

View SE | North and west (primary) elevations

View SW | North and east (rear) elevations

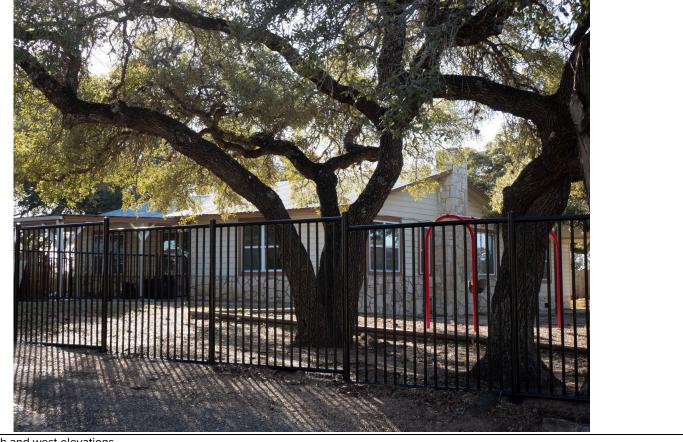
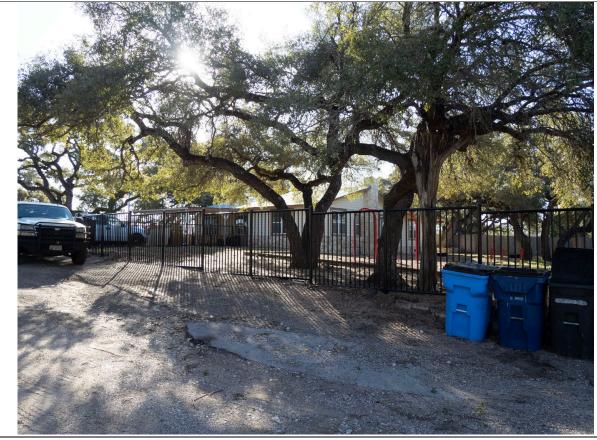
NOTES Metal fencing surrounding the property and gravel covering the lawn detracts from integrity of setting and the feeling/association of a rural landscape.

View SE | North and west elevations

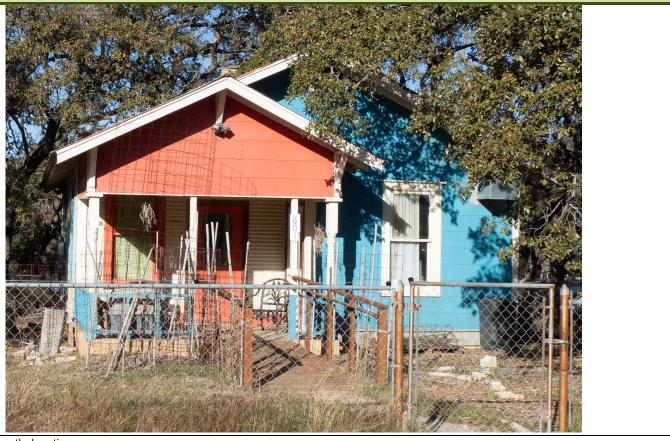
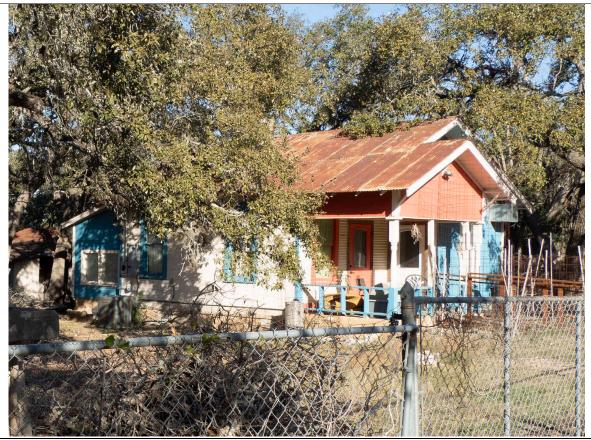
View W | East (front) elevation

View NW | East (front) and south elevations

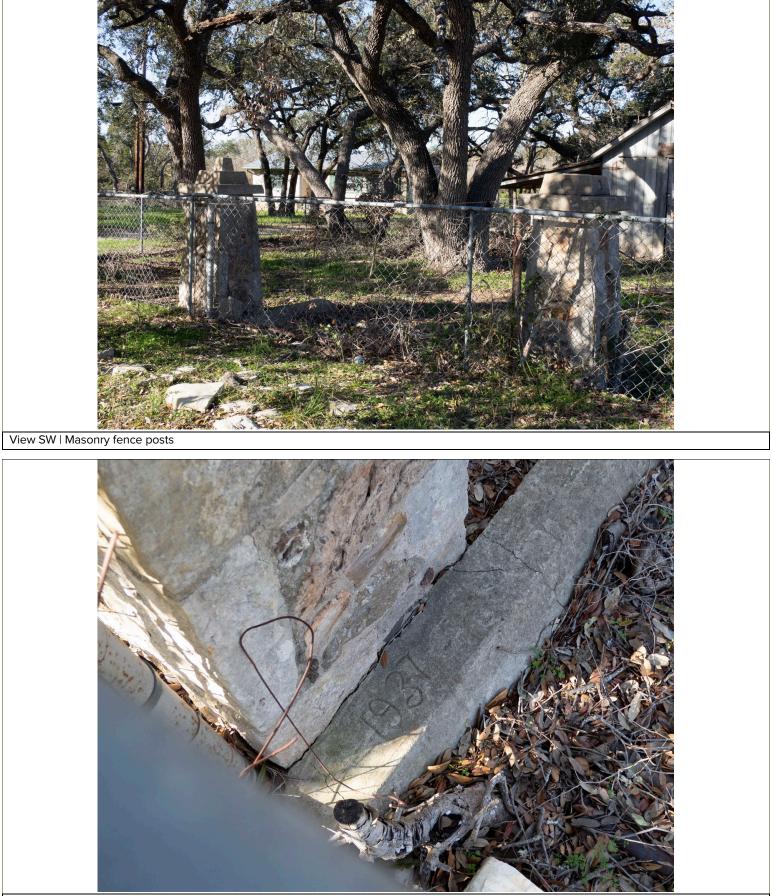
View NW | 1937 date at masonry fence post

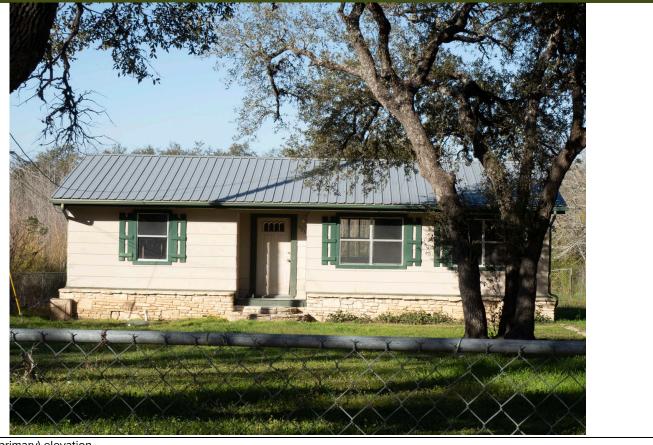
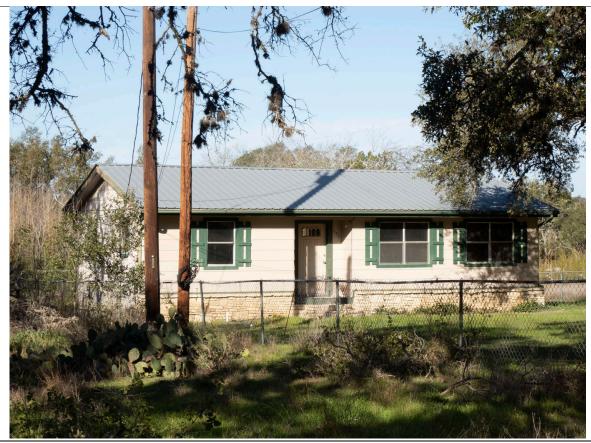
PRIORITY ASSESSMENT
PRIORITY High Medium Low
INTEGRITY Location Setting Design Materials Workmanship Feeling Association Not historic-age
ALTERATIONS Not historic-age; no alterations noted.
NOTES Although not yet 50 years old, the building retains excellent integrity from its date of construction. c. 1975.

View W | East (primary) elevation

View NW | South and east (primary) elevation

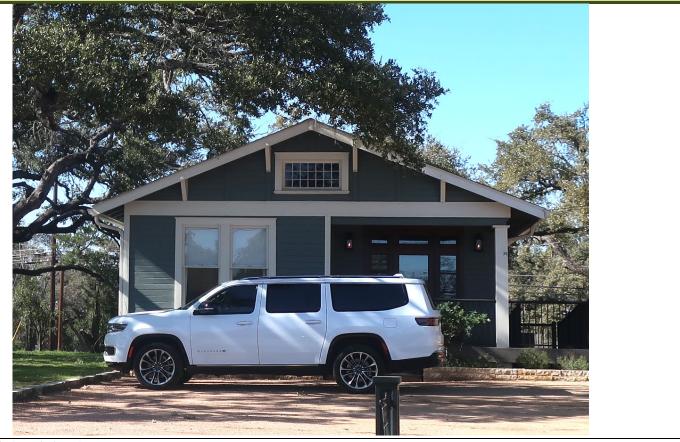
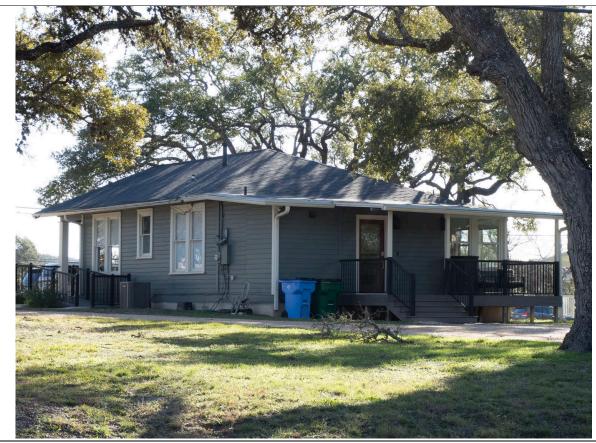
ALTERATIONS C. 2022, ramp with wood/composite decking and metal railings added along the north elevation leading to the front porch/primary entrance; front entrance appears to have been replaced.

NOTES A gravel parking lot covers a significant portion of the parcel to the east of the building, which somewhat detracts from integrity of setting and the feeling/association of a rural landscape.

View W | East (primary) elevation

View SE | North and west (rear) elevations

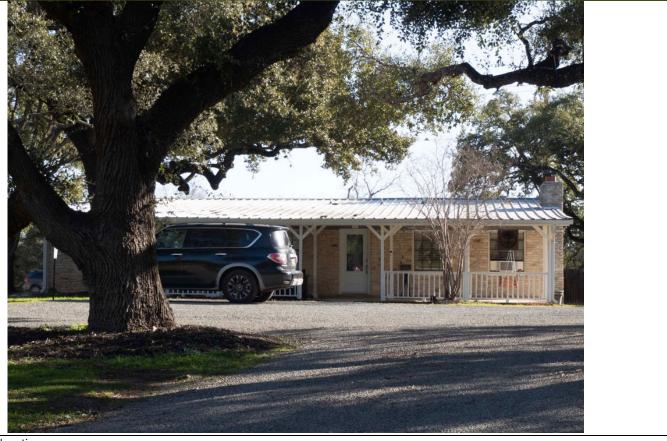
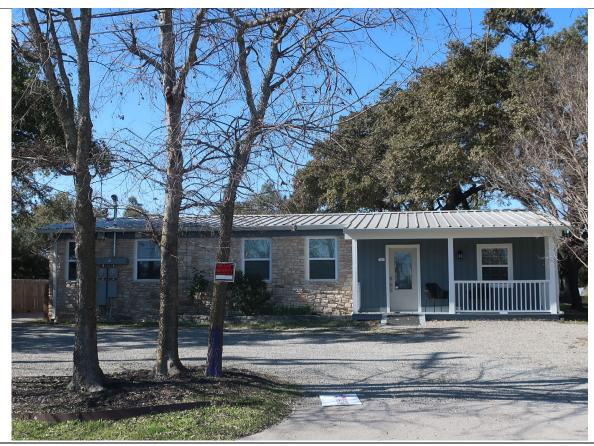
NOTES A gravel drive and parking lots cover a significant portion of the parcel, which detracts from integrity of setting and the feeling/association of a rural landscape.

View E | West elevation

View W | East elevation

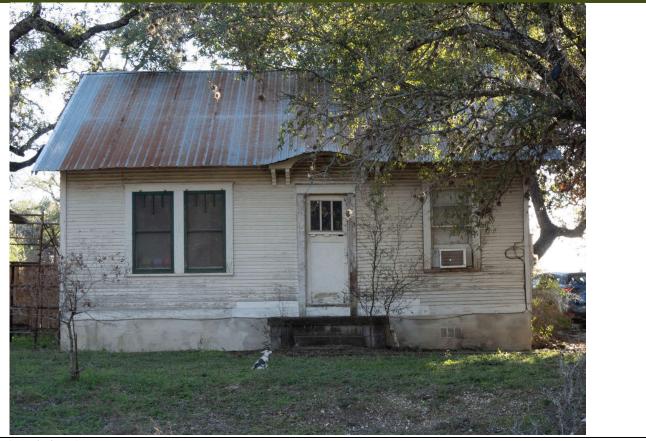
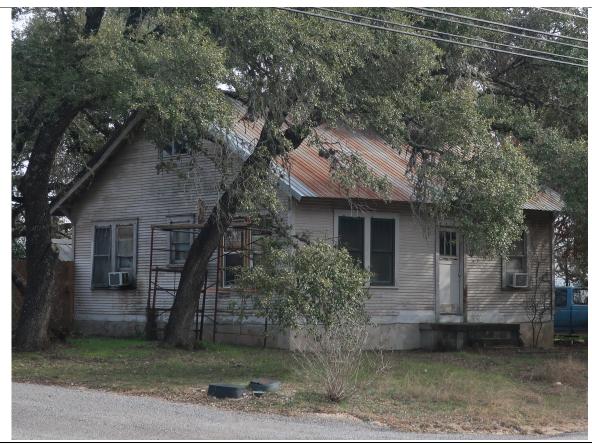
PRIORITY High Medium Low
INTEGRITY 🛛 Location 🖾 Setting 🖾 Design 🖾 Materials 🖾 Workmanship 🖾 Feeling 🖾 Association 🗌 Not historic-age
ALTERATIONS Non-original foundation.
NOTES It is unknown if the building was moved within the period of significance.

View E | West (primary) elevation

View SE | North and west (primary) elevations

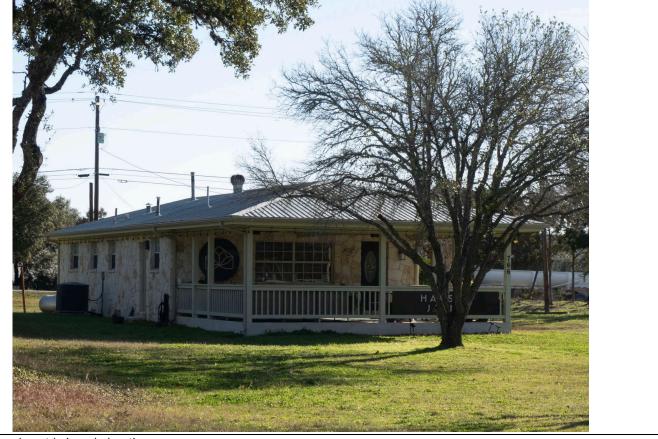
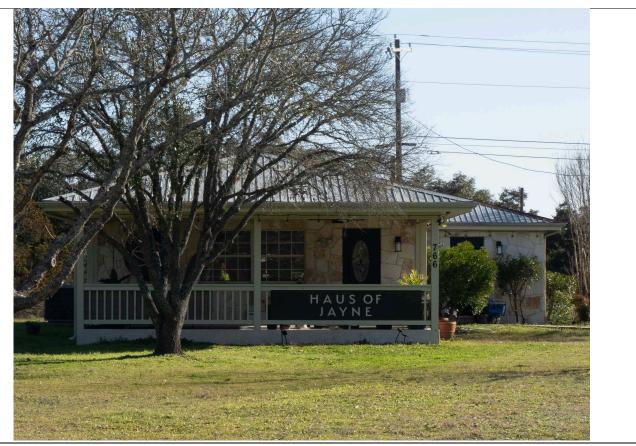
PRIORITY ASSESSMENT
PRIORITY High Medium Low
INTEGRITY Location Setting Design Materials Workmanship Feeling Association Not historic-age
ALTERATIONS 2006, west elevation porch added.
NOTES

View E | North and west (primary) elevations

View E | West (primary) elevation

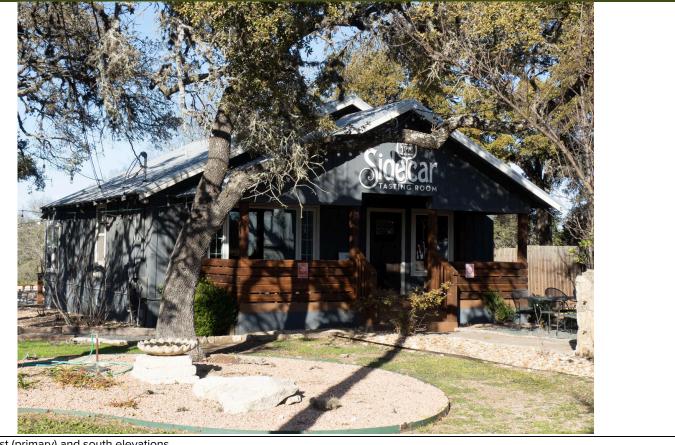
View NW | East (primary) and south elevations

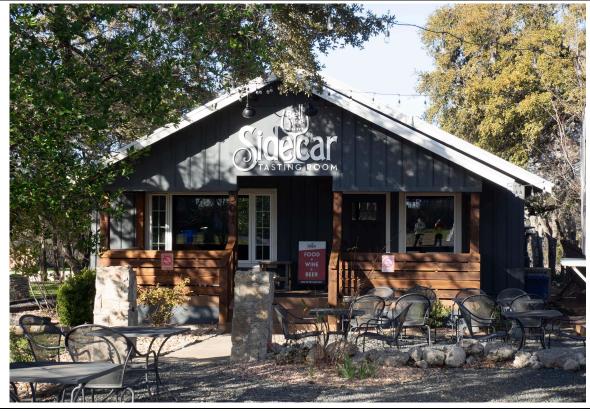
View W | East elevation

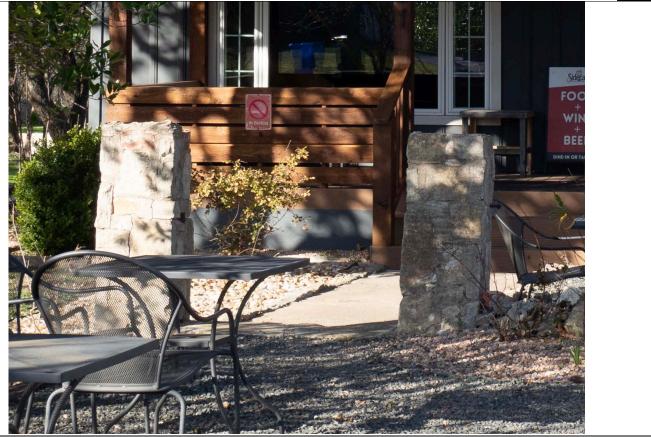
View W | Masonry posts

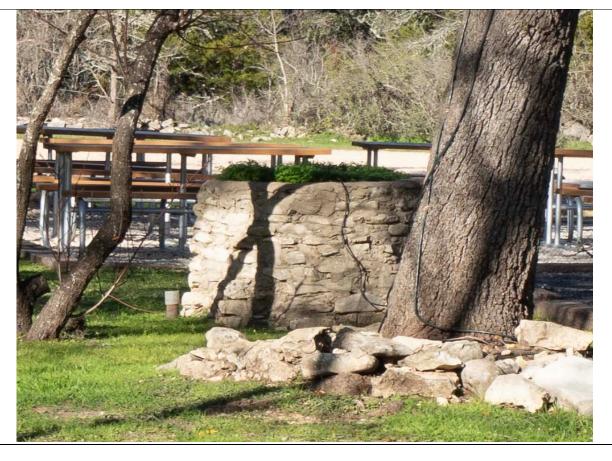
View W | Well

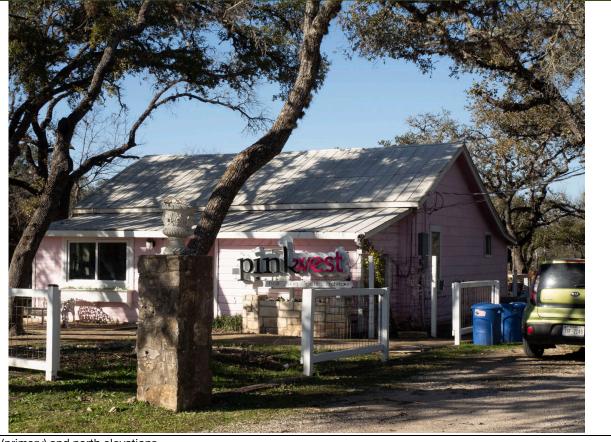
PRIORITY ASSESSMENT
PRIORITY High Medium Low
INTEGRITY 🛛 Location 🖾 Setting 🗋 Design 🗍 Materials 🖾 Workmanship 🖾 Feeling 🖾 Association 🗍 Not historic-age
ALTERATIONS Non-historic siding; non-historic windows; enclosed porch (north side pre-2008, south side c. 2015); 2021 west deck addition.
NOTES

View SW | East (primary) and north elevations

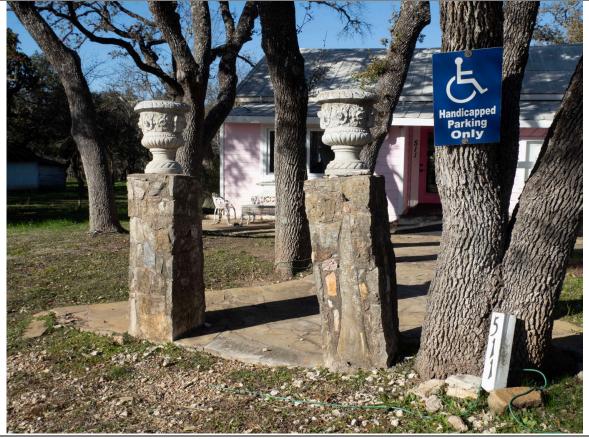
View SW | Masonry posts

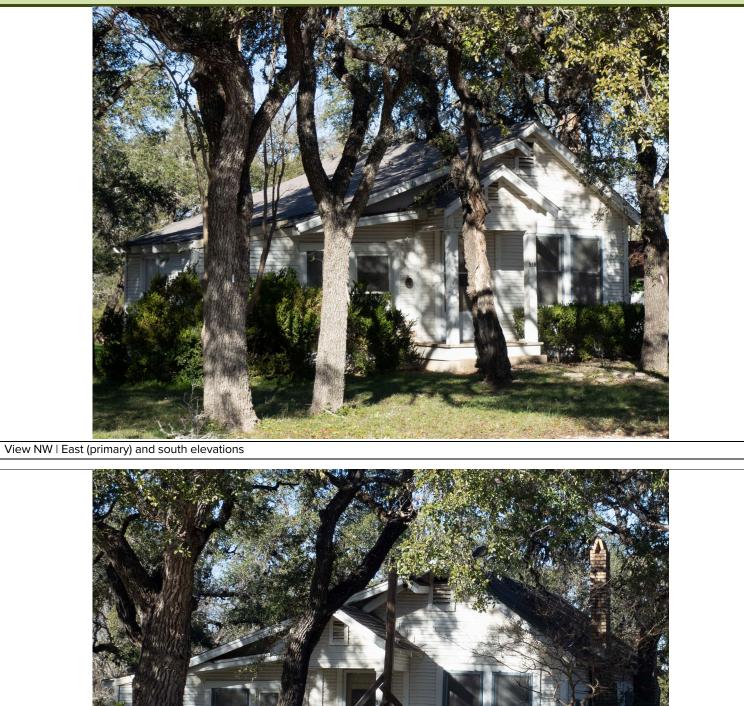
PRIORITY High Medium Low
INTEGRITY 🖾 Location 🖾 Setting 🖾 Design 🖾 Materials 🖾 Workmanship 🖾 Feeling 🖾 Association 🗌 Not historic-age
ALTERATIONS Historic-age south addition
NATES
NOTES

View W | East (primary) elevation

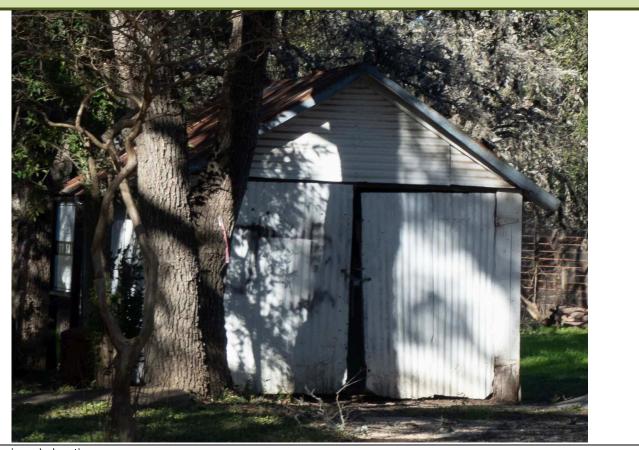
NOTES Despite replacement materials, the structure retains importance as one of the few early historic-age automobile-related ancillary structures to remain extant in the district.

View W | East (primary) elevation

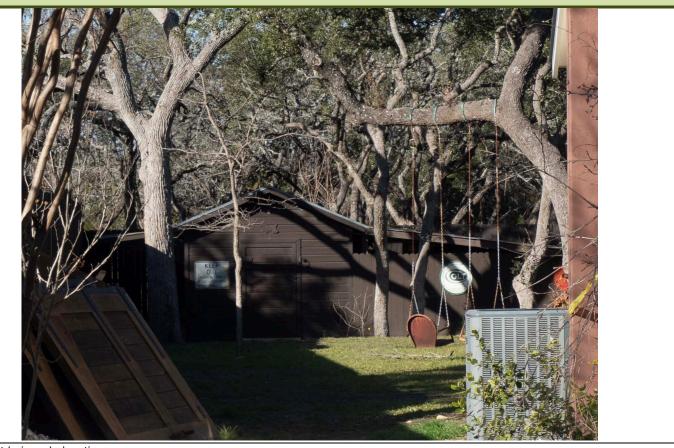
View W | East (primary) elevation

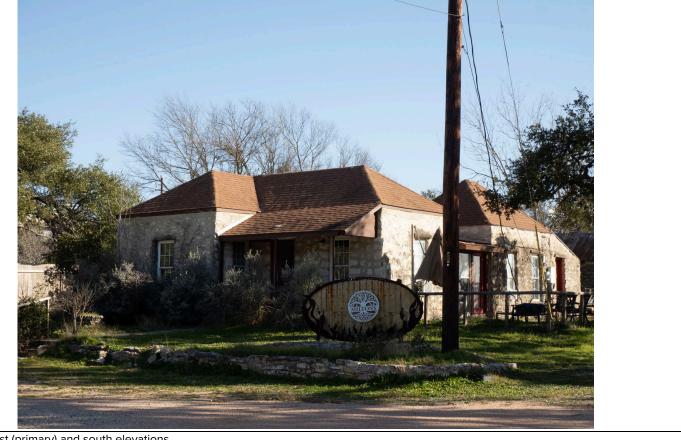
PRIORITY 🛛	gh Medium Low		
INTEGRITY	ocation 🛛 Setting 🖾 Design 🖾 Materials 🖾 Workmanship 🖾 Feeling 🖾 Association 🗌 Not historic-age		
ALTERATIONS Stone veneer added during period of significance; non-original vinyl windows; non-original porch roof.			
NOTES Vinyl	ndows somewhat detract from integrity of materials.		
ENDANGERE	(No Yes

View NE | West (primary) and south elevations

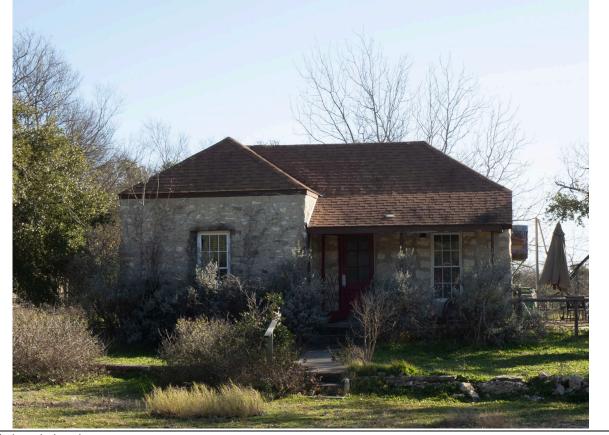
View E | West (primary) elevation

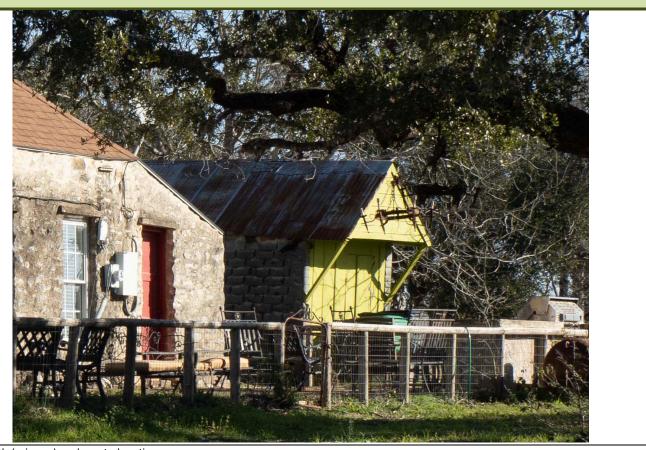
RIORITY High	Medium Low	
NTEGRITY 🛛 Lo	cation 🛛 Setting 🖾 Design 🗌 Materials 🖾 Workmanship 🖾 Feeling 🖾 Association 🗌 Not historic-age	
LTERATIONS It	appears the resource may have some replacement siding, but it was difficult to view from the public ROW.	
NOTES

View NE | South (primary) and west elevations

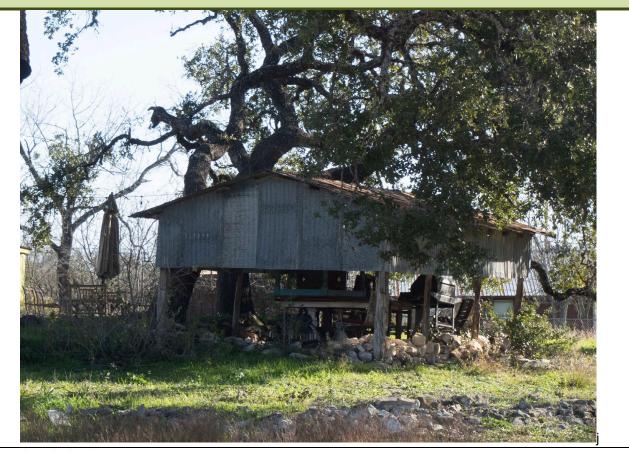
PRIORITY High Medium Low
INTEGRITY 🛛 Location 🖾 Setting 🖾 Design 🖾 Materials 🖾 Workmanship 🖾 Feeling 🖾 Association 🗌 Not historic-age
ALTERATIONS No apparent alterations.
NOTES
ENDANGERED No Yes

View E | West and south elevations

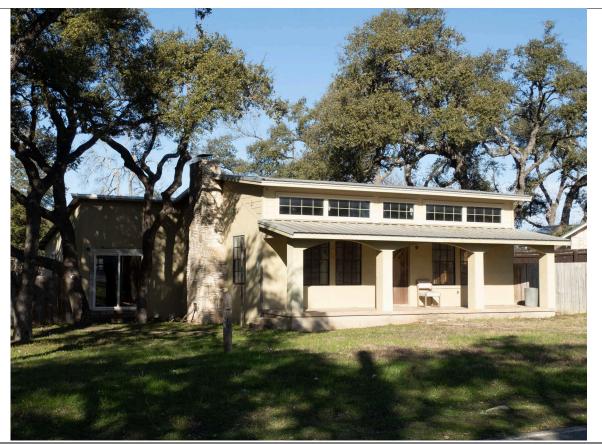
PRIORITY ASSESSMENT
PRIORITY High Medium Low
INTEGRITY 🛛 Location 🖾 Setting 🗋 Design 🖾 Materials 🗍 Workmanship 🗍 Feeling 🗍 Association 🗍 Not historic-age
ALTERATIONS Non-historic clerestory addition; 2013 covered porch on west (rear) elevation; non-original roof; non-original windows and
doors.
NOTES The clerestory addition detracts from integrity of design, feeling, and association.

View NW | East (primary) and south elevations

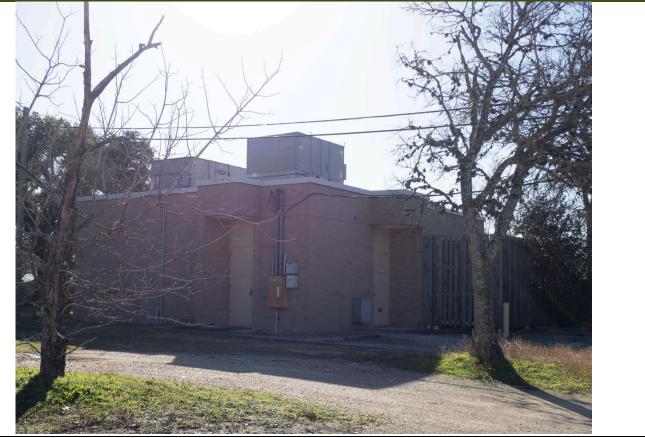
View SE | North and west elevations

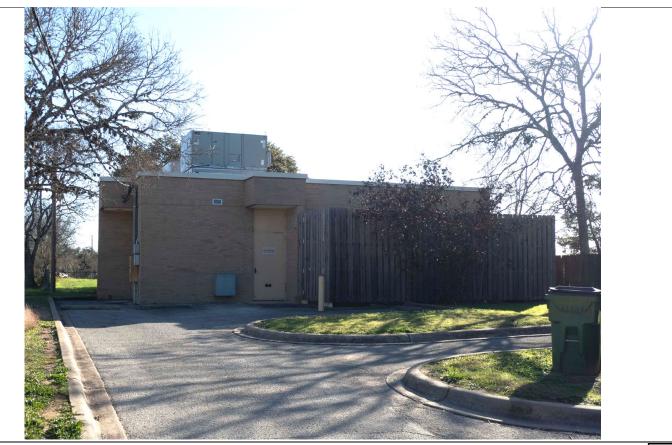
View E | West elevation

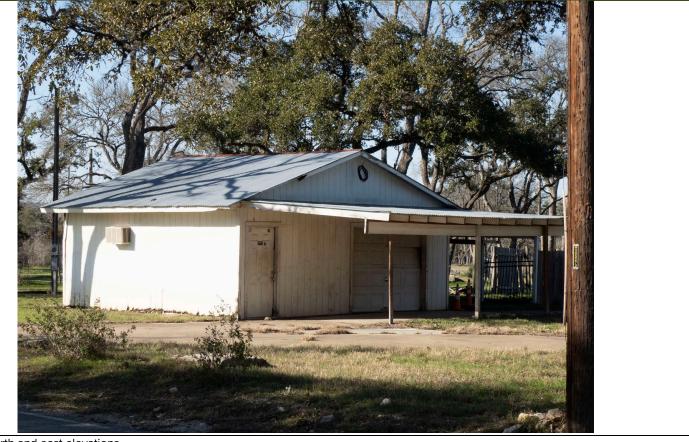
PRIORITY High Medium Low
INTEGRITY Location Setting Design Materials Workmanship Feeling Association Not historic-age
ALTERATIONS Main residence (a mobile home) and numerous outbuildings on the property demolished ca. 2018.
NOTES
ENDANGERED 🕅 No 🗍 Yes

View SW | North and east elevations

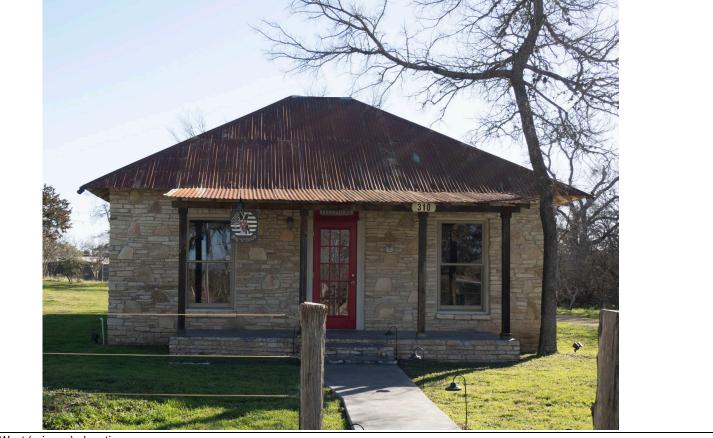
NOTES The gravel drives and parking lot, which cover a significant portion of the parcel, somewhat detract from the integrity of setting and the feeling/association of a rural landscape. Potentially eligible for listing on the NRHP due to its association with the early twentieth century development of telecommunications in Dripping Springs.

View E | West (primary) elevation
