Historic Preservation Commission Regular Meeting

City of Dripping Springs Council Chambers 511 Mercer Street – Dripping Springs, Texas Thursday, May 02, 2024, at 4:00 PM

- 2. Public hearing, discussion, and consideration of approval of COA2024-0003: Application for a Certificate of Appropriateness for the installation of signage at Roxie's located at 299 Mercer Street in the Mercer Street Historic District. Applicant: Silver Garza, Roxie's LLC.
 - a. Presentationb. Staff Reportc. Public Hearingd. COA2024-0003
- **3.** Presentation, discussion, and consideration of acceptance of the Old Fitzhugh Road Local Historic District Resurvey Historic Resources Survey Report. Post Oak Preservation Solutions LLC
- **<u>4.</u>** Discuss and consider possible action regarding the Historic Preservation Commission Fiscal Year 2025 Budget Recommendation.

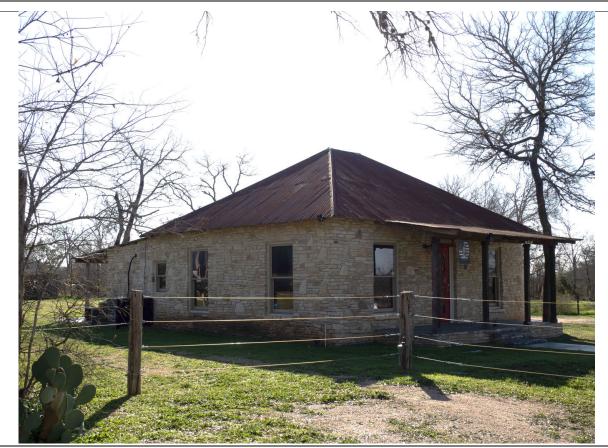
View SE | West (primary) and north elevations

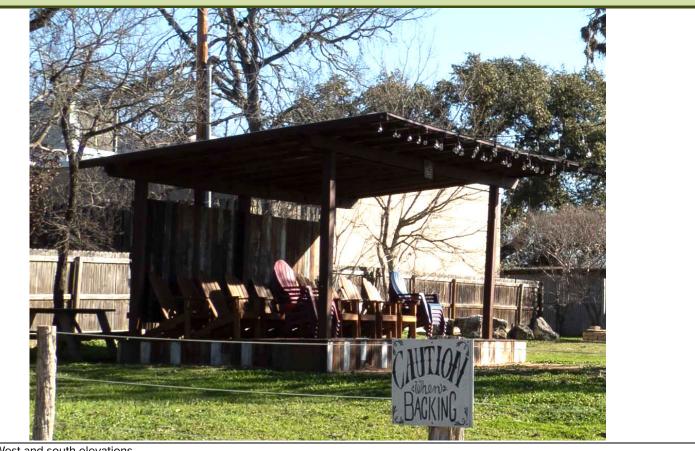
View NE | West and south elevations

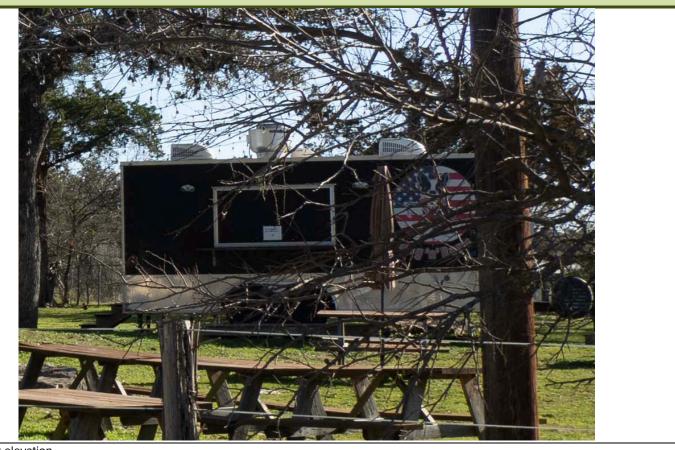
View E | West elevation

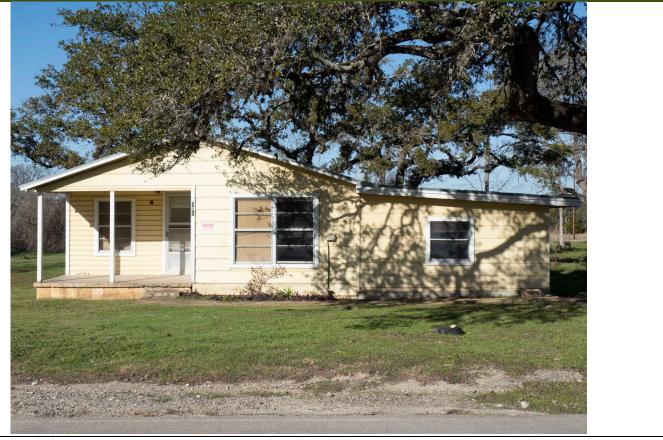
PRIORITY ASSESSMENT
PRIORITY High Medium Low
INTEGRITY 🛛 Location 🖾 Setting 🖾 Design 🗍 Materials 🖾 Workmanship 🖾 Feeling 🖾 Association 🗍 Not historic-age
ALTERATIONS Possibly historic-age addition on north elevation; non-original aluminum lap siding.
NOTES
ENDANGERED No Yes

View W | East (primary) elevation

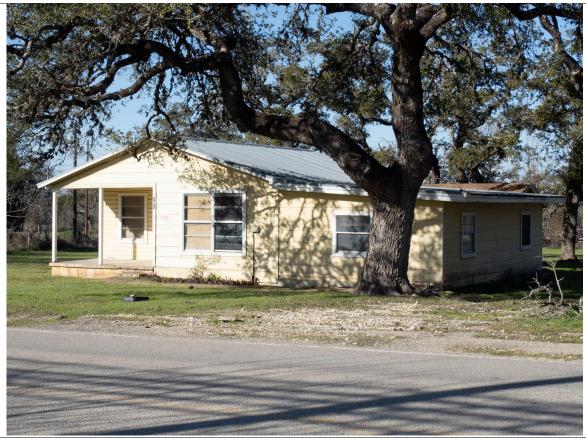
View SW | East (primary) and north elevations

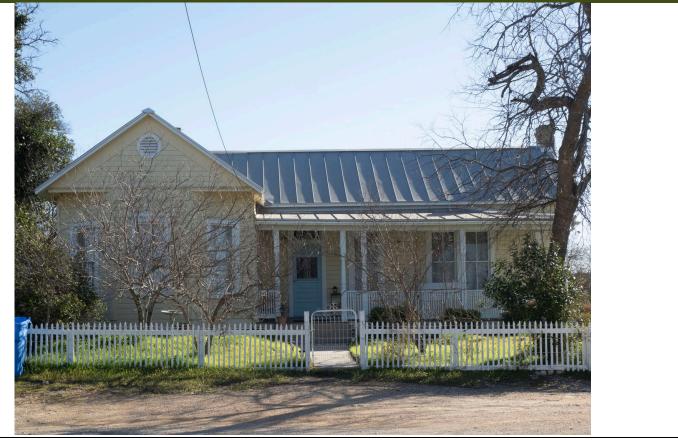
View E | West (primary) elevation

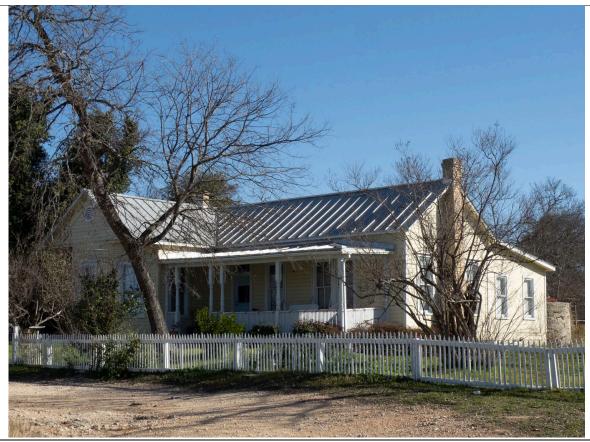
View NE | West (primary) and south elevations

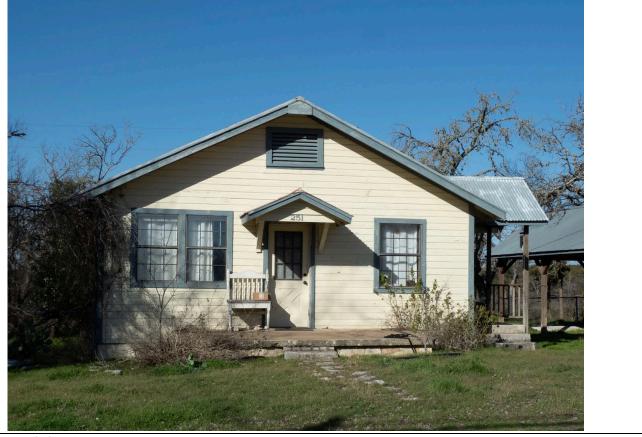
PRIORITY High Medium Low		
INTEGRITY		
ALTERATIONS Non-original windows; non-original front door; possible historic-age rear addition and side porch on north elevation.		
NOTEC		
NOTES		
ENDANGERED KINO I Tes

View W | East (primary) elevation

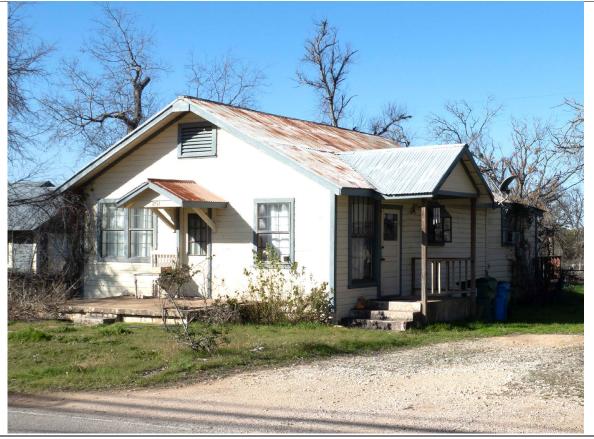
View SW | East (primary) and north elevations

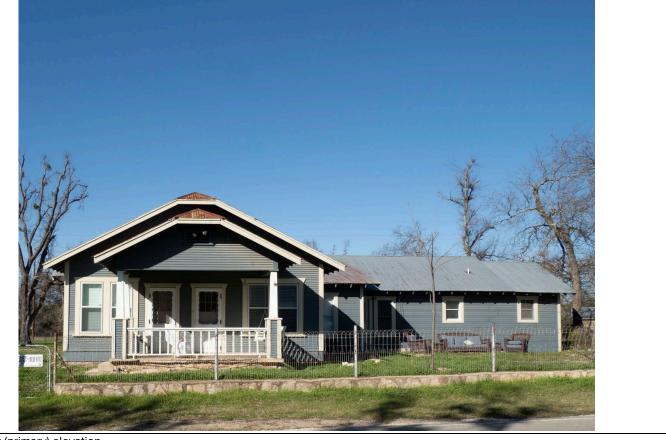
NOTES The house has two side-by-side primary entrances on the east elevation. Both doors are replacements.

View W | East (primary) elevation

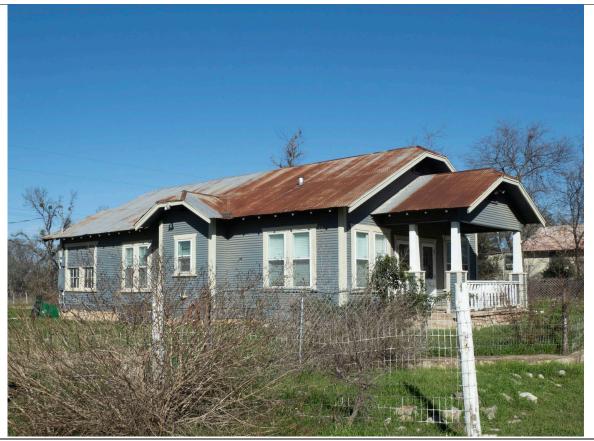
View NW | East (primary) and south elevations

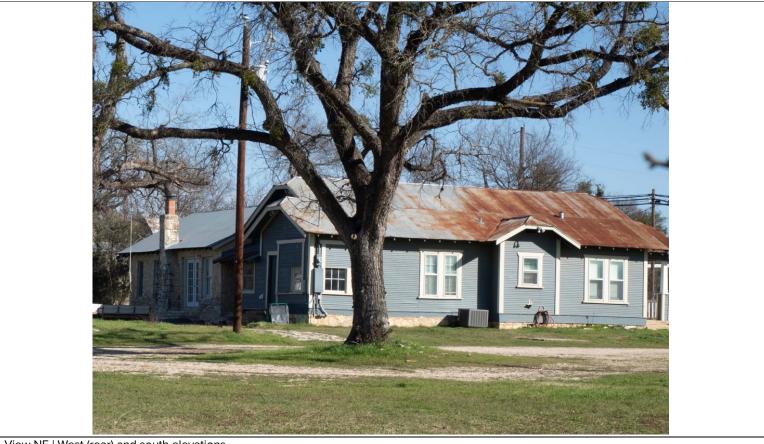
NOTES The c. 1980 addition is significant in size, but it is compatible with the existing building and does not overly detract from the integrity of the building.

View NE | West (rear) and south elevations

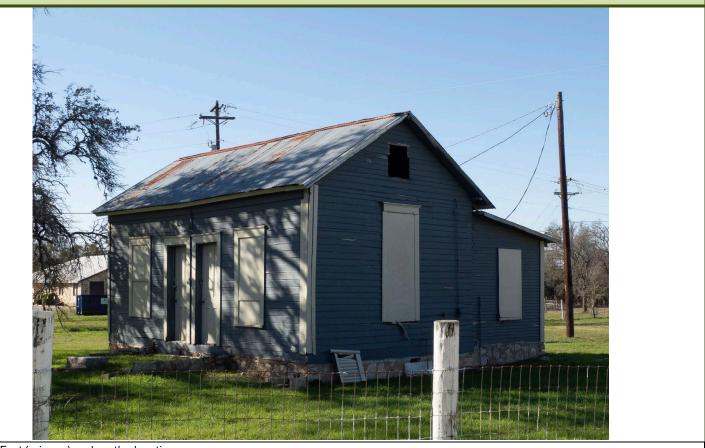
ALTERATIONS Loss of the main portion of the house occurred during the period of significance. Additional alterations include replacement front doors and concealed windows.

NOTES This building is one of the oldest remaining dwellings in the area, and retains its limestone foundation and most of its original clapboard siding.

View SW | East (primary) and north elevations

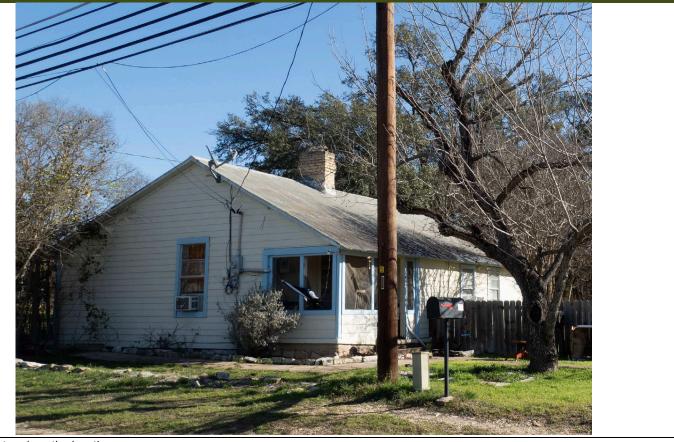
ENDANGERED No Yes Building is leaning/sinking

View NE | West and south elevations

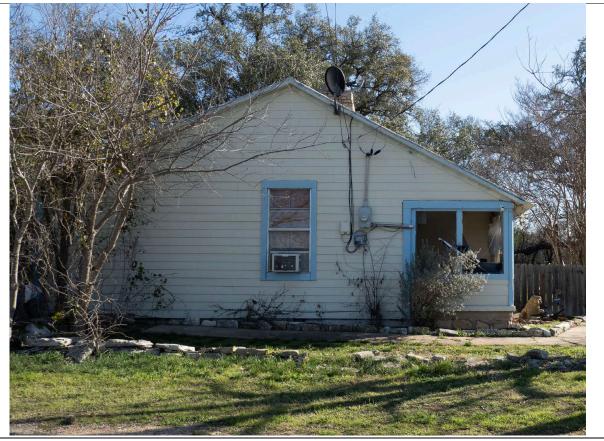
View E | West elevation

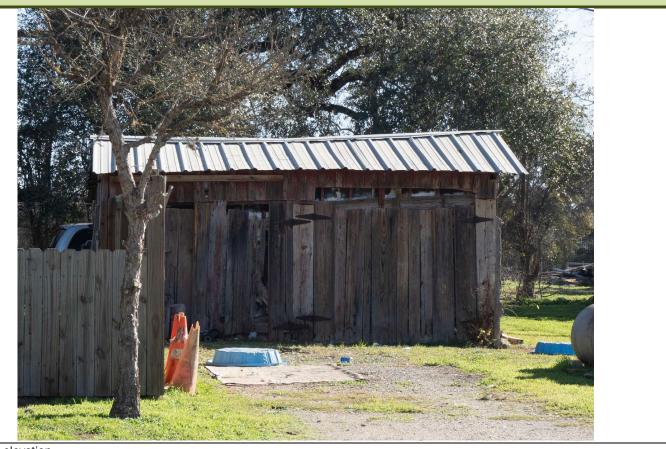
PRIORITY High Medium Low		
INTEGRITY 🖾 Location 🖾 Setting 🖾 Design 🖾 Materials 🖾 Workmanship 🖾 Feeling 🖾 Association 🗌 Not historic-age		
ALTERATIONS Replacement roof; non-original wood plank doors cover what appear to be historic wood doors with glazing.		
NOTES

View E | West elevation

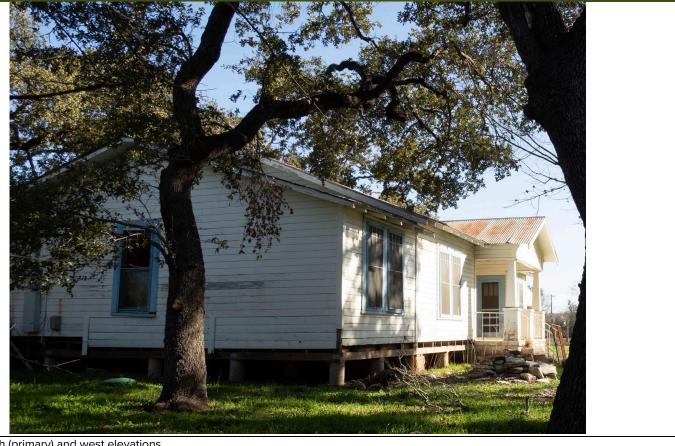
ALTERATIONS Possible early alterations prior to 1930; non-historic carport on north elevation; non-original porch railings; c. 2016, historic foundation removed and replaced with concrete piers

ENDANGERED No Yes; Structural issues appear to have been addressed c. 2016 with concrete foundation piers. However, lower clapboards have not been replaced, leaving the apron and lower walls exposed to the elements and susceptible to rot and deterioration.

View NE | South (primary) and west elevations

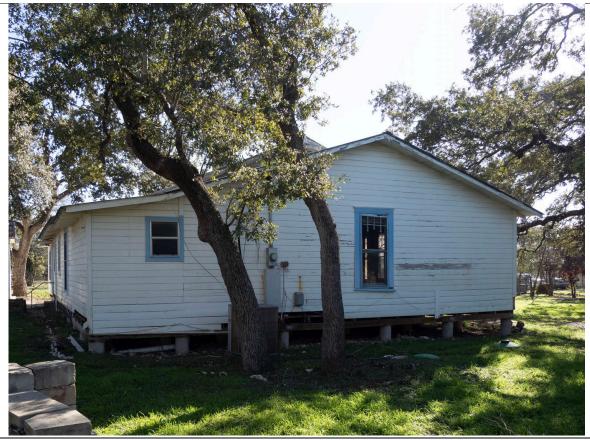
View SE | North and west elevations

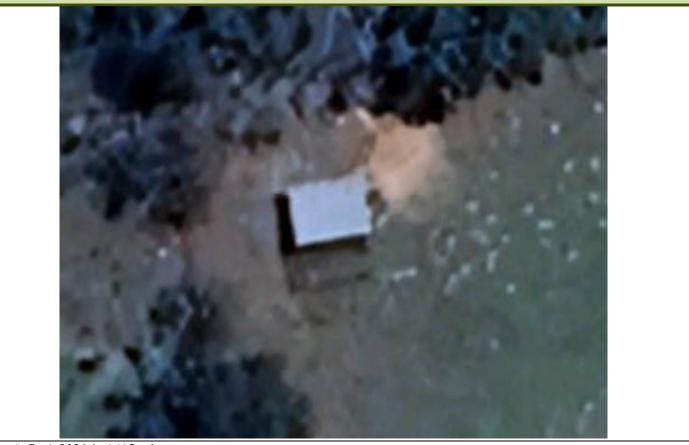
View Google Earth 2024 Aerial | Roof

ANCILLARY STRUCTURE #38C	
CATEGORY Building Site Structure Object	CONSTRUCTION DATE c. 2000
CURRENT USE Outbuilding	HISTORIC USE n/a; not historic-age
NO. OF STORIES 1	EXTERIOR WALL CLADDING Unknown; not visible from ROW
ROOF TYPE Flat	ROOF MATERIAL Metal
NOTES

PRIORITY ASSESSMENT
PRIORITY High Medium Low
INTEGRITYLocationSettingDesignMaterialsWorkmanshipFeelingAssociationNot historic-age
ALTERATIONS Not historic-age; no alterations noted.
NOTES

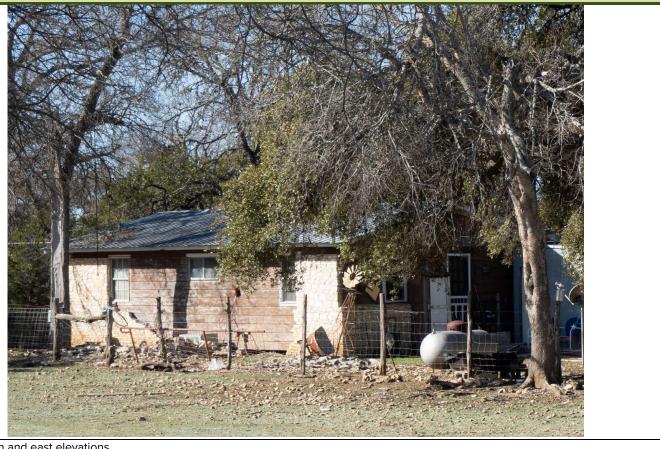
View SW | North and east elevations

ENDANGERED No Yes Deteriorated cladding has left the building structure exposed to the elements

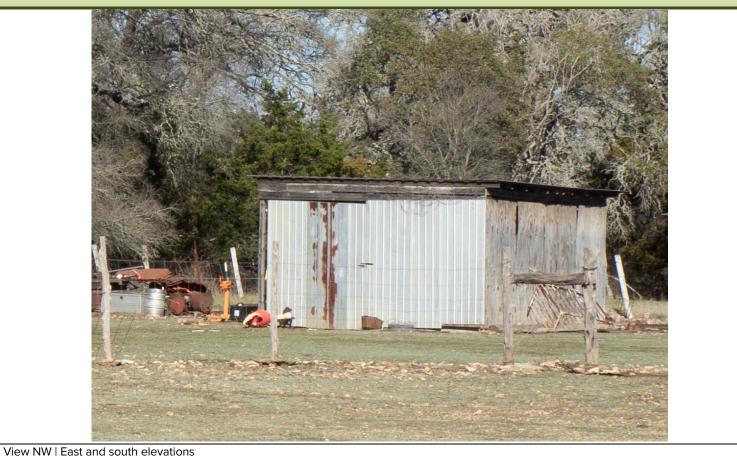
PRIORITY ASSESSMENT
PRIORITY High Medium Low
INTEGRITYLocationSettingDesignMaterialsWorkmanshipFeelingAssociationNot historic-age
ALTERATIONS Not historic-age; replacement siding.
NOTES

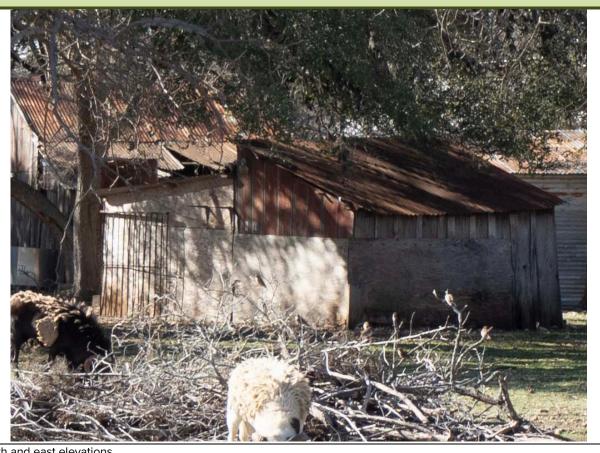
View SW | North and east elevations

ANCILLARY STRUCTURE #40C	
CATEGORY Building Site Structure Object	CONSTRUCTION DATE c. 1975
CURRENT USE Agriculture / Outbuilding	HISTORIC USE n/a; not historic-age
NO. OF STORIES 1	EXTERIOR WALL CLADDING Vertical wood plank, plywood
ROOF TYPE Gable	ROOF MATERIAL Corrugated metal
NOTES Likely constructed during the period of Garza family ownership

PRIORITY ASSESSMENT
PRIORITY High Medium Low
INTEGRITYLocationSettingDesignMaterialsWorkmanshipFeelingAssociationNot historic-age
ALTERATIONS Not historic-age; replacement siding.
NOTES

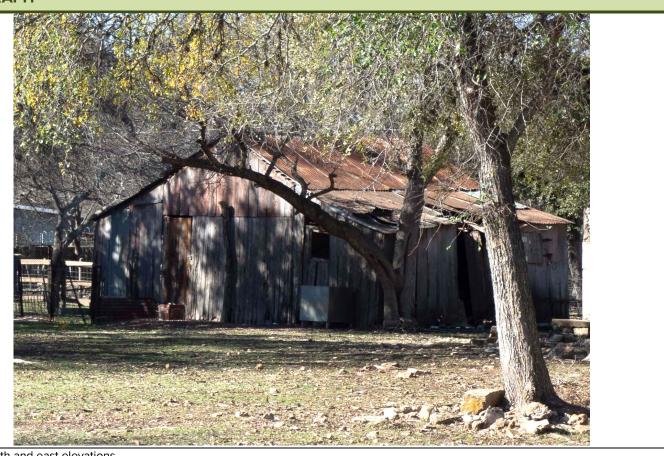
View SW | North and east elevations

ANCILLARY STRUCTURE #40E CATEGORY Building Site Structure Object CONSTRUCTION DATE c. 1940 CURRENT USE Agriculture / Barn HISTORIC USE Agriculture / Barn NO. OF STORIES 1 EXTERIOR WALL CLADDING Vertical wood plank ROOF TYPE Broken Gable ROOF MATERIAL Corrugated metal NOTES Likely constructed during the period of Garza family ownership

PRIORITY High Medium Low
INTEGRITY 🛛 Location 🏹 Setting 🖾 Design 🖾 Materials 🖾 Workmanship 🖾 Feeling 🖾 Association 🗌 Not historic-age
ALTERATIONS No significant alterations noted, some missing roof material.
NOTES

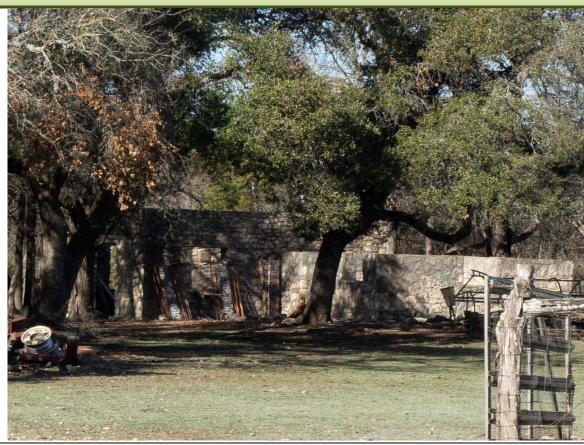
ENDANGERED No Yes Ruins, at risk of further deterioration/demolition.

View W | East elevation

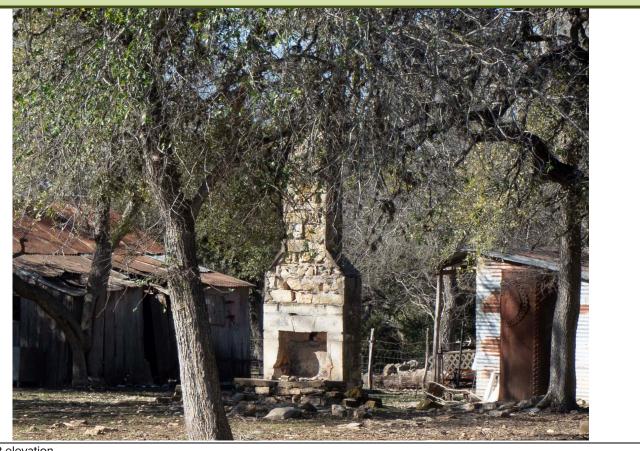
View SW | East elevation

PRIORITY ASSESSMENT
PRIORITY High Medium Low
INTEGRITY 🛛 Location 🖾 Setting 🗋 Design 🖾 Materials 🖾 Workmanship 🗍 Feeling 🗍 Association 🗍 Not historic-age
ALTERATIONS This limestone chimney is all that remains of a former residence.
NOTES
ENDANGERED No Yes Ruins, at risk of further deterioration/demolition.
