CITY OF FOREST PARK URBAN REDEVELOPMENT AUTHORITY REGULAR MEETING

RE: FORT GILLEM WESTERN POND DAM INSPECTION WA&A J.O. 4300100

WALDEN, ASHWORTH & ASSOCIATES, INC. FORT GILLEM WEST POND DAM VISUAL INSPECTION

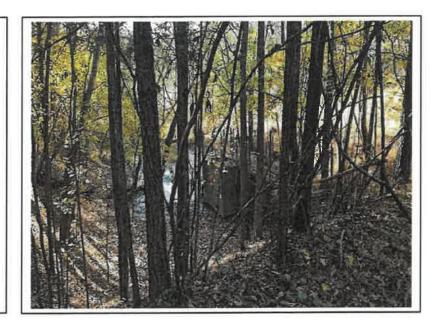
Photo No. 5 Description:

The outflow of the pond is controlled by the primary spillway which consists of a concrete riser structure, low level pipe, and an impact basin. The primary spillway structure is located near the center of the dam and appeared to be generally good condition. However, there was an abundance of debris collected at the trash rack making a detailed inspection of the structure not possible. No detailed observations were possible of the primary spillway structure because of this.

View of primary spillway riser structure.

- 1. Clear the crest and upstream slope of the dam of trees and heavy brush.
- 2. Grass the cleared upstream slope and crest.
- 3. Clean off downstream embankment concrete armoring and look for any cracking.
- 4. Heavy vegetation and/or brush around the primary spillway outlet needs to be cleared to allow for easier inspection.
- 5. Clear debris from trash rack on primary spillway riser structure. Clear trees/debris from upstream pond area.
- 6. Apply grassing to all areas cleared in the upstream pond area.
- 7. Provide periodic maintenance/inspection of the dam (2-4 times a year). Look for any issues, clear any debris from trash rack etc.

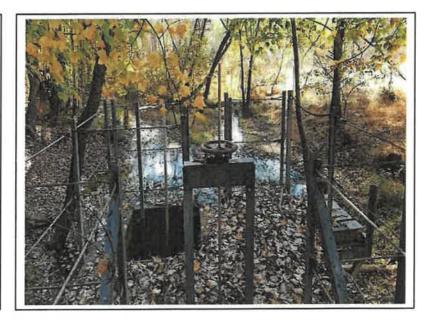
Photo No. 6 Description:

The drawdown outlet works, which is intended to provide a means for stopping outflow into the impact basin, consist of a control gate on the primary spillway concrete riser structure allowing the pond to drain through a low level pipe. The low level outlet pipe terminates at the downstream toe of the dam and discharges into an impact basin. The impact basin and channel appear to be providing adequate dissipation of the energy from flows discharging through the pipe. There was overgrown brush/vegetation growing around the impact basin and outlet channel making inspection difficult. This area should be cleared of overgrown brush to allow for easier inspection.

View of primary spillway riser structure and slide gate wheel.

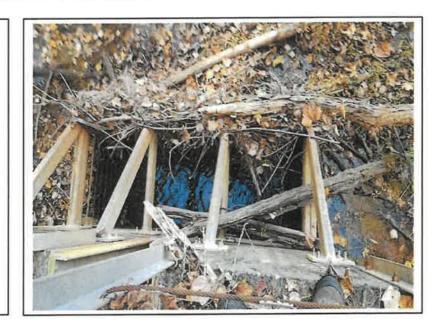
Photo No. 9 Description:

View of primary spillway riser structure trash rack. Note debris build up and blockage.

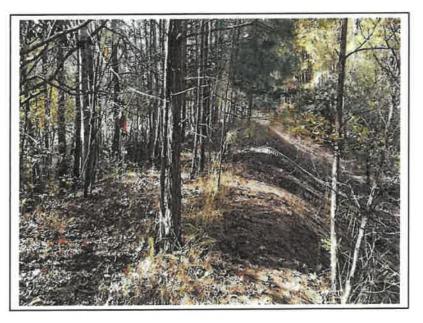
Photo No. 10 Description:

The downstream slope of the dam is armored with concrete with some vegetation growing on it. A detailed inspection of the condition of the concrete was not possible due to vegetation but appeared to be in good condition with no major cracking observed. This armoring is protection for the dam overtopping. No Hydrology or Hydraulic analysis has

View of downstream embankment. Note concrete armoring with some vegetation growing.

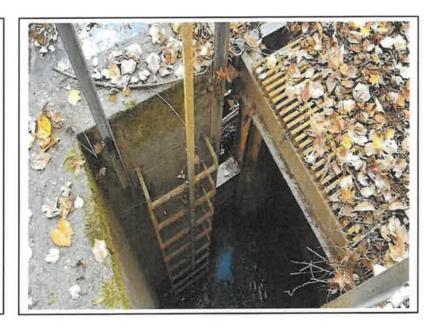
Photo No. 7 Description:

View of primary spillway riser structure. Note weir and access ladder.

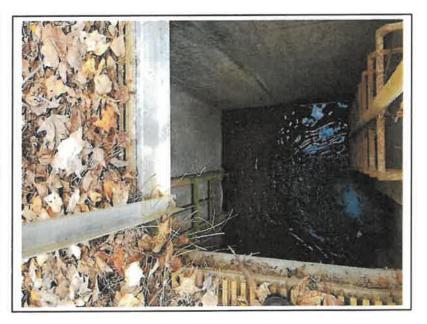
Photo No. 8 Description:

View of primary spillway riser structure. Note outlet pipe with slide gate.
