# Historic Preservation Commission

**November 07, 2022 at 4:00 PM**

Property owner and applicant Ashley Fusco requests approval to remove the non-historic stucco from the façade at 827 10<sup>th</sup> Street, clean the brick and repoint mortar joints as needed, paint the sign band if needed, replace the existing awning with a retractable awning, and install gooseneck light fixtures.

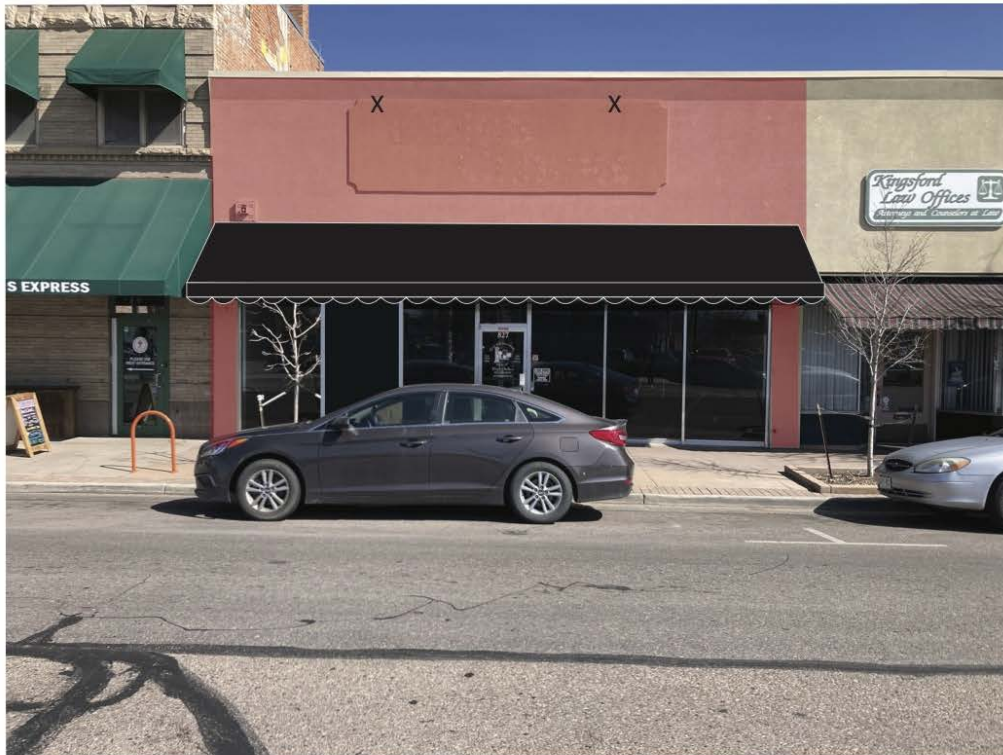
New retractable awning - scalloped edge: 4'2" projection - 32' width

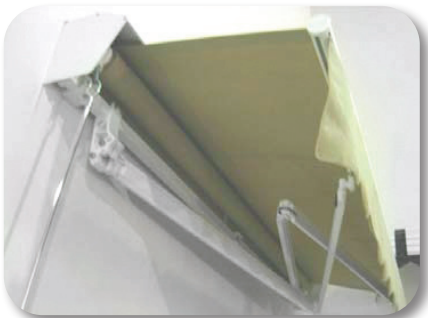
SUNAIR® XP CROSSOVER ARMS

Sometimes the area on the wall to mount the awning is very narrow, yet a larger projection is desired. The Sunair® XP offers the ability to overlap the arms in order to fit larger projection arms onto a narrow frame. This cross-arm version is available when the desired projection exceeds the width.

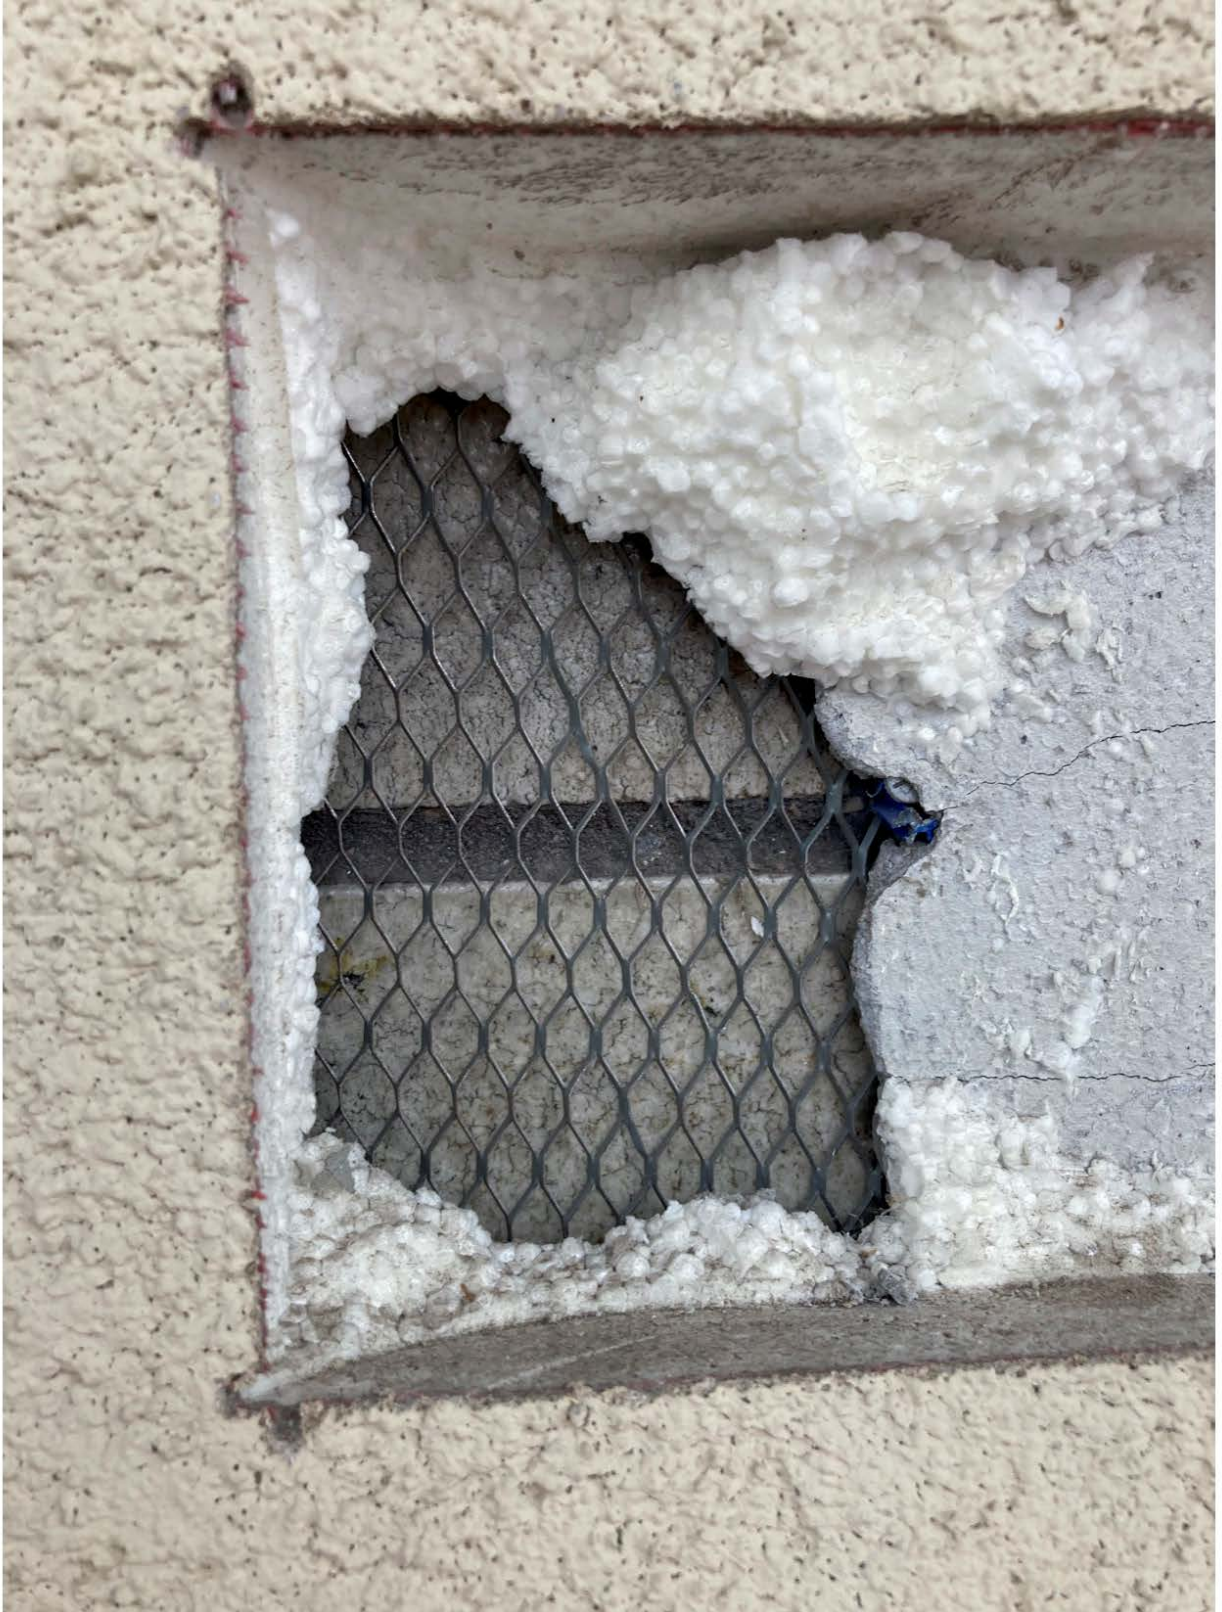
Test spot of uncovered brick

Attached are two pics of what the brick looks like under the stucco. It looks to match the colors of the corner building (Points West.) They did mesh it, so my stucco guy says that the brick should all be really good condition.

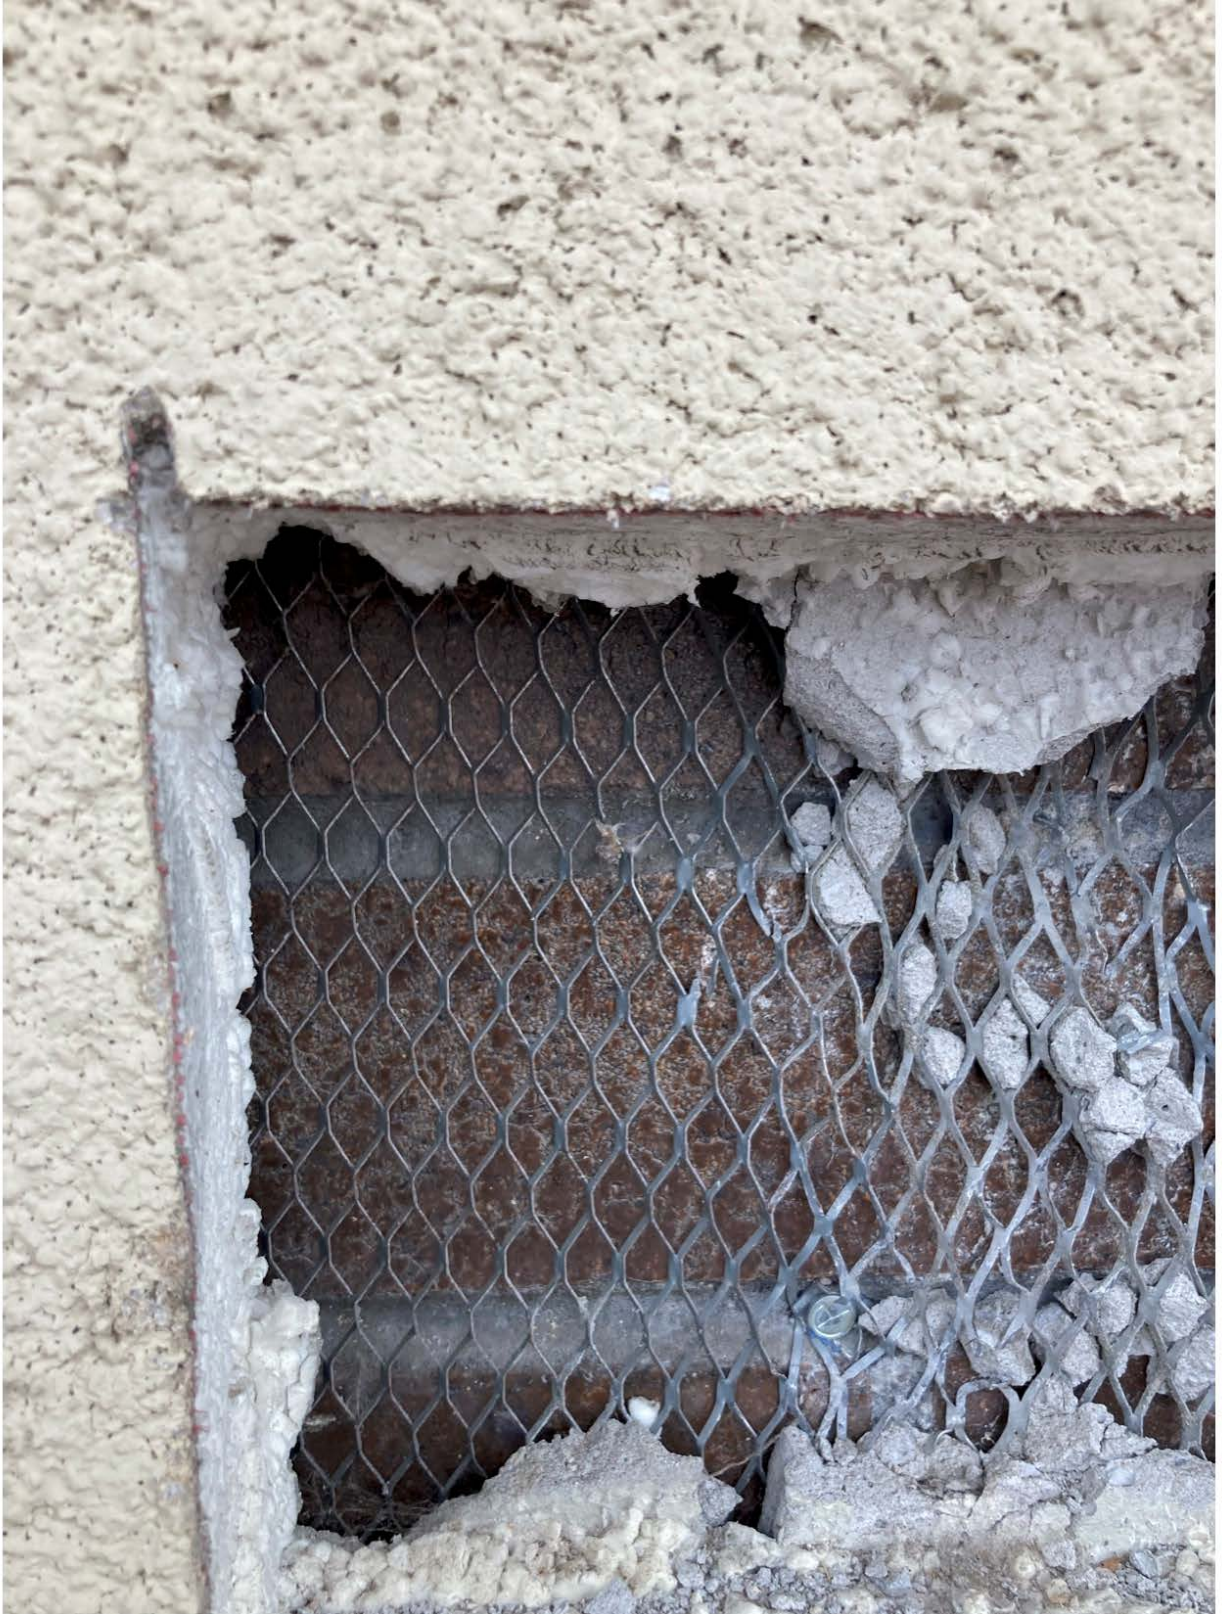
Test spot of uncovered brick

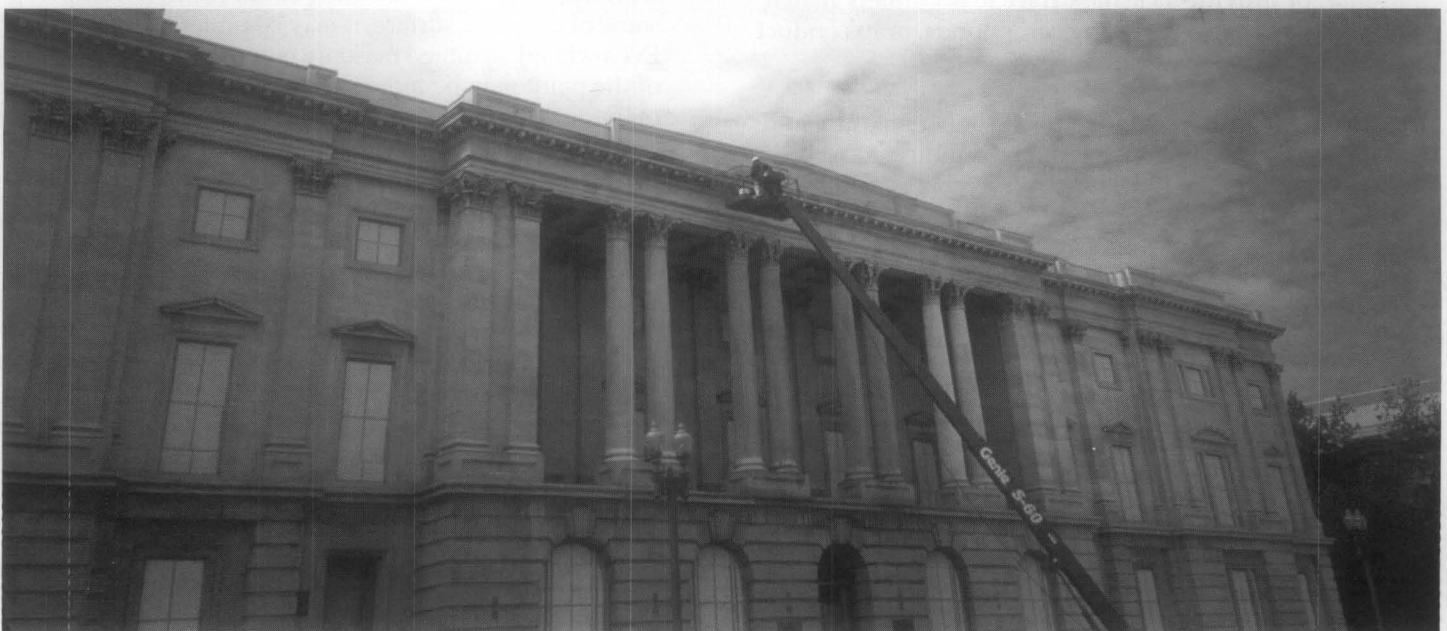
Figure 1. Low-to medium-pressure steam (hot-pressurized water washing), is being used to clean the exterior of the U.S. Tariff Commission Building, the first marble building constructed in Washington, D.C., in 1839. This method was selected by an architectural conservator as the "gentlest means possible" to clean the marble. Steam can soften heavy soiling deposits such as those on the cornice and column capitals, and facilitate easy removal. Note how these deposits have been removed from the right side of the cornice which has already been cleaned.

The Brief is intended to help develop sensitivity to the qualities of historic masonry that makes it so special, and to assist historic building owners and property managers in working cooperatively with architects, architectural conservators and contractors (Fig. 1). Although specifically intended for historic buildings, the information is applicable to all masonry buildings. This publication updates and expands *Preservation Brief 1: The Cleaning and Waterproof Coating of Masonry Buildings*. The Brief is not meant to be a cleaning manual or a guide for preparing specifications. Rather, it provides general information to raise awareness of the many factors involved in selecting cleaning and water-repellent treatments for historic masonry buildings.

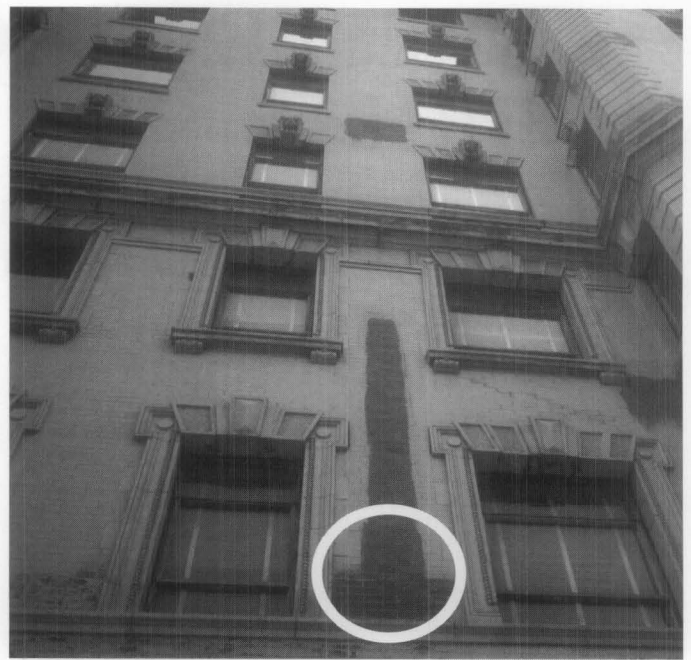
Figure 2. Biological growth as shown on this marble foundation can usually be removed using a low-pressure water wash, possibly with a non-ionic detergent added to it, and scrubbing with a natural or synthetic bristle brush.

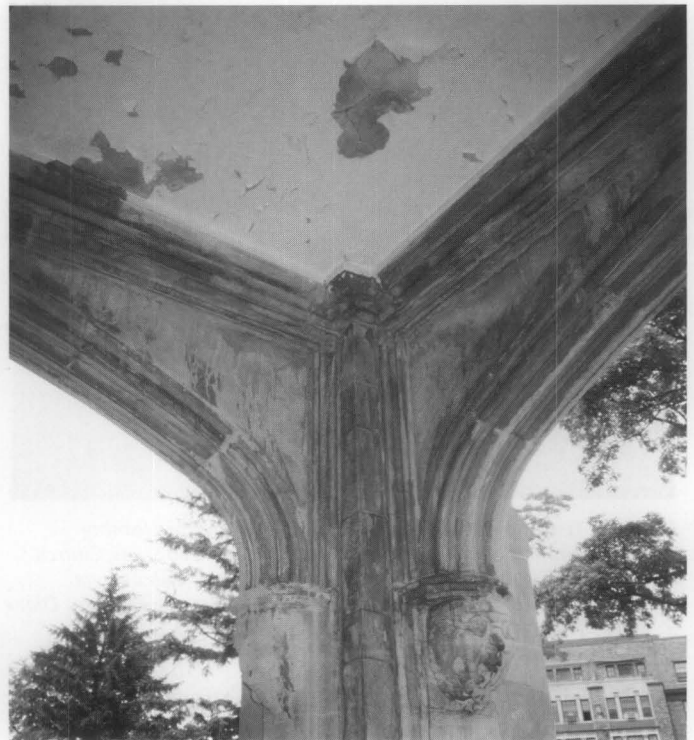
Figure 5. Repeated water washing did not remove the staining inside this limestone porte cochere. Upon closer examination, it was determined to be a water-repellent coating that had been applied many years earlier. An alkaline cleaner may be effective in removing it.

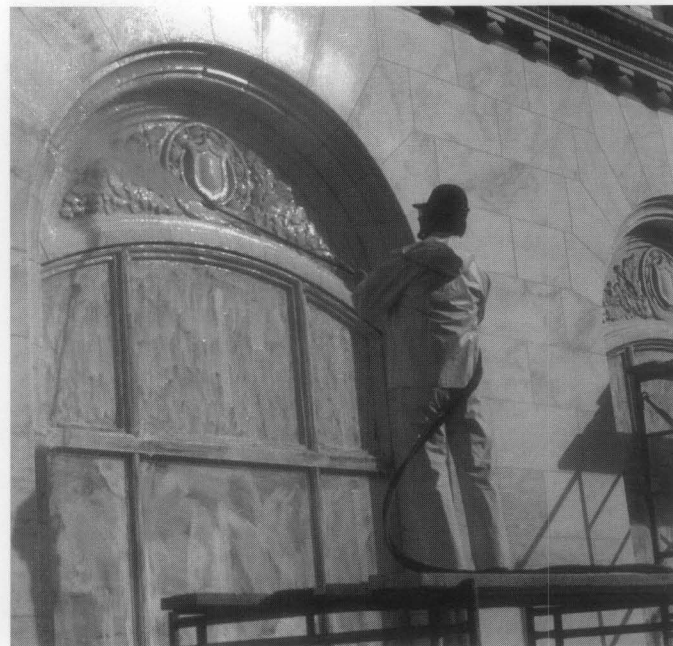
Figure 7. Glazed architectural terra cotta often may be cleaned successfully with a low-pressure water wash and hand scrubbing supplemented, if necessary, with a non-ionic detergent. Photo: National Park Service Files.

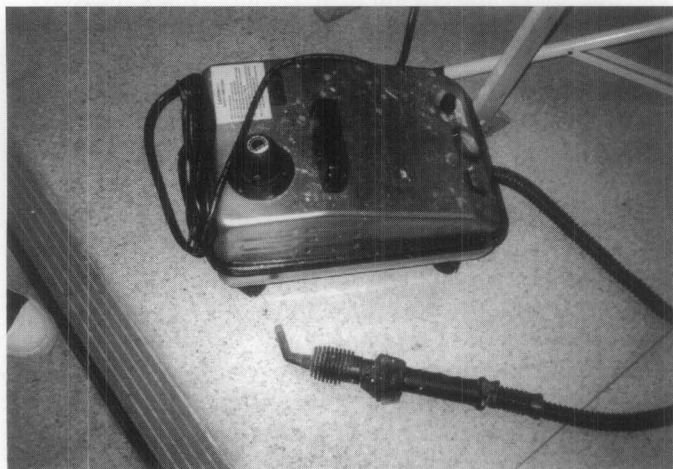
Figure 9. (Left) This small steam cleaner—the size of a vacuum cleaner—offers a very controlled and gentle means of cleaning limited, or hard-to-reach areas or carved stone details. (Right) It is particularly useful for interiors where it is important to keep moisture to a minimum, such as inside the Washington Monument, Washington, D.C., where it was used to clean the commemorative stones. Photos: Audrey T. Tepper.

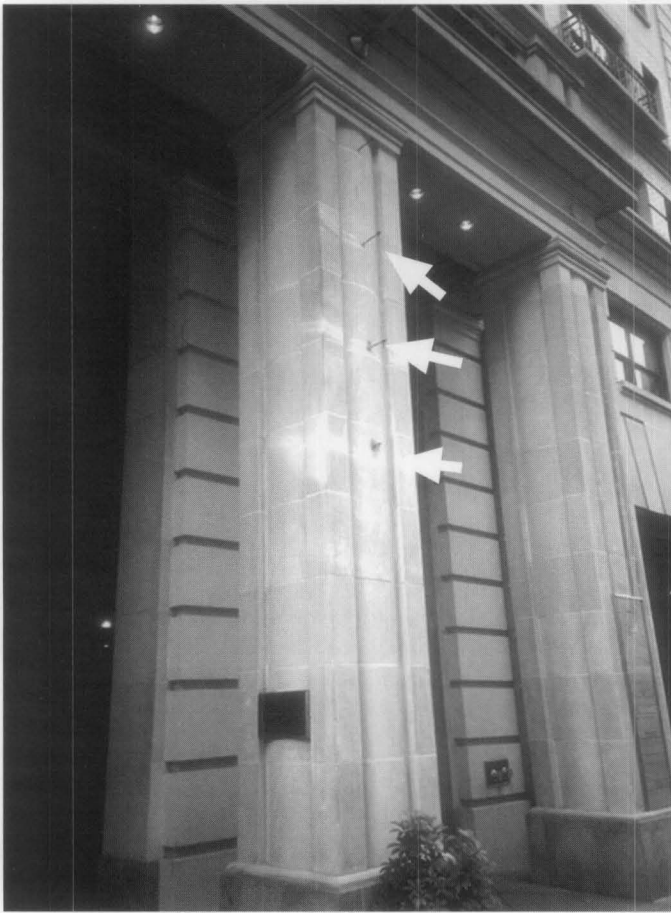
Figure 10. High-pressure water washing too close to the surface has abraded and, consequently, marred the limestone on this early-20th century building.

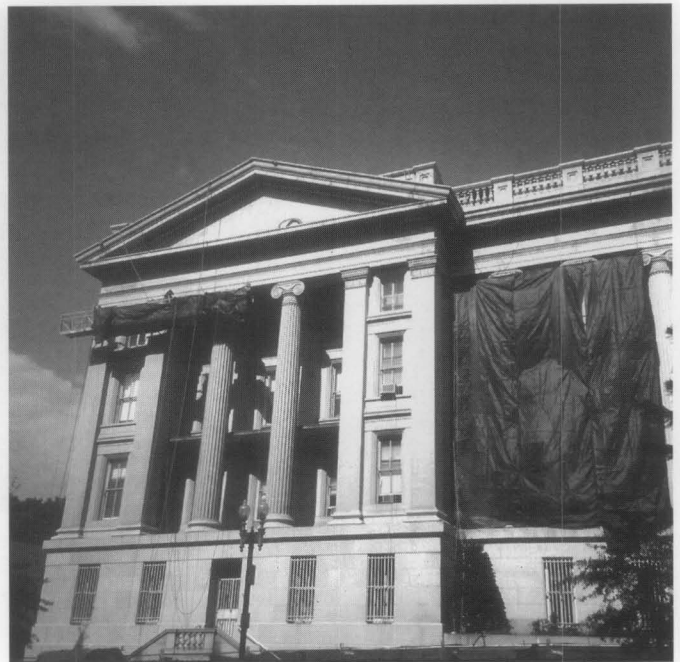
Figure 23. A tarpaulin protects and shields pedestrians from potentially harmful spray while chemical cleaning is underway on the granite exterior of the U.S. Treasury Building, Washington, D.C.

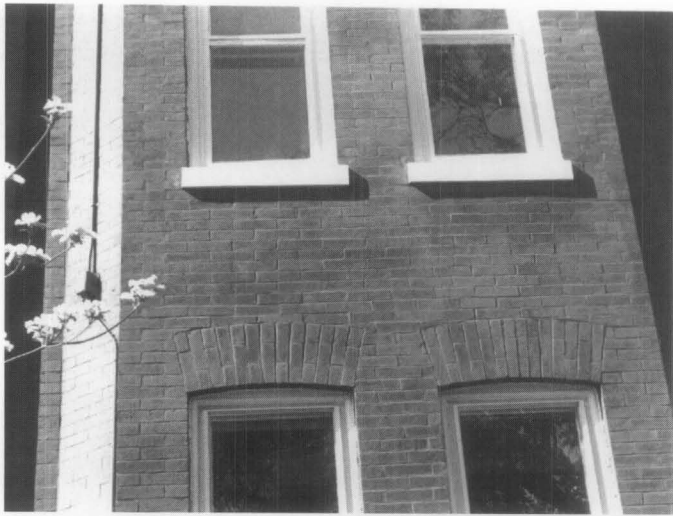
Figure 24. Although the application of a water-repellent coating was probably not needed on either of these buildings, the coating on the brick building (above), is not visible and has not changed the character of the brick. But the coating on the brick column (below), has a high gloss that is incompatible with the historic character of the masonry.

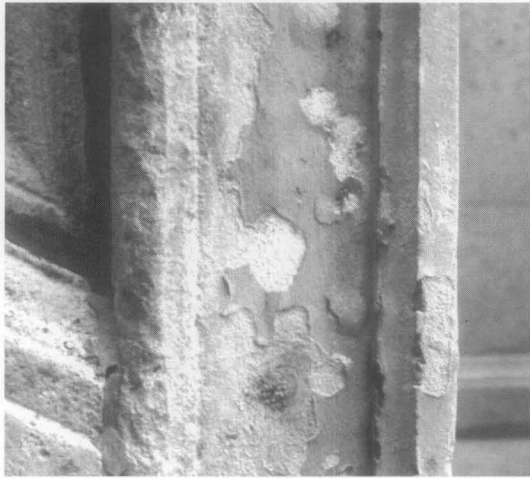
Figure 25. The clear coating applied to this limestone molding has failed and is taking off some of the stone surface as it peels. Photo: Frances Gale.

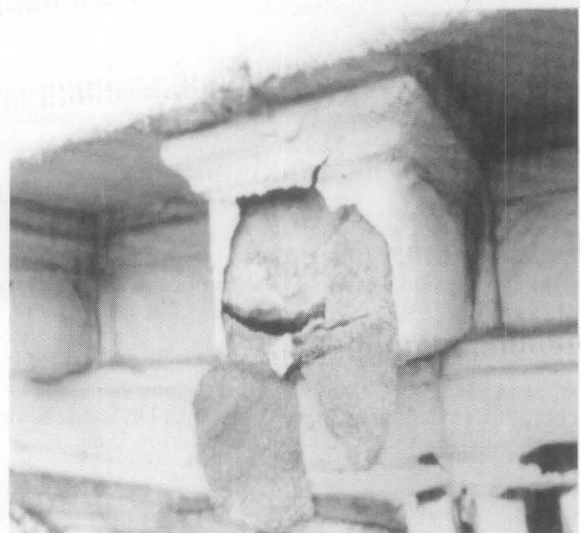
Figure 27. Instead of correcting the roof drainage problems, an elastomeric coating was applied to the already saturated limestone cornice. An elastomeric coating holds moisture in the masonry because it does not "breathe" and does not allow liquid moisture to escape. If the water pressure builds up sufficiently it can cause the coating to break and pop off as shown in this example, often pulling pieces of the masonry with it. Photo: National Park Service Files.

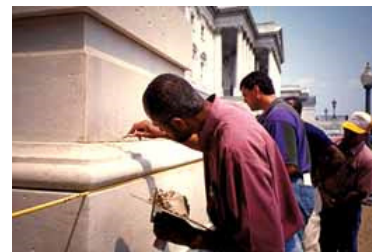
Masons practice using lime putty mortar to repair historic marble. Photo: NPS files.

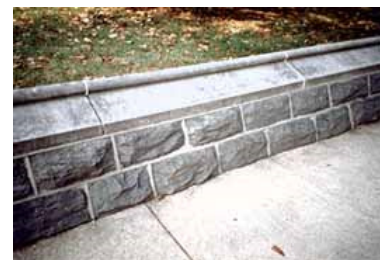
Caulking was inappropriately used here in place of mortar on the top of the wall. As a result, it has not been durable. Photo: NPS files.

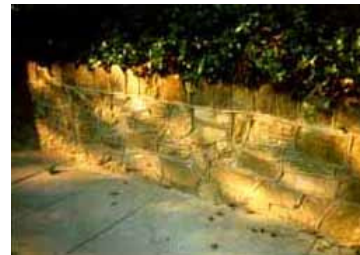
When repairing this stone wall, the mason matched the raised profile of the original tuckpointing. Photo: NPS files.

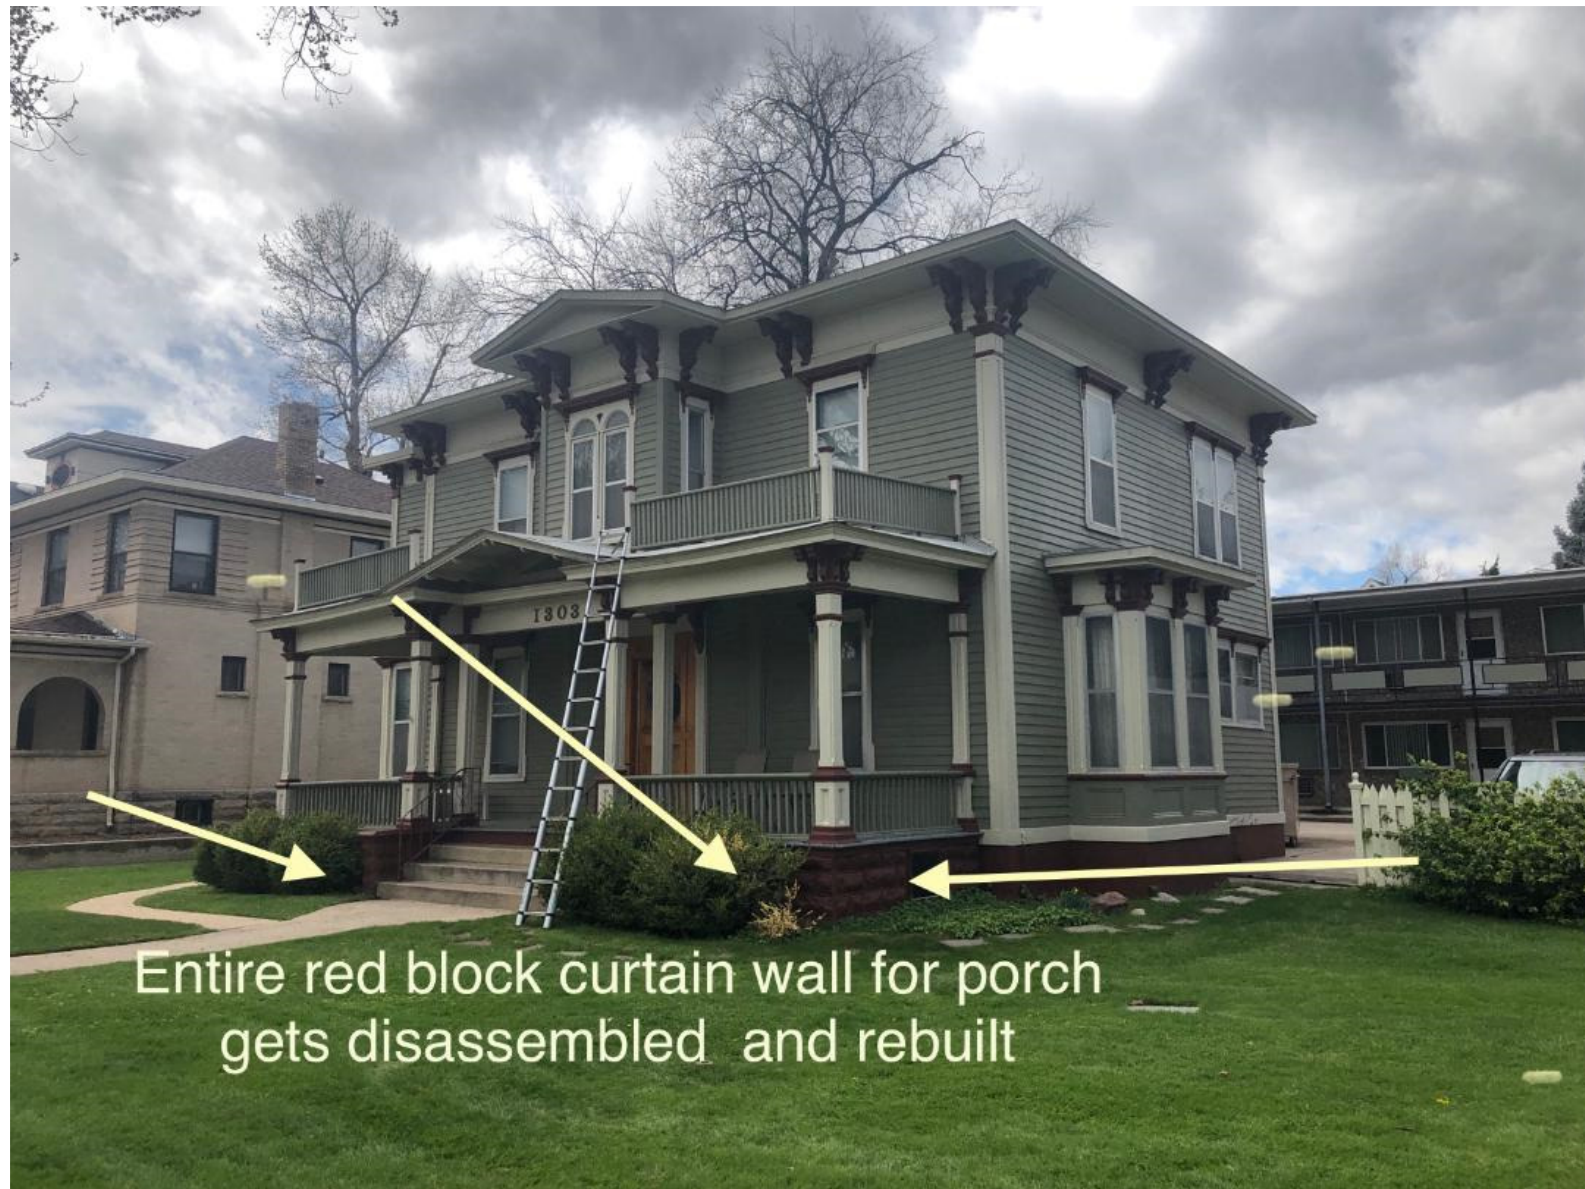
Entire red block curtain wall for porch  
gets disassembled and rebuilt

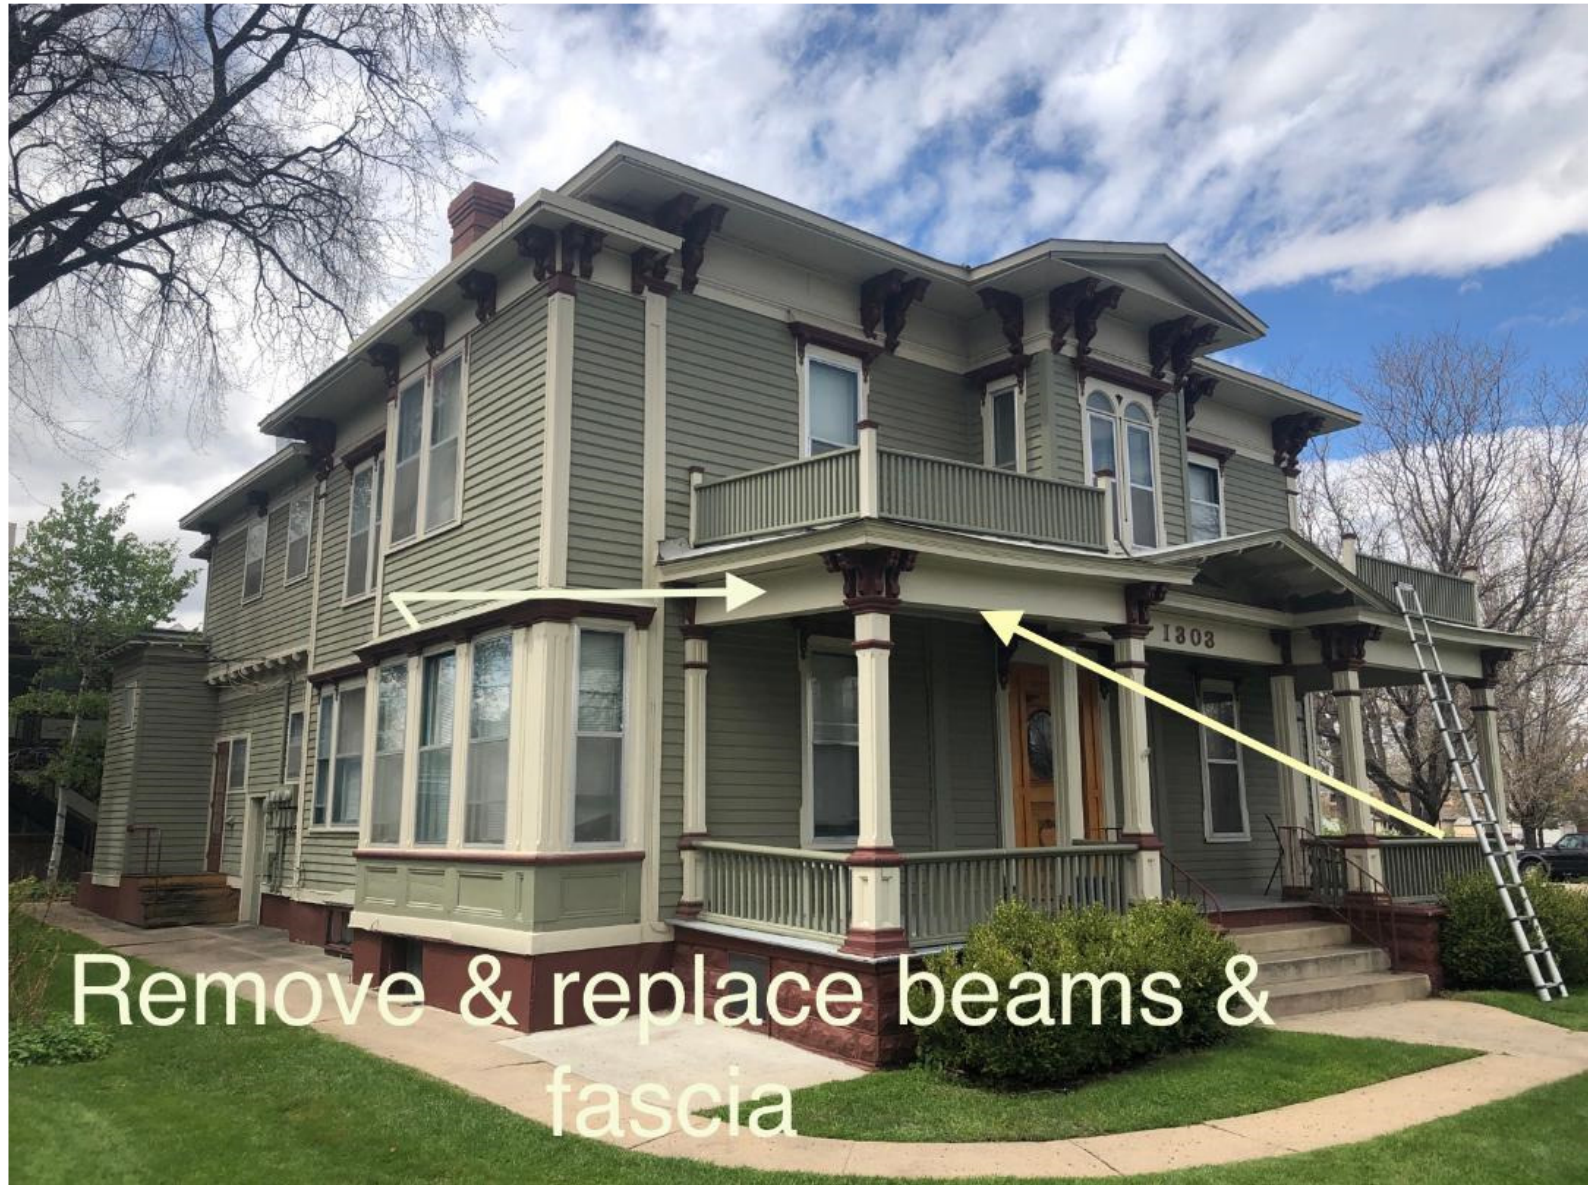
Remove & replace beams & fascia

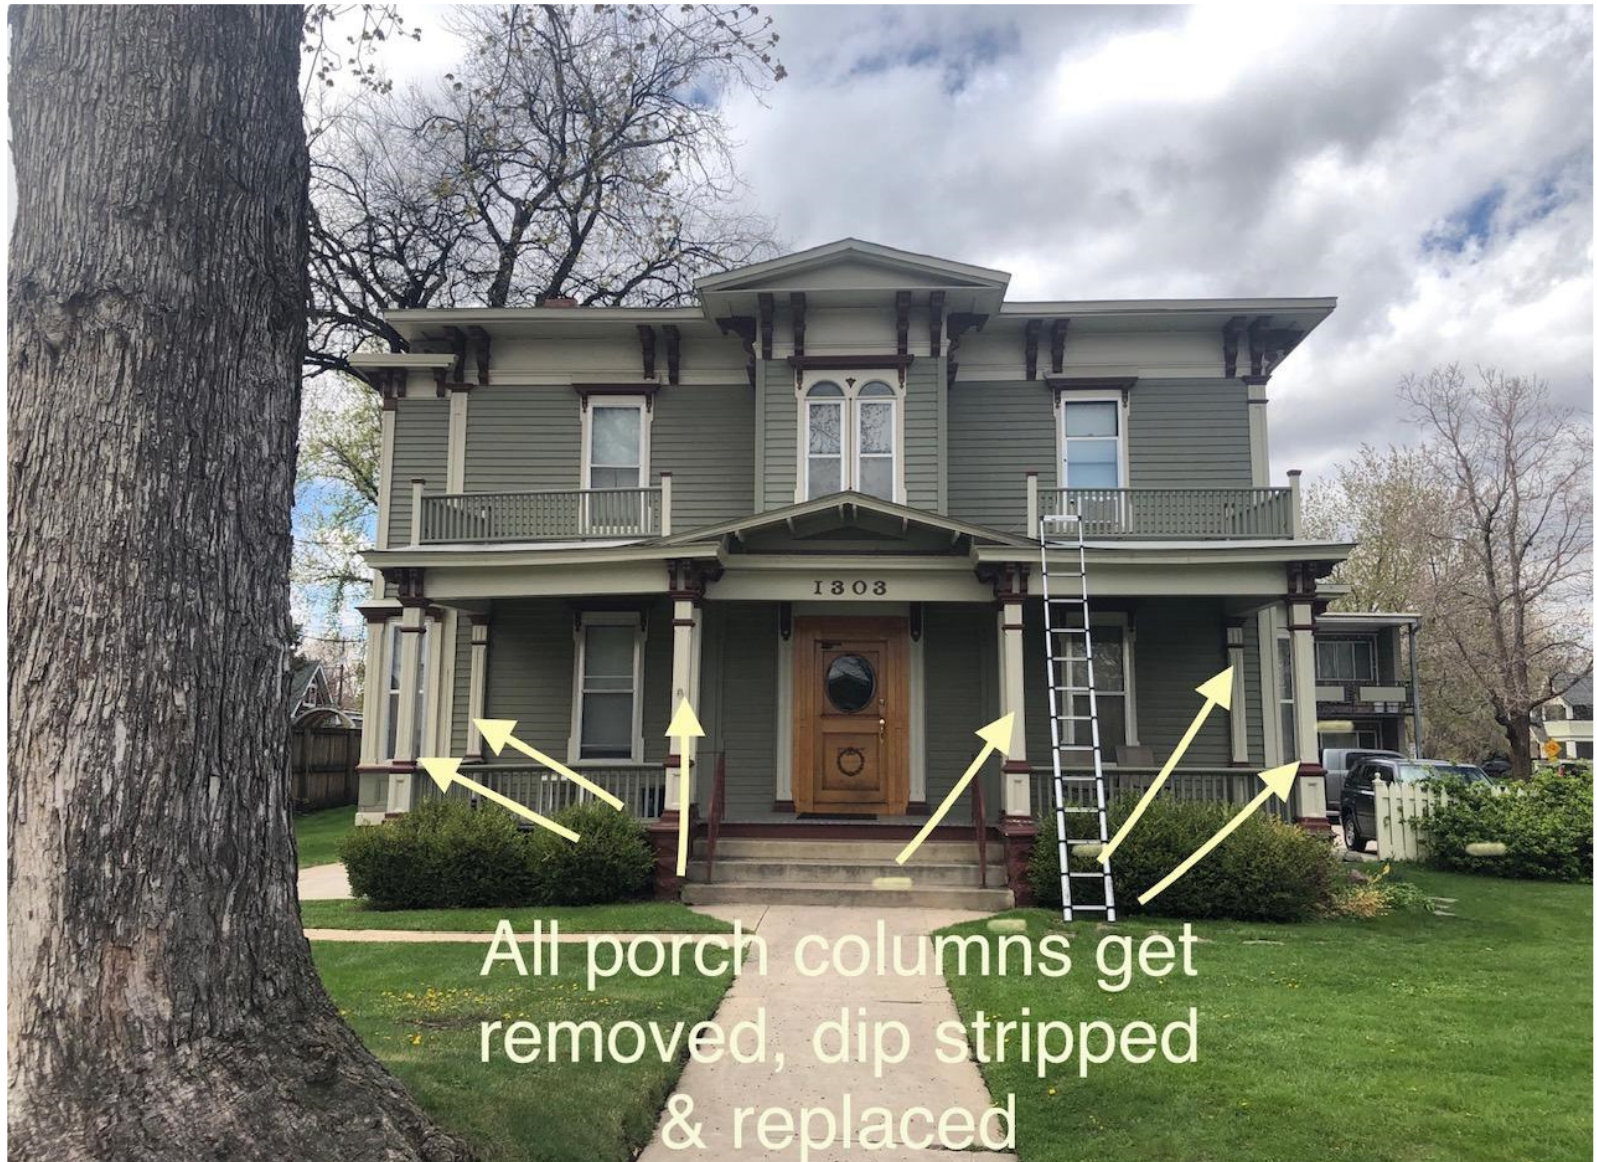
All porch columns get  
removed, dip stripped  
& replaced

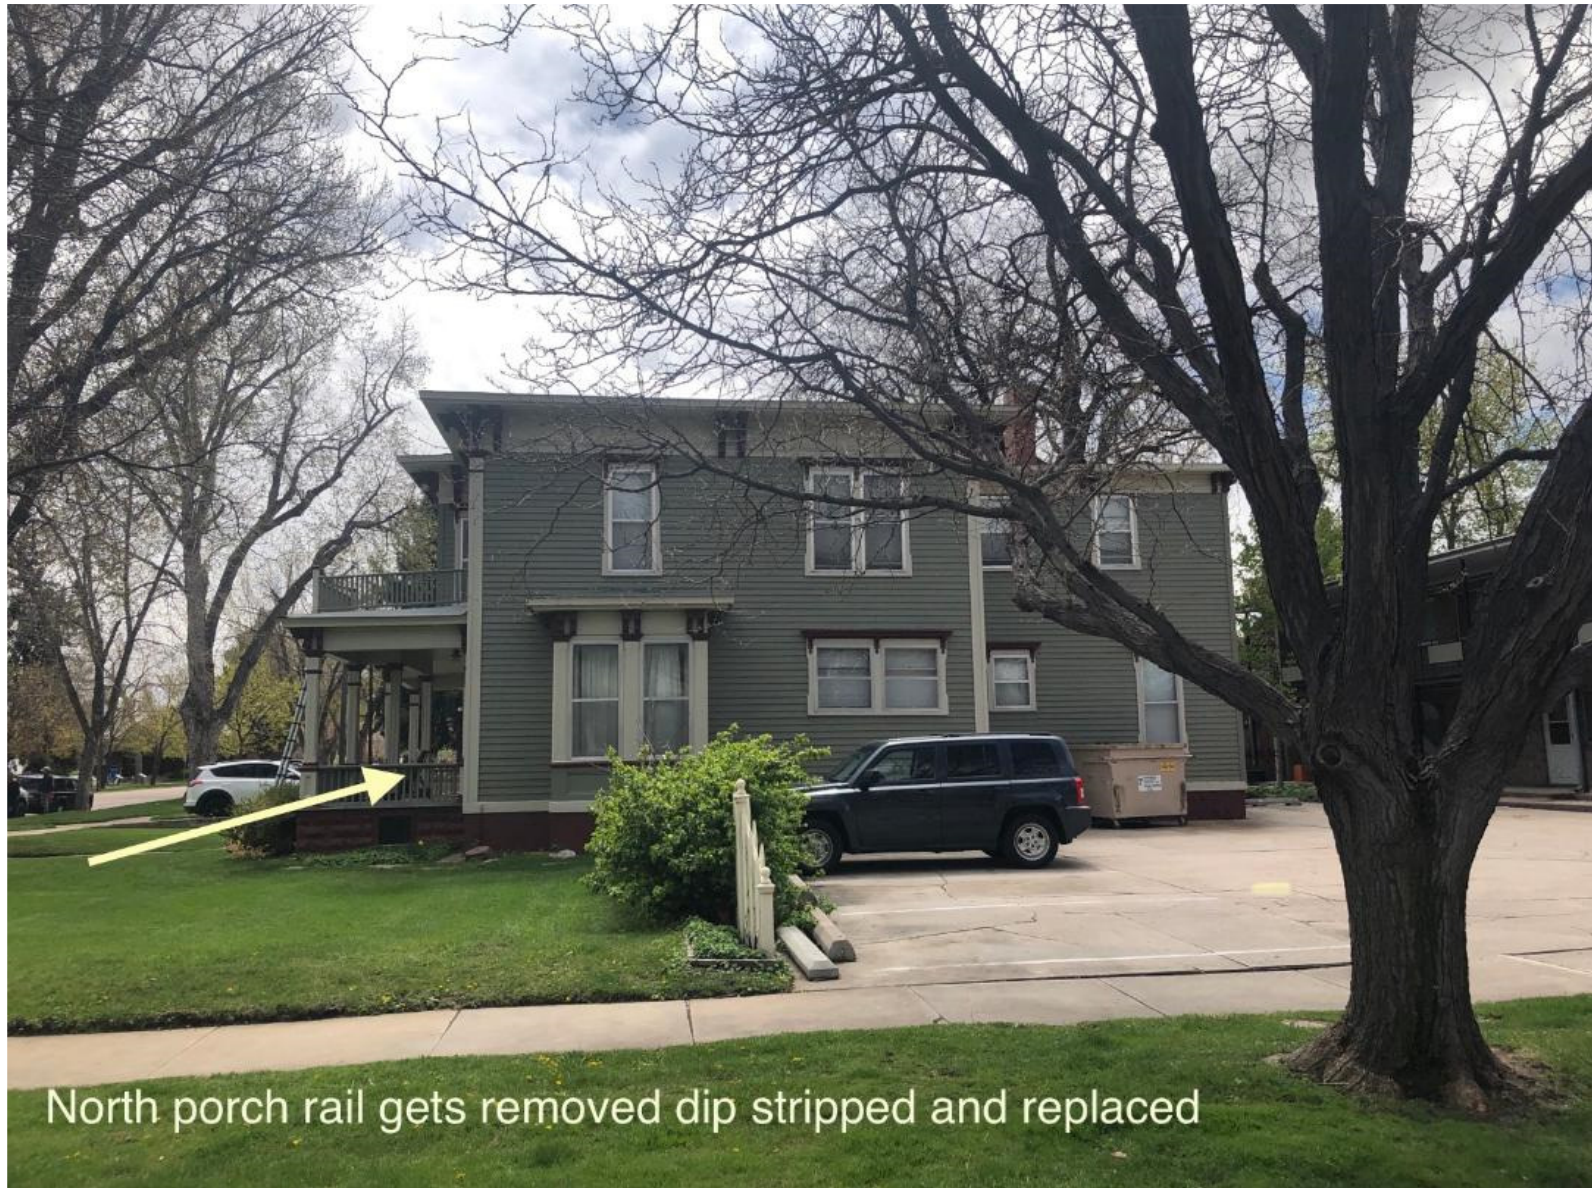
North porch rail gets removed dip stripped and replaced

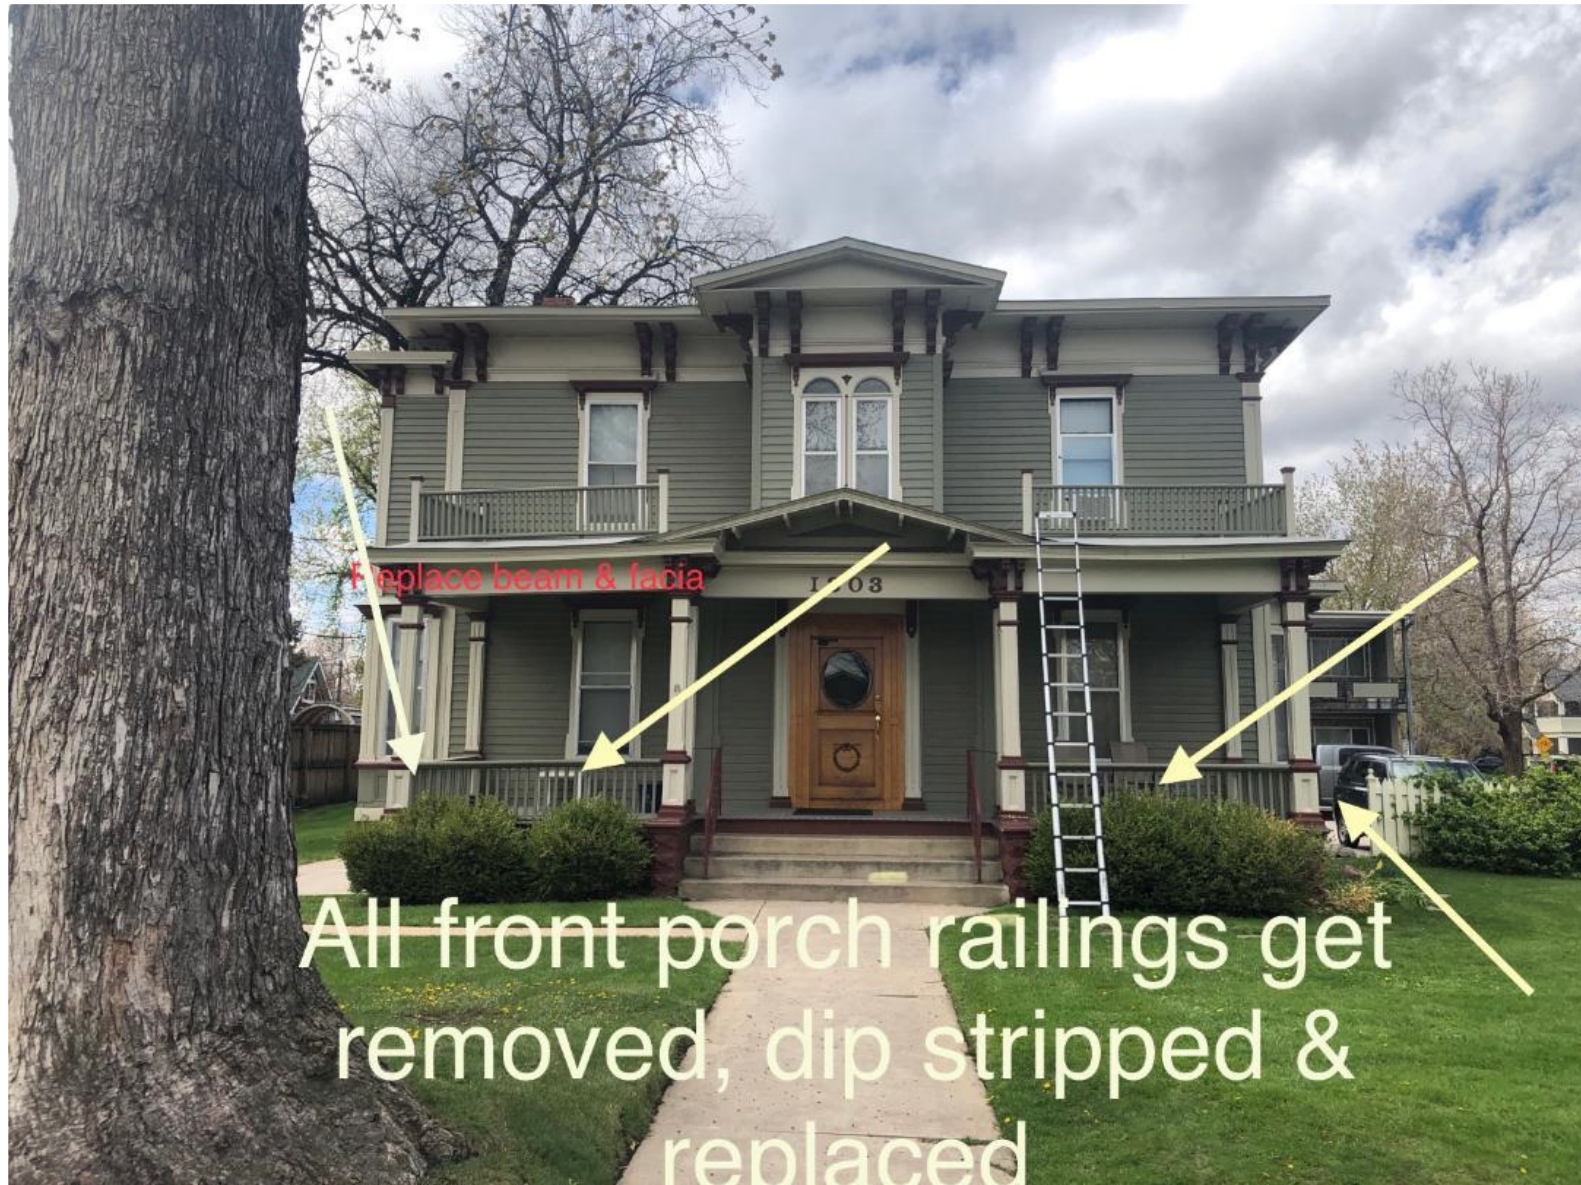
Replace beam & facia

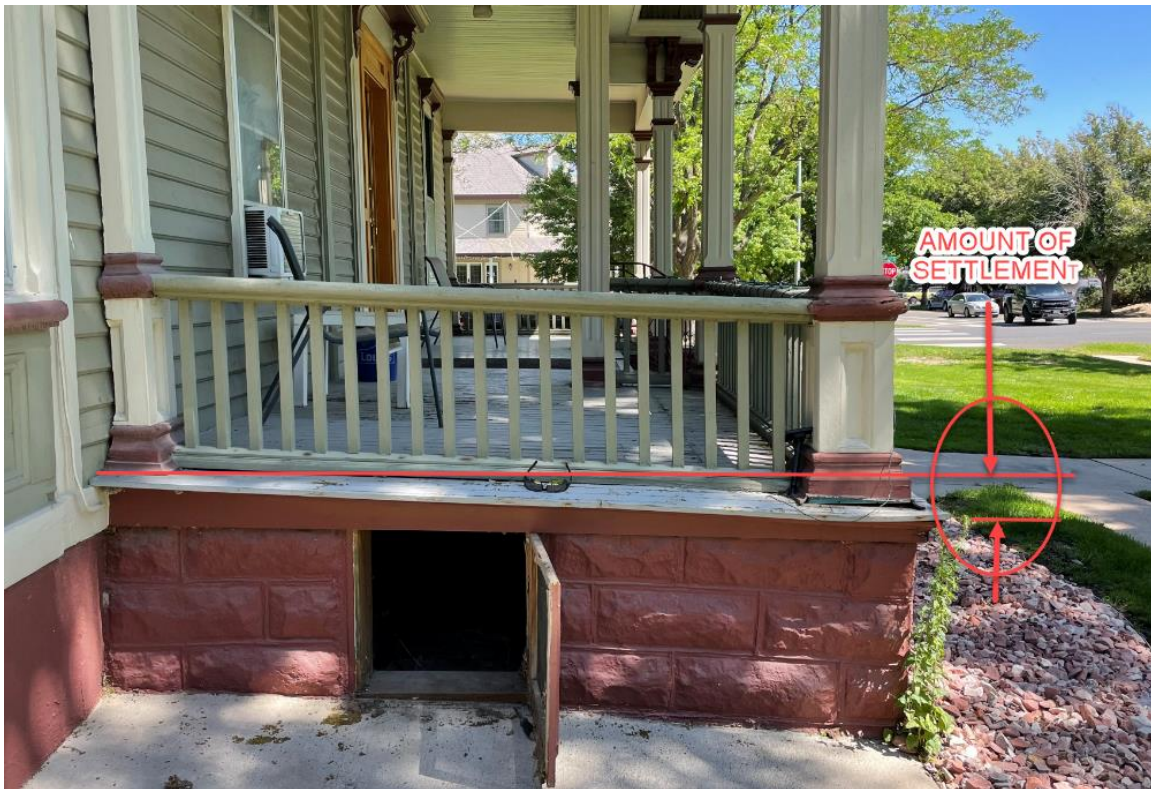
- Porch framing for decking and support posts is in poor condition. Floor joists have been propped up over the years with wood posts placed on and bricks or pieces of concrete.

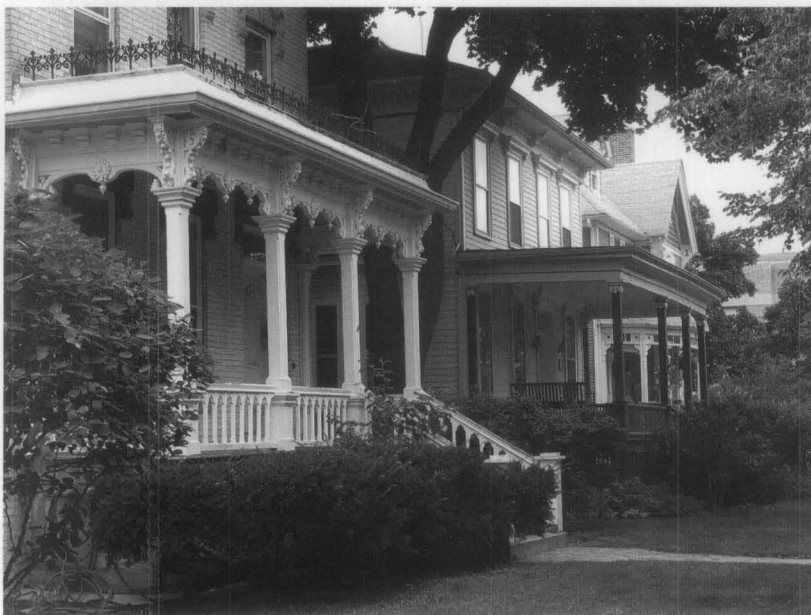
Figure 1. Distinctive yet different, these front porches are important features along the street. The rhythm would be diminished if the front porch from one of the houses was dramatically altered or removed. Photo: Aleca Sullivan.

Few architectural features evoke more romantic notions or do more to define a building's historic character than the American porch. The size, style, detailing, and location of a porch can tell volumes about the age and use of a building. Each component, from handrail or baluster to column or post, enhances the architectural character of the porch. Alter or remove the porch and a historic building or streetscape can lose its visual integrity and historic authenticity (Fig 1).

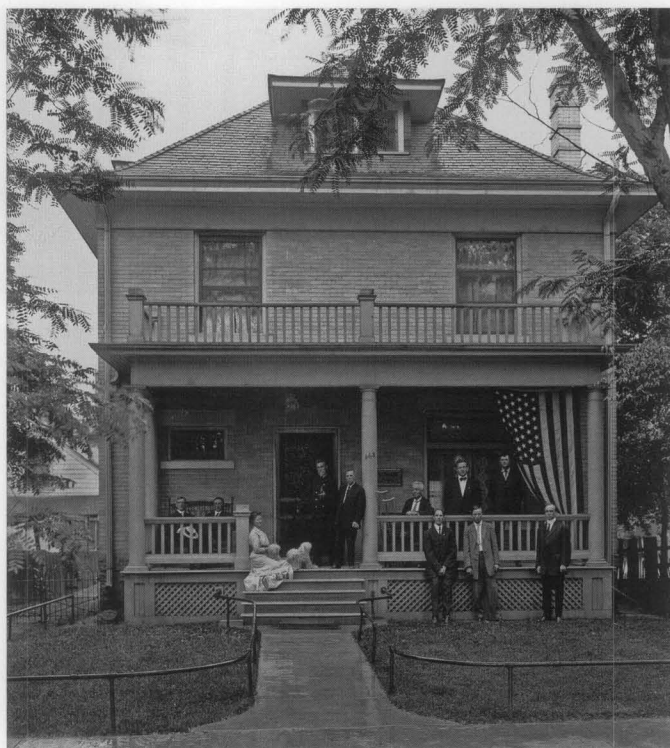
*Figure 4. Celebrating the 4th of July in 1912, this gathering of family and friends reflects the popularity of the porch as a social gathering place. While not overly ornate, each detail of the porch from the roof balustrade to the turned columns to the simple lattice work facing the deck contributes to its character, creating in effect the dominant architectural feature of the building. Photo: © Utah State Historical Society*

The open qualities are one of the key features of most historic porches. Overall size, shape and design are obviously important components as well. There are numerous other contributing features which may exist, including the shape of the porch roof, the way a large porch is divided into distinct bays as with columns, the nature of the supporting foundation, the style and size of columns and balustrade, and whether the porch is raised or largely at grade. The simplicity of a porch or its richness in detail will also help define it. Materials are usually important as well, not just the wood features, but also whether other materials exist such as masonry columns and steps (Fig 4).
