# Historic Preservation Commission

**November 07, 2022 at 4:00 PM**

Property owner and applicant Ashley Fusco requests approval to remove the non-historic stucco from the façade at 827 10<sup>th</sup> Street, clean the brick and repoint mortar joints as needed, paint the sign band if needed, replace the existing awning with a retractable awning, and install gooseneck light fixtures.

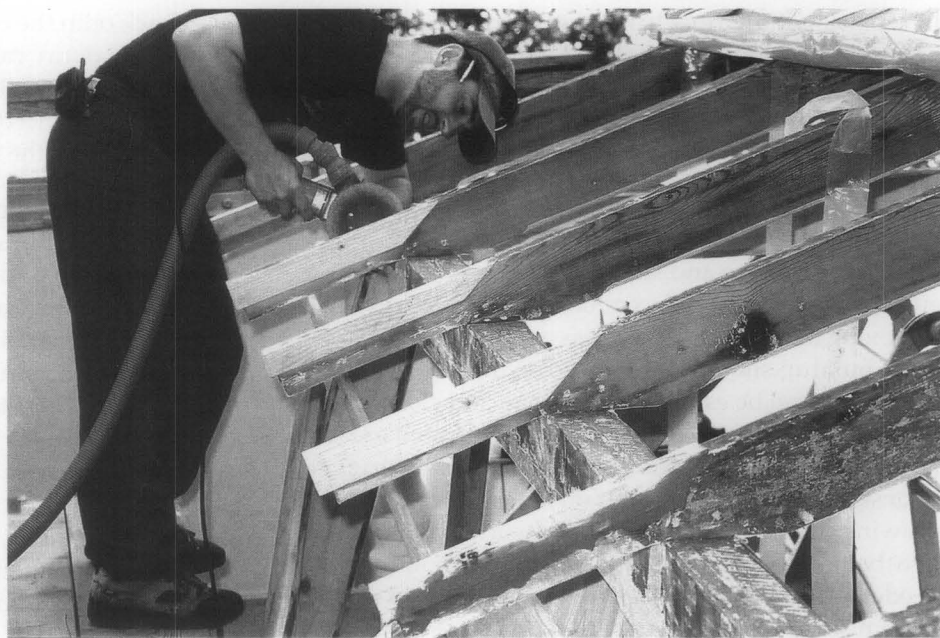
Figure 9. The ends of porch roof rafters are often susceptible to moisture decay. When concealed by a soffit or ceiling, rafters can be repaired by adding new sister boards. Where roof rafter ends are exposed, splicing new wood onto the old (*dutchman* repair) and use of epoxy consolidants and fillers both preserve sound historic fabric while retaining the historic appearance.

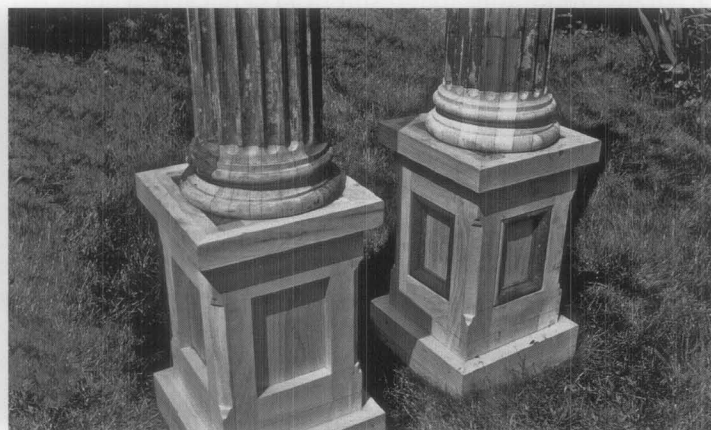
Figure 10. This nineteenth century porch column is made of wood staves, similar to the way a wood barrel is put together. After replacing the torus and making dutchman repairs to the apophyge along the base, the column and pedestal are ready to be reinstalled on the porch. Photos: NPS files.

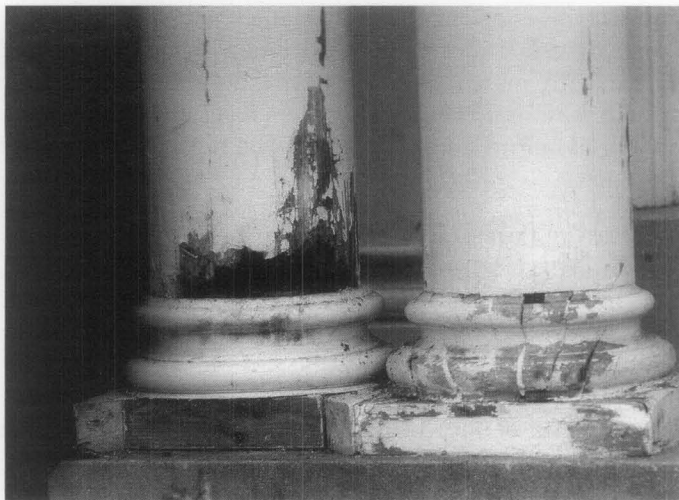
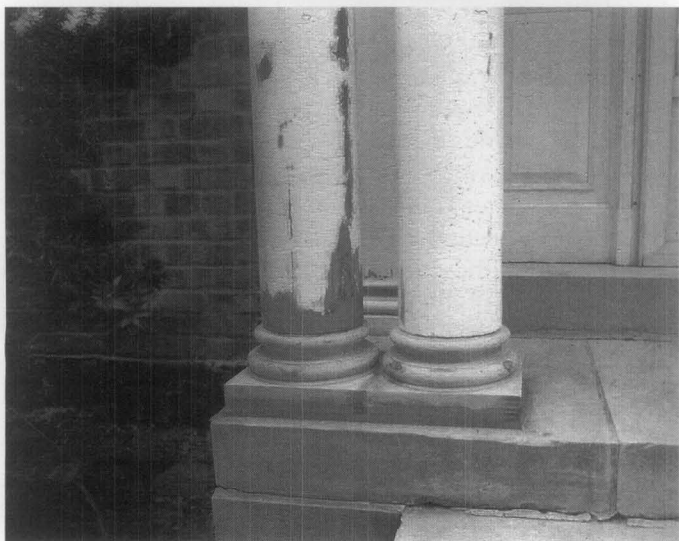
*Figure 11. The lower shaft of the porch columns had decayed as water wicked up through the end grain (top). The column shafts were repaired in place by cutting out the deteriorated wood and making repairs using epoxy consolidants and fillers. (bottom). The column bases were replaced. Photos: Paul Marlowe, Marlowe Restorations.*

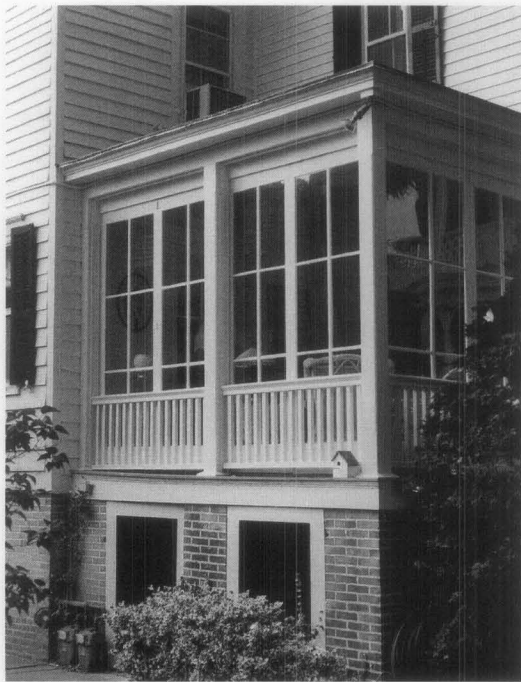
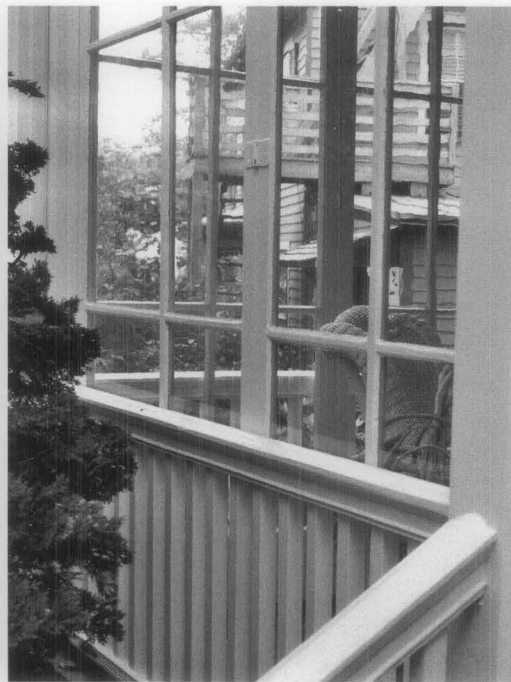
*Figure 12. This old porch enclosure, located on the back side of a house, has acquired significance over time and is remarkable both in the appropriateness of its detailing for use by others today, as well as its high degree of maintenance. The enclosure is set behind the columns; the balustrade has been retained; and the light divisions and the size of the glass panes echo that of the windows above. Within each bay there are two well-crafted, inward swinging doors, providing for greater seasonal use of the porch. Photos: Charles Fisher.*

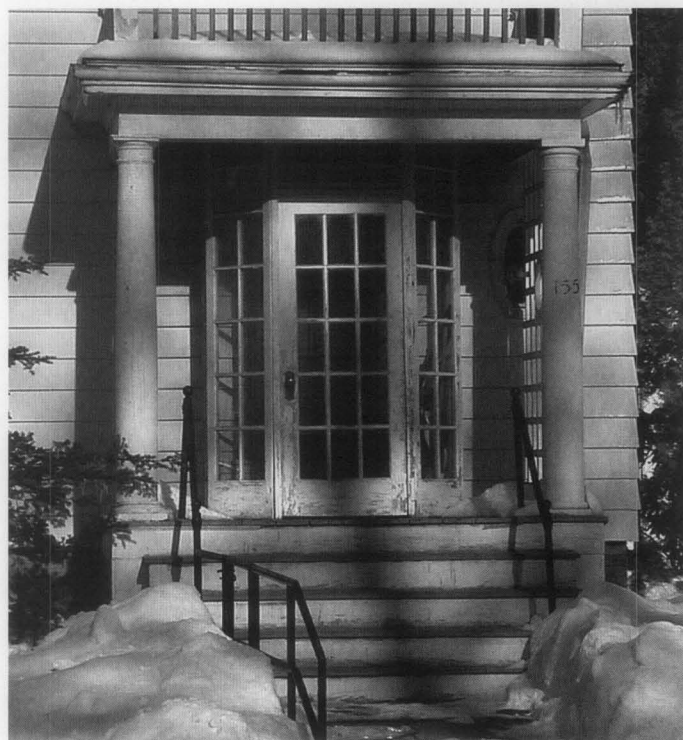
Figure 13. Particularly in New England, there is a cold weather tradition of installing temporary glass and wood panels at entrance doors, thereby creating an enclosed vestibule. These enclosures with their small divided lights were generally removed in the spring.

months while not permanently altering its appearance. In fact some have become historic features of buildings. Particularly in New England, there is a continuing tradition of installing relatively substantial glass and wood panels on porches during the winter, especially around an entrance door. These tended to have small divided lights. Sometimes porches were fully enclosed with a divided light glass door for entry, creating an enclosed vestibule that reduced the amount of cold air entering the house when the door was opened. Others consisted of simple sidewalls perpendicular to an existing entrance door, serving as a windbreak. Such enclosures were generally removed in the spring (Fig. 13).

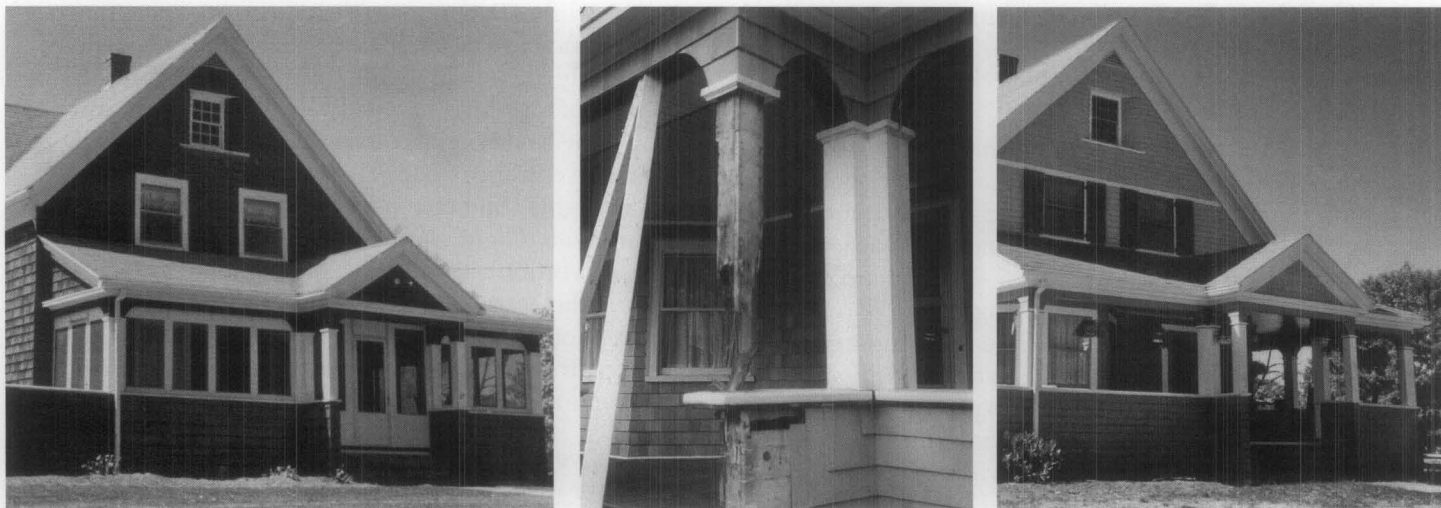
Figure 14. The enclosure of a prominent porch can dramatically change the historic character of a building. The L-shaped porch on this 1896 Shingle-style New England residence was later enclosed with aluminum windows and screens. Recent owners elected to reopen the historic porch. Among the other work, it was necessary to correct structural damage, as with this post, where beneath the wood casing carpenter ants had done serious damage. In reopening the porch, the historic character of the residence has been brought back and the traditional use of the porch is once again enjoyed. Photos: Mark Landry, Landmark Services.

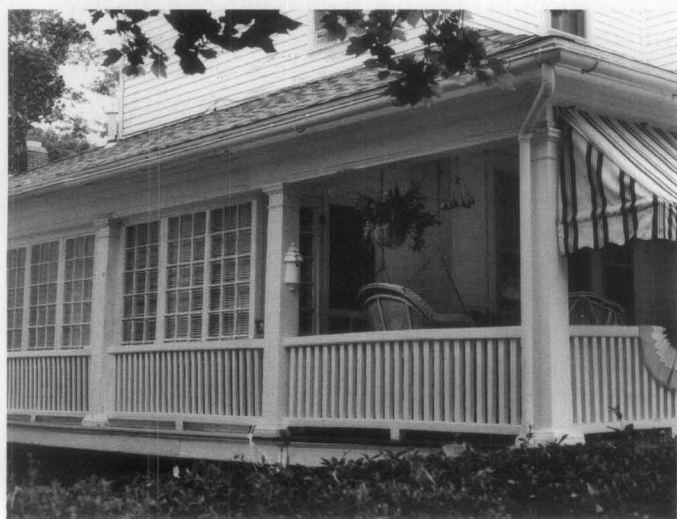
Figure 15. A traditional technique of porch enclosures still used today involves the insertion in each column bay of one or more glass enclosures set in wood frames. This enclosure is properly set back an entire porch bay from the front of the house and utilizes traditional light divisions and wood frames. The balustrade, added here for illustration purposes, shows the importance of retaining this linear feature within the enclosed bays. Photo: Charles Fisher.

Where the enclosure of all or part of a historic porch is appropriate, the selection of a compatible design and materials is important. Windows, doors, and wall material selection, along with how the new infill fits within the existing porch, are all factors to consider. A traditional technique of porch enclosures still used today involves the insertion in each column bay of one or more glass enclosures set in wood frames. The enclosures are located between or behind the columns, depending upon the nature of the porch, and mimic the pattern or size of glass panes found in historic windows on the building (Fig 15). An alternate treatment involves the use of much larger sheets of clear, non-reflective glass recessed behind the porch supports, balustrade and railing. This more contemporary treatment may be appropriate, depending upon the historic character of the building, location of the porch, and other factors (Fig 16). Windows, doors, and wall material selection, along with how the new infill fits within the existing porch, are all factors to consider.

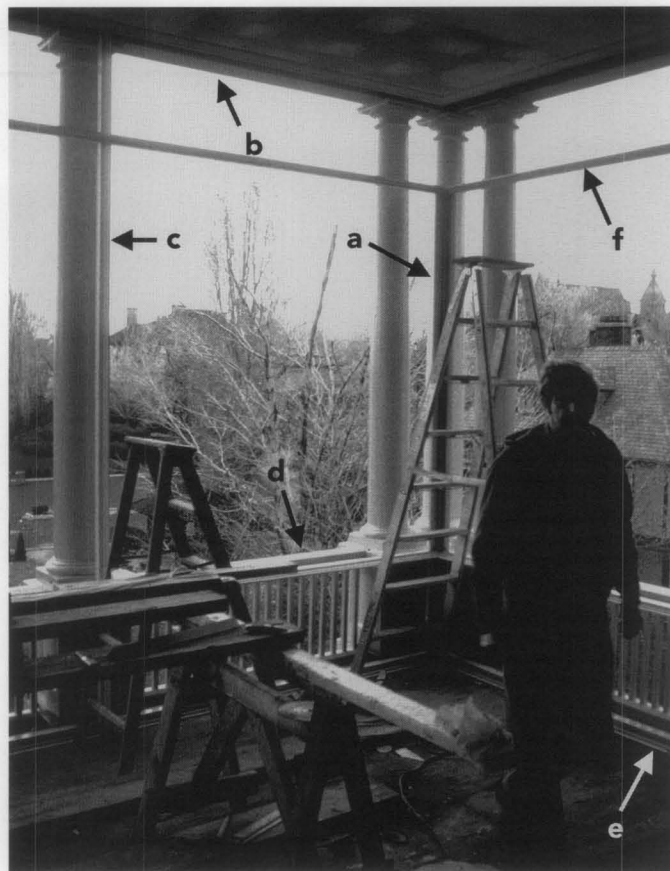
Figure 16. The use of near full glazing to enclose a porch may be appropriate depending upon the historic character of the building, location of the porch, how the interior space is to be treated, and other factors. This enclosure of a rear porch to create a conference room successfully utilizes large expanses of glass and narrow metal framing set behind existing porch elements (a through e). Where an additional horizontal support was needed (f), the frame was placed at a location that is found in many traditional insect screen enclosures. Photo: Charles Fisher.

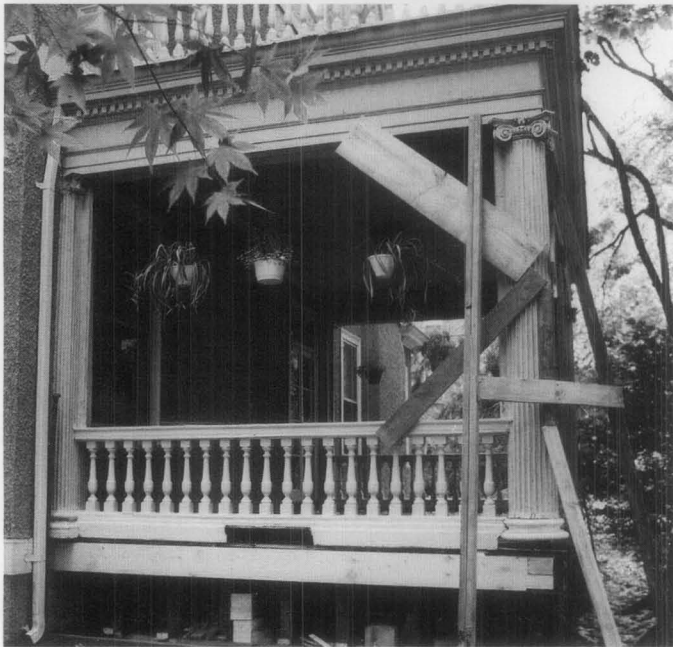
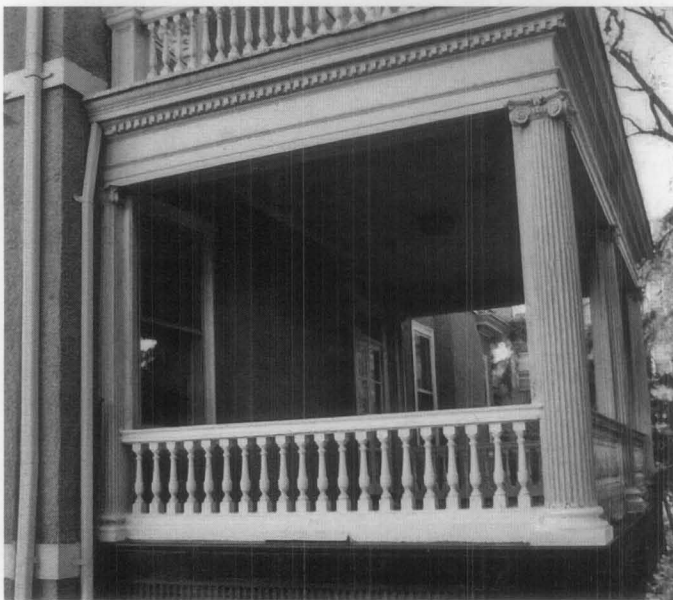
Figure 17. The porch's structural system must be capable of supporting today's loads. In this case moisture led to the deterioration of the wood girder at the corner, creating a major structural deficiency (top). A new solid timber was installed to replace the girder (middle); alternatively a built-up girder could have been used since a fascia board would conceal it. The column base was repaired and portions replaced and the balustrade and column reset and secured (bottom). Photos: Paul Marlowe, Marlowe Restorations.

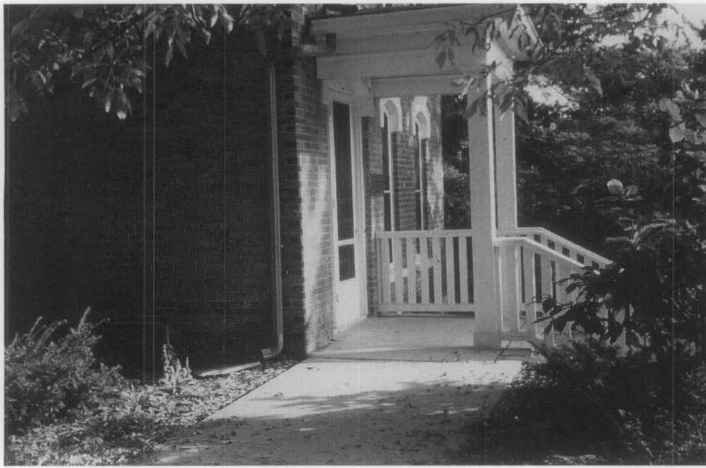
Figure 18. When a porch is used as a wheelchair accessible entrance, it may be possible to retain the historic stairs by adding a ramp parallel to the building. Through plantings and some re-grading, the new ramp built parallel to the building (left) allows retention of the historic stairs and does not impact the historic character of the entrance (right). Photo: Iowa State University Extension.
