ZONING BOARD OF APPEALS MEETING

Wednesday, September 11, 2024 at 7:00 PM Hamburg Township Hall Board Room

ZBA 2024-005

Request: Variance application to permit the construction of a single-family home. Applicant requests a 21.2-foot variance from the required wetland setback of 50 feet., per Section 36-293(C)(2) a.

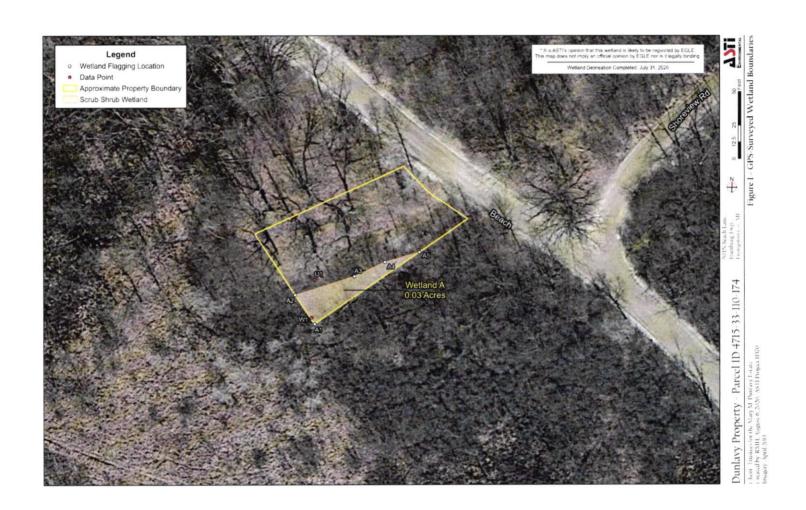
Attachments: Figure 1 – GPS-Surveyed Wetland Boundaries

Wetland A is a scrub/shrub wetland 0.03 acres in size on-site and located in the southeastern portion of the Property (see Figure 1). Wetland A continues off-site to the west and south. Dominant vegetation found within Wetland A included glossy buckthorn (*Rhamnus frangula*), false nettle (*Boehmeria cylindrica*), maddog skullcap (*Scutellaria lateriflora*), and fringe sedge (*Carex crinita*). Soils within Wetland A were mucky loam and are considered hydric because the criteria for a loamy mucky mineral soil were met. Indicators of wetland hydrology observed within Wetland A included saturation and water stained leaves.

Wetland boundaries were marked in the field with day-glow pink and black striped with the flagging numbers A-1 through A-5.

Attached are Figure 1, which shows the GPS-surveyed locations of wetland flagging on the Property, and completed US Army Corps of Engineers (ACOE) Wetland Data Forms. Please note that the data sheet numbers match the data collection sampling points shown on Figure 1.

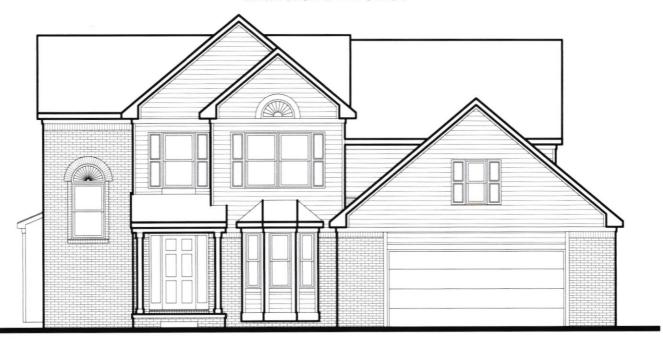
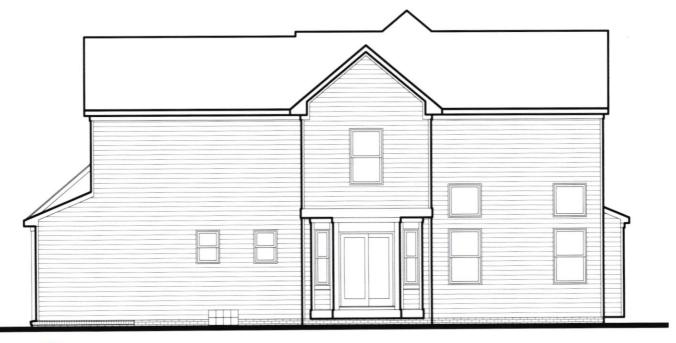
Front Elevation

Tony Van Oyen Development, LLC Hartford Model

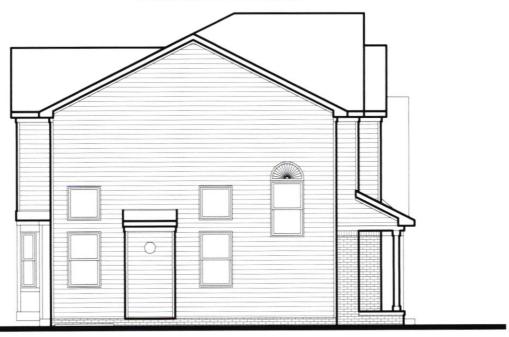
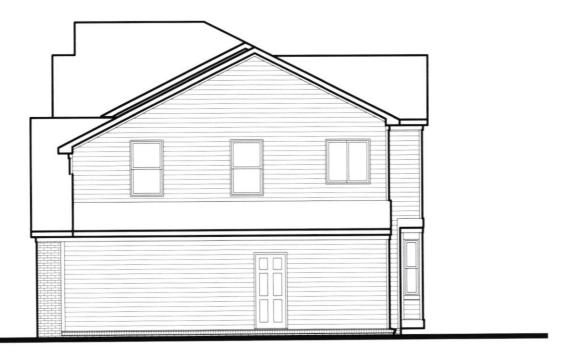
Left Elevation

Tony Van Oyen Development, LLC Hartford Model
