### **Board of Trustees Regular Meeting Agenda Hartland Township Hall Tuesday, September 01, 2020 7:00 PM**

# HARTLAND SENIOR LIVING

12371 HIGHLAND ROAD,  
HARTLAND TOWNSHIP, MI 48353

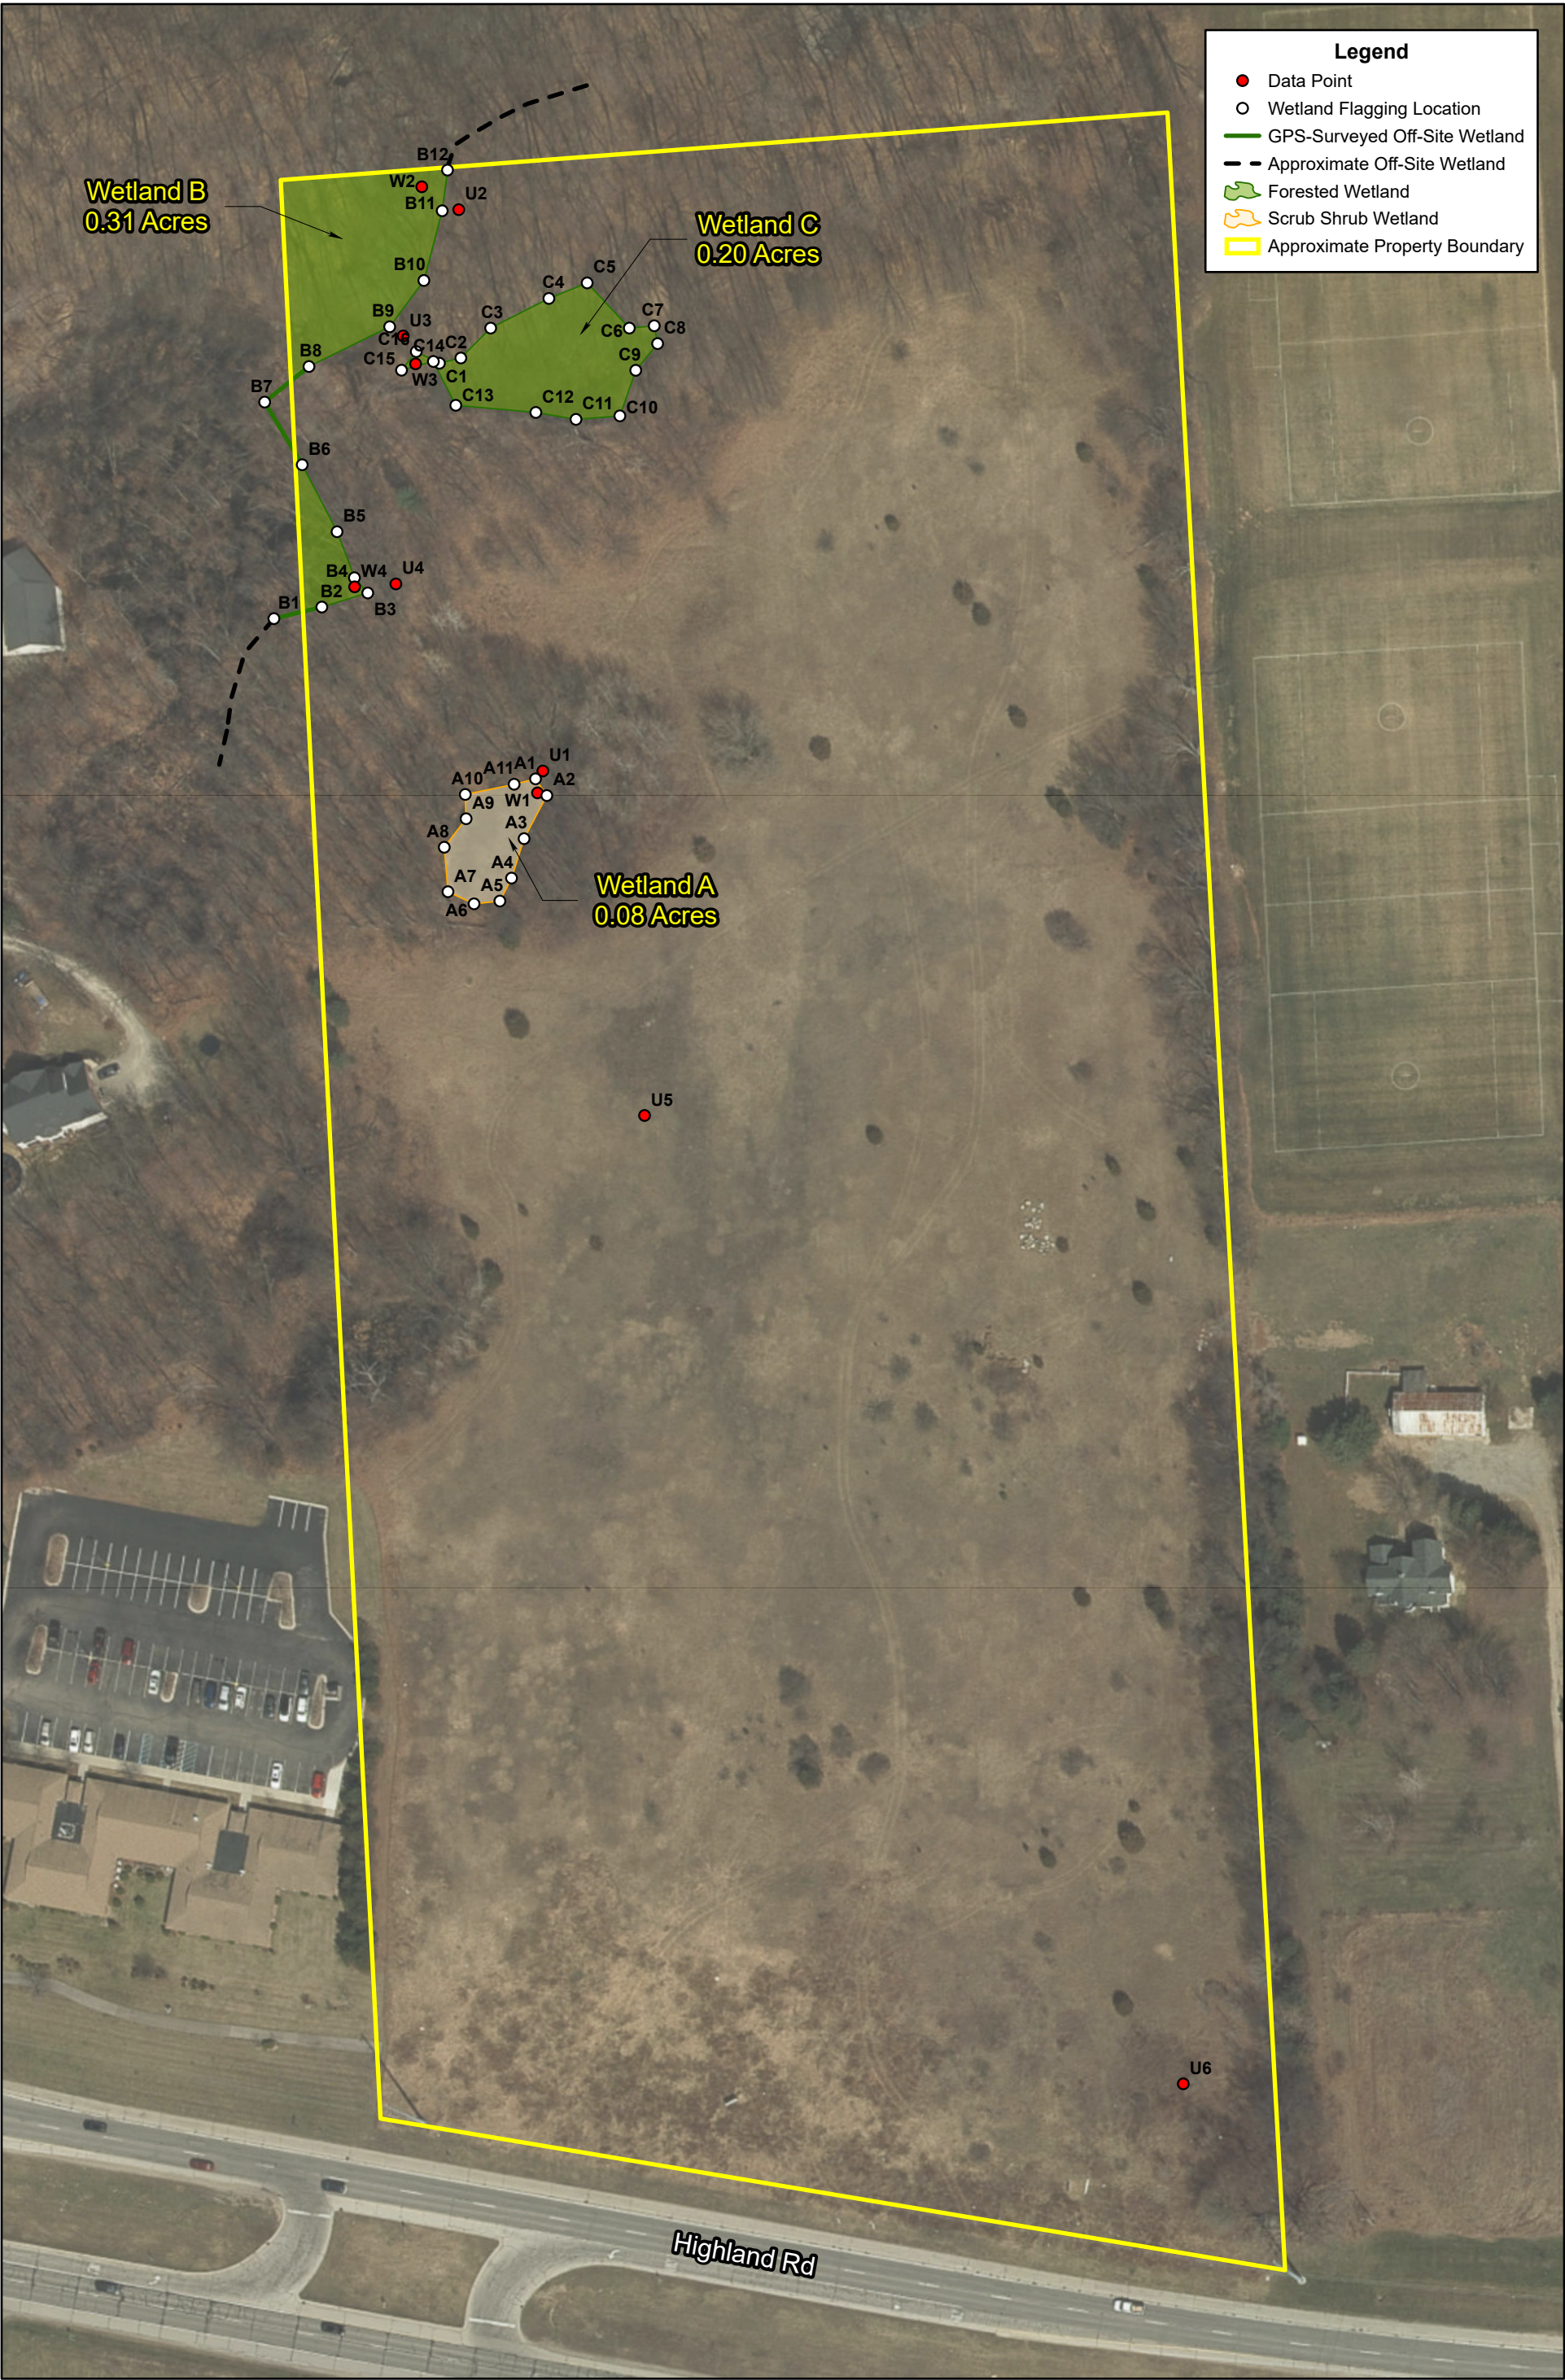
Attachments: Figure 1 – *GPS-Surveyed Wetland Boundaries*  
Completed ACOE Wetland Data Forms

Wetland A is a scrub/shrub wetland 0.08 acres in size located entirely on the Property (see Figure 1). Dominant vegetation found within Wetland A included silky dogwood (*Cornus amomum*), gray dogwood (*Cornus racemosa*), and stinging nettle (*Urtica dioica*). Soils within Wetland A were mucky sand and are considered hydric because they met the hydric soil criteria for a sandy mucky mineral and a sandy redox. Indicators of wetland hydrology observed within Wetland A included surface water, high water table, saturation, and sparsely vegetated concave surface.

Wetland B is a forested wetland 0.31 acres on the Property (see Figure 1); it continues off-site to north and west of the Property. Dominant vegetation found within Wetland B included silver maple (*Acer saccharinum*), gray birch (*Betula populifolia*), American hornbeam (*Carpinus caroliniana*), and skunk-cabbage (*Symplocarpus foetidus*). Soils within Wetland B were a muck and are considered hydric because they met the hydric soil criteria for a histosol. Indicators of wetland hydrology observed within Wetland B included surface water, high water table, and saturation.

Wetland C is a scrub/shrub wetland 0.20 acres in size, located entirely on the Property (see Figure 1). Dominant vegetation found within Wetland C included gray birch (*Betula populifolia*), American hornbeam (*Carpinus caroliniana*), sensitive fern (*Onoclea sensibilis*), royal fern (*Osmunda spectabilis*), and green ash (*Fraxinus pennsylvanica*). Soils within Wetland C were mucky sand and are considered hydric because they met the hydric soil criteria for a sandy mucky mineral, a thick dark surface, a sandy redox, and a stripped matrix. Indicators of wetland hydrology observed within Wetland C included surface water, high water table, saturation, and sparsely vegetated concave surface.

On March 24, 2020, ASTI Environmental (ASTI) conducted a site investigation to delineate wetland boundaries on approximately 17.9 acres at 12371 Highland Road, east of Bullard Road, and west of Fenton Road in Hartland Township, Livingston County, Michigan (Property). Three wetlands were found on the Property (Figure 1 – *GPS-Surveyed Wetland Boundaries*). Wetland boundaries, as depicted on Figure 1, were located using a professional grade, hand-held Global Positioning System unit (GPS).

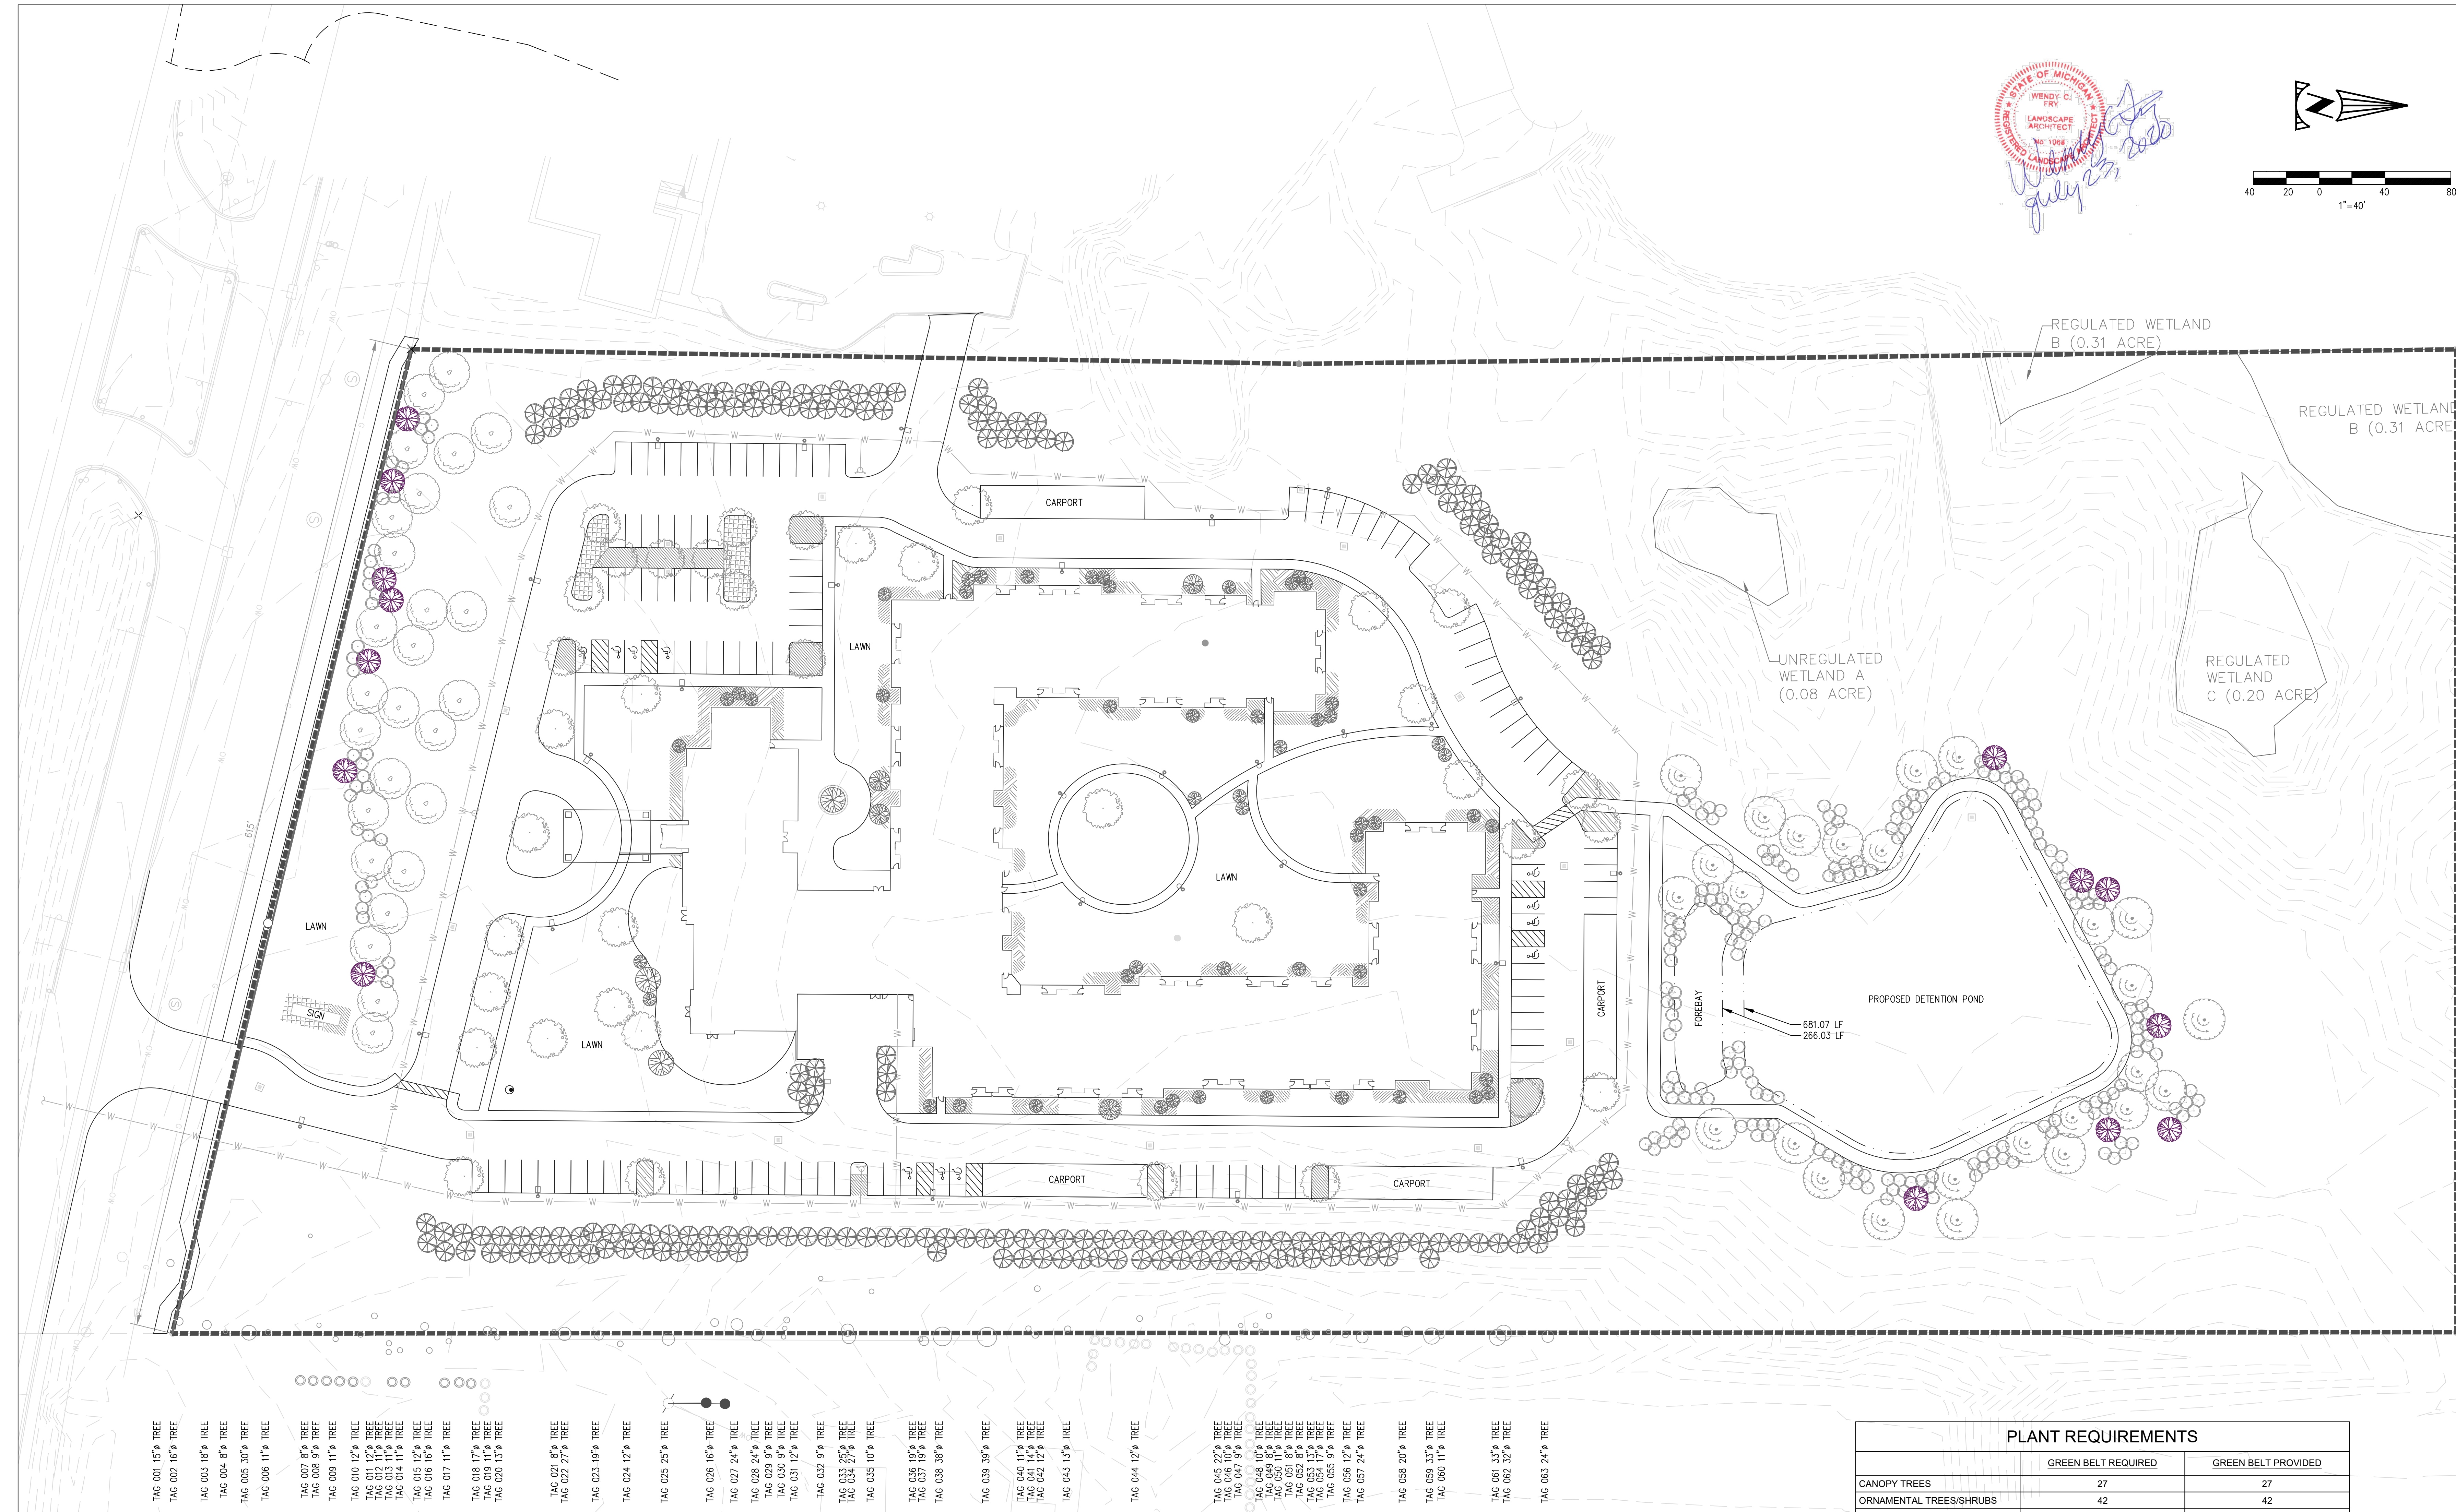
OVERALL  
PRELIMINARY  
LANDSCAPE PLAN

PLANT CALCULATIONS

GREEN BELT: 615 LF  
CANOPY TREE: 1 TREE / 30'  
SHRUBS: 3 SHRUBS IN FIRST 40' AND 1 SHRUB / 20'

- Sheet 9 (Overall Preliminary Landscape Plan) labels several areas as “Lawn”, which are generally around the formal areas of the site, in the greenbelt, around the building and in the courtyard. Staff assumes these are mowed turf areas which should be irrigated. Other areas on the site appear to be lawn areas but are not labeled. These areas, as noted on the landscape plan provided by staff, should be labeled and the seed mix should be provided on Sheet 14 or Sheet 15. Depending on the seed mix and type of lawn, irrigation may or may not be required.

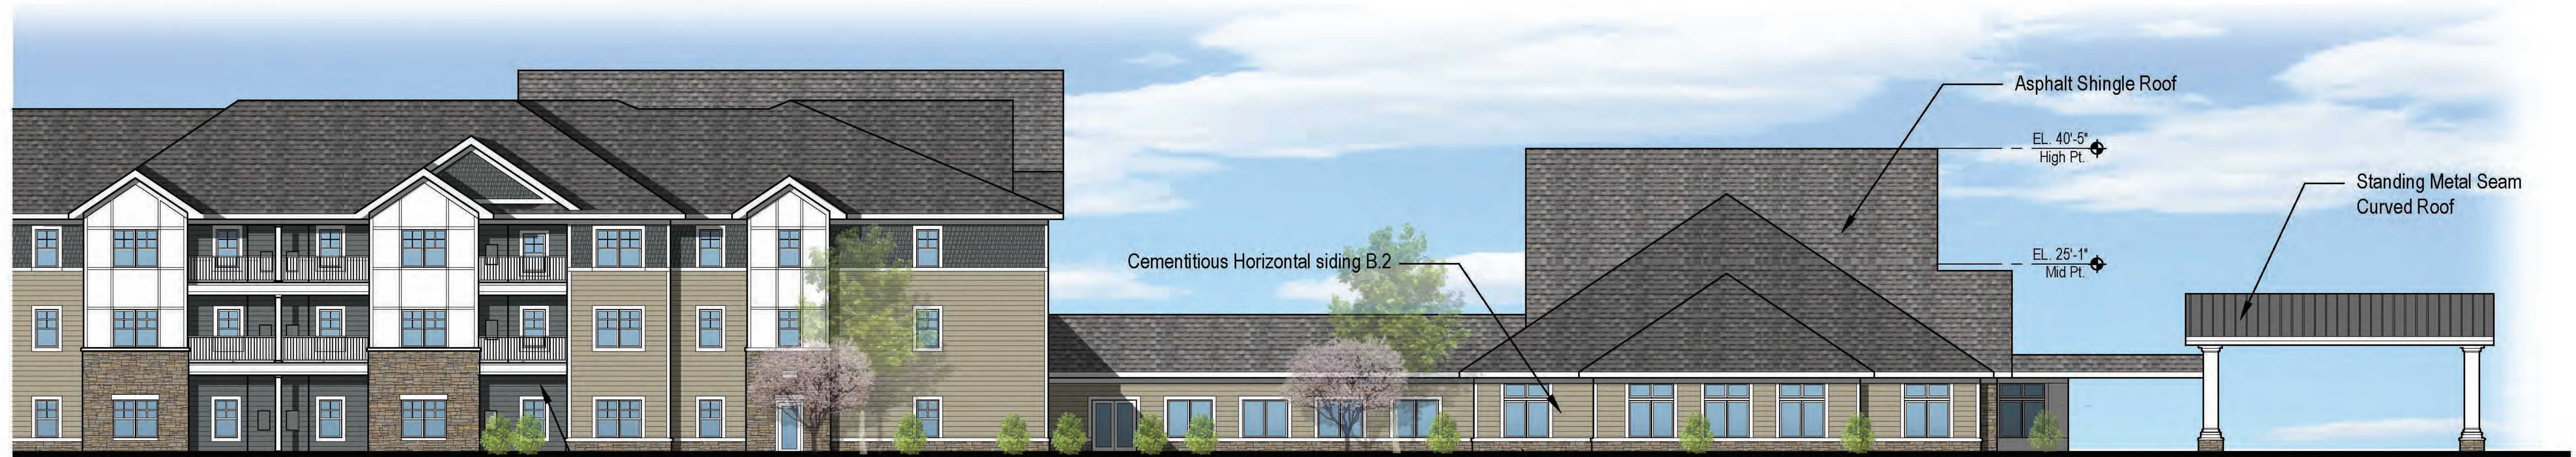
**C - WEST ELEVATION - Commons**

Cementitious Horizontal siding B.1

Standing Metal Seam  
Curved Roof

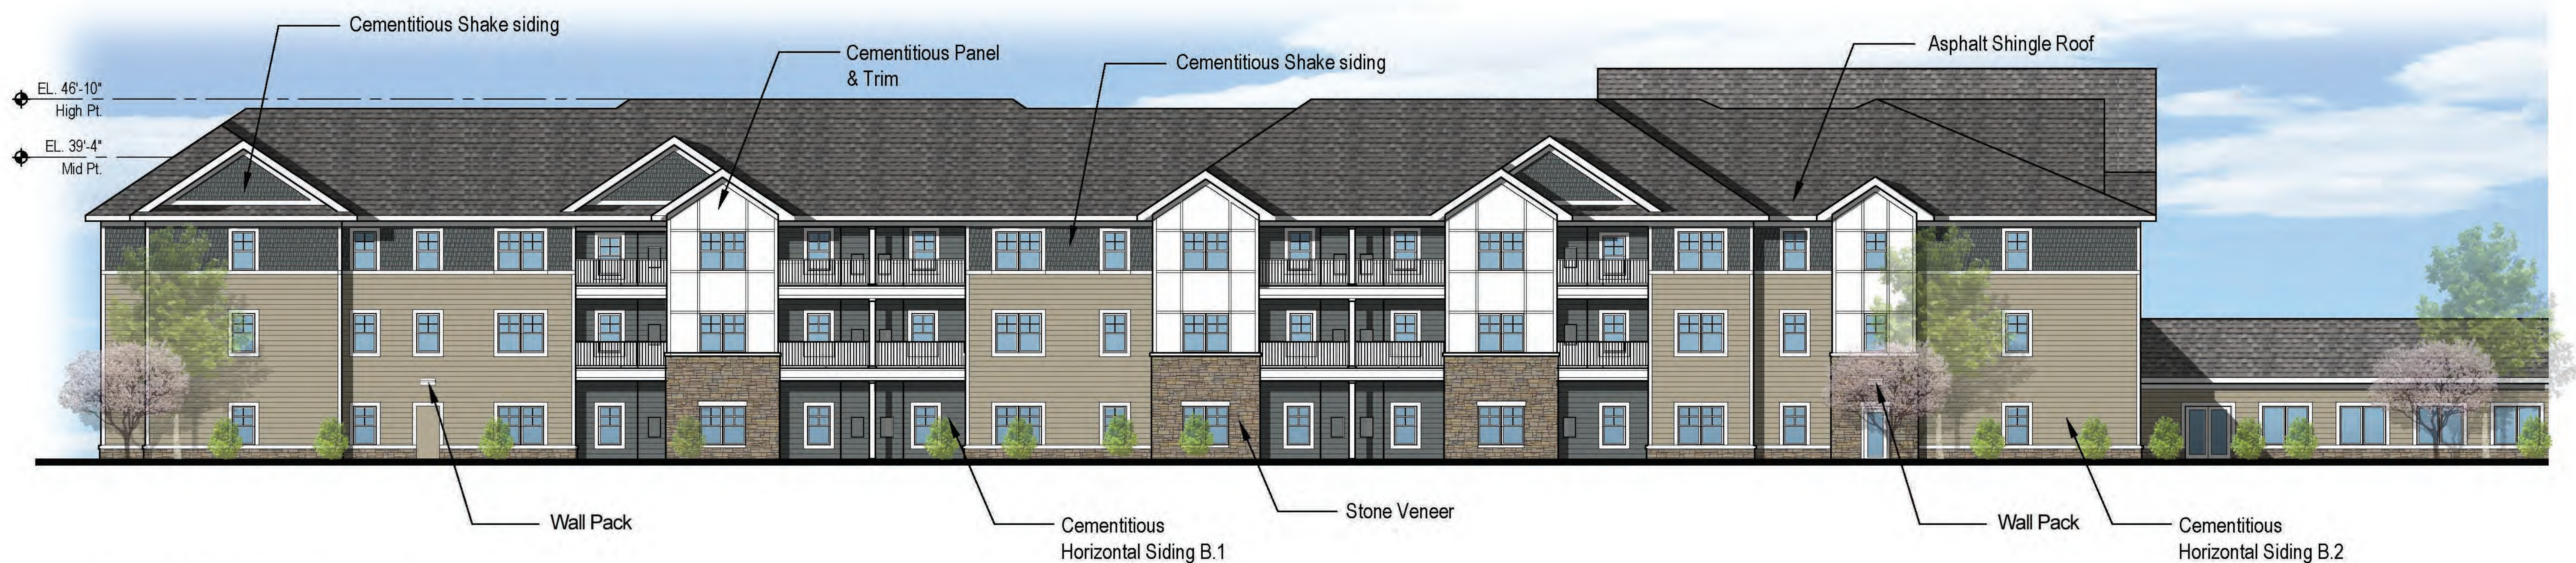
**C - WEST ELEVATION- Apartment**

Cementitious Shake siding

Cementitious  
Horizontal Siding B.2

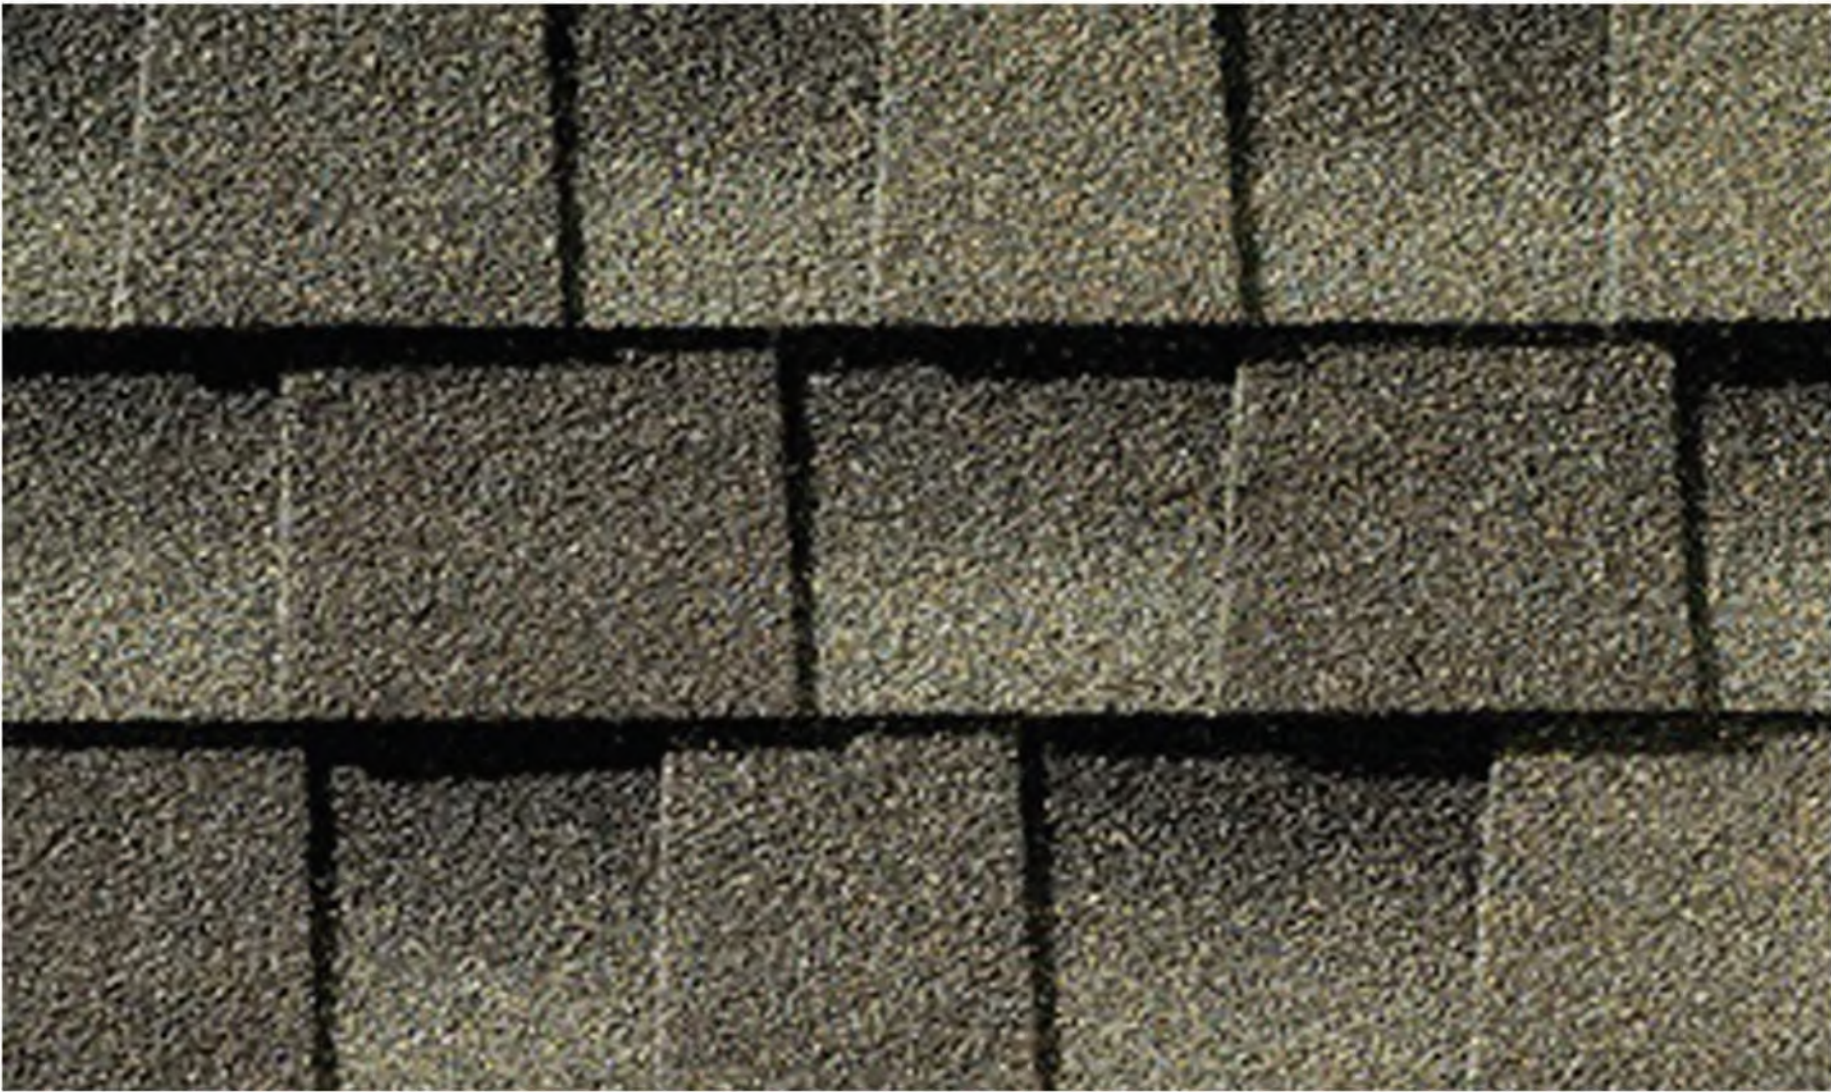
**FIBERGLASS SHINGLE ROOFING**  
GAF TIMBERLINE ARCHITECTURAL ROOF SHINGLES

COLOR: WEATHERED WOOD

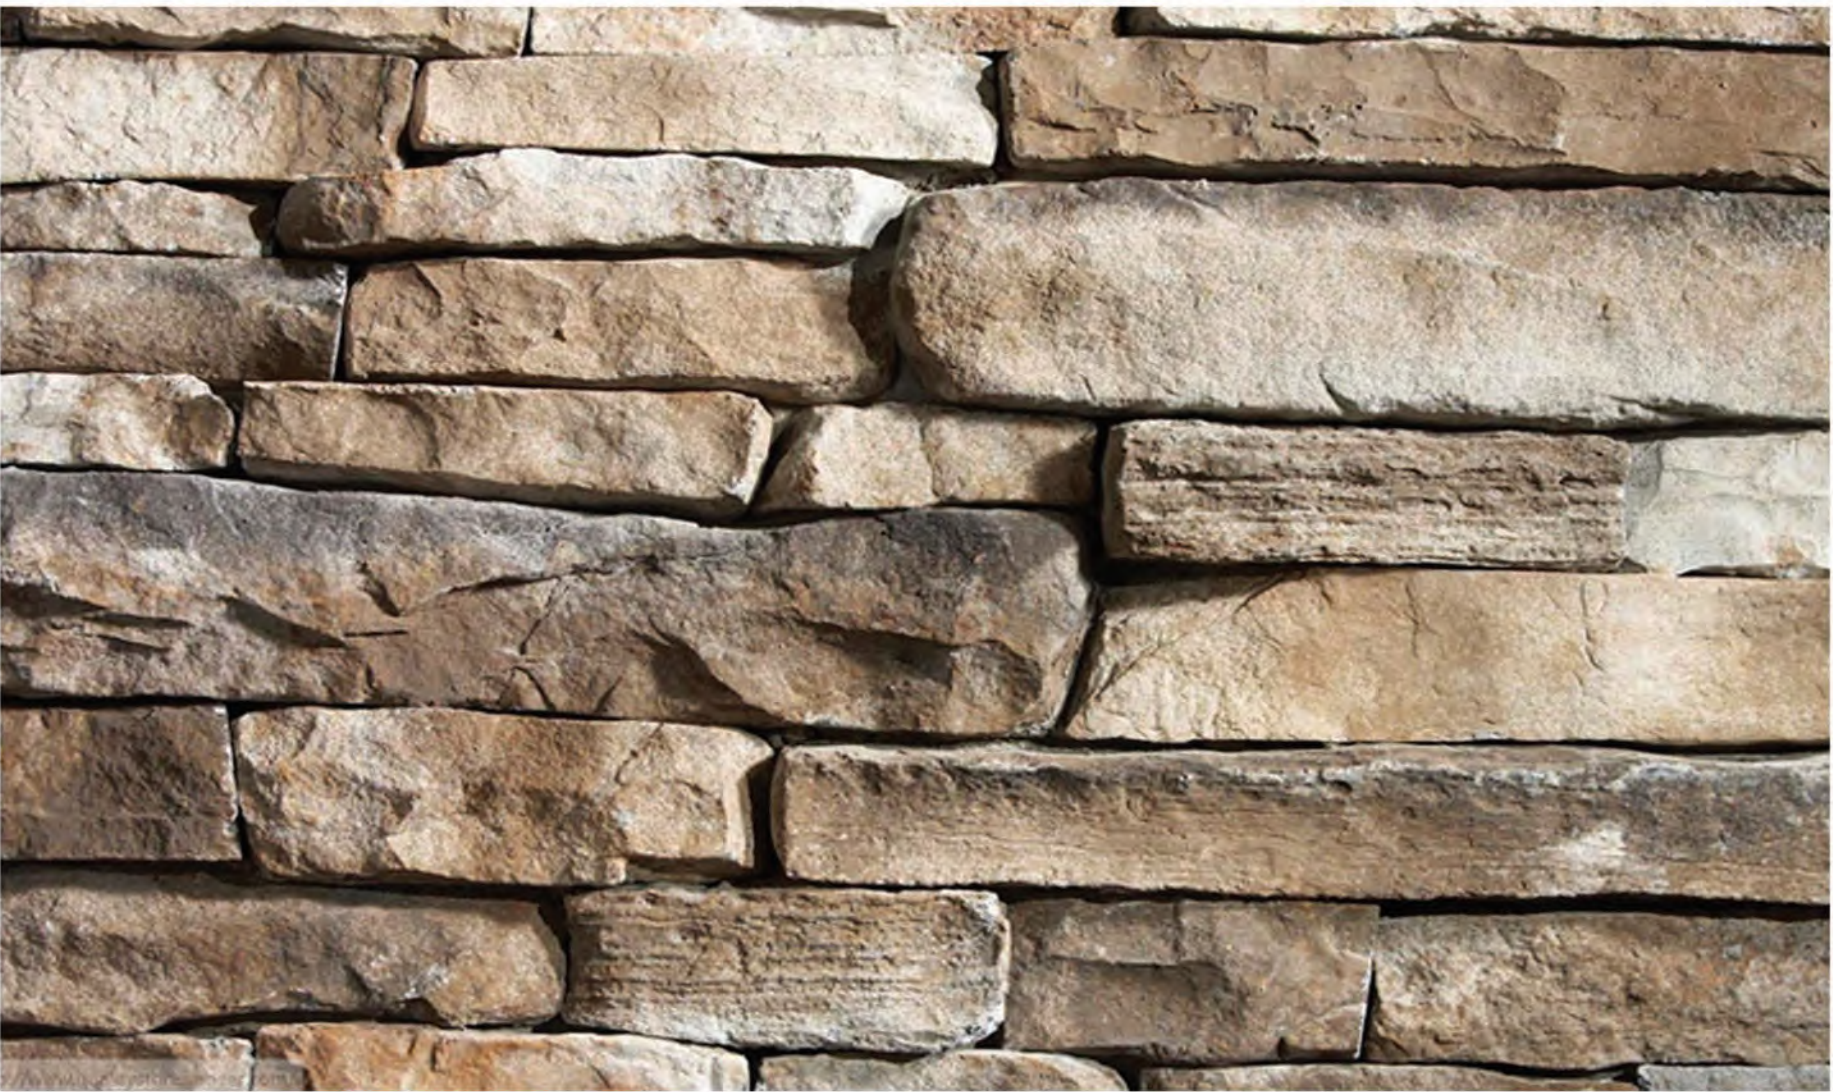
**PANELIZED STONE VENEER SYSTEM**  
QUALITY STONE VENEER

STYLE / COLOR: POWDER RIDGE DRystack CLIP

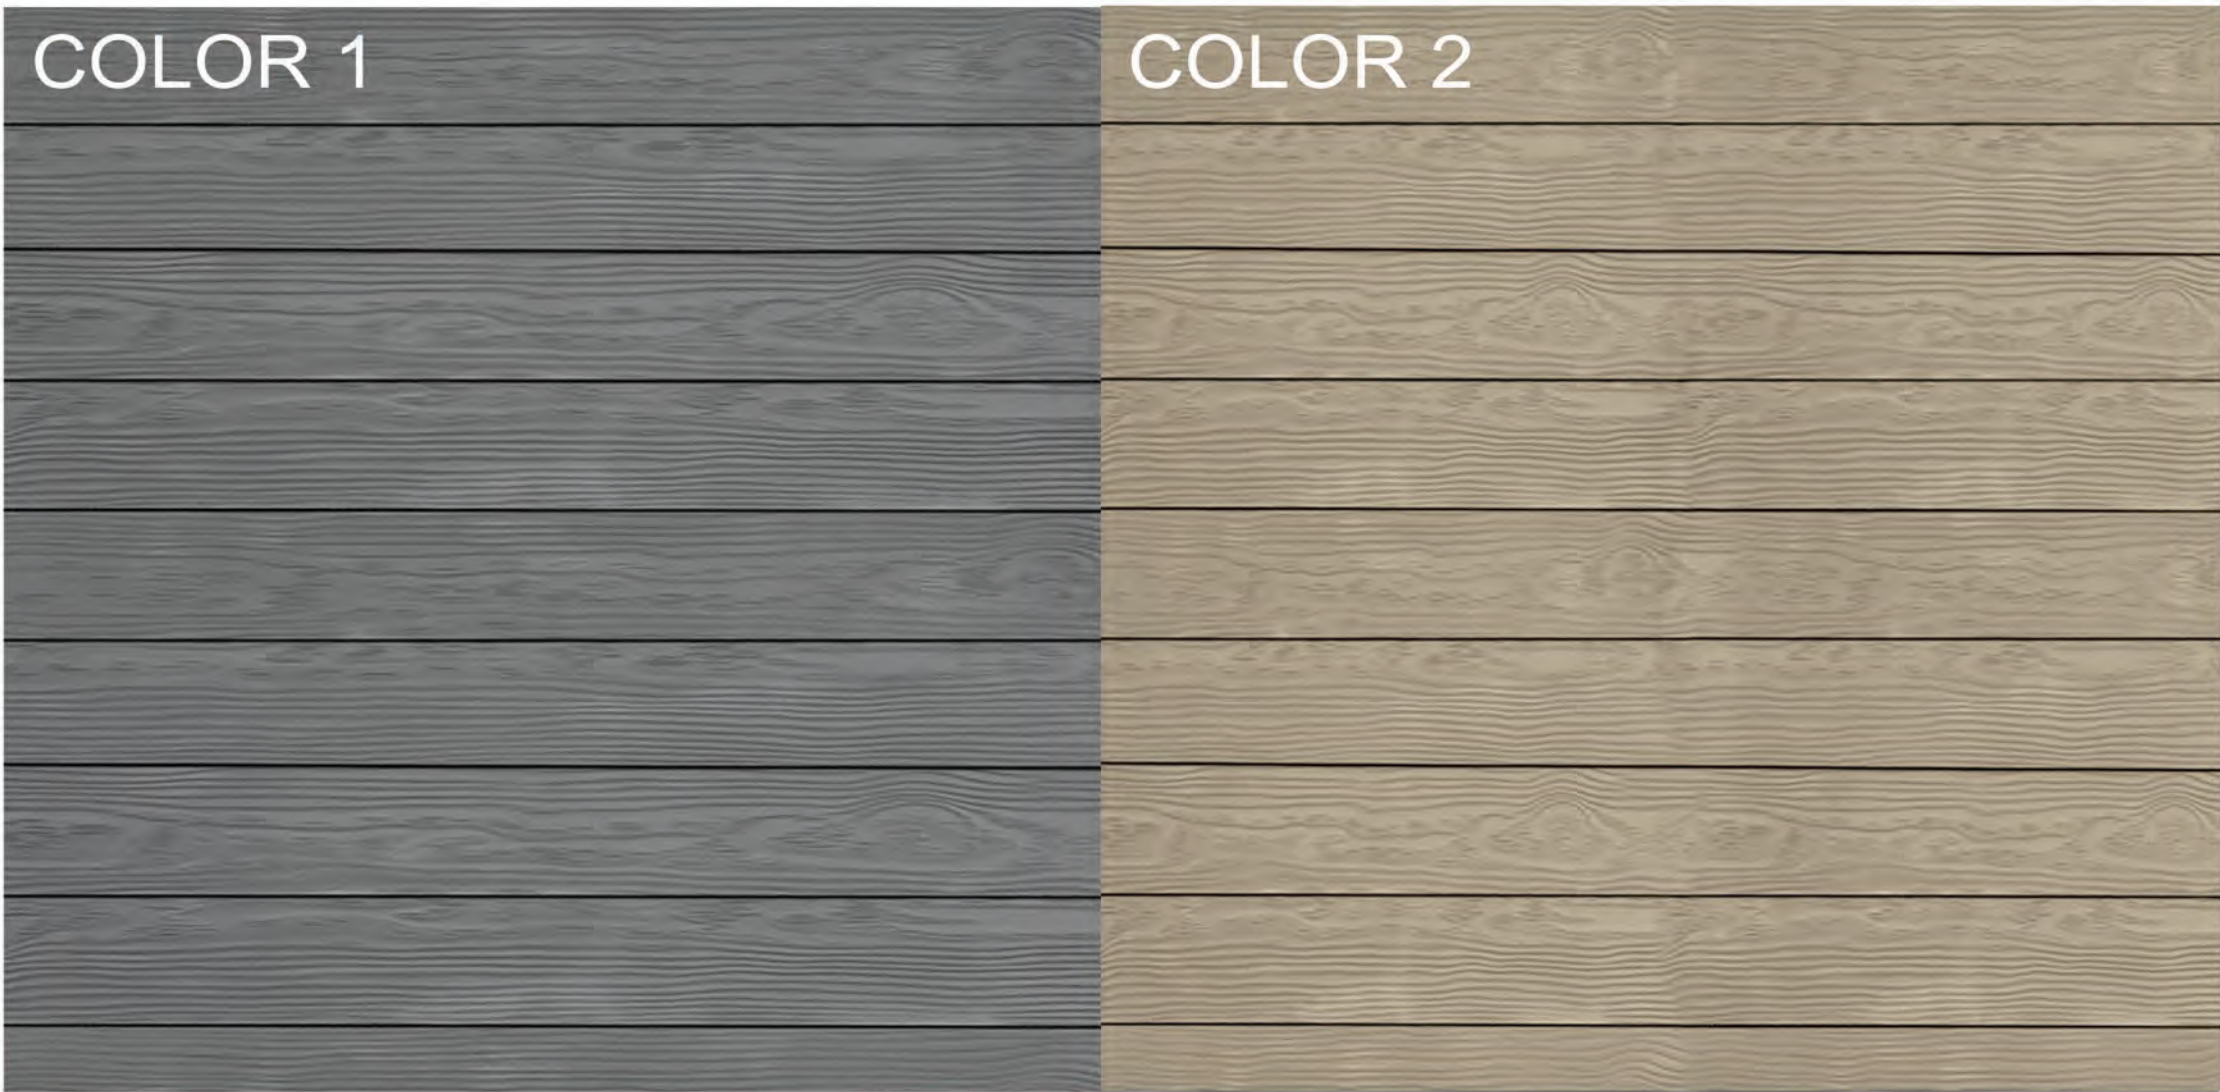
**SIDING B.1: CEMENTITIOUS HORIZONTAL SIDING**  
ALLURA FIBER CEMENT SIDING: 5" LAP SIDING

**SIDING B.2: CEMENTITIOUS HORIZONTAL SIDING**  
ALLURA FIBER CEMENT SIDING: 5" LAP SIDING

COLOR 1: COOL CHARCOAL  
COLOR 2: NATURAL CLAY

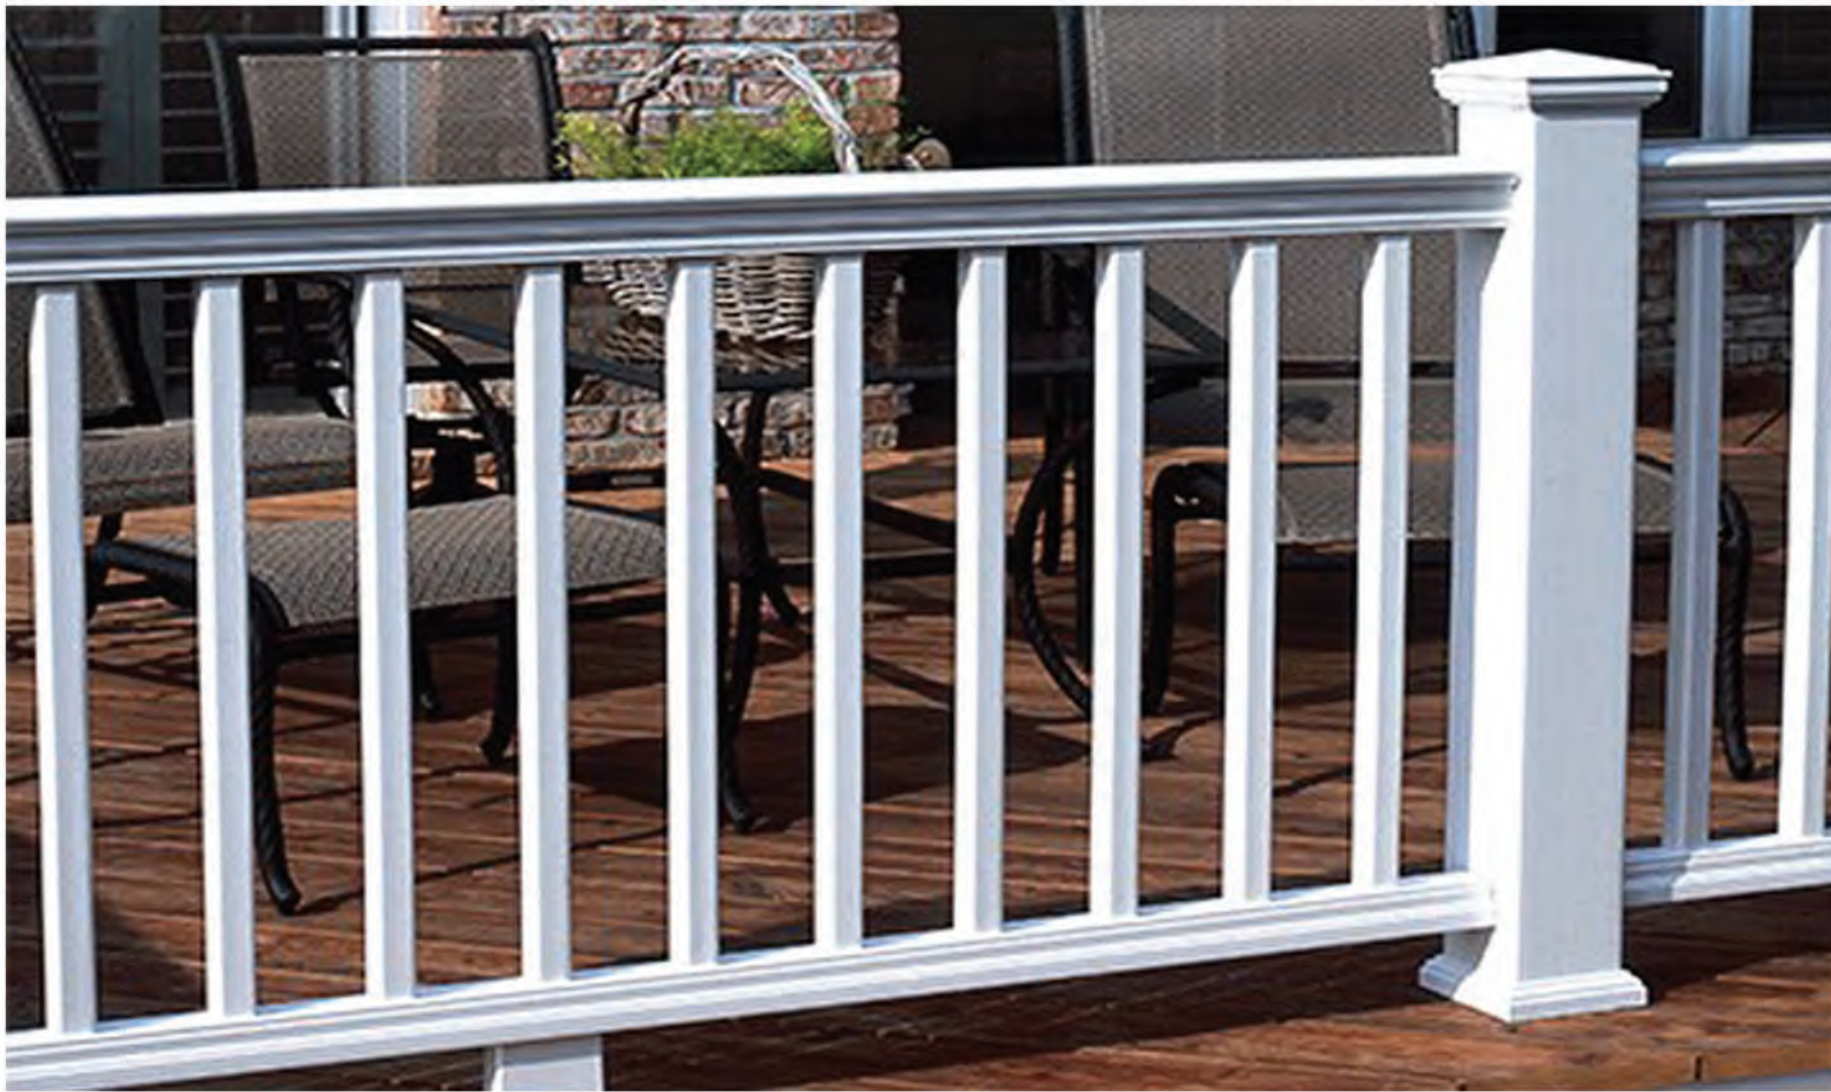
**BALCONY RAILINGS & DECKING**  
CERTAINTEED EVERNEW RAILING AND DECKING SYSTEM

COLOR: WHITE
