HISTORIC DISTRICT COMMISSION

6:30 p.m. July 10, 2024

Certificate of Appropriateness Application: **404 W. King Street** – Applicant is requesting to construct a new detached garage with an ADU adjacent to the existing residence (PIN 9864766393)

- A. Certificate of Appropriateness Application: **437 Dimmocks Mill Rd.** – Applicant is requesting to install windows in the northwest wall of the mill, demolish Suite 50, regrade, and add a bus drop-off. (PIN 9864646207.006)

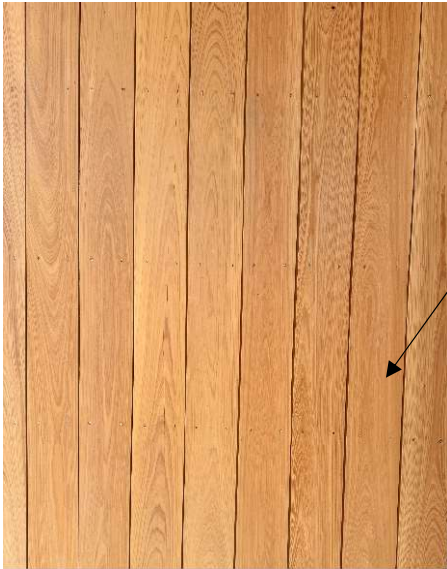
(Vertical
Tongue and
Groove
Cypress
Siding)

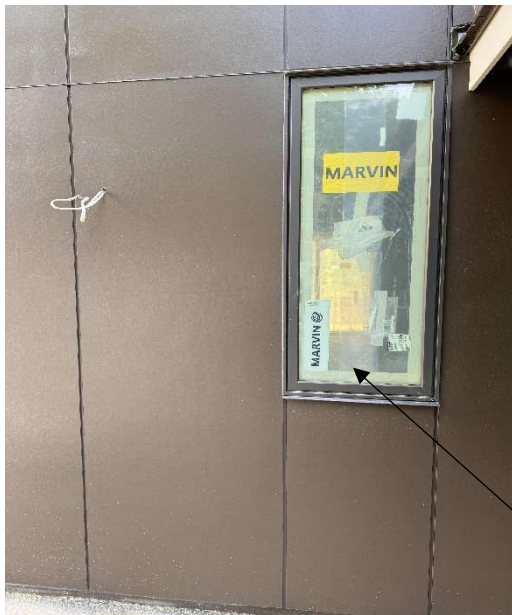
Cementitious
Panels

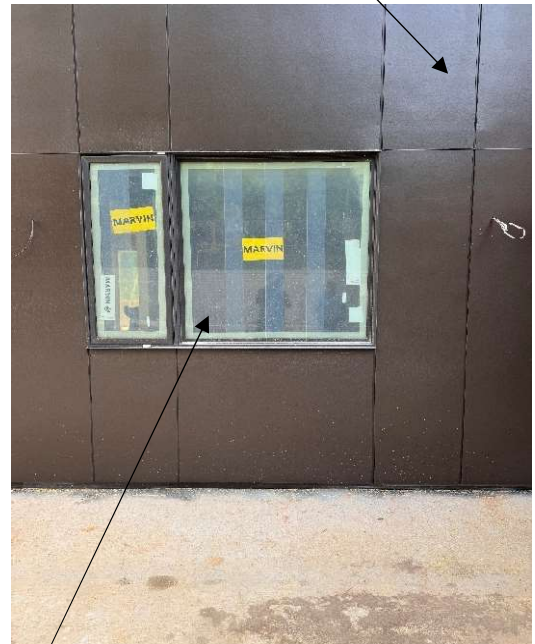
Casement Window
with Cementitious
Trim – Marvin
Elevate Casement
Windows

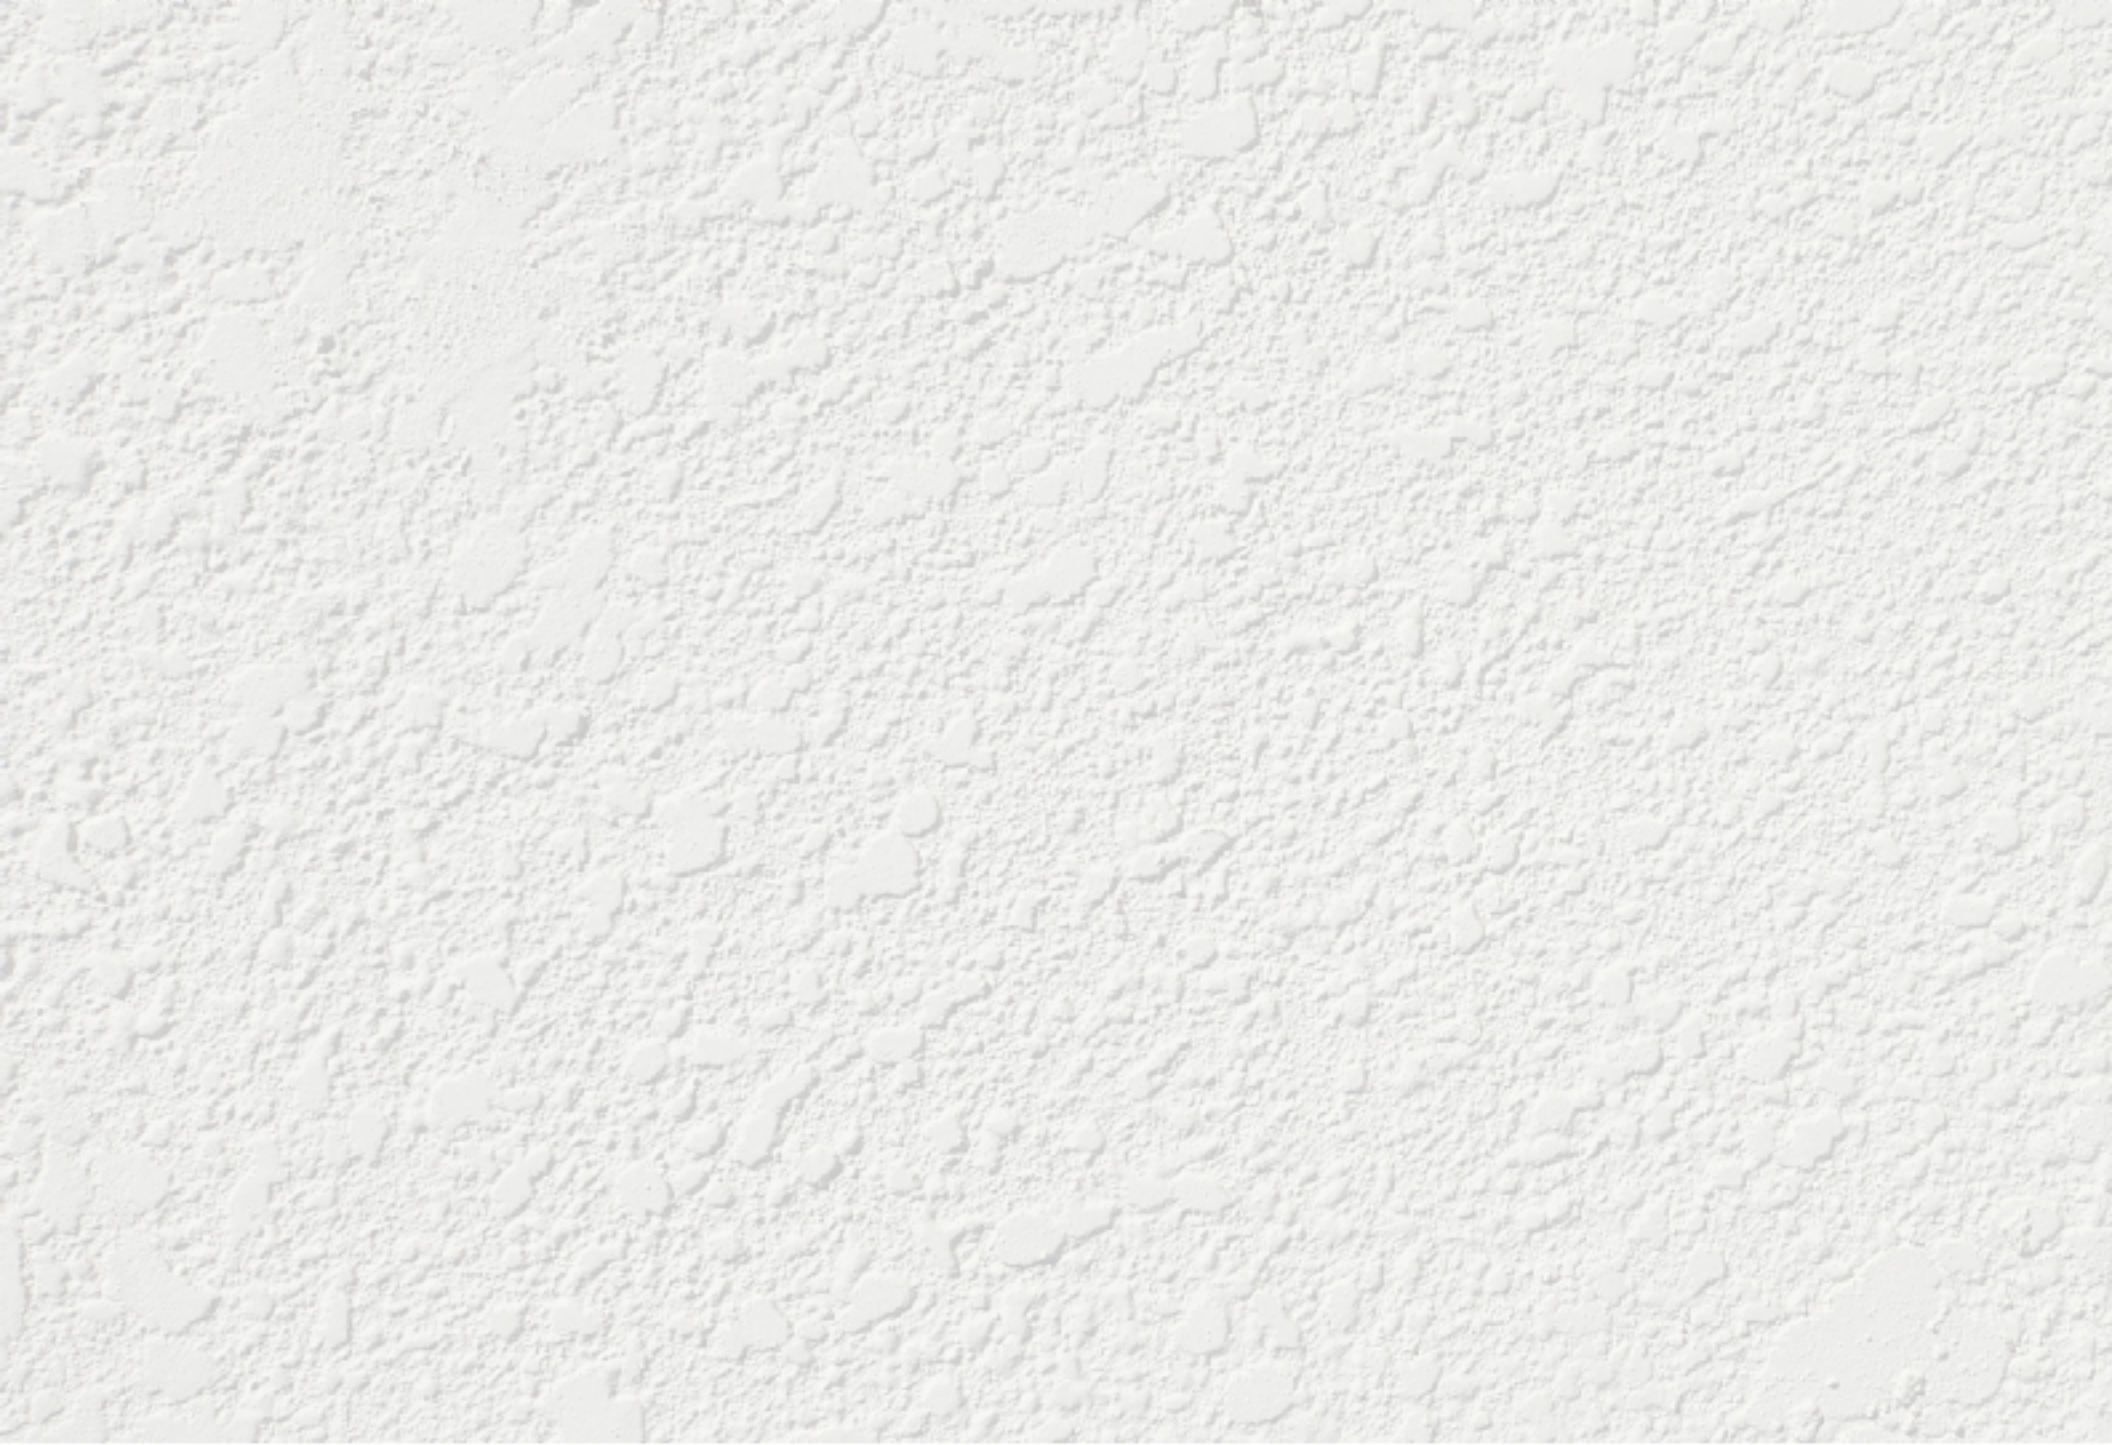
Photo of existing parge finish at Eno River Mill - proposed for high school patio wall-actual size

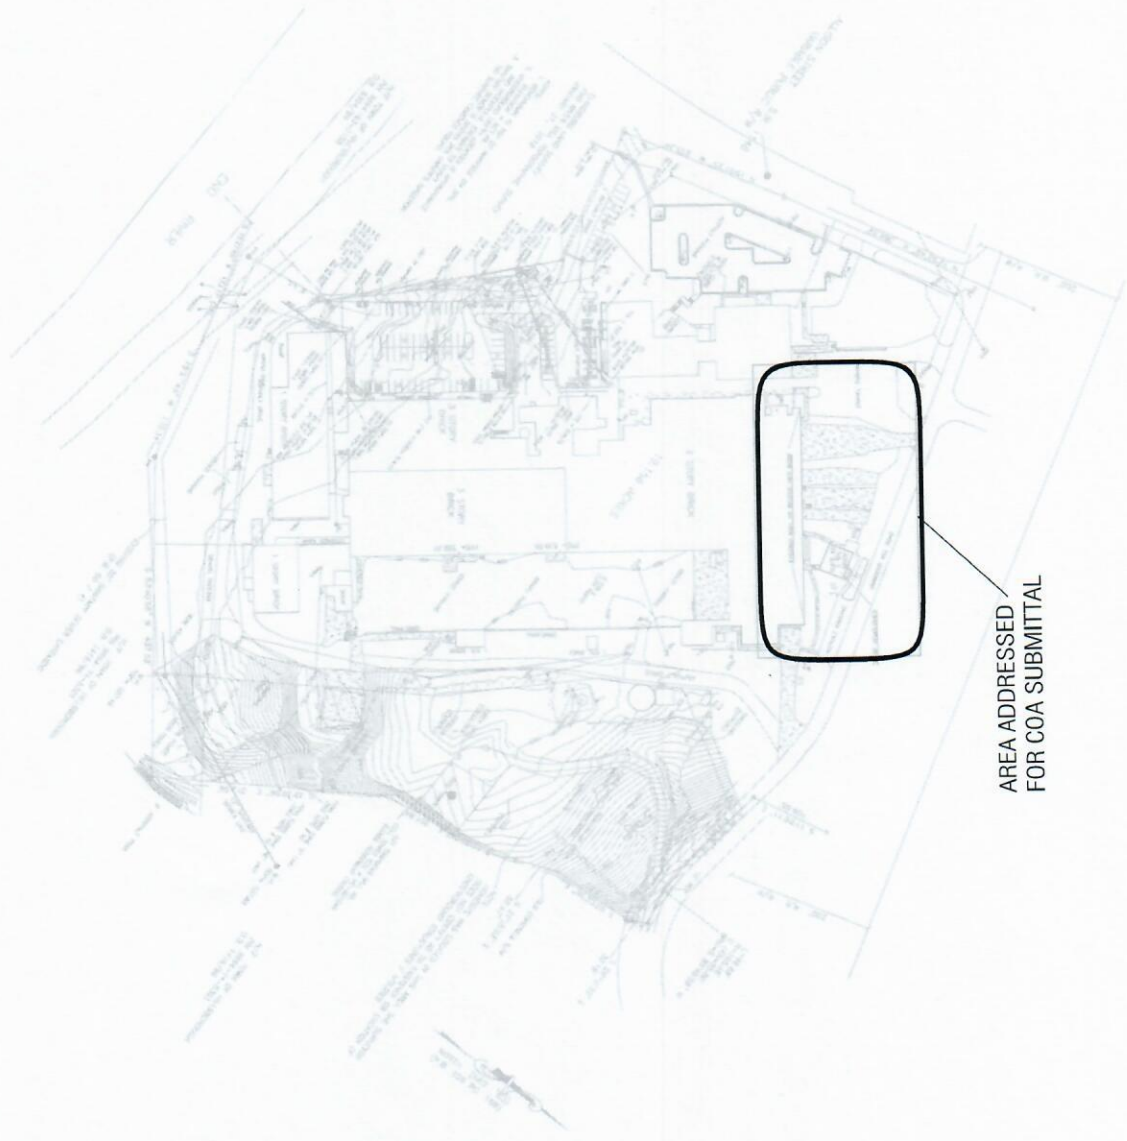
OVERALL SITE PLAN
 NTS

AREA ADDRESSED
 FOR COA SUBMITTAL

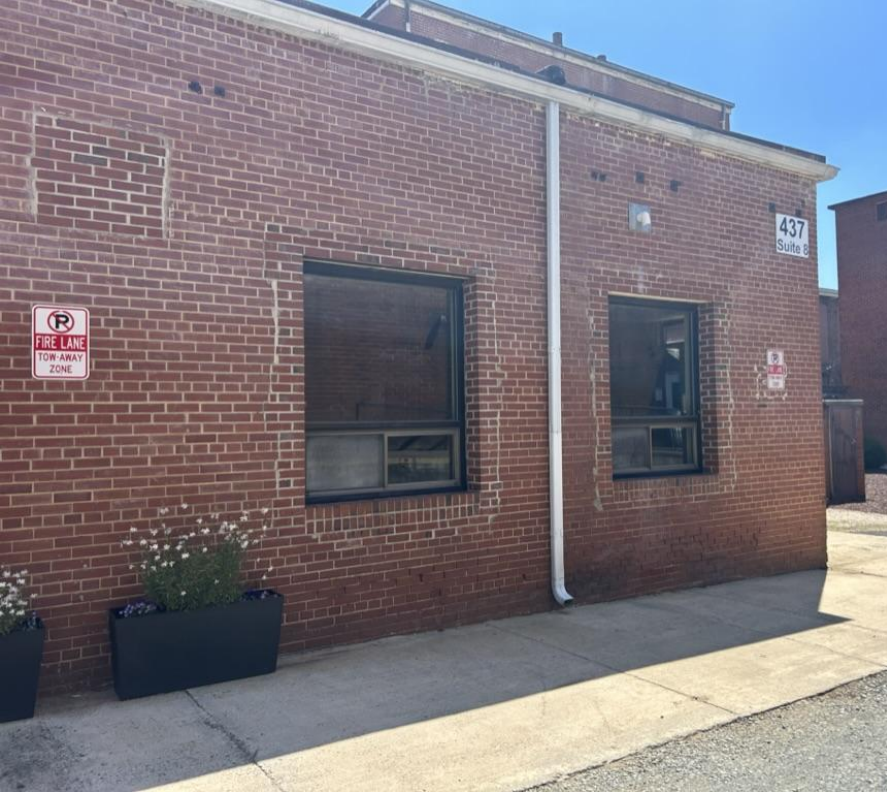
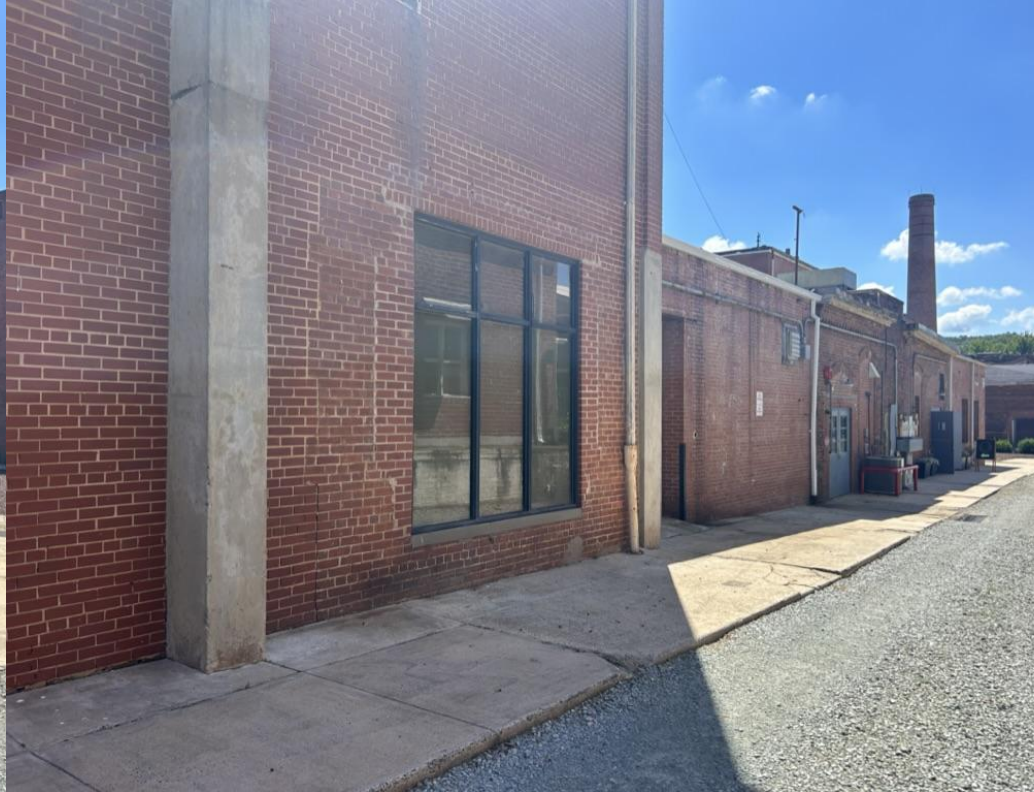
1923 and 1931- SW Facade

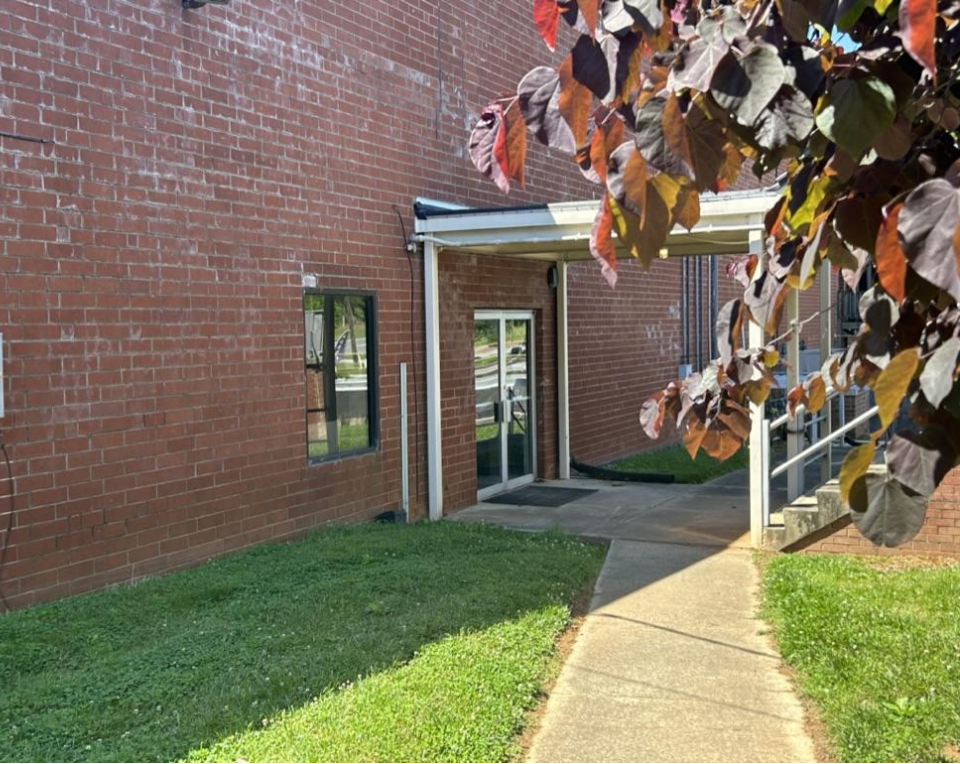
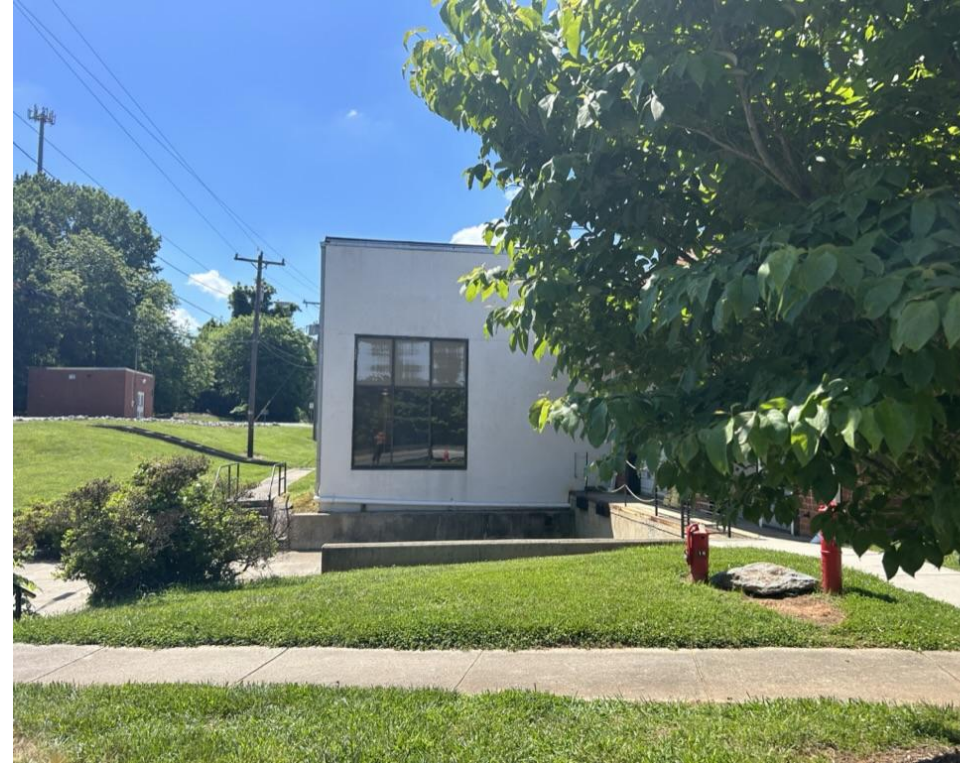
1971- NW Facade

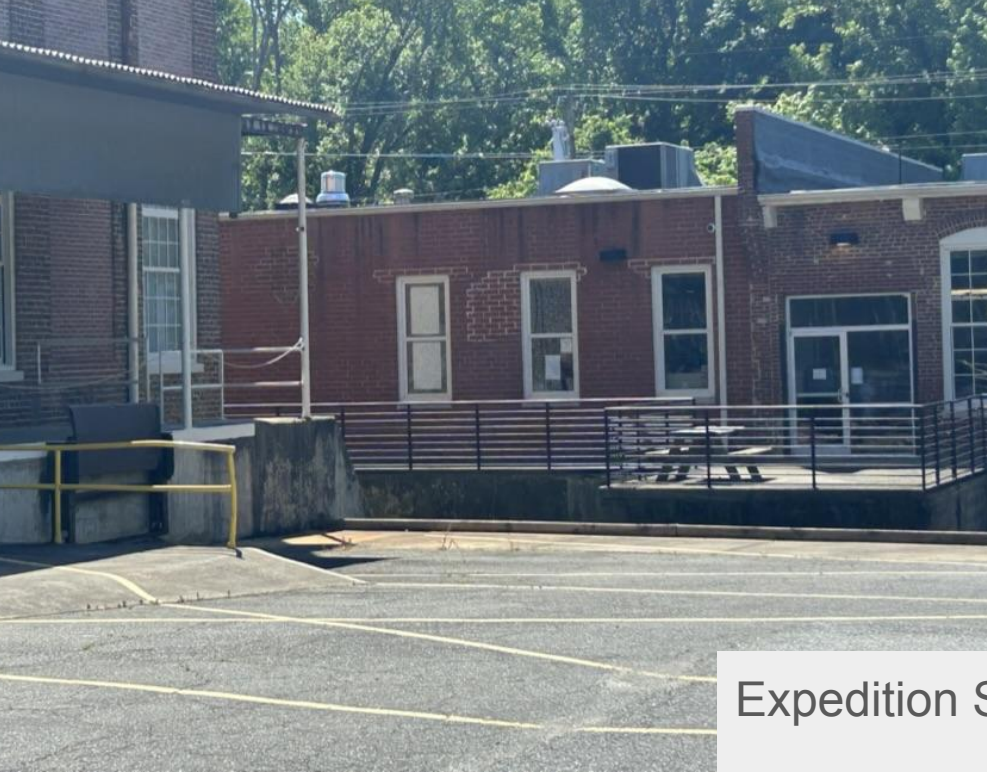
1908 SE
Window openings that were added during the school's construction

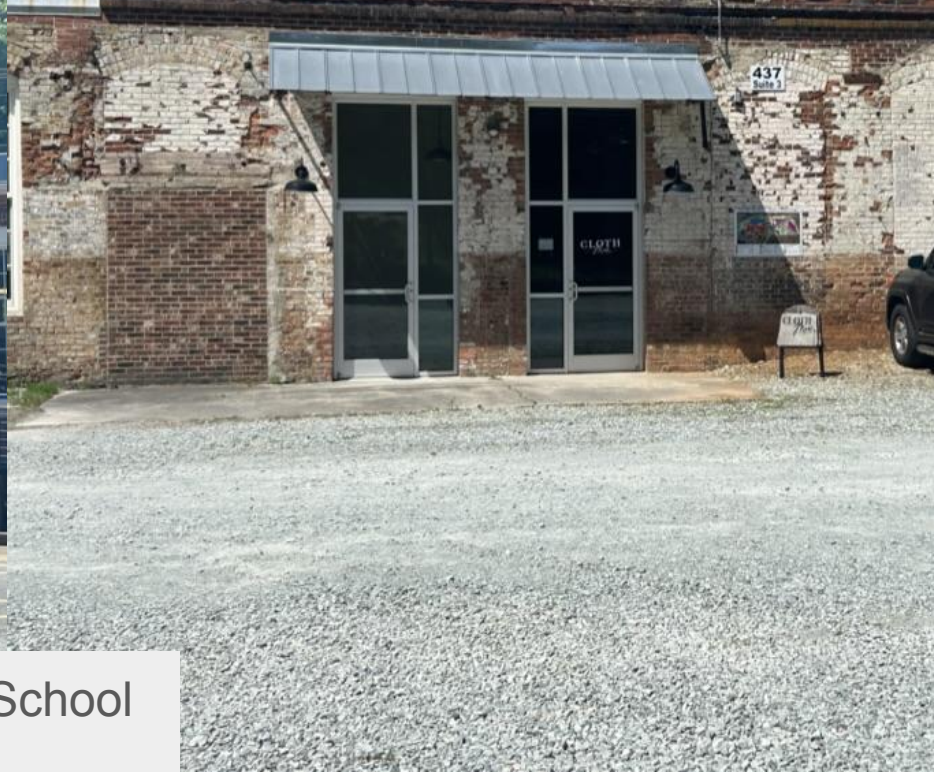
1917 NE
Doors that were added to be a secondary entrance to the school.

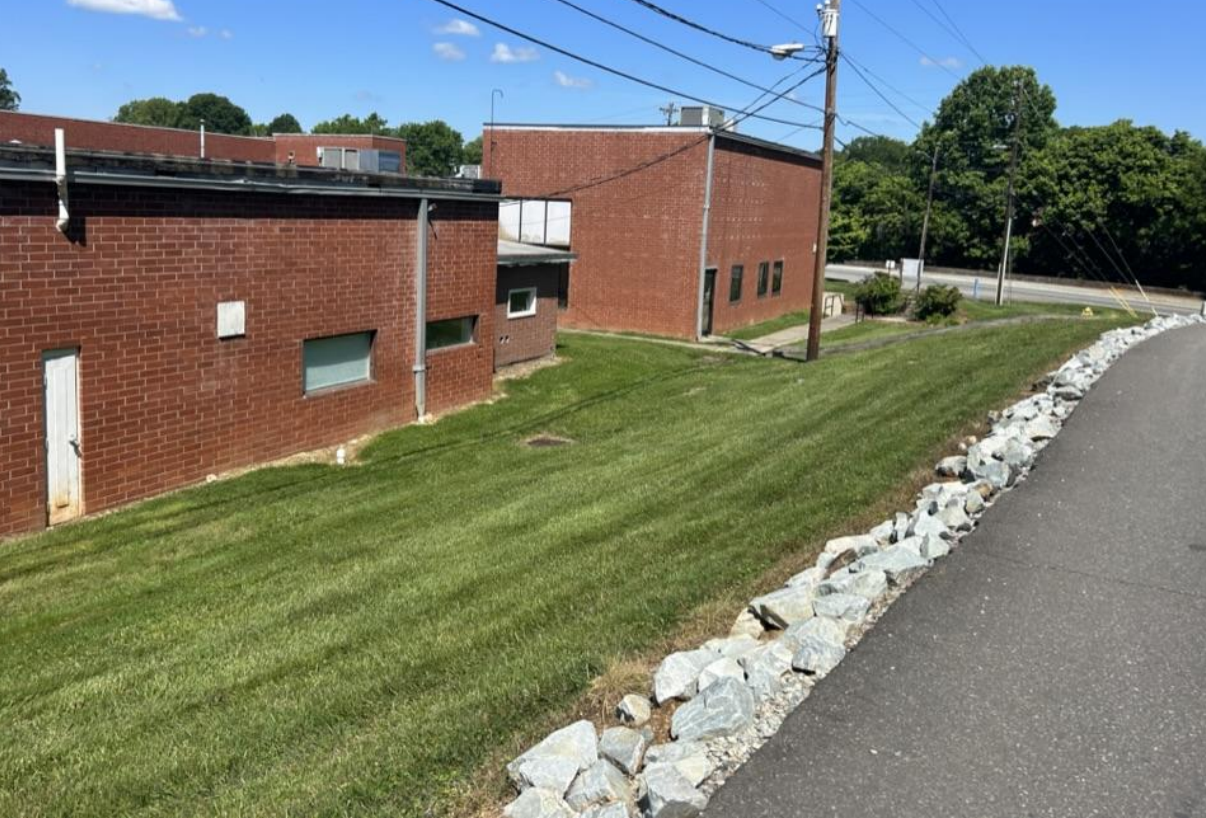
1971- NE Facade
