PRELIMINARY ENGINEERING REPORT

**LABORATORY EXPANSION AND NEW
ADMINISTRATION BUILDING**

**HOPEWELL WATER RENEWAL
CITY OF HOPEWELL, VIRGINIA
DRAFT FOR HWR REVIEW**

APRIL 2022

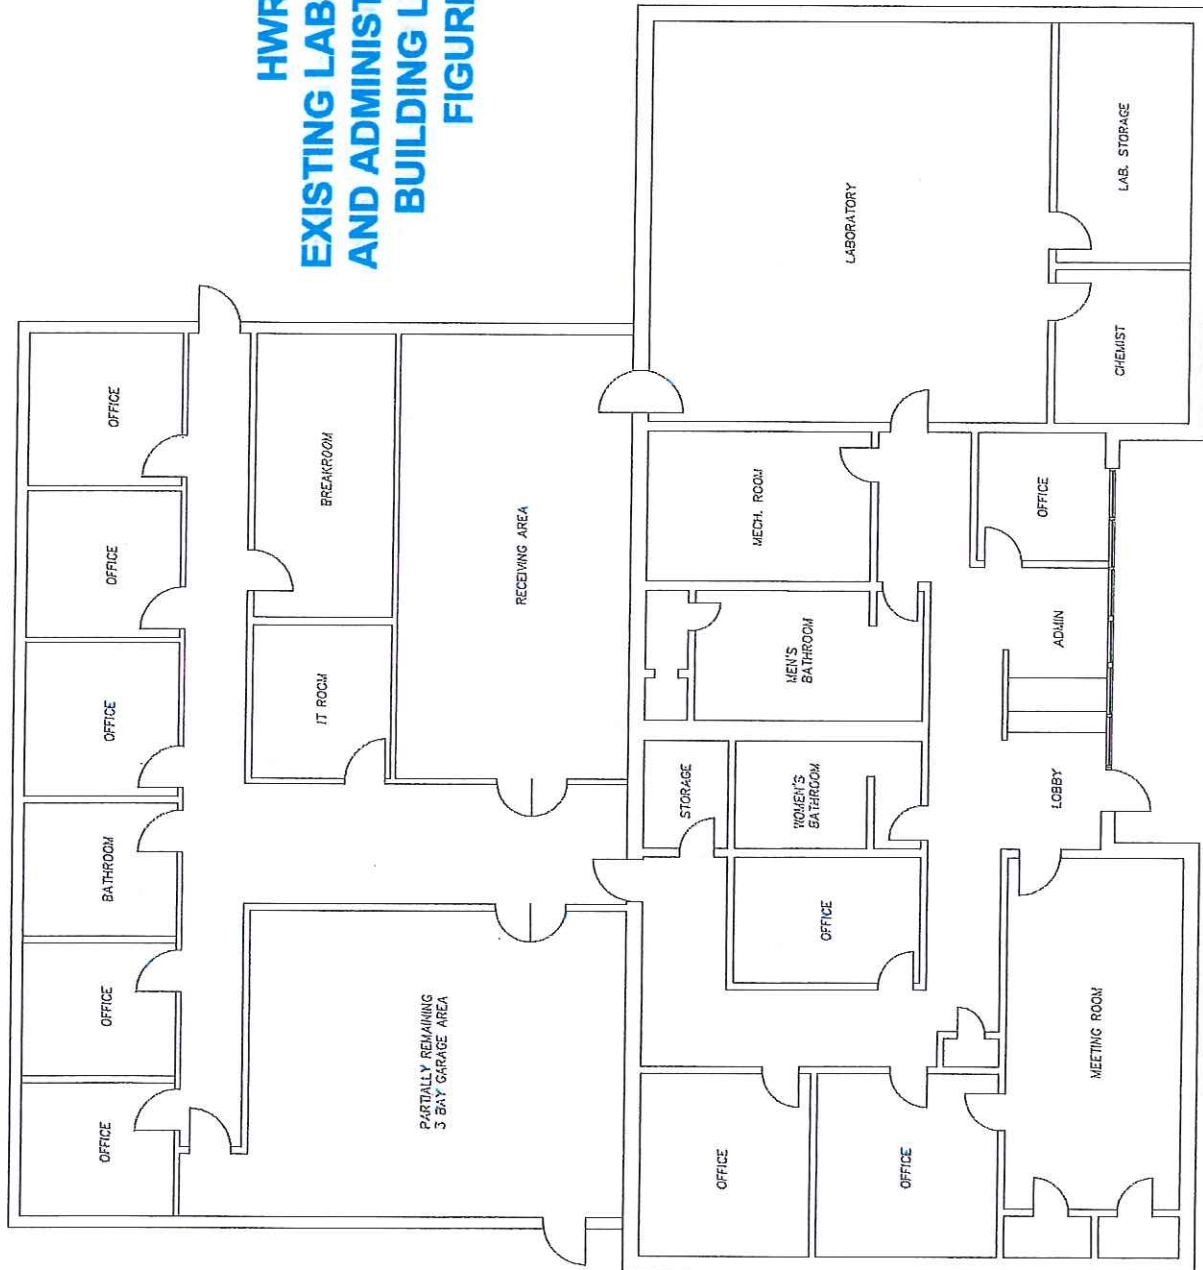
HWR EXISTING LABORATORY AND ADMINISTRATION BUILDING LAYOUT FIGURE 1

The current laboratory/administration building was constructed in three different projects. The first project was designed in 1974. This included a lobby, meeting room, director's office, office staff room, plant supply room, mechanical room, laboratory, chemist office, lab storage, and men's and women's bathrooms. The first edition of the building is approximately 3,500 square feet. The second project, designed in 2000, included the expansion of the existing building from 1974. This expansion included a 2,900 addition of the western side of the building. This expansion included three offices, an IT room, a breakroom, a receiving area, and a 3-bay garage. The final project, completed around 2015-2016, included a renovation of the space created in the second project. This renovation provided three more rooms used as office spaces and was constructed in the 3rd bay of the garage. The layout of the building after all three projects is generally shown below in the figure.

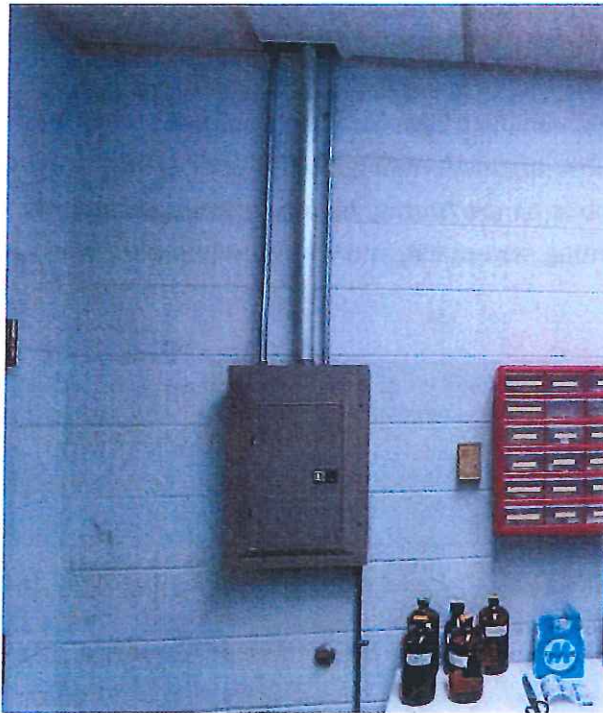
Existing Sub Panel

Most of the original panels have had breakers replaced with various and different manufacturer's due to age and availability of discontinued breakers. Given the age of these panels (over forty-five years) and amount of renovation being proposed all original panels, transformers, branch circuits would be recommended to be replaced as they have reached their useful life.

As detailed in Section 1.2.2, the electrical systems in the facility are at the end of their useful life and should be replaced in conjunction with the overall building renovations. This would include upgrades to the communication systems to more modern equipment in conjunction with the relocation of the IT equipment.

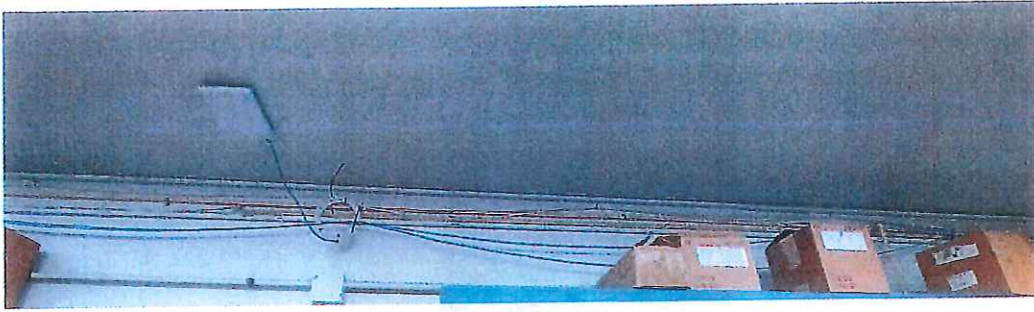
Exposed communication cables with wireless router

Also, communications in the building will be upgraded to current standards and a new IT room will be constructed to house the IT with dedicated HVAC. Communications system since the 70's has changed, and upgrades were done over the years to address technology changes. However, with the proposed renovations now is the time to fully upgrade the system to the latest communication infrastructure.

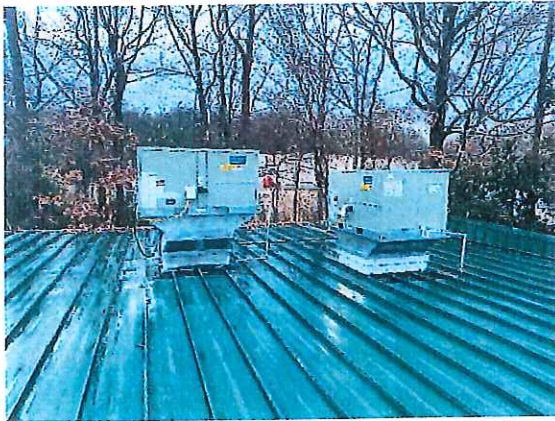
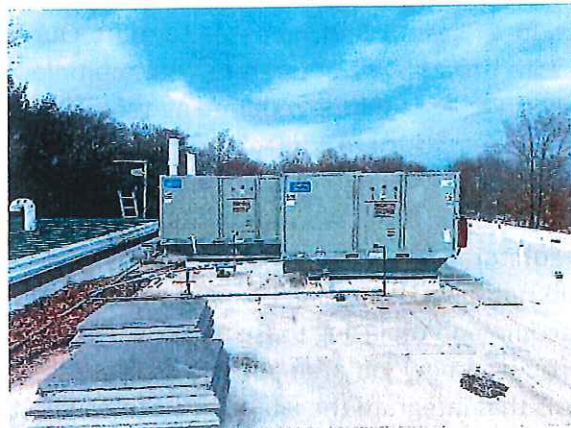
The heating and cooling for the existing building is served by four Trane gas rooftop units and two Ameristar ductless mini-split units. The rooftop units were all replaced in 2019 and seem to be in good condition. We reviewed the model numbers of the existing units with a Trane representative and determined these are basic units with gas forced air furnace, cooling coils, and have single zone control. We noted that HWR staff indicated the existing laboratory area tends to be warm. Also, the two mini-split units may have been added to address warm areas caused by capacity shortfalls.

Existing rooftop units (two on the older flat roof and two on the metal roof)

Typically for a laboratory building we would specify HVAC units that have more options for multiple zone control using variable air volume (VAV) to each space. This allows the air to be delivered to the load more efficiently and increases comfort. Our recommendation is to replace the existing rooftop units with units that can operate with multiple zones of VAVs. The ductwork should be replaced and reworked to meet the required air for each space. We also recommend installing a direct digital control system (DDC) to control the rooftop units, VAVs, and laboratory hoods.

As detailed in Section 1.2.3, while the existing HVAC equipment is in good condition, replacement of all of the existing equipment is recommended due to limitations of the existing equipment and its inability to provide for multiple zone control. The new units are proposed to be rooftop units like the current equipment and will be designed in conjunction with the roof replacement.

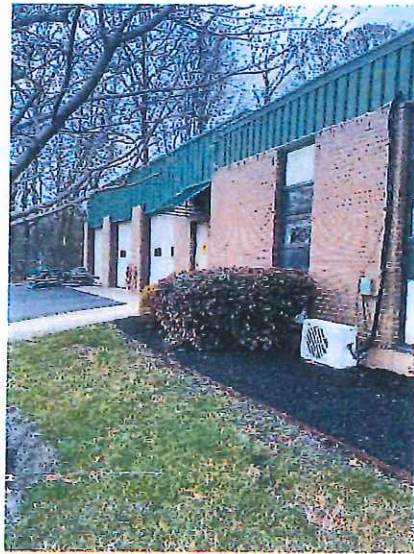
Existing outdoor ductless mini-split unit

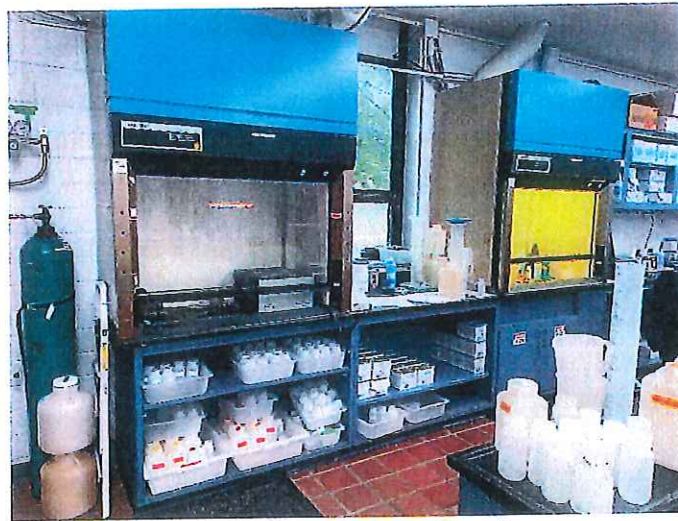
There are two existing laboratory hood systems in the lab area. The existing units do not have air flow monitoring and seem to be at their typical end of service life. Also, the roof mounted exhaust fans do not have the mixing box and bypass damper required to meet current code requirements. We recommend replacing these two existing systems and providing three new lab hood systems in the proposed new lab area spaces, as requested by HWR staff. Lastly, we recommend providing controls that integrate the lab hood systems into the DDC system for the building HVAC system.

Existing laboratory hood

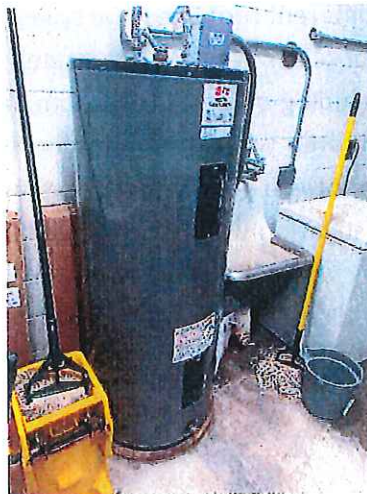
The building is served by a 2" domestic water line that routes to the mechanical room. The existing water entry to the building does not have a backflow preventer. The building is served by an 80-gallon electric water heater. We recommend replacing the existing water heater with two new water heaters that have adequate storage capacity to deliver tepid water for the safety showers. Current codes require the delivery of tepid (85°F) water to safety showers for 15 minutes.

Existing Water Heater

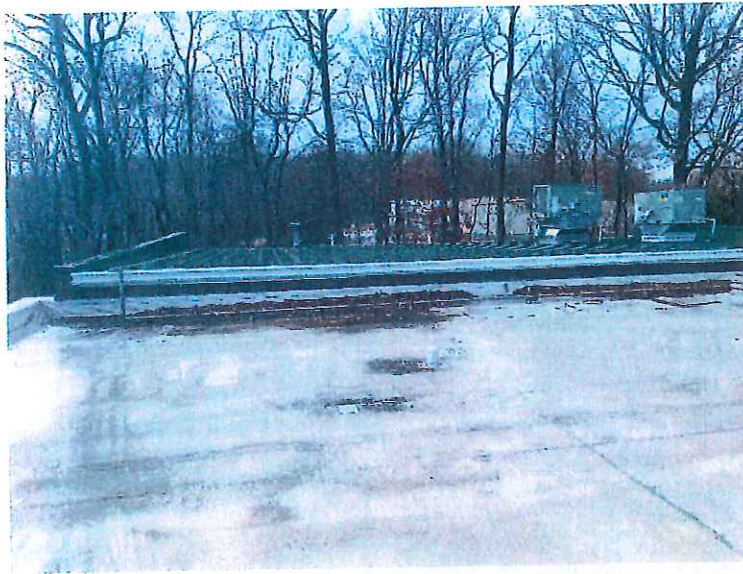
As noted above the current laboratory/administration building was constructed in three different projects, beginning in the mid-70's, then 2000 and finally interior additions in the 2016 timeframe. The block wall construction of the original building, with the addition of the metal framed construction in 2000 ended up with 2 different roof lines and types. One of the significant concerns of the existing building is the amount of rainwater that penetrates the roof and ends up in various locations throughout the structure, including offices, breakroom, laboratory, receiving areas, and significant leaking in the bayed garage area where the addition shares a common wall with the original construction. As seen in the photos below, efforts have been made to repair the original roof. However, a more thorough investigation will be conducted in the next phase of this project to determine what exactly is happening with the seam where the 2 roofs were combined in 2000. It appears there is leaking around the HVAC rooftop units noted in the prior section when these units were replaced in 2019.

Original building roof looking toward newer section

As documented previously, the existing roof system leaks and needs significant repair or replacement. Failure to address this situation will allow water damage to the building interior to continue and likely worsen with time. A structural engineer has been engaged during this preliminary evaluation and will be an integral part of the schematic design phase which will address both the issue of the roof line as well as the incorporation of any existing or new roof mounted HVAC equipment, including those associated with the laboratory vent hoods. The preliminary estimate presented below assumes a complete roof replacement with an allowance for structural improvements as necessary.

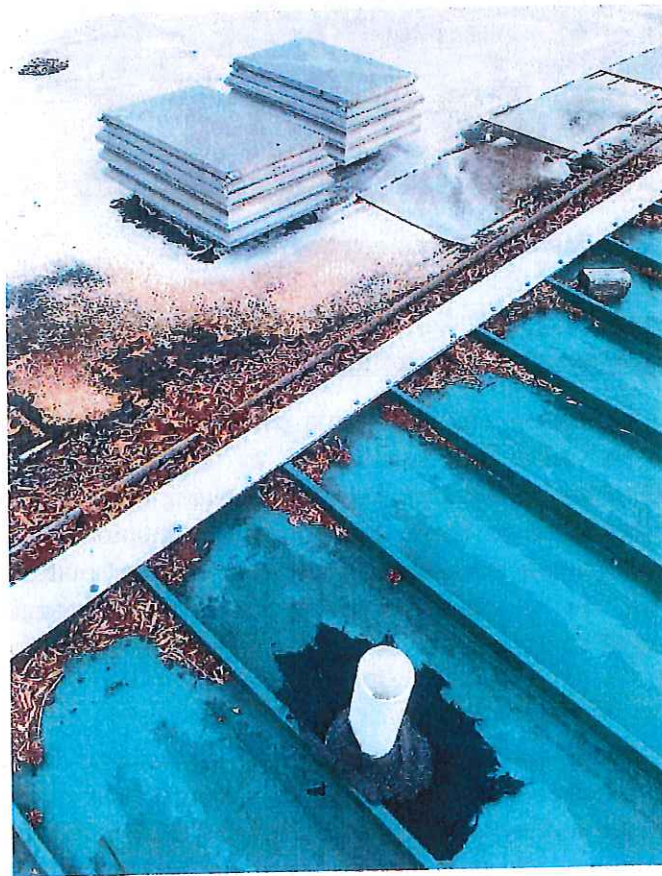
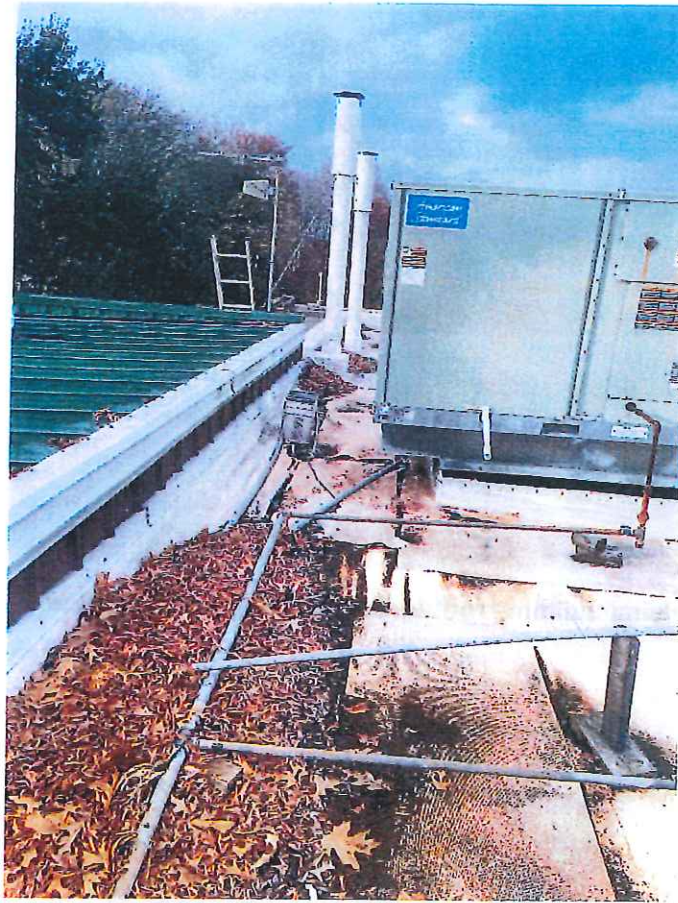
Transition between two roof lines

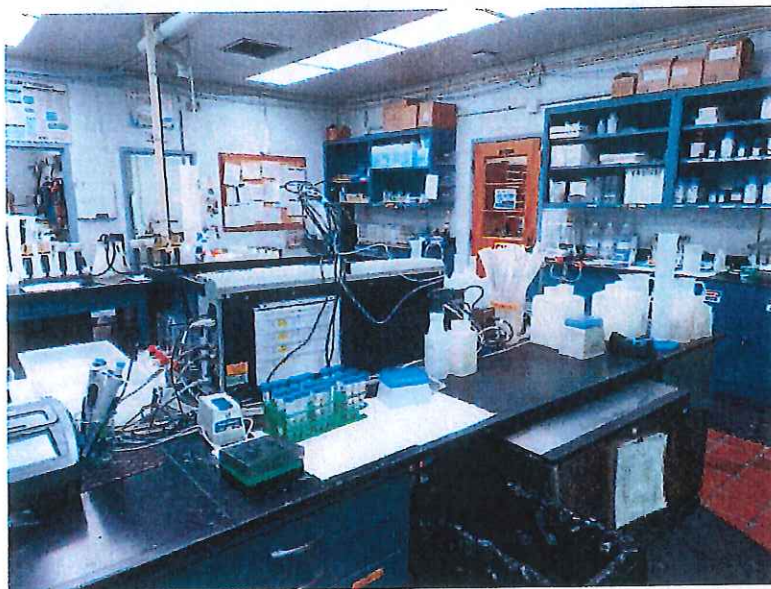
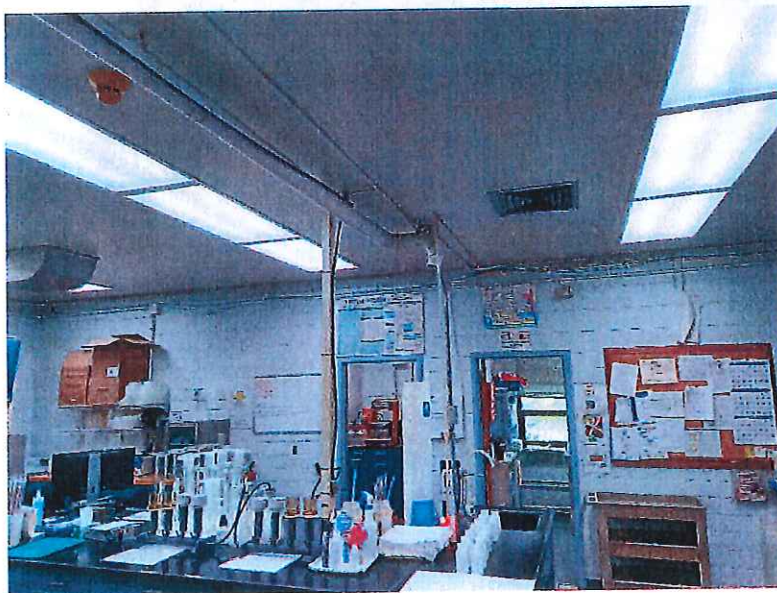
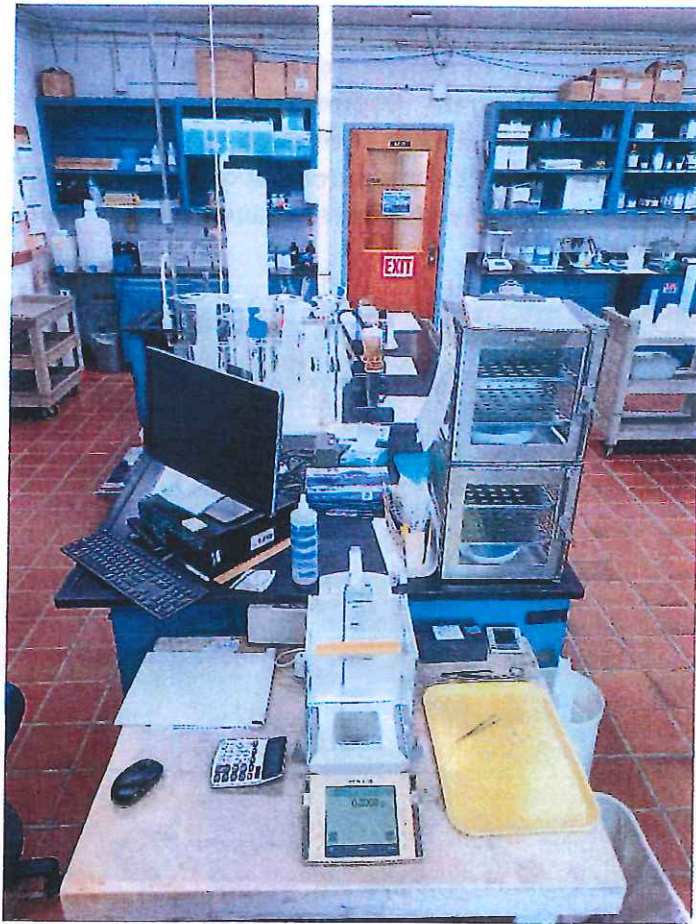
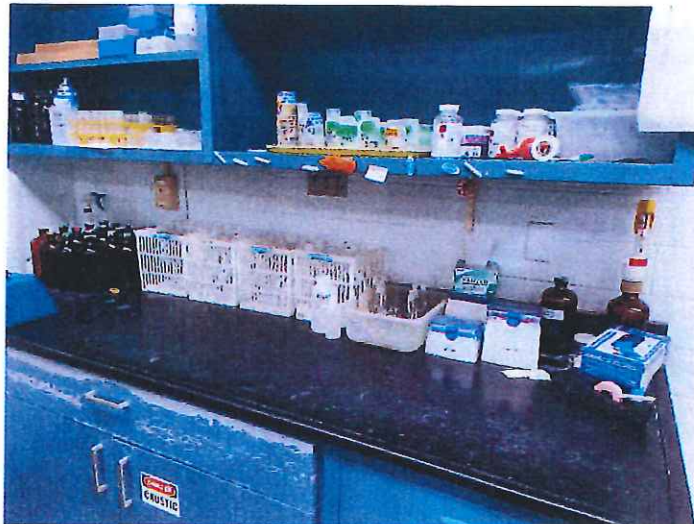
The tests performed for the wastewater treatment plant are all currently performed in the laboratory which equates to about 822 square feet or approximately 13% of the existing laboratory/administration building. When including the receiving area, there is roughly a total of 1,200 square feet (19%) dedicated to these two functions. Countertop and floor spaces are overloaded with equipment, sample containers, supplies and other materials required for the analytical work. Walkways are narrowed, impeding movements throughout the lab areas. Locations and configuration of computer workstations can hinder staff productivity and diminish sample testing throughput.

Cabinets and countertops exhibiting age of original laboratory grade casework

As seen in the pictures above, the lab space provides minimal space for testing and there are not enough dedicated workstations for tests and staff.
