# CITY OF HENDERSONVILLE HISTORIC PRESERVATION COMMISSION

A. Landmark Nomination – Columbus Mills Pace House (26-01-LL) – *Sam Hayes, Planner II*

**Prepared by  
Sybil H. Argintar  
Southeastern Preservation Services  
Asheville, North Carolina**

Columbus Mills Pace House

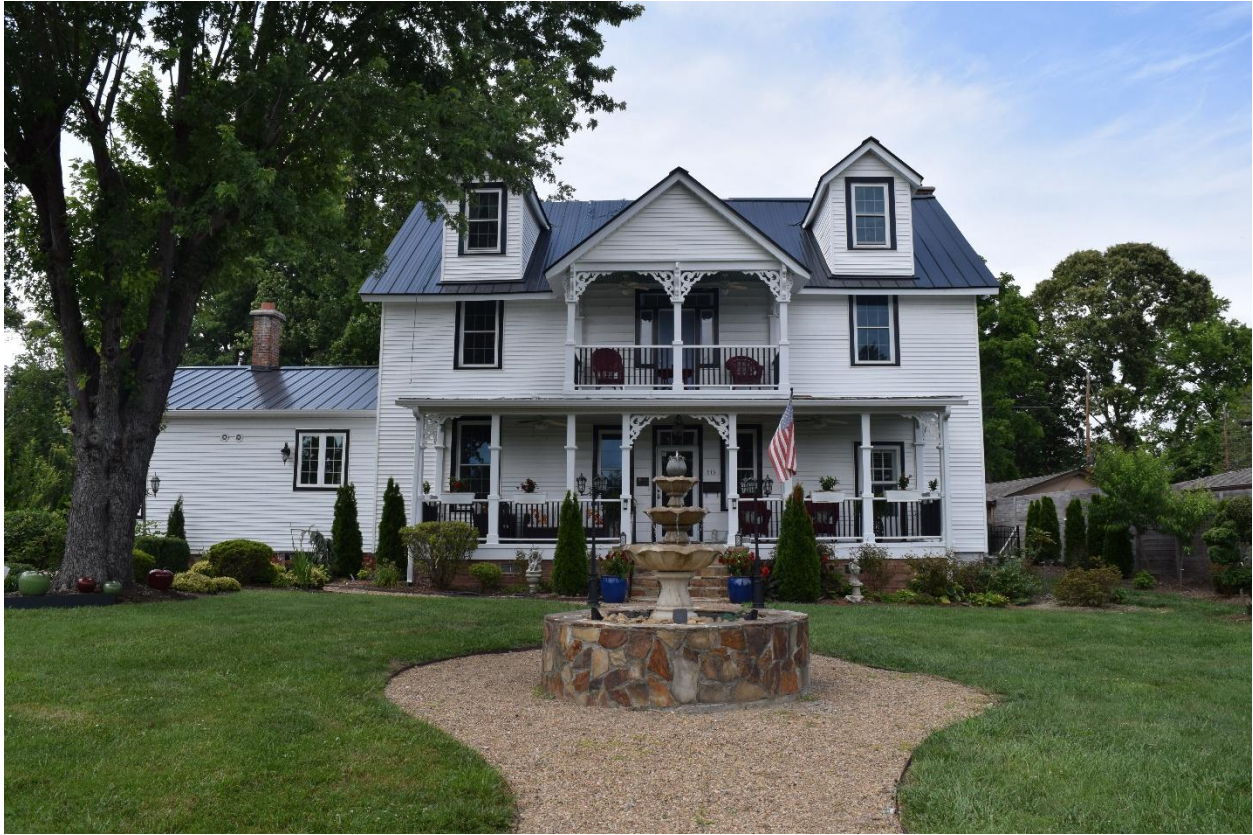
4. Front of house, view north

The front, south elevation of the house, is five bays on the first level and three bays on the second, with the nearly full-width front porch as noted. Beginning on the west end of the first floor, there is a single window, with the four-panel front door with transom lights flanked by single windows. There is a second single window on the east end. The front-gable dormers flank either side of the centrally-located porch. On the second floor, there are single windows on either end, with the four-panel door with transom and sidelights in the center, and the centrally-located front porch extending out from the door bay.

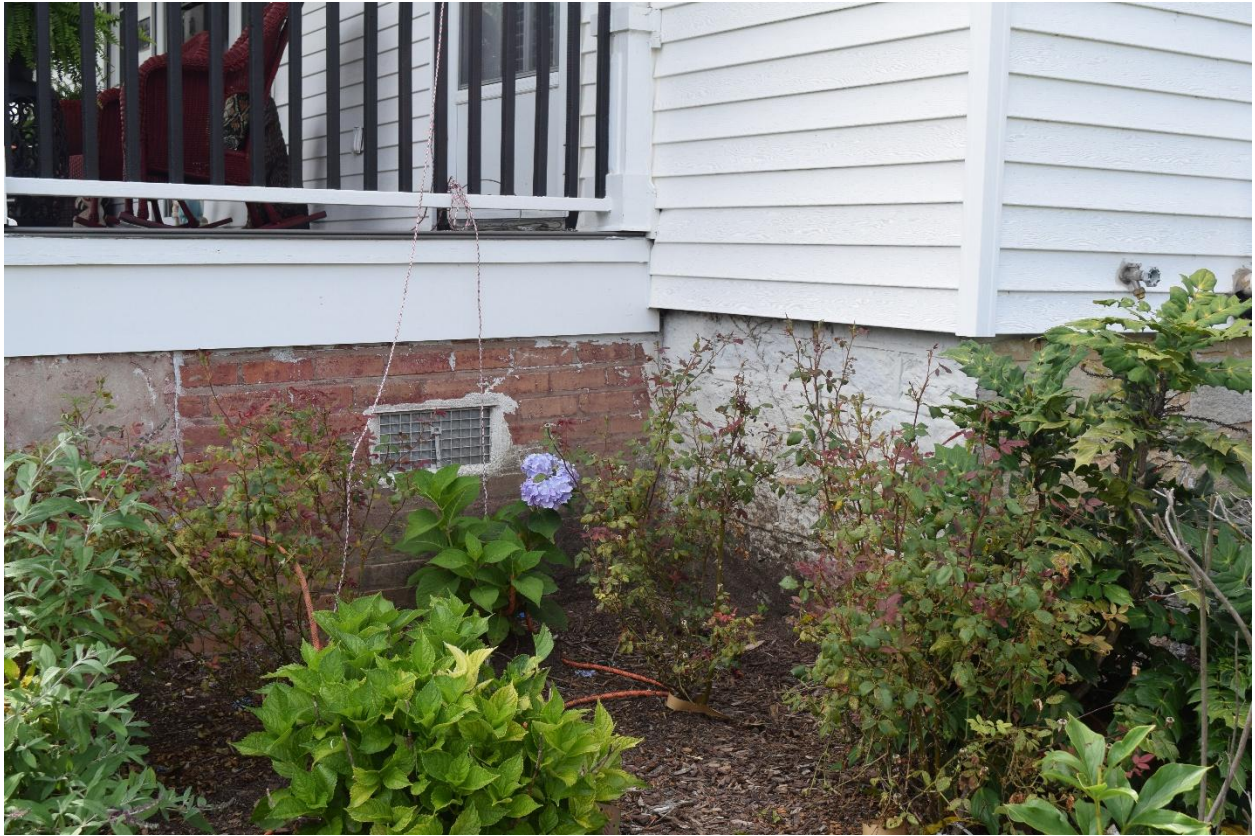
8. House and porch foundation, southeast corner of house

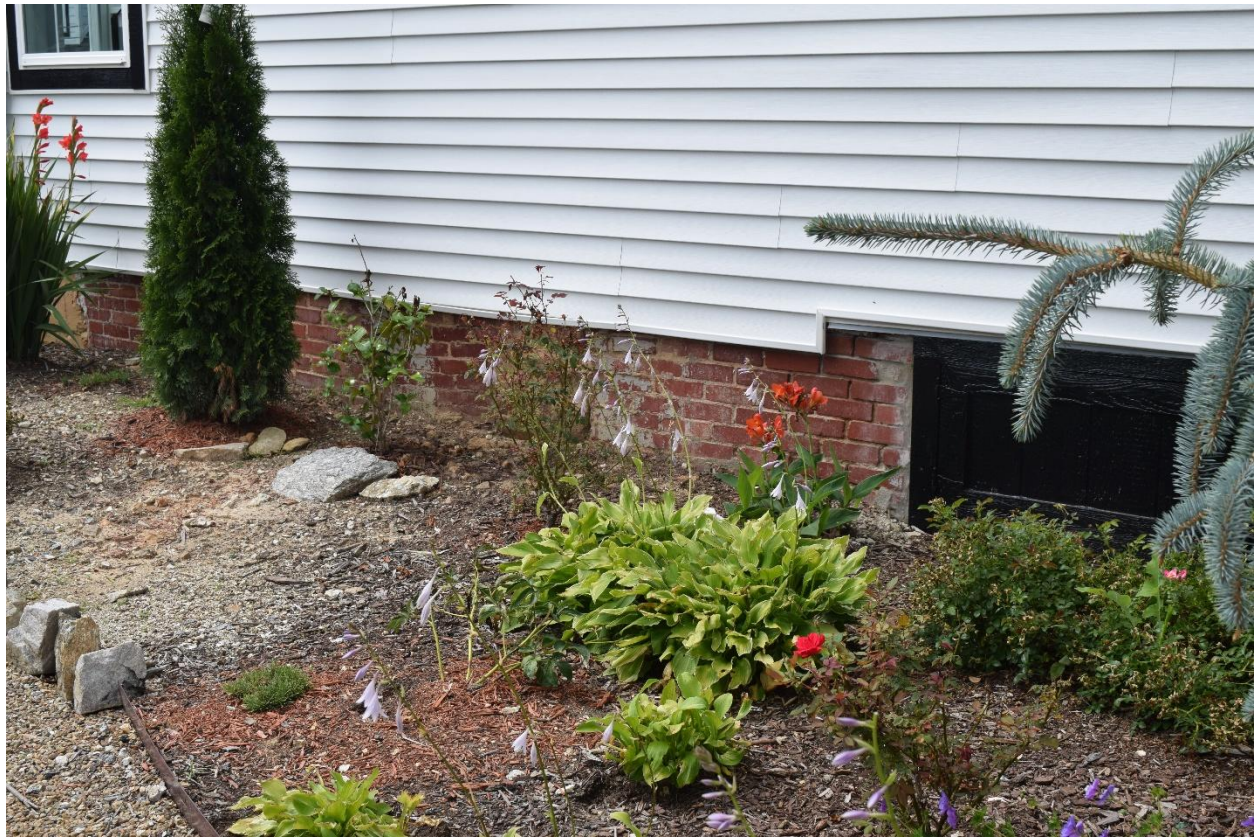
9. Brick foundation beneath kitchen wing, view northwest

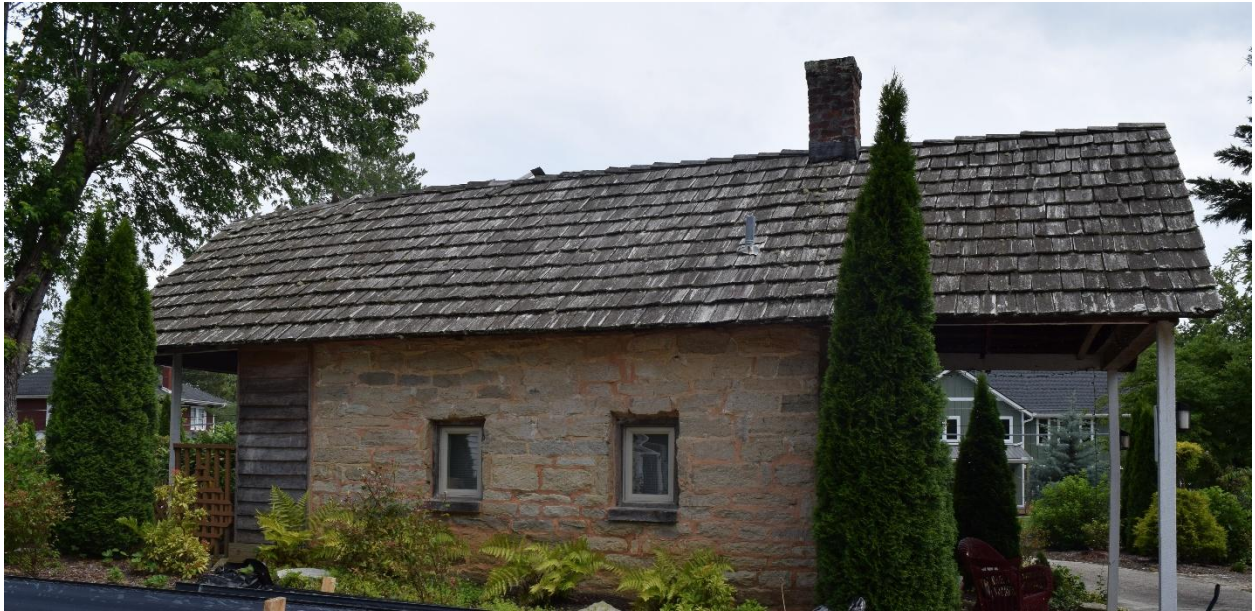
14. Carriage repair stone outbuilding, view south

Located southwest of the house, this one-story stone building with a side-gable, shake roof, has a recessed porch on either end. Facing south, there are two bays on the south elevation, one of which is an enclosed door that has a window added in the upper portion, and the other being a five-panel wood door. There are fixed-light replacement windows on the north elevation, deeply recessed, with wood sills. The porches are located on the east and west sides, with the roof supported by narrow wood posts and no balustrade. In the West Side Historic District, this building was noted as a well house. According to the current owners, this building was used as a carriage repair for those traveling along what is now Fifth Avenue West. It is the only remaining historic outbuilding.

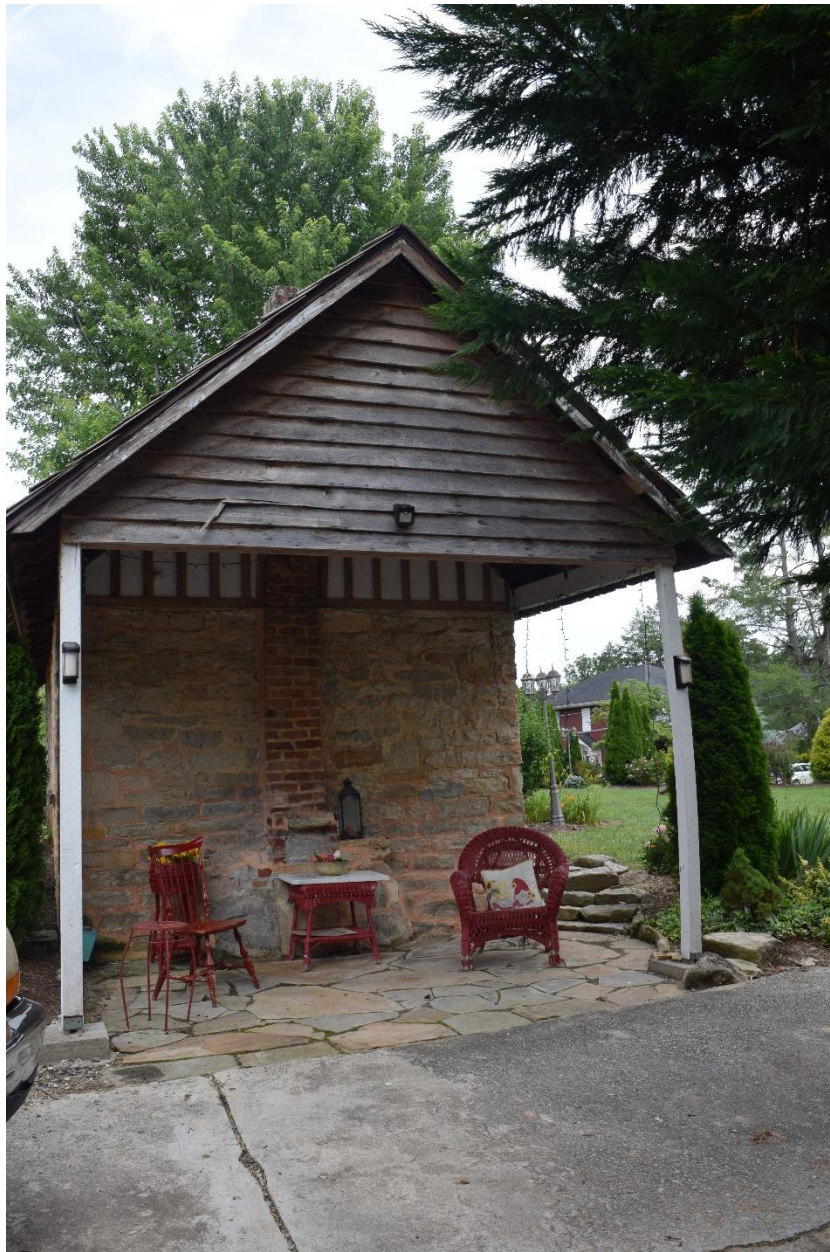
15. West elevation, carriage repair stone outbuilding, view southeast

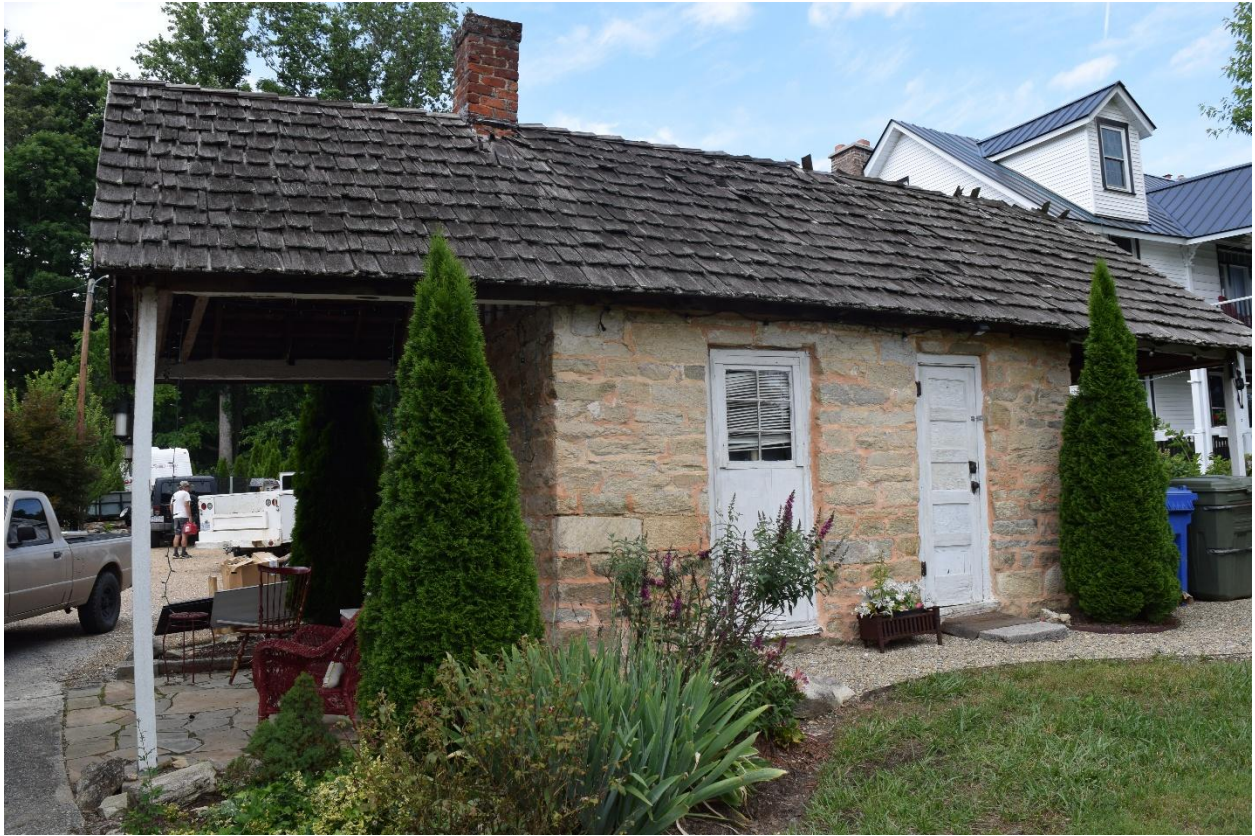
16. South elevation carriage repair stone outbuilding, view north

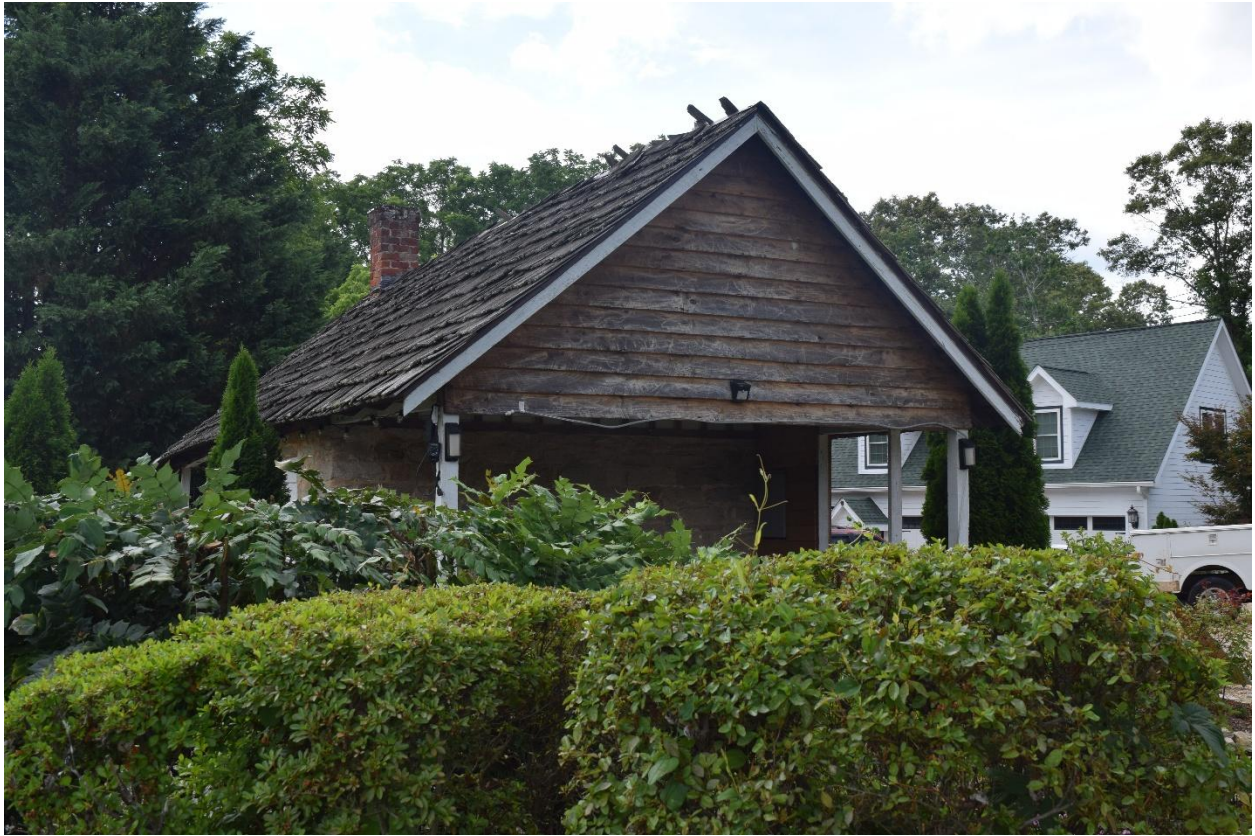
17. East elevation, carriage repair stone outbuilding, view west

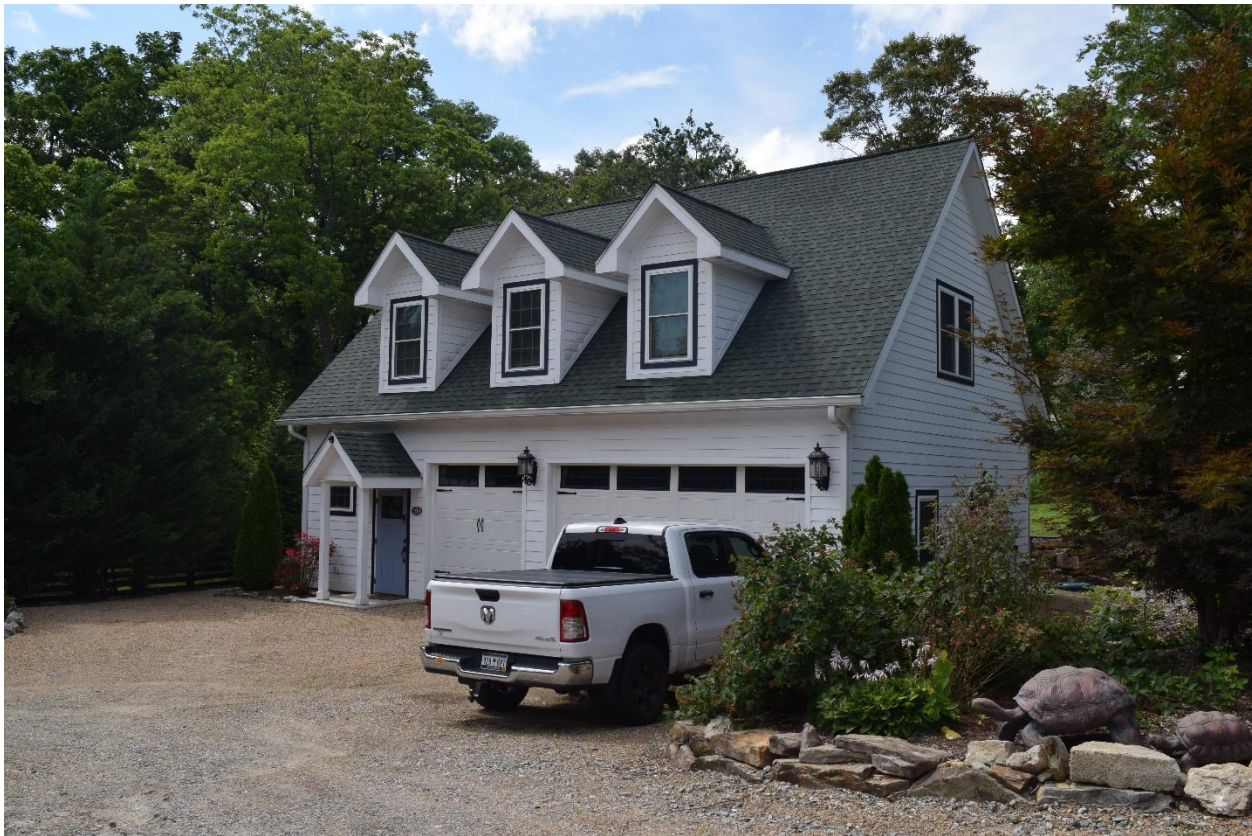
18. Non-historic garage, built 2018, view northwest

The Columbus Mills Pace House was listed as a contributing building in the West Side Historic District (NR 2001). At that time, the changes to the exterior of the kitchen wing, the addition to the kitchen on the west, the addition of vinyl siding, and the enclosure of the porch at the rear had already been completed. The stone outbuilding, along with another frame outbuilding, remained. Before the current owners bought the property the frame outbuilding had been torn down. The current owners, since 2017, have replaced the windows throughout the house, remodeled the interior of the kitchen wing, added the deck at the rear, and are in the process of building a one-story addition at the rear northeast corner of the house. They also built the current garage and added the storage building.

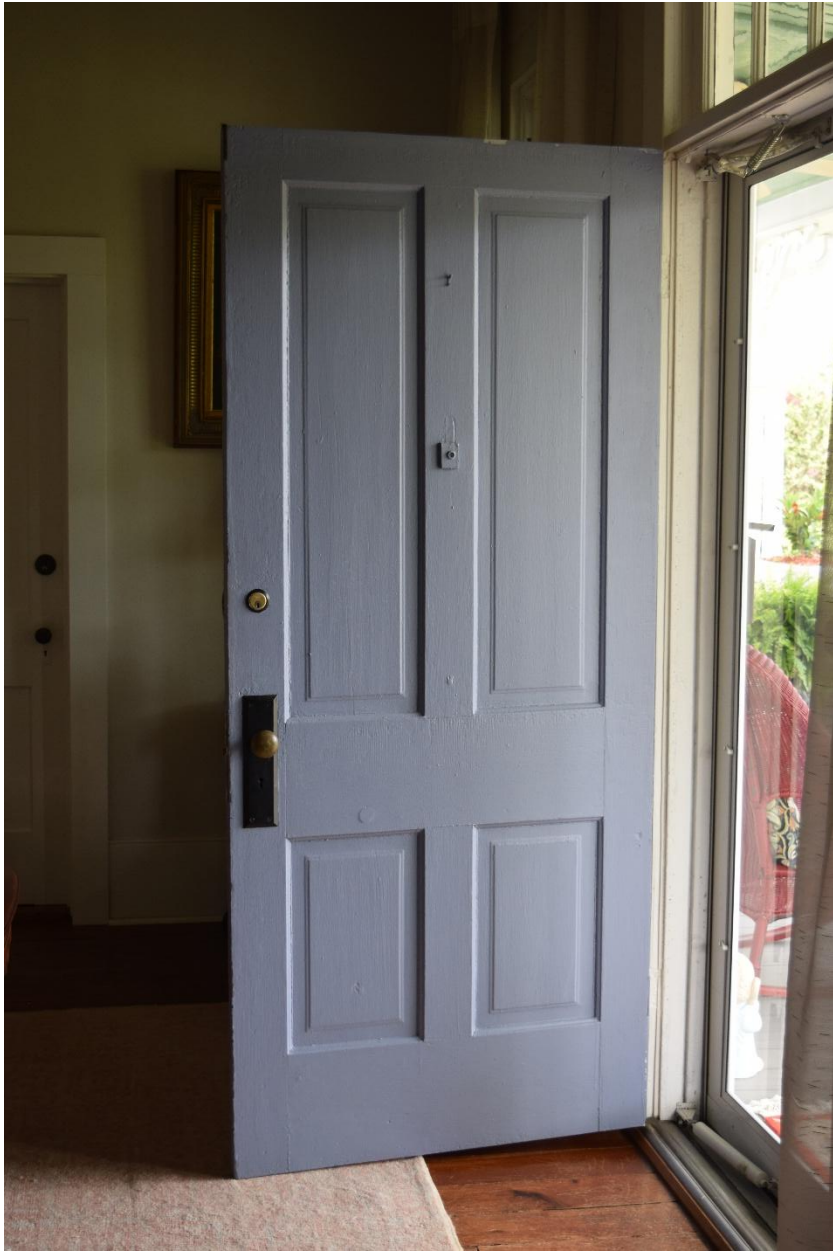
23. Four-panel front door

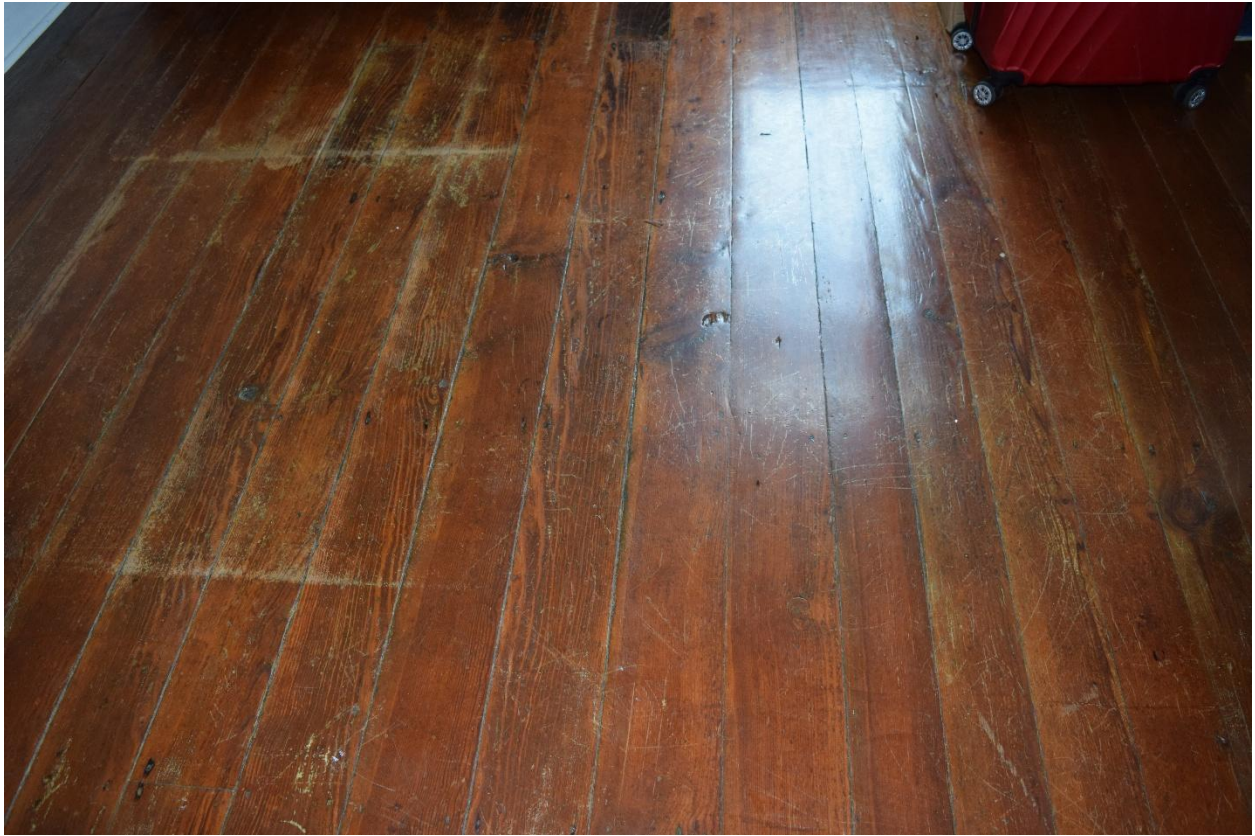
27. Wide heart pine flooring throughout the house

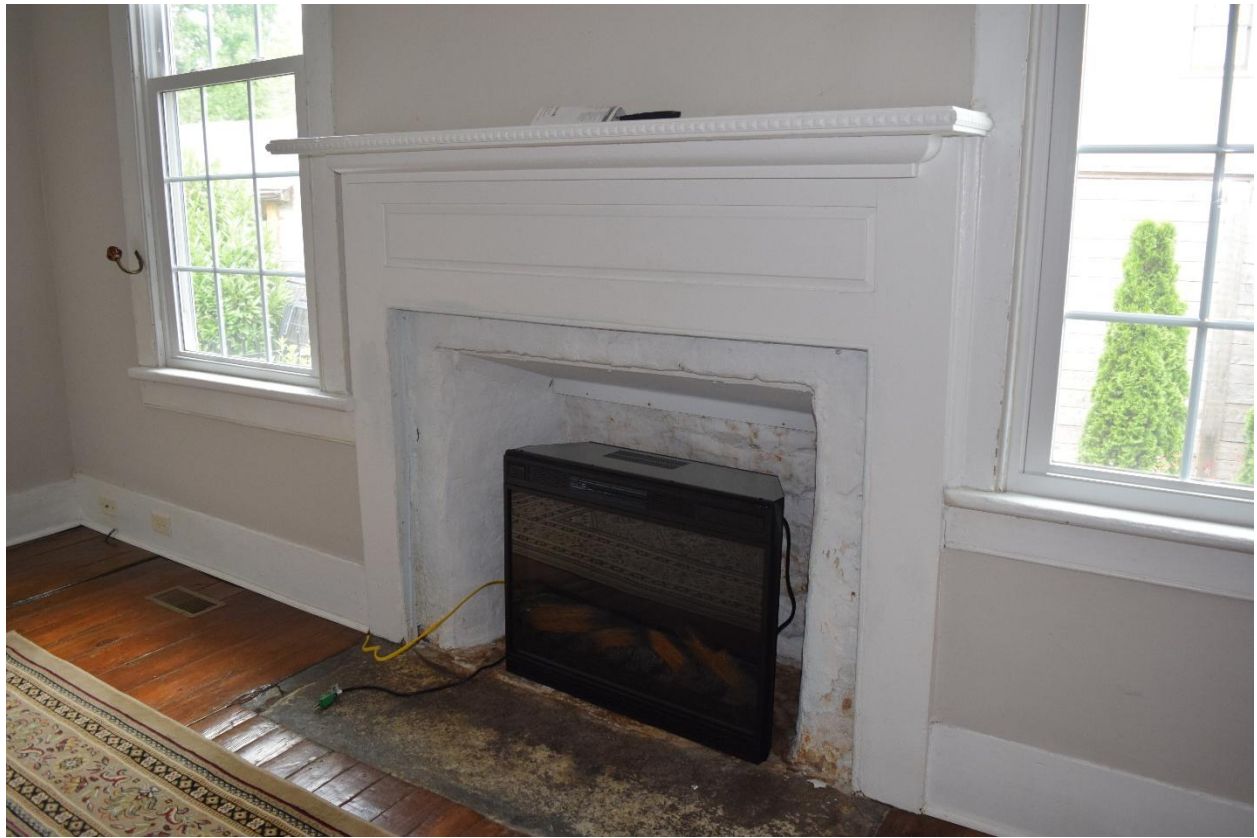
29. First floor bedroom mantel

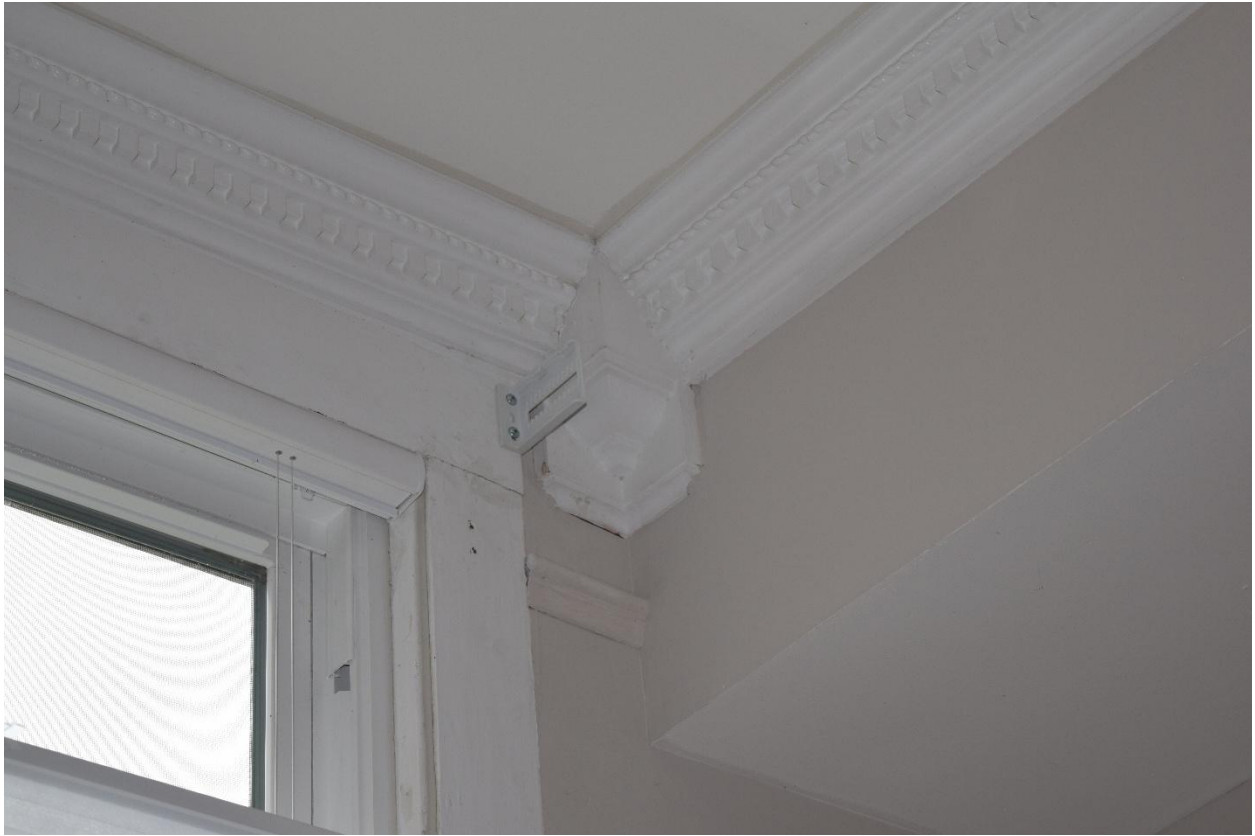
32. First floor crown molding

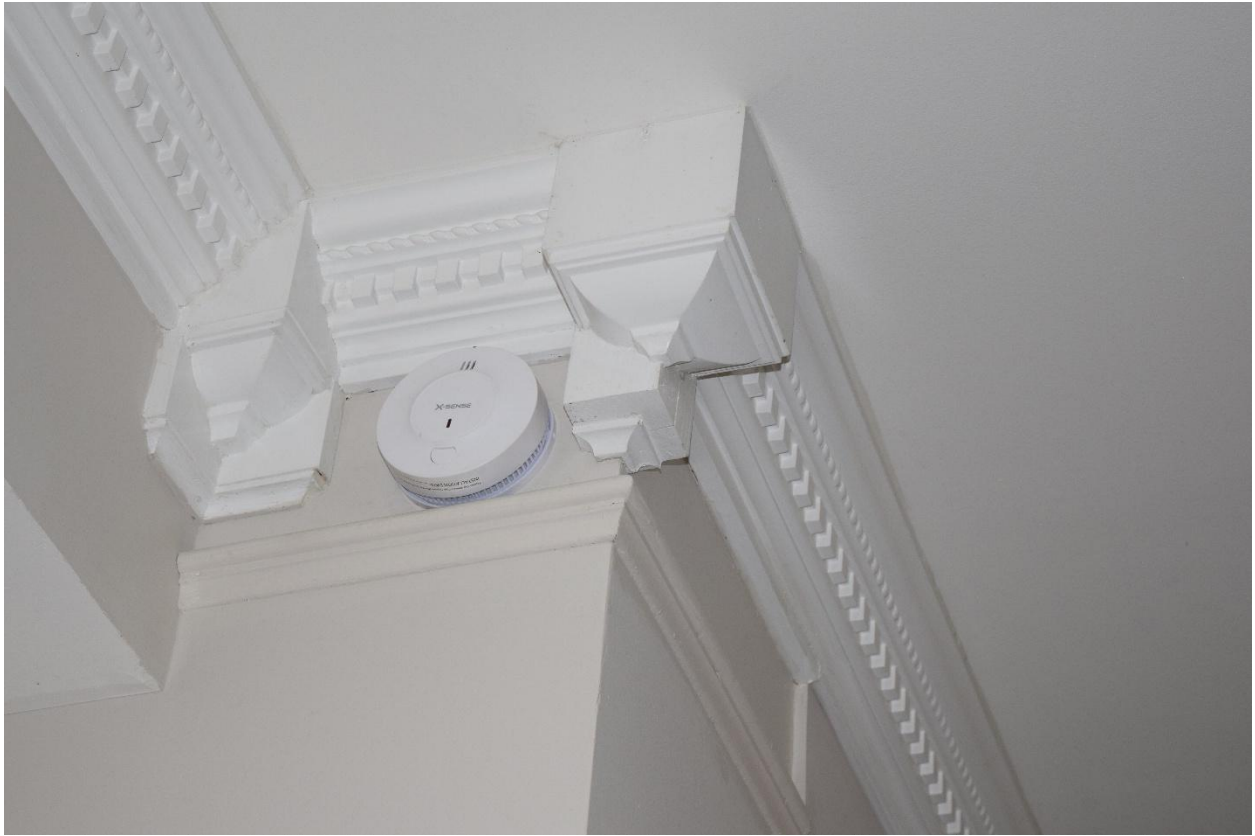
33. First floor crown molding

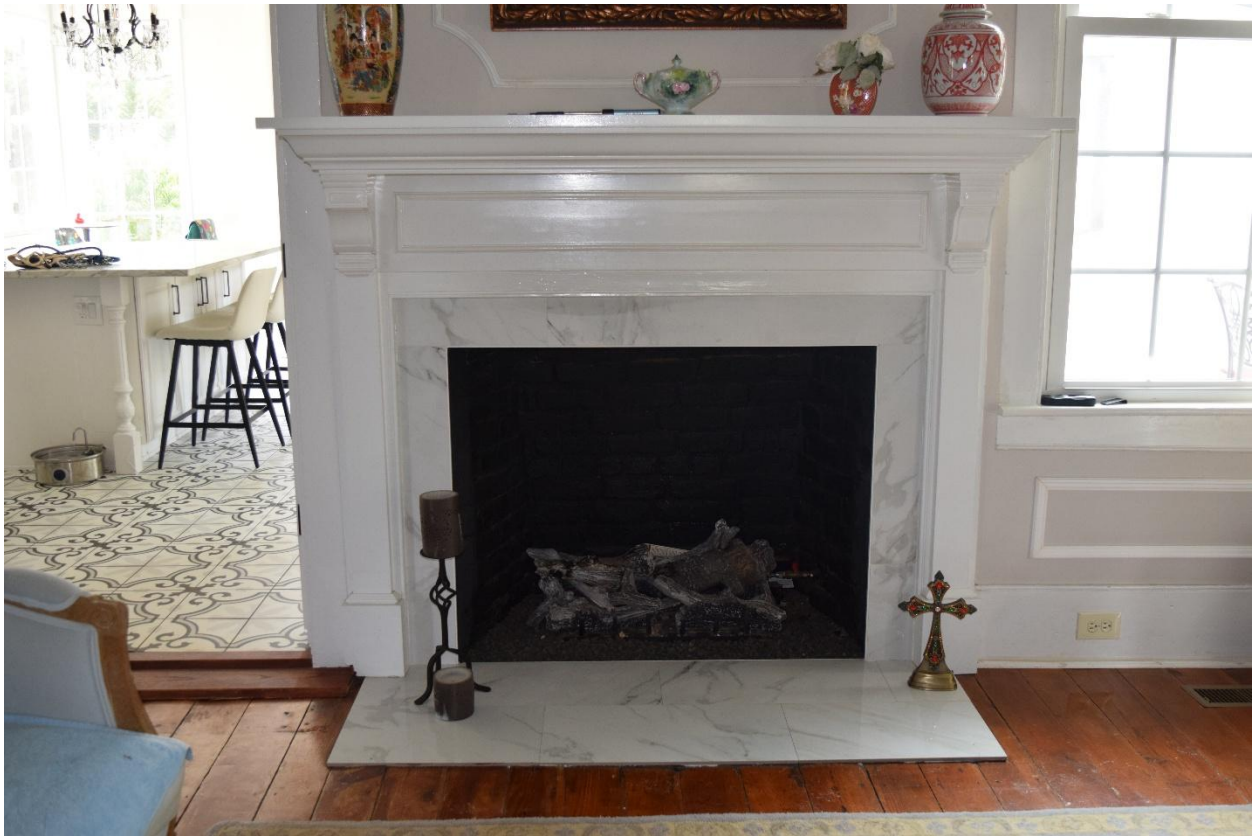
44. First floor living room mantel

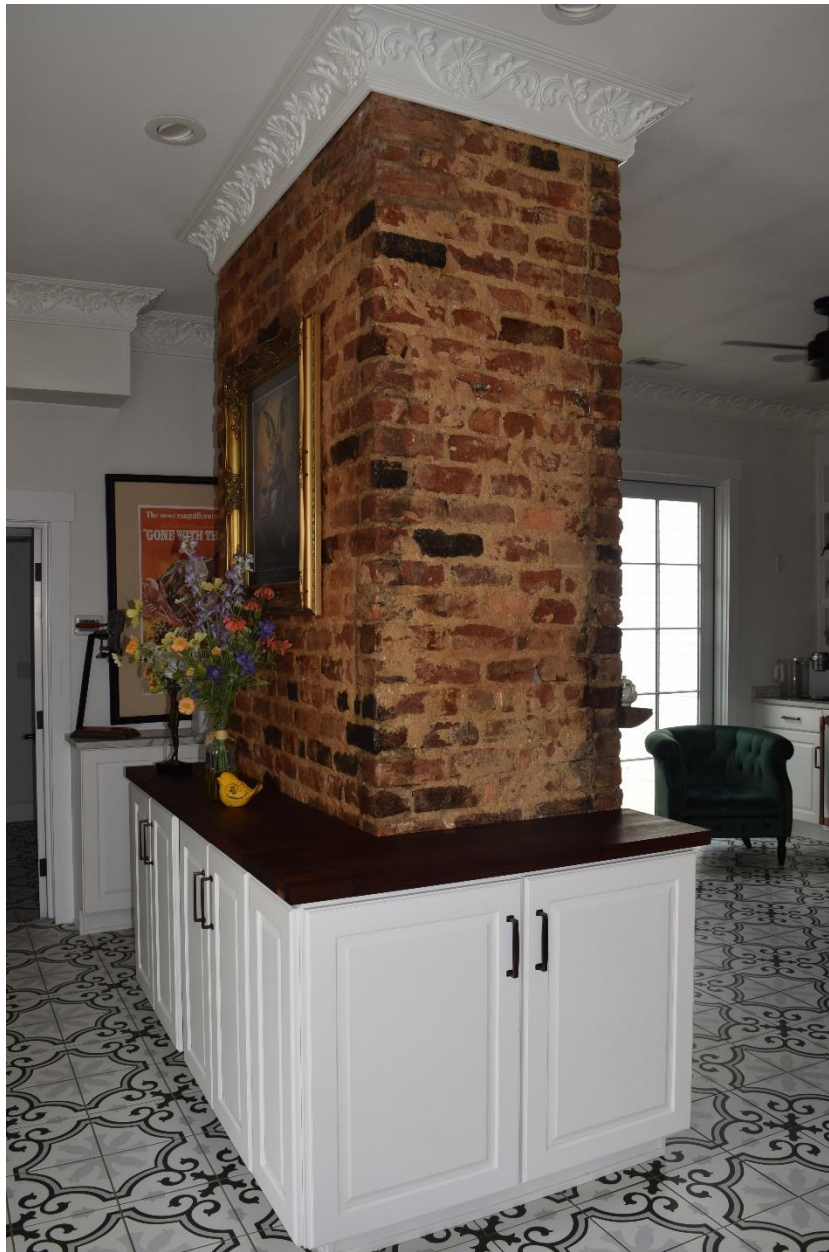
47. Chimney in kitchen wing

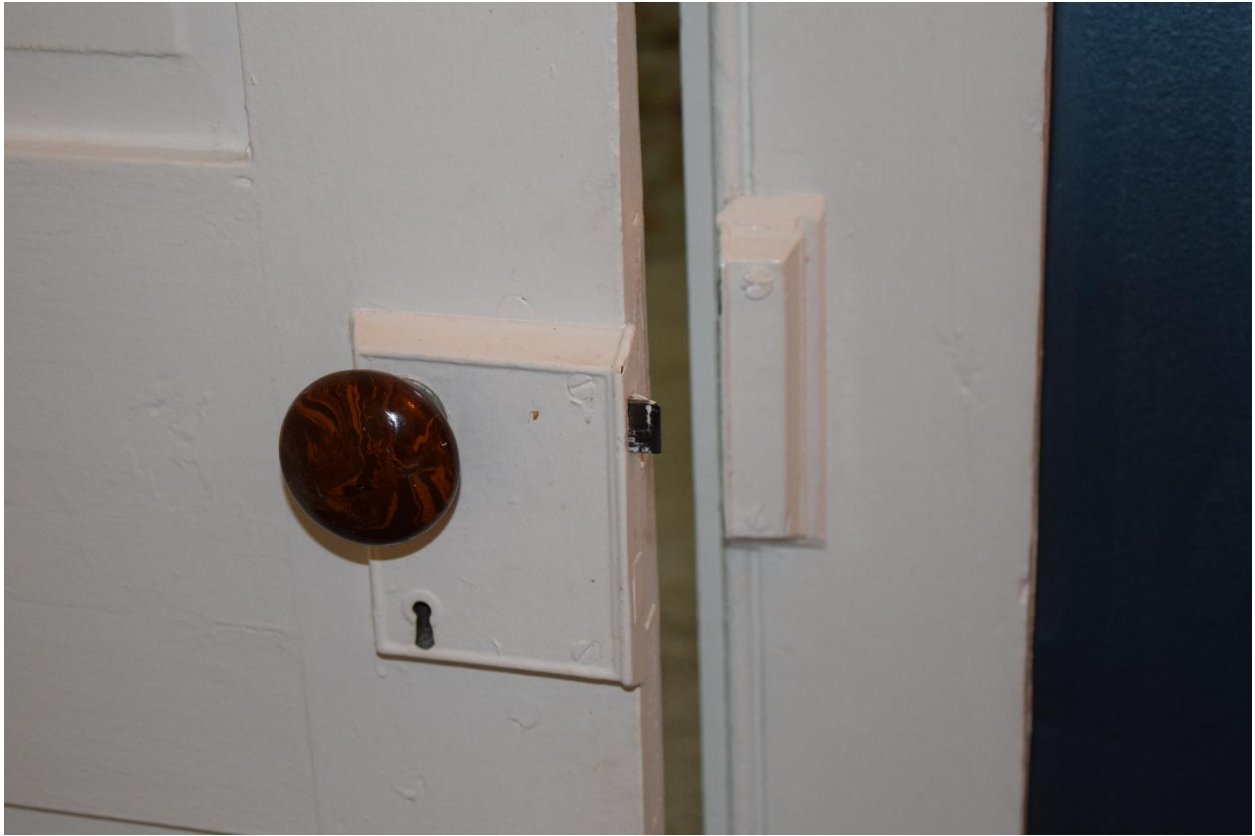
52. Typical hardware throughout house

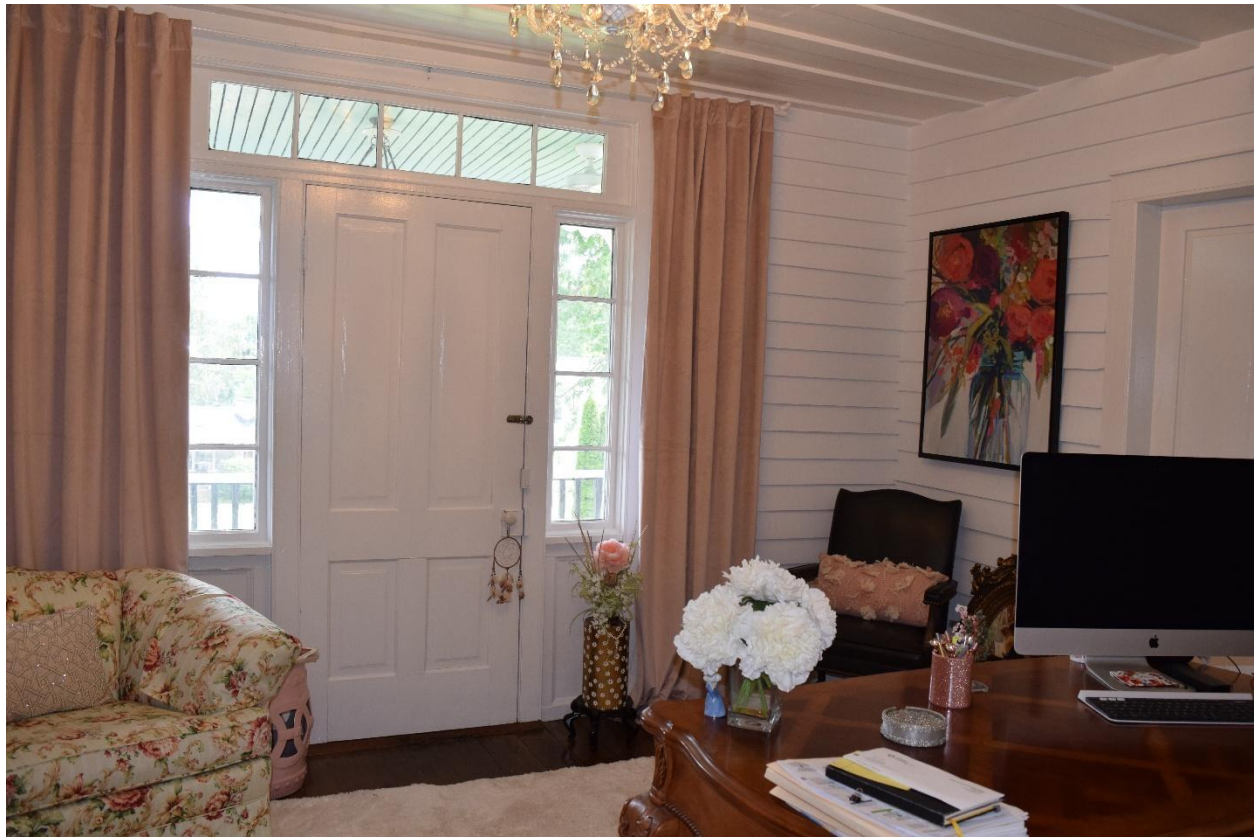
53. Second floor sitting room, view southwest, possible former porch

The second floor consists of the stair hall with four bedrooms, two on each side, and two baths within the two-story wing at the rear. There is a room on the south end, as noted, which likely was a former porch, with weatherboard siding remaining on three walls, and different siding in evidence where the south wall was enclosed. Doors are four-panel, with simple surrounds and the original hardware. Floors here are also the wide-board heart pine, and both crown and picture molding remain in all of the rooms, although not as elaborate in design as on the first floor. An unusual feature is that the picture molding, on both floors, is set within the plaster walls, rather than applied to the surface. The mantel in the bedroom on the east side is simple in design, with a plain shelf, a recessed panel, and some decorative scrollwork. The mantel on the west bedroom also has a recessed panel and some decorative molding along the shelf. The door onto the upper level porch retains its original transom and sidelights.

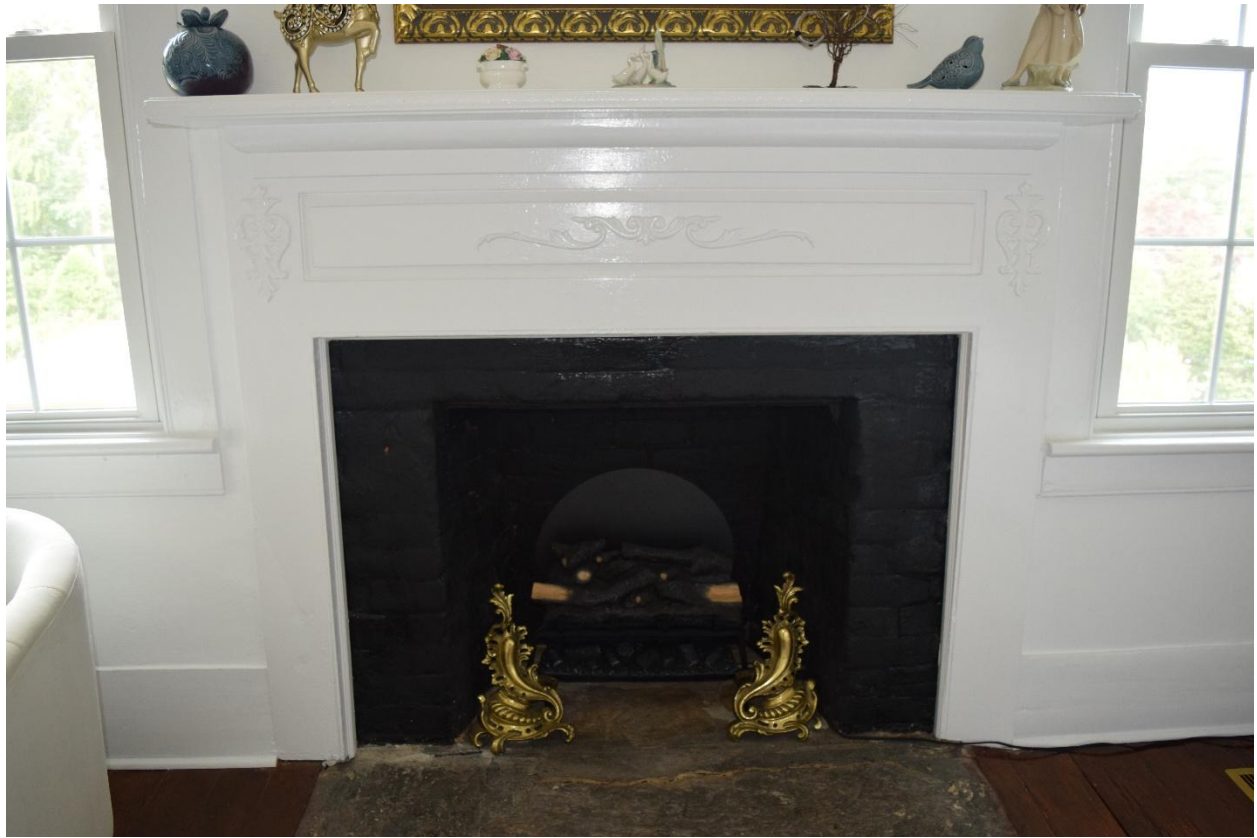
61. Second floor bedroom mantel

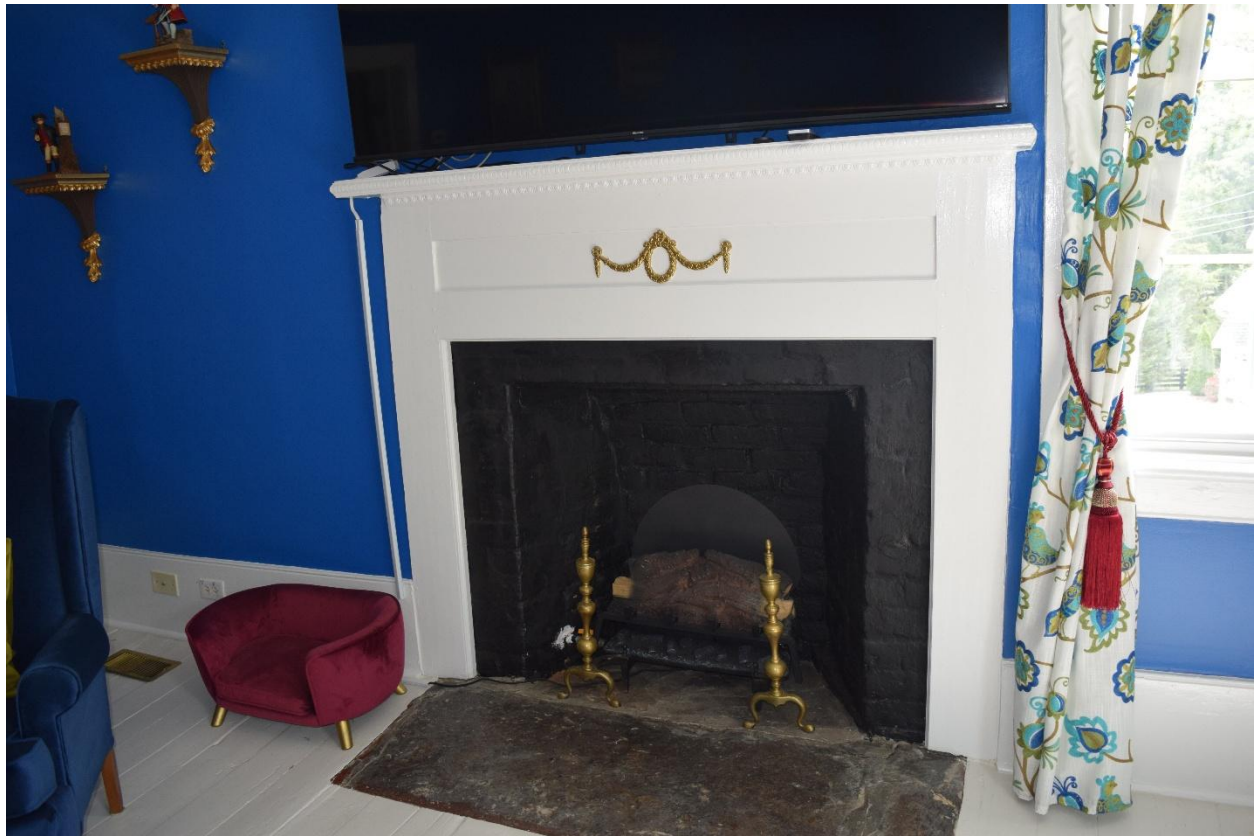
63. Second floor bedroom mantel

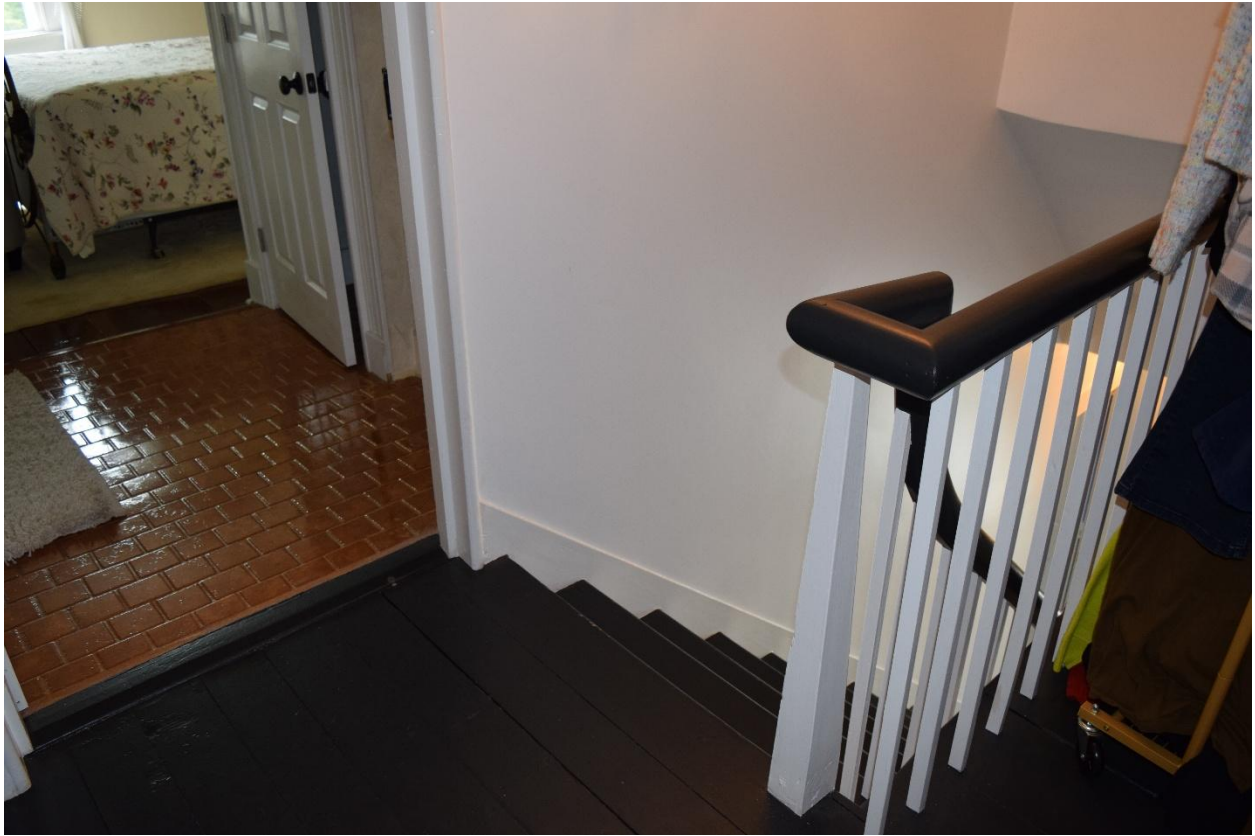
69. Attic stair detail
