# ZONING BOARD OF APPEALS MEETING

Lansing Town Hall Board Room  
Wednesday, July 10, 2024  
6:30 PM

**c. Project:** Use Variance to construct a Solar Energy Facility off N. Triphammer Road

**Location:** 0 North Triphammer Road, TPN 44.-1-1.2 and 44.-1-3.3

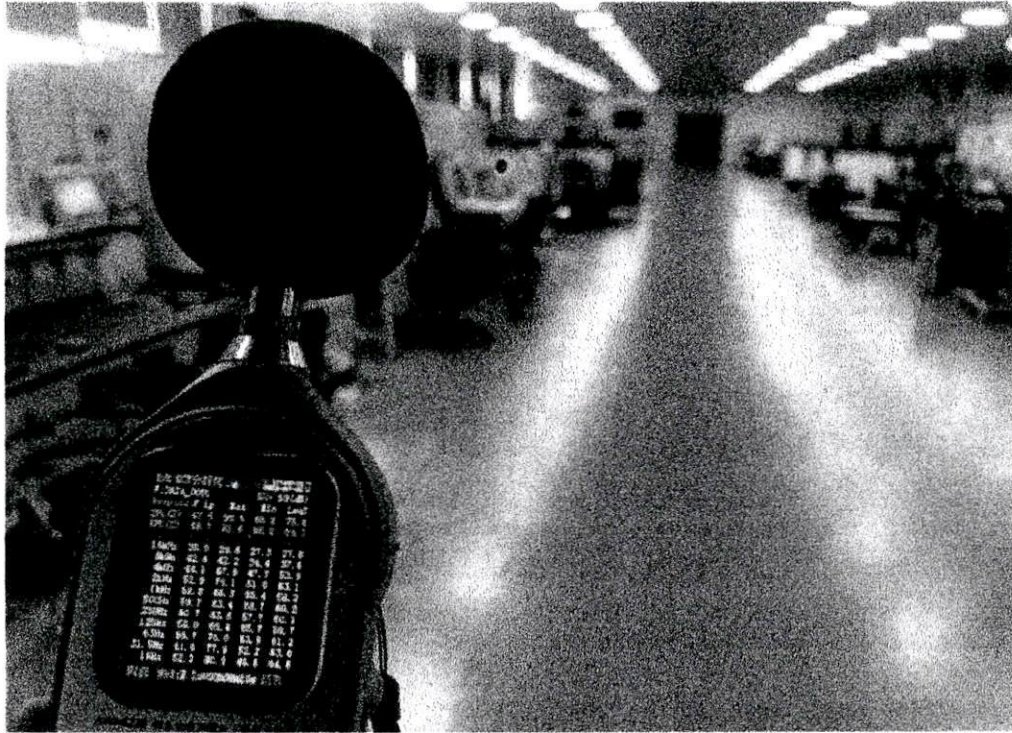
Front

2) 10m noise photo

1) Rated working condition (10m)

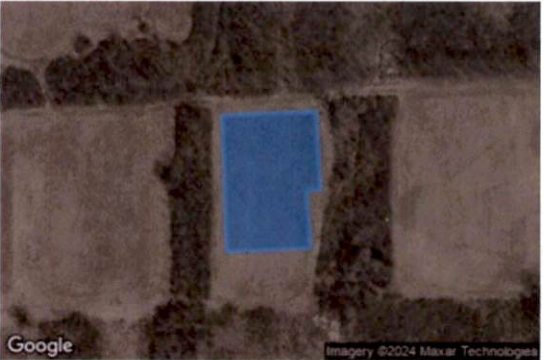
**Name:** 2A

Vertex	Latitude (°)	Longitude (°)	Ground elevation (ft)	Height above ground (ft)	Total elevation (ft)
1	42.506749	-76.486220	1049.04	20.00	1069.04
2	42.507651	-76.486266	1056.46	20.00	1076.46
3	42.507677	-76.485426	1057.49	20.00	1077.49
4	42.507161	-76.485392	1053.73	20.00	1073.73
5	42.507157	-76.485512	1054.03	20.00	1074.03
6	42.506775	-76.485477	1051.02	20.00	1071.02

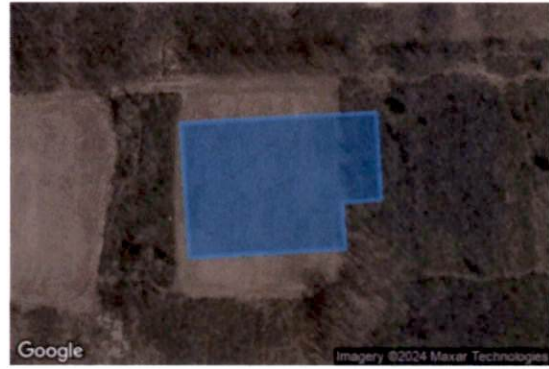
**Name:** 2B  
**Axis tracking:** Single-axis rotation  
**Backtracking:** Shade-slope  
**Tracking axis orientation:** 180.0°  
**Max tracking angle:** 60.0°  
**Resting angle:** 0.0°  
**Ground Coverage Ratio:** 0.5  
**Rated power:** -  
**Panel material:** Light textured glass with AR coating  
**Reflectivity:** Vary with sun  
**Slope error:** correlate with material

Vertex	Latitude (°)	Longitude (°)	Ground elevation (ft)	Height above ground (ft)	Total elevation (ft)
1	42.506700	-76.484614	1052.31	20.00	1072.31
2	42.507576	-76.484697	1059.58	20.00	1079.58
3	42.507649	-76.482953	1066.97	20.00	1086.97
4	42.507080	-76.482908	1062.06	20.00	1082.06
5	42.507060	-76.483259	1058.19	20.00	1078.19
6	42.506757	-76.483224	1058.78	20.00	1078.78

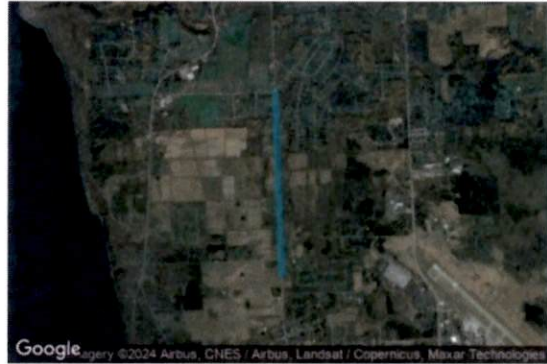
**Name:** N Triphammer Road  
**Path type:** Two-way  
**Observer view angle:** 50.0°

Vertex	Latitude (°)	Longitude (°)	Ground elevation (ft)	Height above ground (ft)	Total elevation (ft)
1	42.516086	-76.491333	983.06	4.00	987.06
2	42.512045	-76.491172	1011.74	4.00	1015.74
3	42.506854	-76.490904	1005.04	4.00	1009.04
4	42.500558	-76.490593	955.07	4.00	959.07
5	42.498232	-76.490410	939.67	4.00	943.67
6	42.496945	-76.490325	929.07	4.00	933.07

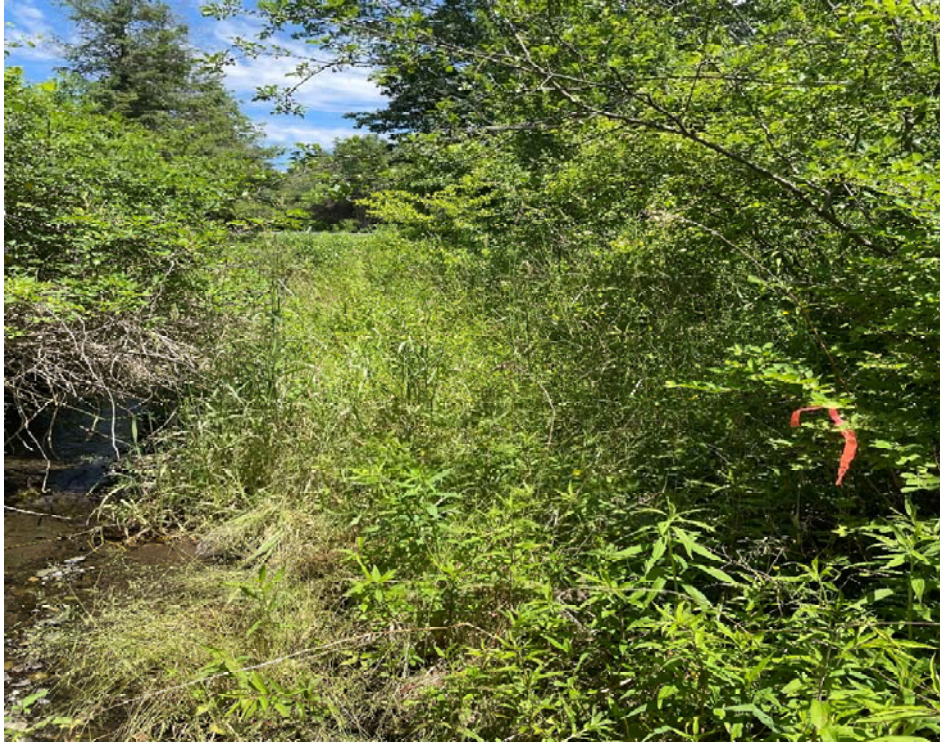
Photo 3. View facing south looking at a drainage channel (photo left) within a delineated wetland.

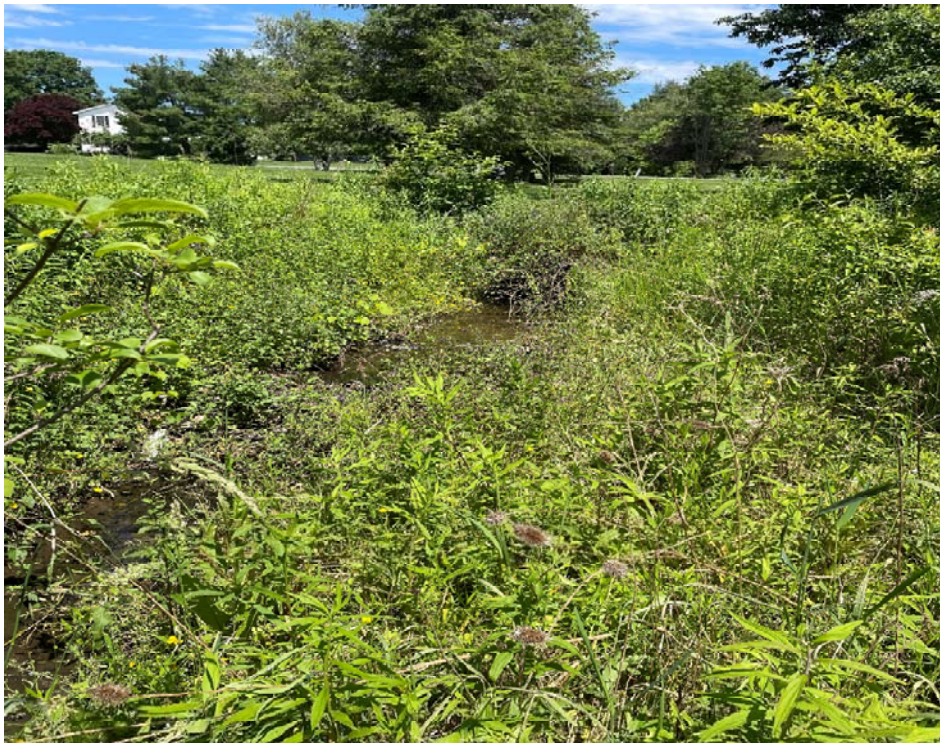
Photo 4. View facing north looking at a drainage channel near the northern border of the inspection area.

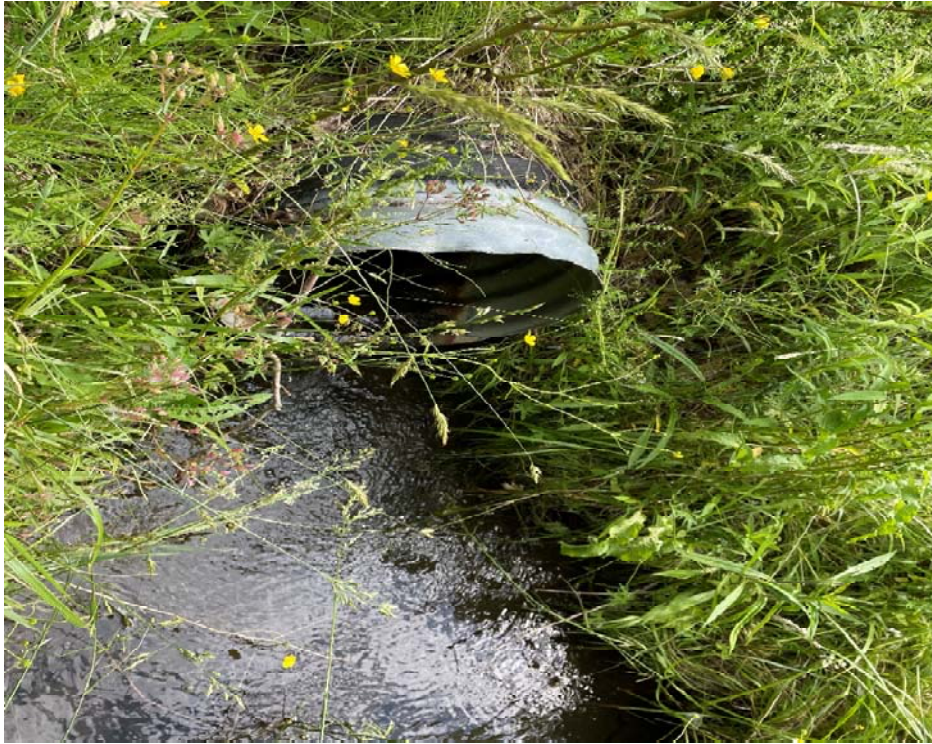
*Photo 7. View of a culvert feeding wetland areas within hedgerows .*

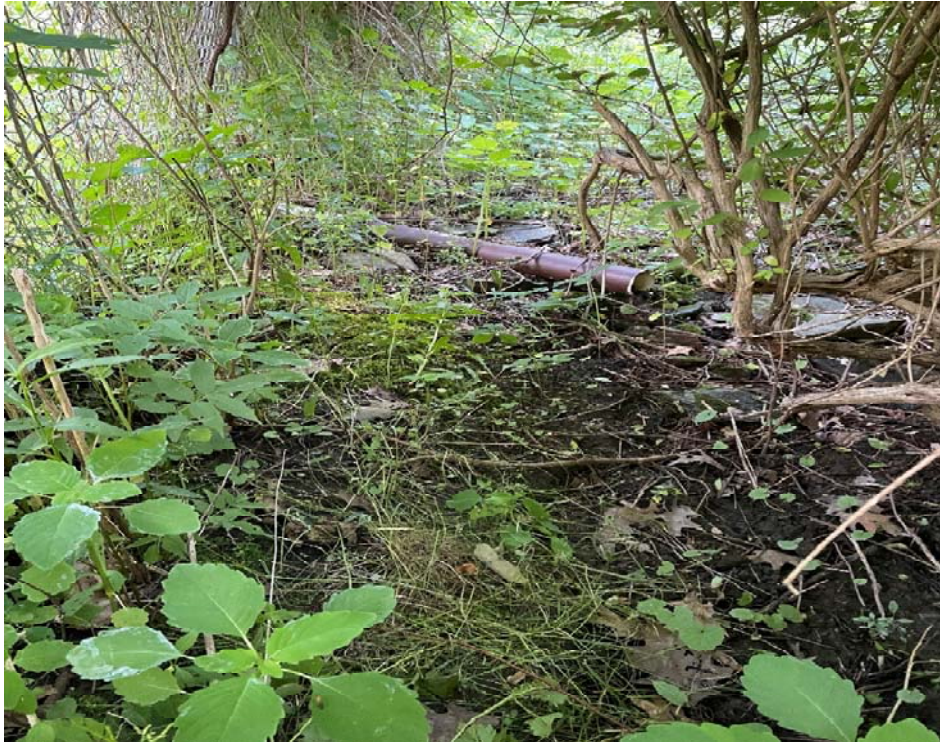
*Photo 10. View facing east looking at a pipe culvert feeding water into the site from the northern boundary of the inspection area.*

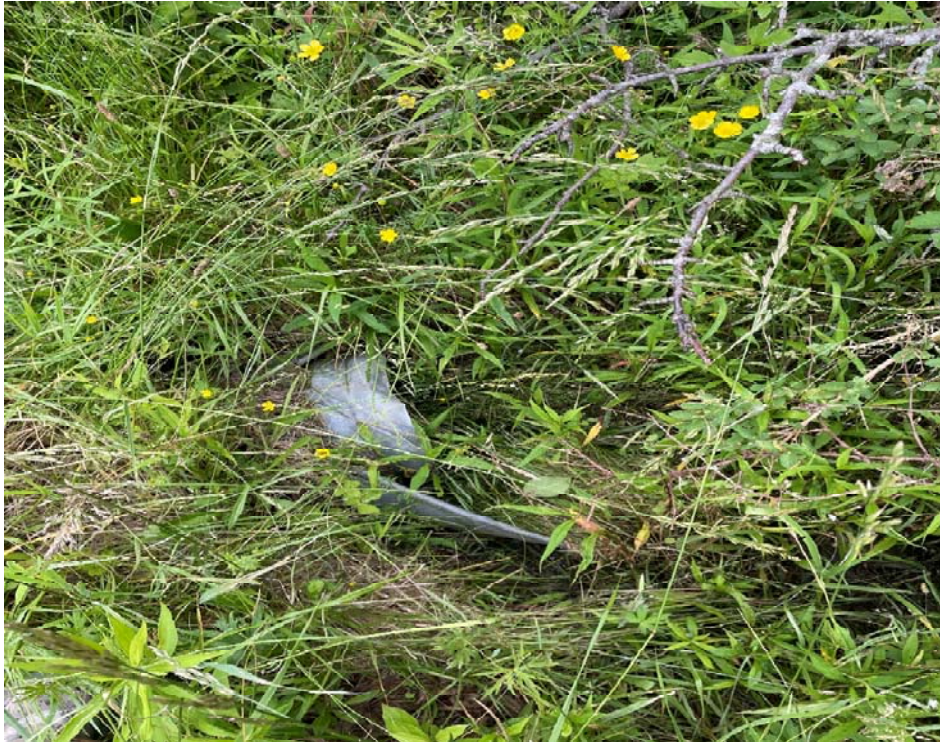
*Photo 12. View looking at a pipe culvert feeding water from the 'A/B' flagged wetland towards the 'C/D' wetland.*

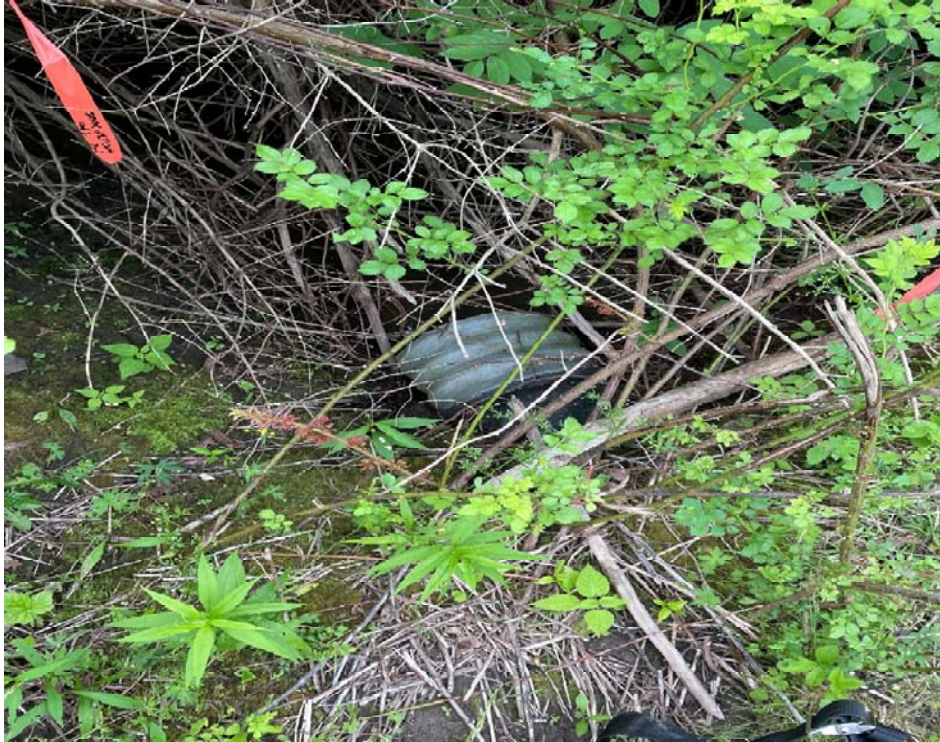
*Photo 13. View looking at a pipe culvert feeding water from the northern arm of the 'E' flagged wetland towards the 'E' flagged wetland to the south.*

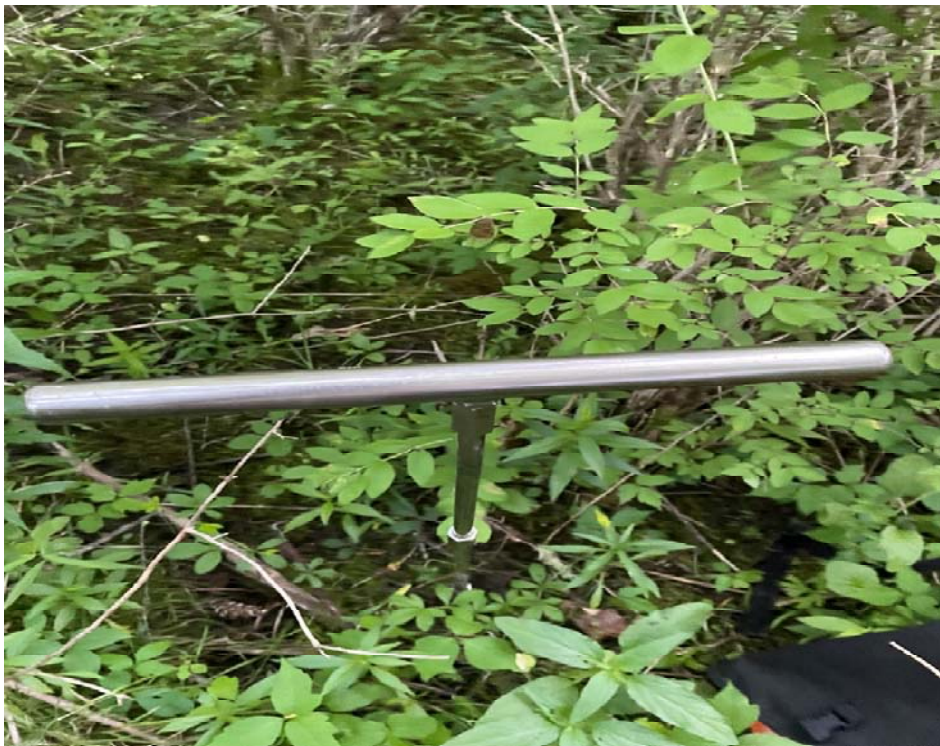
*Photo 14. View looking at a soil auger used to collect soil samples for analysis.*
