MINUTES CITY OF LAUREL CITY COUNCIL WORKSHOP TUESDAY, MARCH 18, 2025

EXISTING INFRASTRUCTURE CONDITION REPORT

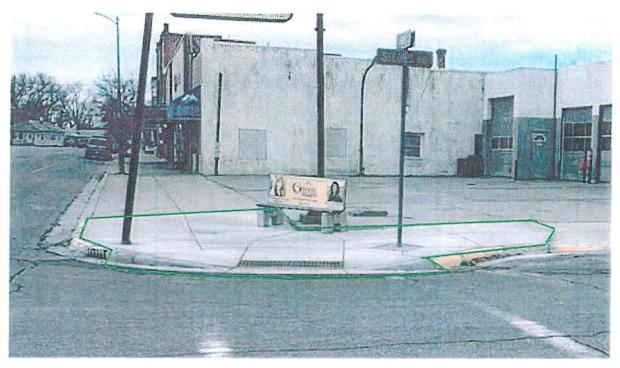
Category I - Like New

Likely replaced within the last few years. Up to current standards and no deterioration shown.

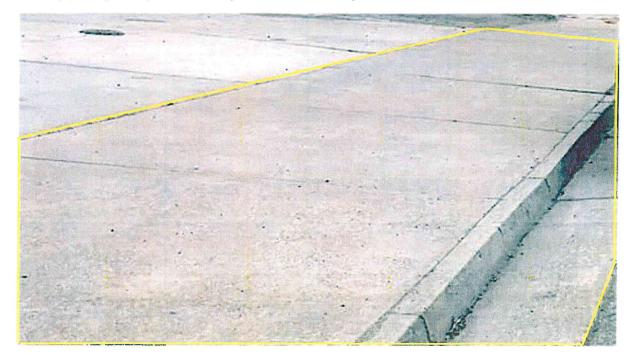
<u>Category II – Good Condition</u>

Generally good operating condition. Very little deterioration is present.

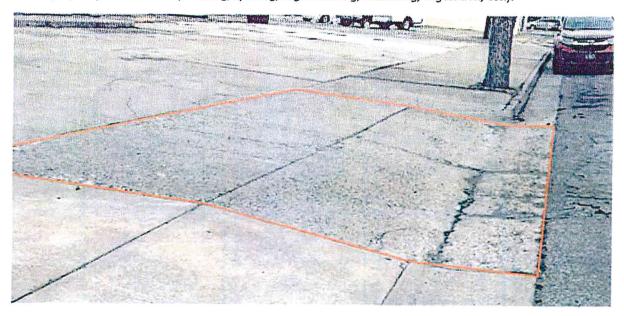
Category III - Poor Condition

Showing signs of deterioration (Cracking, spalling, slight heaving, crumbling, vegetation, etc.).

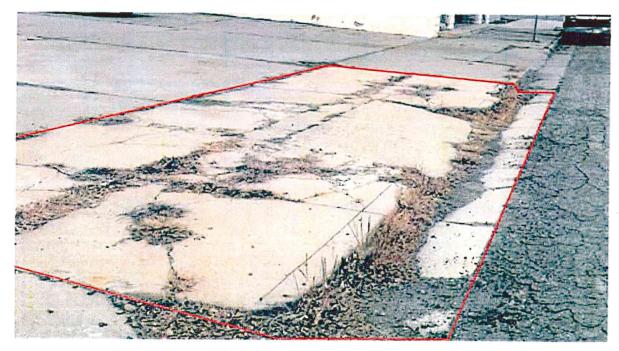
Category IV - Needs Replaced

Completely deteriorated and no longer functions as intended. Concrete is either missing, completely crumbled, or major heaving is present. Portions are also considered Category IV if the location doesn't meet current standards and requires replacement.

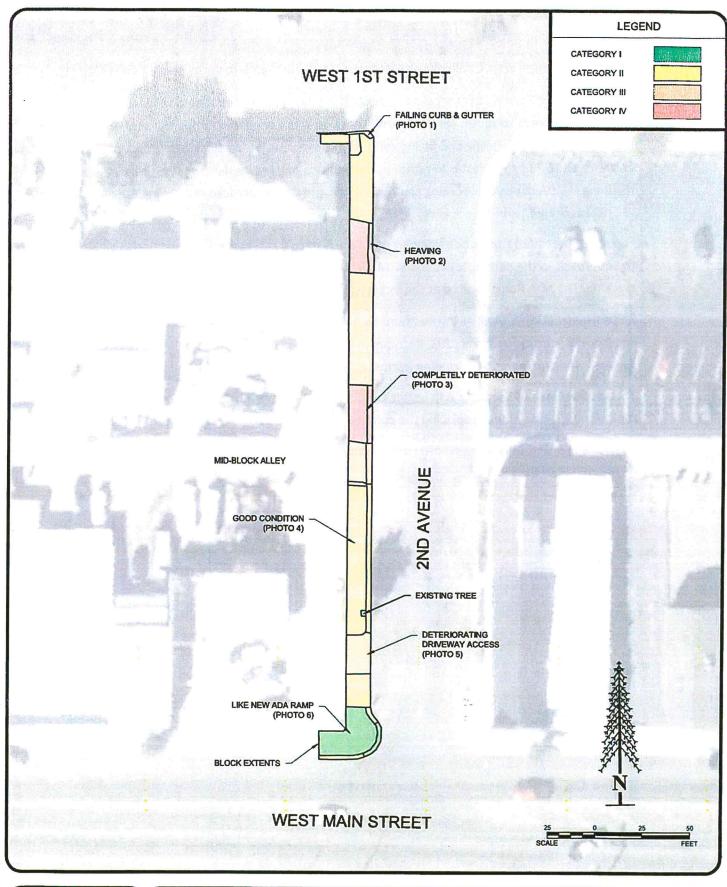
2ND AVENUE - W. MAIN TO W. 1ST - WEST BLOCK 2 INFRASTRUCTURE ASSESSMENT

Condition Category(s): I, II, III, IV. All categories are present with majority being II and III.

Comments: C&G conditions vary greatly throughout the block and condition tends to improve working from north to south. The northern ADA ramp is out of spec in both grade and dimensions. Curb along W 1st St is failing and falling away from the sidewalk. The sidewalk in front of the entrance to 16 2nd Ave West is in rather poor condition and is experiencing significant heaving resulting in ADA concerns. Working south, sidewalk and C&G conditions remain in Categories III and IV until reaching the mid-block alley.

The southern half of the block's sidewalk and C&G is mainly categorized as I and II with exception to the approach to the parking lot at 201 W Main Street. The approach is experiencing deterioration and cracking. The ADA Ramp located at the intersection with Main Street is in like new condition.

Recommendations: Most of the northern half of the block needs replacement with exception of a small portion of sidewalk and C&G. Recommend replacement of all Category III and IV portions of sidewalk and curb and C&G including northern ADA ramp.

The southern half of the block is in better condition, and for the most part is not in need of replacement. Recommend replacing the concrete approach to 201 W Main Street.

It should be noted that the northern portion replacements take precedence to replacements in the southern half of the block.

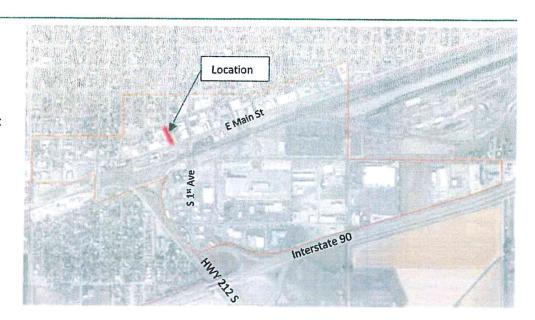
West Right-of-Way

Description of Existing Sidewalk: Existing sidewalk and curb & gutter are present throughout the block in varying conditions. Stormwater inlets are present at the south and north ends. Back of sidewalk ties to buildings, parking areas, and landscaping areas. ADA ramps are present at both ends of the block. Trees and tree wells are present.

Dimensions & Area: The existing sidewalk is approximately 10' in width throughout the block. Curb & gutter generally follows a standard 2' in width but varies in depth and shape. Northen and southern portions of curb have rounded gutters while portions near the center have a sharp gutter shape.

Condition Category(s): I, II, III, IV. All categories are present with majority being II and III.

Comments: C&G conditions vary greatly throughout the block and condition tends to improve working from north to south. The northern ADA ramp is out of spec in both grade and dimensions. Curb along W 1st St is failing and falling away from the sidewalk. The sidewalk in front of the entrance to 16 2nd Ave West is in rather poor condition and is experiencing significant heaving resulting in ADA concerns. Working south, sidewalk and C&G conditions remain in Categories III and IV until reaching the mid-block alley.

The southern half of the block's sidewalk and C&G is mainly categorized as I and II with exception to the approach to the parking lot at 201 W Main Street. The approach is experiencing deterioration and cracking. The ADA Ramp located at the intersection with Main Street is in like new condition.

Recommendations: Most of the northern half of the block needs replacement with exception of a small portion of sidewalk and C&G. Recommend replacement of all Category III and IV portions of sidewalk and curb and C&G including northern ADA ramp.

The southern half of the block is in better condition, and for the most part is not in need of replacement. Recommend replacing the concrete approach to 201 W Main Street.

It should be noted that the northern portion replacements take precedence to replacements in the southern half of the block.

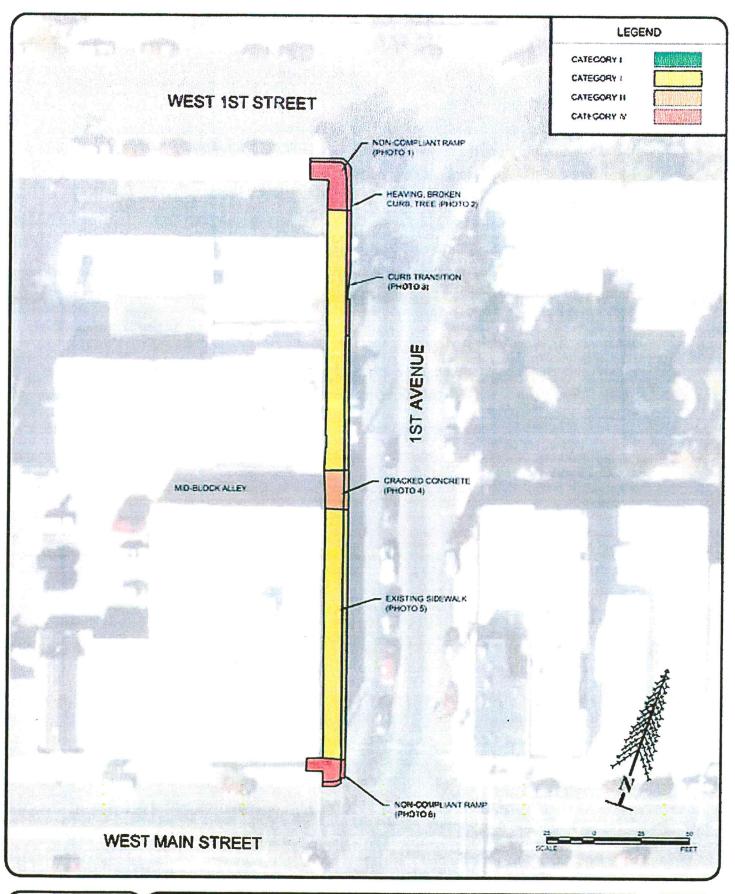
1ST AVENUE - W. MAIN TO W. 1ST - WEST INFRASTRUCTURE ASSESSMENT

Condition Category(s): II, III, IV. Majority is category III and IV.

Comments: The northern ADA ramp is out of spec in both grade and dimensions. The southern ramp is out of spec in grade. Sidewalk panels near the trees have experienced uplift and cracking. Beyond the ADA ramps and trees, the overall sidewalk appears to be in good condition. A few large cracks were observed in the mid-block alley that could warrant replacement if a priority, but do not appear to have any functionality issues at this time.

The existing curb and gutter appeared to be in good condition as well, with exception of sections around the two existing trees. The trees have visibly pushed curb and gutter segments out, interrupting the flow path. Transition between curb and gutter shapes was observed near the most southern tree. This area appears to have additionally experienced settlement in varying areas causing a "wave" like profile within the gutter.

Recommendations: With 1st Avenue seeing a high volume of foot traffic, the ADA ramp replacement at both ends should be prioritized. The north ramp will abut other recommended replacements within sidewalk panels and curb and gutter, making a logical sequence to address all problems within that area.

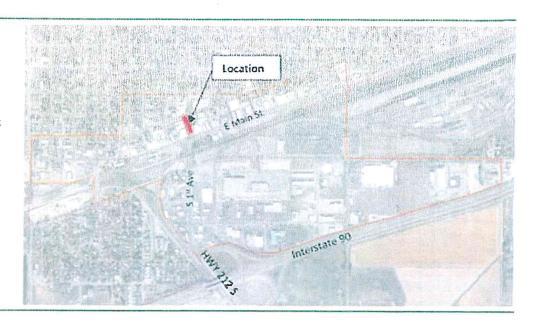
East Right-of-Way

Description of Existing Sidewalk: Existing sidewalk and curb & gutter are present throughout the block in varying conditions. Stormwater inlets are present at the south and north ends. Back of sidewalk ties to buildings, landscaping areas, decorative brick, and retaining walls. Decorative brickwork is included in the sidewalk near the open space area, just north of the alley. Concrete in this area appears to be more recent. There are ramps on both ends of the block, however the south ramp is not ADA compliant. The north ramp appears to be ADA compliant but is oriented diagonally, when only a perpendicular crossing to the West exists. Tree wells are present, with multiple trees.

Dimensions & Area: The existing sidewalk is approximately 10' in width throughout the block. Curb & gutter generally follows a standard 2' in width on the north half, and a 2.5' width on the south half. The sidewalk transitions between 2.5' and 2' just south of the mid-block alley.

Condition Category(s): I, II, III, IV. All categories are present with majority being II and IV.

Segments of curb and gutter appear older and show signs of use, settlement has been observed near the south end. Trees have pushed out curb segments towards the north and are beginning to show effects on sidewalk panels.

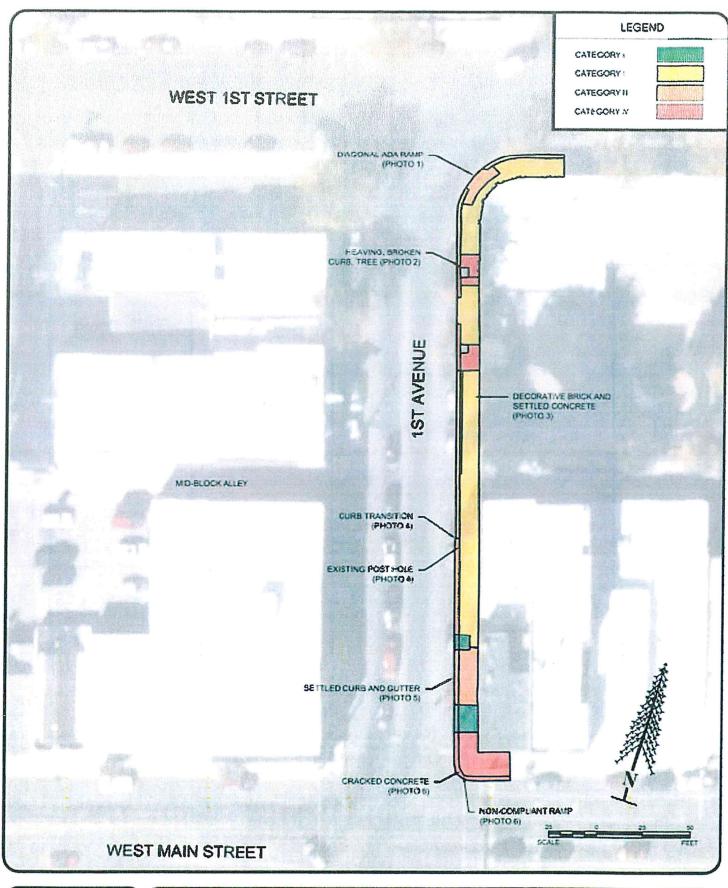
1ST AVENUE - W. MAIN TO W. 1ST - WEST INFRASTRUCTURE ASSESSMENT

Comments: The northern ADA ramp appears to be within spec for grade and dimensions. The ramp is oriented diagonally, even though the only crossing is perpendicular, towards the west across 1st avenue. The crossing to the north is located around the block corner. Given the spread dynamic and lengthy sight distance of this intersection, consideration should be given to better organizing pedestrian traffic across the intersection. The southern ramp does not meet ADA specs and shows significant cracking within ramps and around poles.

Curb sections need replaced where trees have pushed them out, and in areas where older curbs show signs of deterioration. Some areas along the curbs show signs of settlement and should be addressed for drainage purposes. Near the open space, a newer strip of concrete behind the back of curb sits lower than the top of the curb. This is likely due to settlement and is not considered a critical part of the project but should be noted.

Trees have begun to break and uplift sidewalks on the north end; those panels should be replaced.

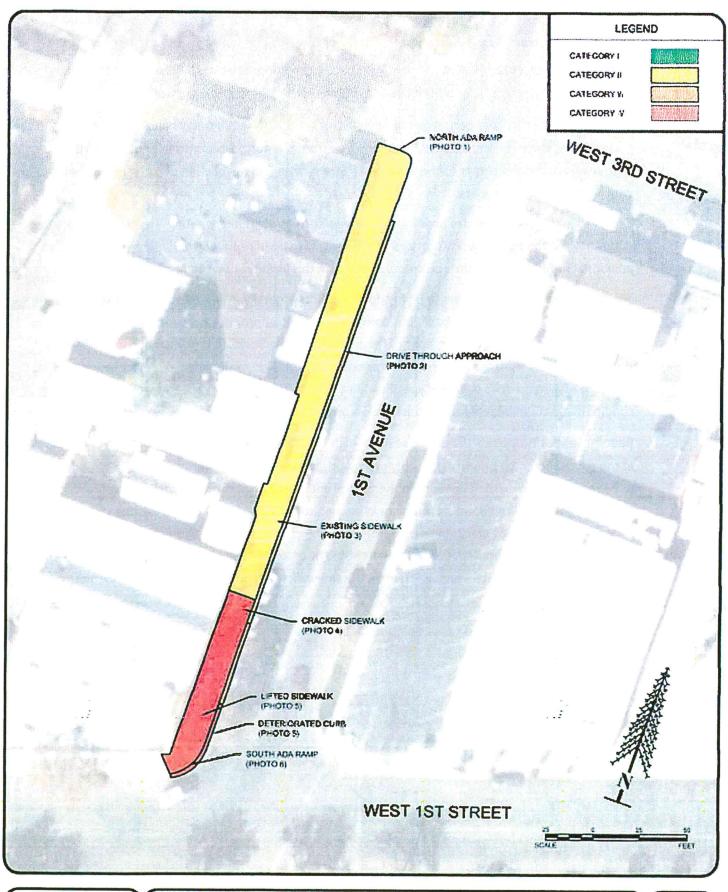
1ST AVENUE - W. 1ST TO W. 3RD - WEST INFRASTRUCTURE ASSESSMENT

The remaining sidewalk appears to be in good condition generally. A few cracks were observed within the drive-thru approach at the bank, but do not appear to compromise any functionality of the approach. The curb and gutter in front of the bank approach shows signs of wear and deterioration, this area could be replaced if considered a priority but is outside of the original project limits. The northern ADA ramp does not meet specifications, despite the concrete appearing to be in good condition and could be replaced if considered a priority but is outside of the original project limits.

Recommendations: With 1st Avenue seeing a high volume of foot traffic, the ADA ramp replacement at the south should be prioritized. Curb, gutter, and sidewalk panels in the adjacent areas also need to be replaced. The existing sidewalk in the central and northern part of the block do not present signs warranting full replacement, but should be monitored in the future where existing cracks are located. Sealing existing cracks in the concrete could be considered as an alternative to help prevent weathering and deterioration. Consideration should be given to removing the trees on the north end to prevent foreseeable uplift and cracking on the sidewalk that appears to be in good condition currently.

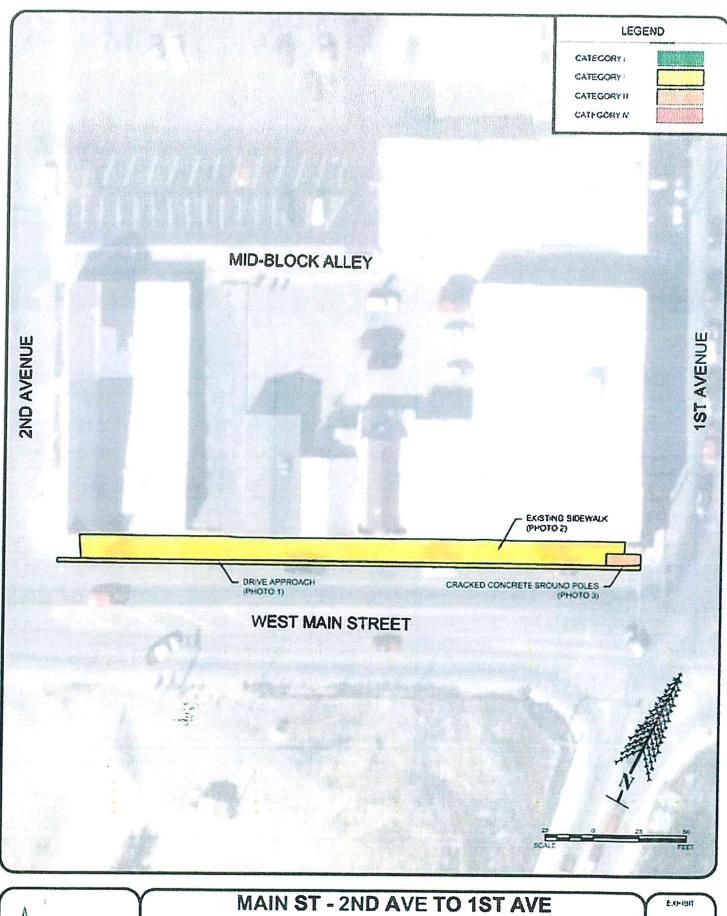
MAIN ST - 2ND AVE TO 1ST AVE INFRASTRUCTURE ASSESSMENT

Description of Existing Sidewalk: Existing sidewalk and curb & gutter are present throughout the block, primarily in Class II condition. Stormwater inlets are present at the East and West ends, with an additional inlet near the center of the block. Back of sidewalk ties to buildings and entrances. One lot near the west end contains a drive approach through the sidewalk. Concrete throughout the block (between ramps) appears to be more recent. Tree wells are present, with multiple trees throughout the block.

Recommendations: Because the adjacent ADA ramp will be replaced at the east end, the cracked panels bordering the ramp should additionally be replaced.

Consideration should be given to removing existing trees throughout the block prior to them damaging sidewalk via cracking or uplift as displayed in other areas of the survey.

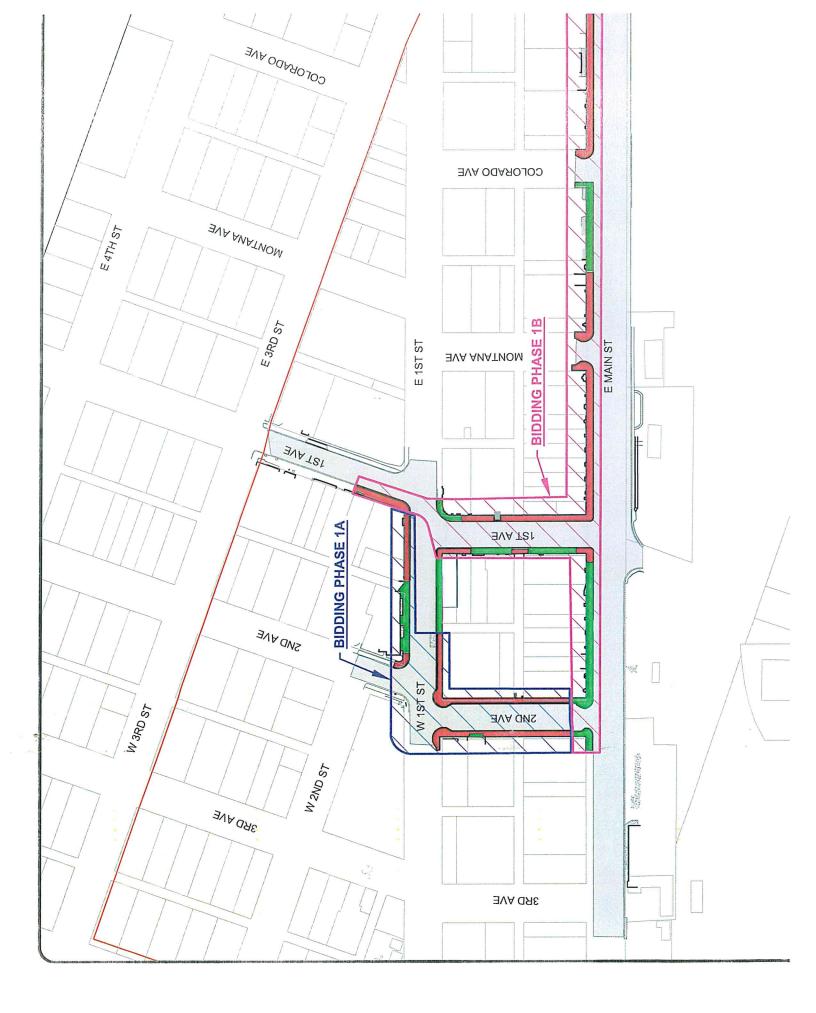
Draft Proposed Project Map

- i. The draft project survey has been completed.
- ii. Exhibit 2 includes the draft layout, showing the proposed improvements.
 - a. Areas in green are in good condition, and not proposed for replacement at this time.

- i. Some sidewalk in the green areas will require removal/replacement to accommodate pull boxes for pedestrian lighting.
 - b. Areas in red are proposed for replacement.

- i. Deteriorating sidewalk
 - ii. Drainage issues
 - iii. Non-ADA compliance
 - iv. Areas where conditions vary. (Some good, some bad)
 - Based on discussions with the pedestrian lighting engineer, it is more economical to replace some additional sidewalk and trench than to bore multiple short sections. Therefore in areas where condition varies, it is proposed to replace the whole sidewalk to accommodate the pedestrian lighting project.
