## **HISTORICAL COMMISSION MEETING AGENDA**

- 4. H22-0001 – Brownhouse Design – 151 Hawthorne Avenue**  
Advisory review application for an addition, alterations and improvements to an existing one-story house, which is a Historic Resource. The project includes a 609 square-foot one-story addition to the existing house, a new 533 square-foot detached garage, and 26 square-foot addition to the existing basement. The project is considered categorically exempt from further

**5. HPA22-0001 - Brownhouse Design – 151 Hawthorne Avenue**

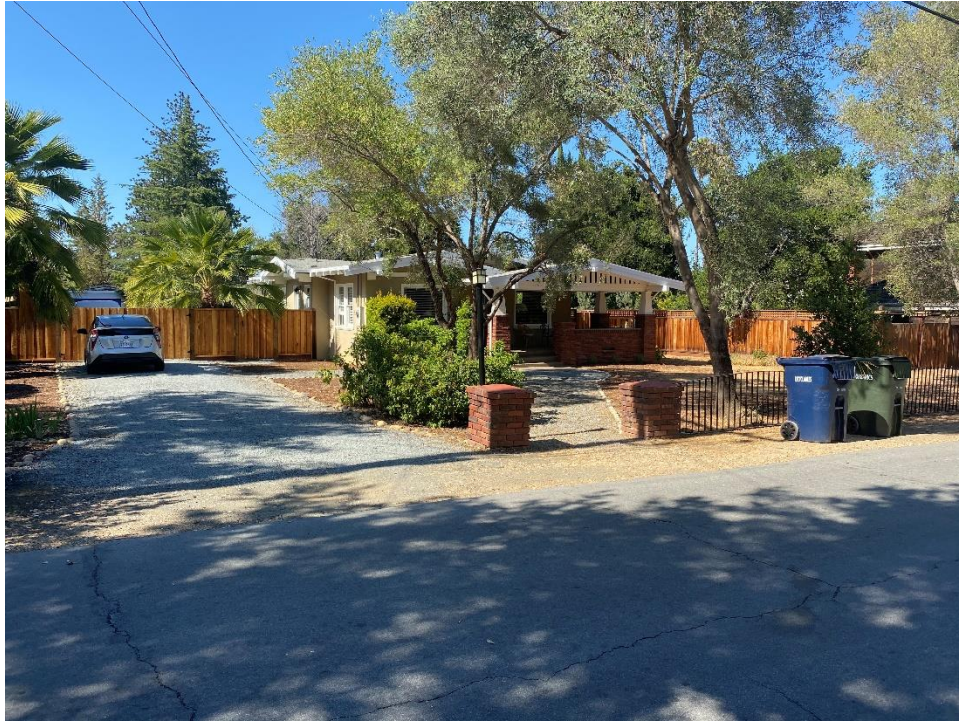
**Figure 22. South elevation, facing north.**

The south elevation consists of an asymmetrical design with a main front-gabled roof form, a lower projecting front gable, and an extending front gable porch roof (Figure 22 and Figure 23). The extending porch roof consists of decorative vertical wood boards with open slates that provide ventilation to the porch roof. The porch is supported by three battered columns that rest on square piers clad with red brick (Figure 24). There is a solid porch balustrade clad in red brick laid out in a running bond pattern. The front porch floor is accessed via a set of concrete steps along the primary façade and a set of concrete steps and a secondary entrance along the rear of the porch at the southeast corner of the house. The porch floor is stamped concrete, and the porch ceiling is clad in contemporary stucco, which likely covers the original wood-clad porch roof (Figure 25). Fenestration along this elevation includes two large picture windows that are not original to the house, set in wood window casings (not original) and wide decorative window trim and an oversized wooden front door with three vertical beveled glass and asymmetrical patterns (Figure 26).

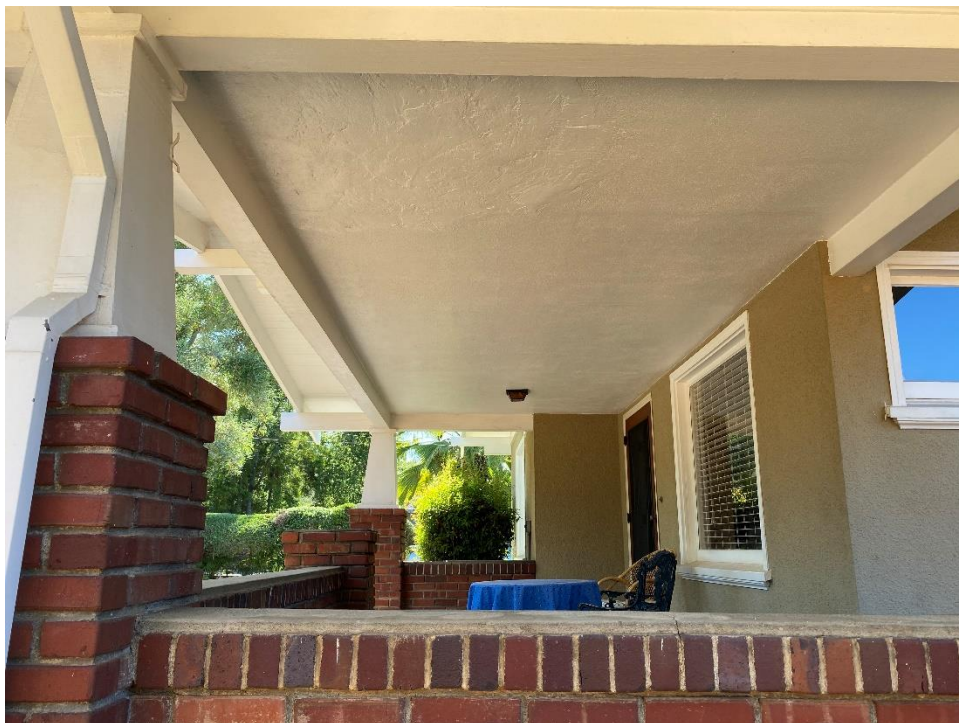
**Figure 25. Photograph showing the front porch, facing west.**

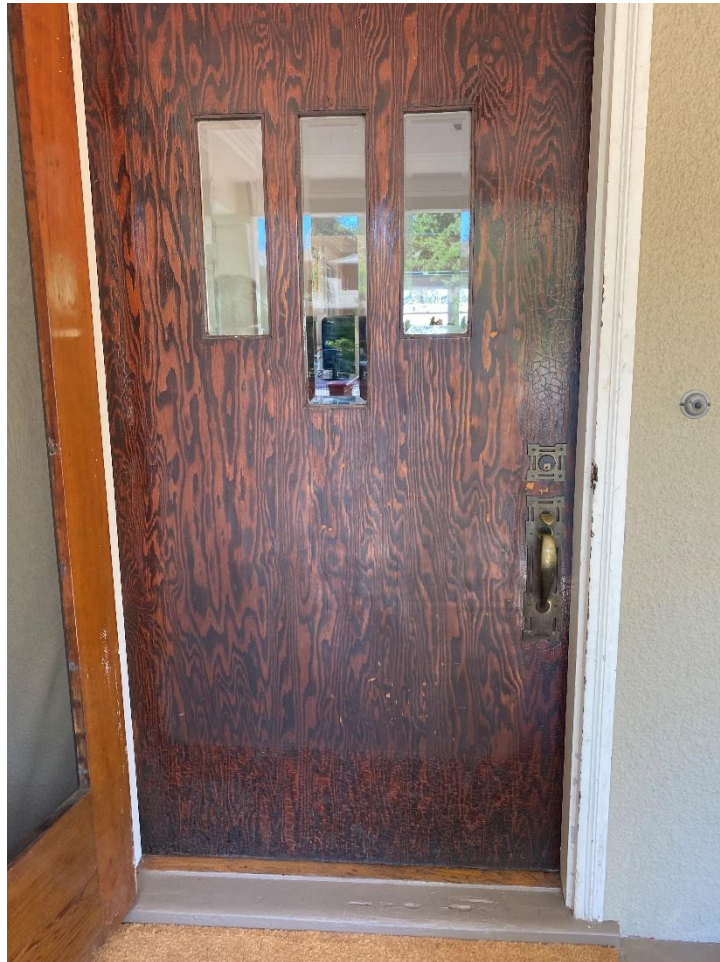
Figure 26. Photograph showing the front door, facing north.

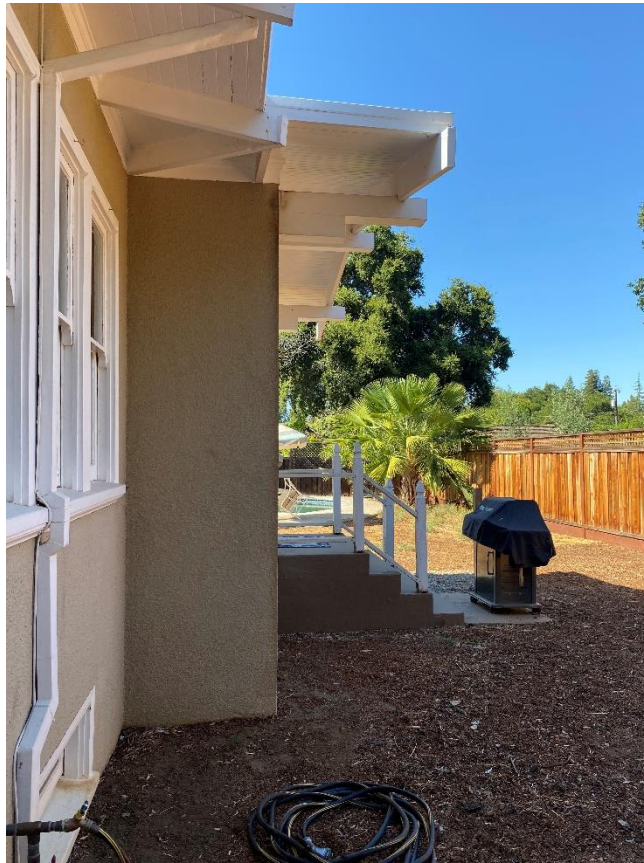
**Figure 27. East elevation, facing north.**

The east elevation consists of a dormer side gable roof that sets above the porch roof and a projecting side gable addition/enclosed porch, both of which appear to be additions and not original to the design (Figure 27 and Figure 28). The side gable roof is set above the porch roof, consisting of exposed beams with the exterior of the original brick chimney projecting through the center of the roof along the roof ridge. The projecting side gable roof addition appears to be an enclosed porch that was altered in the ca. 1950s to allow access to the half-width basement that seems to have been initially accessed via an exterior cellar door that is no longer present. The projecting side gable addition consists of concrete steps and a contemporary hand railing that leads to a rear porch door. Fenestration along this elevation includes a series of three double-hung wood windows with lugs, two casement windows, and a basement window that appears original to the house, and a pair of double-hung wood windows with lugs and a wooden door with upper glazing and lower wood paneling that appear to have been added in the ca. 1950s or ca. 1960s as part of the rear porch enclosure.

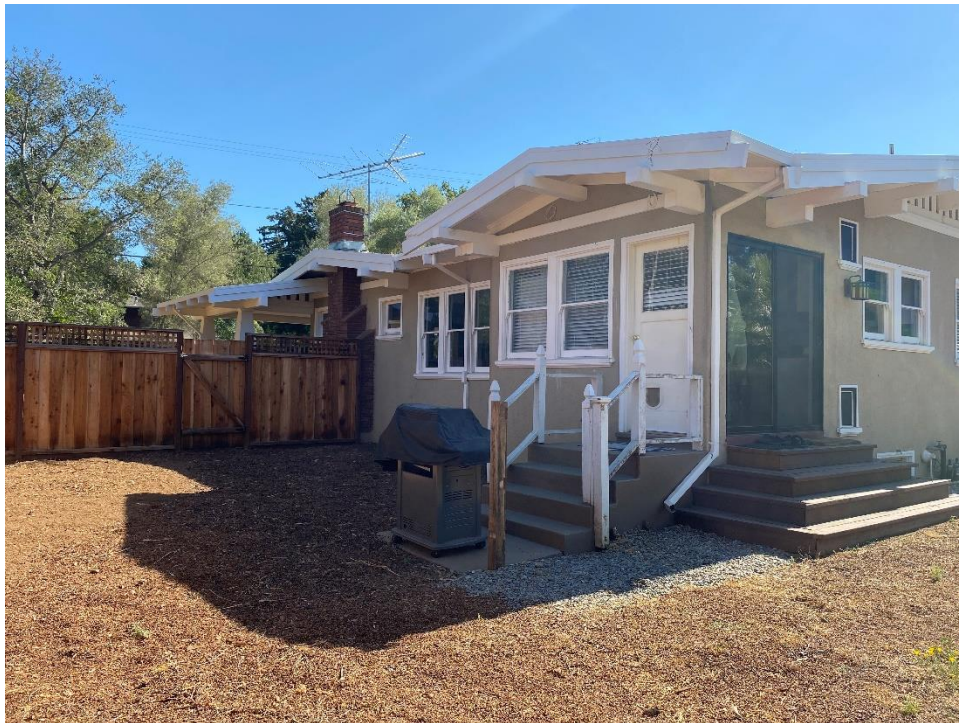
**Figure 28. Photograph showing the east elevation, facing southwest.**

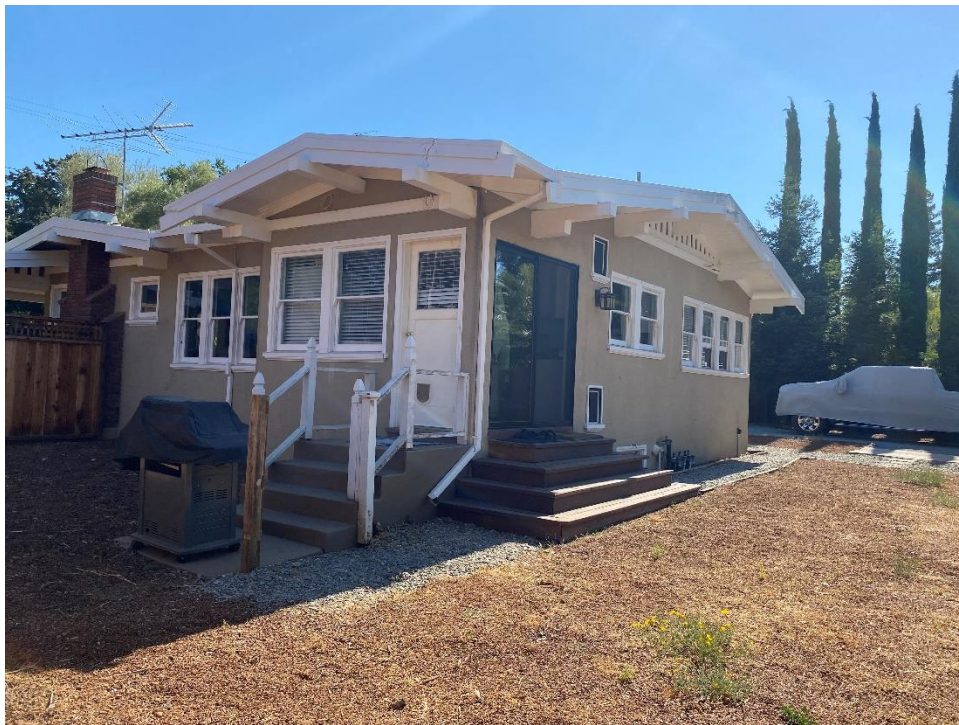
The north elevation consists of an extending gabled roof with wide overhanging eaves and wood beams (Figure 29). The rear gable mimics the front porch gable detail, with decorative, vertical wood boards with open slates that provide ventilation (Figure 30). There are changes to this elevation that includes a vinyl sliding glass door, added during the 2015 kitchen remodel, which is accessed via a set of steps constructed of what appears to be fiber cement or Hardie decking. There are two narrow, fixed windows that may be original to the house but appear to have been relocated due to either the 1985 or 2015 kitchen remodel. There are also a series of four double-hung wood windows with lugs that appear original to the house, as well as a narrow rectangular basement hopper window. There are two -square vents along this elevation that are not original and were likely added during one of the kitchen remodels.

Figure 29. Photograph showing the north elevation rear roof gable and decorative vertical wood boards along the gable, facing southwest.

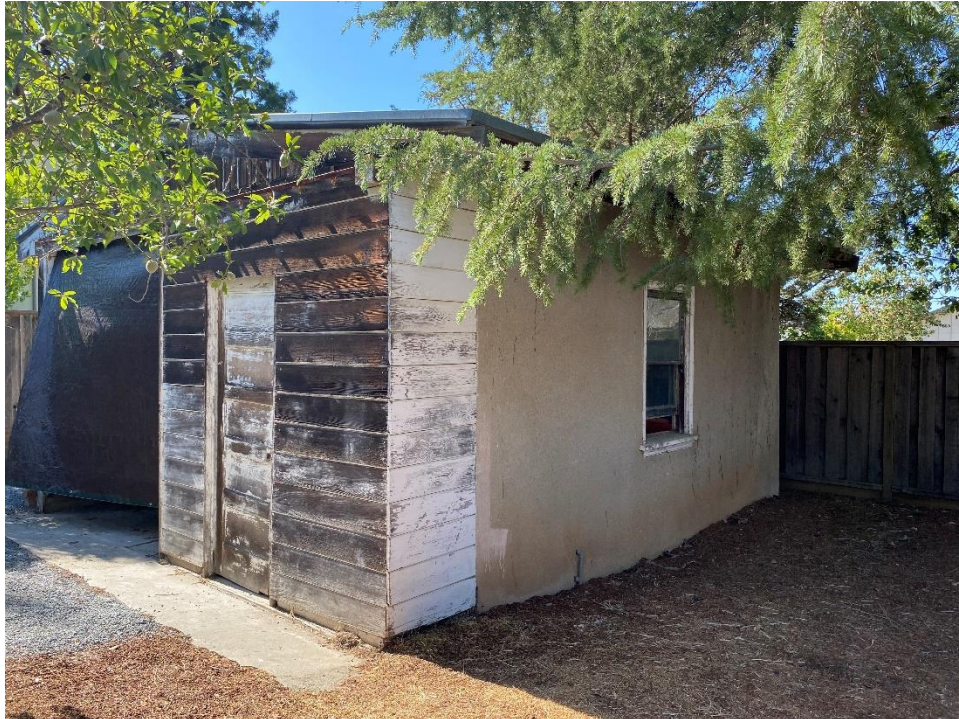
The ca. 1922 shed is a wood-framed front gable form with a low-pitched roof and a wide eave overhang with exposed rafter tails. Along the south elevation, a portion of the building is clad in original horizontal wood boards, and the east, west, and north elevations are clad in contemporary stucco (Figure 33). There are two five-panel wood doors, one along the south elevation (primary façade) and another along the north elevation. There is a tarp covering a wide door opening (Figure 34). There are two windows, including a vinyl sliding window along the north elevation and a double-hung wood window along the east elevation.

Figure 33. Photograph showing the cladding along south and east elevations, facing northwest.

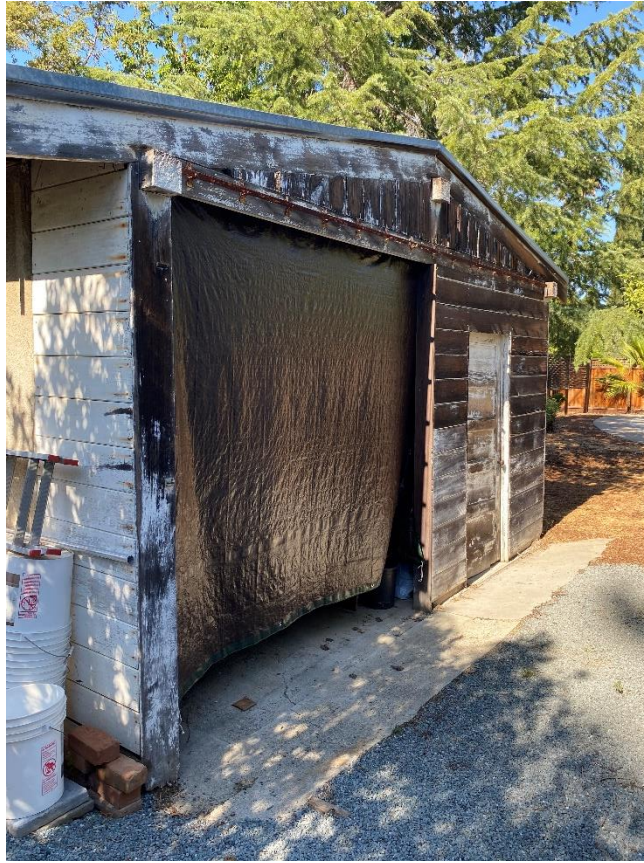
Figure 34. Photograph showing the tarp covering the wide door opening and the front entrance to the shed.

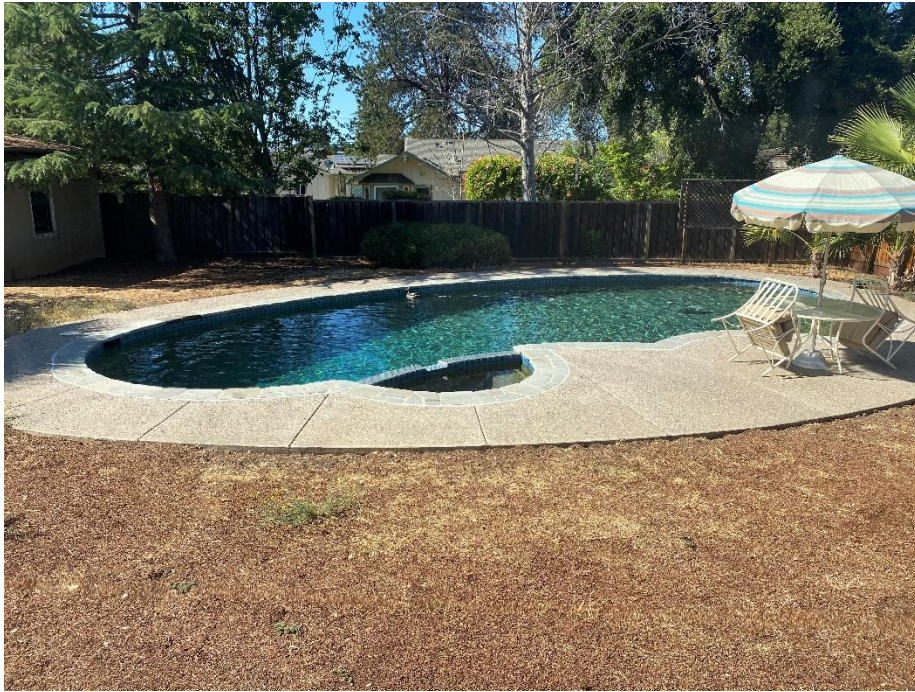
The 1972 inground swimming pool is kidney-shaped and includes a semicircular hot tub attached to the southern end of the swimming pool (Figure 35). The pool decking is constructed of stamped cobblestone and concrete. There is decorative blue tile along the top edge of the pool.

Figure 35. Photograph showing the 1972 inground swimming pool with the hot tub, facing north.

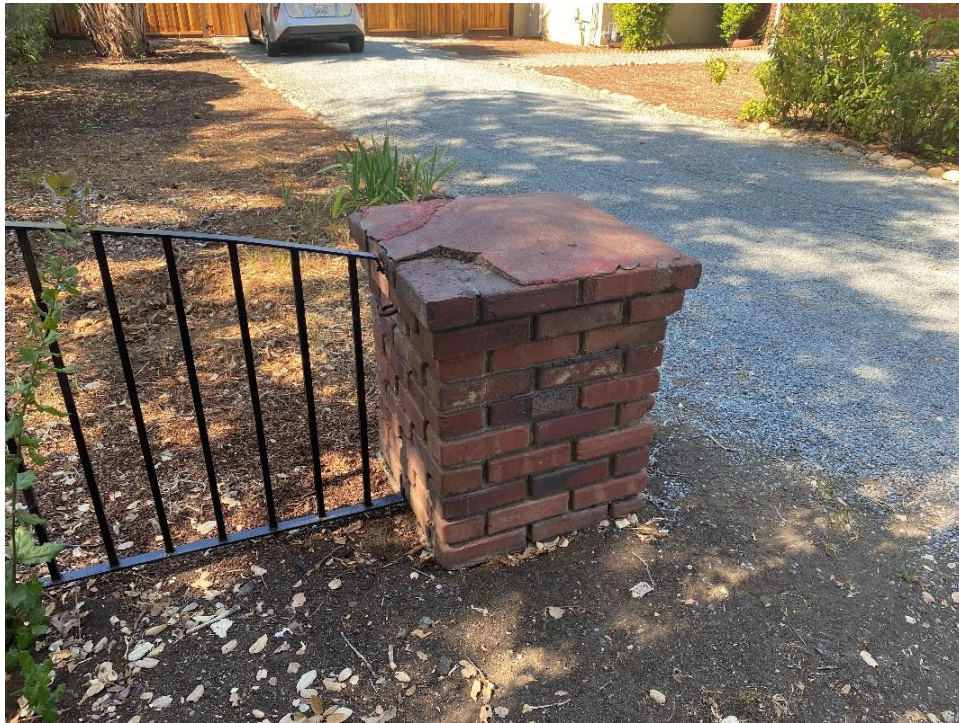
The associated landscape includes original square concrete pillars clad in decorative red brick that appear original to the house (Figure 36). The brick-clad concrete pillars are linked together by contemporary iron fencing designed in a semicircular shape. A gravel driveway leads to a wooden fence, which appears to be new (Figure 37).

**Figure 36. Photograph showing a concrete pillar and contemporary iron gate along the primary façade, facing north.**

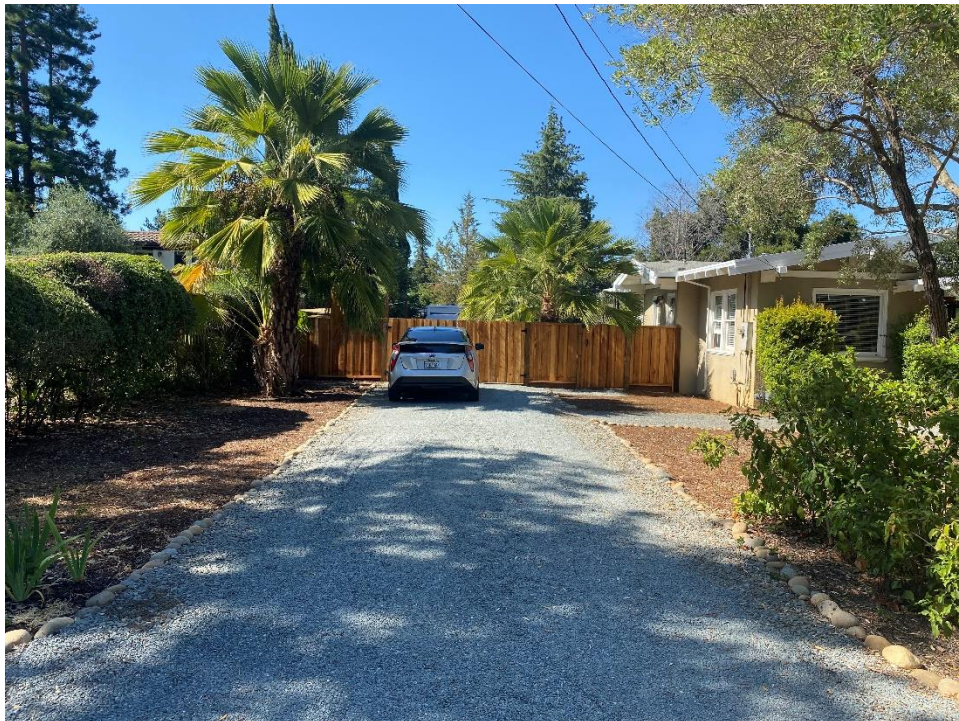
**Figure 37. Photograph showing the gravel driveway and new wooden fence, facing north.**

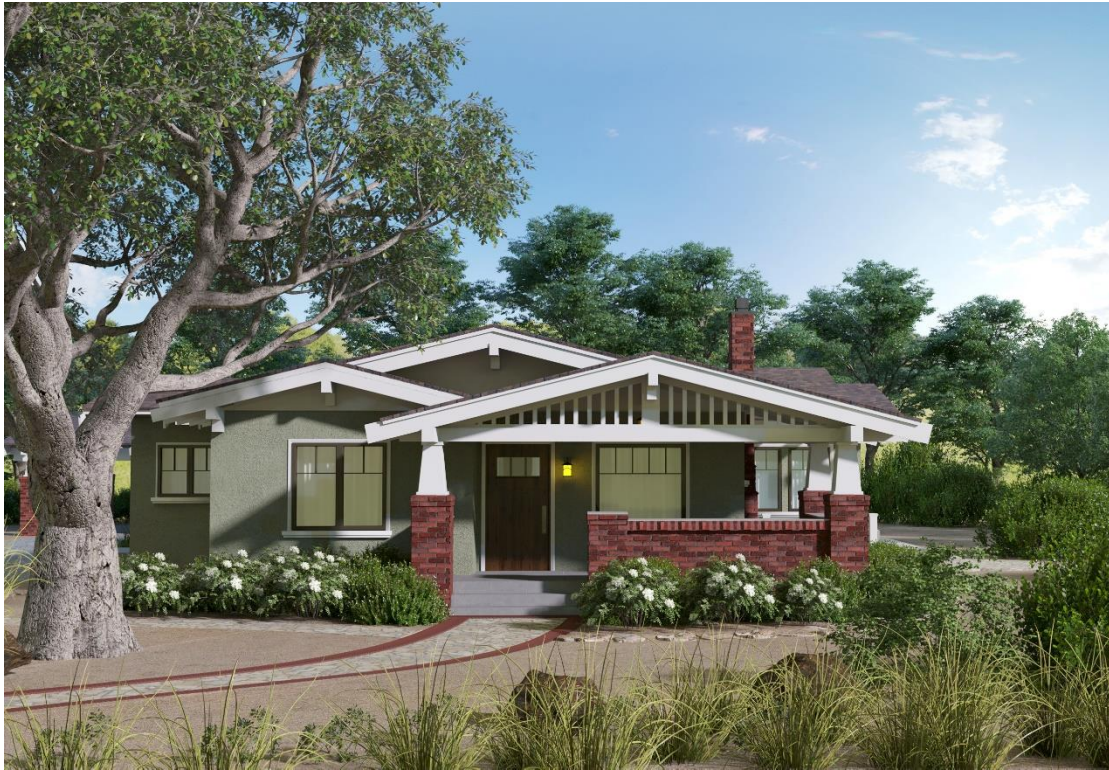
The design of the new addition and proposed alterations to the primary façade of the ca. 1922 house, including the new windows and doors, have been carefully considered to complement the original Craftsman Bungalow design of the ca. 1922 house and will not create a false sense of historical development (Figure 44). The new detached garage consists of a modern garage door and extended covered parking supported by narrow and shorten tapered columns set on tall pillars clad in 1/3 running bond pattern, which does not mimic the original tapered columns along the primary façade of the ca. 1922 house (Figure 45).

Figure 44. The rendering shows the proposed primary façade with shingle cladding and new windows, with narrow upper sash windows (Brownhouse Design; dated 5/27/2022).

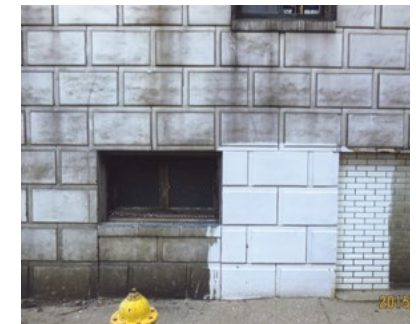
[1] A test patch should always be done before using a chemical cleaner to ensure that it will not damage historic masonry, as in this instance, terra cotta.

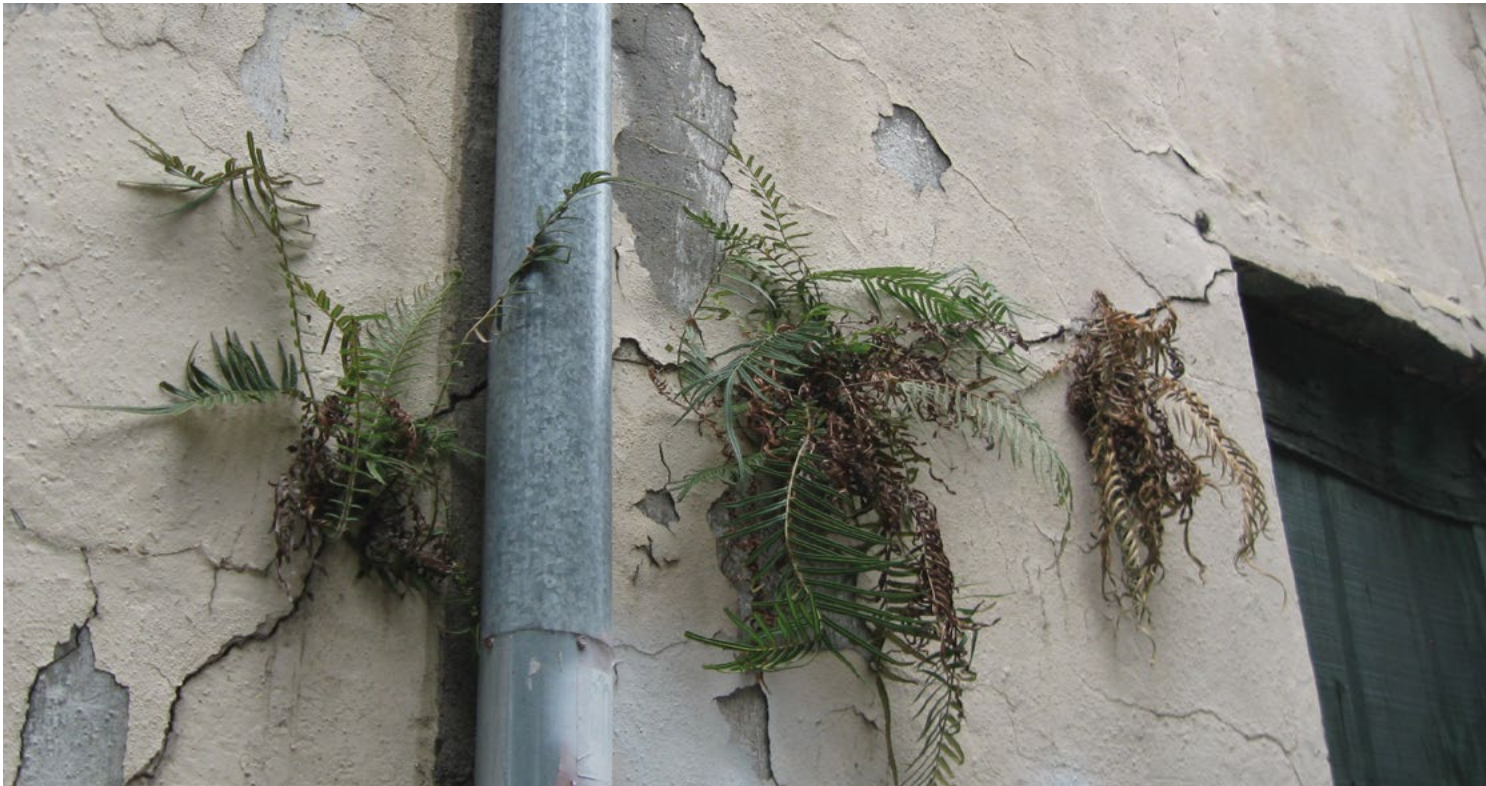
[3] **Not Recommended:** Cracks in the stucco have not been repaired, thereby allowing ferns to grow in the moist substrate which will cause further damage to the masonry.

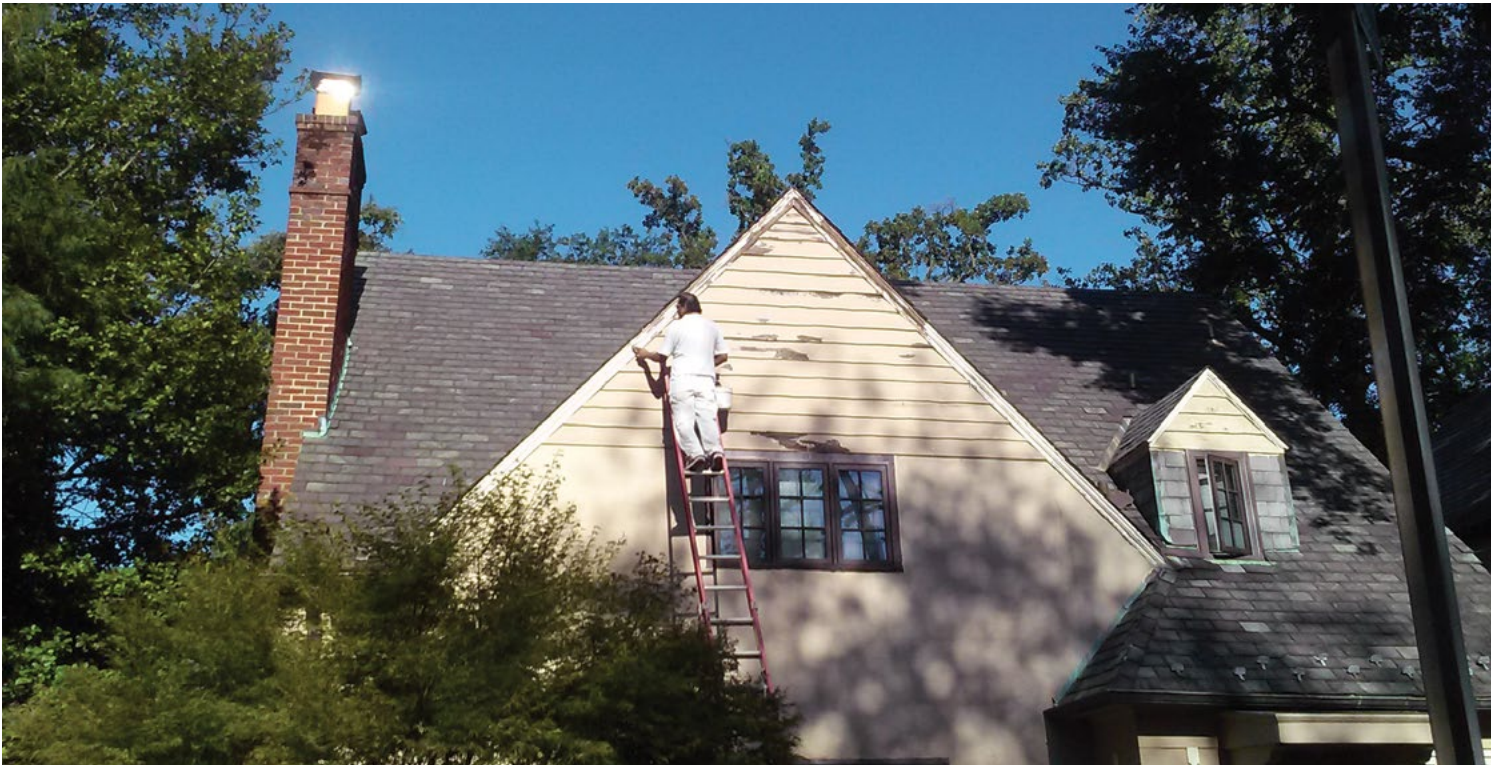
[4] Hand scraping to remove peeling paint from wood siding in preparation for repainting is an important part of regularly-scheduled maintenance.

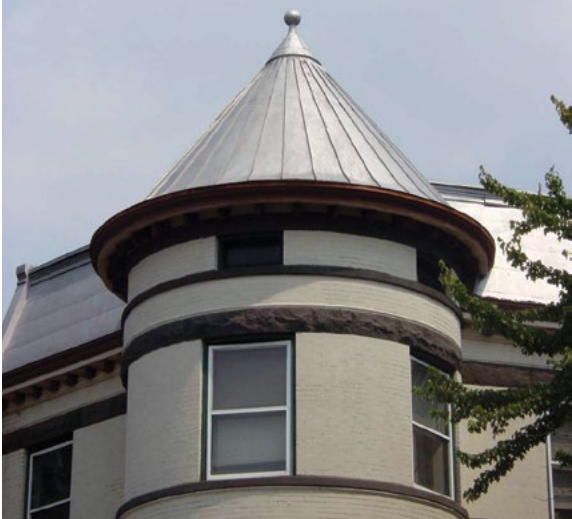
[6] A standing-seam sheet metal roof, like the one on the turret of this late 19<sup>th</sup> century row house, must be kept painted to ensure its preservation.

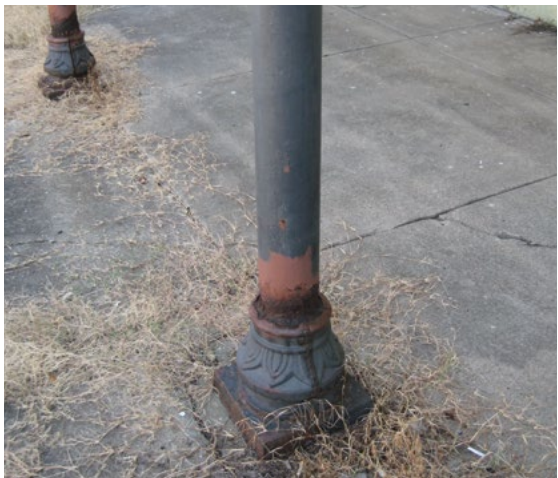
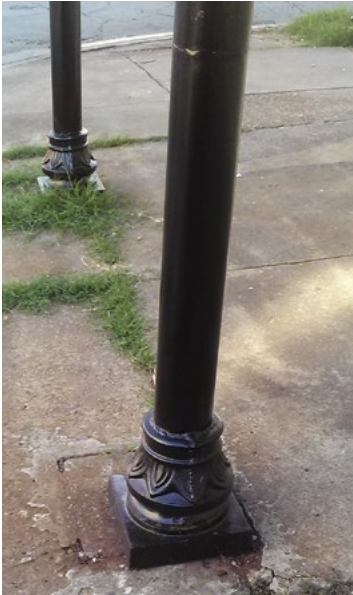
[7] (a) After the damaged portions of the base were repaired, (b) the cast-iron columns were cleaned and repainted to protect the metal from rusting.

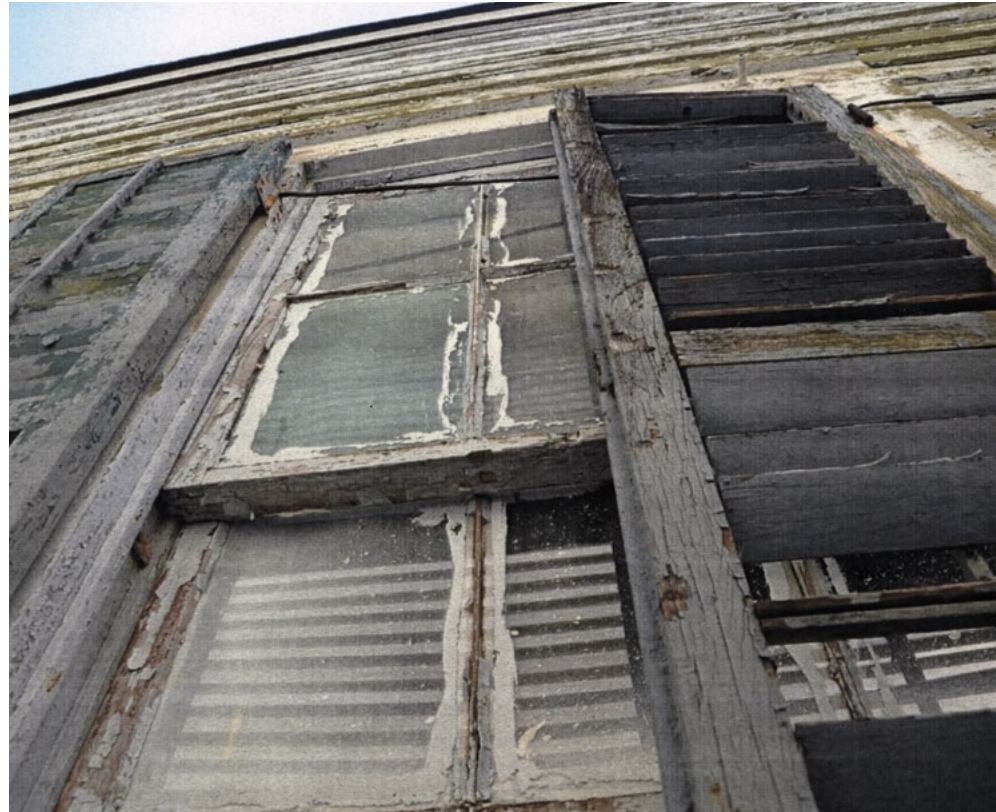
[11] Old and brittle glazing putty should be removed carefully before reputtying to keep window glazing weathertight.

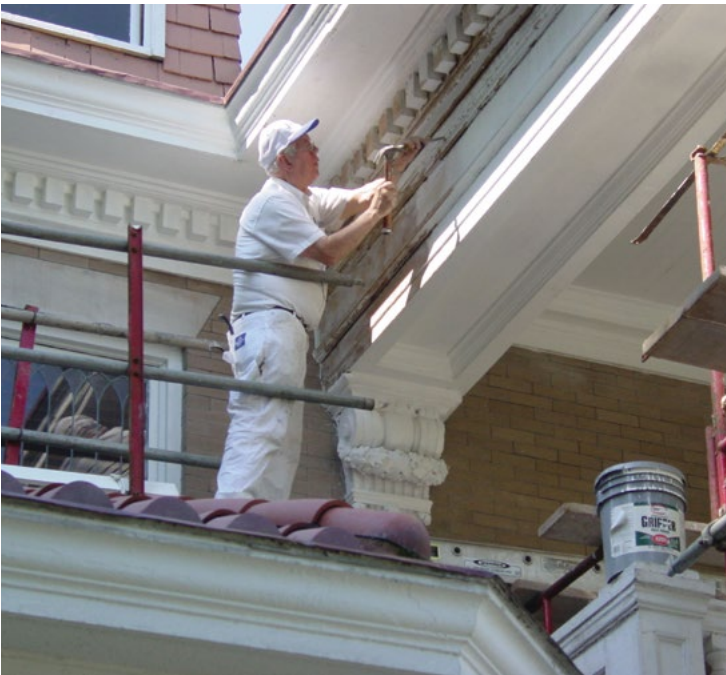
[13] It is important that exposed swallow tail porch rafters be kept painted to protect them from water damage.

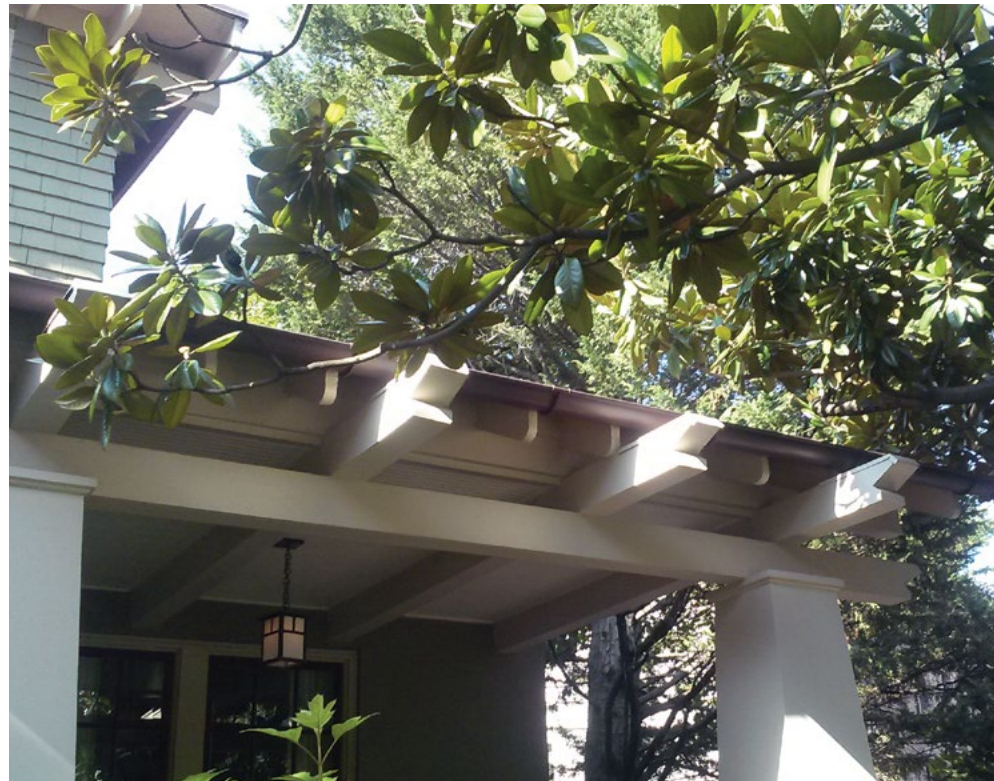
[12] Repair and limited replacement in kind to match deteriorated wood porch features is always a recommended preservation treatment.

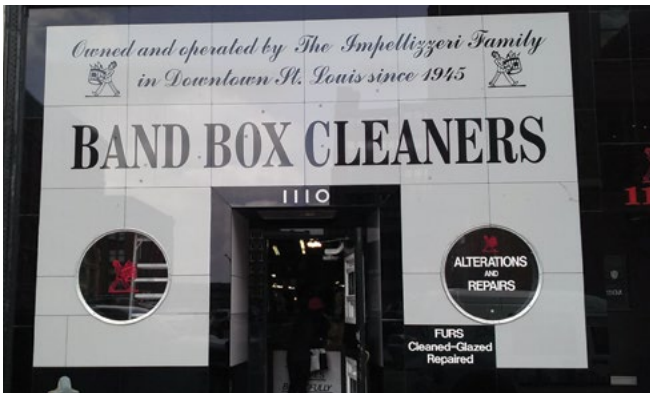
[14] The signage is an original and integral part of this historic Carrara glass storefront.

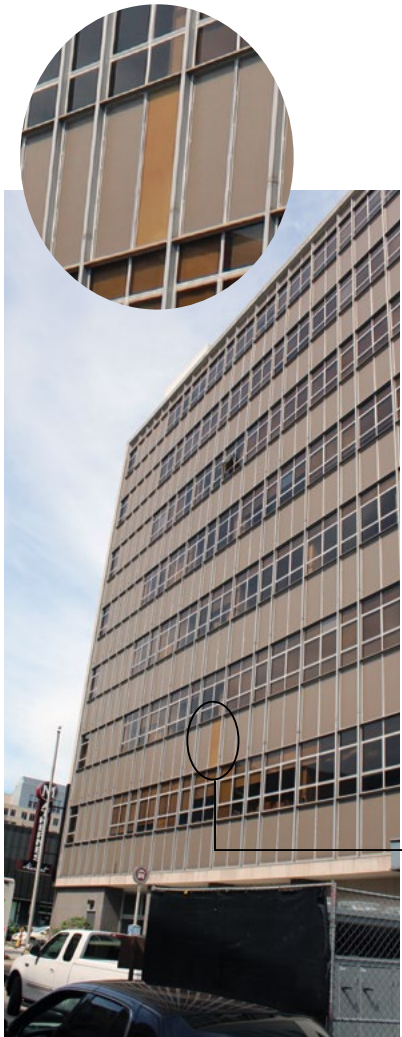
[16] Plywood provides temporary protection for an opening where a damaged spandrel panel was removed until a matching replacement panel can be installed.

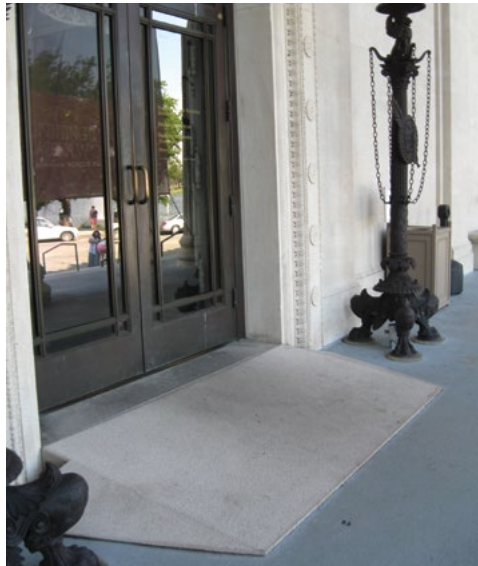
[26] A temporary ramp—unobtrusive and easily removed—facilitates access to the entrance of this museum and does not affect its historic character.

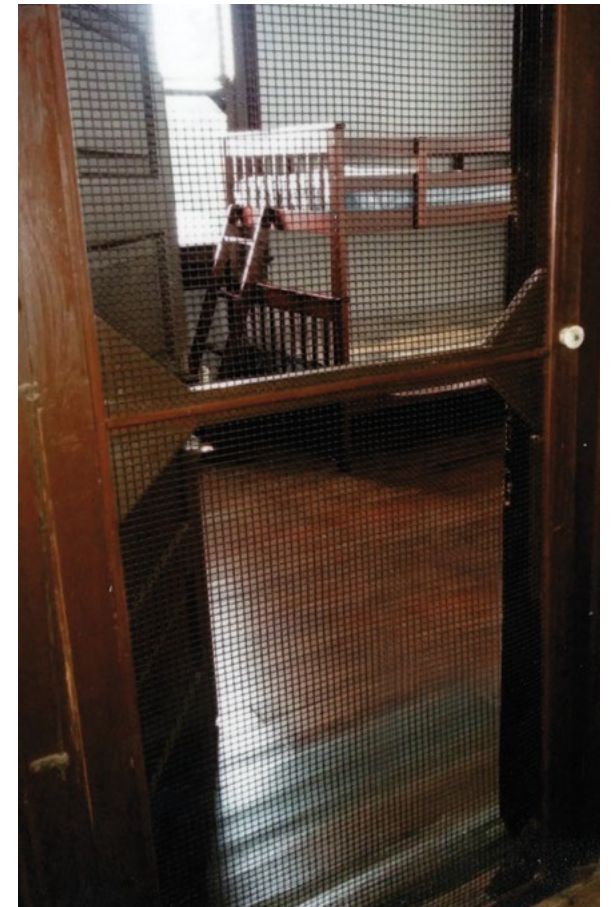
[31] An interior screen door at the entrance to individual apartments is a historic feature traditionally used to help circulate air throughout the building.

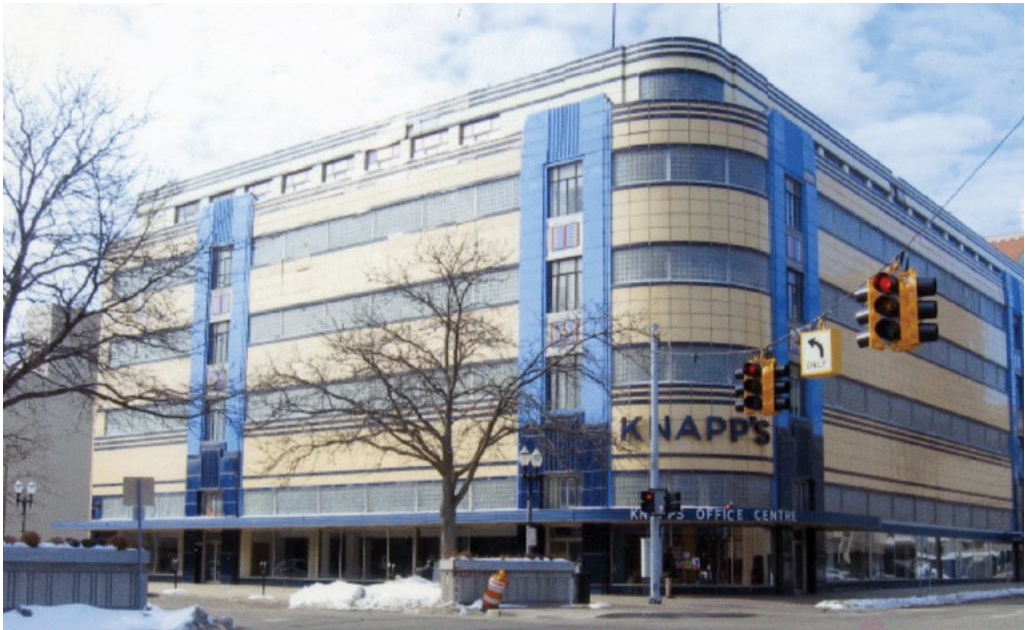
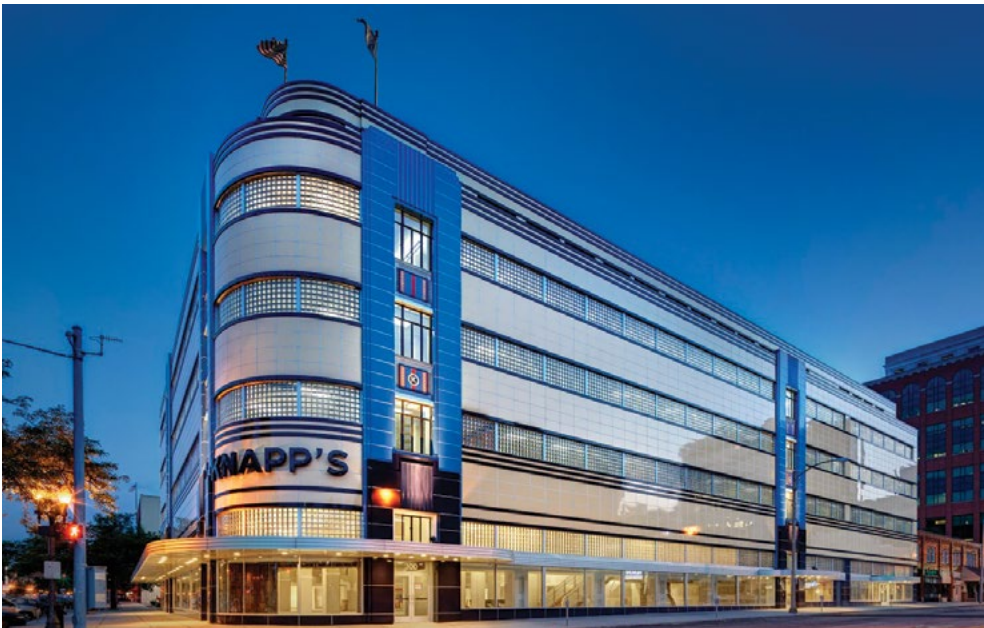
[7] (a) J.W. Knapp's Department Store, built 1937-38, in Lansing, MI, was constructed with a proprietary material named "Maul Macotta" made of enameled steel and cast-in-place concrete panels. Prior to its rehabilitation, a building inspection revealed that, due to a flaw in the original design and construction, the material was deteriorated beyond repair. The architects for the rehabilitation project devised a replacement system (b) consisting of enameled aluminum panels that matched the original colors (c). Photos and drawing (a-b): Quinn Evans Architects; Photo (c): James Haefner Photography.

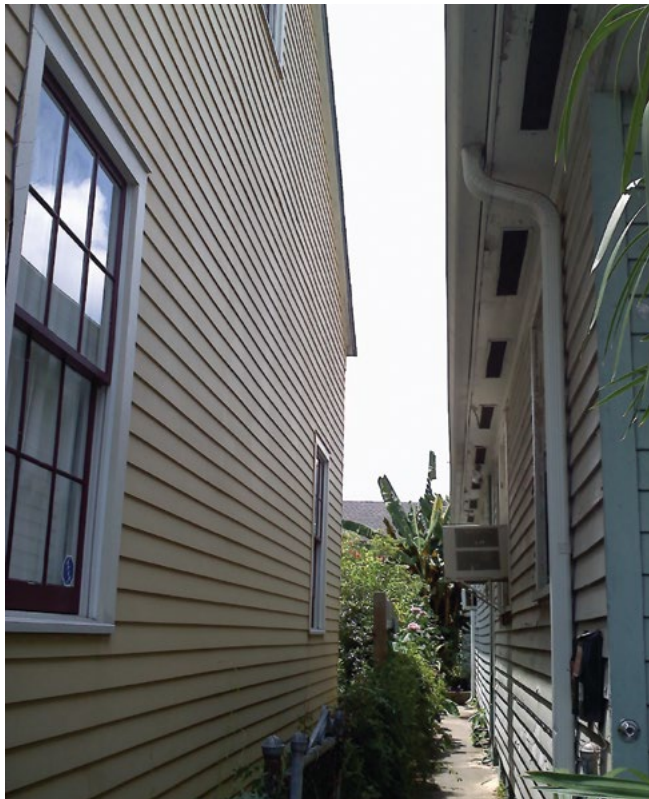
[9] Smooth-surfaced cementitious siding (left) may be used to replace deteriorated wood siding only on secondary elevations that have minimal visibility.

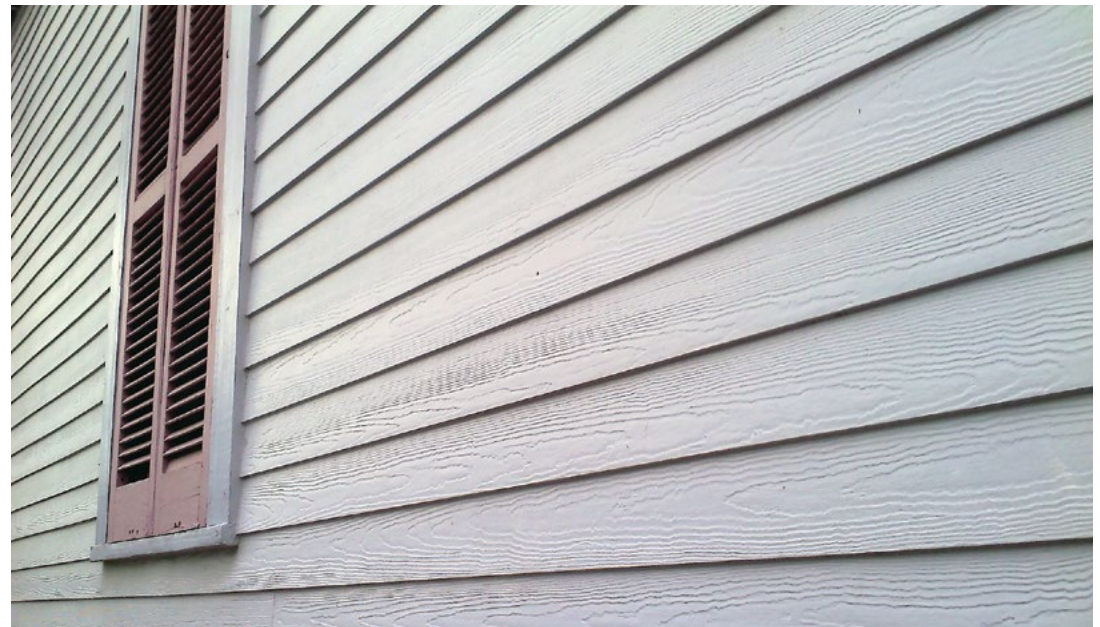
[10] **Not Recommended:** Cementitious siding with a raised wood-grain texture is not an appropriate material to replace historic wood siding, which has a smooth surface when painted.

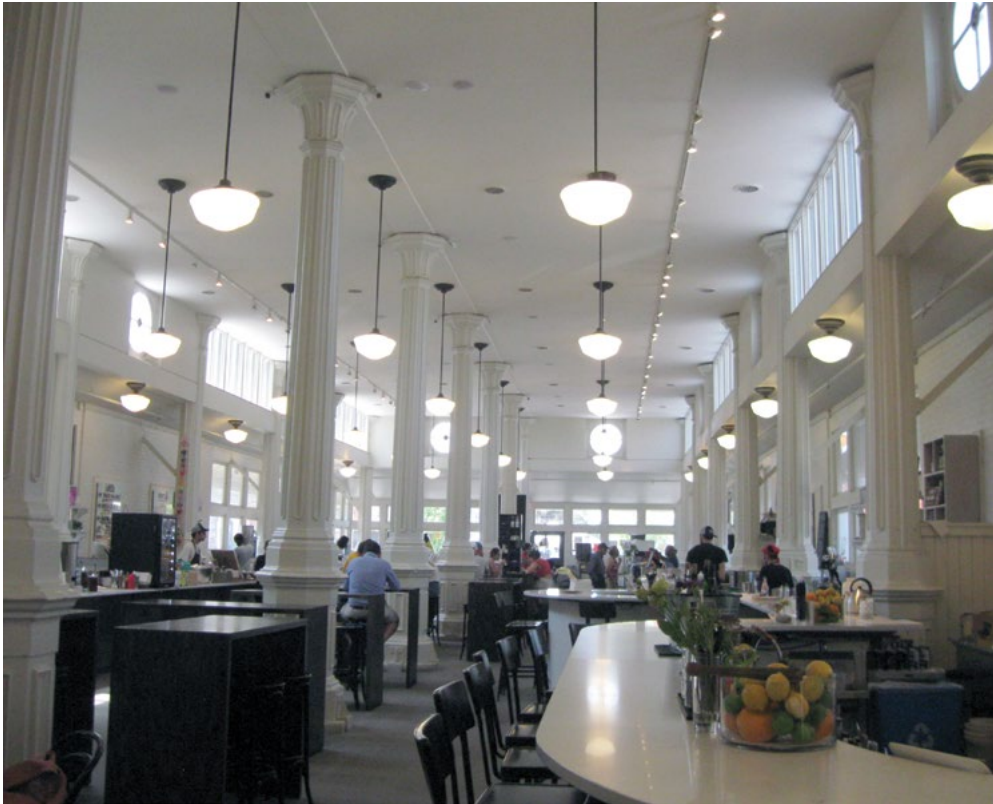
[14] Interior cast-iron columns have been cleaned and repainted as part of the rehabilitation of this historic market building for continuing use.

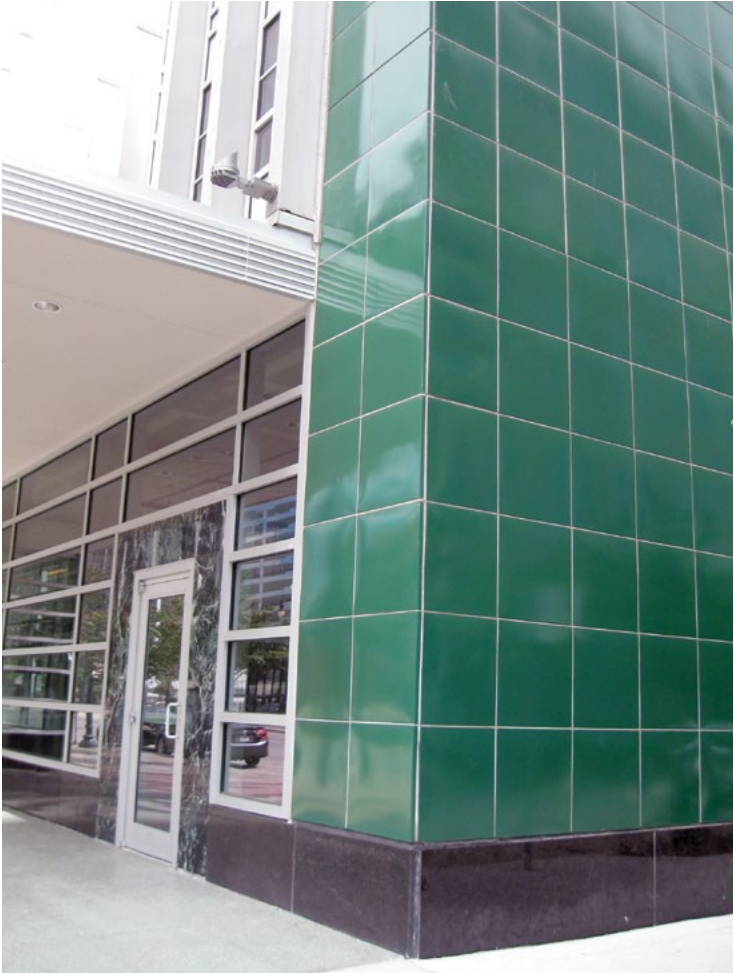
[15] New enameled-metal panels were replicated to replace the original panels, which were too deteriorated to repair, when the storefront of this early 1950s building was recreated.

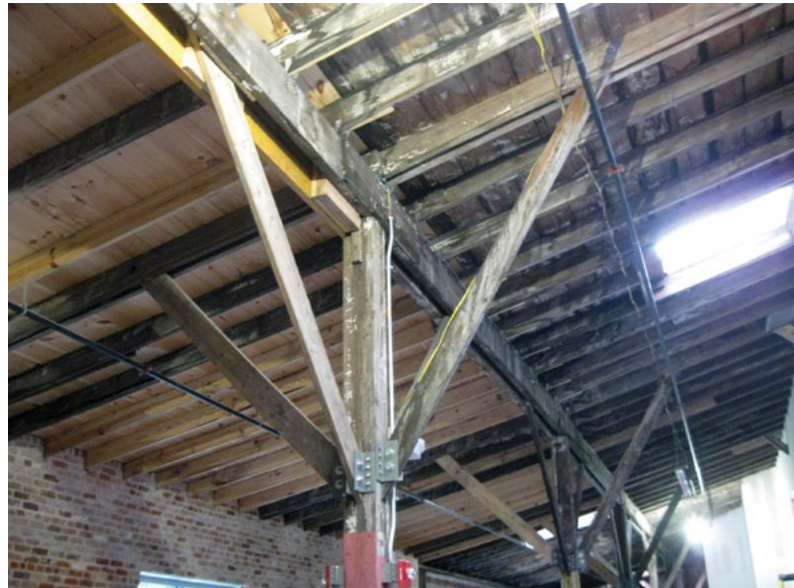
[17] New wood elements have been used selectively to replace rotted wood on the underside of the roof in this historic warehouse.

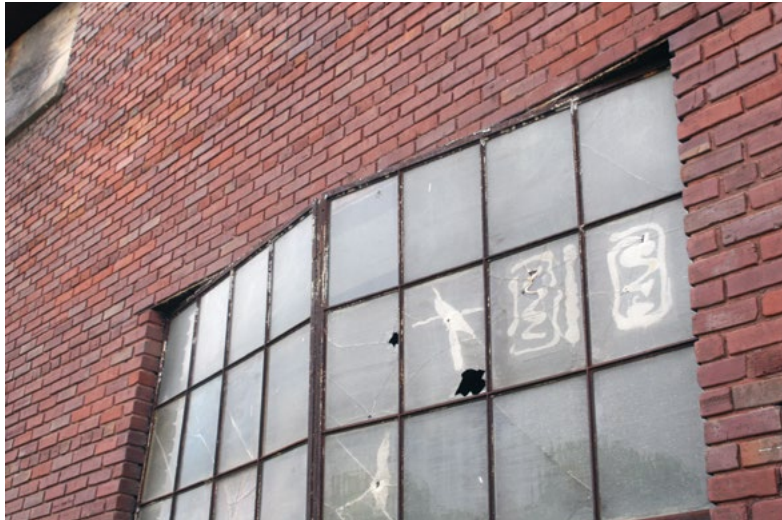
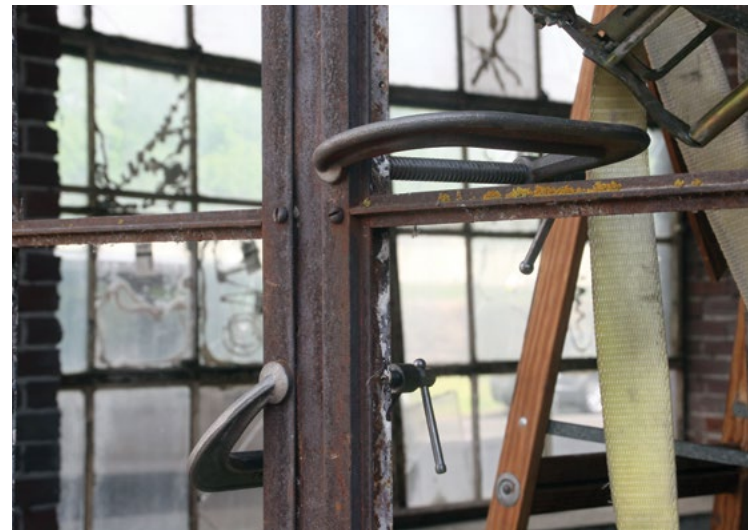
[20 a-d] The original steel windows in this industrial building were successfully repaired as part of the rehabilitation project (left).
