## **HISTORICAL COMMISSION MEETING AGENDA**

- 4. H22-0001 – Brownhouse Design – 151 Hawthorne Avenue**  
Advisory review application for an addition, alterations and improvements to an existing one-story house, which is a Historic Resource. The project includes a 609 square-foot one-story addition to the existing house, a new 533 square-foot detached garage, and 26 square-foot addition to the existing basement. The project is considered categorically exempt from further

**5. HPA22-0001 - Brownhouse Design – 151 Hawthorne Avenue**

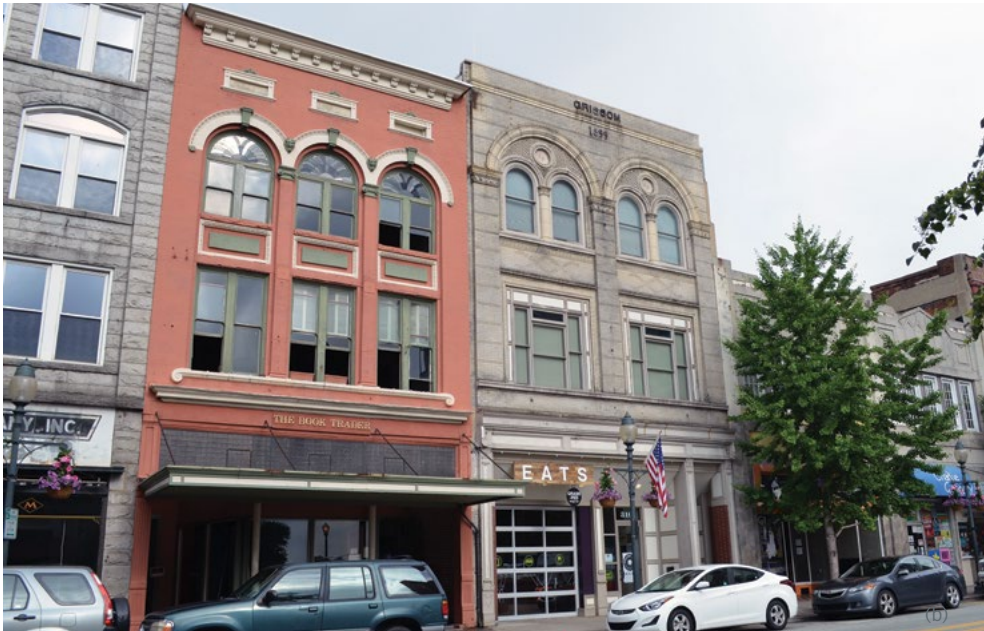
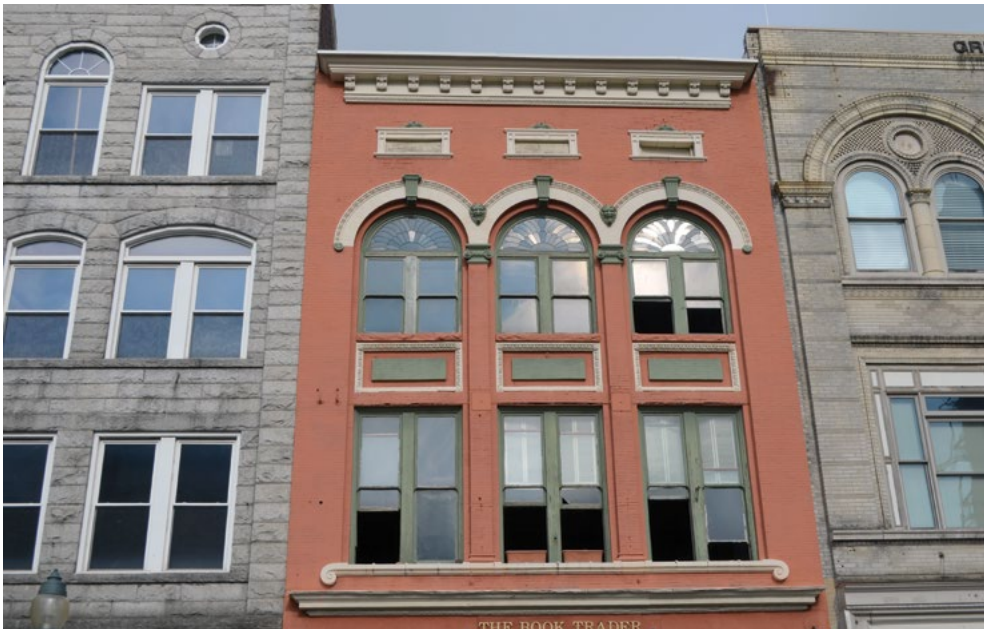
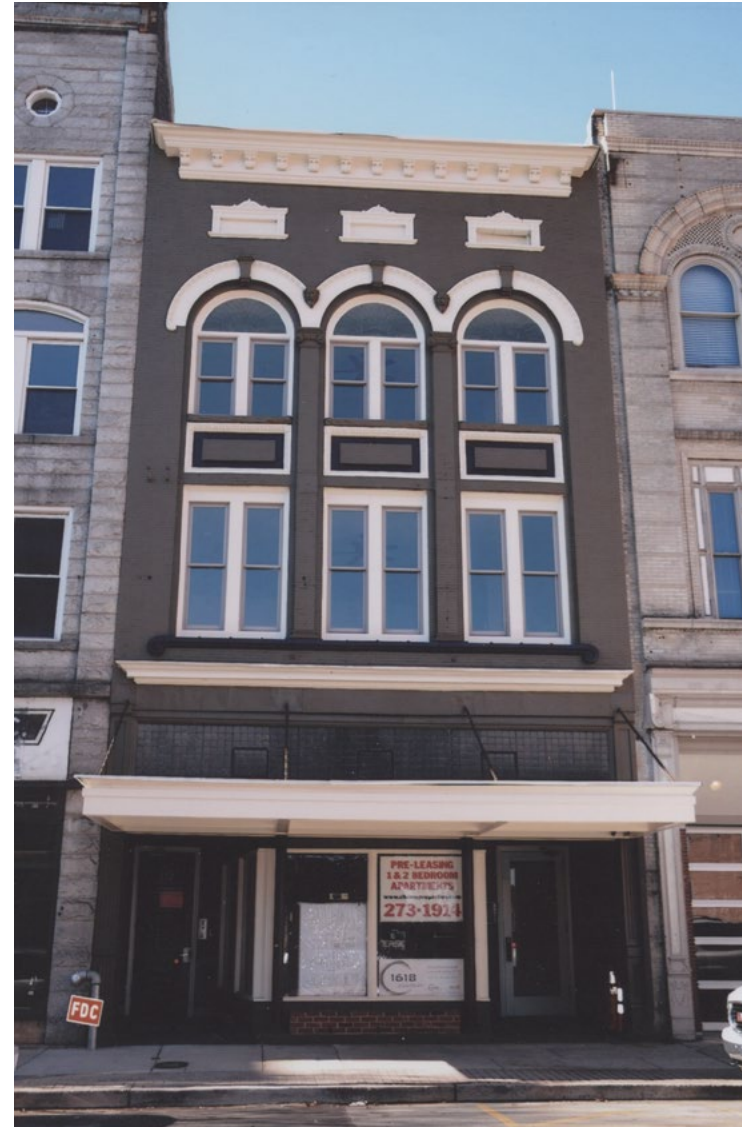
[22] **Not Recommended:** (a-b) The original wood windows in this late-19<sup>th</sup>-century building, which were highly decorative, could likely have been repaired and retained. (c) Instead, they were replaced with new windows that do not match the detailing of the historic windows and, therefore, do not meet the Standards (above).

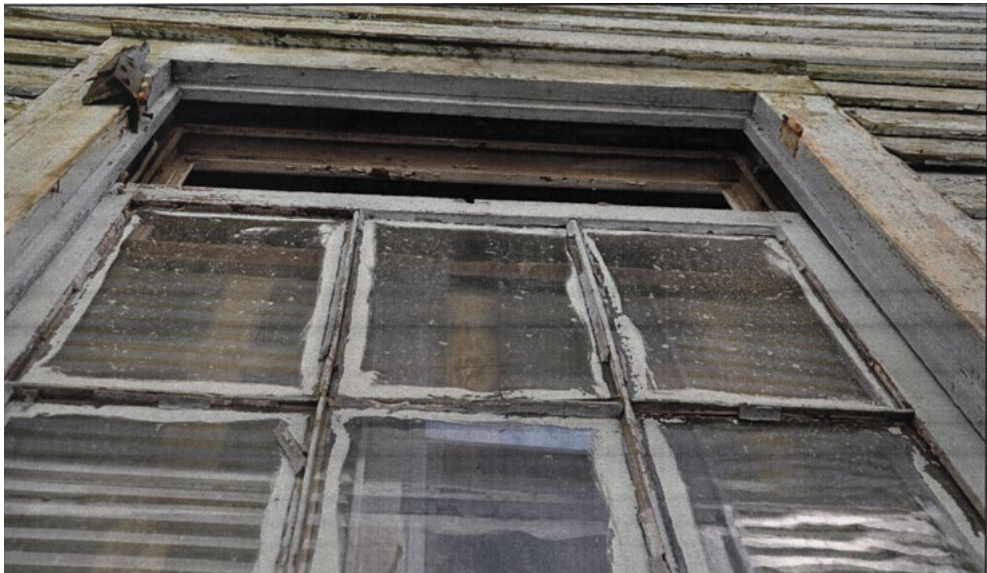
[23] (a) This deteriorated historic wood window was repaired and retained (b) in this rehabilitation project.

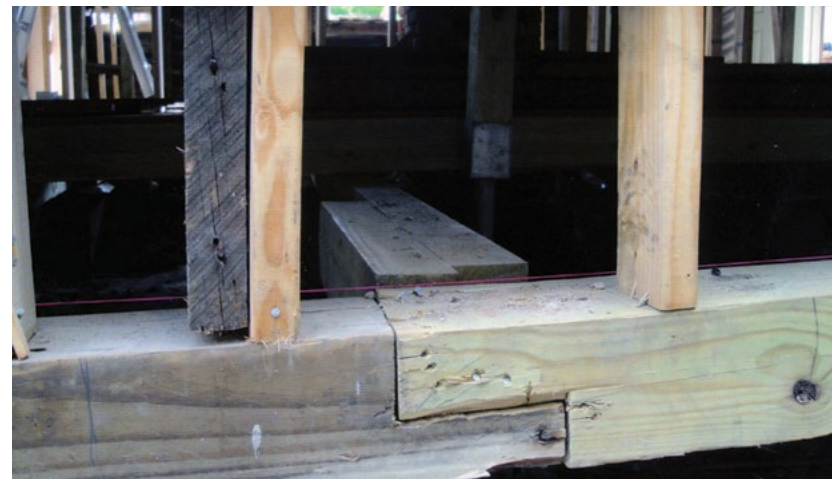
[33] Retaining as much as possible of the historic wood sill plate and replacing only the termite-damaged wood is always the preferred and recommended treatment.

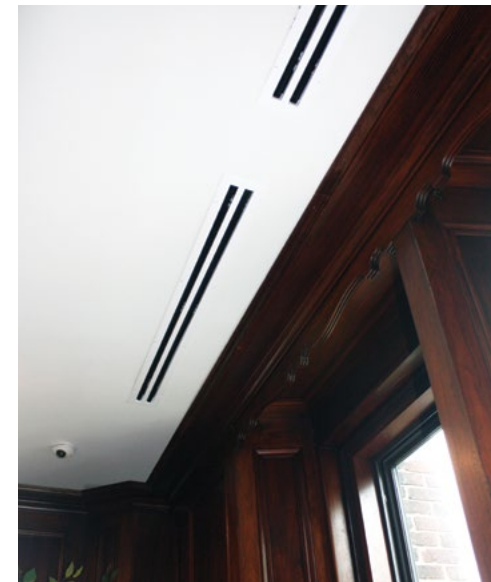
[34] The new ceiling ducts installed during the conversion of this historic office building into apartments are minimal in design and discretely placed above the windows.

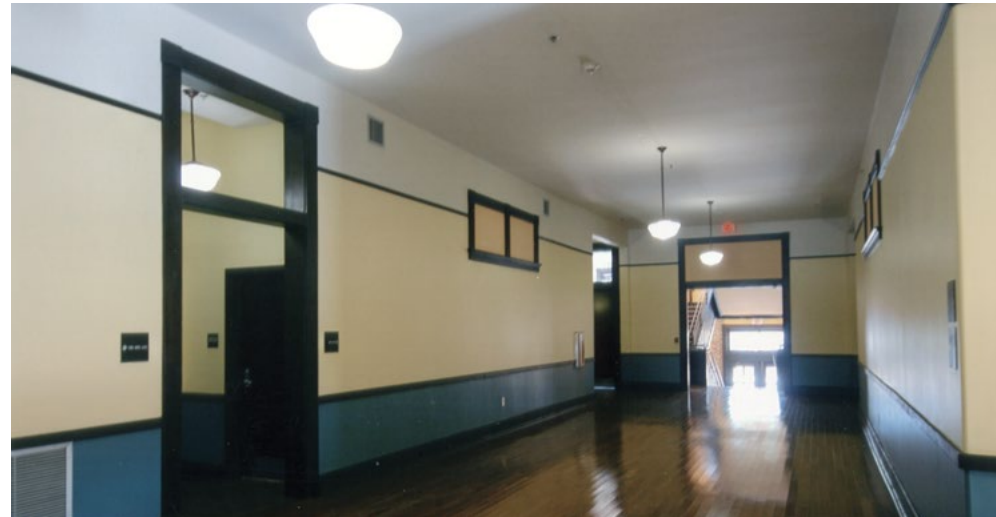
[35] (a) Although deteriorated, the historic school corridor, shown on the left, with its character-defining features, including doors and transoms, was retained and repaired as part of the rehabilitation project (b).

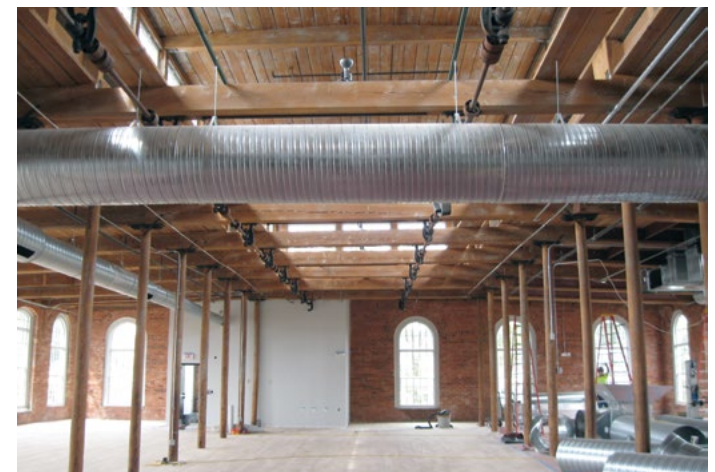
[39] Leaving the ceiling structure exposed and installing exposed ductwork where it does not impact the windows, are appropriate treatments when rehabilitating an industrial building for another use.

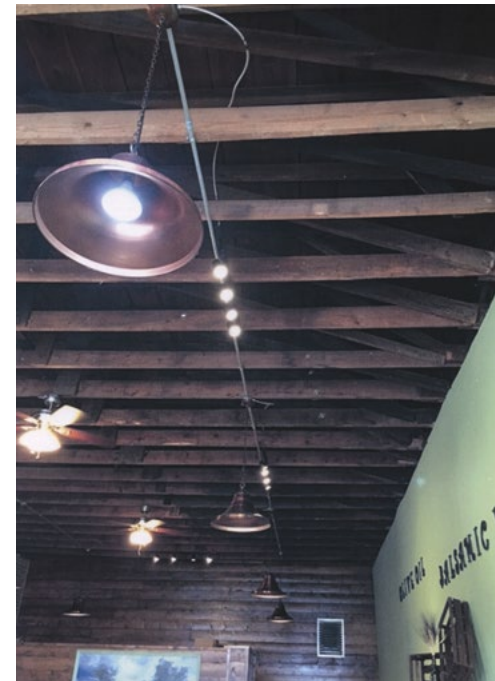
**[41] Not Recommended:**  
Leaving fragments of deteriorated or "sculpted" plaster is not a compatible treatment for either finished or unfinished interior spaces.

**[40] Not Recommended:**  
Removing a finished ceiling and leaving the structure exposed in a historic retail space does not meet the Standards for Rehabilitation.

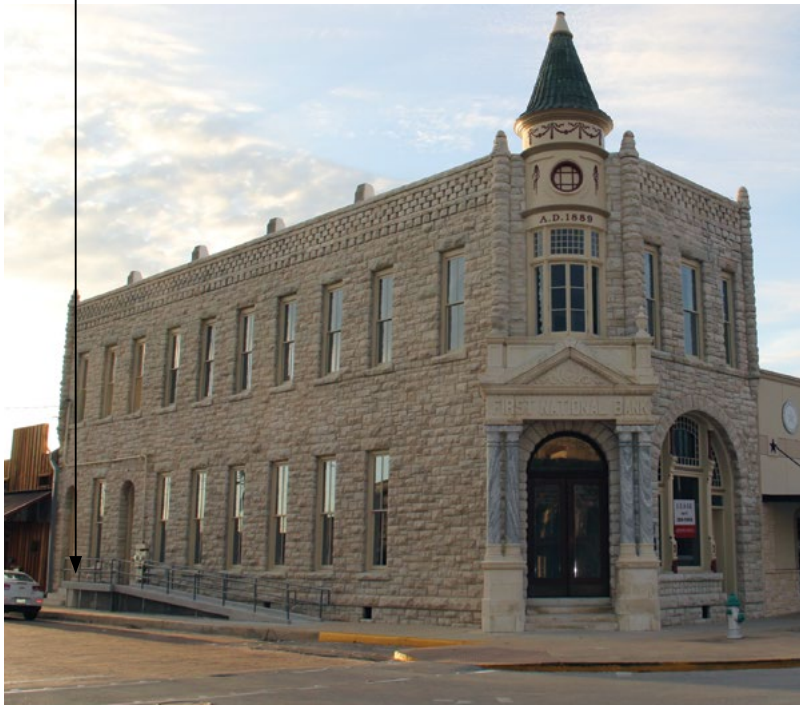
[52] The access ramp blends in with the stone façade of the First National Bank in Stephenville, TX, and is appropriately located on the side where it does not impact the historic character of the building. Photo: Nancy McCoy, QuimbyMcCoy Preservation Architecture, LLP.

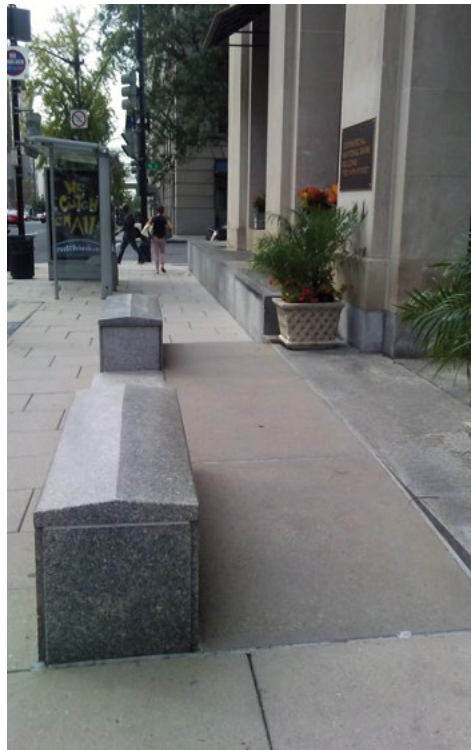
[53] This entrance ramp (right) is compatible with the historic character of this commercial building.

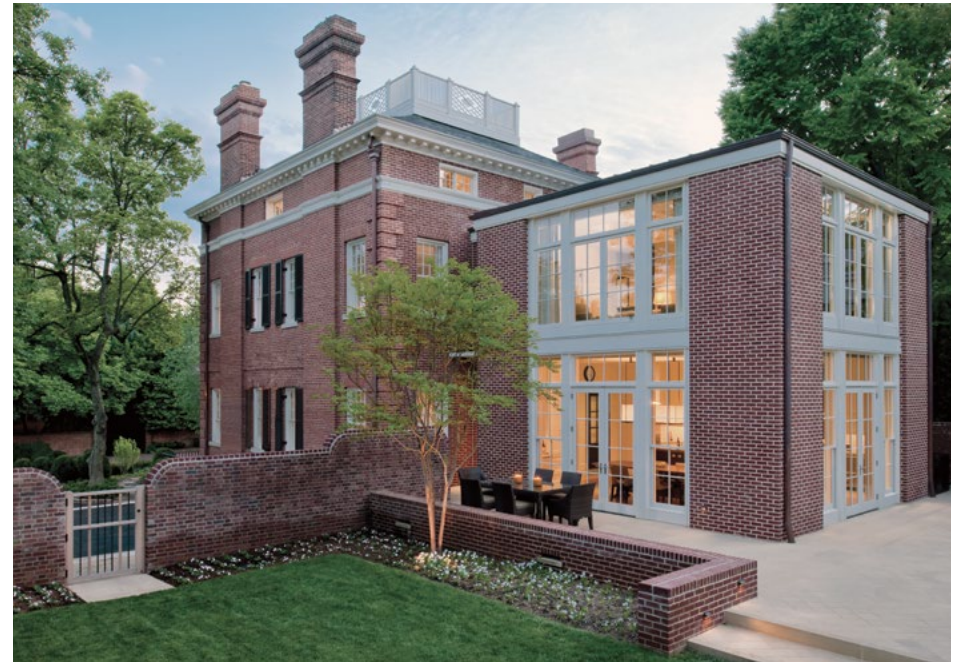
[61 a-b] The materials, design, and location at the back of the historic house are important factors in making this a compatible new addition. Photos: © Maxwell MacKenzie.

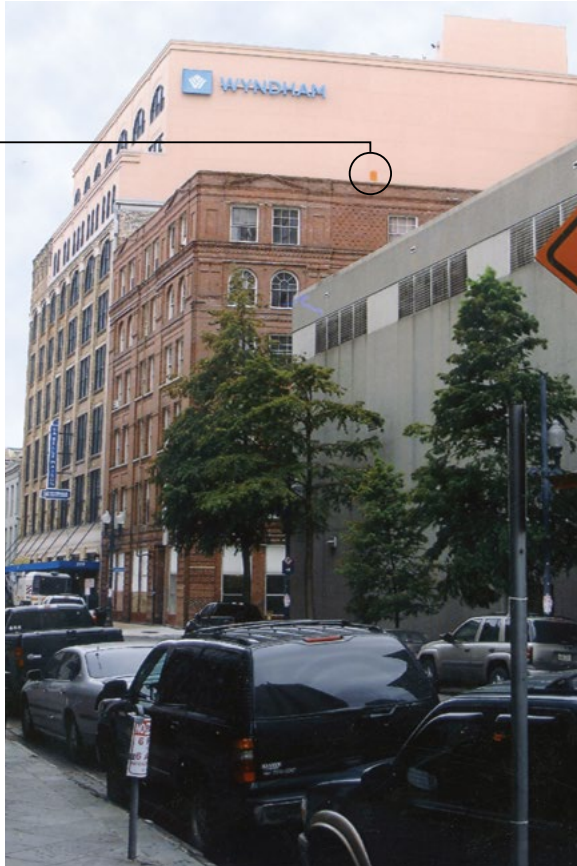
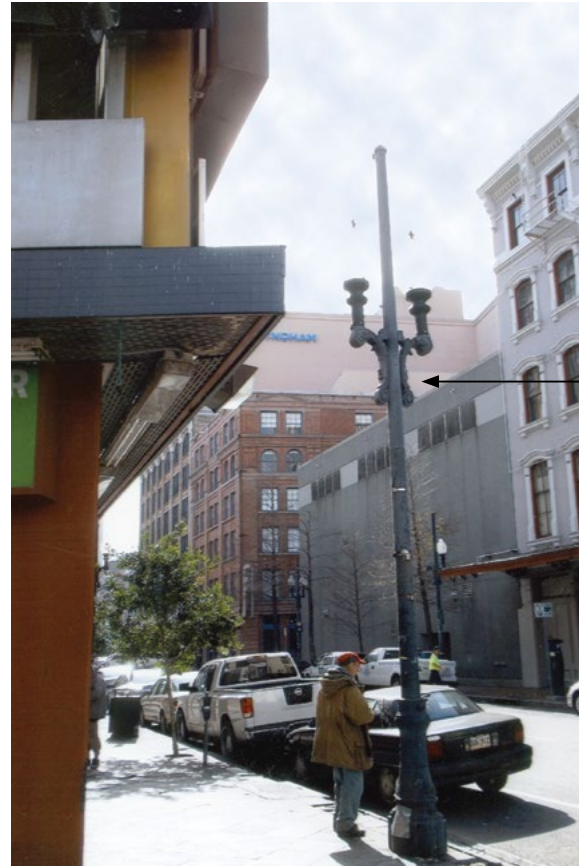
[ 63] (a) A mockup should be erected to demonstrate the visibility of a proposed rooftop addition and its potential impact on the historic building. Based on review of this mockup (orange marker), it was determined that the rooftop addition would meet the Standards (b). The addition is unobtrusive and blends in with the building behind it.

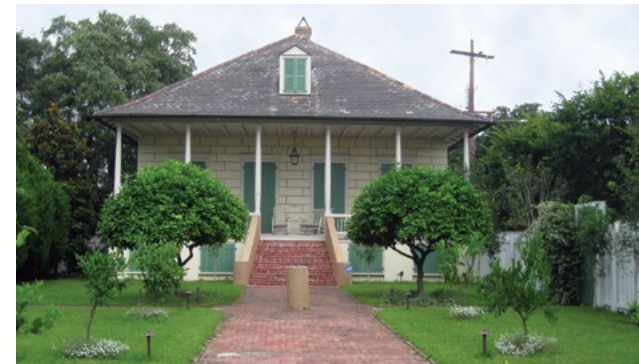
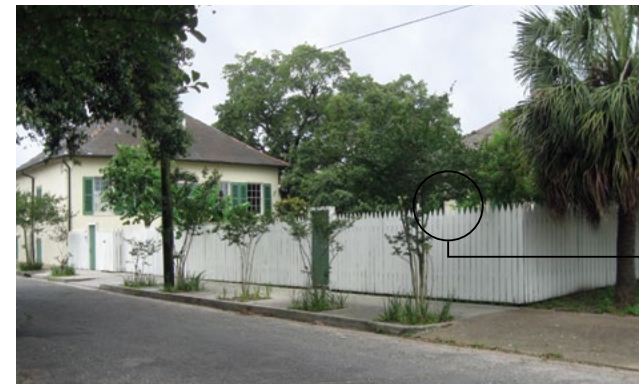
[65] (a) This (far left) is a compatible new outbuilding constructed on the site of a historic plantation house (b). Although traditional in design, it is built of wood to differentiate it from the historic house (which is scored stucco) located at the back of the site so as not to impact the historic house, and minimally visible from the public right-of-way (c).

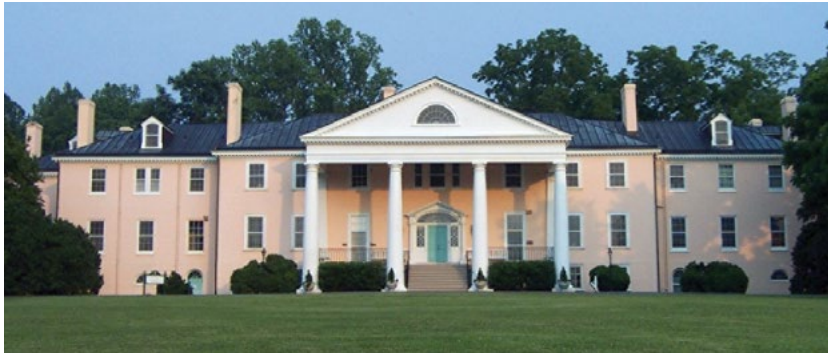
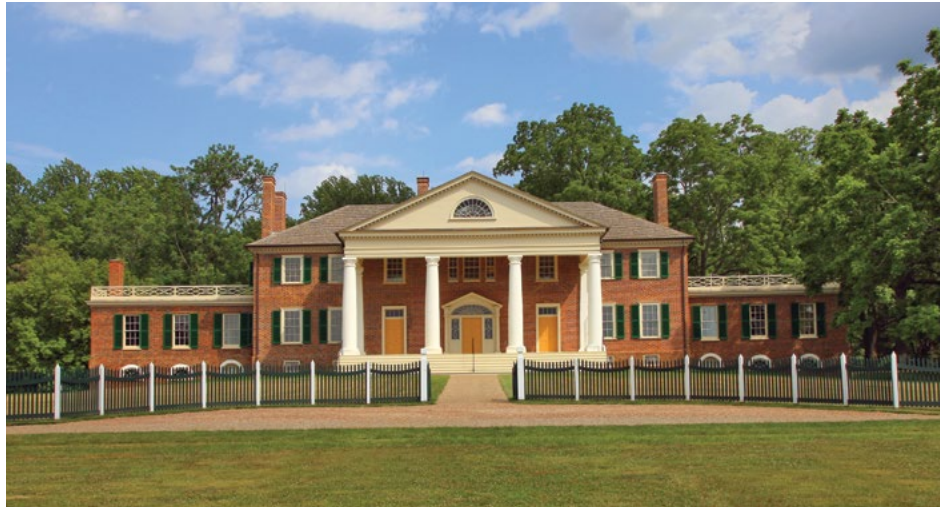
[1] (a) When it was acquired by the National Trust for Historic Preservation in the 1980s, Montpelier in Montpelier Station, VA, the home of James and Dolley Madison, had been much altered and enlarged since it was first constructed. Based on historical documentation and research, Montpelier was accurately restored to its 1820s appearance when the president and his wife lived there (b). Photos: Courtesy of The Montpelier Foundation.

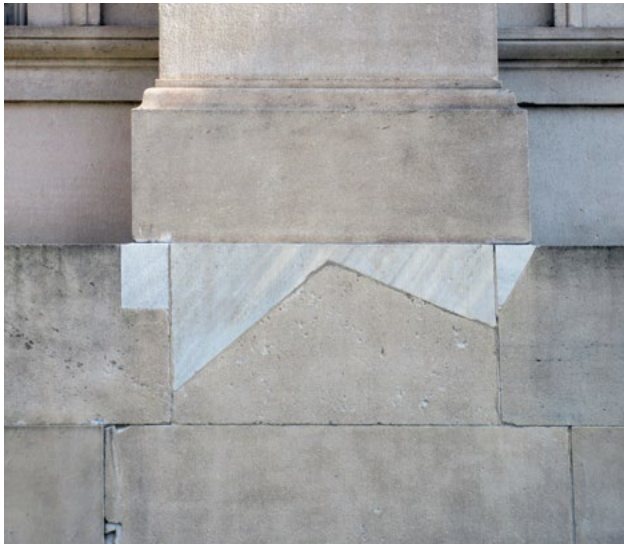
[3] **Not Recommended:** Although the Dutchman stone repair has been well executed, the replacement stone is not a good color match.

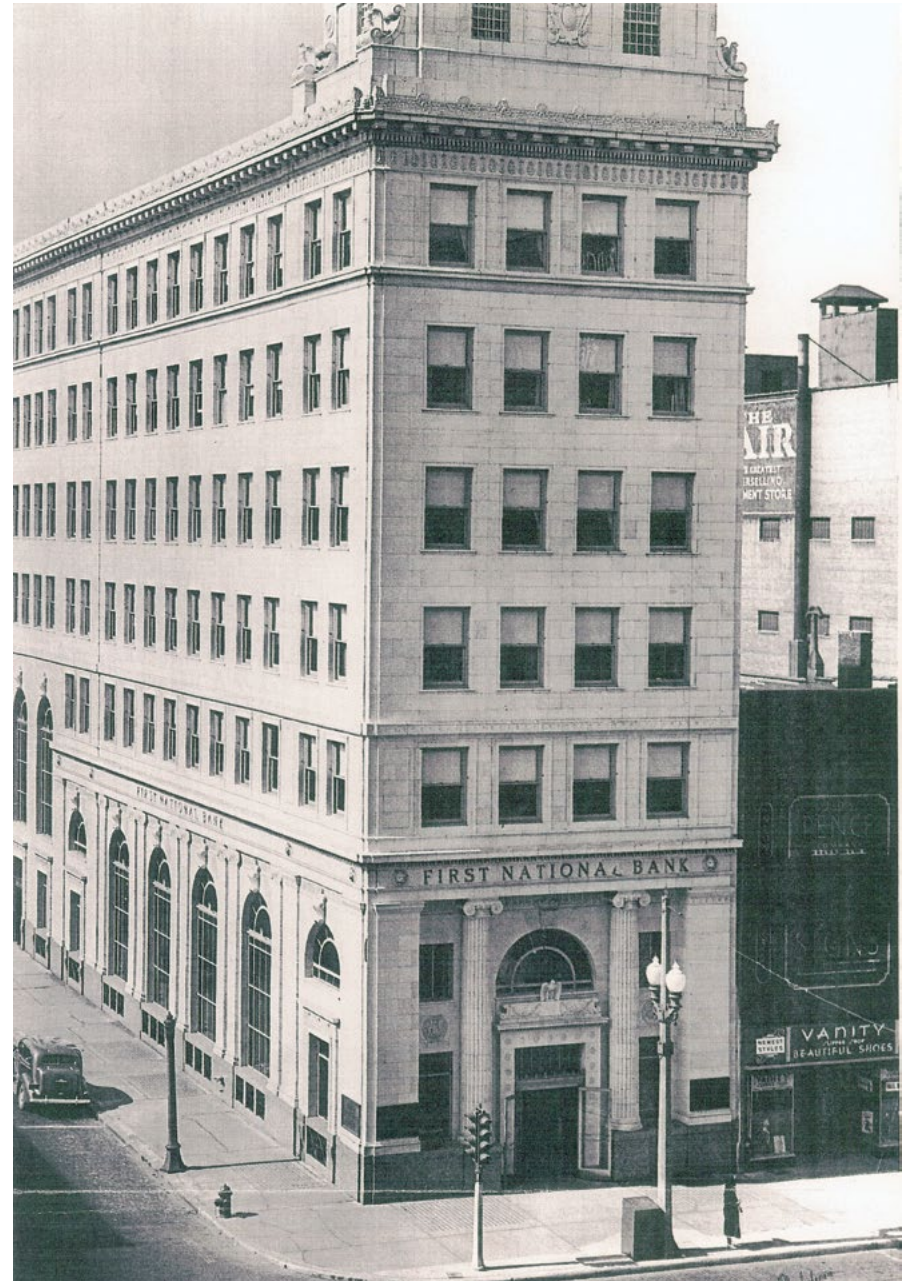
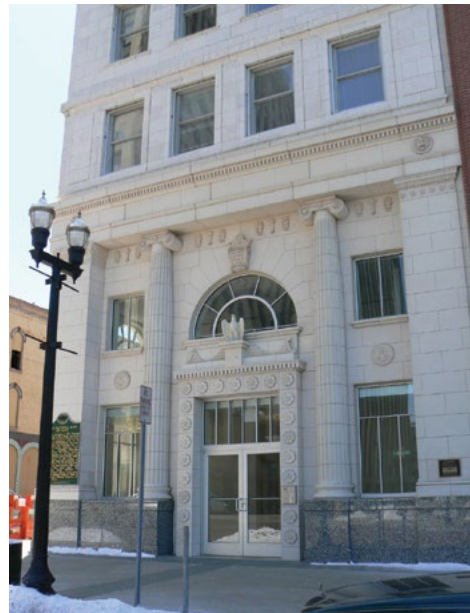
[4] (a) Over the years terra-cotta cladding had been replaced on the lower floors of this early-20<sup>th</sup> century bank building with a storefront and incompatible windows. (b) A 1936 photograph of the building provided the documentation to restore its historic appearance. (c) Glass fiber reinforced plastic (GFRP) was chosen as a substitute material, and samples were made in a variety of colors and textures to obtain the best match for the missing and damaged terra cotta. (d) This photo taken after restoration shows that the GFRP replacements successfully blend in with the original terra cotta. Photo (d): Blamonet at English Wikipedia.

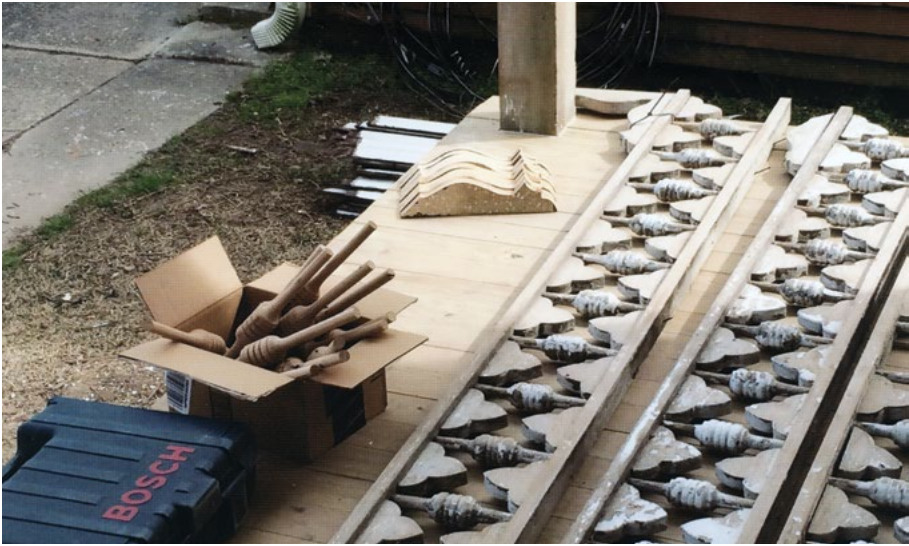
[5] New wood trim pieces were milled to match the few remaining historic features to replace those that were missing.

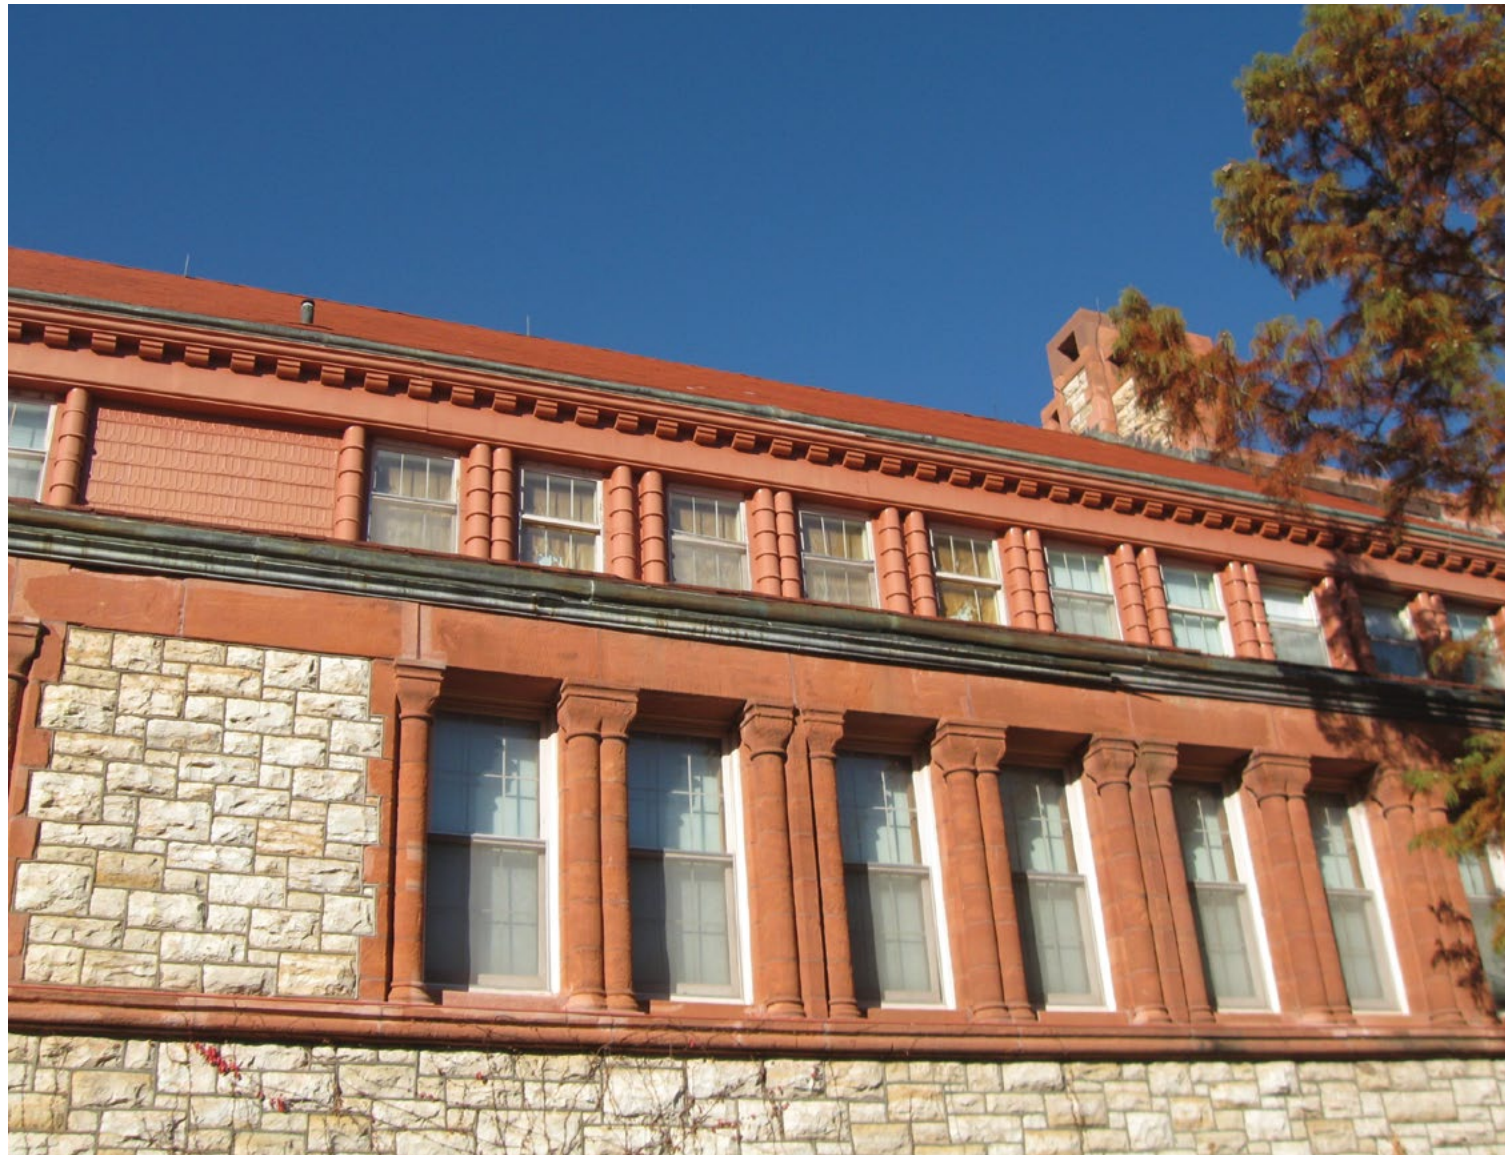
[6] Preliminary work before starting restoration revealed that the columns and the decorative shingles ornamenting the top floor of this historic building were fabricated of metal to imitate the red sandstone used elsewhere on the building.

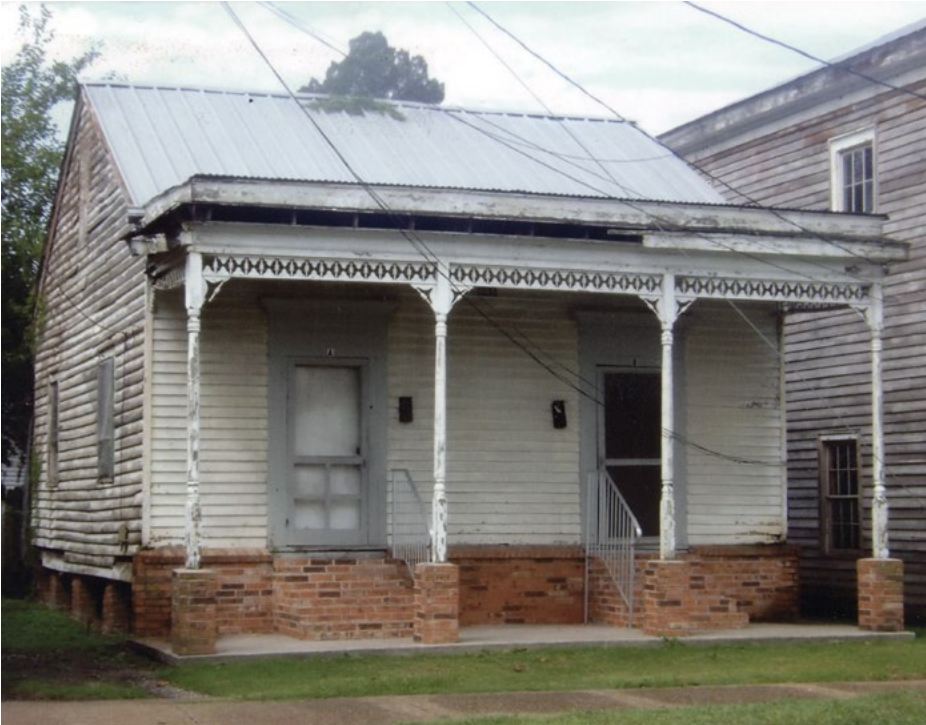
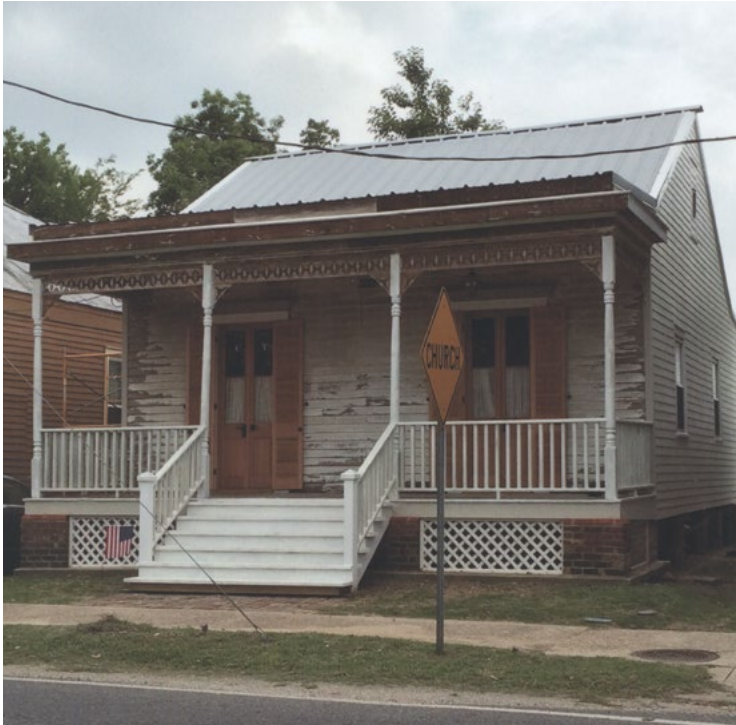
[10] (a) The entrance of this house had been altered over the years, including removal of the porch floor and steps. (b) This photograph shows the house after the porch and steps were restored to their historic appearance.

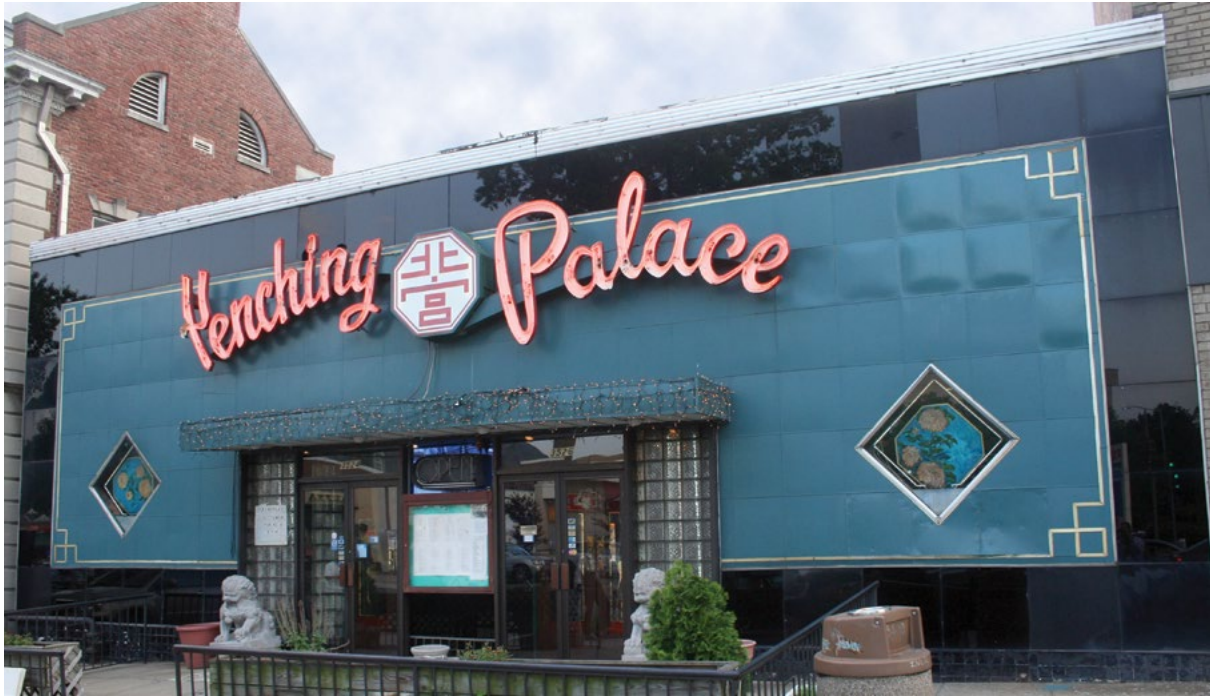
[11] (a) Some of the materials on the front of this historic building had been previously replaced, but the façade retained its essential distinctive features and design. (b) A vintage postcard of the building (far left) provided sufficient documentation to restore the façade to its historic 1945 appearance, using spandrel glass as a replacement for the original Carrara glass (c). Photo (b): Courtesy Kelsey & Associates.

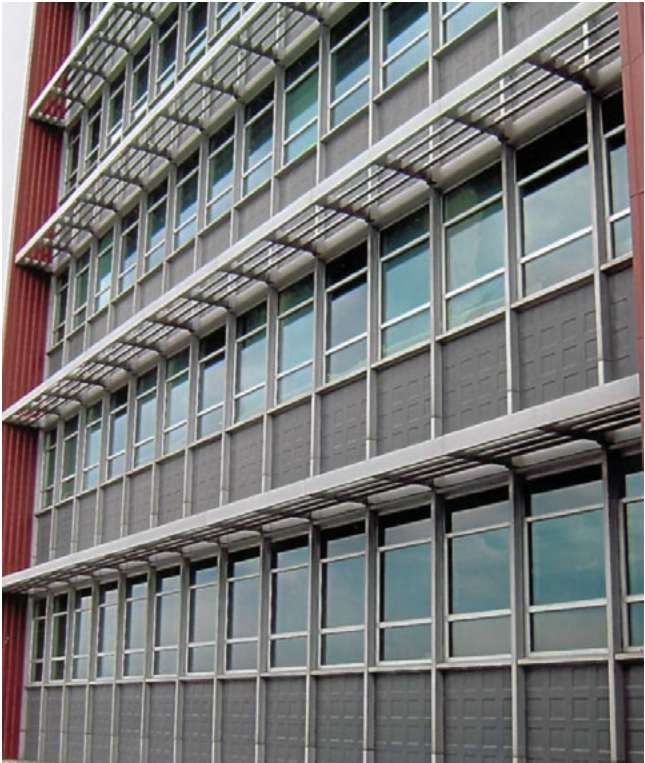
[12] This historic curtain wall features a distinctive variety of panel types which must be repaired or replicated in a restoration project if any are damaged or missing.

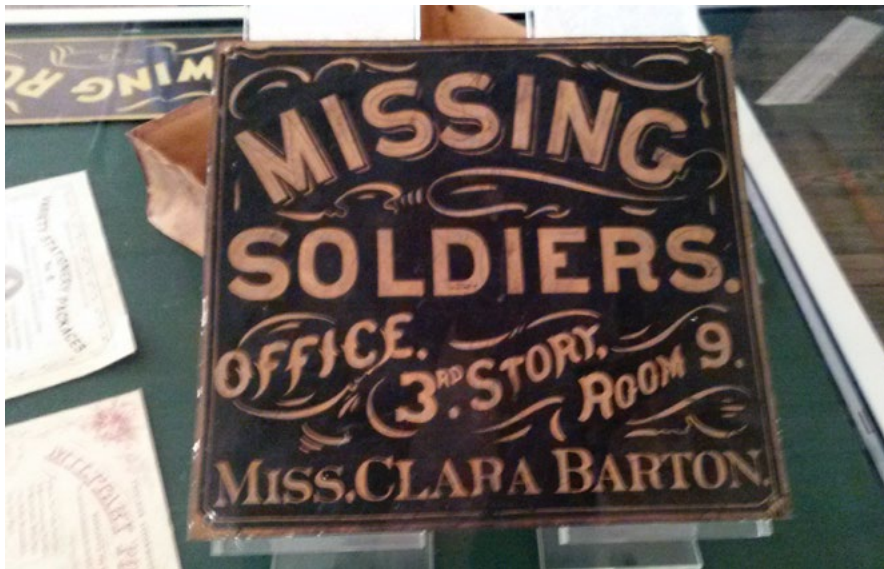
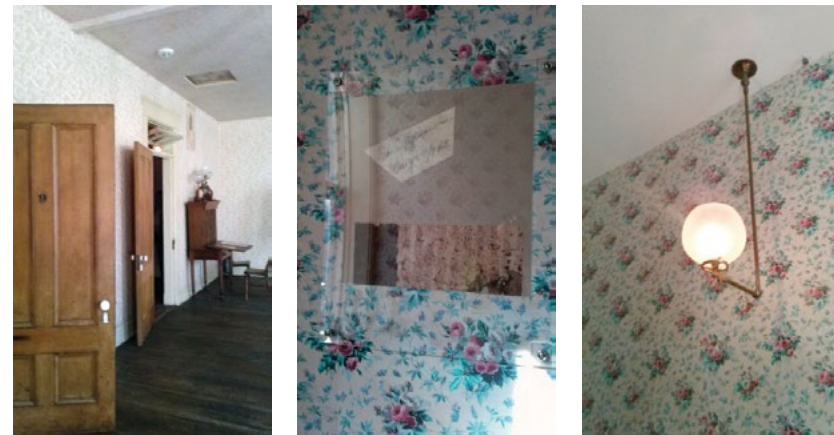
[13] (a) In the 1990s the Missing Soldier's Office—established by Clara Barton at the end of the Civil War—was discovered still extant on the third floor of a building in Washington, DC, that was slated for demolition. The office was restored to its historic appearance using physical and documentary evidence. The original numeral '9' is still on the door to the office, and wall paper was reproduced from scraps found on the walls (b-d).

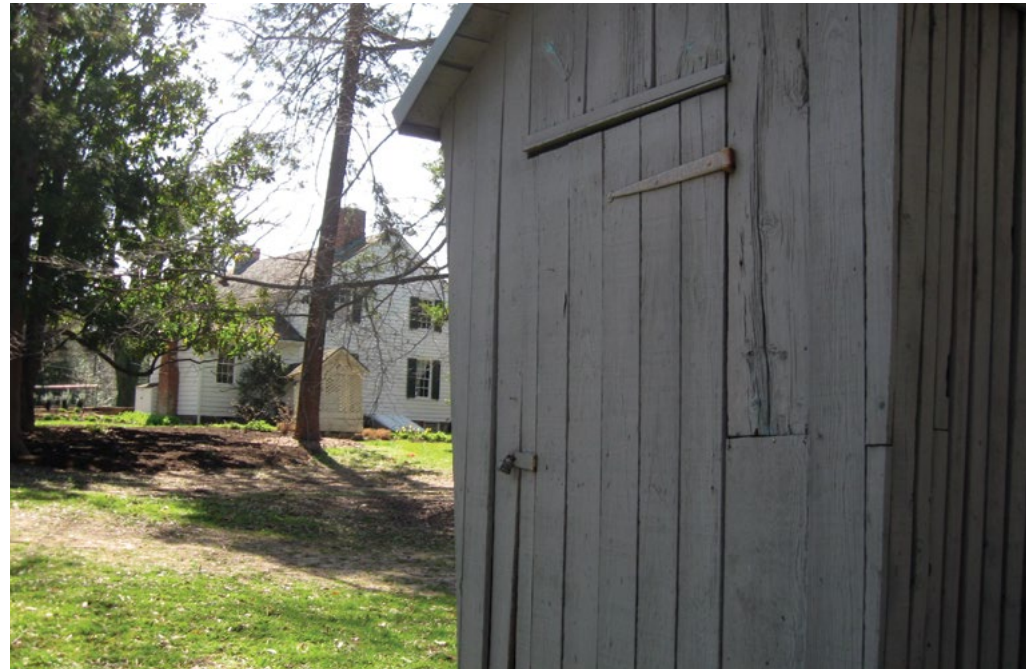
[15] (a) Cherry Hill House and Farm (c. 1845) in Falls Church, VA, was the site of encampments during the Civil War. Outbuildings on the property, such as the corn crib (b) in the foreground which was the source of provisions for the soldiers, are important in interpreting its role during the war.

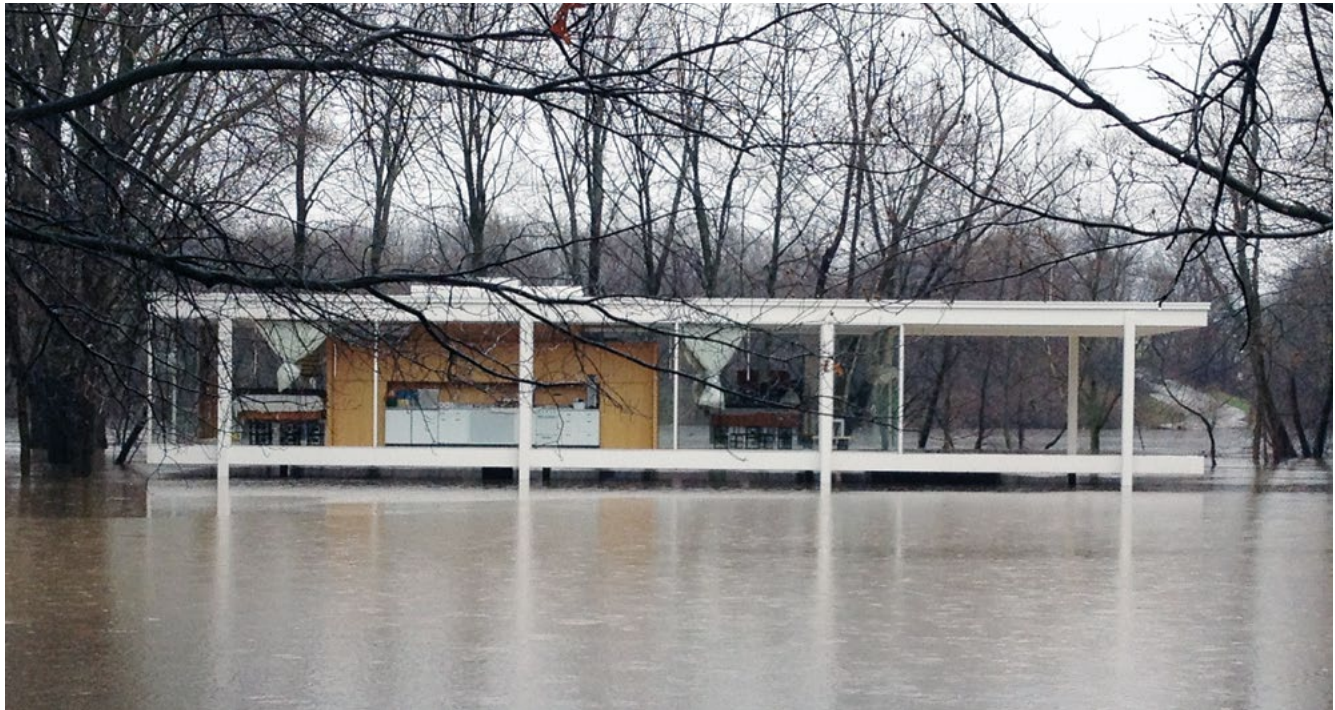
[19] The 1951 Mies van der Rohe-designed Farnsworth House, Plano, IL, was built close to the Fox River, which is increasingly prone to floods. To preserve the house in its original location, historic preservation architects and engineers continue to explore ways to protect it from the flooding, including a possible system that would lift the house above the flood waters and lower it back to the ground. Photo: Courtesy Farnsworth, A Site of the National Trust for Historic Preservation.

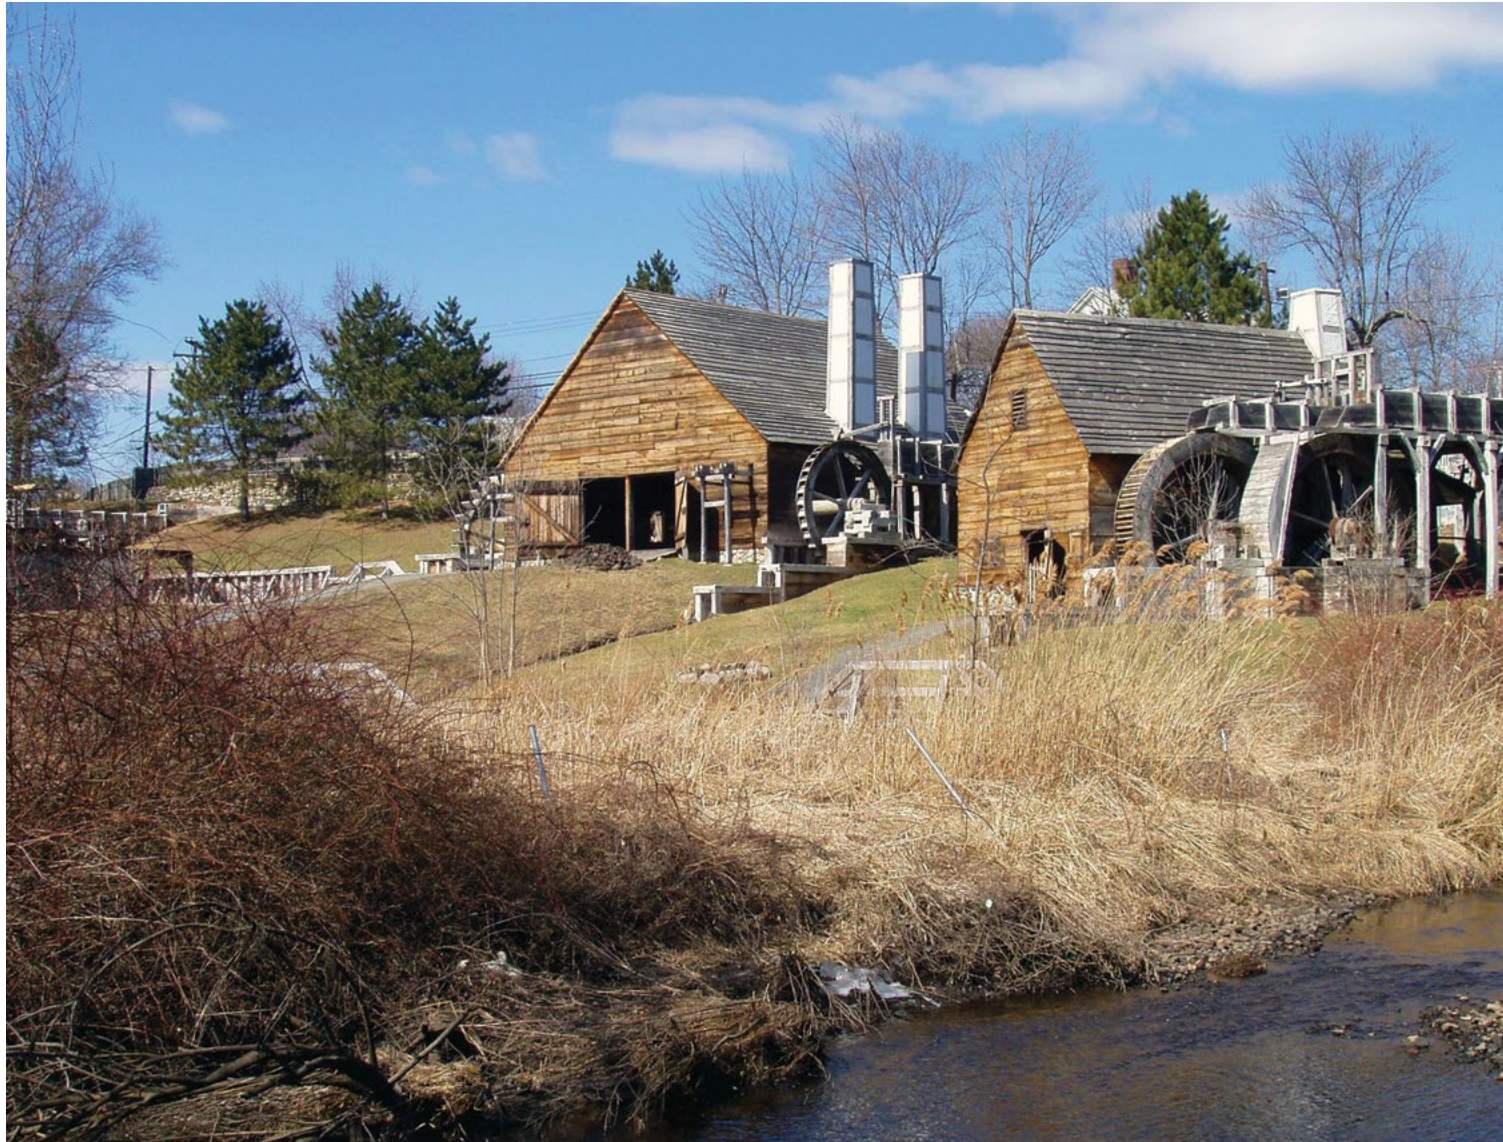
[2] The Saugus Iron Works, Saugus, MA, a National Historic Site, was active from 1646 to about 1670 and was the first integrated iron works in North America. The forge and mill (shown here) are part of the site which was reconstructed based on archeological research and historic documents and opened in 1954. *Photo: Daderot at the English language Wikipedia.*

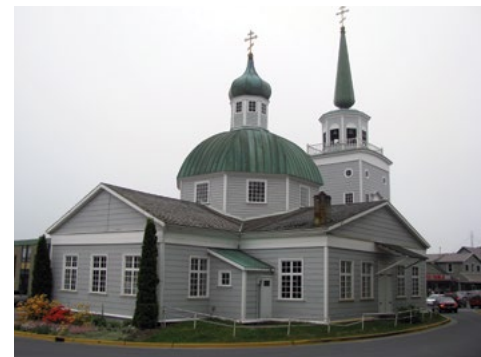
[3] The Cathedral of Saint Michael the Archangel, built in the early 1840s in Sitka, AK, was devastated by fire in 1966. It was reconstructed using measured drawings done in 1961 by the Historic American Buildings Survey (HABS). While the original cathedral was built of logs covered on the exterior with wood siding, its replacement is a fire-resistant structure with concrete and steel walls that replicates the historic building's appearance. *Photo: Barek at Wikimedia Commons.*

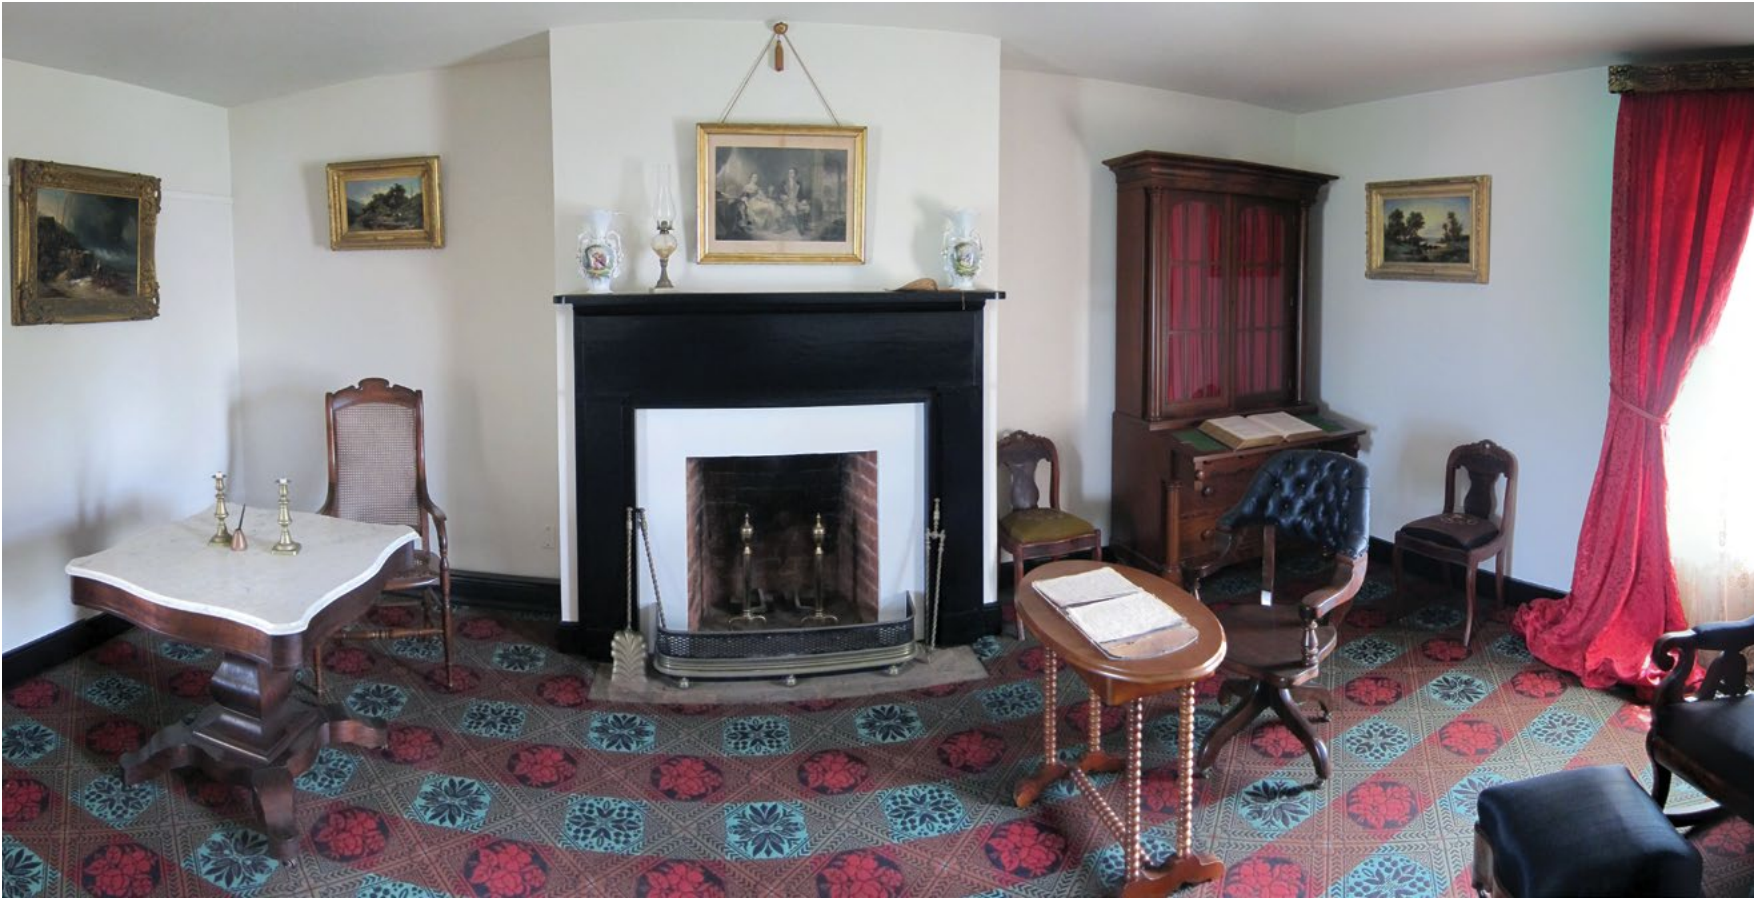
[5] The parlor of the McLean House was reconstructed to its appearance on the occasion of Robert E. Lee's surrender to Ulysses S. Grant in this room on April 9, 1865.
