## **HISTORICAL COMMISSION MEETING AGENDA**

- 4. H22-0001 – Brownhouse Design – 151 Hawthorne Avenue**  
Advisory review application for an addition, alterations and improvements to an existing one-story house, which is a Historic Resource. The project includes a 609 square-foot one-story addition to the existing house, a new 533 square-foot detached garage, and 26 square-foot addition to the existing basement. The project is considered categorically exempt from further

**5. HPA22-0001 - Brownhouse Design – 151 Hawthorne Avenue**

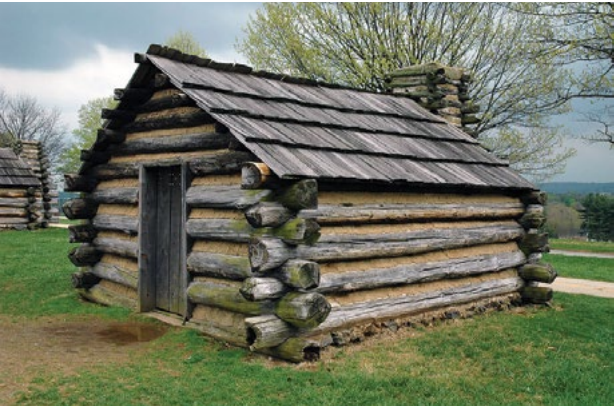
[7] The Muhlenberg Brigade Huts are reconstructions of nine log huts erected in 1777 at Valley Forge during the Revolutionary War. They have been reconstructed on the historic road with logs cut with modern power tools and finished with cement, unlike the original logs which were hand hewn and finished with traditional chinking. *Photo: Rdsmith4 at Wikimedia Commons.*

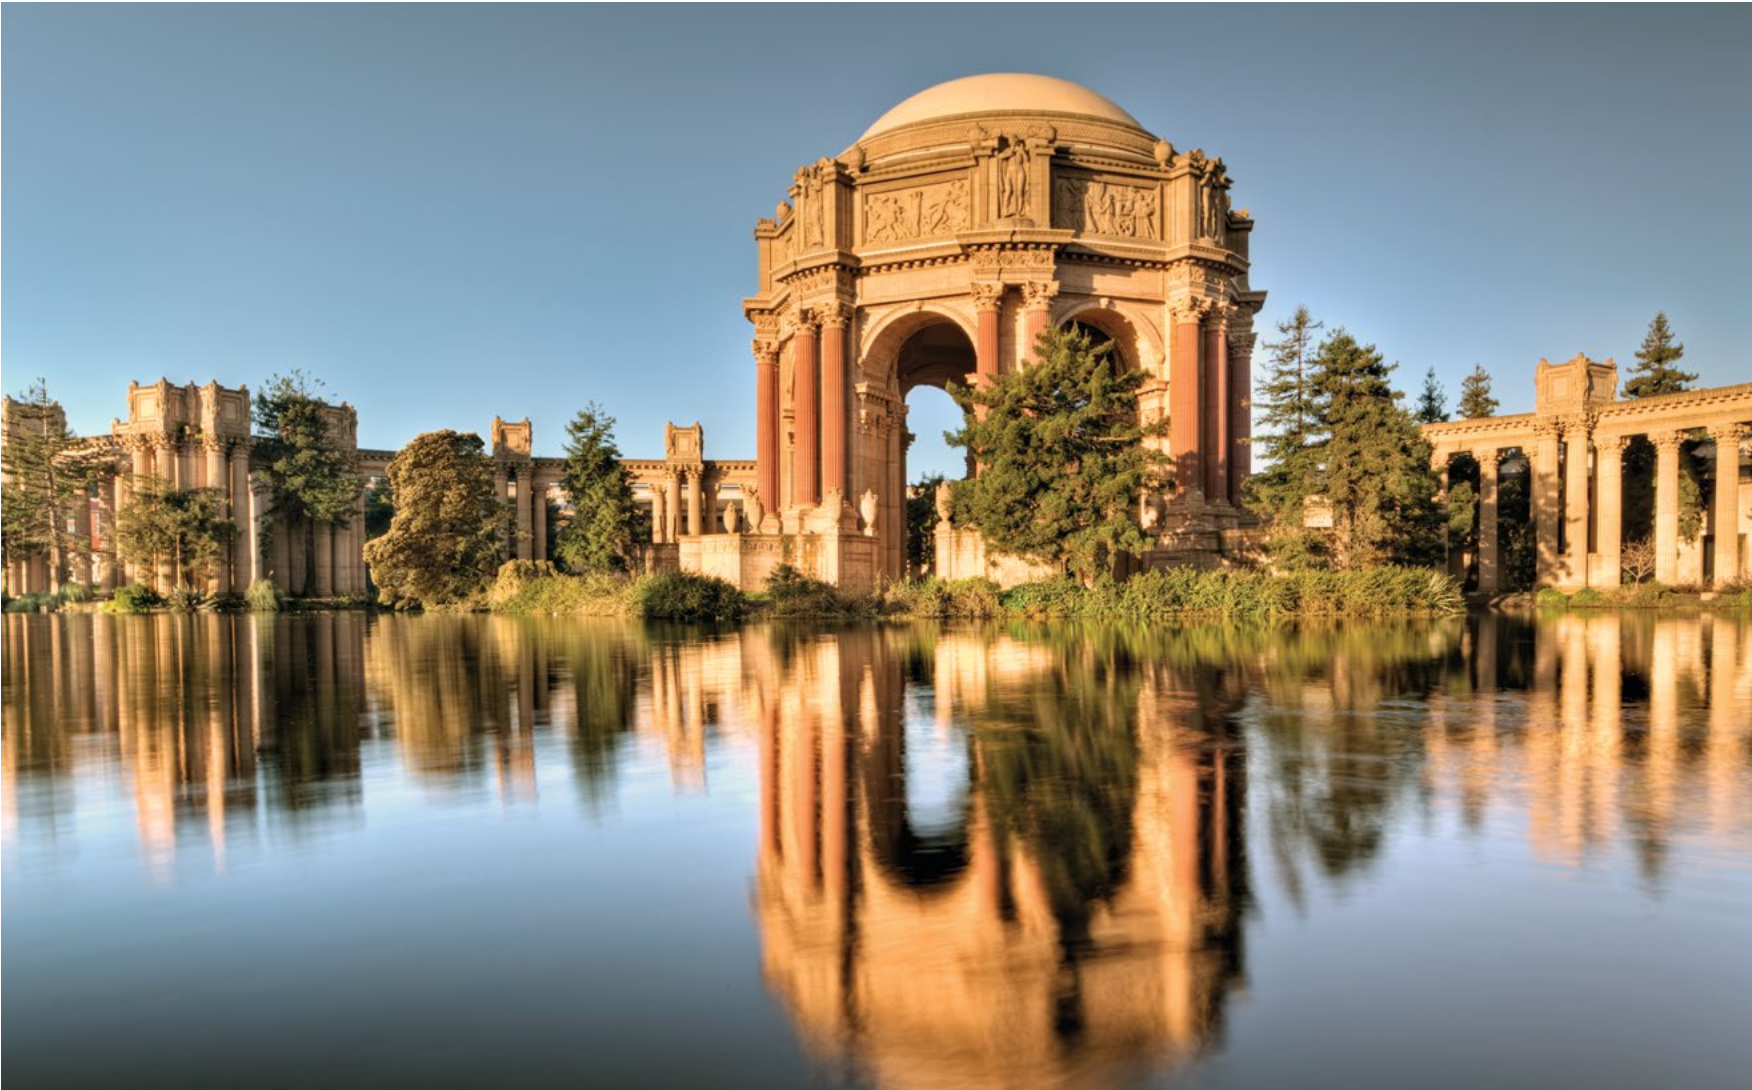
[8] The Palace of Fine Arts was designed by Bernard Maybeck and built for the 1915 Panama-Pacific Exposition in San Francisco. The pavilion was intended to be temporary and, although it had a steel structure, the exterior was finished only with stucco, an impermanent material composed of plaster and fiber. The building was not torn down after the exposition, and it eventually fell into ruin. In 1964, all but the steel structure was demolished, and the building was reconstructed with lightweight poured-in-place concrete. *Photo: KevinCole at Wikimedia Commons.*

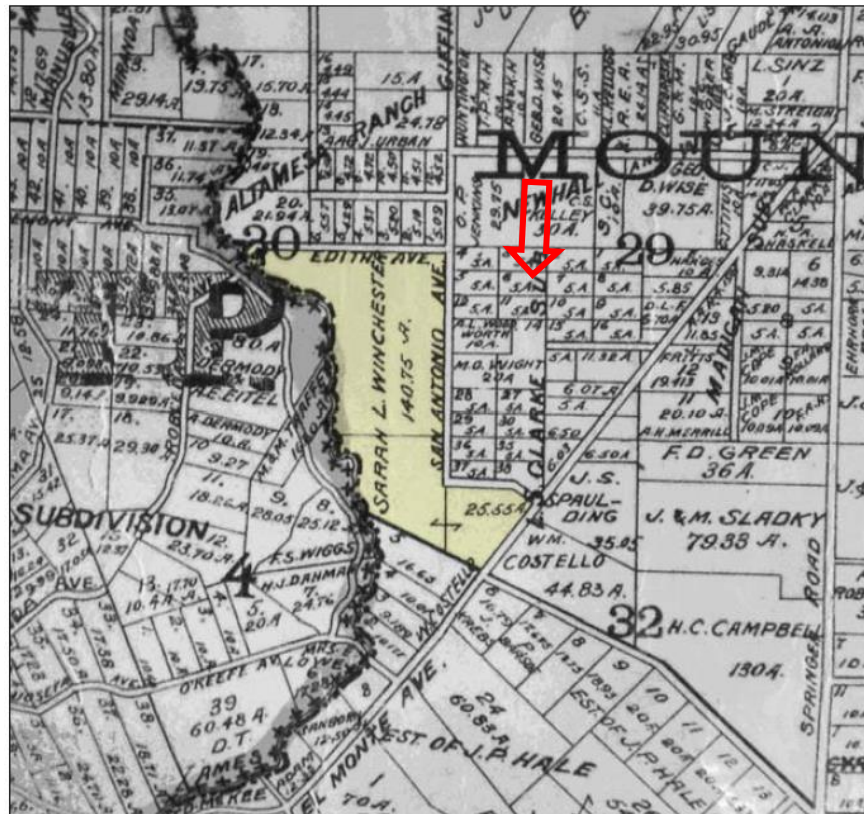
Figure 3. A 1906 tract map is showing the Property (red arrow) concerning the Sarah Winchester parcel (highlight center parcel) that was sold to the Altos Land Company and later became the townsite for Los Altos (courtesy of the Los Altos History House Museum Archives).

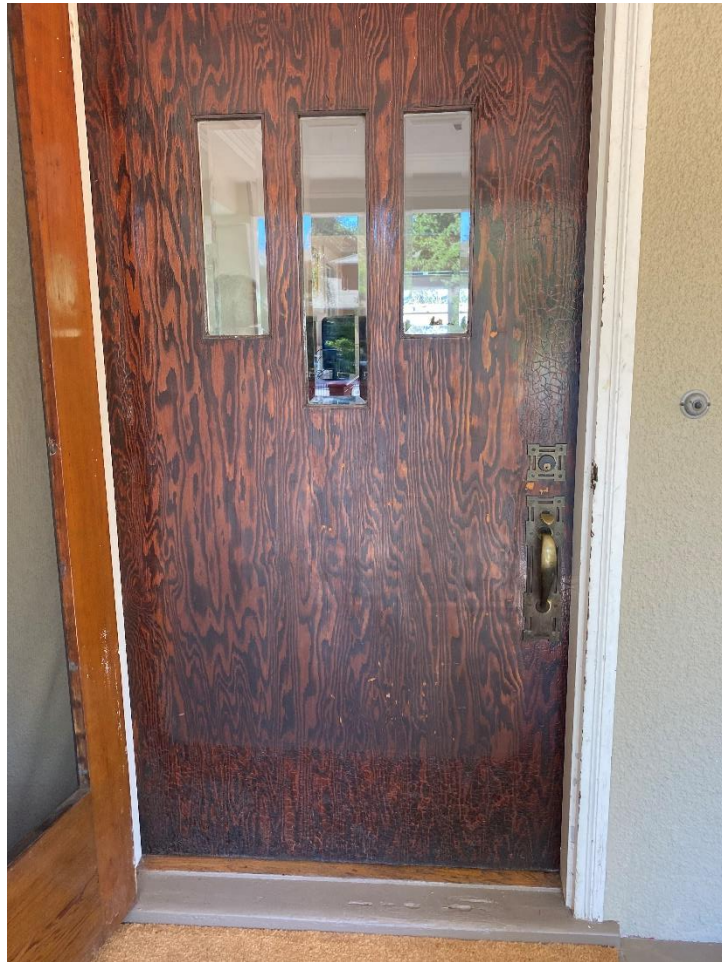
Figure 26. Photograph showing the front door, facing north.

The south elevation consists of an asymmetrical design with a main front-gabled roof form, a lower projecting front gable, and an extending front gable porch roof (Figure 22 and Figure 23). The extending porch roof consists of decorative vertical wood boards with open slates that provide ventilation to the porch roof. The porch is supported by three battered columns that rest on square piers clad with red brick (Figure 24). There is a solid porch balustrade clad in red brick laid out in a running bond pattern. The front porch floor is accessed via a set of concrete steps along the primary façade and a set of concrete steps and a secondary entrance along the rear of the porch at the southeast corner of the house. The porch floor is stamped concrete, and the porch ceiling is clad in contemporary stucco, which likely covers the original wood-clad porch roof (Figure 25). Fenestration along this elevation includes two large picture windows that are not original to the house, set in wood window casings (not original) and wide decorative window trim and an oversized wooden front door with three vertical beveled glass and asymmetrical patterns (Figure 26).

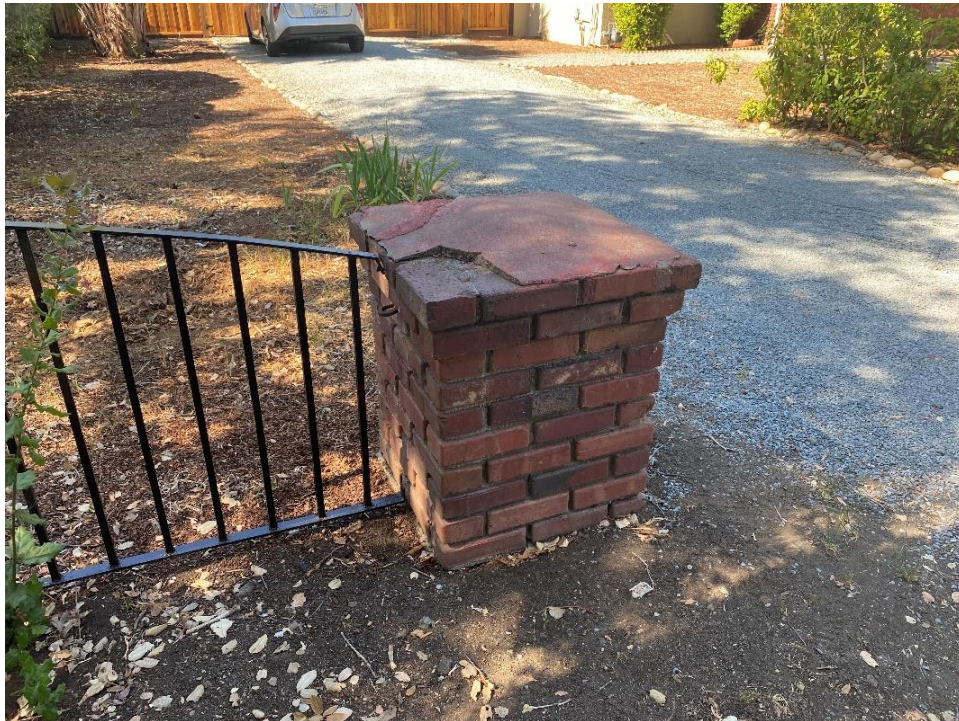
**Figure 36. Photograph showing a concrete pillar and contemporary iron gate along the primary façade, facing north.**

The associated landscape includes original square concrete pillars clad in decorative red brick that appear original to the house (Figure 36). The brick-clad concrete pillars are linked together by contemporary iron fencing designed in a semicircular shape. A gravel driveway leads to a wooden fence, which appears to be new (Figure 37).

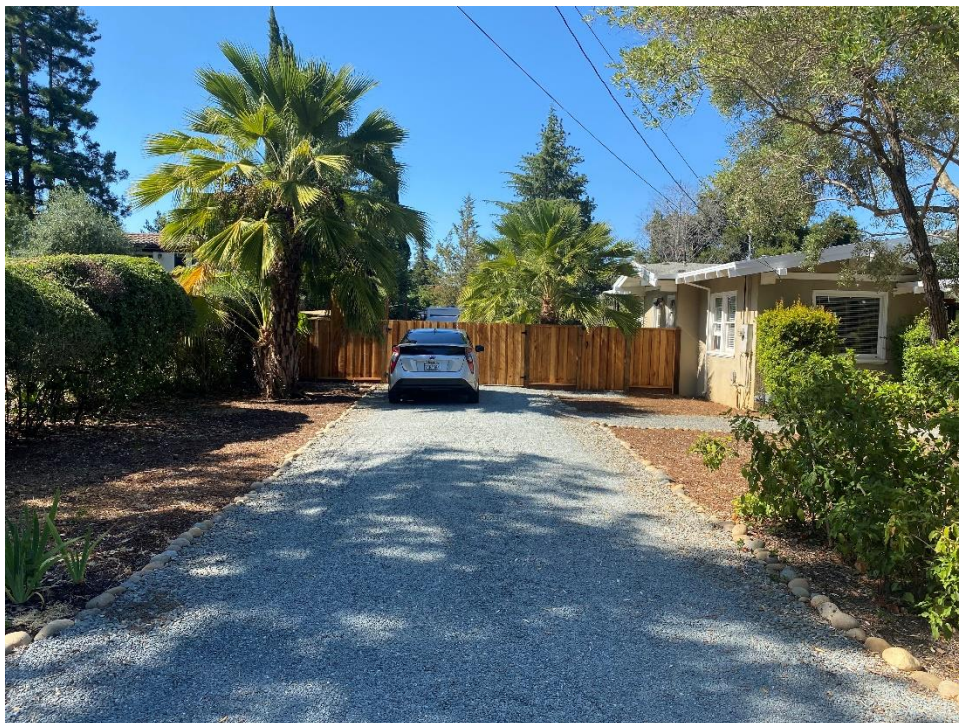
**Figure 37. Photograph showing the gravel driveway and new wooden fence, facing north.**

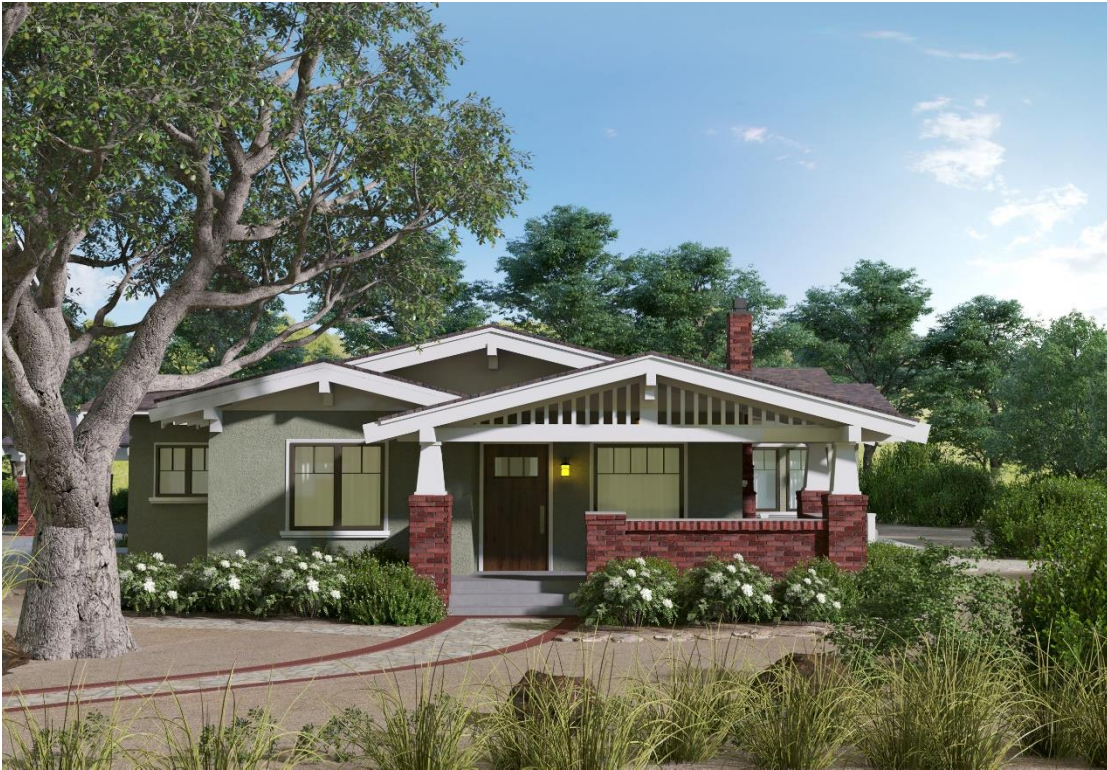
Figure 44. The rendering shows the proposed primary façade with shingle cladding and new windows, with narrow upper sash windows (Brownhouse Design; dated 5/27/2022).

The design of the new addition and proposed alterations to the primary façade of the ca. 1922 house, including the new windows and doors, have been carefully considered to complement the original Craftsman Bungalow design of the ca. 1922 house and will not create a false sense of historical development (Figure 44). The new detached garage consists of a modern garage door and extended covered parking supported by narrow and shorten tapered columns set on tall pillars clad in 1/3 running bond pattern, which does not mimic the original tapered columns along the primary façade of the ca. 1922 house (Figure 45).
