## **JUNE 2, 2025 CITY COUNCIL WORK SESSION AGENDA**

| <b>Subject:</b> | Discussion of Miscellaneous Drainage Items |

# Moisture Analysis Report For

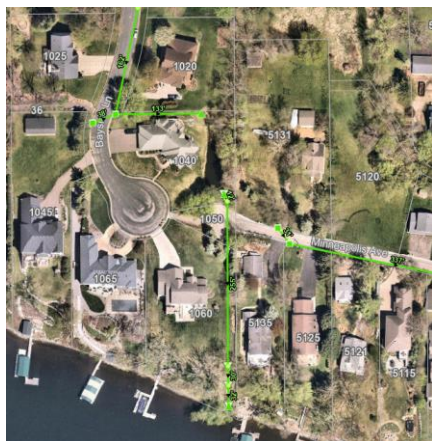
Figure 1. Storm system at 1040 Bayside Lane

There is a storm sewer system that conveys discharge from the pond located at 1040 Bayside Lane (west end of Minneapolis Avenue) to Lake Minnetonka. There are several rock pools along the length of the channel that serve to slow down water and reduce erosion. The last 70 feet or so of the east side of the channel is eroding. To address the issue it is proposed to install riprap so that water would pool upstream of the rip rap, slowing down the erosive forces of the drainage.

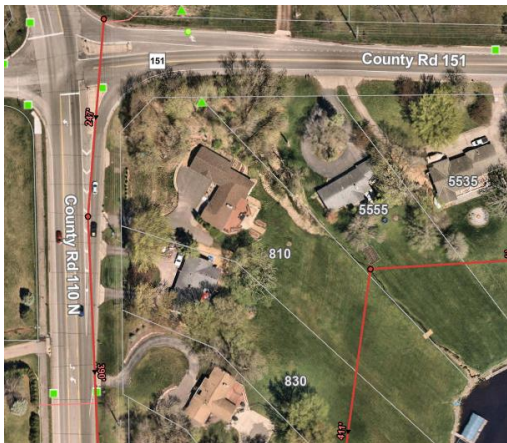
Figure 3. Storm sewer (green) and sanitary sewer (red) at CR 110 and CR 151

The discharge from the culvert under CR 151 at 810 CR 110 has caused some erosion along the property line. Hennepin County asset management indicates that this is not an issue for them to fix. As shown in Figure 3 there is a sanitary sewer manhole in the area that is susceptible to inflow. To address the issue, the vegetation in the drainageway would be removed and some rip rap placed to dissipate some of the energy from the runoff.

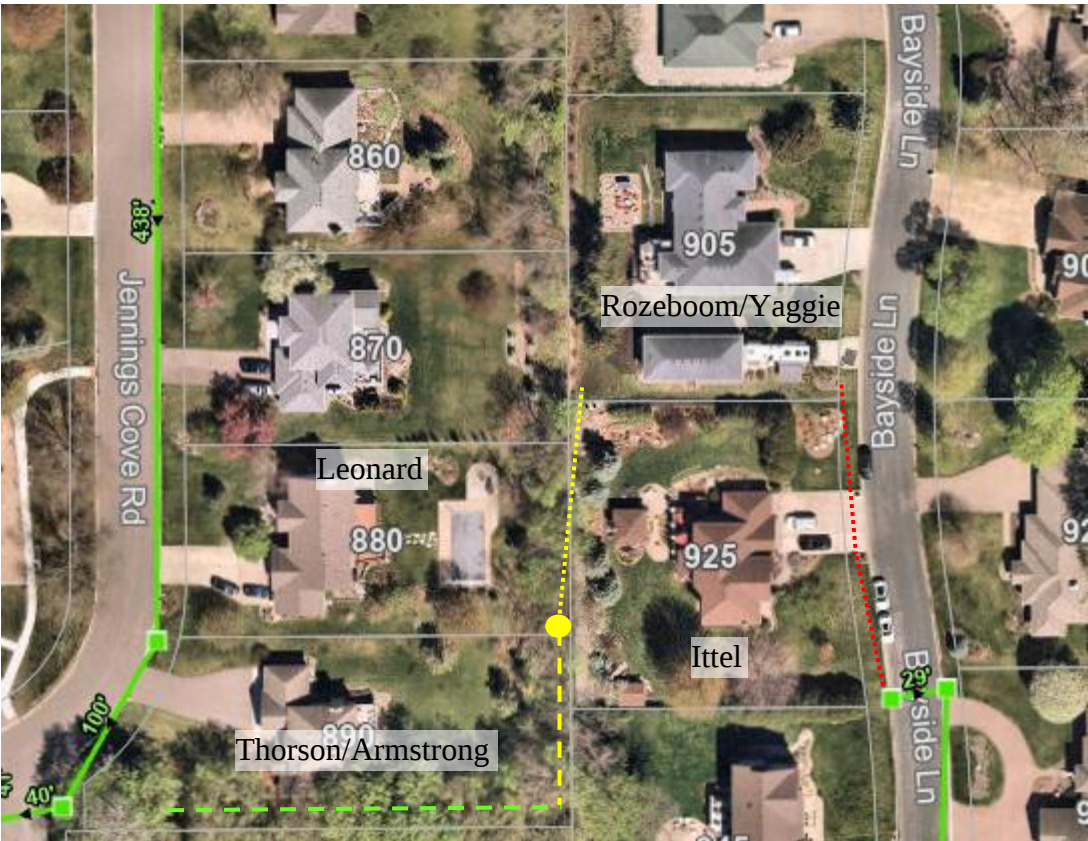
Figure 5. Storm sewer in the area of 905 Bayside Lane

Throughout the years storm pipe has been extended to neighboring properties. The approximate locations are shown in Figure 5. In 2002 the city extended storm sewer to 925 Bayside Lane, shown as a green dashed line in Figure 5. As instructed at the October 7, 2024 work session the City Attorney determined that there’s no legal documentation showing that the city owns this pipe. Additionally, staff has been told that this pipe is partially collapsed.

At some point a catch basin was installed at the northeast corner of 880 Jennings Cove Road. The city does not have record of this pipe being installed. The assumed alignment of the pipe and the approximate location of the catch basin are shown as the yellow dashed line in Figure 5. The owner of 905 Bayside would prefer to connect to this pipe (the yellow dotted line in Figure 5) but was not granted permission to do so.

The other alternative to address the issue at 905 Bayside is to extend drintile from the existing catch basin within Bayside Lane, shown as a red dotted line in Figure 5. If council supports the use of city funds to help pay for the extension, staff would like direction as to whether the portion in the right of way should be public drintile. If not, a license agreement allowing private drain tile within the public right of way would be required.

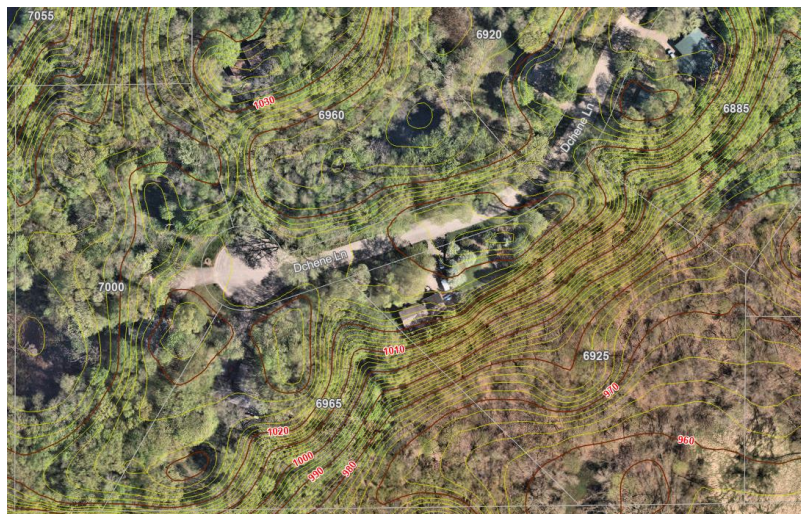
Figure 6. Grades along D'Chene Lane

Staff met with some of the residents on the south side of D'Chene to discuss their concerns with the erosion taking place on their property. Based on the contour data shown in Figure 6 the average slope extending from the road is 25%, with slopes behind the homes as steep as 45%.

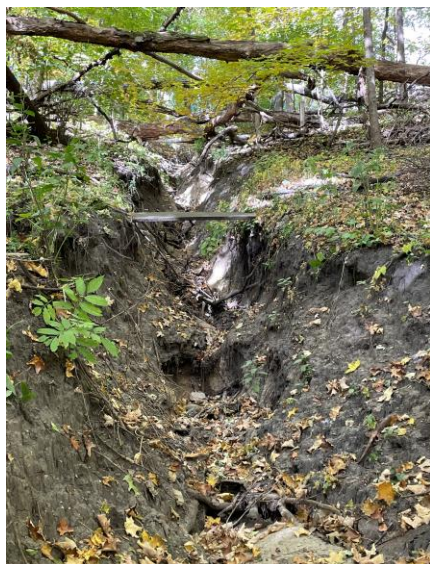
Figure 7. Erosion south of D'Chene Ln

Staff is not aware of any public storm sewer in this area. Approximately 185' of the road drains to the low point at 6965 D'Chene, and approximately 200' drains to the low point between 6885 and 6925 D'Chene. The drainage is eroding the channel as shown in Figures 7 and 8. Residents have safety concerns with the erosion and tree loss within the channel and are asking the city to stabilize the channel.

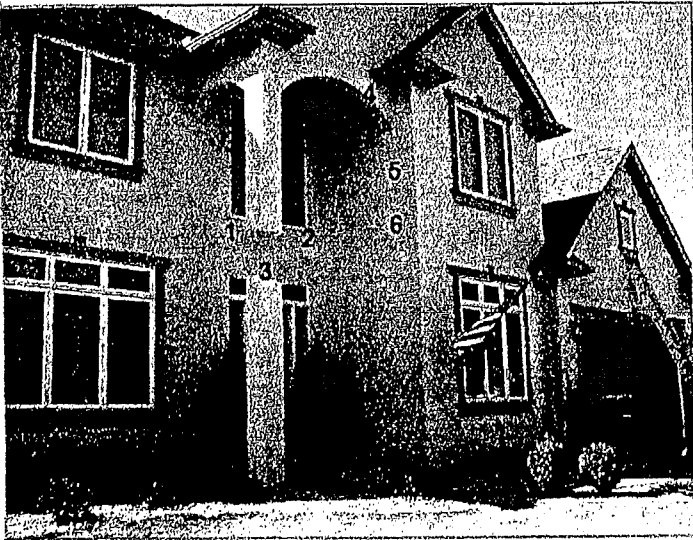
Photo Number: **2**

| Site | Moisture | Item / Locale | Description |
|---|---|---|---|
| 4 | 11% | Kickout<br>under kickout | See detail photo 2, Missing kickout flashing. |
| 8 | | | See detail photo 3, Stucco lacks clearance to shingles. |

**Windows lack caulking around their frames.**

**Windows lack caulking inside their frames (sill, jamb, tracks, sashes, etc.).**

**Foam Insulation and/or stucco within six inches of grade may need modifications.**

**Breaches lack caulking (fixtures, faucets, utility boxes, vents, etc.).**

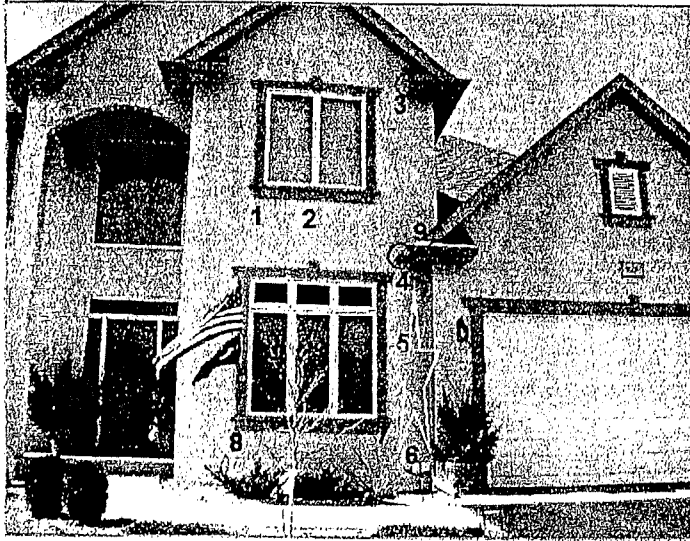
Photo Number: **3**

| Site | Moisture | Item / Locale | Description |
|---|---|---|---|
| 4 | 25% | Kickout<br>under kickout | See detail photo 4, Missing kickout flashing. |
| 5 | 28% | under kickout | |
| 7 | 27% | Window<br>lower right | |

**Windows lack caulking around their frames.**

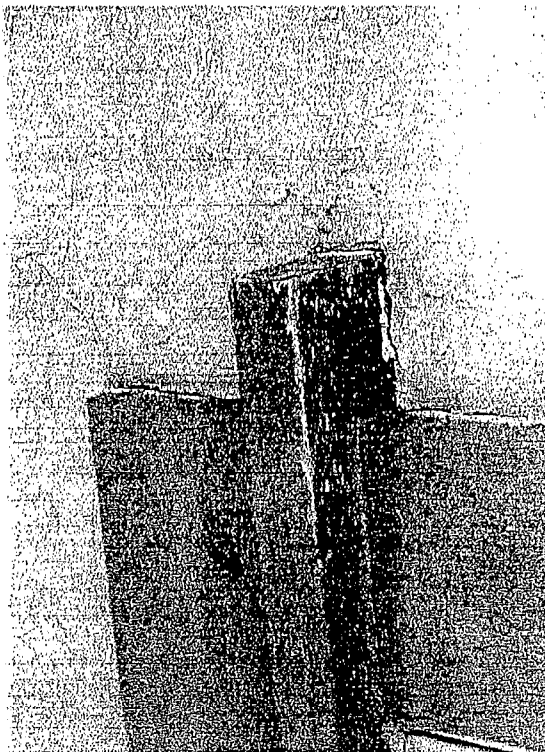
Detail photo 1

Accents around windows in area lack caulk.

All the flat accents and quoins need to be caulked or recaulked. These areas will need to be monitored and maintained for the life of your home to prevent moisture intrusion.
