New Castle Historic Preservation Commission (Regular Meeting)

New Castle - Reconnaissance Survey

The Town of New Castle (New Castle) is conducting a reconnaissance-level survey of historic resources along Main Street (US Highway 6). The survey will identify and recommend individual resources for future intensive-level survey to determine potential eligibility under National Register of Historic Places (NRHP) criteria in accordance with NRHP and State of Colorado Historic Survey Standards. In addition, this survey assesses the potential for a historic district as well as identify and recommend resources that may contribute toward a potential NRHP historic district. This survey represents the most recent evaluation of historic resources in the Town of New Castle. Previous historic resource surveys have mostly focused on residential and commercial buildings/structures in the central quadrant of the town. Resources in the survey area—bounded by Elk Creek to the west, Burning Mountain Avenue to the east, and adjacent to Main Street—are the focus of this reconnaissance report.

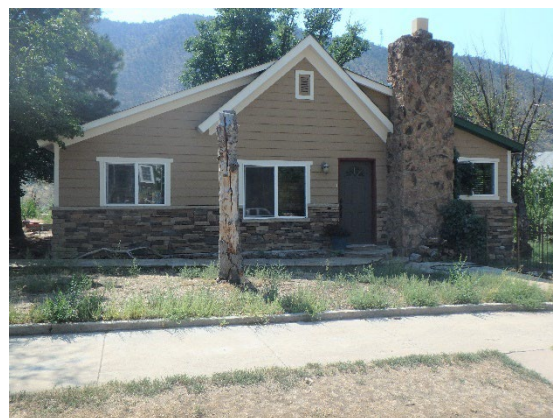
Common characteristics include:

- Does not yield a cohesive architecture
- Limited architectural detail
- Mostly unornamented surfaces
- Variety of roof types including front gable, side gable, or hipped roof

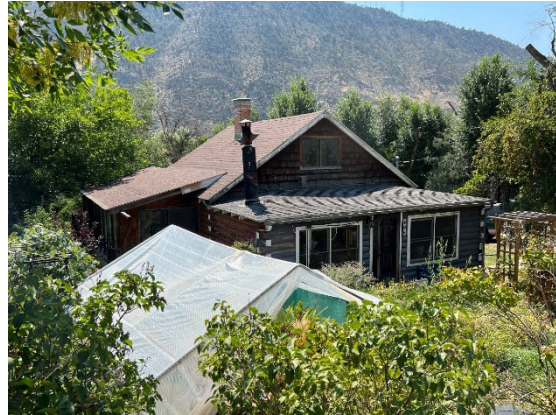
Rustic

Common characteristics include:

- Log construction
- Overhanging eaves
- Exposed rafter tails
- Front or side gable roof
- Brick masonry or metal flue chimney
- Commercial hardware including window frames and doors

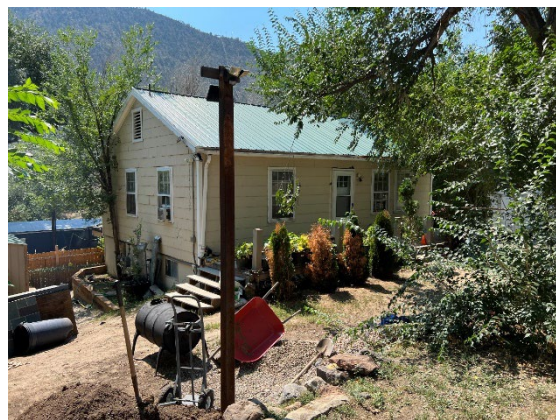
Minimal Traditional

Common characteristics include:

- Boxy appearance; minimal architectural detail
- Rectangular or square plan
- One-story
- Low roof; usually side gabled
- Closed roof eaves
- Central main entry
- Weatherboard, asbestos, or brick siding

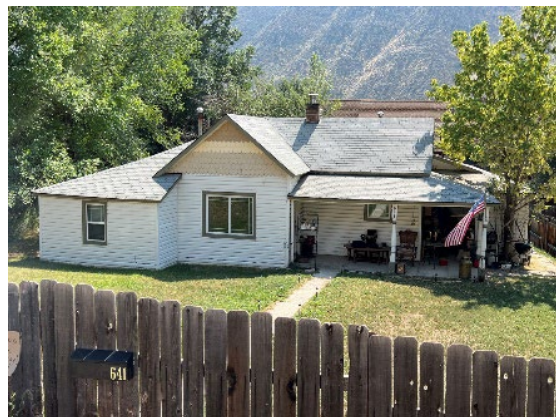
Gabled-EII

Common characteristics include:

- L-shaped layout
- Two intersecting front gables
- Clapboard siding
- Typically incorporates a partial- or full-length porch
- Some examples feature Queen Anne style elements including decorative fish scale shingles and turned spindle work

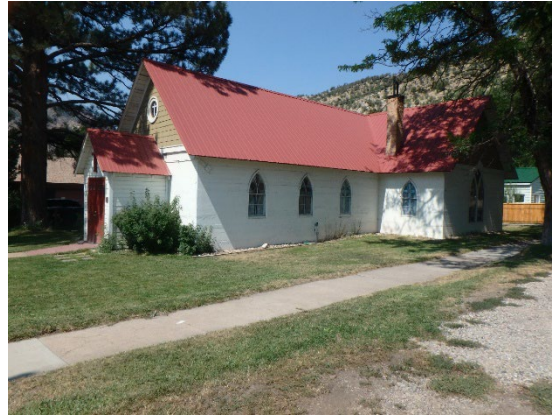
Gothic Revival

Common characteristics include:

- Gothic (pointed) arch windows
- Steep pitched gable roof
- Masonry construction
- Limited or wide overhanging eaves
- Exposed rafter tails
- Open rake roof-wall junctions

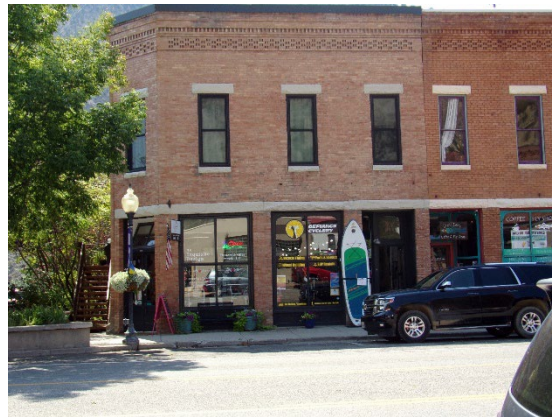
Nineteenth Century Commercial

Common characteristics include:

- Multi-story
- Decorative frieze
- Door transom
- May have corbelled cornice
- Decorative brickwork
- Stone or brick belt course
- Parapet
- Usually single or double entryway; multiple entryways present with corner building

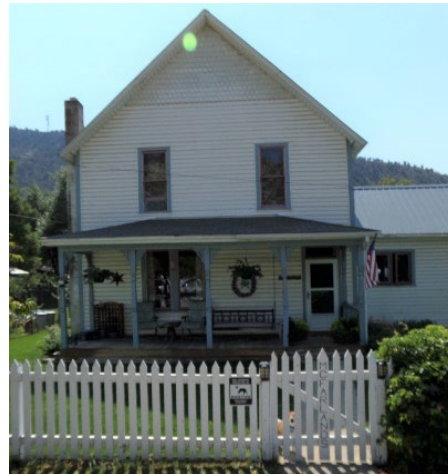
Edwardian

Common characteristics include:

- Multi-story
- Partial or full-length porch
- Multi-gable roof
- Asymmetrical
- Typically features some Queen Anne style elements including decorative fish scale shingles and/or turned spindle work

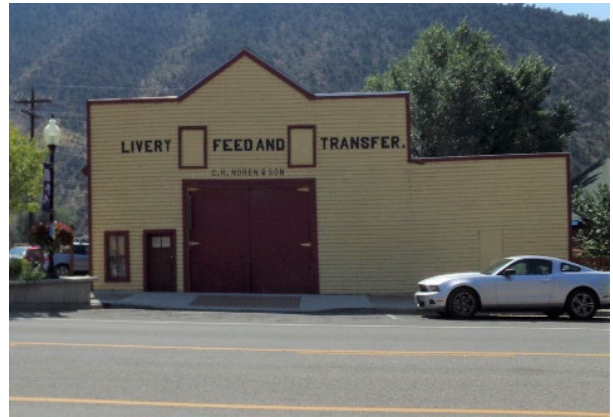
False Front Commercial

Common characteristics include:

- Multi-story
- Parapet that extends above the roof and sides of a building
- Early examples constructed of wood; later examples utilized brick masonry
- Decorative cornice
- Typically, a front gable roof behind false front

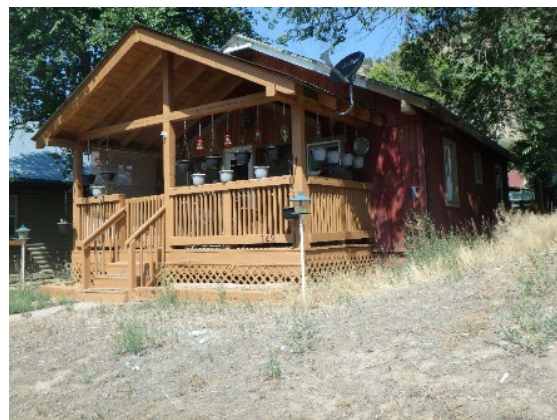
Bungalow

Common characteristics include:

- One or 1.5-story construction
- Typically incorporates a clapboard exterior envelope
- Exposed rafter tails under eaves
- Typically utilized a full-length porch

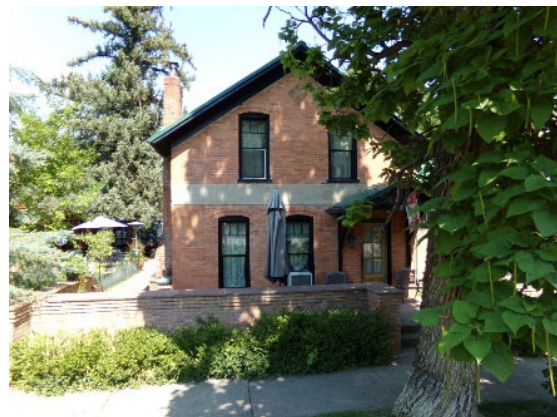
Italianate

Common characteristics include:

- Multi-story
- Segmental arch windows
- Tall and narrow windows
- Molded window surrounds
- Decorative brickwork
- Typically incorporates brick masonry, although stone masonry was also utilized

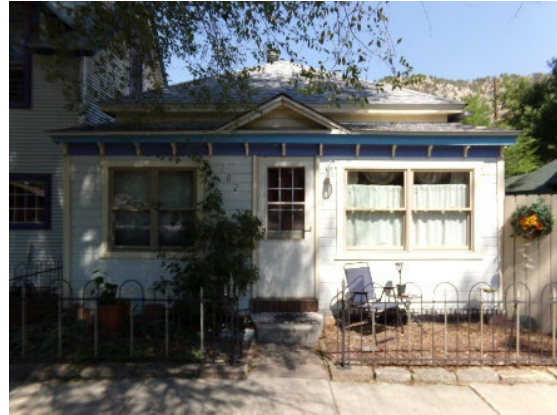
Hipped Roof Box

Common characteristics include:

- One-story
- Square plan
- Hipped roof
- Overhanging eaves with exposed rafter tails
- Decorative woodwork
- Typically utilized a clapboard exterior envelope

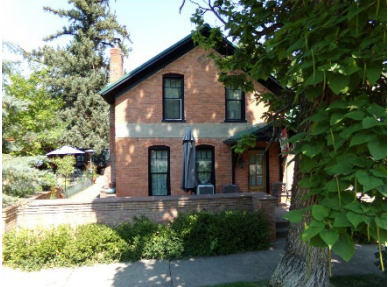
Address/Site Number	Year built	Notes	Individual Assessment (high, medium, low)	Contributes to potential Historic District	Photographs
802 West Main Street (5GF.5891)	1895	Italianate; 1.5-story; Brick masonry	High	Yes

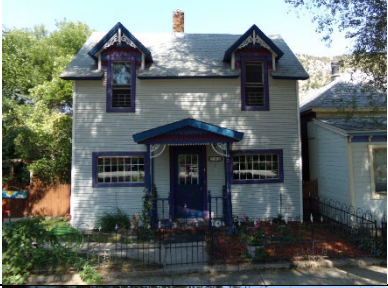
792 West Main Street (5GF.5892)	Ca. 1899	Vernacular Queen Anne; Two-story; Horizontal weatherboard	High	Yes

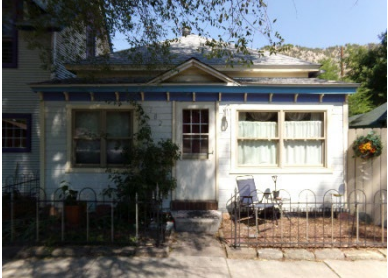
782 West Main Street (5GF.5893)	1893	Hipped roof box; One-story; Horizontal weatherboard	Medium	Yes

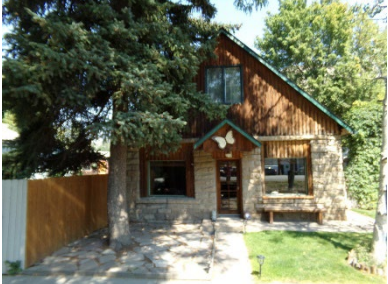
Address/Site Number	Year built	Notes	Individual Assessment (high, medium, low)	Contributes to potential Historic District	Photographs
752 West Main Street (5GF.5894)	1893	Rustic; 1.5-story; Stone masonry	Low	Yes

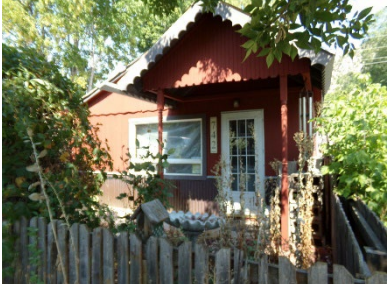
742 West Main Street (5GF.5895)	1893	No Style; One-story; Vertical weatherboard	Low	Yes

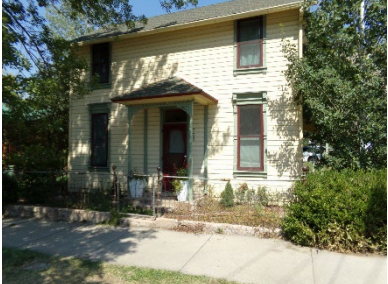
Address/Site Number	Year built	Notes	Individual Assessment (high, medium, low)	Contributes to potential Historic District	Photographs
702 West Main Street (5GF.5898)	Ca. 1904	Vernacular Queen Anne; Two-story; Horizontal weatherboard	Medium	Yes

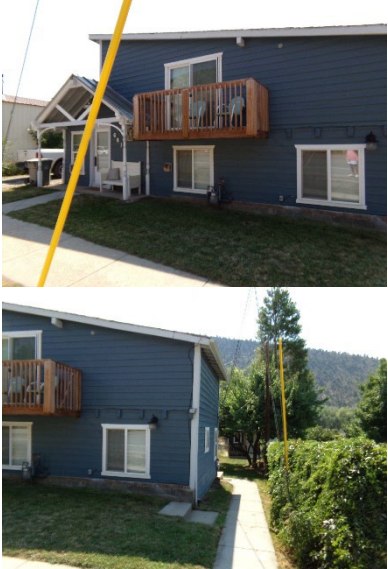
681 West Main Street (5GF.5899)	1893	No Style; Two-story; Horizontal weatherboard	Low	No

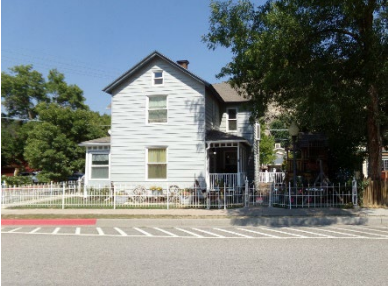
Address/Site Number	Year built	Notes	Individual Assessment (high, medium, low)	Contributes to potential Historic District	Photographs
644 West Main Street (5GF.5900)	Ca. 1904	Edwardian; Two-story; Composite siding	Low	Yes

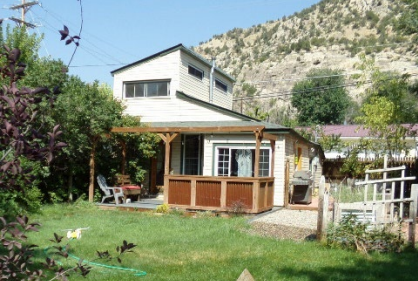
640 West Main Street (5GF.5901)	1893	No Style; Two-story; Vinyl siding	Low	No

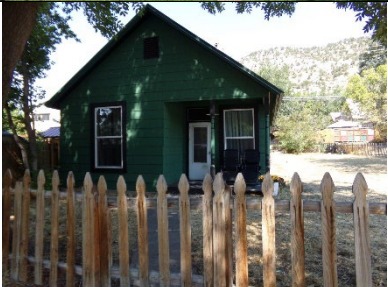
620 West Main Street (5GF.5902)	Ca. 1899	No Style; One-story; Composite siding	Low	Yes

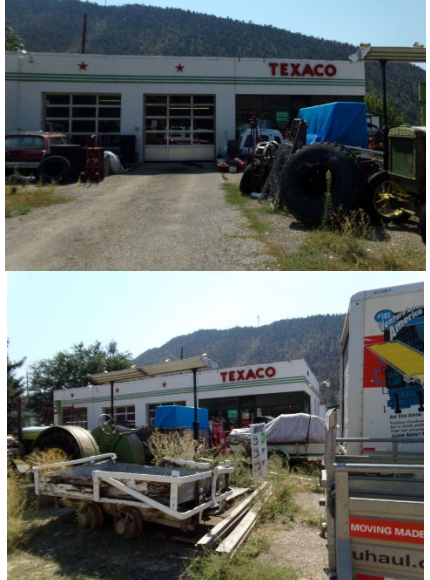
Address/Site Number	Year built	Notes	Individual Assessment (high, medium, low)	Contributes to potential Historic District	Photographs
589 West Main Street (5GF.5903)	1951	Mixed Style; One-story Stucco	High	Yes

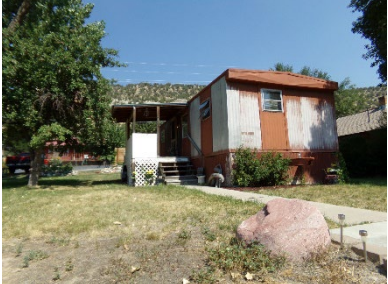
562 West Main Street (5GF.5904)	1974	Prefabricated mobile trailer; One-story; Corrugated metal	N/A (outside period of significance)	No

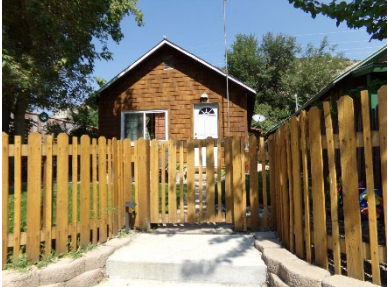
Address/Site Number	Year built	Notes	Individual Assessment (high, medium, low)	Contributes to potential Historic District	Photographs
552 West Main Street (5GF.5905)	1942	Shotgun; One-story; Wood shingle	Low	Yes

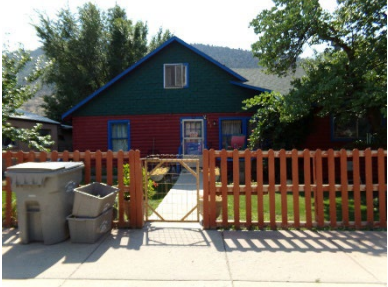
543 West Main Street (5GF.5906)	1948	No Style; 1.5-story; Faux log	Low	Yes

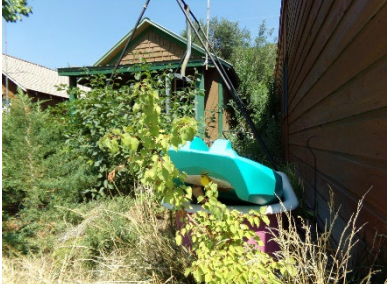
542 West Main Street (5GF.5907)	1942	Shotgun; One-story; Vertical weatherboard	Low	Yes

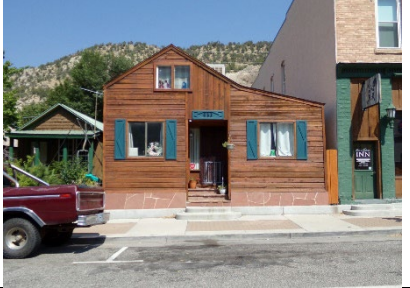
Address/Site Number	Year built	Notes	Individual Assessment (high, medium, low)	Contributes to potential Historic District	Photographs
532 West Main Street (5GF.5908)	1893	No Style; One-story; Horizontal and vertical weatherboard	Low	Yes

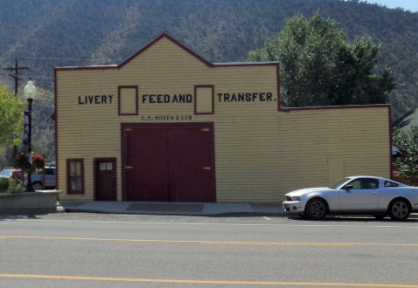
503 West Main Street (5GF.2380)	Ca. 1905	False Front Commercial; One-story; Horizontal weatherboard and embossed asphalt siding Field - Not Eligible (1996)	Low	Yes

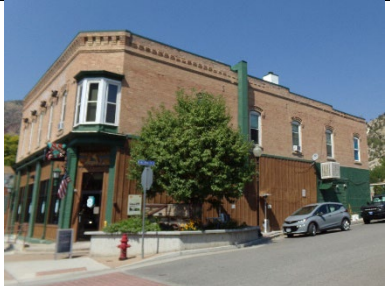
502 West Main Street (5GF.1166)	Ca. 1893	Nineteenth Century Commercial; Two-story; Brick masonry Field - Not Eligible (1996); Local landmark	Medium	Yes

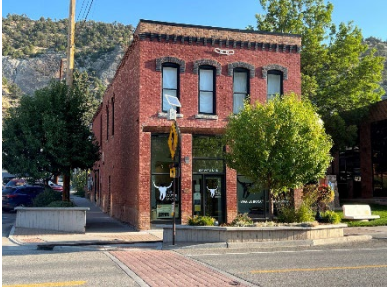
Address/Site Number	Year built	Notes	Individual Assessment (high, medium, low)	Contributes to potential Historic District	Photographs
500 West Main Street (5GF.1488)	Ca. 1890	Nineteenth Century Commercial; Two-story; Brick masonry Field- Not Eligible (1996); Local landmark	Medium	Yes

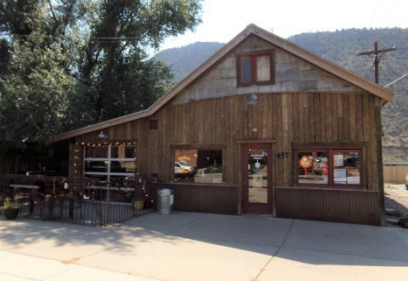
457 West Main Street (5GF.5909)	Ca. 1899	Commercial; One-story; Vertical weatherboard	Low	Yes

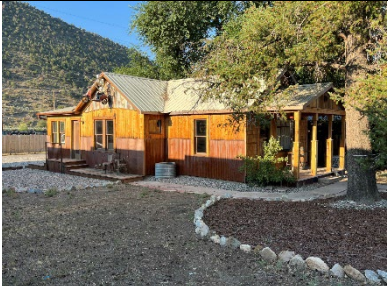
437 West Main Street (5GF.5910)	1929	Bungalow	Low	No

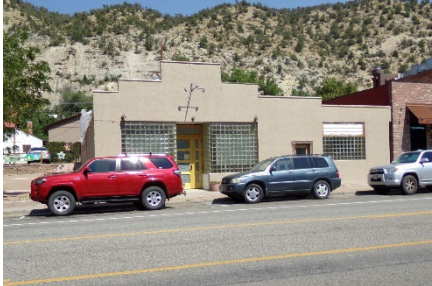
366 West Main Street (5GF.5912)	1928	False Front Commercial; One-story; Stucco	High	Yes

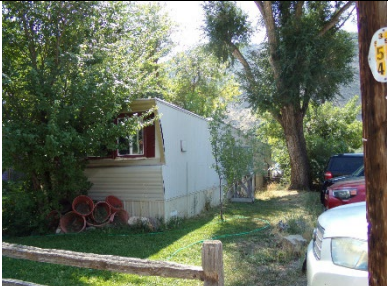
335 West Main Street (5GF.5913)	1971	Prefabricated mobile trailer; One-story; Corrugated metal	Low	No

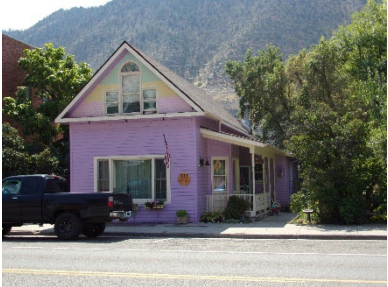
Address/Site Number	Year built	Notes	Individual Assessment (high, medium, low)	Contributes to potential Historic District	Photographs
333 West Main Street (5GF.5914)	1909	Vernacular Queen Anne; 1.5-story; Horizontal weatherboard	Medium	Yes

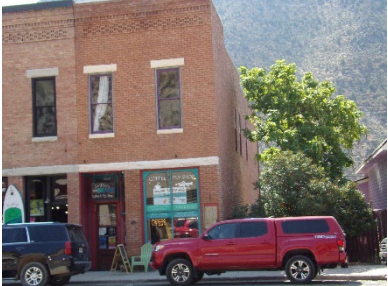
331 West Main Street (5GF.2379)	1895	Nineteenth Century Commercial; Two-story; Brick masonry Officially - Eligible (2001)	High	Yes

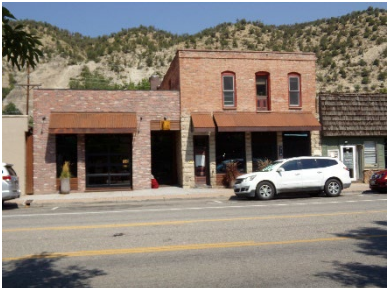
316 West Main Street (5GF.2378)	1890	Nineteenth Century Commercial; Two-story; Stone/brick masonry Officially - Eligible (2001); Field - Not Eligible (1996)	Medium	Yes

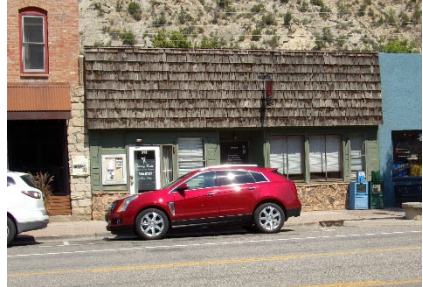
Address/Site Number	Year built	Notes	Individual Assessment (high, medium, low)	Contributes to potential Historic District	Photographs
312 West Main Street (5GF.2377)	1889	Commercial; One-story; Horizontal weatherboard Field - Not Eligible (1996)	Low	Yes

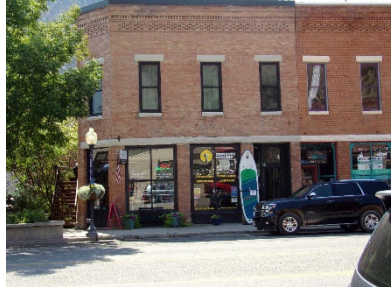
303 West Main Street (5GF.2376)	Ca. 1893	Nineteenth Century Commercial; Two-story; Brick masonry Officially - Eligible (2001)	High	Yes

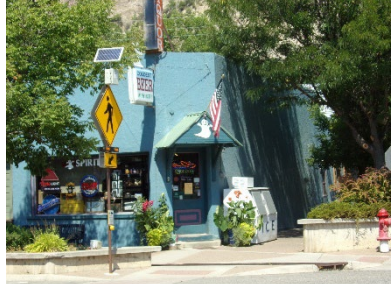
302 West Main Street (5GF.2375)	1889	Nineteenth Century Commercial; One-story; Stucco Field - Not Eligible (1996)	Low	Yes

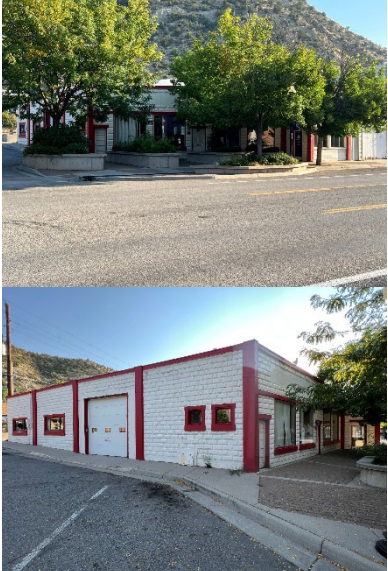
Address/Site Number	Year built	Notes	Individual Assessment (high, medium, low)	Contributes to potential Historic District	Photographs
298 West Main Street (5GF.2373)	1937	<p>Rusticated Commercial; One-story; Rusticated concrete block</p> <p>Field - Eligible (1996); Local landmark</p>	High	Yes

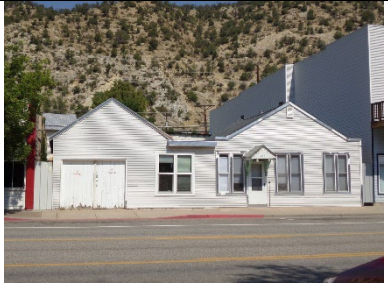
286 West Main Street (5GF.5915)	1892	<p>No Style; One-story; Vinyl siding</p>	Low	Yes

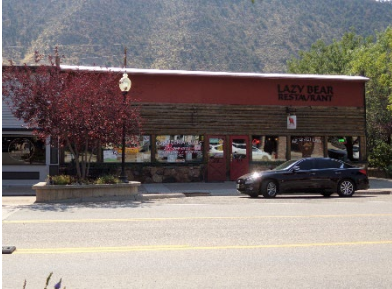
Address/Site Number	Year built	Notes	Individual Assessment (high, medium, low)	Contributes to potential Historic District	Photographs
275 West Main Street (5GF.2374)	Ca. 1888	Nineteenth Century Commercial; One-story; Stucco (Formally 299 West Main Street) Field - Not Eligible (1996); Local landmark	Low	Yes

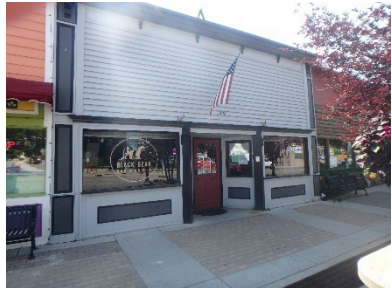
219 West Main Street (5GF.2372)	1892	Nineteenth Century Commercial; One-story; Brick masonry (Formally 239 West Main Street) Field - Not Eligible (1996); Local landmark	Low	Yes

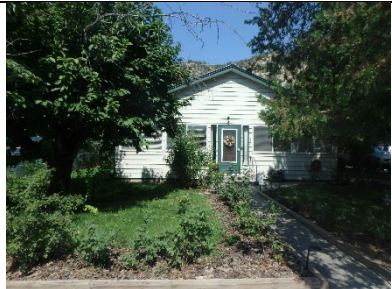
202 West Main Street (5GF.5918)	1923	No Style; 1.5-story; Composite siding	Low	Yes

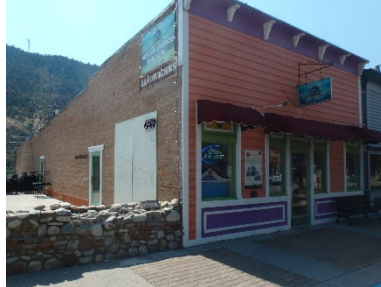
Address/Site Number	Year built	Notes	Individual Assessment (high, medium, low)	Contributes to potential Historic District	Photographs
201 West Main Street (5GF.2371)	Ca. 1890	Nineteenth Century Commercial; One-story; Brick masonry Field - Not Eligible (1996)	Low	Yes

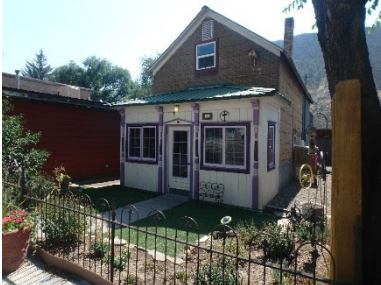
181 West Main Street (5GF.2370)	Ca. 1905	No Style; 1.5-story; Embossed asphalt siding Field - Not Eligible (1996)	Low	Yes

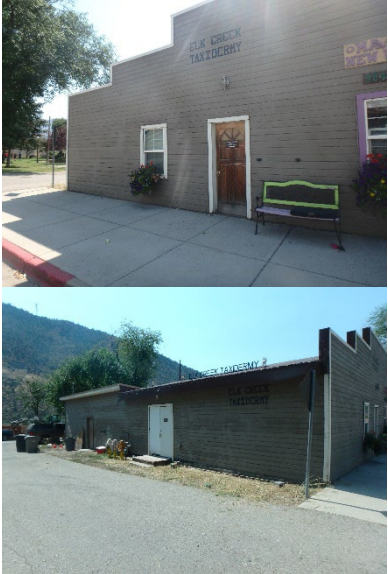
Address/Site Number	Year built	Notes	Individual Assessment (high, medium, low)	Contributes to potential Historic District	Photographs
161 West Main Street (5GF.5919)	1900	False Front Commercial; One-story; Horizontal weatherboard Local landmark	Low	Yes

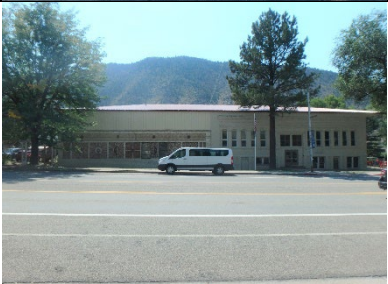
151 West Main Street (5GF.2369)	1913; 1939	Mixed Style; Two-story; Brick masonry Field - Not Eligible (1996)	Low	Yes

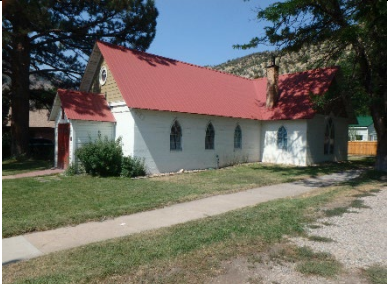
100 East Main Street (5GF.2368)	1909	Gothic Revival; One-story; Concrete Field - Eligible (1996); Local landmark	High	Yes

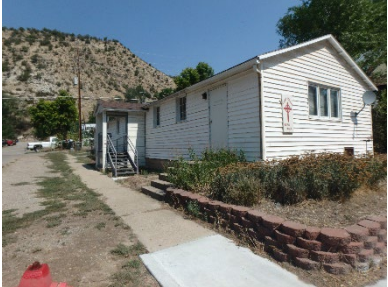
Address/Site Number	Year built	Notes	Individual Assessment (high, medium, low)	Contributes to potential Historic District	Photographs
102 East Main Street (5GF.5921)	1948 (moved to site)	No Style; One-story; Vinyl siding	Low	No

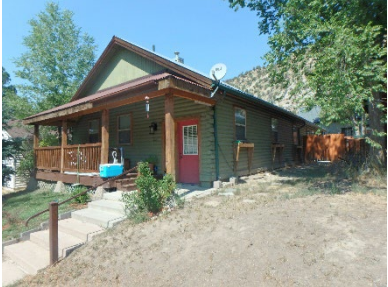
122 East Main Street (5GF.5922)	1941	Rustic; One-story; Log	Low	Yes

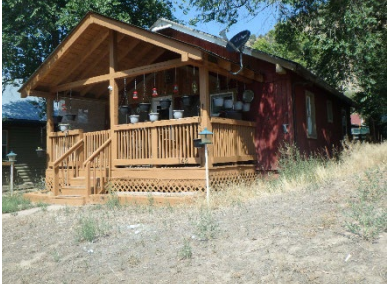
142 East Main Street (5GF.5923)	1941	Bungalow; One-story; Vertical weatherboard	Low	Yes

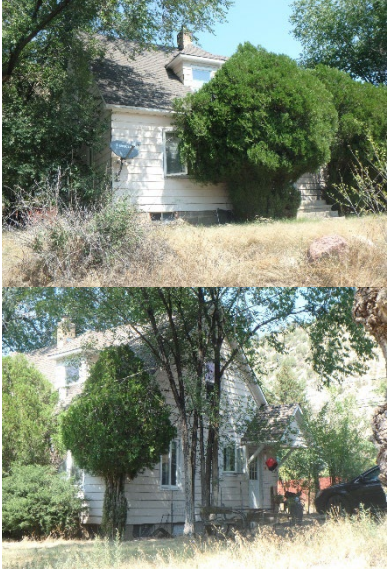
Address/Site Number	Year built	Notes	Individual Assessment (high, medium, low)	Contributes to potential Historic District	Photographs
162 East Main Street (5GF.5924)	1942	Cape Cod; 1.5-story; Horizontal weatherboard	High	Yes

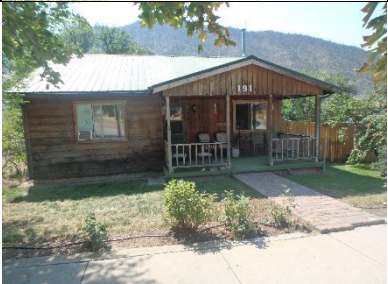
191 East Main Street (5GF.5925)	1950	Rustic; One-story; Horizontal weatherboard	Low	Yes

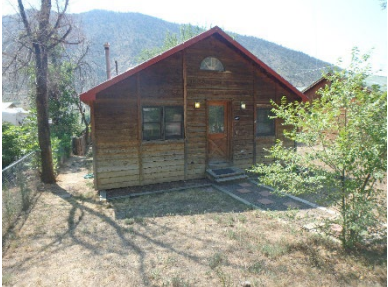
Address/Site Number	Year built	Notes	Individual Assessment (high, medium, low)	Contributes to potential Historic District	Photographs
203 East Main Street (5GF.5926)	1936	Rustic; One-story; Novelty siding	Low	Yes

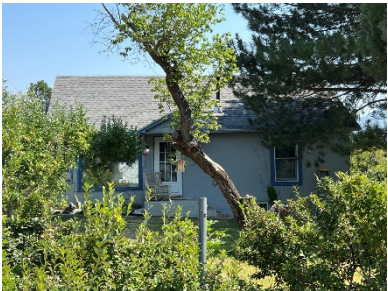
Address/Site Number	Year built	Notes	Individual Assessment (high, medium, low)	Contributes to potential Historic District	Photographs
316 East Main Street (5GF.5932)	1938	Minimal Traditional; One-story; Stucco	Medium	Yes

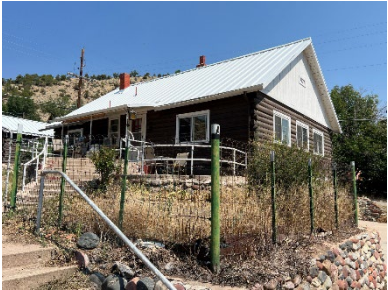
396 East Main Street (5GF.5933)	1940	Rustic; One-story; Log	Medium	Yes

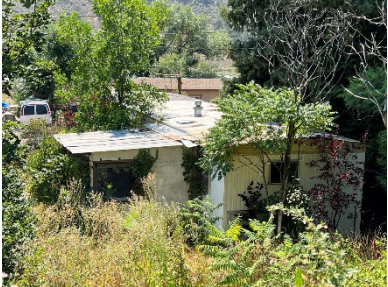
Address/Site Number	Year built	Notes	Individual Assessment (high, medium, low)	Contributes to potential Historic District	Photographs
405 East Main Street (5GF.5934)	1973	Prefabricated mobile trailer; One-story; Corrugated metal	Low	No

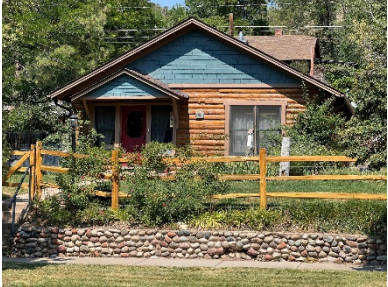
406 East Main Street (5GF.5935)	1934	Rustic; One-story; Log	Medium	Yes

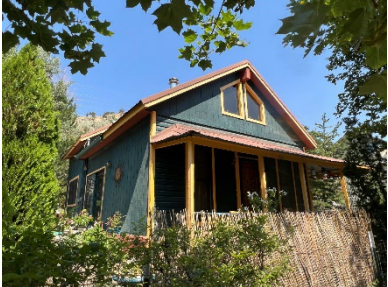
466 East Main Street (5GF.5938)	1893	No Style; One-story; Vertical weatherboard	Low	Yes

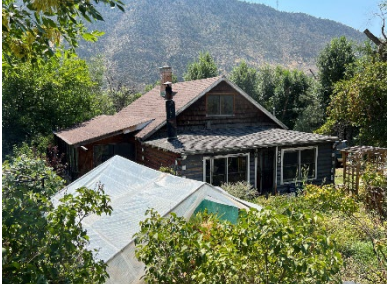
505 East Main Street (5GF.5939)	1945	Rustic; One-story; Log	High	Yes

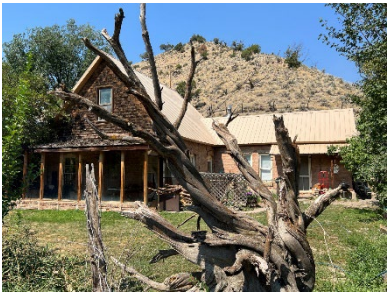
Address/Site Number	Year built	Notes	Individual Assessment (high, medium, low)	Contributes to potential Historic District	Photographs
696 East Main Street (5GF.5943)	1903	Shingle/Gabled Ell; 1.5-story; Shingle and brick masonry	Medium	Yes

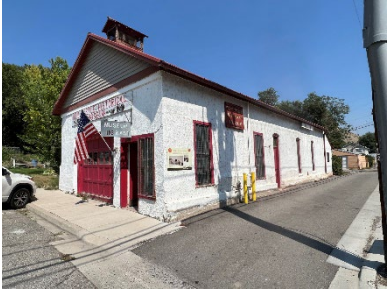
116 North 4th Street (Front) (5GF.1665)	Ca. 1893-1894	No Style; One-story; Stucco New Castle Museum Officially - Not Eligible (1992); Field - Not Eligible 1996); Local landmark	Low	Yes

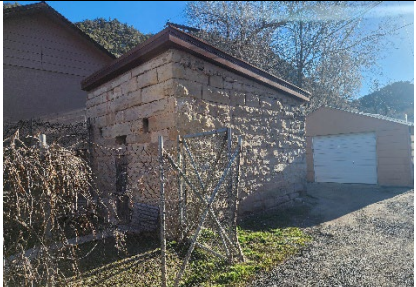
116 North 4th Street (Rear) (5GF.2367)	Ca. 1893-1894	No Style; One-story; Stone masonry Stone masonry Old Town Jail Field - Eligible (1996)	High	Yes

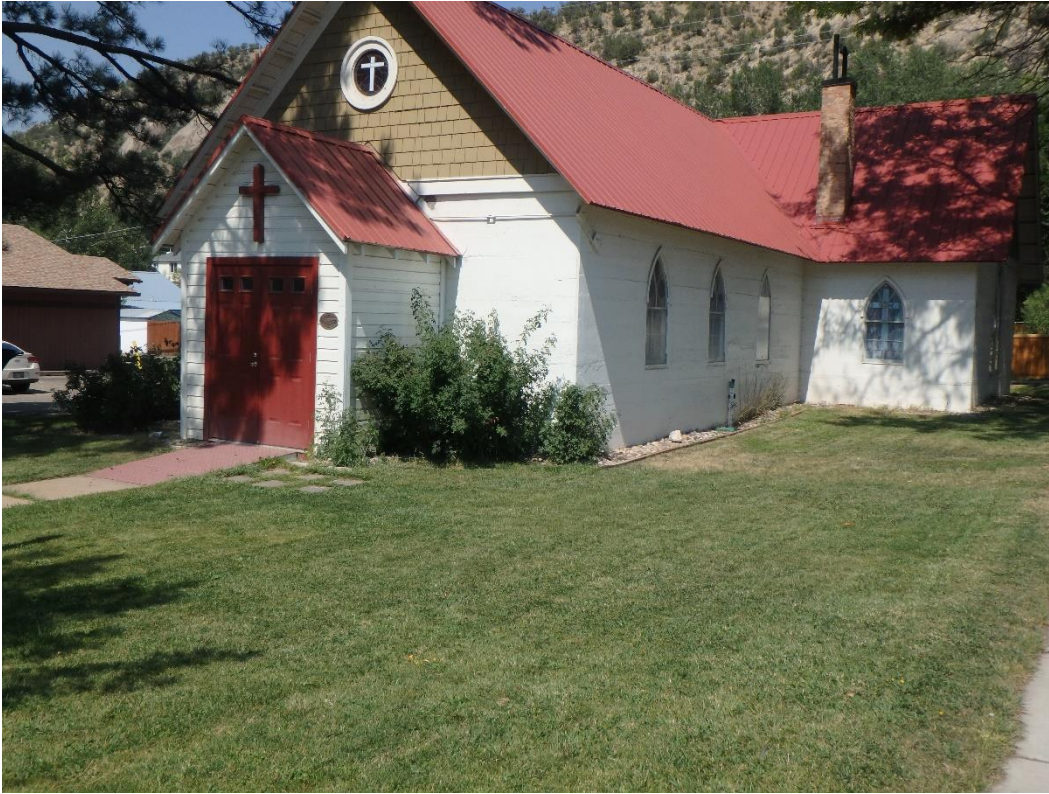
Photo Number: 5GF.2368_1
Description: Looking at the primary (south) and east elevations of the building. Note the historic brick masonry chimney; exposed rafter tails under the eaves; and the gothic arch window units.
Date: 9/6/2022
View: Northwest

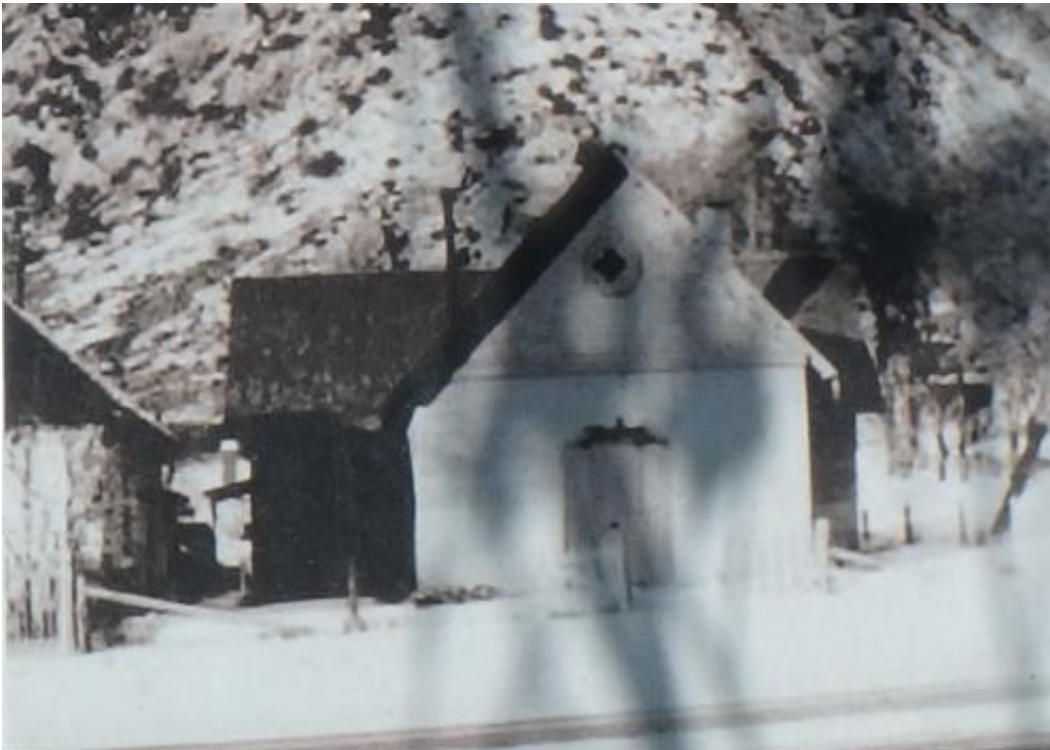
Historic Photo 1
Description: Looking at the primary (south) elevation of the church. Note that the front gable bay was not extant at the time, yet the oxeye, brick masonry chimney, and wood shingles in the gable end are extant.
Date: Unknown; likely early-Twentieth Century
Source: "New Castle Museum on the Street" sign along primary (south) elevation of the church

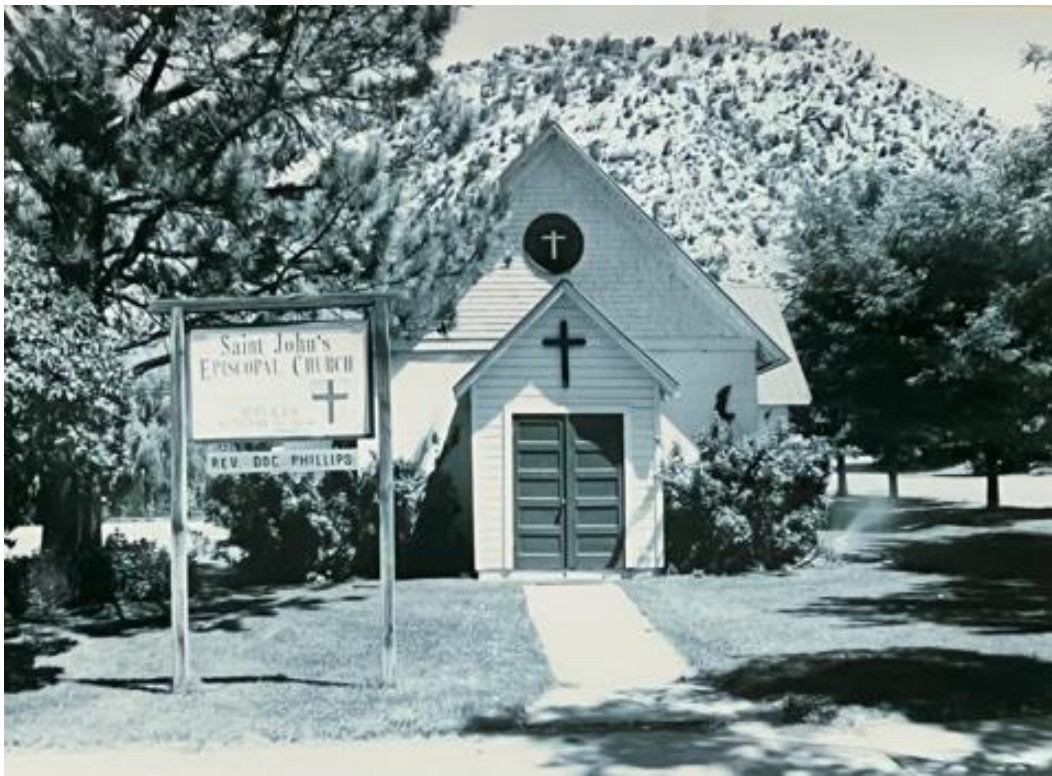
Historic Photo 2

Description: Looking at the primary (south) elevation of the church. Note the historic double wood panel doors are extant at the time.

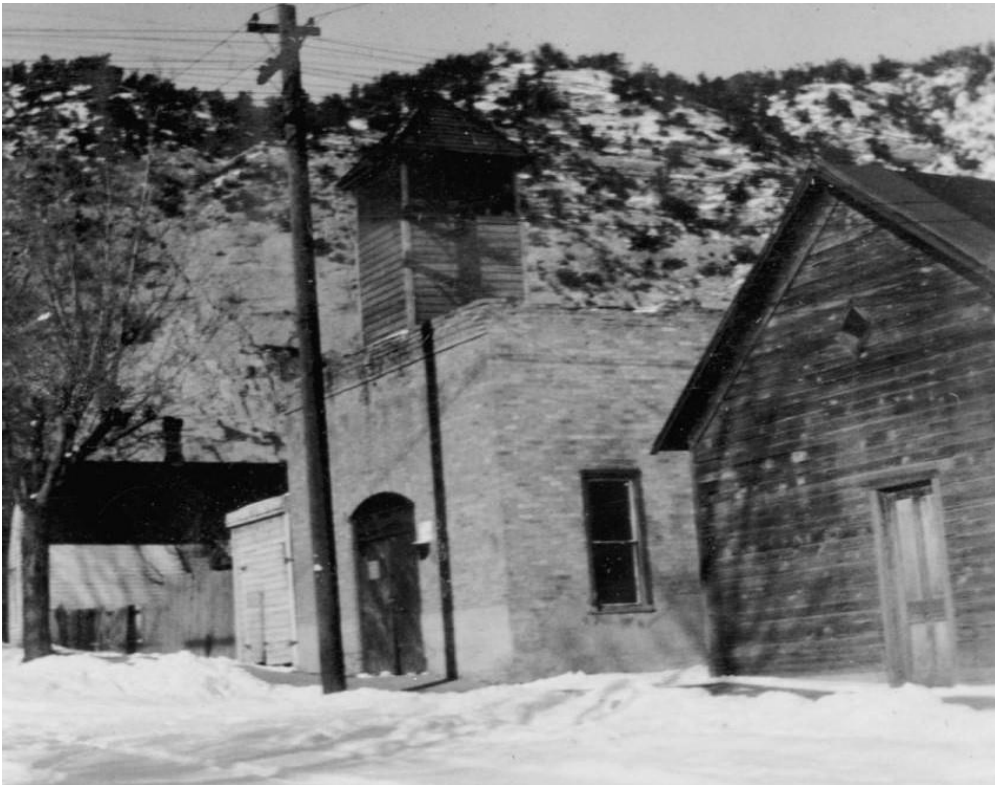
Historic Photo 1
Description: Looking at the primary (west) elevation and south elevation of the building. Note the building's historic flat roof and pyramid roof cupola.
Date: Circa 1910
Source: Denver Public Library – Digital Collections [Not for publication]

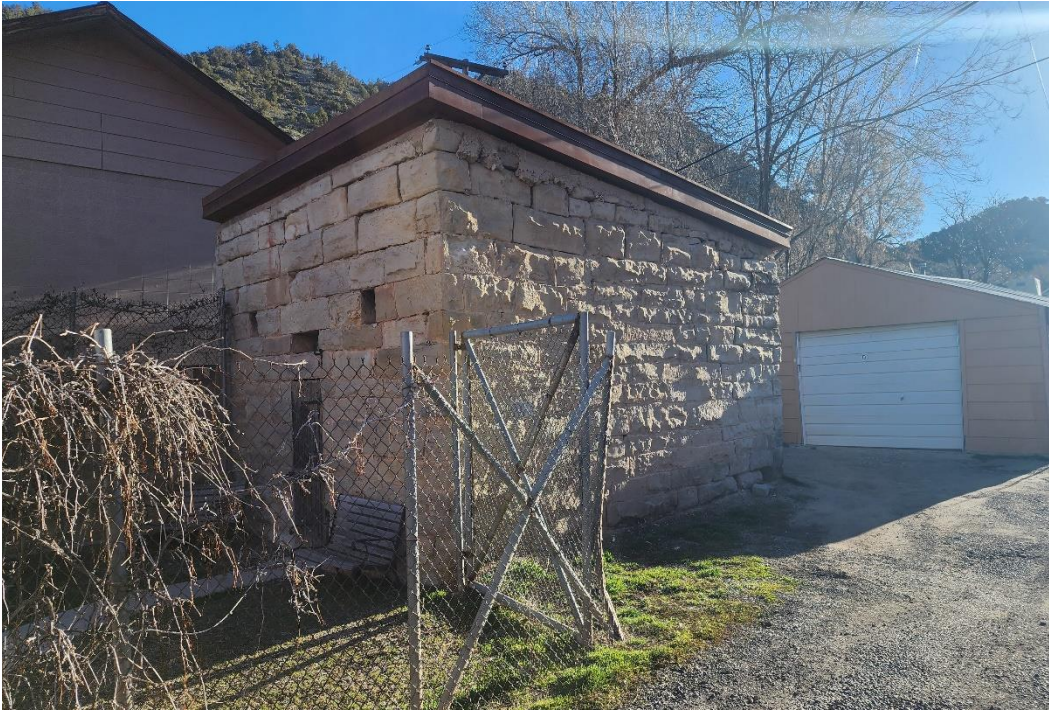
Photo Number: 5GF.2367_1
Description: Looking at the primary (west) and south elevations of the building. Note the three vent openings above the main entryway.
Date: 4/7/2023
View: Northeast

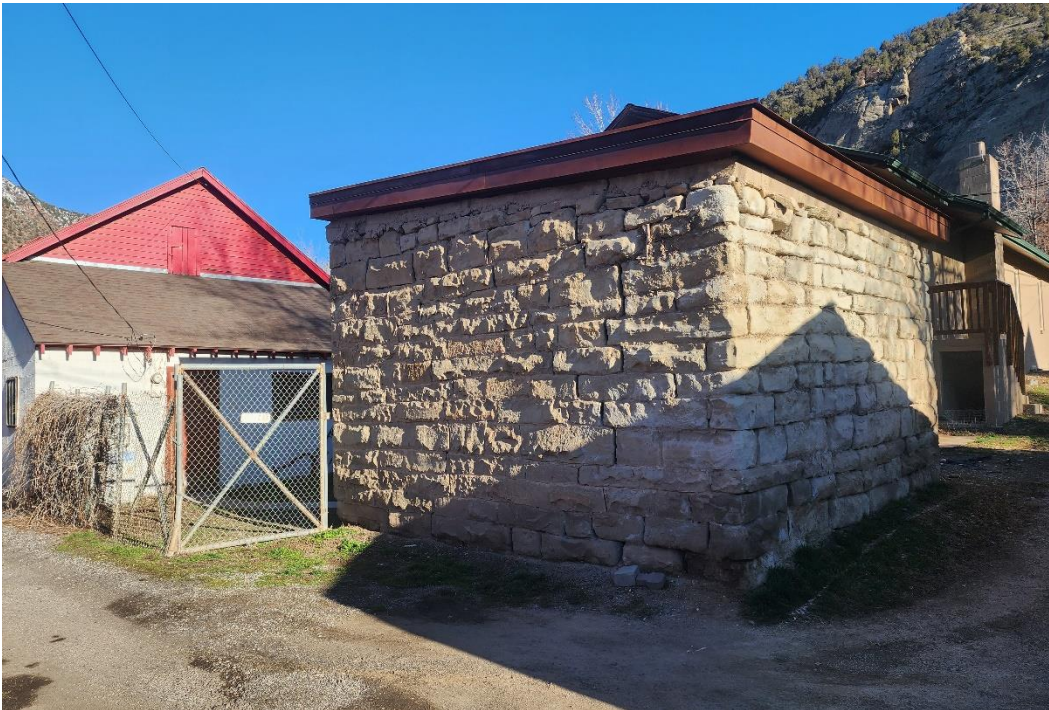
Photo Number: 5GF.2367_2
Description: Looking at the south and east elevations of the building.
Date: 4/7/2023
View: Northwest

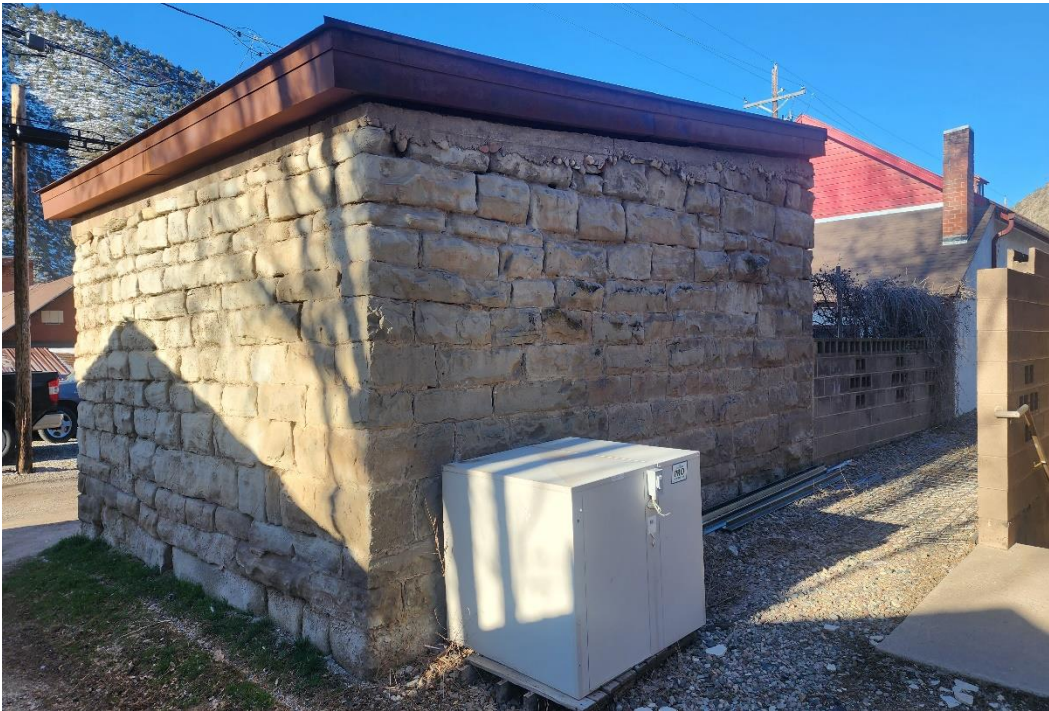
Photo Number: 5GF.2367_3
Description: Looking at the east and north elevations of the building.
Date: 4/7/2023
View: Southwest

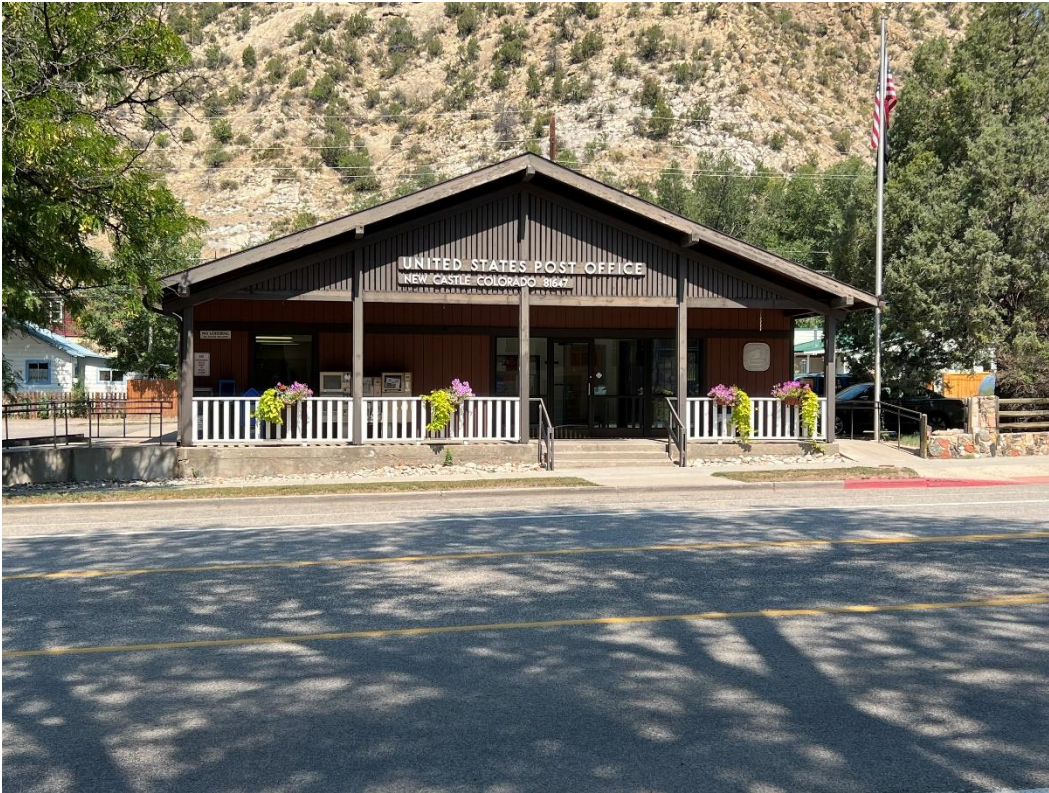
Photo Number: 5GF.5890_1
Description: Looking at the primary (south) elevation of the building.
Date: 9/6/2022
View: North

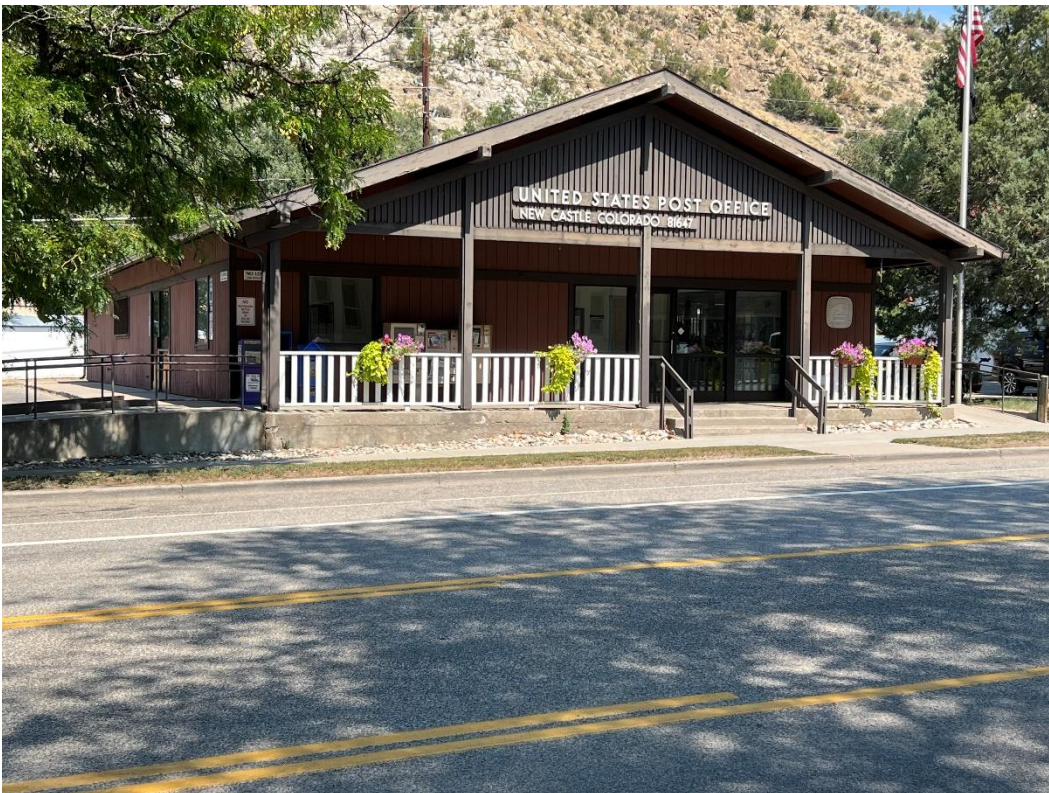
Photo Number: 5GF.5890_2
Description: Looking at the west and primary (south) elevations of the building.
Date: 9/6/2022
View: Northeast

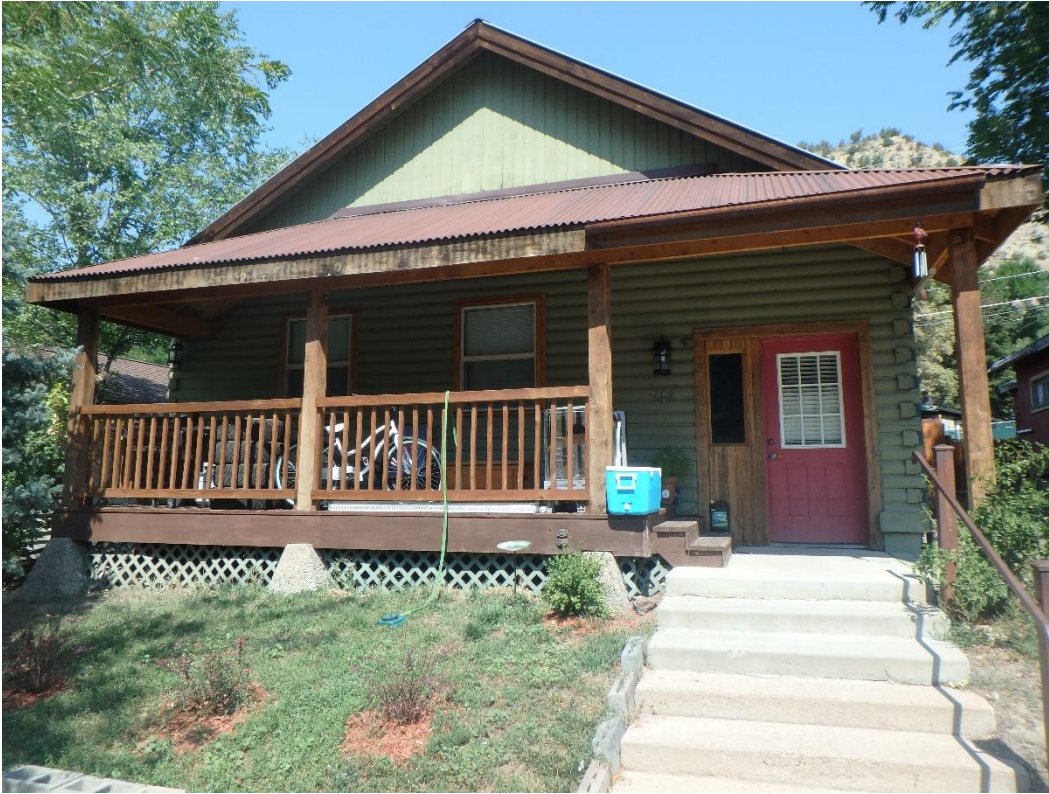
Photo Number: 5GF.5922_1
Description: Looking at the primary (south) elevation of the building.
Date: 9/6/2022
View: North

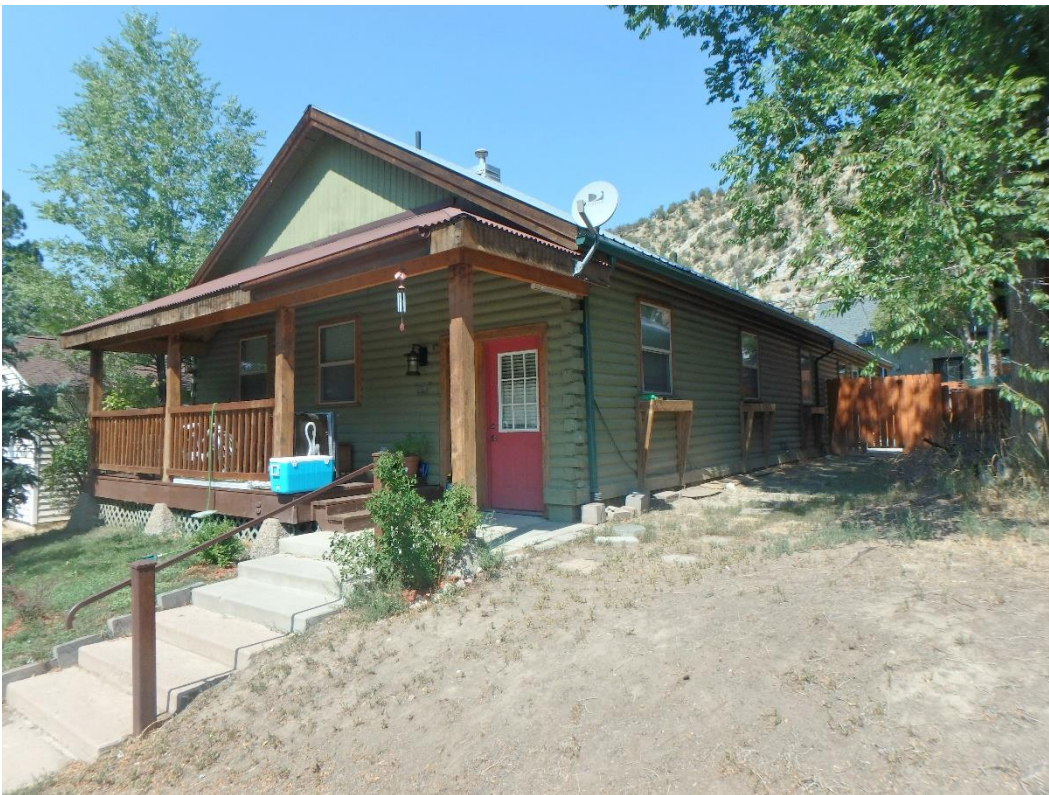
Photo Number: 5GF.5922_2
Description: Looking at the primary (south) and east elevations of the building.
Date: 9/6/2022
View: Northwest

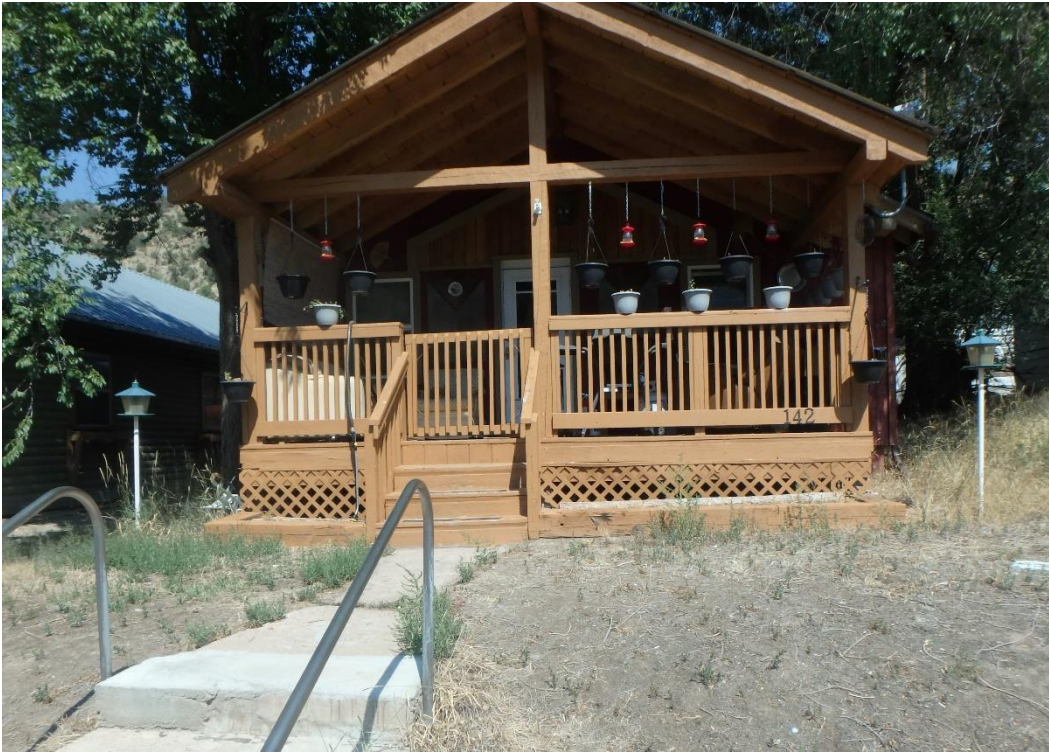
Photo Number: 5GF.5923_1
Description: Looking at the primary (south) elevation of the building. Note the decorative arrangement of the overhang support posts and the woodwork along the facade.
Date: 9/6/2022
View: North
