New Castle Historic Preservation Commission (Regular Meeting)

New Castle - Reconnaissance Survey

The Town of New Castle (New Castle) is conducting a reconnaissance-level survey of historic resources along Main Street (US Highway 6). The survey will identify and recommend individual resources for future intensive-level survey to determine potential eligibility under National Register of Historic Places (NRHP) criteria in accordance with NRHP and State of Colorado Historic Survey Standards. In addition, this survey assesses the potential for a historic district as well as identify and recommend resources that may contribute toward a potential NRHP historic district. This survey represents the most recent evaluation of historic resources in the Town of New Castle. Previous historic resource surveys have mostly focused on residential and commercial buildings/structures in the central quadrant of the town. Resources in the survey area—bounded by Elk Creek to the west, Burning Mountain Avenue to the east, and adjacent to Main Street—are the focus of this reconnaissance report.

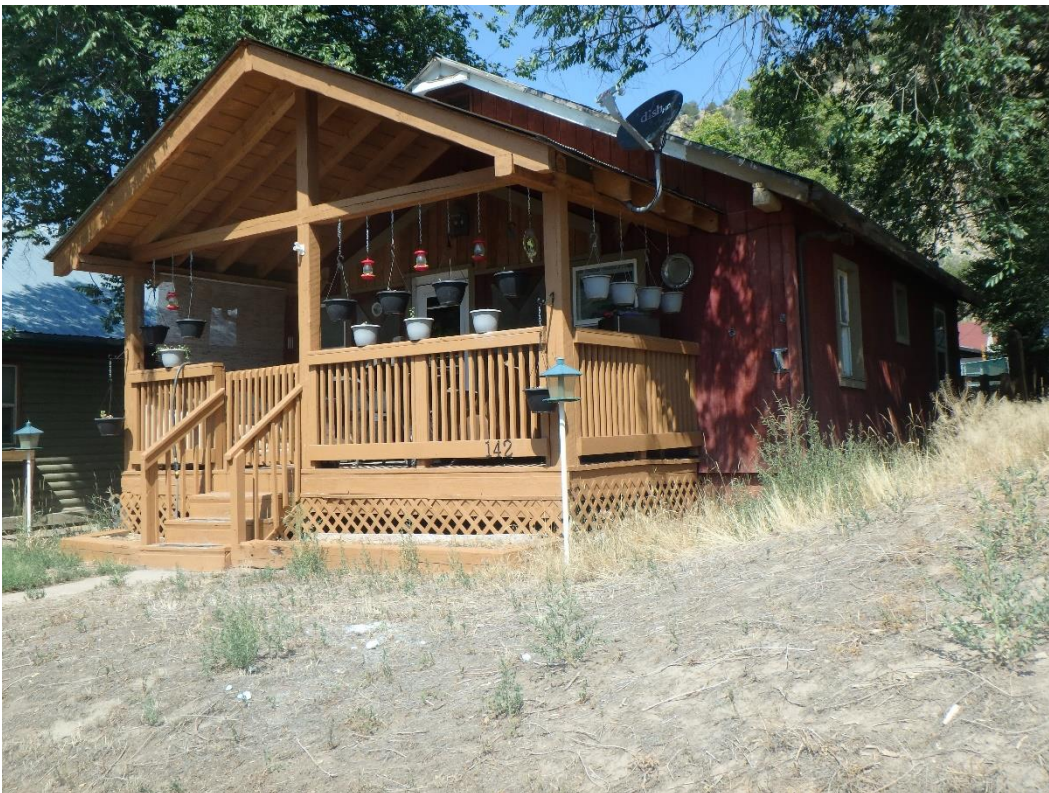
Photo Number: 5GF.5923_2
Description: Looking at the primary (south) elevation and east elevation of the residence.
Date: 9/6/2022
View: Northeast

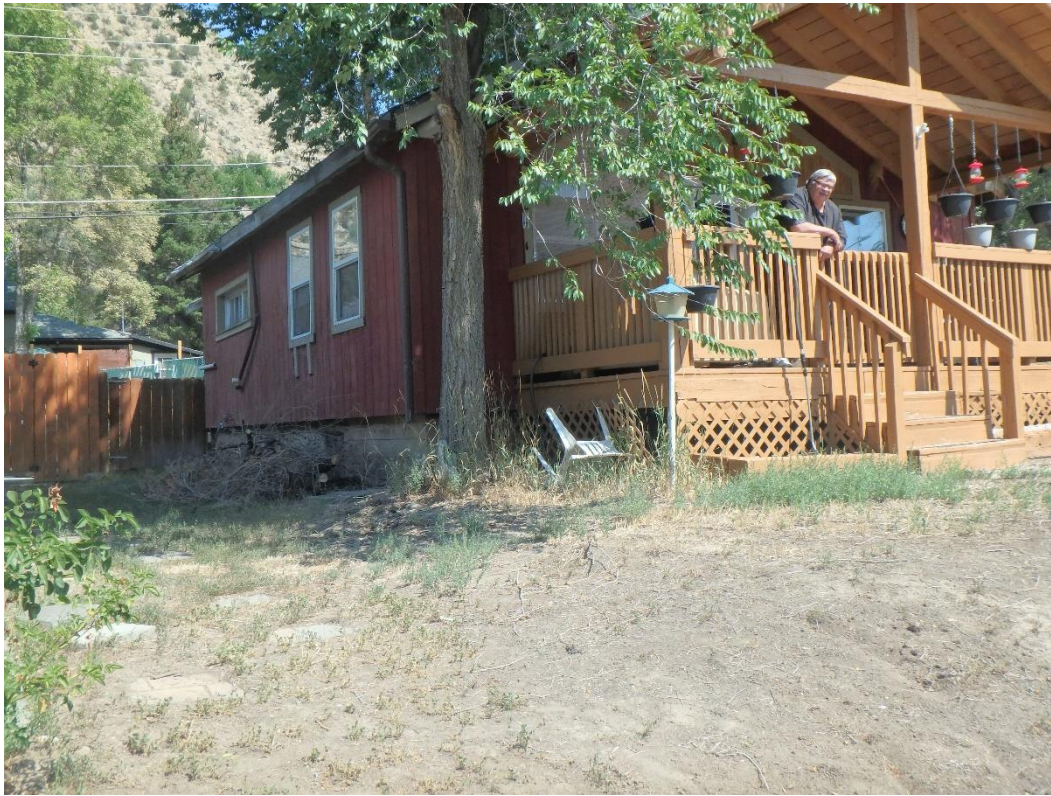
Photo Number: 5GF.5923_3
Description: Looking at the west and primary (south) elevations of the residence.
Date: 9/6/2022
View: Northeast

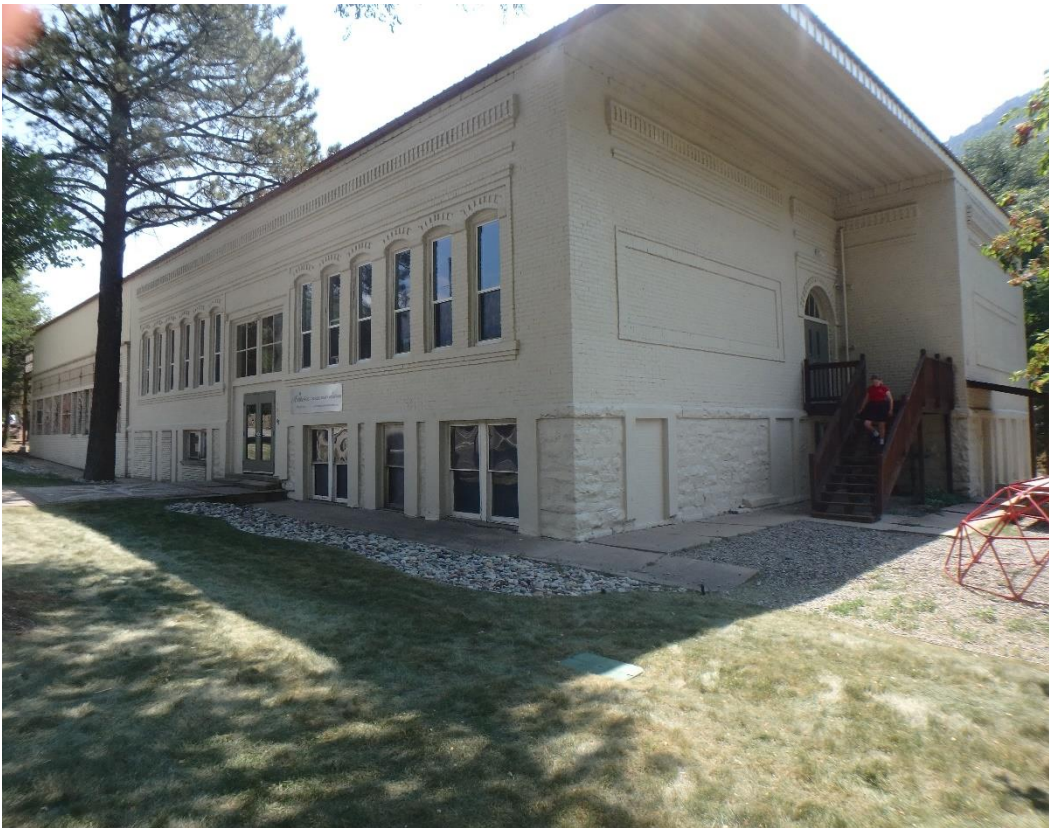
Photo Number: 5GF.2369_1
Description: Looking at the primary (north) and west elevations of the building. Note the several ornate brickwork features along the facade.
Date: 9/6/022
View: Southeast

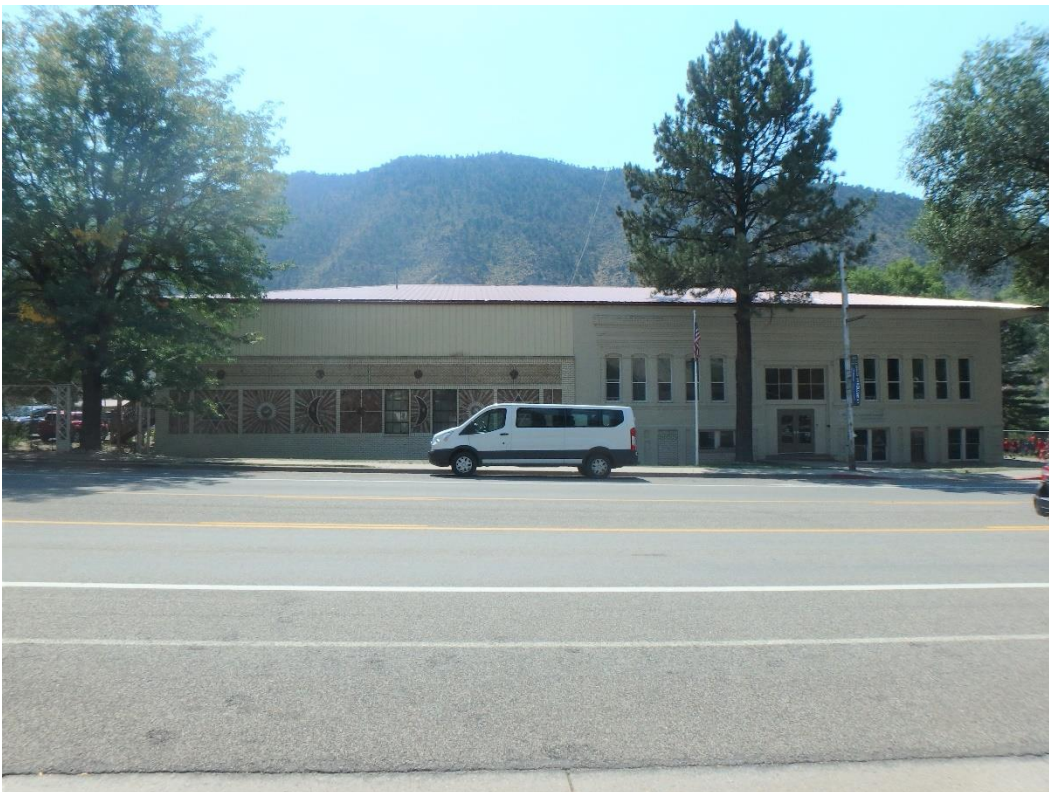
Photo Number: 5GF.2369_2
Description: Looking at the primary (north) elevation of the building.
Date: 9/6/2022
View: South

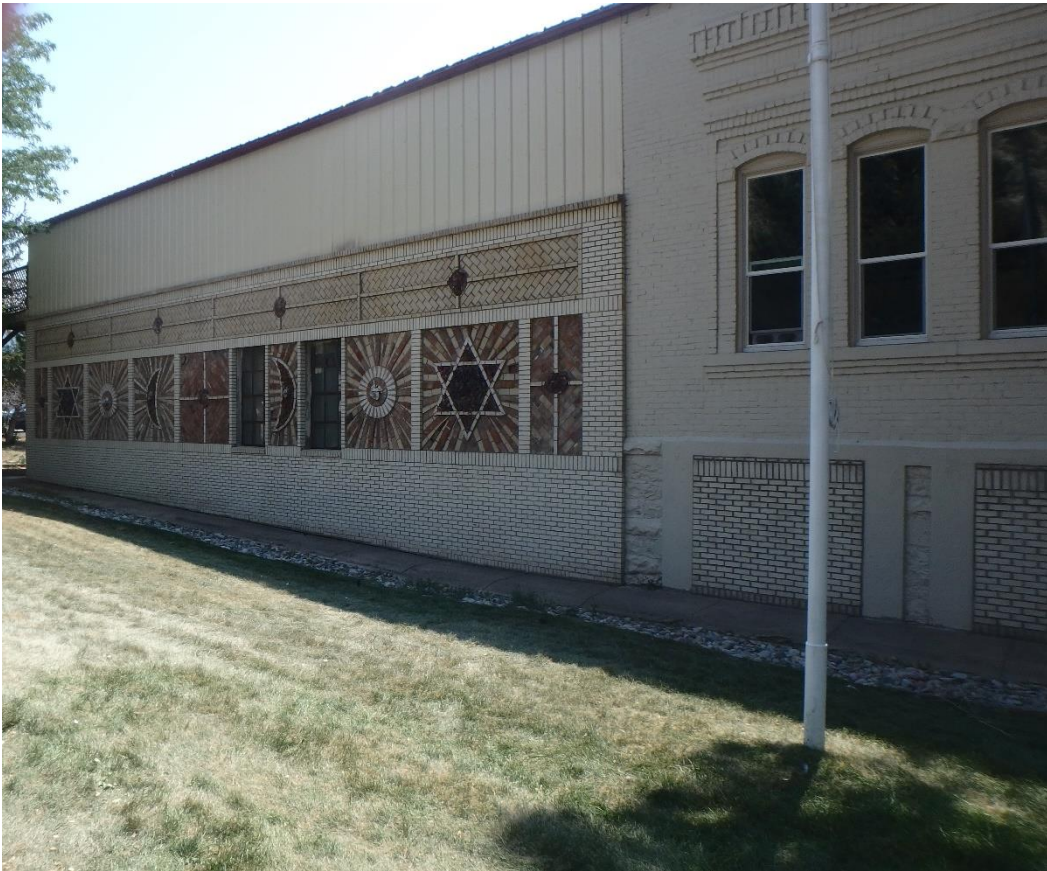
Photo Number: 5GF.2369_3
Description: Looking at the 1939 adobe brick addition to the original 1913 building.
Date: 9/6/2022
View: Southeast

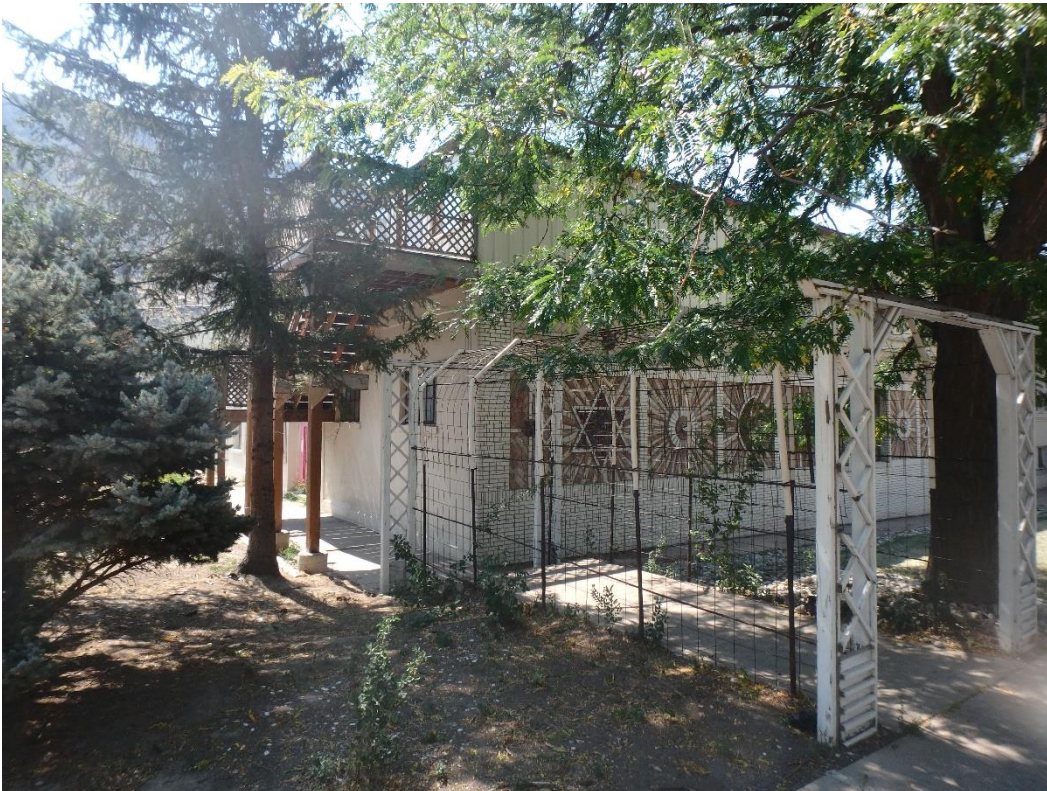
Photo Number: 5GF.2369_4
Description: Looking at the corner of the east elevation and the primary (north) elevation. Note the staircase leading to the second level addition to the building.
Date: 9/6/2022
View: Southwest

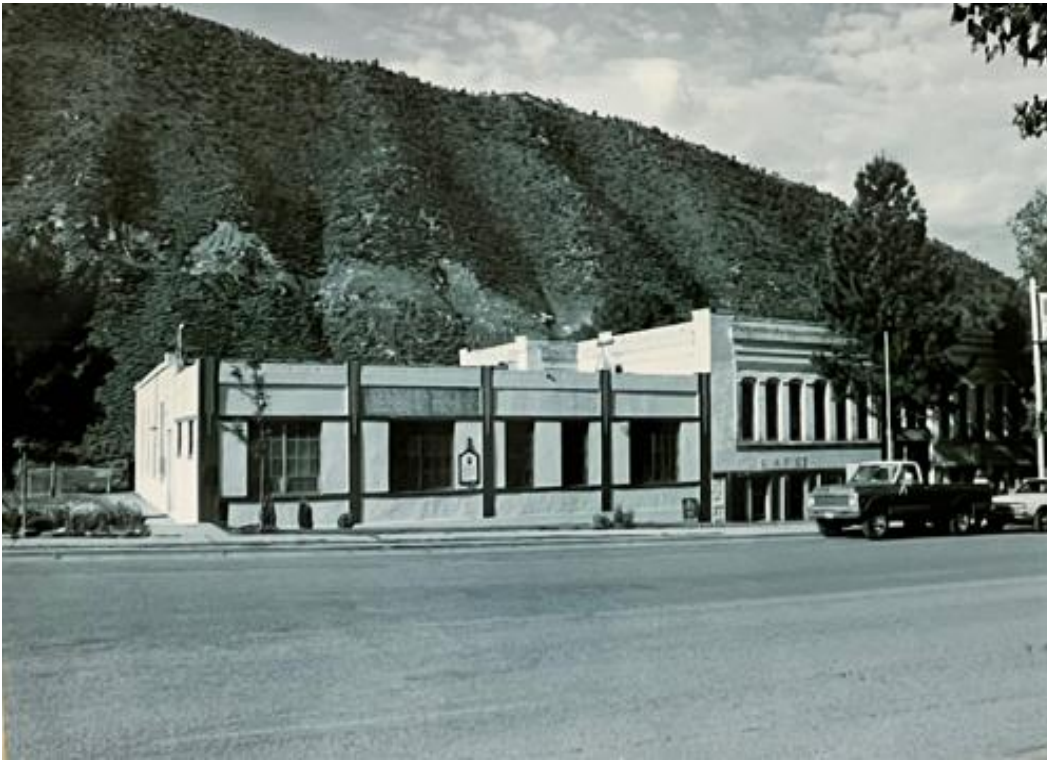
Historic Photo 1

Description: New Castle School built in 1913, addition of adobe brick made in 1939. School operated until 1978, later becoming apartments. It was converted back to a private school in 2021.

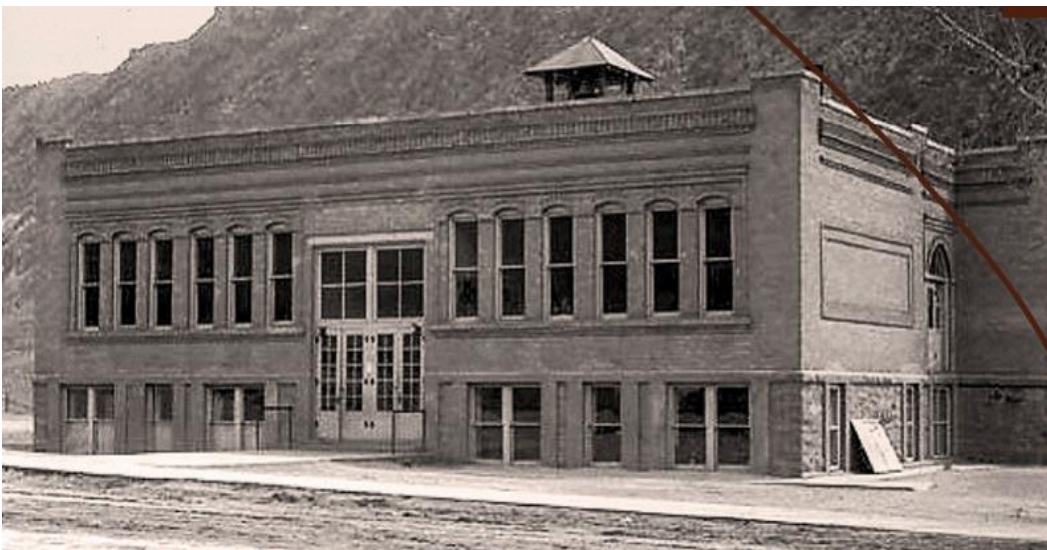
Historic Photo 2

Description: Image of the primary (north) and a portion of the east elevations of the building. Note the school bell on the flat roof that is protected by a pyramid roof.

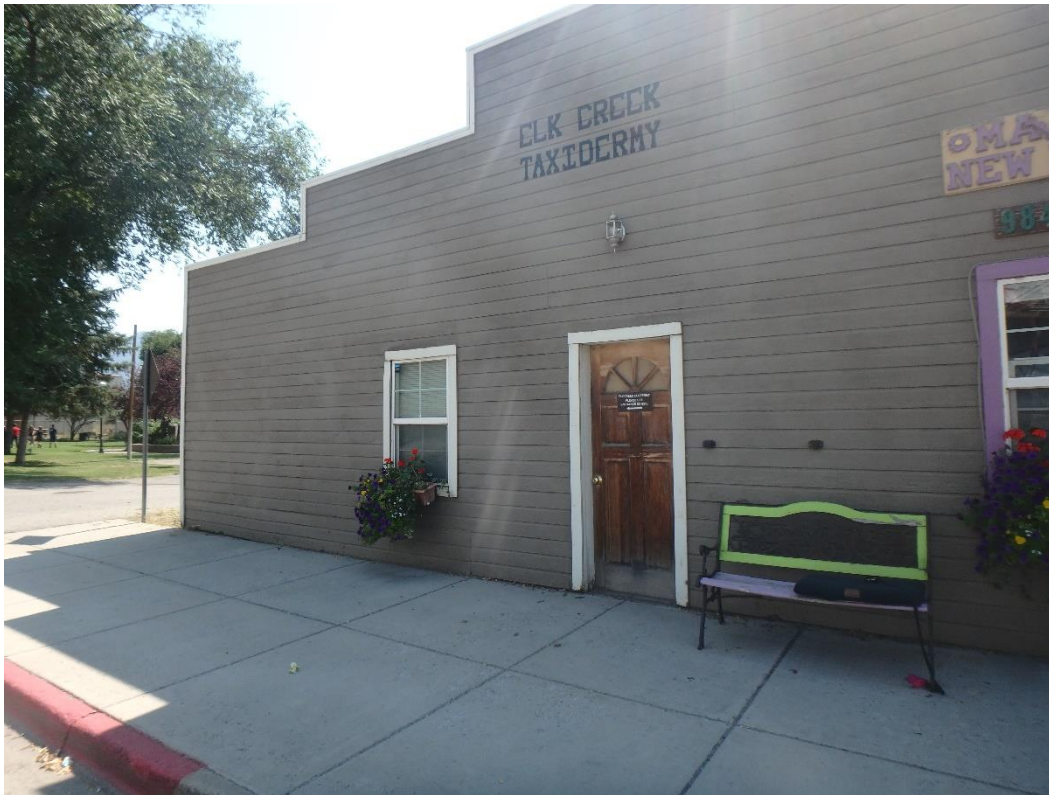
Photo Number: 5GF.5919_1
Description: Looking at the primary (north) elevation of the building. Note the false front that features a stepped parapet design.
Date: 9/6/2022
View: Southeast

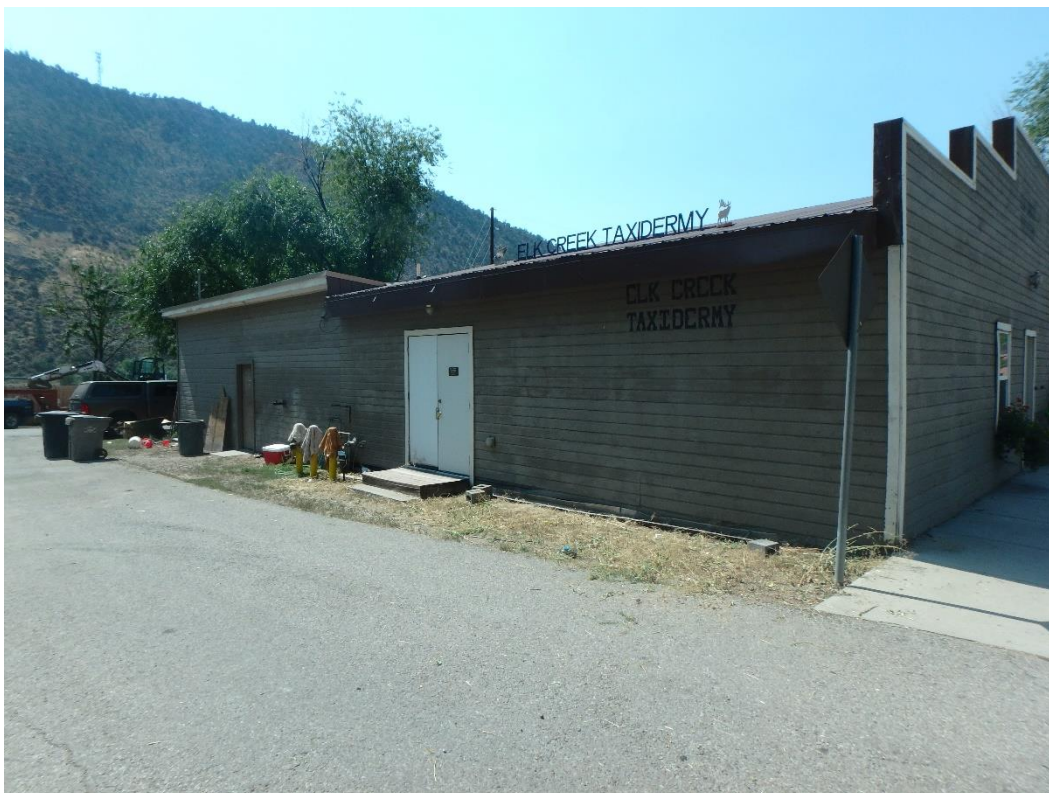
Photo Number: 5GF.5919_2
Description: Looking at the east and primary (north) elevations of the building.
Date: 9/6/2022
View: Southwest

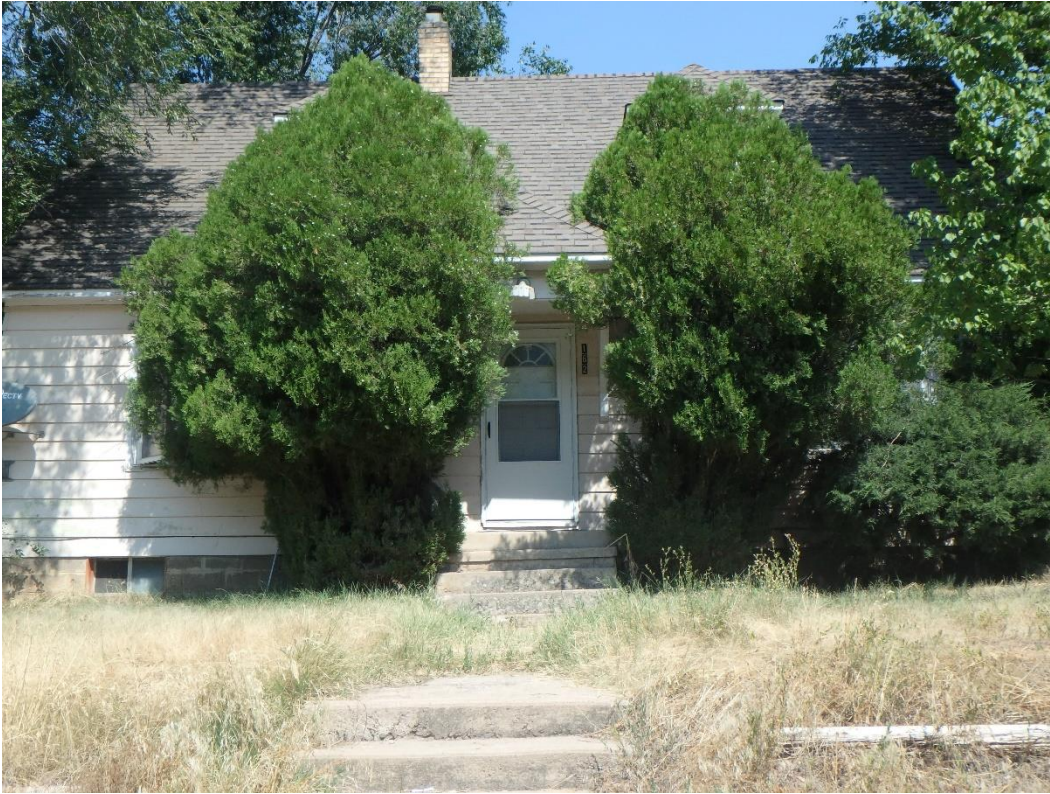
Photo Number: 5GF.5924_1
Description: Looking at the primary (south) elevation of the building. Note that the two recessed dormers are mostly obscured by the tall vegetation.
Date: 9/6/2022
View: North

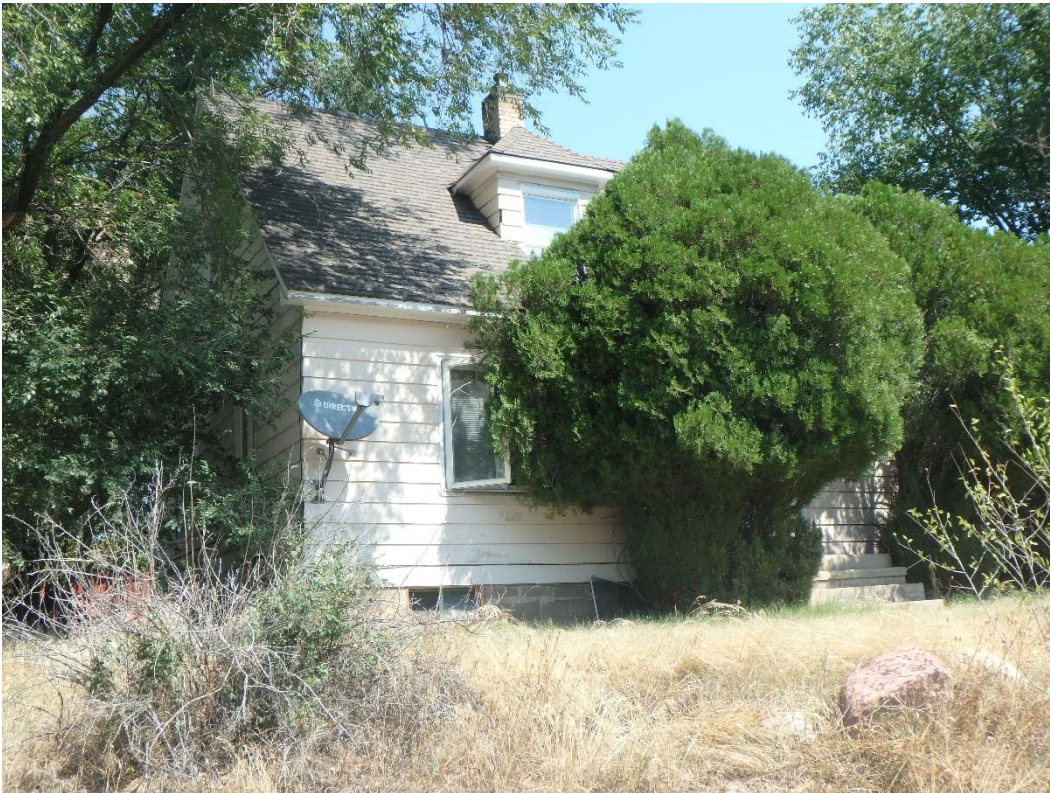
Photo Number: 5GF.5924_2
Description: Looking at the west and primary (south) elevation of the building.
Date: 9/6/2022
View: Northeast

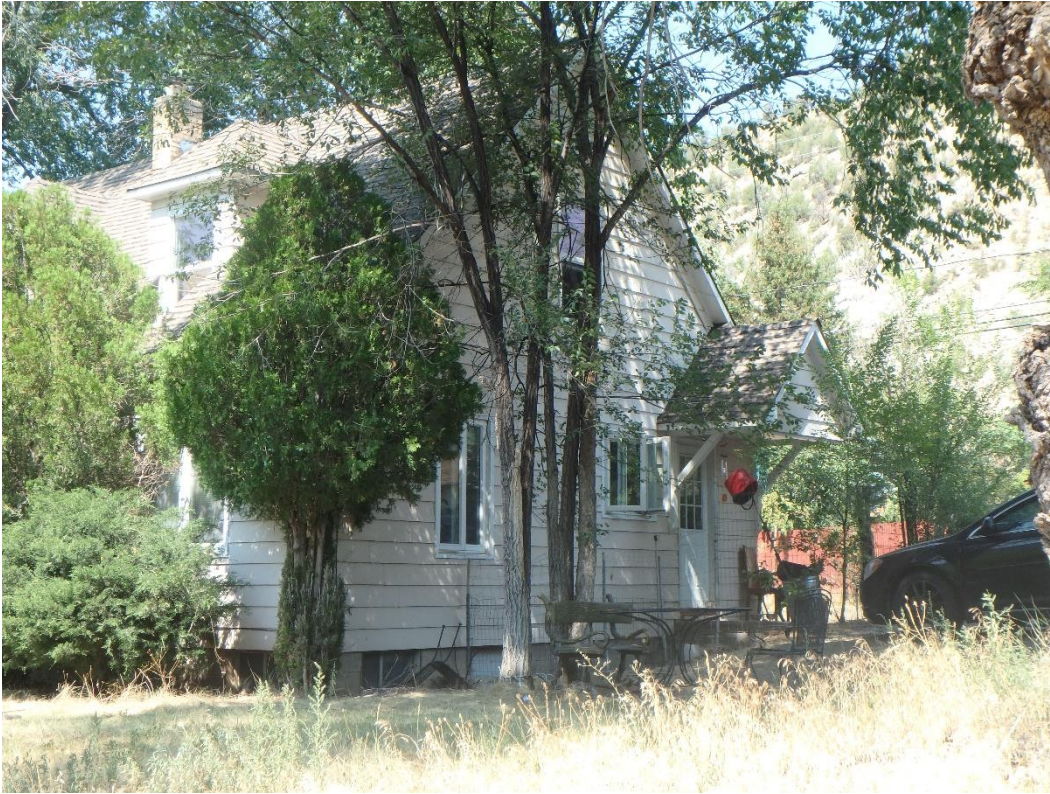
Photo Number: 5GF.5924_3
Description: Looking at the primary (south) and east elevations of the residence. Note the gable overhang that protects the secondary entryway.
Date: 9//6/2022
View: Northwest

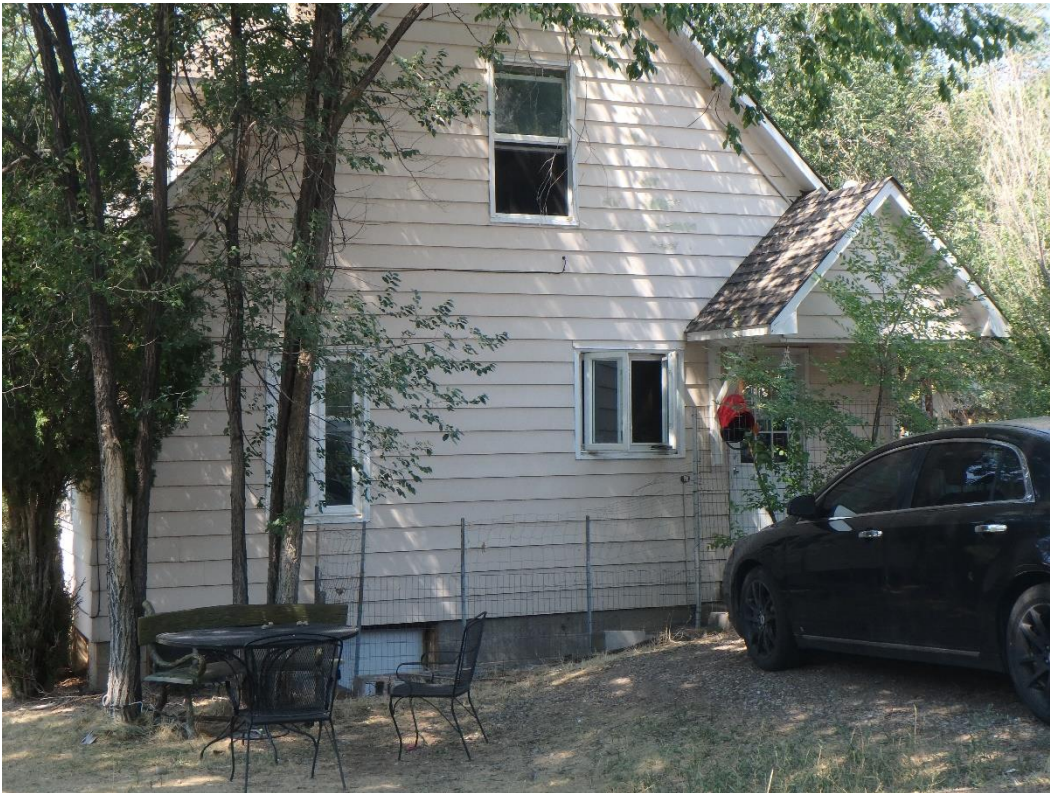
Photo Number: 5GF.5924_4
Description: Looking at the east elevation of the building.
Date: 9/6/2022
View: Northwest

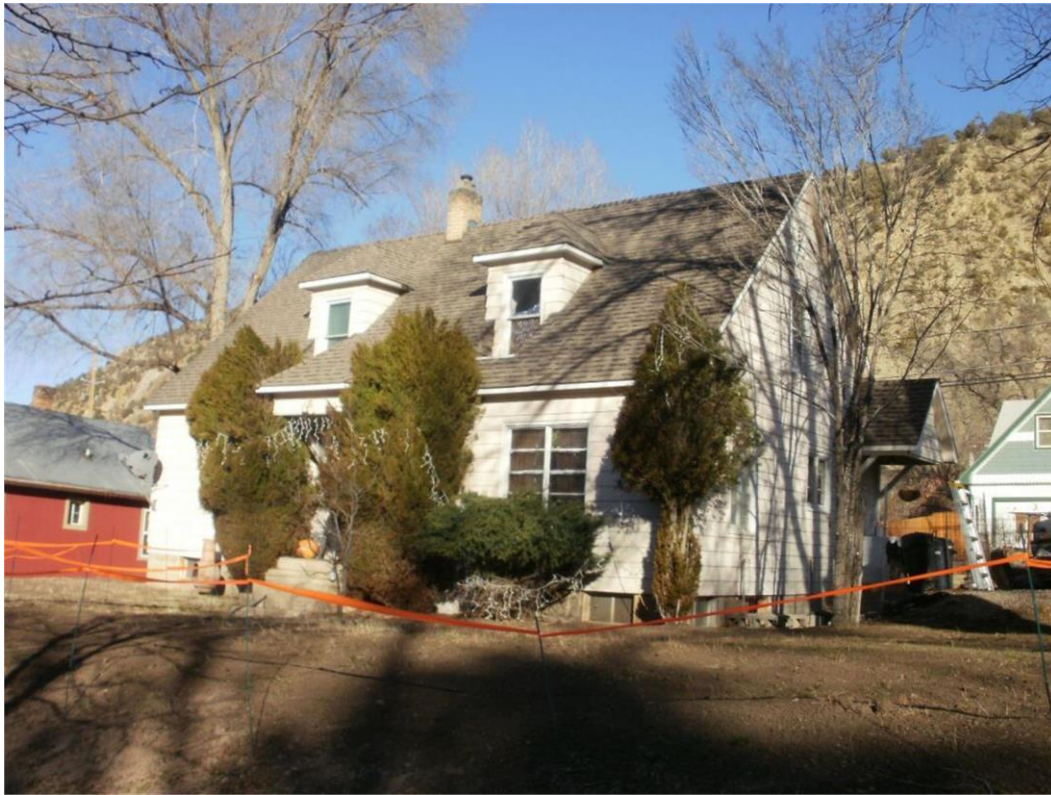
Reference Photo 1

Description: Looking at the primary (south) and east elevations of the residence. The image was taken prior to 2012 due to historic windows remaining extant.

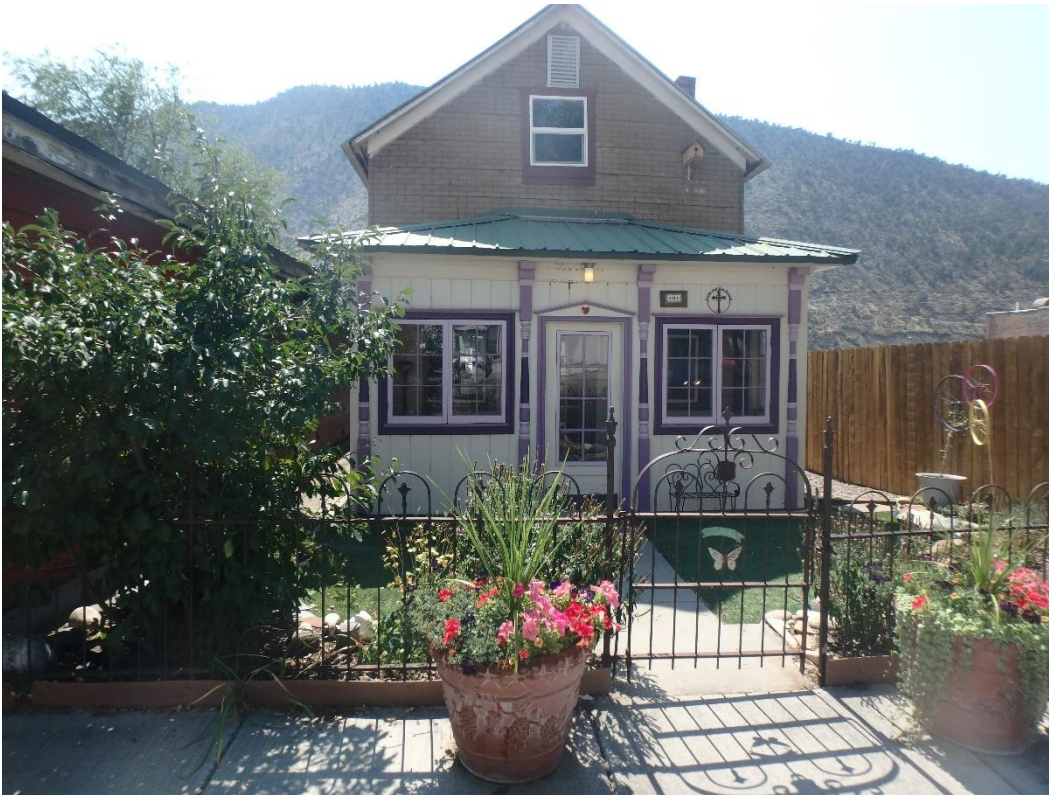
Photo Number: 5GF.2370_1
Description: Looking at the primary (north) elevation of the building. Note the 1976 enclosed porch addition to the façade.
Date: 9/6/2022
View: South

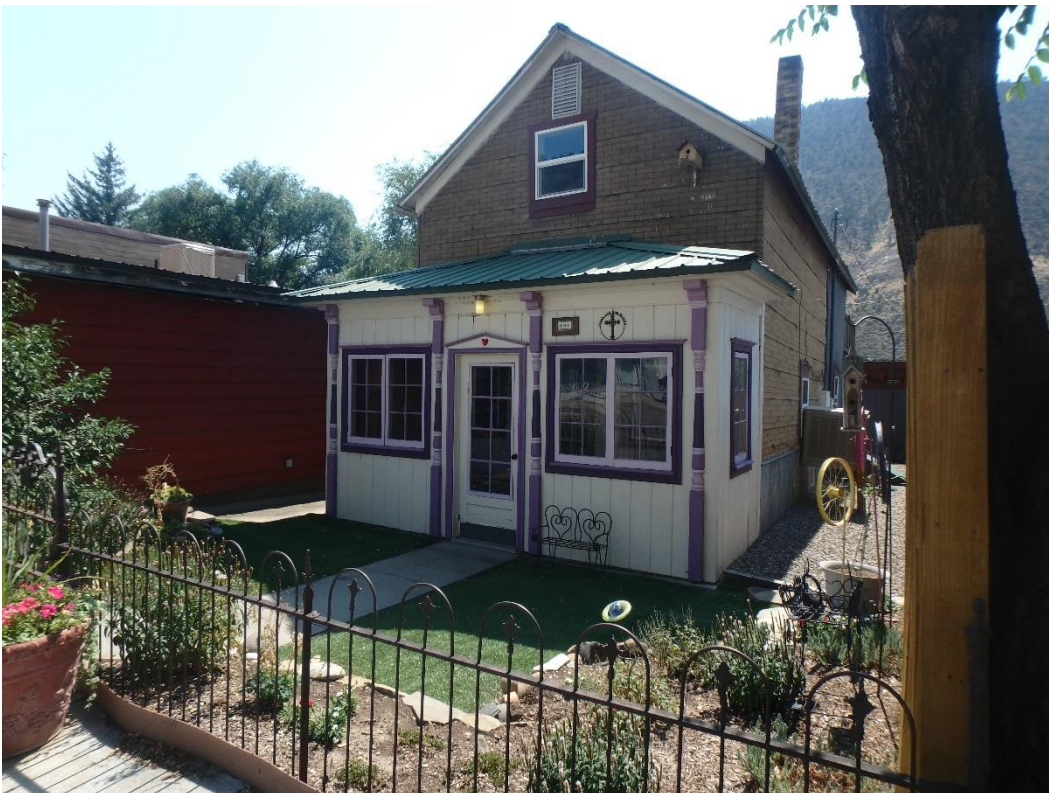
Photo Number: 5GF.2370_2
Description: Looking at the primary (north) and west elevations of the residence. Note the weatherboard, asphalt, and corrugated metal siding transitions.
Date: 9/6/2022
View: Southeast

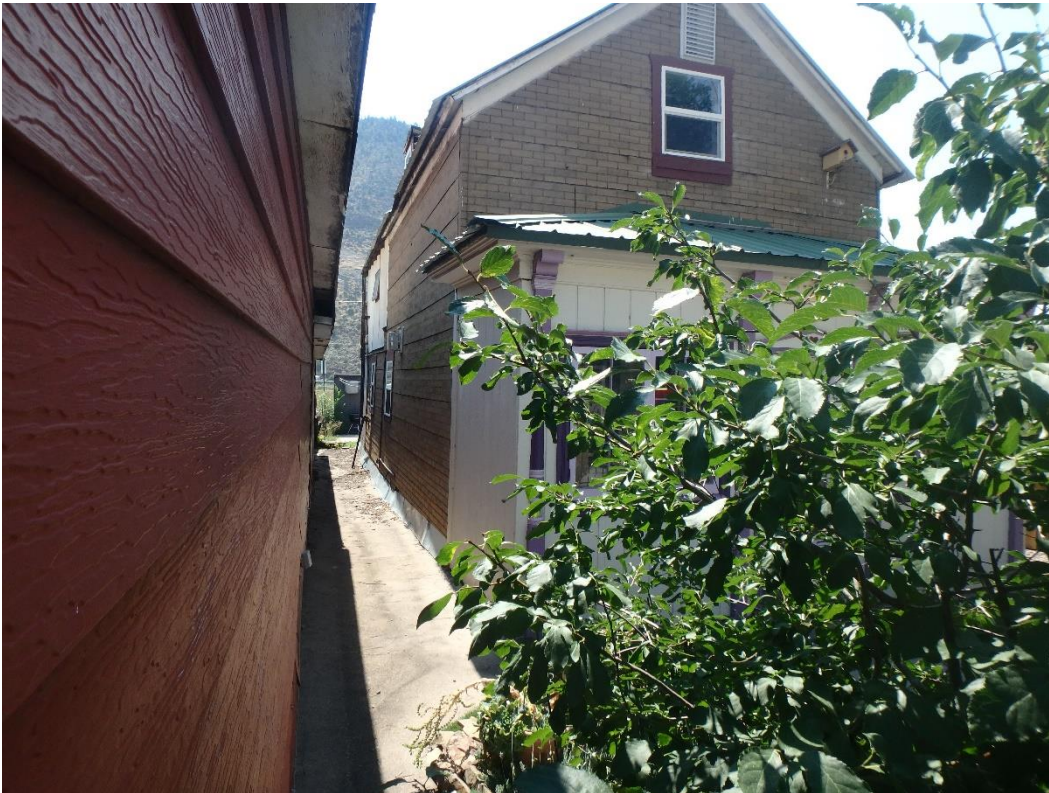
Photo Number: 5GF.2370_3
Description: Looking at the east and primary (north) elevations of the building.
Date: 9/6/2022
View: Southwest

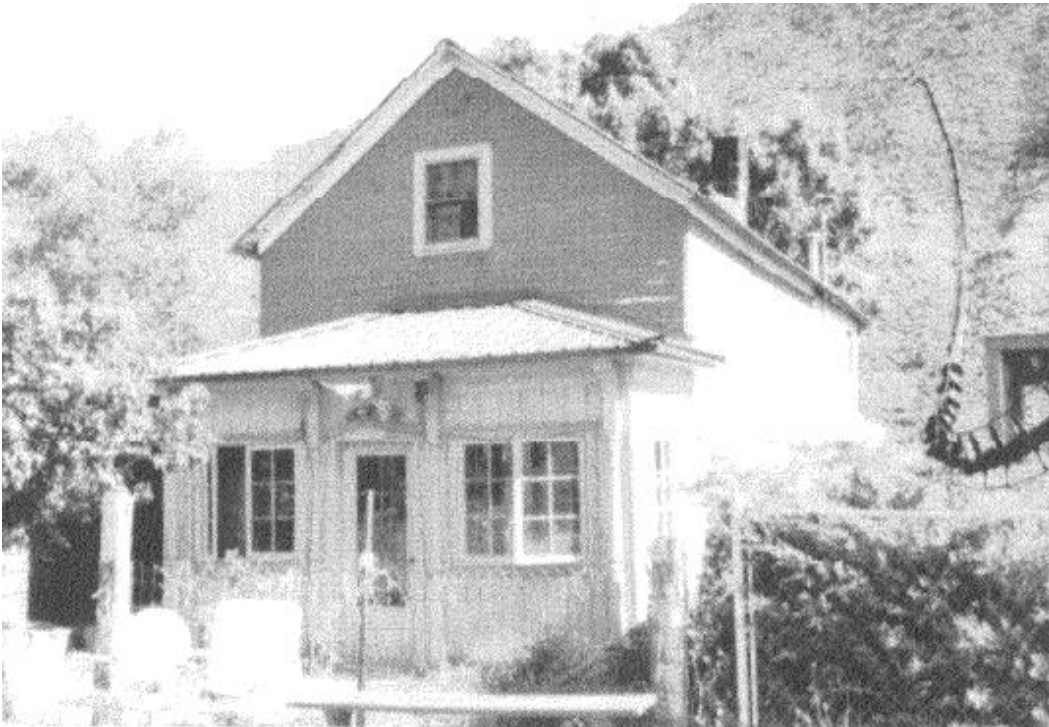
Historic Photo 1
Description: Looking at the primary (north) and west elevations of the building in 1996.
Source: 1996 OAHP Historic Building Inventory Record (5GF.2370)

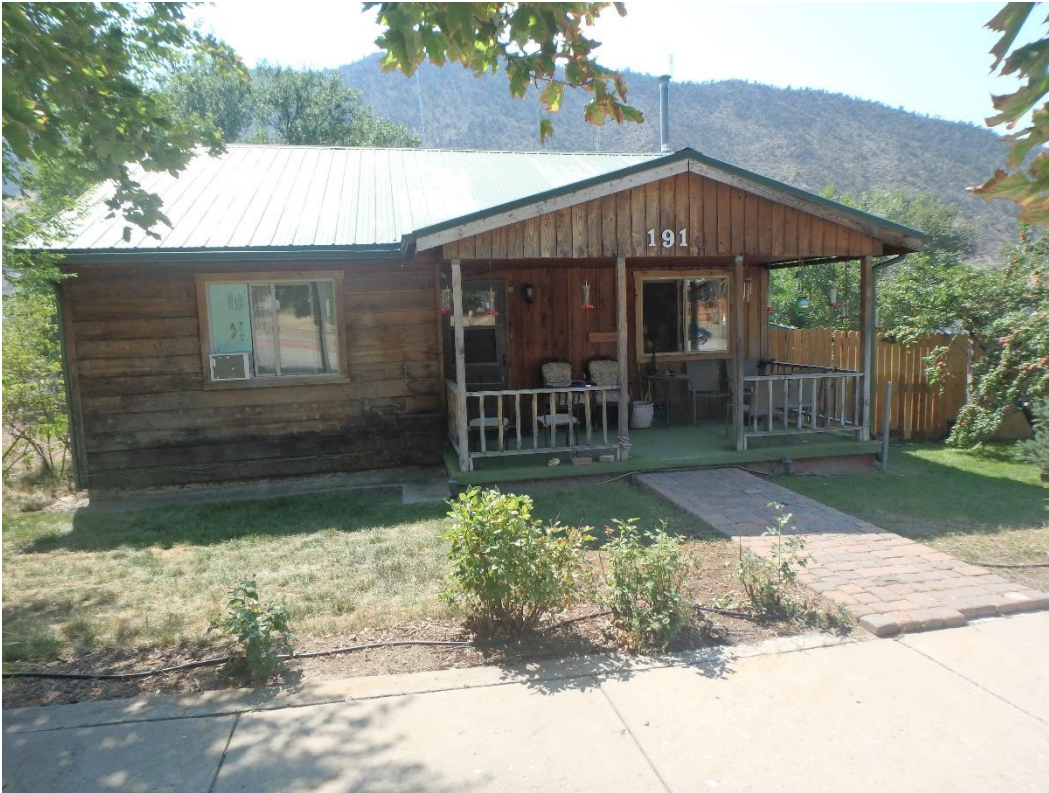
Photo Number: 5GF.5925_1
Description: Looking at the primary (north) elevation of the building.
Date: 9/6/2022
View: South

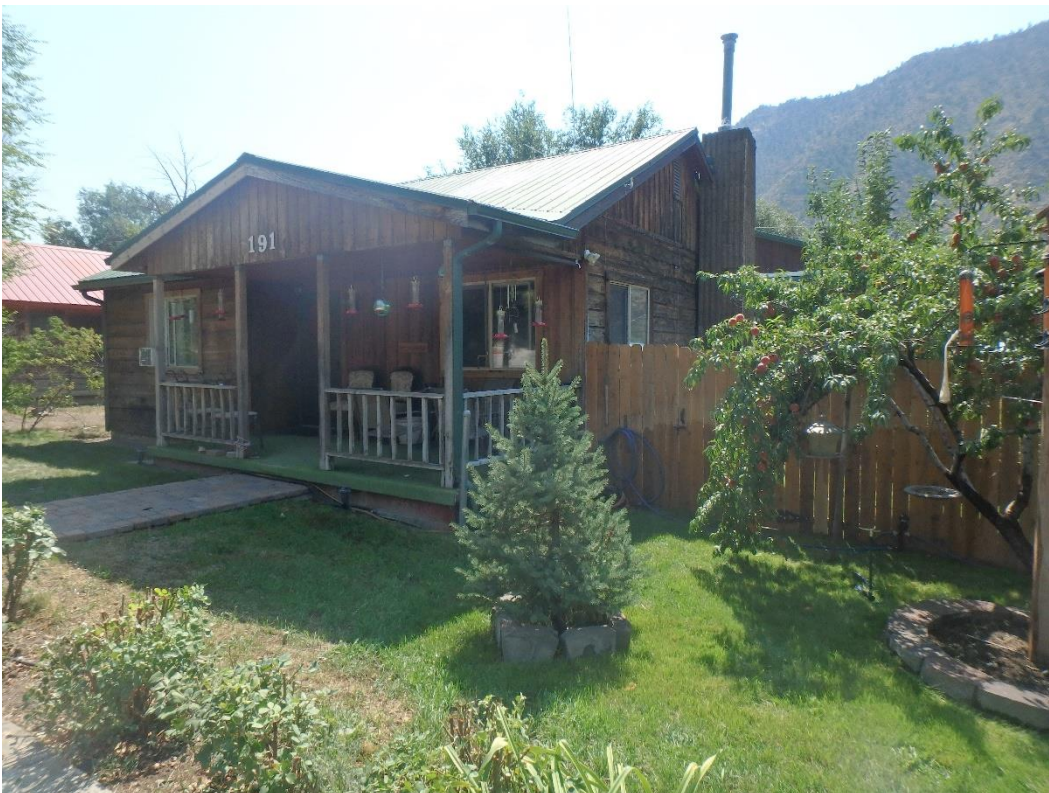
Photo Number: 5GF.5925_2
Description: Looking at the primary (north) and west elevations of the residence.
Date: 9/6/2022
View: Southeast

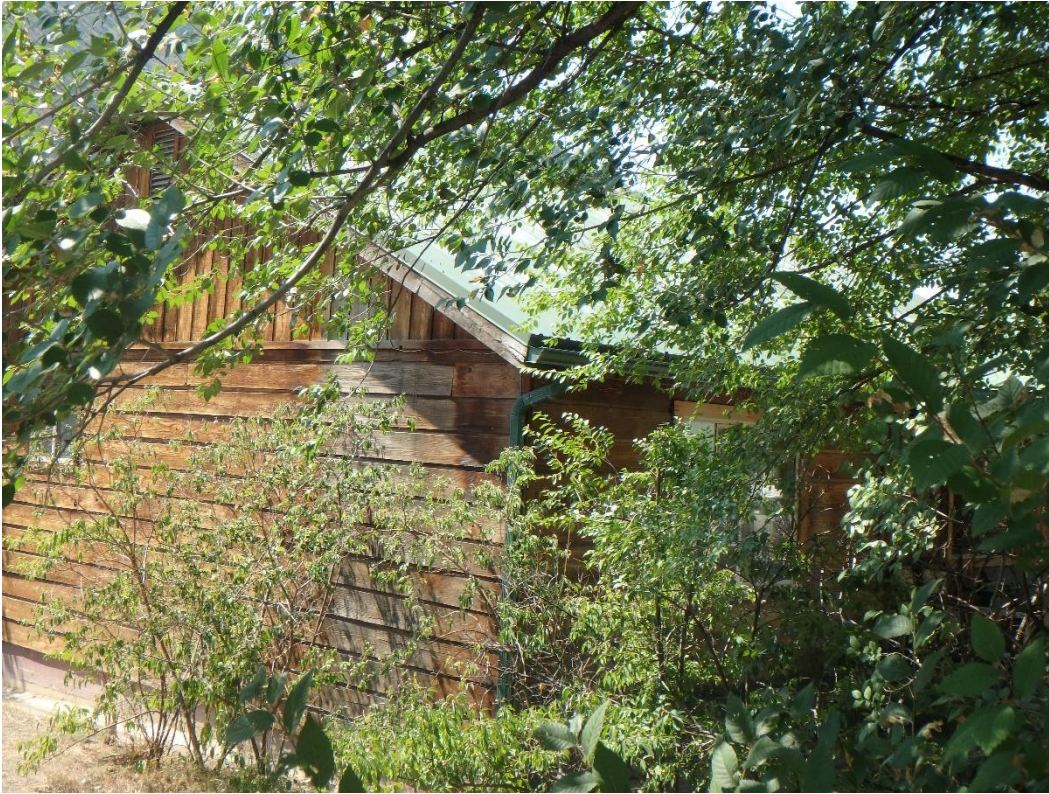
Photo Number: 5GF.5925_3
Description: Looking at the east and primary (north) elevations of the building.
Date: 9/6/2022
View: Southwest

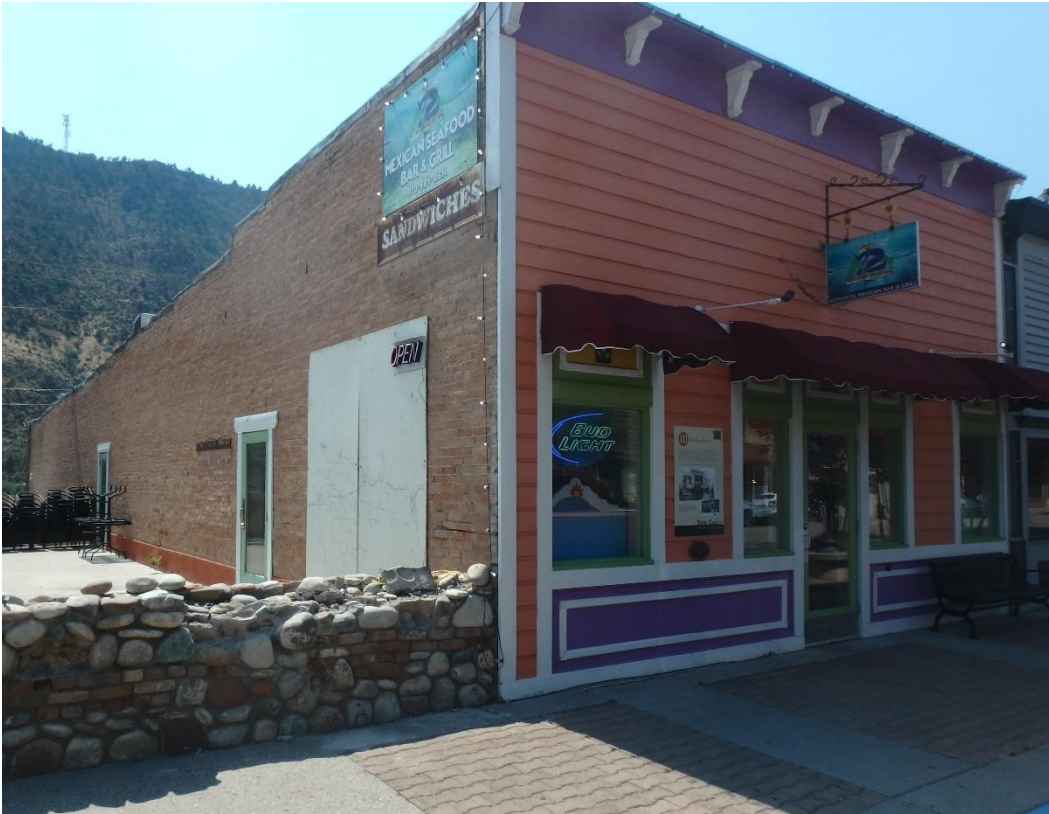
Photo Number: 5GF.2371_1
Description: Looking at the east and primary (north) elevations of the building.
Date: 9/6/2022
View: Southwest

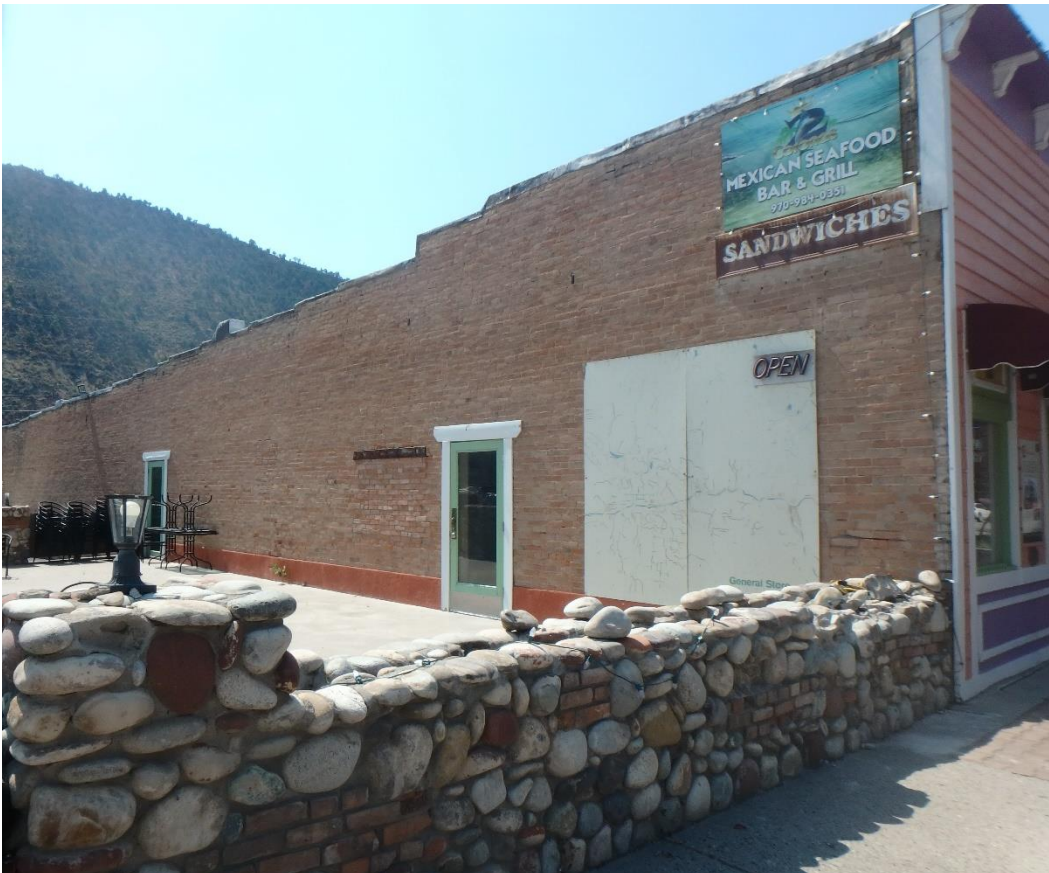
Photo Number: 5GF.2371_2
Description: Looking at the east elevation of the building.
Date: 9/6/2022
View: Southwest

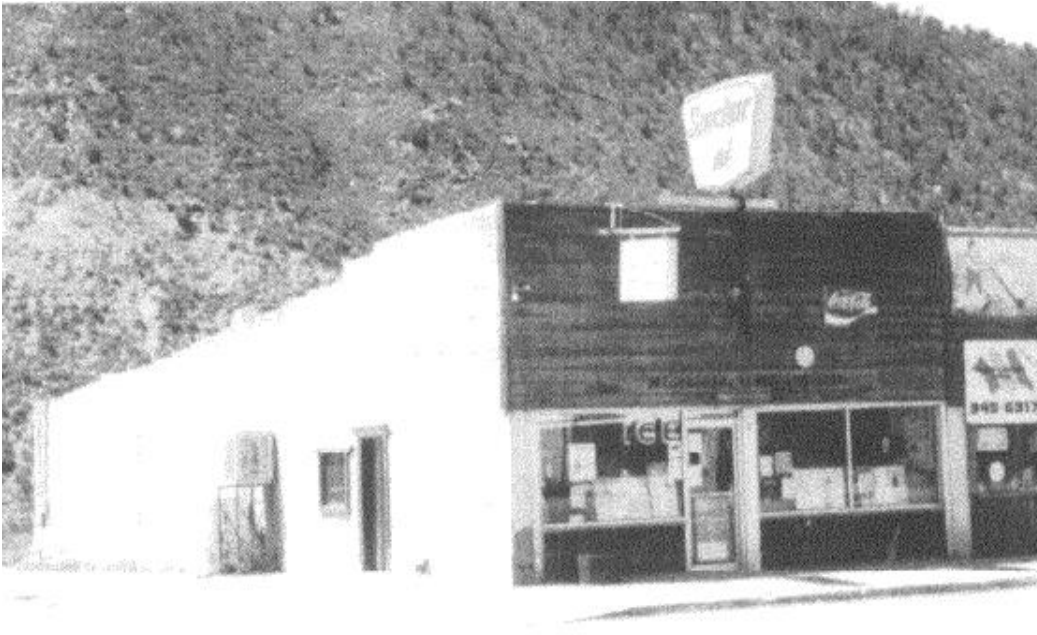
Reference Photo 1

Description: Looking at the west and primary (north) elevations of the building. Note the façade treatment prior to the 2012 alterations.

Historic records indicate that the building was altered in the early Twentieth Century after Ritter & MacRae renovated the east brick wall, roof, and floor of the building. However, is noted that the western elevation of the building was retained well into the 1940s. By 1996, historic photos reveal that "Sinclair" signage was placed on top of the cornice along the primary (north) elevation. In addition, the main entryway had been replaced by a glazed door and was flanked by plate glass window units with metal framing. The top portion of the façade was clad in horizontal weatherboard by this time. A window near the far-right entryway along the east elevation was also present. By 2012, the window along the east elevation was removed and the opening covered with brick masonry. The fenestration pattern along the primary (north) elevation was further altered by the removal of the plate glass windows, horizontal weatherboard, and replacement of the main entryway door. These materials were replaced by typical windows; novelty siding; decorative brackets under the cornice; convex awing and decorative faux transoms. Signage above the main entryway stating, "Authentic Mexican Bar & Grill" was also added to the façade.

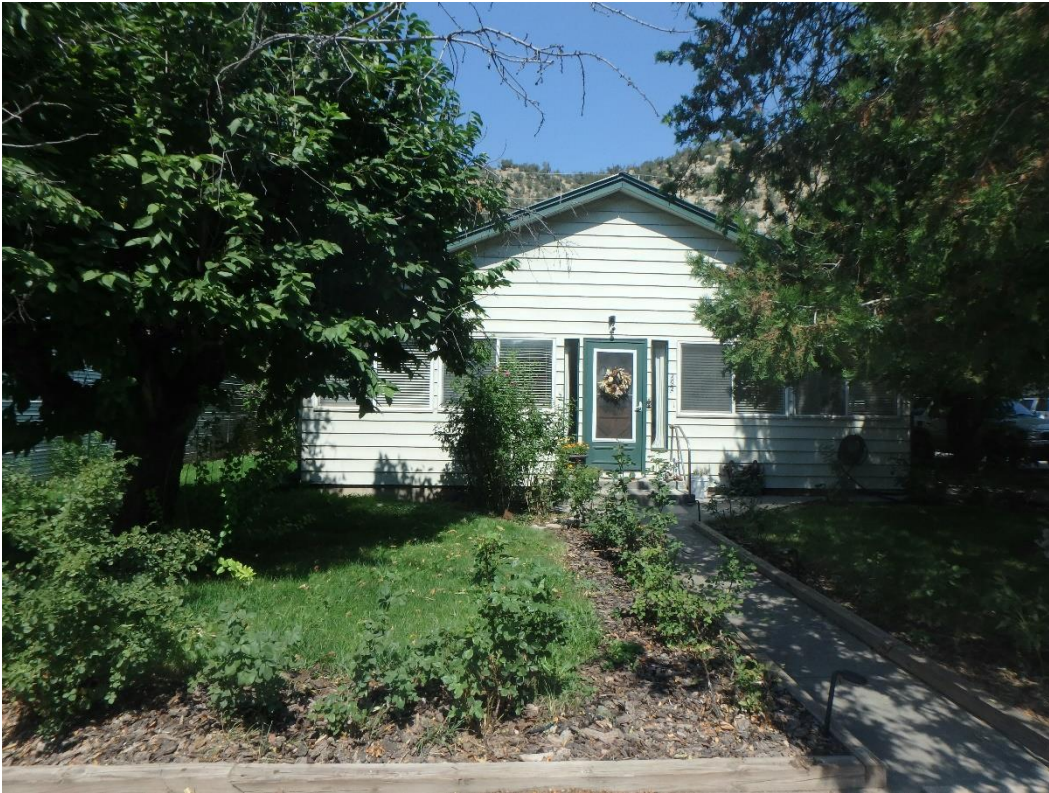
Photo Number: 5GF.5918_1
Description: Looking at the primary (south) elevation of the building.
Date: 9/6/2022
View: North
