New Castle Historic Preservation Commission (Regular Meeting)

New Castle - Reconnaissance Survey

The Town of New Castle (New Castle) is conducting a reconnaissance-level survey of historic resources along Main Street (US Highway 6). The survey will identify and recommend individual resources for future intensive-level survey to determine potential eligibility under National Register of Historic Places (NRHP) criteria in accordance with NRHP and State of Colorado Historic Survey Standards. In addition, this survey assesses the potential for a historic district as well as identify and recommend resources that may contribute toward a potential NRHP historic district. This survey represents the most recent evaluation of historic resources in the Town of New Castle. Previous historic resource surveys have mostly focused on residential and commercial buildings/structures in the central quadrant of the town. Resources in the survey area—bounded by Elk Creek to the west, Burning Mountain Avenue to the east, and adjacent to Main Street—are the focus of this reconnaissance report.

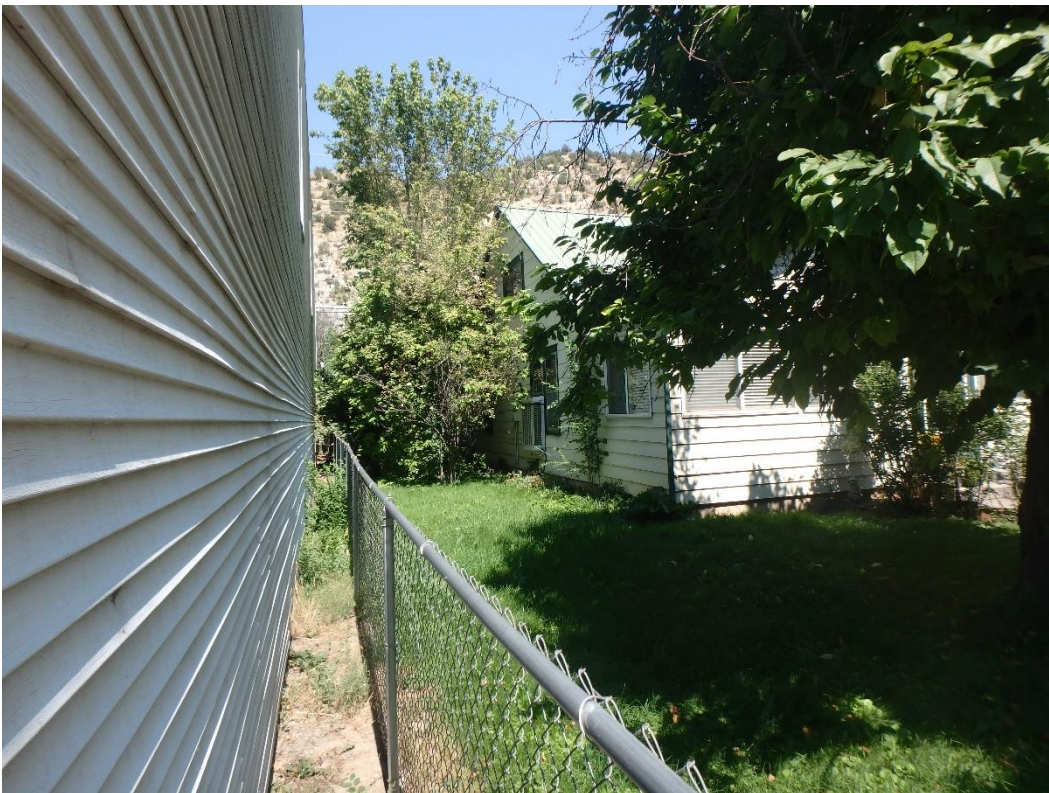
Photo Number: 5GF.5918_2
Description: Looking at the west and primary (south) elevation of the building. Note that the wall to the left is not a part of the residence.
Date: 9/6/2022
View: Northeast

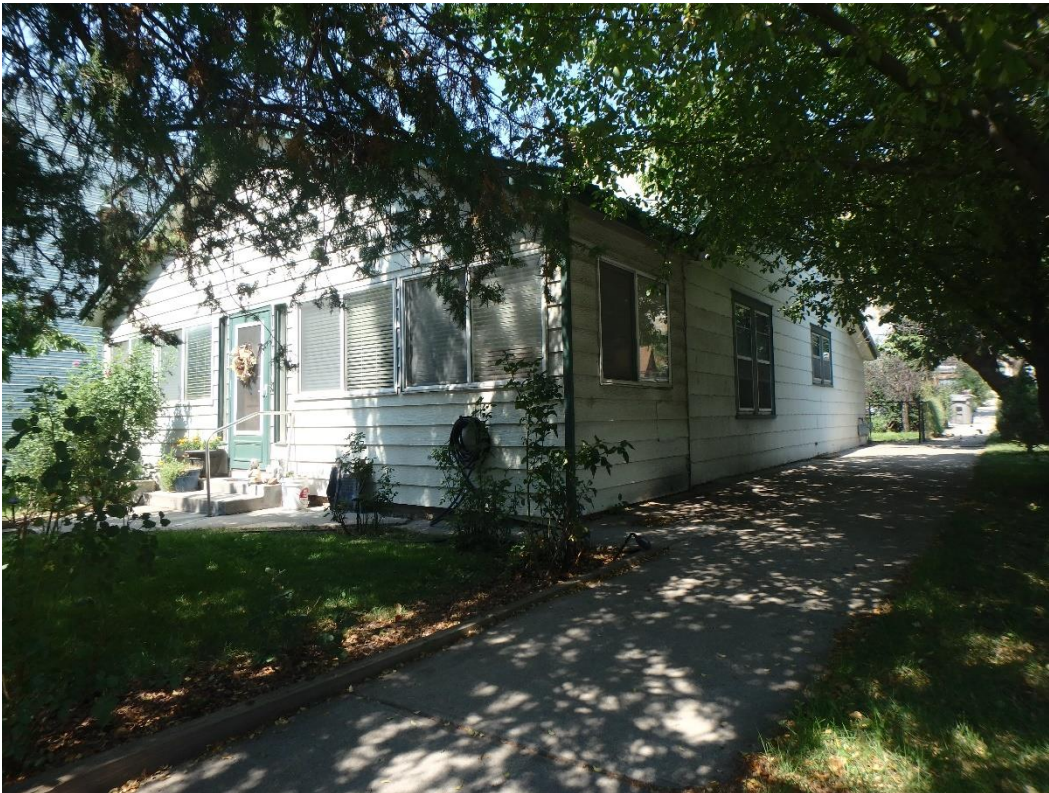
Photo Number: 5GF.5918_3

Description: Looking at the primary (south) and east elevations of the building. Note the composite siding on the exterior of the front gable projection while the side gable is clad with asbestos siding.

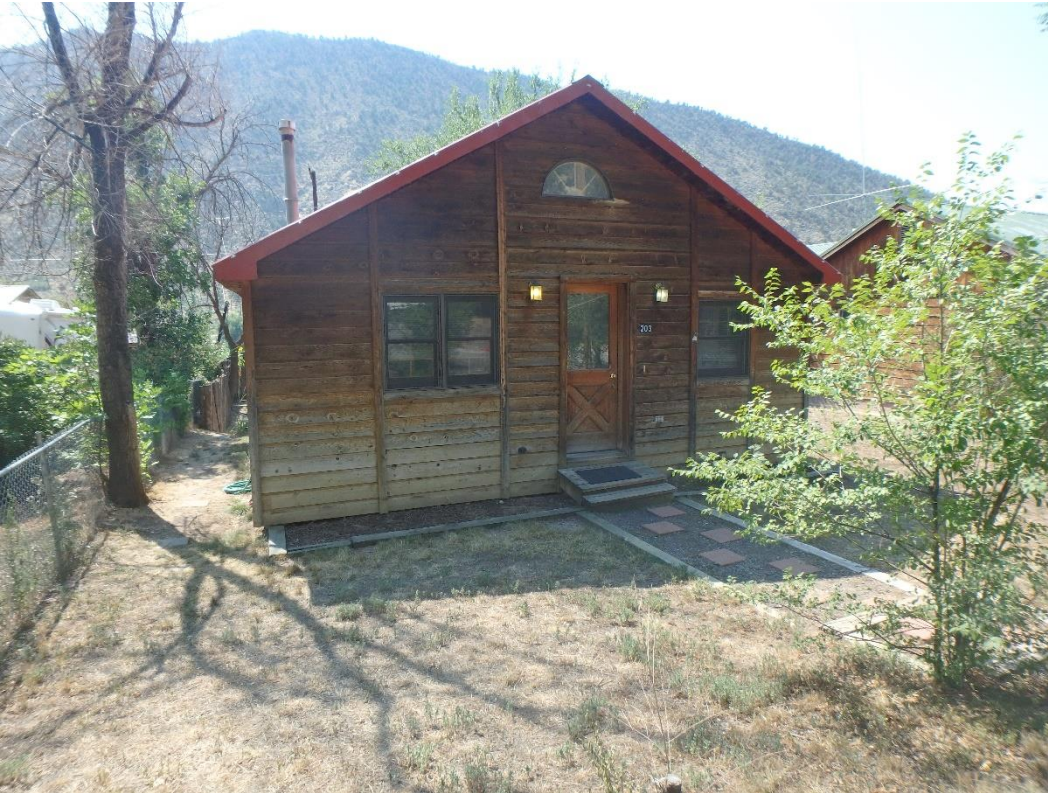
Photo Number: 5GF.5926_1
Description: Looking at the primary (north) elevation of the residence.
Date: 9/6/2022
View: Southwest

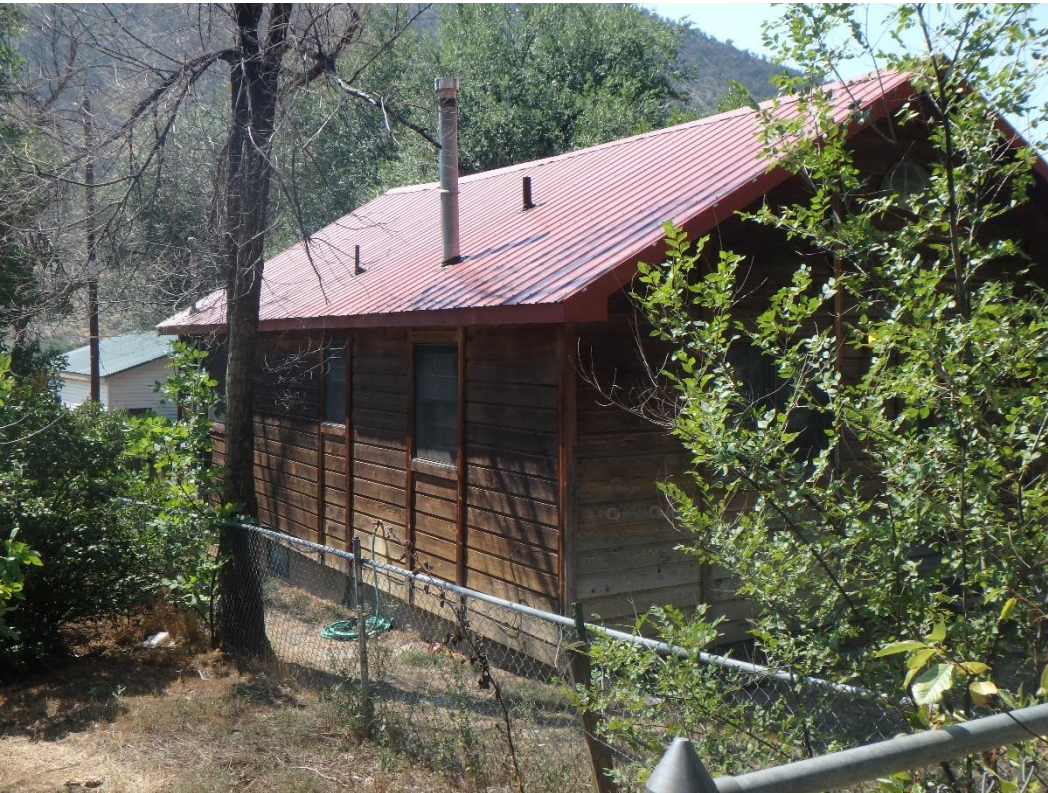
Photo Number: 5GF.5926_2
Description: Looking at the east and primary (north) elevation of the building.
Date: 9/6/2022
View: Southwest

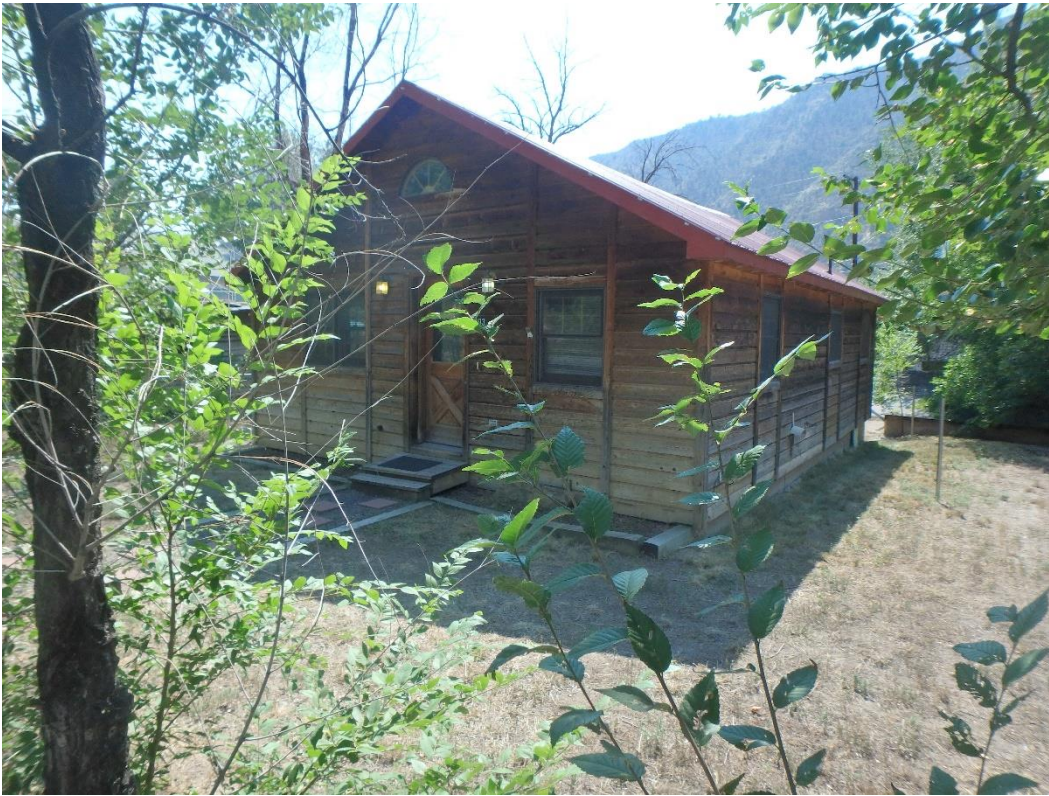
Photo Number: 5GF.5926_3

Description: Looking at the primary (north) and west elevations of the residence.

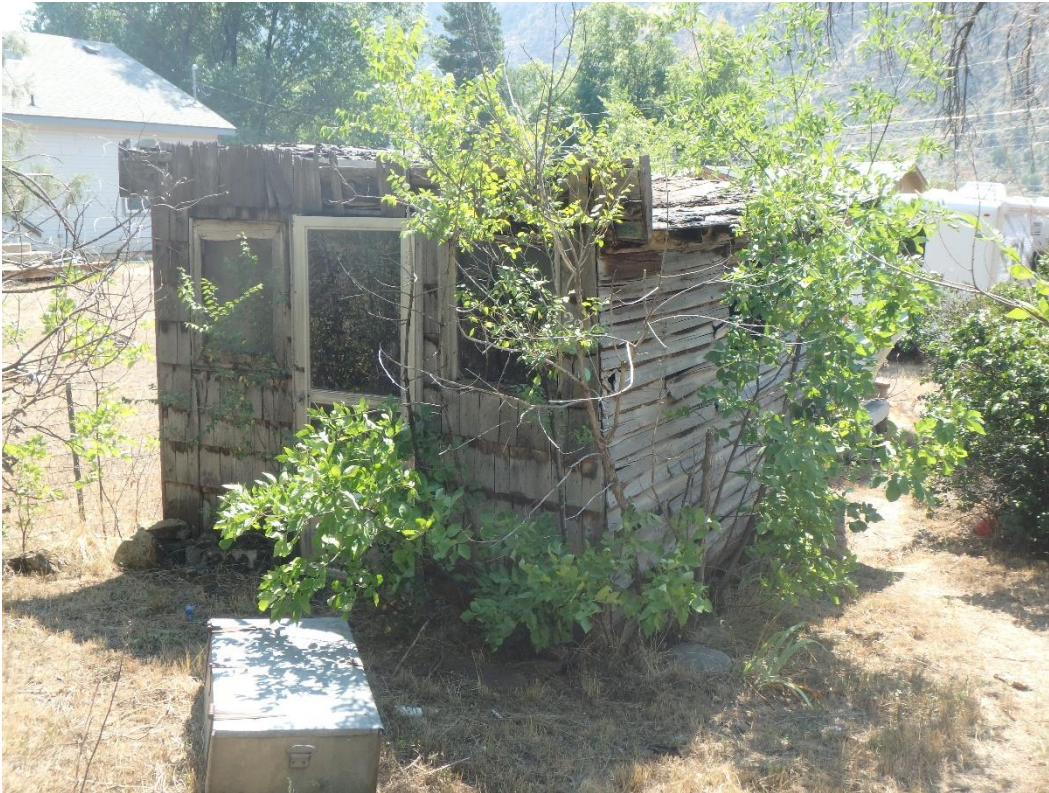
Photo Number: 5GF.5927_1
Description: Looking at the primary (north) and west elevations of the building. Note the wood shingle and horizontal weatherboard siding.
Date: 9/6/2022
View: Southeast

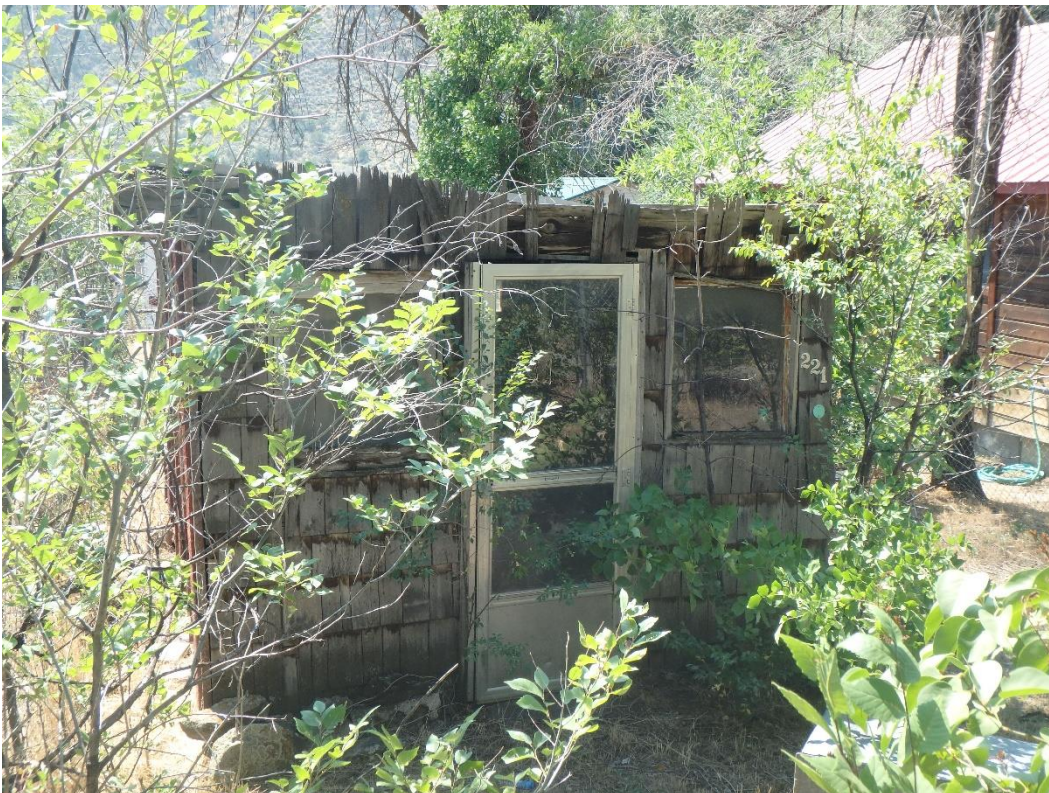
Photo Number: 5GF.5927_2
Description: Looking at the primary (north) elevation of the building.
Date: 9/6/2022
View: South

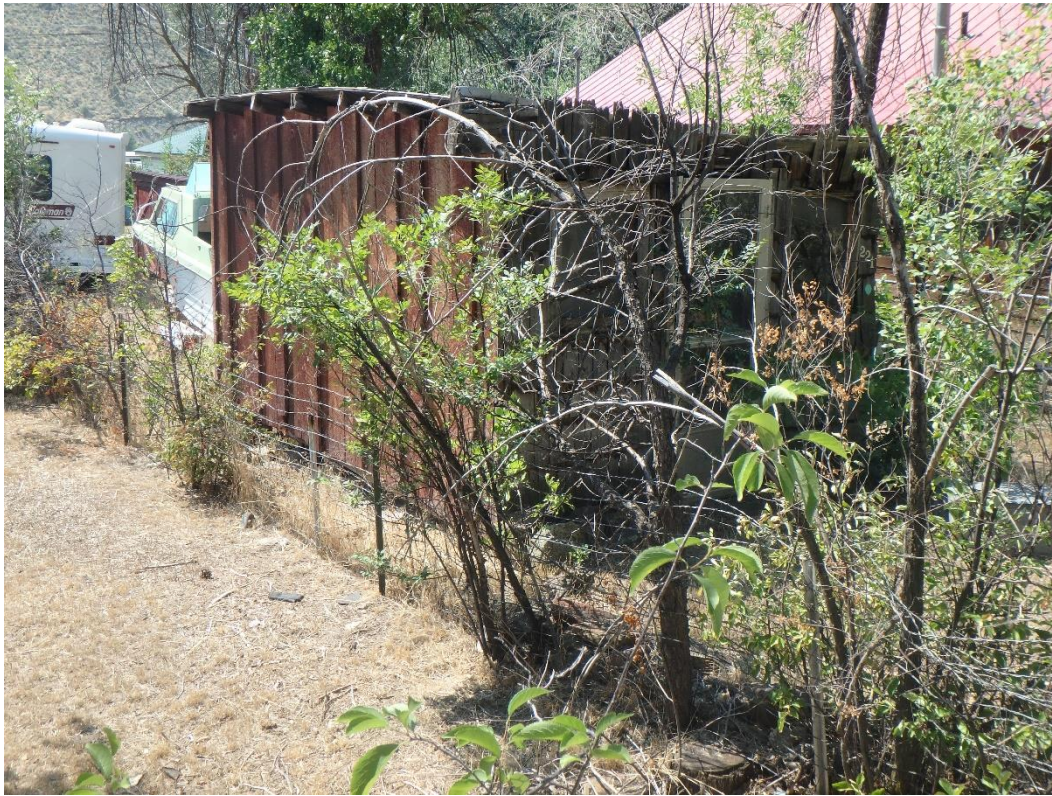
Photo Number: 5GF.5927_3

Description: Looking at the east and primary (north) elevations of the building. Note the shed roof with false front.

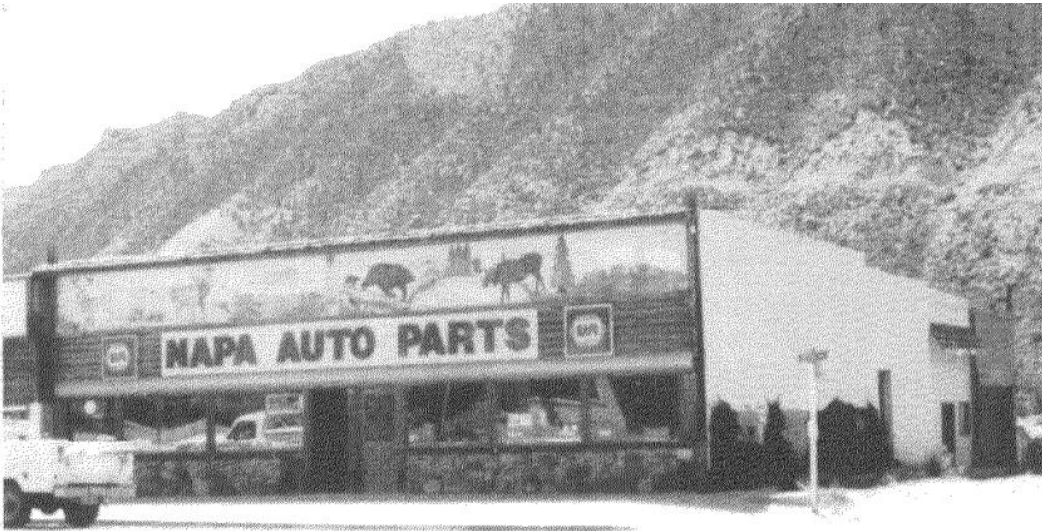
Reference Photo 2

Description: Looking at the primary (north) and west elevations of the building. Note that the building has transitioned from a guide and taxidermy business to a NAPA Auto Parts store.

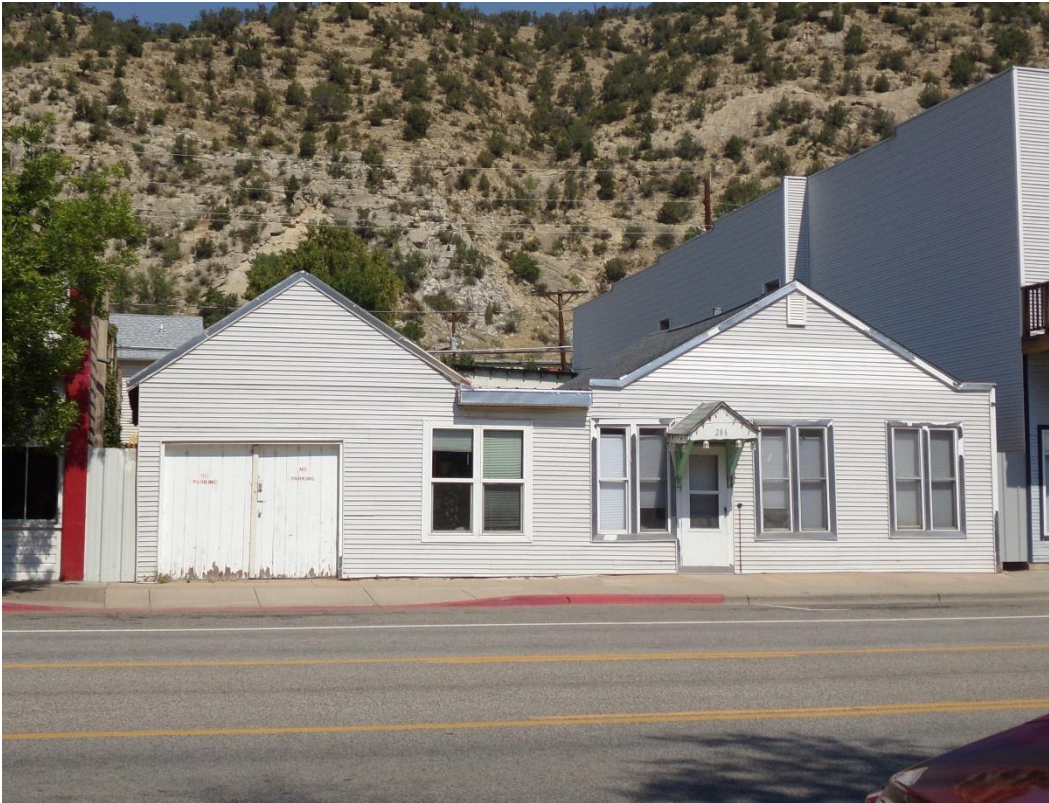
Photo Number: 5GF.5915_1

Description: Looking at the primary (south) elevation of the building. Note the former harness building on the left that was joined with the dwelling on the right.

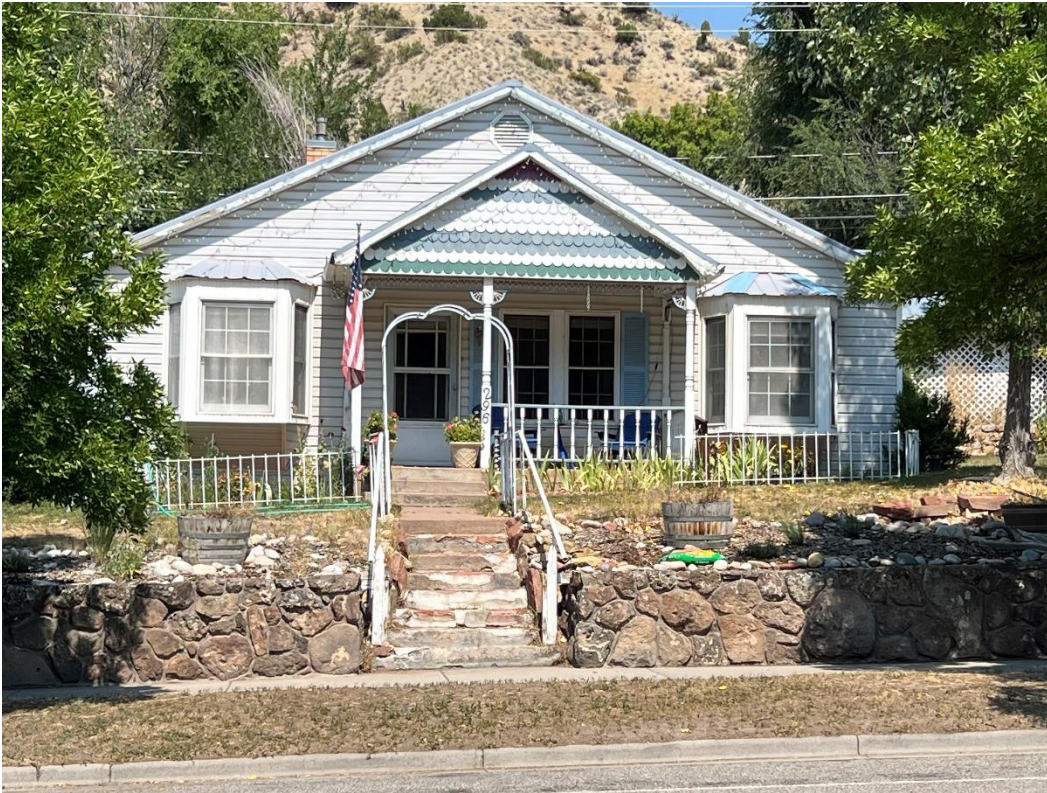
Photo Number: 5GF.5929_1
Description: Looking at the primary (south) elevation of the primary building. Note the decorative wood spindlework and brackets under the gable ceiling of the porch overhang.
Date: 9/6/2022
View: North

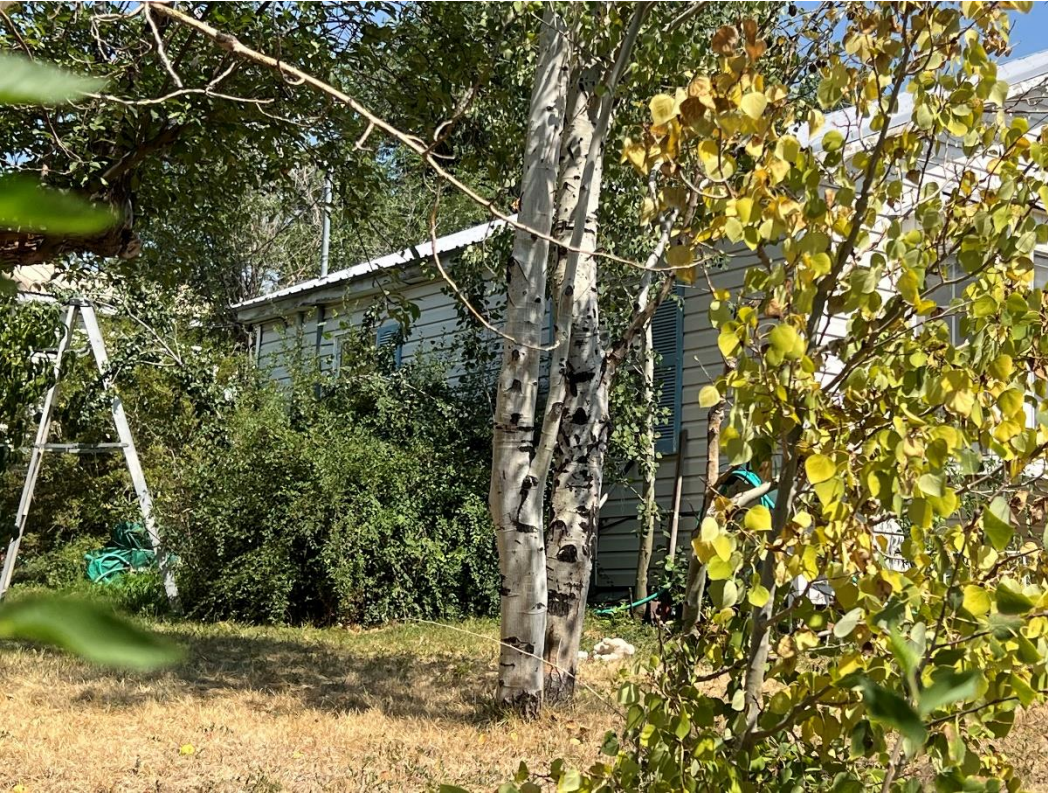
Photo Number: 5GF.5929_3
Description: Looking at the west elevation of the primary building. A majority of the elevation is obscured by vegetation.
Date: 9/6/2022
View: Northeast

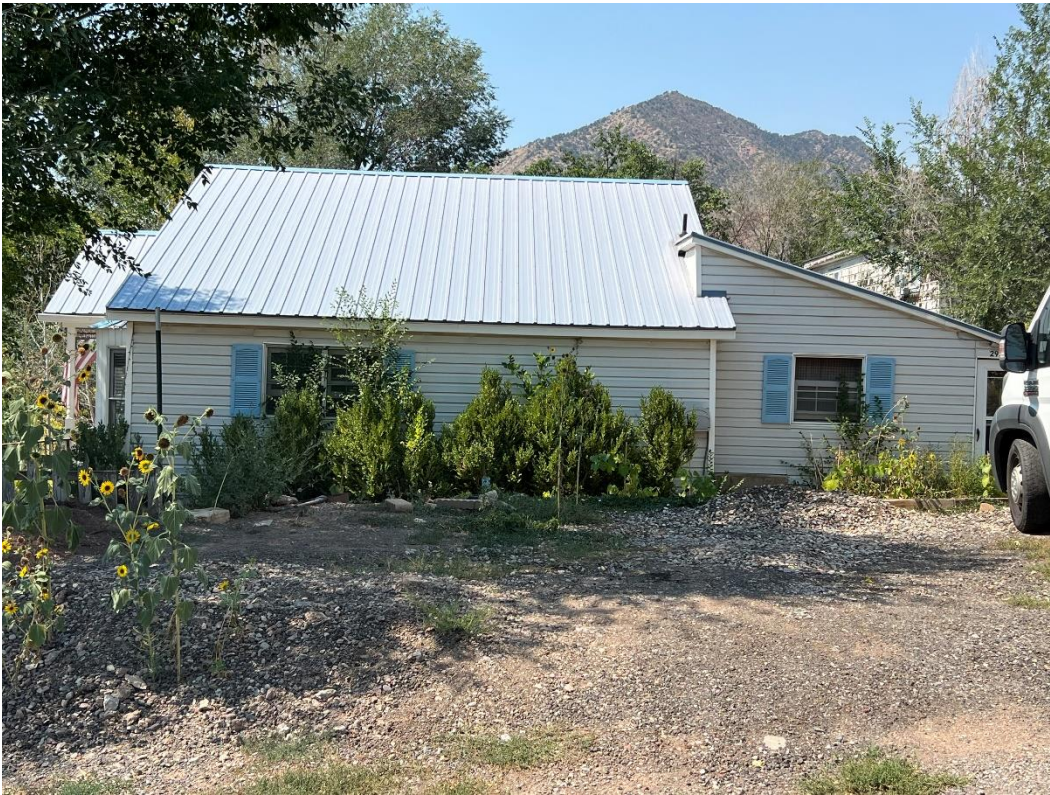
Photo Number: 5GF.5929_5

Description: Looking at the east elevation of the primary building. Note the shed roof addition to the north elevation (right side of photo).

window incorporates a typical window consisting of a six-over-six double hung sash unit. The center window of the bay unit is flanked on both sides by a four-over-four double hung sash unit. A shed roof addition was constructed along the north elevation of the building at some point. Additionally, the metal roof likely replaced a prior asphalt shingle roof.

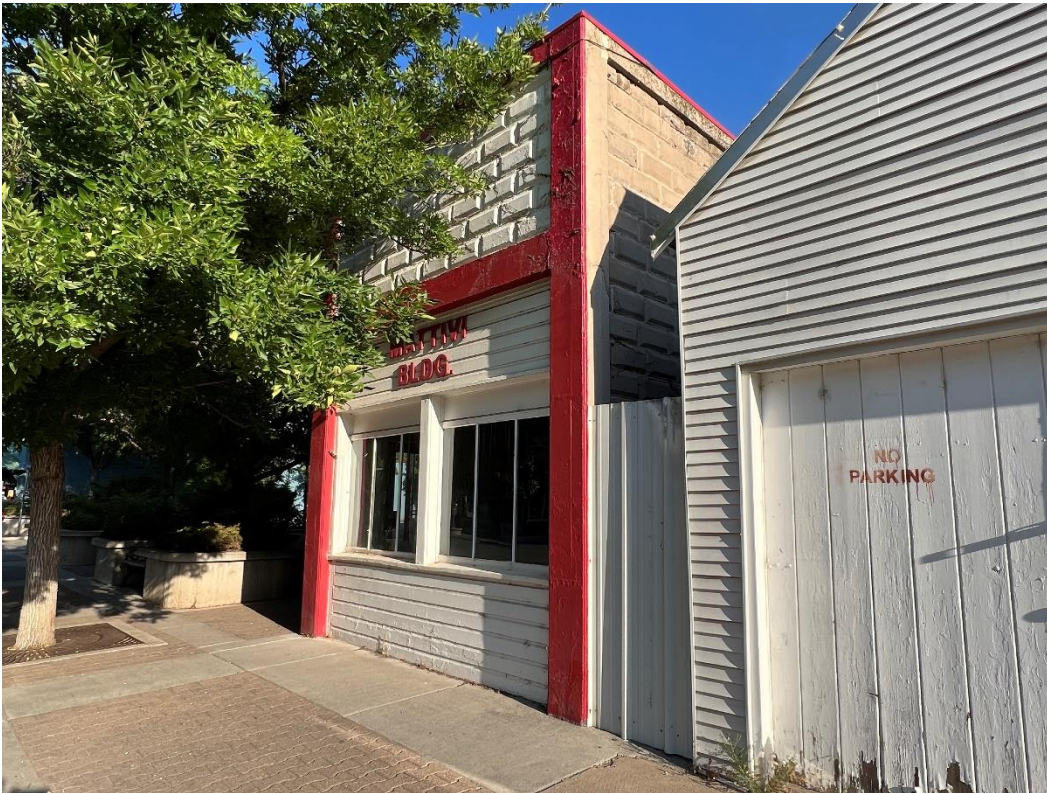
Photo Number: 5GF.2373_4
Description: Looking at the far-right side of the primary (south) and a portion of the east elevations. Note the former garage door opening that was covered by the mid to late Twentieth Century.
Date: 9/6/2022
View: Northwest

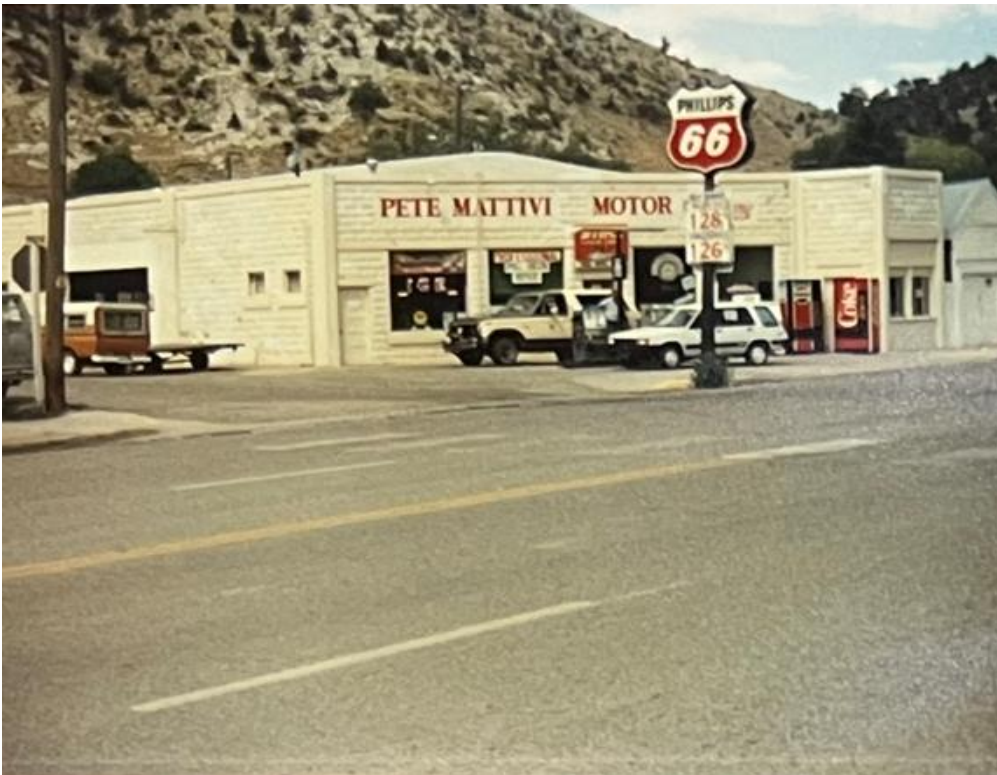
Historic Photo 1
Description: Looking at the west and primary (south) elevations of the building. Note that the garage opening on the far right of the primary (south) elevation was covered by this time.
Date: Circa 1980
Source: New Castle Museum Collection

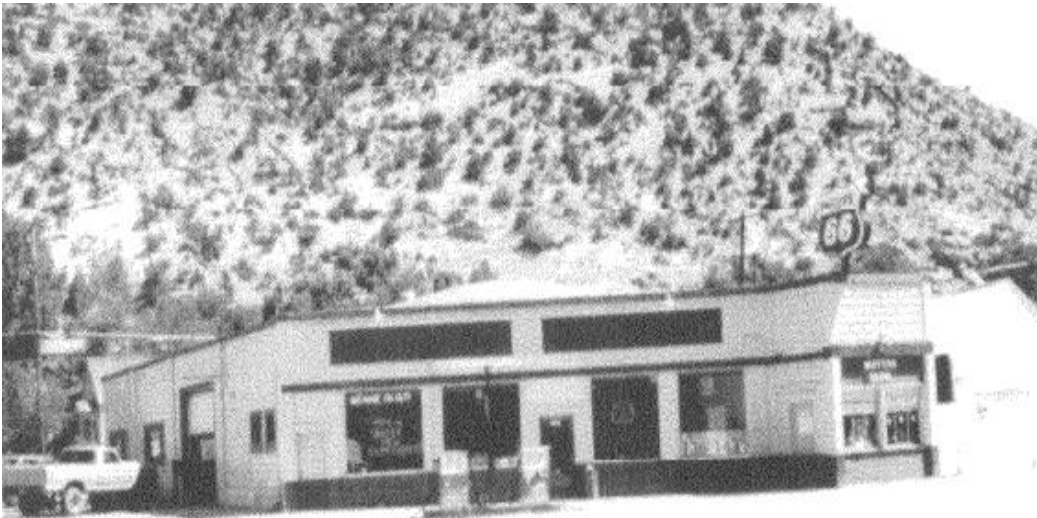
Reference Photo 1

Description: Looking at the west and primary (south) elevations of the building. Note the extant fuel island and Phillips 66 sign on the roof of the building.

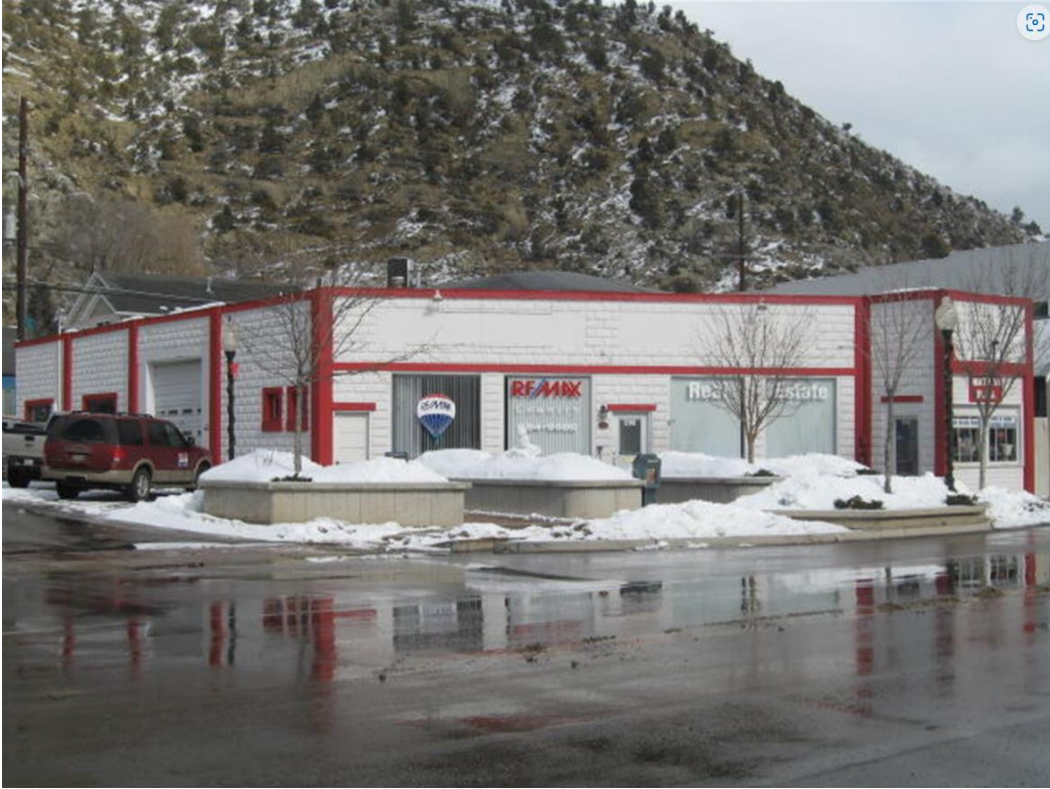
Reference Photo 2

Description: Looking at the west and primary (south) elevations of the building. Note that the fuel island and pumps have been removed by this time.

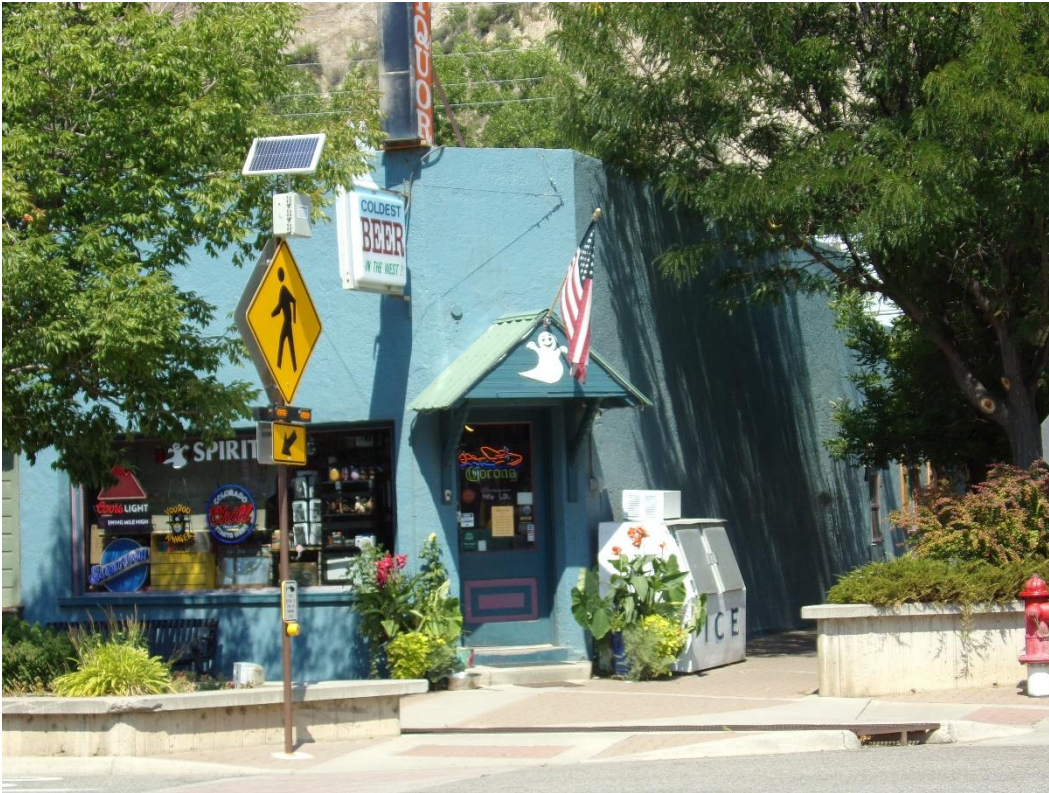
Photo Number: 5GF.2375_1
Description: Looking at the primary (south) and east elevations of the building.
Date: 9/6/2022
View: Northwest

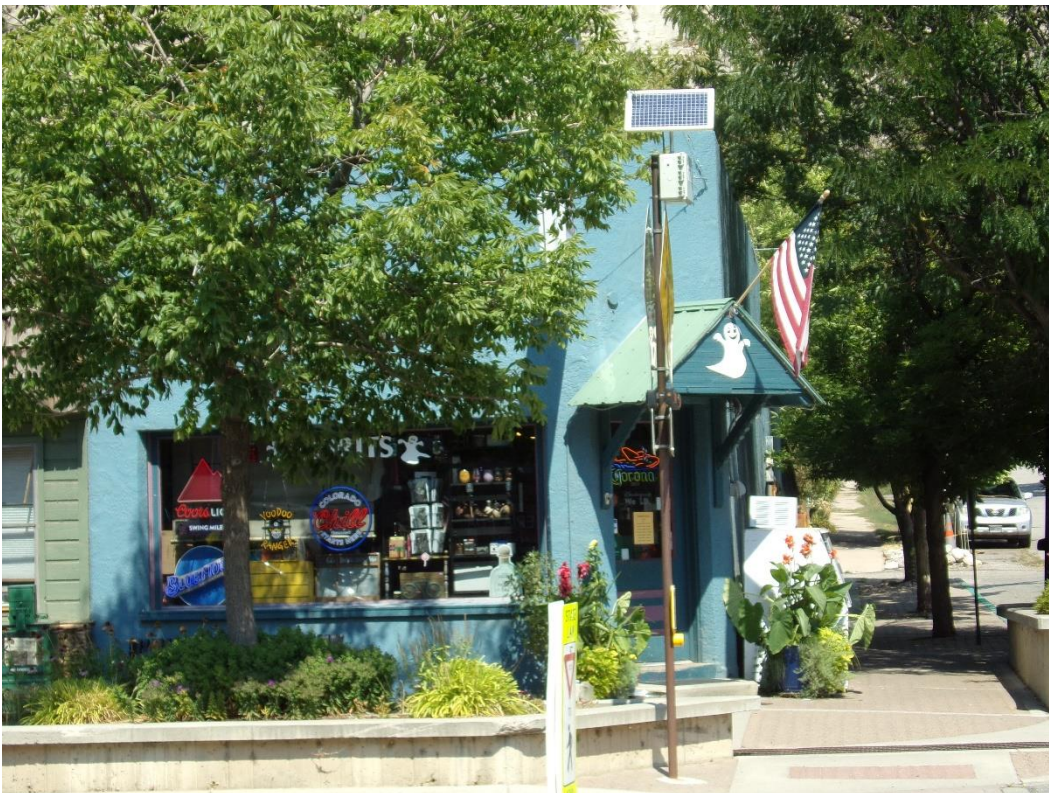
Photo Number: 5GF.2375_2
Description: Looking at the primary (south) elevation of the building.
Date: 9/6/2022
View: North

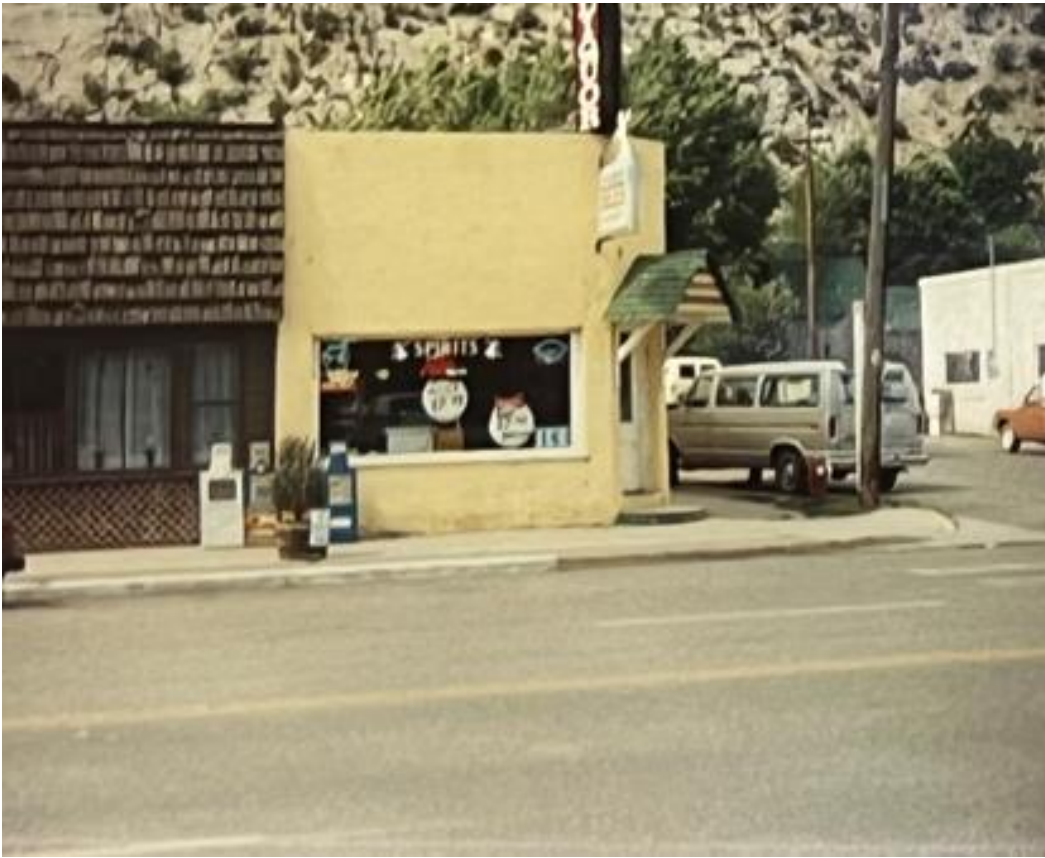
Reference Photo 1

Description: Image of the south elevation of the resource with the label stating, "Office building/ has been home of many businesses. New Castle State Bank 1909-1939. Now a liquor store."

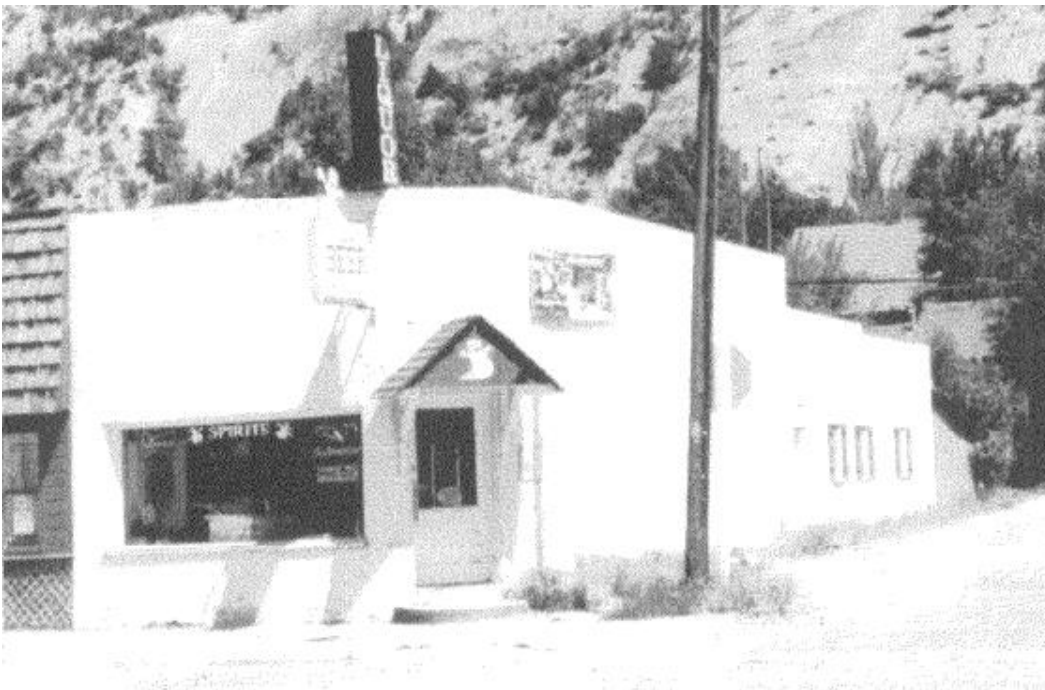
Reference Photo 2

Description: Looking at the primary (south) and east elevations of the building.

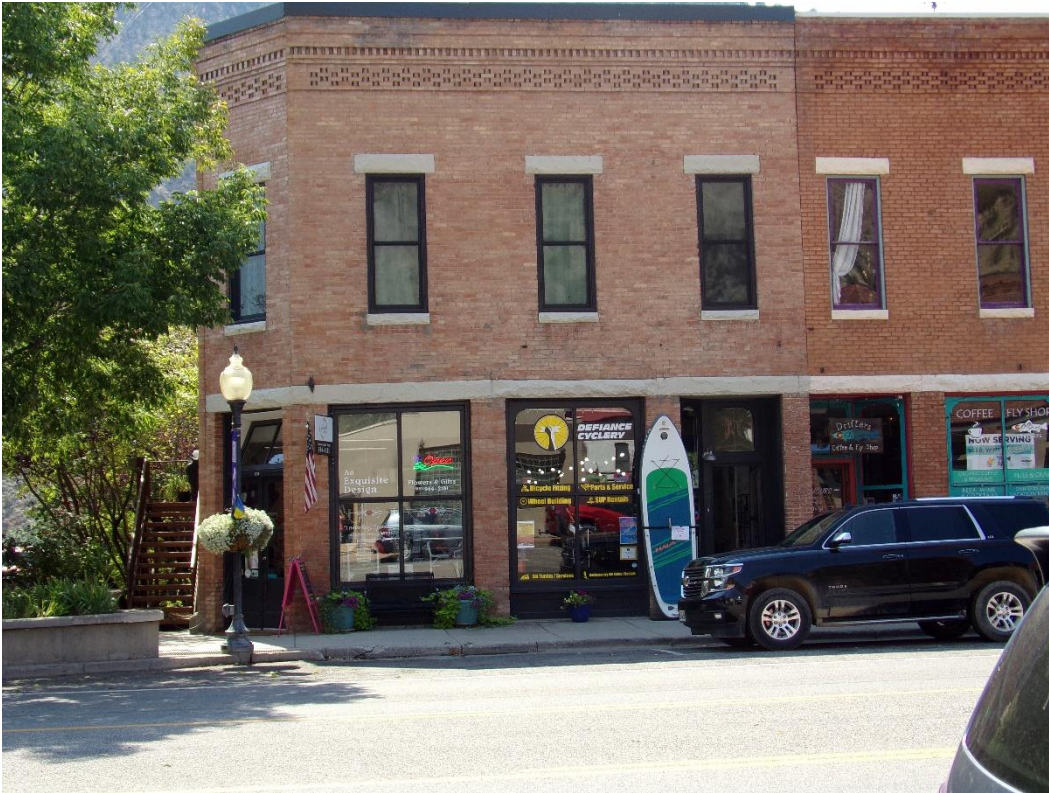
Photo Number: 5GF.2376_1
Description: Looking at the primary (north) elevation of the building. Note the decorative brickwork underneath the cornice.
Date: 9/6/2022
View: South

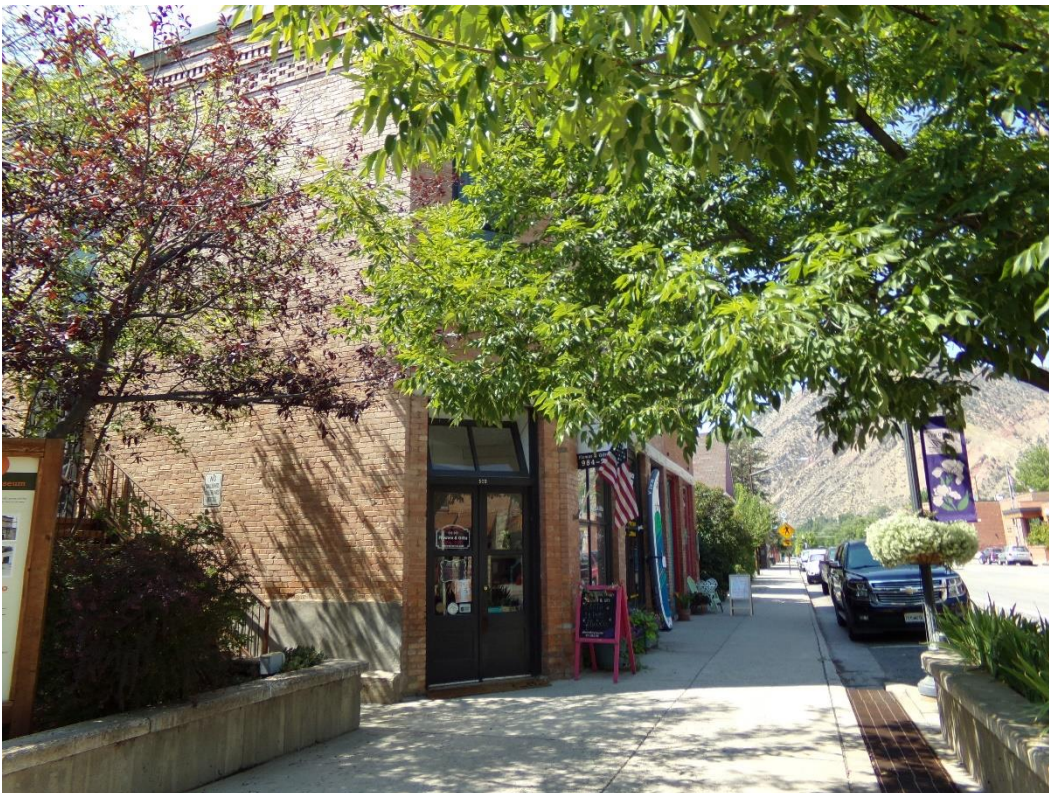
Photo Number: 5GF.2376_2
Description: Looking at the east and angled main entryway along the primary (north) elevation of the building.
Date: 9/6/2022
View: West

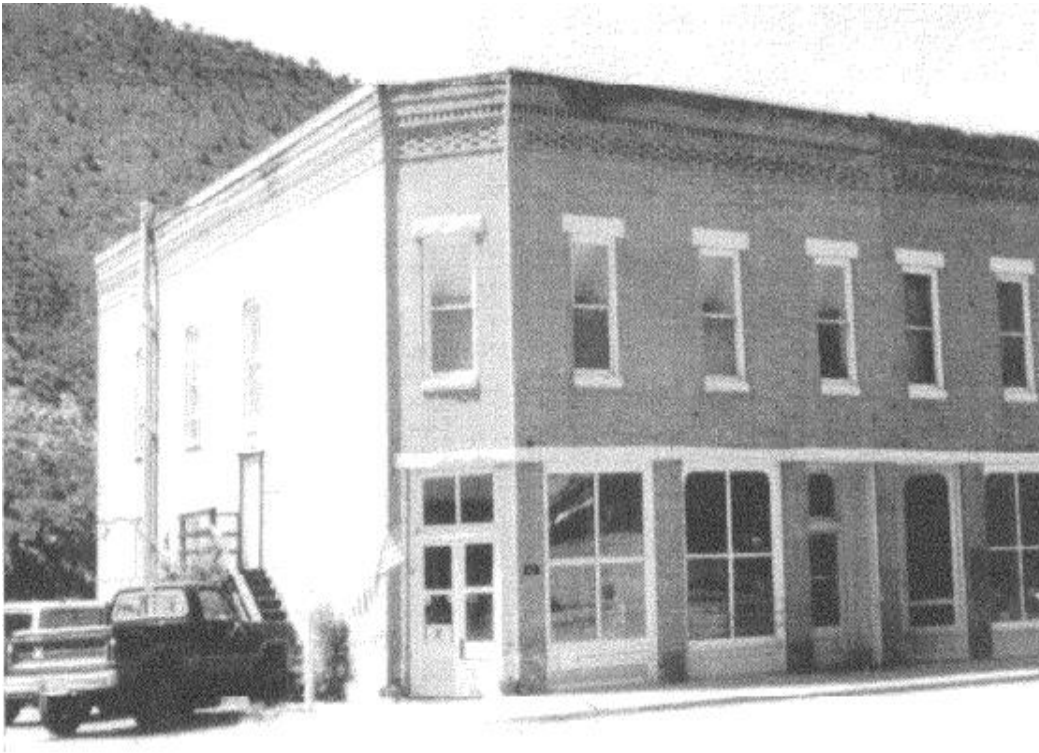
Reference Photo 2

Description: Looking at the east and (primary) north elevation of the building.

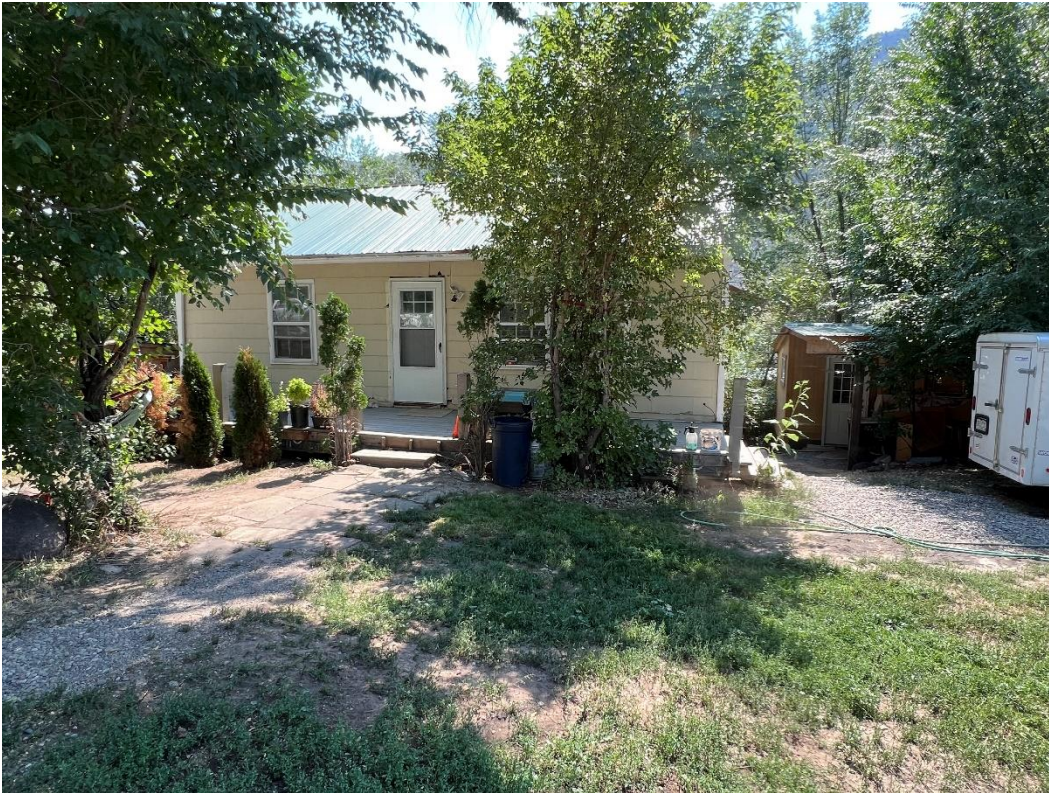
Photo Number: 5GF.5930_1
Description: Looking at the primary (north) elevation of the building.
Date: 9/6/2022
View: South

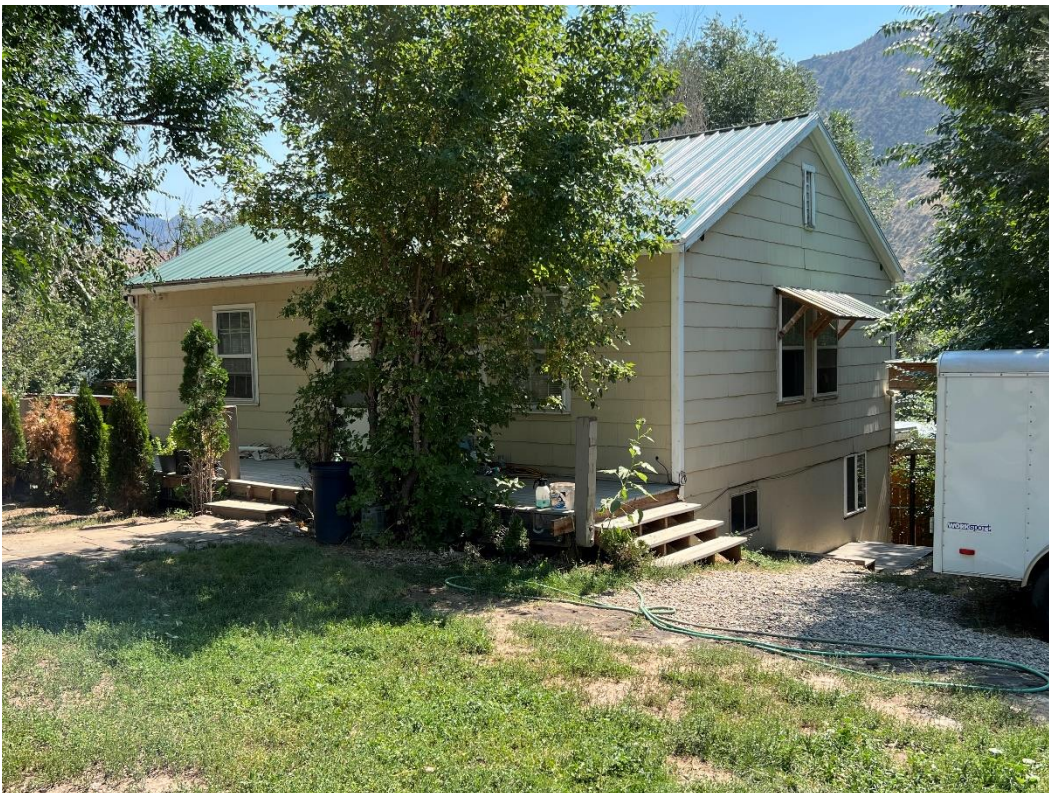
Photo Number: 5GF.5930_2
Description: Looking at the primary (north) and west elevations of the residence. Note the shed roof awning that protects the typical windows.
Date: 9/6/2022
View: Southeast
