New Castle Historic Preservation Commission (Regular Meeting)

New Castle - Reconnaissance Survey

The Town of New Castle (New Castle) is conducting a reconnaissance-level survey of historic resources along Main Street (US Highway 6). The survey will identify and recommend individual resources for future intensive-level survey to determine potential eligibility under National Register of Historic Places (NRHP) criteria in accordance with NRHP and State of Colorado Historic Survey Standards. In addition, this survey assesses the potential for a historic district as well as identify and recommend resources that may contribute toward a potential NRHP historic district. This survey represents the most recent evaluation of historic resources in the Town of New Castle. Previous historic resource surveys have mostly focused on residential and commercial buildings/structures in the central quadrant of the town. Resources in the survey area—bounded by Elk Creek to the west, Burning Mountain Avenue to the east, and adjacent to Main Street—are the focus of this reconnaissance report.

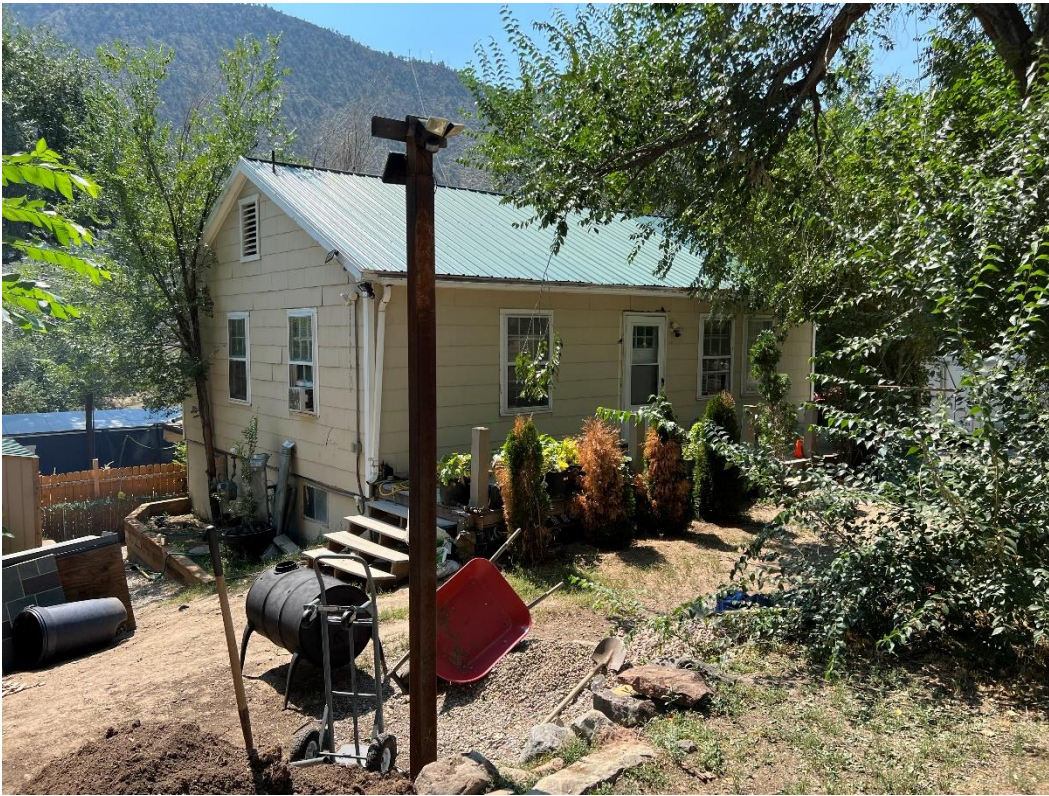
Photo Number: 5GF.5930_3
Description: Looking at the west and primary (north) elevations of the building.
Date: 9/6/2022
View: Southwest

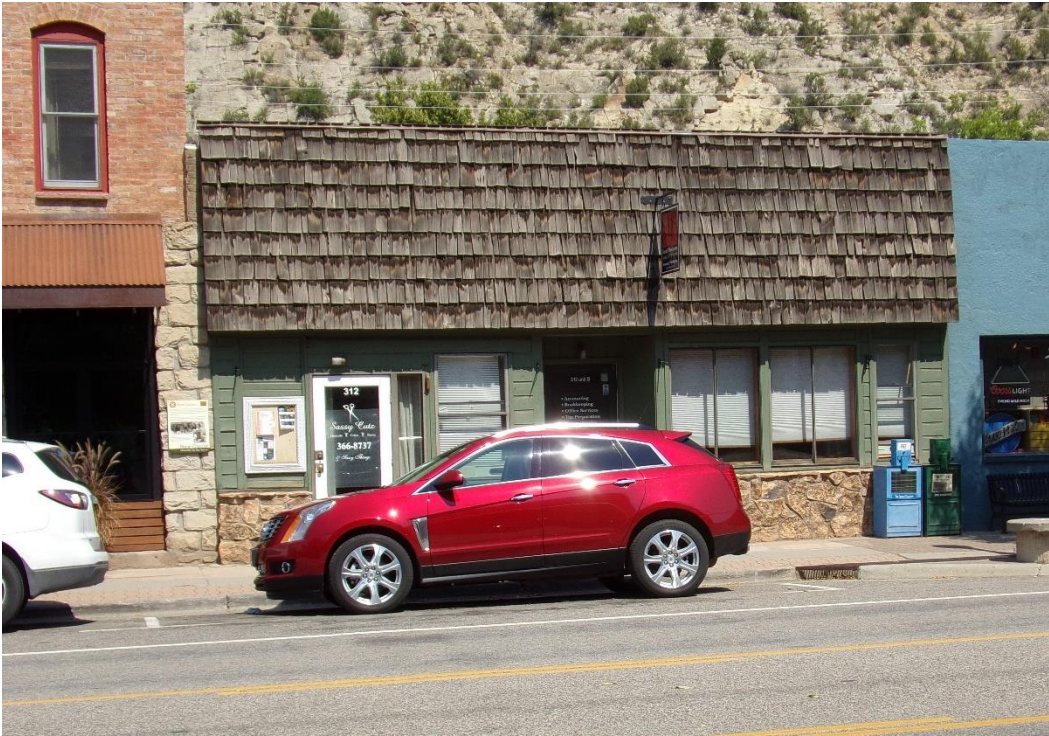
Photo Number: 5GF.2377_1
Description: Looking at the primary (south) elevation of the building.
Date: 9/6/2022
View: North

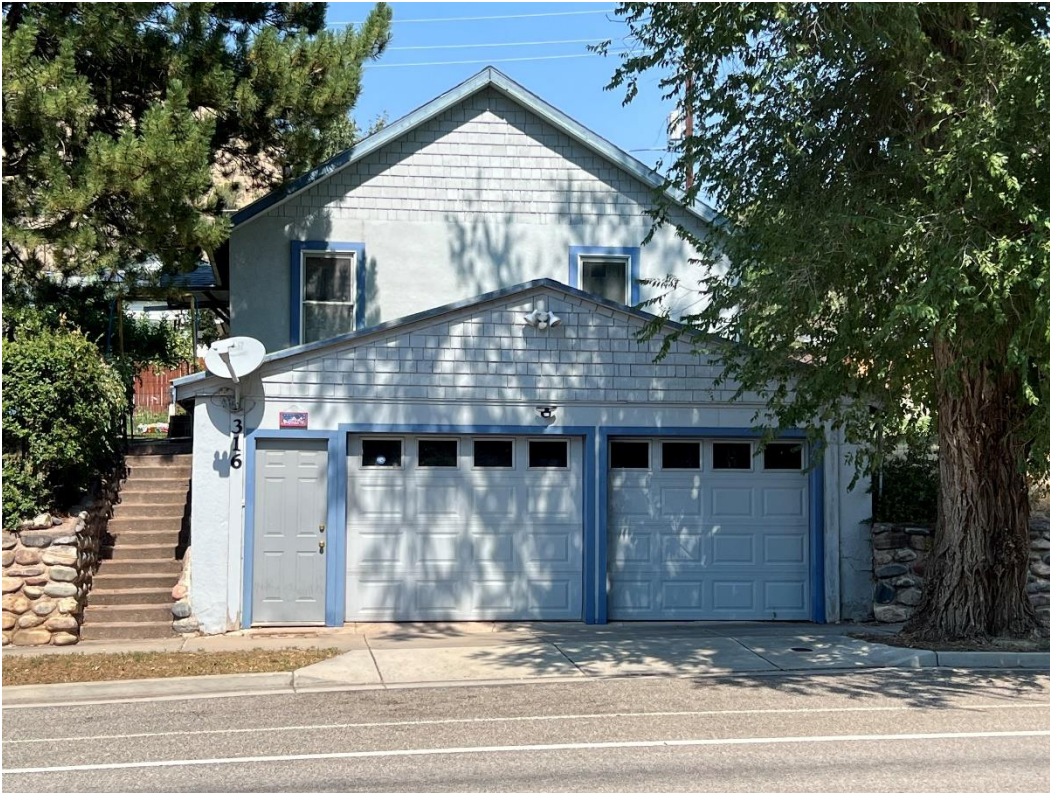
Photo Number: 5GF.5931_1
Description: Looking at the south elevation of the building.
Date: 9/6/2022
View: North

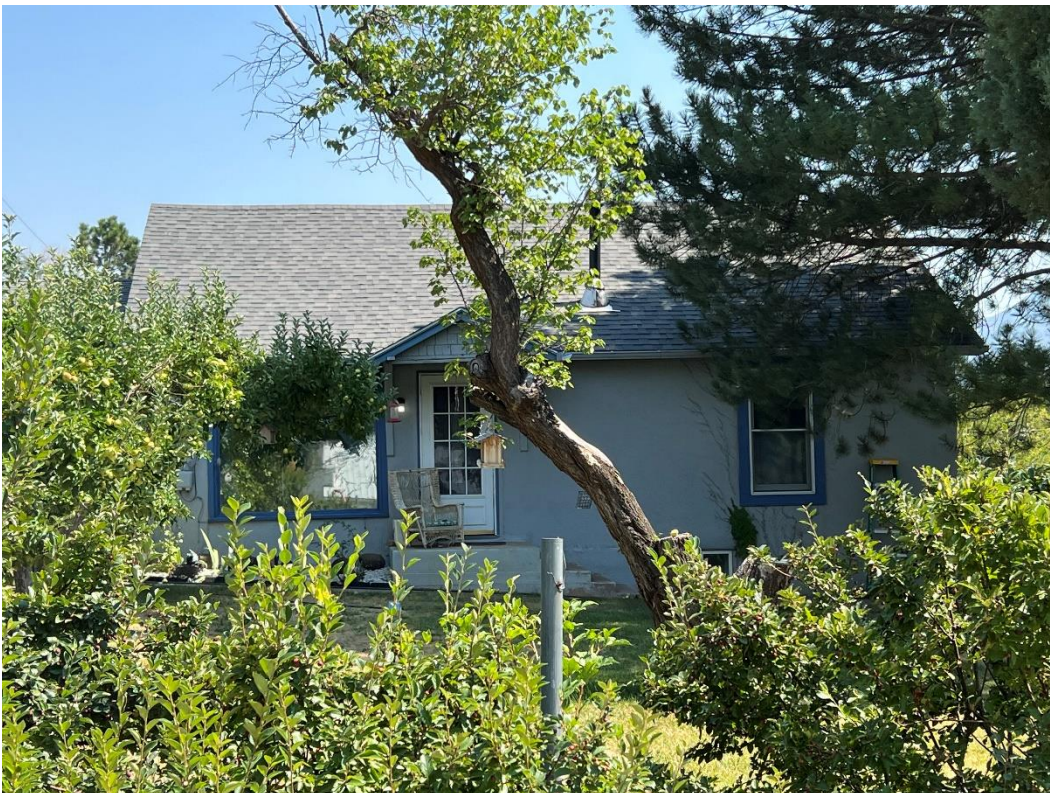
Photo Number: 5GF.5931_2
Description: Looking at the primary (west) elevation of the building.
Date: 9/6/2022
View: East

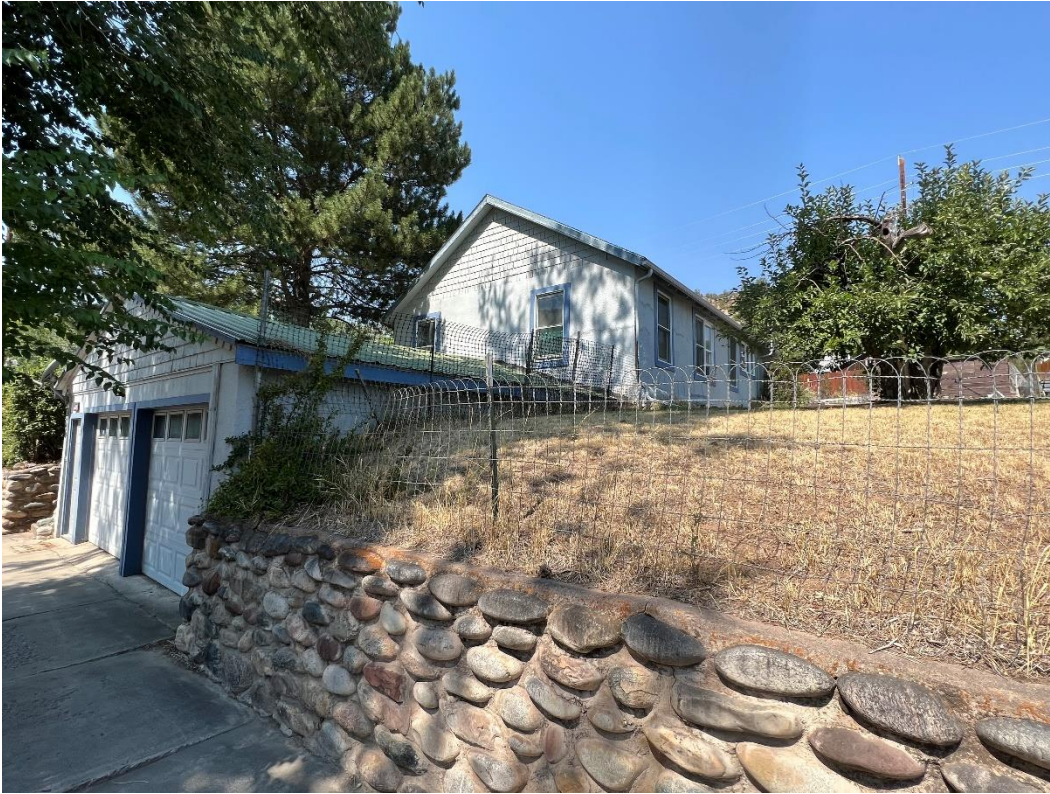
Photo Number: 5GF.5931_3
Description: Looking at the south and east elevations of the residence.
Date: 9/6/2022
View: Northwest

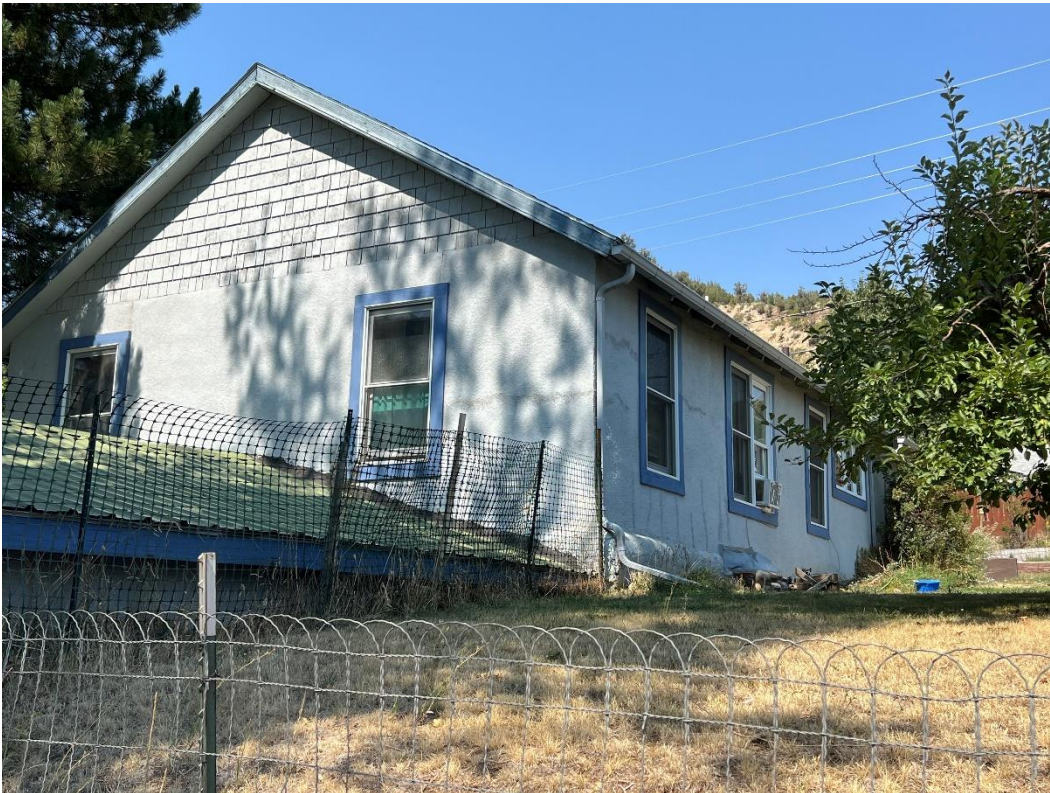
Photo Number: 5GF.5931_4
Description: Close up of the south and east elevations of the residence. Note the exposed rafter tails under the eaves that are partially obscured by the fascia board.
Date: 9/6/2022
View: Northwest

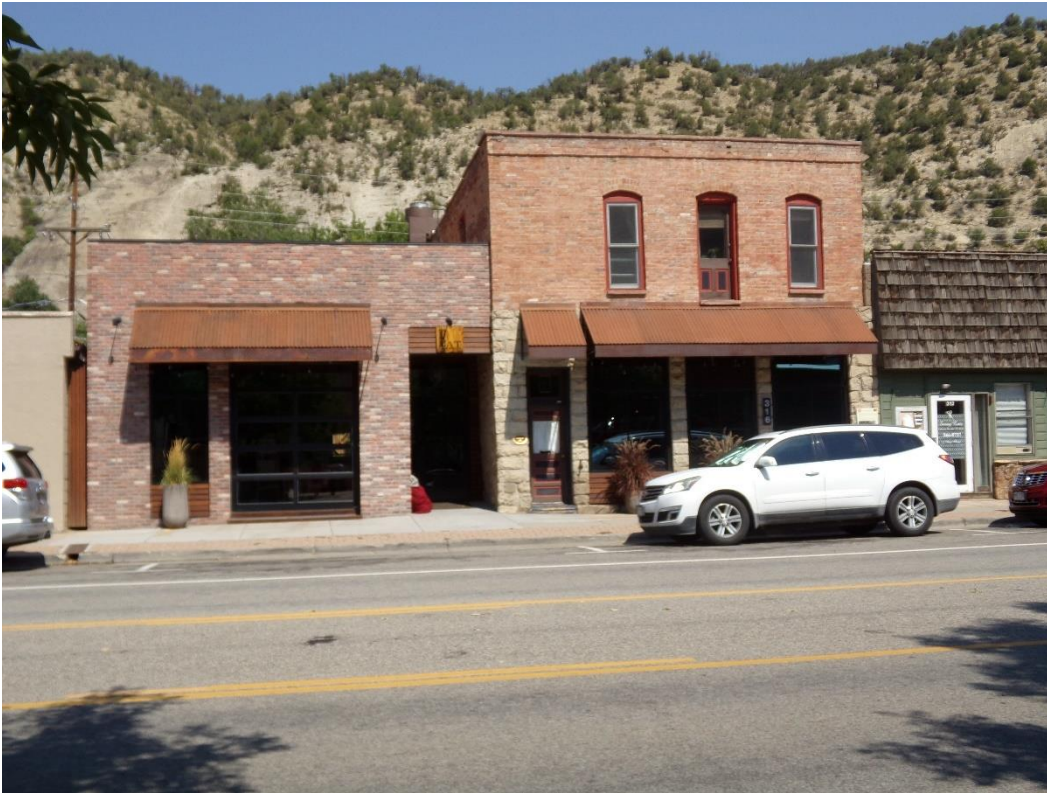
Photo Number: 5GF.2378_1
Description: Looking at the primary (south) elevation of the building. Note that the left half of the building consists of the addition constructed between 2017 and 2019.
Date: 9/6/2022
View: North

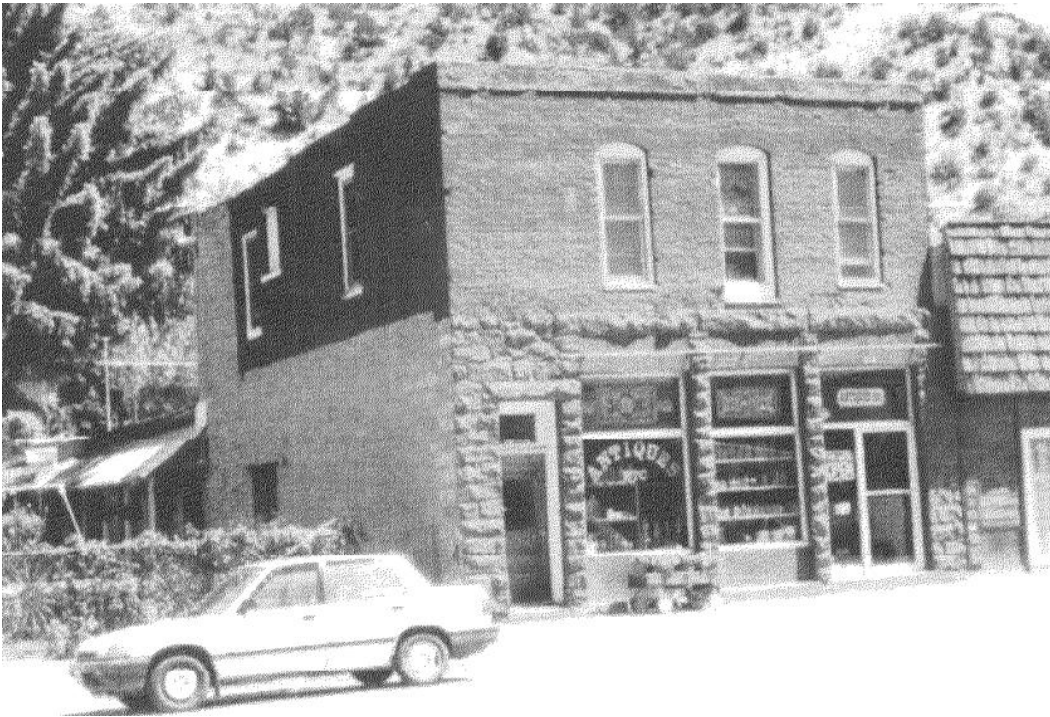
Reference Photo 2

Description: Looking at the primary (south) and west elevations of the building.

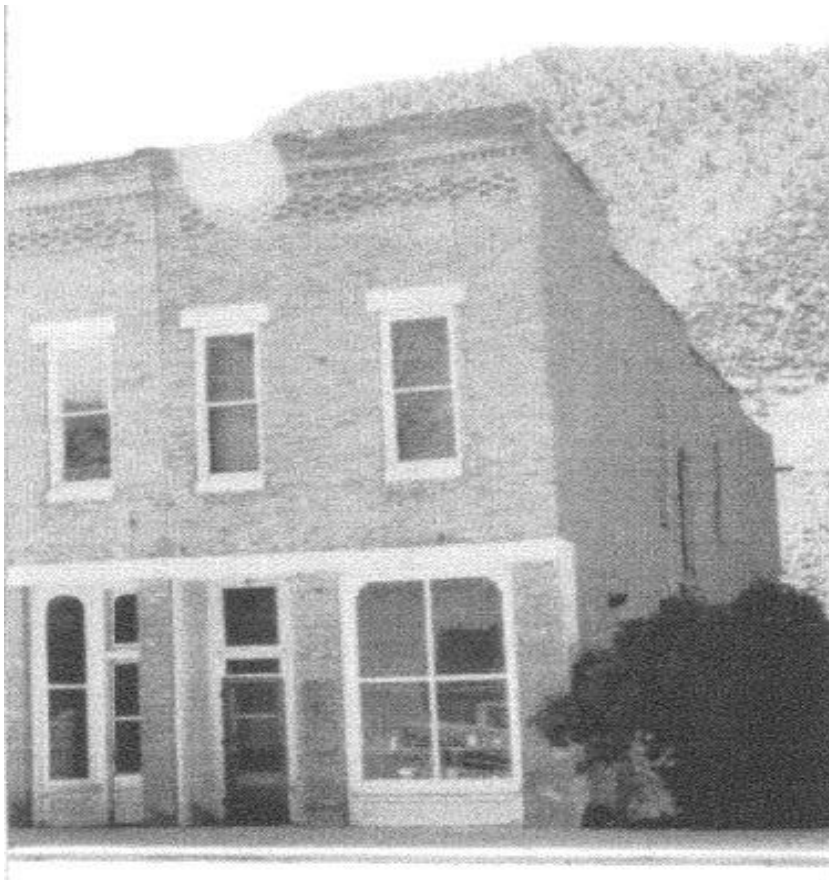
Reference Photo 1
Description: Looking at the primary (north) and west elevations of the building.
Date: 9/6/2022
Source: 1996 OAHP Historic Building Inventory Record (5GF.2379)

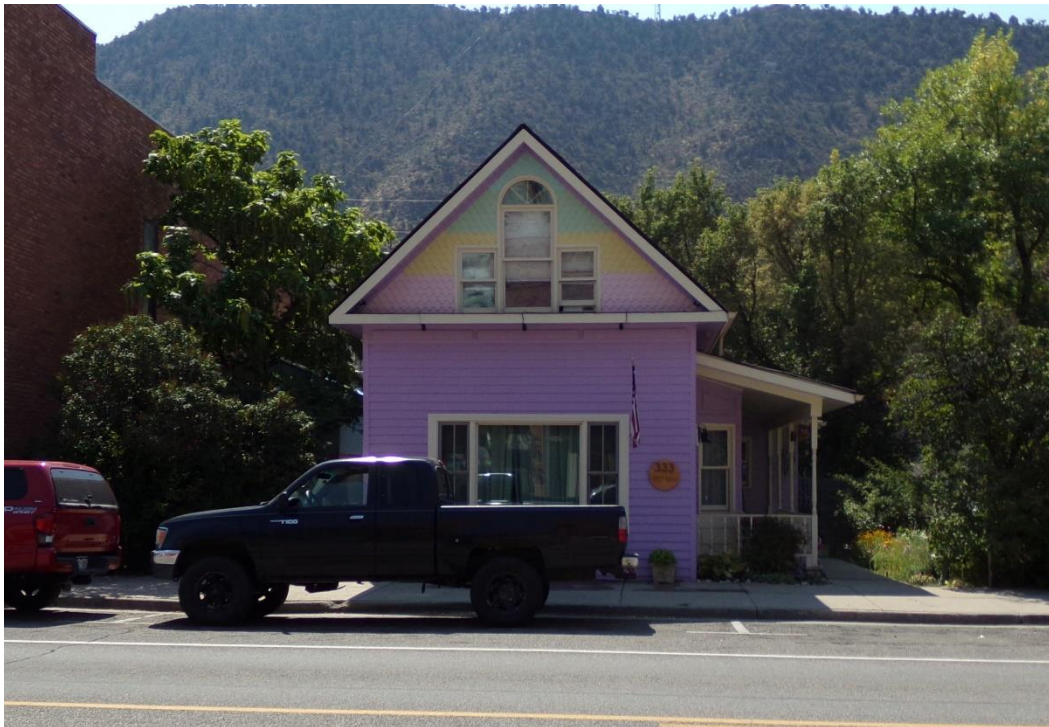
Photo Number: 5GF.5914_1
Description: Looking at the north elevation of the building.
Date: 9/6/2022
View: South

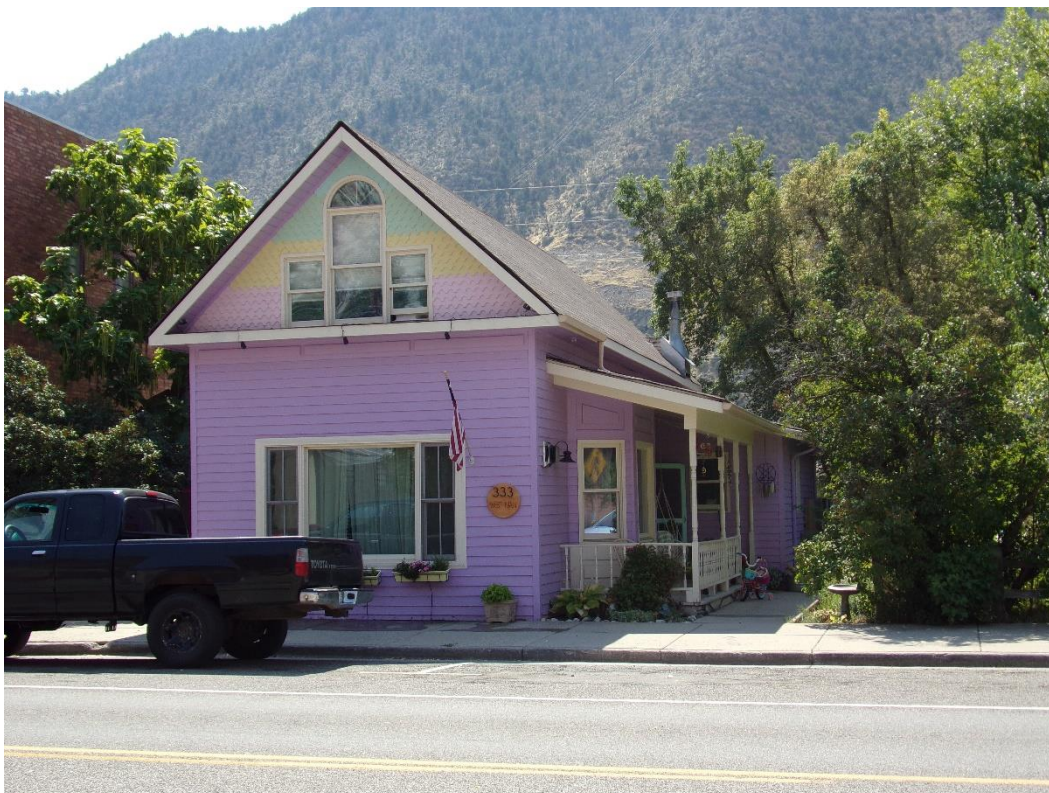
Photo Number: 5GF.5914_2
Description: Looking at the north and primary (west) elevations of the building.
Date: 9/6/2022
View: Southeast

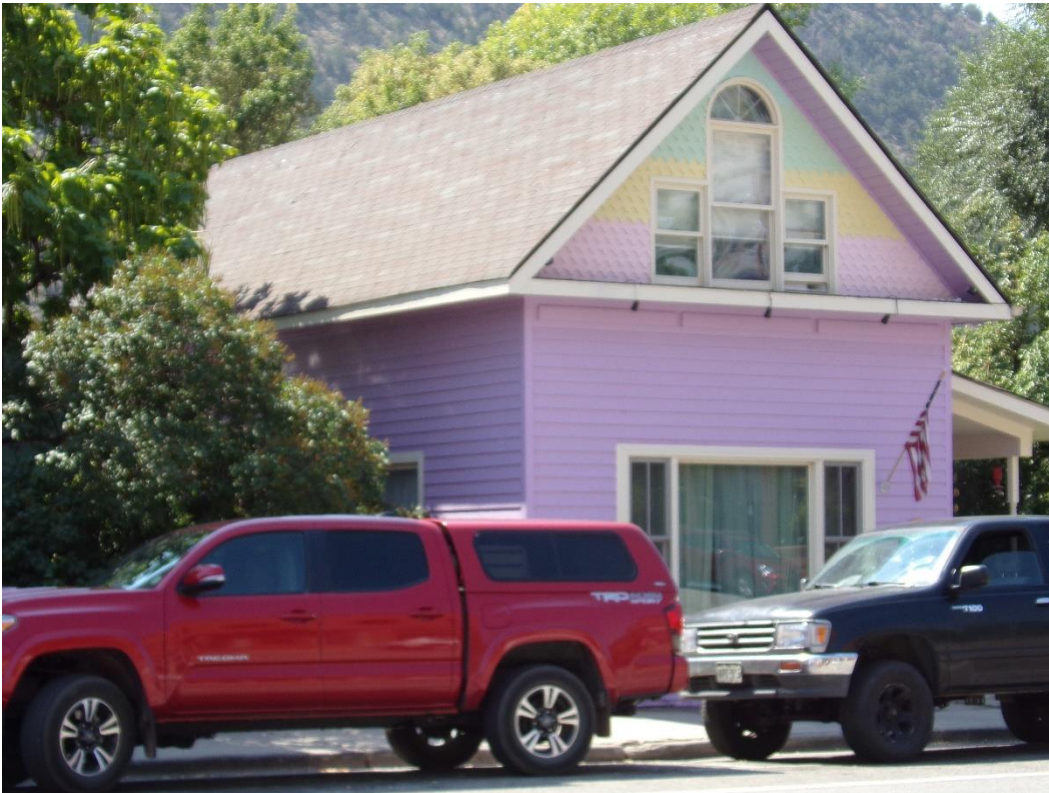
Photo Number: 5GF.5914_3
Description: Looking at the east and north elevation of the building.
Date: 9/6/2022
View: Southwest

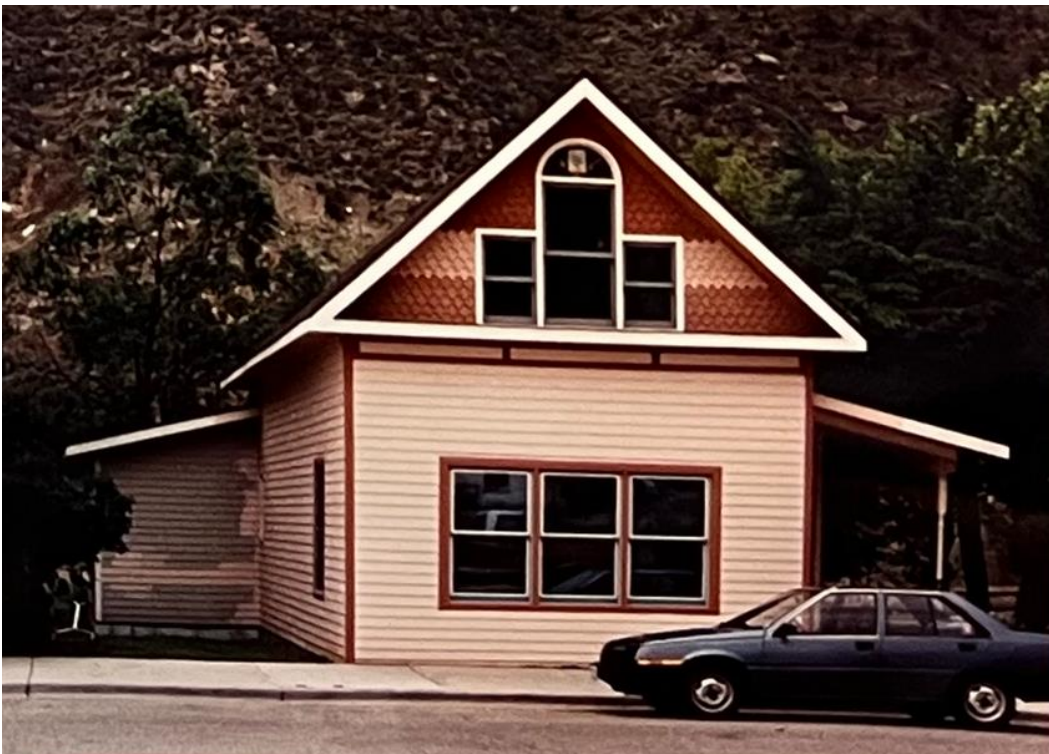
Reference Photo 1
Description: Looking at the west and north elevations of the residence.
Date: Unknown
Source: New Castle Museum Collection

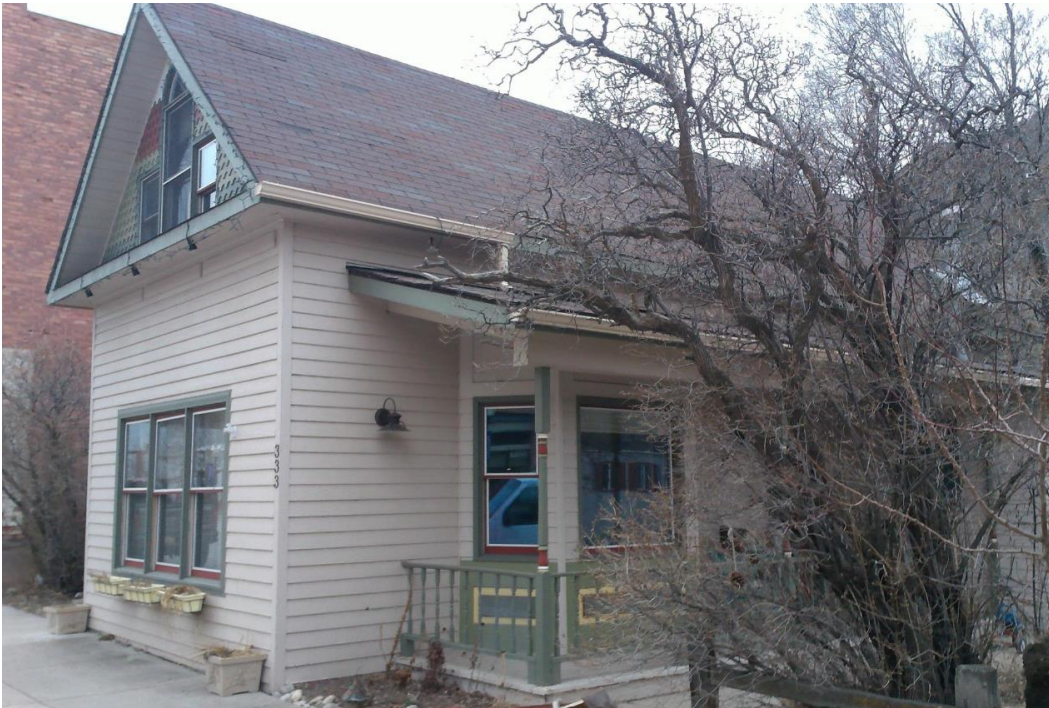
Reference Photo 2

Description: Looking at the north and primary (west) elevations of the building.

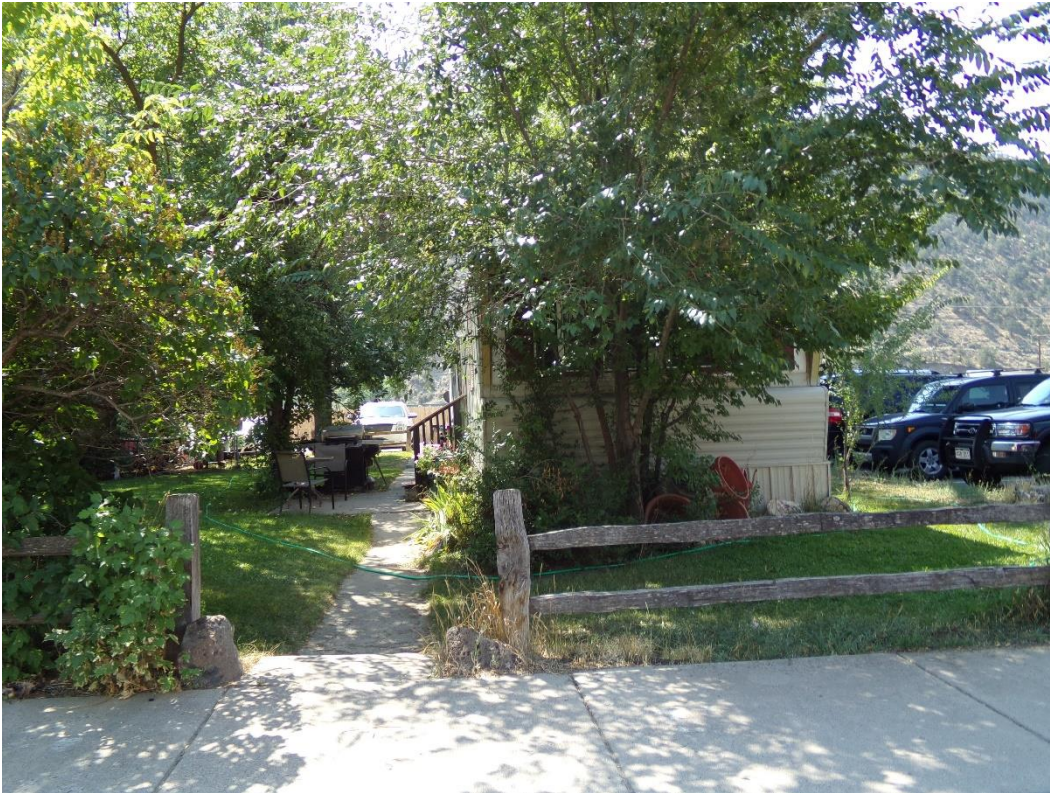
Photo Number: 5GF.5913_1
Description: Looking at the north elevation of the building.
Date: 9/6/2022
View: South

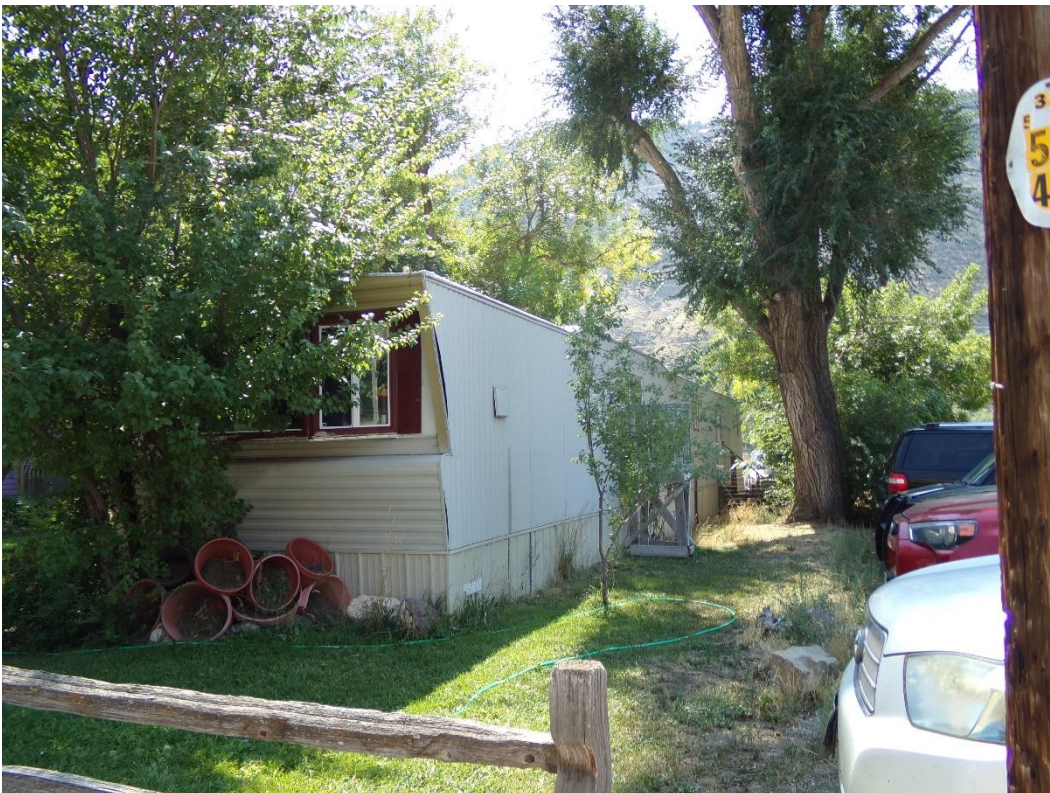
Photo Number: 5GF.5913_2
Description: Looking at the north and east elevations of the building.
Date: 9/6/2022
View: Southeast

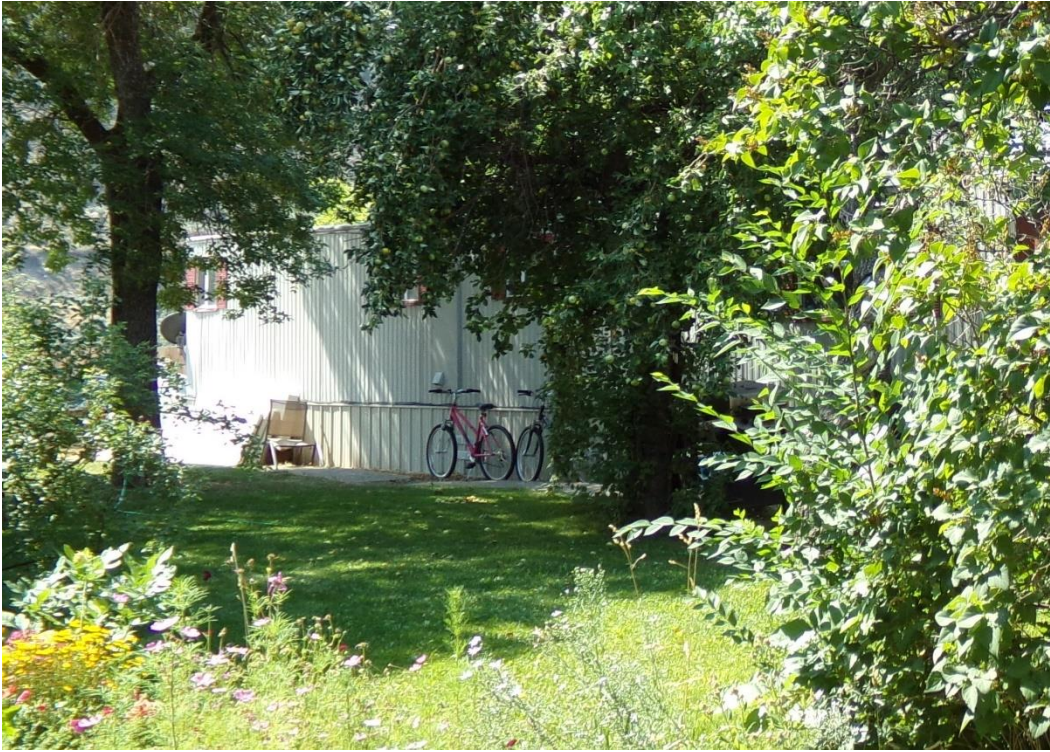
Photo Number: 5GF.5913_3
Description: Looking at the primary (east) elevation of the building.
Date: 9/6/2022
View: Southwest

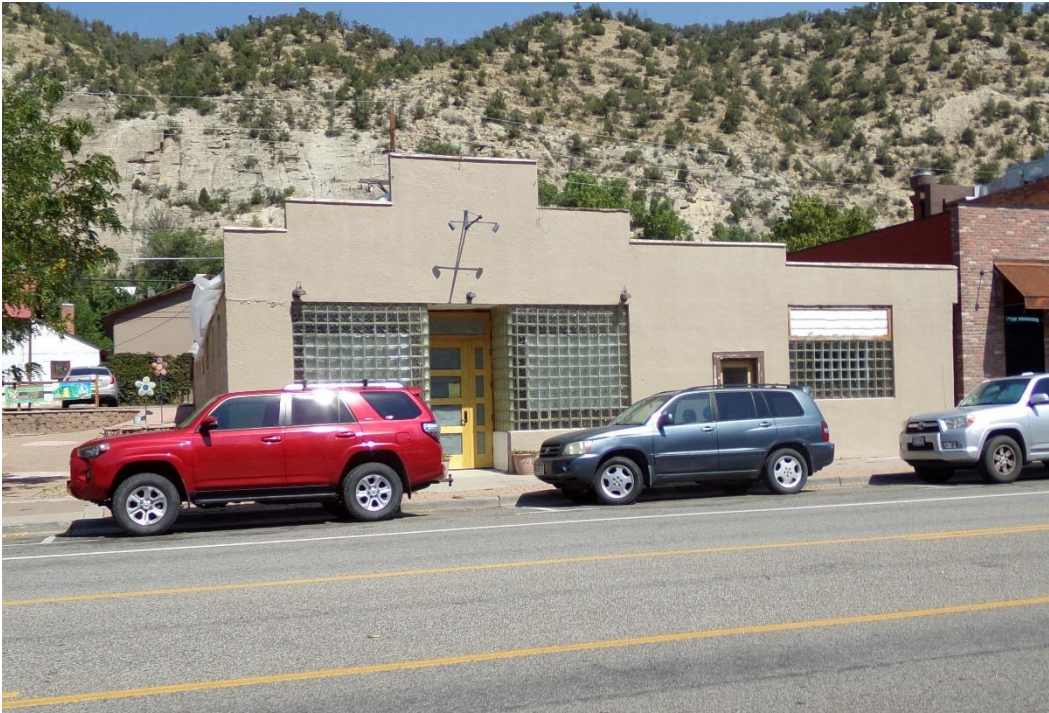
Photo Number: 5GF.5912_1
Description: Looking at the primary (south) elevation of the building.
Date: 9/6/2022
View: North

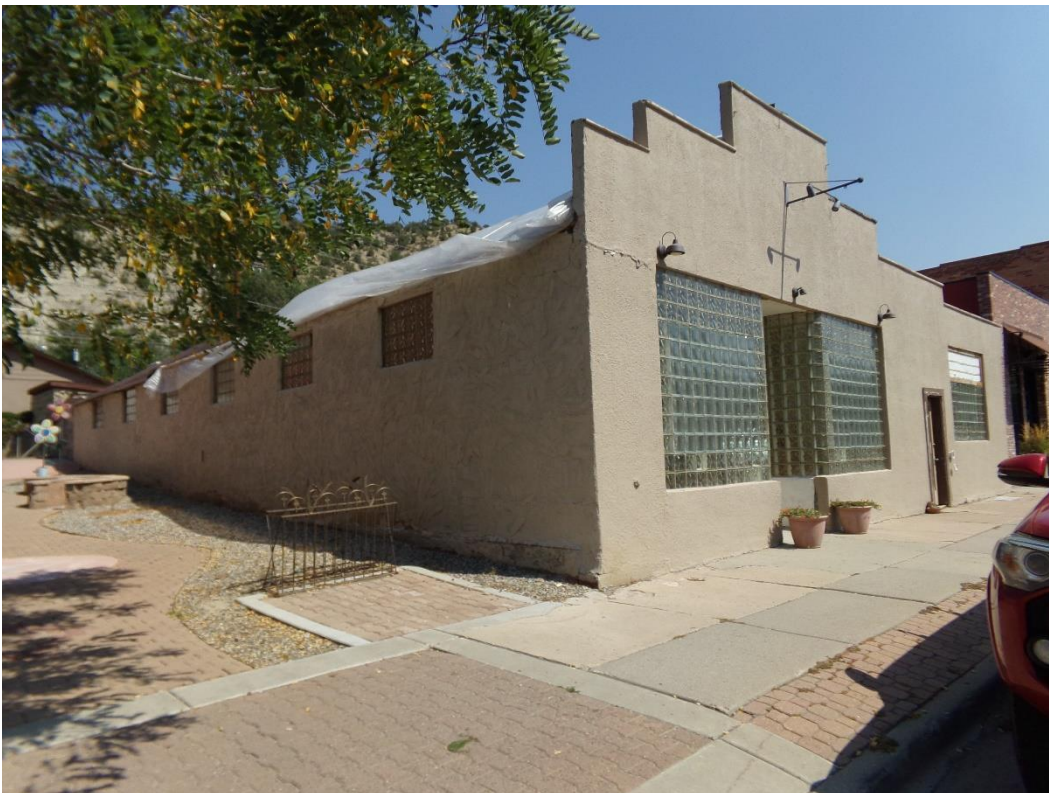
Photo Number: 5GF.5912_2
Description: Looking at the west and primary (south) elevations of the building.
Date: 9/6/2022
View: Northeast

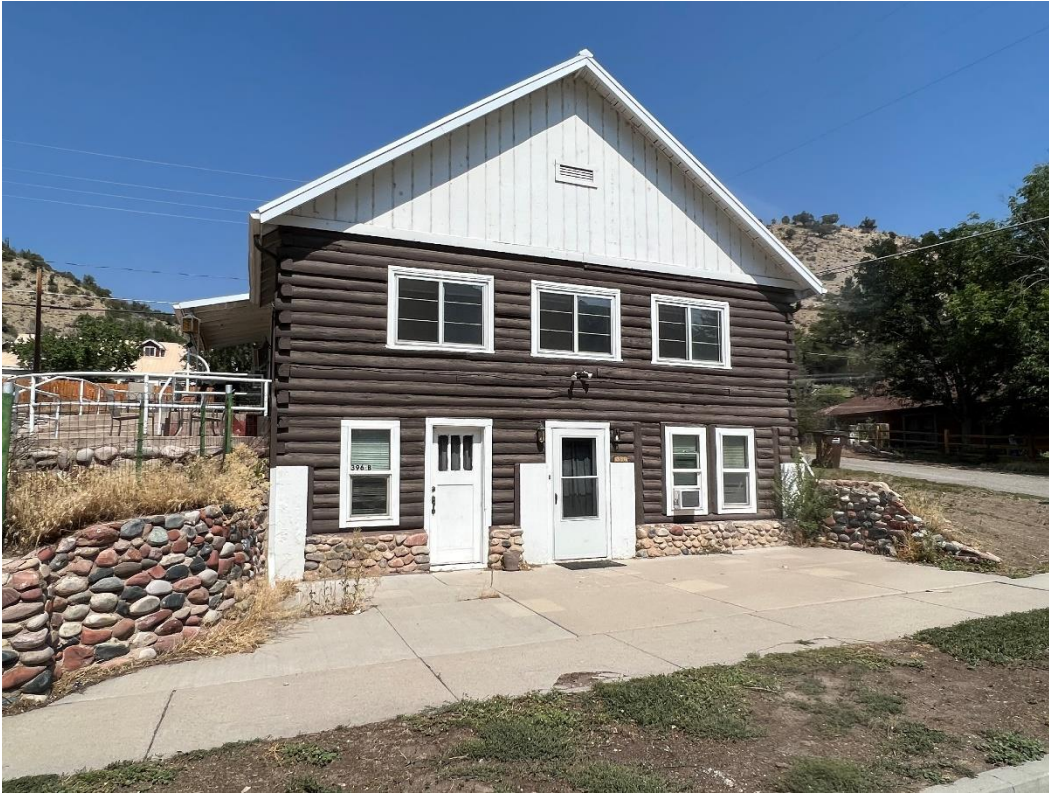
Photo Number: 5GF.5932_1
Description: Looking at the south elevation of the building.
Date: 9/6/2022
View: Northeast

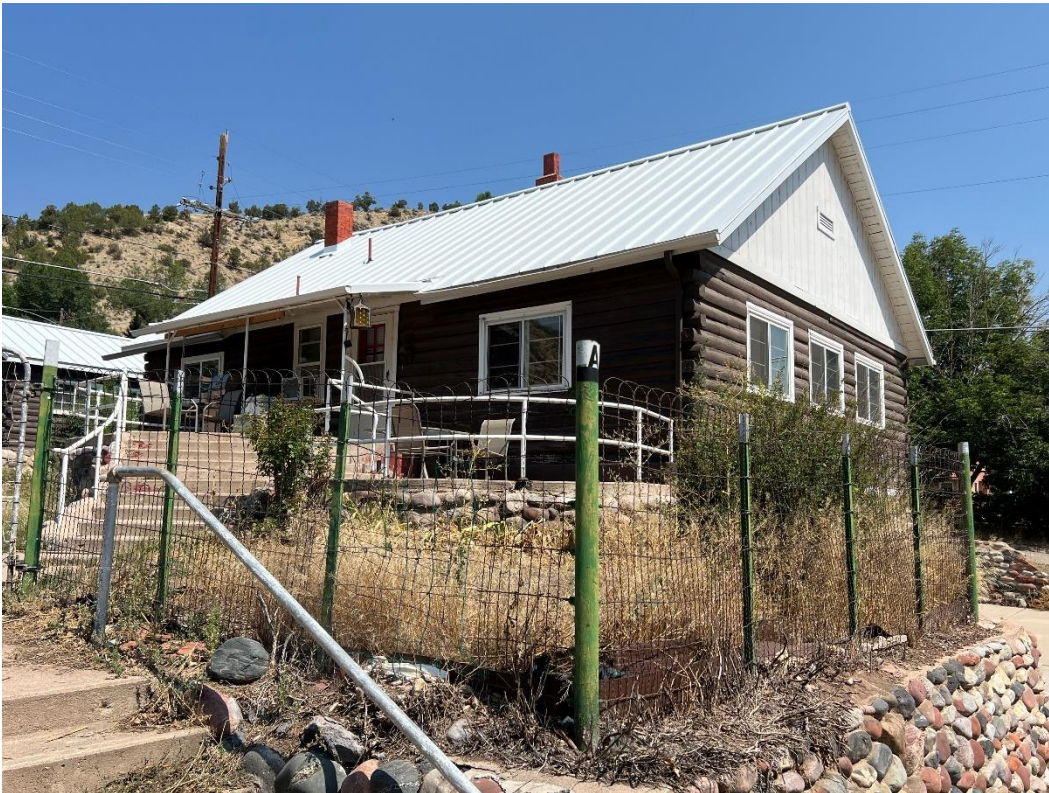
Photo Number: 5GF.5932_2
Description: Looking at the primary (west) and south elevations of the building.
Date: 9/6/2022
View: Northeast

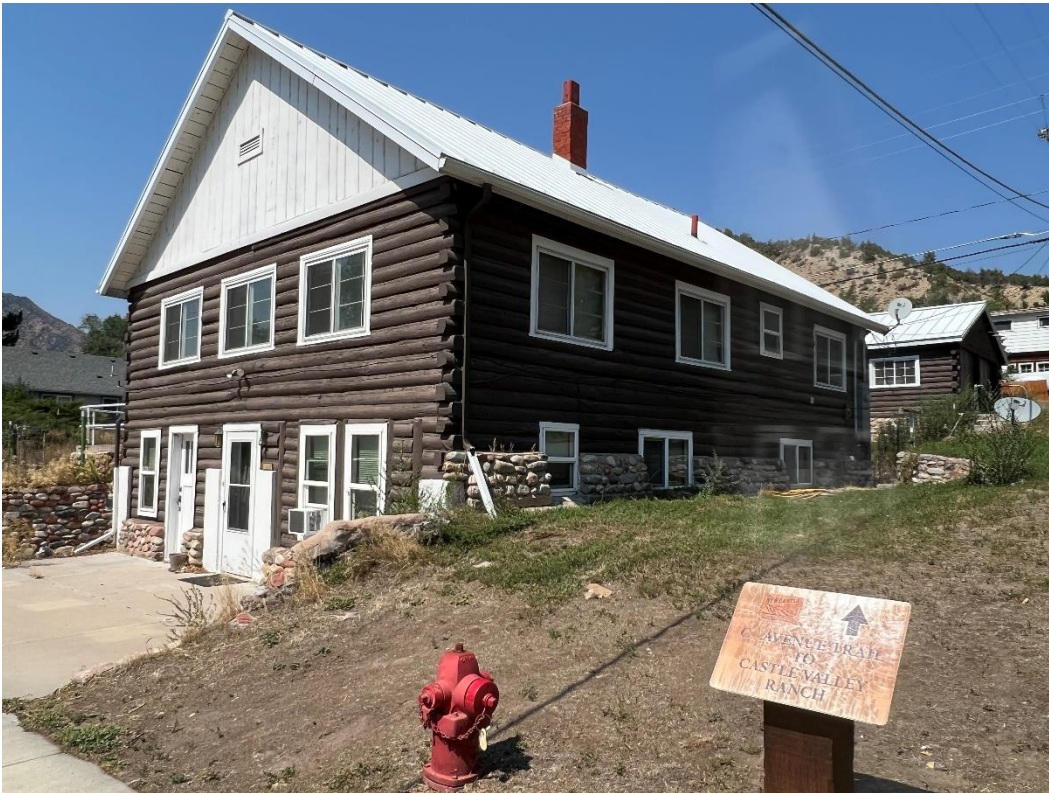
Photo Number: 5GF.5932_3
Description: Looking at the south and east elevations of the building.
Date: 9/26/2022
View: Northwest

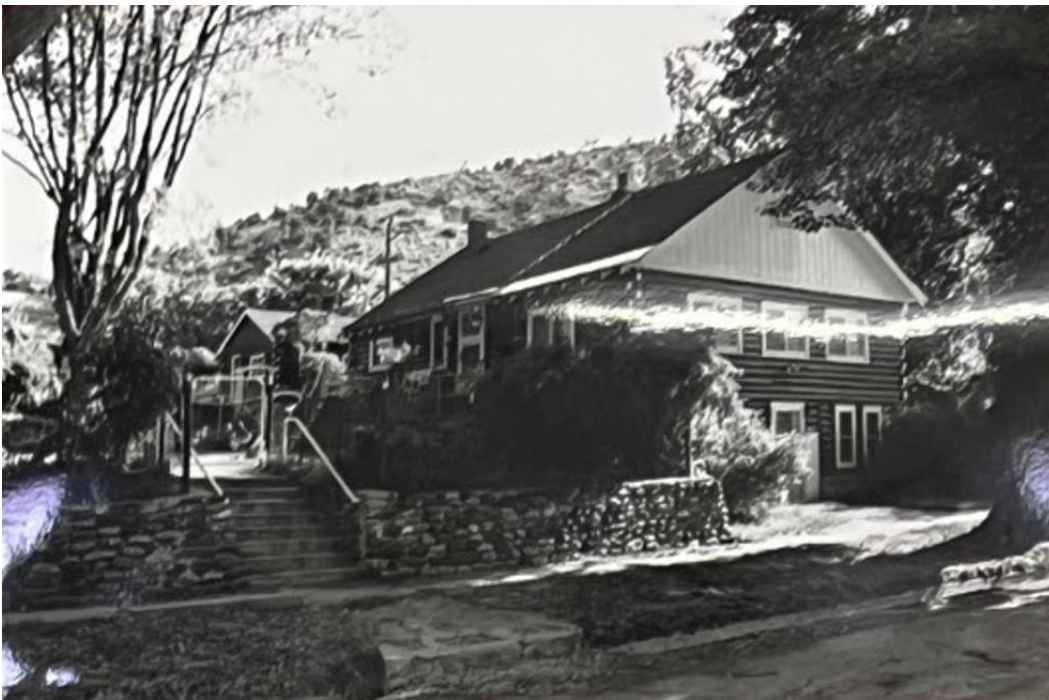
Historic Photo 1
Description: Undated photo looking at the primary (west) and south elevations of the building. Note the exposed rafter tails under the eaves. Additionally, the shed roof overhang above the main entryway is not present. Image is sub-titled, "Dr. Webster Evans Home & Hospital."
Source: New Castle Museum

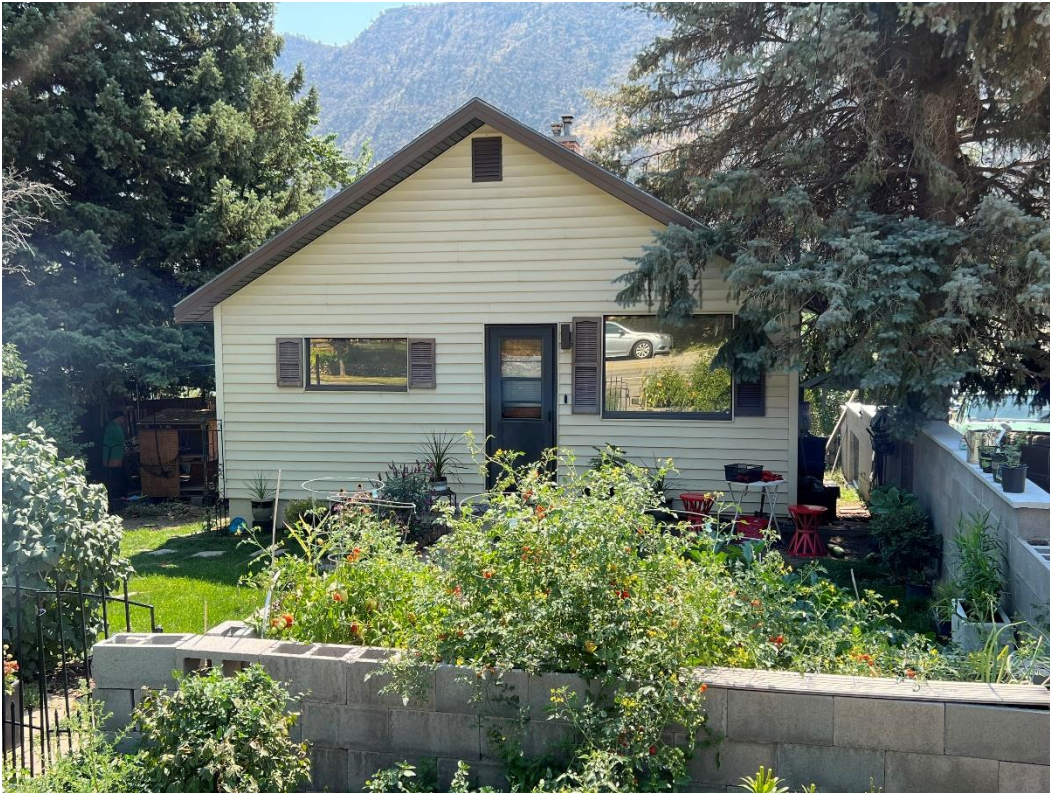
Photo Number: 5GF.5933_1
Description: Looking at the primary (north) elevation of the building.
Date: 9/22/2022
View: South

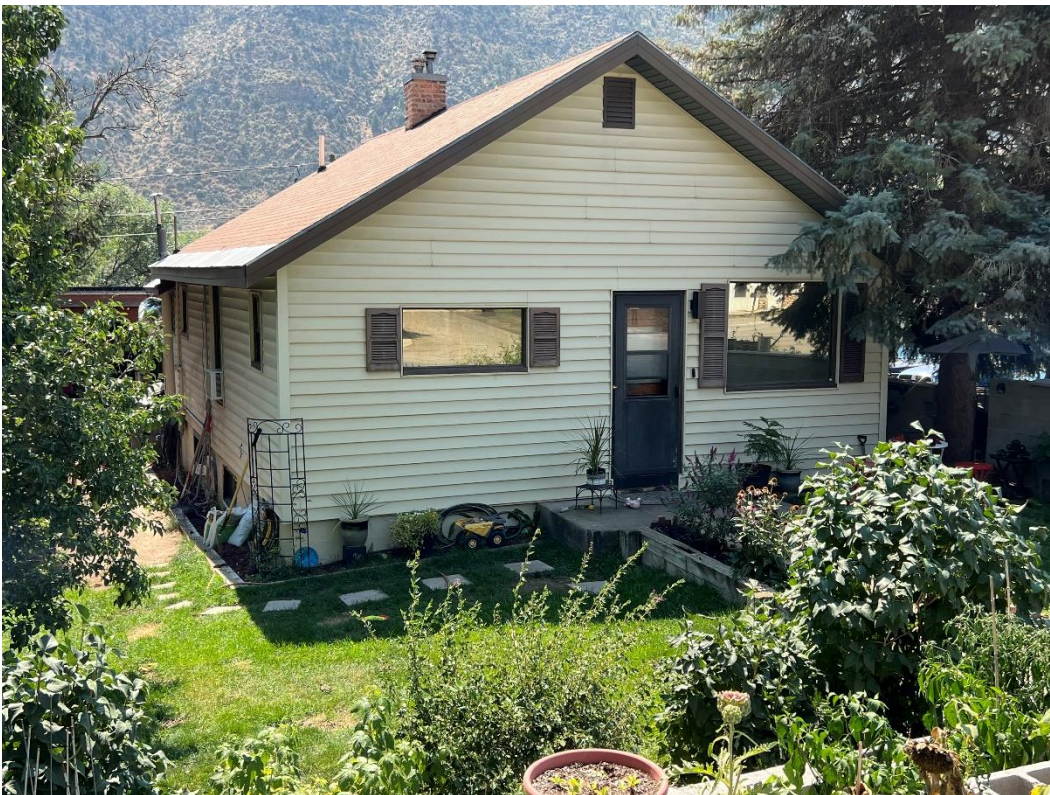
Photo Number: 5GF.5933_2
Description: Looking at the east and primary (north) elevation of the building.
Date: 9/6/2022
View: Southwest

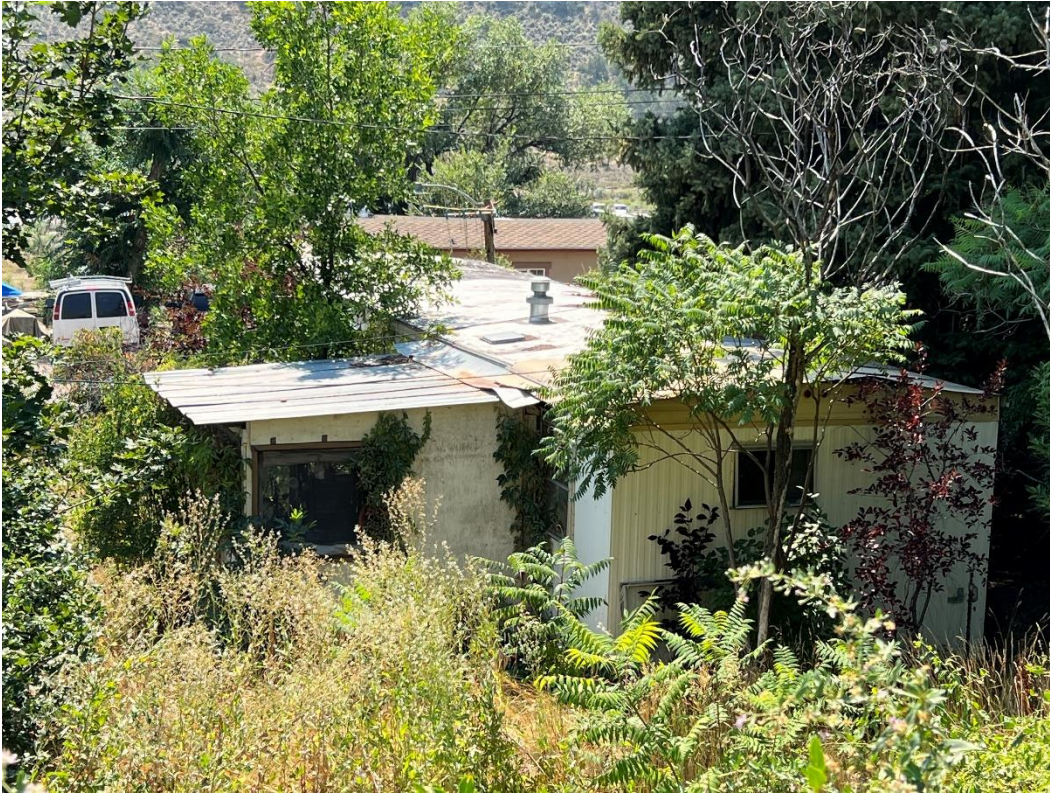
Photo Number: 5GF.5934_1
Description: Looking at the primary (east) and north elevations of the primary trailer.
Date: 9/6/2022
View: Southwest

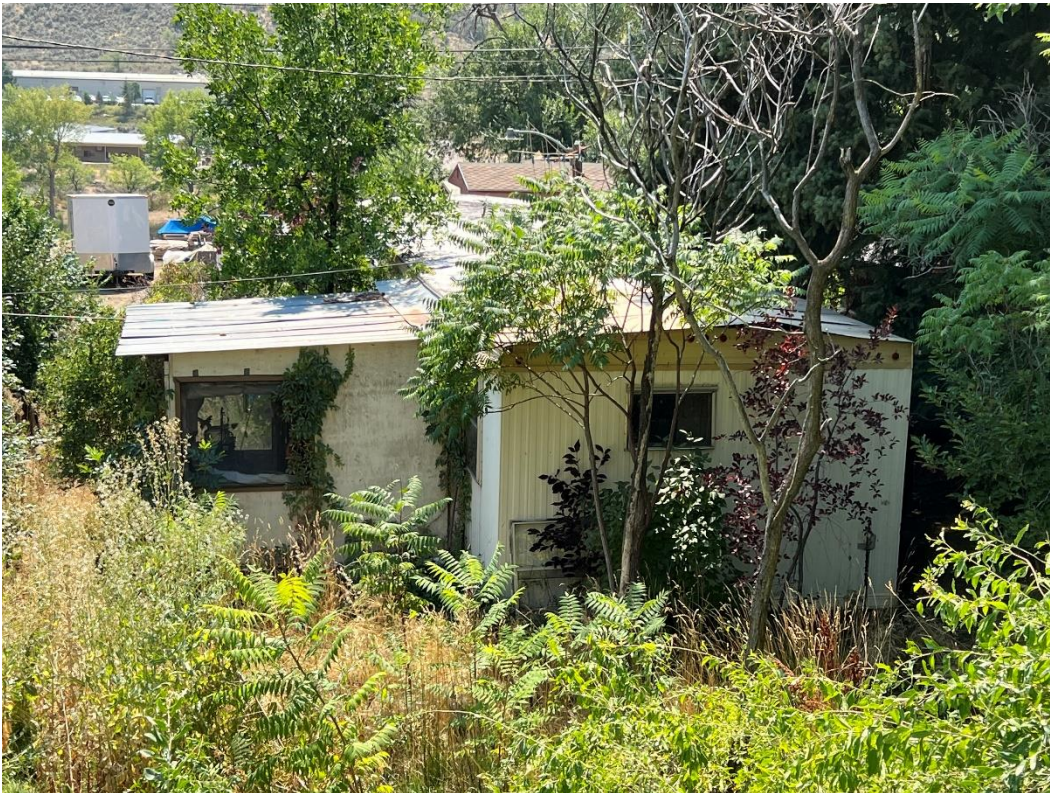
Photo Number: 5GF.5934_2
Description: Additional view of the primary (east) and north elevations of the primary trailer.
Date: 9/6/2022
View: Southwest
