New Castle Historic Preservation Commission (Regular Meeting)

New Castle - Reconnaissance Survey

The Town of New Castle (New Castle) is conducting a reconnaissance-level survey of historic resources along Main Street (US Highway 6). The survey will identify and recommend individual resources for future intensive-level survey to determine potential eligibility under National Register of Historic Places (NRHP) criteria in accordance with NRHP and State of Colorado Historic Survey Standards. In addition, this survey assesses the potential for a historic district as well as identify and recommend resources that may contribute toward a potential NRHP historic district. This survey represents the most recent evaluation of historic resources in the Town of New Castle. Previous historic resource surveys have mostly focused on residential and commercial buildings/structures in the central quadrant of the town. Resources in the survey area—bounded by Elk Creek to the west, Burning Mountain Avenue to the east, and adjacent to Main Street—are the focus of this reconnaissance report.

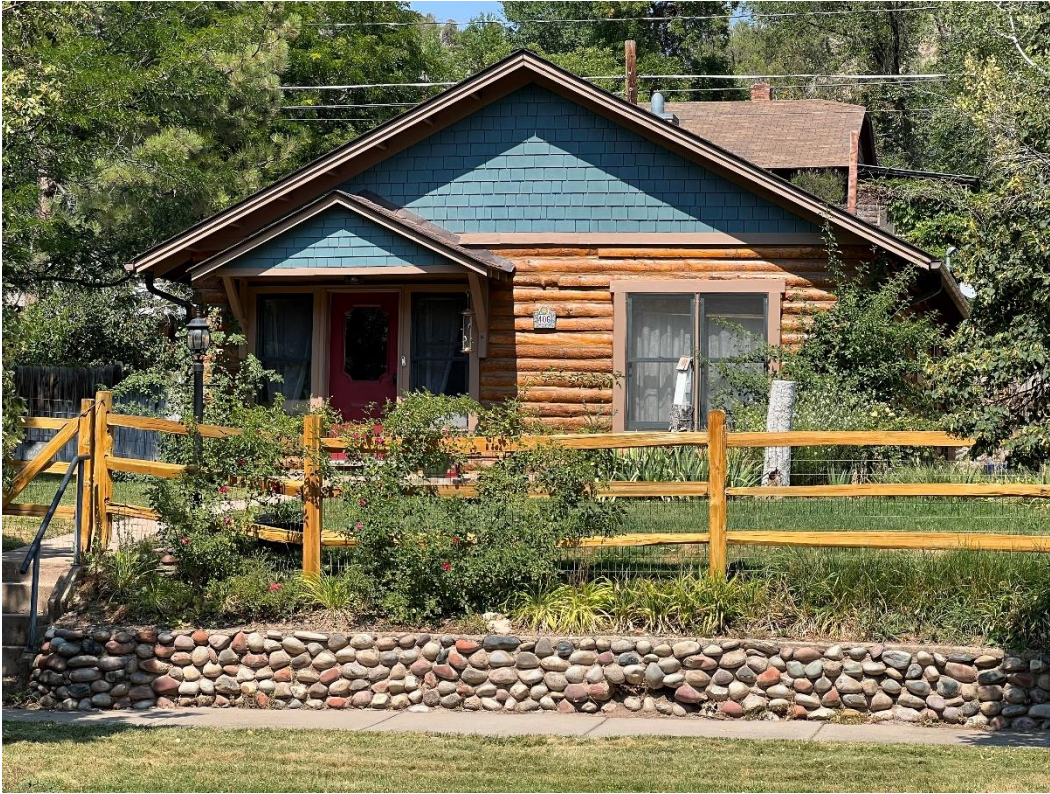
Photo Number: 5GF.5935_1
Description: Looking at the primary (south) elevation of the building. Note the decorative stone masonry wall, and the post and rail fencing.
Date: 9/6/2022
View: North

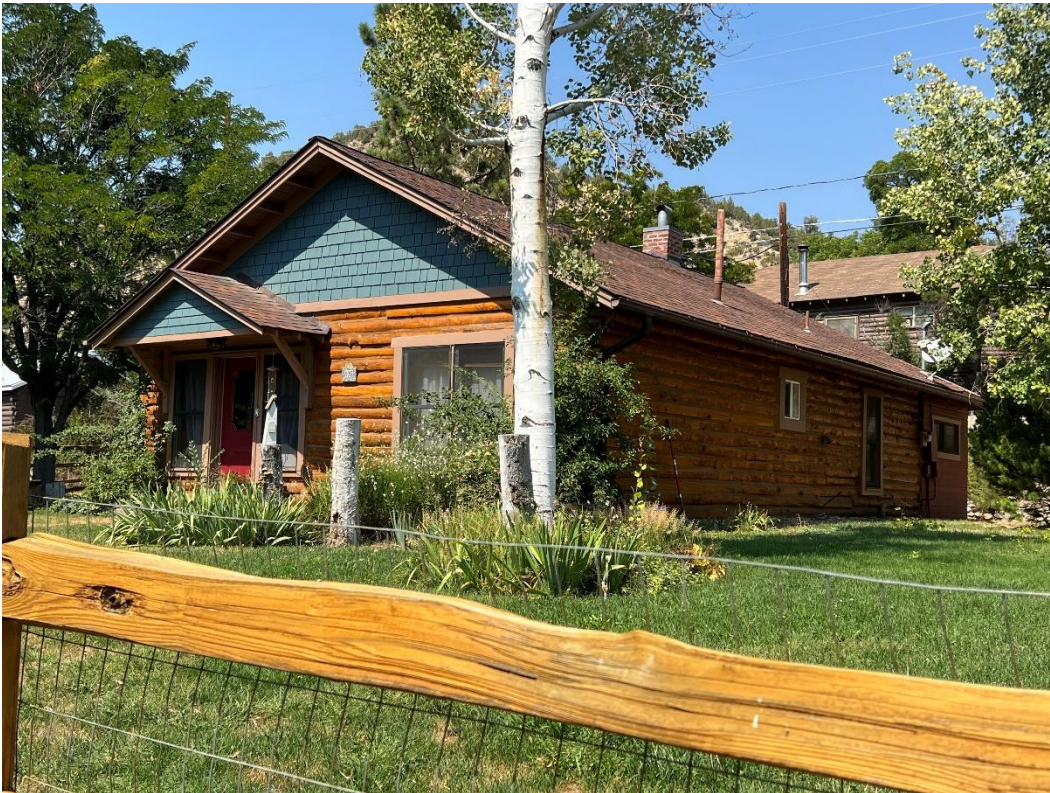
Photo Number: 5GF.5935_2
Description: Looking at the primary (south) and east elevations of the building.
Date: 9/6/2022
View: Northwest

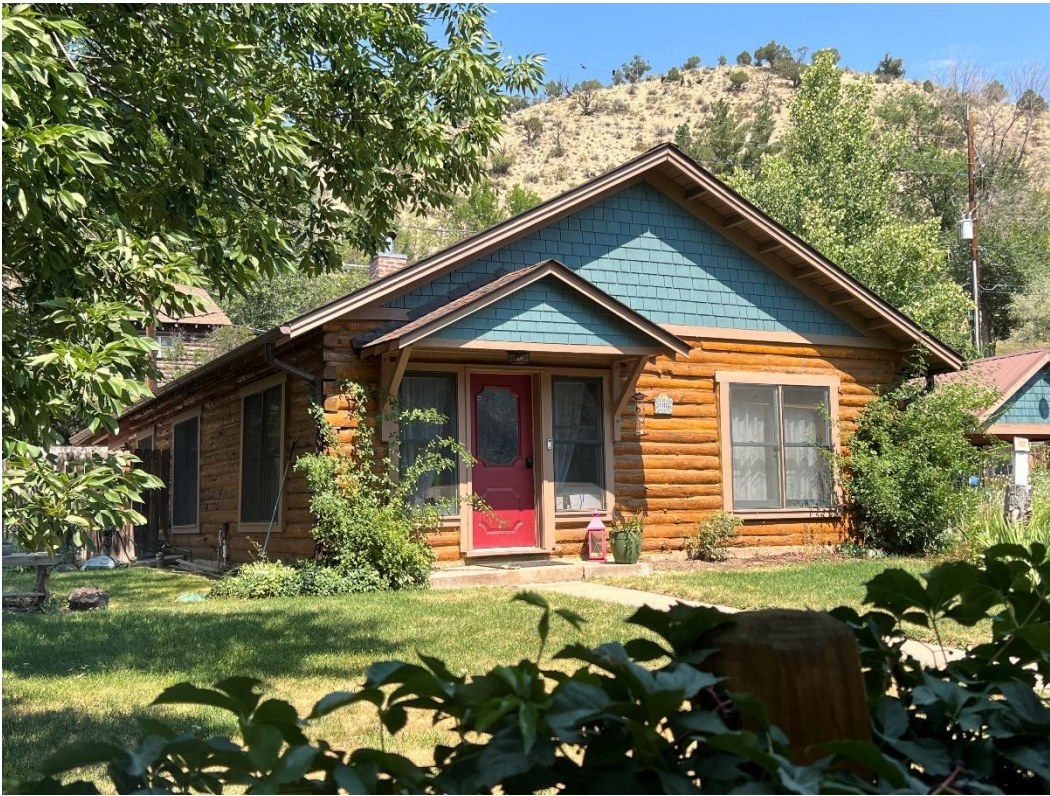
Photo Number: 5GF.5935_3
Description: Looking at the west and primary (south) elevations of the building.
Date: 9/6/2022
View: Northeast

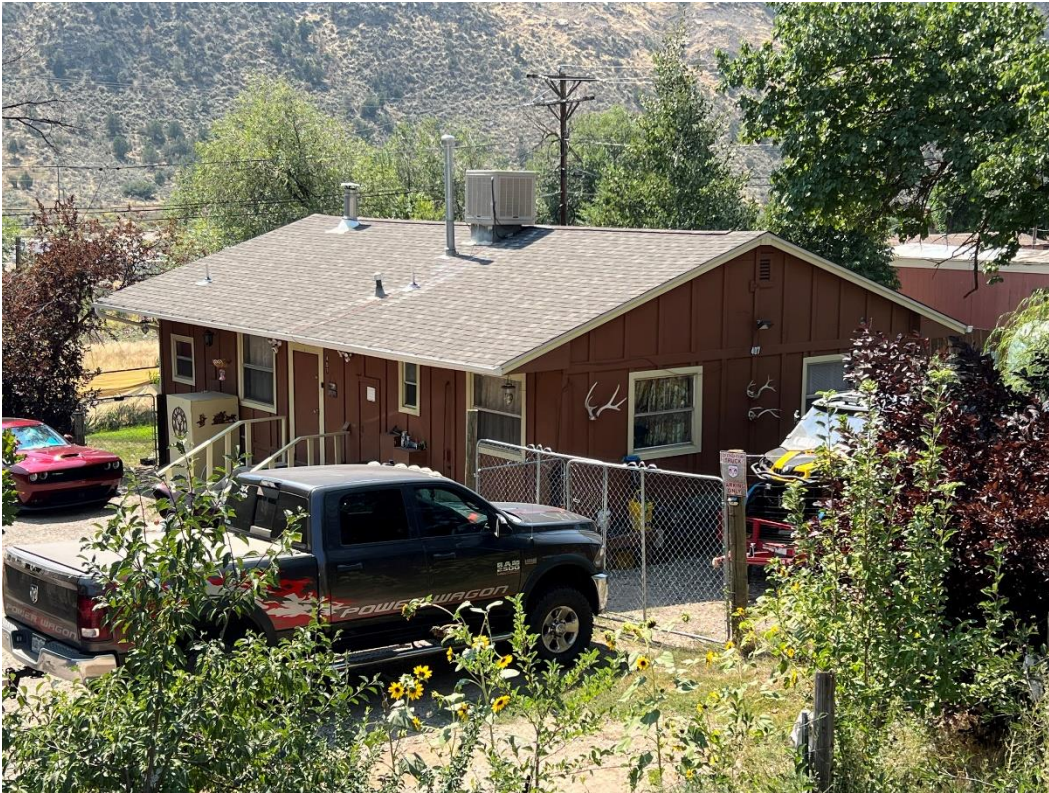
Photo Number: 5GF.5936_1
Description: Looking at the primary (east) elevation and north elevation of the building.
Date: 9/6/2022
View: Southwest

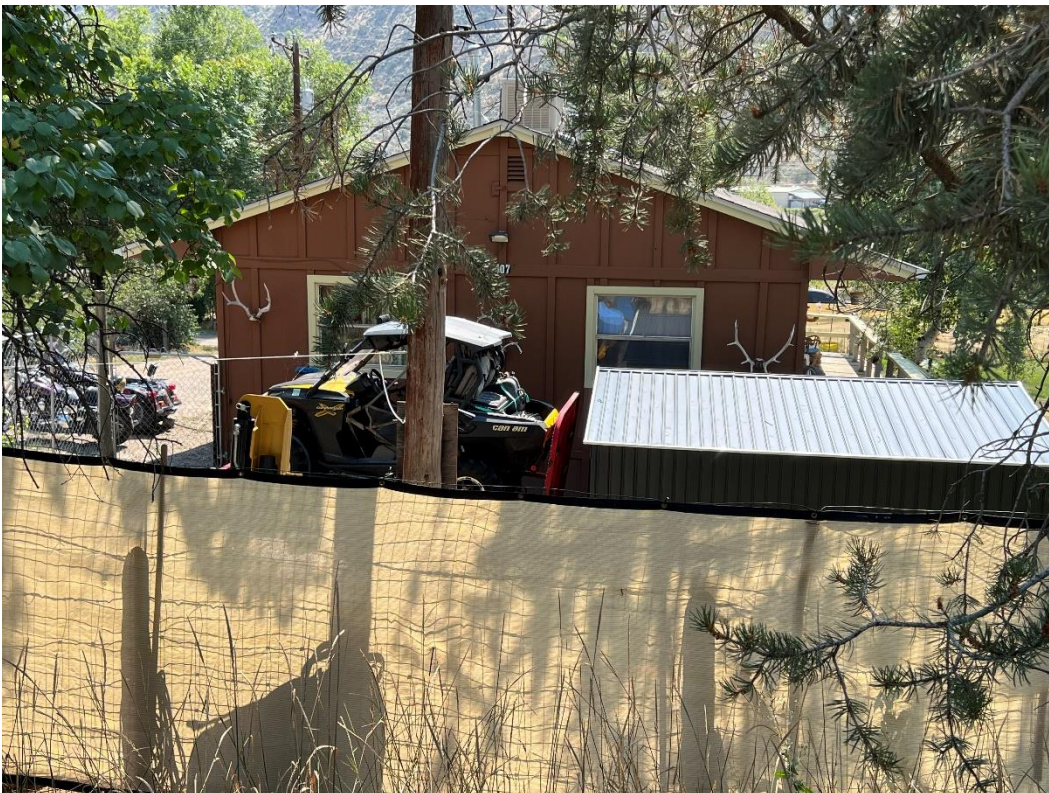
Photo Number: 5GF.5936_2
Description: Looking at the north elevation of the building. Note the horizontal wood belt course in the gable end.
Date: 9/6/2022
View: South

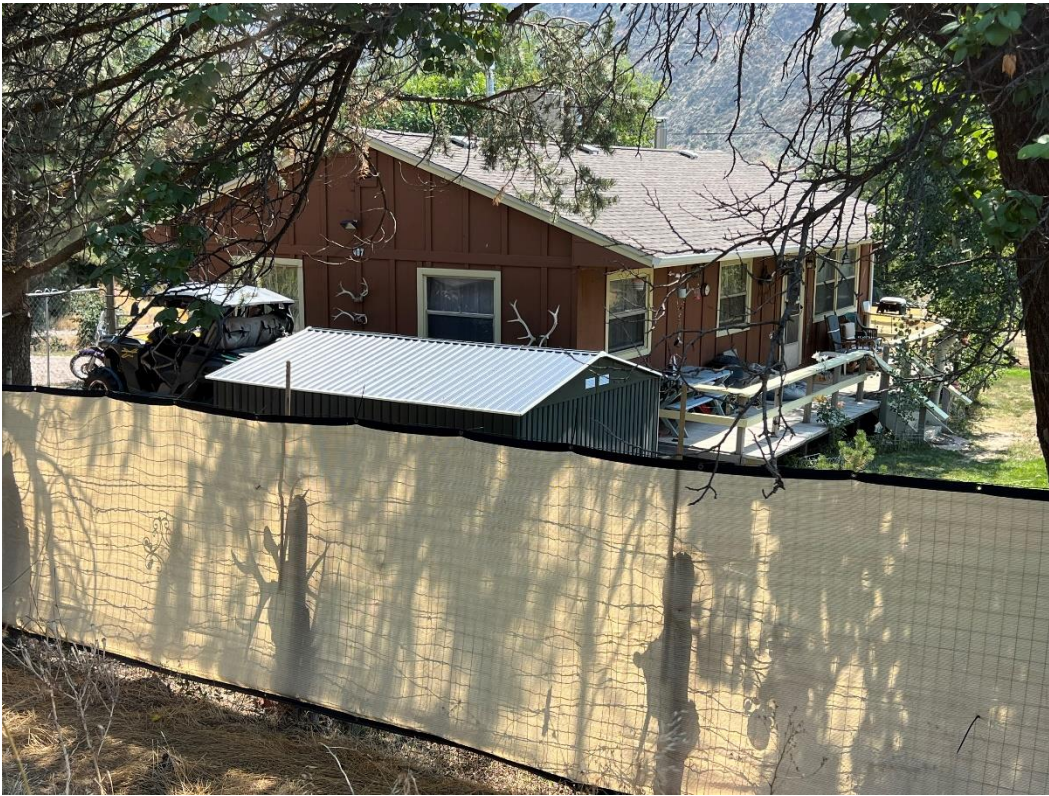
Photo Number: 5GF.5936_3

Description: Looking at the north and west elevations of the building.

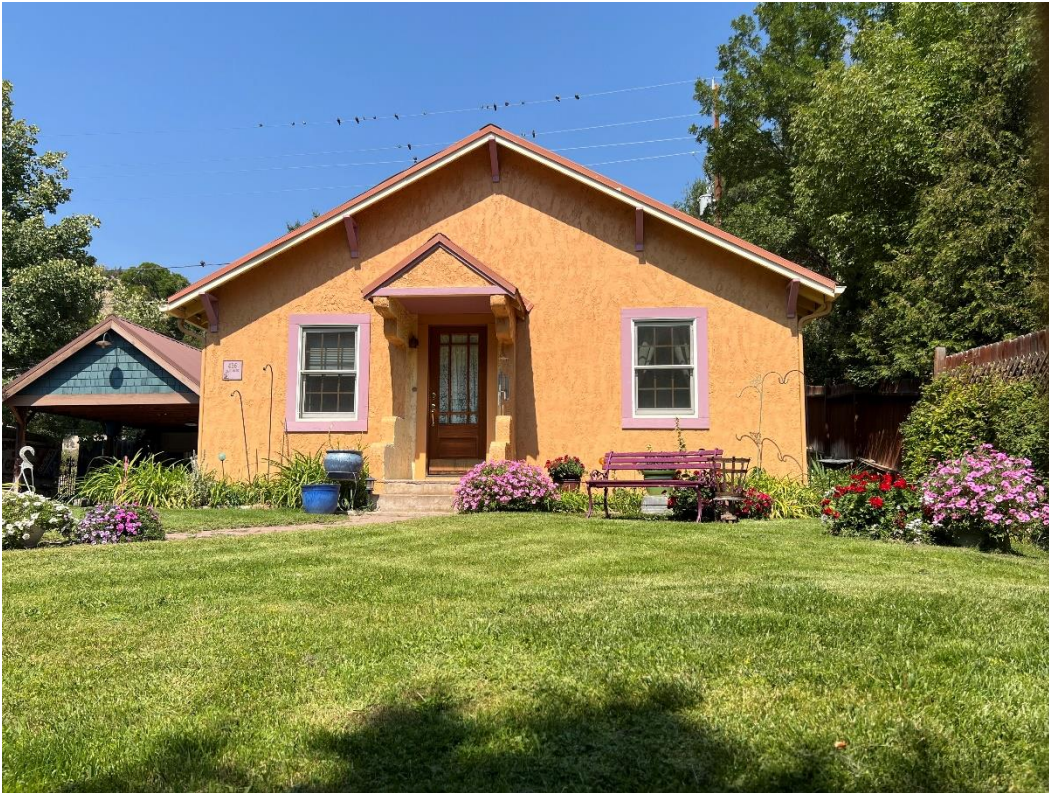
Photo Number: 5GF.5937_1
Description: Looking at the primary (south) elevation of the building. Note the decorative entryway and brackets under the gable peak.
Date: 9/6/2022
View: North

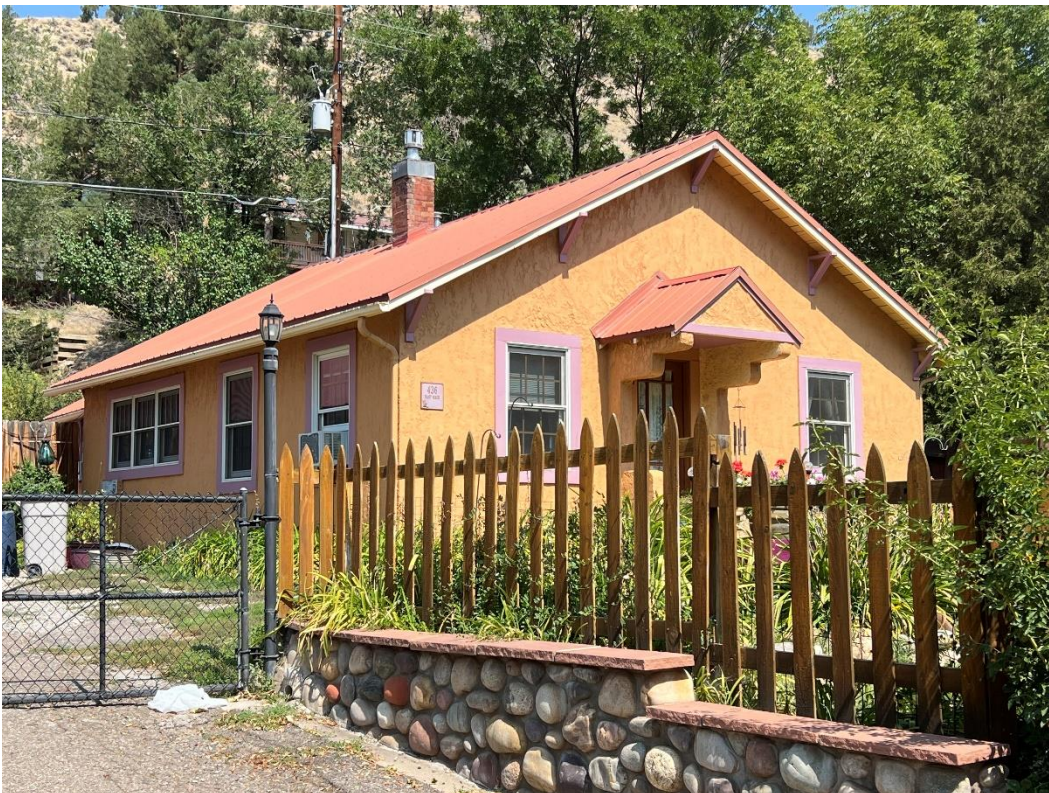
Photo Number: 5GF.5937_2
Description: Looking at the west and primary (south) elevation of the building.
Date: 9/6/2022
View: Northeast

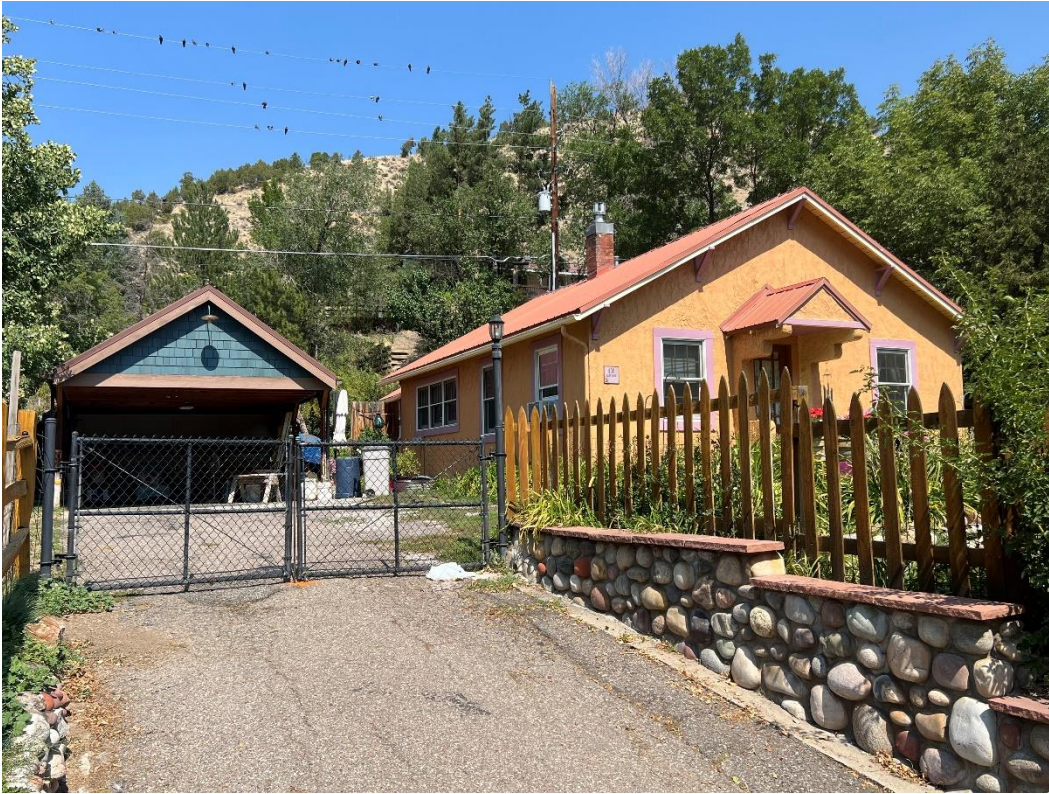
Photo Number: 5GF.5937_3
Description: Context view of the residence's west and primary (south) elevations. Note the stone masonry wall and wood picket fencing along the legal parcel boundary.
Date: 9/6/2022
View: Northeast

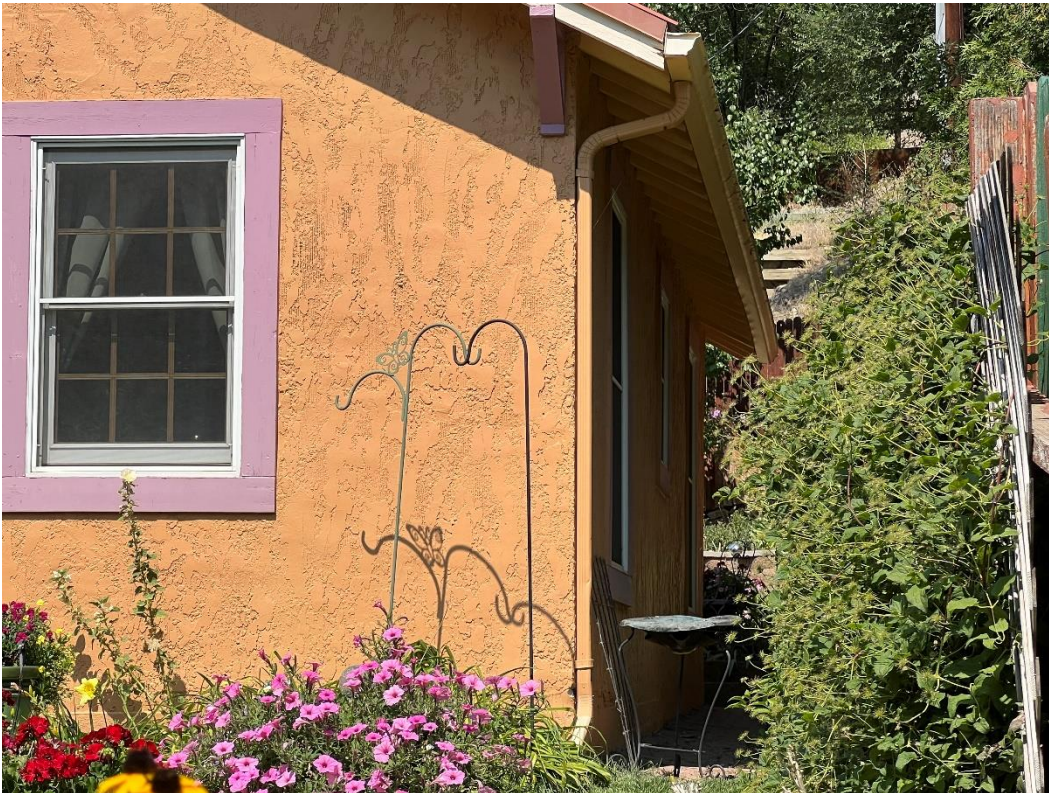
Photo Number: 5GF.5937_4
Description: Looking at the east elevation of the building. The building's proximity to the wall on the right makes it difficult to observe the entire elevation.
Date: 9/6/2022
View: Northwest

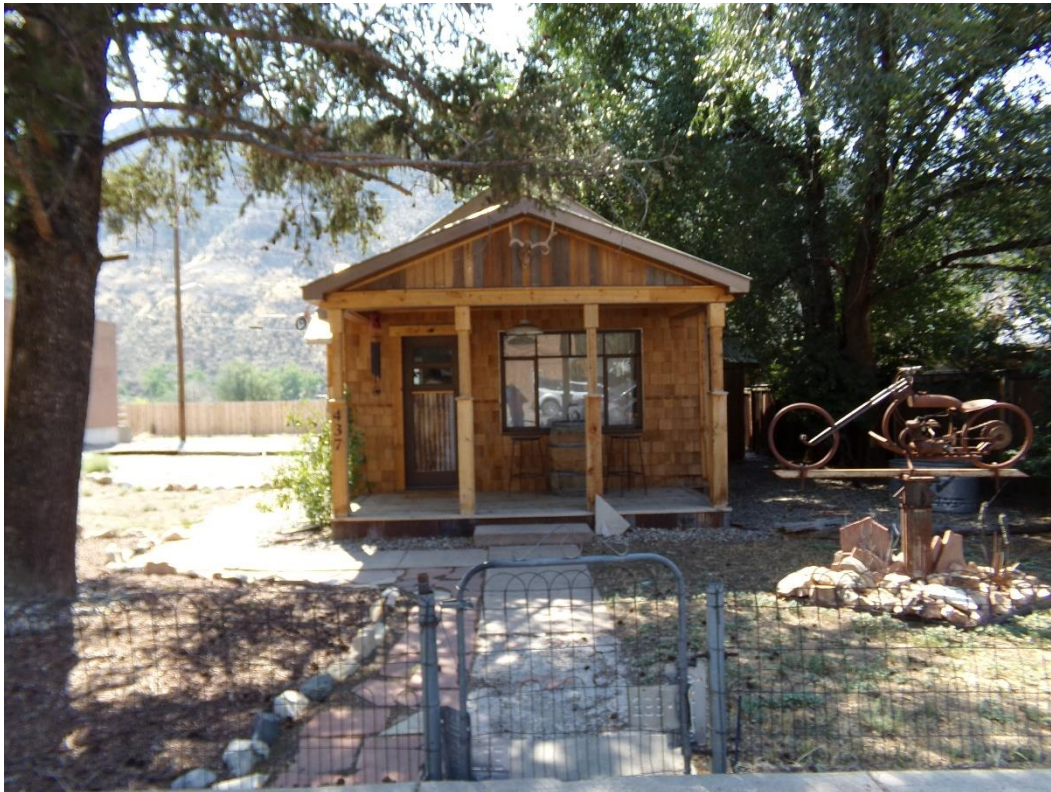
Photo Number: 5GF.5910_1
Description: Looking at the primary (north) elevation of the residence.
Date: 9/6/2022
View: South

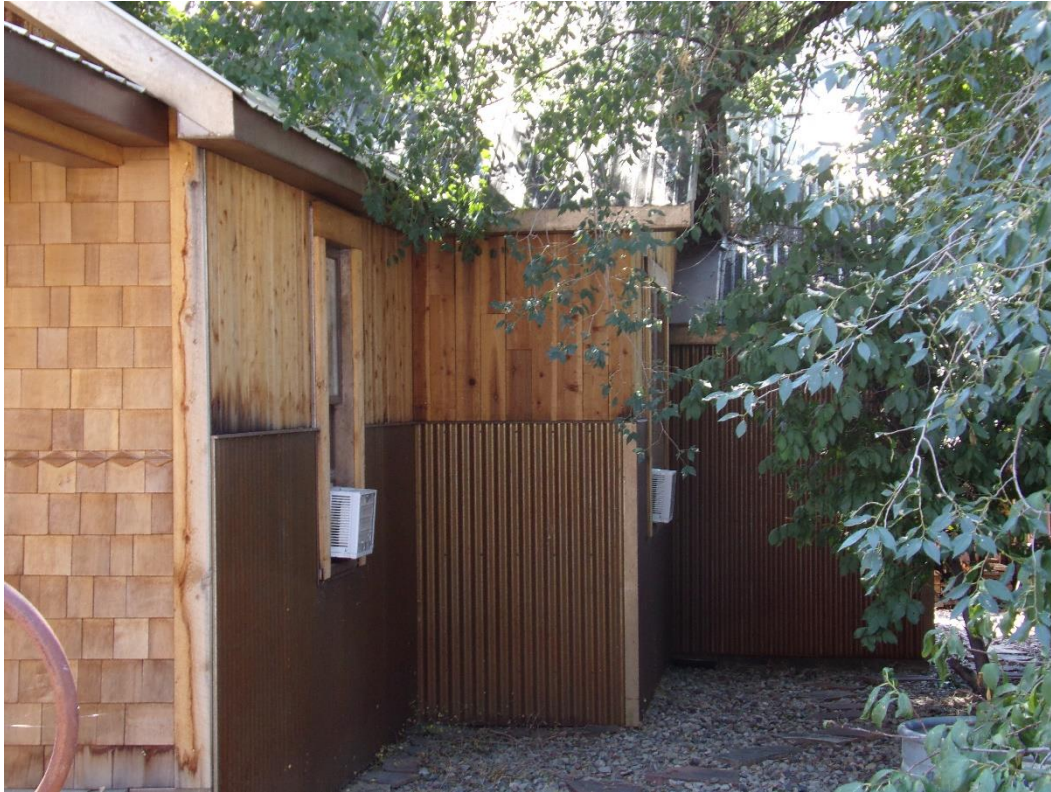
Photo Number: 5GF.5910_2
Description: Looking at the west elevation of the building.
Date: 9/6/2022
View: Southeast

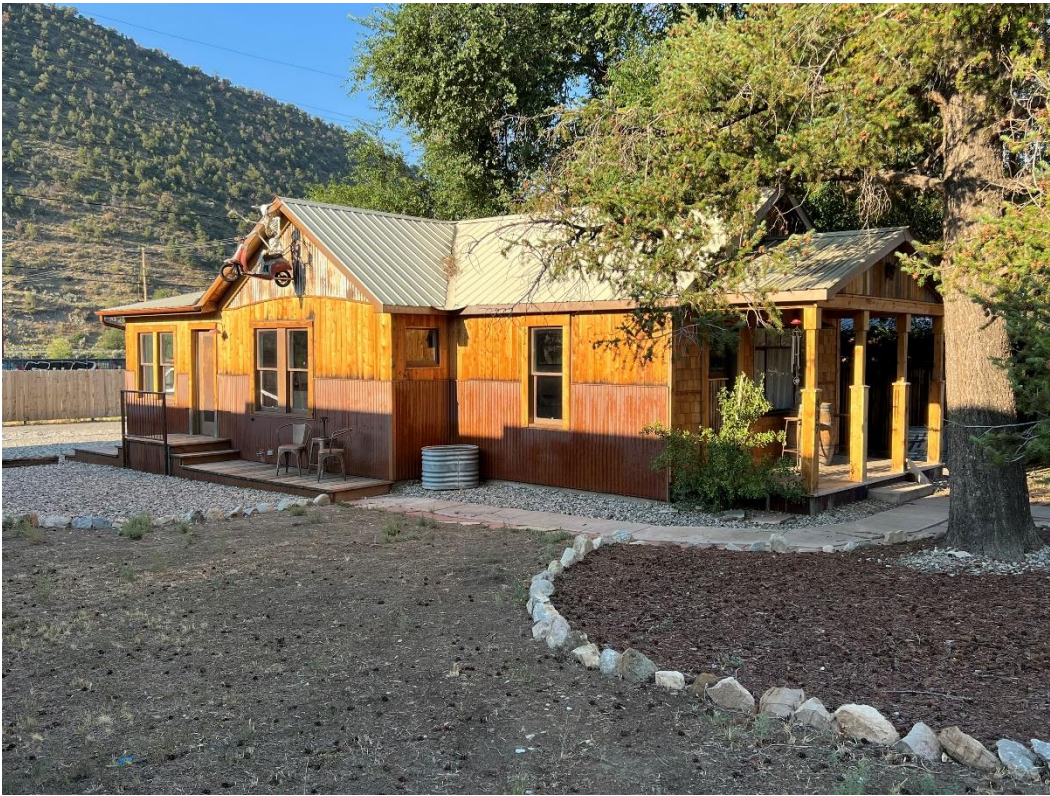
Photo Number: 5GF.5910_3
Description: Looking at the east and primary (north) elevations of the building.
Date: 9/6/2022
View: Southwest

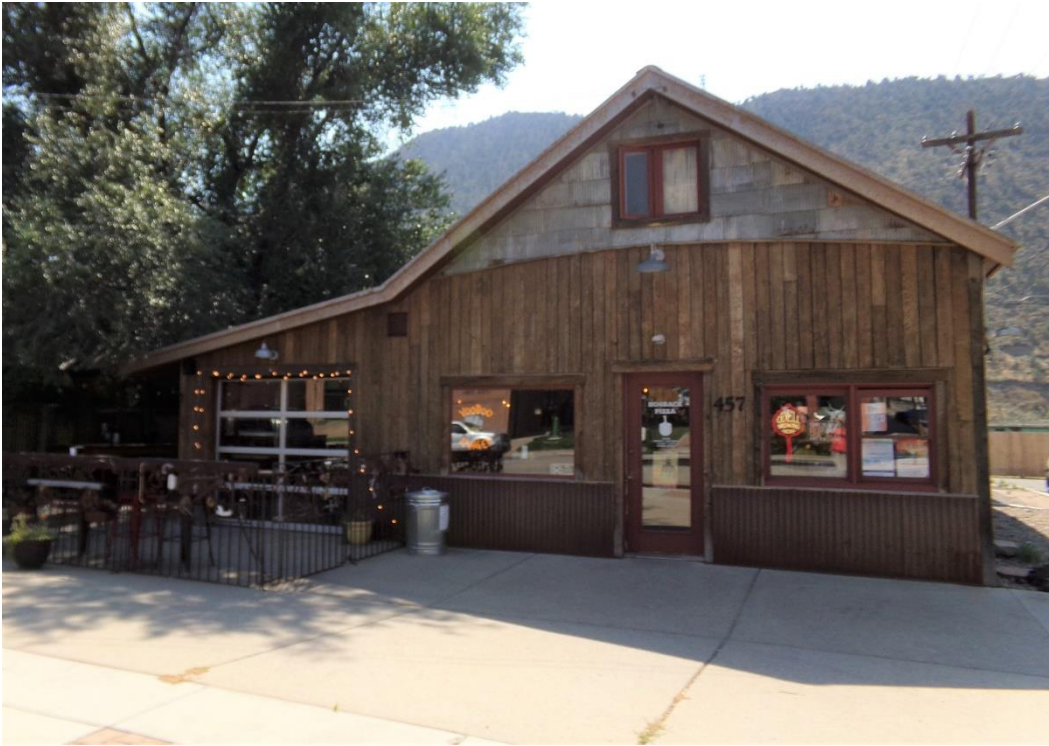
Photo Number: 5GF.5909_1
Description: Looking at the primary (north) elevation of the building.
Date: 9/6/2022
View: South

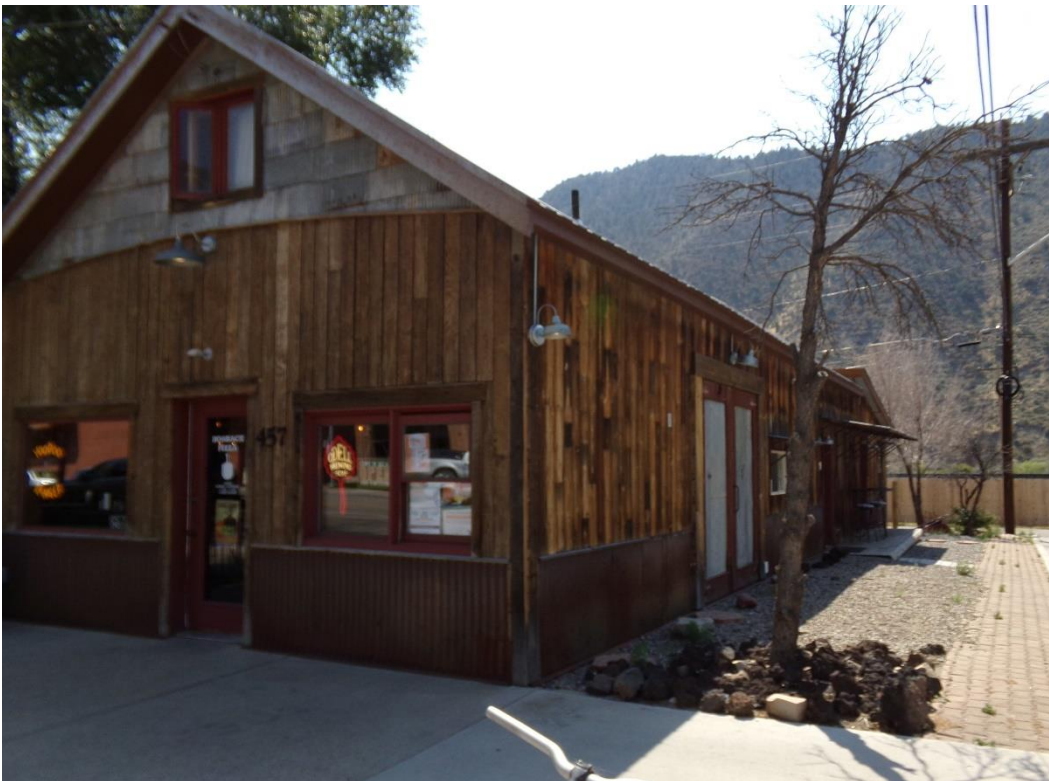
Photo Number: 5GF.5909_2
Description: Looking at the primary (north) and west elevations of the building.
Date: 9/6/2022
View: Southeast

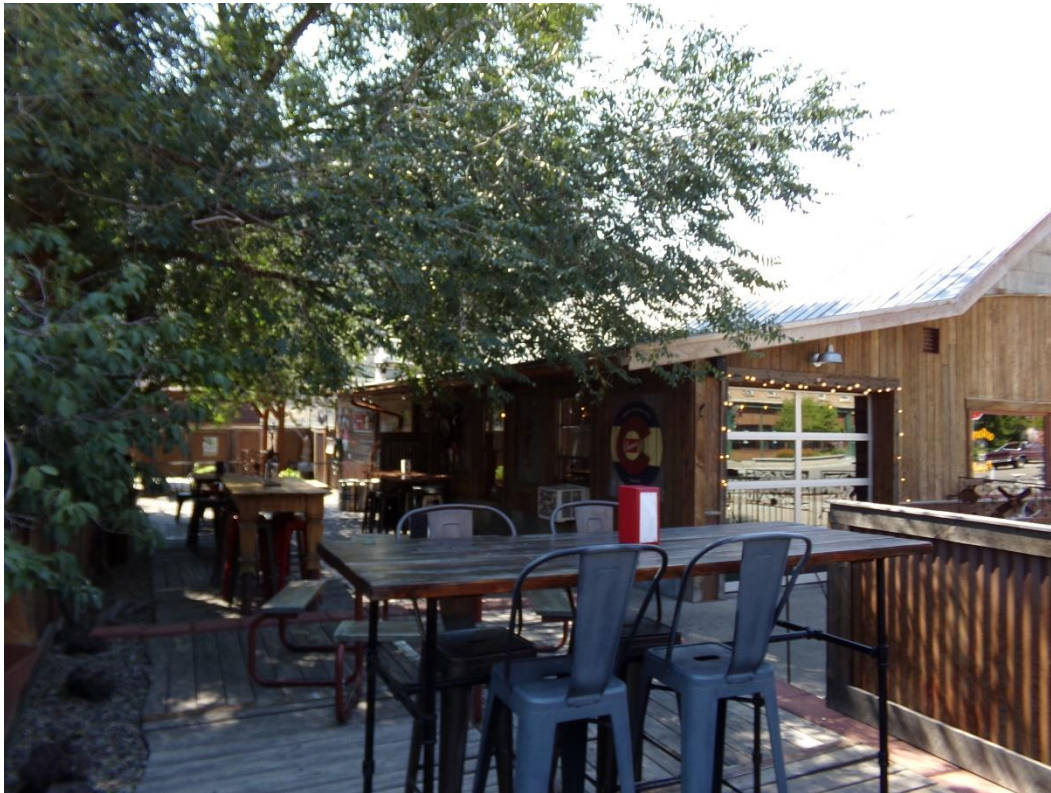
Photo Number: 5GF.5909_3
Description: Looking at the east and primary (north) elevations of the building.
Date: 9/6/2022
View: Southwest

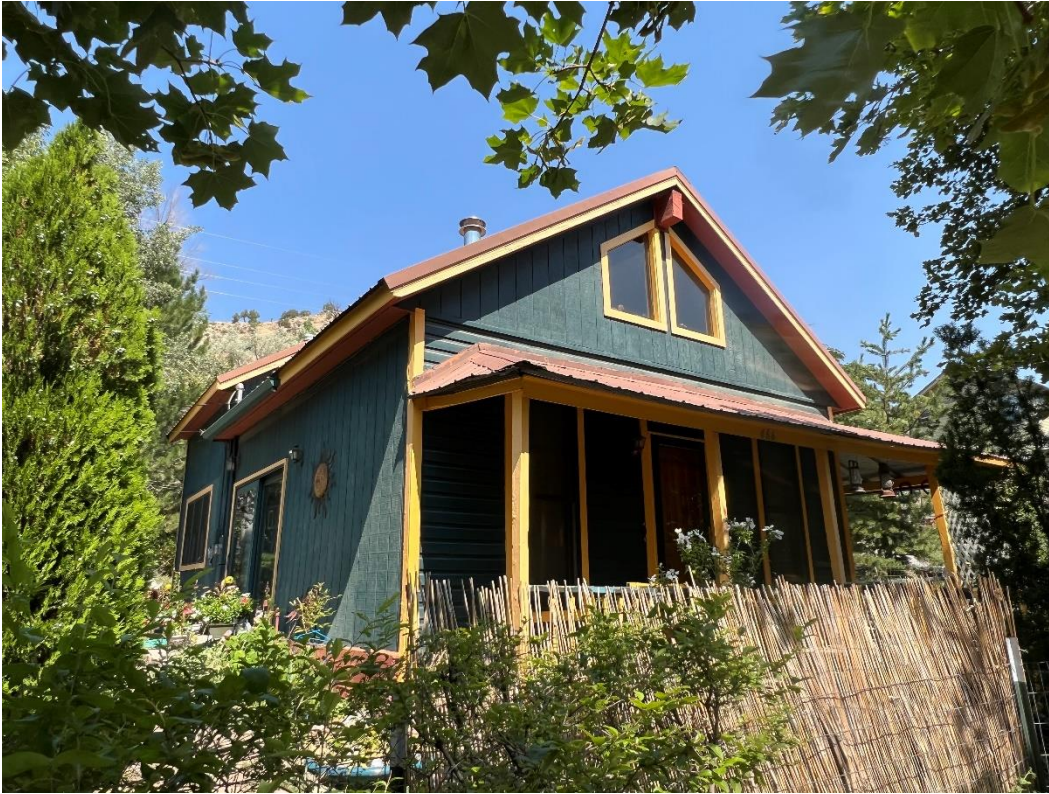
Photo Number: 5GF.5938_1
Description: Looking at the west and primary (south) elevation of the building.
Date: 9/6/2022
View: Northeast

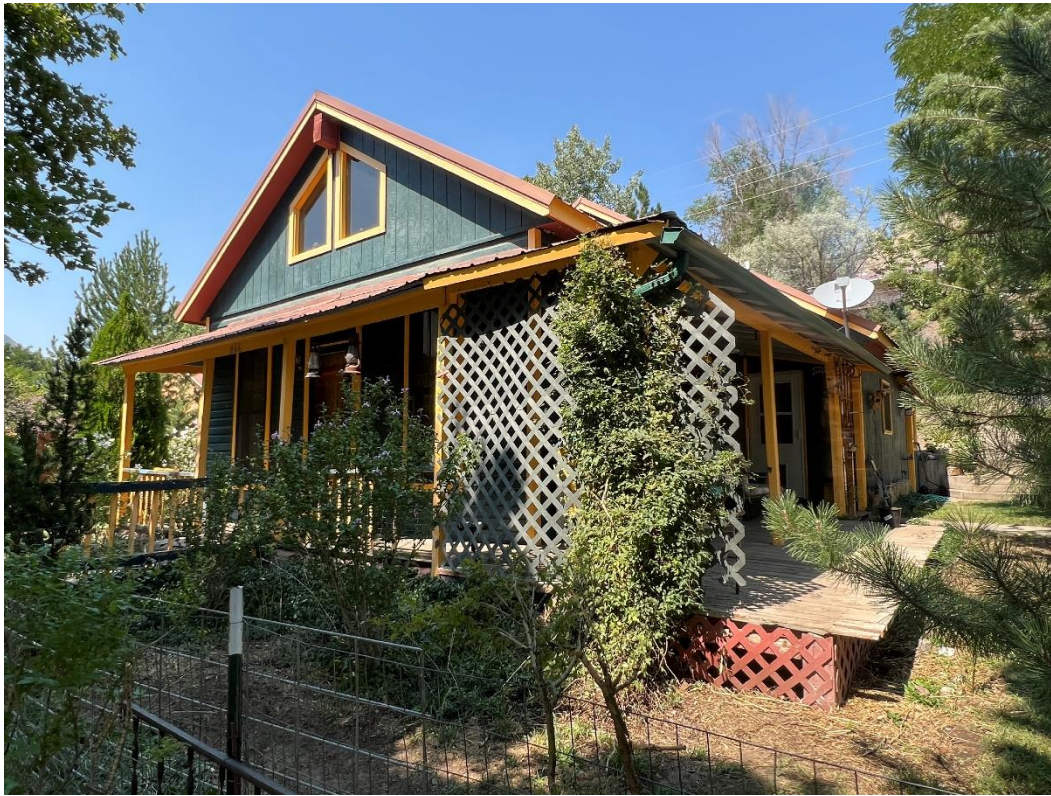
Photo Number: 5GF.5938_2
Description: Looking at the primary (south) elevation of the building. Note that much of the facade is observed by wood fencing and vegetation from the public ROW.
Date: 9/6/2022
View: North

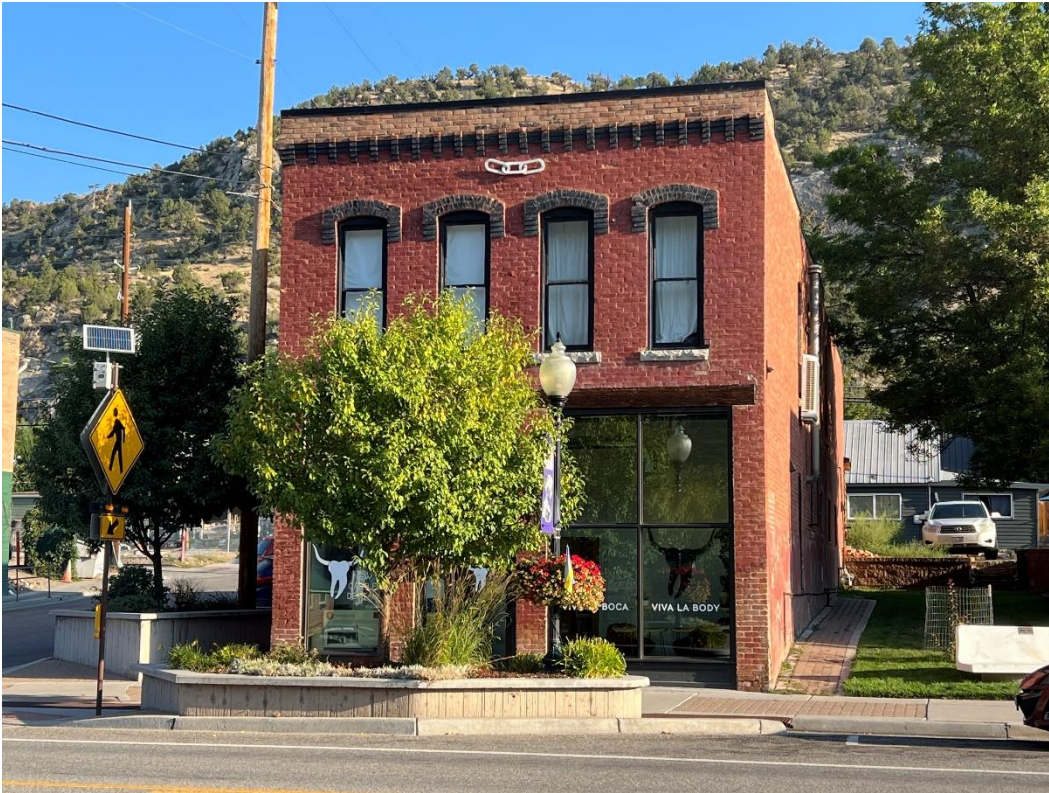
Photo Number: 5GF.1488_1
Description: Looking at the primary (south) elevation of the building.
Date: 9/6/2022
View: North

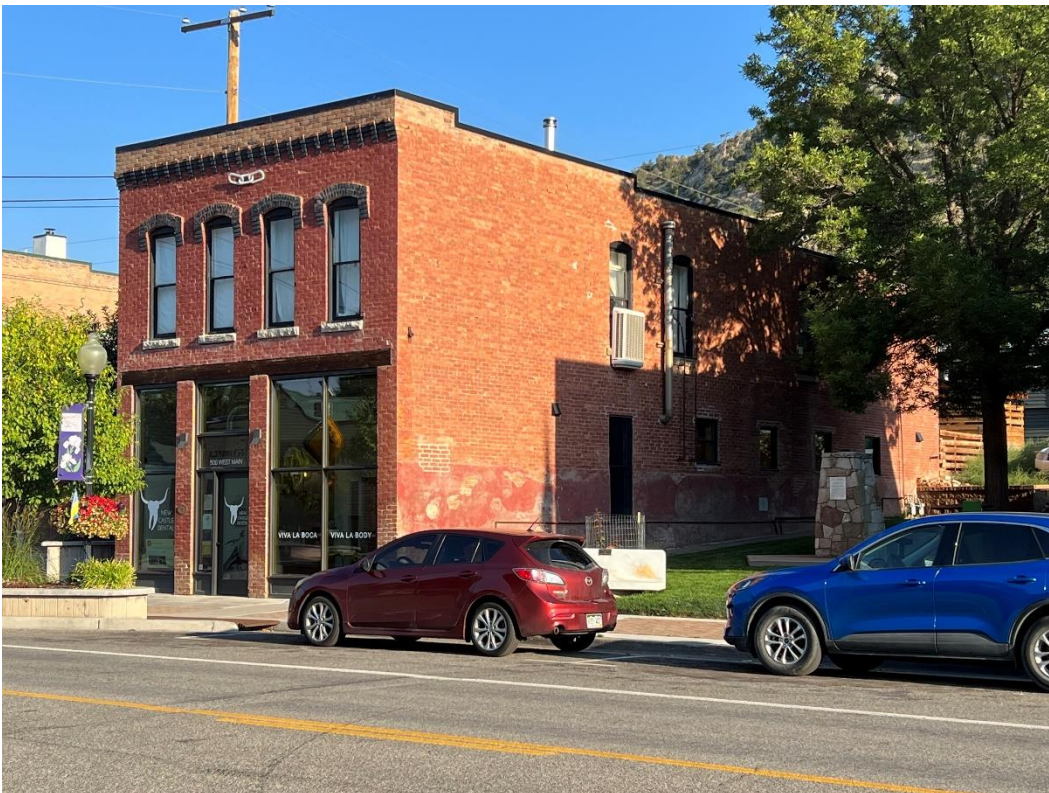
Photo Number: 5GF.1488_2
Description: Looking at the primary (south) and east elevation of the building.
Date: 9/6/2022
View: Northwest

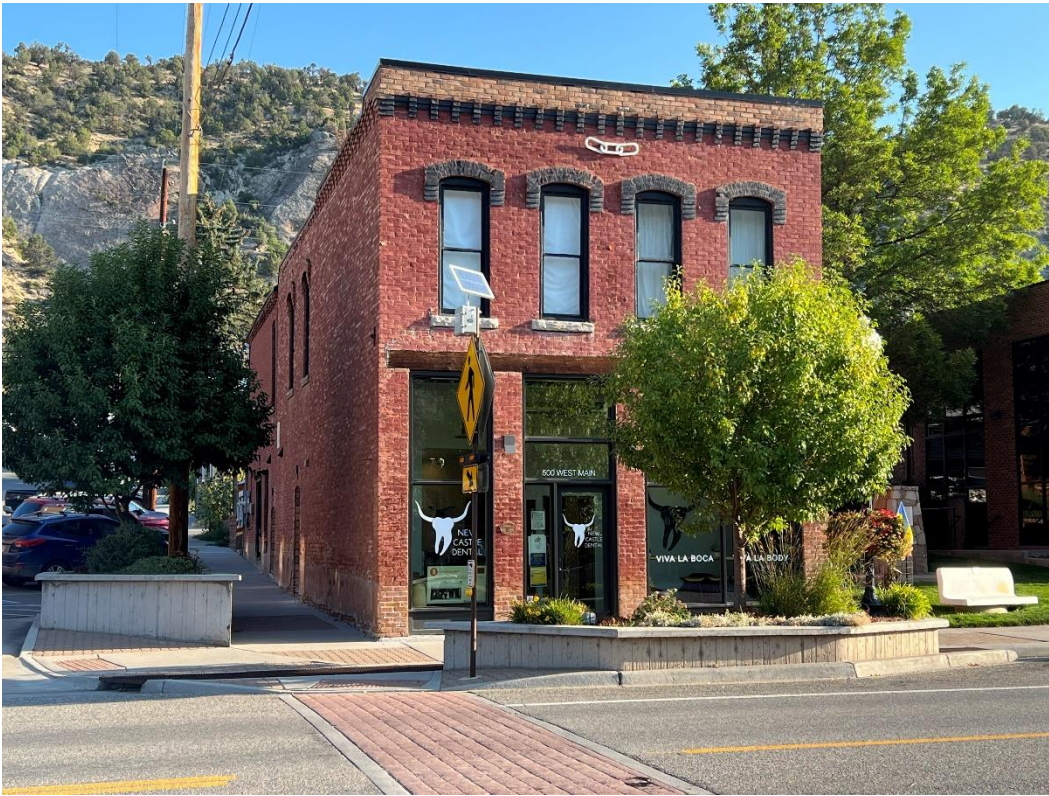
Photo Number: 5GF.1488_3
Description: Looking at the west and primary (south) elevations of the building.
Date: 9/6/2022
View: Northeast

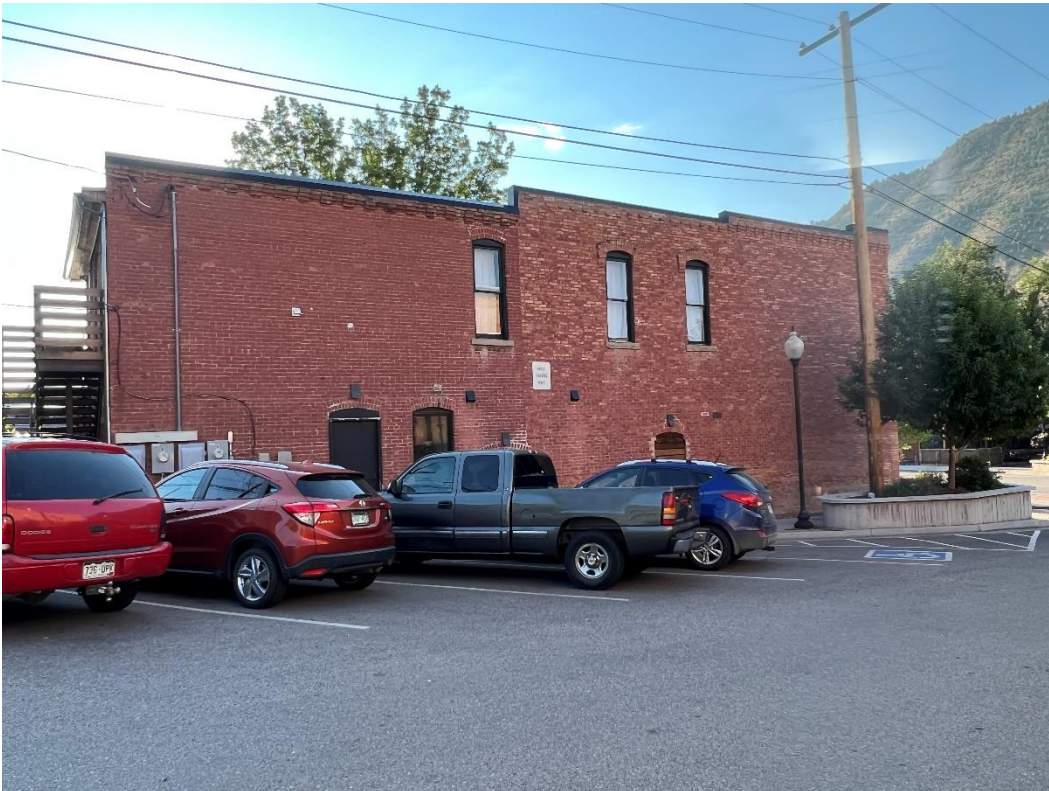
Photo Number: 5GF.1488_4
Description: Looking at the west elevation of the building.
Date: 9/6/2022
View: Southeast

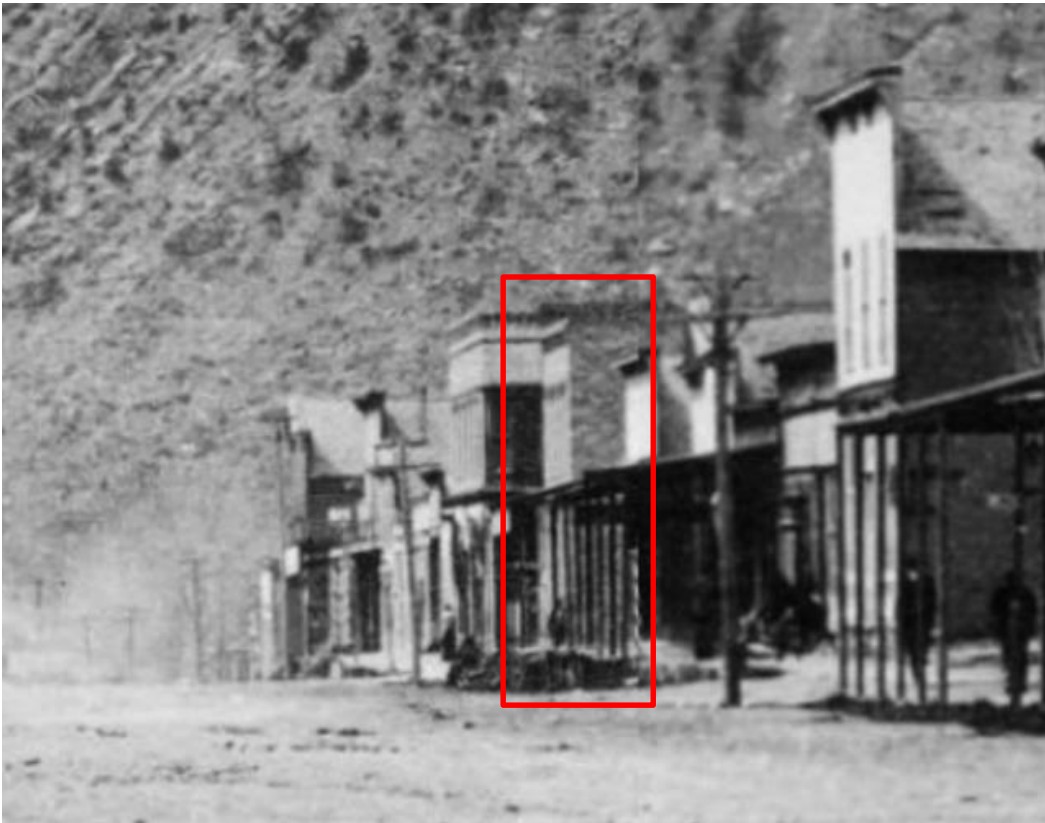
Historic Photo 1

Description: Image of downtown New Castle looking west down Main Street from the intersection of Main Street and North 4th Street. Note that the resource is behind the shed roof overhang which is not associated with the building. The resource is outline in red.

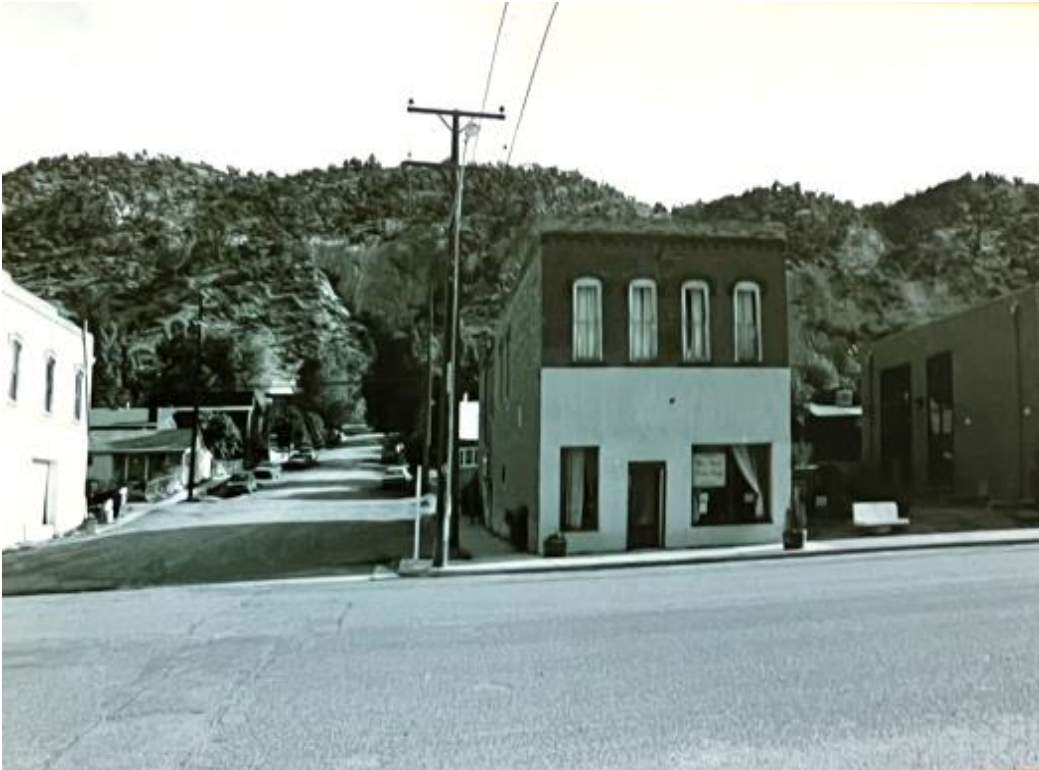
Reference Photo 1

Description: Image states, "Odd Fellows Hall built in 1909. Ground floor housed a meat market, then a mercantile store, and later a "Mane Street Beauty Shop." Note the plywood that covers the first floor of the façade.

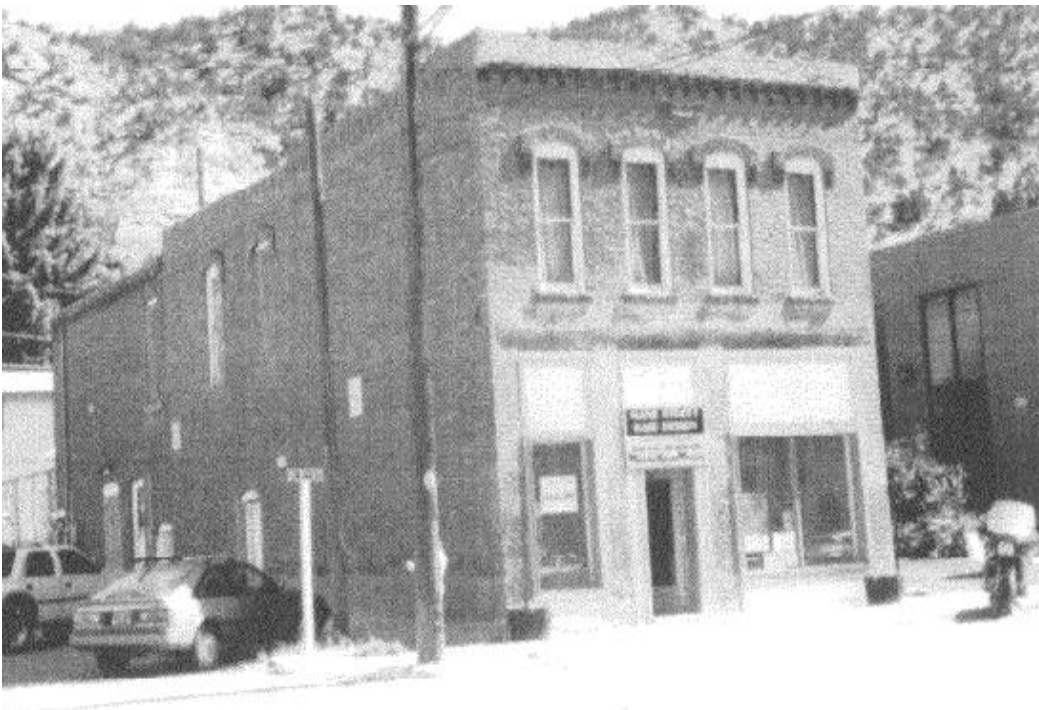
Reference Photo 2

Description: Looking at the west and primary (south) elevation of the building.

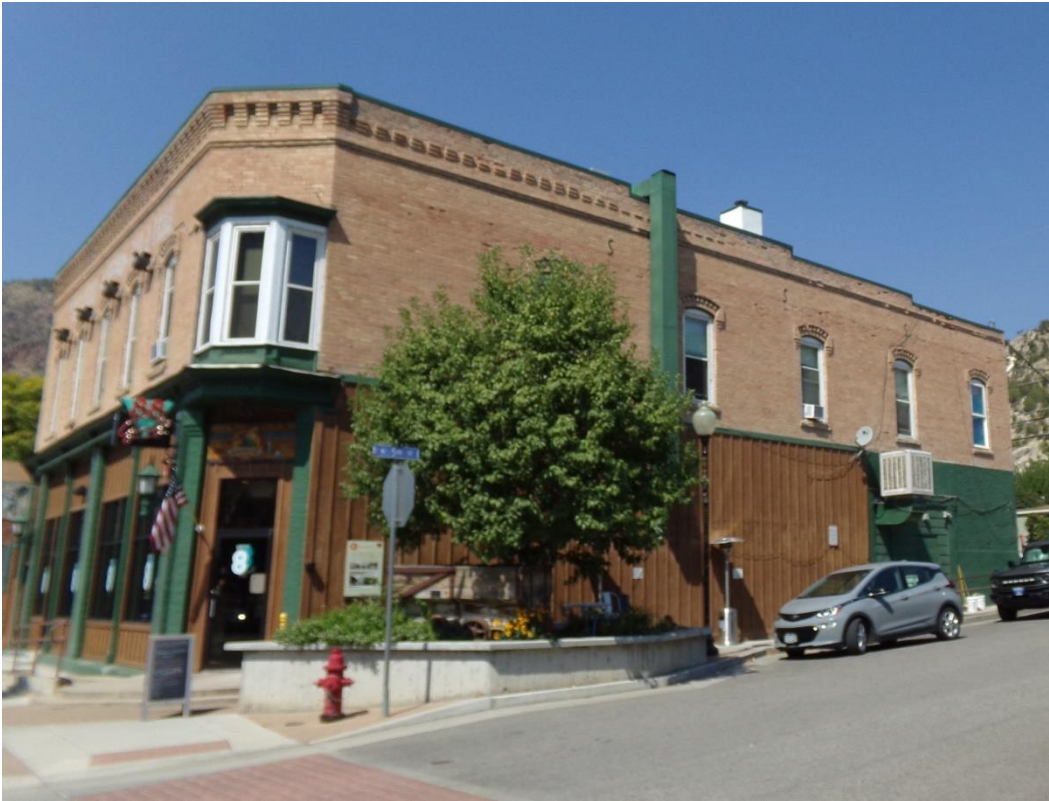
Photo Number: 5GF.1166_1
Description: Looking at the primary (south) and east elevations of the building.
Date: 9/6/2022
View: Northwest
