New Castle Historic Preservation Commission (Regular Meeting)

New Castle - Reconnaissance Survey

The Town of New Castle (New Castle) is conducting a reconnaissance-level survey of historic resources along Main Street (US Highway 6). The survey will identify and recommend individual resources for future intensive-level survey to determine potential eligibility under National Register of Historic Places (NRHP) criteria in accordance with NRHP and State of Colorado Historic Survey Standards. In addition, this survey assesses the potential for a historic district as well as identify and recommend resources that may contribute toward a potential NRHP historic district. This survey represents the most recent evaluation of historic resources in the Town of New Castle. Previous historic resource surveys have mostly focused on residential and commercial buildings/structures in the central quadrant of the town. Resources in the survey area—bounded by Elk Creek to the west, Burning Mountain Avenue to the east, and adjacent to Main Street—are the focus of this reconnaissance report.

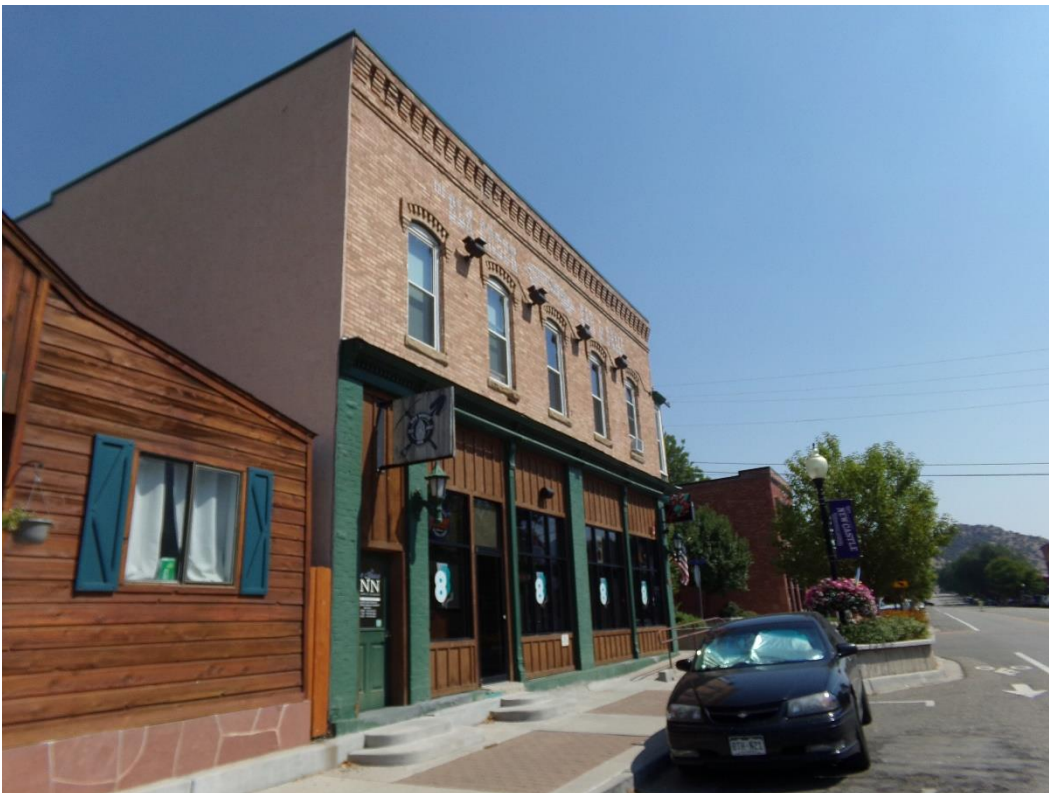
Photo Number: 5GF.1166_1
Description: Looking at the west and primary (south) elevation of the building.
Date: 9/6/2023
View: Northeast

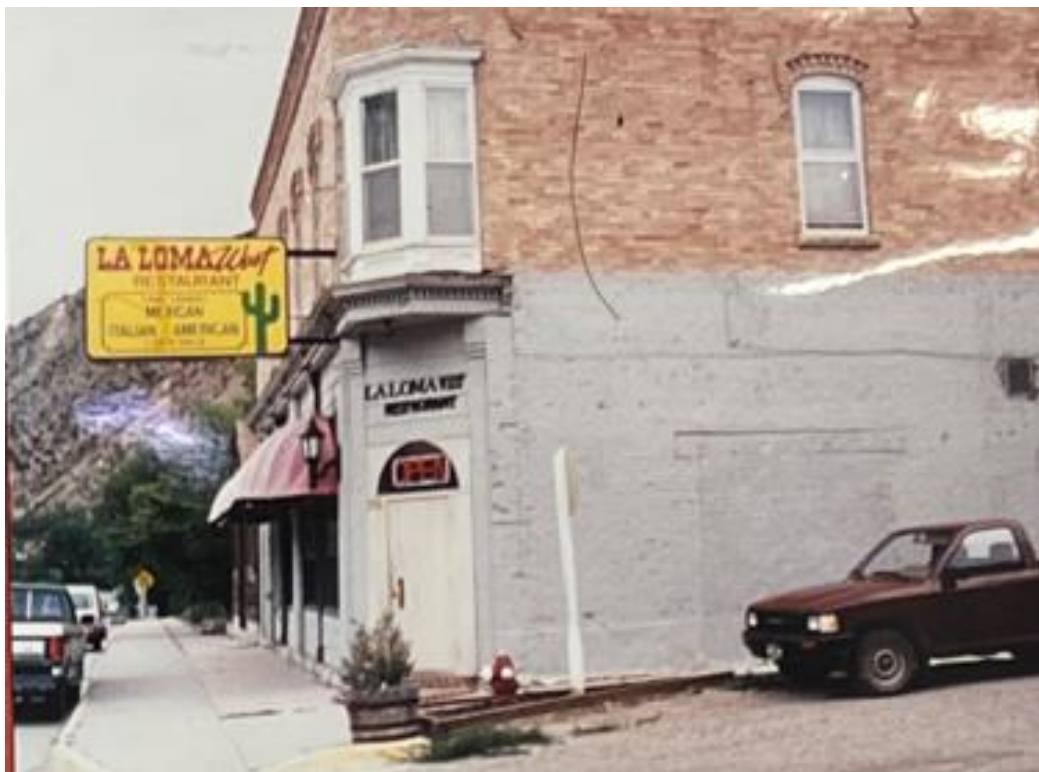
Reference Photo 1

Description: Image states, "Laloma Resturant was Doll Bros. & Rocky Mountain store. It was also the Brunetti Garage. Now Elk Creek Mining Co."

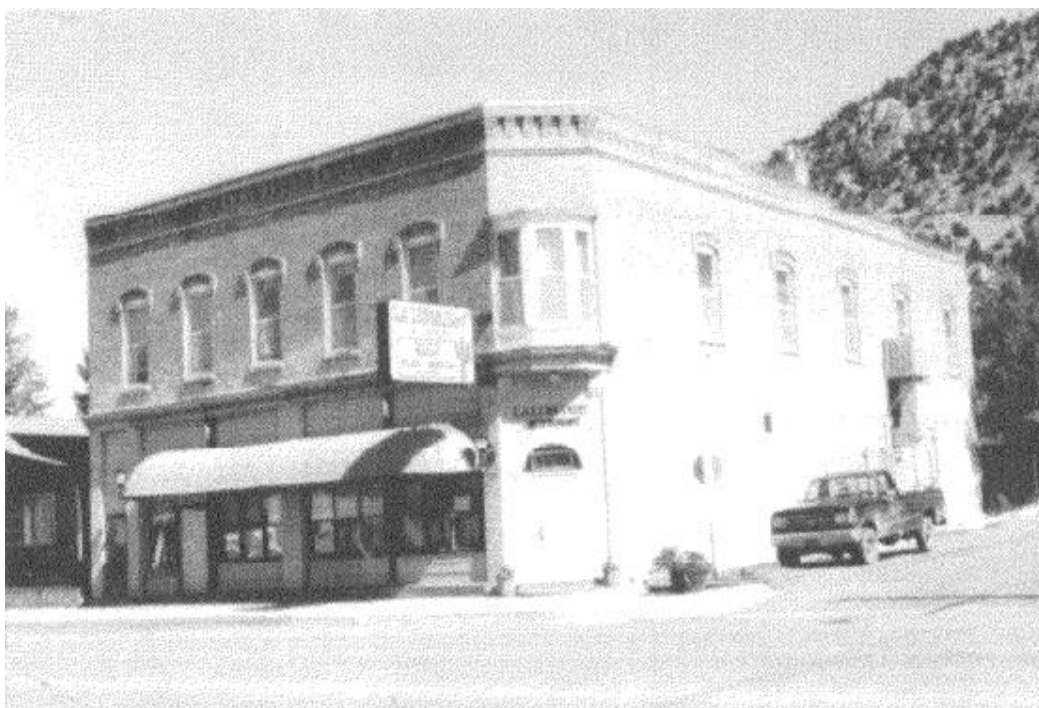
Reference Photo 2

Description: Looking at the primary (south) and east elevations of the building.

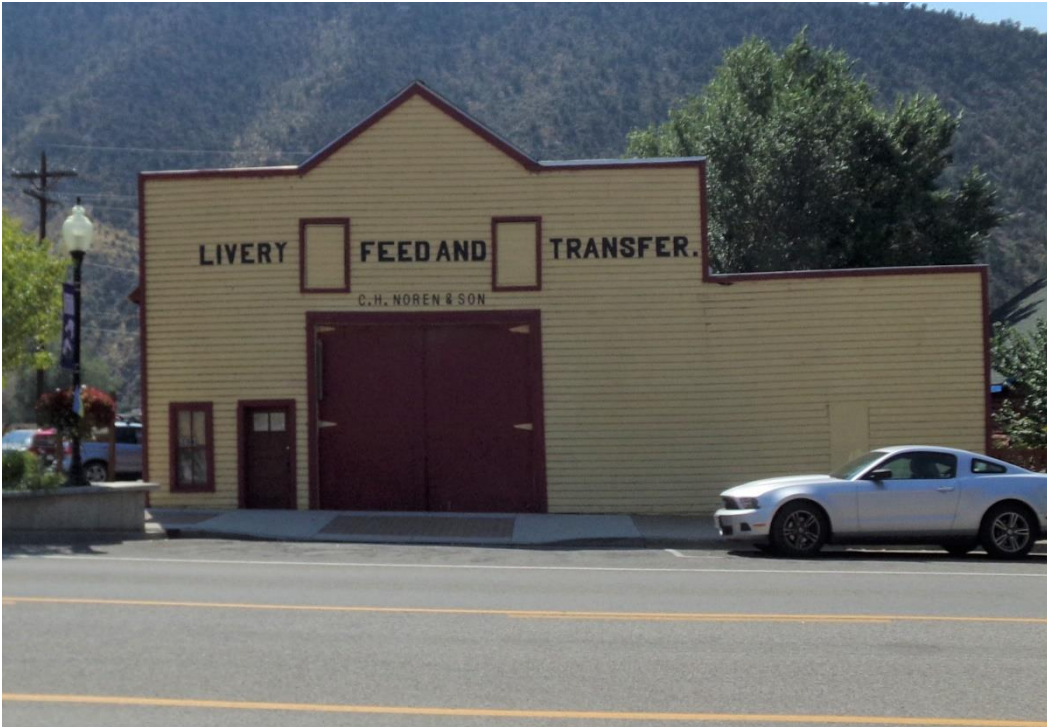
Photo Number: 5GF.2380_1
Description: Looking at the primary (north) elevation of the building.
Date: 9/6/2022
View: South

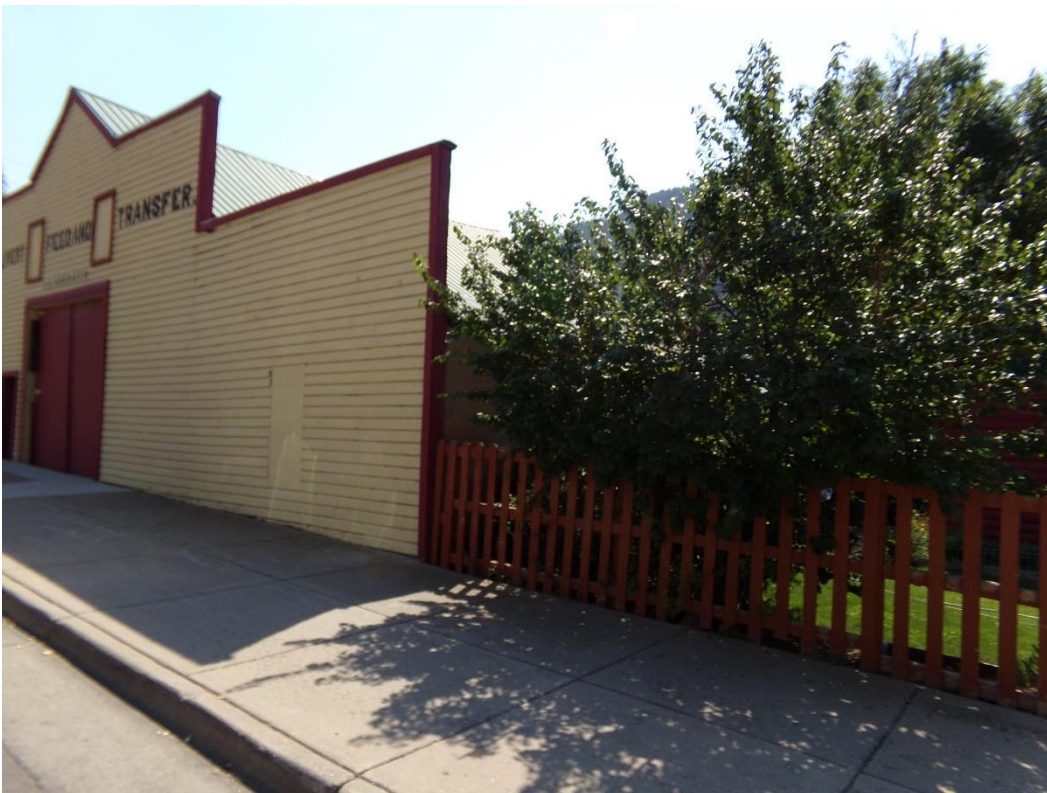
Photo Number: 5GF.2380_2
Description: Looking at the primary (north) and west elevation of the building; though, the west elevation is obscured by vegetation.
Date: 9/6/2022
View: Southeast

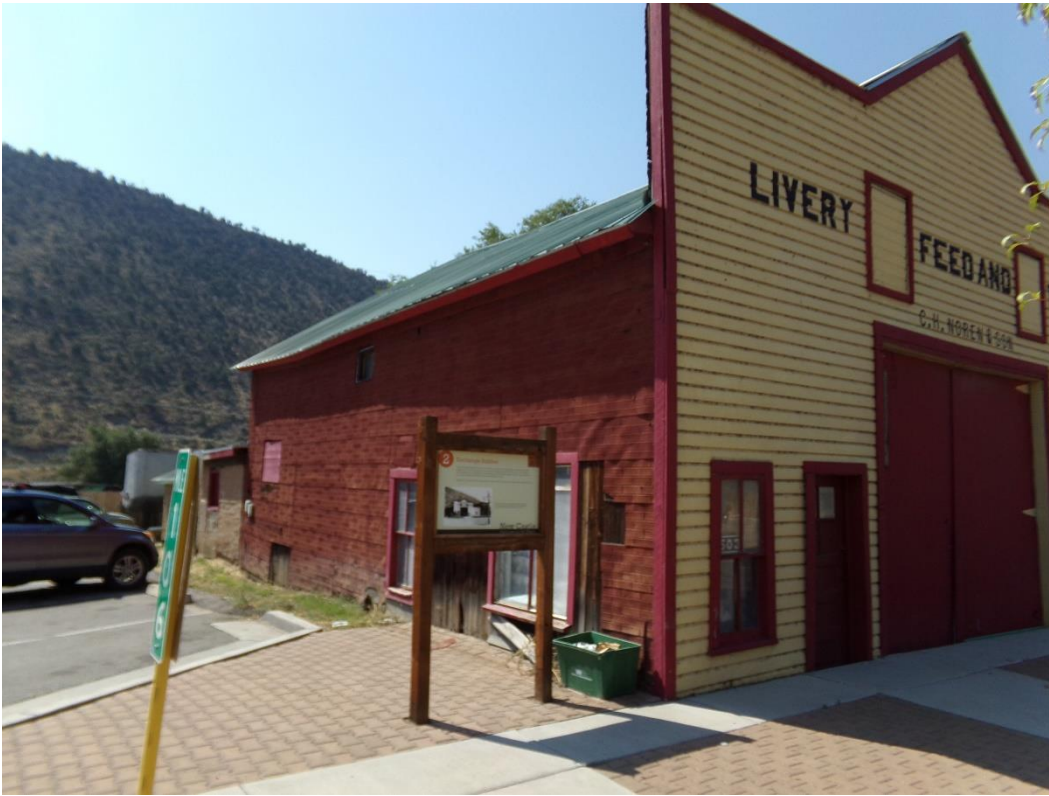
Photo Number: 5GF.2380_3

Description: Looking at the east elevation and primary (north) elevation of the building. Note the embossed asphalt siding.

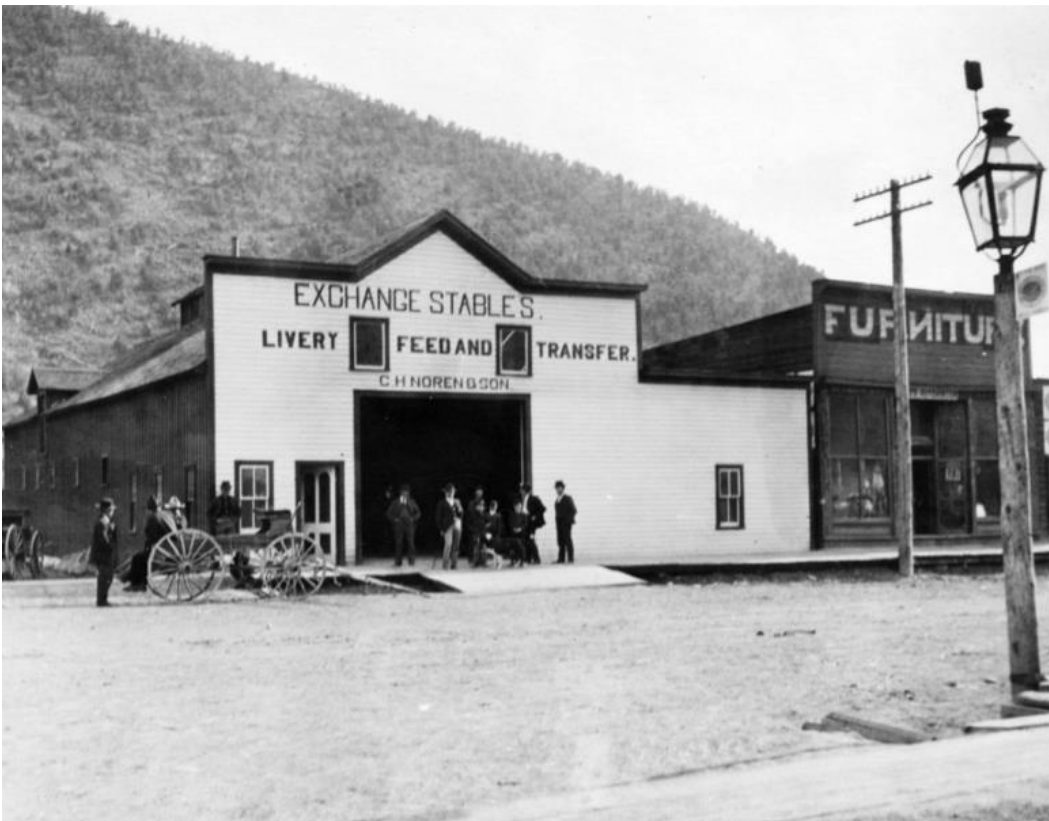
Historic Photo 1

Description: Looking at the east and primary (north) elevations of the building

Historical photos of the building in 1905 demonstrate that the building had a larger footprint along the south elevation. A front gable roof vent was also located in the center of the roofline. A front gable dormer was also located in the center of the east elevation. A cast iron cornice was also present along the false front. By the late Twentieth Century, photos of the building demonstrate that the southern half of the building was removed and several additions to the south elevation were constructed including a residence. In addition, the main entryway door was replaced, and the cast iron cornice was removed. Several door and window openings were also covered. During this same period, embossed asphalt siding was added to the east elevation of the building.

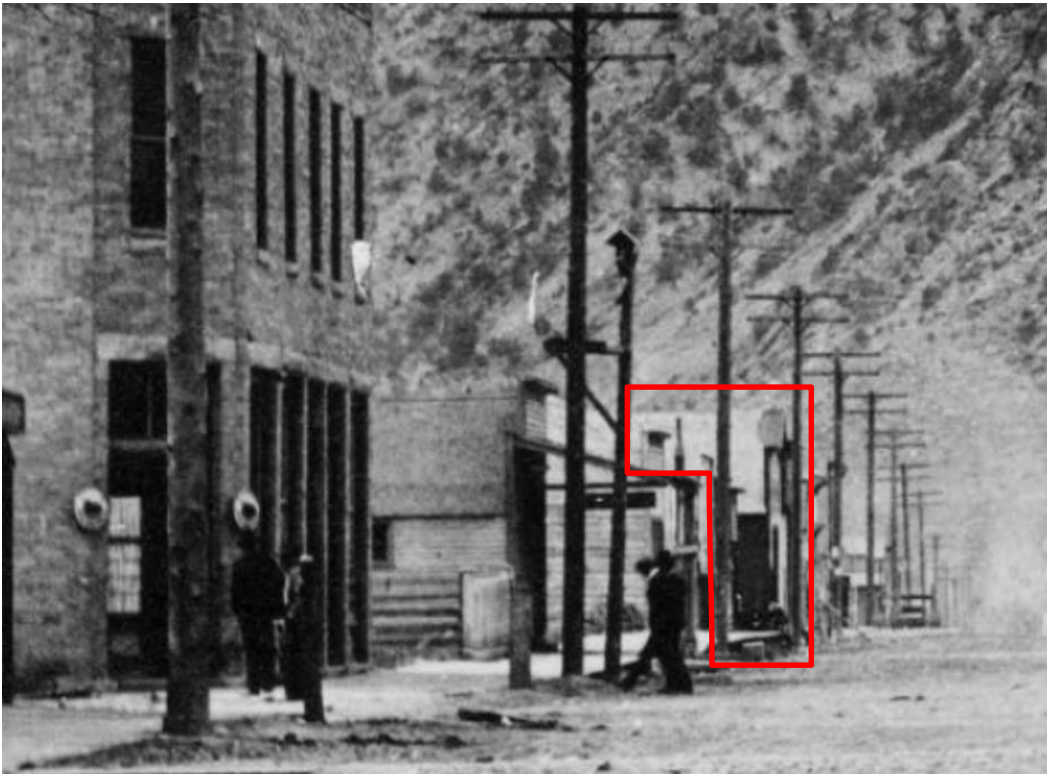
Historic Photo 2

Description: Image of downtown New Castle looking west down Main Street from the intersection of Main Street and North 4th Street. The resource is outline in red.

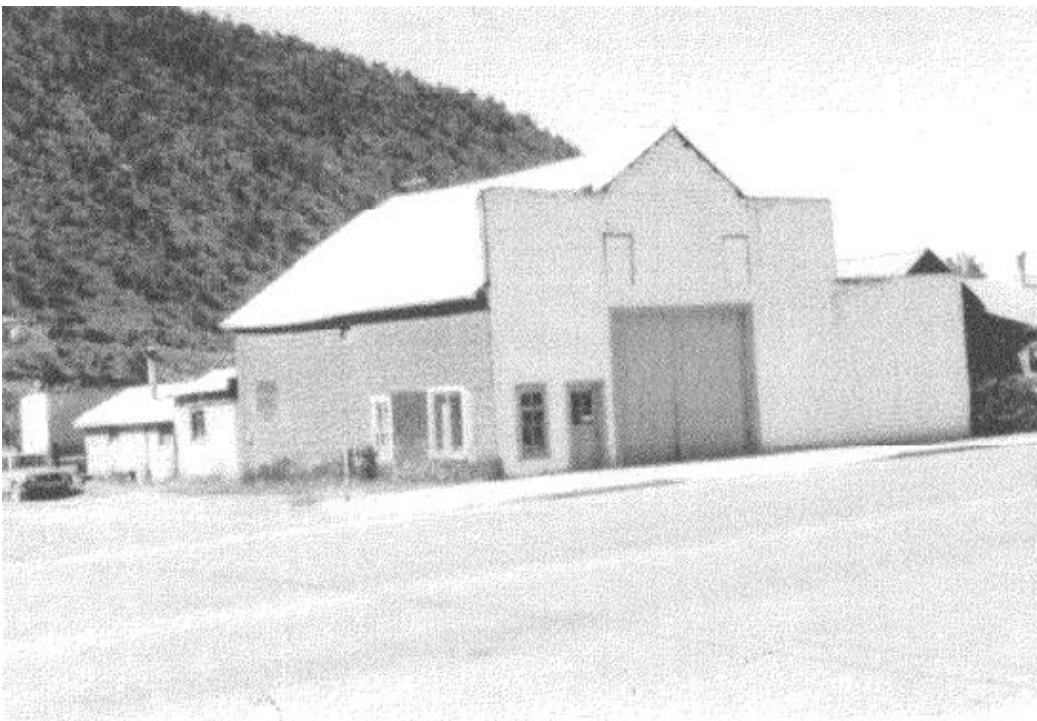
Reference Photo 1

Description: Looking at the east and primary (north) elevation of the building.

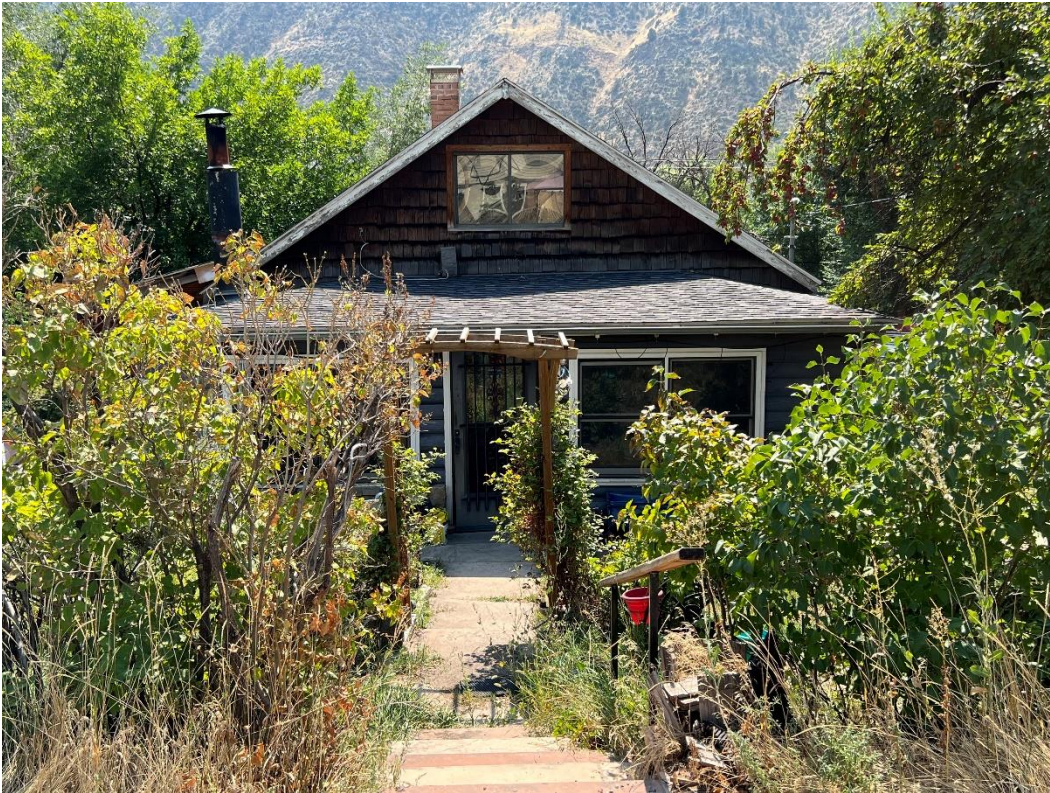
Photo Number: 5GF.5939_1
Description: Looking at the primary (north) elevation of the building. Note the wood shingles under the gable end.
Date: 9/6/2022
View: South

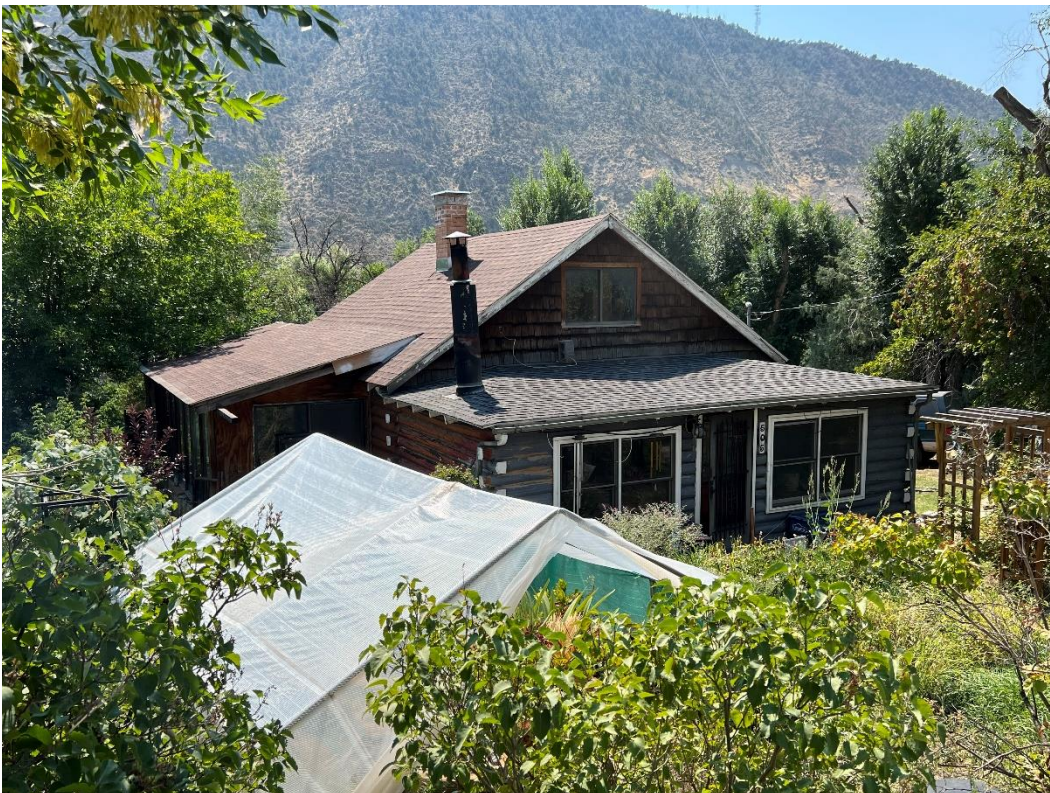
Photo Number: 5GF.5939_2
Description: Looking at the east and primary (north) elevations of the building.
Date: 9/6/2022
View: Southwest

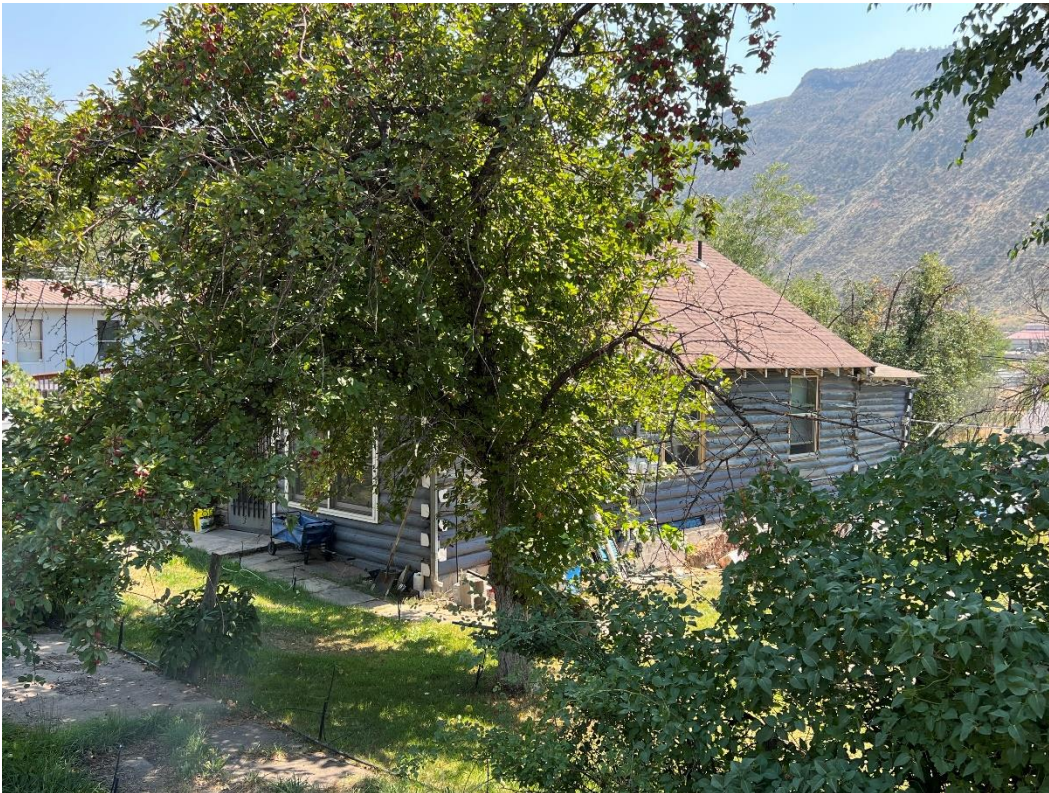
Photo Number: 5GF.5939_3
Description: Looking at an obscured portion of the primary (north) elevation and the west elevation of the building.
Date: 9/6/2022
View: Southeast

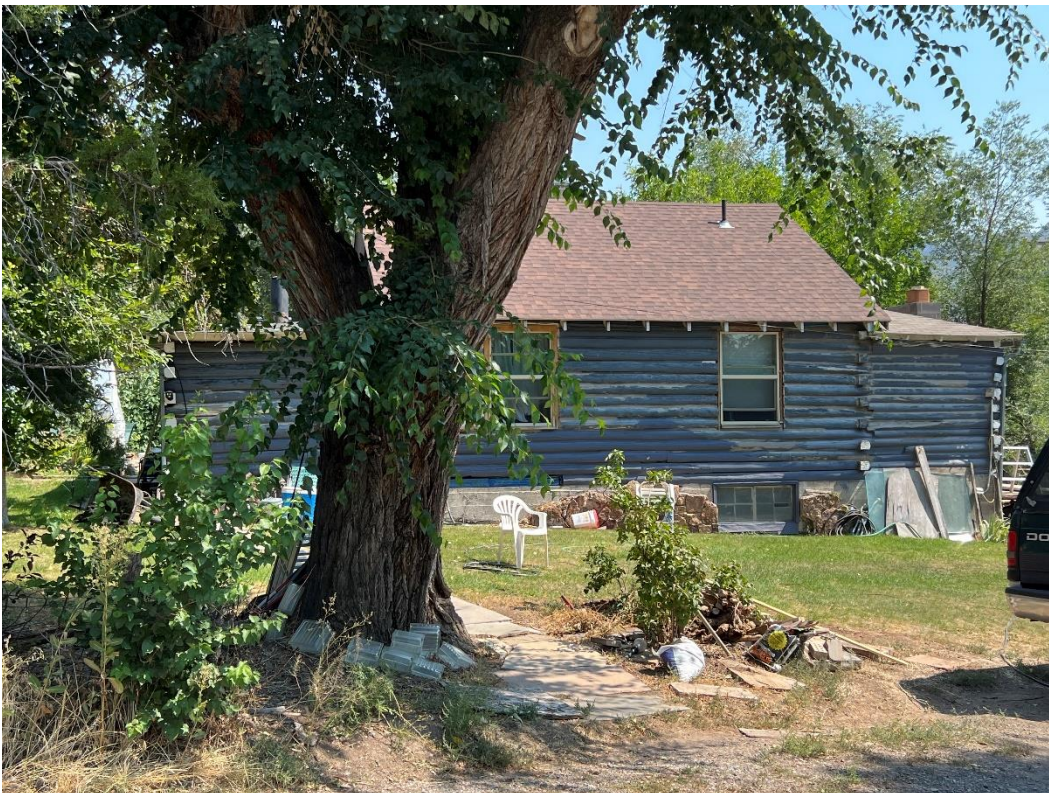
Photo Number: 5GF.5939_4
Description: Looking at the west elevation of the building. Note the CMU block chimney along the south elevation of the building.
Date: 9/6/2022
View: East

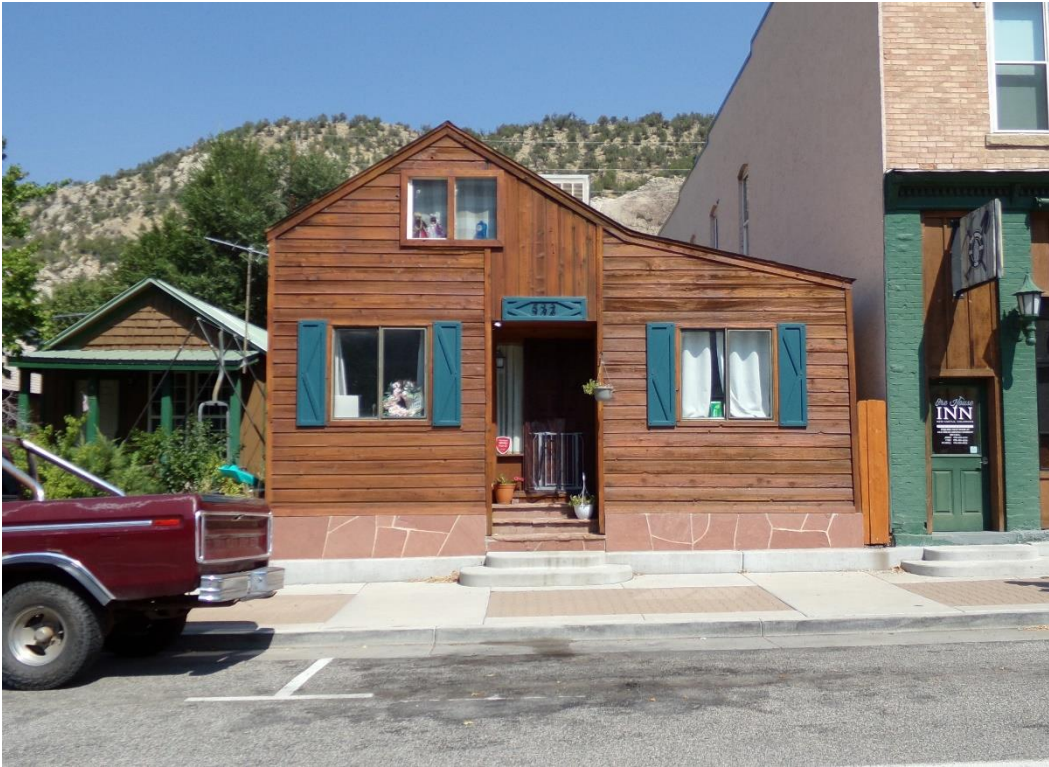
Photo Number: 5GF.5908_1
Description: Looking at the primary (south) elevation.
Date: 9/6/2022
View: North

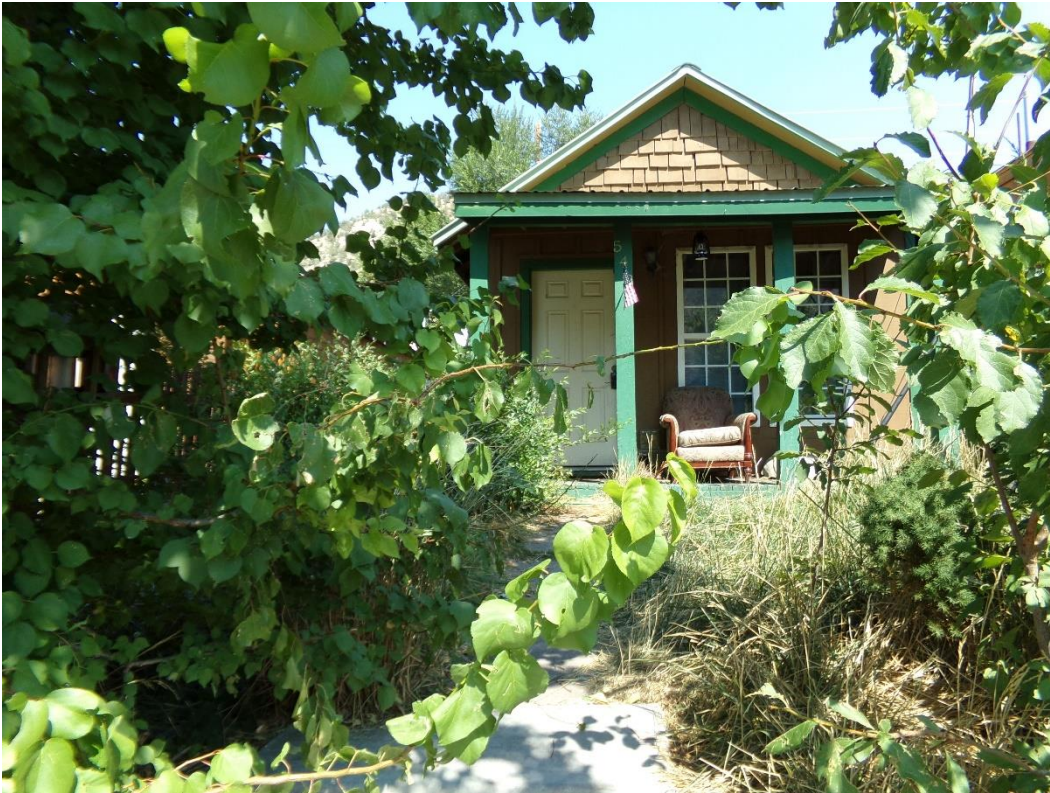
Photo Number: 5GF.5907_1
Description: Looking at the primary (south) elevation of the building.
Date: 9/6/2022
View: North

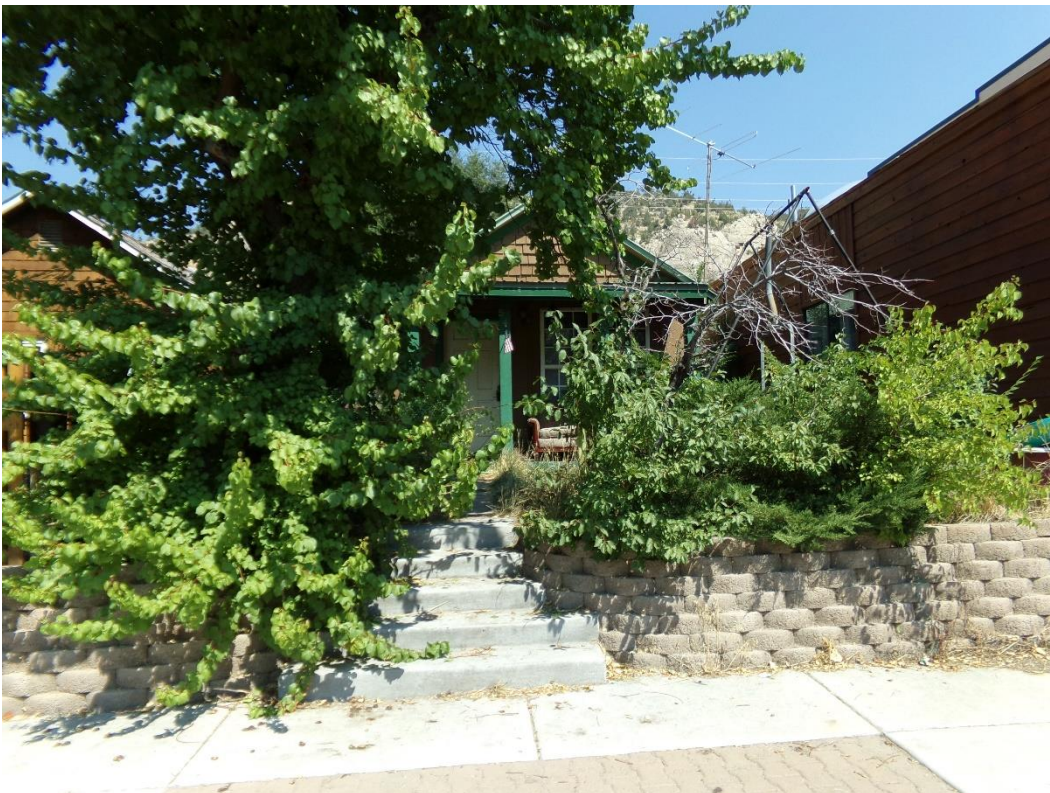
Photo Number: 5GF.5907_2
Description: Context view of the primary (south) elevation of the building.
Date: 9/6/2022
View: North

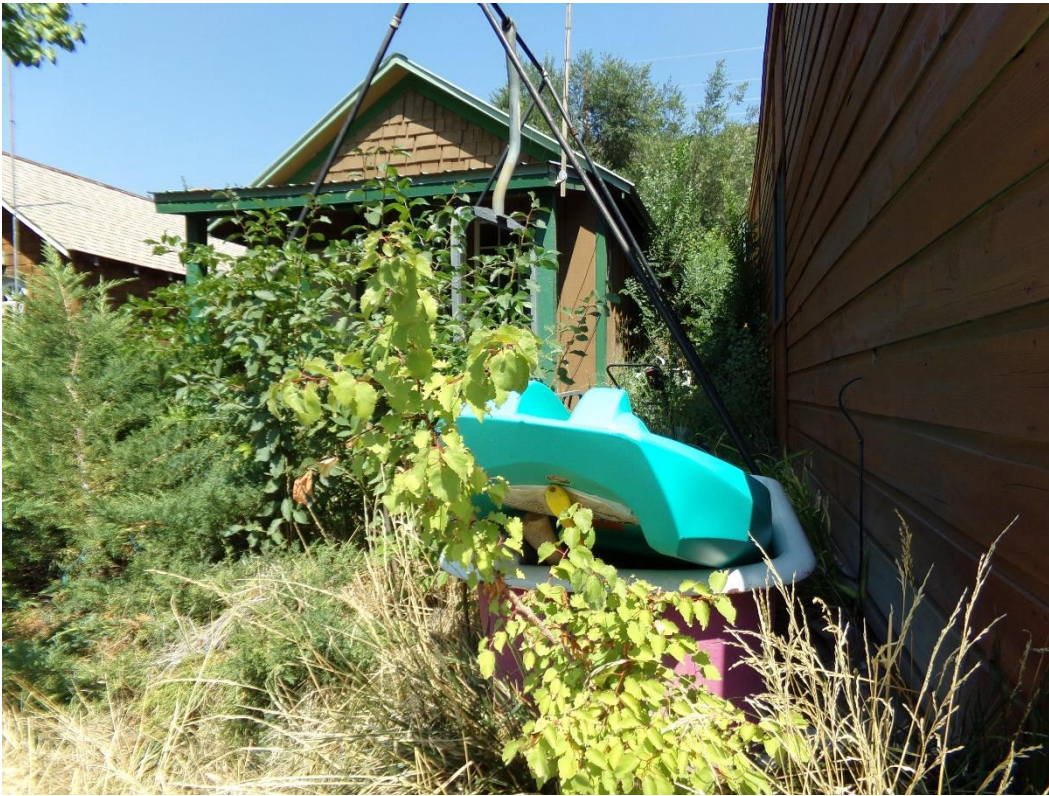
Photo Number: 5GF.5907_3
Description: Looking at the primary (south) and east elevations of the building.
Date: 9/6/2022
View: Northwest

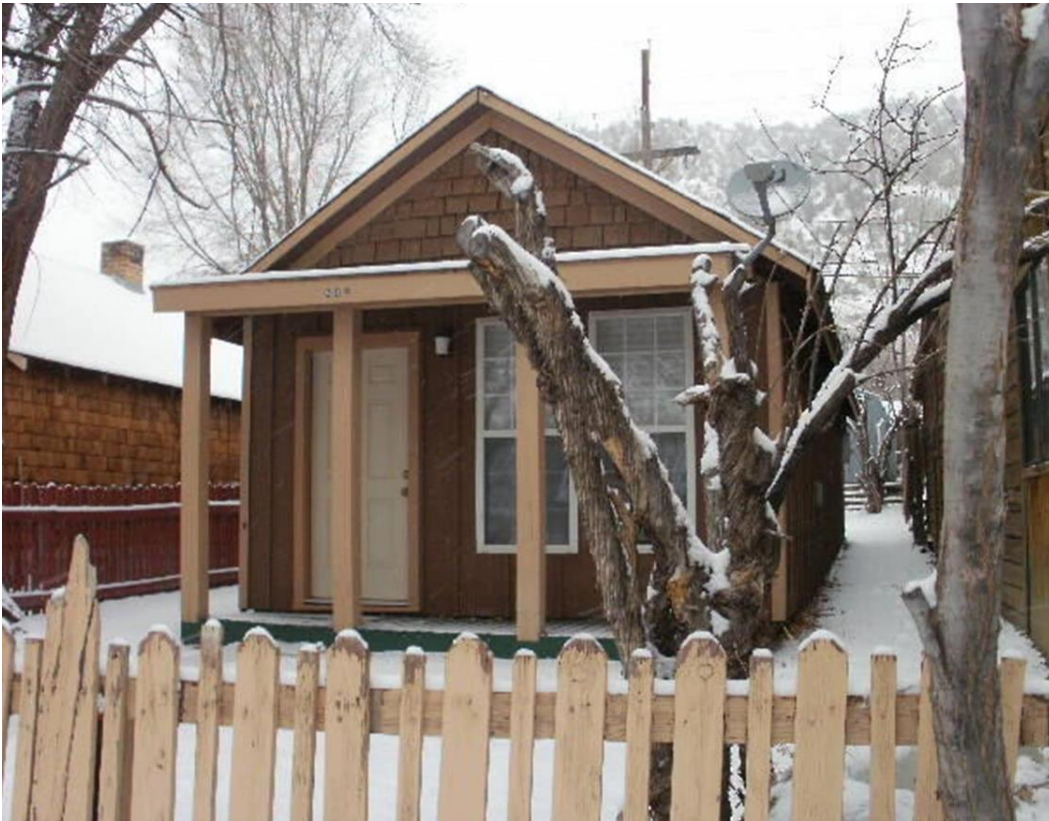
Reference Photo 1
Description: Looking at the primary (south) elevation.
Date: Circa 2009
Source: Garfield County Assessor's Office

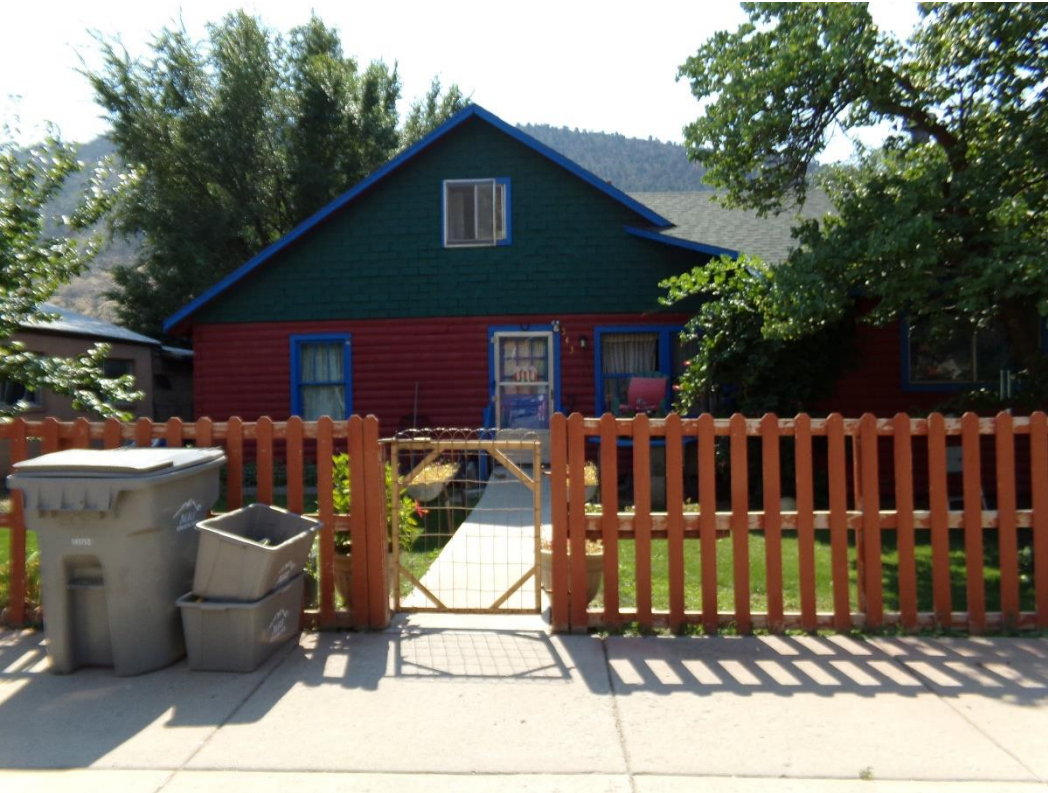
Photo Number: 5GF.5901_1
Description: Looking at the primary (north) elevation of the building.
Date: 9/6/2022
View: South

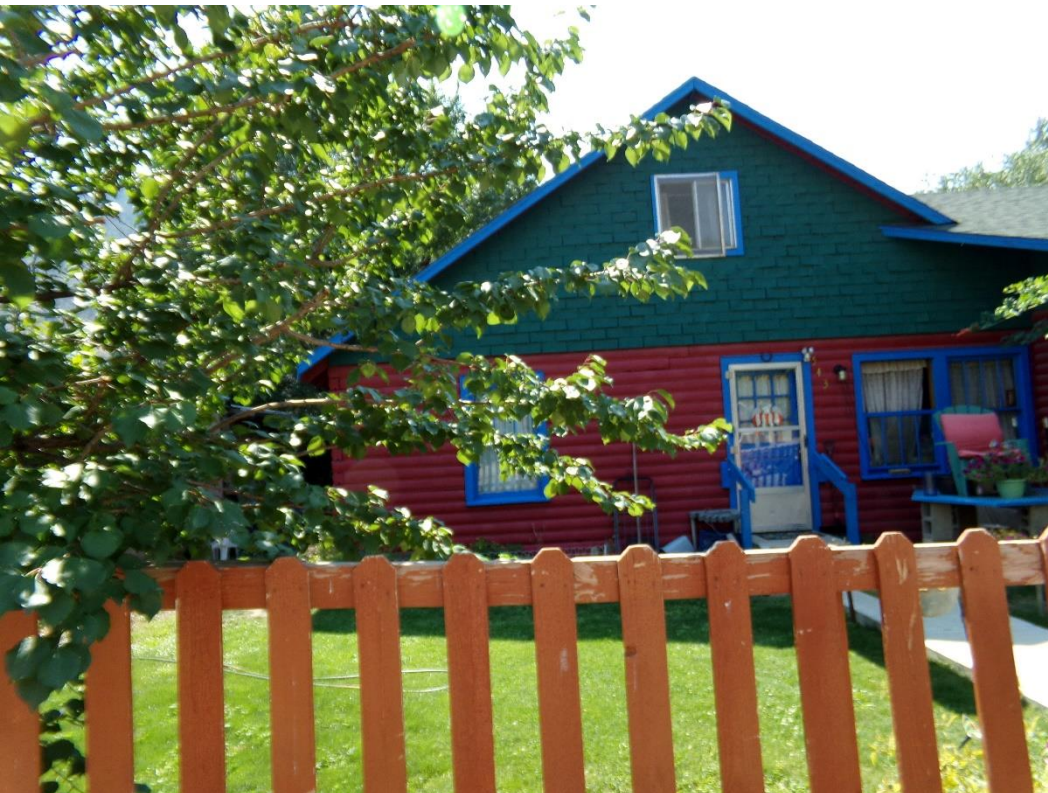
Photo Number: 5GF.5901_2
Description: Looking at the primary (north) elevation of the building
Date: 9/6/2022
View: South

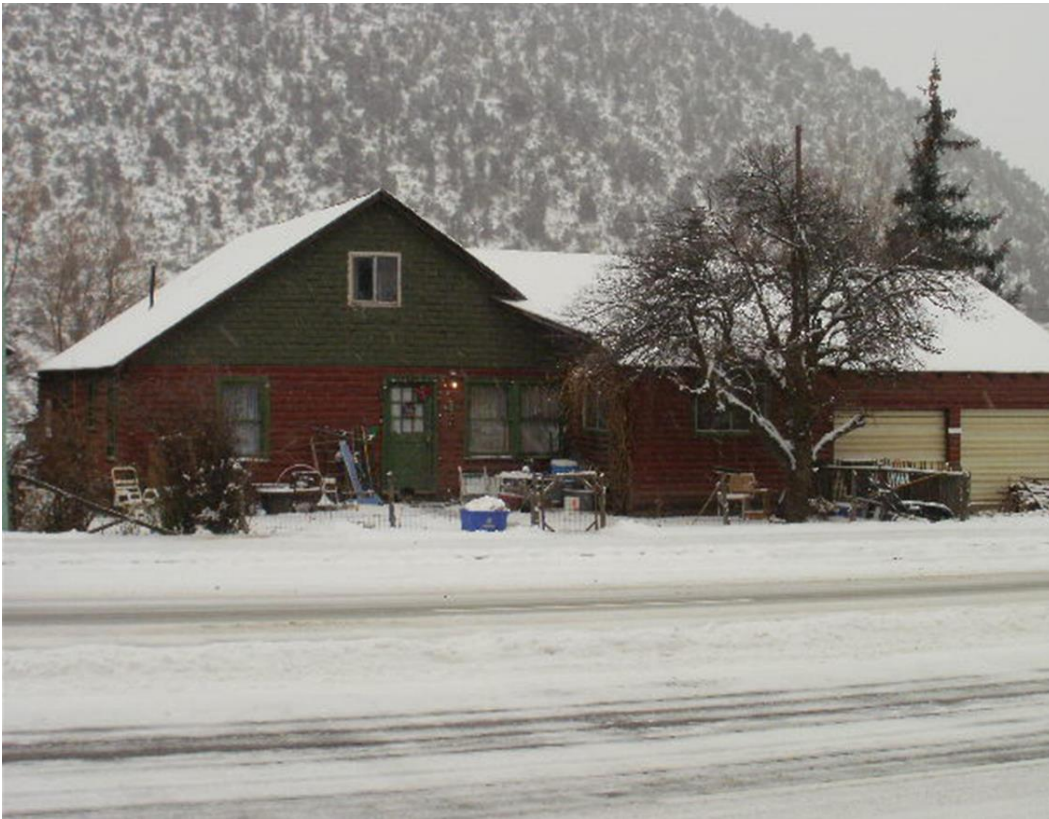
Reference Photo 1

Description: Context image of the east and primary (north) elevations of the building.

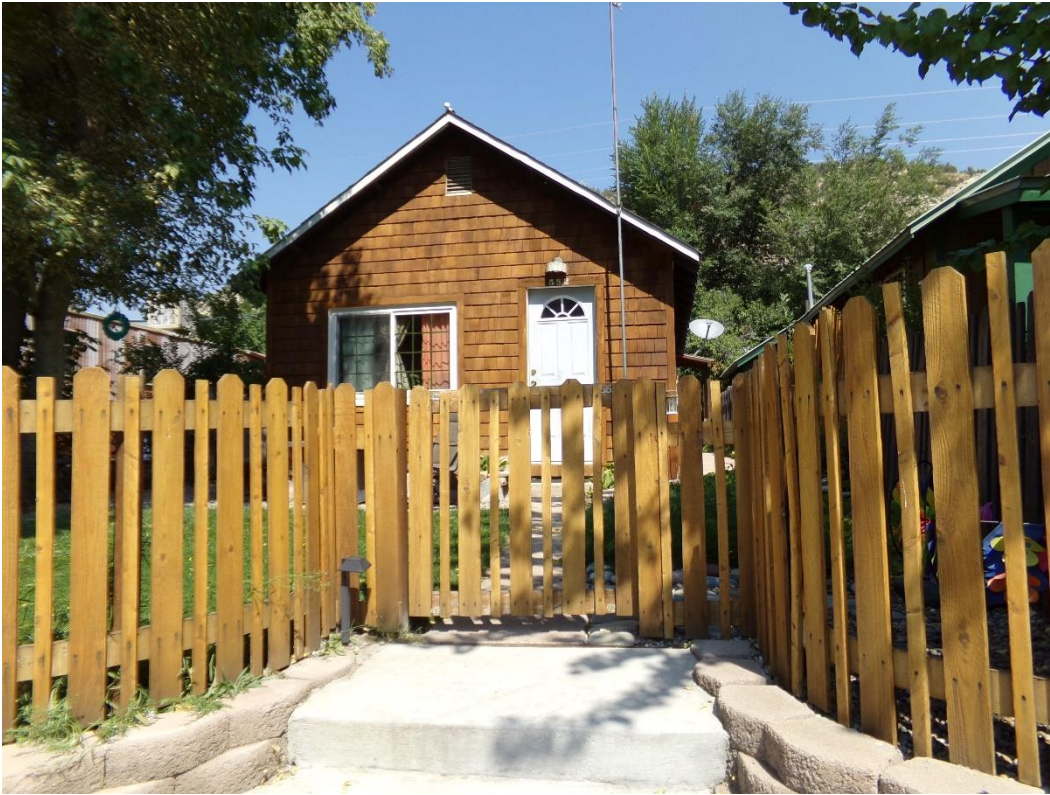
Photo Number: 5GF.5905_1
Description: Looking at the primary (south) elevation of the building.
Date: 9/6/2022
View: North

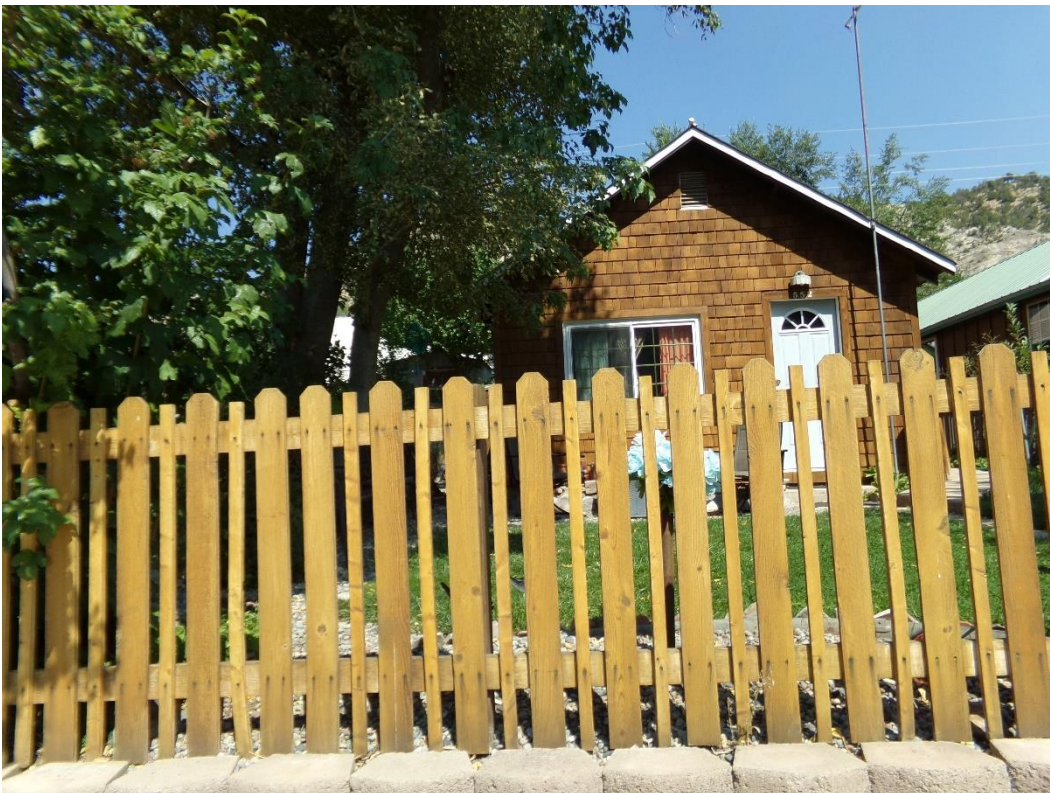
Photo Number: 5GF.5905_2
Description: Looking at the primary (south) elevation of the building.
Date: 9/6/2022
View: North

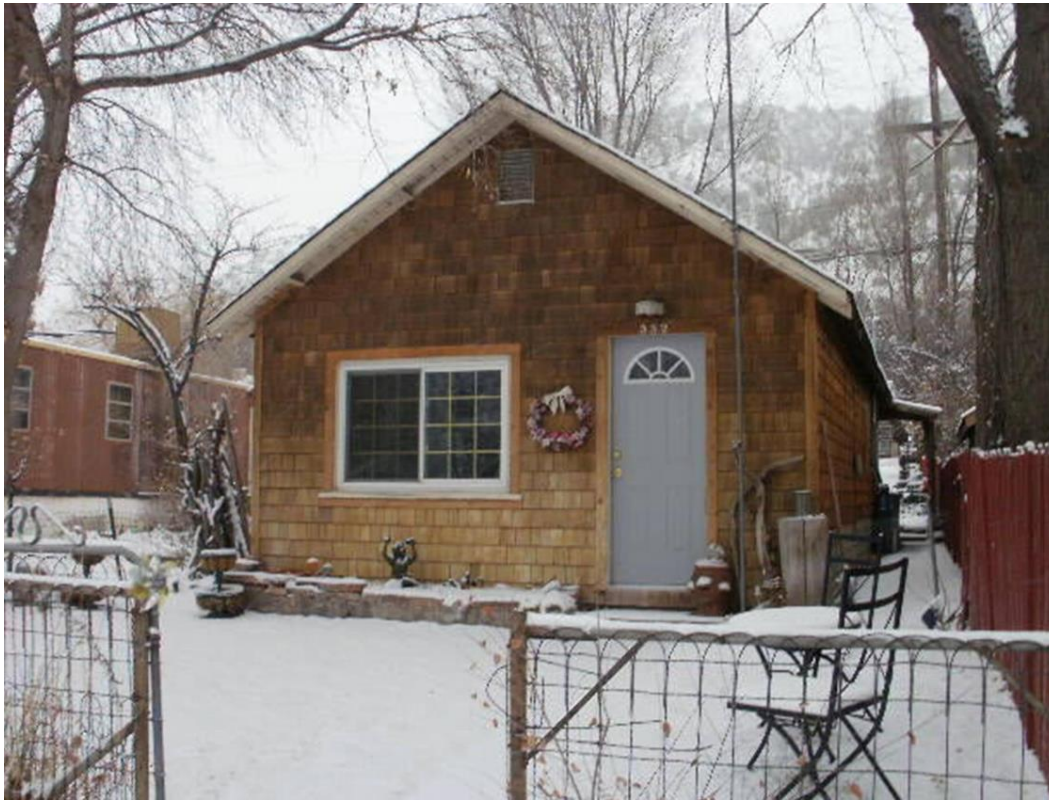
Reference Photo 1

Description: Looking at the primary (south) elevation.

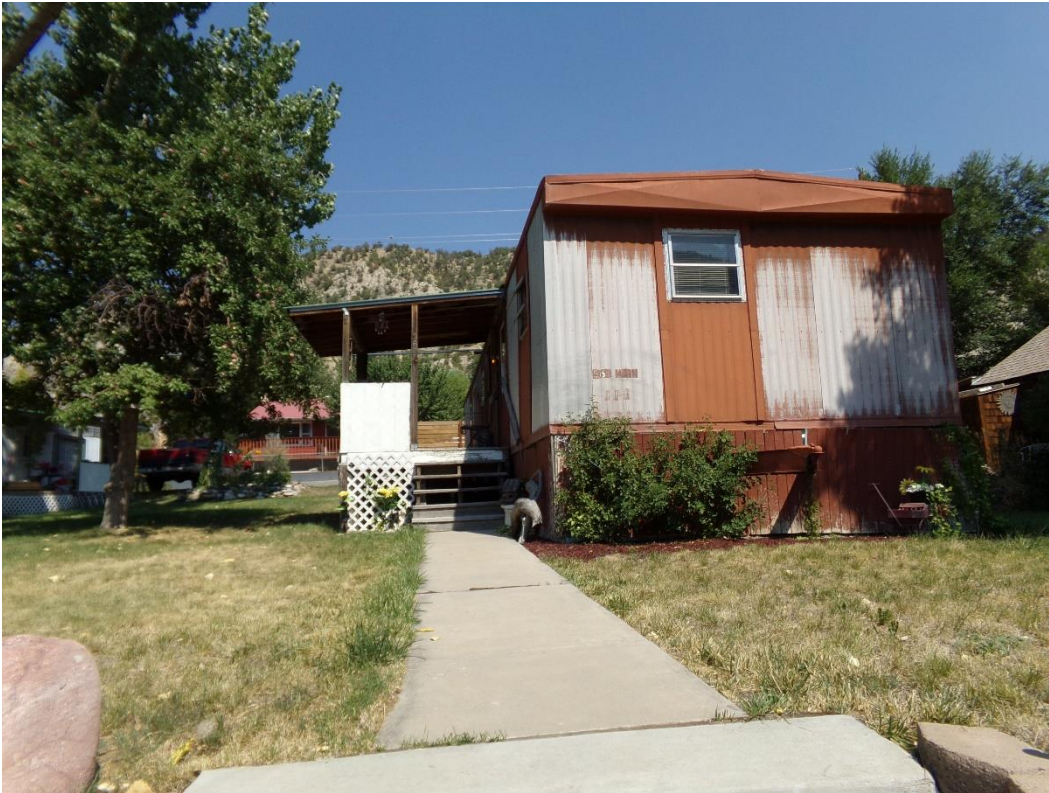
Photo Number: 5GF.5904_1
Description: Looking at the south elevation of the trailer.
Date: 9/6/2022
View: North

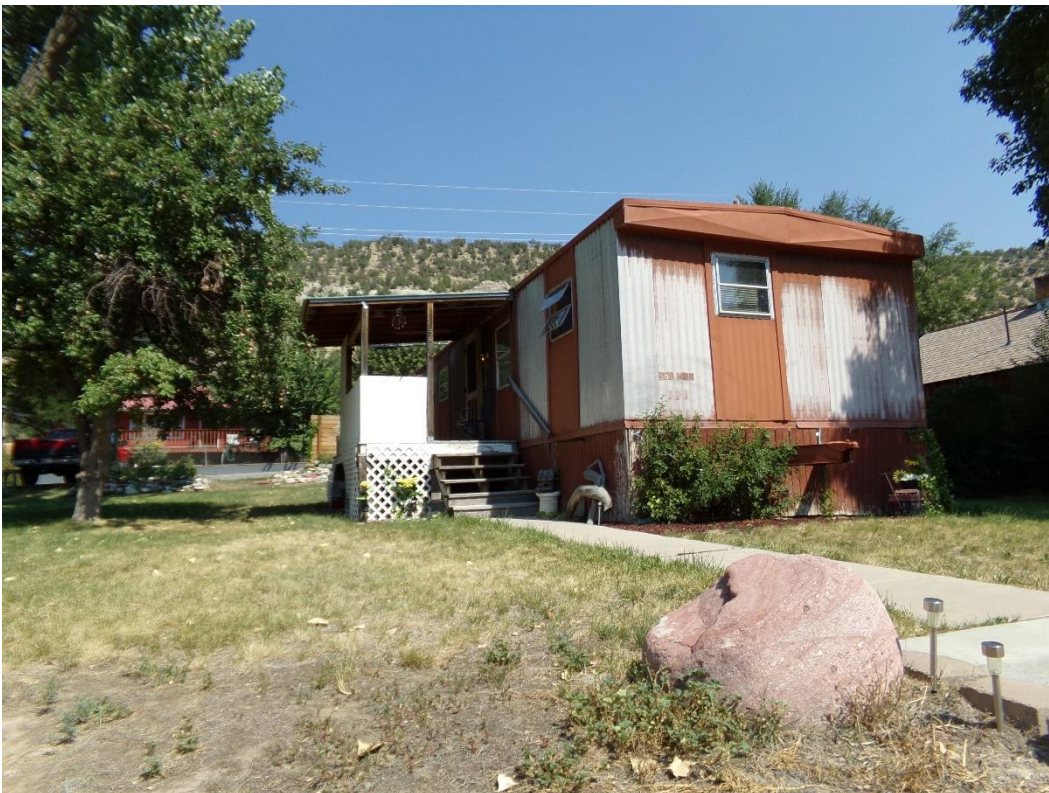
Photo Number: 5GF.5904_2
Description: Looking at the primary (west) and south elevations of the trailer.
Date: 9/6/2022
View: Northeast
