New Castle Historic Preservation Commission (Regular Meeting)

New Castle - Reconnaissance Survey

The Town of New Castle (New Castle) is conducting a reconnaissance-level survey of historic resources along Main Street (US Highway 6). The survey will identify and recommend individual resources for future intensive-level survey to determine potential eligibility under National Register of Historic Places (NRHP) criteria in accordance with NRHP and State of Colorado Historic Survey Standards. In addition, this survey assesses the potential for a historic district as well as identify and recommend resources that may contribute toward a potential NRHP historic district. This survey represents the most recent evaluation of historic resources in the Town of New Castle. Previous historic resource surveys have mostly focused on residential and commercial buildings/structures in the central quadrant of the town. Resources in the survey area—bounded by Elk Creek to the west, Burning Mountain Avenue to the east, and adjacent to Main Street—are the focus of this reconnaissance report.

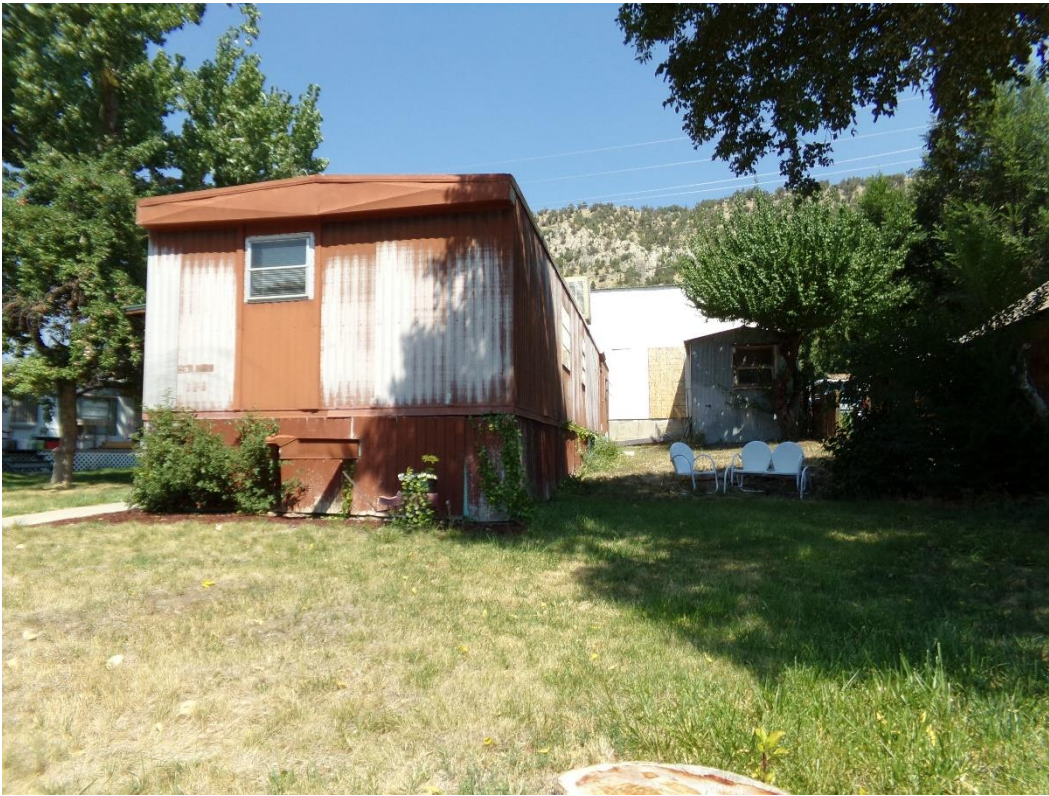
Photo Number: 5GF.5904_3
Description: Looking at the south and east elevations of the trailer.
Date: 9/6/2022
View: Northwest

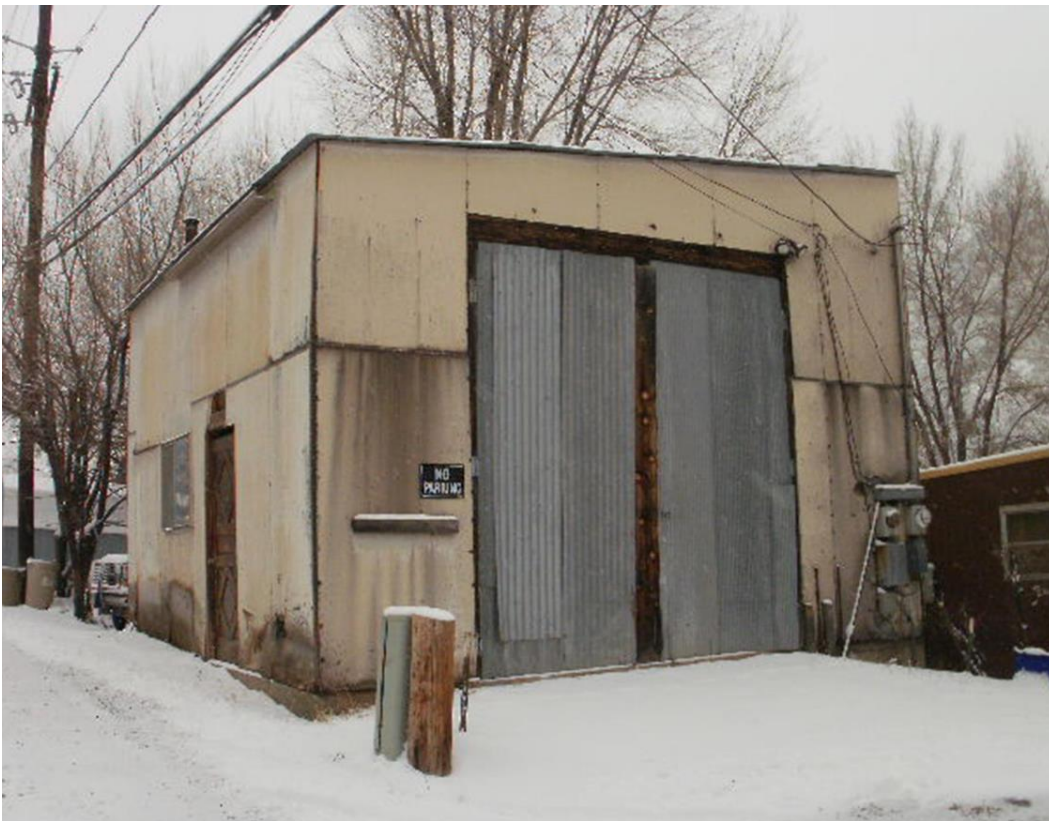
Reference Photo 1
Description: Looking at the north and primary (west) elevation of the outbuilding.
Date: circa 2009
Source: Garfield County Assessor's Office

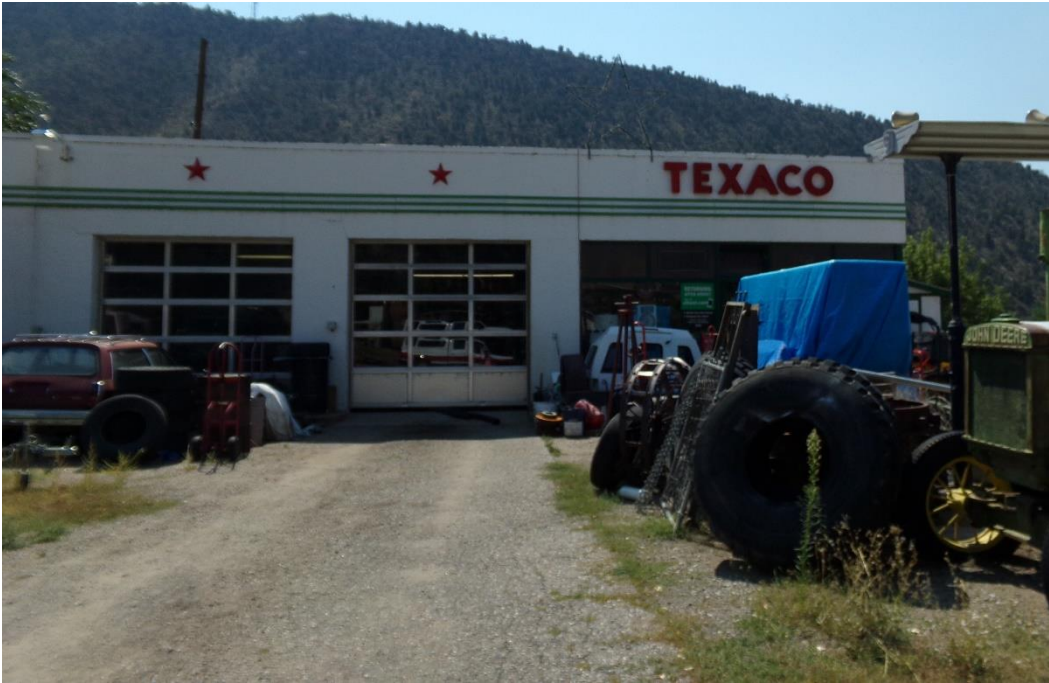
Photo Number: 5GF.5903_1
Description: Looking at the primary (north) elevation of the building from West Main Street. Note the rolled glazed doors in front of the service bays.
Date: 9/6/2022
View: South

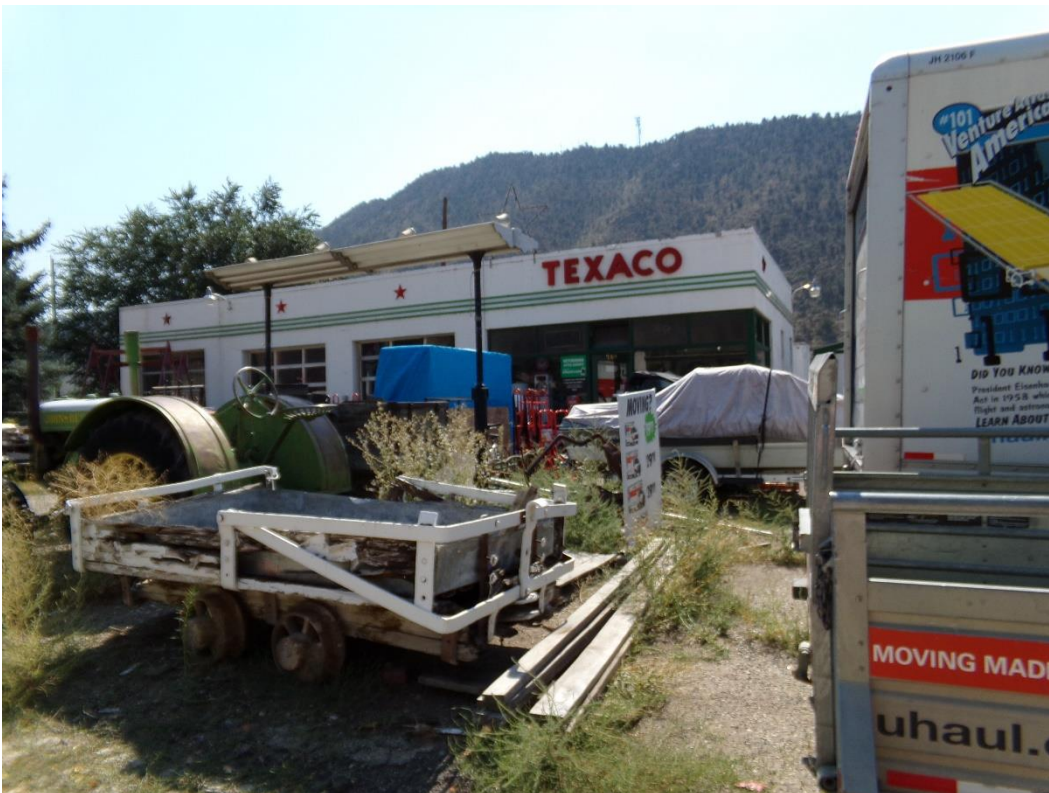
Photo Number: 5GF.5903_2
Description: Looking at the primary (north) and west elevations of the building. Note the fuel island in the foreground.
Date: 9/6/2022
View: Southeast

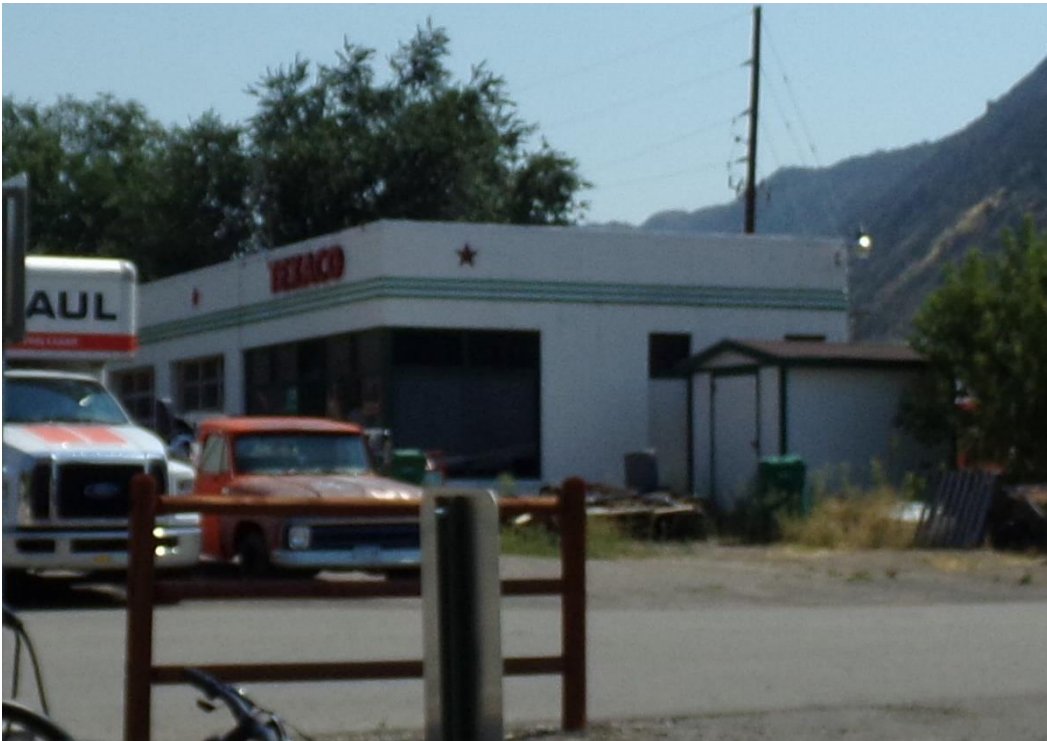
Photo Number: 5GF.5903_3
Description: Looking at the primary (north) elevation and west elevations of the building.
Date: 9/6/2022
View: Southeast

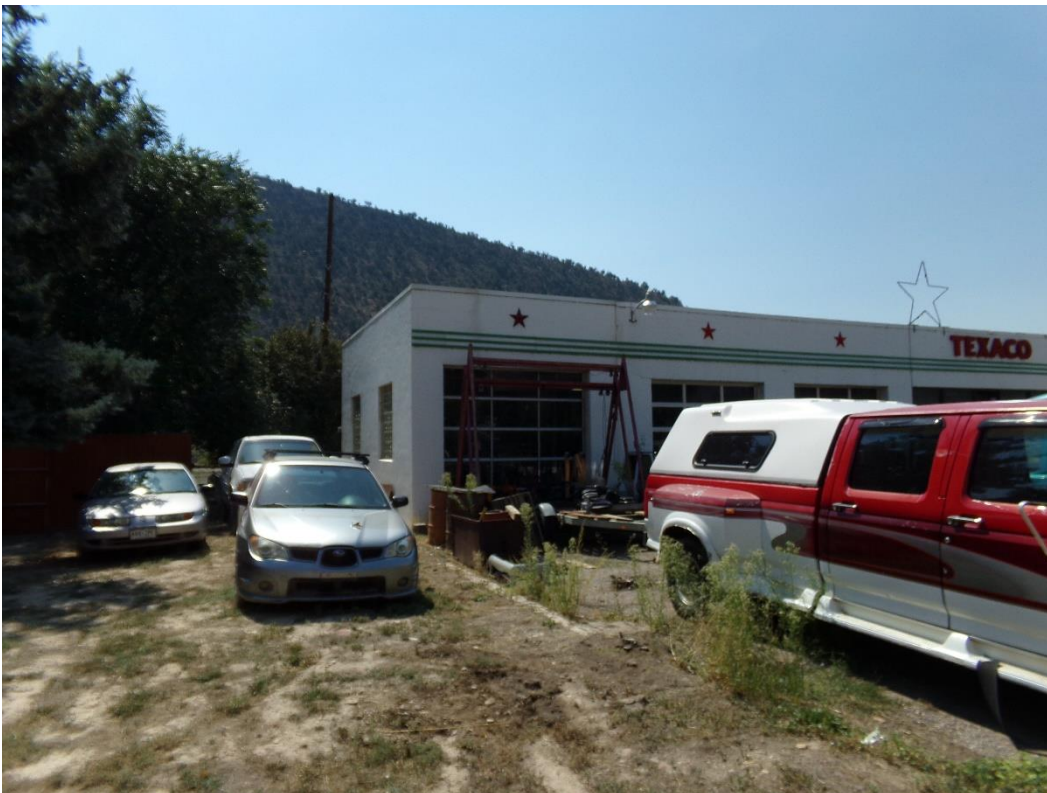
Photo Number: 5GF.5903_4
Description: Looking at the east and primary (north) elevations of the building. The third bay on the far left is likely an addition.
Date: 9/6/2022
View: Southwest

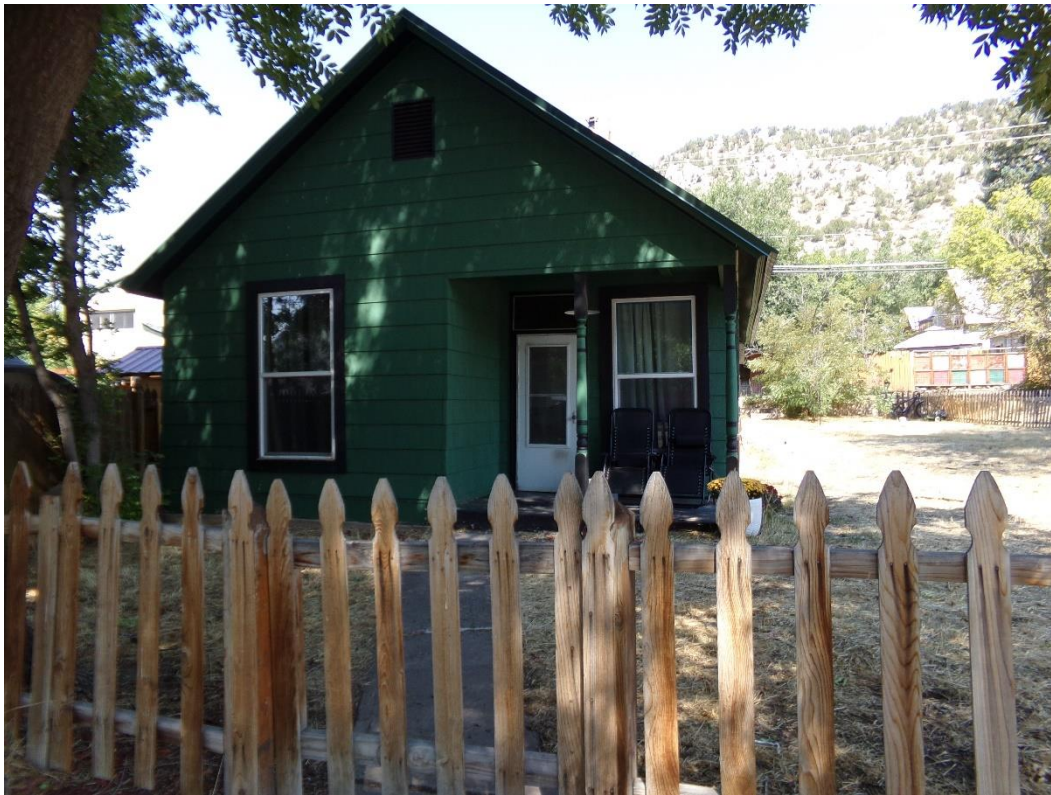
Photo Number: 5GF.5902_1
Description: Looking at the primary (south) elevation of the building.
Date: 9/6/2022
View: North

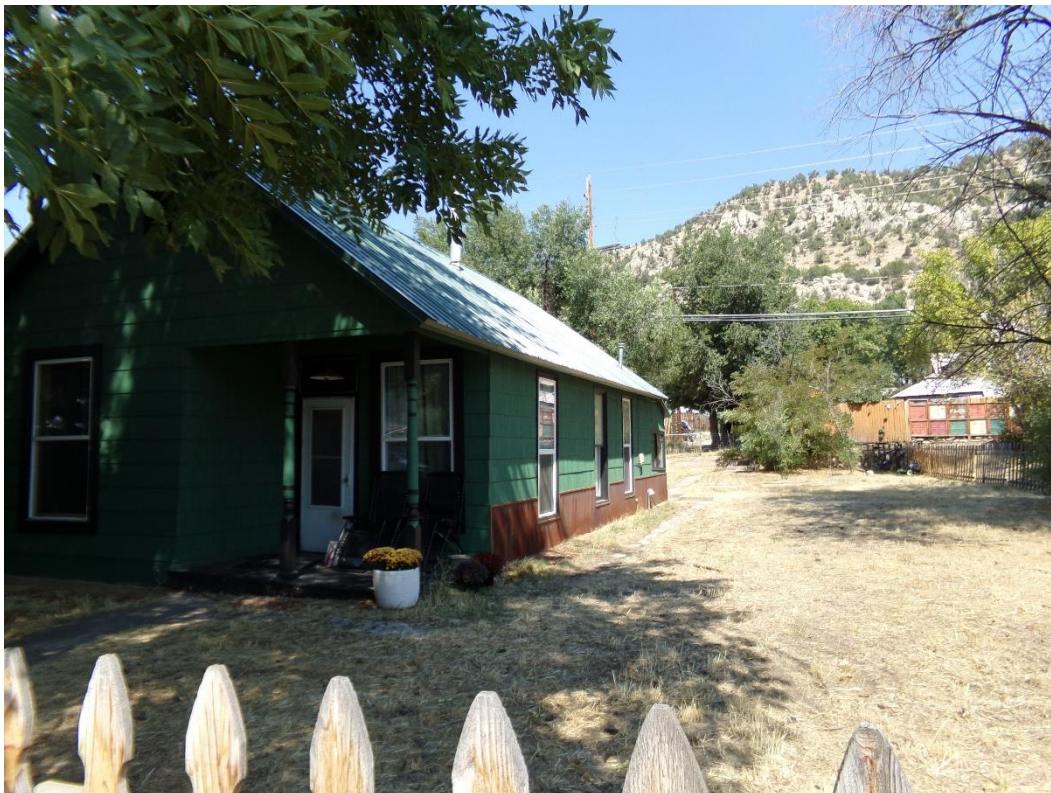
Photo Number: 5GF.5902_2
Description: Looking at the primary (south) and east elevations of the building.
Date: 9/6/2022
View: Northwest

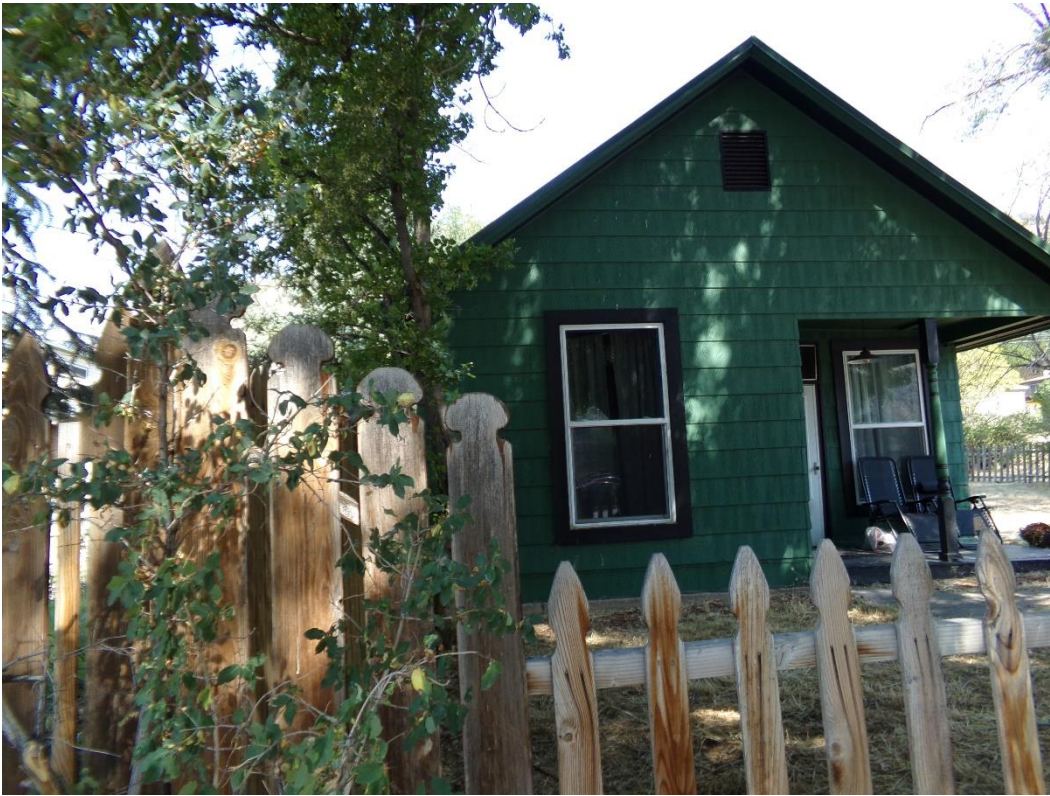
Photo Number: 5GF.5902_3
Description: Looking at the primary (south) elevation of the building.
Date: 9/6/2022
View: North

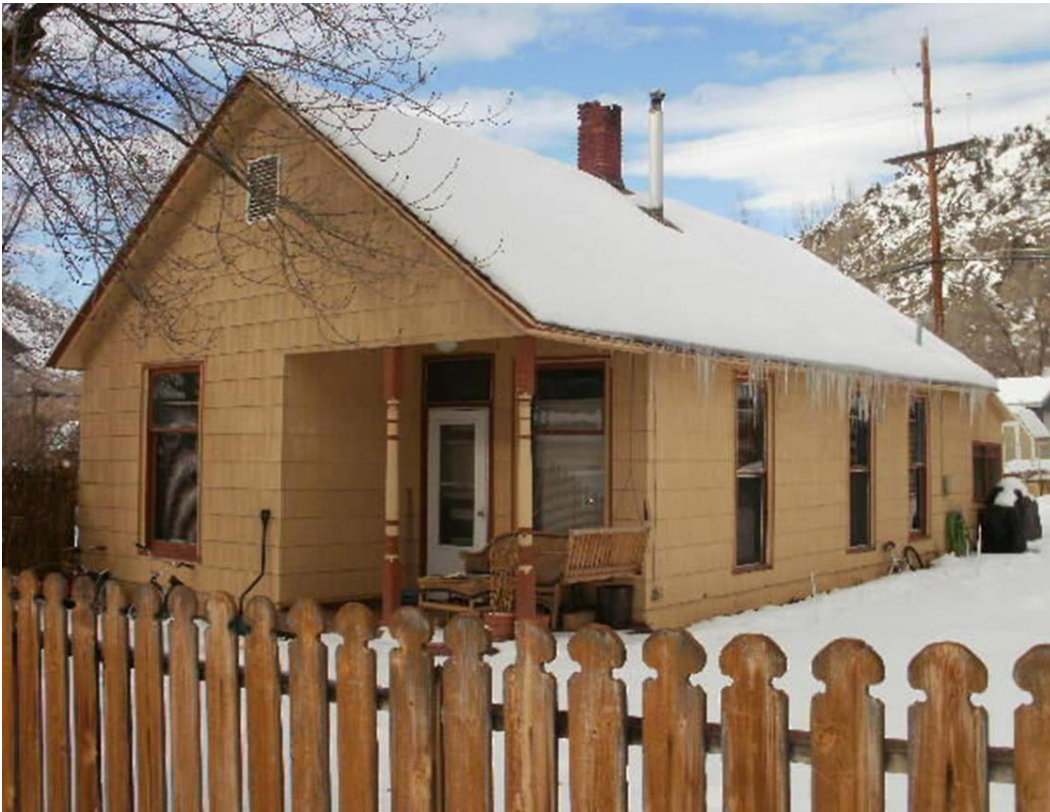
Historical aerial imagery demonstrates that the enclosed porch along the north elevation was constructed by 1960. Historical street imagery reveals that the exterior envelope was replaced between 2012 and 2022. In addition, the roof was replaced along with a majority of windows and the brick masonry chimney was removed from the center roofline.

Reference Photo 1
Description: Looking at the primary (south) and east elevations of the building. This image is shortly before the alterations to the exterior envelope between 2012 and 2022.
Date: circa 2009
Source: Garfield County Assessor's Office

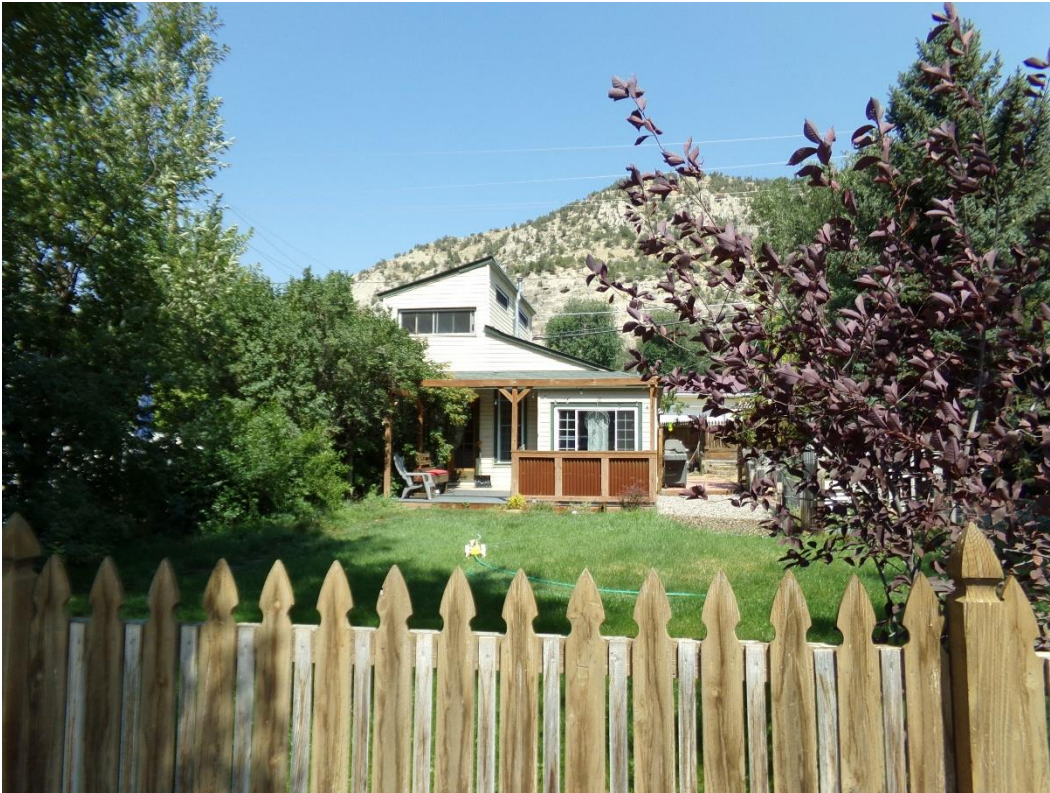
Photo Number: 5GF.5901_1
Description: Context view from Main Street looking at the primary (south) elevation of the building.
Date: 9/6/2022
View: North

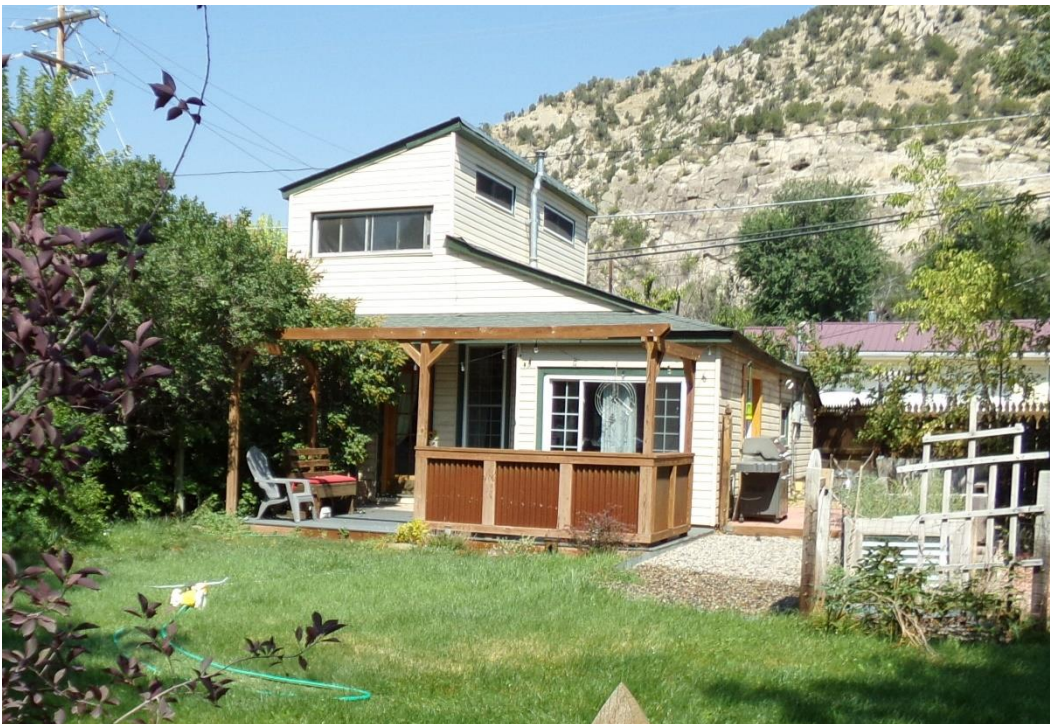
Photo Number: 5GF.5901_2
Description: Looking at the primary (south) and east elevation of the building.
Date: 9/6/2022
View: Northwest

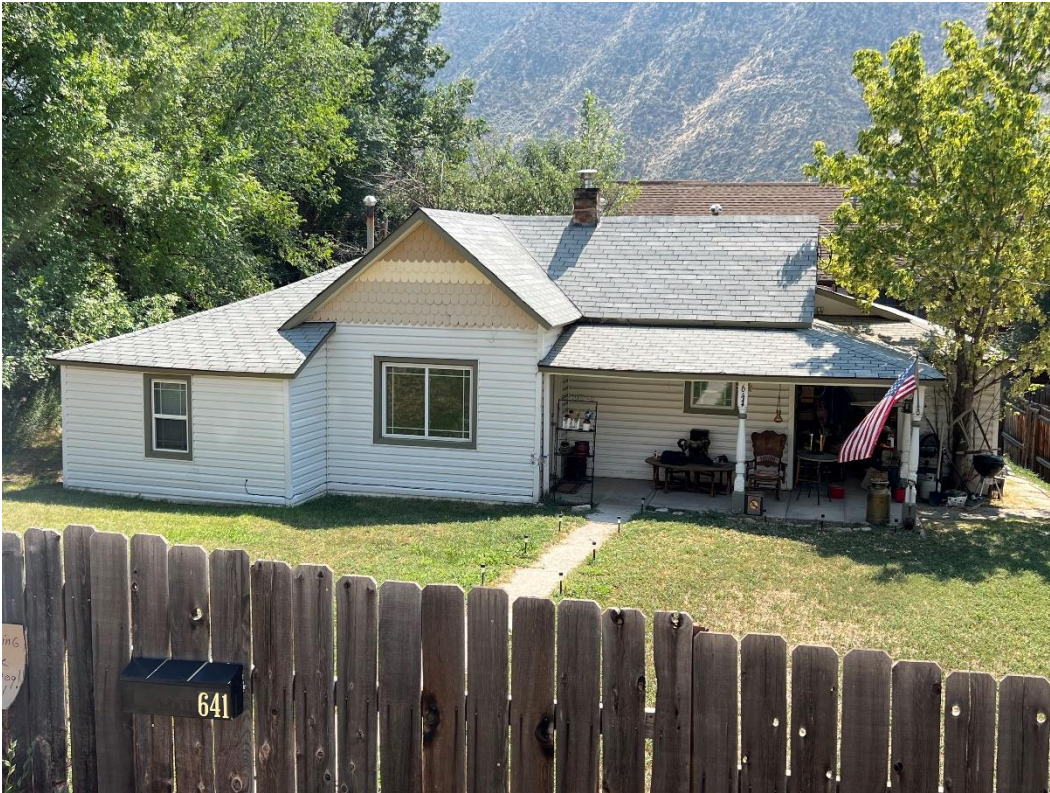
Photo Number: 5GF.5940_1
Description: Looking at the primary (north) elevation of the building.
Date: 9/6/2022
View: Southeast

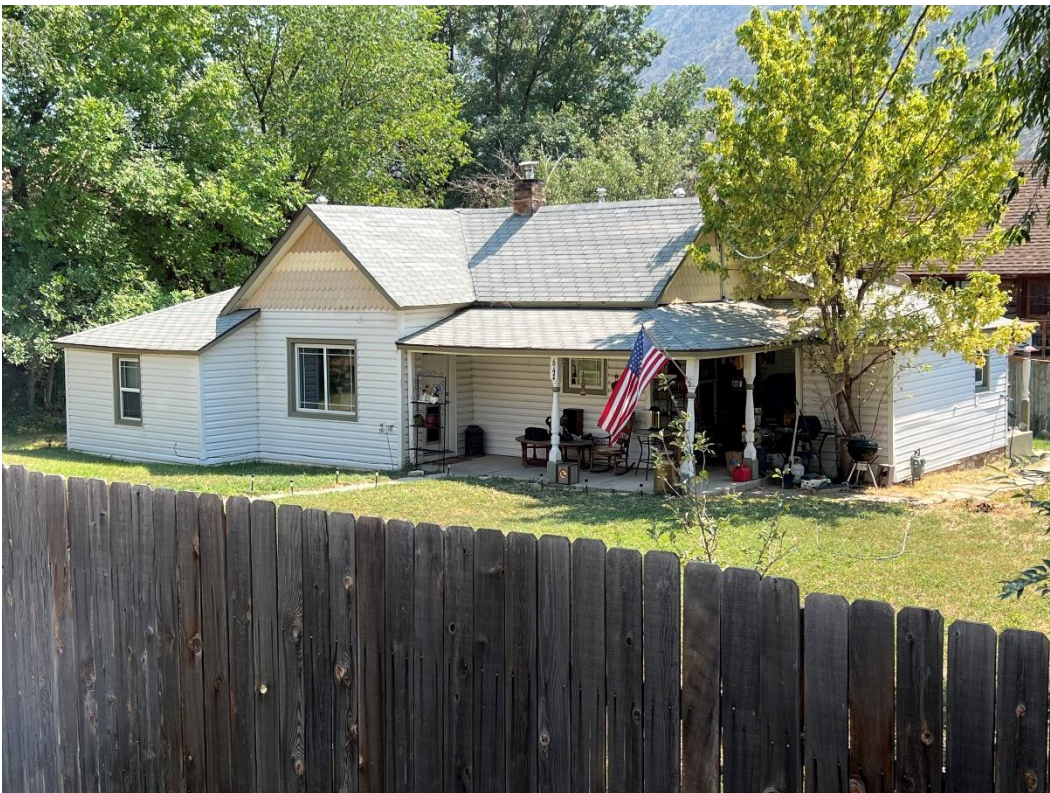
Photo Number: 5GF.5940_2
Description: Looking at the primary (north) and west elevations of the building.
Date: 9/6/2022
View: Southeast

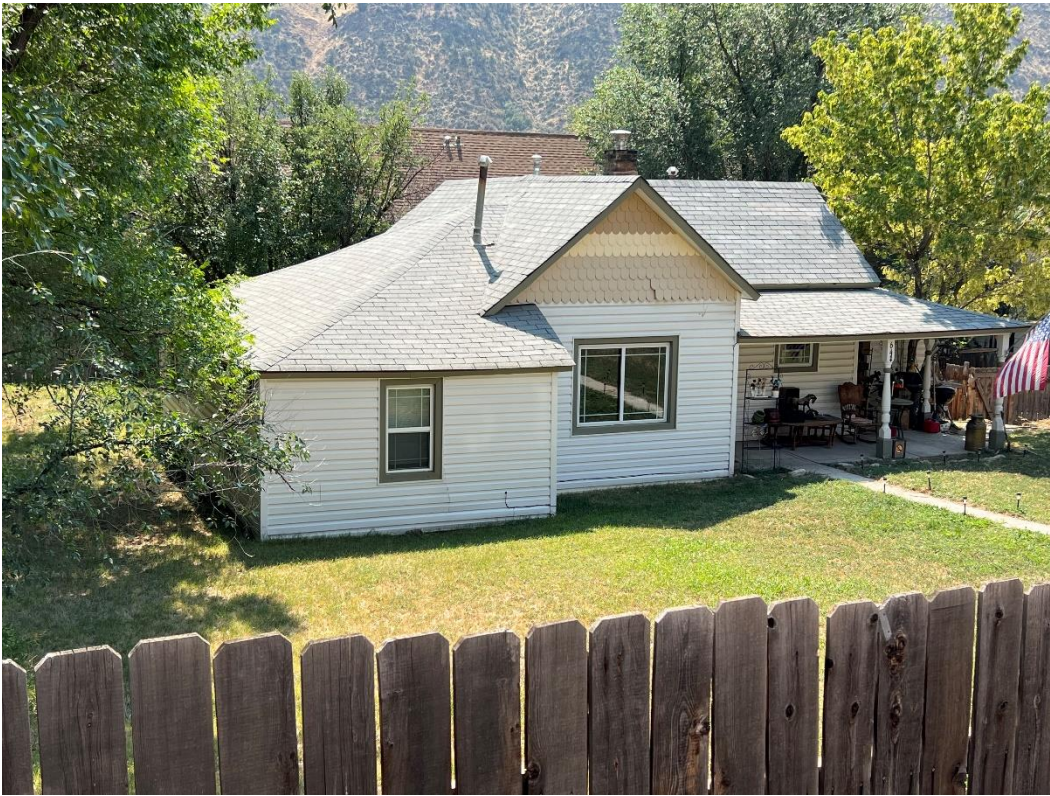
Photo Number: 5GF.5940_3
Description: Looking at the east and primary (north) elevations of the building.
Date: 9/6/2022
View: Southwest

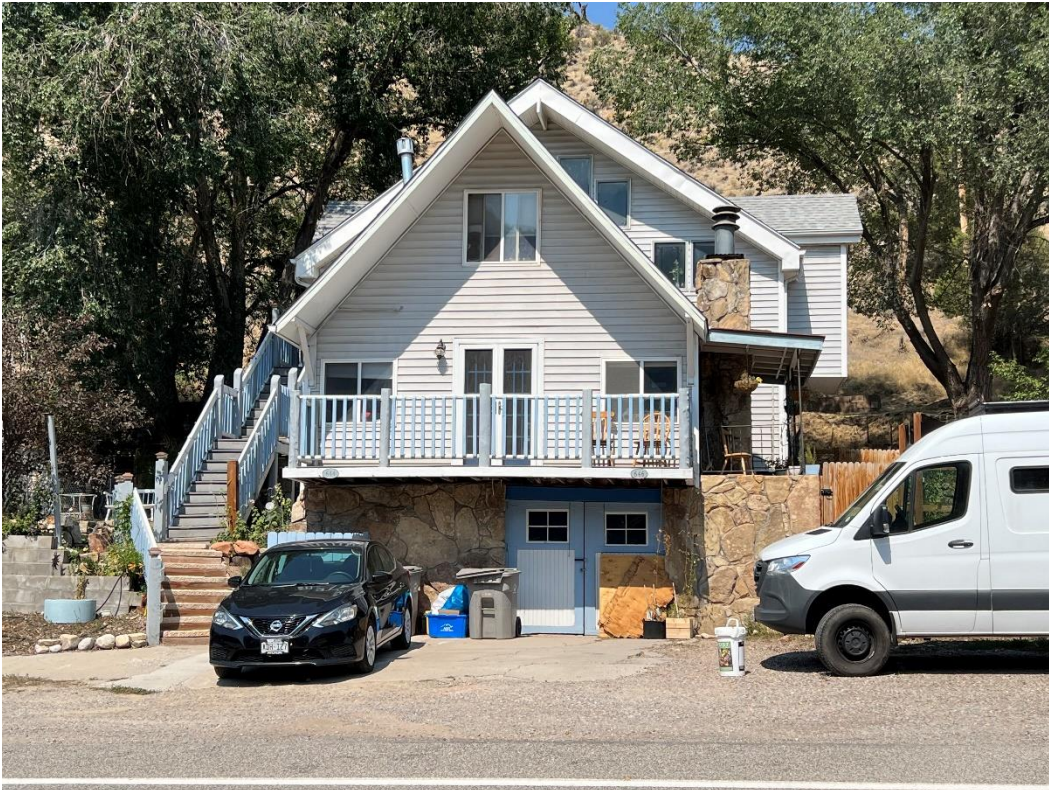
Photo Number: 5GF.5941_1
Description: Looking at the primary (south) elevation of the building. Note the front gable and the side gable projections below the front gable roofline.
Date: 9/6/2022
View: North

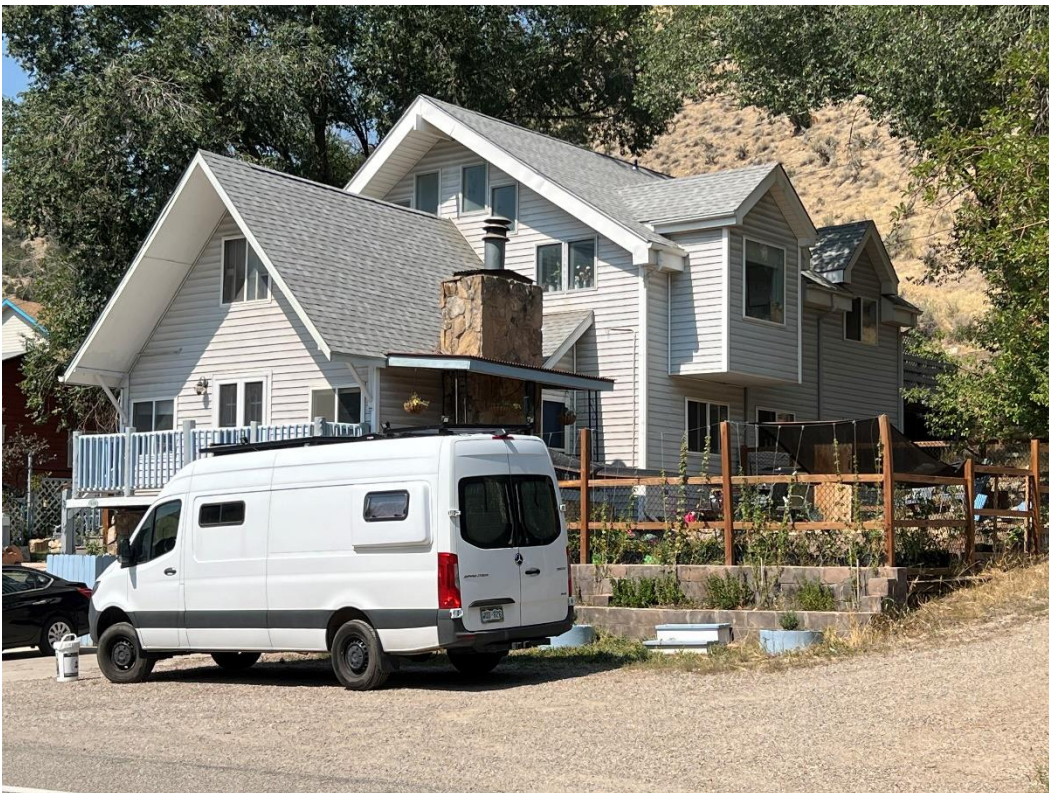
Photo Number: 5GF.5941_2
Description: Looking at the primary (south) and east elevations of the building.
Date: 9/6/2022
View: Northwest

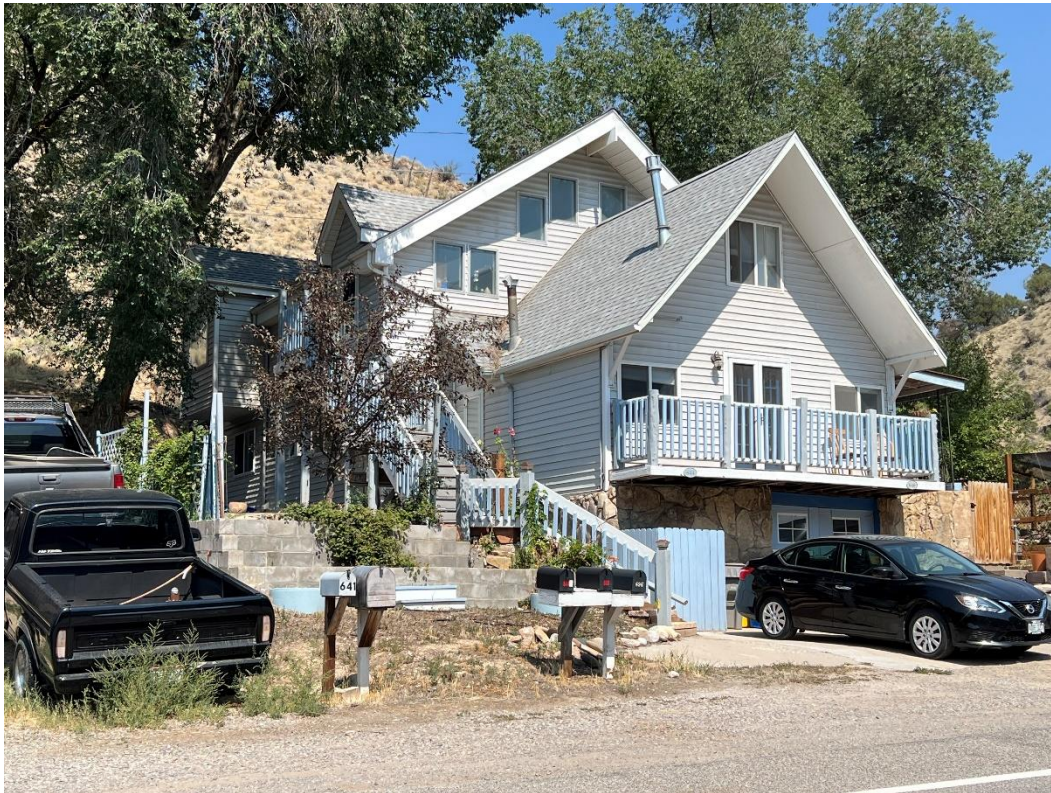
Photo Number: 5GF.5941_3
Description: Looking at the west and primary (south) elevations of the building. Note the staircase leads from the basement level to the second floor.
Date: 9/6/2022
View: Northeast

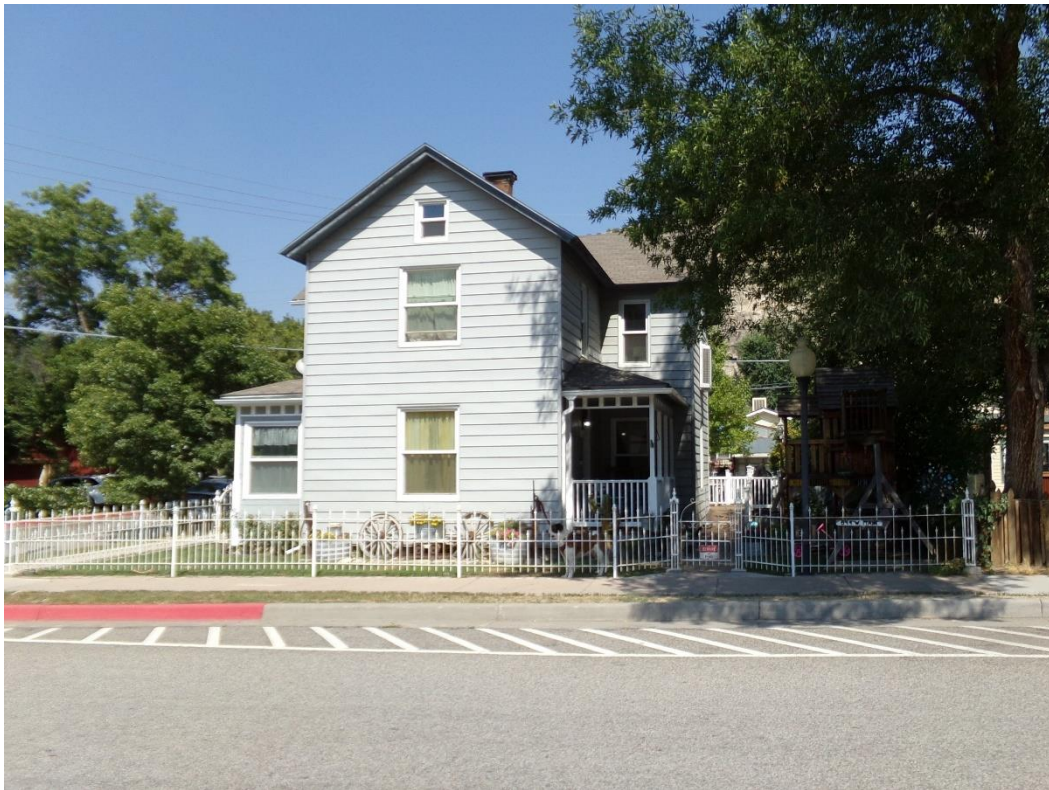
Photo Number: 5GF.5900_1
Description: Looking at the south and primary (east) elevations of the building. Note the decorative wrought iron fence in front of the residence.
Date: 9/6/2022
View: Northwest

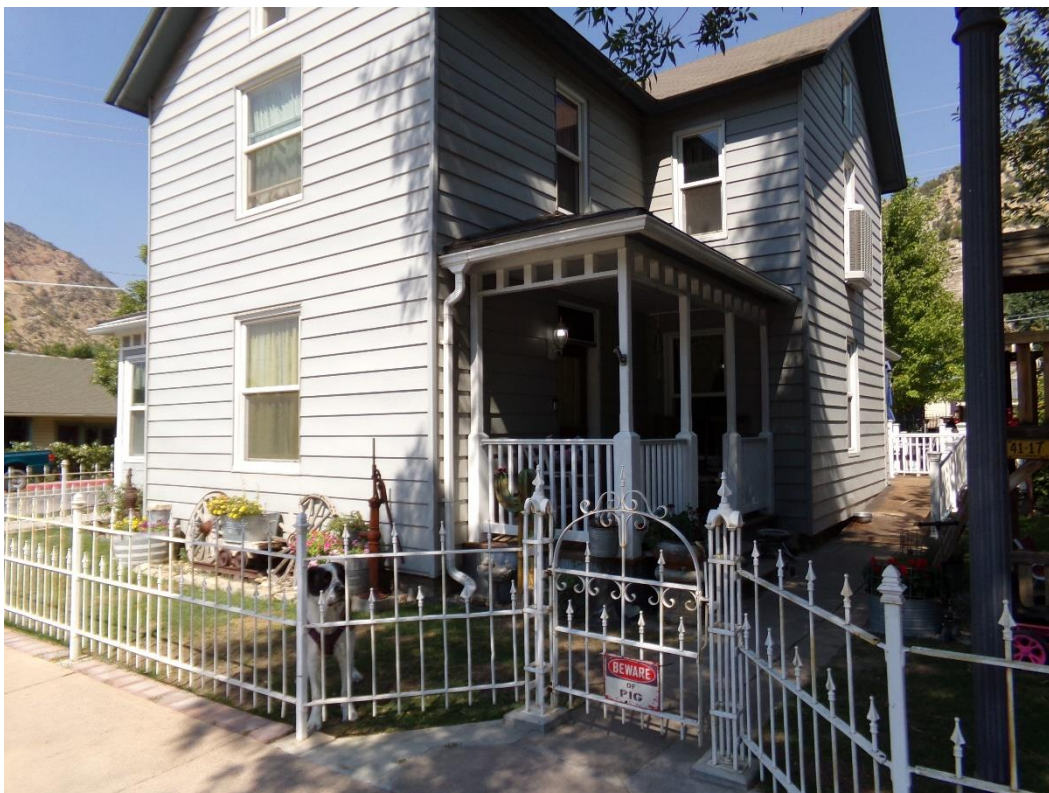
Photo Number: 5GF.5900_2
Description: Looking at the south and primary (east) elevations of the building.
Date: 9/6/2022
View: Northwest

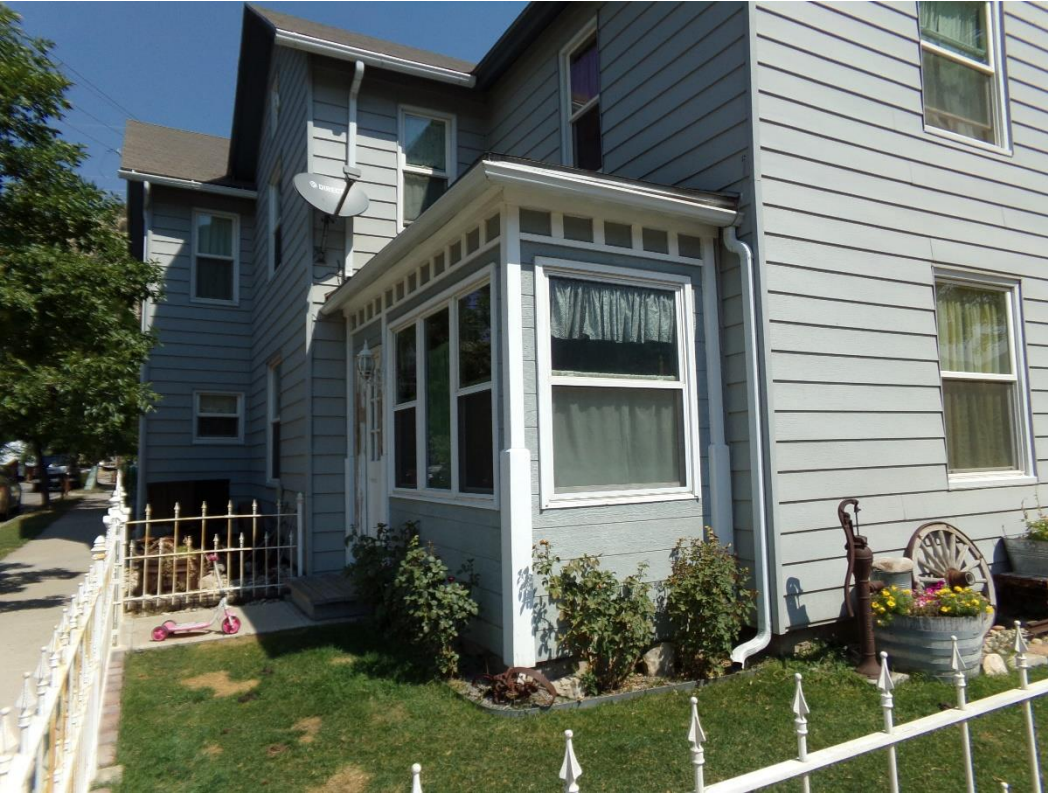
Photo Number: 5GF.5900_3
Description: Looking at the west and south elevations of the building.
Date: 9/6/2022
View: Northeast

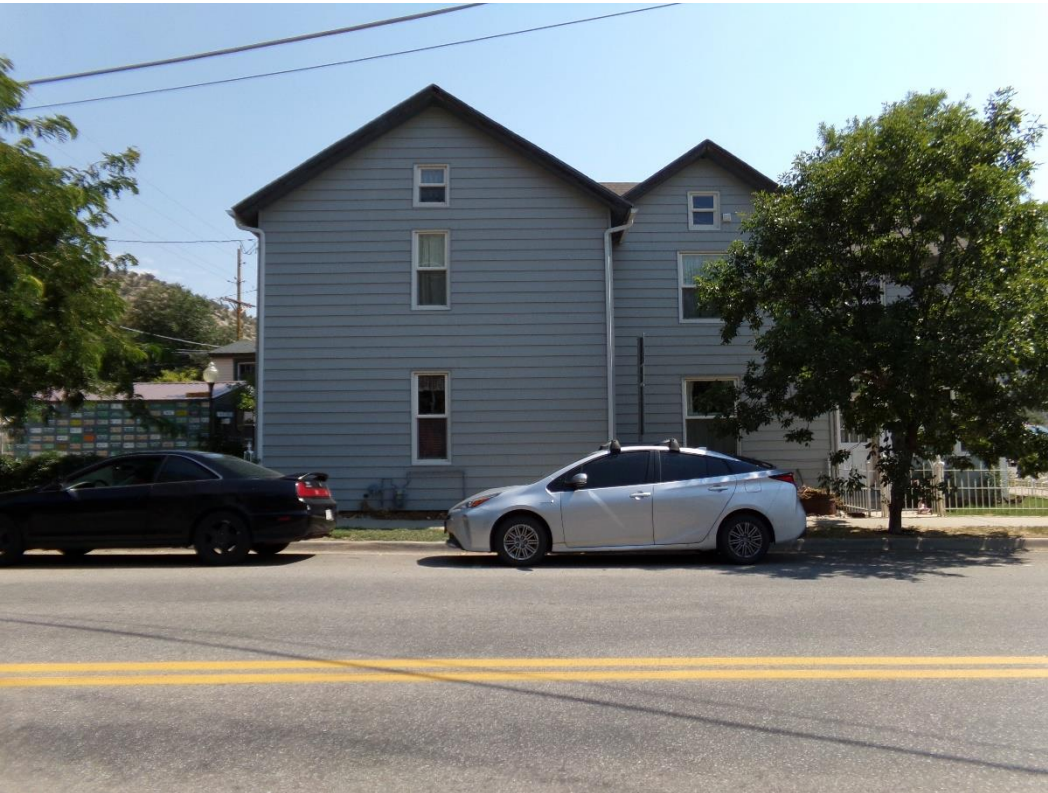
Photo Number: 5GF.5900_4
Description: Looking at the west elevation of the building.
Date: 9/6/2022
View: East

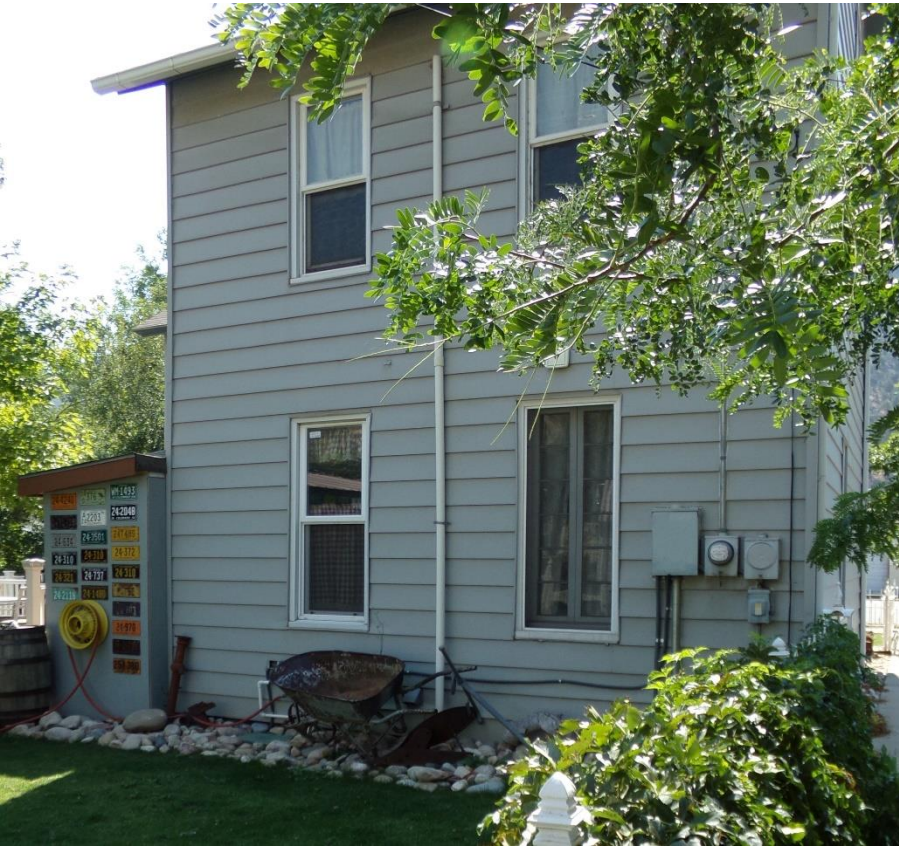
Photo Number: 5GF.5900_5
Description: Looking at the north elevation of the building.
Date: 9/6/2022
View: Southeast

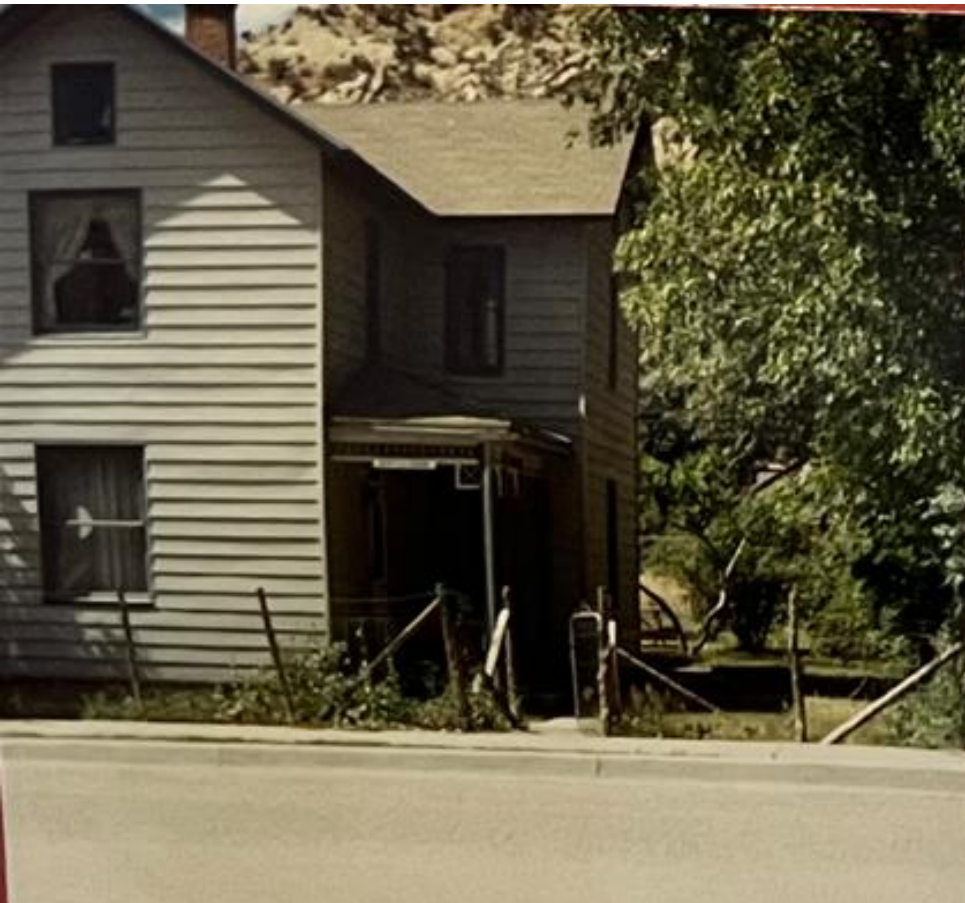
Historic Photo 1
Description: Image label states, "Smith House/First House to have indoor plumbing. 644 West Main Street." Note the turned spindles and spindlework within the porch.
Date: Unknown
Source: New Castle Museum Collection

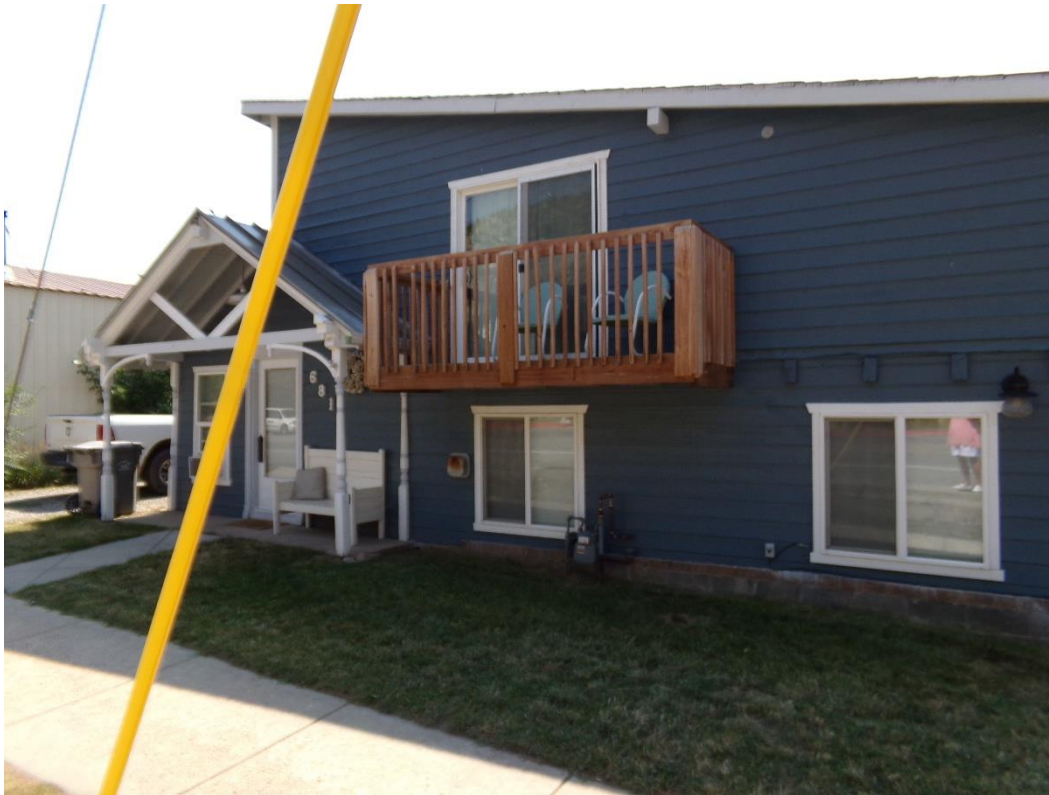
Photo Number: 5GF.5899_1
Description: Looking at the primary (north) elevation of the building.
Date: 9/6/2022
View: Southeast

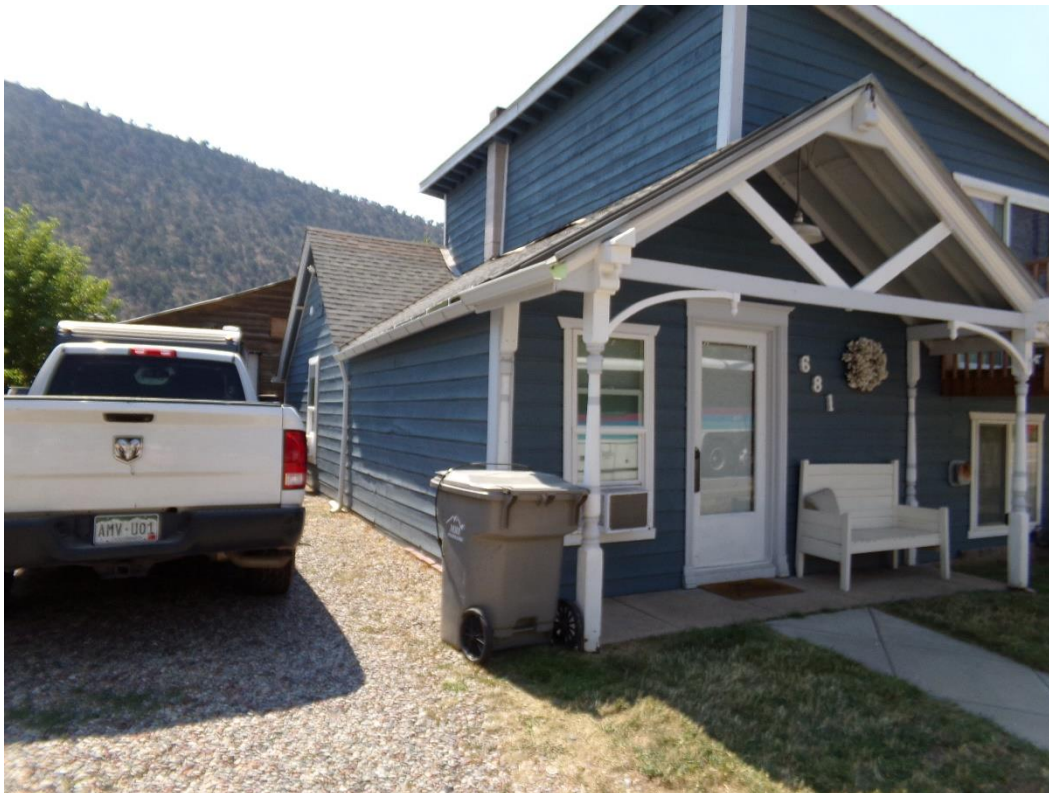
Photo Number: 5GF.5899_2
Description: Looking at the east and primary (north) elevations of the building.
Date: 9/6/2022
View: Southwest
