New Castle Historic Preservation Commission (Regular Meeting)

New Castle - Reconnaissance Survey

The Town of New Castle (New Castle) is conducting a reconnaissance-level survey of historic resources along Main Street (US Highway 6). The survey will identify and recommend individual resources for future intensive-level survey to determine potential eligibility under National Register of Historic Places (NRHP) criteria in accordance with NRHP and State of Colorado Historic Survey Standards. In addition, this survey assesses the potential for a historic district as well as identify and recommend resources that may contribute toward a potential NRHP historic district. This survey represents the most recent evaluation of historic resources in the Town of New Castle. Previous historic resource surveys have mostly focused on residential and commercial buildings/structures in the central quadrant of the town. Resources in the survey area—bounded by Elk Creek to the west, Burning Mountain Avenue to the east, and adjacent to Main Street—are the focus of this reconnaissance report.

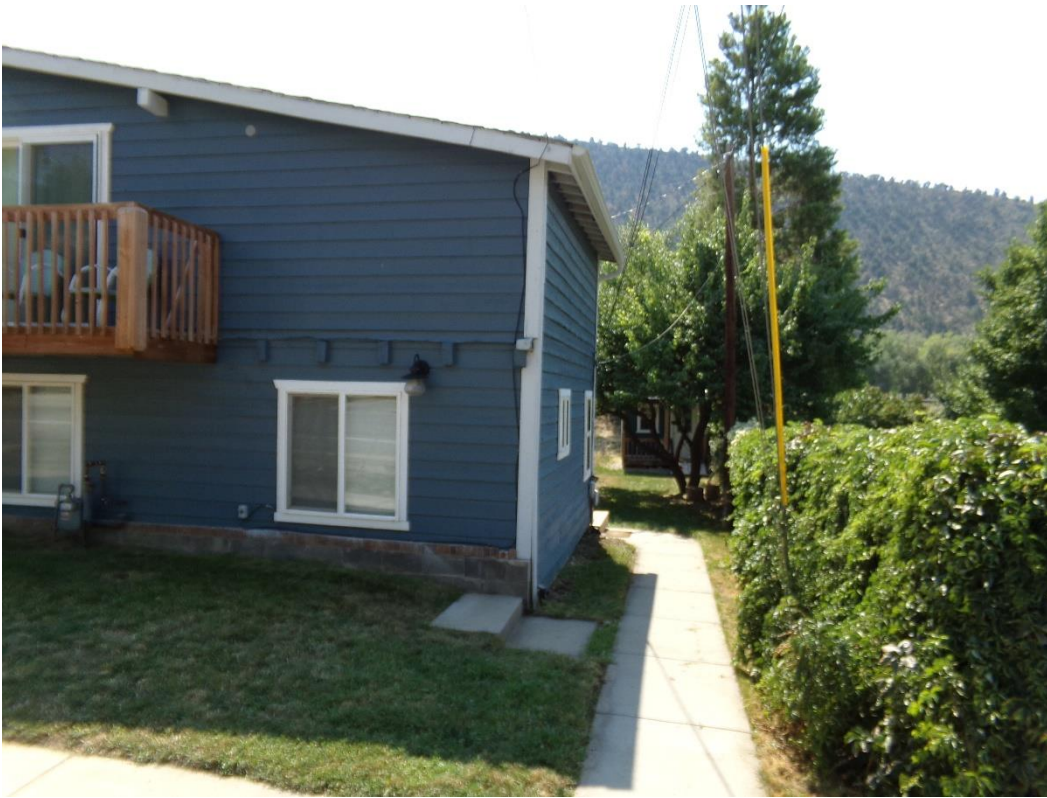
Photo Number: 5GF.5899_3
Description: Looking at the primary (north) and west elevations of the building.
Date: 9/6/2022
View: Southeast

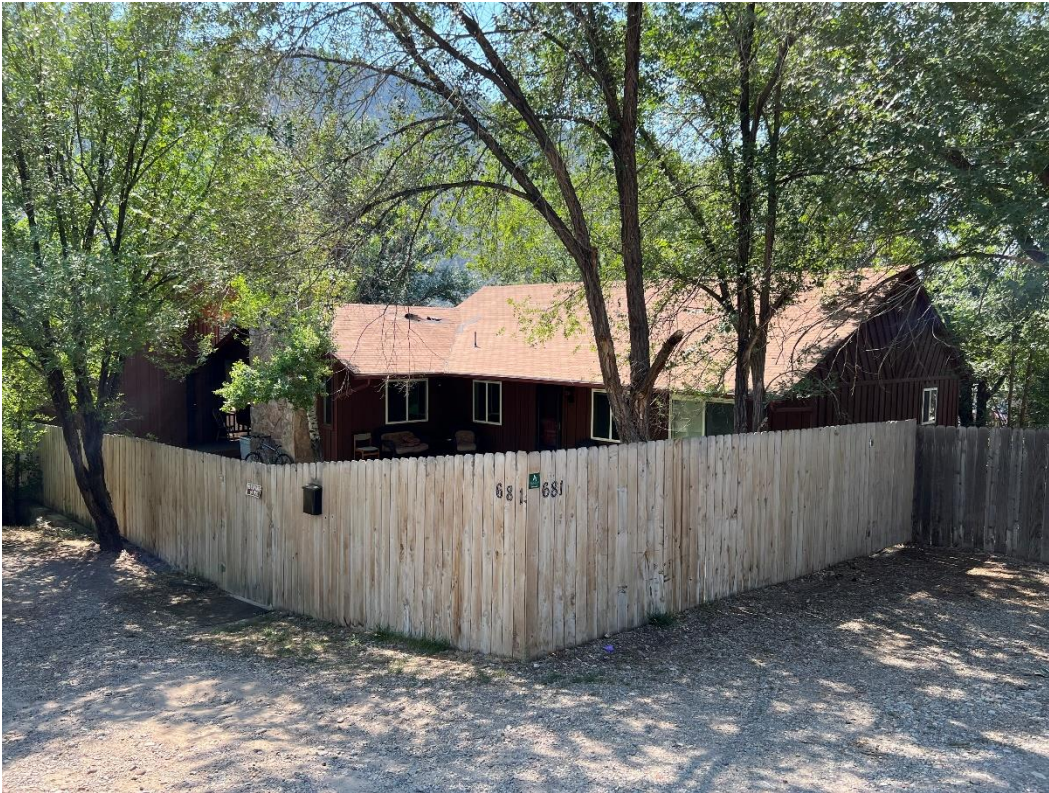
Photo Number: 5GF.5942_1
Description: Looking at the primary (east) and north elevations of the residence.
Date: 9/6/2022
View: Southwest

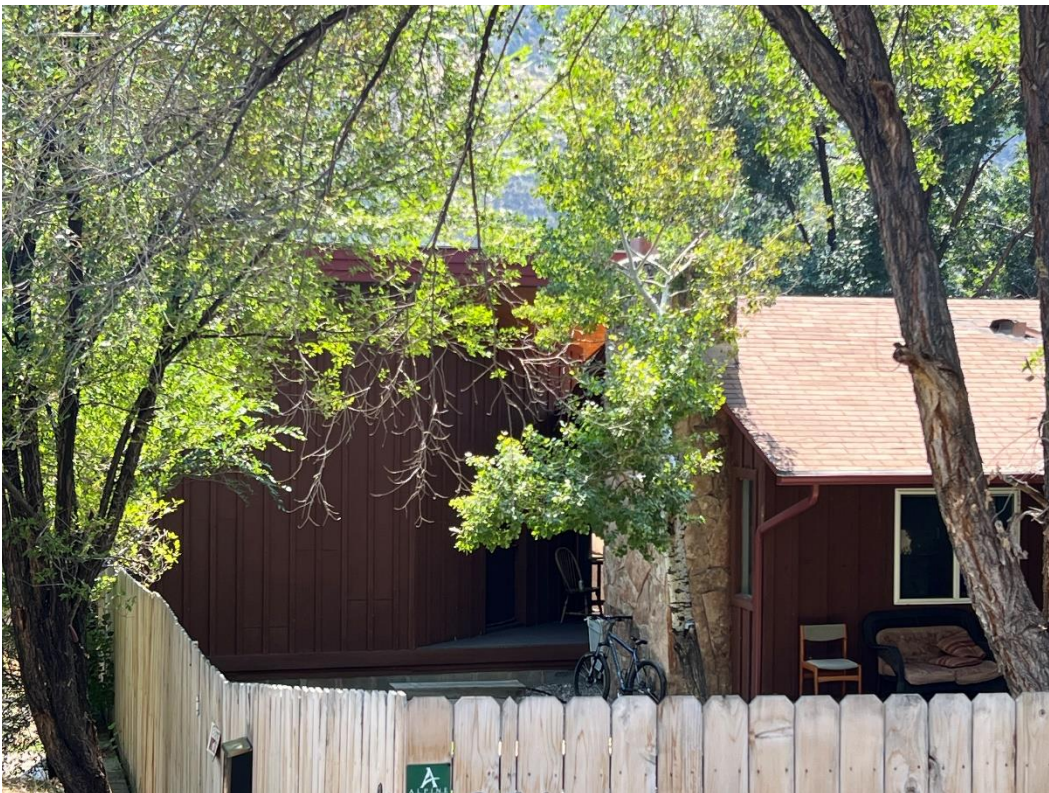
Photo Number: 5GF.5942_2
Description: Close up of the primary (east) elevation of the building. Note the stone masonry chimney.
Date: 9/6/2022
View: Southwest

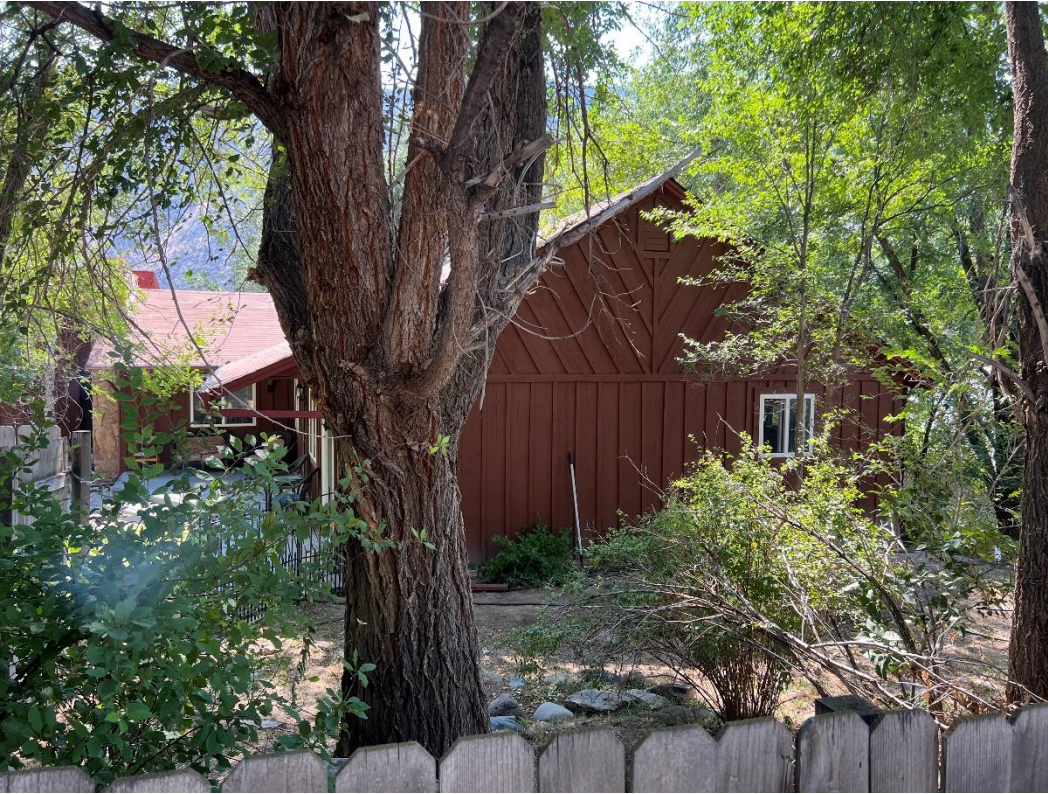
Photo Number: 5GF.5942_3
Description: Looking at the north elevation of the building. Note the decorative chevrons in the gable end.
Date: 9/6/2022
View: South

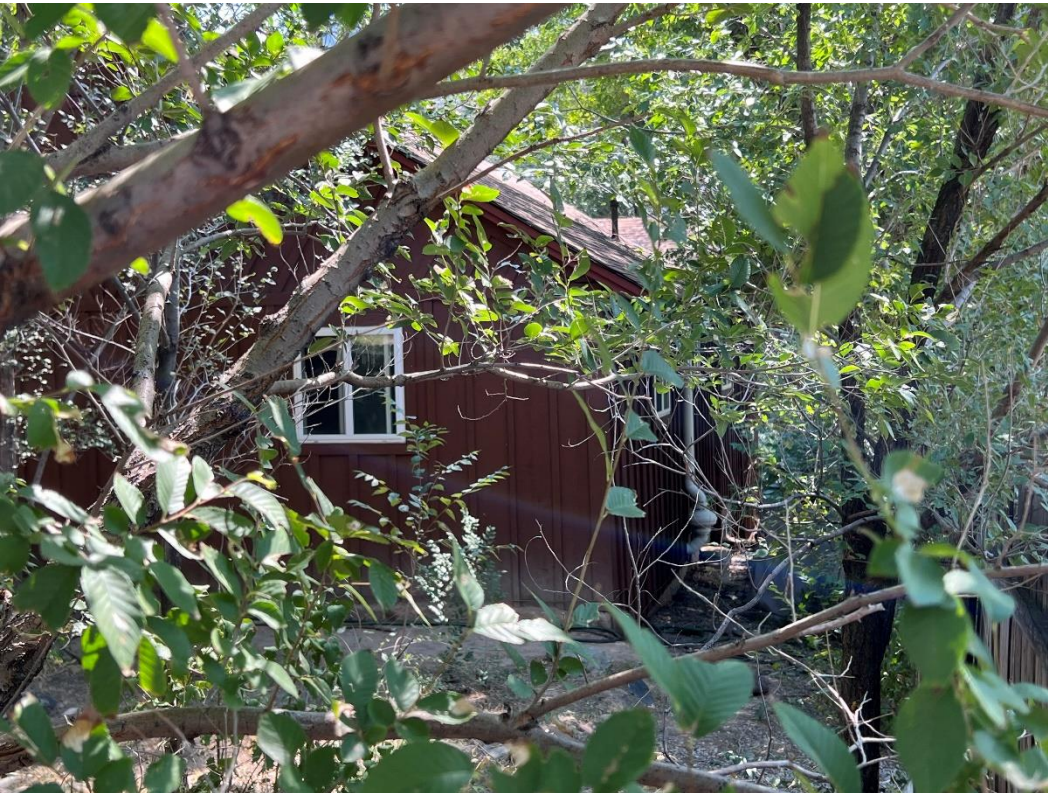
Photo Number: 5GF.5942_4
Description: Looking at the north and west elevations of the building. Note the lower side gable projection near the roofline.
Date: 9/6/2022
View: Southeast

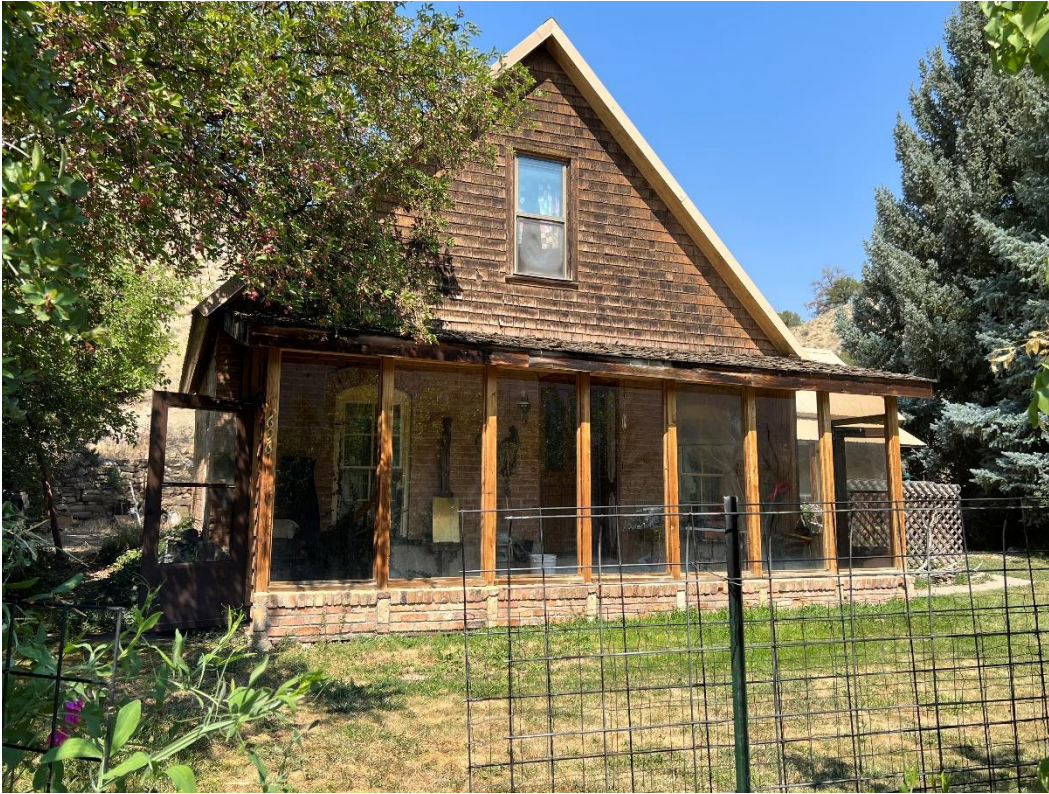
Photo Number: 5GF.5943_1
Description: Looking at the front gable along the primary (south) elevation.
Date: 9/6/2022
View: Northeast

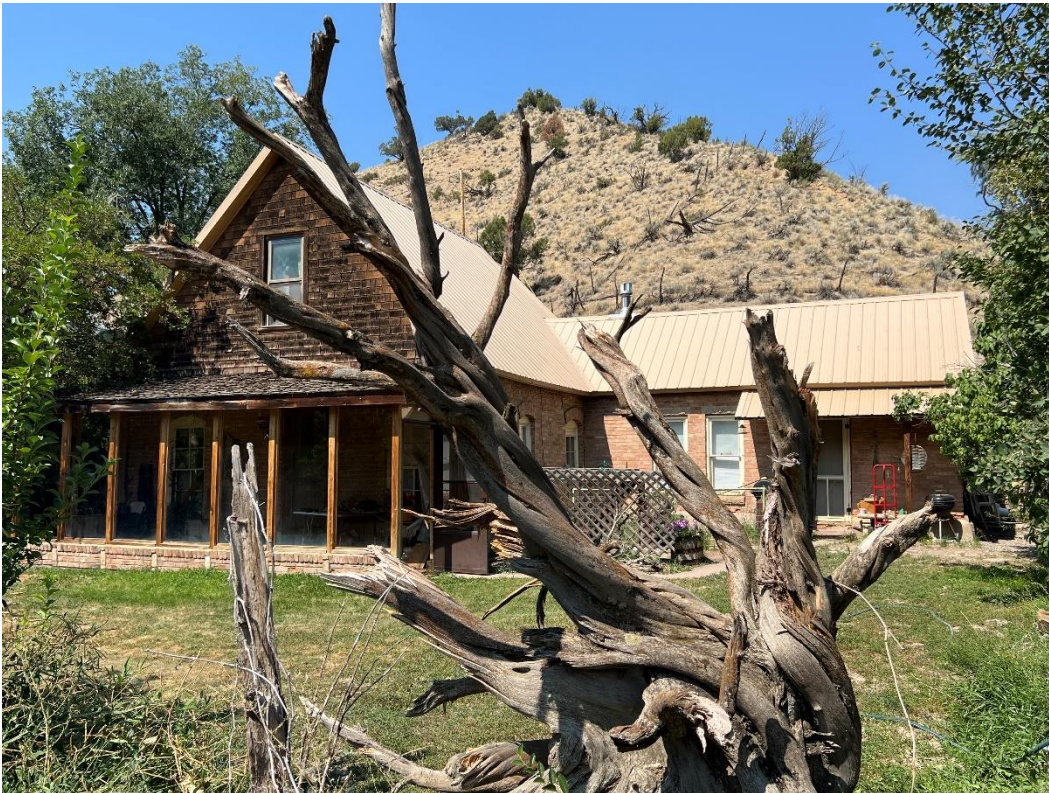
Photo Number: 5GF.5943_2
Description: Looking at the entire facade of the primary (south) elevation. Note the wood shingle exterior in the gable end while brick masonry cladding encompasses the right side of the building.
Date: 9/6/2022
View: Northwest

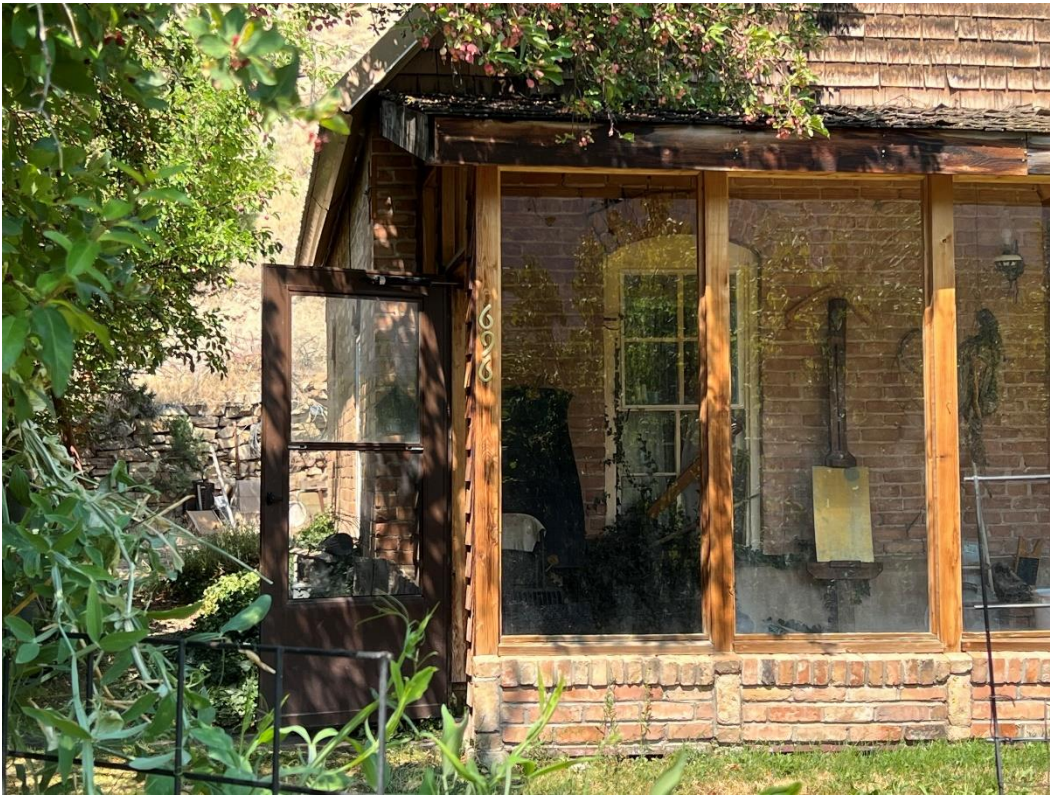
Photo Number: 5GF.5943_3
Description: A small glimpse of the west elevation of the building.
Date: 9/6/2022
View: Northeast

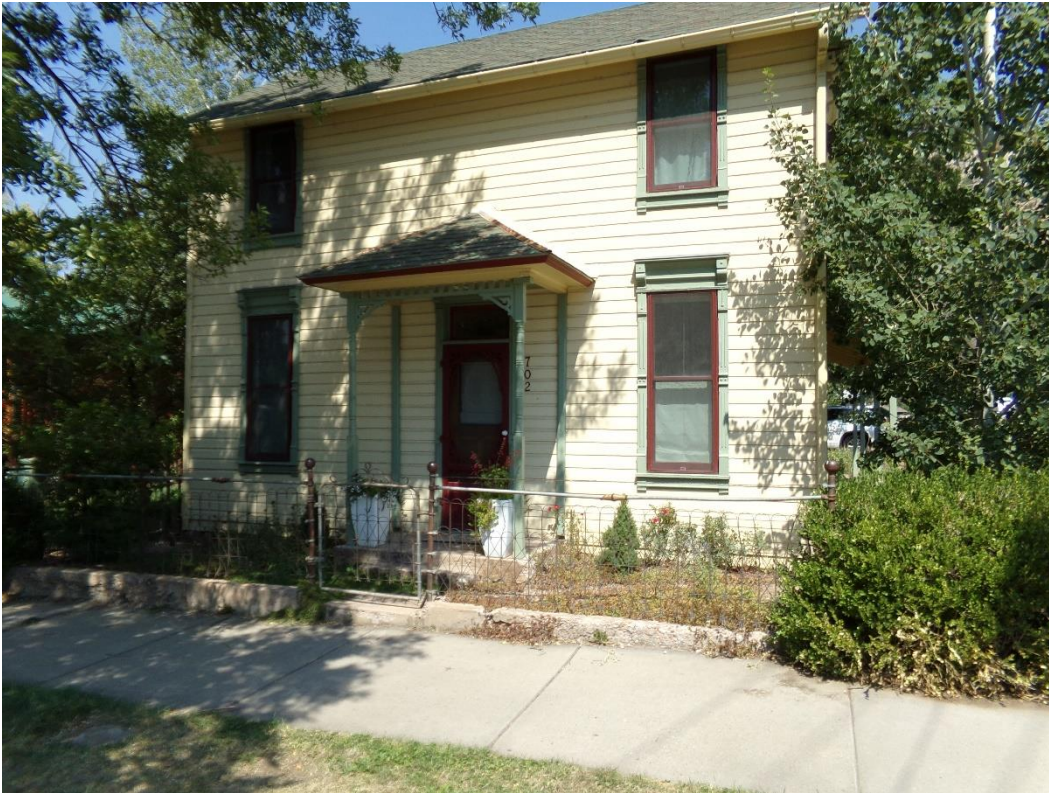
Photo Number: 5GF.5898_1
Description: Looking at the primary (south) elevation of the primary residence.
Date: 9/6/2022
View: Northwest

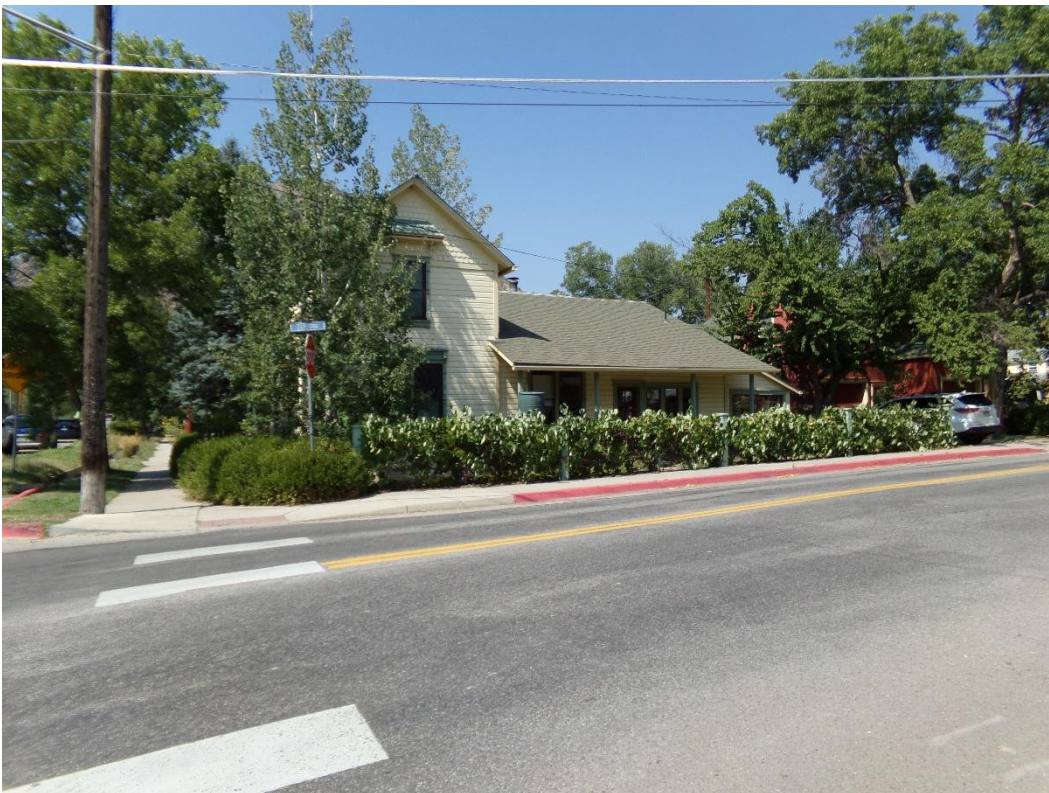
Photo Number: 5GF.5898_2
Description: Looking at the east elevation of the primary residence.
Date: 9/6/2022
View: Northwest

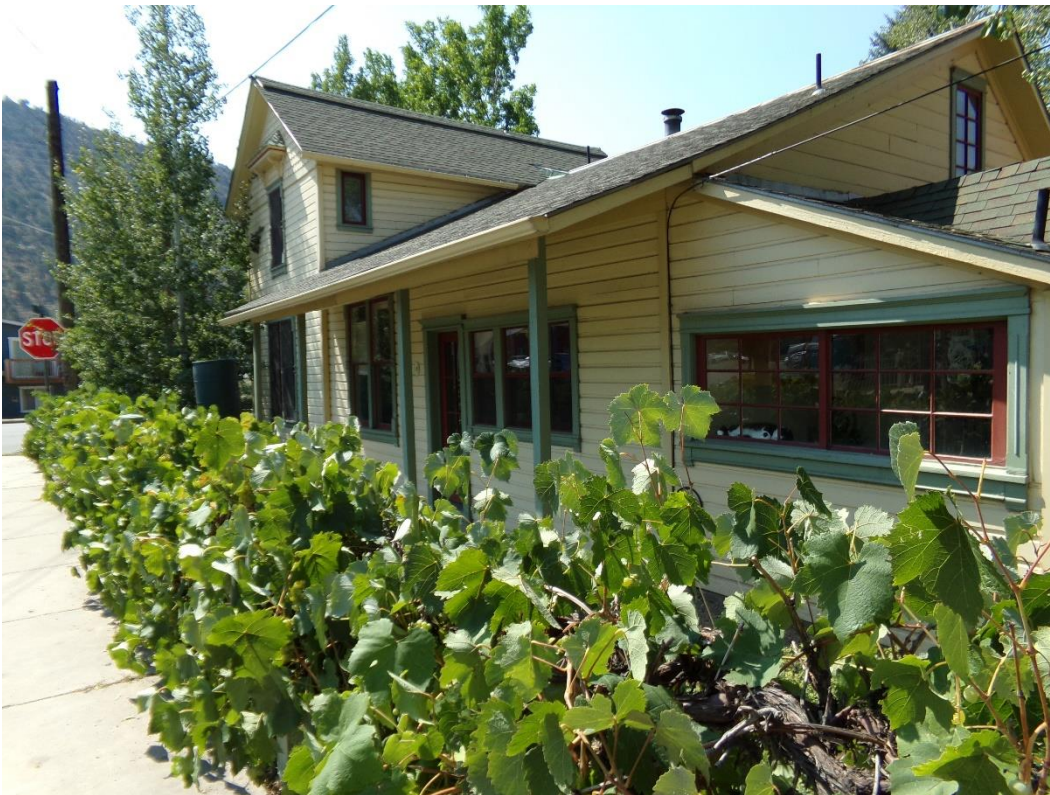
Photo Number: 5GF.5898_3
Description: Looking at the east elevation of the primary residence.
Date: 9/6/2022
View: Southwest

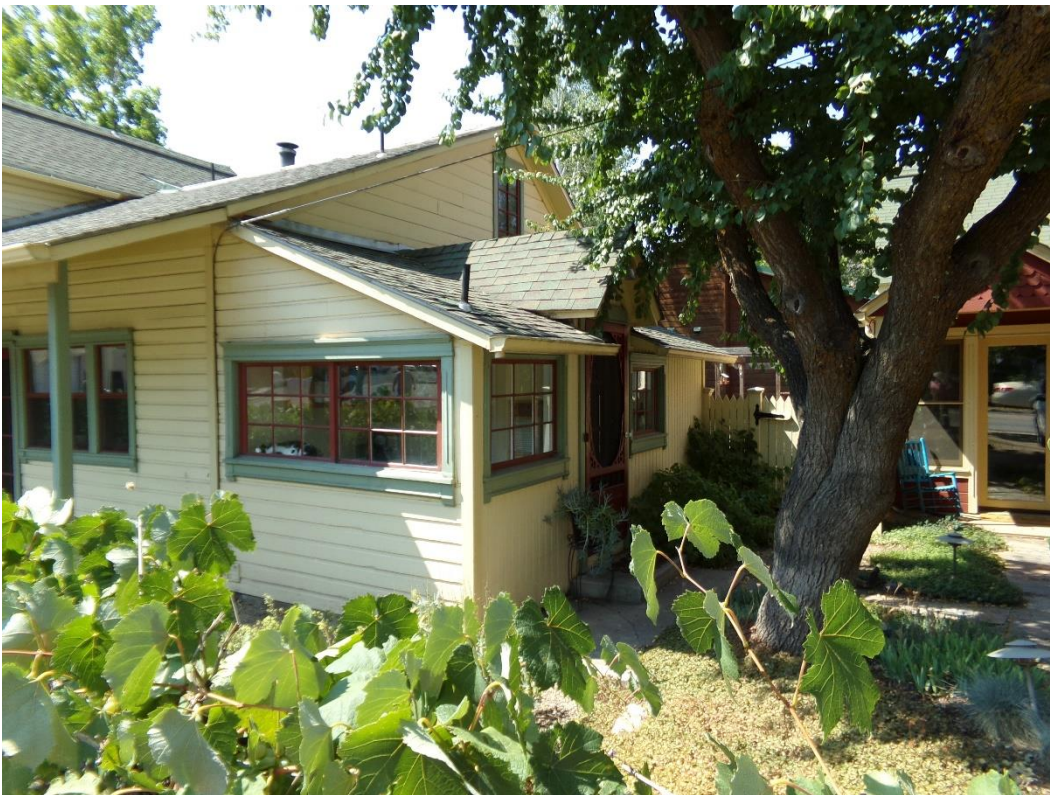
Photo Number: 5GF.5898_4
Description: Looking at the north elevation of the primary residence.
Date: 9/6/2022
View: Southwest

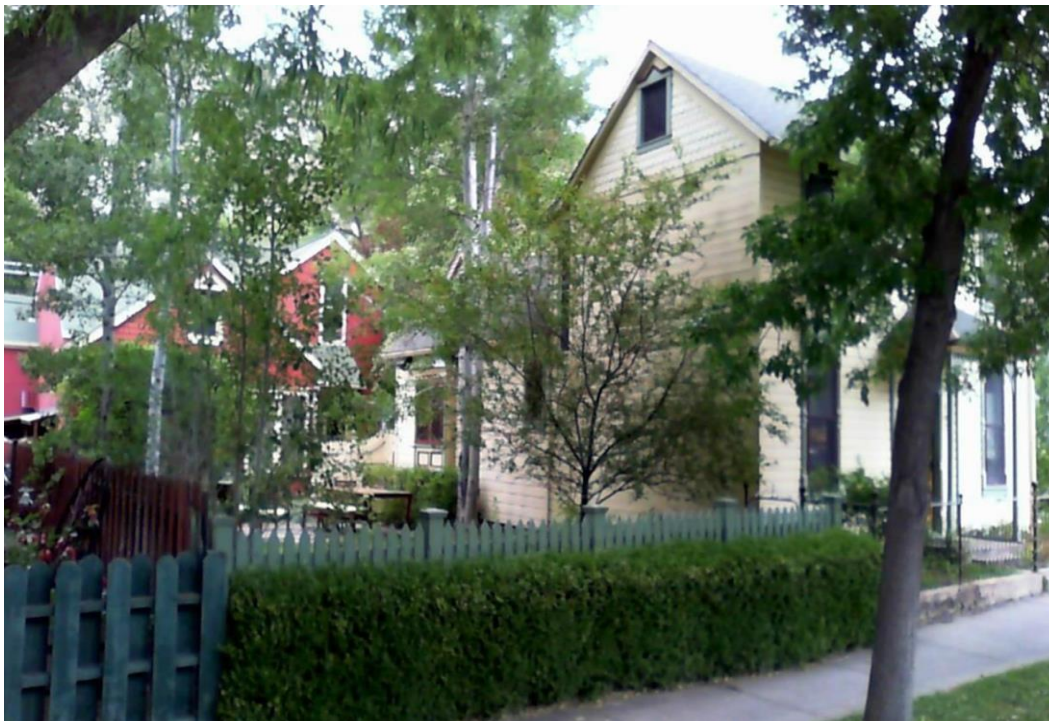
Reference Photo 1

Description: Looking at the west and primary (south) elevation of the primary residence. Note the primary (south) elevation of the secondary residence on the left side of the image.

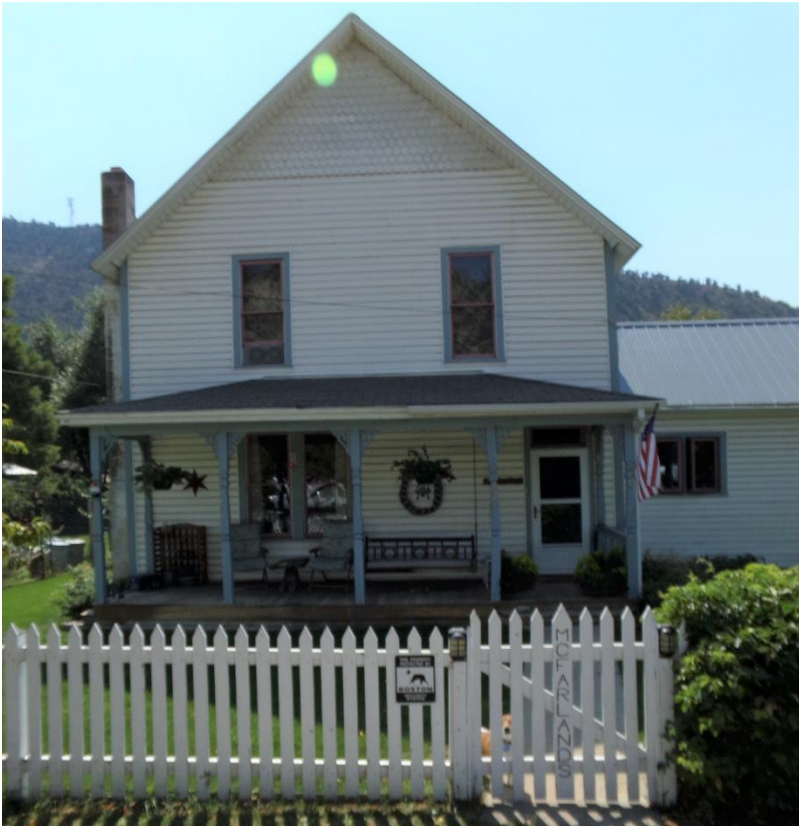
Photo Number: 5GF.5897_1
Description: Looking at the primary (north) elevation of the building.
Date: 9/6/2022
View: South

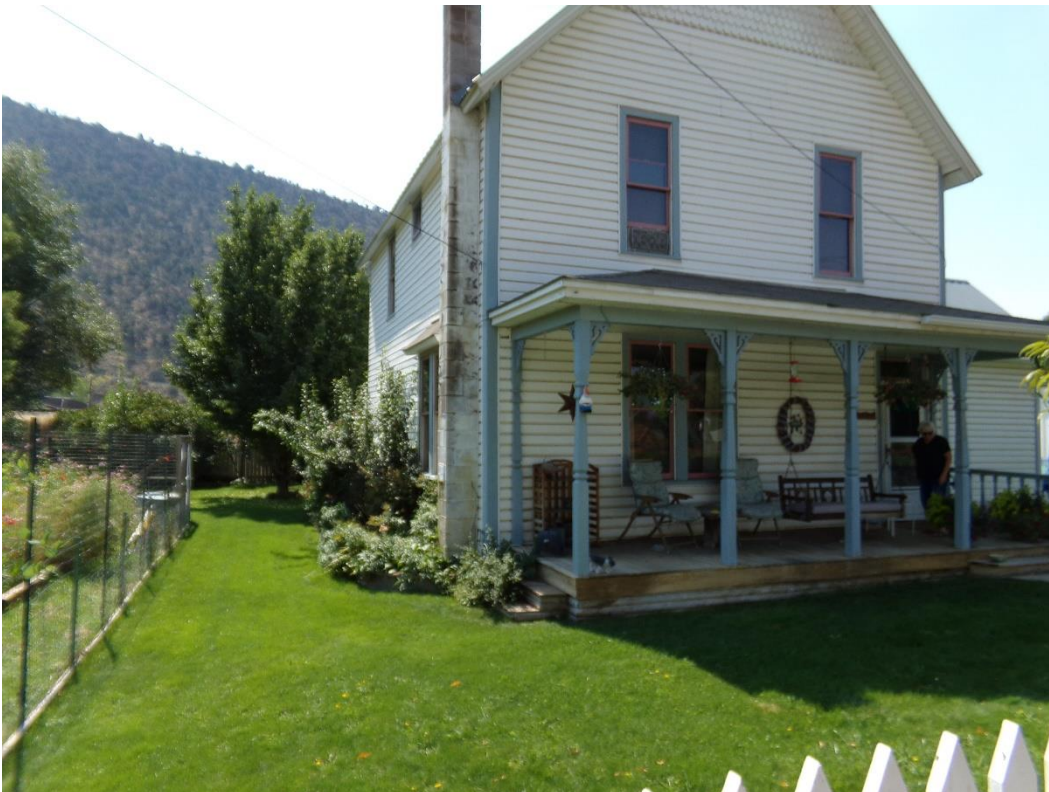
Photo Number: 5GF.5897_2
Description: Looking at the east and primary (north) elevations of the building.
Date: 9/6/2022
View: Southwest

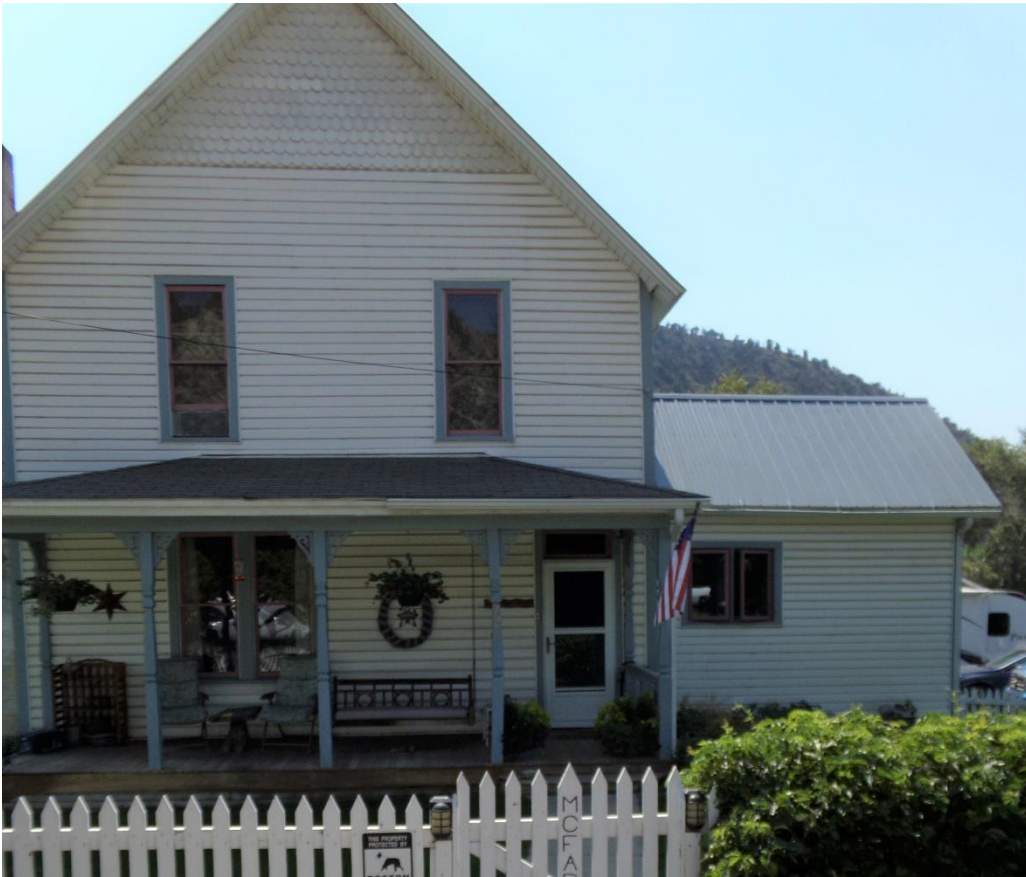
Photo Number: 5GF.5897_3
Description: Looking at the primary (north) elevation of the building.
Date: 9/6/2022
View: South

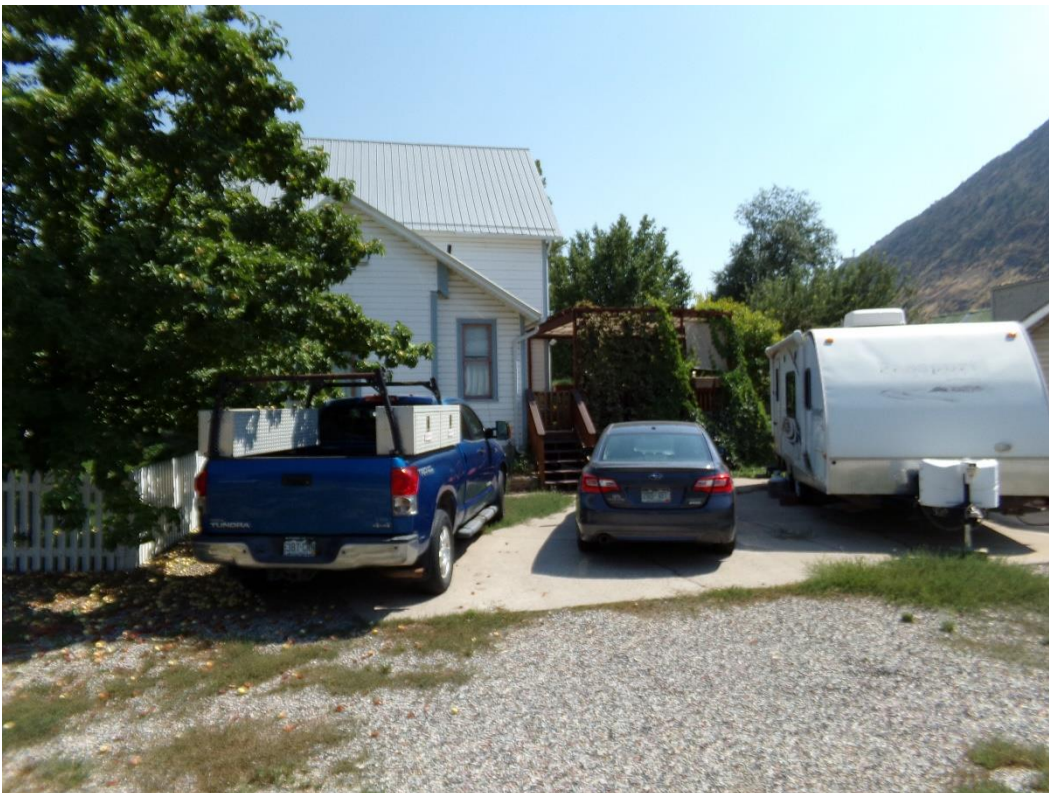
Photo Number: 5GF.5897_4
Description: Looking at the west elevation of the building. Note that the deck is along the south elevation.
Date: 9/6/2022
View: East

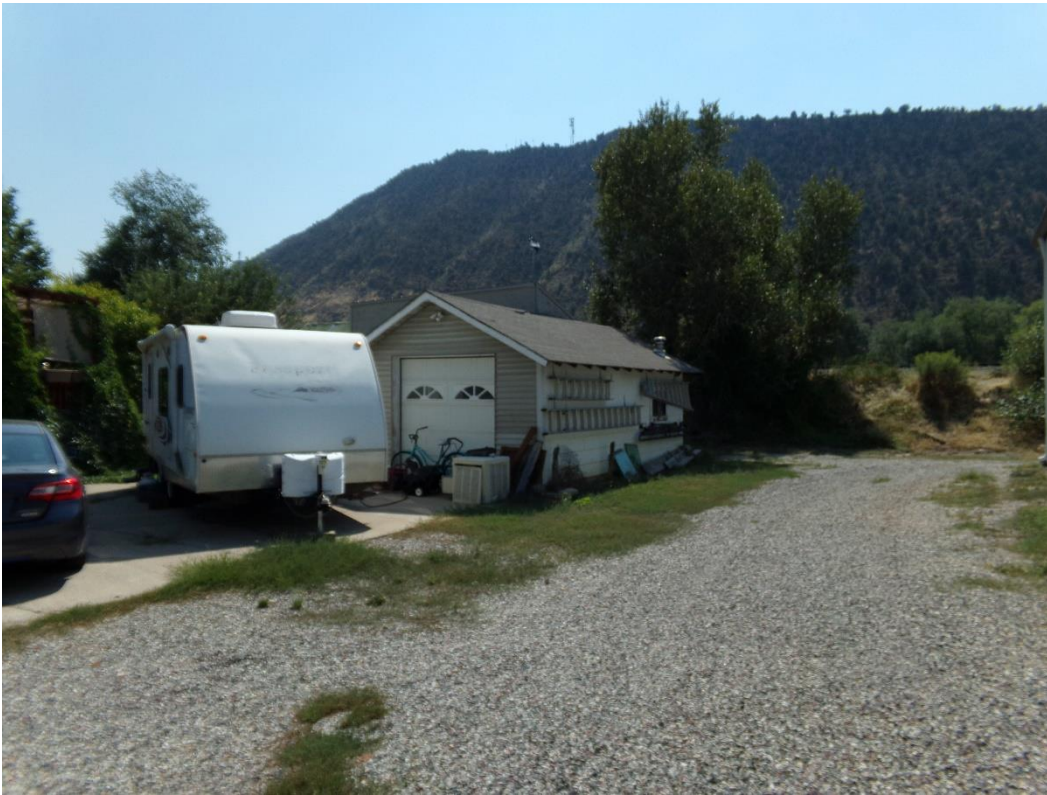
Photo Number: 5GF.5897_5
Description: Looking at the primary (north) and west elevations of the detached garage.
Date: 9/6/2022
View: Southeast

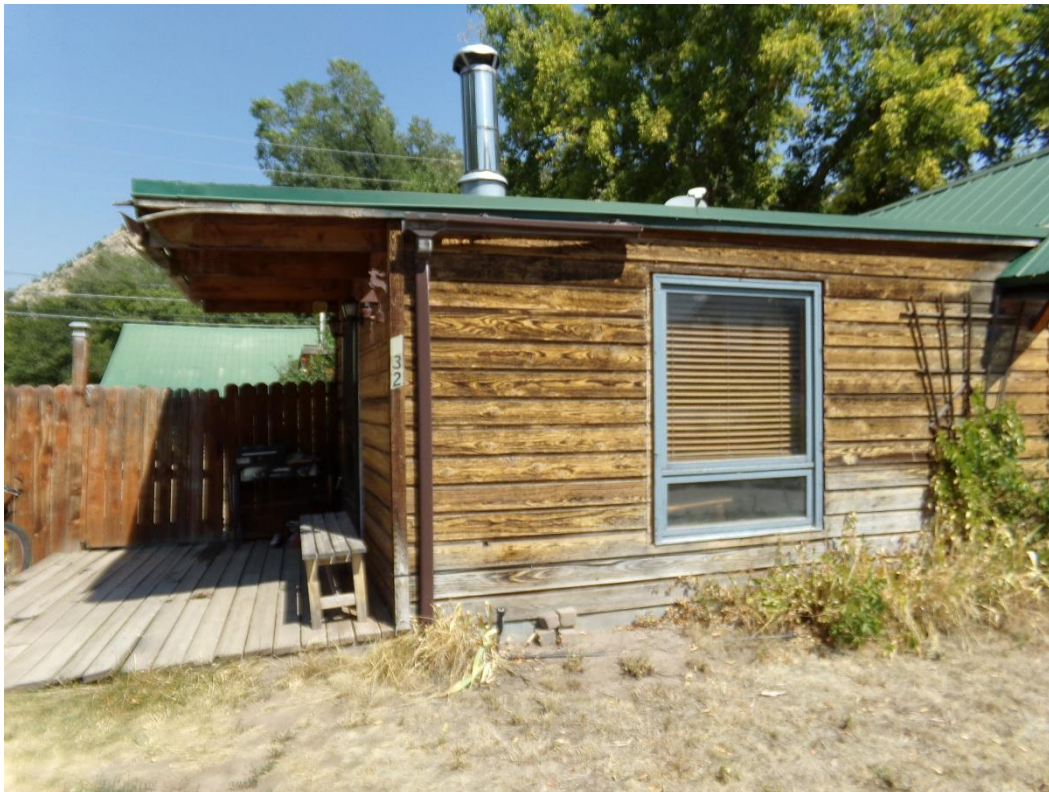
Photo Number: 5GF.5896_1

Description: Looking at the right side of the primary (west) elevation and the left side of the south elevation.

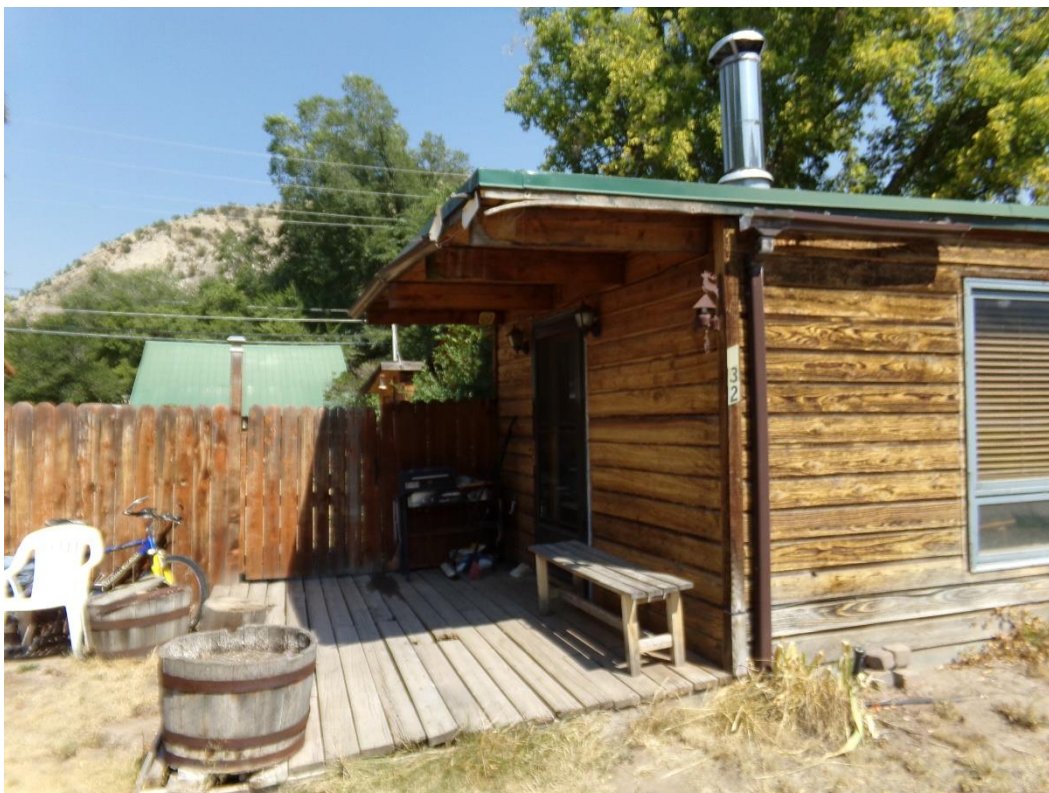
Photo Number: 5GF.5896_2

Description: Looking at the right side of the primary (west) elevation of the building.

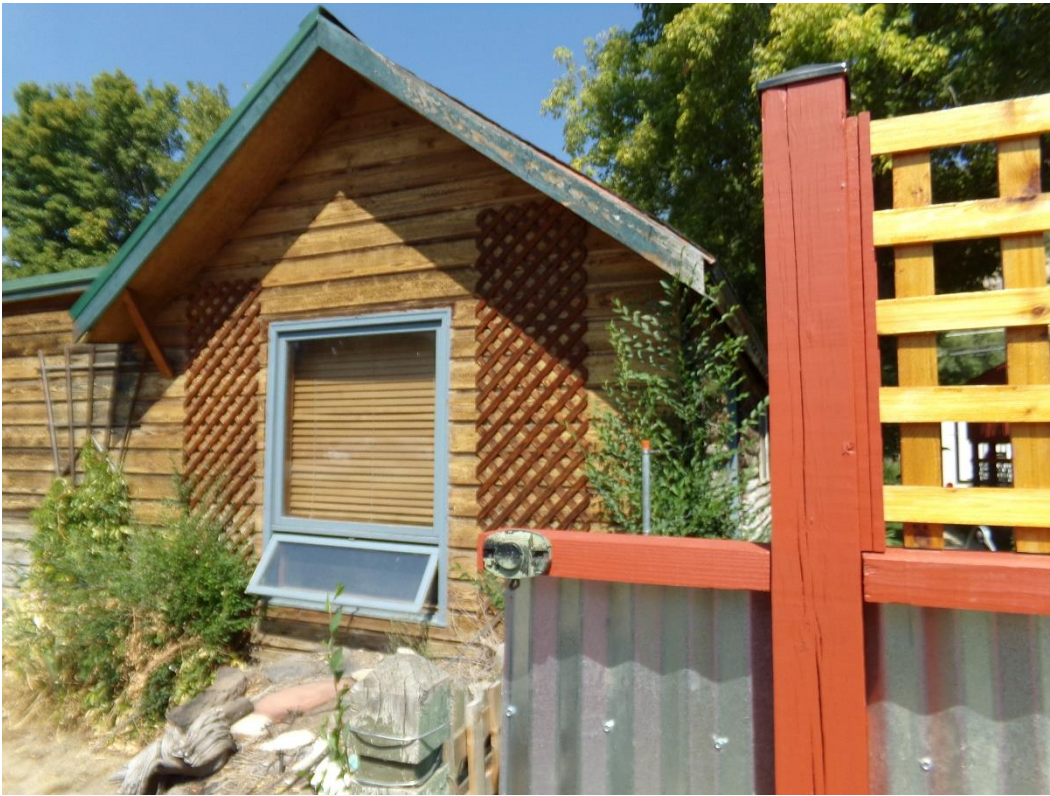
Photo Number: 5GF.5896_3
Description: Looking at the right side of the south elevation of the building.
Date: 9/6/2022
View: Northwest

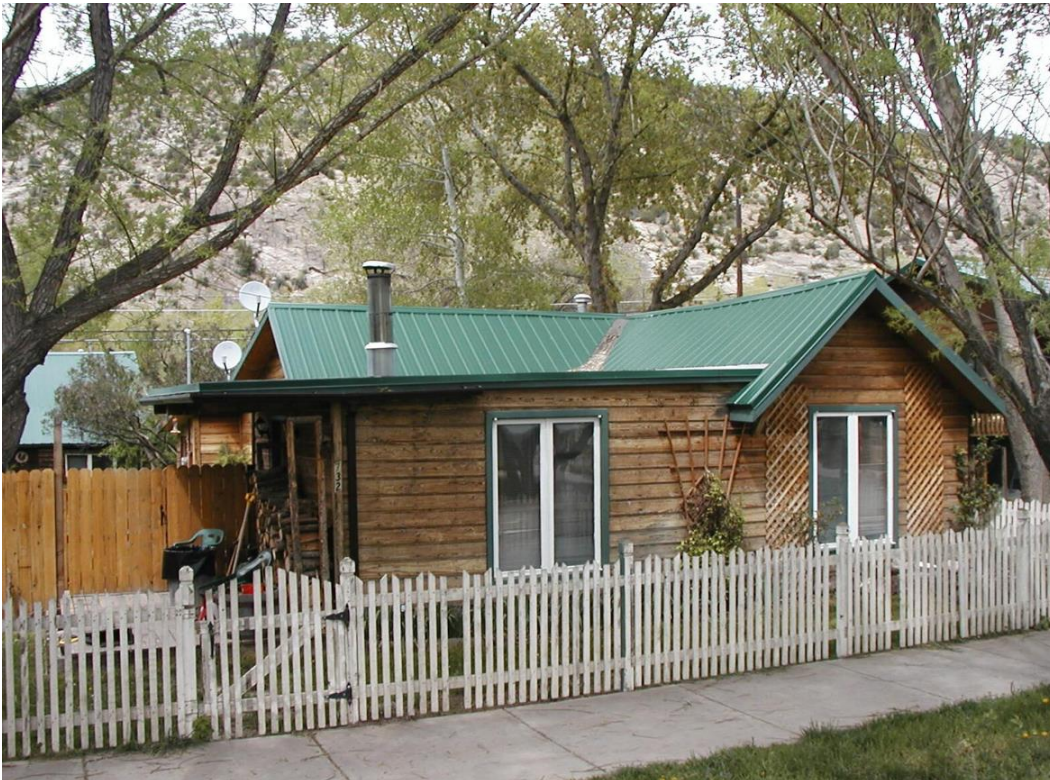
Reference Photo 1
Description: Looking at the primary (west) and south elevations of the building.
Date: circa 2009
Source: Garfield County Assessor's Office

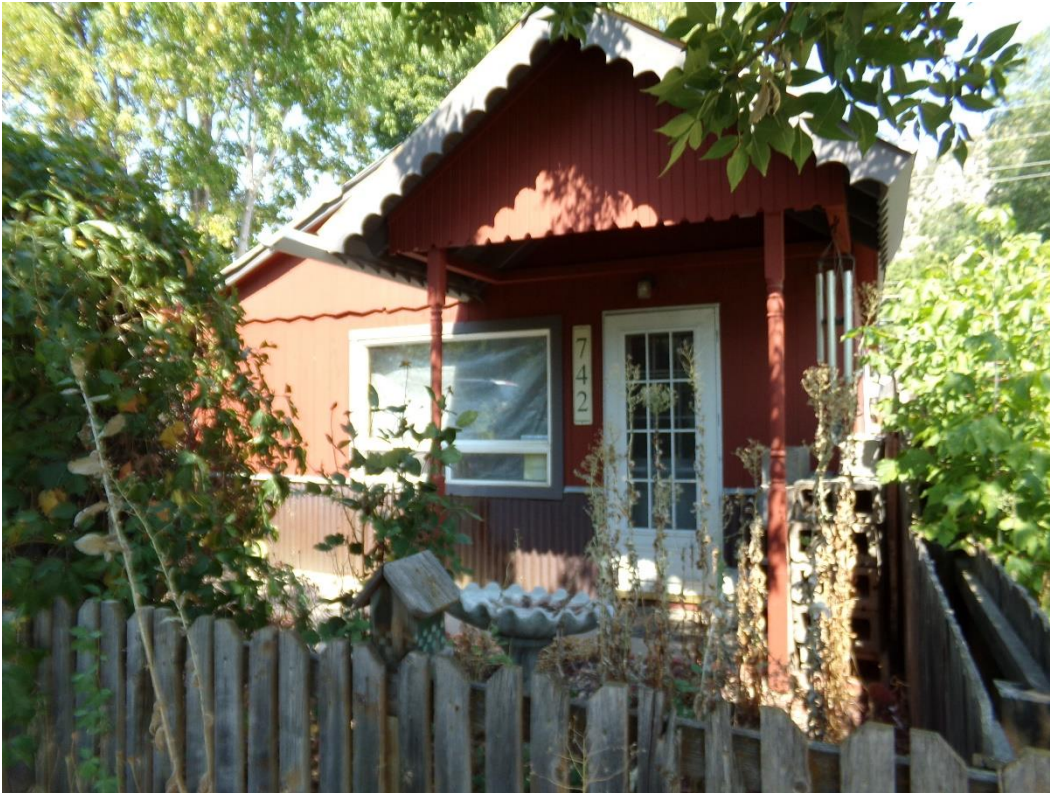
Photo Number: 5GF.5895_1
Description: Looking at the primary (south) elevation of the building.
Date: 9/6/2022
View: Northwest

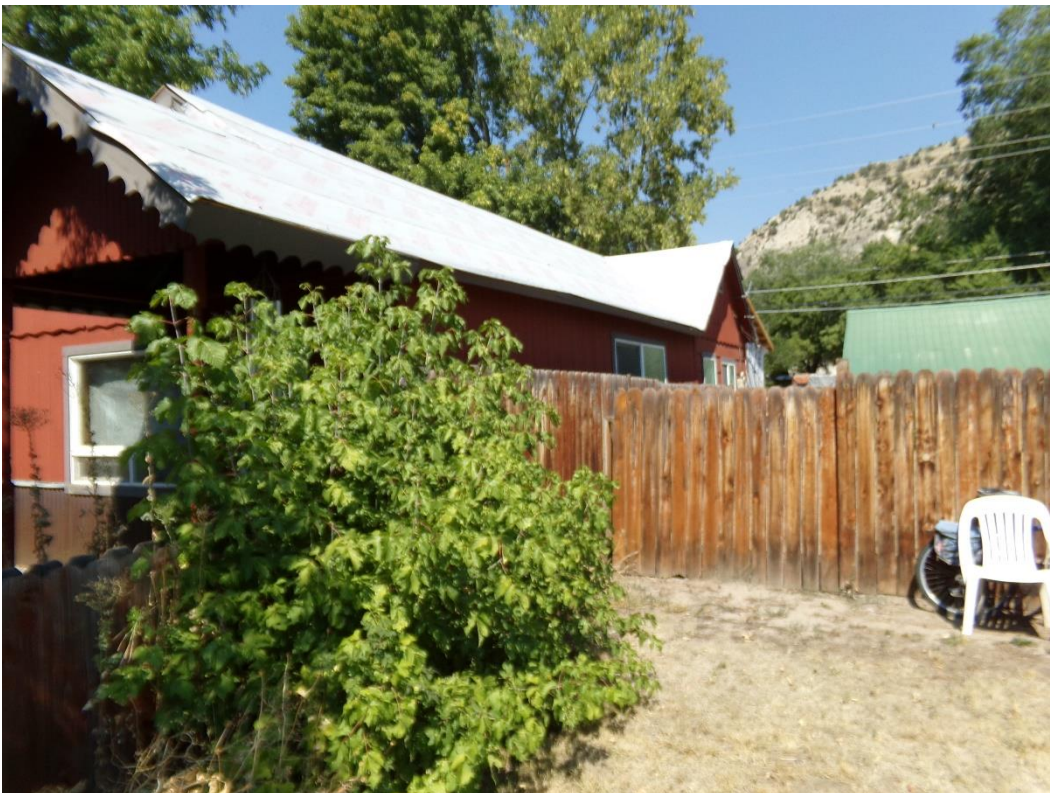
Photo Number: 5GF.5895_2
Description: Looking at the east elevation of the building.
Date: 9/6/2022
View: Northwest

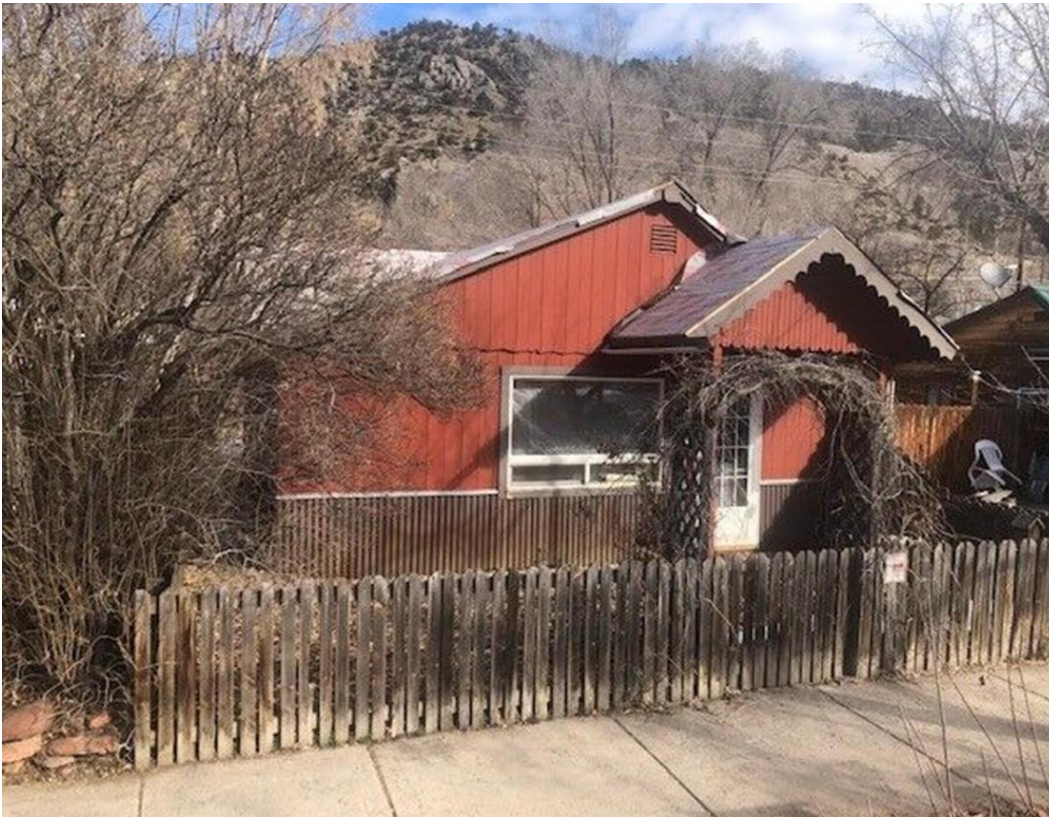
Reference Photo 1

Description: Looking at the primary (south) elevation of the building.

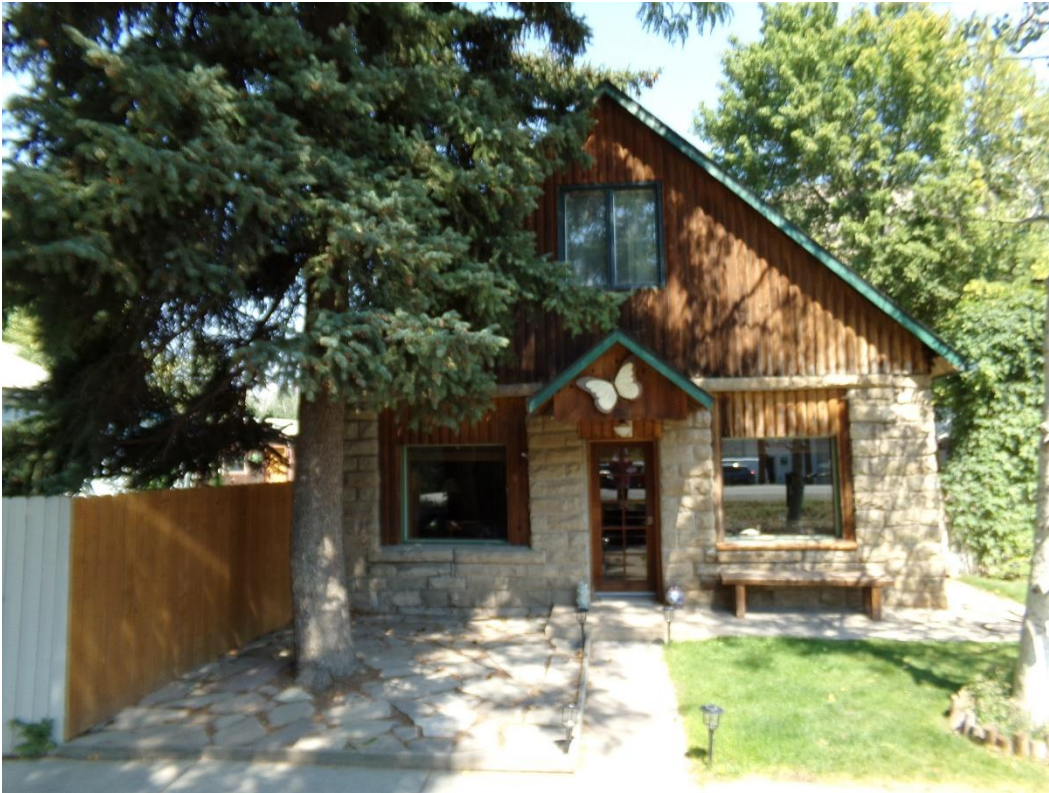
Photo Number: 5GF.5894_1
Description: Looking at the primary (south) elevation of the building.
Date: 9/6/2022
View: North
