New Castle Historic Preservation Commission (Regular Meeting)

New Castle - Reconnaissance Survey

The Town of New Castle (New Castle) is conducting a reconnaissance-level survey of historic resources along Main Street (US Highway 6). The survey will identify and recommend individual resources for future intensive-level survey to determine potential eligibility under National Register of Historic Places (NRHP) criteria in accordance with NRHP and State of Colorado Historic Survey Standards. In addition, this survey assesses the potential for a historic district as well as identify and recommend resources that may contribute toward a potential NRHP historic district. This survey represents the most recent evaluation of historic resources in the Town of New Castle. Previous historic resource surveys have mostly focused on residential and commercial buildings/structures in the central quadrant of the town. Resources in the survey area—bounded by Elk Creek to the west, Burning Mountain Avenue to the east, and adjacent to Main Street—are the focus of this reconnaissance report.

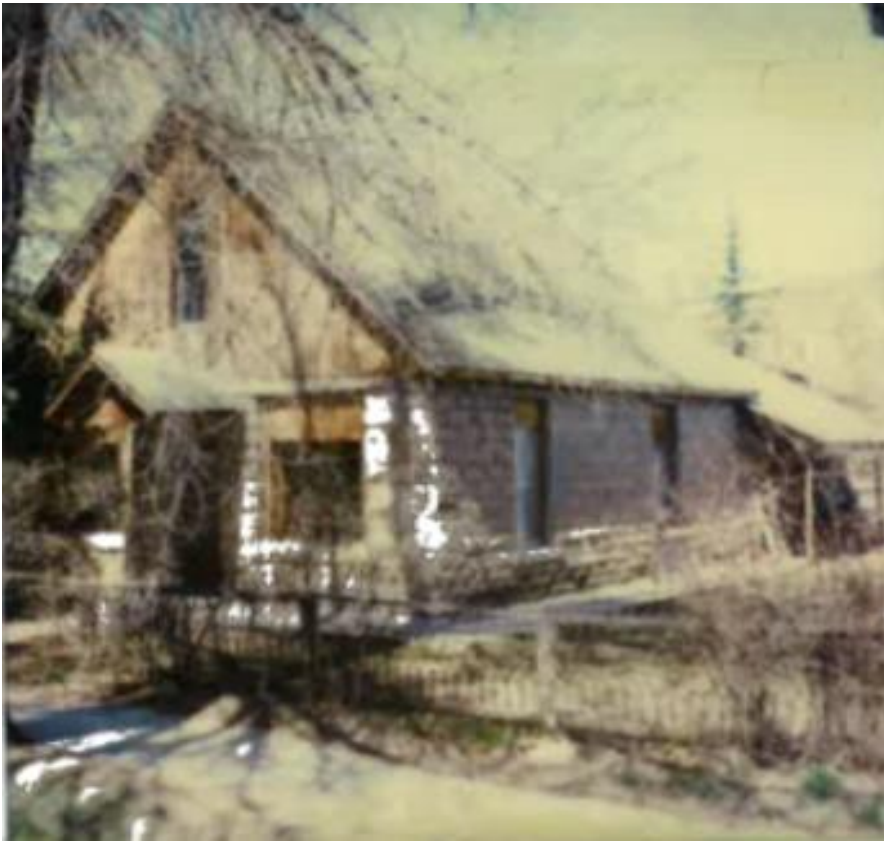
Reference Photo 1

Description: Looking at the primary (south) and east elevations of the building.

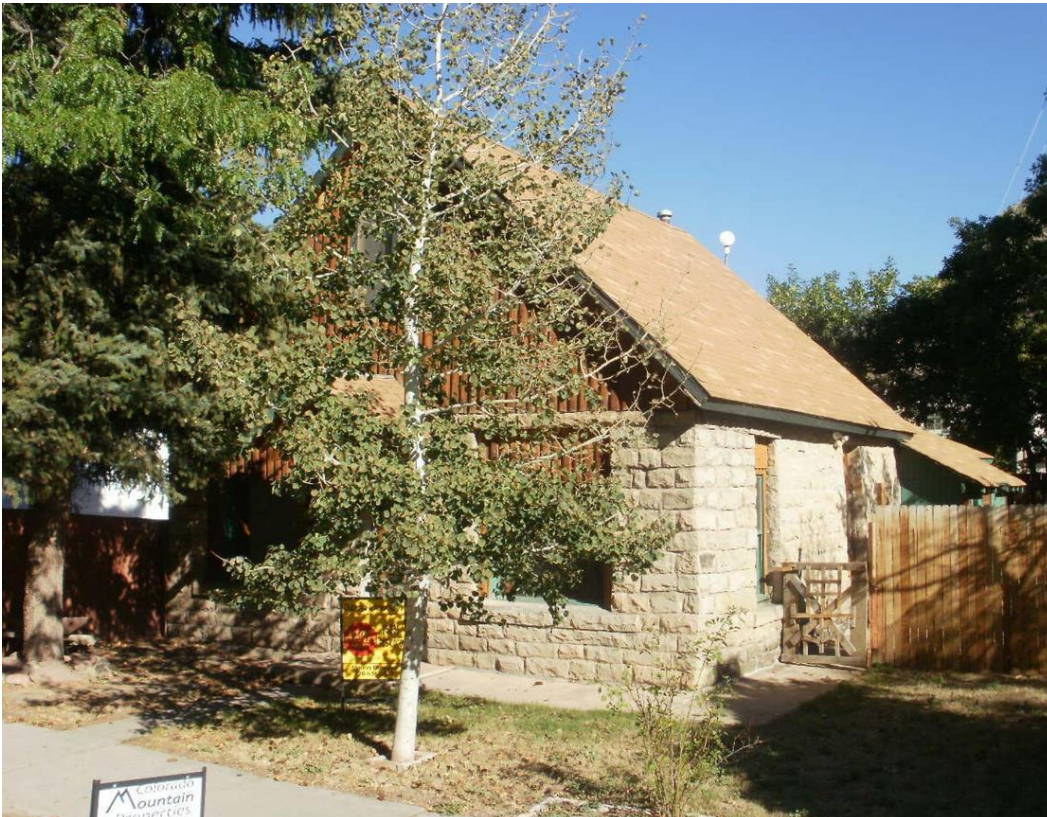
Reference Photo 2

Description: Looking at the primary (south) and east elevations of the building.

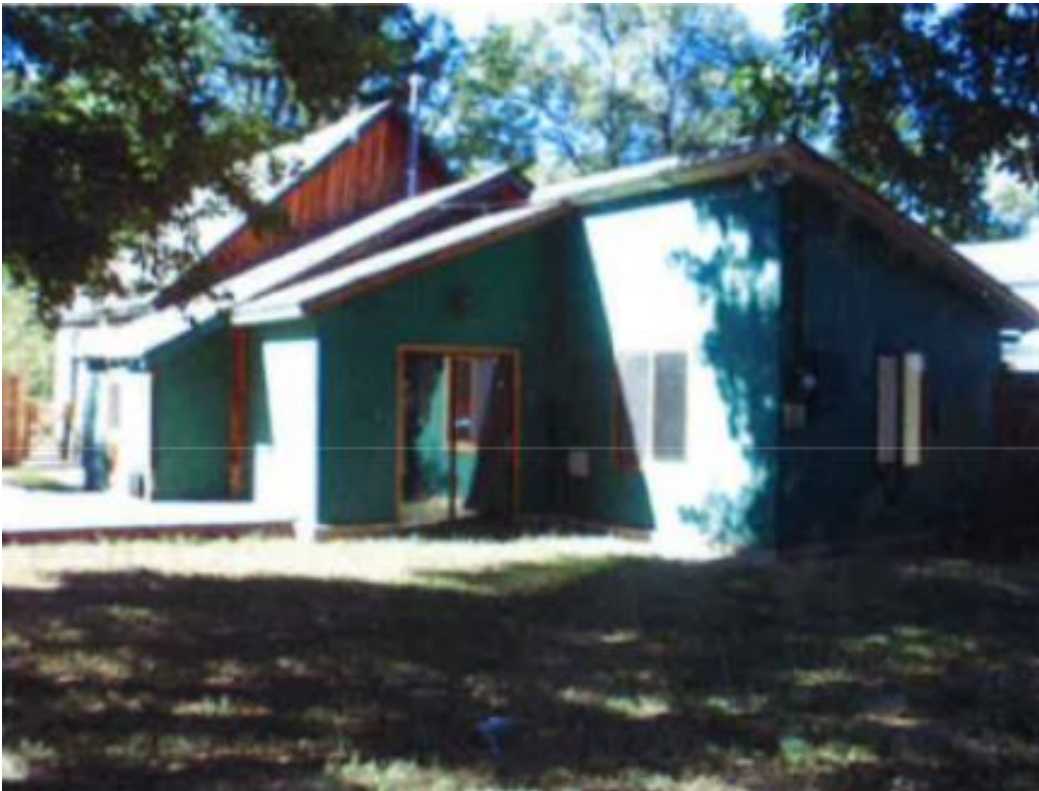
Reference Photo 3

Description: Looking at the east and north elevations of the building.

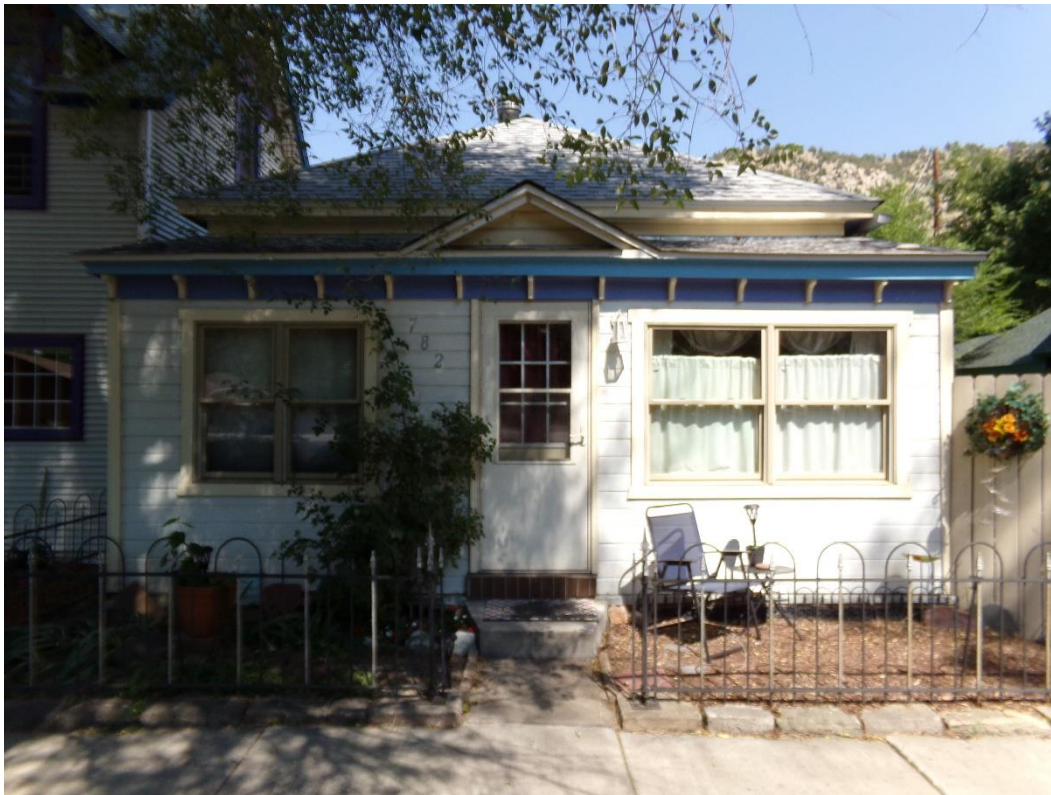
Photo Number: 5GF.5893_1
Description: Looking at the primary (south) elevation of the building.
Date: 9/6/2022
View: North

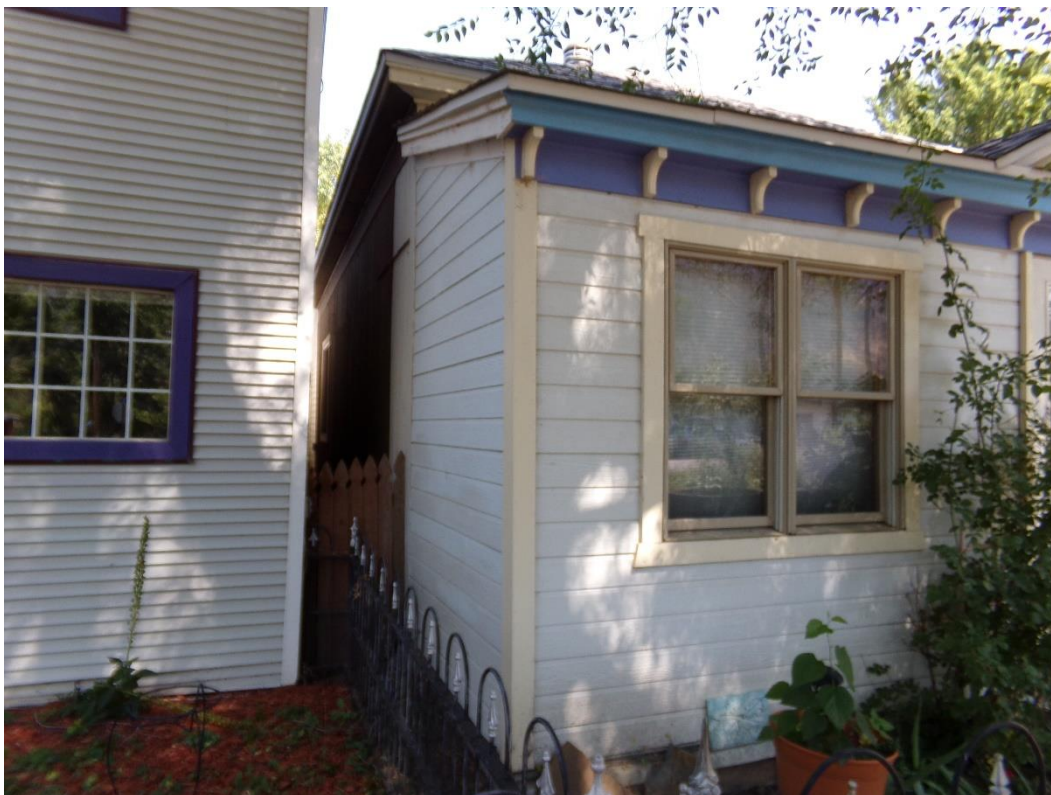
Photo Number: 5GF.5893_2
Description: Looking at the west and left side of the primary (south) elevation of the building.
Date: 9/6/2022
View: Northeast

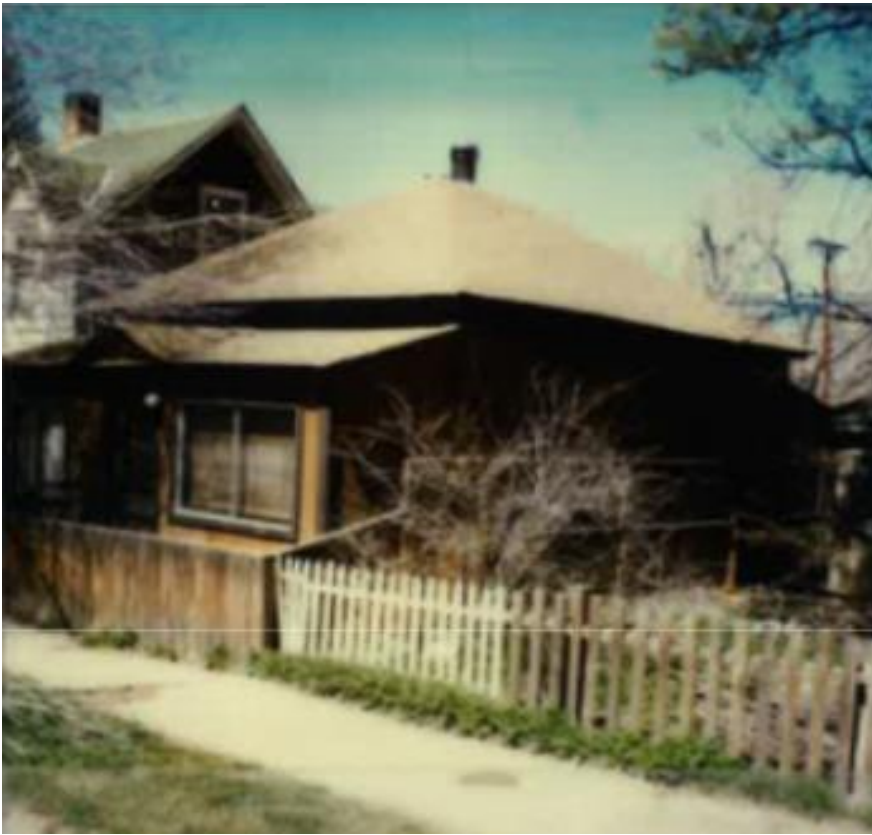
Reference Photo 1

Description: Looking at the primary (south) and east elevations of the building.

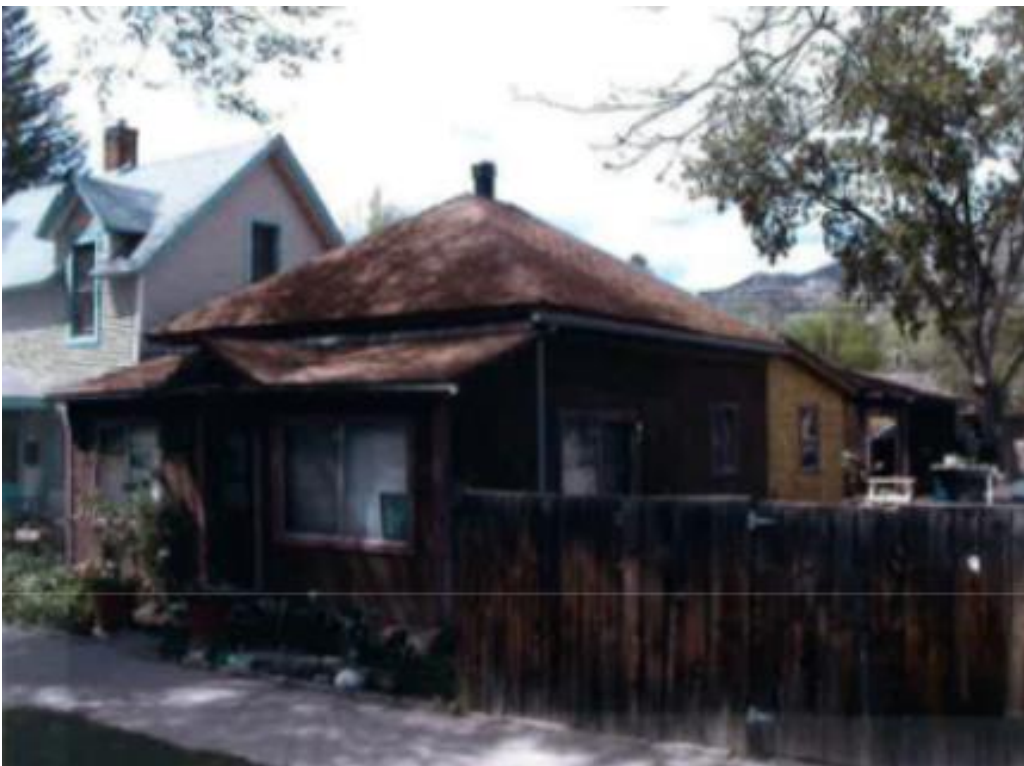
Reference Photo 2

Description: Looking at the primary (south) and east elevations of the building. Note the addition along the north elevation is under construction.

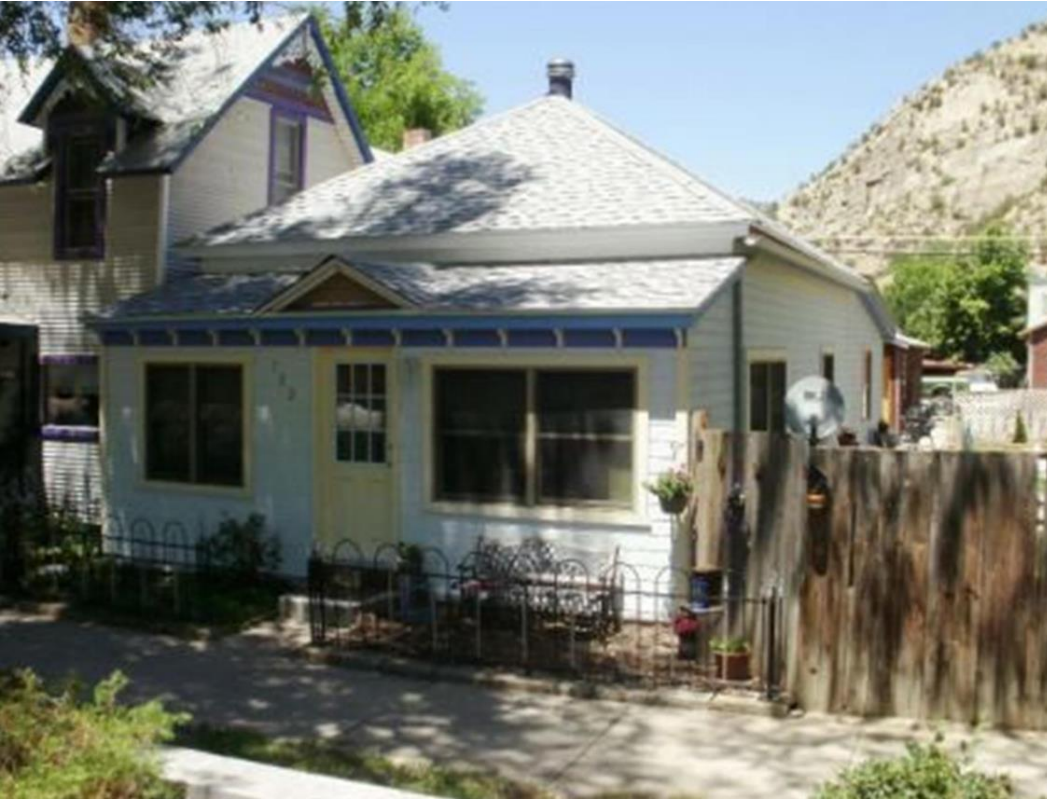
Reference Photo 3

Description: Looking at the primary (south) and east elevations of the building.

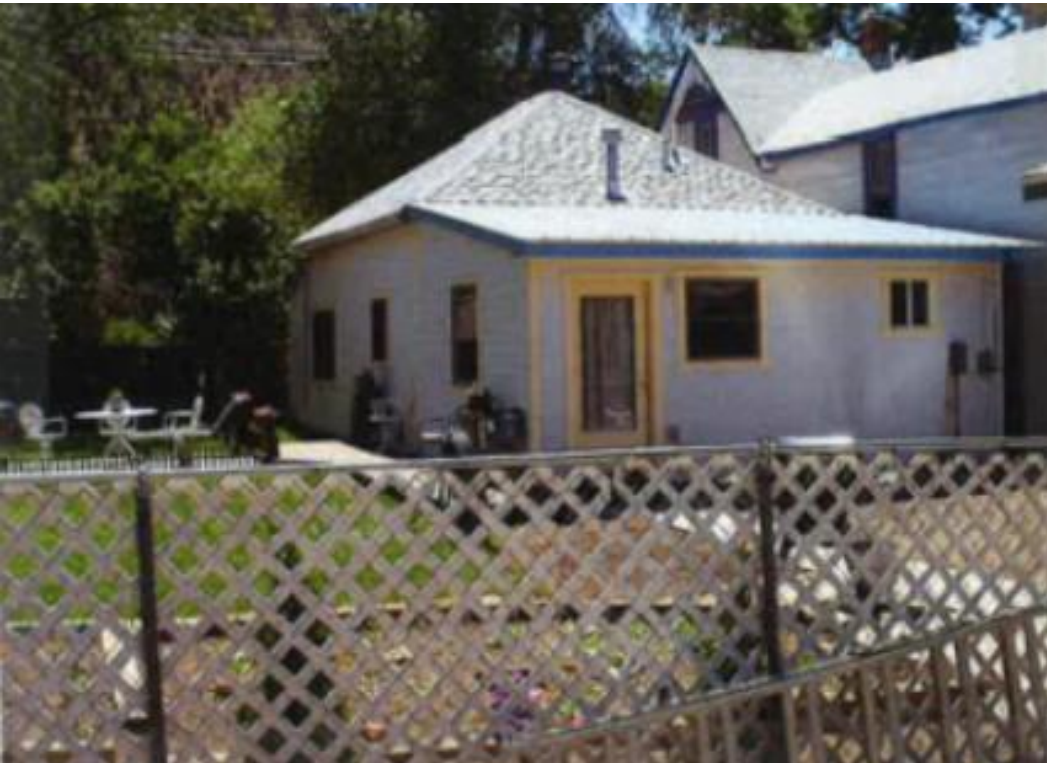
Reference Photo 4

Description: Looking at the east and north elevations of the building.

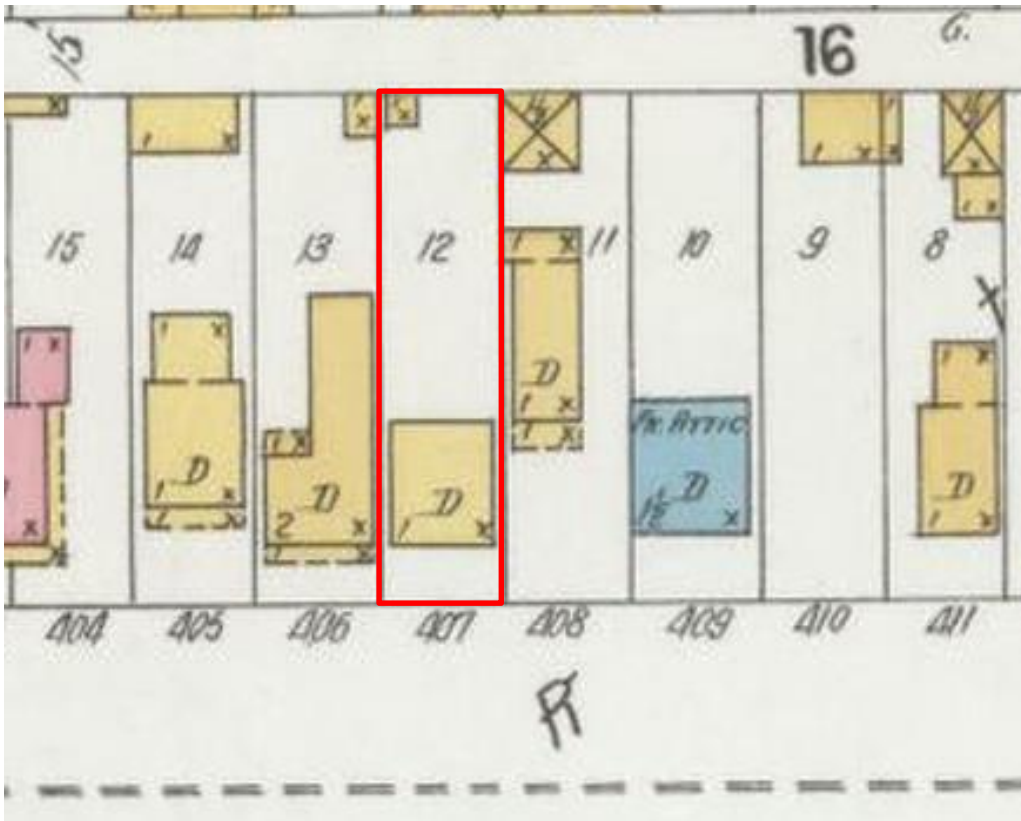
Reference Photo 7

Description: 1904 Sanborn Fire Insurance map illustrating the resource. The property is outlined in red.

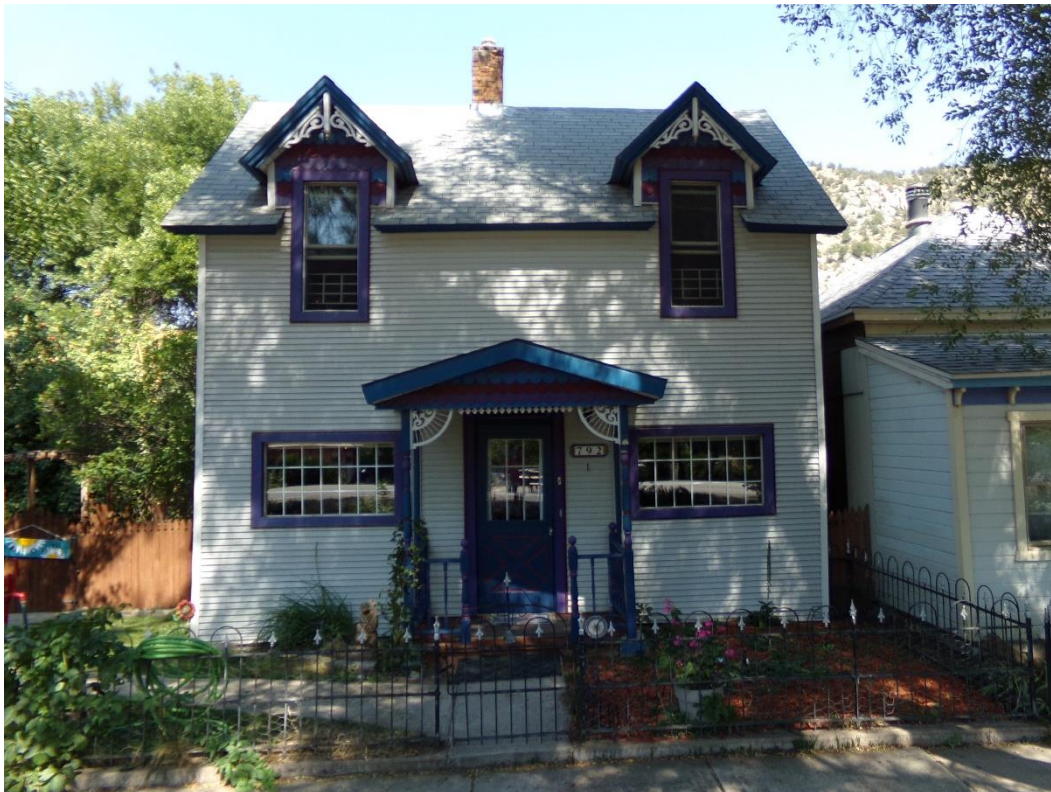
Photo Number: 5GF.5892_1
Description: Looking at the primary (south) elevation of the building.
Date: 9/6/2022
View: North

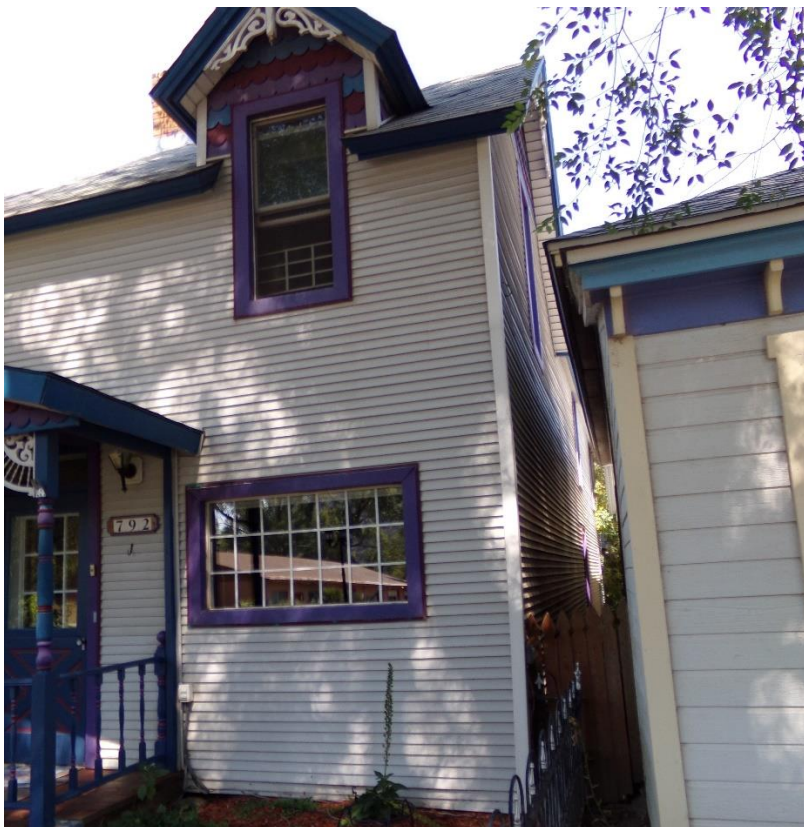
Photo Number: 5GF.5892_2
Description: Looking at the primary (south) and east elevations of the building.
Date: 9/6/2022
View: Northwest

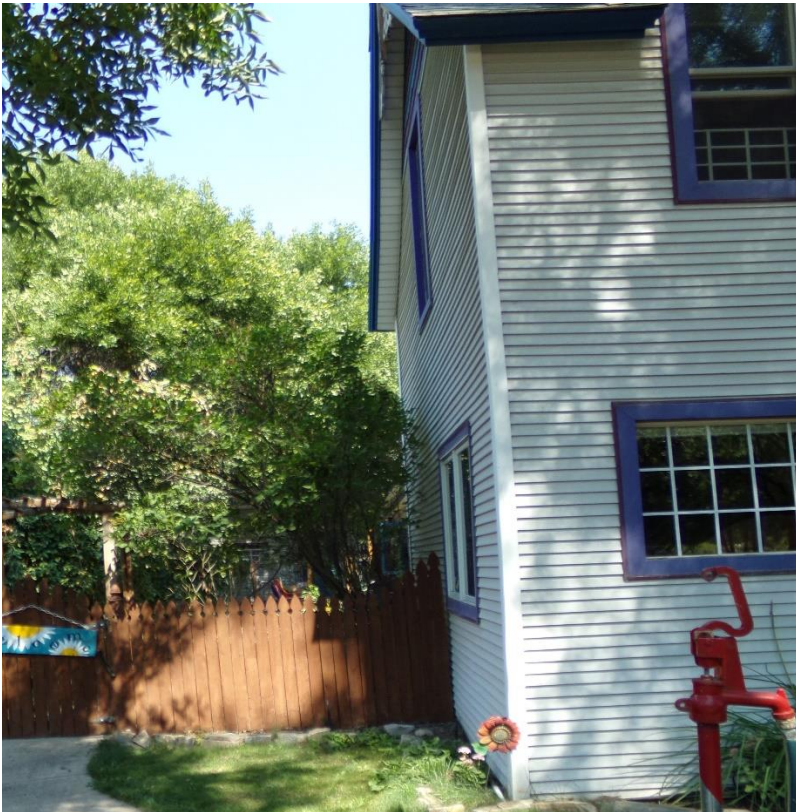
Photo Number: 5GF.5892_3
Description: Looking at the west elevation of the building.
Date: 9/6/2022
View: Northeast

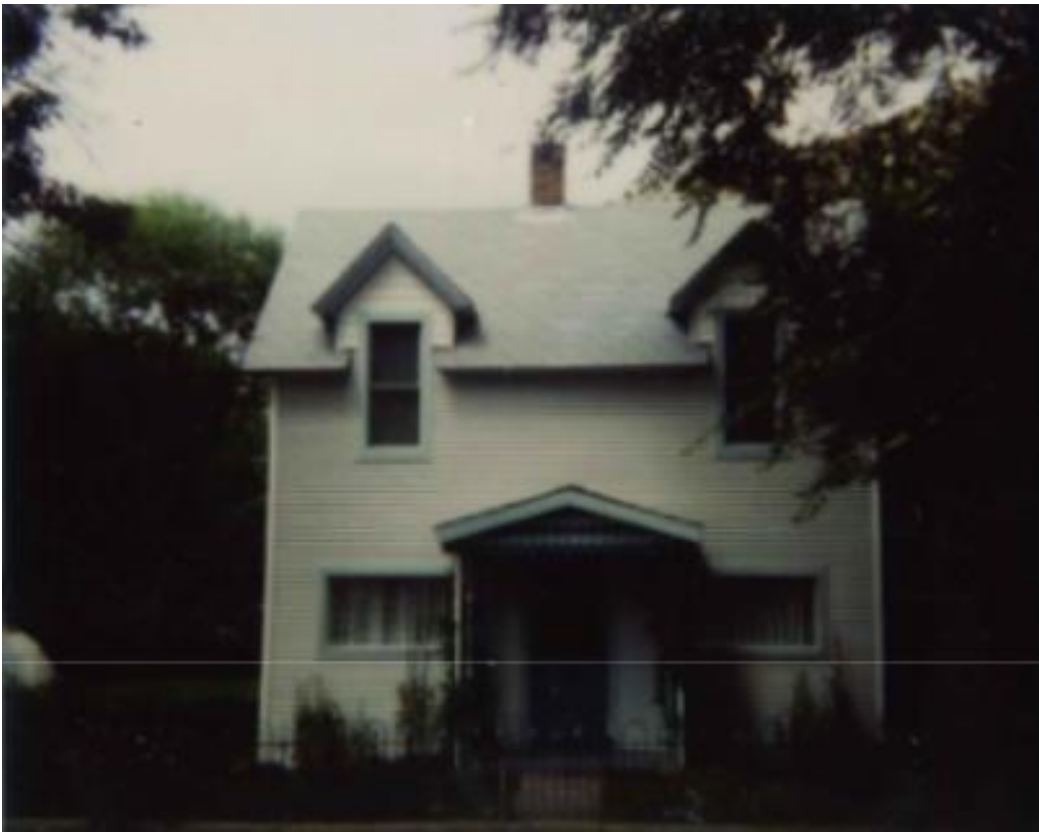
Reference Photo 1
Description: Looking at the primary (south) elevation of the building.
Date: 1995
Source: Garfield County Assessor's Office

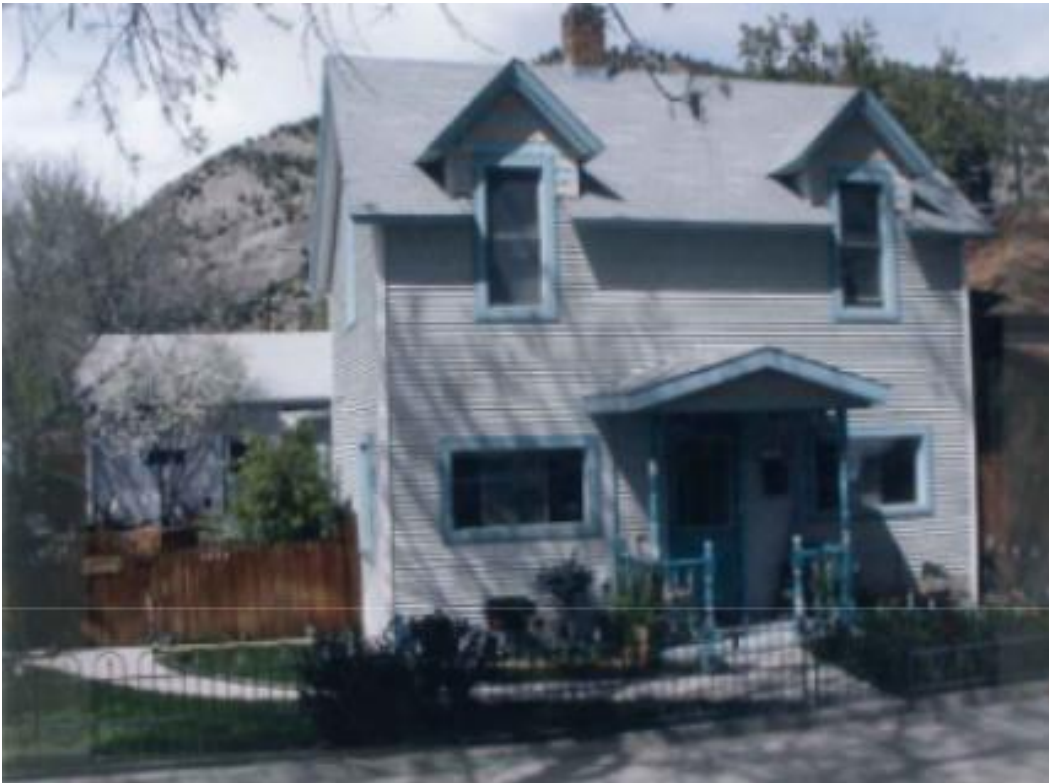
Reference Photo 2

Description: Looking at the west and primary (south) elevation of the building.

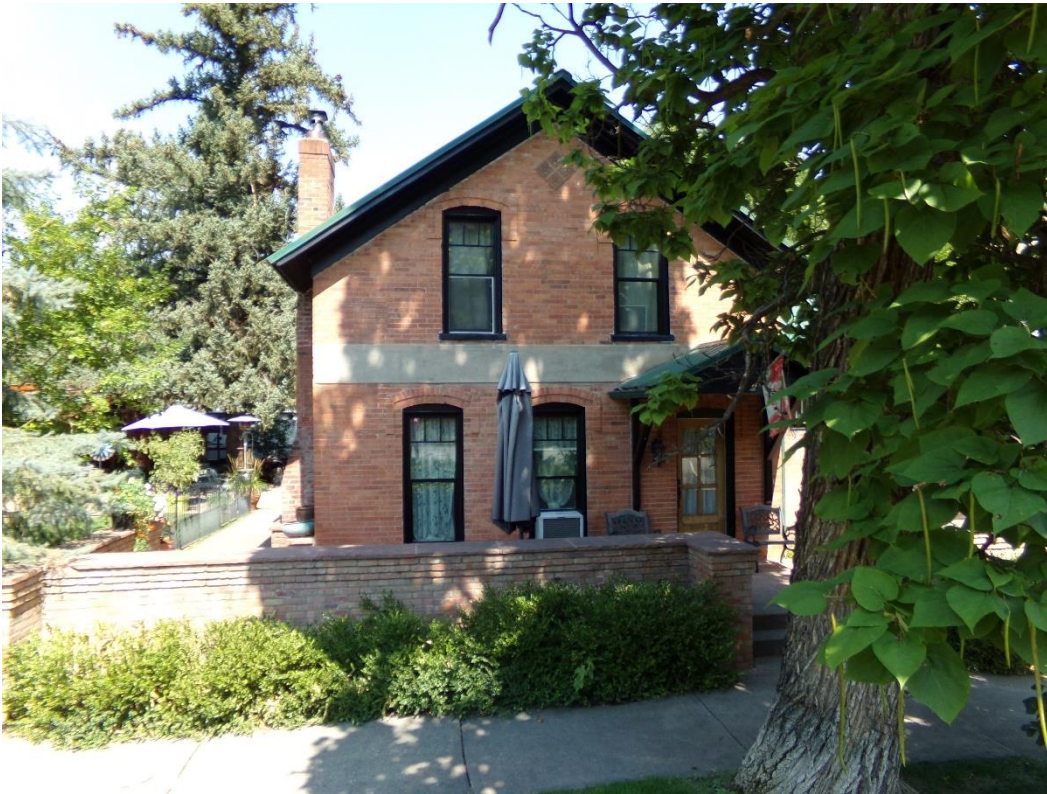
Photo Number: 5GF.5891_1
Description: The primary (south) elevation of the building.
Date: 9/6/2022
View: North

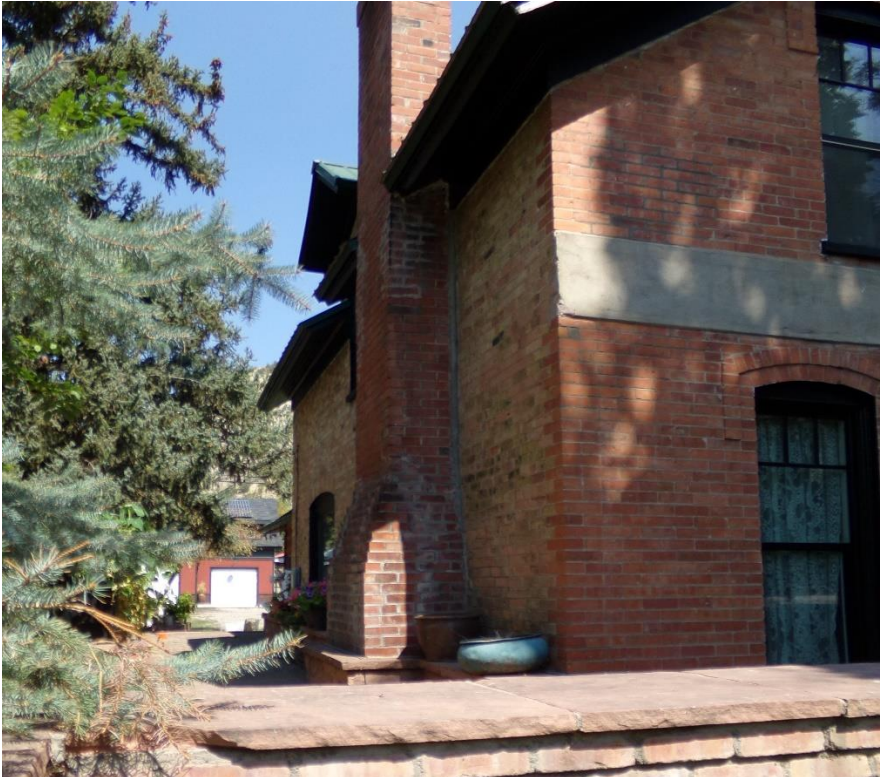
Photo Number: 5GF.5891_2
Description: Looking at the west and primary (south) elevations of the building.
Date: 9/6/2022
View: Northeast

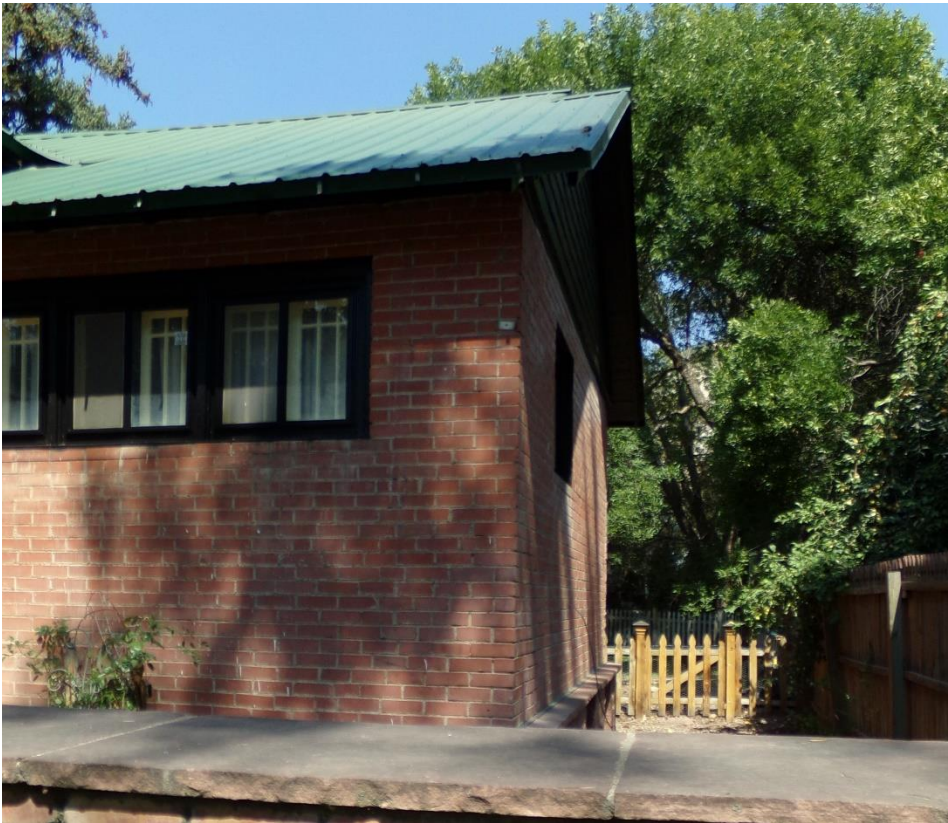
Photo Number: 5GF.5891_3
Description: The far-right side of the primary (south) elevation and east elevation of the building.
Date: 9/6/2022
View: North

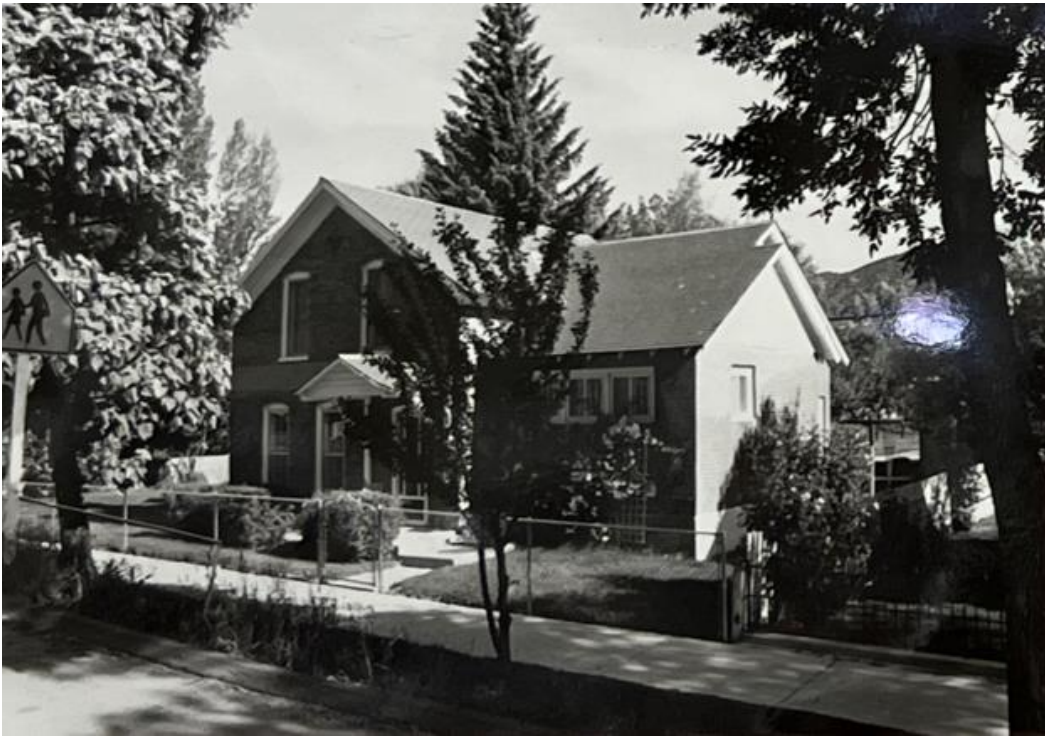
Reference Photo 2

Description: Image label states, "Rittle Family Home"

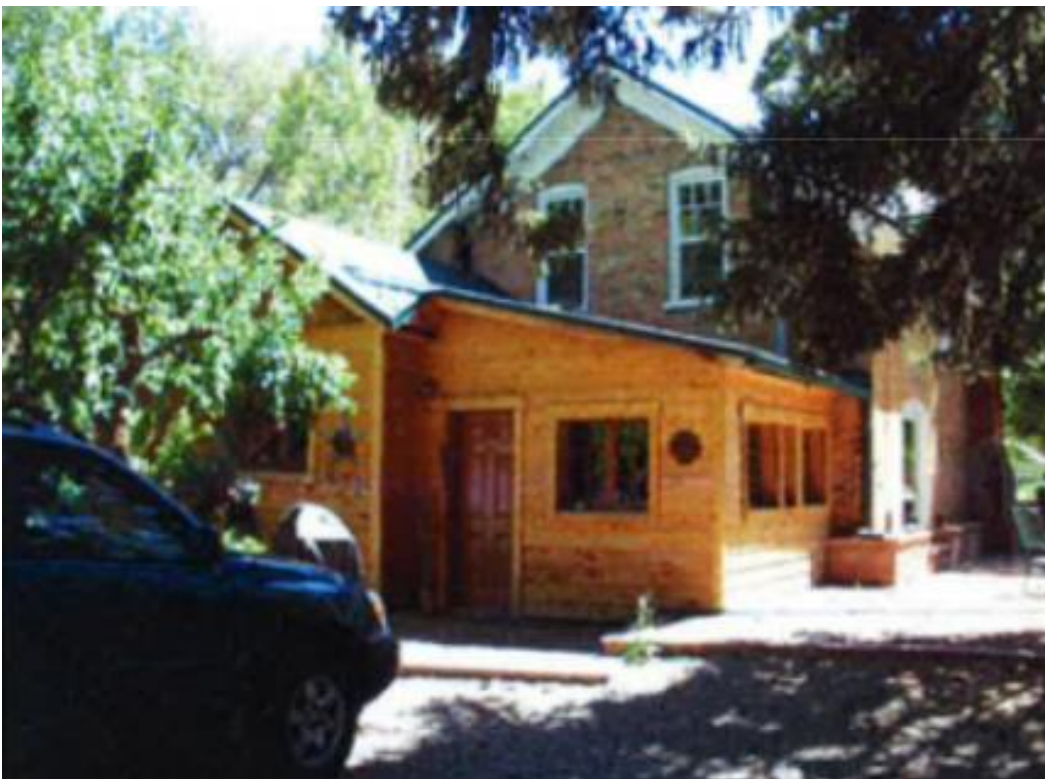
Reference Photo 3

Description: Looking at the north and west elevations of the building.
