Agenda New Castle Historic Preservation Commission Special Meeting

- To: Historic Preservation Commission (HPC)
- From: Remi Bordelon
- Re: Pinyon Environmental, Inc. Review of Draft Report

COLORADO CULTURAL RESOURCES INVENTORY

Historical and Architectural Reconnaissance

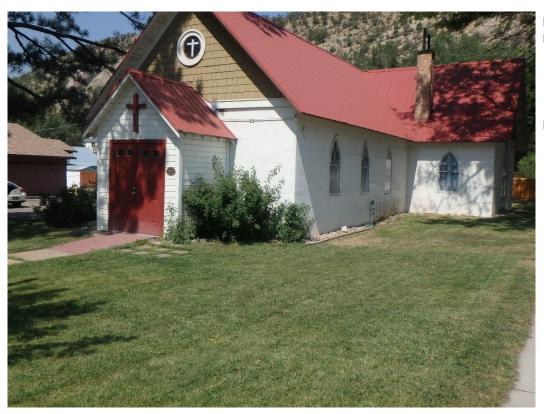
Photo Number: 5GF.2368_1

Description: Looking at the primary (south) and east elevations of the building. Note the historic brick masonry chimney; exposed rafter tails under the eaves; and the gothic arch window units. Date: 9/6/2022

View: Northwest

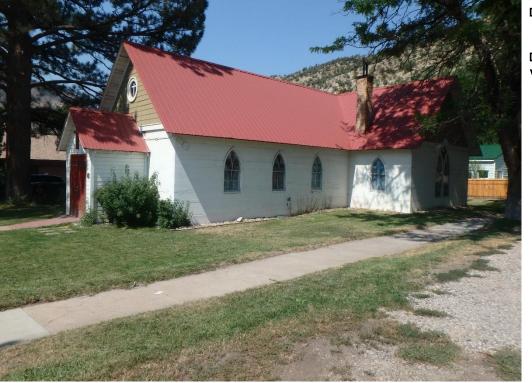
Photo Number: 5GF.2368_2 Description: Looking at the primary (south) and east elevations of the church. Date: 9/6/2022 View: Northwest

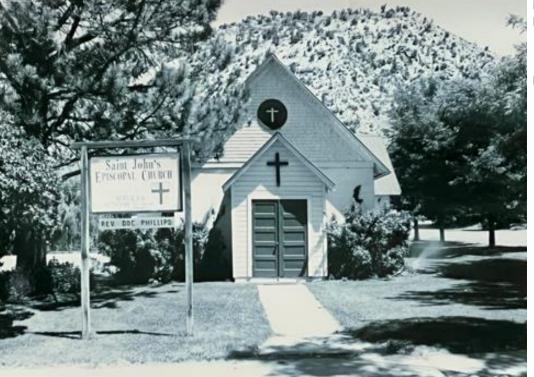
Historic Photo 2

Description: Looking at the primary (south) elevation of the church. Note the historic double wood panel doors are extant at the time. **Date:** Unknown

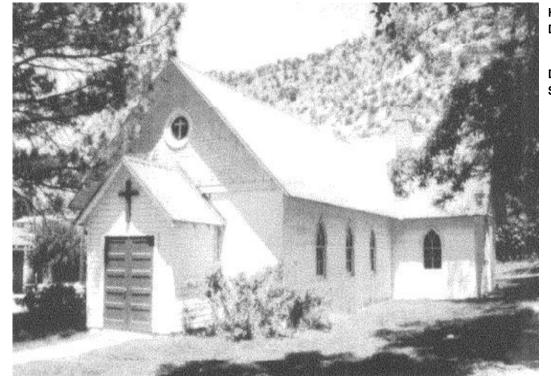
Historic Photo 3

Description: Looking at the primary (south) and east elevations of the church.

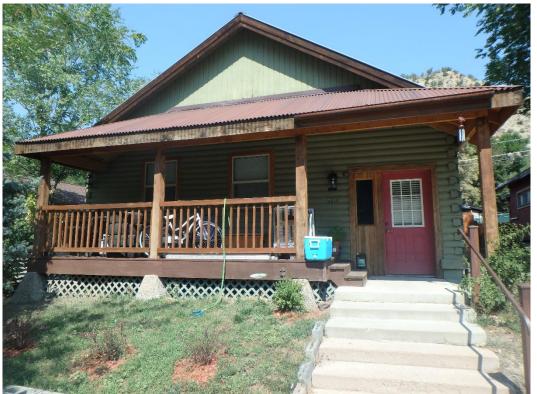
Photo Number: 5GF.5922_1 Description: Looking at the primary (south) elevation of the building. Date: 9/6/2022 View: North

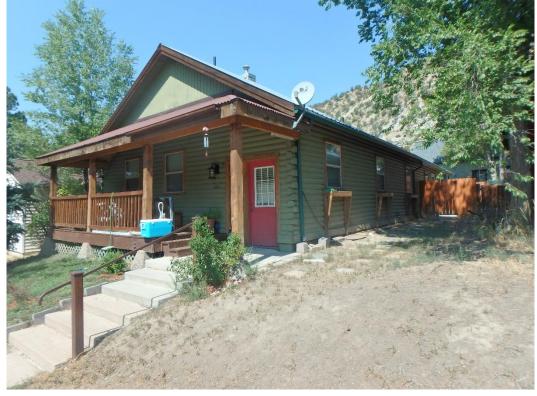
Photo Number: 5GF.5922_2 Description: Looking at the primary (south) and east elevations of the building. Date: 9/6/2022 View: Northwest

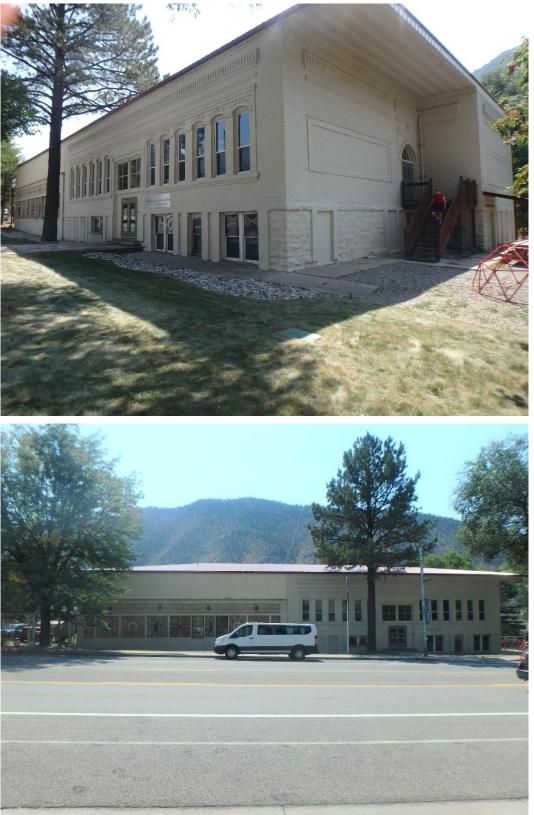
Photo Number: 5GF.2369_1

Description: Looking at the primary (north) and west elevations of the building. Note the several ornate brickwork features along the facade.

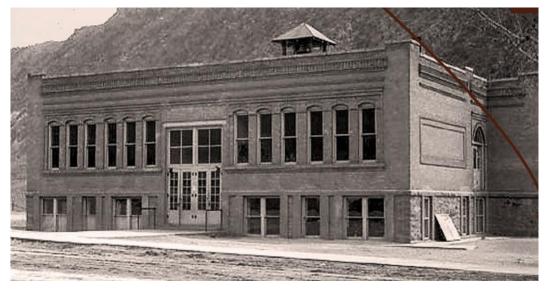
Historic Photo 2

Description: Image of the primary (north) and a portion of the east elevations of the building. Note the school bell on the flat roof that is protected by a pyramid roof. **Date:** Prior to 1939 addition to east elevation.

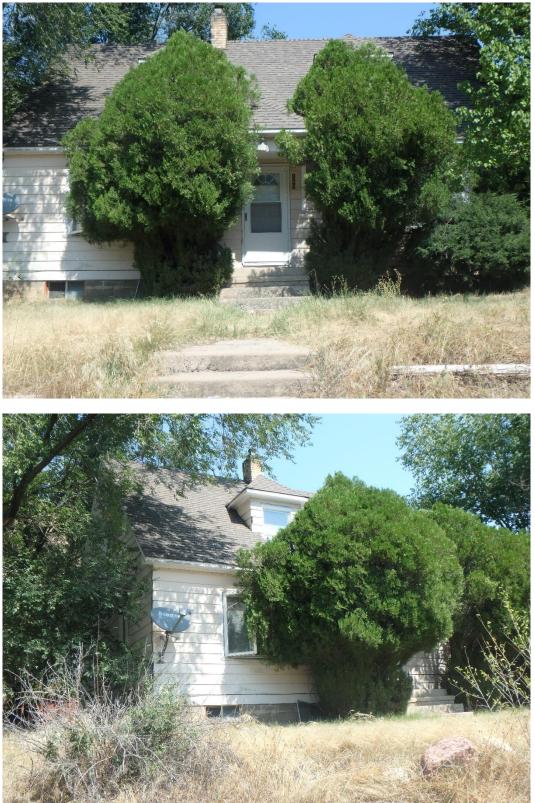
Photo Number: 5GF.5924_1 Description: Looking at the primary (south) elevation of the building. Note that the two recessed dormers are mostly obscured by the tall vegetation. Date: 9/6/2022 View: North

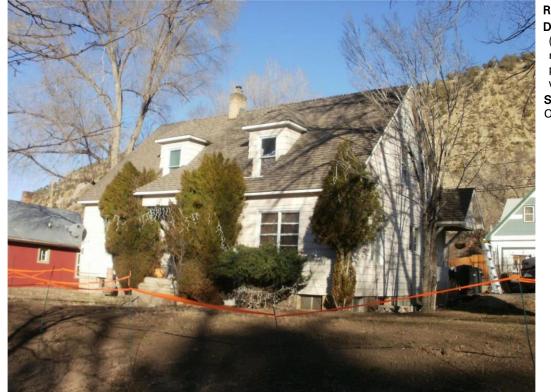
Reference Photo 1

Description: Looking at the primary (south) and east elevations of the residence. The image was taken prior to 2012 due to historic windows remaining extant. **Source:** Garfield County Assessor's Office

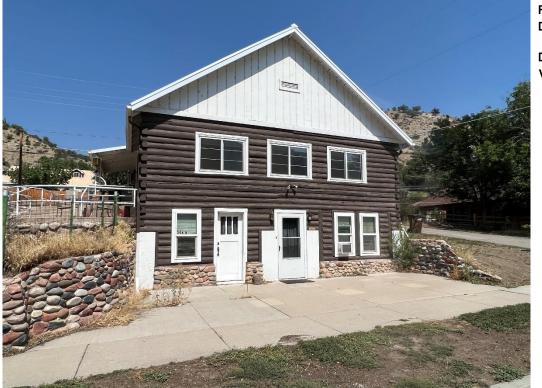
Photo Number: 5GF.5932_1 Description: Looking at the south elevation of the building. Date: 9/6/2022 View: Northeast

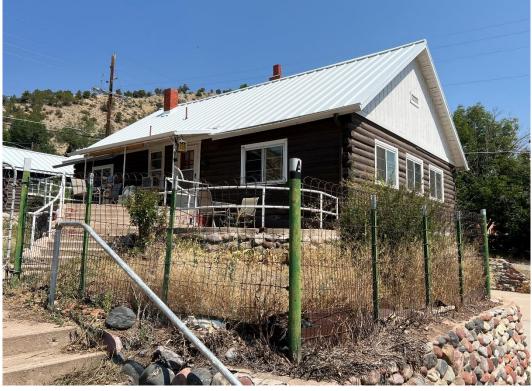
Photo Number: 5GF.5932_2
Description: Looking at the primary (west) and south elevations of the building.
Date: 9/6/2022
View: Northeast

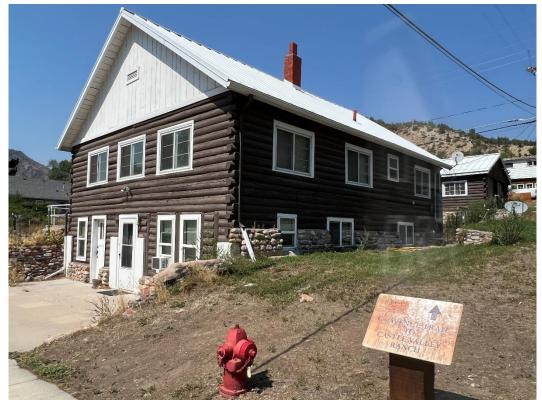
Photo Number: 5GF.5932_3

Description: Looking at the south and east elevations of the building. Date: 9/26/2022 View: Northwest

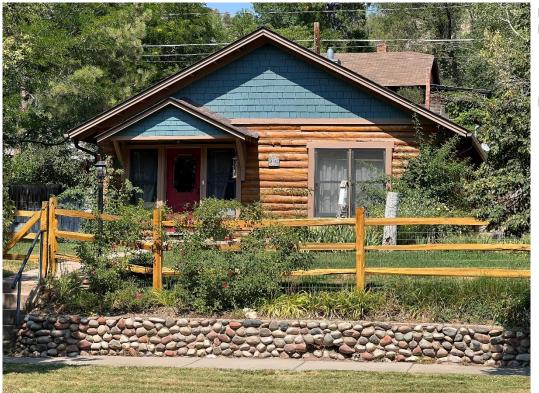
Photo Number: 5GF.5935_1 Description: Looking at the primary (south) elevation of the building. Note the decorative stone masonry wall, and the post and rail fencing. Date: 9/6/2022 View: North

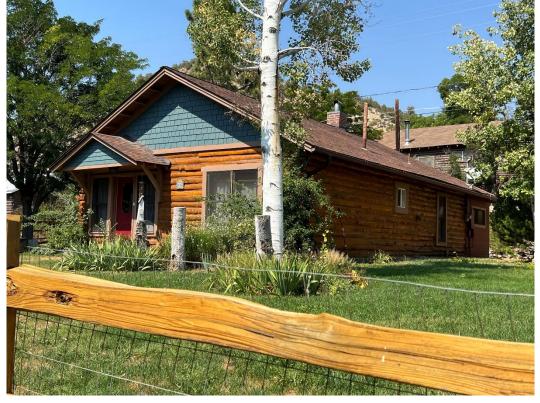
Photo Number: 5GF.5935_2 Description: Looking at the primary (south) and east elevations of the building. Date: 9/6/2022 View: Northwest

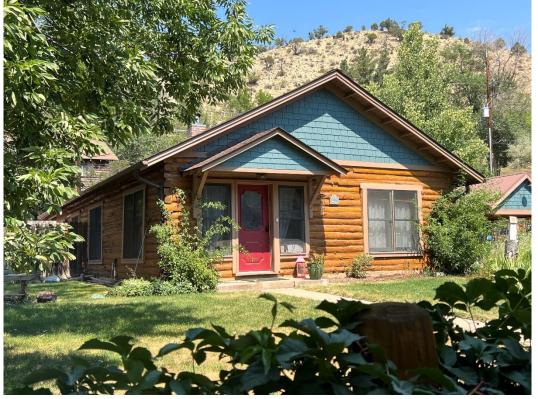
Photo Number: 5GF.5935_3 Description: Looking at the west and primary (south) elevations of the building. Date: 9/6/2022 View: Northeast

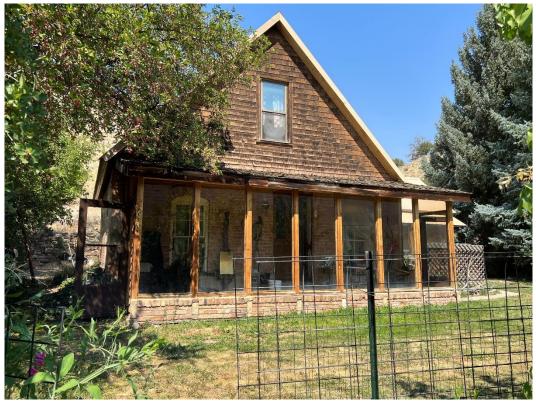
Photo Number: 5GF.5943_1 Description: Looking at the front gable along the primary (south) elevation. Date: 9/6/2022 View: Northeast

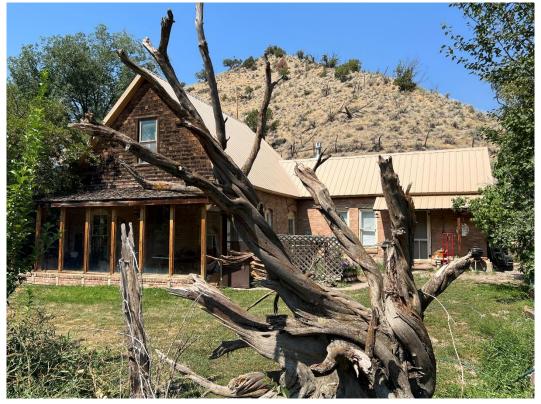
Photo Number: 5GF.5943_2

Description: Looking at the entire facade of the primary (south) elevation. Note the wood shingle exterior in the gable end while brick masonry cladding encompasses the right side of the building. Date: 9/6/2022

View: Northwest

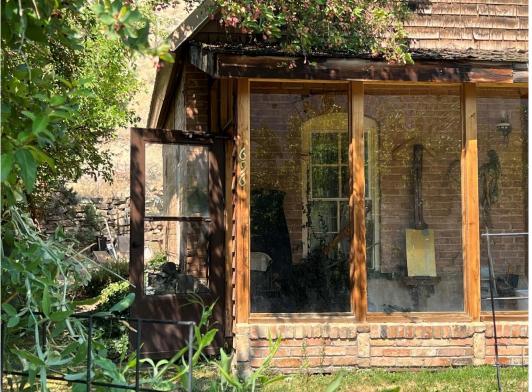
Photo Number: 5GF.5943_3 Description: A small glimpse of the west elevation of the building. Date: 9/6/2022 View: Northeast
