City Council Work Session Meeting
Oelwein City Hall, 20 Second Avenue SW, Oelwein, Iowa
5:30 PM

August 26, 2024
Oelwein, Iowa

- [1.](#) Discussion on the future of 27 South Frederick Avenue.
- [2.](#) Discussion on the 2024 Home Demolition Project.

City of Oelwein
2024
Home Demolition Project
Specs

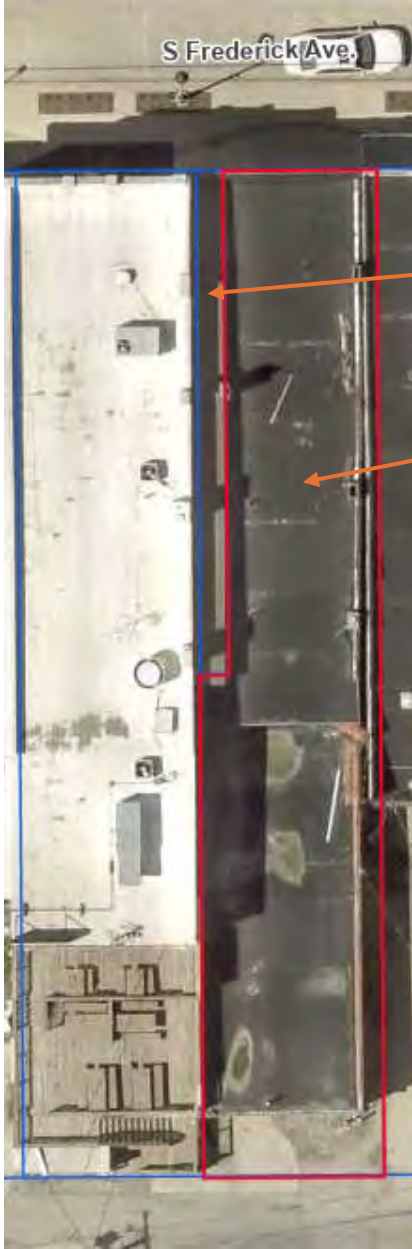
27 S Fred

“Shared” stairwell space

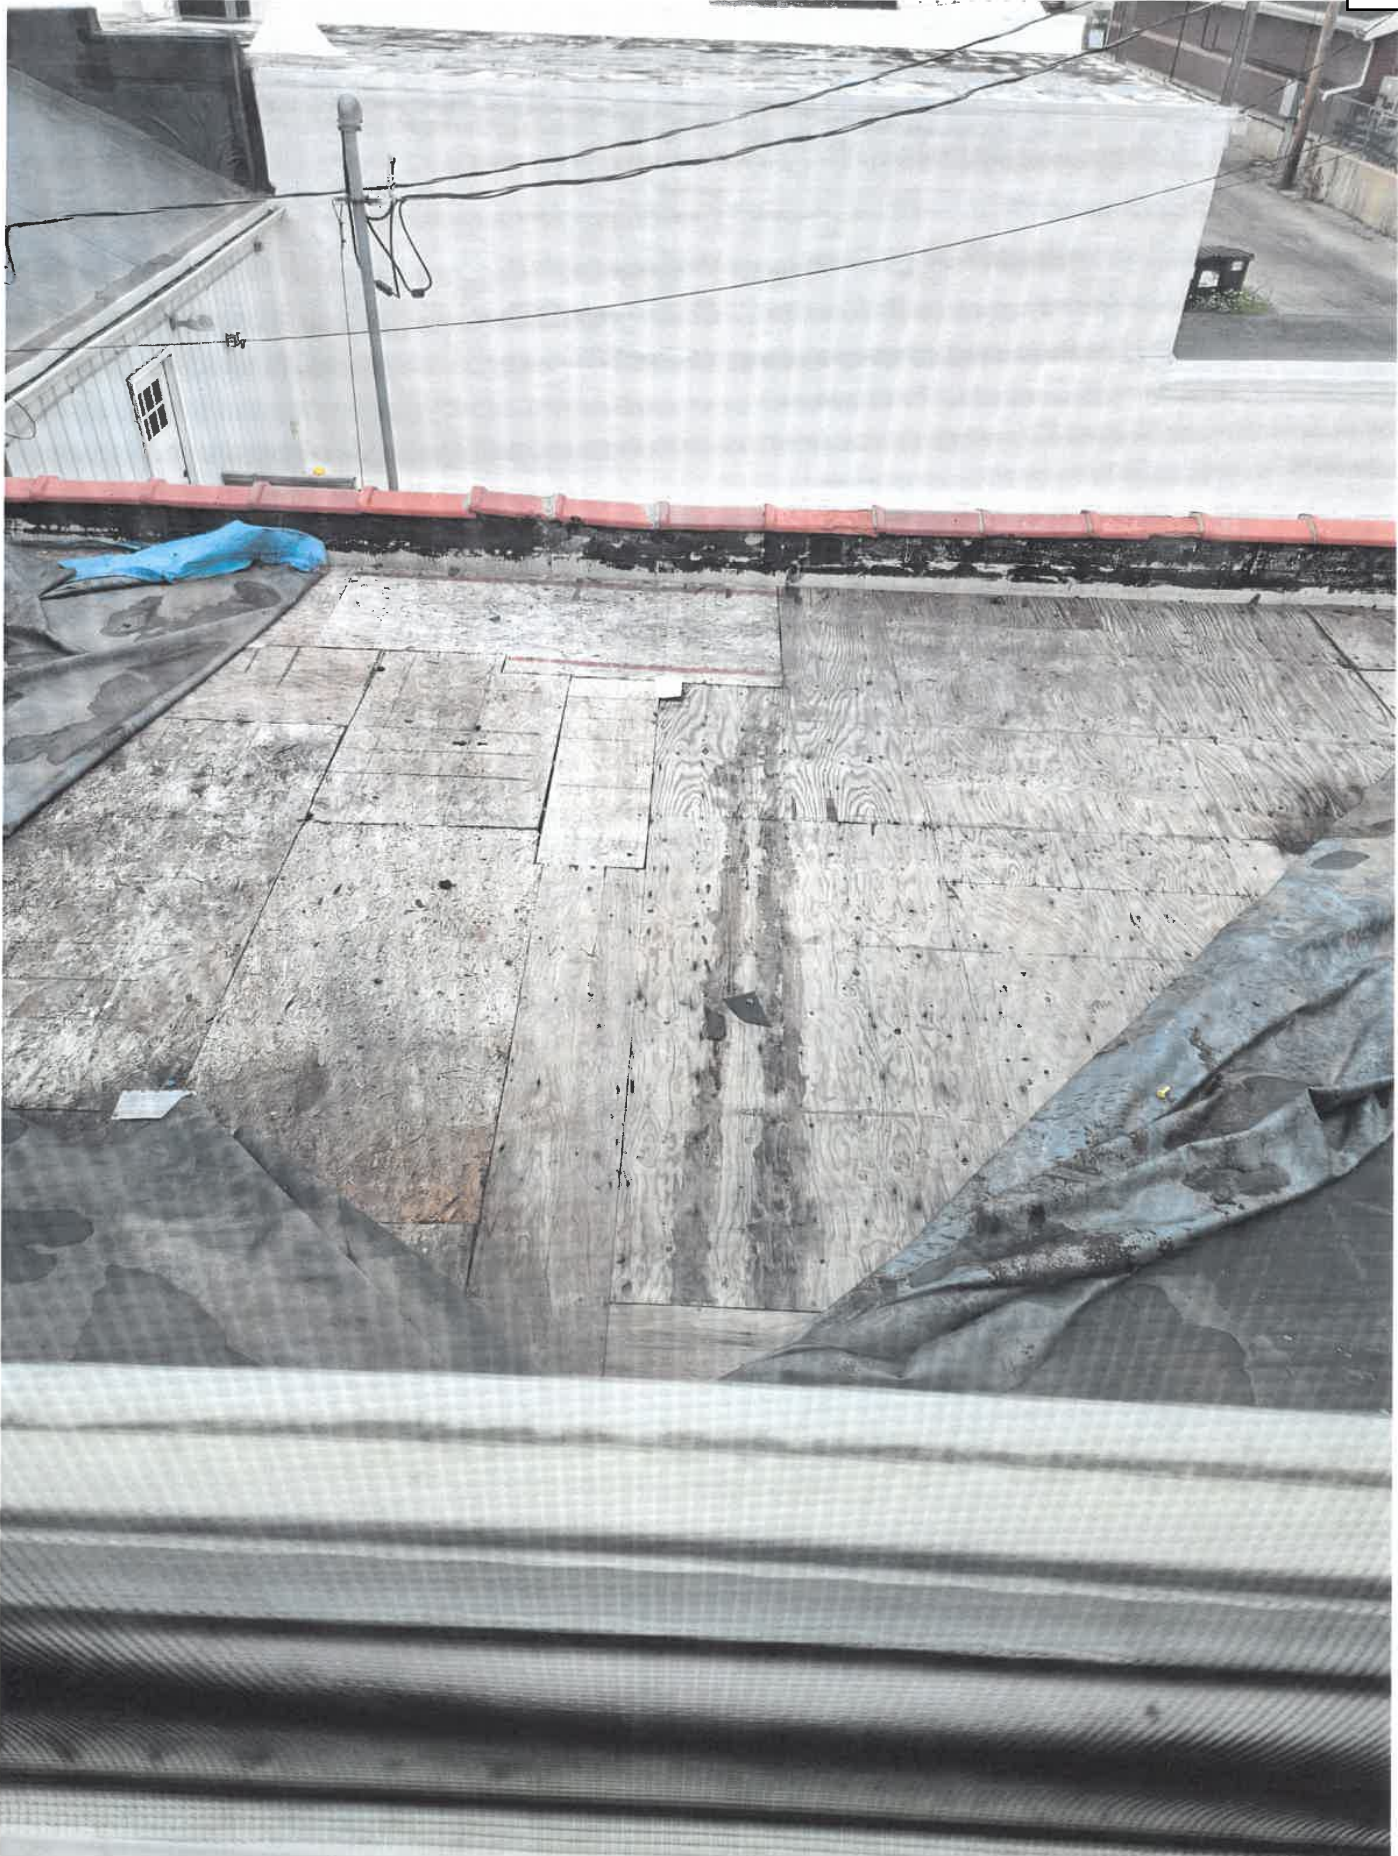
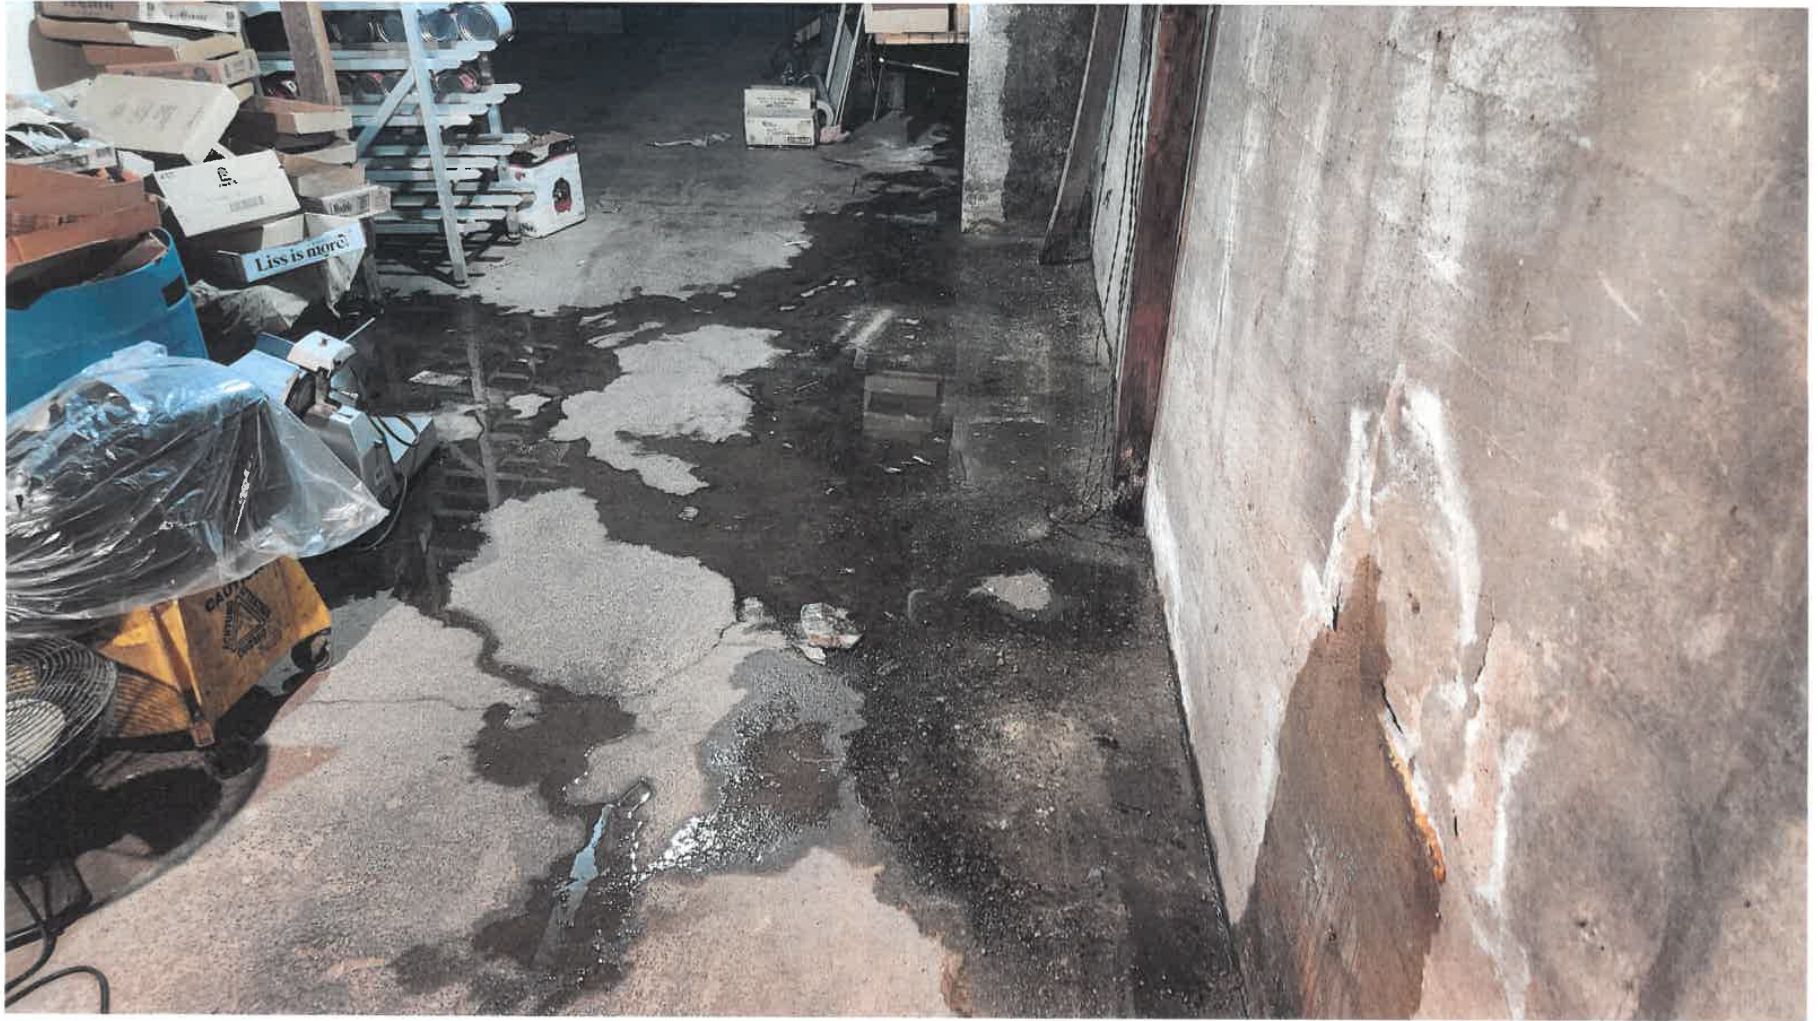
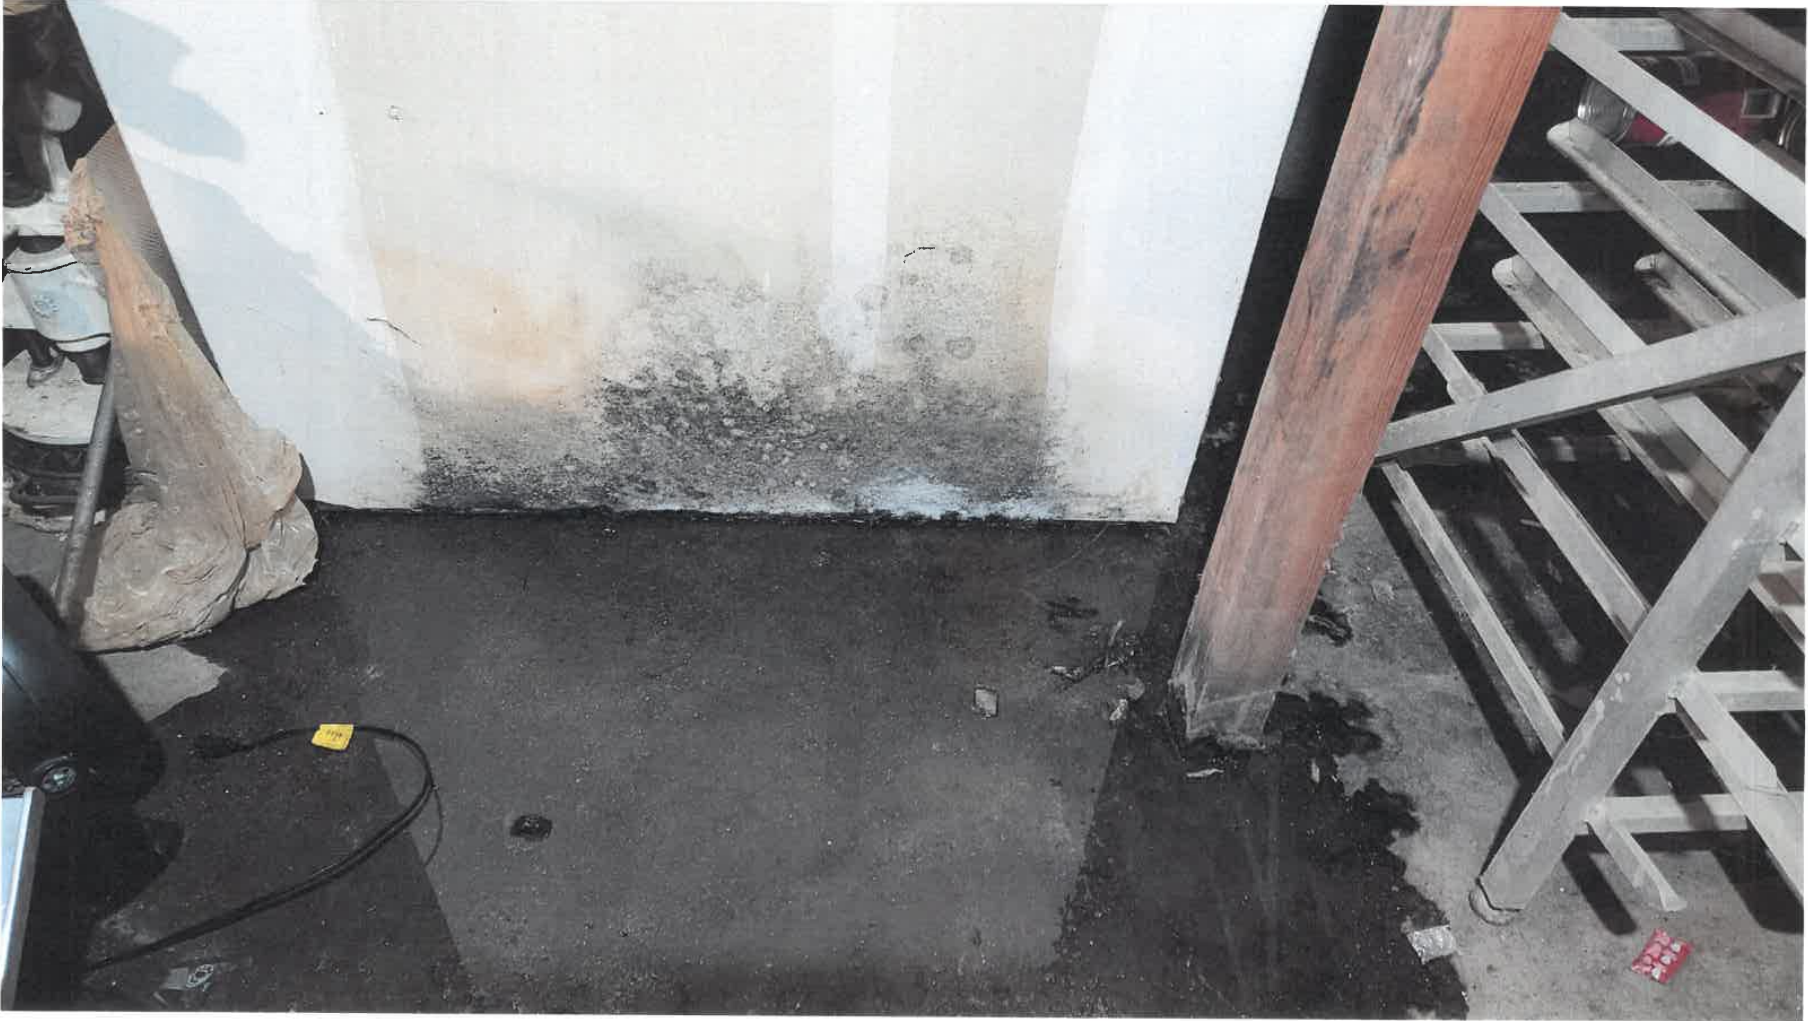
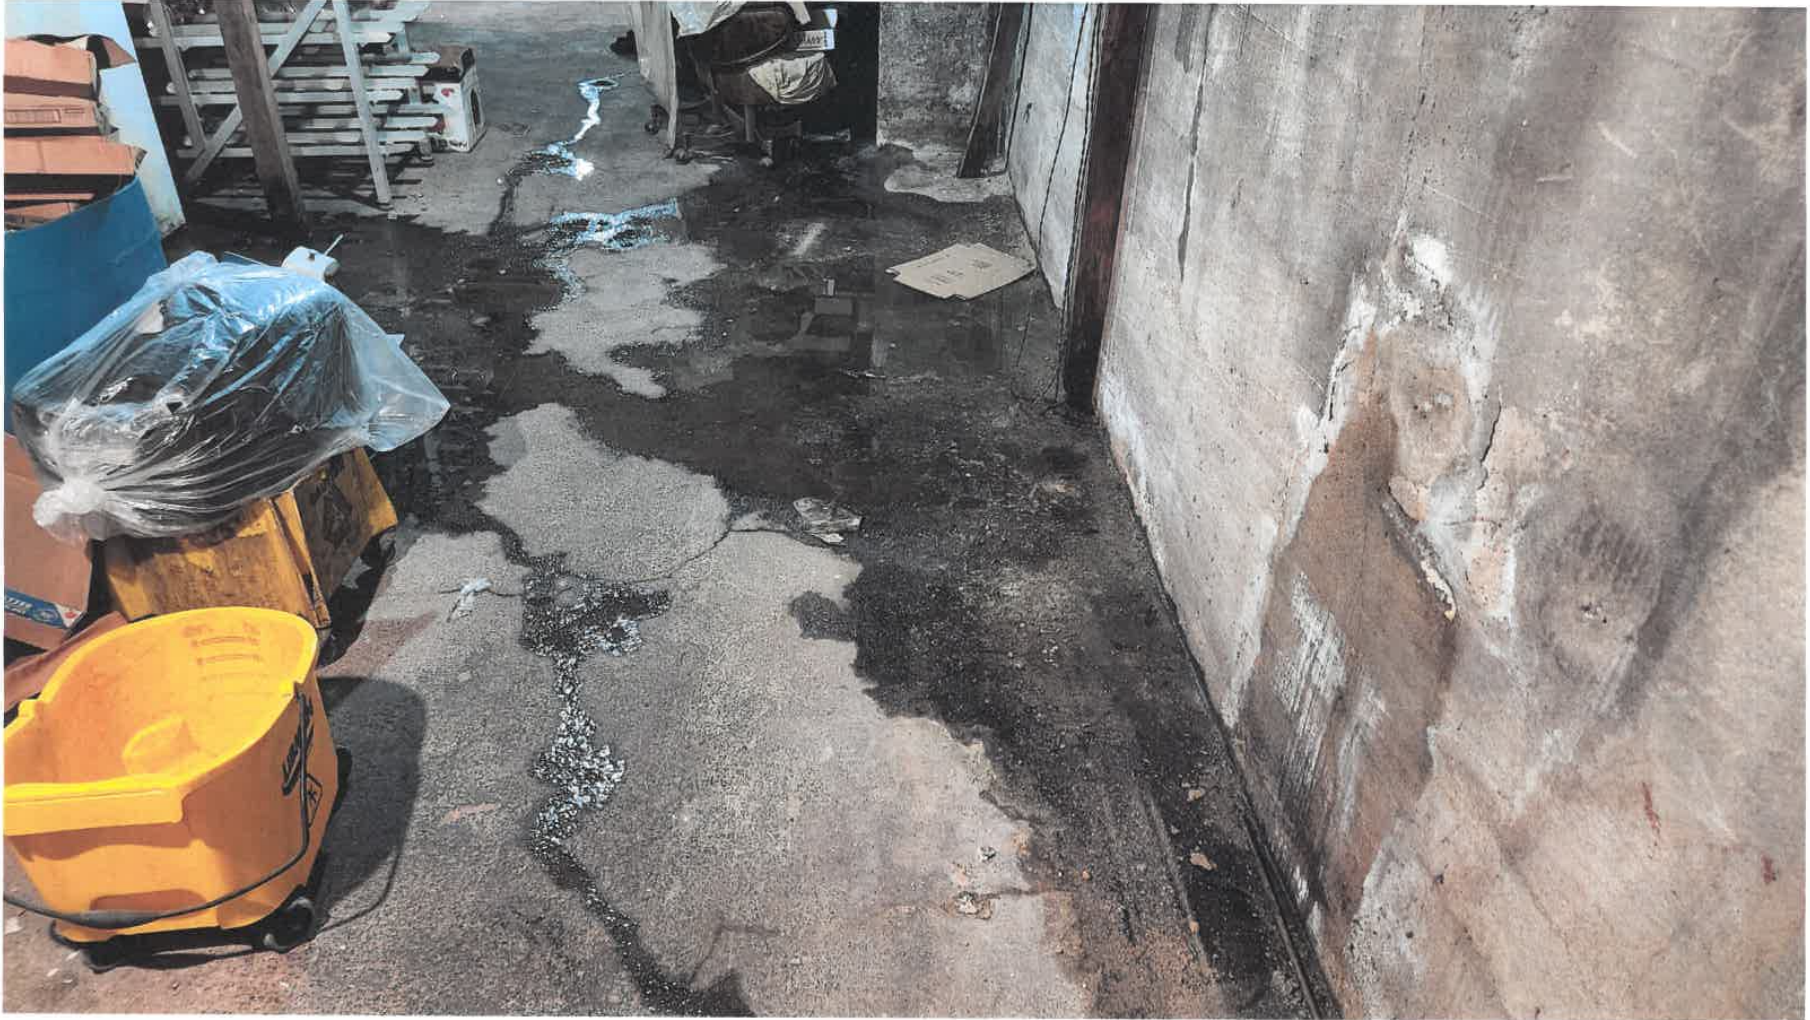
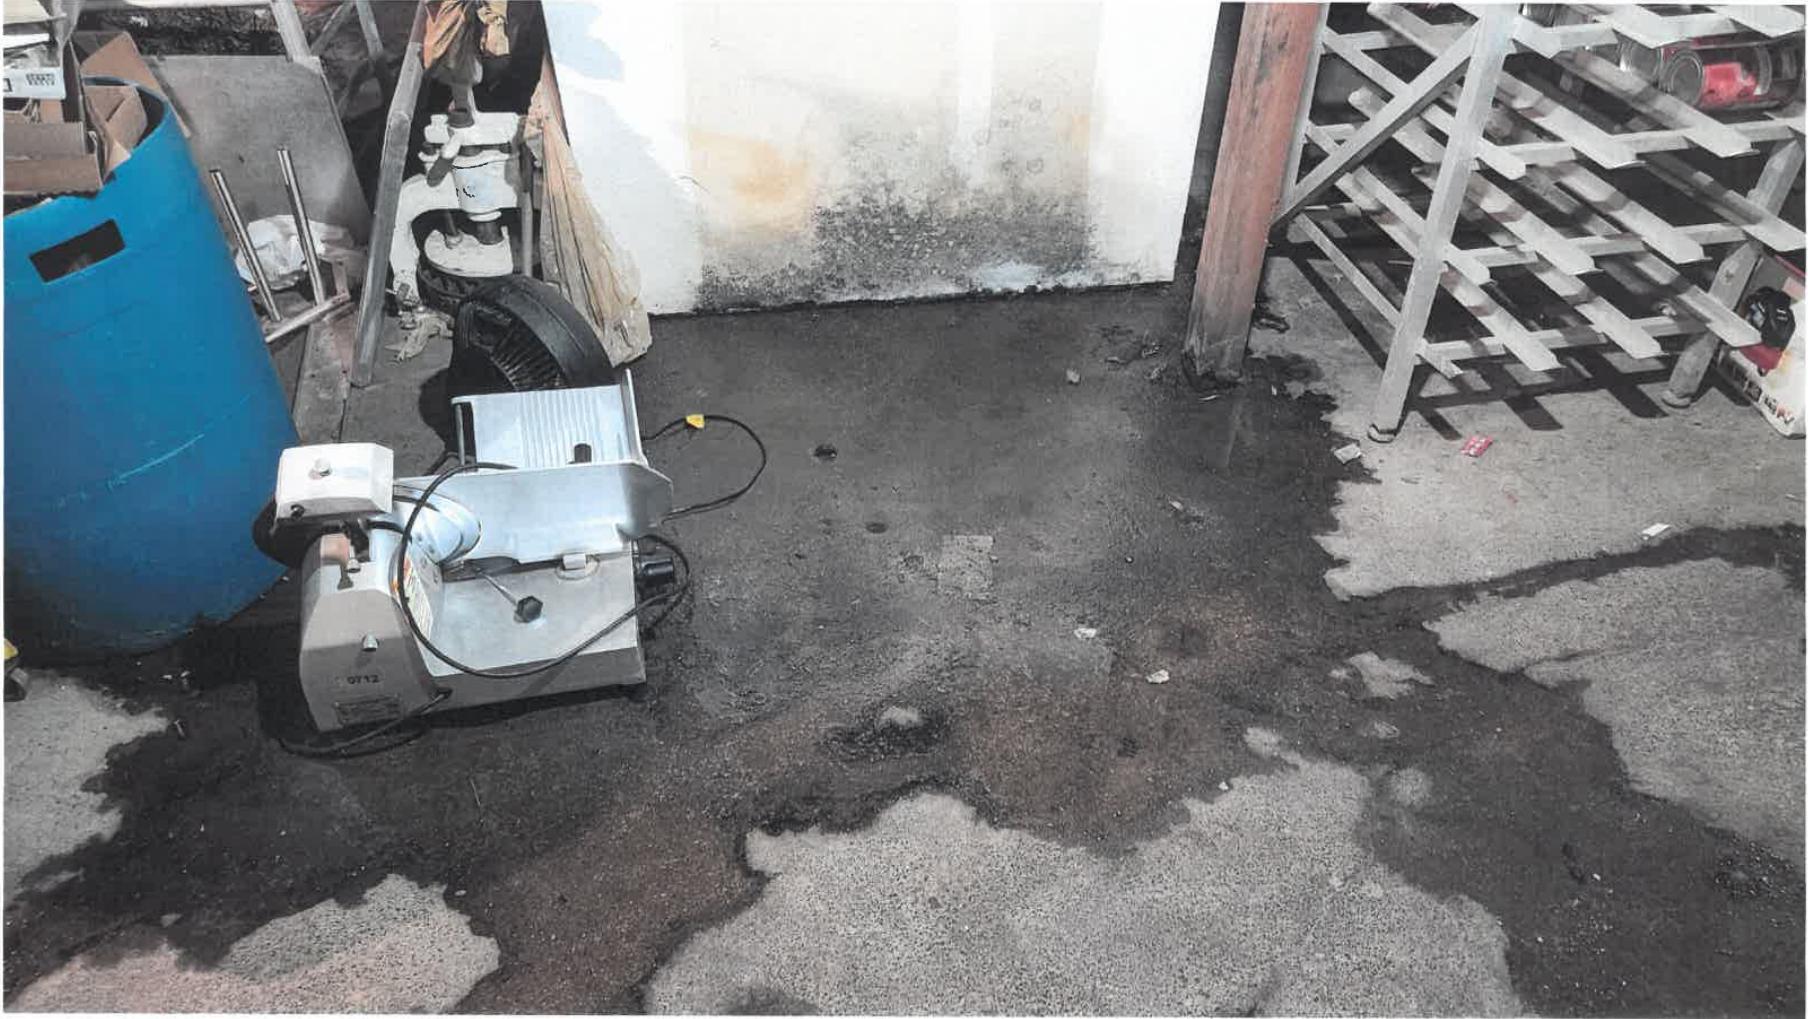
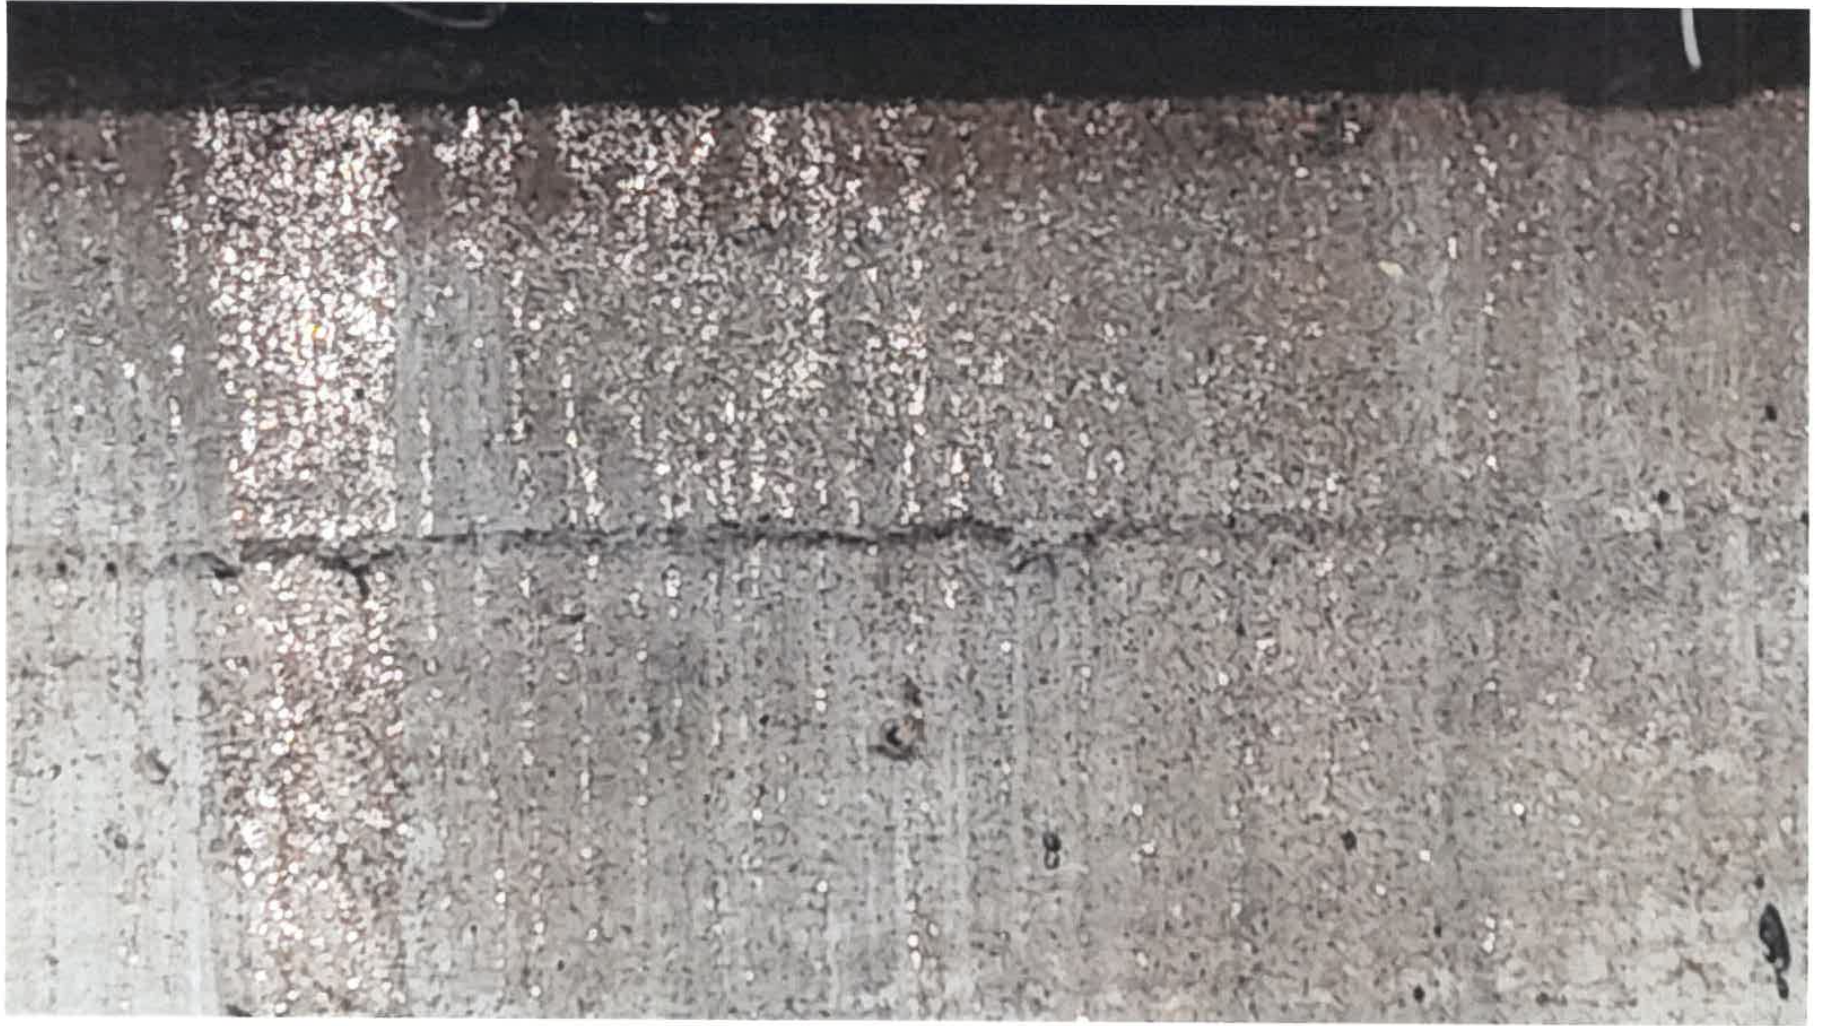
Exhibit 1
Page 1 of 2

The north building complies with none of these provisions. The north building has deteriorated and has become thoroughly exposed to the elements. Holes have developed in the roof and windows are open, allowing water to enter the building when it rains. The state of the building can be seen in the photographs attached to this letter. *See Exhibit 1.*

The intruding water has harmed Leo's. The water runs onto Leo's property and into its basement, events that have been witnessed by several City employees or personnel. Leo's has had to drill holes in the basement of its building in order to allow for water drainage. The intrusion and bore holes can also be seen in the photographs attached to this letter. *See Exhibit 2.* The buildup of water has caused Leo's north stairwell to pull away from its building. The cost to stabilize the stairwell is estimated to be \$10,000 (*see Exhibit 3*) and must be done right away in order to prevent any further damage from occurring. However, this is only an estimate, and further problems may be uncovered upon inspection of the north building, which Leo's and its contractor may need access to in order to conduct said inspection. Leo's anticipates there likely will be other, additional repair work needed now or in the future due to the current and ongoing water damage from the north building.

Through emails with the Dylan Mulfinger, the City Administrator, Leo's understands that the City currently does not have any plans to address the north building, though it has gathered quotes with the intent to bring them to the City Council in either July or August. Given that July has passed, and it does not appear the City Council has taken any steps to address the north building yet, Leo's has serious concerns that this matter will not be adequately addressed this month either. In light of the threat the city-owned north building poses to Leo's—and the public—the City must immediately take steps to redress its concerning condition, either by demolition or extensive repairs to prevent further water intrusion.

The City cannot expect more of its citizens than it is willing to do itself. The state of the north building makes it evident that the City is not complying with its own Code of Ordinances. Please confirm as soon as possible that the City will promptly reimburse Leo's for the damage caused by the water intrusions originating from the north building and specifically identify what timely steps the City intends to take to prevent further damage from occurring, including a description of the work/demolition to be done, the contractor's name, and an approximate date when any demolition work or repair work will be done on the north building

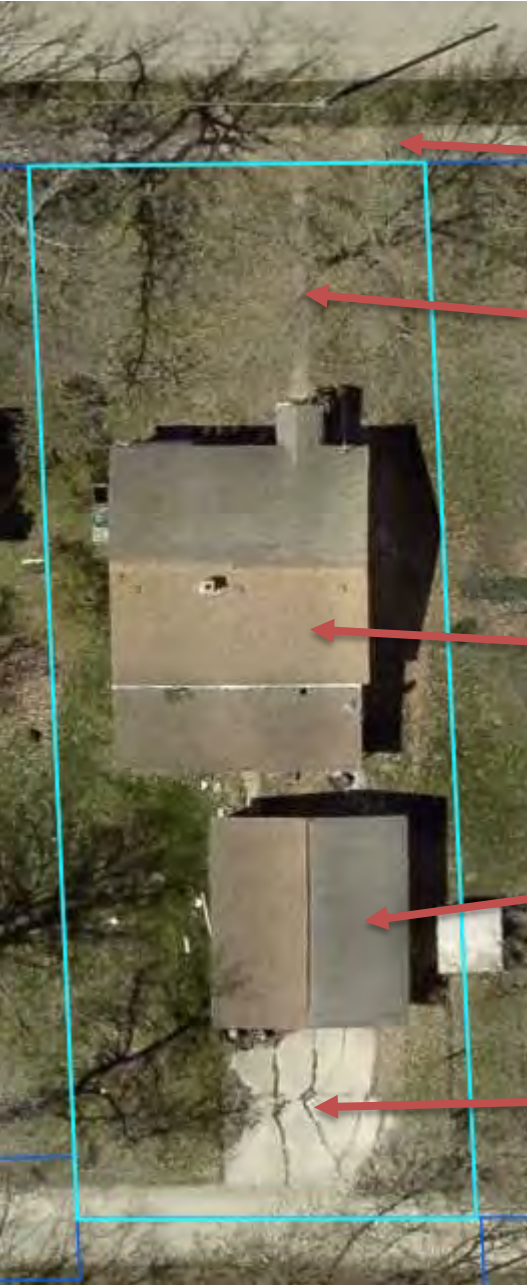
111 5th ave SW

Existing sidewalk to be maintained

Walkup sidewalk to be removed

Primary structure and foundation to be removed, all concrete completely removed

Detached garage and foundation to be removed, all concrete completely removed

Driveway to be removed

- Inspection performed by City Inspector for capping of sewer and water service
- Driveway removed
- Primary structure and detached garage removed
- Foundations and all concrete removed completely
- Walk up sidewalk removed
- Final grading and seeding
- Existing city sidewalk and existing curb properly maintained

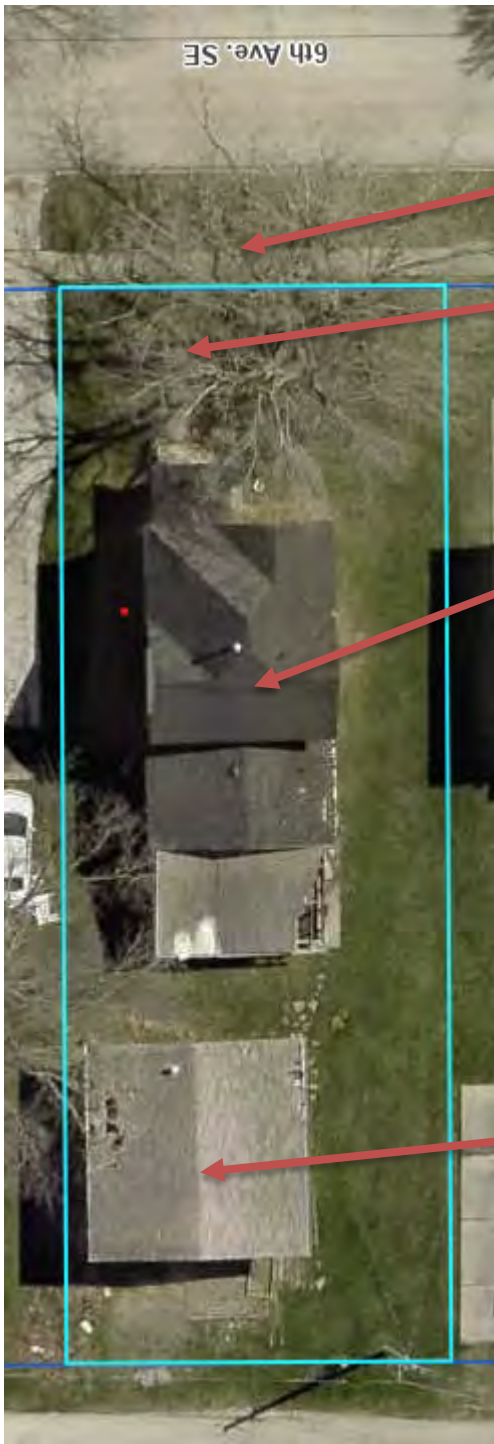
132 6th ave SE

Existing sidewalk to be maintained

Walkup sidewalk to be removed

Primary structure and foundation to be removed

Garage and foundation to be removed

- Inspection performed by City Inspector for capping of sewer and water service
- Driveway removed
- Primary structure and detached garage removed
- Foundations and all concrete removed completely
- Walk up sidewalk removed
- Final grading and seeding
- Existing city sidewalk and existing curb properly maintained

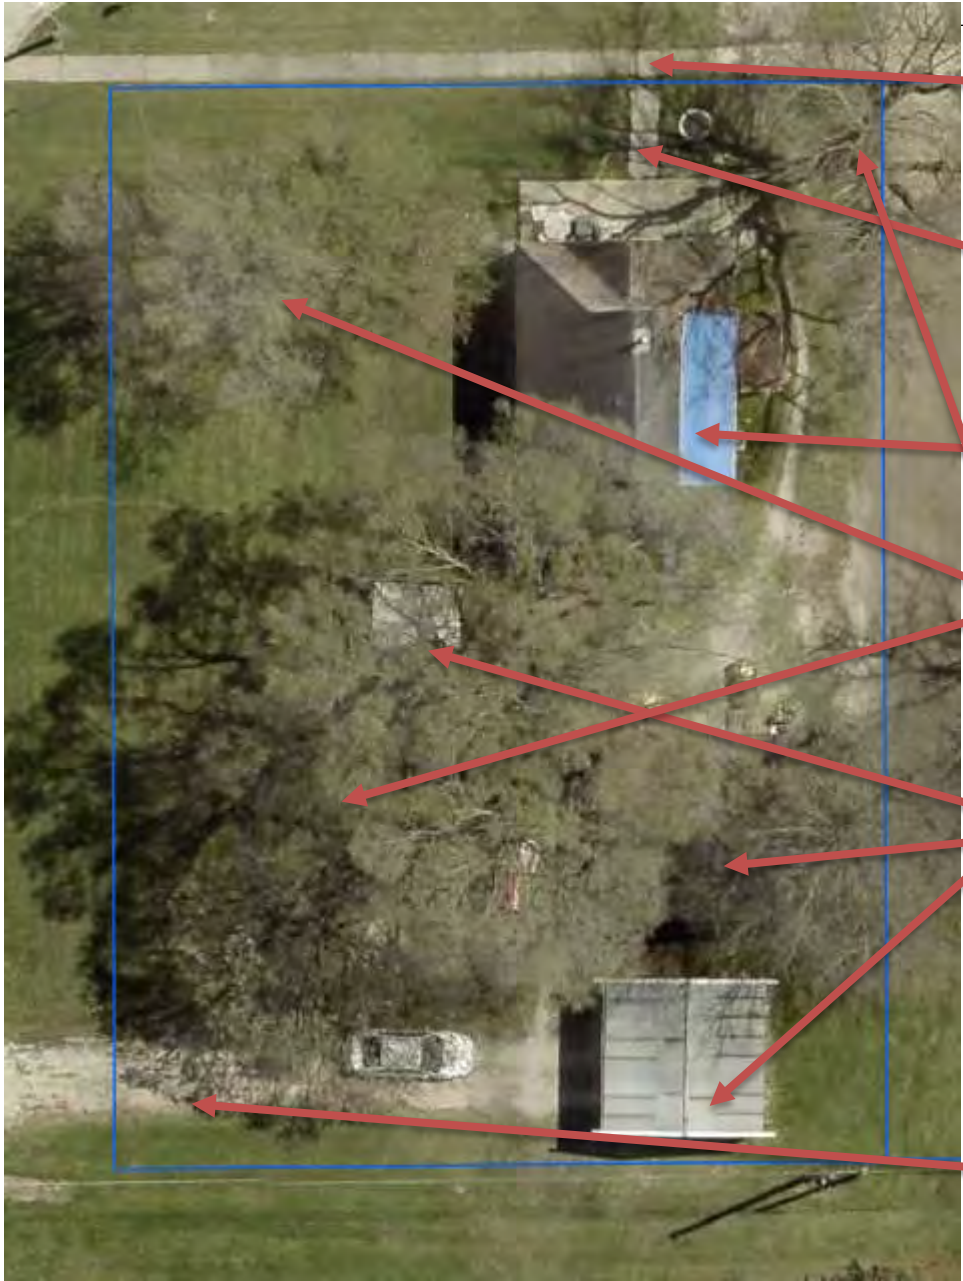
204 8th ave SW

Existing sidewalk to be maintained

Walkup sidewalk to be removed

Primary structure and foundation to be removed

All Trees on parcel removed

Detached garages and foundations to be removed, small accessory shed to be removed

Driveway to be removed

- Inspection performed by City Inspector for capping of sewer and water service
- Driveway removed
- Primary structure and detached garages and shed removed
- All trees on parcel removed
- Foundations and all concrete removed completely
- Walk up sidewalk removed
- Final grading and seeding
- Existing city sidewalk and existing curb properly maintained
