HISTORIC PRESERVATION COMMISSION REGULAR MEETING

STAFF REPORT

AGENDA ITEM TITLE: Welch House, 128 E. First Street- Major Certificate of Approval Application

REQUEST: The request is to receive a Certificate of Approval to construct a new two-unit building behind the existing commercial building at 128 E. First Street.

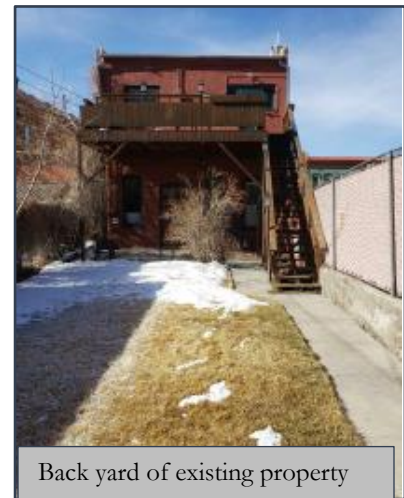
Back yard of existing property

3. The proposal is to construct a 35’ structure containing two residential units in the rear of the property. The height of the existing commercial structure is approximately 32’. The new units will generally only be visible from the alley and neighboring properties.
4. The applicant has included a narrative, photographs and site plans describing the proposed units. On page 5 of 5 they have a massing study to show what the building will like behind the existing commercial building.
5. The applicant is showing the proposed materials on sheet 3 of 5 and are proposing to use wood, stucco and corrugated metal for the exterior materials and metal for the roof. The proposed windows and doors will be metal clad.

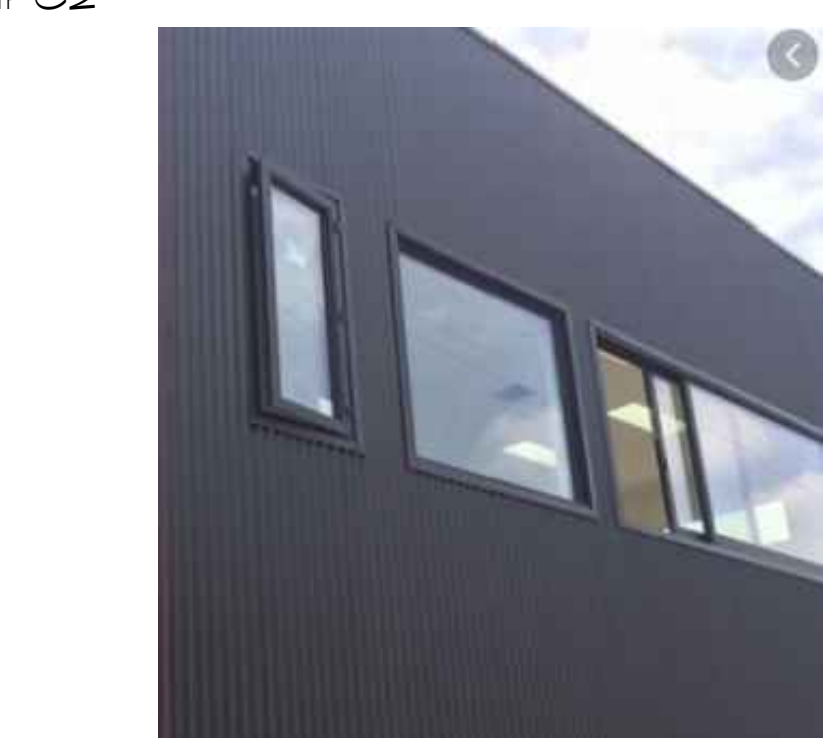
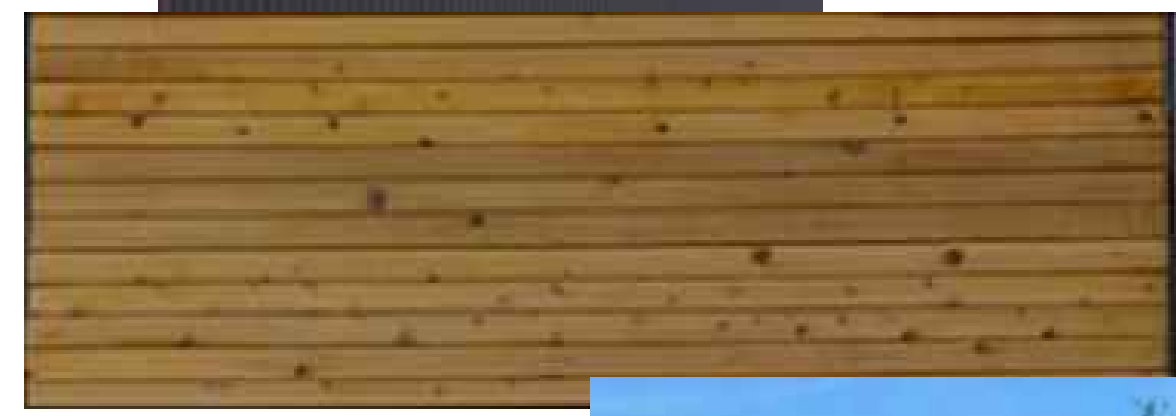
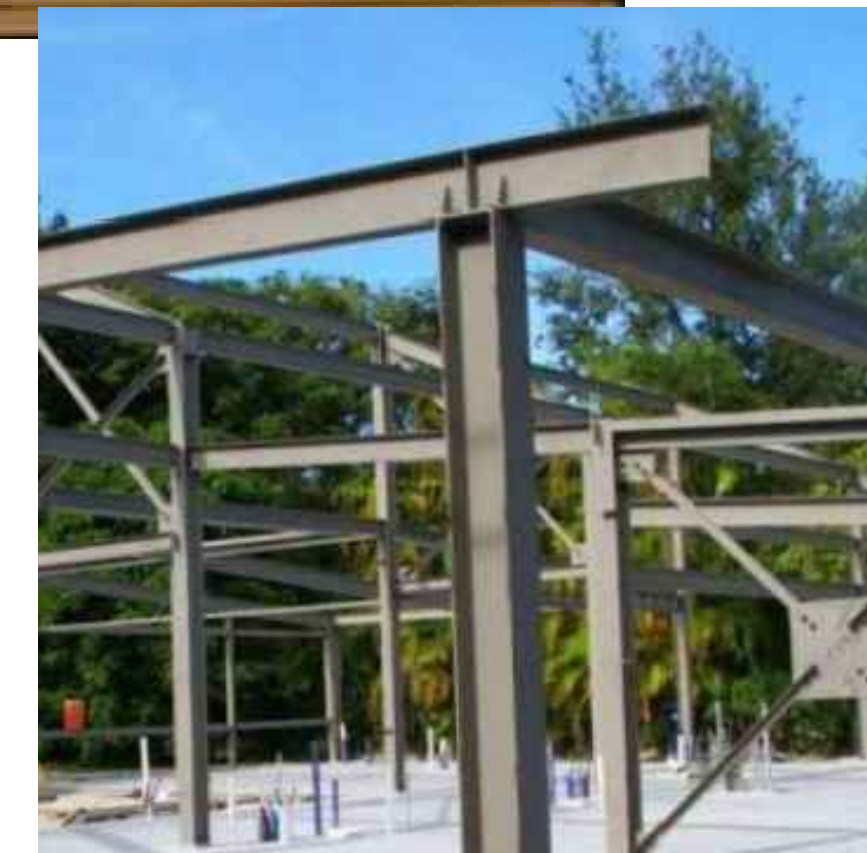
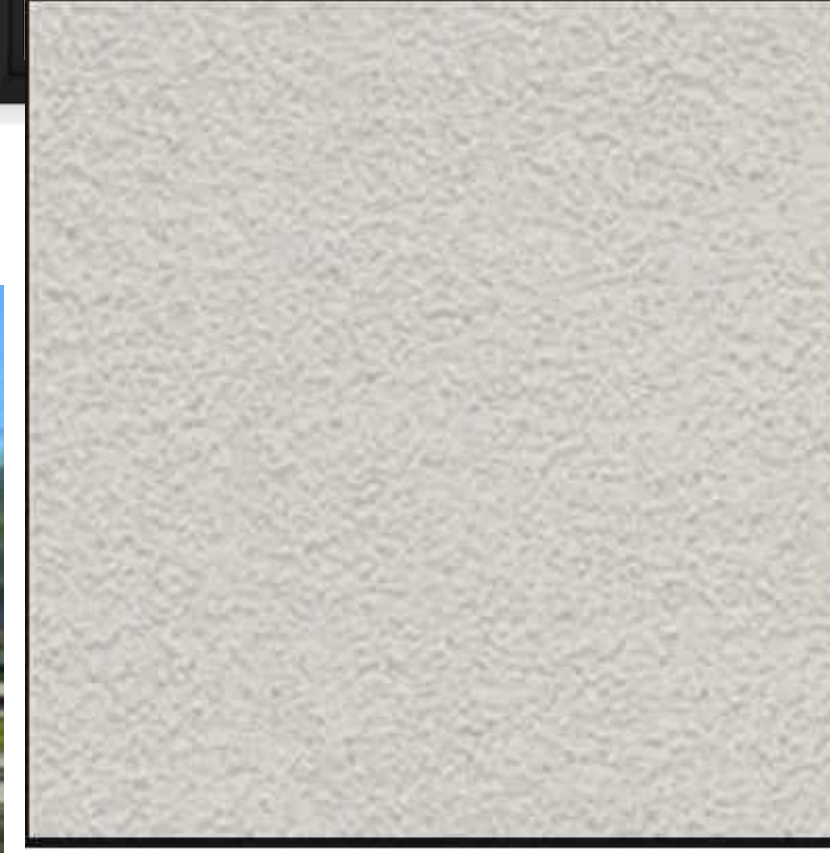
4 MATERIALS
RE: 1HPC3, 2HPC3, 3HPC3

VERTICAL CORRUGATED METAL ACCENT SIDING & ROOFING

WOOD DECK RAILING

EXPOSED STRUCTURAL STEEL FRAME AT GROUND LEVEL

METAL CLAD WINDOW

STUCCO FINISH

- The applicant is showing stucco as the main material for the building with the use of a non-reflective matte finish corrugated metal as accents. The non-reflective corrugated metal will also be used for the roof, the balconies will have a stained wood railing. The proposed windows and doors are metal clad.

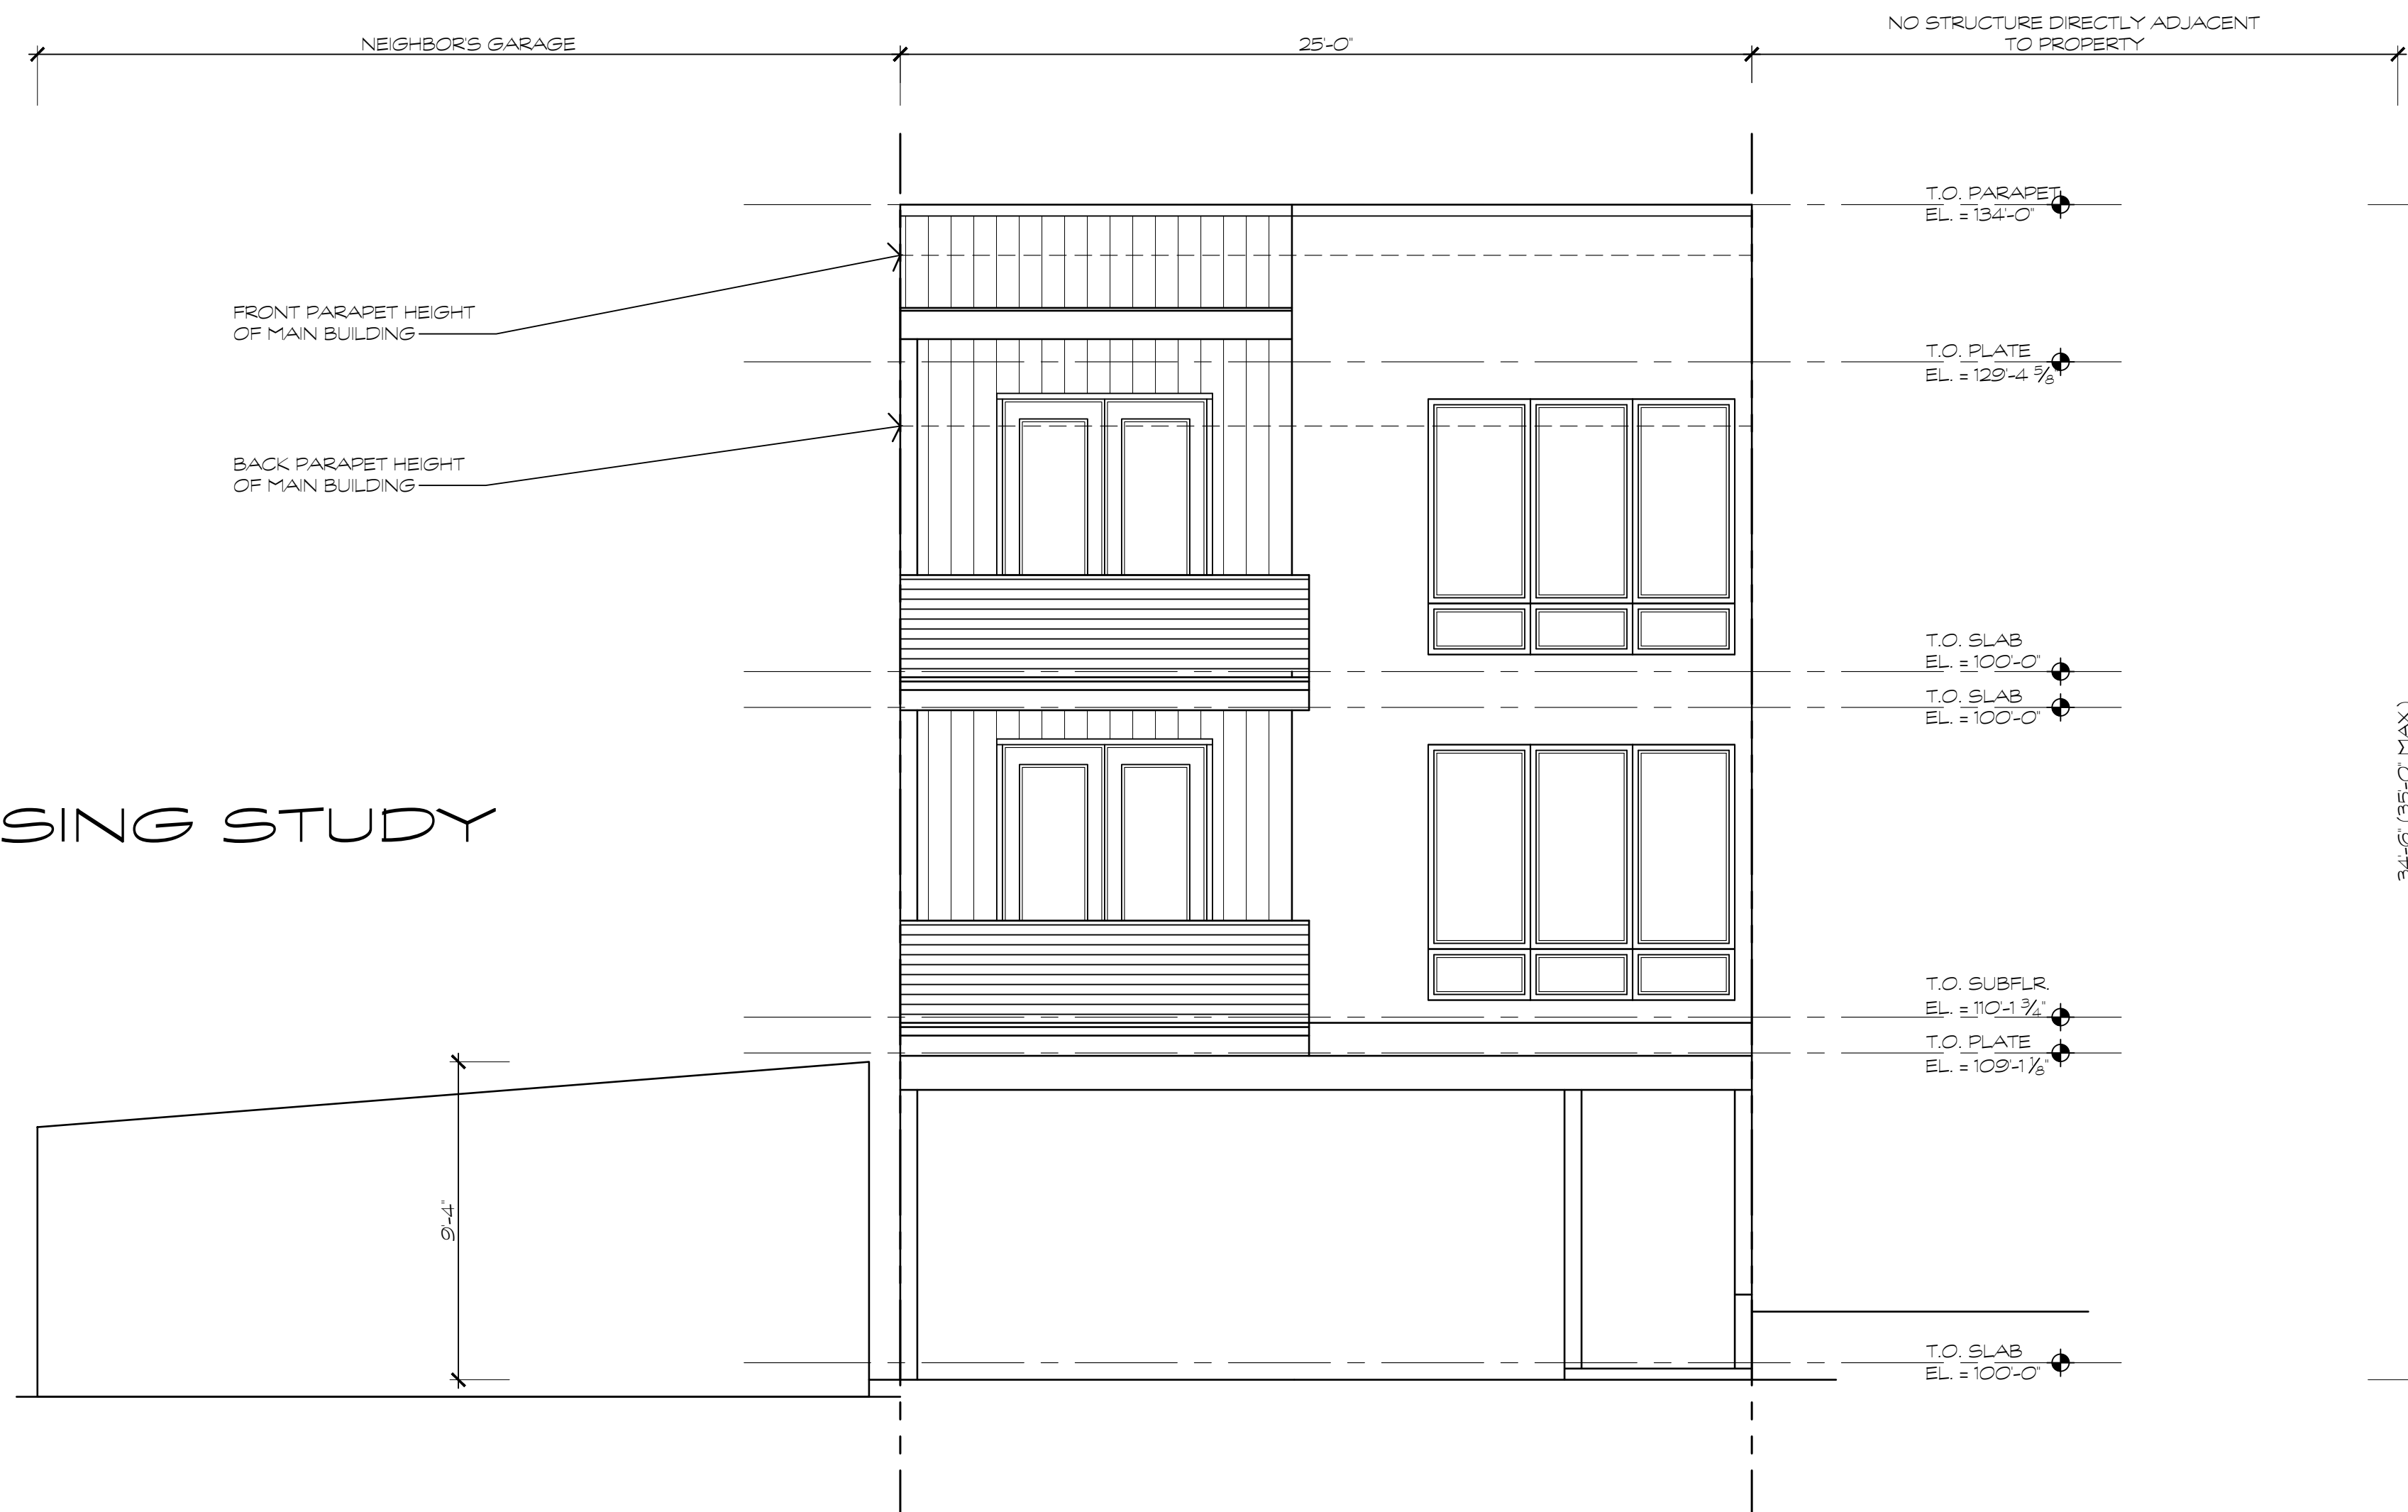
1 NORTHEAST MASSING STUDY
1/4" = 1'-0"
RE: 1HPC3

2 NORTHWEST MASSING STUDY
1/4" = 1'-0"
RE: 3HPC3

- The applicant submitted a massing model which shows the elevation and scale differences between the existing structure and the proposed new structure.

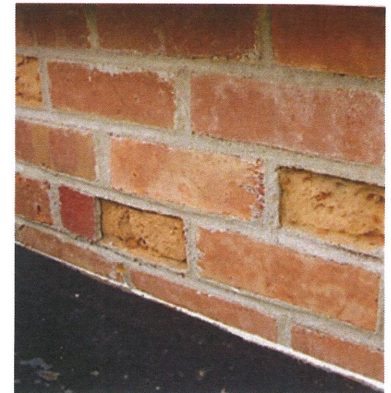
[2] **Not Recommended:** The use of inappropriate Portland cement mortar to repoint these soft 19th-century bricks has caused some of them to spall. Photo: Courtesy Nebraska State Historic Preservation Office.
