HISTORIC PRESERVATION COMMISSION WORK SESSION

CUT BACK TOP OF SLOPE. EXCAVATE AND GRADE ON THREE SIDES OF BLDG. FOR PROPER FINE GRADE AND SLOPE FOR DRAINAGE AS SHOWN

I. IDENTIFICATION

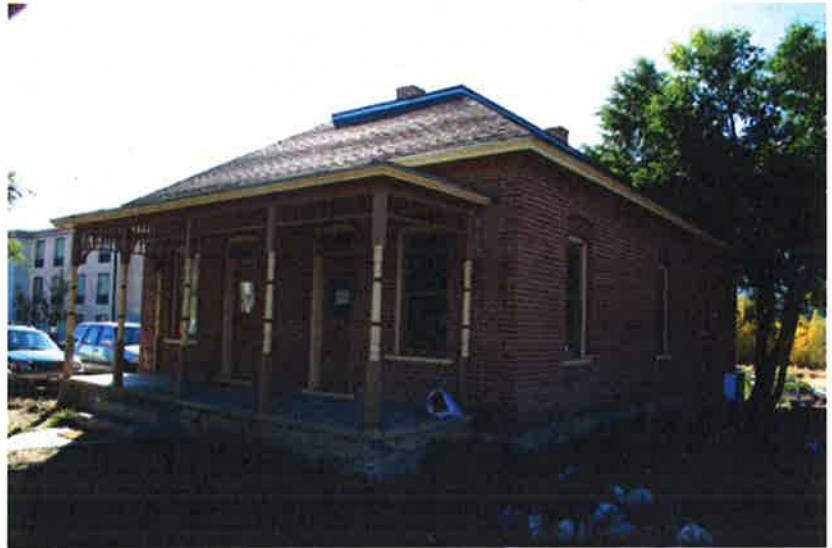
1. **Resource Number:** 5CF.2896
2. **Temporary Resource Number:** N/A
- Parcel Number:** 380705400185
- SHF/CLG Grant Number:** 2010-02-003
- GARNA Survey Number:** 1109
3. **County:** Chaffee
4. **City:** Salida vicinity
5. **Historic Building Name:**
Cowen Farm

6. **Current Building Name:**
Southwest Conservation Corps
