HISTORIC PRESERVATION COMMITTEE WORK MEETING

1. Nevens-Koster Real Estate Agency - 120 West Second Street - Major Certificate of Approval application discussion:

MEETING DATE: October 29, 2020
AGENDA ITEM TITLE: Major Certificate of Approval-120 W. Second Street
PRESENTED BY: Kristi Jefferson, Planner

Re: Major Certificated of Appropriateness for 120 West Second Street
(Contributing Building)

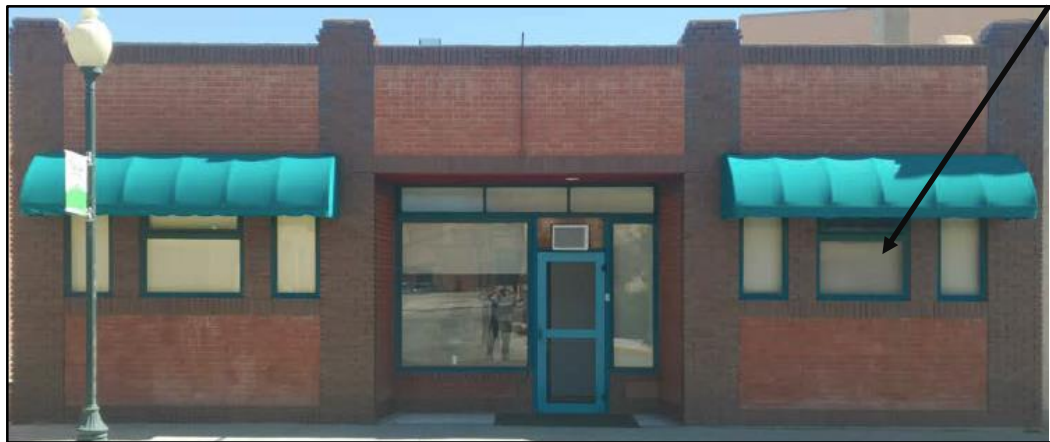
1. On the existing building the request is to remove the easternmost center window to create a new door opening on the Second Street façade. No other work is being proposed for the existing building.

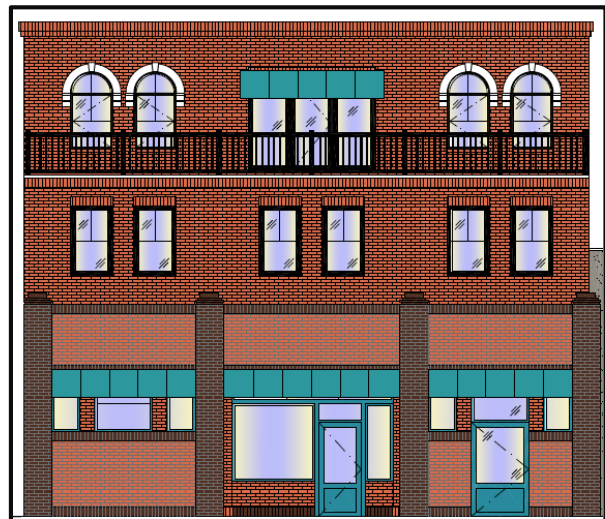
2. Construct two additional stories on the single-story building. The second floor will be approximately 1,200 square feet and the third floor approximately 1,000 square feet with a small balcony along the Second Street facade.

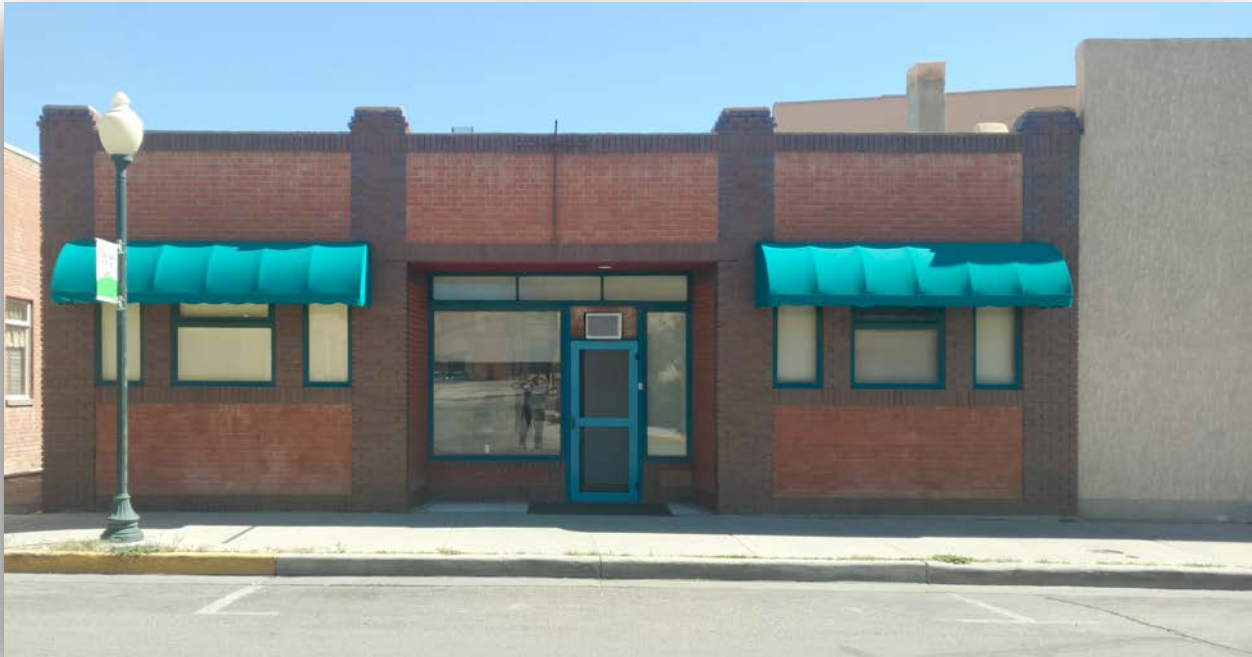
Image #1: Existing condition of contributing 120 West Second Street 1 story building

Image #1 below is a current photo of the front of the contributing building. We propose to make the following changes to the building:

Changes to the existing 1 story portion of the building: We propose replacing the existing center window and demo brick (looking from the street right side of the building) with a custom wood door matching existing door (looking from the street center of building) and matching existing paint colors. There will be no other changes to the 1st story portion of this building other than power washing both street and alley side of the building and repointing brick where needed.

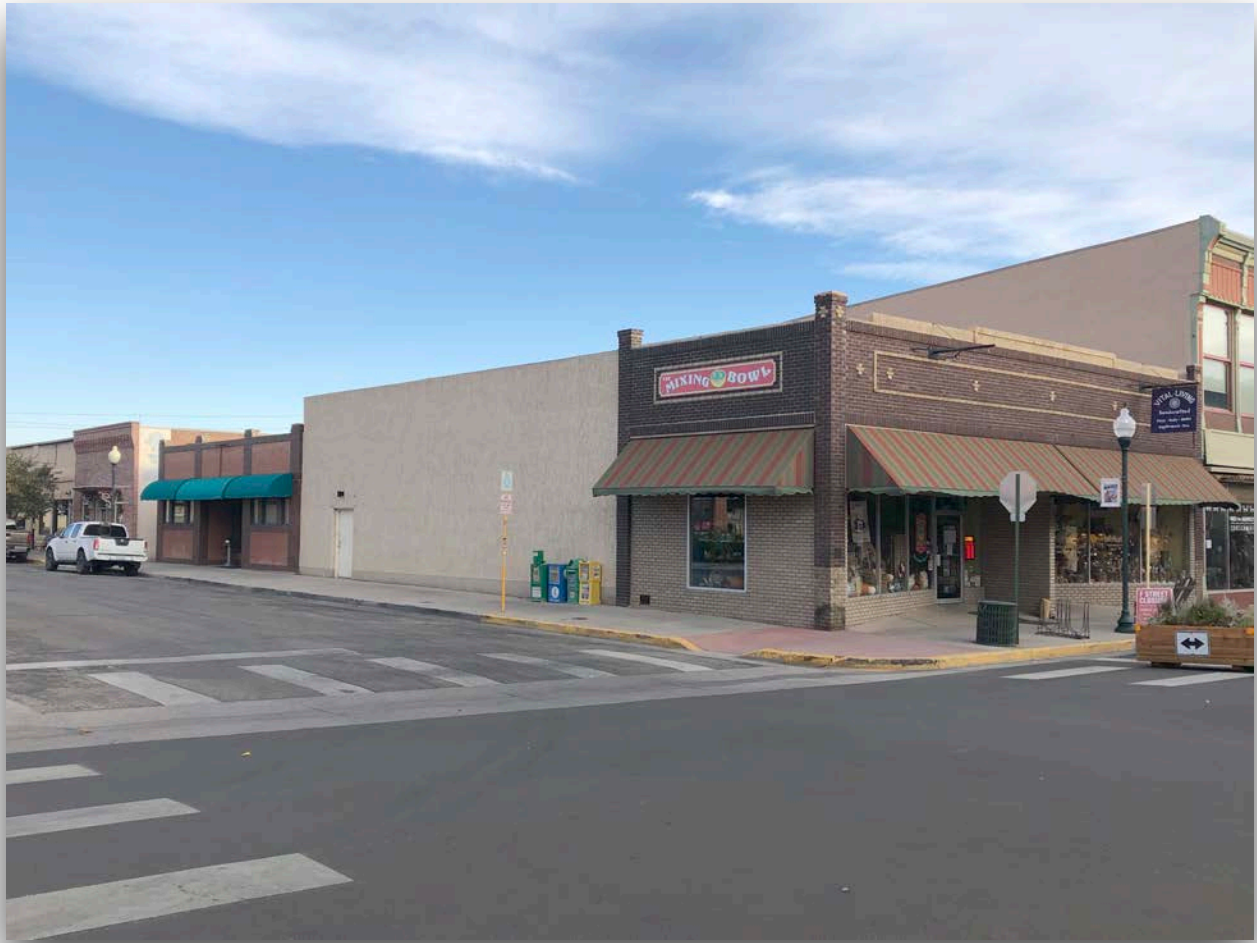
Corner of 2nd and F Street showing neighboring building 148 F Street and 120 West 2nd Street

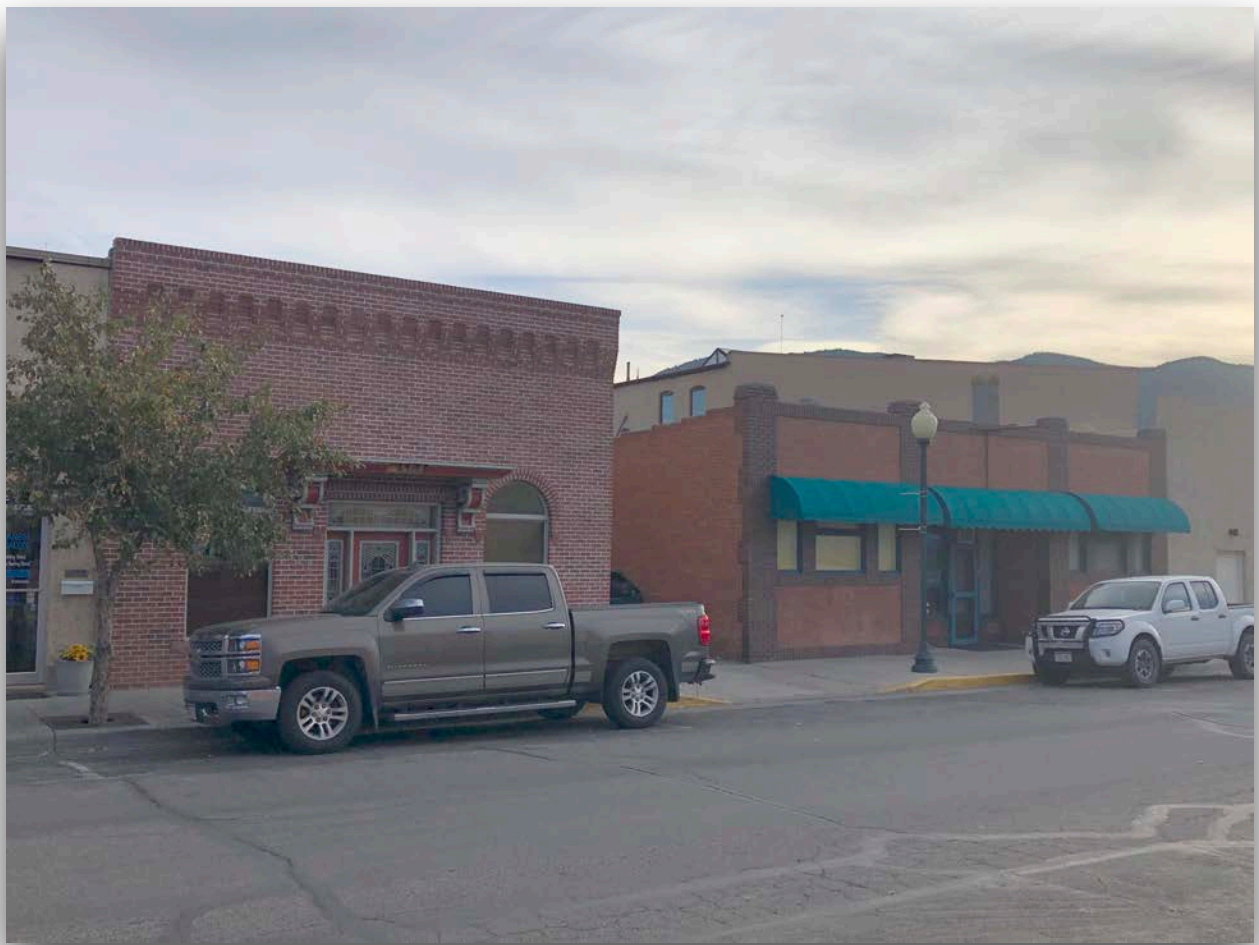
Both 122 and 120 West 2nd Street and 10 foot wide alley

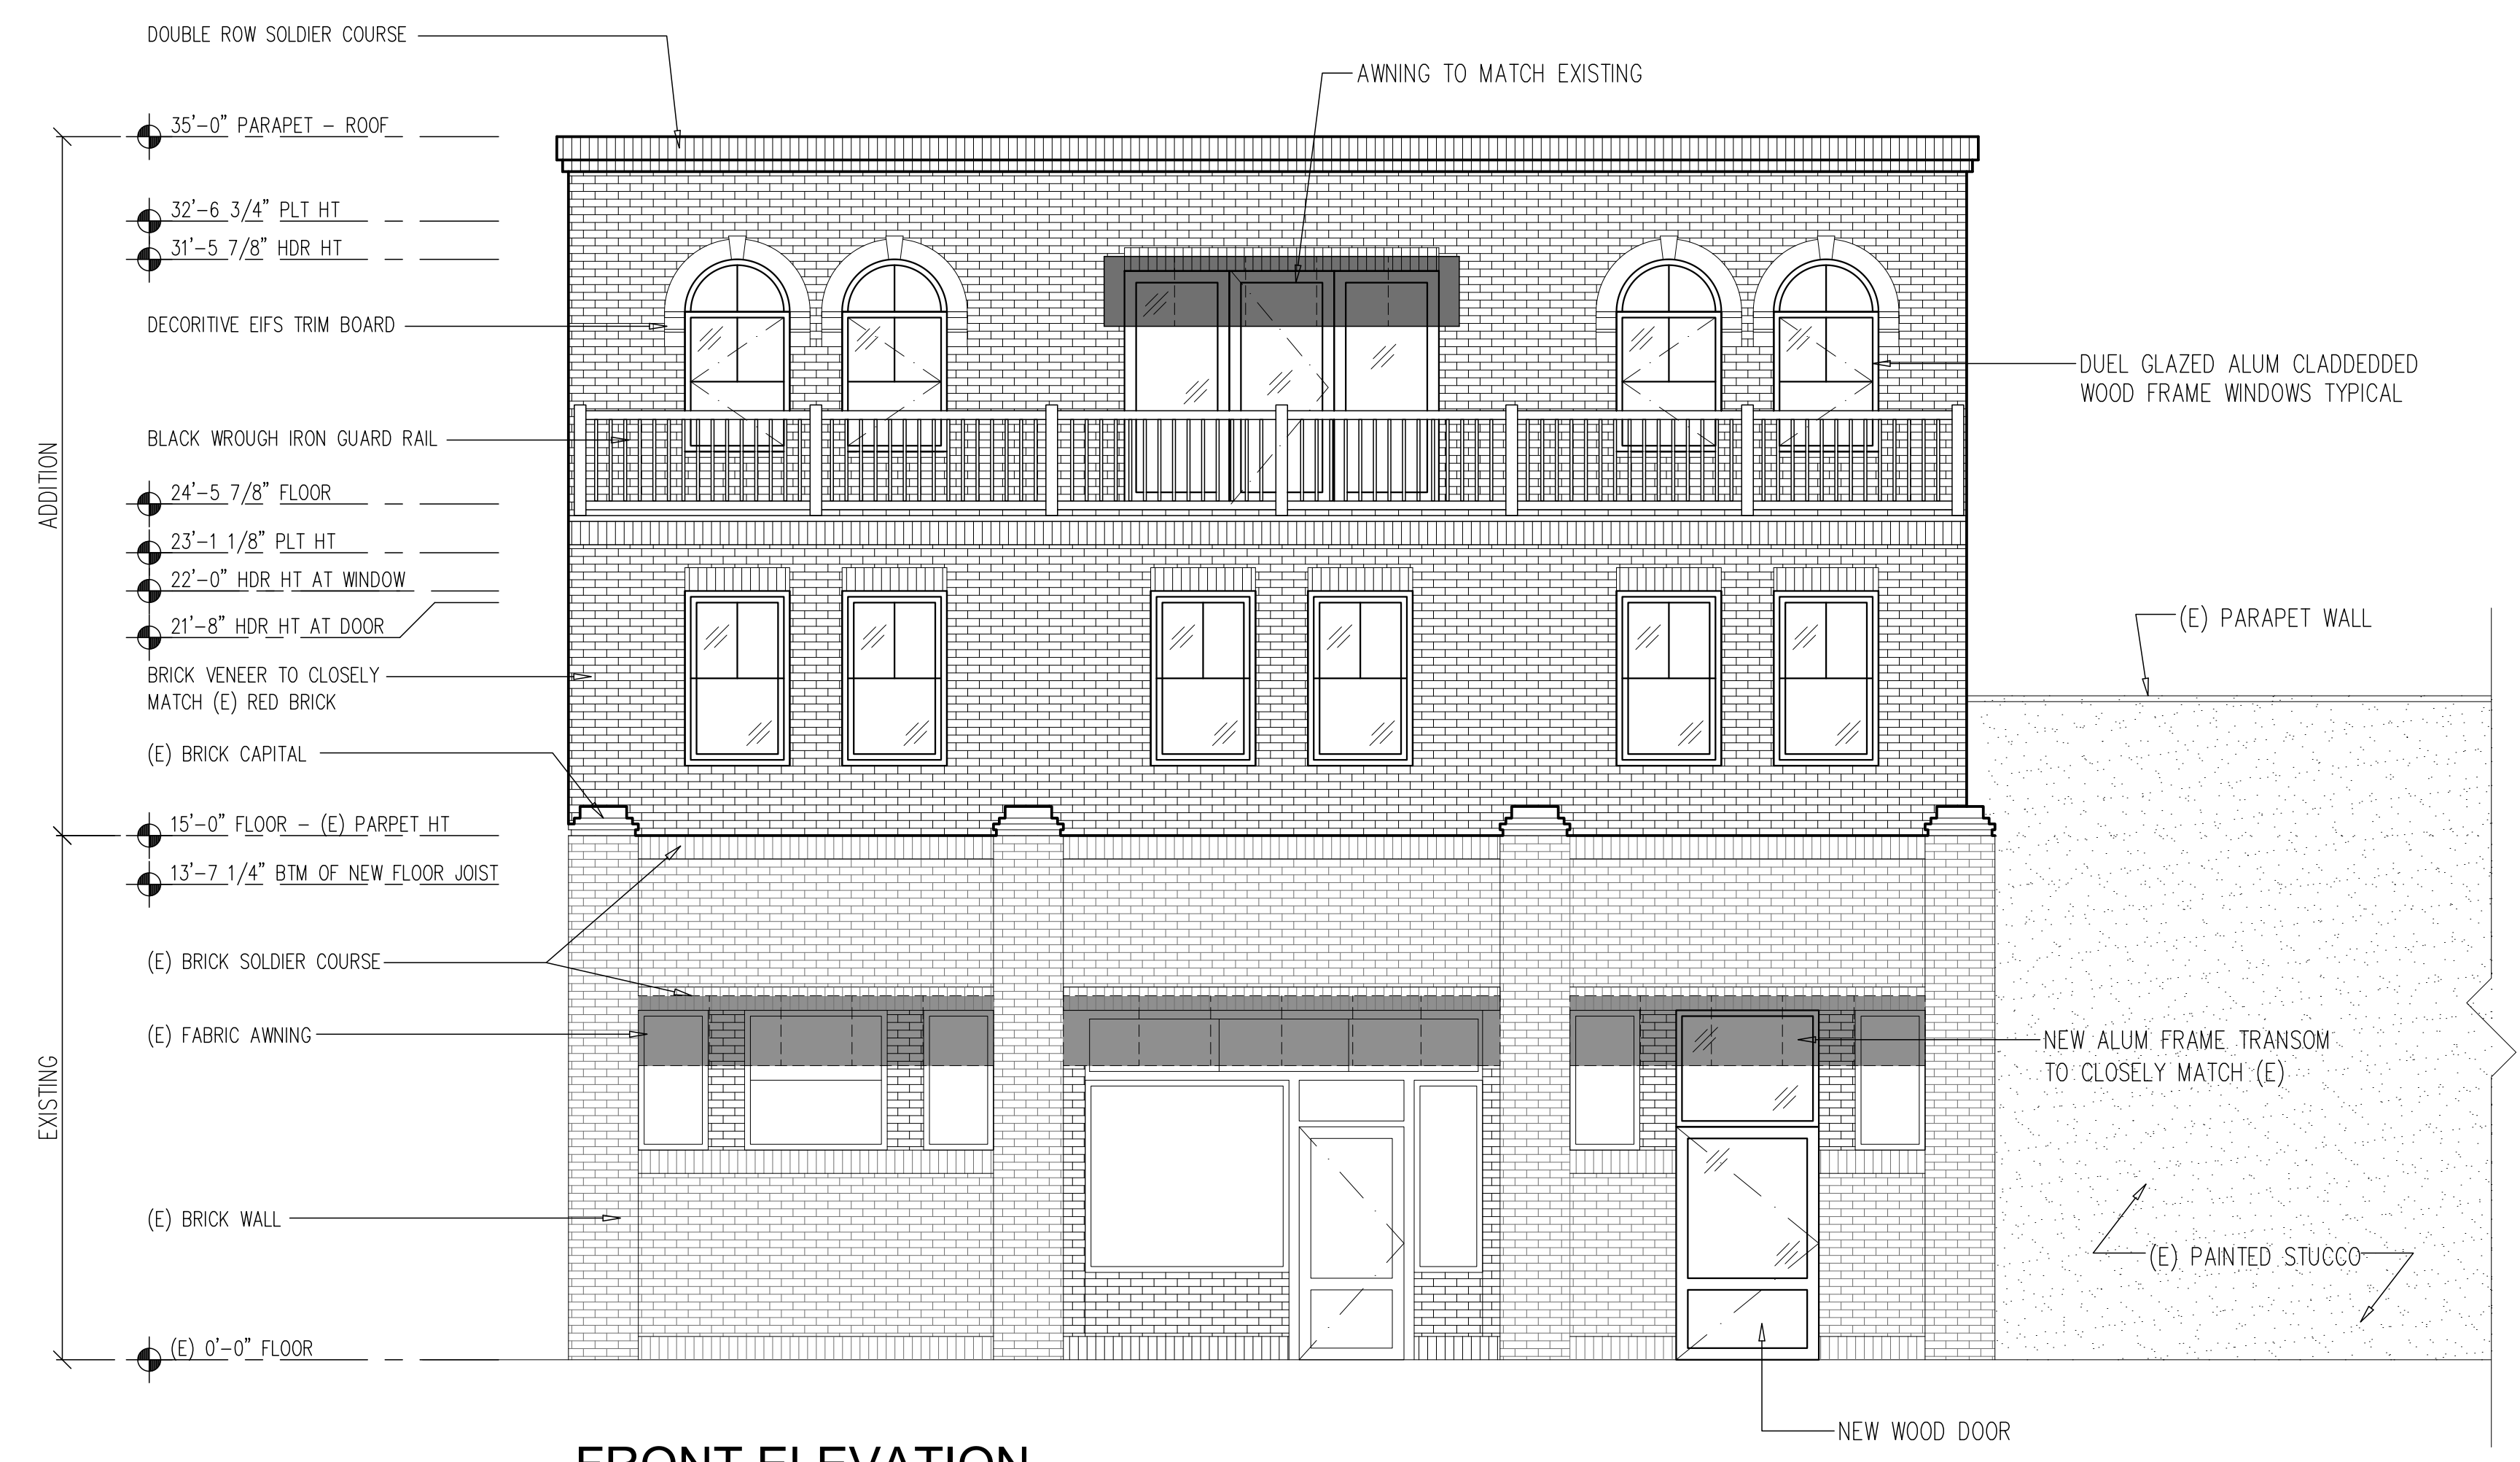
ELEVATIONS FRONT / LEFT

FRONT ELEVATION

LEFT ELEVATION

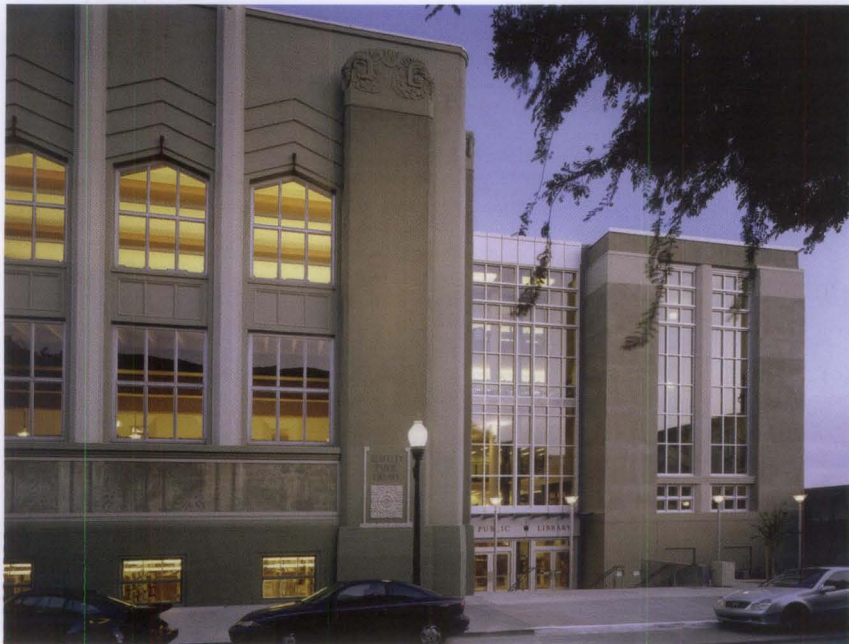
Figure 1. The addition to the right with its connecting hyphen is compatible with the Collegiate Gothic-style library. The addition is set back from the front of the library and uses the same materials and a simplified design that references, but does not copy, the historic building. Photo: David Wakely Photography.

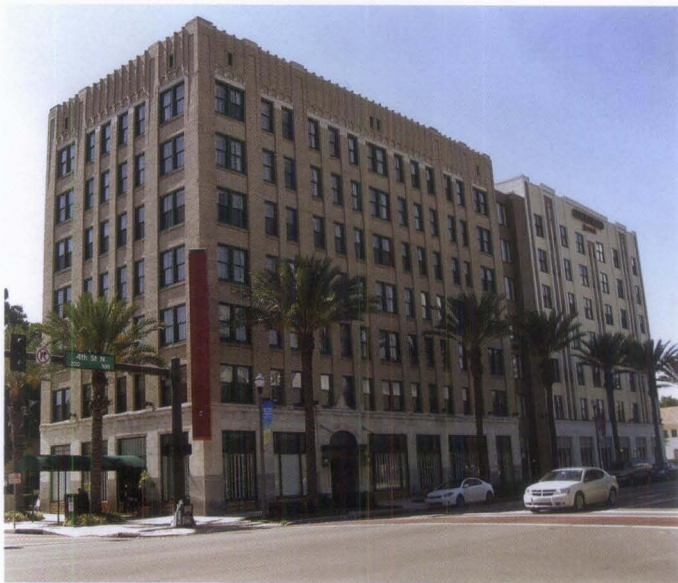
Figure 2. The new section on the right is appropriately scaled and reflects the design of the historic Art Deco-style hotel. The apparent separation created by the recessed connector also enables the addition to be viewed as an individual building.

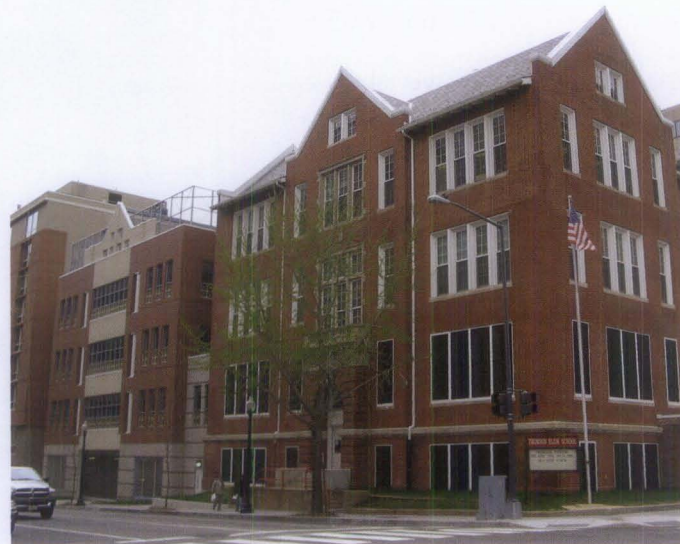
Figure 3. The red and buff-colored parking addition with a rooftop playground is compatible with the early-20th century school as well as with the neighborhood in which it also serves as infill in the urban setting.

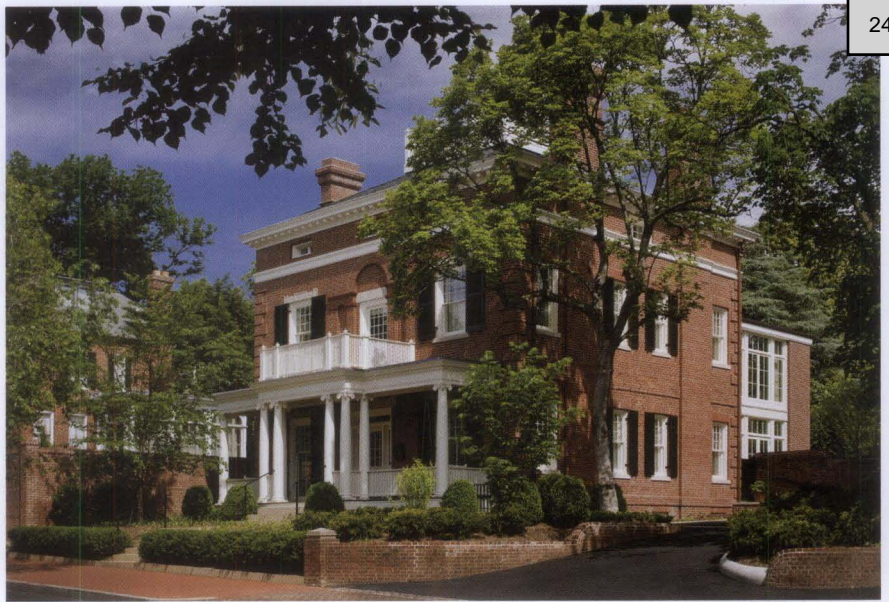
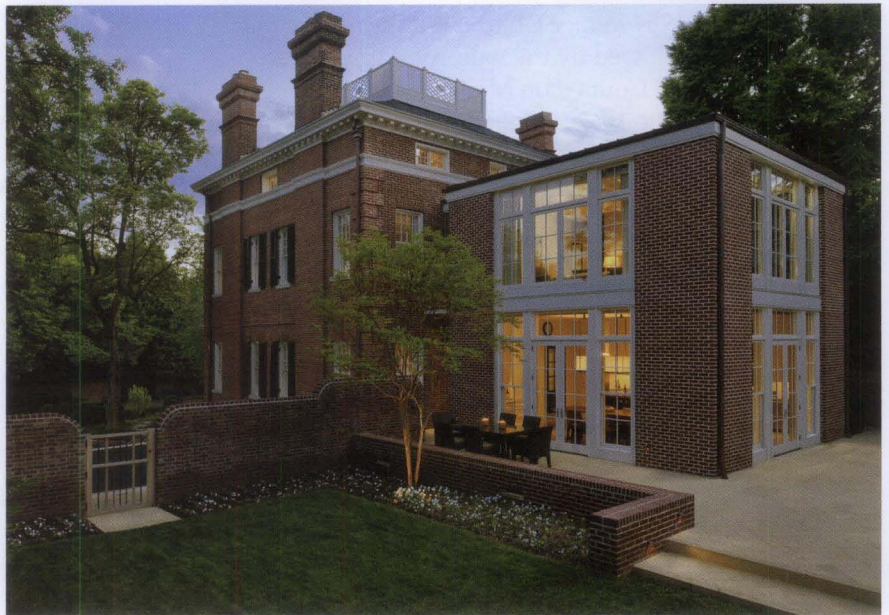
Figure 4. This glass and brick structure is a harmonious addition set back and connected to the rear of the Colonial Revival-style brick house. Cunningham/Quill Architects. Photos: © Maxwell MacKenzie.

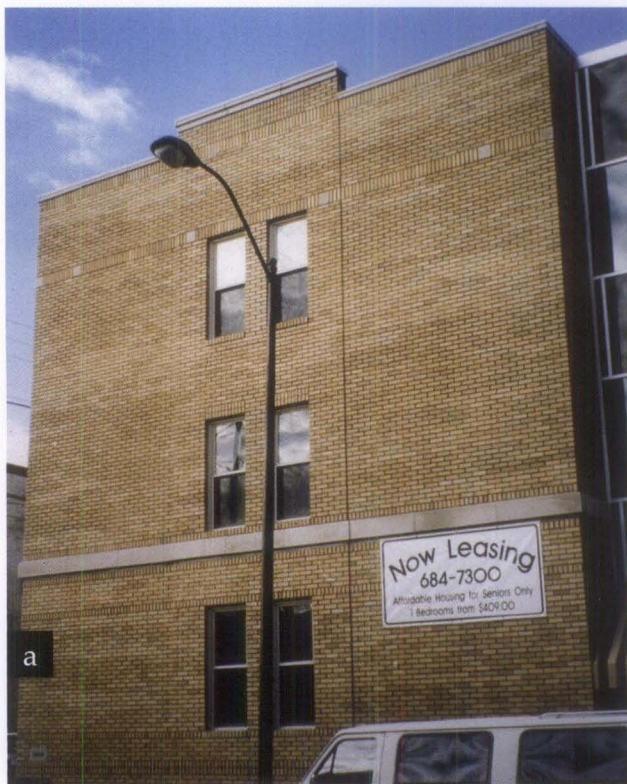
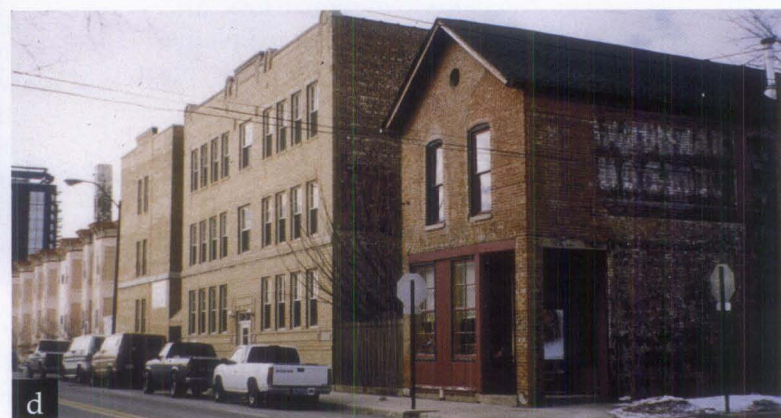
Figure 5. This addition (a) is constructed of matching brick and attached by a recessed connector (b) to the 1914 apartment building (c). The design is compatible and the addition is smaller and subordinate to the historic building (d).

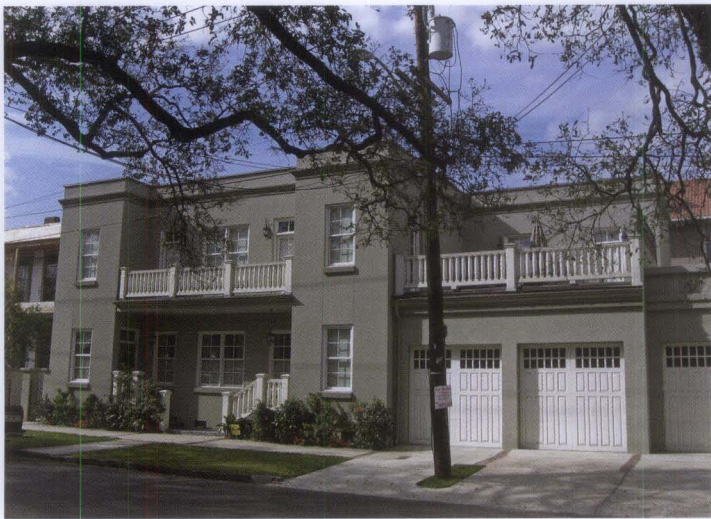
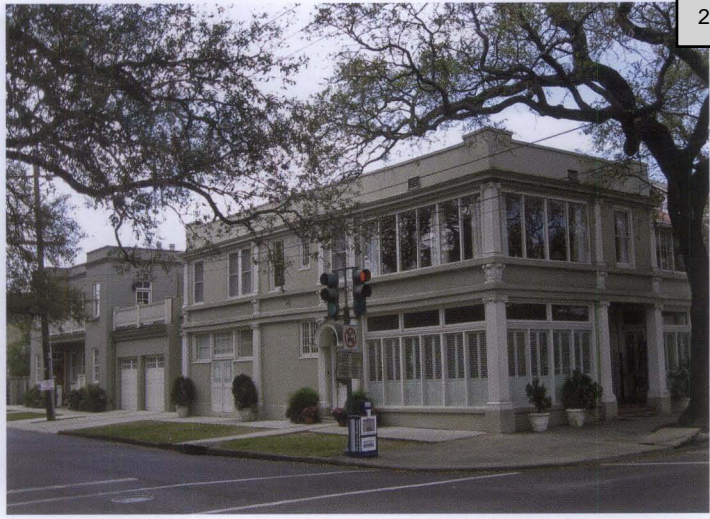
Figure 6. A new addition (left) is connected to the garage which separates it from the main block of the c. 1910 former florist shop (right). The addition is traditional in style, yet sufficiently restrained in design to distinguish it from the historic building.

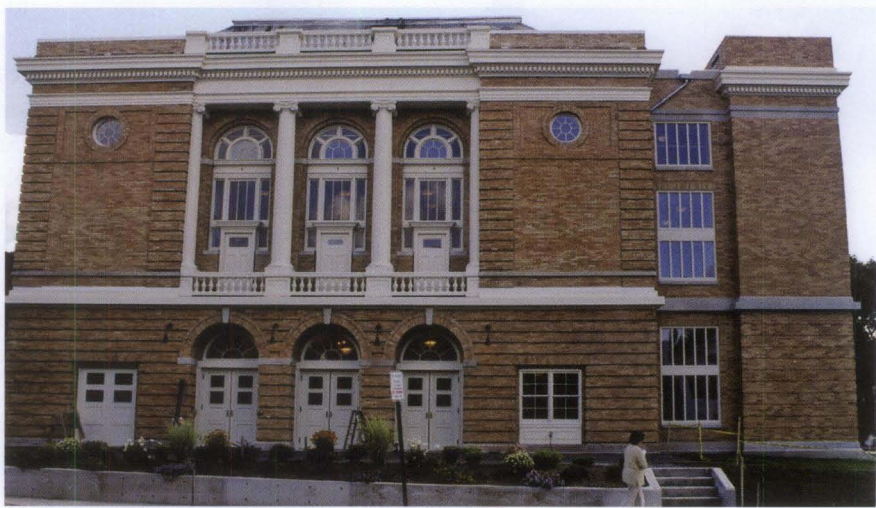
Figure 7. A vacant side lot was the only place a new stair tower could be built when this 1903 theater was rehabilitated as a performing arts center. Constructed with matching materials, the stair tower is set back with a recessed connector and, despite its prominent location, it is clearly subordinate and differentiated from the historic theater.

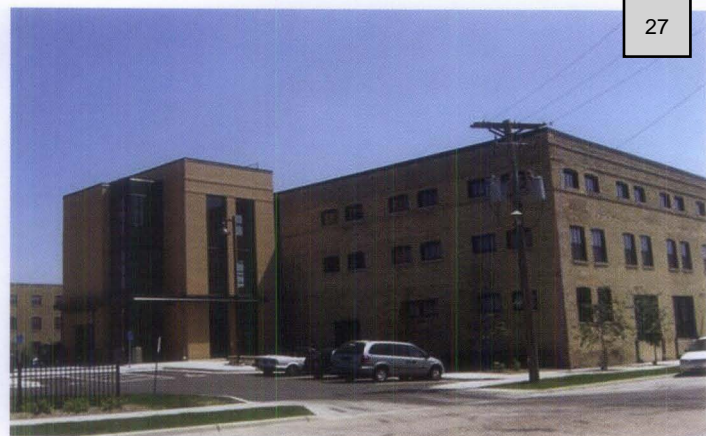
Figure 8. The rehabilitation of this large, early-20th century warehouse (left) into affordable artists' lofts included the addition of a compatible glass and brick elevator/stair tower at the back (right).

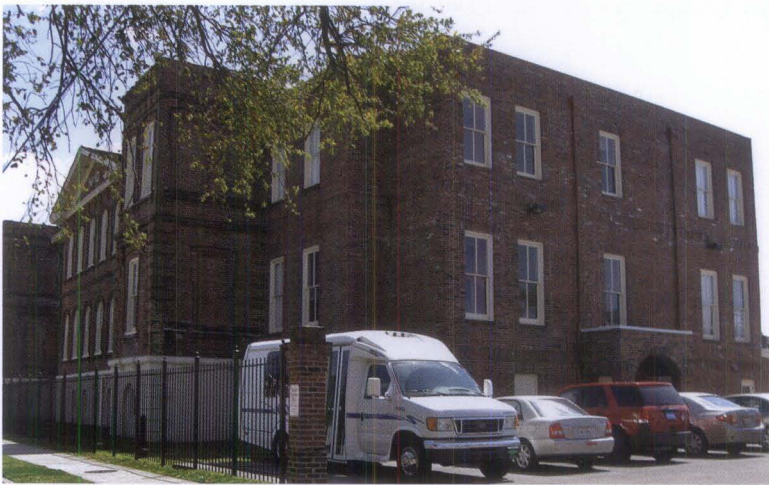
Figure 9. A simple, brick stair tower replaced two non-historic additions at the rear of this 1879 school building when it was rehabilitated as a women's and children's shelter. The addition is set back and it is not visible from the front of the school.

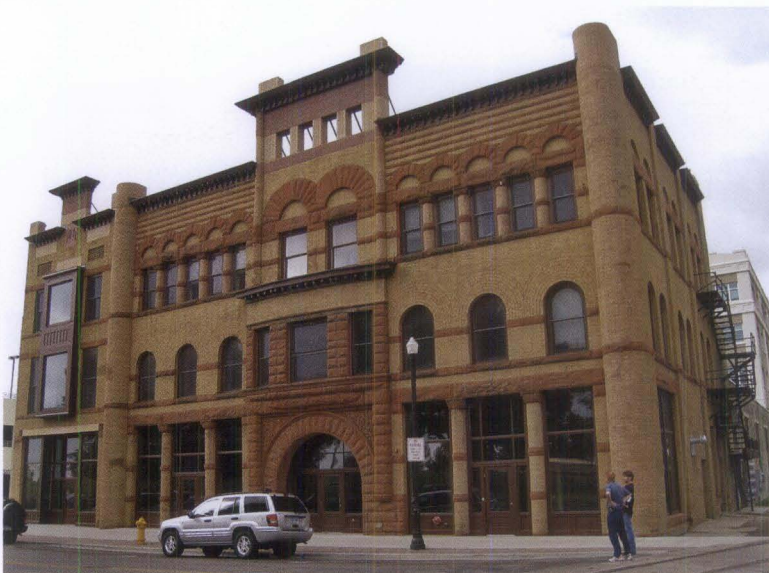
Figure 10. The small size and the use of matching materials ensures that the new addition on the left is compatible with the historic Romanesque Revival-style building.

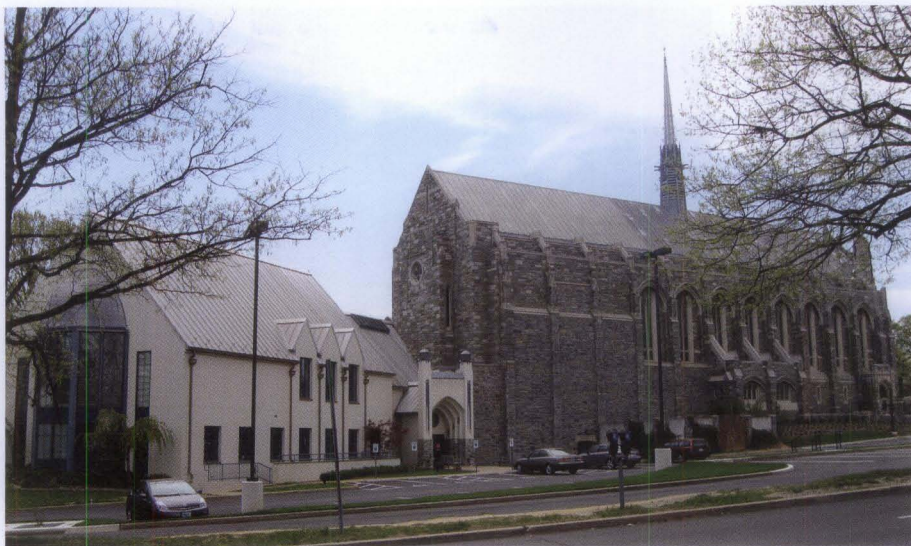
Figure 11. The addition to this early-20th century Gothic Revival-style church provides space for offices, a great hall for gatherings and an accessible entrance (left). The stucco finish, metal roof, narrow gables and the Gothic-arched entrance complement the architecture of the historic church. Placing the addition in back where the ground slopes away ensures that it is subordinate and minimizes its impact on the church (below).

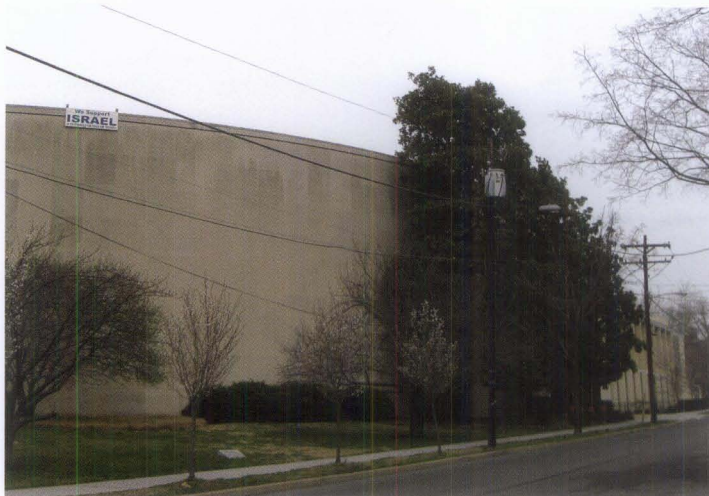
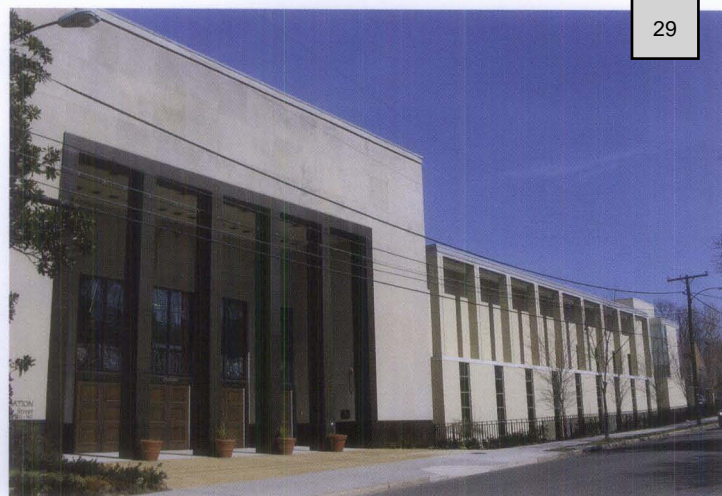
Figure 12. This 1954 synagogue (left) is accessed through a monumental entrance to the right. The new education wing (far right) added to it features the same vertical elements and color and, even though it is quite large, its smaller scale and height ensure that it is secondary to the historic resource.

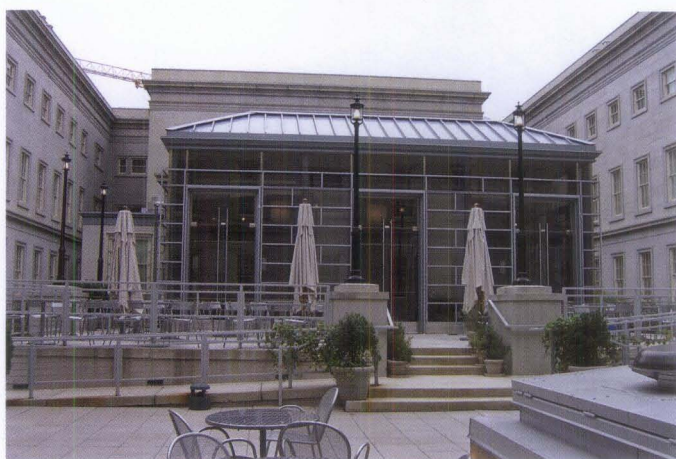
Figure 13. A glass and metal structure was constructed in the courtyard as a restaurant when this 1839 building was converted to a hotel. Although such an addition might not be appropriate in a more public location, it is compatible here in the courtyard of this historic building.

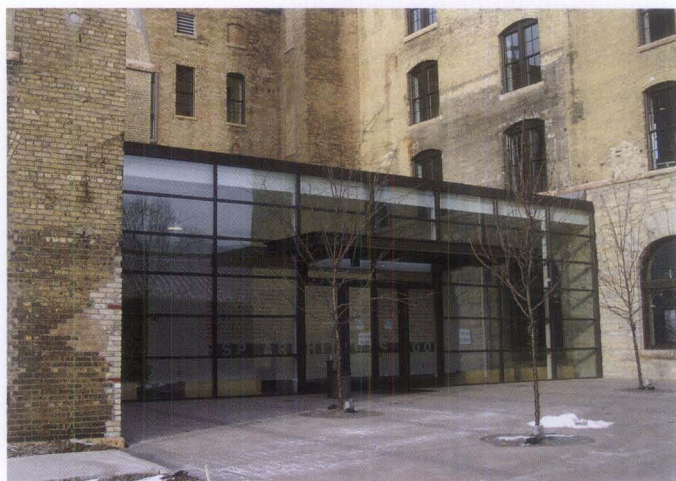
Figure 14. This glass addition was erected at the back of an 1895 former brewery during rehabilitation to provide another entrance. The addition is compatible with the plain character of this secondary elevation.

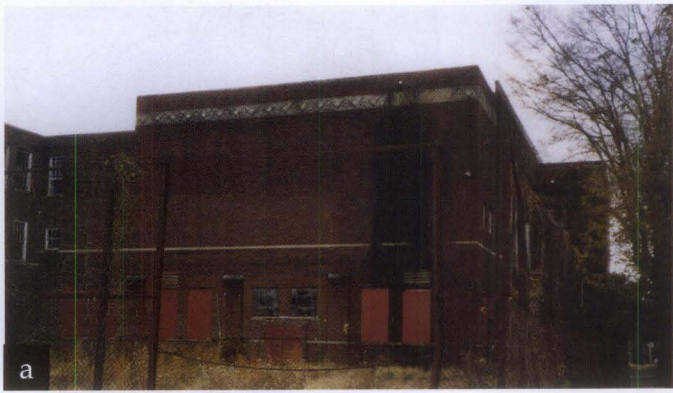
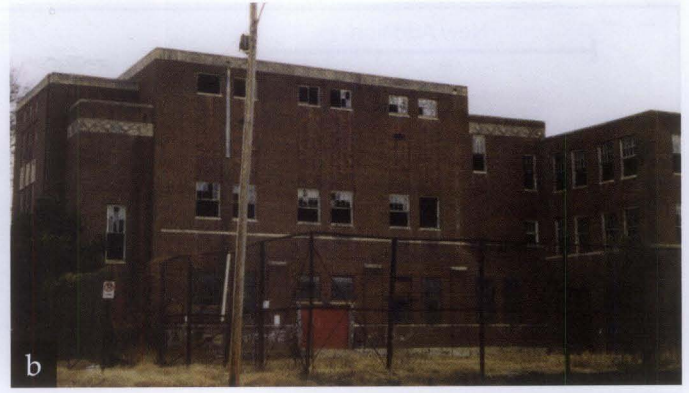
Figure 15. The rehabilitation of a c. 1930 high school auditorium for a clinic and offices proposed two additions: a one-story entrance and reception area on this elevation (a); and a four-story elevator and stair tower on another side (b). The gabled entrance (c) first proposed was not compatible with the flat-roofed auditorium and the design of the proposed stair tower (d) was also incompatible and overwhelmed the historic building. The designs were revised (e-f) resulting in new additions that meet the Standards (g-h).

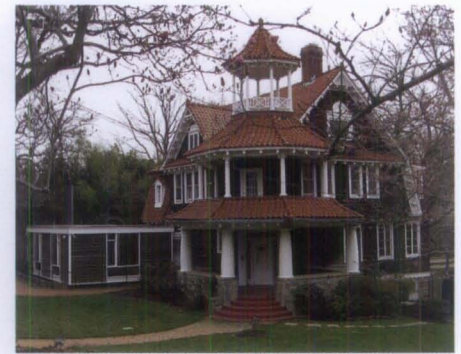
Figure 17. The small addition on the left is starkly different and it is not compatible with the eclectic, late-19th century house.

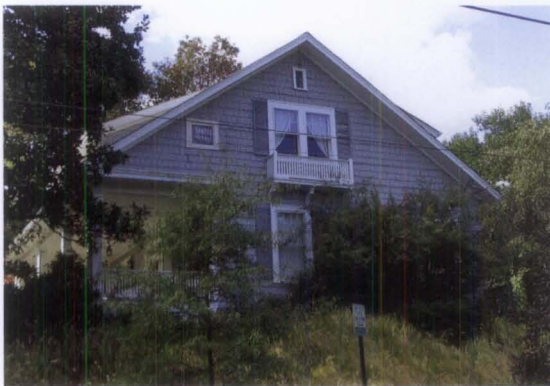
Figure 18. The expansion of a one- and one-half story historic bungalow (left) with a large two-story rear addition (right) has greatly altered and obscured its distinctive shape and form.

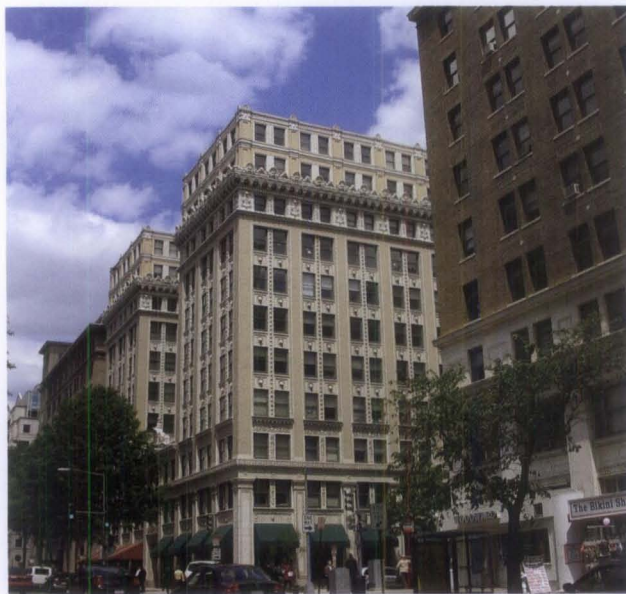
Figure 19. The upper two floors of this early-20th century office building were part of the original design, but were not built. During rehabilitation, the two stories were finally constructed. This treatment does not meet the Standards because the addition has given the building an appearance it never had historically.

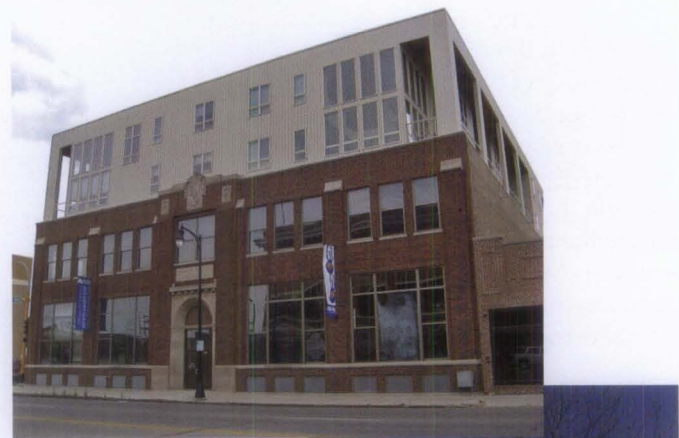
Figure 20. The height, as well as the design, of these two-story rooftop additions overwhelms the two-story and the one-story, low-rise historic buildings.

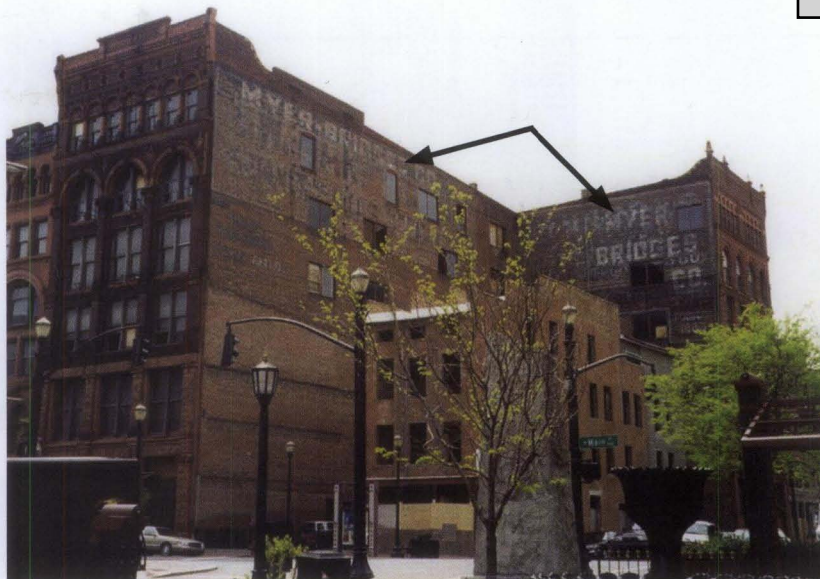
Figure 21. Both wings of this historic L-shaped building (top), which fronts on two city streets, adjoined vacant lots. A two-story addition was constructed on one lot (above, left) and a six-story addition was built on the other (above, right). Like the historic building, which has two different facades, the compatible new additions are also different and appear to be separate structures rather than part of the historic building.

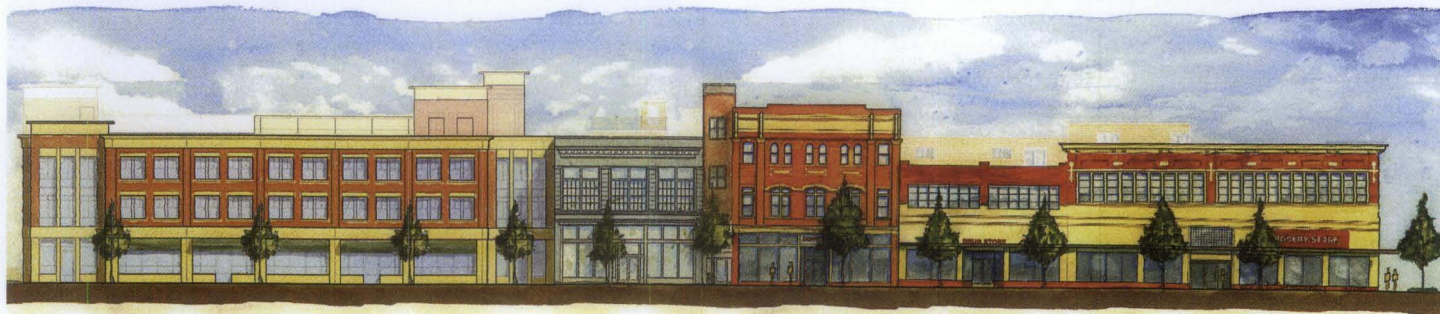
Figure 22. The proposed new addition is compatible with the historic buildings that remain on the block. Its design with multiple storefronts helps break up the mass.

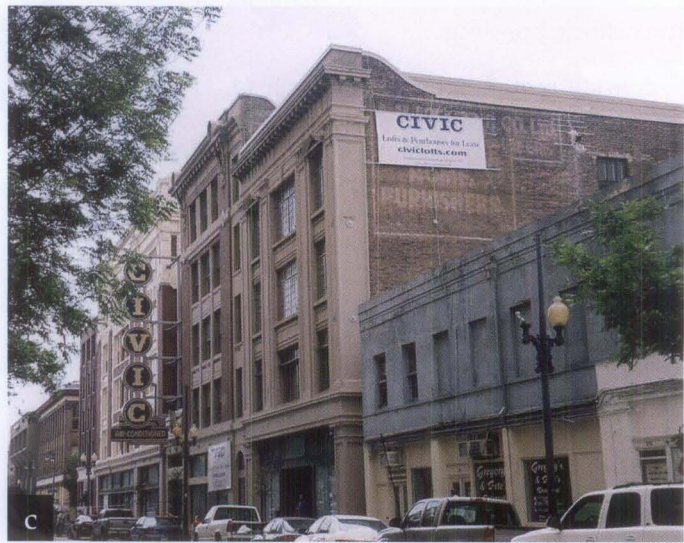
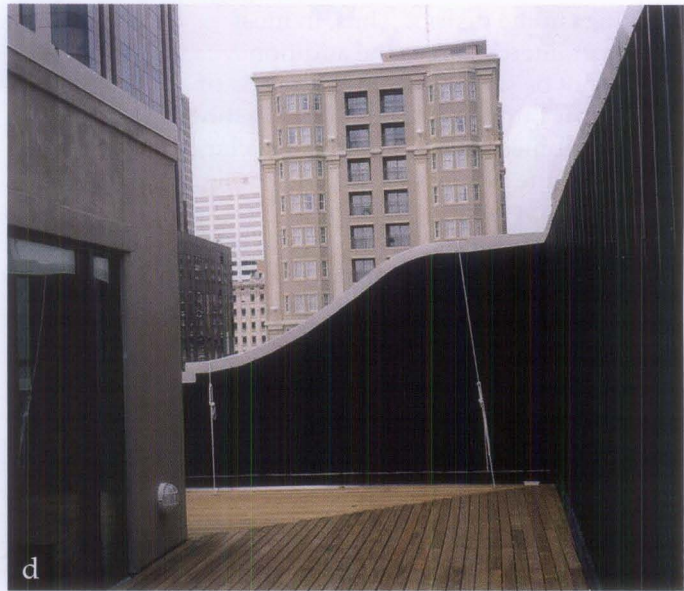
Figure 23. Colored flags marking the location of a proposed penthouse addition (a) were placed on the roof to help evaluate the impact and visibility of an addition planned for this historic furniture store (b). Based on this evaluation, the addition was constructed as proposed. It is minimally visible and compatible with the 1912 structure (c). The tall parapet wall conceals the addition from the street below (d).

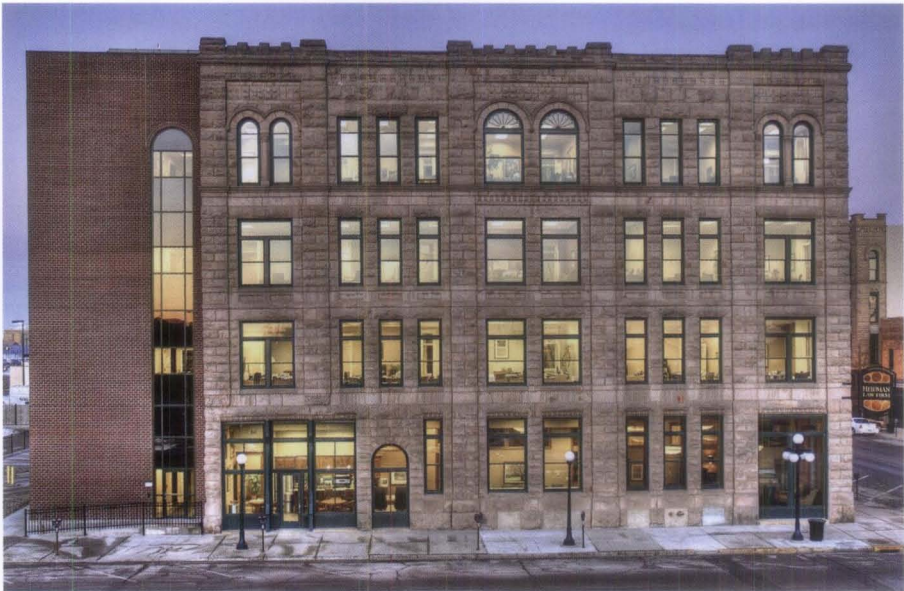
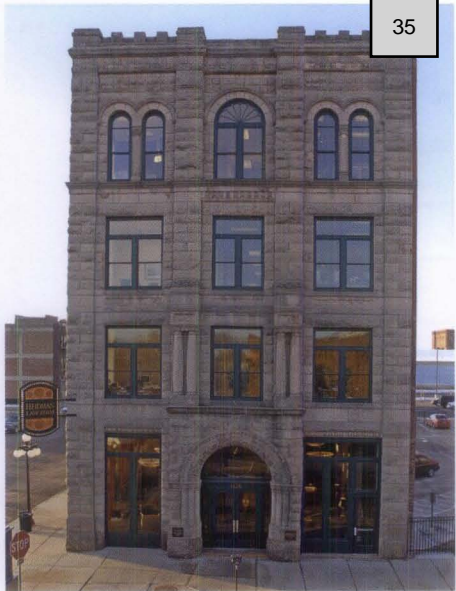
Figure 27. Although the new brick stair/elevator tower (left) is not visible from the front (right), it is on a prominent side elevation of this 1890 stone bank. The compatible addition is set back and does not compete with the historic building. Photos: Chadd Gossmann, Aurora Photography, LLC.

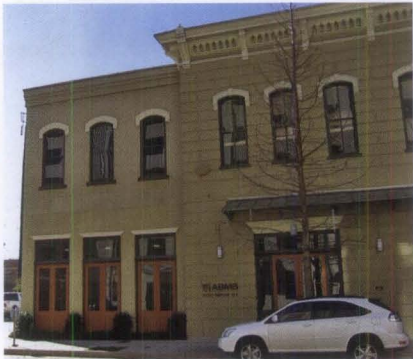
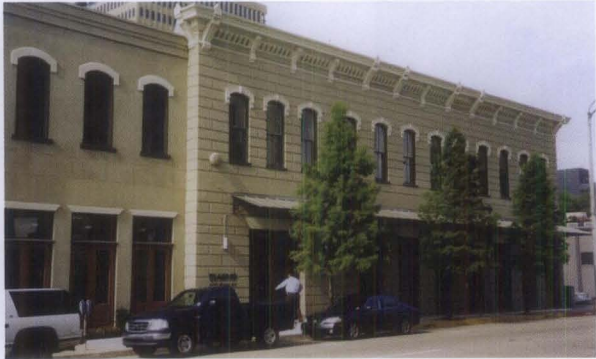
Figure 28. A small addition (left) was constructed when this 1880s train station was converted for office use. The paired doors with transoms and arched windows on the compatible addition reflect, but do not replicate, the historic building (right).

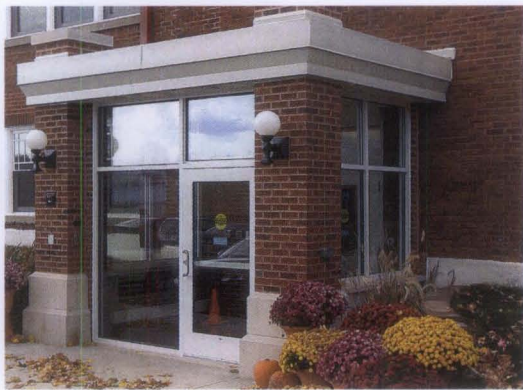
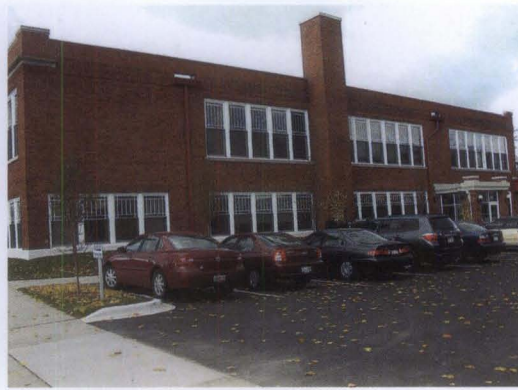
Figure 29. This simple glass and brick entrance (left) added to a secondary elevation of a 1920s school building (right) is compatible with the original structure.

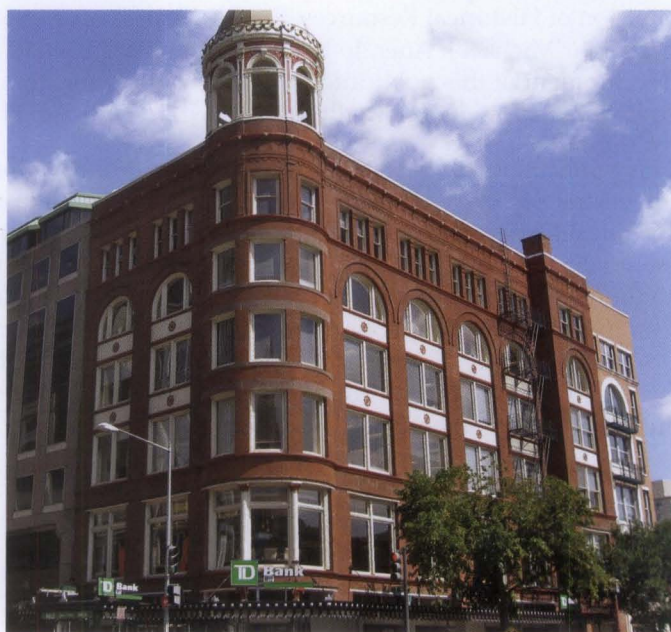
Figure 30. The small addition on the right of this late-19th century commercial structure is clearly secondary and compatible in size, materials and design with the historic building.
