HISTORIC PRESERVATION COMMITTEE WORK MEETING

1. Nevens-Koster Real Estate Agency - 120 West Second Street - Major Certificate of Approval application discussion:

MEETING DATE: October 29, 2020
AGENDA ITEM TITLE: Major Certificate of Approval-120 W. Second Street
PRESENTED BY: Kristi Jefferson, Planner

Re: Major Certificated of Appropriateness for 120 West Second Street
(Contributing Building)

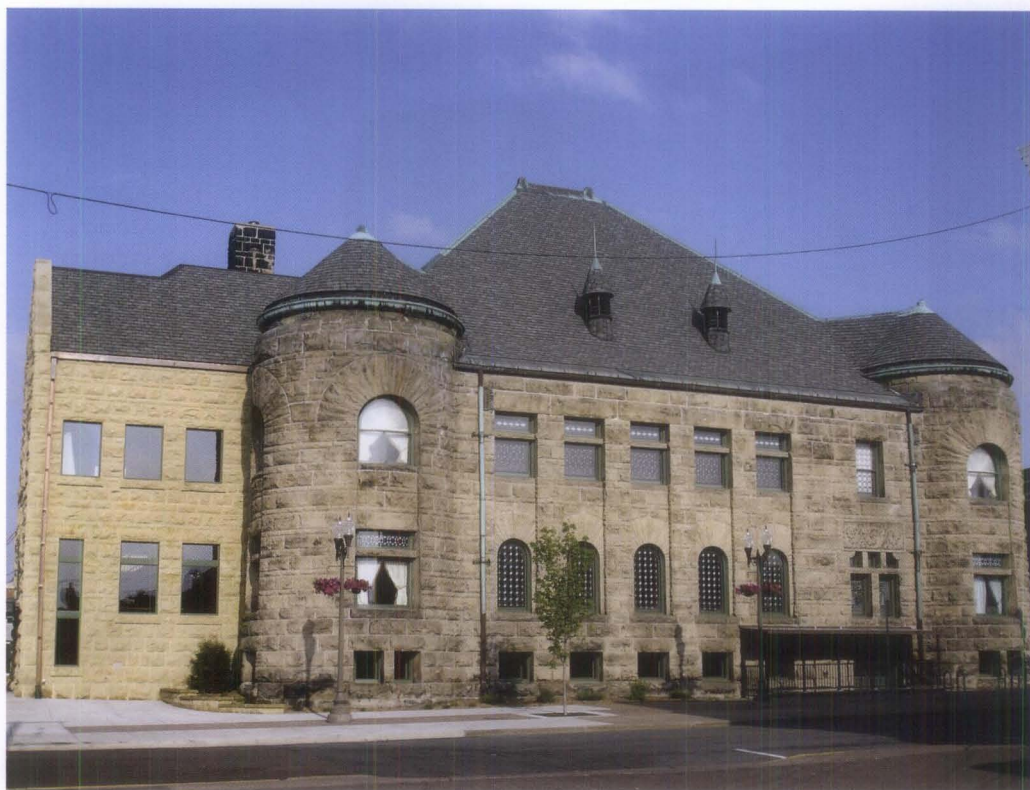
Figure 31. An elevator/stair tower was added at the back of this Richardsonian Romanesque-style theater when it was rehabilitated. Rough-cut stone and simple cut-out openings ensure that the addition is compatible and subordinate to the historic building. Photo: Chuck Liddy, AIA.
