# HISTORIC PRESERVATION COMMISSION REGULAR MEETING

### 2. Cowen Farms- 701 E. Highway 50 - Major Certificate of Approval

**STAFF REPORT**

**AGENDA ITEM TITLE:** The Cowen Farms - Major Certificate of Approval for Demolition

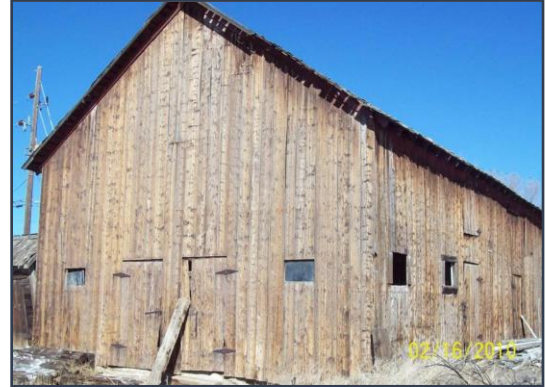
3. In August of 2018 the applicant applied for certificate of approval for a partial rehabilitation of the historic barn but was unable to complete the renovations due to the condition of the structure and the costs to renovate.

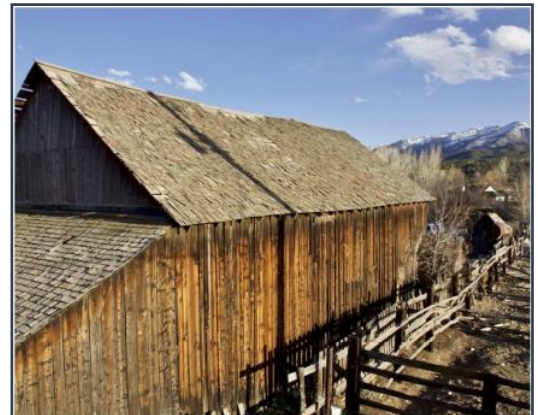
5. The barn is currently not a usable structure and poses a hazard as shown in the application materials. They are now having problems with squatters within the barn which is a liability to the SCC.

- The building has not been maintained for a number of years and there is extensive damage in the entire building which poses a safety issue for the owners and visitors of the property.

1. That the applicant salvage as much of the materials as possible from the demolition of the barn to be used in the proposed new building.
2. That the applicant submit a certificate of approval application for the construction of the new building that will replace the historic barn.

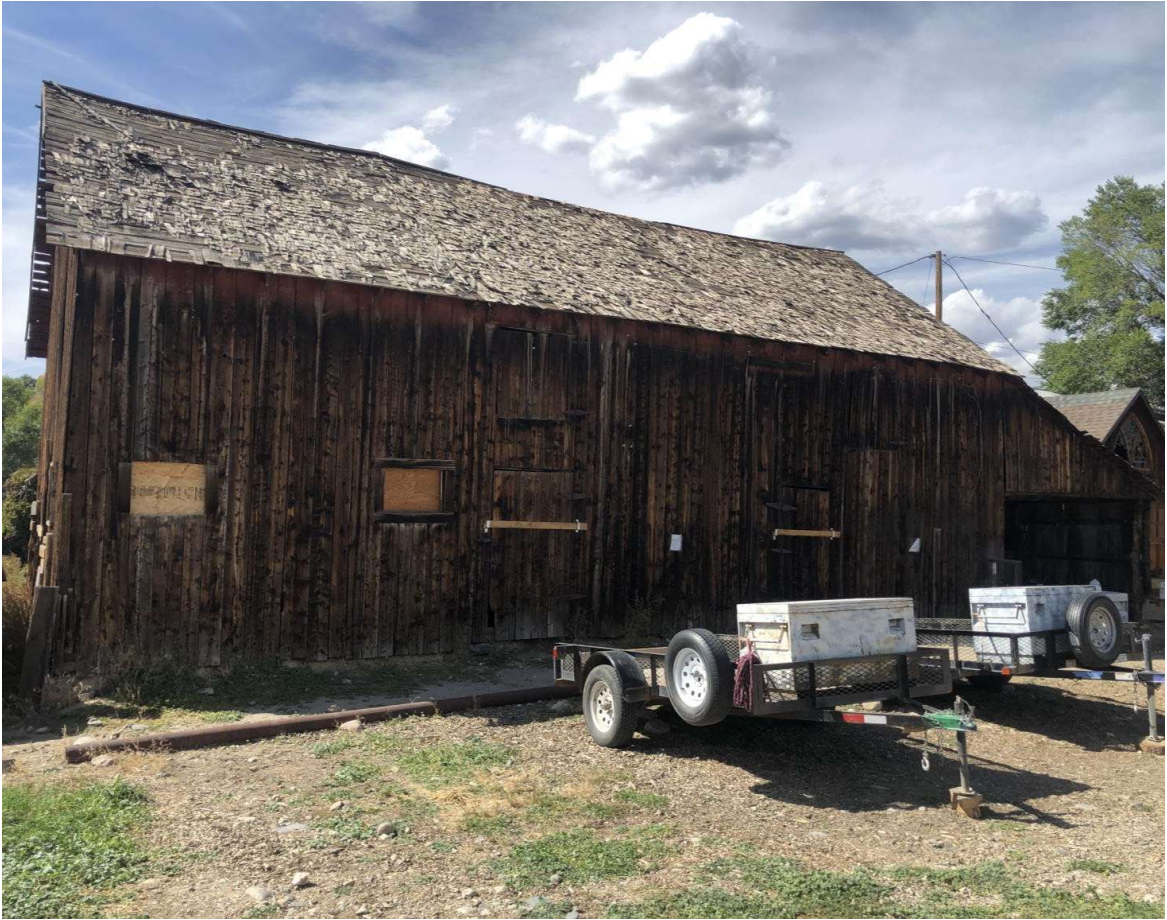
Barn – east side

The building is believed to be greater than 80 years old and was built to standard practice at the time prior to any building codes. The building is sound only because it has stood the test of time. The roof shows significant sag and also the foundation of the south section of the building is settling. By all design requirements of the current building codes the building is structurally inadequate. A structural analysis of the building with the intention of bringing it up to current requirements would be difficult. The modifications required to make the building structurally adequate would exceed the cost of removing the building and replacing it with a pole barn agricultural type building, which would be the most cost effective.

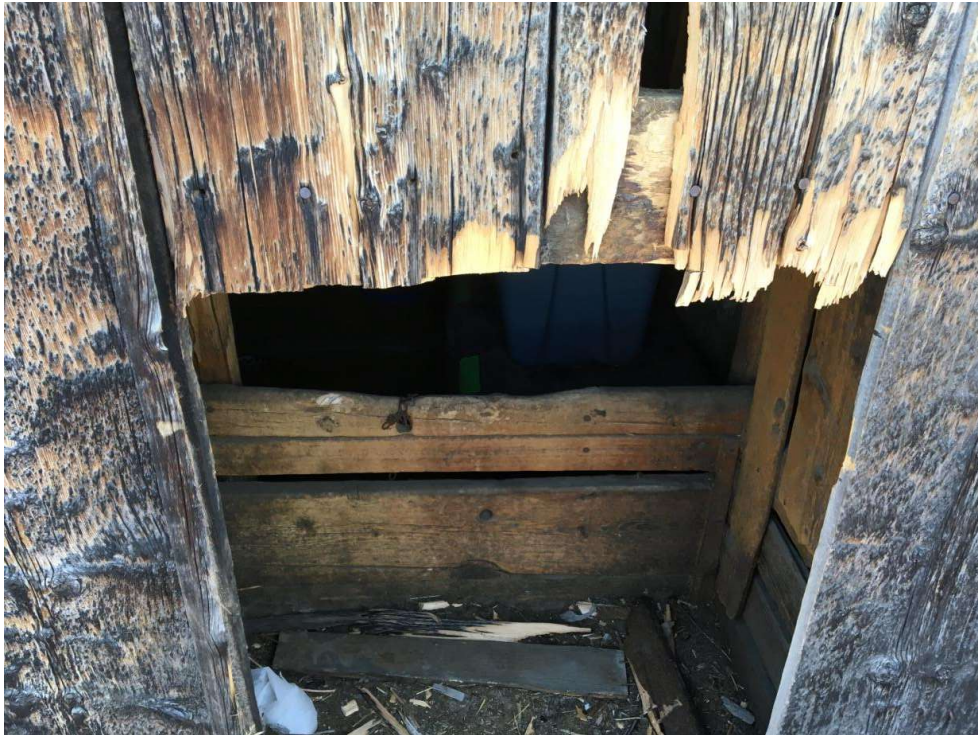
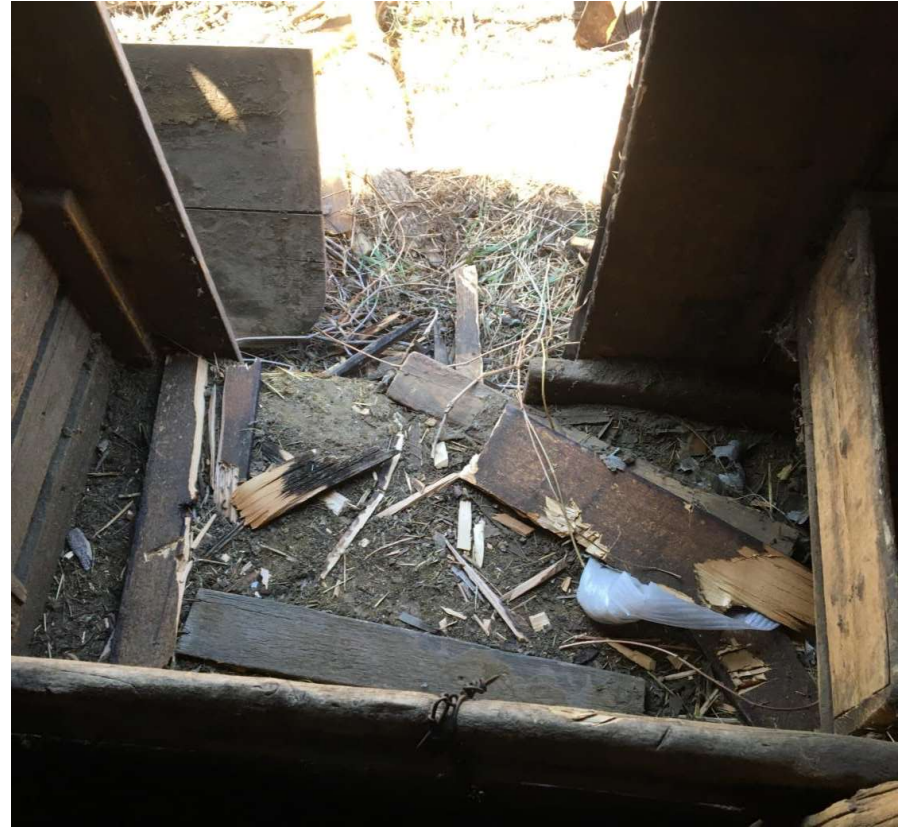
## Damage caused by squatters
