BOARD OF WATERWORKS COMMISSIONERS AGENDA

September 19, 2022 at 3:30 PM

This report is meant to provide a timeline of events in identifying filter #5 IMS cap failures and discussions with the underdrain representative and manufacturer.

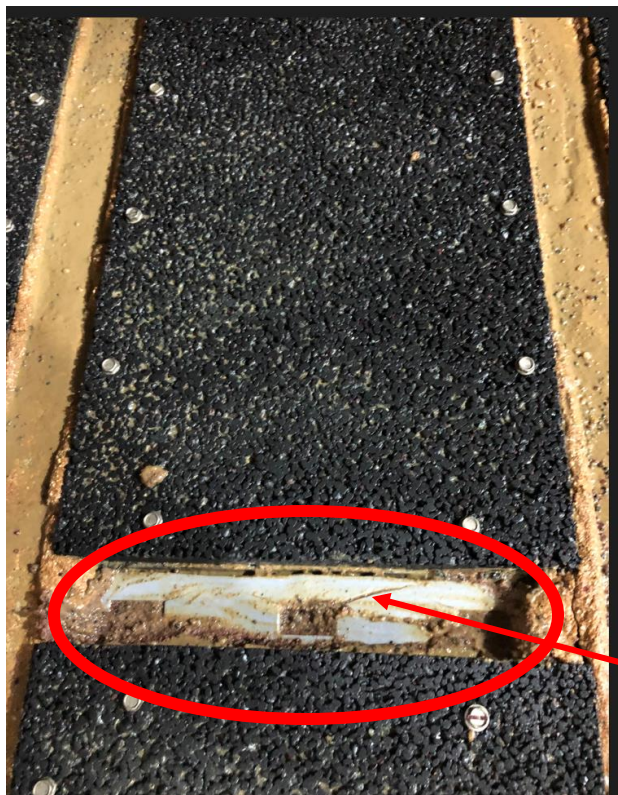
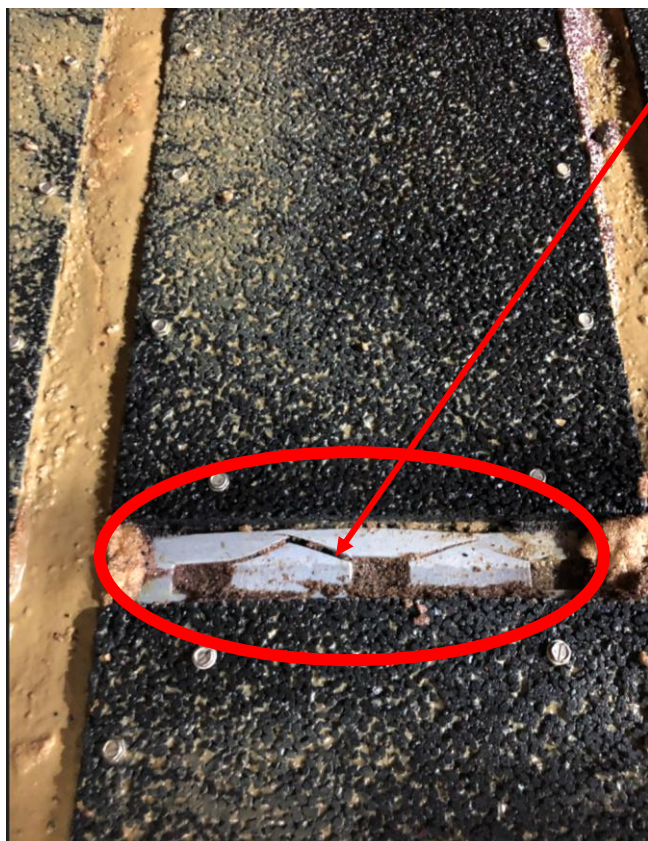
No grout is present at the filter underdrain bell/spigot connection.

Filter underdrain connection is cracked
