## SITE PLAN REVIEW COMMITTEE MEETING AGENDA

MONDAY, JUNE 10, 2024 AT 1:30 PM

A. Review and take action: 700 Hoffman Drive Preliminary Plat

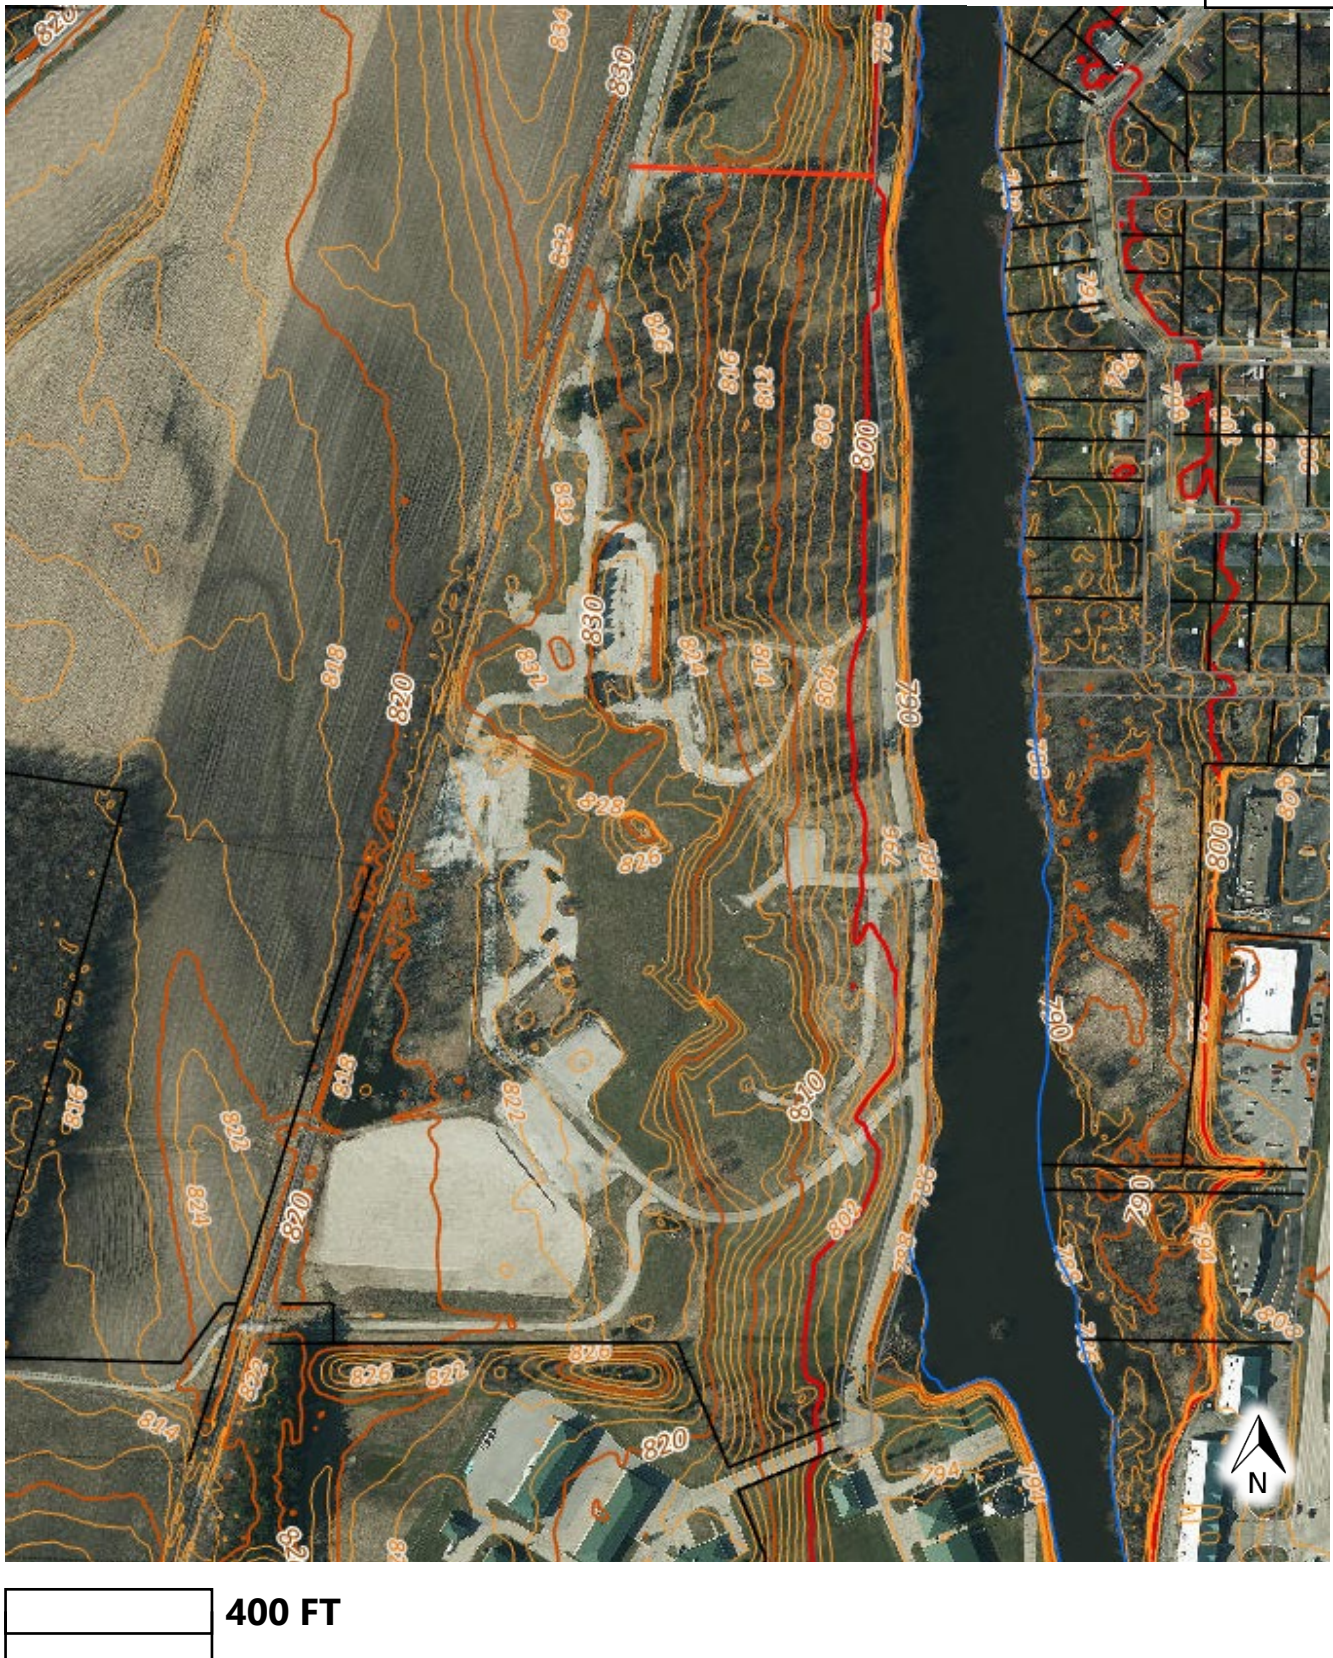
FIGURE 2. TOPOGRAPHIC MAP

The topographic map (**FIGURE 2**) shows that the property slopes towards the Rock River to the east. Elevations are at 830 feet above Mean Sea Level at its highest at the west end and 794 feet at its lowest on the east side. The slope is approximately 5% across the width of the property.

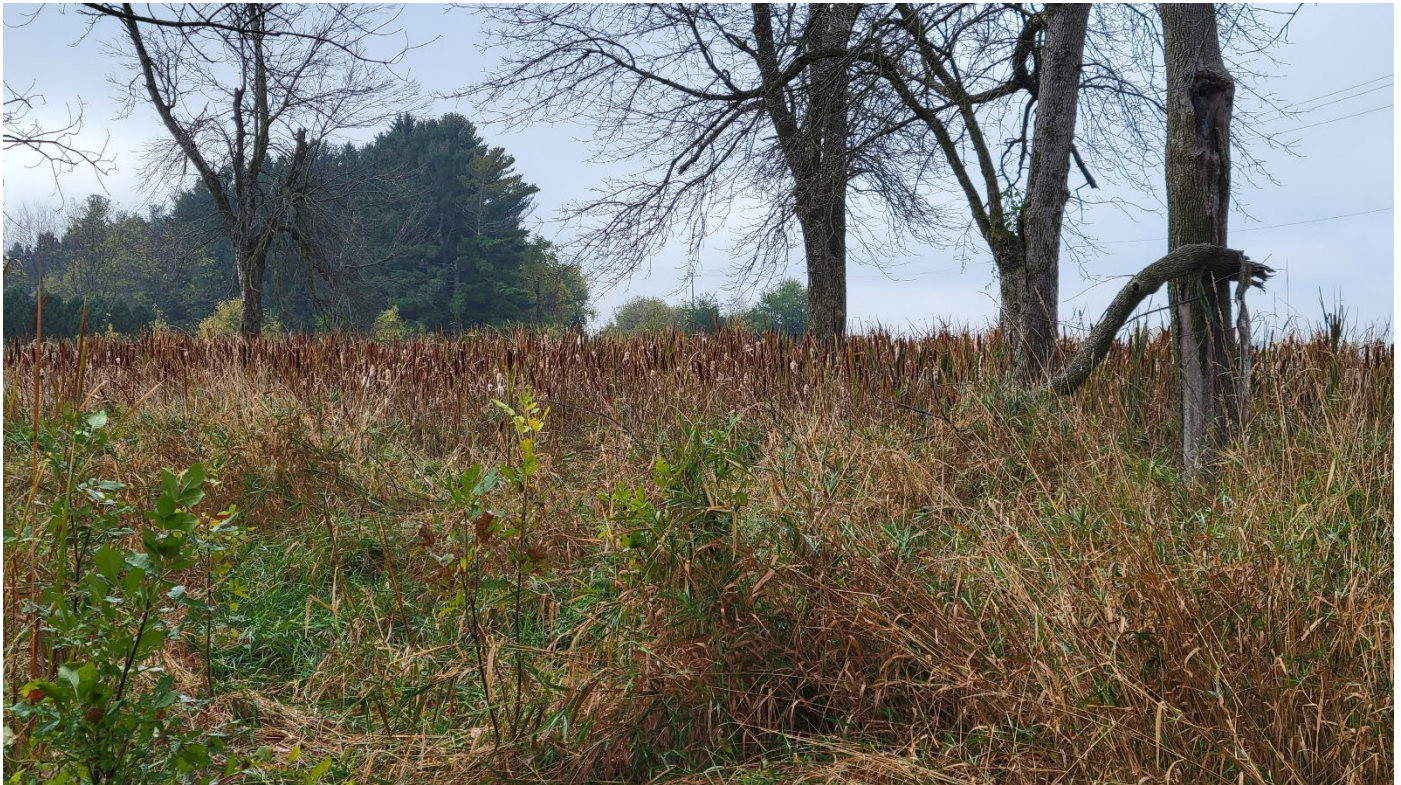
Wetland A.

A total of three wetlands were identified on the property during the field visit. Site photos of the different wetlands are included in **FIGURE 8**. The acreages and types of wetlands that were identified and flagged in the project are shown in **FIGURE 9**. Field data sheets are included in **FIGURE 10**. A description of the wetland areas follows.

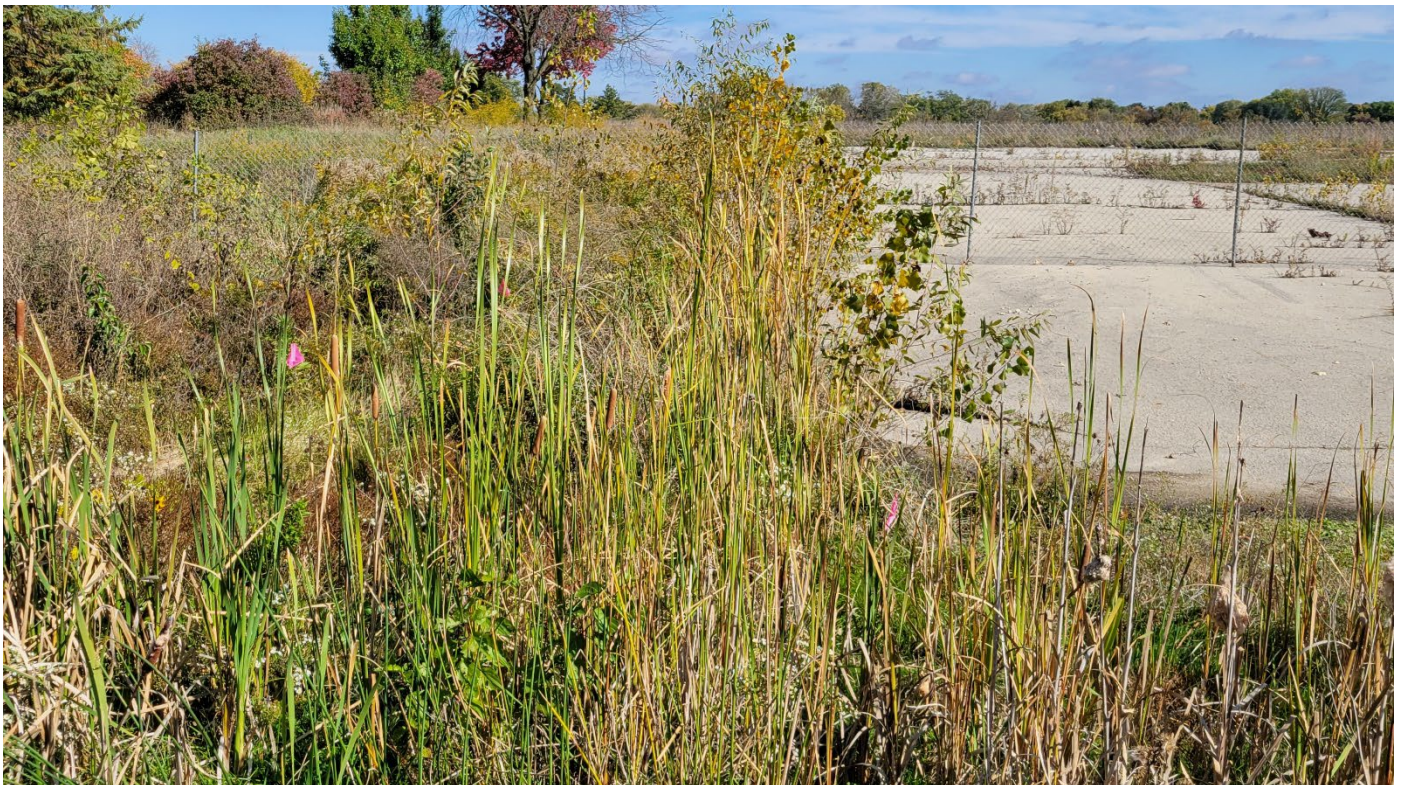
Wetland B.

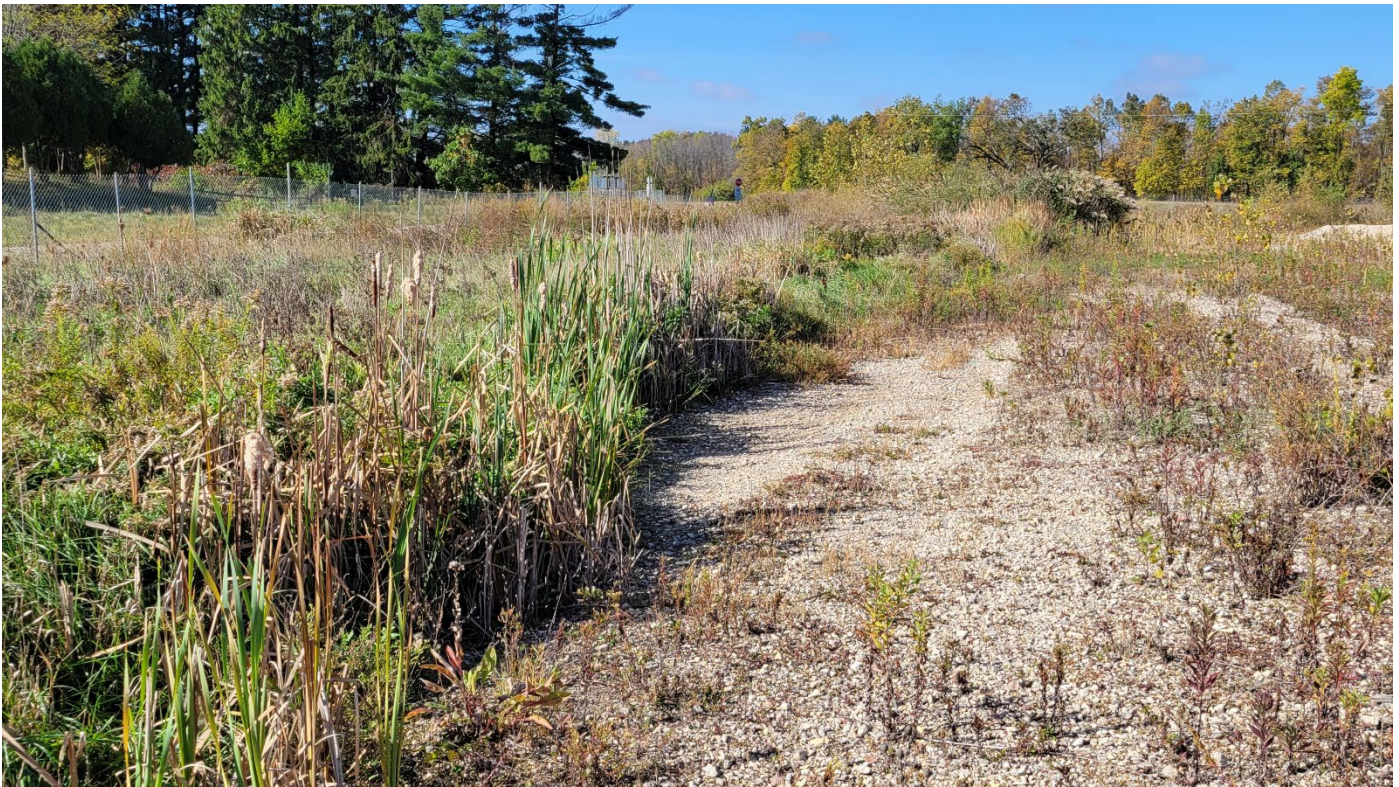
Wetland C.

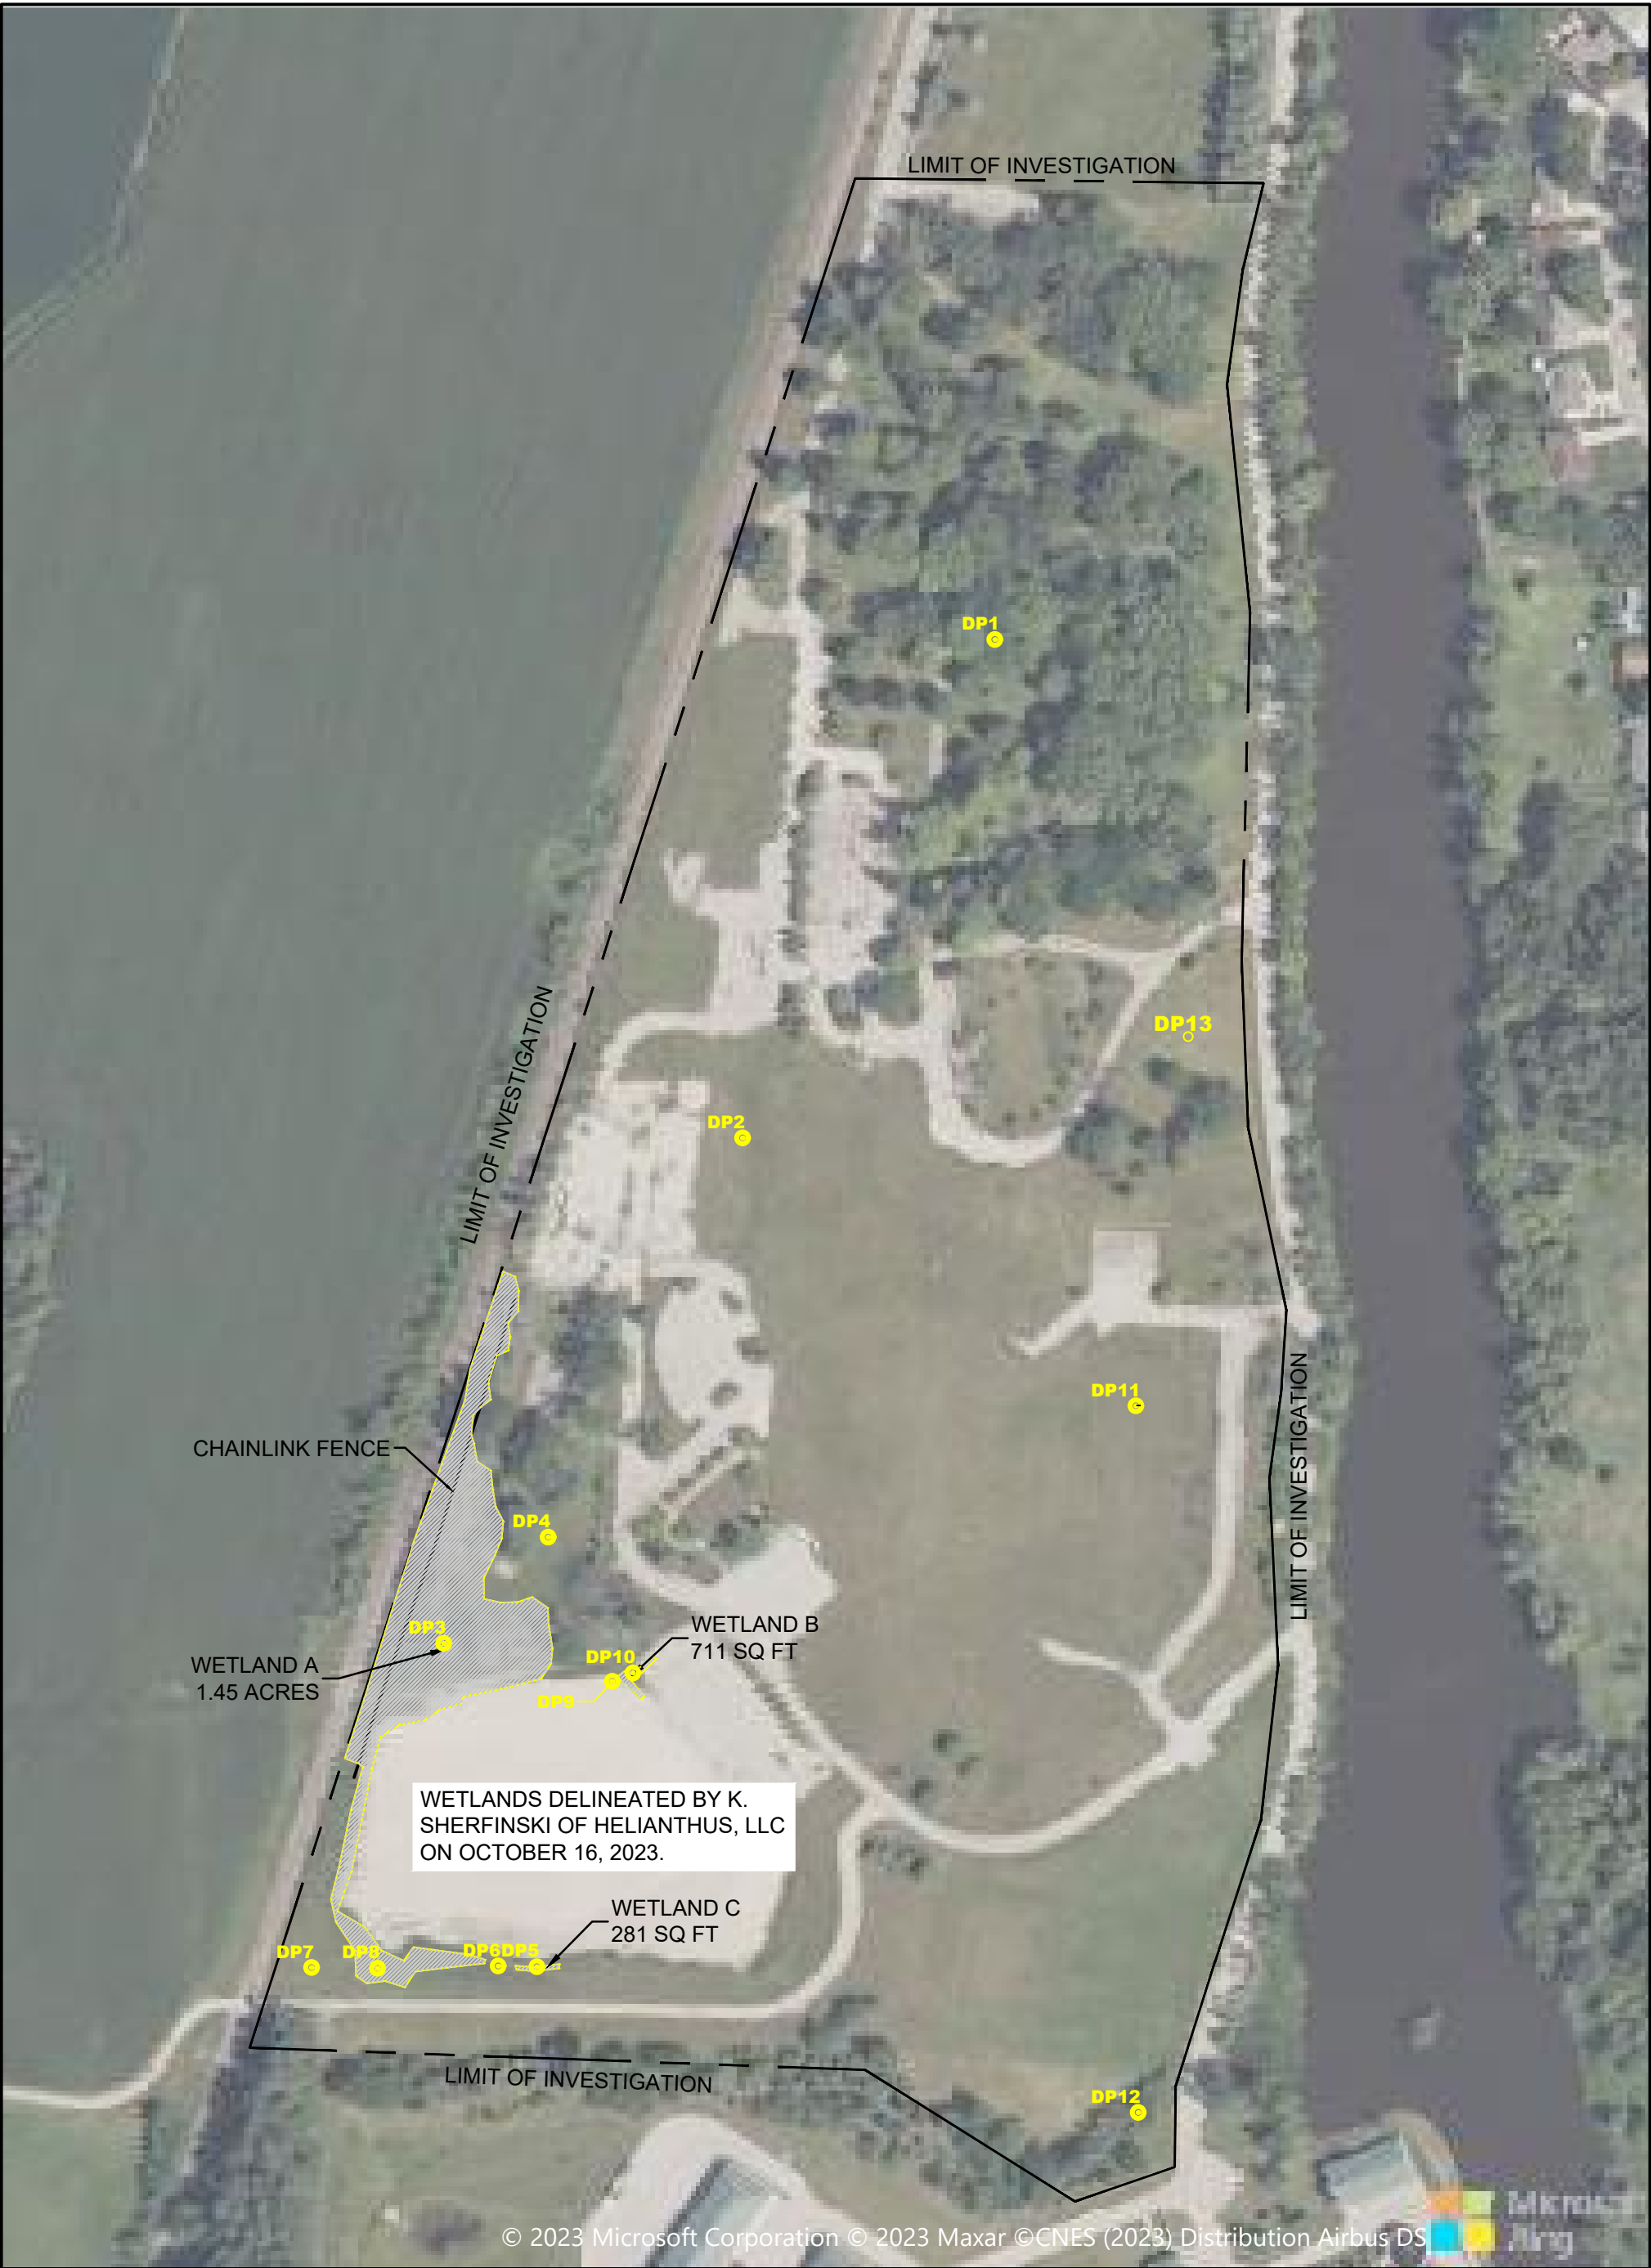
FIGURE 9. WETLAND BOUNDARY MAP

The predominant land cover for this property is a former campus with a collection of buildings that have been recently demolished. The lawn areas have been left unmowed and the parking lots were still present. The purpose of the wetland delineation was to identify the existing wetlands on the property and to create a map of their boundaries. A map of the surveyed wetland boundary is found in **FIGURE 9**.

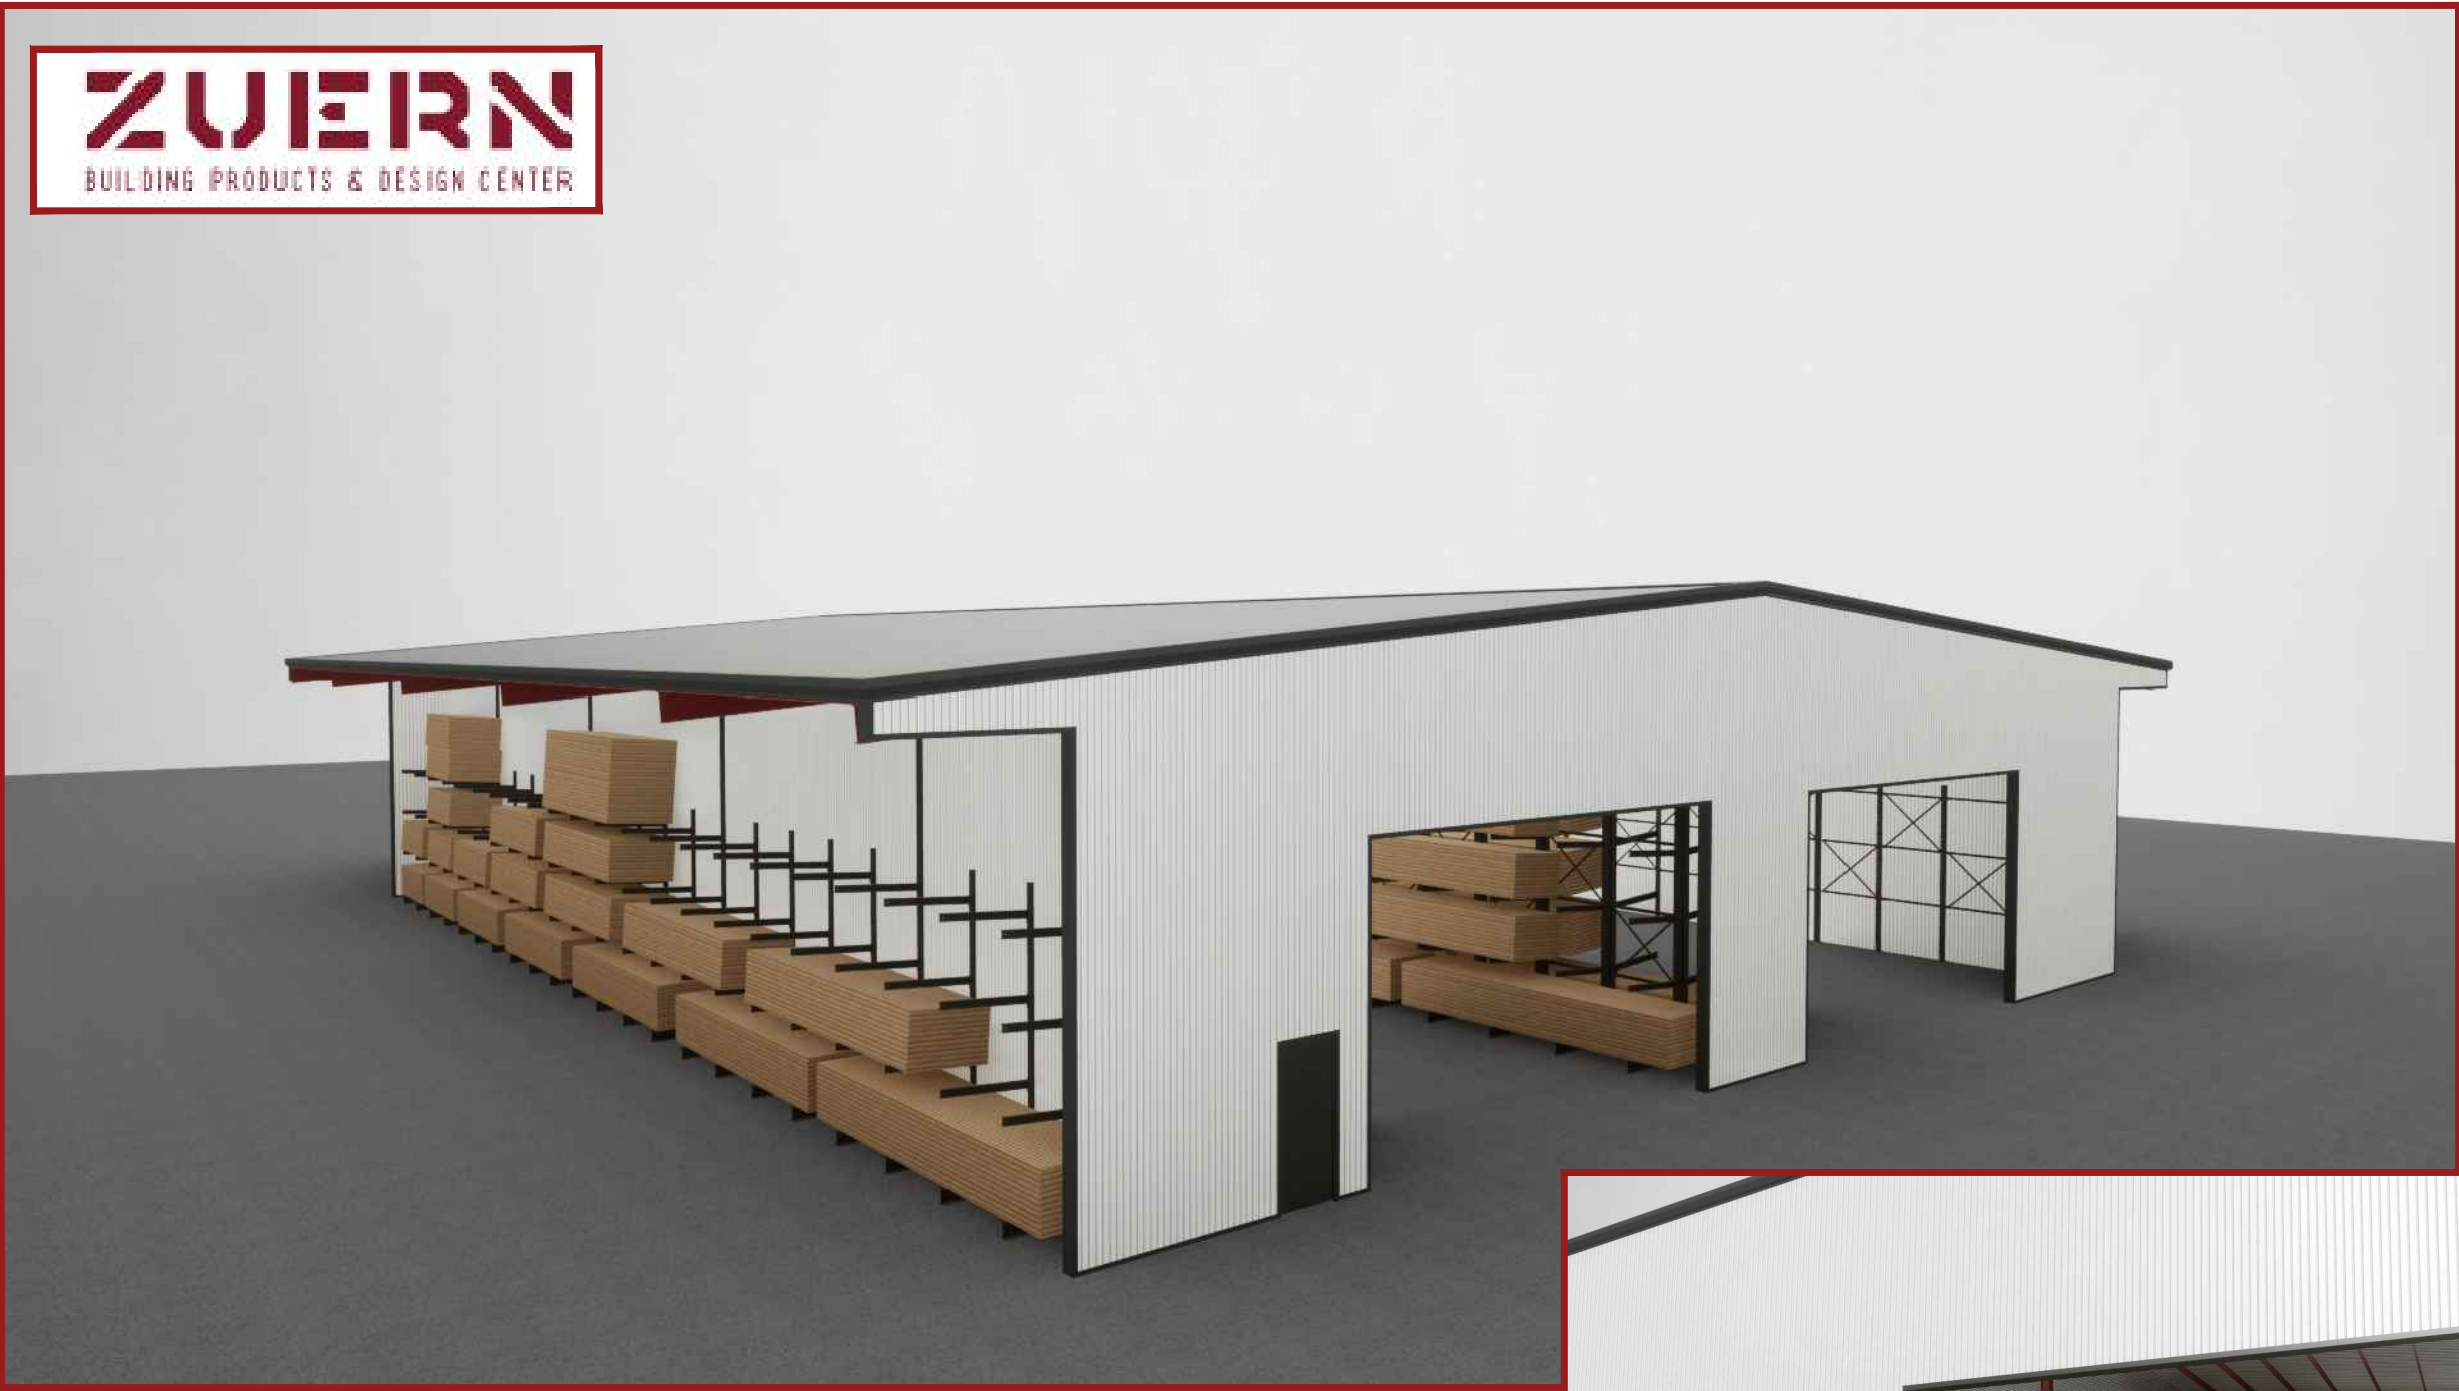
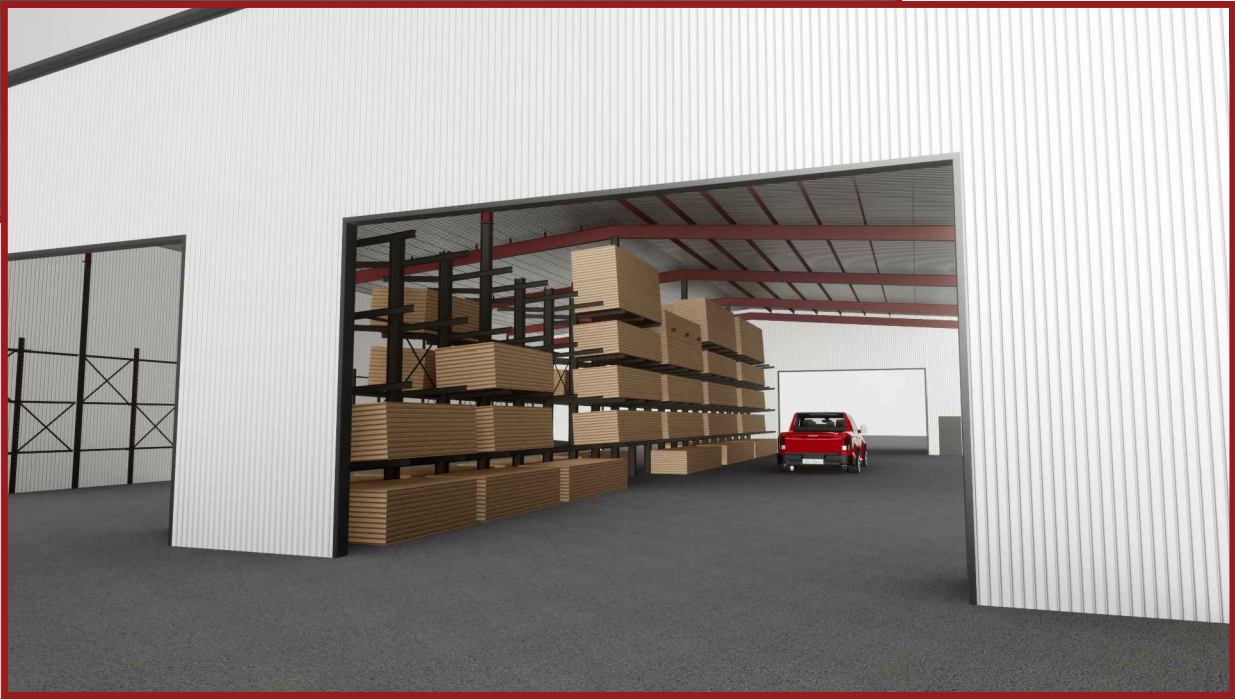
| SHEET DESCRIPTION:<br>SKETCH RENDERING(S) | | <br>CT DARNELL<br>CORPORATION<br>www.CT-Darnell.com | | | | 01 | 04/29/2024 | PRELIMINARY DESIGN | EXAR | |

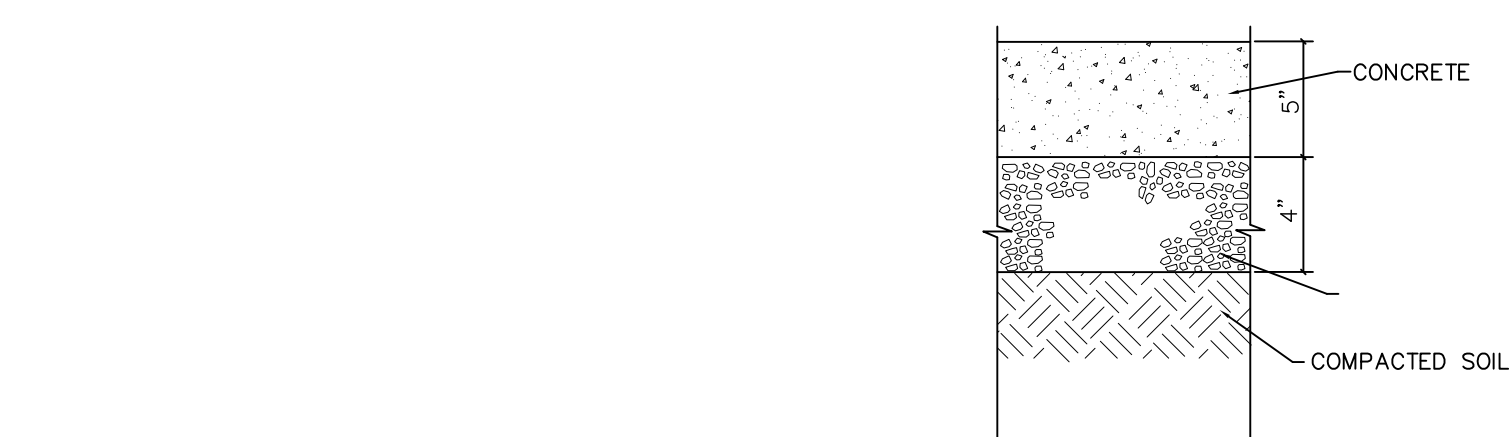
CONCRETE SIDEWALK

NOT TO SCALE

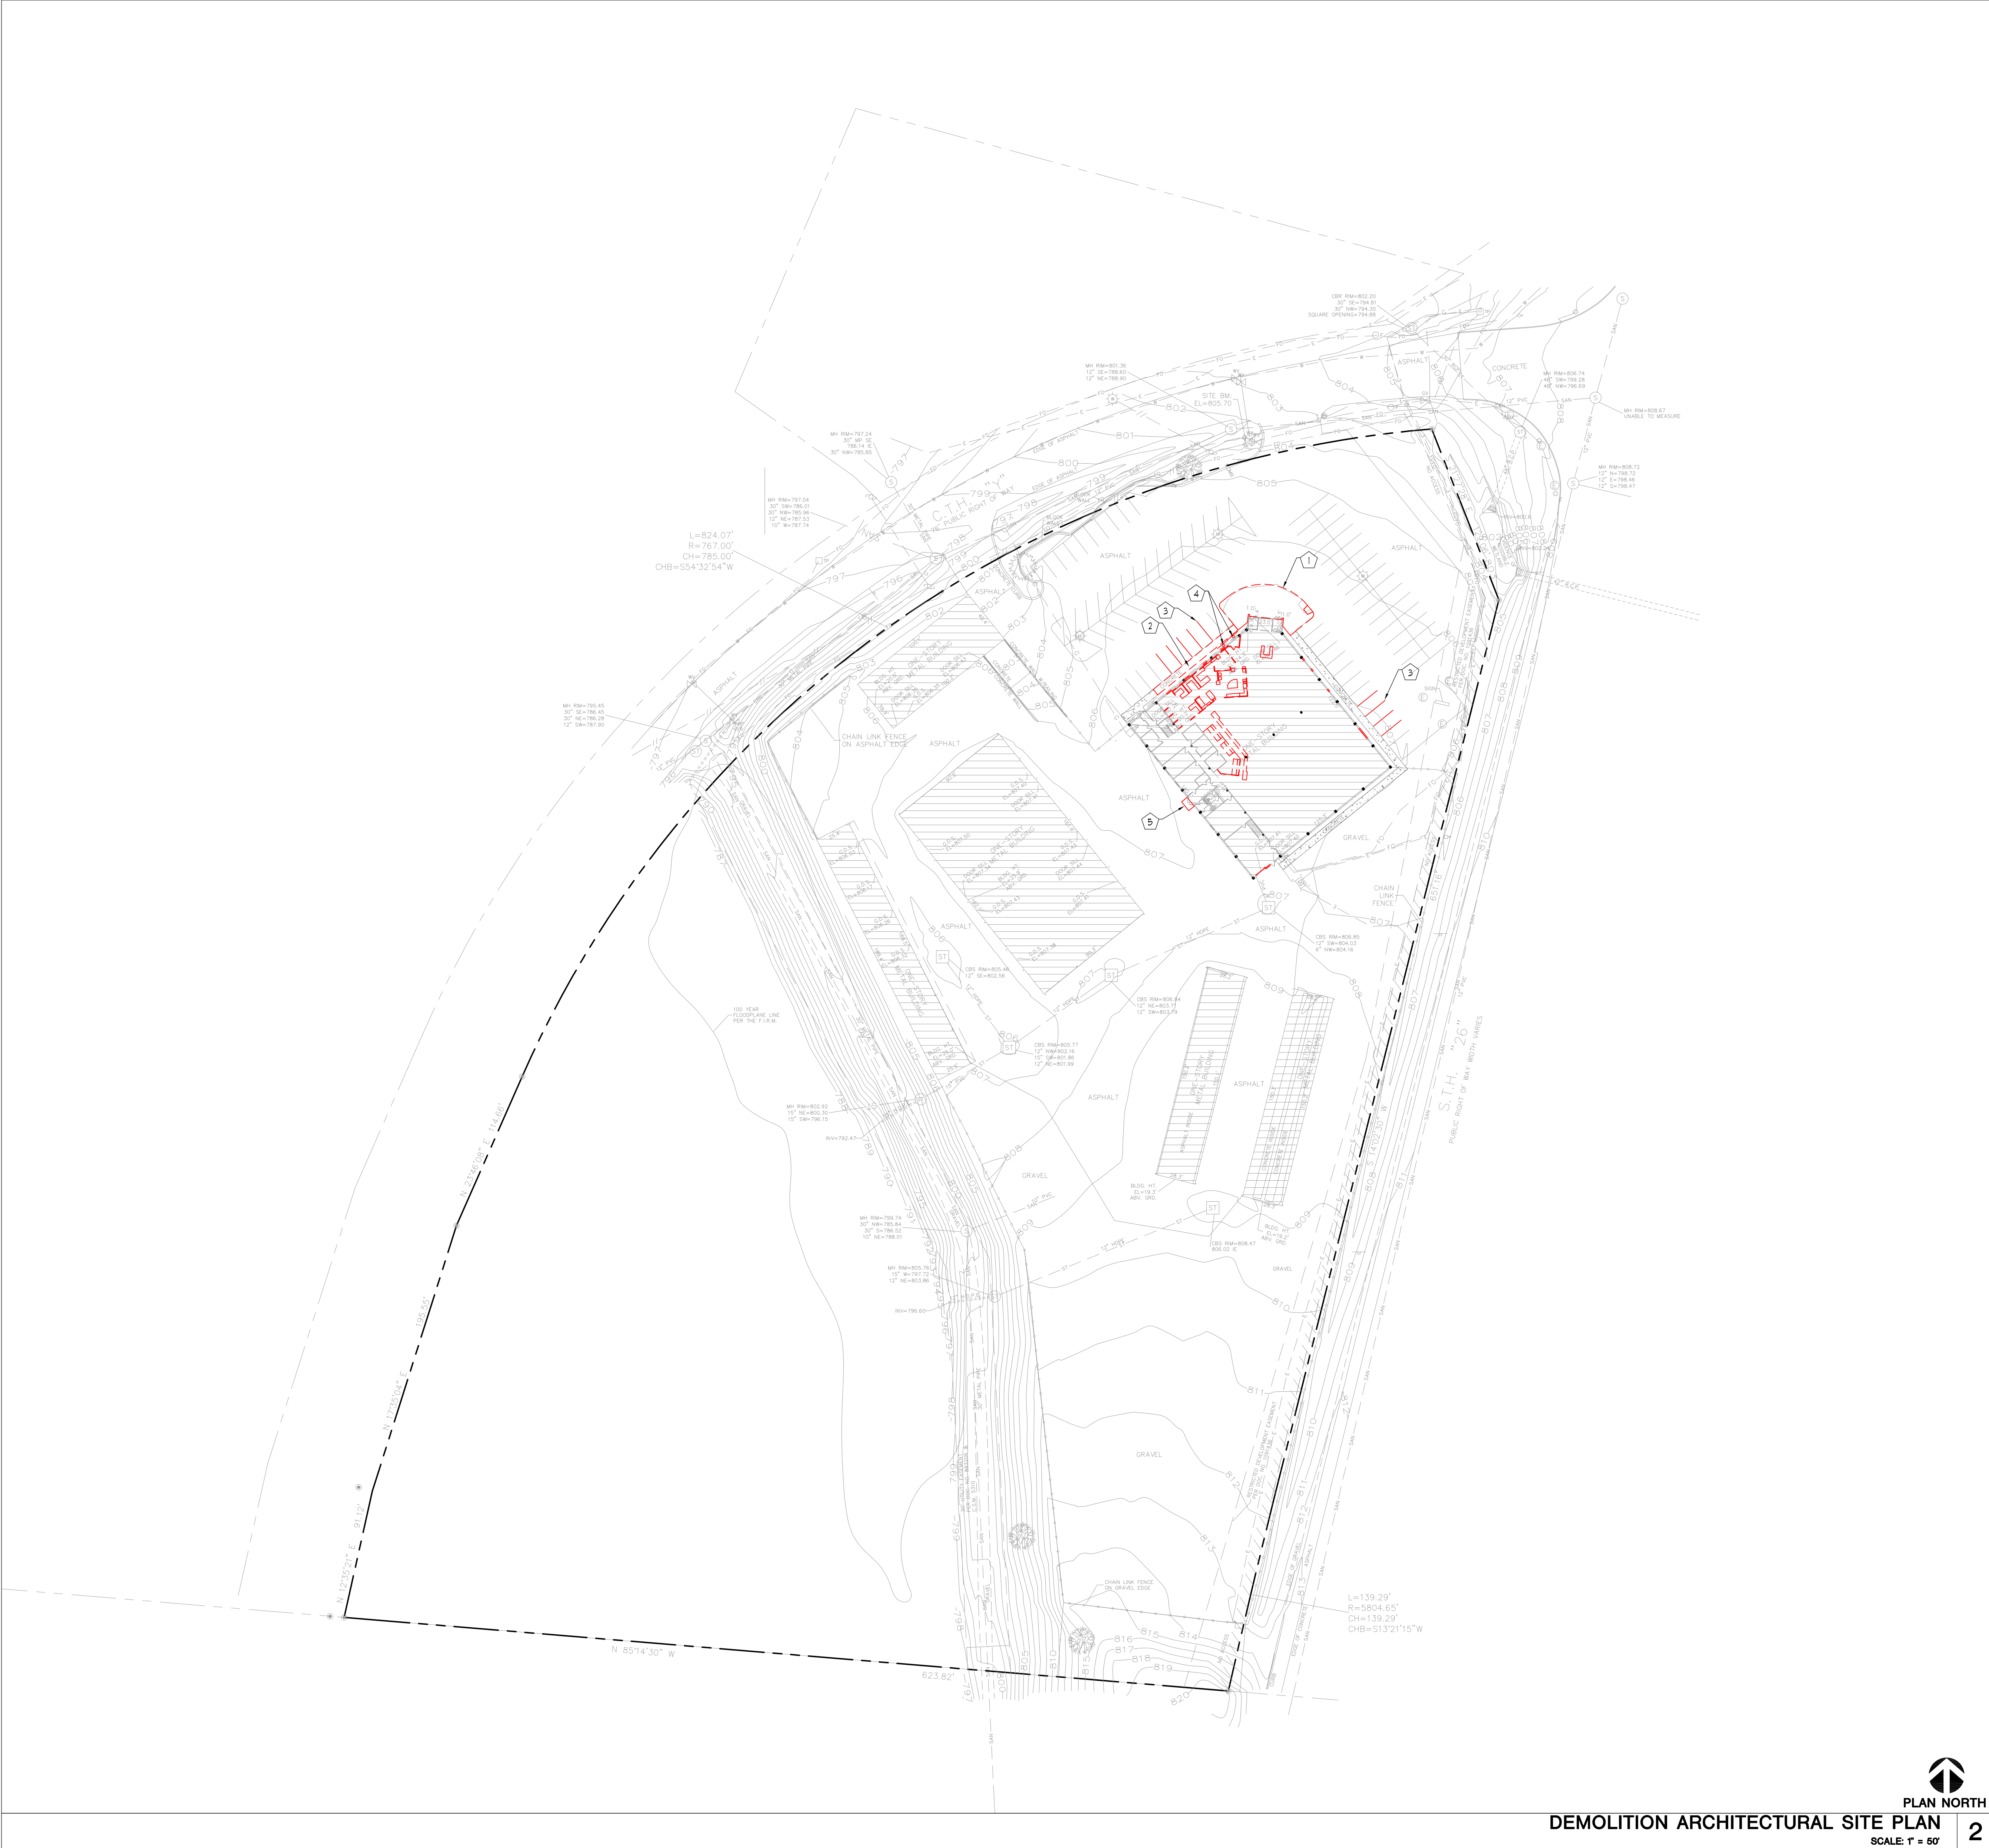
DEMOLITION ARCHITECTURAL SITE PLAN  
SCALE: 1" = 50'  
2

- 1 REMOVE EXISTING CONCRETE ENTRY PAD. SEE CIVIL PLANS FOR ADDITIONAL INFORMATION.
- 2 REMOVE EXISTING CONCRETE SIDE WALK. SEE CIVIL PLANS FOR ADDITIONAL INFORMATION.
- 3 REMOVE EXISTING PARKING LOT PAINT, TYPICAL. SEE CIVIL PLANS FOR ADDITIONAL INFORMATION.
- 4 REMOVE EXISTING ADA PARKING SPACE SIGNAGE. SEE CIVIL PLANS FOR ADDITIONAL INFORMATION.
- 5 REMOVE EXISTING CONCRETE STOOP. SEE ARCHITECTURAL PLANS FOR ADDITIONAL INFORMATION.

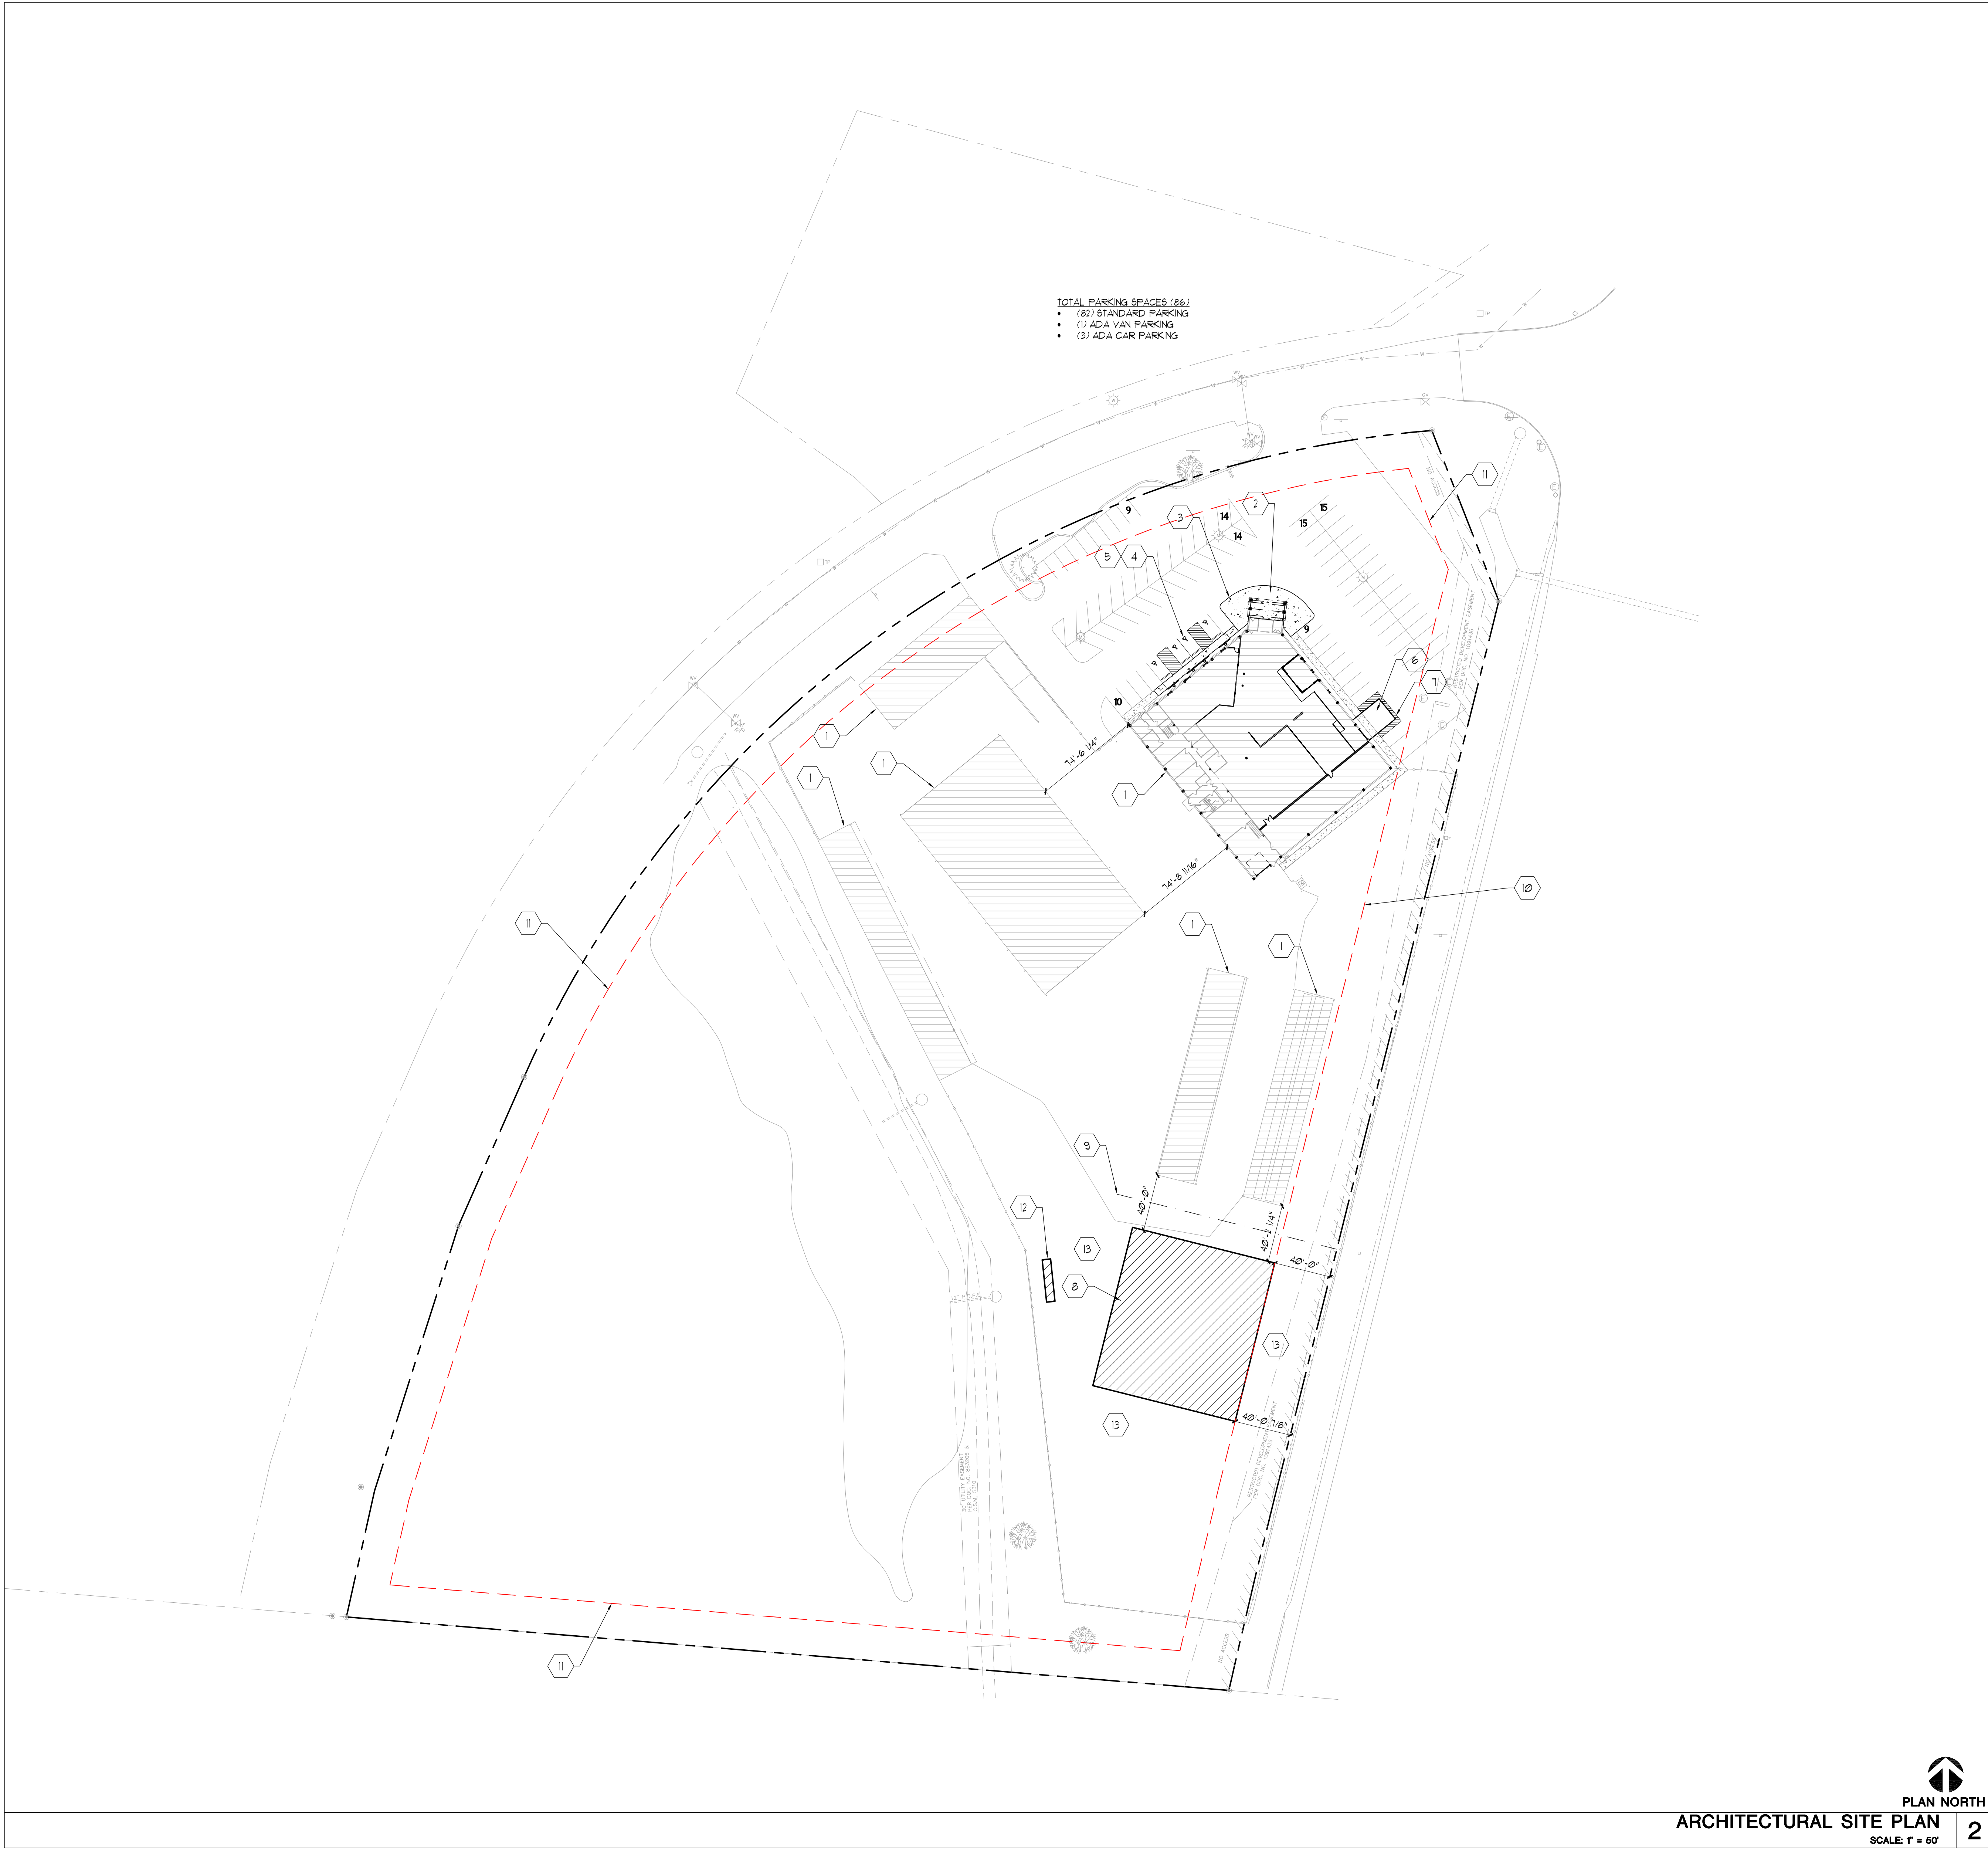
- EXISTING BUILDING STRUCTURE.
- NEW OPEN AIR HEAVY TIMBER ENTRY CANOPY (435 SQ. FT.) / (26'-9-1/2" WIDE x 18'-6" DEEP x 22'-3-3/4" TALL).  
SEE ARCHITECTURAL PLANS FOR ADDITIONAL INFORMATION.

- NEW CONCRETE ENTRY "PAD" AREA TO MIMIC THE PREVIOUS CONCRETE AREA THAT WAS REMOVED DURING THE DEMOLITION PHASE.  
SEE CIVIL PLANS FOR ADDITIONAL INFORMATION.
