Town of Lake Park, Florida
Historic Preservation Board
Meeting Minutes
November 7, 2022, 6:30 P.M.

Town Hall Commission Chamber
535 Park Avenue, Lake Park, Florida 33403

1. HPB 22-001 – SPECIAL CERTIFICATE OF APPROPRIATENESS FOR 414 GREENBRIAR DRIVE FOR THE EXTERIOR MODIFICATION TO THE ACCESSORY STRUCTURE AND RE-PAINTING OF THE MAIN STRUCTURE. OWNER/APPLICANT: J&D WEST PALM BEACH FL PROPERTIES LLC/JESSE GATES.

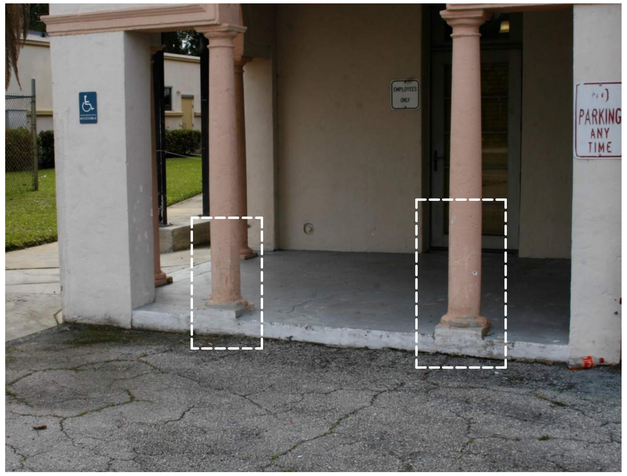
NORTH ELEVATION: FACADE DISCOLORATION. V.I.F. 1

NORTH ELEVATION: LOCALIZED DAMAGED ALONG LENGTH THE OF COLUMNS. V.I.F. 2

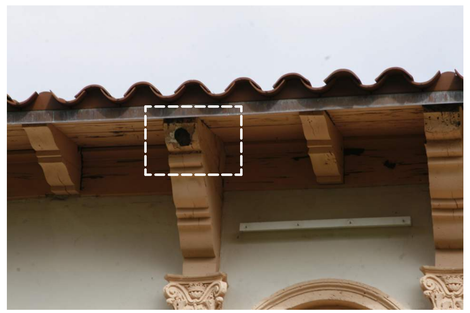
SOUTH ELEVATION: BUILD-UP OF MOLD ON LEGDE SURFACE. REFER TO A-20 EXTERIOR CLEANING. 11

SOUTH ELEVATION: FOREIGN OBJECT EMBEDDED ON RAFTERTAIL. V.I.F. REMOVE AND REPAIR RAFTERTAIL. 12

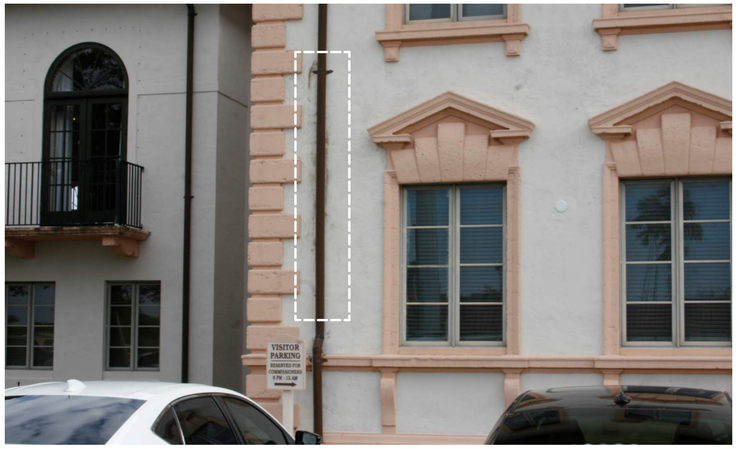
WEST ELEVATION: SURFACE DAMAGE DUE TO RUST. V.I.F. REFER TO A-20 EXTERIOR CLEANING AND A-23, A-24, AND A-25 STUCCO FOR STUCCO REPAIS AND COLOR APPLICATION.

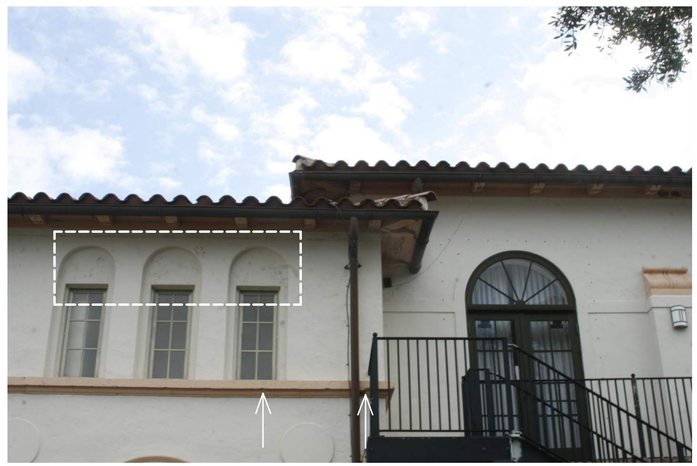
WEST ELEVATION: VERIFY CONDITION OF MOLDING. DETERIORATED STUCCO OR PAINT COAT. V.I.F. IF STUCCO, REFER TO A-23, A-24, A-25 STUCCO FOR STUCCO REPAIS AND COLOR APPLICATION.

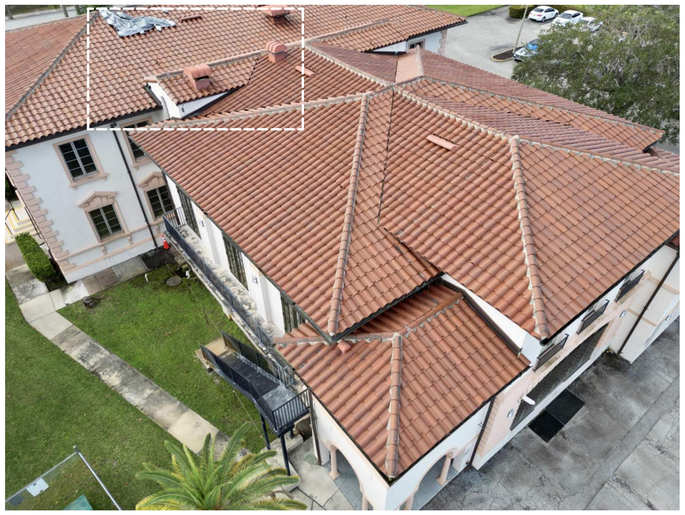
EXISTING ROOF CONDITION: NORTH - EAST AERIAL VIEW/
REMOVE ALL VENTS AS REQUIRED.

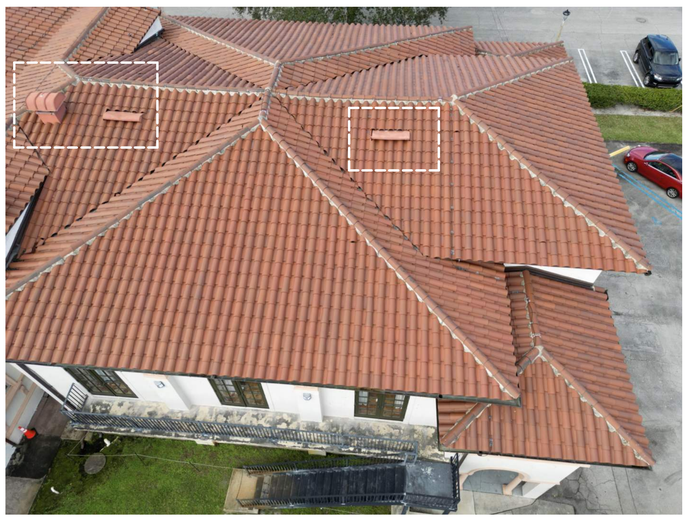
EXISTING ROOF CONDITION: EAST AERIAL VIEW/
REMOVE ALL VENTS AS REQUIRED.

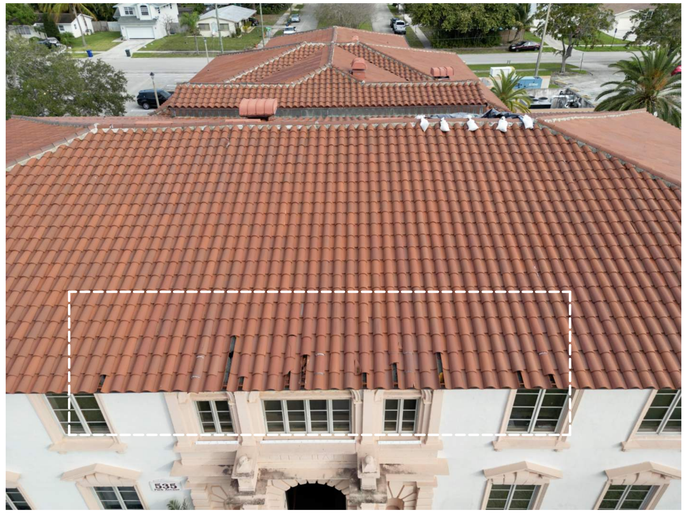
SOUTH AERIAL ROOF VIEW / MISSING AND CHIPPED ROOF TILES, REMOVE ALL VENTS AS REQUIRED.

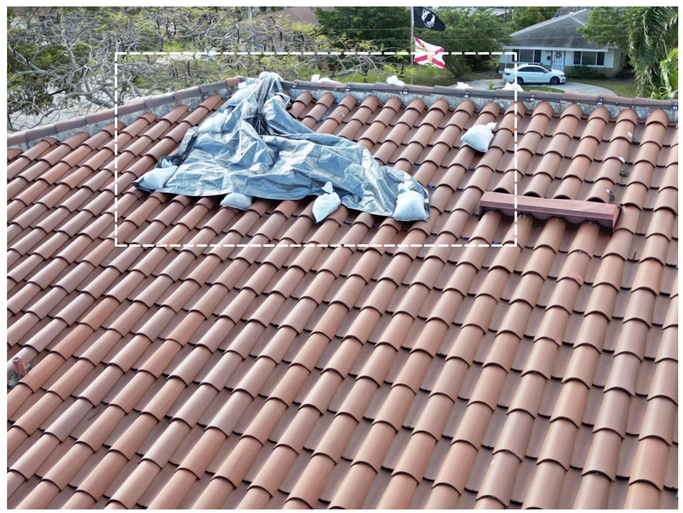
LEAKAGE ON EXISTING ROOF,
WATER INTRUSION

ROOF LEAK SHALL BE REPAIRED

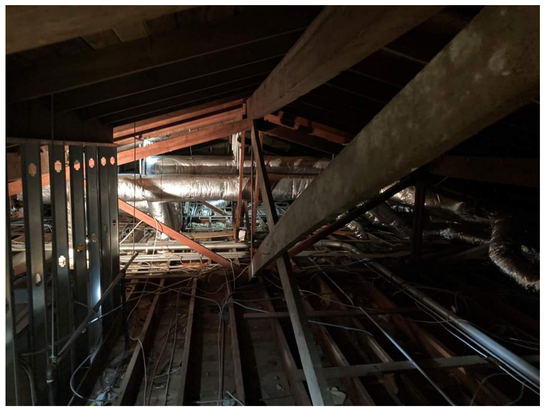
WATER DAMAGE ON CEILING. REFER TO A-26, A-27, A-28, A-29, A-30, A-31 MOISTURE CONTROL. 4
