April 13, 2026 - Historic Preservation Commission Meeting Agenda

April 13, 2026 at 12:00 PM
598 Main Street, Bay St. Louis, MS 39520

7. Motion to conceptually approve demolition of the existing house at 232 Citizen St. (in anticipation of new residence construction; extensive rot, neglect, and termite damage documented; outbuildings and right/rear sections of house may be removed prior to building permit; final demolition approval granted once new house plans are submitted, approved, and building permit paid; new house placement requested forward of existing footprint to allow possible salvage of some portion), submitted by Dianna Webb.

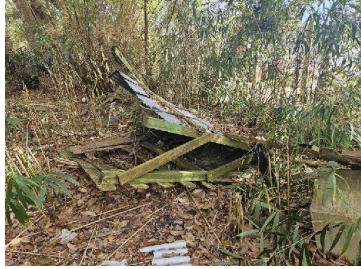
13. Not Inspected Fences: Wood - Inspection of fencing lies beyond the scope of the general home inspection. The fences were not inspected. *Note: Fence and / or gates are in need of repair.

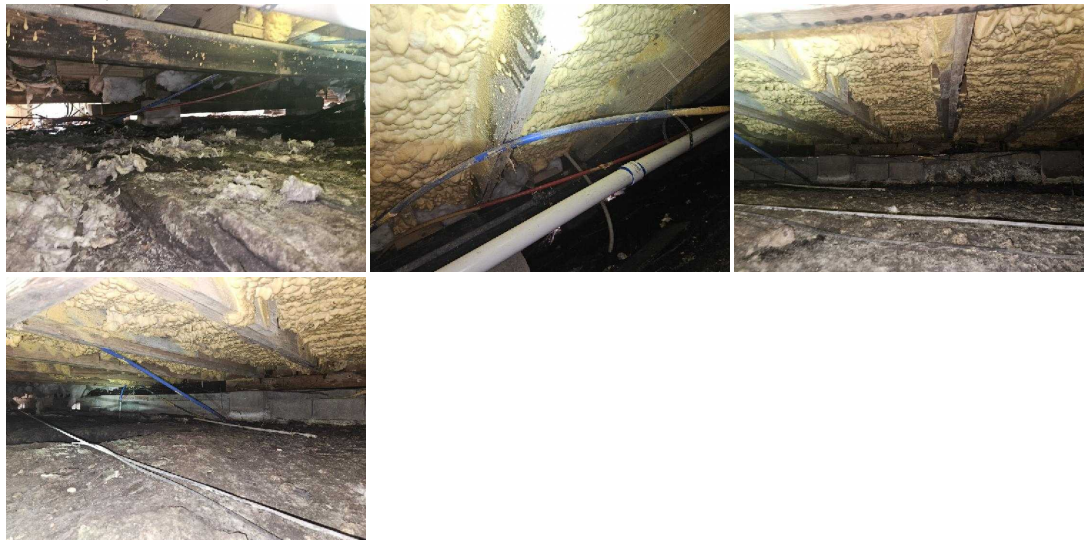
Joists/Trusses: Wood - Many floor joists were observed deteriorated and structurally compromised throughout the crawlspace. Several joists appear to have been previously repaired by scabbing additional lumber to damaged members; however, the existing joists and repair members show continued deterioration consistent with moisture exposure and termite damage. Significant sagging of the floor structure was observed in the rear right portion of the home. Recommend a qualified contractor or structural professional evaluate the framing system and replace damaged joists as necessary to restore structural integrity.

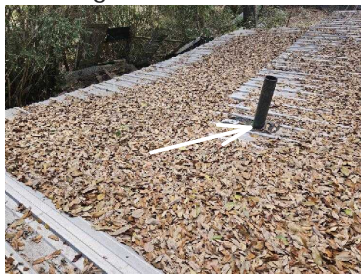
- 8. Major Concern Plumbing Vent Flashings: None present - The plumbing vent penetration through the roof is not properly flashed. Recommend repair or replacement of the flashing to provide a proper watertight seal.

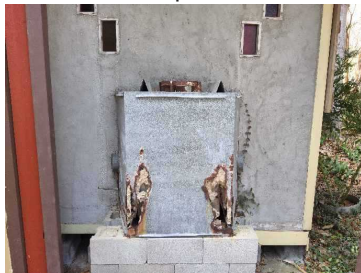
Left side Chimney

- 9. Safety Hazards Chimney: Metal - The chimney is damaged, and missing several components needed for safe use. Recommend a qualified chimney sweep further evaluate to determine the scope of work needed for replacement.

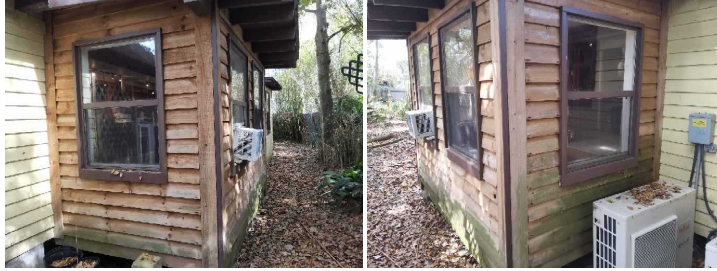
2. Attention Needed Type: Wood - Raw wood siding was observed. Recommend sanding, painting, etc to preserve the life of the materials.

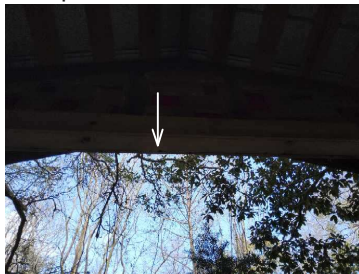
- 6. Attention Needed Trim: Wood - Wood boring bee damage was observed. Recommend filling holes with wood filler and paint.

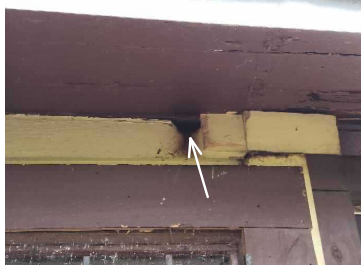
8. Attention Needed Fascia / Soffit: Open (Exposed rafter tails), Wood - Holes were observed chewed where rodents are gaining access to the attic. Recommend repairs.

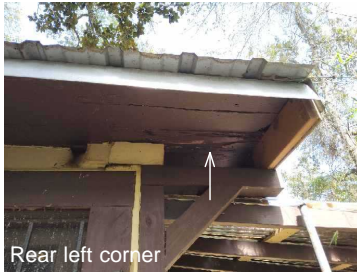
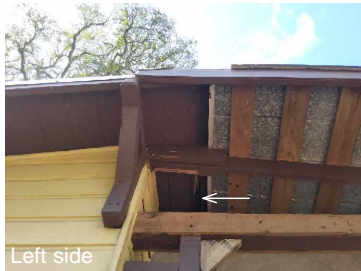
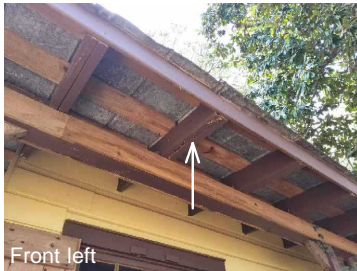
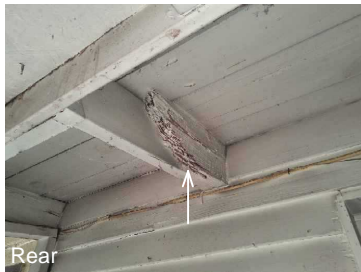
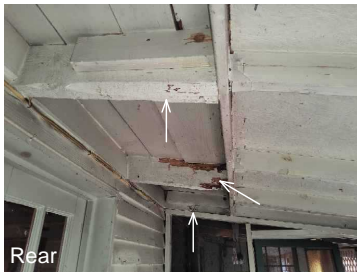
9. Major Concern Fascia / Soffit: Open (Exposed rafter tails), Wood - Fascia observed with wood damage at several locations. Recommend removing / replacing damaged wood. *The inspector was unable to determine if this was from moisture / wood destroying insect.

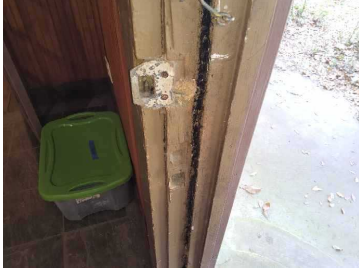
- 11. Attention Needed Window Screens: Not installed - Screens not installed. Recommend installing screens.
- 12. Acceptable Shutters Wood
- 13. Attention Needed Entry Doors: Wood - Strike plates are missing at the door casing. Recommend replace.

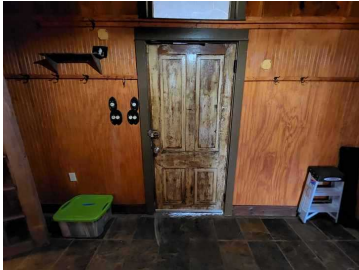
14. Attention Needed Entry Doors: Wood - Door does not seal to the weather stripping at all sides of the door. Recommend correction.

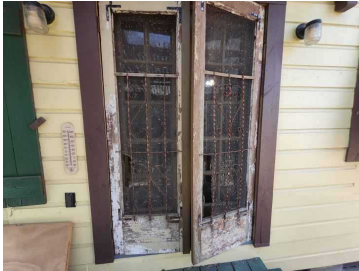
15. Attention Needed Patio Door: French door - Loose peeling paint conditions are in need of maintenance. Recommend scraping and recoating the areas with this condition. *Note: Houses built prior to 1978 may have concerns for lead base paint. Proceed with caution when prepping paint that may contain lead and / or consult with qualified professionals.

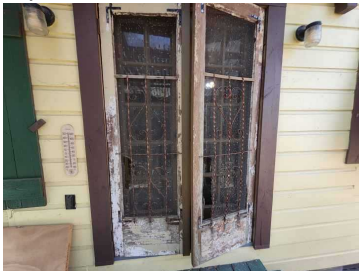
16. Attention Needed Patio Door: French door - Torn screens are observed on the outer door. Recommend repair / replace.

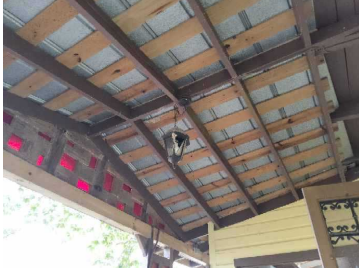
20. Attention Needed Exterior Lighting: Surface mount, Ceiling mount - Glass pane was loose. Recommend replace.

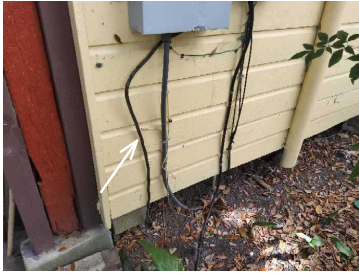
21. Safety Hazards Exterior Electrical: 110V - Romex wiring was observed run outside of conduit. Recommend a licensed electrician make the needed corrections.

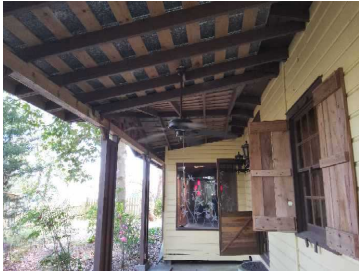
22. Attention Needed Ceiling Fans: Surface mount - The ceiling fan is operable but the blades are sagging from humidity. Recommend replace.

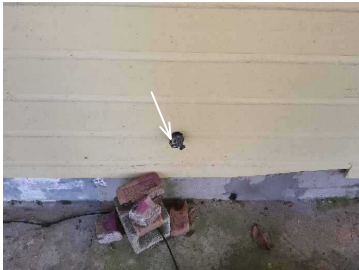
23. Attention Needed Hose Bibs: Gate - The hose bib at the front of the home is not secured to the home. Recommend repairs.

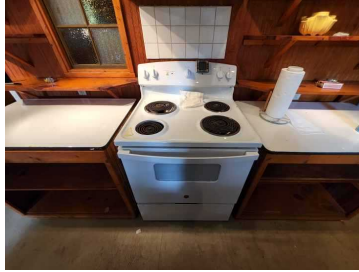
1. Safety Hazards Cooking Appliances: General Electric - Anti-tip bracket not installed to avoid tipping. Recommend installing anti-tip per manufacture instruction.

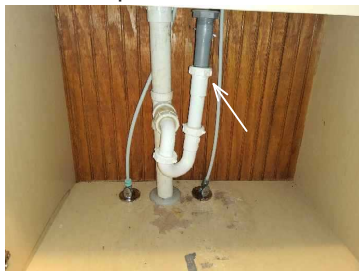
- 1. Acceptable Floor: Wood, Tile
- 2. Acceptable Walls: Paneling
- 3. Acceptable Ceiling: Wood
- 4. Acceptable Doors: Wood
- 5. Acceptable Windows: Wood
- 6. Acceptable Cabinets: Wood
- 7. Acceptable Counter Tops: Plastic
- 8. Major Concern Sink/Basin: Plastic - The vanity sink drain is leaking in the primary bathroom. Recommend a licensed plumber make the needed corrections.

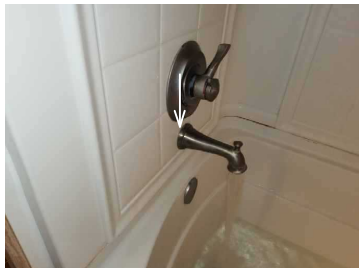
- 9. Attention Needed Plumbing / Fixtures: Double Valve Split Fixture, Single Valve Scald Proof Fixture - Spigot is not sealed to the tubs surround. Recommend sealing.

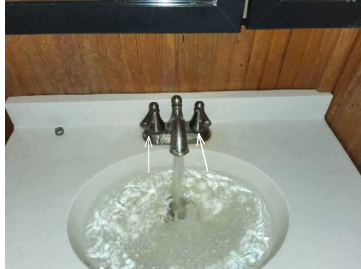
10. Major Concern Plumbing / Fixtures: Double Valve Split Fixture, Single Valve Scald Proof Fixture - The vanity sink faucet leaks at the valve stems. Recommend a licensed plumber make the needed corrections.

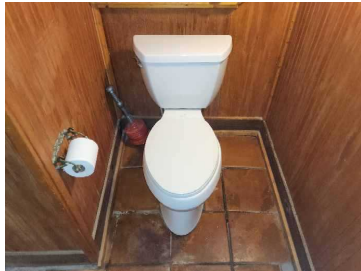
11. Acceptable Tub/Surround: Fiberglass tub and fiberglass surround
12. Attention Needed Toilets: Kohler - The toilet bowl in the bathroom is loose at the floor, which can lead to movement during use. This condition may cause damage to the wax gasket seal, potentially resulting in leaks and water damage. To maintain proper function and avoid further issues, Recommend that the toilet be properly secured to the floor by a qualified professional.

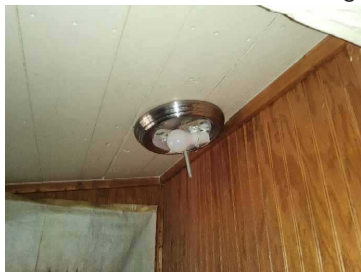
16. Acceptable Ceiling: Paneling
17. Acceptable Walls: Paneling , Wood
18. Acceptable Floor: Wood, Other
19. Attention Needed Doors: Wood with glass, Wood - The door to the commode drags the casing when closed. Recommend adjustments.
20. Acceptable Windows: Wood
21. Attention Needed Electrical: 110 VAC - The light fixture is missing its globe. Recommend replace.

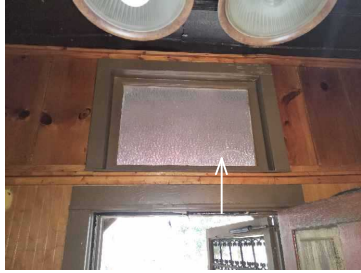
6. Safety Hazards Windows: Non-opening - The window in the foyer has cracked glass. Recommend replace.

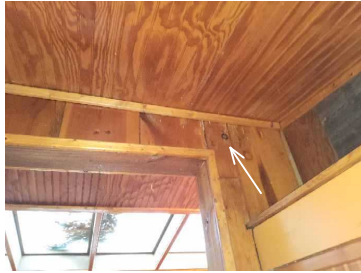
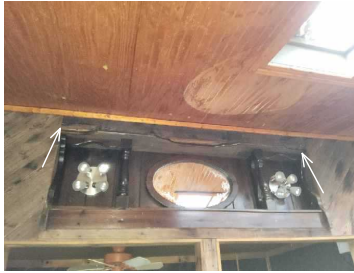
9. Acceptable Ceiling: Paneling
10. Major Concern Walls: Paneling - Dirt tubes and wood destroying insect damage were observed above the beam. Recommend having the home further evaluated by a qualified pest control company as well as a licensed contractor remove and replace all damaged wood.

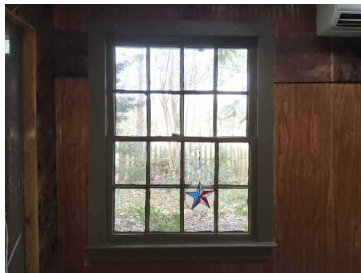
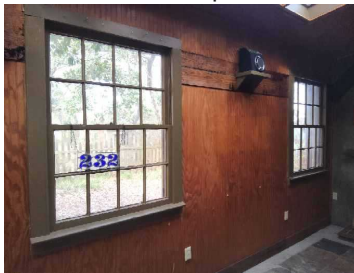
13. Attention Needed Windows: Wood - Windows were stuck shut at the time of the inspection. Recommend maintenance needed to make the windows operable.

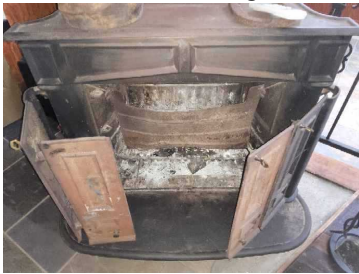
5. Major Concern Freestanding Stove: Wood burning - Due to the age and condition of this unit the inspector recommends having further evaluated by a qualified chimney sweep before use.

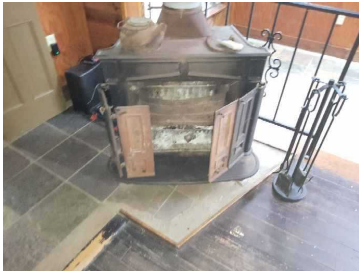
6. Type: Wood burning
7. Acceptable Flue: Metal
8. Safety Hazards Hearth: Flush mounted - The hearth at the wood burning stove is incorrect. Recommend a licensed contractor make the needed corrections.

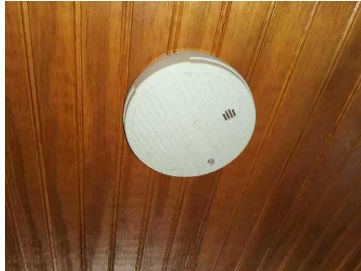
9. Safety Hazards

Smoke Detector: Battery operated - Smoke detected did not function when manually tested. Recommend repair or replace.

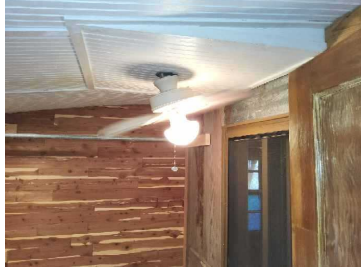
18. Acceptable Electrical: 110 VAC
19. Safety Hazards Ceiling Fan Switched - The ceiling fan is hanging by its wiring in the closet. Recommend repairs.

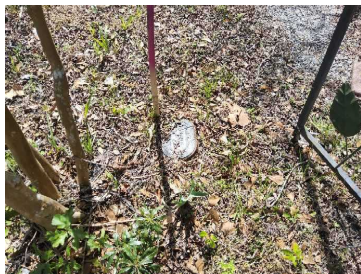
2. Not Inspected Main Water Shutoff: Not Visible, not located - Water shut off was not located. Recommend installing water shut off and / or locate and make accessible.

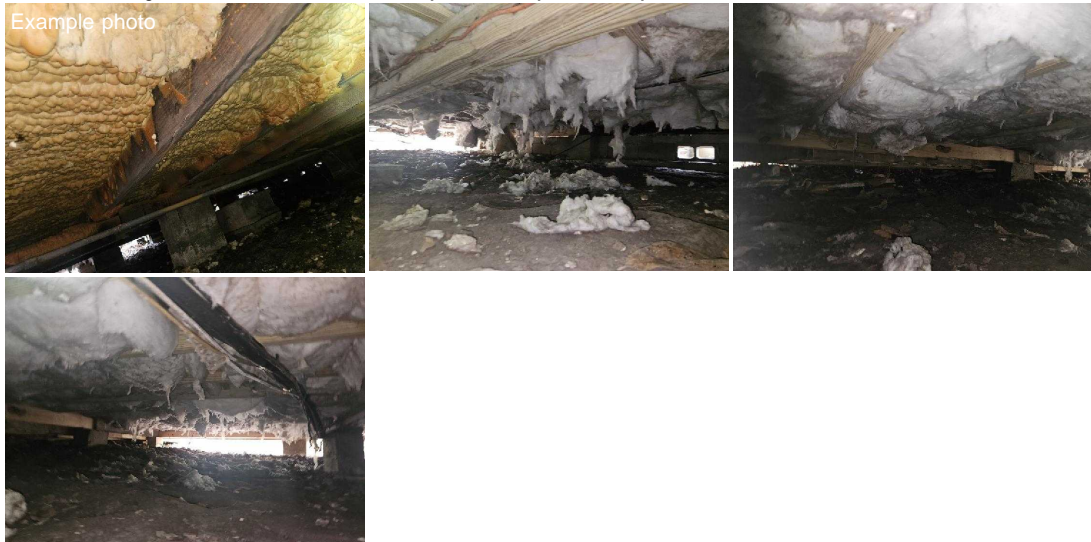
Insulation: Fiberglass batt - The underside of the floor system is insulated with spray foam and fiberglass batt insulation which conceals large portions of the framing system. Evidence of termite damage was observed in accessible areas; however, concealed framing prevents determination of the full extent of deterioration. In the inspector's professional opinion, removal of insulation may be necessary to fully evaluate the structural framing and determine the scope of required repairs.

The spray foam and fiberglass insulation conceal large portions of the framing system, preventing determination of the full extent of termite damage and structural deterioration. In the inspector's professional opinion, removal of insulation and comprehensive structural evaluation is necessary to determine the scope of required repairs.

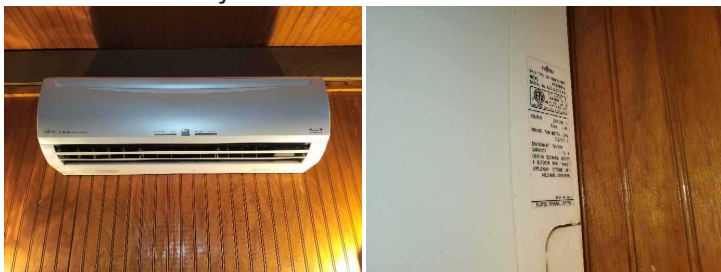
1. Major Concern Heating System Operation: Inoperable - The unit did not function in heat mode when tested.
Recommend a licensed HVAC technician service the units.
2. Manufacturer: Fujitsu

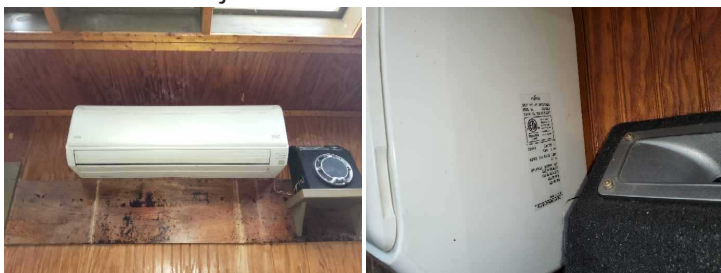
9. Major Concern Heating System Operation: Inoperable - The unit did not function in heat mode when tested.
Recommend a licensed HVAC technician service the units.
10. Manufacturer: Fujitsu

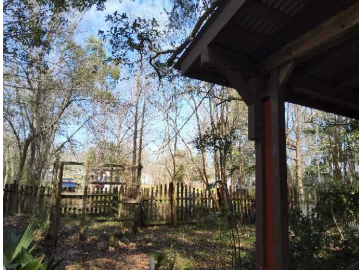
2. Safety Hazards Service: Milbank - Service wire from the street is in contact with the tree limbs. Recommend tree limbs are trimmed away from the service wire.

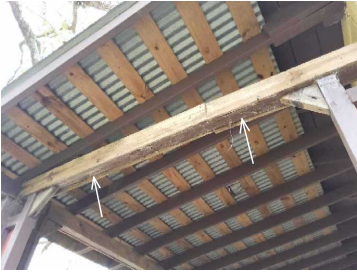
1. Porch: Wood - The wood framing supporting the front porch shows visible deterioration consistent with wood destroying insect activity. Structural wood members exhibiting insect damage may have reduced structural capacity and may continue to deteriorate if the infestation remains active. Recommend evaluation by a licensed pest control professional to determine if active infestation is present and a qualified contractor remove and replace all structurally compromised wood components.

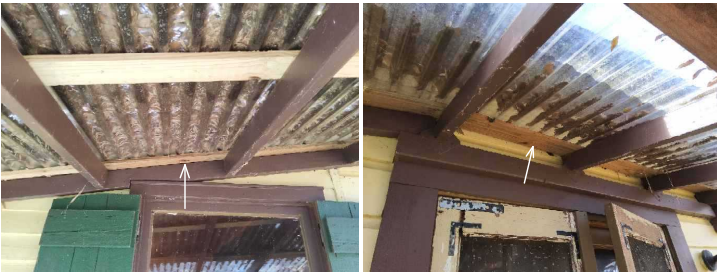
2. Patio Cover: Wood - The left side patio cover is not properly attached / flashed to the home. Recommend a licensed contractor make the needed corrections.

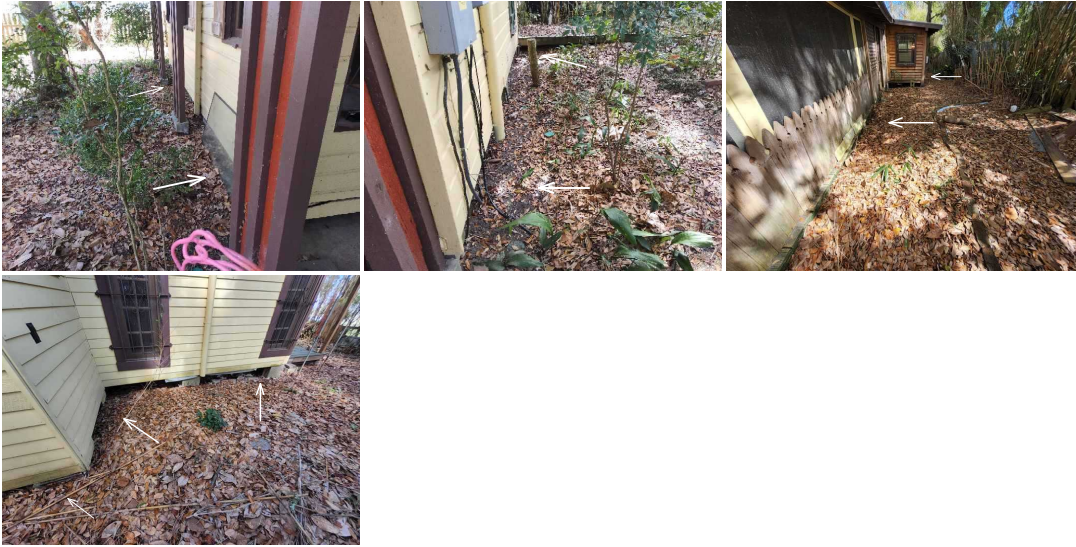
5. Grading: Negative slope - The exterior grade slopes toward the structure allowing rainwater to collect beneath the crawlspace. Standing moisture was observed beneath the structure during the inspection despite no recent rainfall. Chronic moisture conditions in crawlspaces can accelerate wood deterioration and create conditions conducive to termite activity and fungal growth. Recommend correction of site grading and drainage to divert surface water away from the structure.

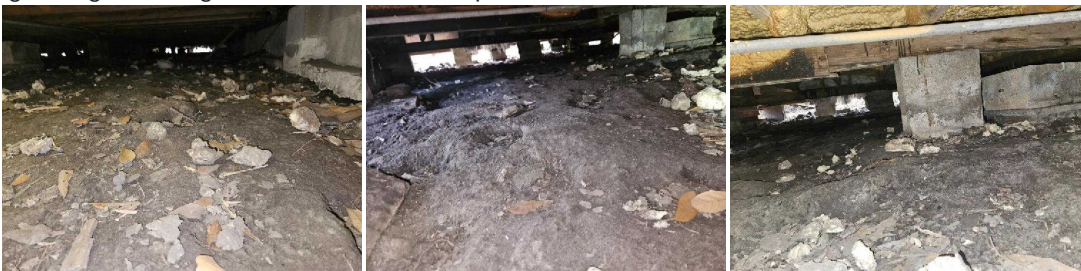
6. Floor/Slab: Dirt - Wet soil conditions were observed beneath the structure during the inspection despite no recent rainfall. Persistent crawlspace moisture can accelerate wood deterioration and contribute to conditions favorable for termite activity and fungal growth. Recommend further evaluation and correction of moisture sources including grading, drainage, and ventilation improvements.

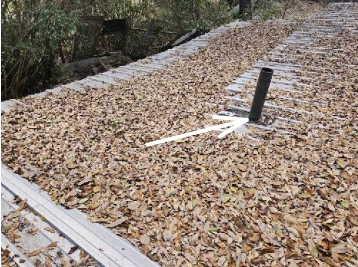
16. Plumbing Vent Flashings: None present - The plumbing vent penetration through the roof is not properly flashed. Recommend repair or replacement of the flashing to provide a proper watertight seal.

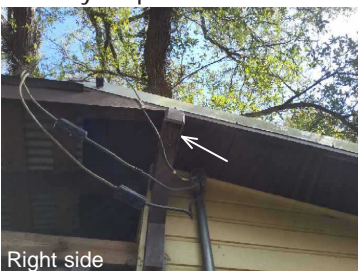
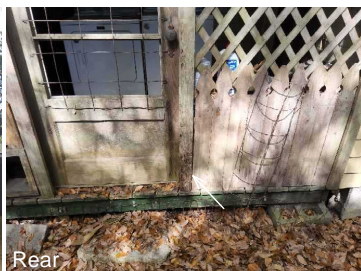
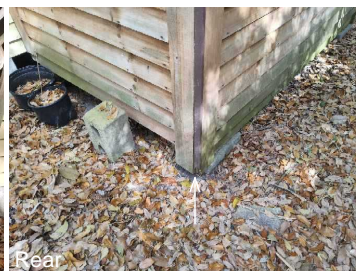
19. Trim: Wood - Damaged wood consistent with wood destroying insect activity was observed at several areas of the exterior siding and trim. Wood components affected by insect damage may continue to deteriorate if infestation remains active. Recommend evaluation by a licensed pest control professional and replacement of all damaged wood by a qualified contractor.

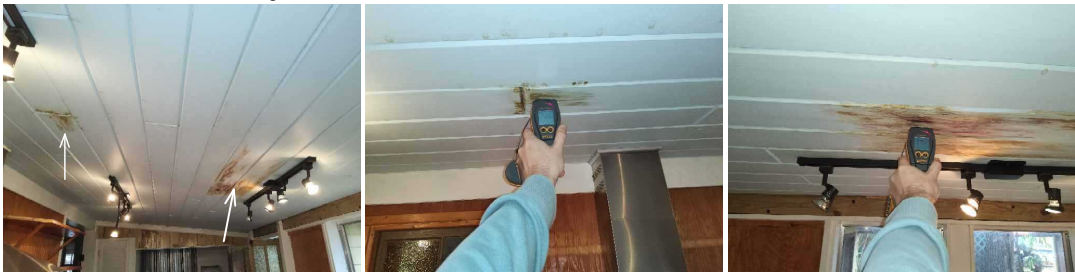
22. Middle Kitchen Ceiling: Wood - Moisture staining was observed on the kitchen ceiling and elevated moisture readings were detected during the inspection. Elevated moisture levels indicate an active or recent moisture intrusion source. Continued exposure to moisture may lead to structural deterioration and microbial growth. Recommend a qualified contractor locate and repair the source of moisture and replace damaged building materials as necessary.

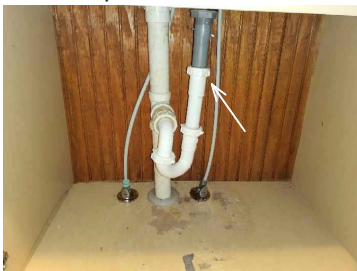
24. Primary Bathroom Sink/Basin: Plastic - The vanity sink drain is leaking in the primary bathroom. Recommend a licensed plumber make the needed corrections.

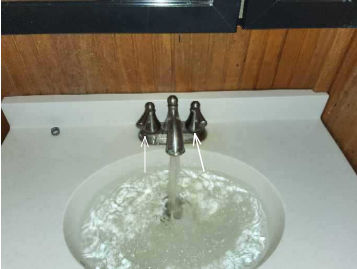
25. Primary Bathroom Plumbing / Fixtures: Double Valve Split Fixture, Single Valve Scald Proof Fixture - The vanity sink faucet leaks at the valve stems. Recommend a licensed plumber make the needed corrections.

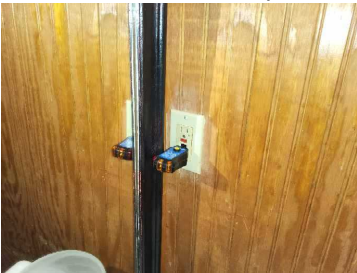
26. Rear Half Bathroom Electrical: 110 VAC GFCI - The GFCI outlet was tripped and will not reset. Recommend a licensed electrician replace the outlet.

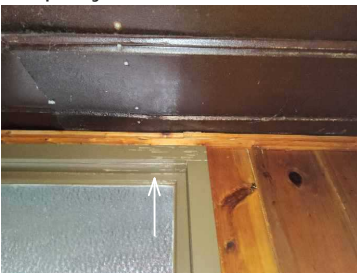
27. Foyer Living Space Walls: Wood, Paneling, Drywall - Dirt tubes and wood destroying insect damage were observed above the front door. Recommend having the home further evaluated by a qualified pest control company as well as a licensed contractor remove and replace all damaged wood.

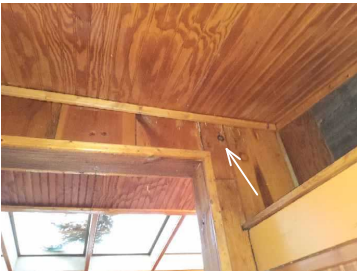
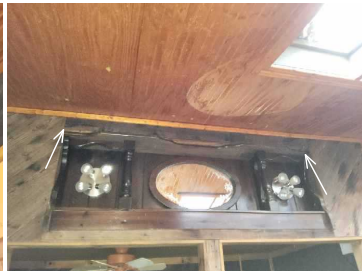
28. Family Room, Bar Living Space Walls: Paneling - Dirt tubes and wood destroying insect damage were observed above the beam. Recommend having the home further evaluated by a qualified pest control company as well as a licensed contractor remove and replace all damaged wood.

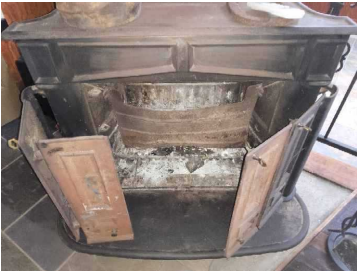
30. Family Room Fireplace Freestanding Stove: Wood burning - Due to the age and condition of this unit the inspector recommends having further evaluated by a qualified chimney sweep before use.

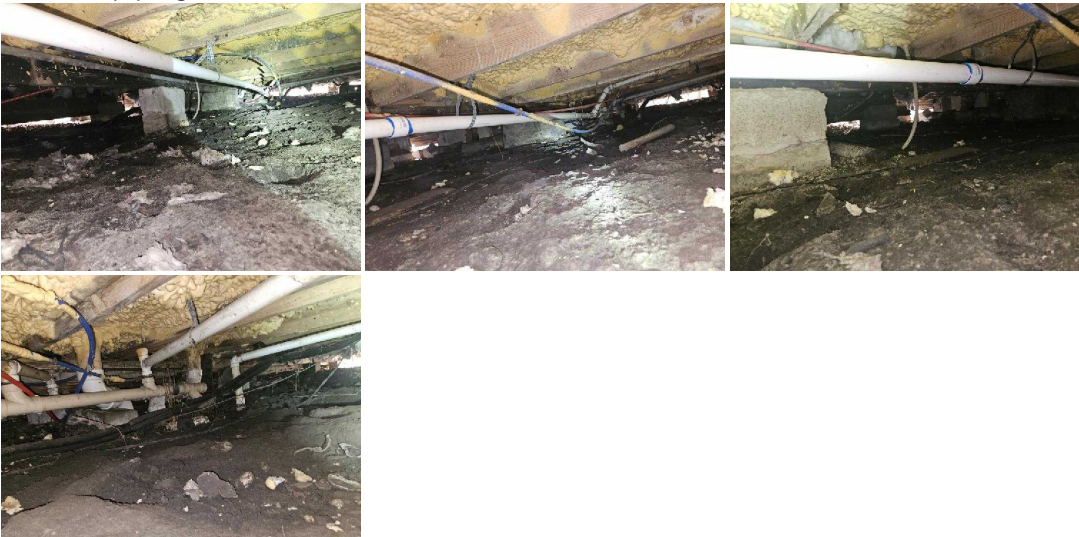
32. Drain piping: PVC - Drain piping beneath the structure appears improperly installed in areas. Portions of the piping run up and over structural framing members rather than maintaining a continuous downward slope toward the discharge point. Improper slope can restrict drainage and allow waste accumulation within the piping. Some sections also appear inadequately supported. Recommend a qualified plumbing contractor evaluate and correct the drain piping installation.

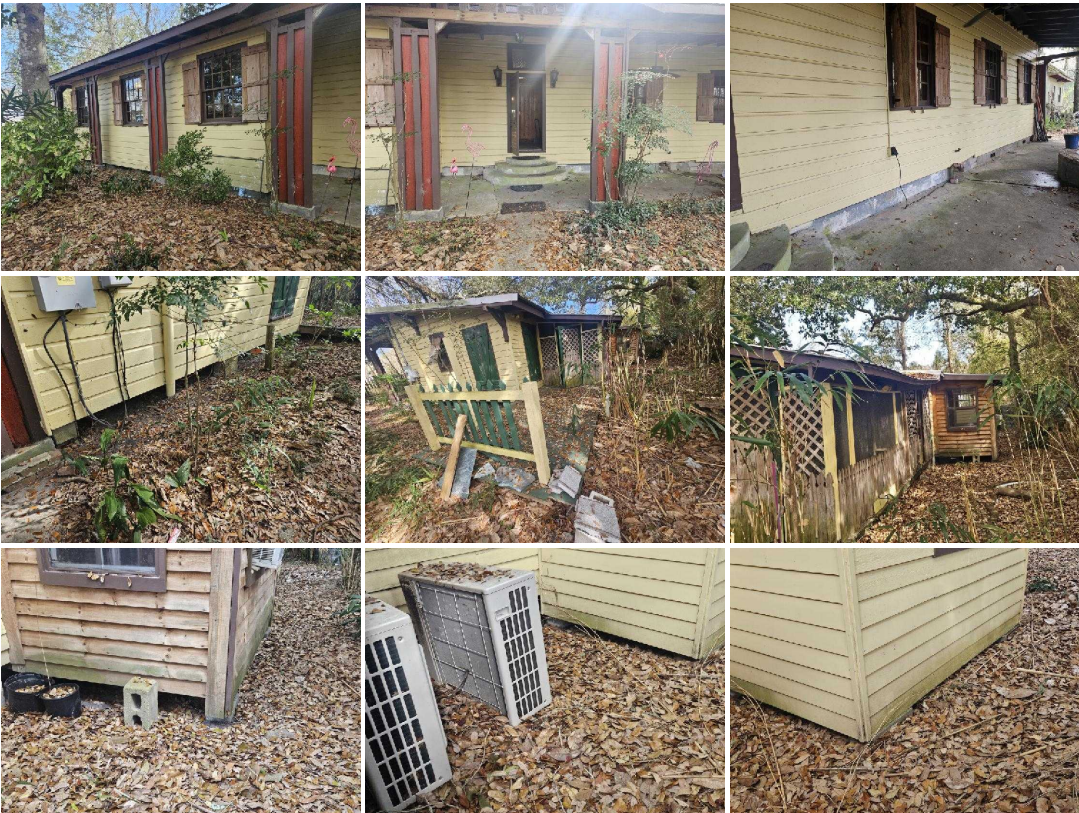
34. All Crawl Space Moisture Penetration: Ongoing source for moisture - Reference structure page for soil conditions in the crawlspace.
35. All Crawl Space Ventilation: Open at perimeter (3 Sides) - Crawlspace ventilation was observed to be open along much of the perimeter, with limited venting present only at portions of the front and rear right corner of the structure. Soil conditions beneath the home were wet at the time of the inspection despite no recent rain events, which suggests moisture may be accumulating beneath the structure. Excessive crawlspace moisture can contribute to wood deterioration, elevated humidity levels within the home, and conditions conducive to fungal growth or wood-destroying organisms. Recommend a qualified contractor further evaluate the crawlspace moisture conditions and improve drainage and/or ventilation as needed to reduce moisture accumulation beneath the structure.

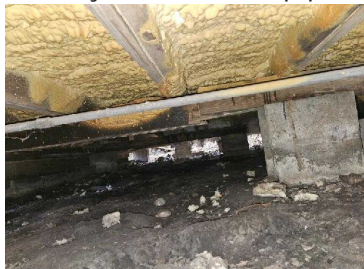
37. All Crawl Space Vapor Barrier: Not installed - No soil cover was installed at the time of the inspection. Soil covers help reduce humidity levels in crawlspaces by limiting moisture evaporation into the air from soil. Reducing humidity levels can help prevent conditions that encourage mold growth and wood decay.

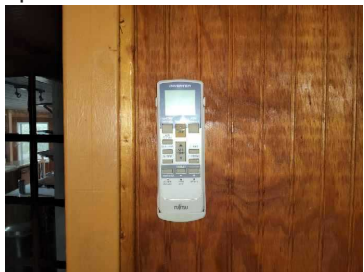
43. Thermostats: Remote controlled - The remote for the left bedroom Mini-split did not respond, batteries were replaced and unit still did not function. Recommend repair / replace.

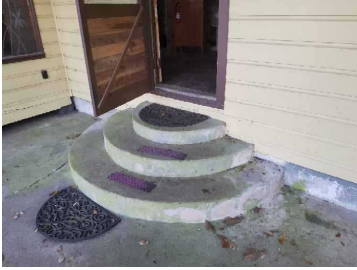
1. Steps/Stoops: Concrete - Exterior steps had no handrail. Generally-accepted modern safety standards dictate that stairs with 4 or more risers should have a handrail. You should consult with a qualified contractor before the expiration of your Inspection Objection Deadline to discuss options and costs for handrail installation.

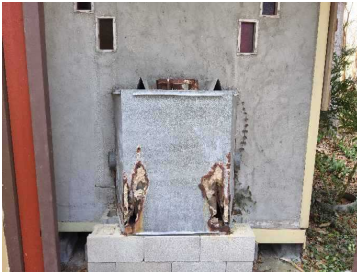
2. Left side Chimney Chimney: Metal - The chimney is damaged, and missing several components needed for safe use. Recommend a qualified chimney sweep further evaluate to determine the scope of work needed for replacement.

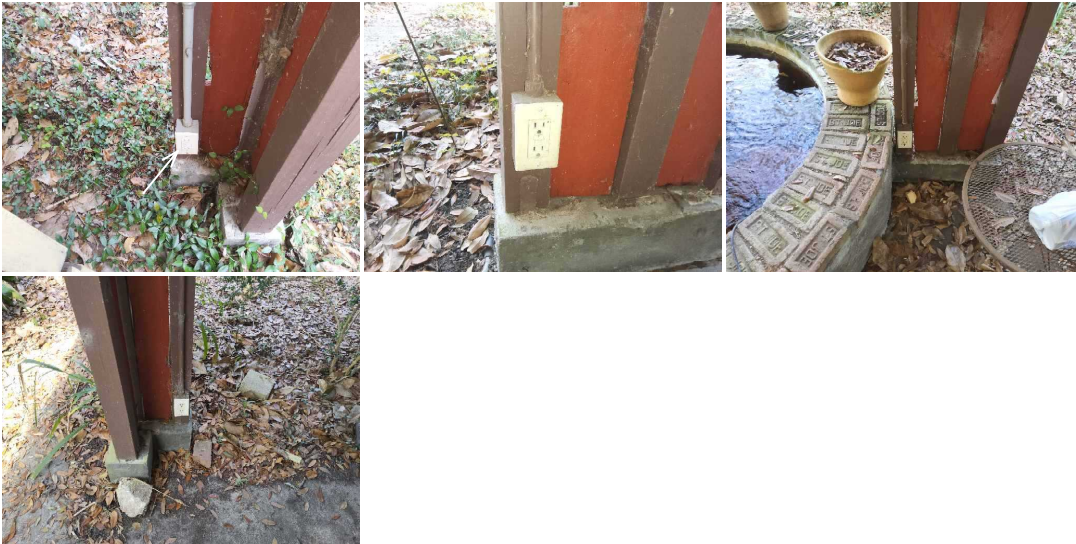
3. Exterior Electric Outlets: 110 VAC GFCI - Exterior outlets are missing weathertight covers. Recommend a licensed electrician replace missing covers.

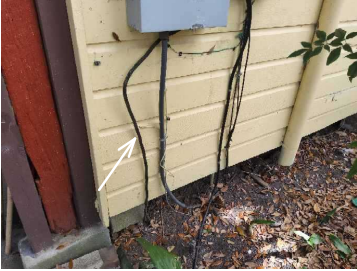
4. Exterior Electrical: 110V - Romex wiring was observed run outside of conduit. Recommend a licensed electrician make the needed corrections.

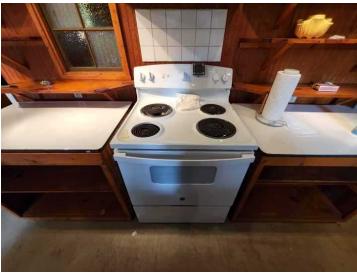
5. Middle Kitchen Cooking Appliances: General Electric - Anti-tip bracket not installed to avoid tipping. Recommend installing anti-tip per manufacture instruction.

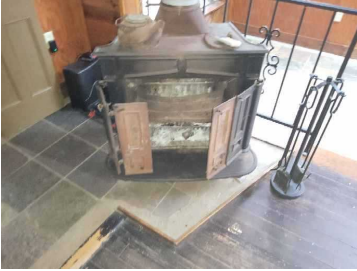
9. Family Room Fireplace Hearth: Flush mounted - The hearth at the wood burning stove is incorrect. Recommend a licensed contractor make the needed corrections.
