NATURAL RESOURCES PRESERVATION ADVISORY BOARD REGULAR MEETING

Wednesday, May 01, 2024 AT 11:00 AM

TOWN OF HIGHLAND BEACH, FLORIDA
3618 S. OCEAN BOULEVARD
HIGHLAND BEACH, FL 33487
Telephone: (561) 278-4548

At the April 16, 2024 Town Commission meeting, a presentation on the 2023 Beach Restoration Feasibility Study (“Study”) was made by Douglas Mann, Lead Coastal Engineer, of Aptim Environmental & Infrastructure, LLC. Note that a video recording of the meeting is available on the Town’s website. The Study includes a site-specific Beachfront Property Evaluation which provides beach and dune observations and corresponding recommendations for each beachfront property (see appendix B of Study). While the Commission did not provide any specific direction to the Board on educational outreach of the Beachfront Property Evaluations to residents, the Town Manager has indicated that such outreach efforts should be pursued by the Board in the form of communication strategies or a plan (e.g. letter, email, etc.). Given the latter, the item has been placed on the Board’s agenda for discussion.

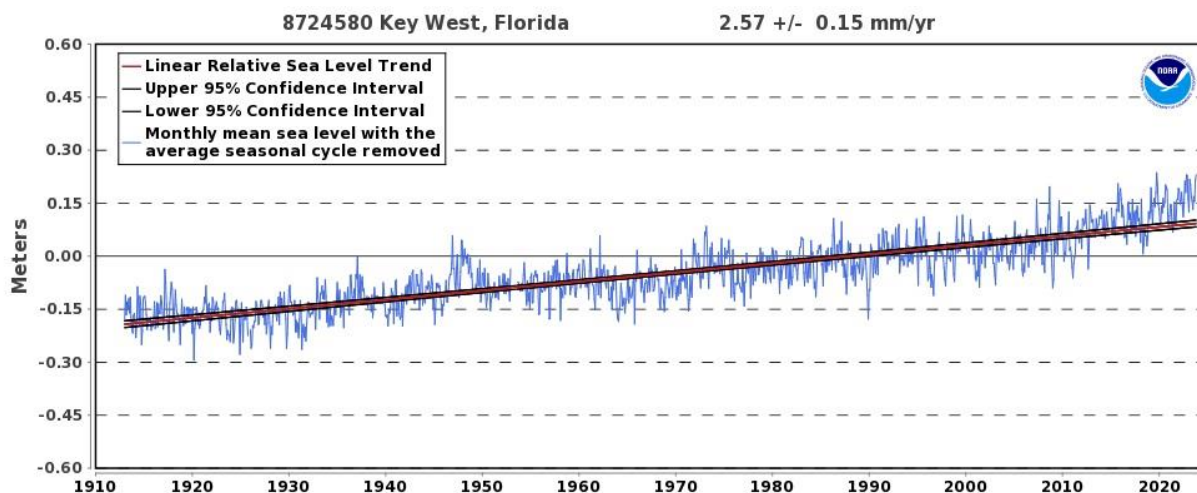
The global sea level has both risen and fallen throughout geological history. Recent trends in local sea level changes can be used as indicators of what will occur in the near future. Experience indicates that as the relative sea level rises, the shoreline will be subjected to increased flooding, shoreline recession, and profile erosion. NOAA has published sea level trends for regions along the United States coasts based on measured yearly mean sea level records. The longest tide gage record in southeast Florida is based in Key West (Figure 4). Based on the Key West tide gage records, NOAA has estimated that sea level is rising along the southeast Florida coast at 2.57 mm/year (NOAA). This is equivalent to 0.84 feet/century.

Figure 4. Long term record of sea level rise in Key West, Florida.

An increase in sea level will also reduce the appearance of the width of the beach due to higher mean water levels. The data in Figure 4 suggests that mean sea level is approximately 1 foot higher today than it was in 1910 (at the beginning of the Key West tidal record). As many beaches in Palm Beach County have a beach face slope of $1V:10H$, the increase in water level has reduced the apparent width of the beach by 10 feet in the last century. Ongoing sea level rise (linear or accelerated) will further reduce the apparent width of the beach.

The estimates of storm surge for recurring storms presented in Table 4 were computed based on a specific tidal elevation (Dean et al., 1992). With increasing time since the 1992 study, the expected value of the storm surge should also increase based on the actual rise in sea level (Figure 4). Increased storm surge elevations will result in increased shoreline recession, beach erosion, and dune impacts.

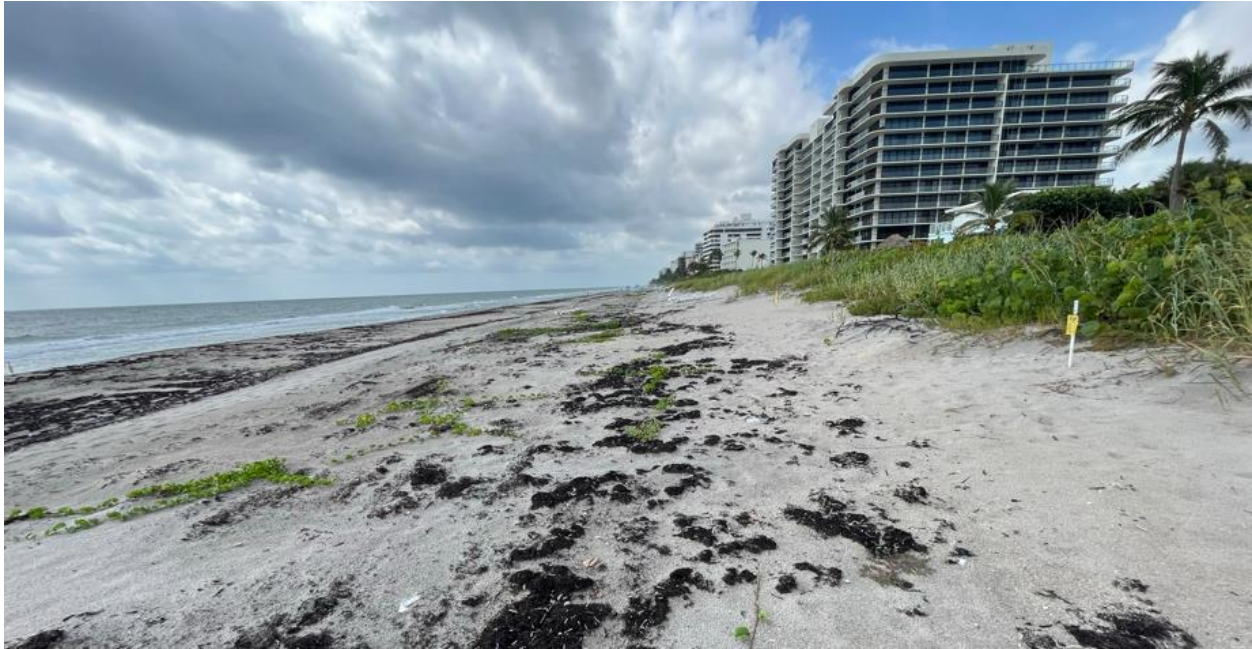
Photo 4. Southerly view of the beach berm and dune near R-192.

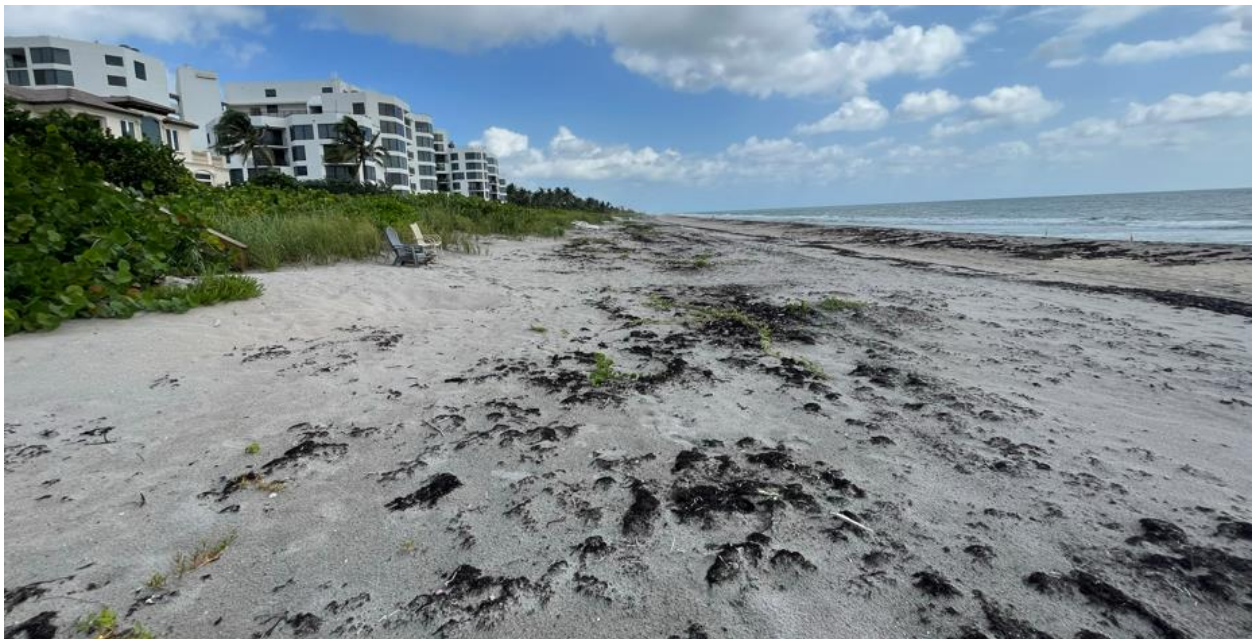
Photo 5. View of the beach berm and dune near R-192 looking north.

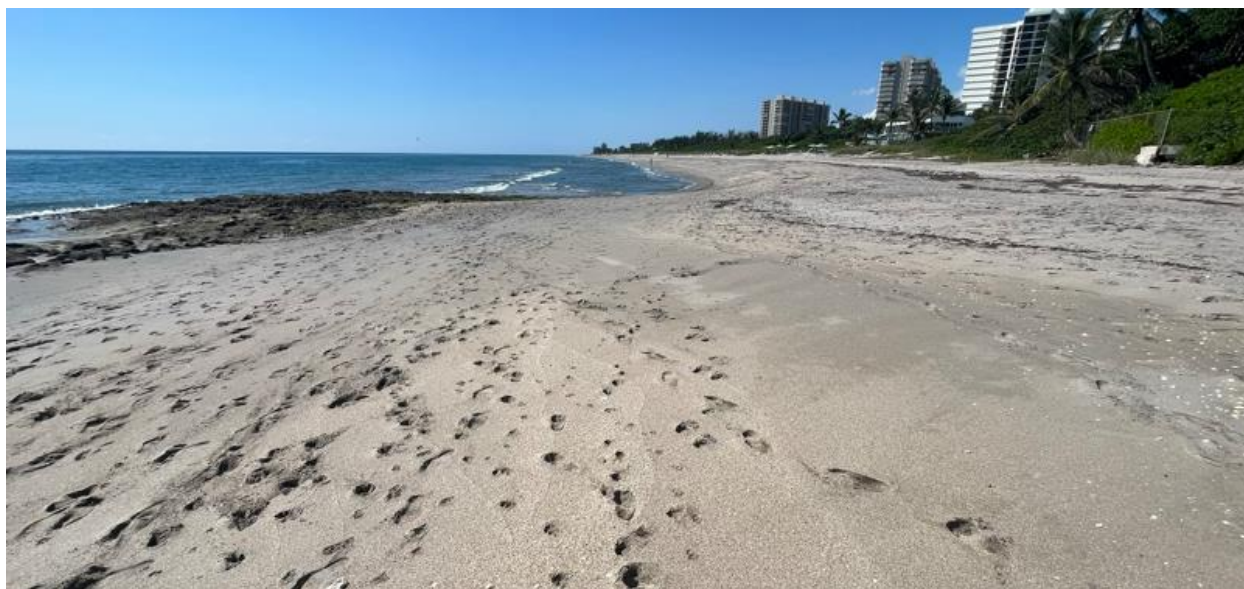
South of Yamato Rock, the beach is stable and healthy, and the three properties (4713, 4715 and 4801 South Ocean Boulevard) have a 50-foot-wide vegetated dune and an approximate 80 to 100-foot beach in front of the structures (Photo 13). Historically, this section of beach has benefited from the North Boca Raton Beach nourishment projects constructed in 1988, 1998, 2010, 2014, and 2020.

Photo 13. View of the beach looking south at Yamato Rock.

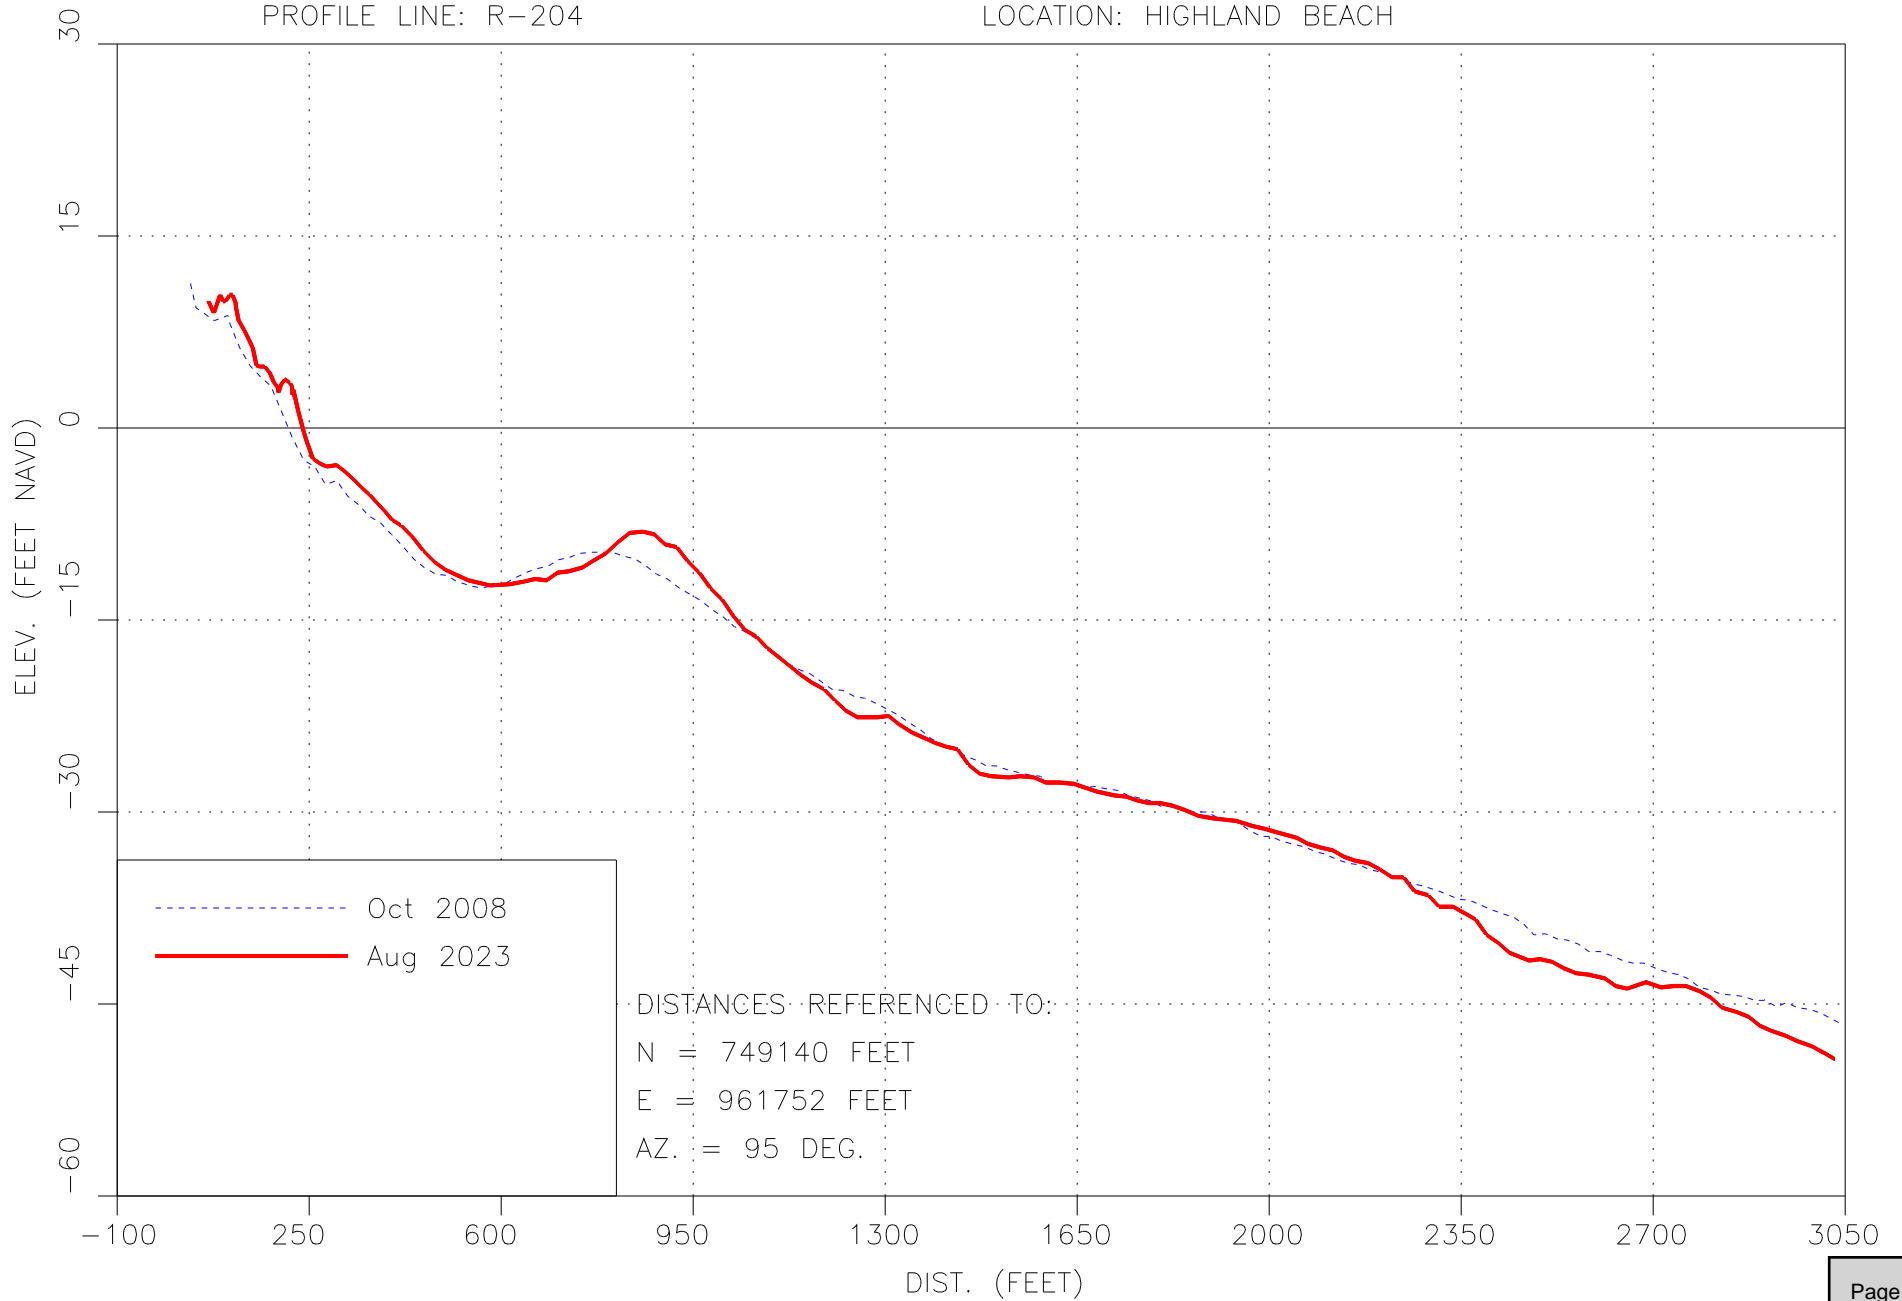
PROFILE LINE: R-204

The beach access for the Admiral Walk Towers is at the limits of Highland Beach, with a 100-foot-wide vegetated dune with no structures present on this beach parcel. While the dune is wide in this area, the dune crest is at approximately +10 feet, NAVD (FDEP profile R-204, Appendix A), which is the lowest dune in Highland Beach. The dune crest is at the elevation of 100-year return period storm surge (Photo 14).

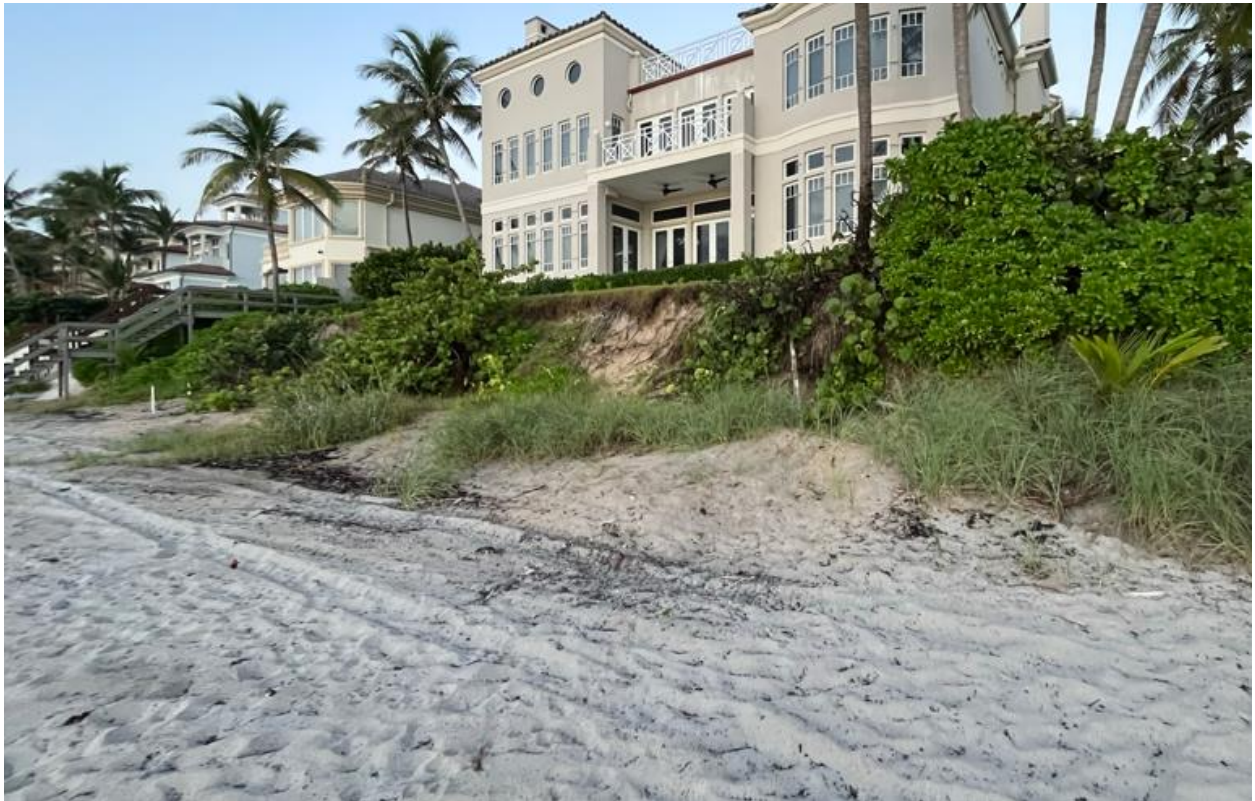
Beach Naupka is an exotic invasive plant that grows well on the dune face in Palm Beach County (Photo C-1). It is characterized by oval (or club shaped) shiny green leaves. It should be removed from all dune ecosystems as it crowds out and shades native dune species. Any FDEP permit issued will require its removal.

Photo C-1. Seagrapes at the left center of the photograph and Beach Naupka on the right side of the photograph.
