City of Homer Agenda

City Council Worksession

TO: Marvin Yoder, City Manager
FROM: Carey S. Meyer, City Engineer
DATE: May 14, 2020
SUBJECT: Seawall Considerations

Subject: Homer Seawall Alternatives Analysis

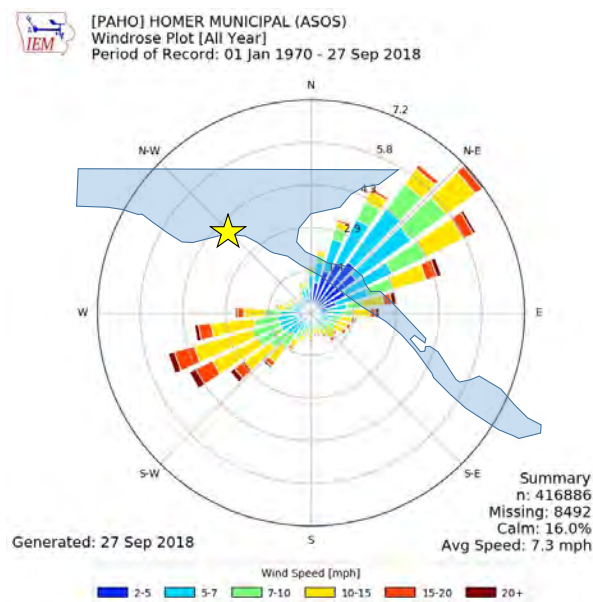
Figure 6 provides a wind rose from data gathered at the Homer airport. The wind rose graphically shows the wind direction, magnitude, and frequency of occurrence. A silhouette of the Homer spit with the seawall location shown as a “star” is also included in the figure in the background. This provides a graphical orientation of the shoreline at the seawall in relation to the wind trends. From the figure, it can be seen that annually wind predominantly blows in two directions: northeast and west southwest.

Figure 6. Wind rose showing predominant wind direction, frequency, and magnitude at Homer, AK (ISU 2019).

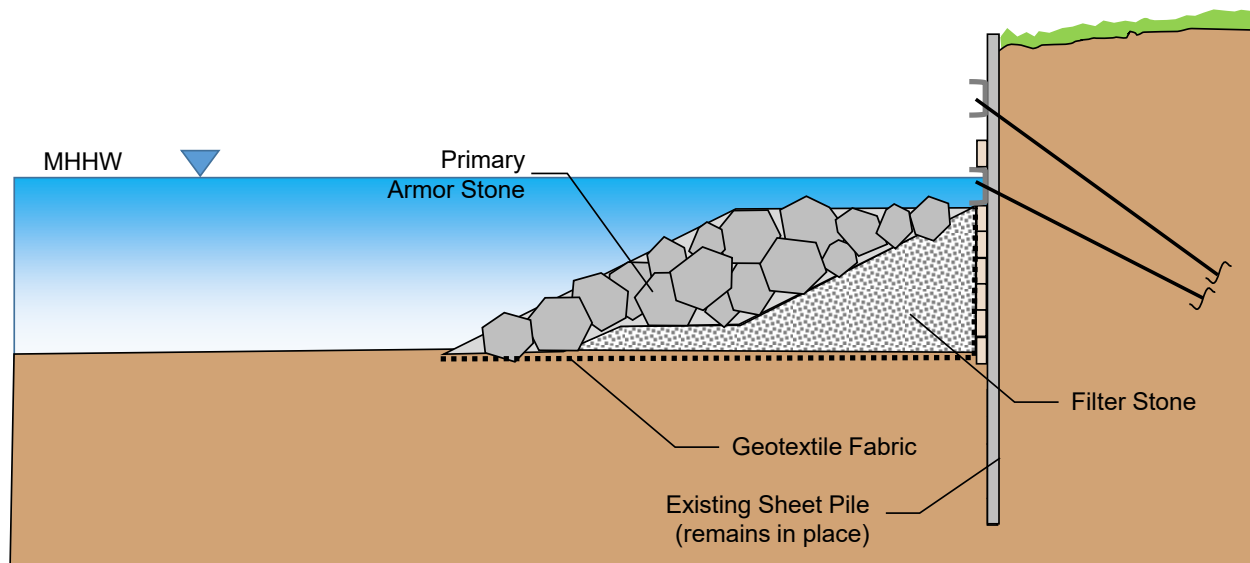
CONCEPT 1 – ARMOR STONE SCOUR PROTECTION

Figure 8. Concept 1 - Armor stone scour protection schematic.

Armor stone scour protection involves constructing a revetment type structure at the base of the existing seawall. The structure would utilize at least two stone material classes: a filter stone and a primary armor stone. A non-woven geotextile fabric would be placed as a barrier between the filter stone and the seawall as well as the beach. Filter stone would then be placed as a wedge between the primary armor stone and the seawall. This rock material and geotextile fabric will act as filter layers to reduce sediment migration through the structure. Sediment loss behind the seawall should thereby be minimized, which would reduce localized failure from “sink holes.” The filter stone will also provide protection to the existing seawall from the larger primary armor stone which could damage the seawall during construction or if stones moved during a storm event. This revetment concept would reduce scour (lowering of the beach) at the base of the seawall, which if were to continue, could result in the collapse of the seawall. This concept should also prevent continued damage at the base of the seawall such as the “kicking out” of the seawall at the base as observed during the site visit. However, it should be noted that repairing a localize failure of the seawall would become significantly more challenging with a rock structure in place at the toe. Figure 8 provides a schematic of this concept.

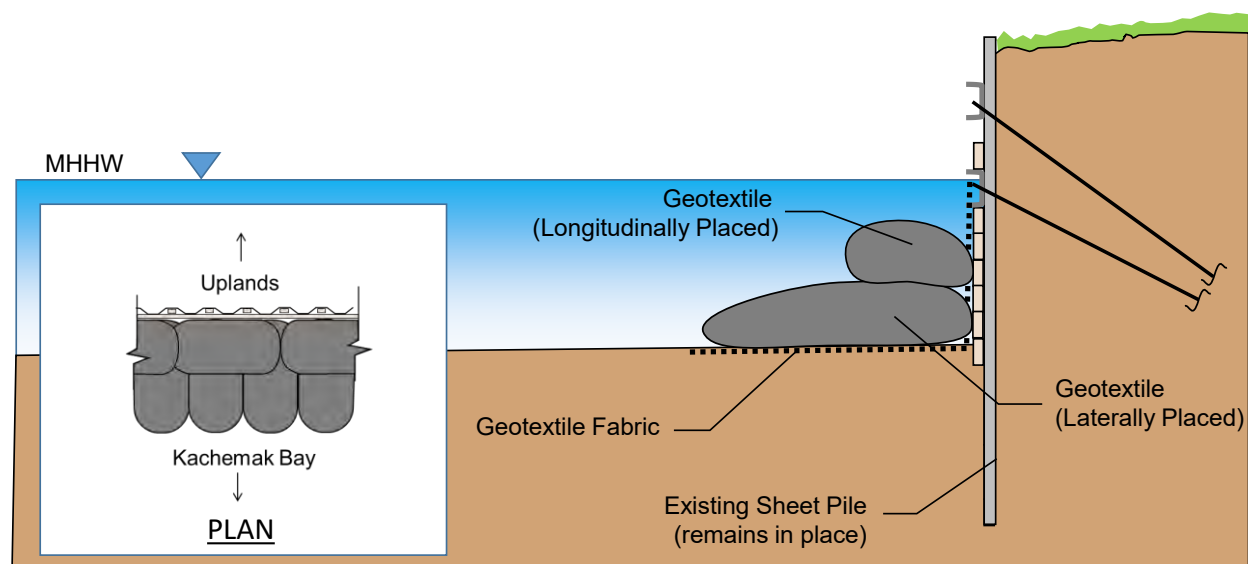
CONCEPT 2 – GEOTEXTILE CONTAINER SCOUR PROTECTION (SECTION)

Figure 9. Concept 2 - Geotextile container scour protection section schematic.

Geotextile container scour protection would be very similar to the shape and functionality of the armor stone scour protection (Concept 1), however, the primary building material would be a sand-filled geotextile fabric container. The container would be made using a two-layer geotextile fabric system. The inner-fabric of the container would be made of non-woven geotextile material to prevent sediment migration through the container. The outer-fabric would be made of a strong woven geotextile fabric to support the weight of the container which can be upwards of 2,000 lbs. Containers would be fabricated with three sides pre-fabricated (sewn) similar to a pillow case. The container would also have pre-fabricated straps sewn in to allow a spreader bar to place the container in the desirable location. The containers would then be filled with locally sourced sand using a hopper and the remaining side sewn in the field. Ideally containers would be sized to be the maximum weight the construction equipment could handle and maneuver. The containers would be placed along the toe of the seawall to prevent scour. Figure 9 provides a schematic showing the section and plan of this concept. Figure 10 provides an example of a geotextile container revetment, however, note the containers are placed differently (pyramid-layout) than shown in Figure 9 and are not placed directly against the seawall.

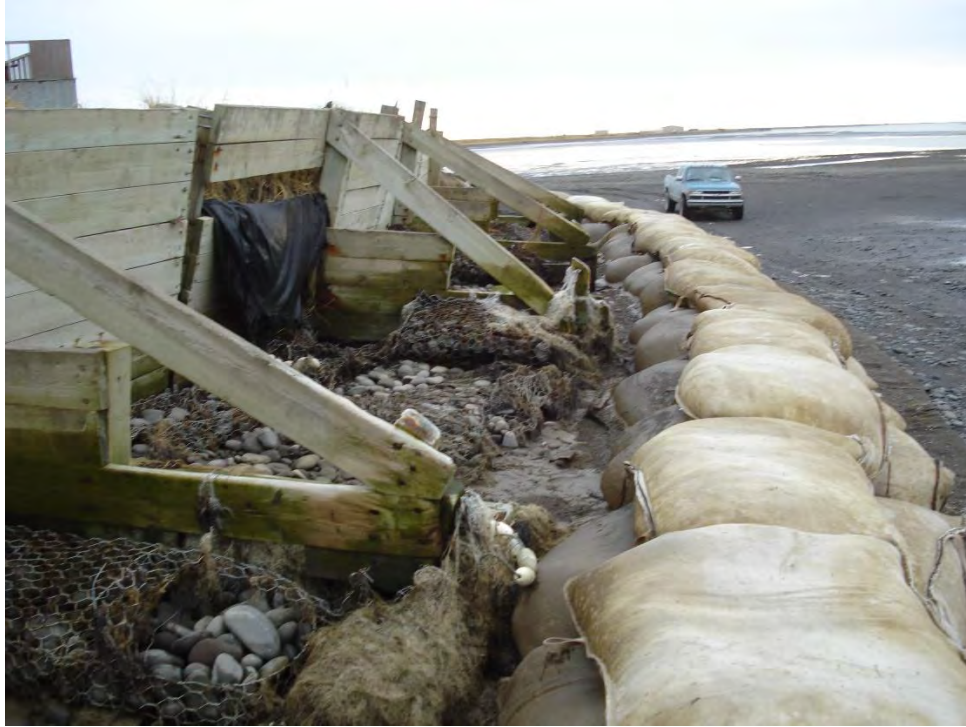
Figure 10. Example of geotextile container revetment (pyramid layout). In the Homer seawall case, the containers would be placed against the seawall.

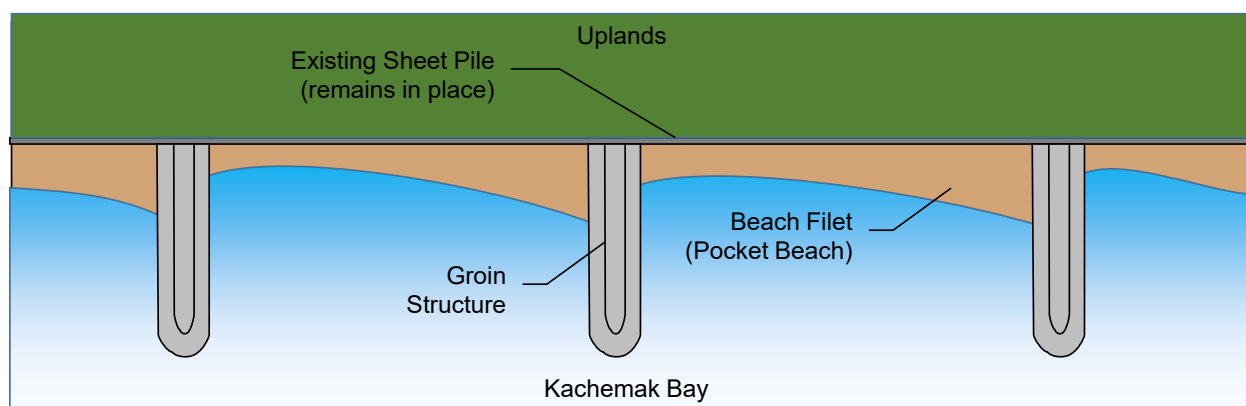
CONCEPT 3 – GROIN FIELD (PLAN)

Figure 11. Concept 3 - Groin field plan schematic.

A groin is a coastal structure that is orientated perpendicular to the shoreline with the intent of disrupting the long shore sediment transport. A groin field is a series of groins placed relatively uniformly along a shoreline that create pocket beaches between structures. Groins can be constructed with a variety of materials but are most often constructed with armor stone. As sediment travels along the shoreline due to wave action and currents, a groin will disrupt the flow of sediment and accrete sediment along the up-drift side of the groin (called a filet). Since wave action and/or currents will continue to move sediment, the down-drift side of the groin will lose sediment/erode. In the situation of a groin field, sediment between groins is relatively stable. The most down-drift groin, however, is still subject to this potential erosional effect. Since there is a significant net long shore sediment transport along the seawall, a groin field would be very effective at retaining sediment in front of the seawall. However, erosion effects at the down-drift side of the seawall could be very significant with minimal opportunities for wave action to replenish the down-drift side with sediment. A potential solution to offset the significance of the down-drift erosion is to create a groin structure that is quasi-porous allowing a portion of the sediment to transport through the groin structure. An example of this would be a series of timber piles driven close to each other or armor rock structure with a low crest elevation. Making the groin structure quasi-porous also limits the effectiveness of the groin. Figure 11 provides a plan-view schematic of this concept.

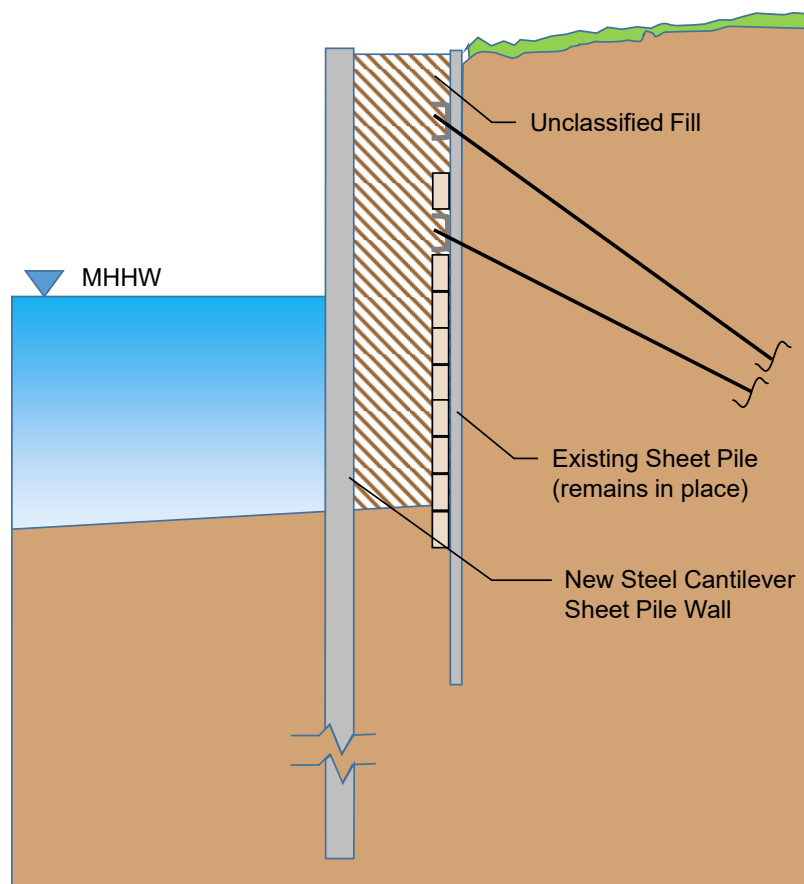
CONCEPT 4 – NEW STEEL SHEET PILE WALL

Figure 12. Concept 4 - New steel sheet pile wall schematic.

A new steel sheet pile wall, similar to the wall used to repair the seawall on the eastern side could be installed just seaward of the existing wall. The wall could be design to be cantilevered (i.e. requiring no tie backs). Fill would be placed between the new steel sheet pile wall and the existing sheet pile wall effectively encapsulating the structure. The design life of the existing structure would then be negated as the design life would solely rely on the new steel sheet pile wall. This concept would be similar to the current seawall, but with a more robust structure. Figure 12 provides a schematic of this concept.

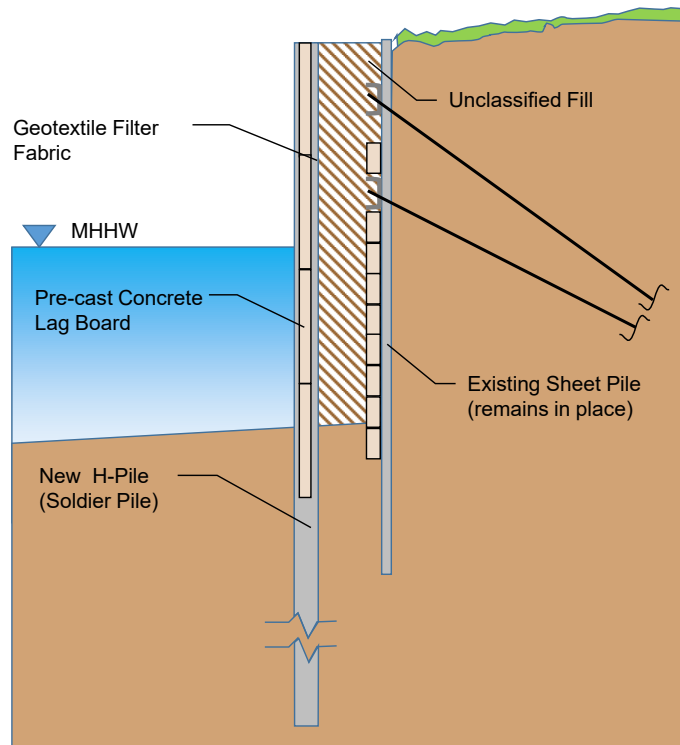
CONCEPT 5 – NEW SOLDIER PILE AND CONCRETE LAG WALL (SECTION)

Figure 13. Concept 5 - New soldier pile and concrete lag wall section schematic.

A soldier pile and concrete lag wall would be an innovative approach to shoring up the existing seawall. A soldier pile is a single pile that is designed to be stout and handle significant loading. A concrete lag is a pre-cast concrete block. This concept would entail driving steel H-piles and then sliding concrete lags between H-piles to create a wall. The overall wall would be designed to be cantilevered (i.e. does not require tie-backs). This wall would be installed just seaward of the existing seawall and fill would be placed between the new seawall and the existing seawall. A unique feature of this concept is that as the beach elevation lowers over time, the concrete lags can be lowered to meet the new beach grade (and might lower due to their own weight). Then additional lags can be placed on top of the existing lags to continue expanding the height of the wall. Note, placing additional lags would require mobilizing construction equipment. A geotextile filter fabric would need to be installed on the landward side of the wall to prevent sediment from piping through the concrete lags. If existing lags are moved deeper and additional lags are placed, careful maintenance of the geotextile filter fabric will be required to mitigate sediment from migrating through the wall. Figure 13 and Figure 14 provide schematics of Concept 5. An example of this concept is shown in Figure 15

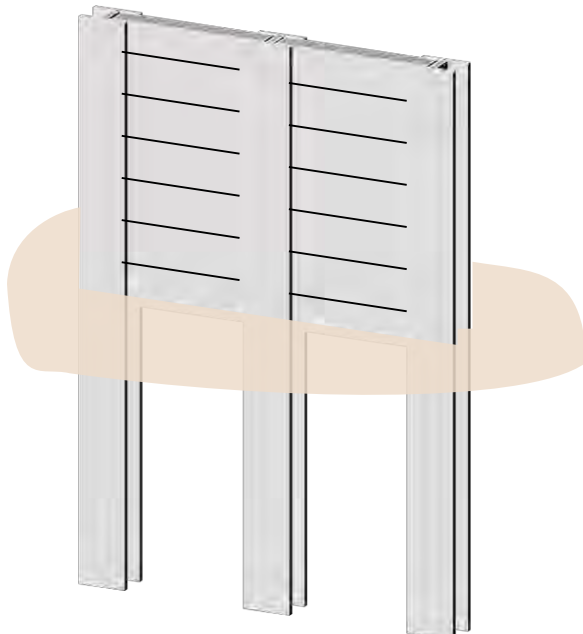
CONCEPT 5 – NEW SOLDIER PILE
AND CONCRETE LAG WALL (OBLIQUE)

Figure 14. Concept 5 - New soldier pile wall and concrete lag wall section oblique and plan schematic.

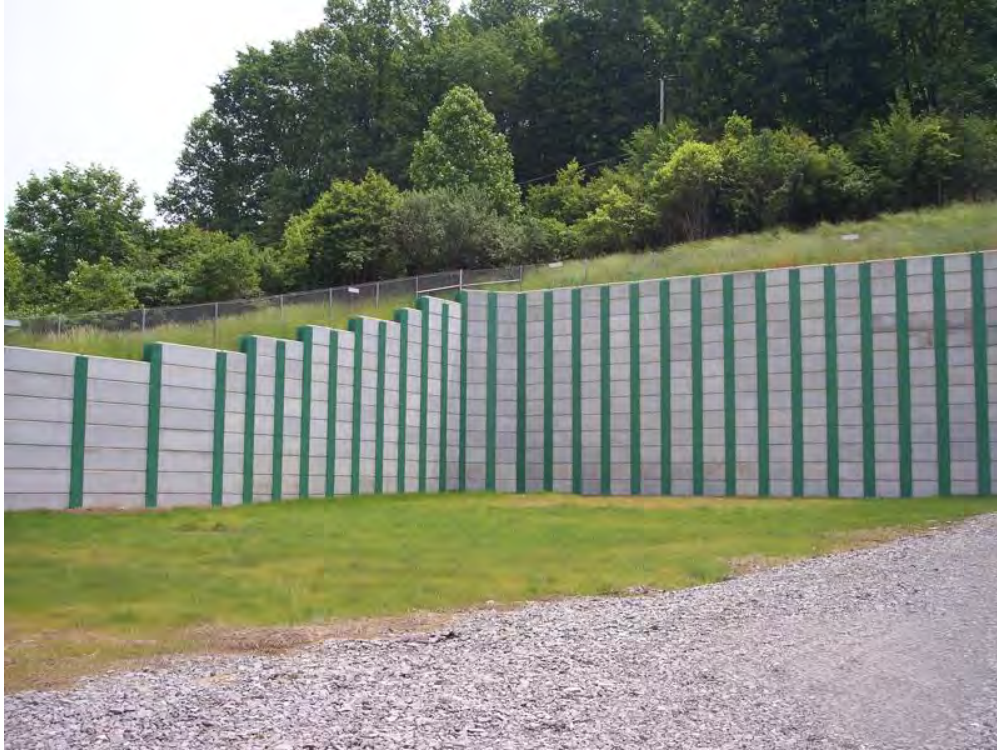
Figure 15. Example of a concrete lag wall (source: easternvault.net).
