HISTORIC RESOURCES ADVISORY COMMITTEE - SPECIAL MEETING AGENDA

March 20, 2024 at 12:00 PM

STRUCTURAL CONDITION SURVEYS

Telephone Hill is located in downtown Juneau, Alaska. This neighborhood consists of historic homes that were built between 1882 and 1947. The City and Borough of Juneau owns this neighborhood and is exploring potential options for redeveloping the land. RESPEC Company, LLC (RESPEC) was retained to provide a structural condition survey of each of the seven residences.

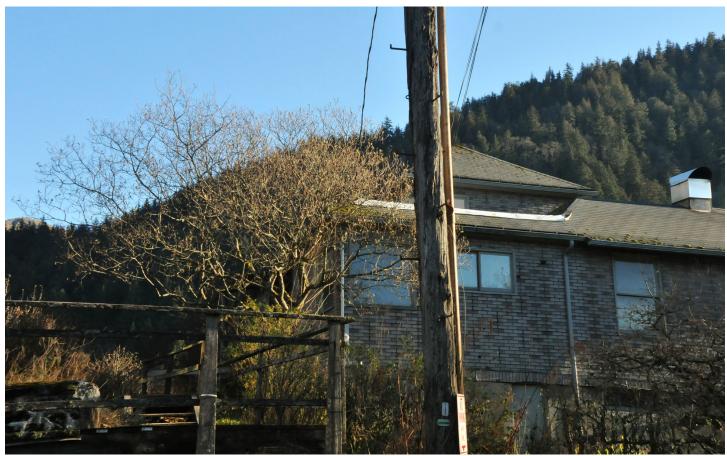
D-02: Edward Webster House

West Facade; Higher roofline reflects the initial, two-story house. Lower roofline shows later renovation encompassing the original house.

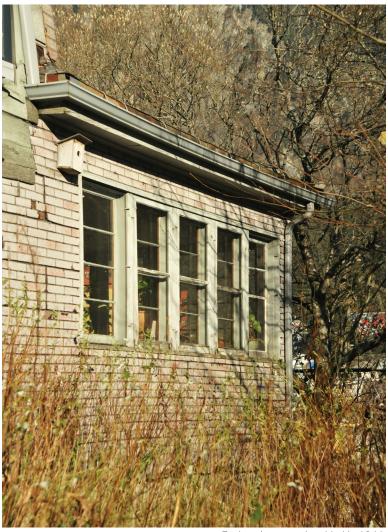
Enclosed sun porch, added in 1946. Edward Webster House, 2023

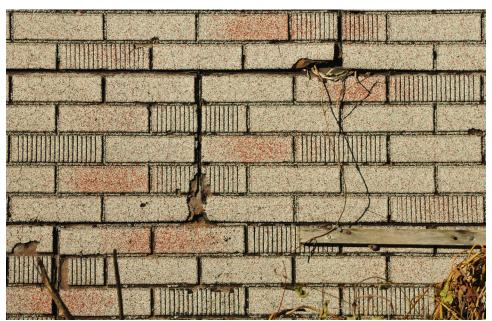
Asphalt-shingle siding covers the original clapboard siding. Therefore the residence does not retain the key exterior materials dating from the period of its historic significance. Edward Webster House, 2023

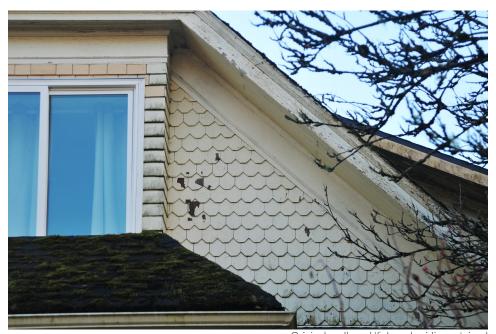
Original scalloped/fish scale siding retained Bosch-Carrigan House, 2023

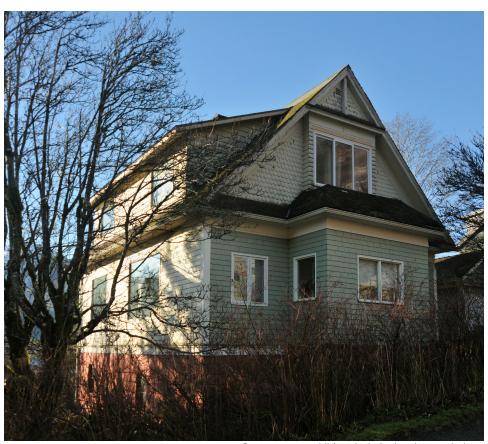
Throughout the evolution of the property, certain windows have been replaced. Notably, a decorative bay window on the south facade has been substituted with a large picture window, contributing a contemporary element to the structure. Additional fixed-sash windows have been added on the front and rear facades.

Contemporary additions include the picture windows and dormer on the south facade Bosch-Carrigan House, 2023

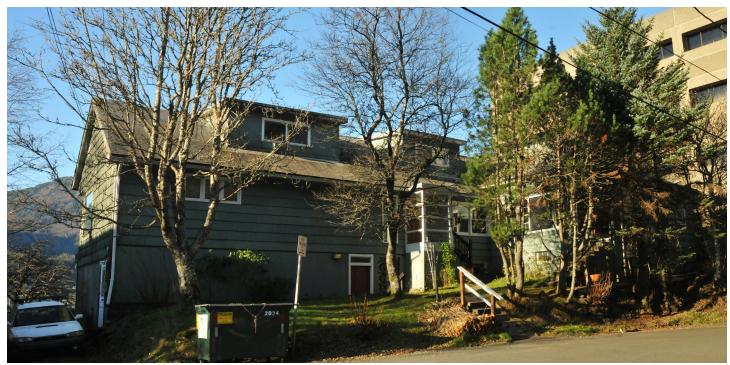
D-04: Peterson-Kasnick House

East Facade. Additions have encompassed the original residence.
Peterson-Kasnick House, 2023

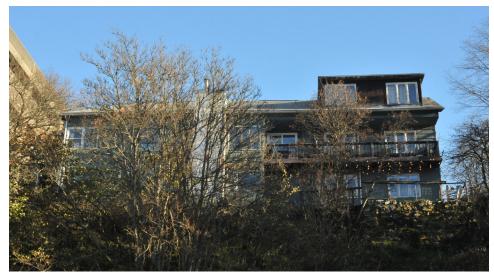
West Facade. Contemporary decks added to allow access to the three basement apartments. The dormer is also a contemporary addition. Peterson-Kasnick House, 2023

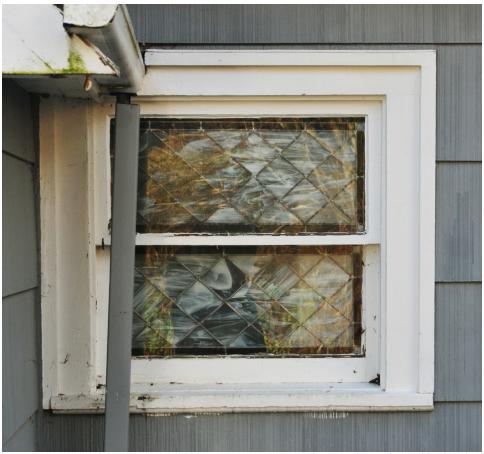
East Facade. Retention of diagonal leaded glass patterned window. Martin-Johnston House, 2023

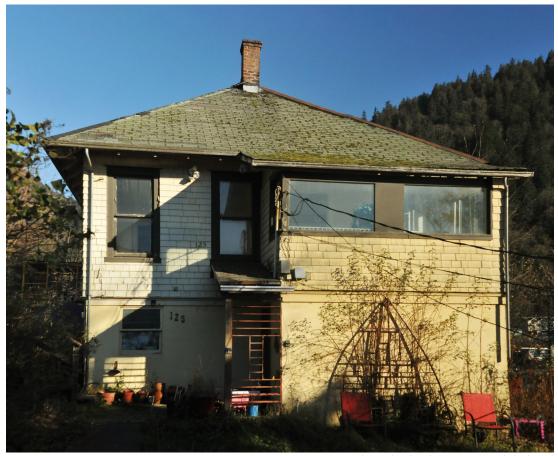
D-07: Worthen-Hurley House

West Facade. Cedar shingles cover original clapboard siding. The large, picture windows in the upper left are part of the open porch that was enclosed in the 1950s.

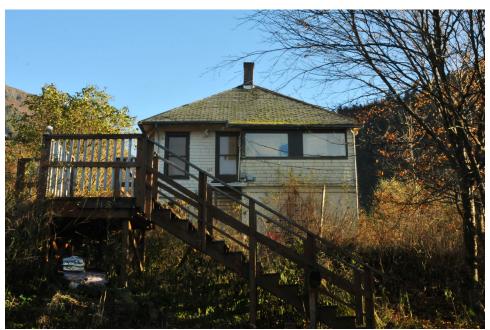
West Facade. Stairs and decks are contemporary additions. Worthen-Hurley House, 2023

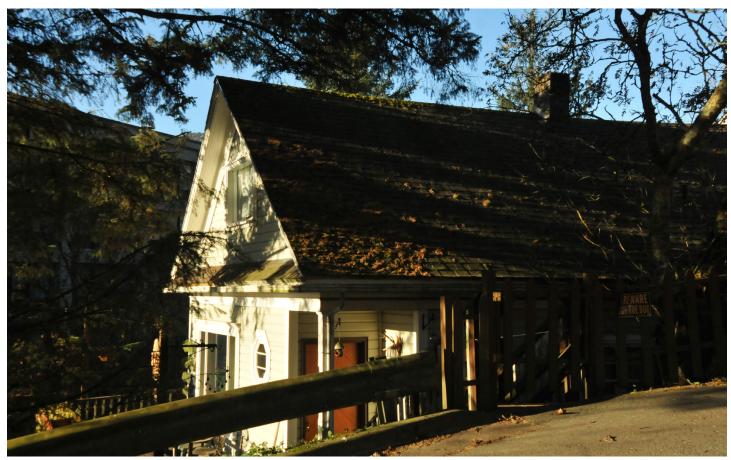
D-08: Augustus Brown House

South and East Facades. Augustus-Brown House, 2023

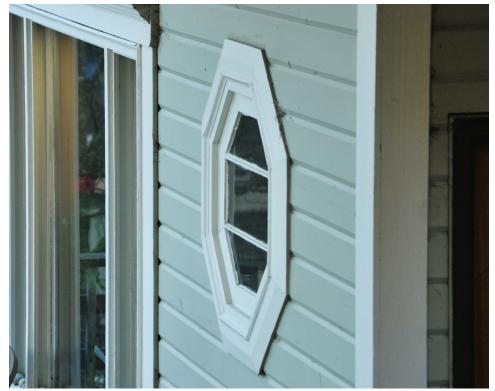
South Facade. Contemporary vinyl siding clads the residence.

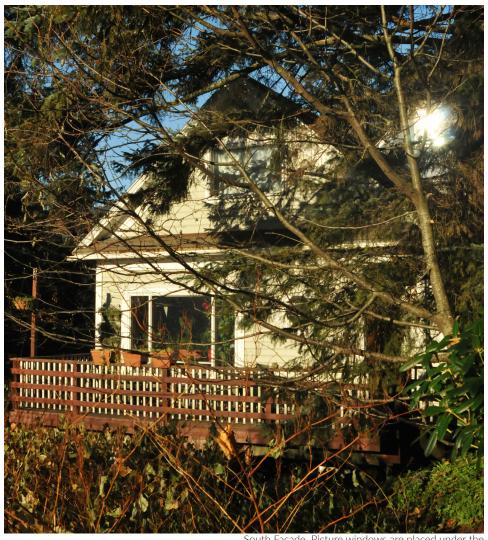
South Facade. Picture windows are placed under the gable and at the main level of the residence. Augustus-Brown House, 2023
