**Item:** Sandalwood Stormwater Evaluation

**DAM AND CULVERT REPORT  
FOR  
SANDALWOOD TOWNHHOMES**

**SHOAL CREEK TRIBUTARY 4.1**

### APPENDIX A - Visual Existing Condition on Dam

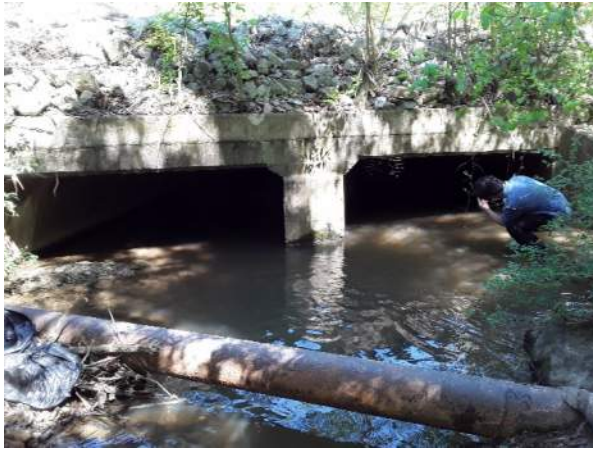
**Picture 1:** Upstream Headwall

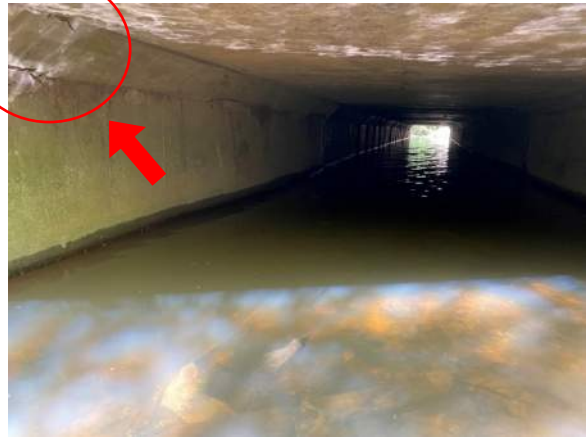
**Picture 2:** Right box culvert (facing East/downstream) has ~7" of sediment. Very small chips present in concrete at the south end in the top left corner (as seen in the picture).

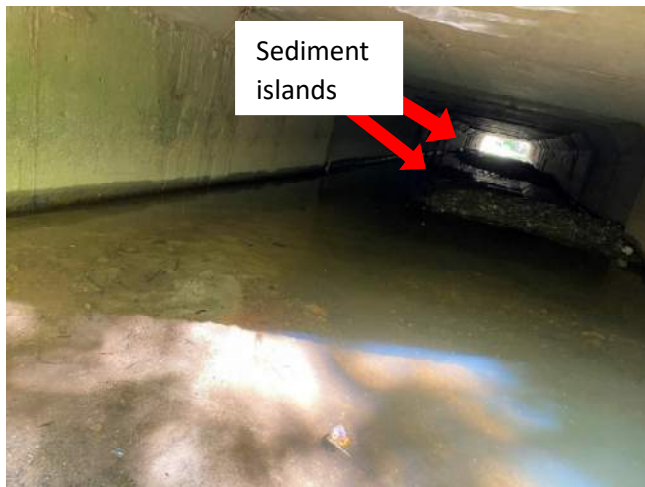
**Picture 3:** Left box culvert (facing East/downstream) has about 2' of sediment. There are islands of sediment about a quarter of distance downstream and halfway through the culvert causing 6" of ponding.

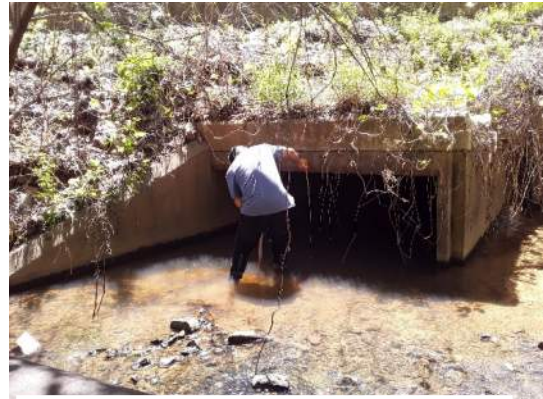
**Picture 4:** Left downstream headwall

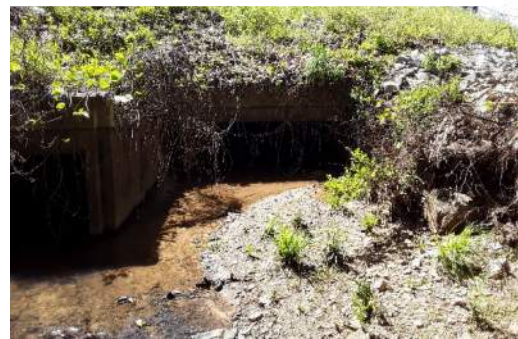
**Picture 5:** Right downstream headwall

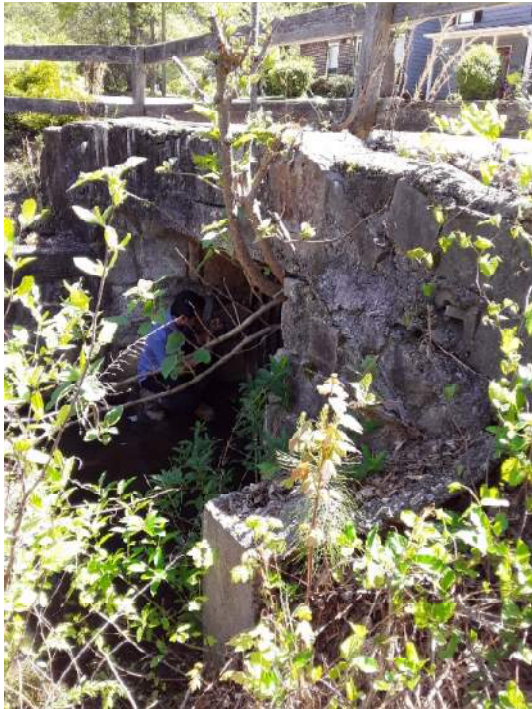
**Picture 1:** Downstream headwall

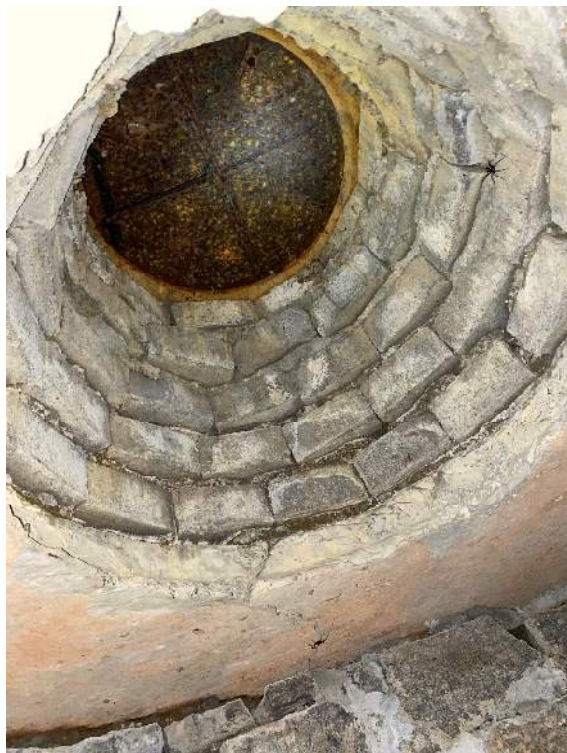
**Picture 7:** Customized junction box structure where the pipe turns.

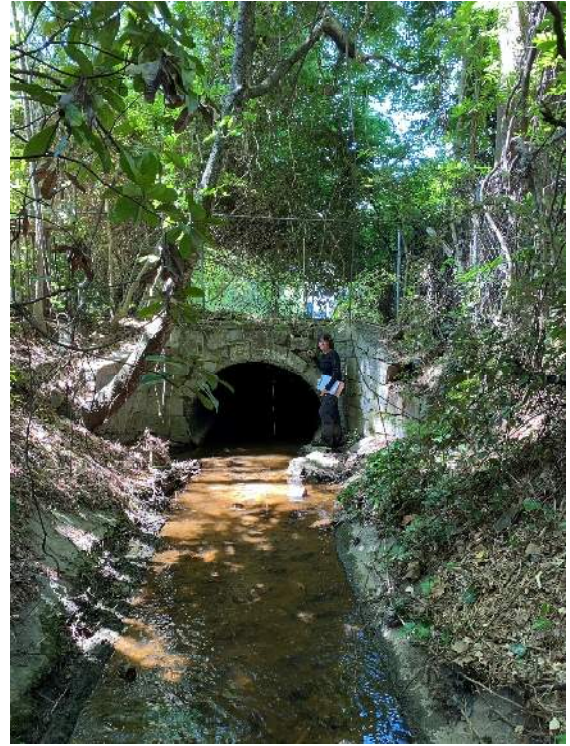
**Picture 13:** Upstream headwall

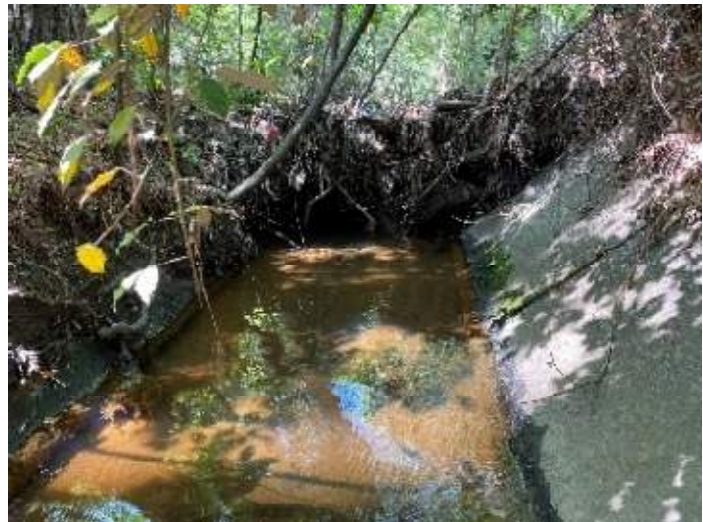
approximately 2" of flow within the pipe. Upstream of the pipe is a concrete flume approximately 52" wide with 3:1 side slopes ranging in height. The flume is in good condition considering the age. There are some cracks along the side slopes. There is a large blockage approximately 3' high upstream of the headwall. (See Photo 15 Page C-32).

**Picture 15:** Logs and branches have clogged up the flume upstream of the pipe. Lack of freeboard endangers adjacent town homes.

It is critical to remove the 3' deep blockage within the concrete channel. The resulting backwater from this blockage is very likely to flood the adjacent townhomes.

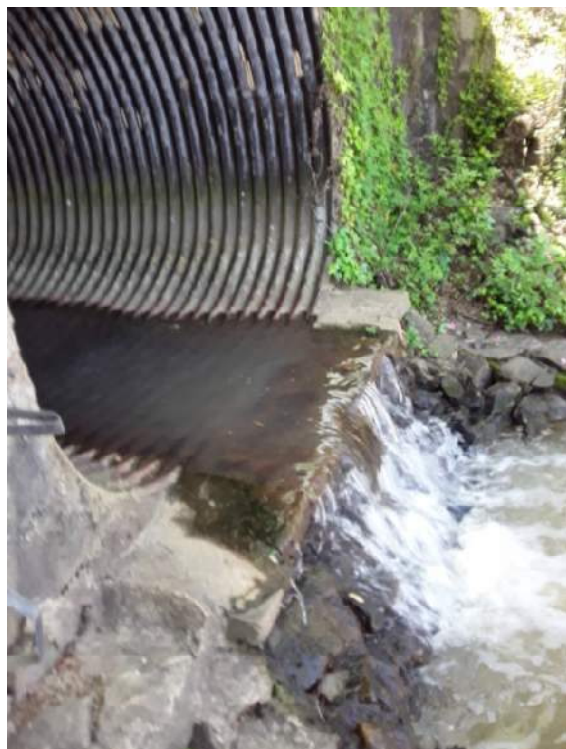
**Picture 1:** Downstream headwall.

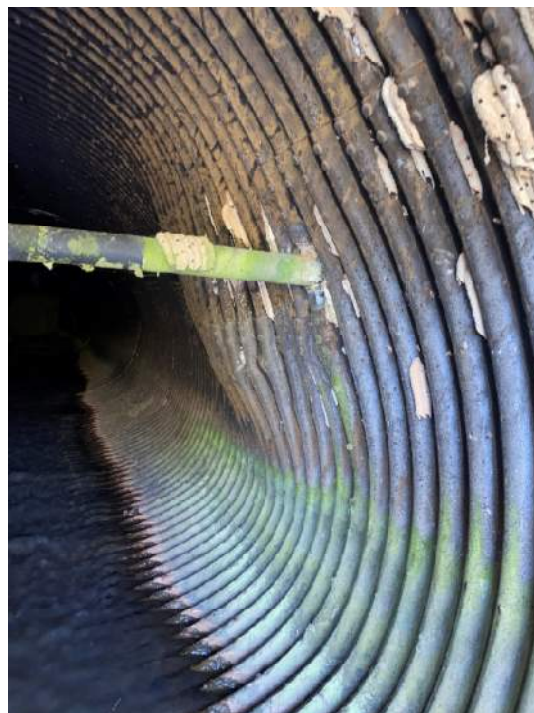
**Picture 2:** Gas pipe crosses at  $\pm 5'$  from downstream headwall.

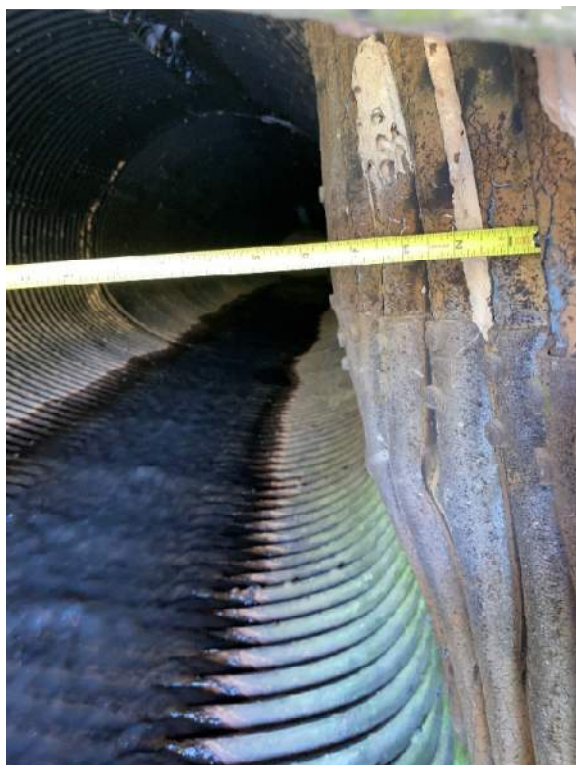
**Picture 3:** 5" bulge next to pipe in picture 2.

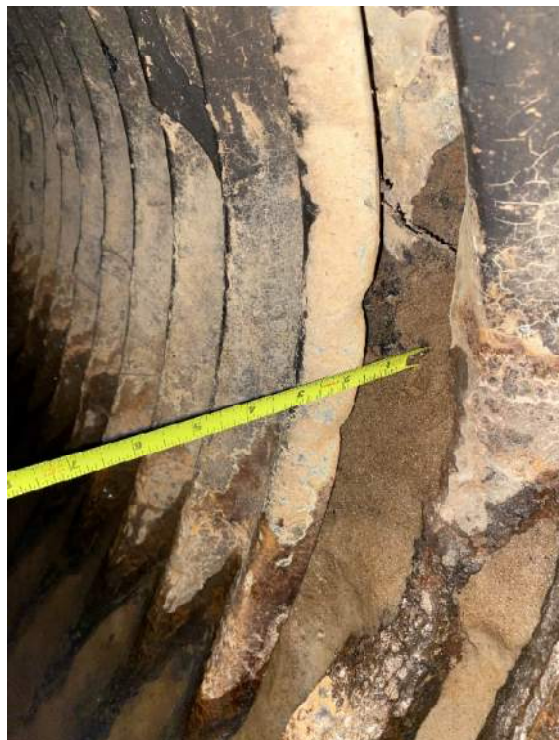
**Picture 4:** 2" gap between pipes at pipe joint. Some sediment making its way into the pipe.

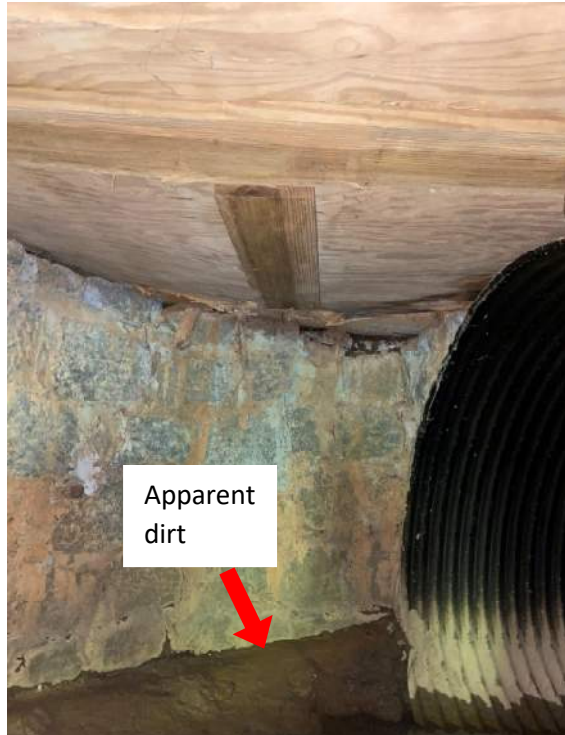
**Picture 5:** Customized junction box where pipe turns. A small embankment of dirt against one of the walls.

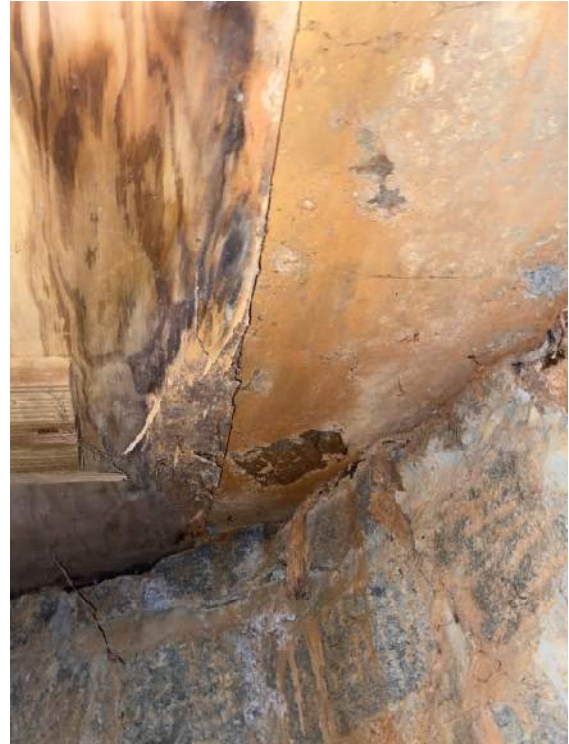
**Picture 6:** Concrete slab as roof of junction box. Wood forms remain across structure.

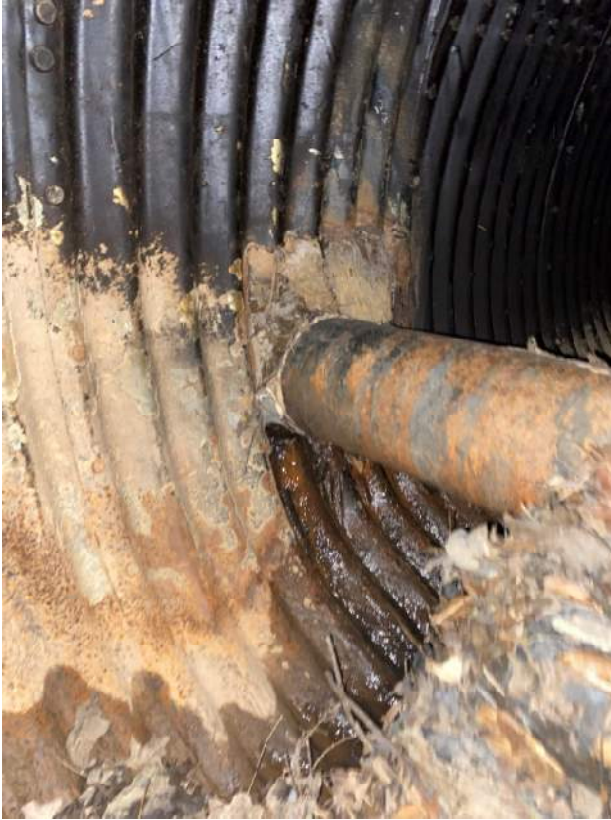
**Picture 13:** Small gap where pipe penetrates. Some sediment is escaping into the pipe.

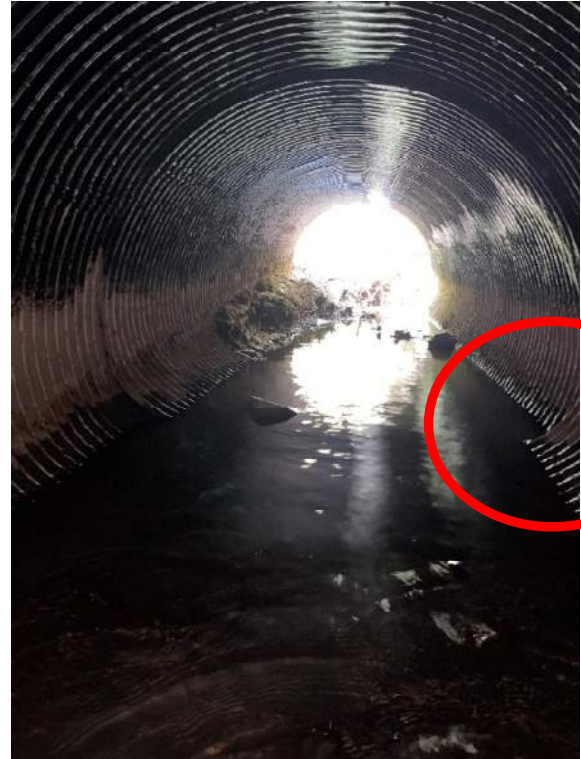
**Picture 14:** Gap between pipes at pipe joint. Gap located  $\pm 25'$  from upstream headwall.

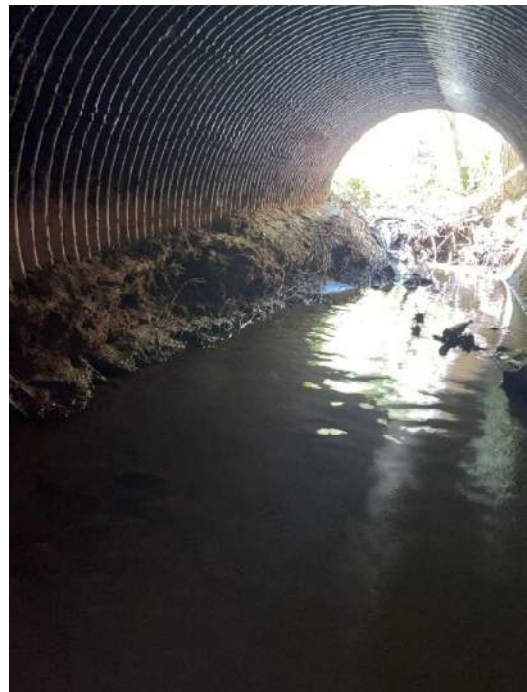
**Picture 16:** Solid sediment berm on the upstream end of the pipe.

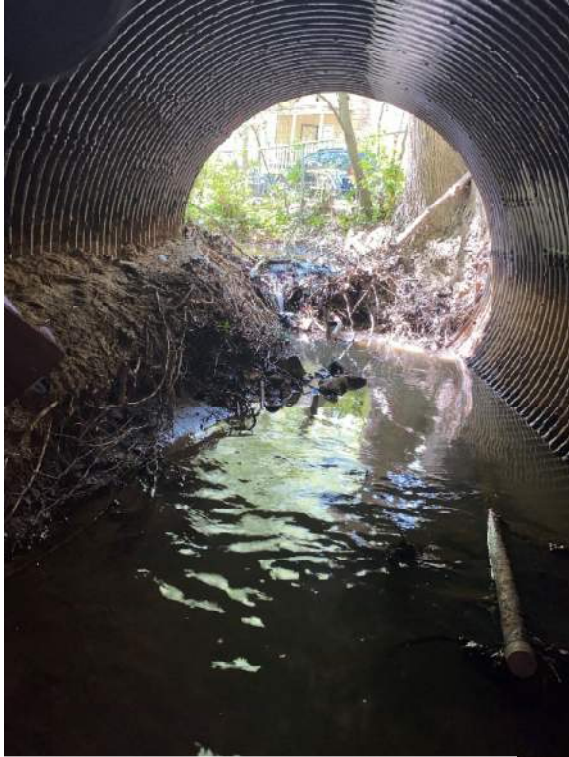
**Picture 17:** Branches, logs, and sediment clogging the upstream headwall of the pipe.

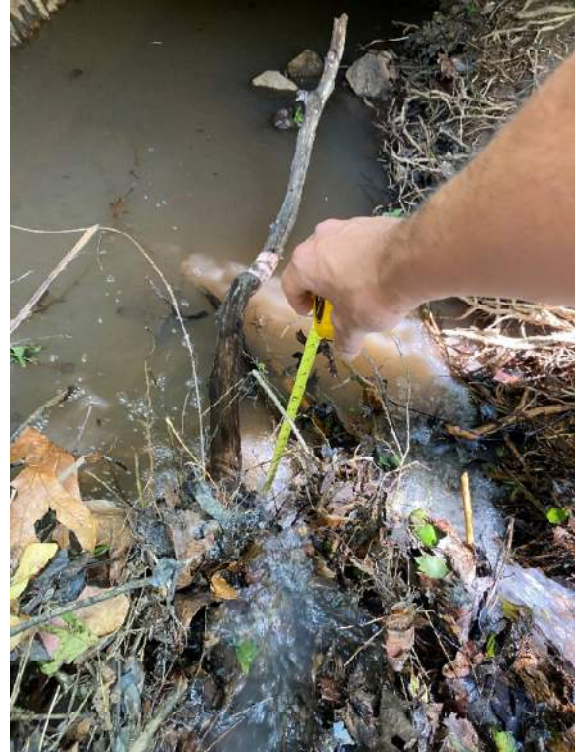
**Picture 18:** 1.5-2" of debris/sediment build up at upstream headwall.

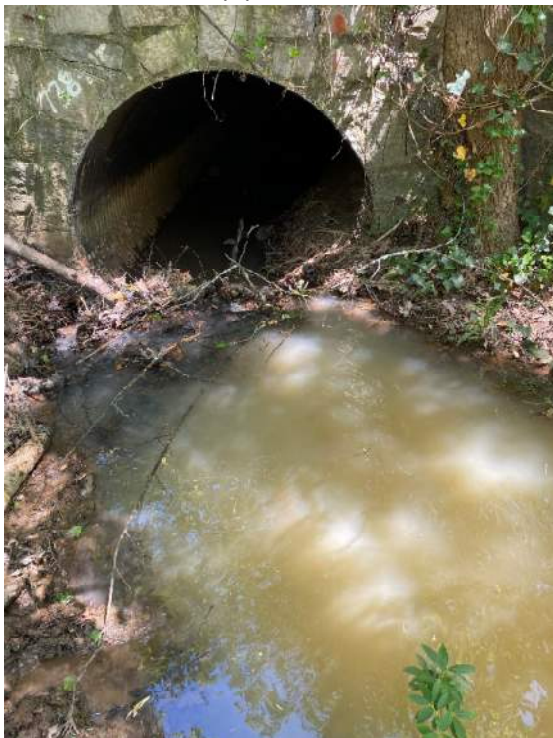
**Picture 19:** Water ponding up at upstream headwall.

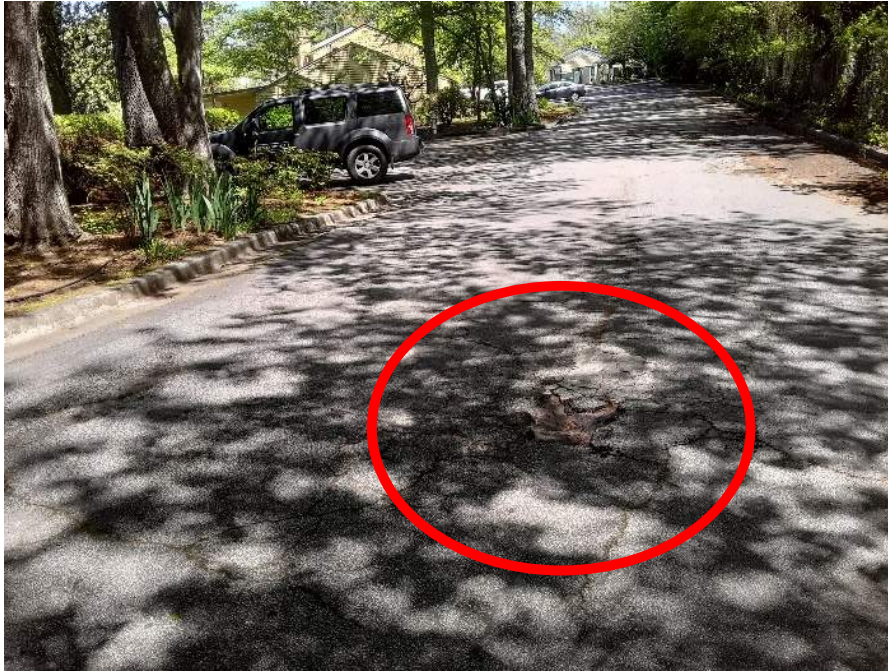
**Picture 21:** Pothole on road in the vicinity of the pipe.

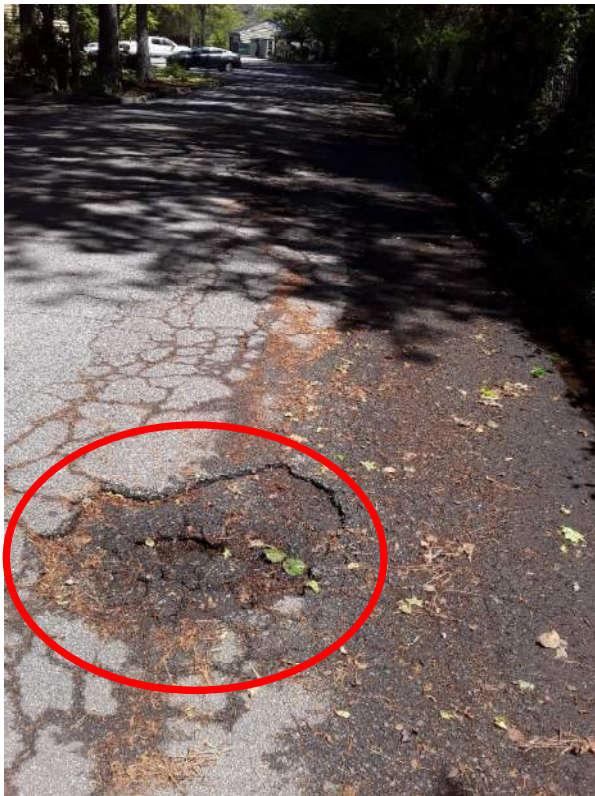
**Picture 22:** Second pothole on road in the vicinity of the pipe.

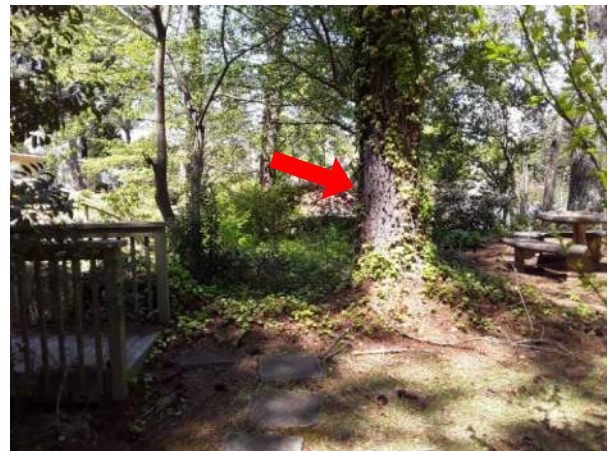
**Picture 23:** Tree appears to be above the pipe's path.

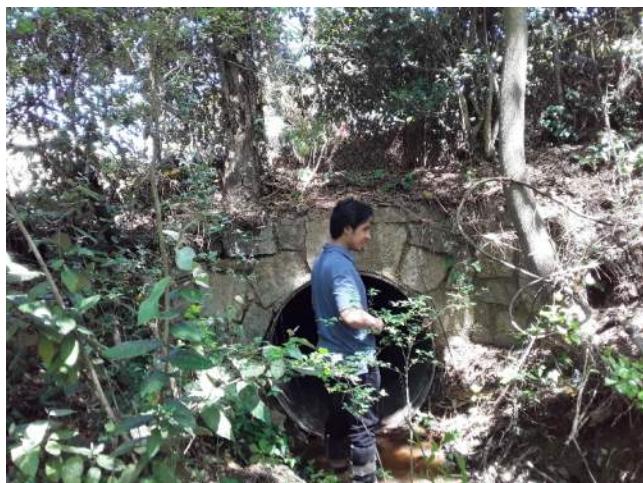
**Picture 1:** Upstream headwall.

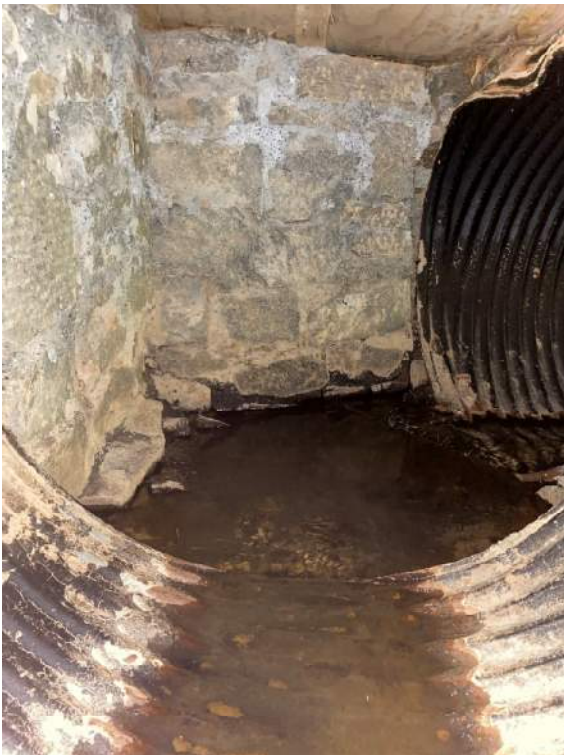
**Picture 9:** Customized junction box where pipe turns.

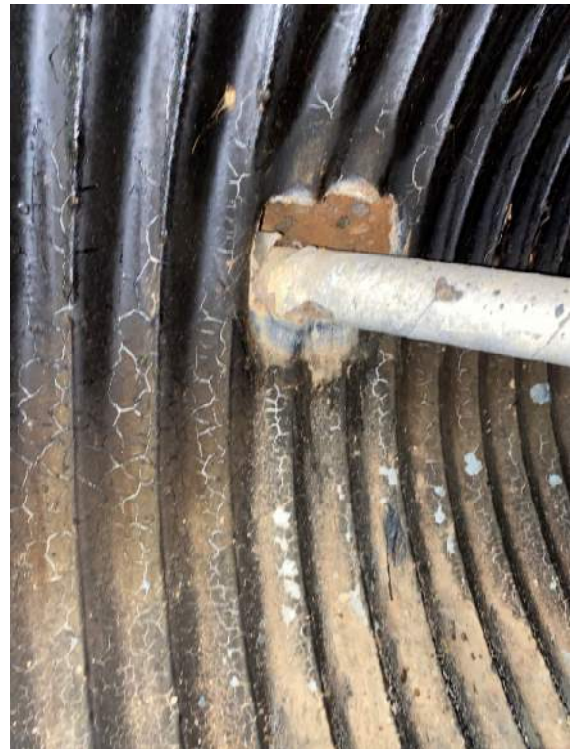
**Picture 10:** 4" pipe crossing close to downstream headwall. Dirt is visible where pipe penetrates.

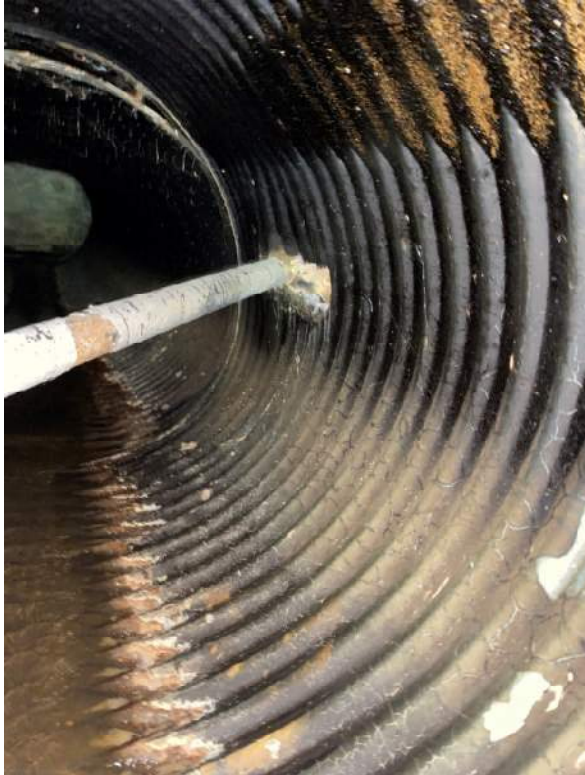
**Picture 11:** Other end of crossing pipe shown on picture 8. Dirt visible where pipe penetrates.

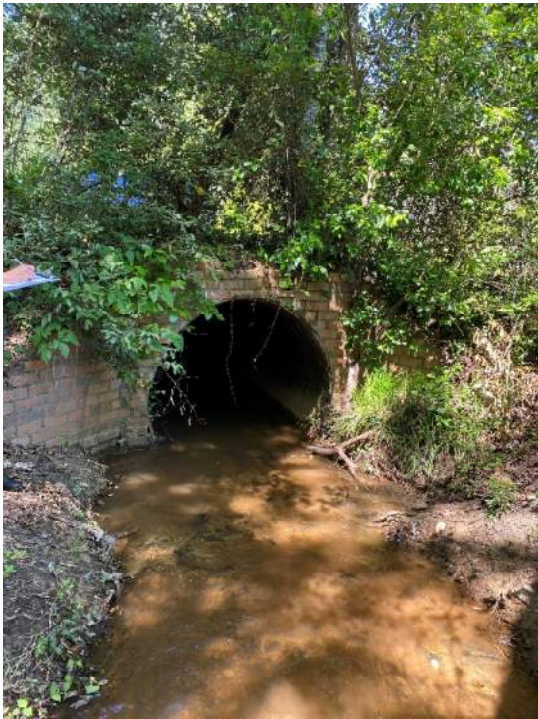
**Picture 1:** Upstream headwall

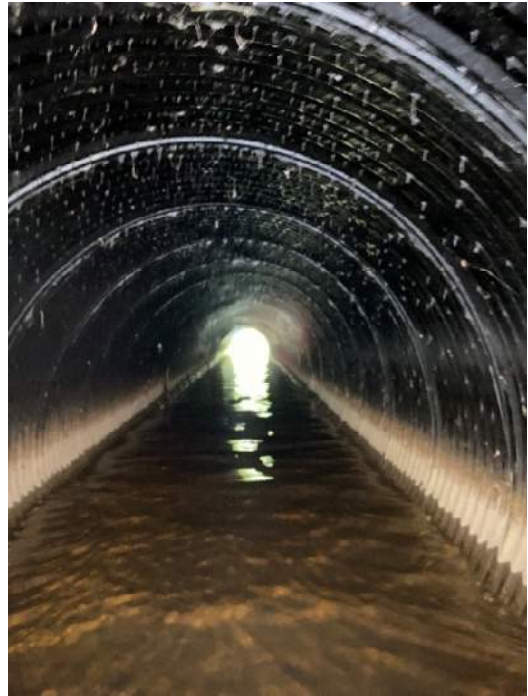
**Picture 2:** 6"-18" of sediment in pipe bottom.

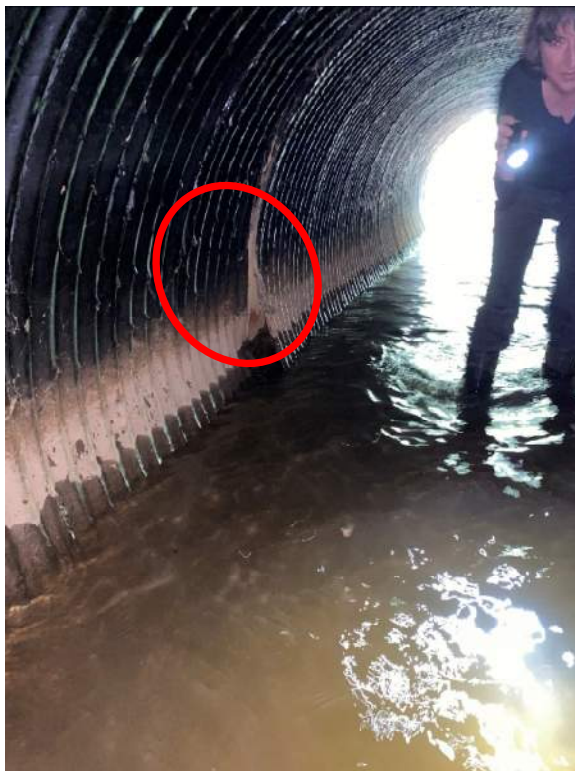
**Picture 3:** Gap at pipe joint.

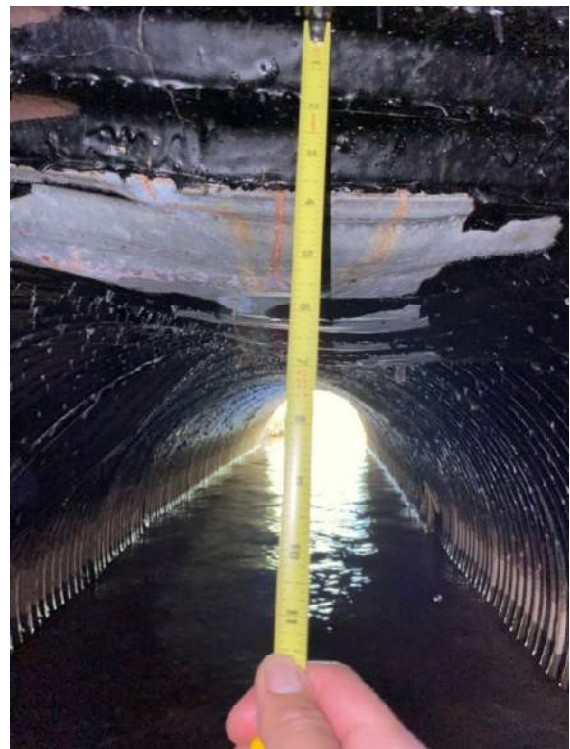
**Picture 4:** Approximately midway through the pipe a 6" bulge protrudes  $\pm$  3' along the top of the pipe.

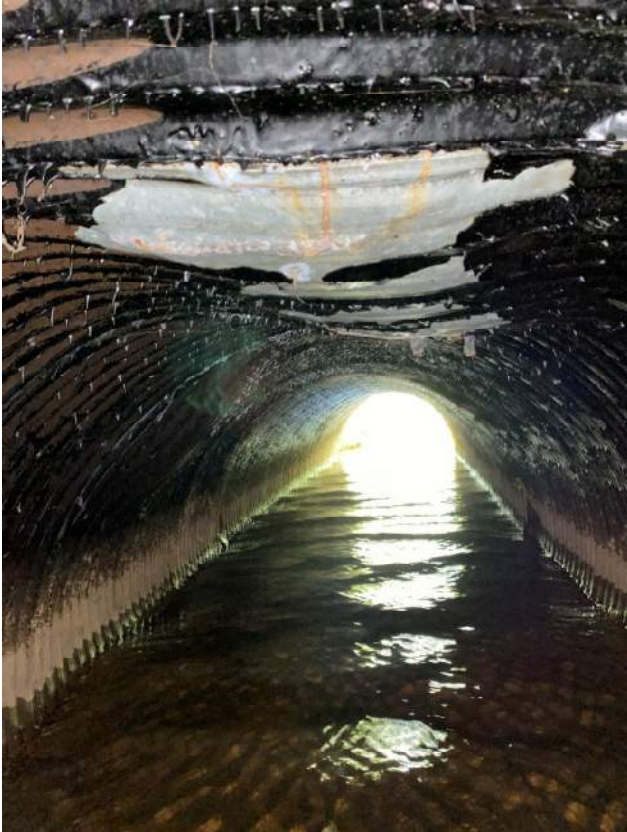
**Picture 5:** 6" bulge shown in picture 4.

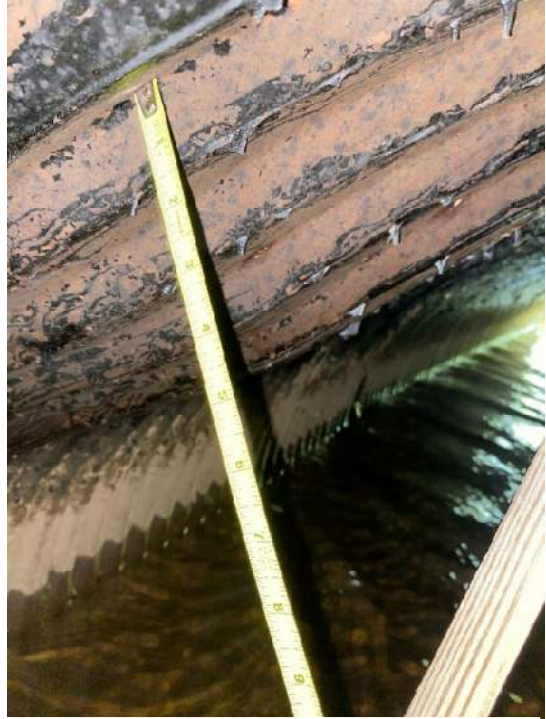
**Picture 6:**  $\pm 4$ " bulge protrudes from the side of the pipe.

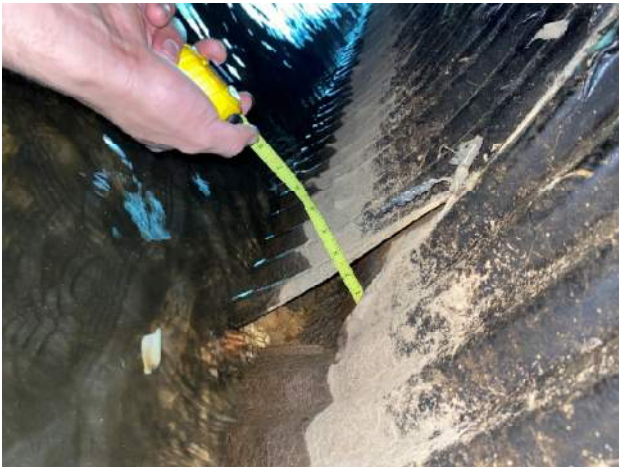
**Picture 7:**  $\pm 2$ " gap at pipe joint.

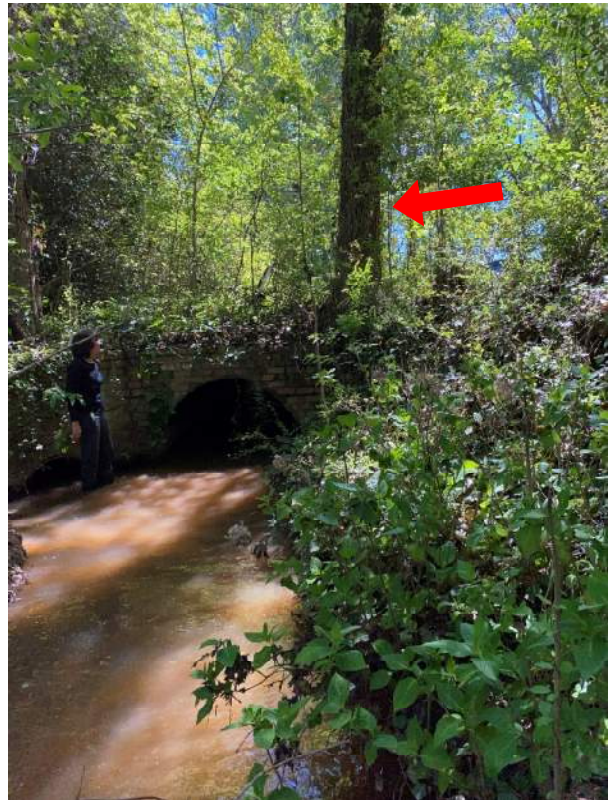
**Picture 8:** Downstream headwall. Large tree sits on top of headwall.
