**TOWN OF LOS GATOS
HISTORIC PRESERVATION COMMITTEE
JANUARY 28, 2026
110 EAST MAIN STREET
TOWN COUNCIL CHAMBERS
4:00 PM**

2. Consider a Request to Remove a Pre-1941 Property from the Historic Resources Inventory for Property Zoned R-1:10. **Located at 8 Central Court.** APN 529-35-034. Exempt Pursuant to CEQA Section 15061(b)(3). Request for Review PHST-26-001. Property Owner: William Holt and Elizabeth LaSorsa. Applicant: Joel Stieber. Project Planner: Sean Mullin.
3. Consider a Request for Approval to Construct a New Second-Story Addition and Exterior Alterations to an Existing Pre-1941 Single-Family Residence on Property Zoned R-1D. **Located at 34 Pleasant Street.** APN 529-26-018. Exempt Pursuant to CEQA Guidelines, Section 15301: Existing Facilities. Minor Residential Development Application MR-25-003. Property Owner: Michael Hyman. Applicant: Maia Gendreau. Project Planner: Ryan Safty.

FOUNDATION INSPECTION AND CONDITION ASSESSMENT
8 Central Court, Los Gatos, CA

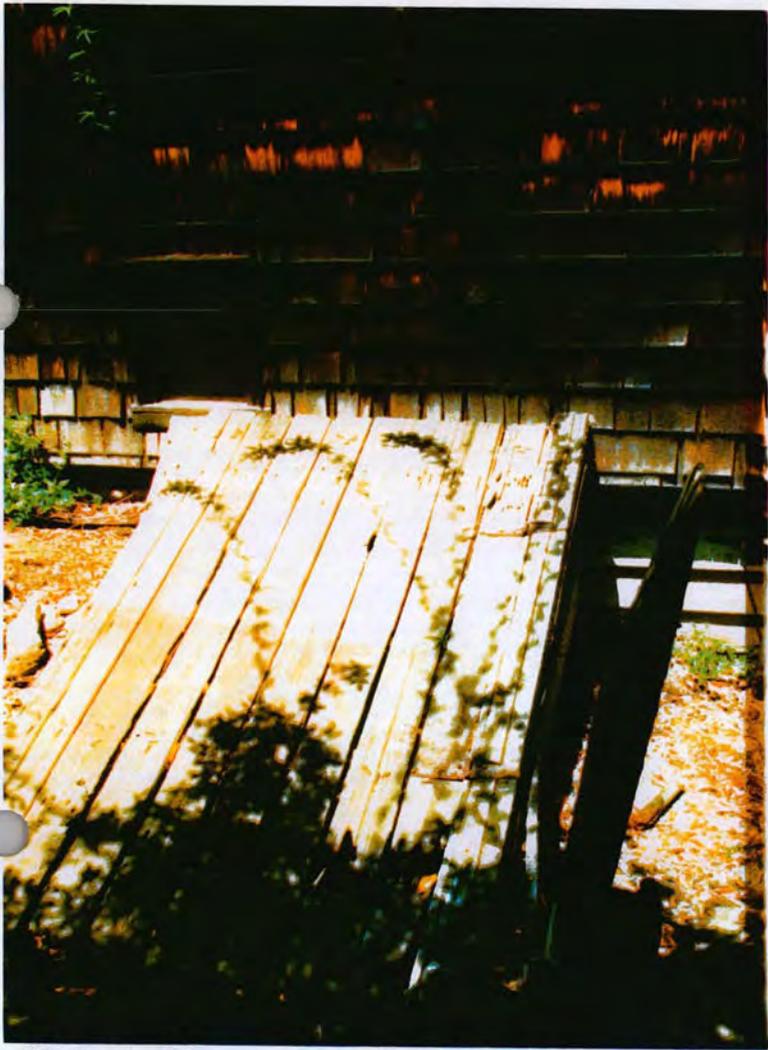
#9 Central Court - Basement View VIEW V12

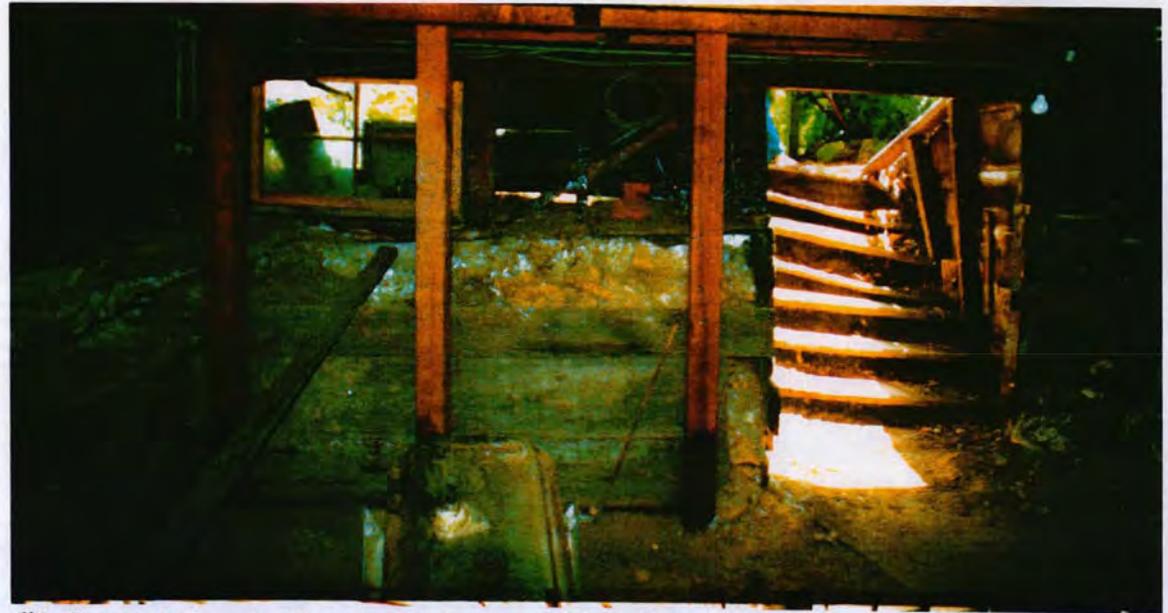
#9 Central Court - Basement Access - West Side of House

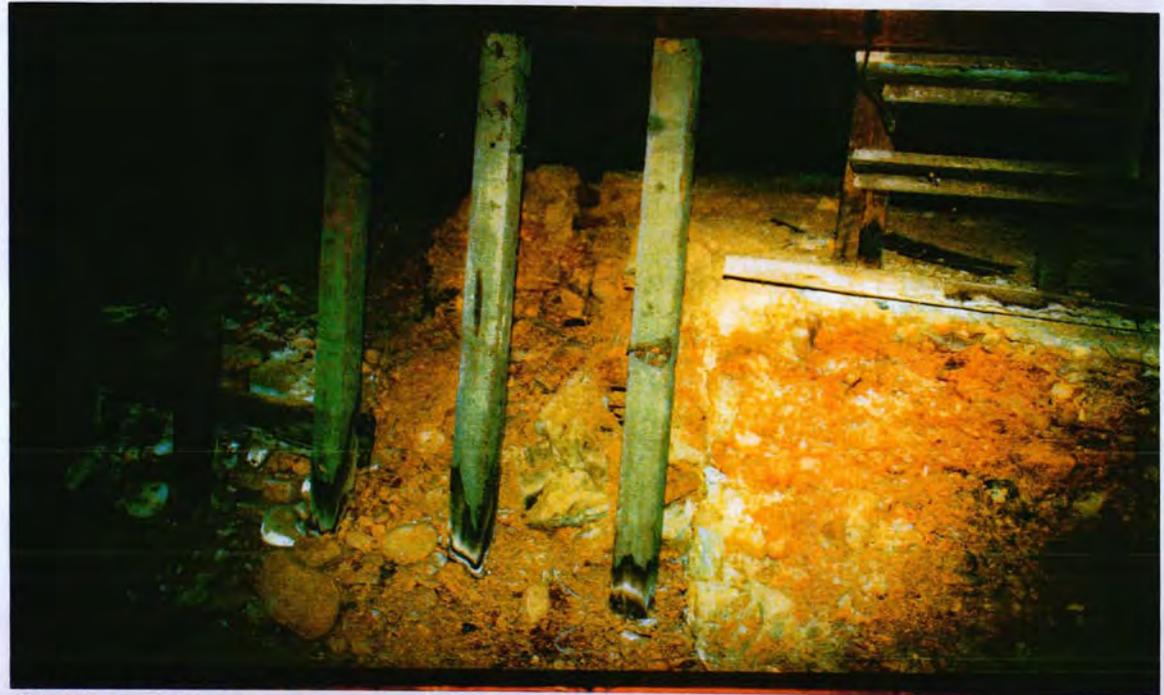
#9 Central Court - Basement View

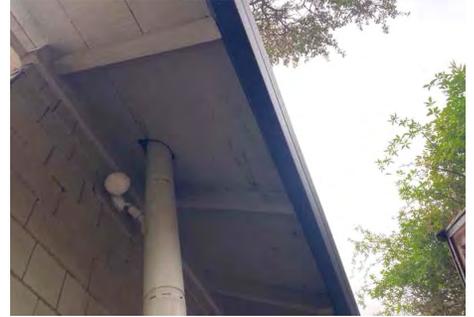
Photo 56

29. There is insufficient clearance between the furnace exhaust flue and combustible materials. This should be corrected. (See Photo 56)

- ! 1. There is insufficient clearance between the furnace exhaust flue and combustible materials. This should be corrected. (See Photo 56)

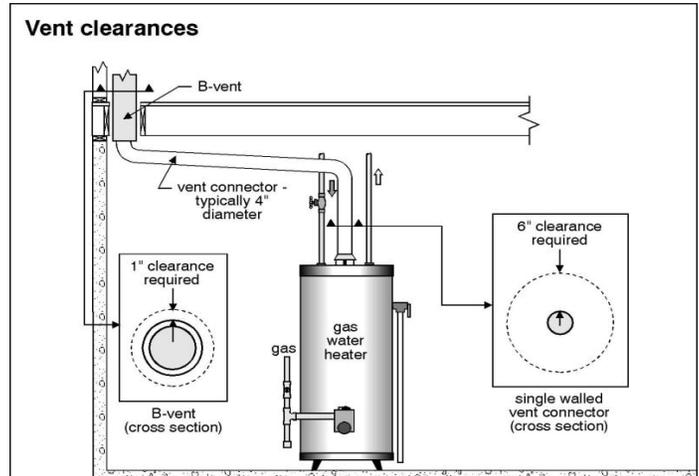
Illustration 8C

- ! 3. There is insufficient clearance between the water heater exhaust flue and combustible materials. This condition should be corrected. (See Illustration 8C) (See Photo 30)

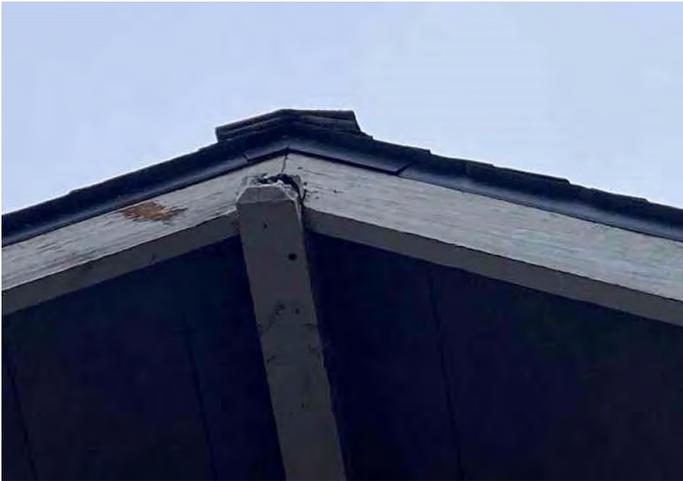
Photo 01

- ! 15. The jamb is cracked, split or damaged at the back storage shed door. We recommend it be repaired or replaced. (See Photo 12)
- ! 16. Mechanical damage was observed to the beam ends at the left and right side. We recommend the services of a licensed general contractor and/or structural pest control company. (See Photo 1)

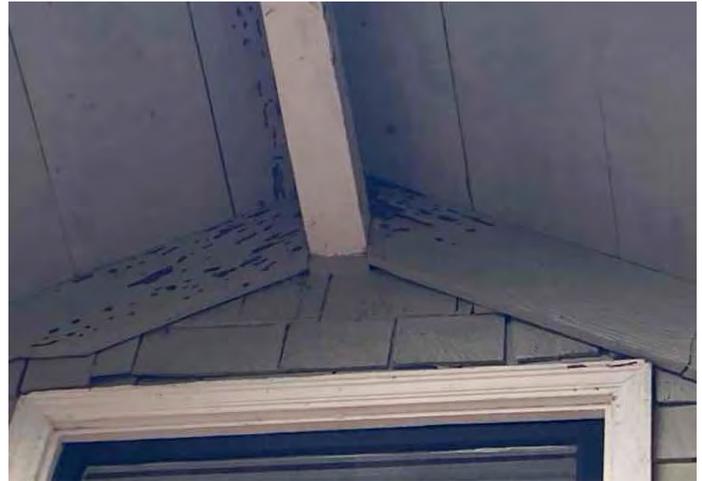
Photo 02

- ! 8. Mechanical damage was observed to the rafters at the left side and various areas. We recommend the services of a licensed general contractor and/or structural pest control company. (See Photo 2) (See Photo 29)

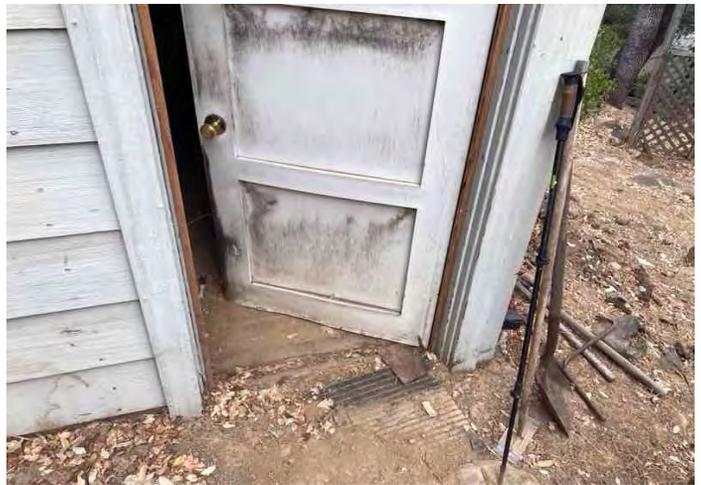
Photo 10

- ! 5. Water damage was noted at the back storage shed door. We recommend the services of a licensed general contractor and/or structural pest control company regarding repairs. (See Photo 10)

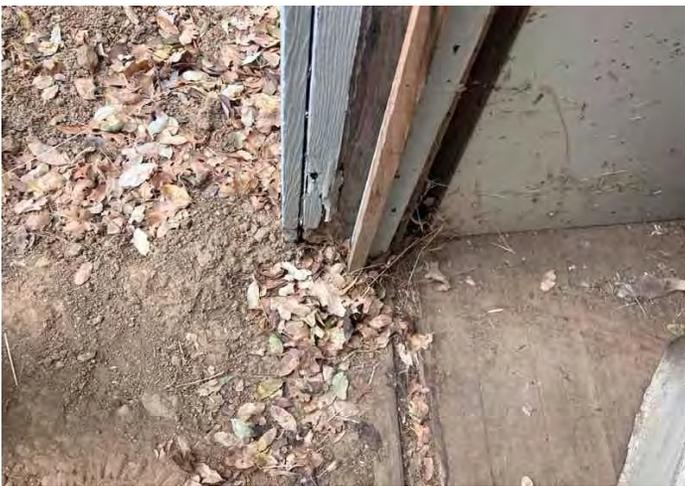
Photo 11

- ! 17. Water damage was noted at the back storage shed door jamb. We recommend the services of a licensed general contractor and/or structural pest control company. (See Photo 11)

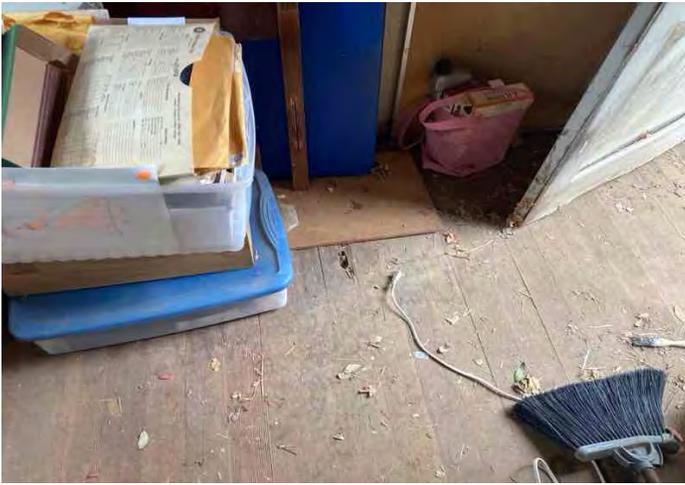
Photo 13

- ! 20. Damage to the front bathroom and bathroom storage shed hardwood flooring was observed. The extent of damage is difficult to predict without removing floor coverings. It is recommended that the source of the damage be identified and corrected by the appropriate trades. (See Photo 13) (See Photo 34)**

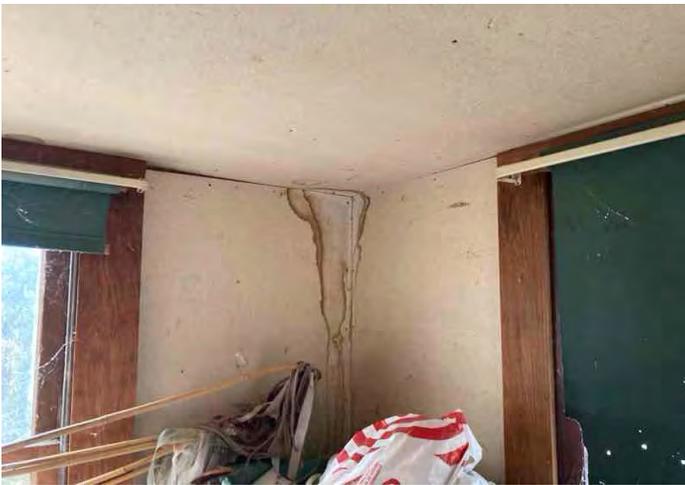
Photo 15

- ! 1. The ceiling at the back shed and side shed shows evidence of water stains. It is recommended that the source of these stains be identified and corrected and the surface be refinished. (See Photo 15)

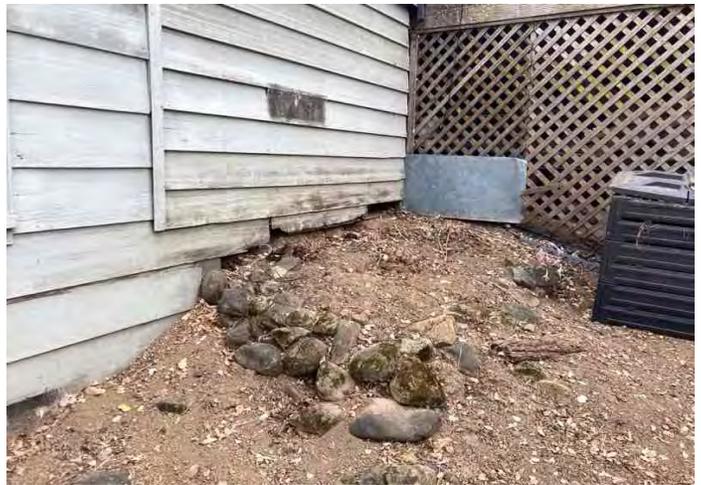
Photo 16

- ! 10. Water damage was observed to the wood siding at the front and various areas exterior walls. We recommend the services of a licensed general contractor and/or structural pest control company. (See Photo 16) (See Photo 26) (See Photo 54)

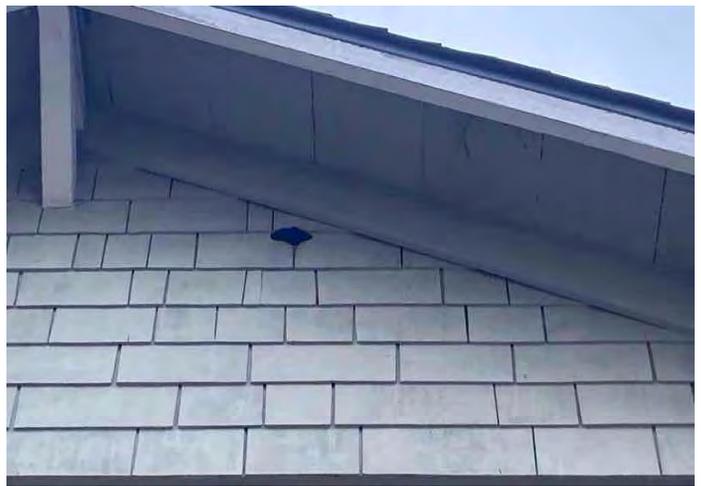
Photo 18

- ! 12. There is an opening or hole in the siding at the right side and various areas of the rear exterior wall. We recommend this area be repaired or replaced to eliminate moisture or rodent entry. (See Photo 18)

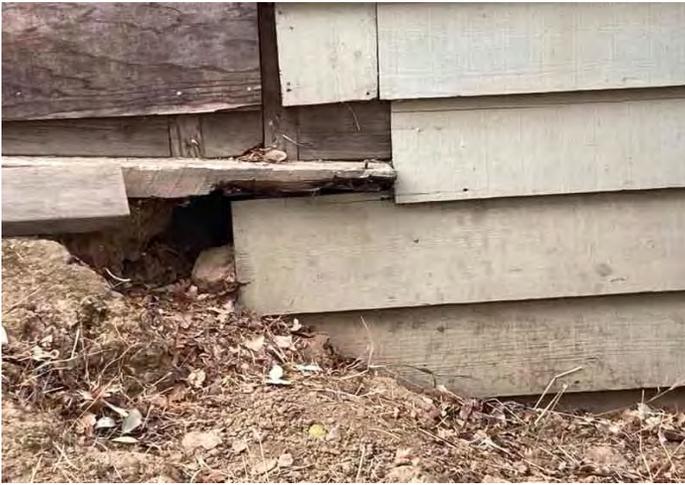
Photo 19

- ! 11. Water damage was observed to the exterior trim at the back and left rear corner. We recommend the services of a licensed general contractor and/or structural pest control company. (See Photo 19) (See Photo 21)

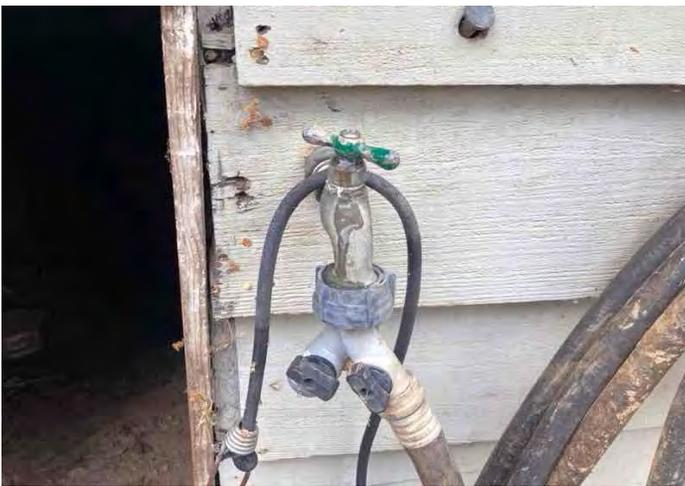
Photo 23

- ! 4. The exterior hose bib at the back is leaking. We recommend all leaks be repaired. (See Photo 23)
 5. Due to the water heater being covered with a insulating blanket, which was not removed we were unable to determine the general specification (age, manufacturer, capacity etc.). We recommend the blanket be removed if this information is desired by interested parties.

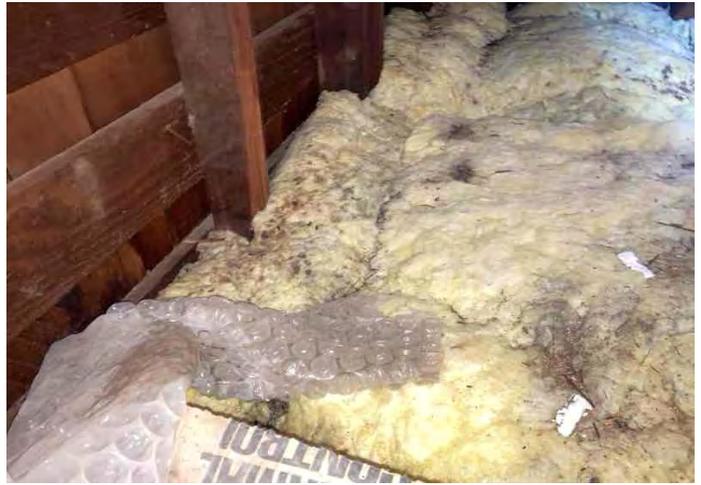
Photo 32

- ! 2. Evidence of vermin activity was observed within the structure. It is likely this evidence will extend into inaccessible areas. The owner is advised to contact the appropriate trade for further evaluation and remedial measures if necessary. (See Photo 32)

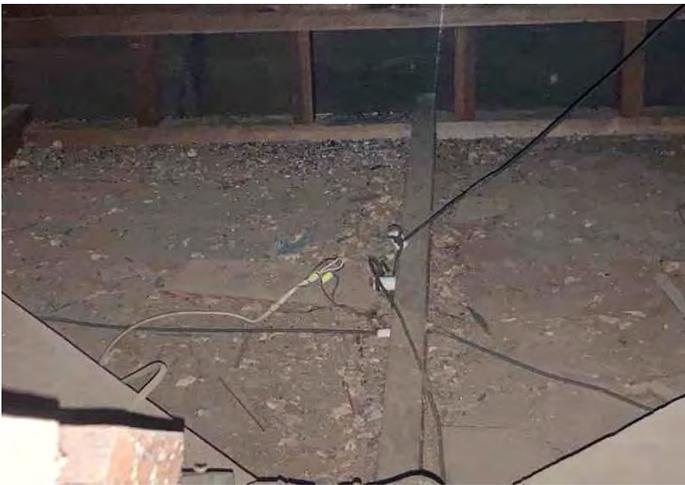
Photo 33

- ! 2. Running splices, which are improper connections outside of a junction box, were observed in the attic. We recommend connections be joined with approved connectors inside a junction box to prevent accidental contacts or mechanical damage. (See Photo 33) (See Photo 47)

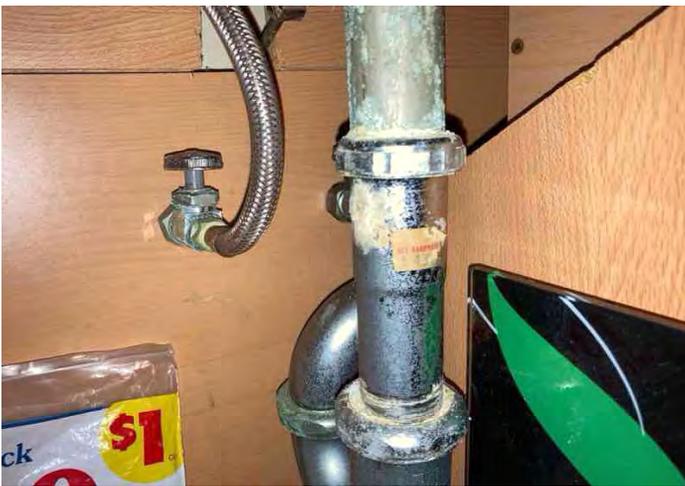
Photo 35

- ! 7. The plastic/metallic waste piping is leaking at the front bathroom toilet. We recommend all leaks be repaired. (See Photo 52)
 - ! 8. There is evidence of heavy corrosion and rust, but no leakage on the exterior of the exposed and accessible metal drain piping in the front bathroom. This piping should be monitored for leakage and repaired as necessary. Upgrading this piping and connections should also be considered. (See Photo 35)

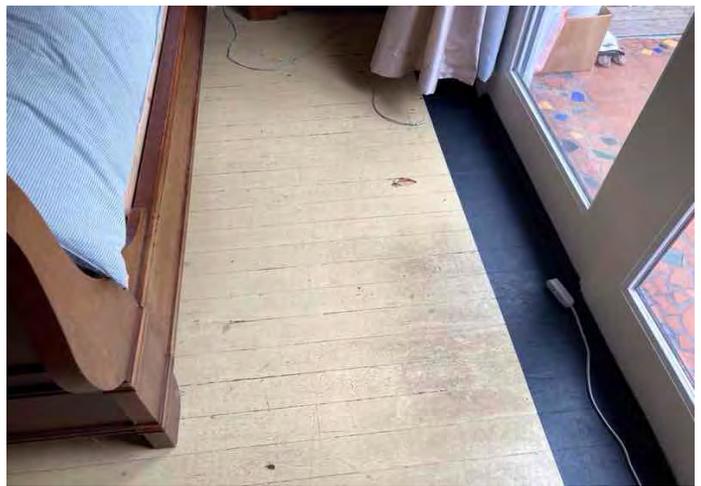
Photo 36

- ! 3. Minor water damage to the master bedroom hardwood flooring was observed. It is recommended that the source of the damage be identified and corrected, and the surface be repaired and refinished to restore its appearance. (See Photo 36)

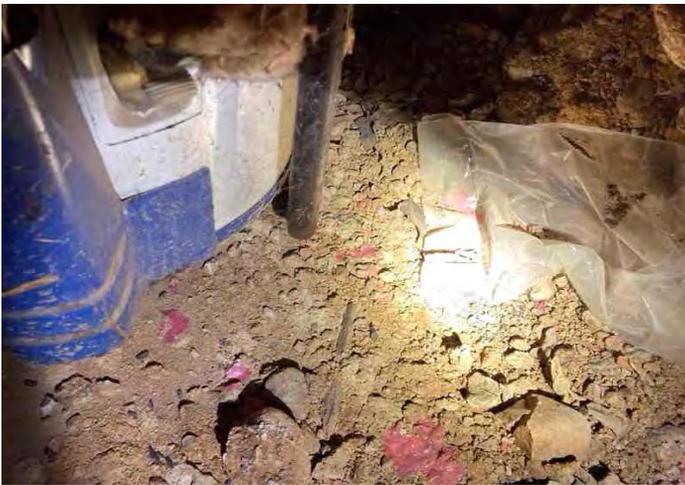
Photo 45

- ! 1. The temperature and pressure relief discharge pipe for the water heater is improper. We recommend the installation of a proper discharge pipe to an approved location. (See Photo 45)

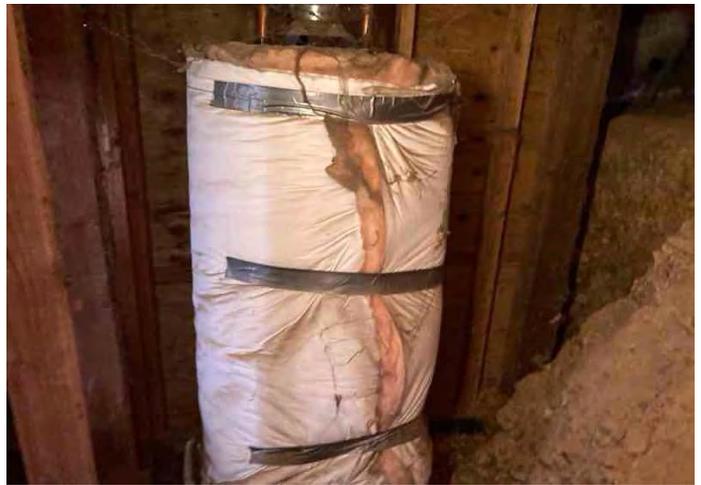
Photo 46

5. Straps should be secured to adjacent wall or stud and from opposing directions
 6. Straps should be secured to the wall or studs using 1/4" diameter by 3" long lag bolts with washers. (See Illustration 8E) (See Photo 46)

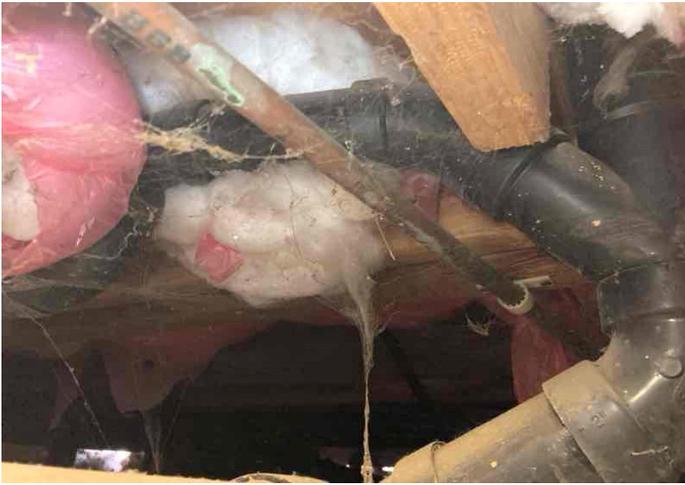
Photo 49

- ! 6. The drain system adjacent to the laundry area and master bathroom shower was improperly installed. We recommend the drains be reconfigured according to industry standards. (See Photo 49) (See Photo 51)

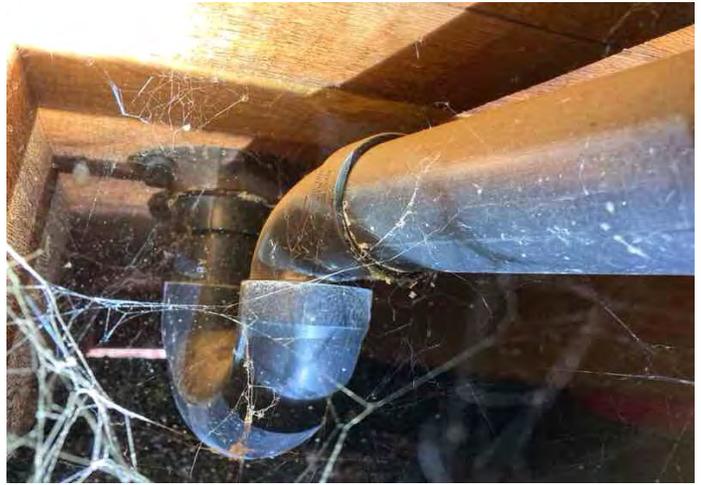
Photo 50

- ! 9. There is a cracked and leaking Plastic drain pipe at the front bathroom stall shower. This is a potential health hazard. We recommend the piping in question be repaired or replaced. (See Photo 50)

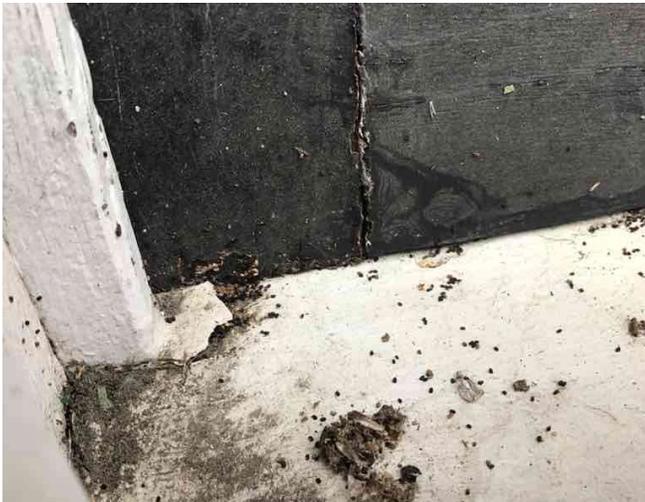
Photo 03

1S. FINDING: Infestation by Drywood Termites was noted at the exterior, interior. [\(See Photo 3\)](#) [\(See Photo 11\)](#) [\(See Photo 33\)](#)

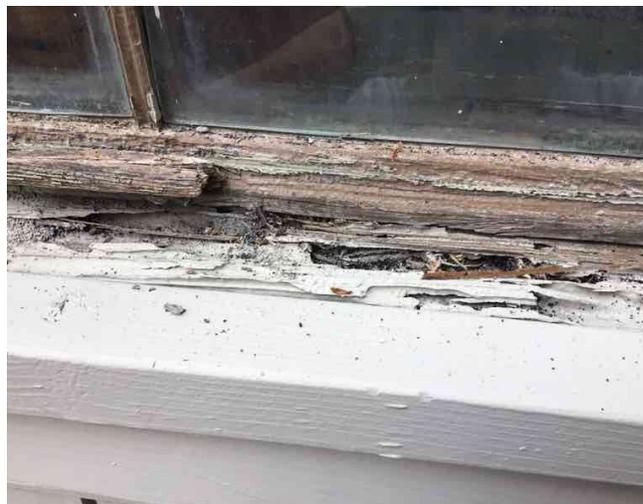
Photo 10

1H. FINDING: The window sill and trims have been damaged by drywood termites at the right side exterior as indicated on the diagram. Refer to item(s) 1S for recommendations to control contributing moisture source and or infestation. (See Photo 10) (See Photo 11)

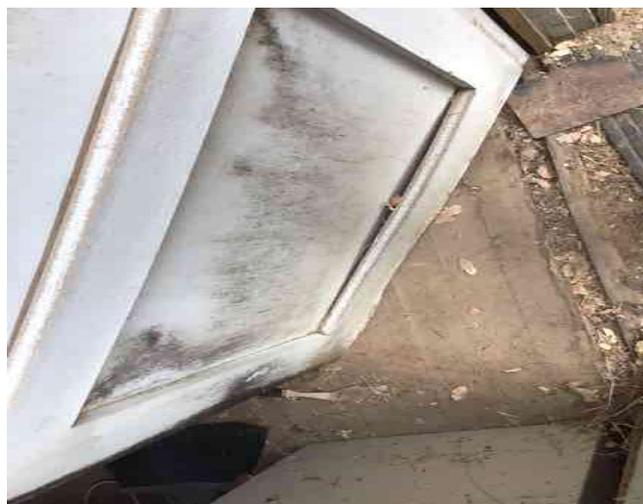
Photo 12

1I. FINDING: The storage closet door and jamb were found to be damaged by fungus and drywood termites. (See Photo 12) (See Photo 13) (See Photo 14)

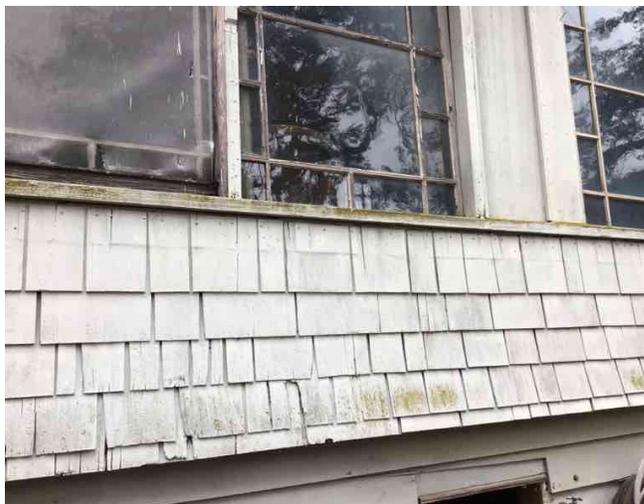
Photo 15

1J. FINDING: The wooden windows and window screens have been damaged by fungus. The contributing moisture source appears to be exposure to the weather. (See Photo 15) (See Photo 16) (See Photo 25)

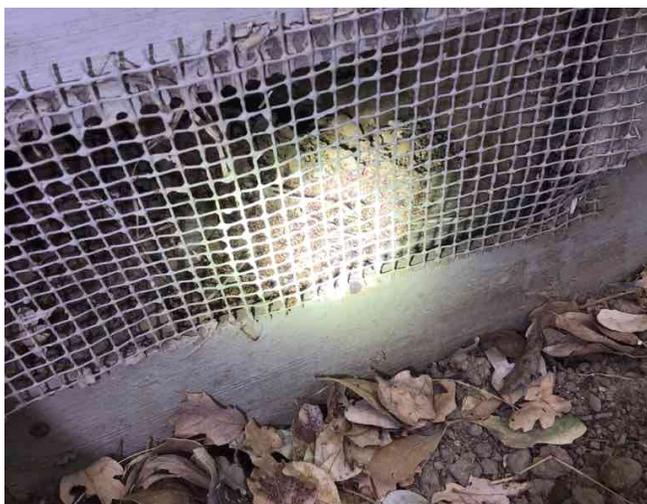
Photo 16

1A. FINDING: The siding has been damaged by fungus at the exterior as indicated on the diagram. The contributing moisture source appears to be exposure to the weather. [\(See Photo 1\)](#) [\(See Photo 16\)](#)

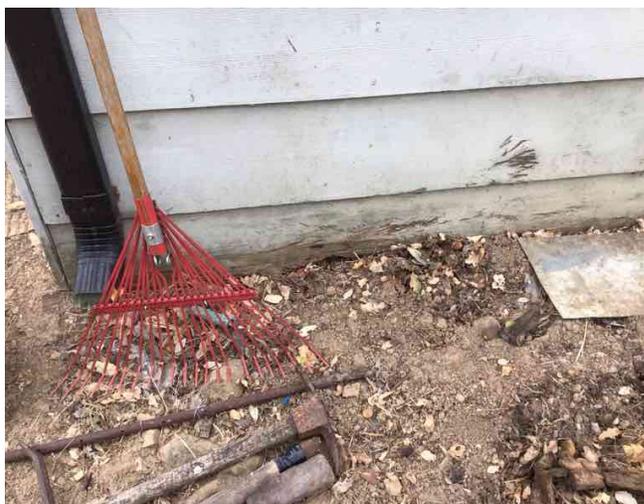
Photo 17

1L. FINDING: A portion of the structure at the downstairs storage closet appears to be a sleeper floor construction and was inaccessible for inspection. Visible fungus damage and drywood termite pellets were observed. (See Photo 17) (See Photo 20)

1T. FINDING: Drywood termite pellets were evident as noted in the above recommendation. [\(See Photo 3\)](#) [\(See Photo 17\)](#) [\(See Photo 33\)](#)

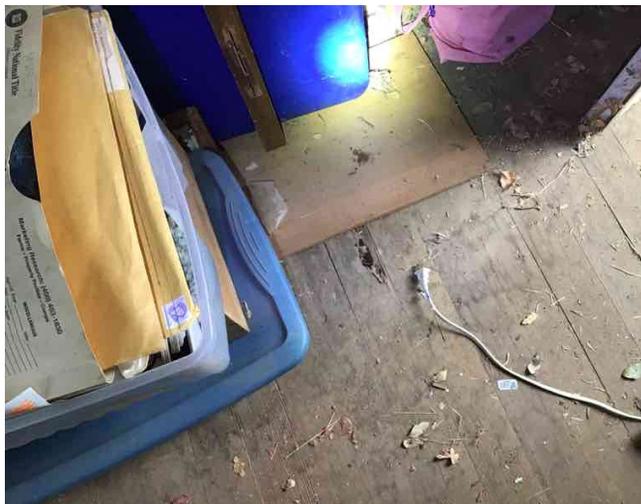
Photo 19

3B. FINDING: We were unable to inspect the interior of the upstairs and downstairs storage closets due to stored personal property. (See Photo 19) (See Photo 26) (See Photo 27)

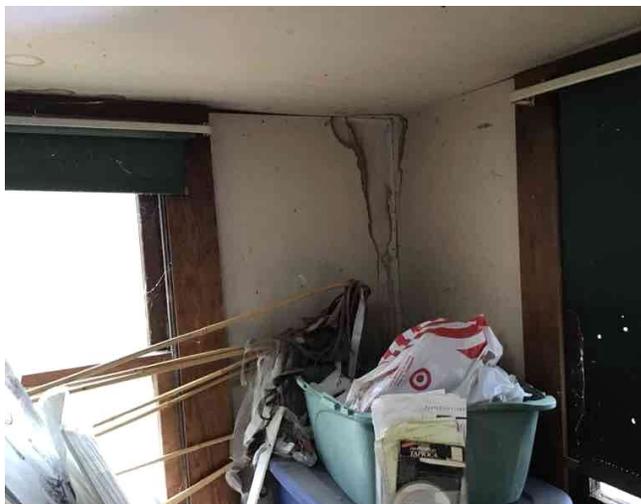
Photo 21

3A. FINDING: Water stains were noted on the ceiling in the downstairs storage closet. (See Photo 21) (See Photo 22) (See Photo 23)

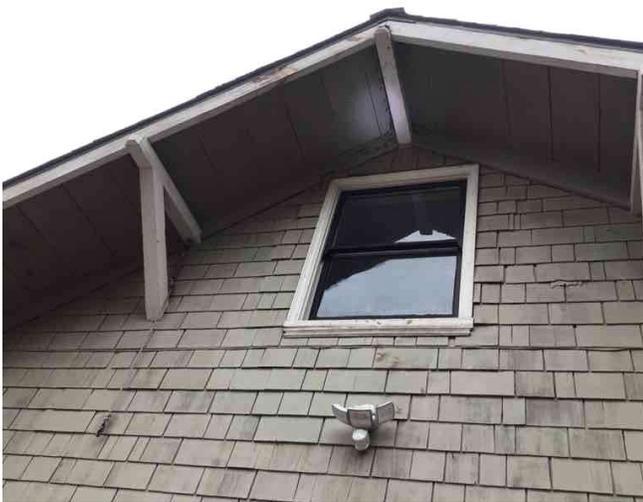
Photo 28

1M. FINDING: The roof sheathing has been damaged by carpenter bees where indicated on the diagram. (See Photo 28) (See Photo 29)

1V. FINDING: There is evidence of an infestation of Carpenter Bees at the left side sheathing and trims. [\(See Photo 28\)](#) [\(See Photo 29\)](#)

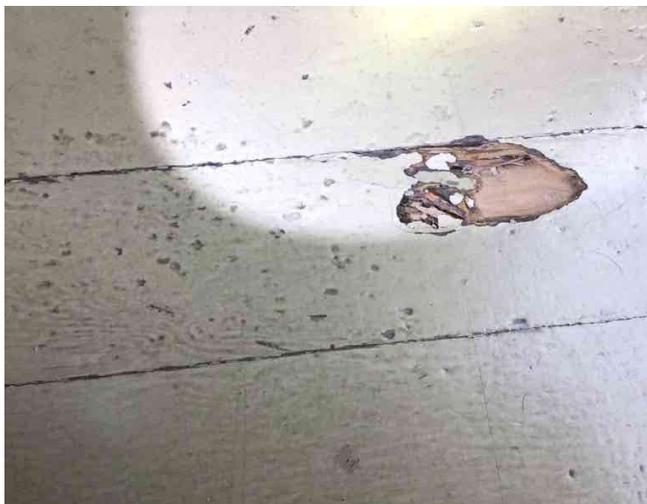
Photo 32

1W. FINDING: Water has gotten under the hardwood floor in the bathroom. This has caused fungus damage to the subfloor and hardwood floor. (See Photo 32)

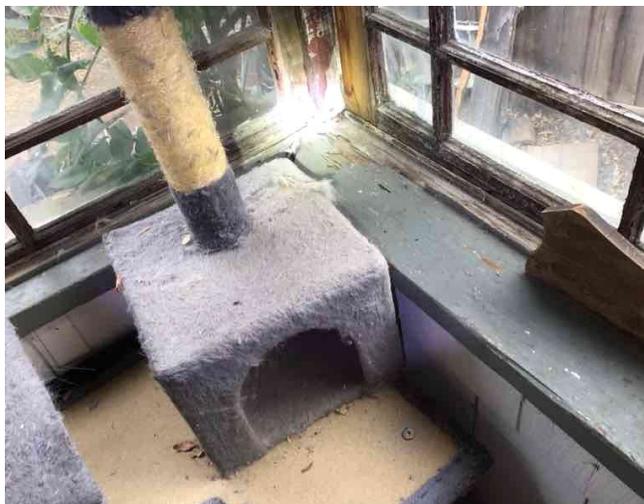
Photo 33

1P. FINDING: The hardwood flooring at the master bedroom adjacent to the French door has been damaged by drywood termites. Refer to item(s) 1S for recommendations to control contributing moisture source and or infestation (See Photo 33)

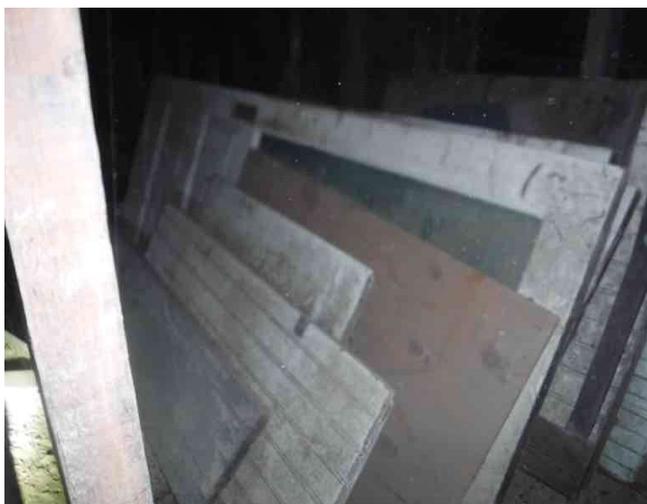
Photo 34

1Q. FINDING: The trim has been damaged by drywood termites at the interior sunroom as indicated on the diagram. Refer to item(s) 1S for recommendations to control contributing moisture source and or infestation. (See Photo 34)

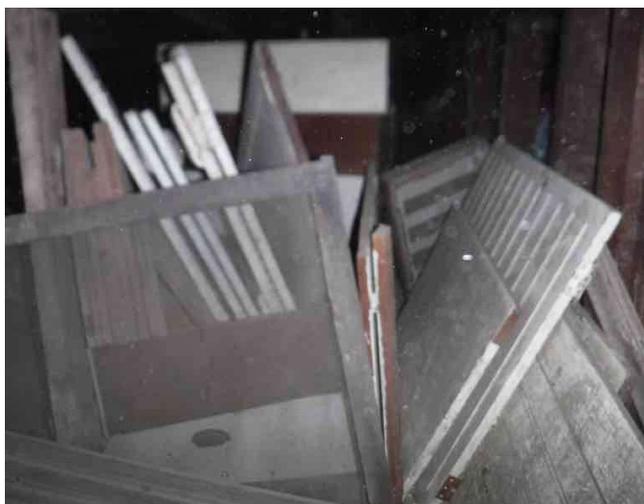
Photo 35

3C. FINDING: Portions of the subarea were inaccessible for inspection due to storage. (See Photo 36) (See Photo 35)

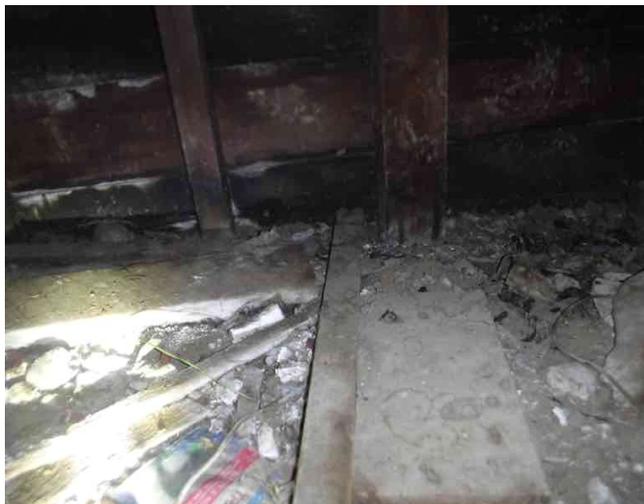
Photo 37

3D. FINDING: The subfloor was insulated; however, no outward infections or infestations were noted at this time. Further inspection is recommended. (See Photo 37)

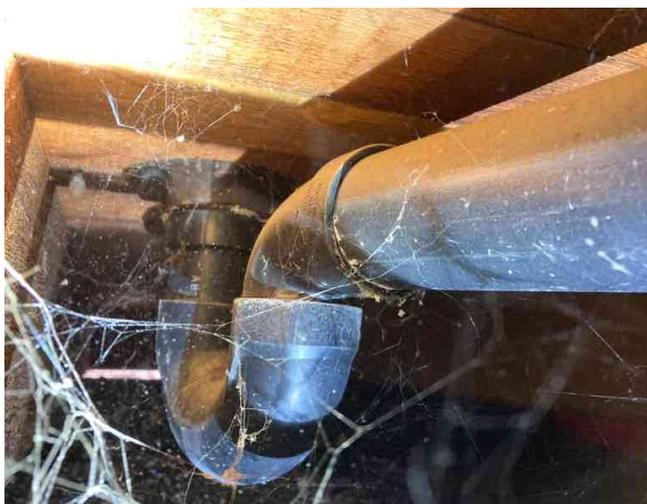
Photo 40

1R. FINDING: There is a plumbing leak at the front hall bathroom toilet and shower drain. This led to the damage outlined in item 1W. [\(See Photo 40\)](#) [\(See Photo 41\)](#)
